Fort Barrancas

Guide to Fort Barrancas

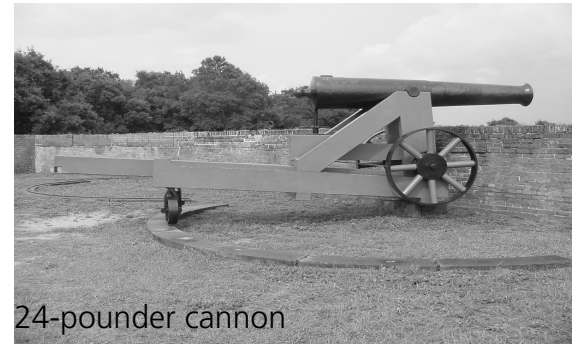
24-pounder cannon

9. Parade: The center of the fort held a hot shot furnace where cannonballs were heated for firing at wooden sailing ships. In 1845 the armament of Fort Barrancas was: ten 24-pounders (pdrs), two 8-inch howitzers, five 18-pdrs, three 12-pdrs, one 8-inch mortar, two coehorn mortars, two 6-pdrs, a 12-pdr on a field carriage, plus eight 24-pdr flank howitzers in the counterscarp. In the water battery there were eleven 32-pdrs, two 8-inch seacoast howitzers, and two 10-inch mortars.
