# Status of Climate and Water Resources at Guadalupe Mountains National Park

*Water Year 2018*

Natural Resource Report NPS/CHDN/NRR—2020/2132

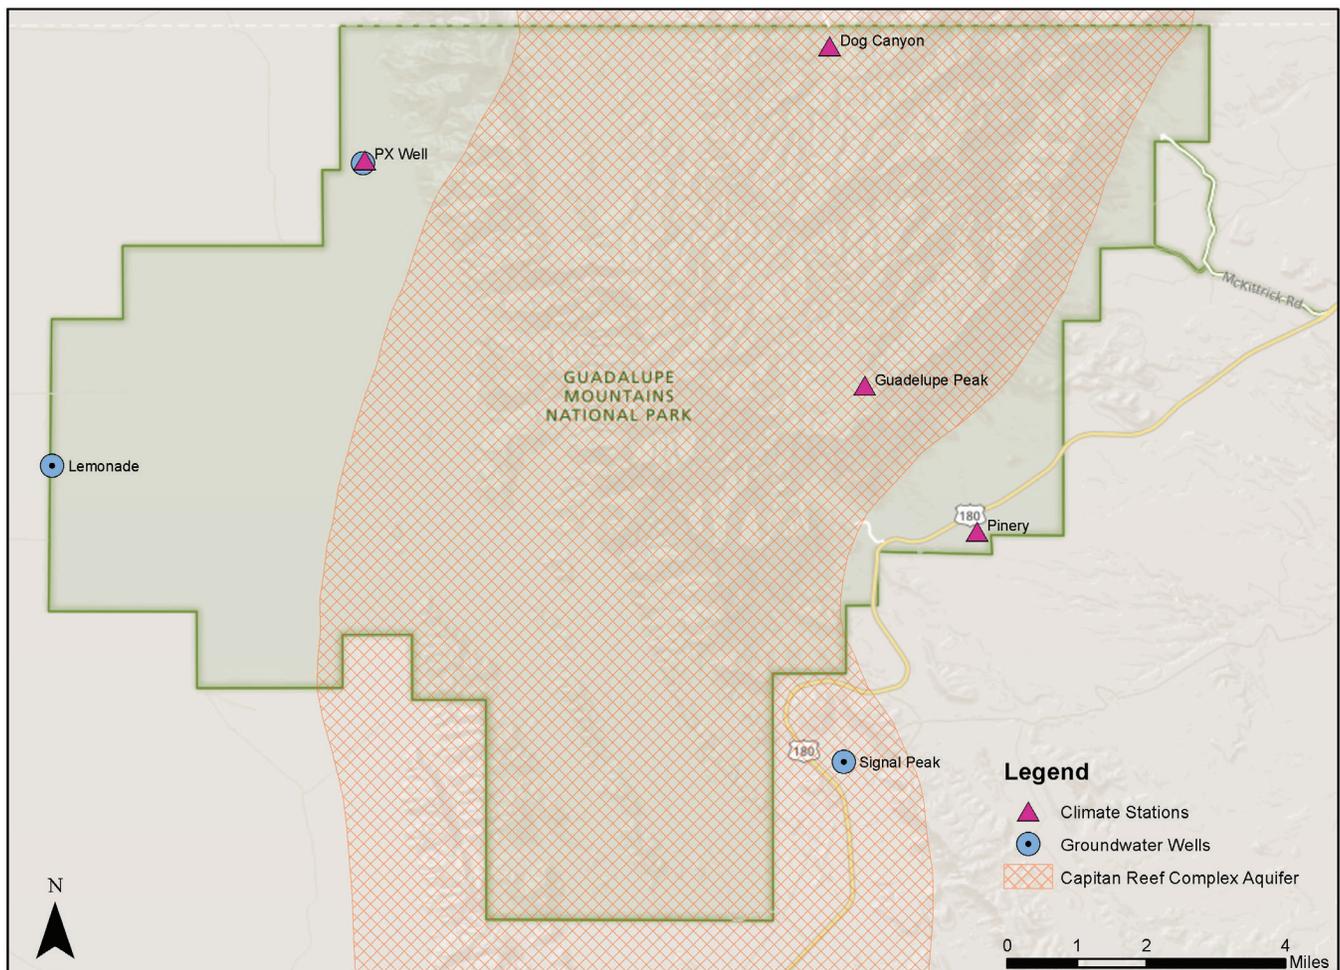
Figure 2-1. Climate stations and monitoring groundwater monitoring wells at Guadalupe Mountains National Park

Guadalupe Mountains NP has four Remote Automated Weather Stations (RAWS) (Figure 2-1). The Guadalupe (sic) Peak RAWS (GDBT2) is at an elevation of 7,755 ft (2,364 m) and has been in operation since 2003. The Dog Canyon RAWS (DGCT2) is at 6,262 ft (1910 m) and has been in operation since 2010. The Pinery RAWS (PSGT2) is at 5,381 ft (1,640 m) and has been in operation since 2001. The PX Well RAWS is at 3,873 ft (1,180 m) and has been in operation since 2010. The station data were obtained from [Climate Analyzer](#) (Walking Shadow Ecology 2019a; 2019b; 2019c; 2019d), a website that allows users to make on-demand tables and graphs with data from weather stations that are updated daily (Walking Shadow Ecology 2019e). Previously, the National Park Service operated two National Oceanic and Atmospheric Administration (NOAA) Cooperative Observer Program (COOP)

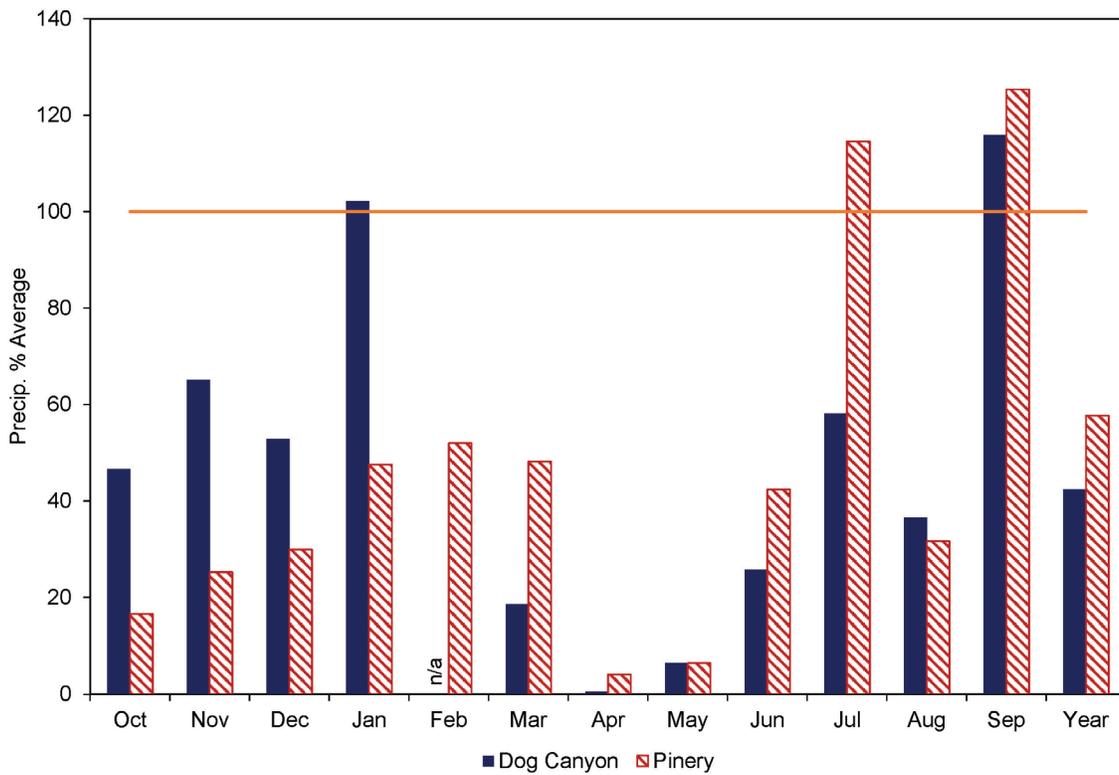
Figure 2-2. Departures from 30-year (1981–2010) normal monthly precipitation at the Dog Canyon and Pinery RAWs, Guadalupe Mountains NP, water year 2018 (October 2017–September 2018). “n/a” = insufficient data to generate reliable data.

Overall, annual precipitation in WY2018 was below normal for Guadalupe Mountains NP: 58% of normal for Pinery (10.37 in vs. 17.97 in) and 42% of normal for Dog Canyon (8.99 in vs. 21.24 in). Precipitation at Dog Canyon is likely underrepresented due to missing data.

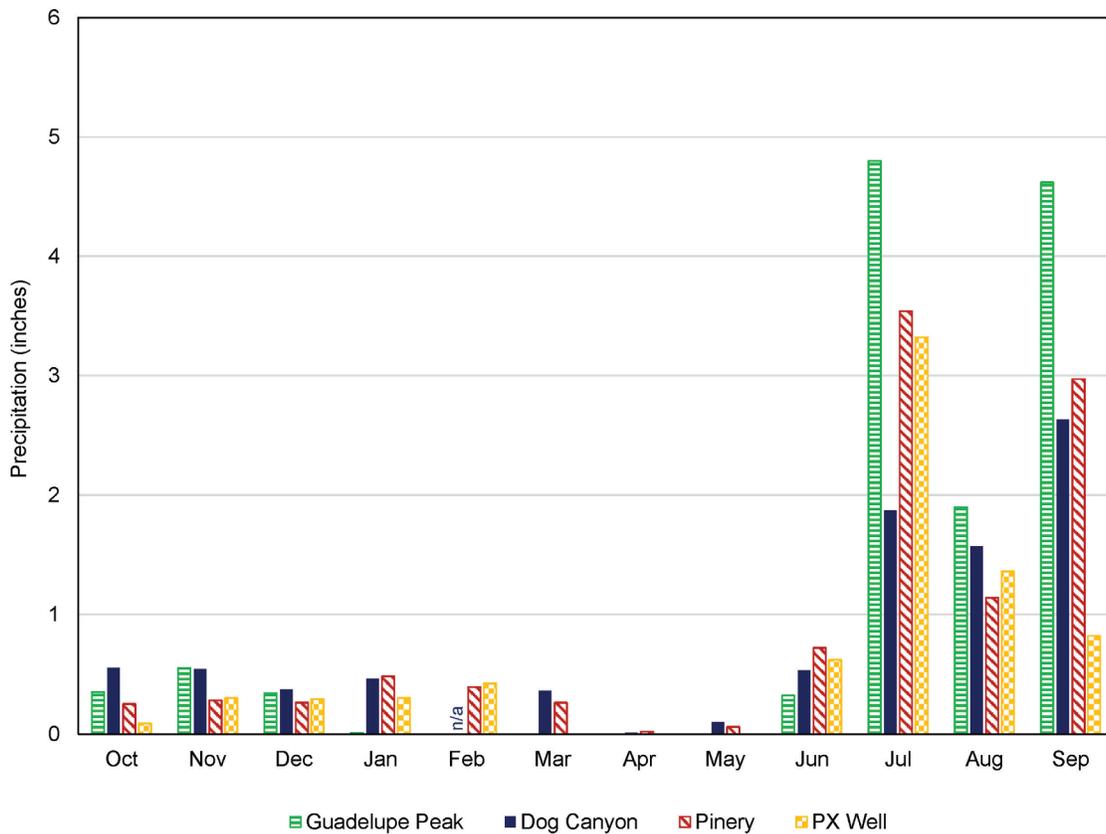
Figure 2-3. Monthly precipitation for Guadalupe Mountains NP, water year 2018 (October 2017–September 2018). “n/a” = insufficient data to generate reliable data.

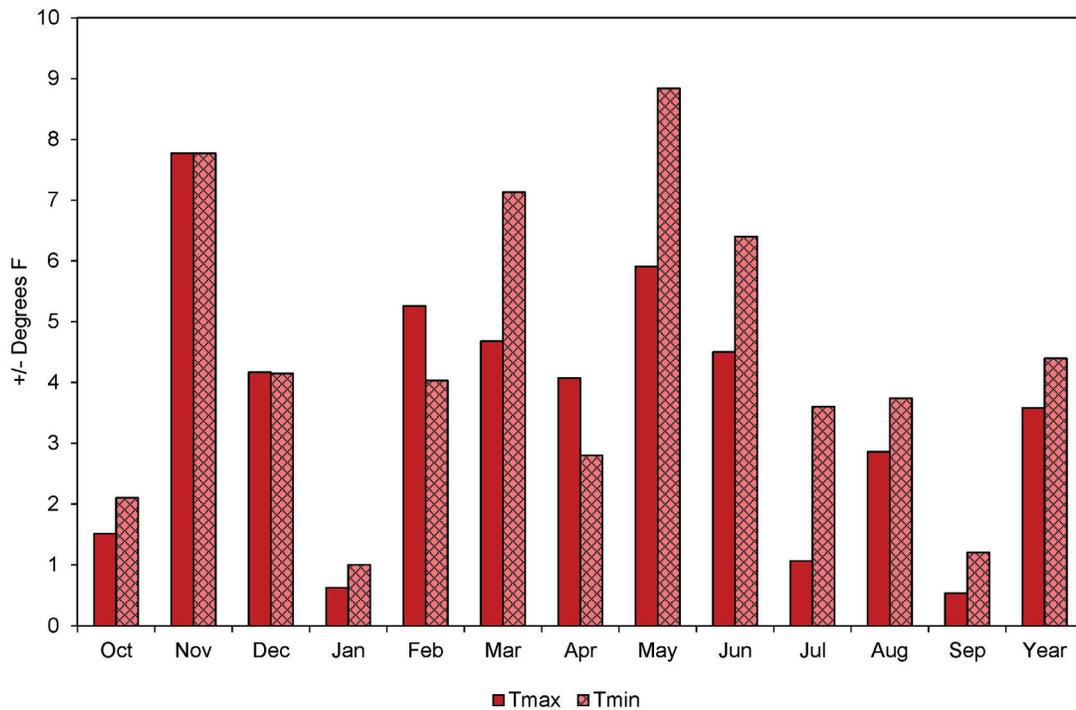
Figure 2-4. Departures from 30-year (1981–2010) normal monthly minimum and maximum air temperatures at the Pinery climate station, Guadalupe Mountains NP, water year 2018 (October 2017–September 2018).

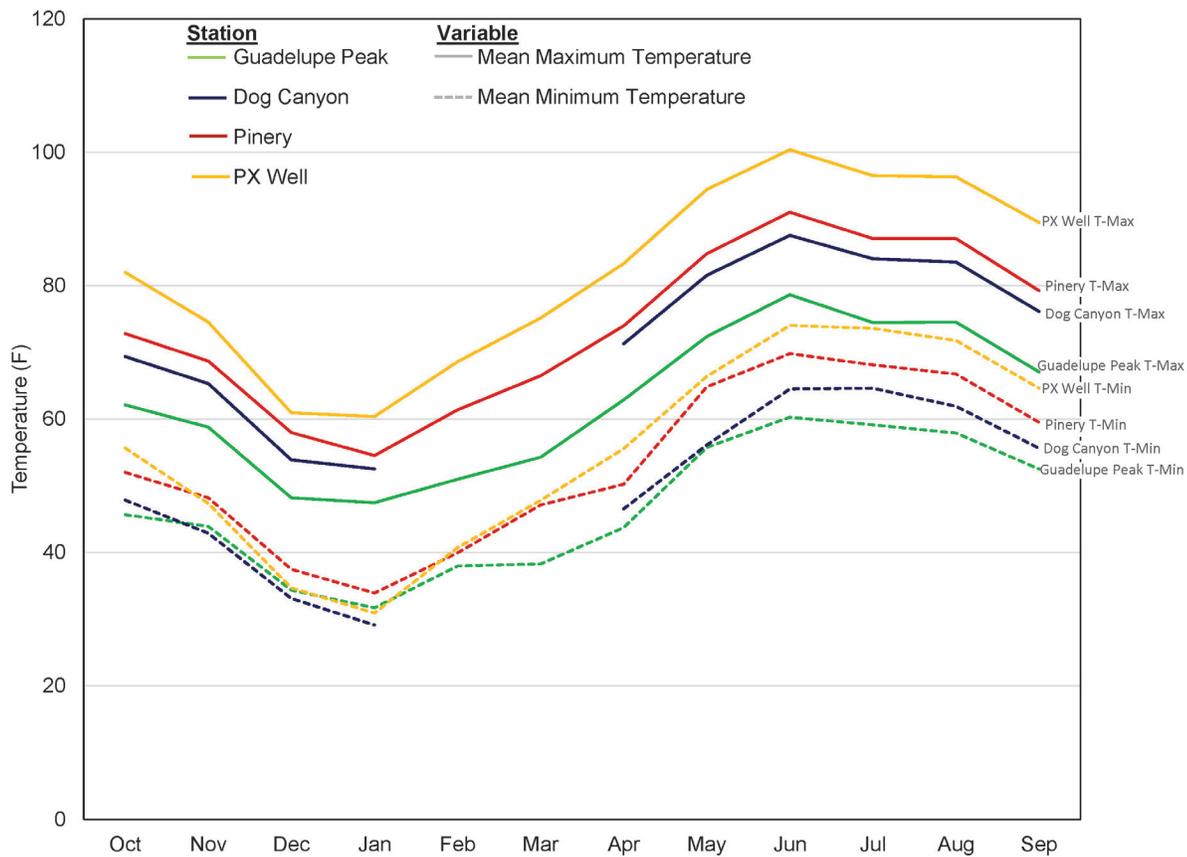
Figure 2-5. Mean monthly minimum and maximum air temperatures for Guadalupe Mountains NP, water year 2018 (October 2017–September 2018).

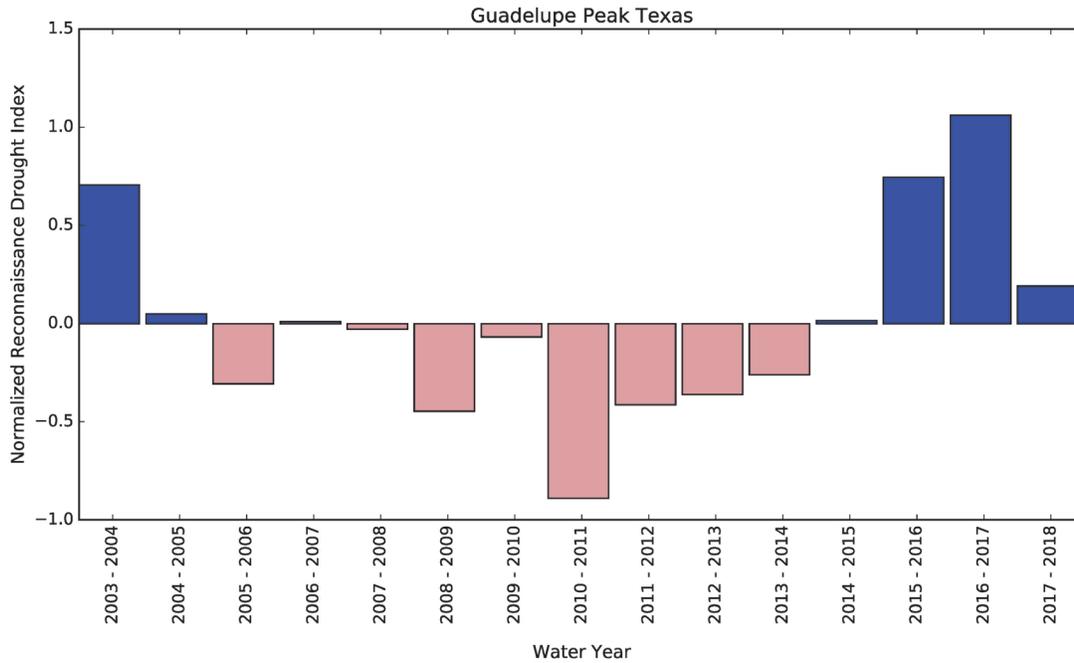
Figure 2-6. Reconnaissance drought index (RDI), Guadalupe (sic) Peak RAWS, Guadalupe Mountains NP, water years 2004–2018. Graphic generated by [climateanalyzer.org](http://climateanalyzer.org) (Walking Shadow Ecology 2019a).

Reconnaissance drought index (RDI; Tsakiris and Vangelis 2005) provides a measure of drought severity and extent relative to the long-term climate based on the ratio of average precipitation to average potential evapotranspiration over shorter periods of time (seasons to years). The RDI at the Guadalupe Peak RAWS indicated that WY2018 was the fourth consecutive year with wetter conditions compared to the average for WY2004 through WY2018 (Figure 2-6). The RDI at the Pinery RAWS indicated drier conditions in WY2018 based on the average for WY2002 through WY2018 from the perspective of precipitation and evaporative demand (Figure 2-7). The RDI was not calculated for the Dog Canyon RAWS and PX Well RAWS due to their limited monitoring record.

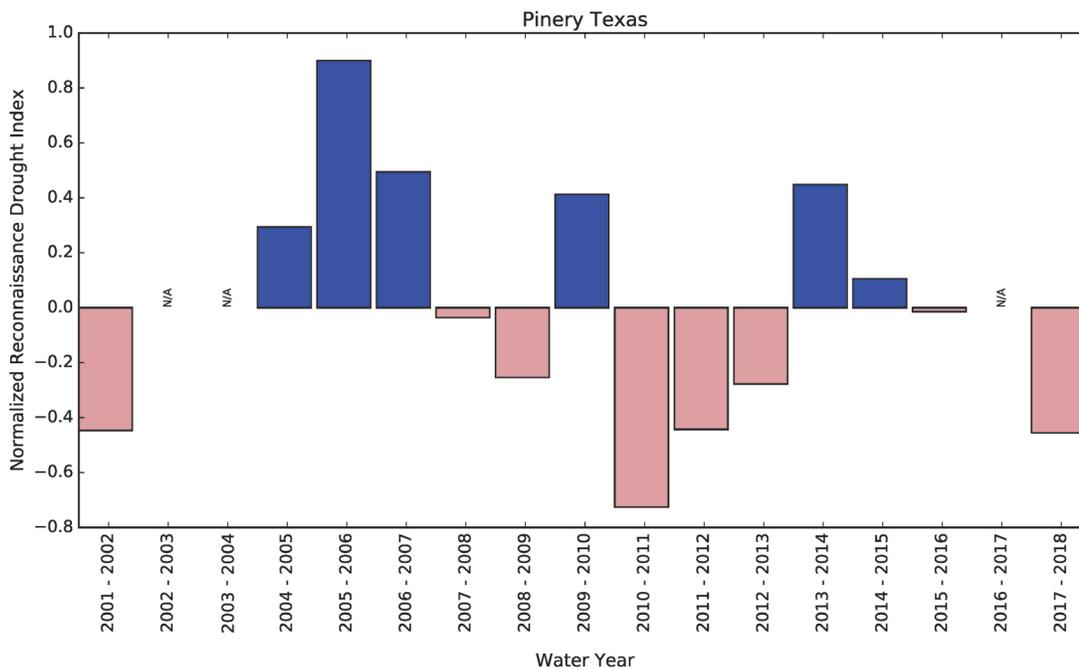
Figure 2-7. Reconnaissance drought index (RDI), Pinery RAWS, Guadalupe Mountains NP, water years 2002–2018. “n/a” = insufficient data to generate reliable data. Graphic generated by [climateanalyzer.org](http://climateanalyzer.org) (Walking Shadow Ecology 2019c).

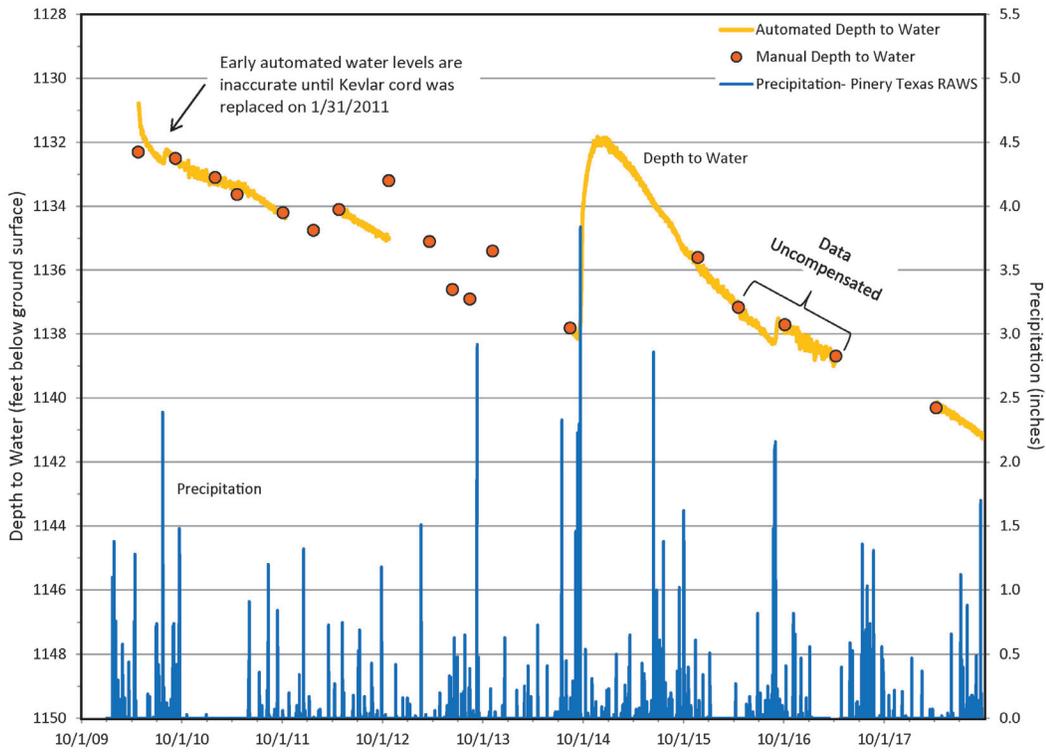
**Figure 3-1. Depth to water below ground surface (bgs) at Signal Peak Well with daily precipitation from the Pinery RAWS, water years 2010–2018, Guadalupe Mountains NP**

Monitoring equipment was replaced at three groundwater wells in April 2018. Signal Peak Well water level was 1141.22 ft below ground surface (bgs) at the end of WY2018, indicating a decline of 8.92 ft since monitoring began in WY2010, and 11.32 ft since the well was installed in 1978. Lemonade Well water level was 29.22 ft bgs at the end of WY2017, 0.54 ft lower than in WY2017. Lemonade Well water level has been relatively stable over the monitoring period, except when nearby pumping or leaking pipes temporarily impacted groundwater levels. PX Well water level was 278.98 ft bgs at the end of WY2018, indicating a decline of 4.91 ft since monitoring began in WY2010.

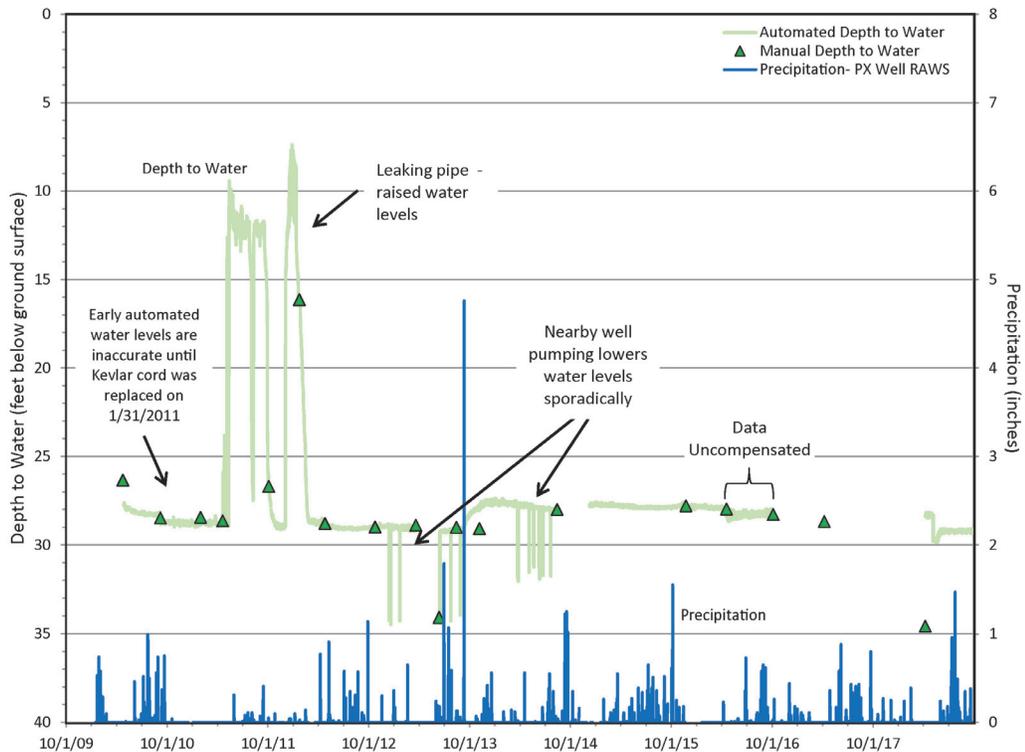
**Figure 3-2. Depth to water below ground surface (bgs) at Lemonade Well with daily precipitation from the PX Well RAWS, water years 2010–2018, Guadalupe Mountains NP**

Depth to water at Lemonade Well on April 9, 2018, was 28.38 ft bgs (Figure 3-2). In May, the water level dropped approximately 1.4 ft and then increased 0.5 ft. This step down and step up is unusual in the record and its cause is unclear. However, from June to the end of WY2018, the water level remained

relatively static, ending at 29.22 ft bgs, 0.54 ft lower than the manual measurement in WY2017. The water level in Lemonade Well has been variable over the monitoring record due to nearby groundwater pumping and leaking pipes (C. Filippone, pers. comm.). However, excluding these periods, water levels have been relatively static, only varying within a range of approximately 1.5 ft. The largest increase occurred in September and October 2013 following a 4.76-in rain event recorded at the PX Well RAWS.

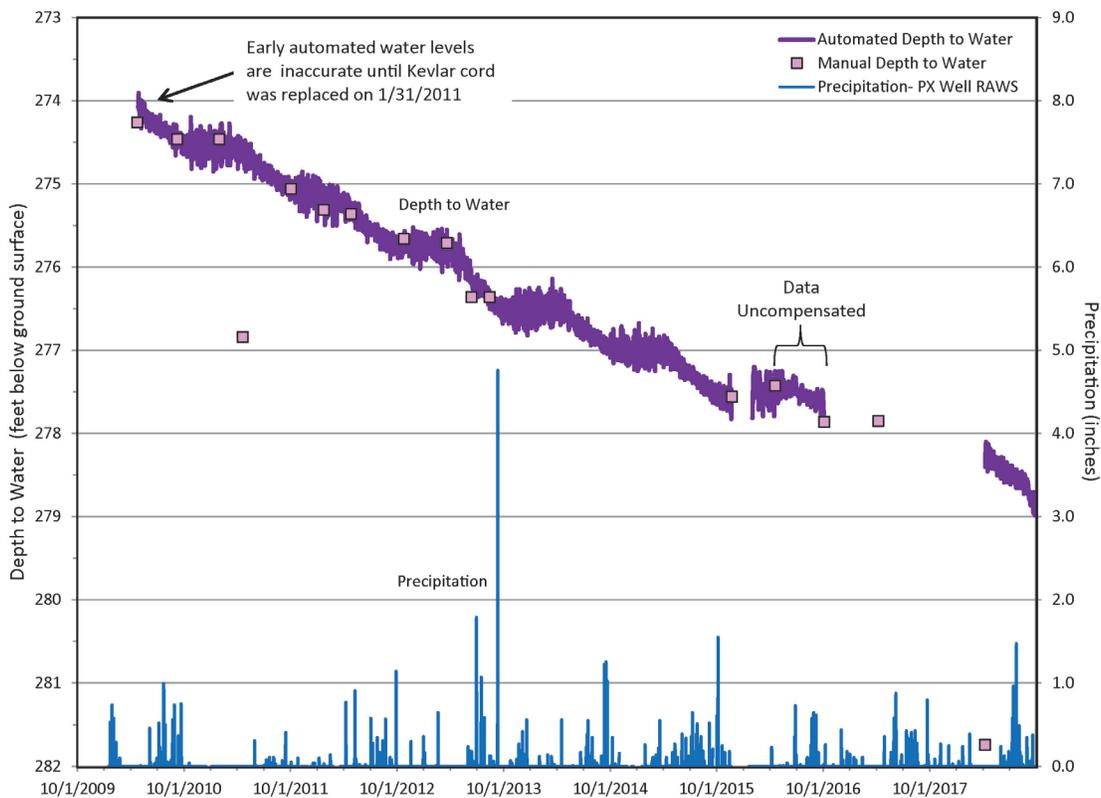
**Figure 3-3. Depth to water below ground surface (bgs) at PX Well with daily precipitation from the PX Well RAWs, water years 2010–2018, Guadalupe Mountains NP**

Depth to water at PX Well on April 9, 2018, was 278.40 ft bgs (Figure 3-3). Water level continued to decline throughout the rest of WY2018, with the lowest water level of the monitoring record on September 26, 2018, at 278.98 ft bgs. This indicates a net decline of 4.91 ft since monitoring began in WY2010. Water levels in PX Well demonstrate seasonal variability: stable or slightly increasing water levels in fall and winter, followed by declining water levels in spring and summer, creating an overall downward trend.

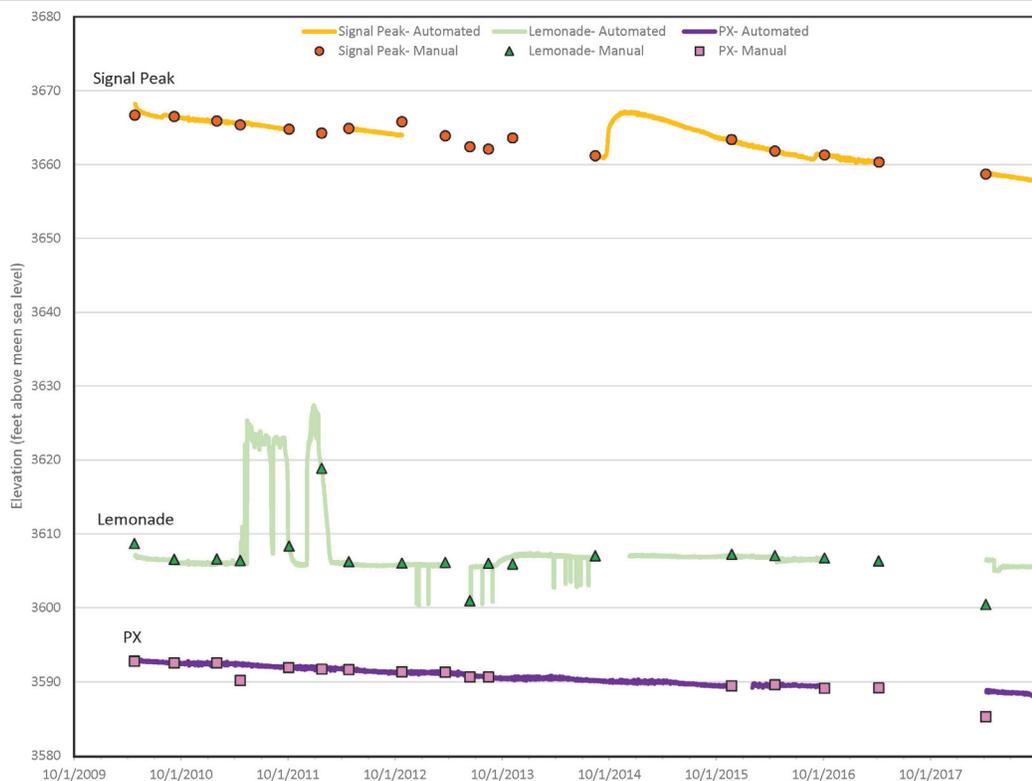
**Figure 3-4. Water level elevation at three groundwater monitoring wells, water years 2010–2018, Guadalupe Mountains NP**

Water level in the three wells were within 80 ft of elevation for the entire monitoring period (Figure 3-4). The aquifers that the three wells are completed in are hydraulically connected, but they also show localized responses to withdrawals and recharge, as observed in Lemonade and Signal Peak wells.

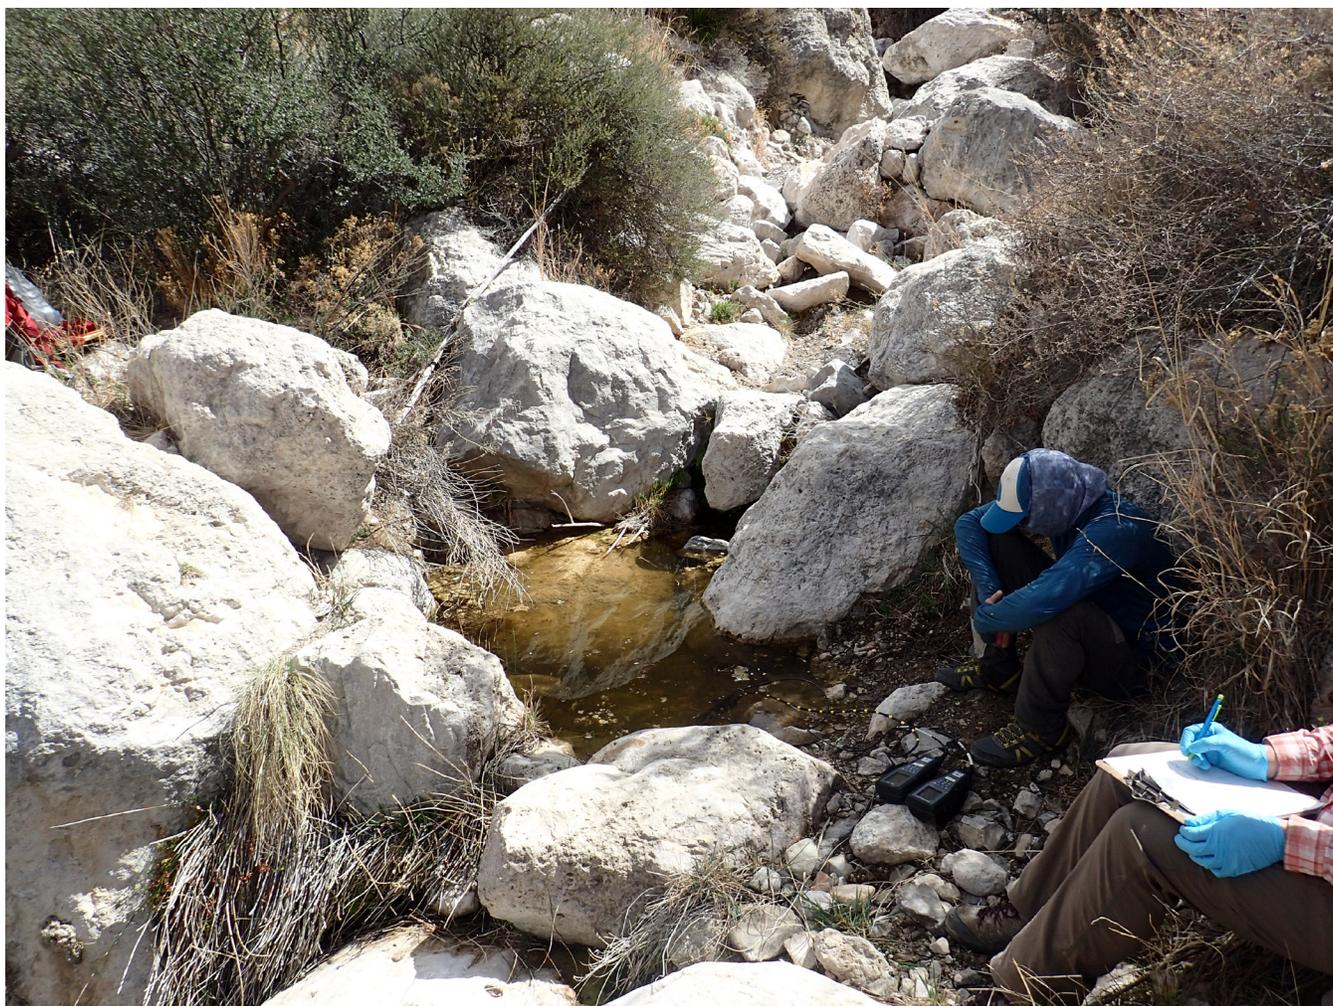
Figure 4-1. Bone Spring orifice, Guadalupe Mountains NP, March 2018

Bone Spring (Figure 4-1) is a rheocrene spring (a spring that emerges as a flowing stream) in a larger drainage. It was visited on March 24, 2018. The spring emerges between two medium boulders as a small trickle among maidenhair ferns (*Adiantum* sp). The cool and clear flow spills into a plunge pool, the first of many interspersed along the springbrook (of which the first 100 m (328 ft) were measured per the protocol). Most of the pools range from a surface area of 2 m<sup>2</sup> (21.5 ft<sup>2</sup>) to 4 m<sup>2</sup> (43.1 ft<sup>2</sup>) and a depth of 0.5 m (1.6 ft) to 1.0 m (3.3 ft). The substrate is dominated

by boulders with gravel deposits present in flatter sections of the system. Some areas of the springbrook are incised and there is evidence that runoff events in the drainage affect the overall system.

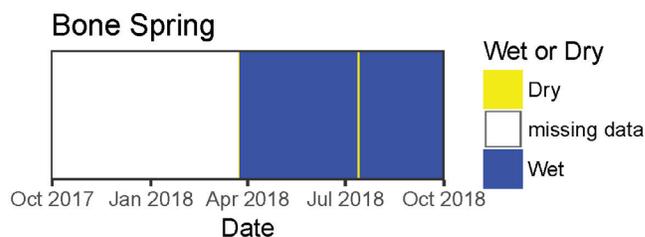
Figure 4-2. Estimated wet/dry days at Bone Spring, Guadalupe Mountains NP, WY2018

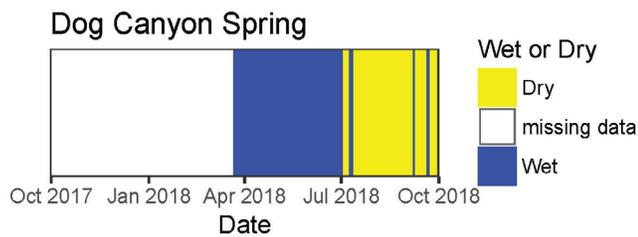
Figure 4-3. Estimated wet/dry days at Dog Canyon Spring, Guadalupe Mountains NP, WY2018

Temperature sensors indicated that the spring was wetted until early July and was generally dry for the remainder of the water year (Figure 4-3). The sensor was found approximately 0.3 m (1 ft) above the water in 2019, and the dry readings in the last quarter of WY2018 may not represent actual conditions. Sensors were not deployed in 2017 and there are no data available from October 2017 to March 2018. Discharge was not measurable in this limnocrene system. Due to the inaccessibility of the pool, the crew measured a single length and width to roughly estimate the size of this rectangular pool: length was 288 cm (9.4 ft) and width was 350 cm (11.5 ft).

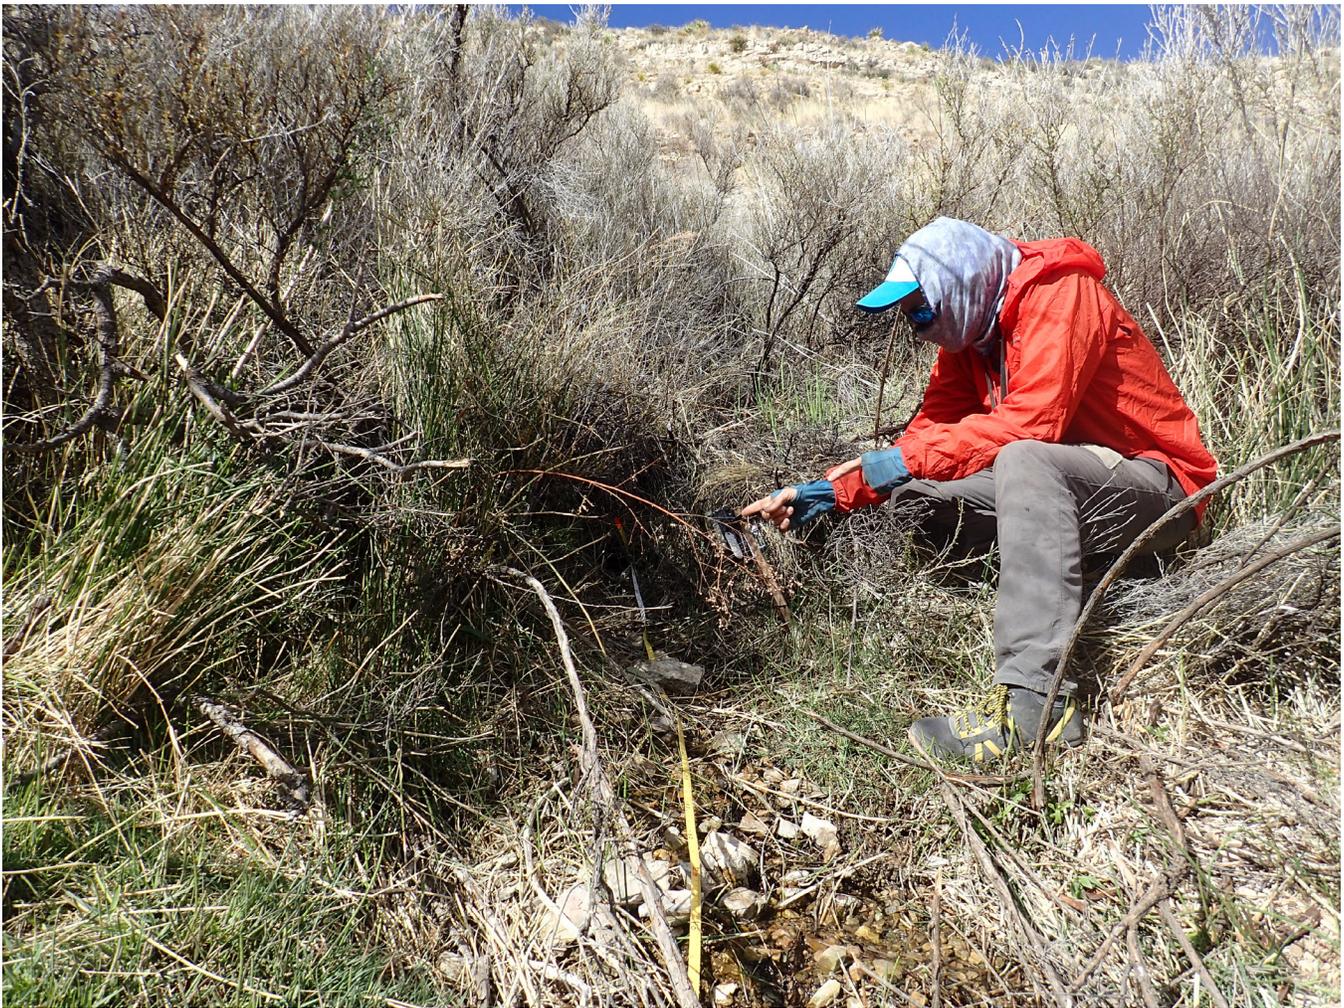
Figure 4-4. Guadalupe Spring orifice A, Guadalupe Mountains NP, March 2018

The crew visited Guadalupe Spring (Figure 4-4), a rheocrene spring, on March 23, 2018. The spring emerges as a trickle underneath a dense patch of Apache plume (*Fallugia paradoxa*). This trickle

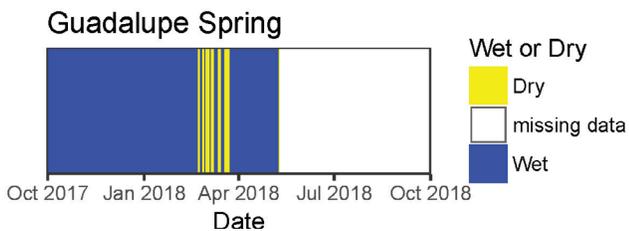
Figure 4-5. Estimated wet/dry days at Guadalupe Spring, Guadalupe Mountains NP, WY2018

Temperature sensors indicated that the spring was wetted for the majority of the sampled interval (October 2017–May 2018) with drying events in the spring (Figure 4-5). Data from the latter half of the year are missing due to sensor failure. Discharge from orifice A was estimated at  $19.9 \pm 0.4$  L/min ( $5.3 \pm 0.1$  L/min). The channel length was not measured but was estimated to be 200–500 m (656–1640 ft). The first 100 m (328 ft) had a mean wetted width of 76.6 cm (2.5 ft) and mean depth of 1.8 cm (0.1 ft).

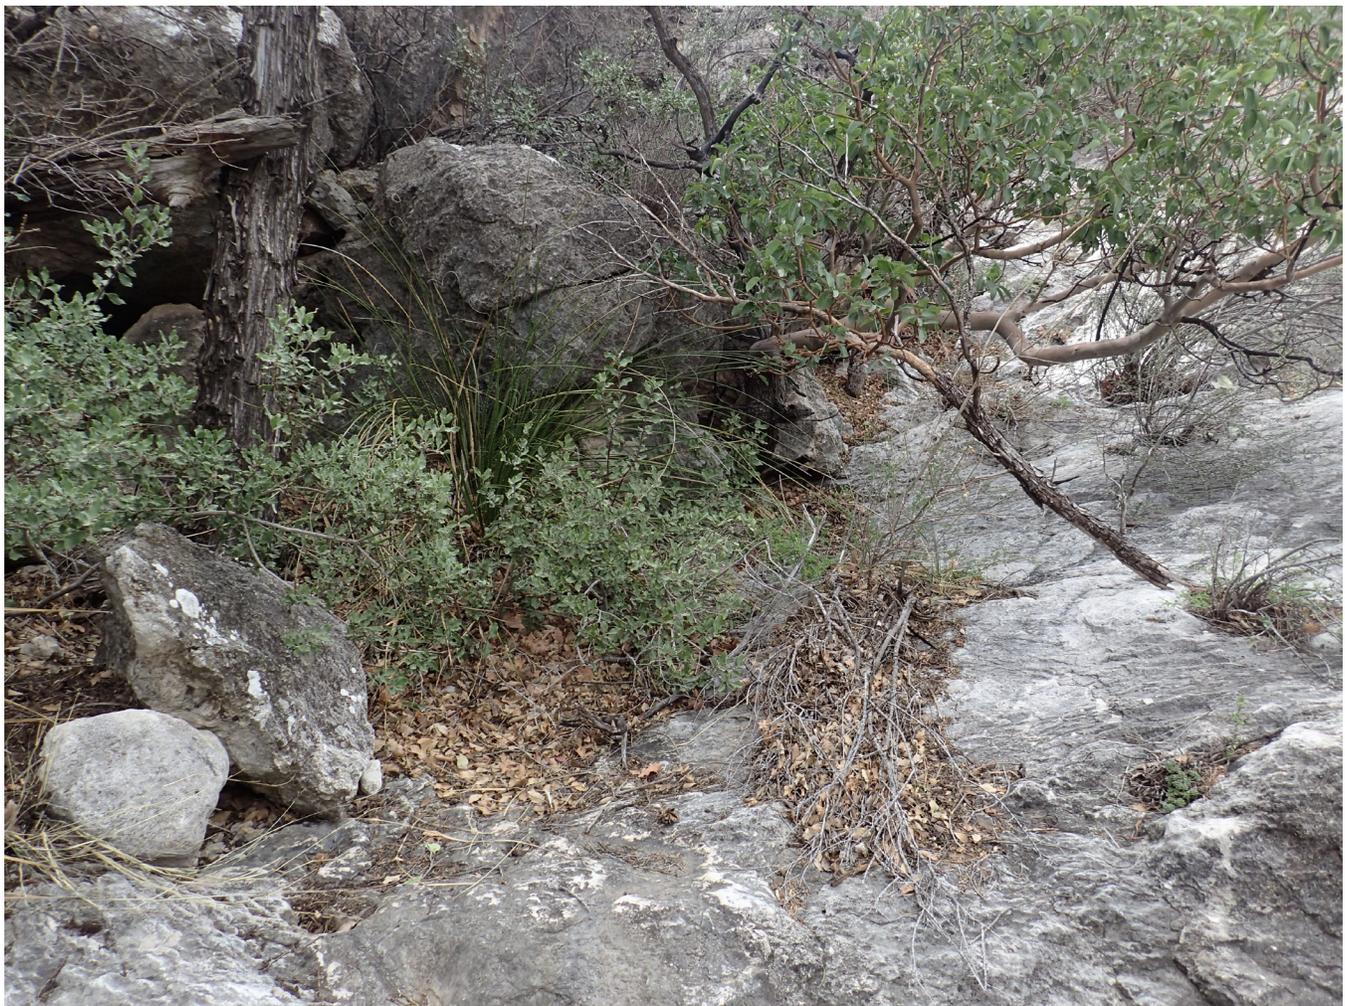
Figure 4-6. Sharp Rock Spring orifice, Guadalupe Mountains NP, March 2018

At the time of the visit on March 25, 2018, the spring orifice was completely dry, as was most of the downstream channel (Figure 4-6). A few small depressions in the bedrock contained water and leaf litter, but it is unclear if this was from rain the

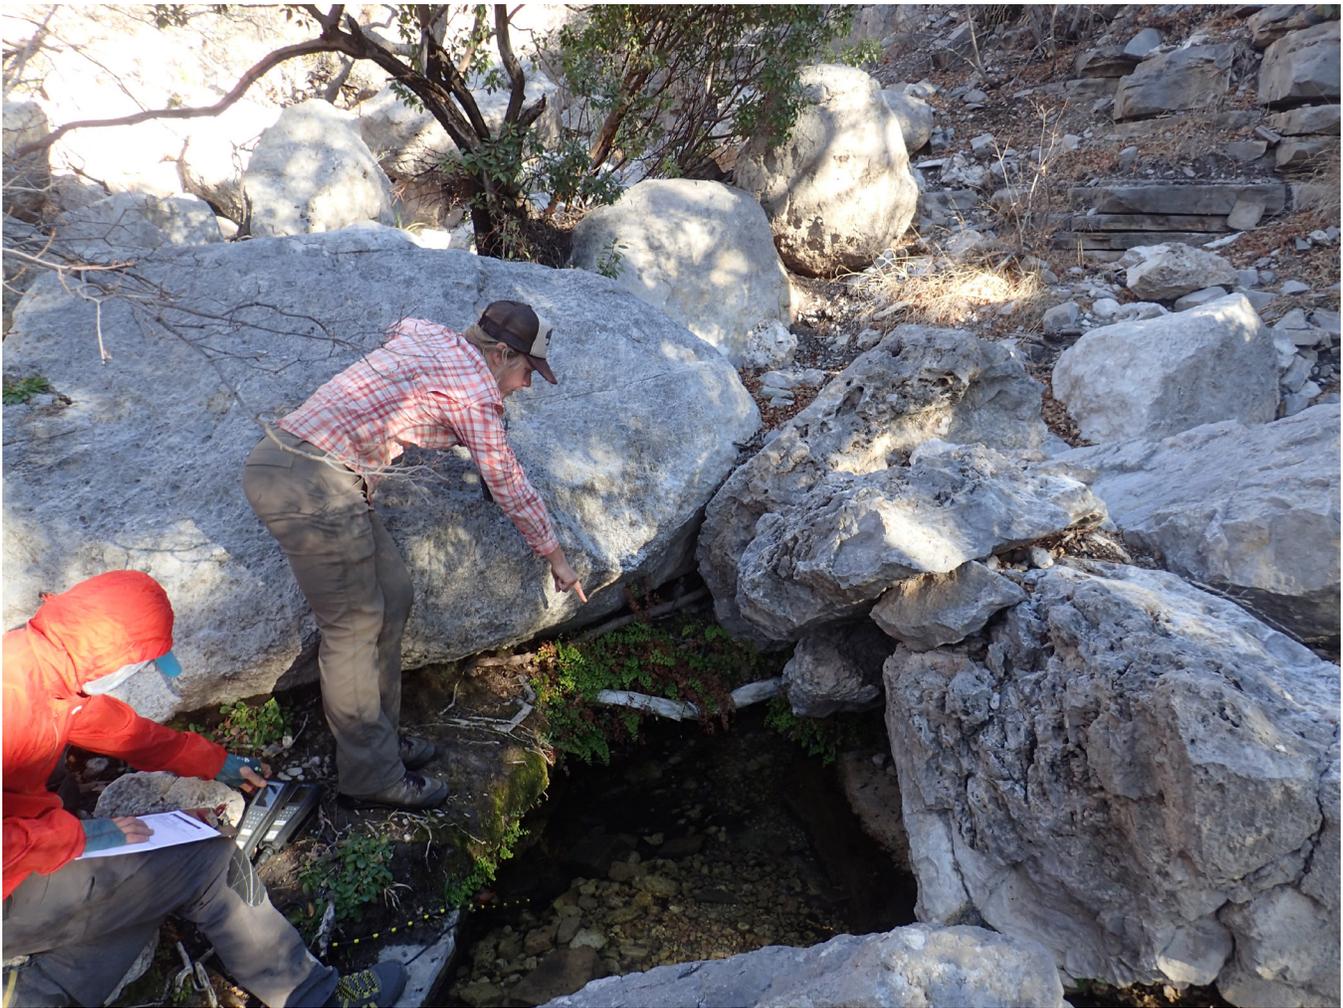
**Figure 4-7. Smith Spring orifice A, Guadalupe Mountains NP, March 2018**

Smith Spring (Figure 4-7) was classified as a rheocrene spring on March 25, 2018. The spring emerges from a boulder pile within an oak- and madrone-forested drainage. Orifice A creates a cool and clear pool. Orifice B emerges from a scoured channel as a shallow flow. These orifices combine to create a mostly straight-running stream characterized by a pool and drop profile. The cool and clear flow is limited to the channel and pools, which are lined with large boulders and occasional eroded banks stabilized by tree roots. Downstream, the channel narrows to 20–30 cm (0.65–0.98 ft) into a chute that spills into

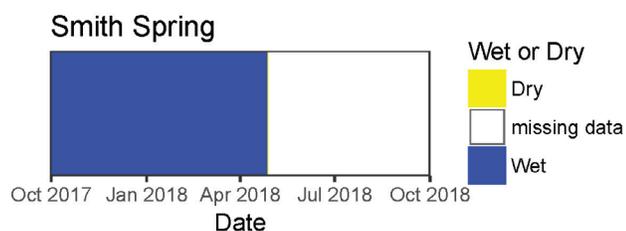
Figure 4-8. Estimated wet/dry days at Smith Spring, Guadalupe Mountains NP, WY2018

The temperature sensor indicated that the spring was wetted for the entirety of the sampled period (October 2017–April 2018). The sensor failed on April 28, 2018, and the one dry day estimated was near that failure and may not indicate actual conditions (Figure 4-8). Discharge was measured at three locations. Discharge was  $101.2 \pm 1.8$  L/min ( $26.7 \pm 0.5$  gal/min) at 2.5 m (3.2 ft) downstream of orifice A, and  $65.4 \pm 1.8$  L/min ( $17.3 \pm 0.5$  gal/min) at 2.5 m (8.2 ft) downstream from orifice B. Approximately 35 m (114 ft) downstream of orifice A, which is downstream of where flow from the two orifices join, discharge was  $138.8 \pm 2.1$  L/min ( $36.7 \pm 0.6$  gal/min). The first 100 m (328 ft) of the springbrook had a mean wetted width of 140 cm (55.1 in) and mean depth of 3.6 cm (1.4 in).

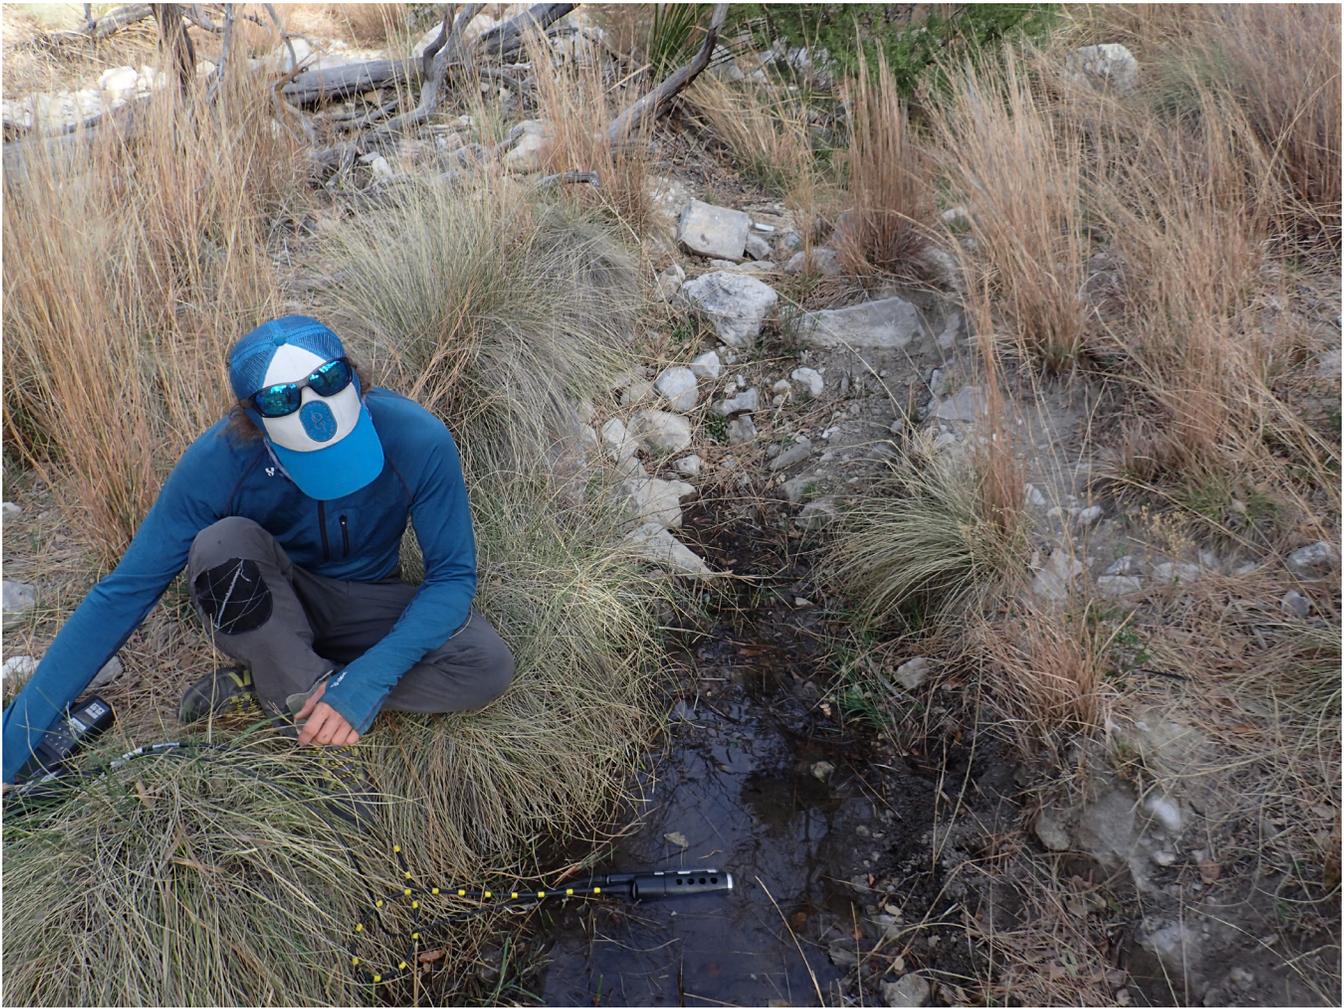
**Figure 4-9. Upper Pine Spring orifice A, Guadalupe Mountains NP, March 2018**

Upper Pine spring (Figure 4-9) was classified as a rheocrene spring and was visited on March 23, 2018. The discharge is spring-dominated, emerging from two orifices. Orifice A begins near the left bank of the drainage and forms a cool, clear pool (approximately 0.5 x 2.7 m; 1.6 x 8.9 ft) with a silty substrate. It then narrows into a small channel with small boulders for approximately 4 m (13 ft). Orifice B emerges approximately 4 m (13 ft) from orifice A as a cool and clear trickle from below a small boulder. Orifice B flows into an approximately 1.0 x 1.5-m (3.2 x 0.9-ft) pool with a thick algae mat. There is no discernable discharge from this pool and it does not connect to the main channel. The narrow channel from orifice A continues to a 4.0 x 2.0 x 0.5-m (13.1 x 6.6 x 1.6-ft) pool with 60% algae cover and a silty substrate. The springbrook then constricts again before forming another 1.5 x 3.0-m (4.9 x 9.8-ft) pool next to an alligator juniper (*Juniperus deppeana*). The substrate here ranges from silt to cobble and boulders. Leaf litter from surrounding trees accumulate where rocks have decelerated the flow in the channel. Downstream, the brook narrows again and then forms a 6.0 x 1.0-m (19.6 x 3.2-ft) pool that is 0.25 m (0.82 ft) deep and has a silty substrate. The brook narrows once again to flow over rocks and vegetation debris before pouring over a travertine slide into a shallow terminal pool.

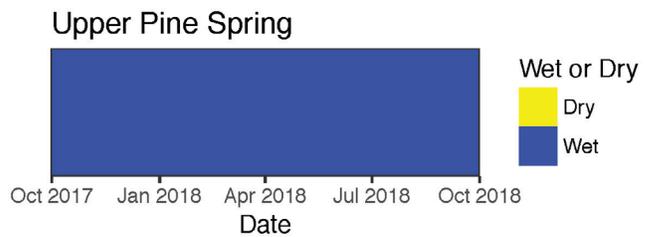
**Figure 4-10. Estimated wet/dry days at Upper Pine Spring, Guadalupe Mountains NP, WY2018**

The temperature sensors indicated that the spring was wetted throughout WY2018 (Figure 4-10). Discharge from orifice A was estimated at  $1.2 \pm 0.02$  L/min ( $0.3 \pm 0.005$  gal/min). Discharge from orifice B was not estimated. The 73-m (240-ft) springbrook had a mean wetted width of 65.2 cm (2.1 ft) and mean depth of 8.2 cm (0.3 ft).
