CULTURAL LANDSCAPE REPORT FOR HAMPTON NATIONAL HISTORIC SITE

VOLUME I: SITE HISTORY, EXISTING CONDITIONS, ANALYSIS &
EVALUATION

TOWSON, MARYLAND

Olmsted Center for Landscape Preservation
National Park Service, Boston, Massachusetts, 2014

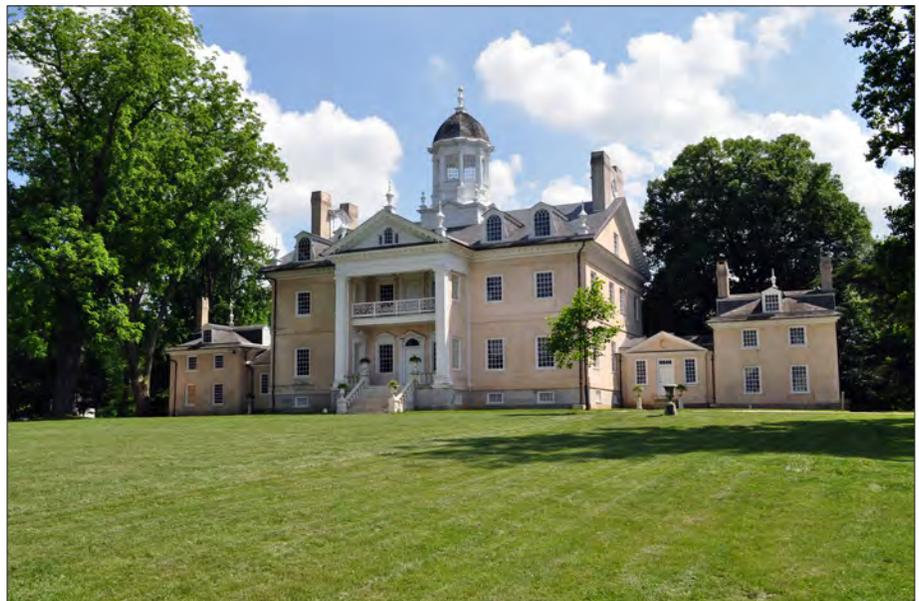
Figure 0.2. The Hampton Mansion
from the North Lawn. View looking
south, 2012 (OCLP).

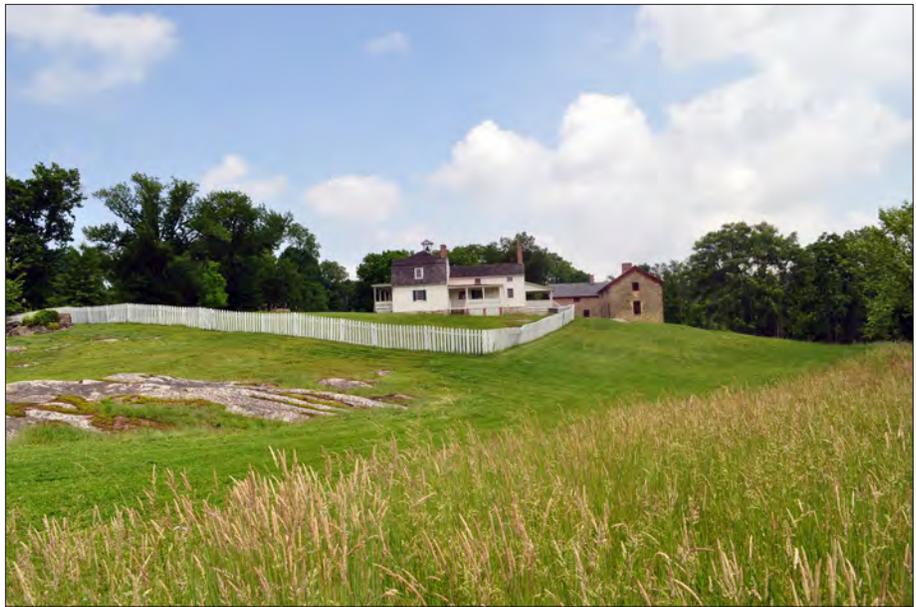
Figure 0.4. The Farm House Cluster from the Dairy stream. View looking north, 2012 (OCLP).

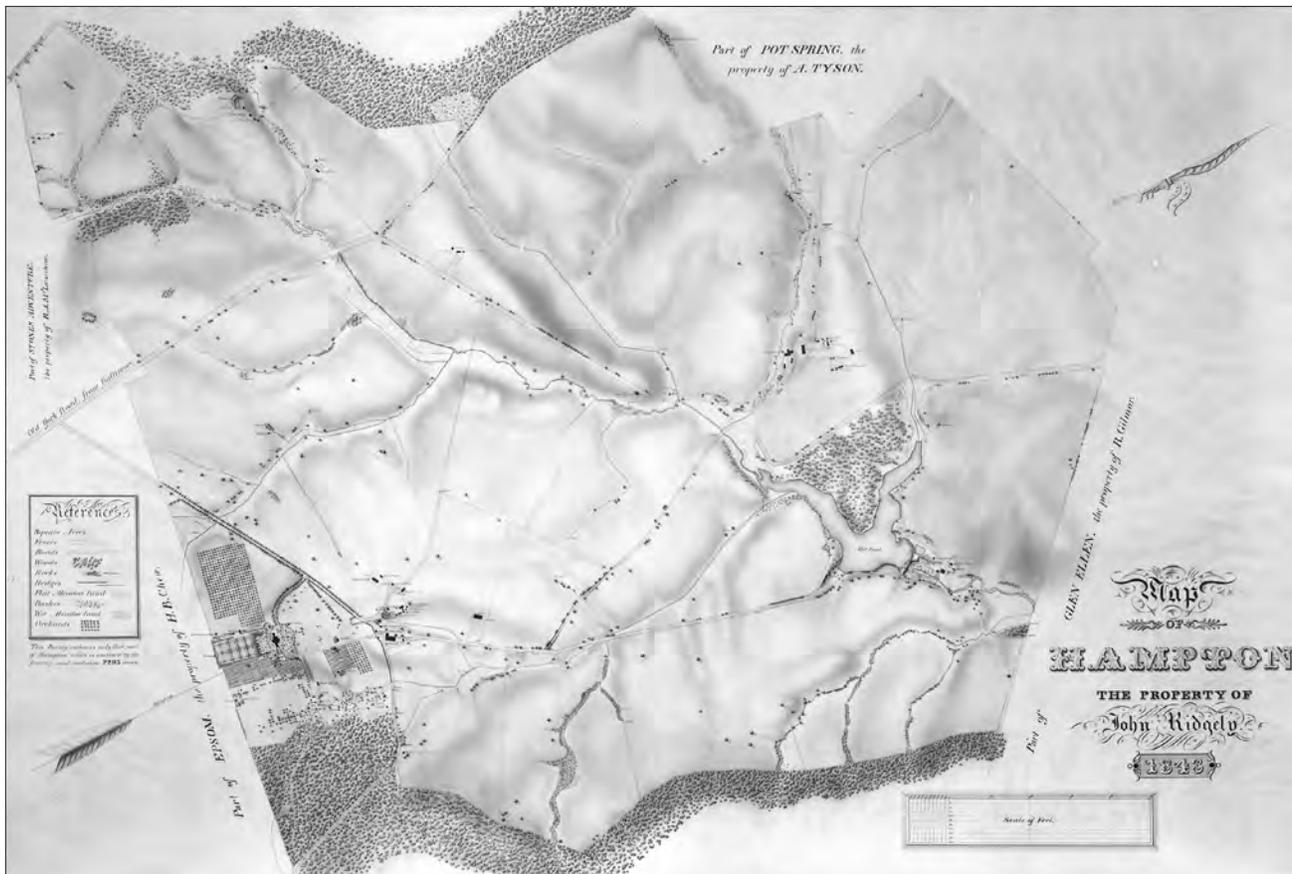
Figure 1.7. “Map of Hampton” by Joshua Barney. Plan view, 1843 (HAMP 1127, neg. HAMP 21905).

In the early 1840s, John Carnan Ridgely had the 'fenced' lands of Hampton, a total of 2,293 acres, surveyed and mapped by Joshua Barney (Figures 1.7 and 1.8). This portion of the Hampton estate contained the Mansion, Farm House and associated buildings, the Northampton Furnace, and the mill seat. While Barney's 1843 map does not portray the entire Ridgely lands at Hampton, it probably portrays most, if not all, of the improved acres. The 1843 map appears to be exceptionally accurate in its depiction of the landscape. Both built and natural features detailed by Barney can be verified by later aerial photographs.¹²¹

Outside of the Farm House complex, the 1843 Barney *Map of Hampton* details an agricultural landscape with an intricate system of paths and farm roads, evidence of quarries, lime kilns (used to restore fertility to soil), numerous springs, and dispersed housing, presumably for farmers or the slave population. Five roads radiate from the Farm House complex. This radial system of interconnected roads reinforces the Farm’s central road in the larger landscape. One road runs south from the Cow Barn past the horse stables to the Mansion (Stable Drive). A second road runs north from the Cow Barn to the Ridgely Mill complex. A third road runs southwest from the Dairy to its intersection with the ‘Old York Road,’ which ran to Baltimore. A fourth road, possibly a continuation of the third, runs east from the Dairy to its intersection with ‘Mine Bank’ road. Lastly, an unidentified farm road runs in a northwesterly direction from the hay barracks and corn house to intersect with the road that led to the Northampton Furnace. All of the roads appear to be fenced and lined with trees.¹²⁴

At least twenty-six individually fenced fields are shown on the Barney *Map of Hampton*. The fields are connected by roads and bisected by Peterson’s Run and several smaller drainages and springs. Gates facilitated the flow of people and animals from field to field. Barney notes many gates on his map, which provides good evidence of how the landscape was used.¹²⁵ A total of thirty-two marked springs were identified on Barney’s *Map of Hampton*. The springs were spread throughout the larger farm landscape but were predominantly located in the southern half of the property.

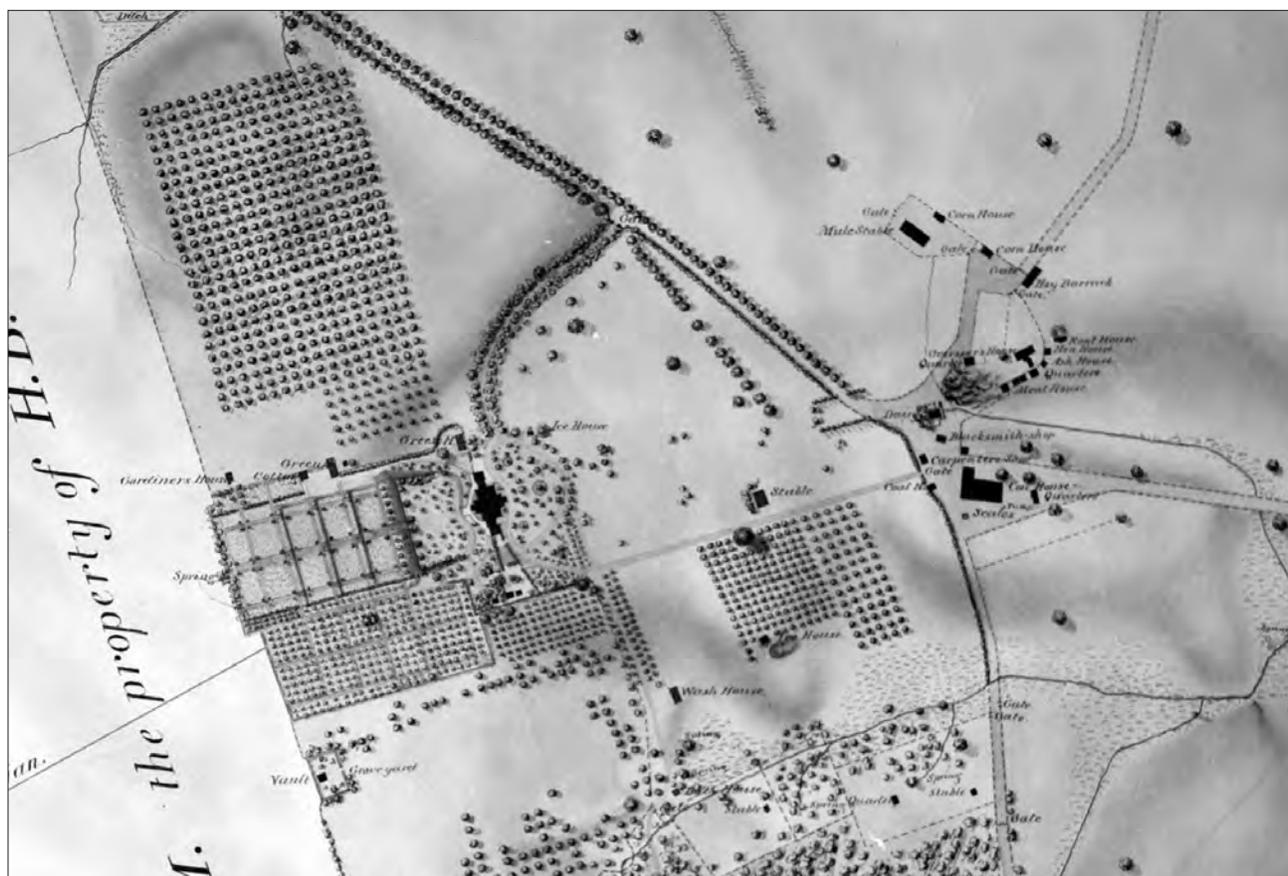
Figure 1.8. Enlargement of “Map of Hampton” by Joshua Barney showing the portion of the estate that constitutes Hampton National Historic Site. Plan view, 1843 (HAMP 1127, neg. HAMP 21905).

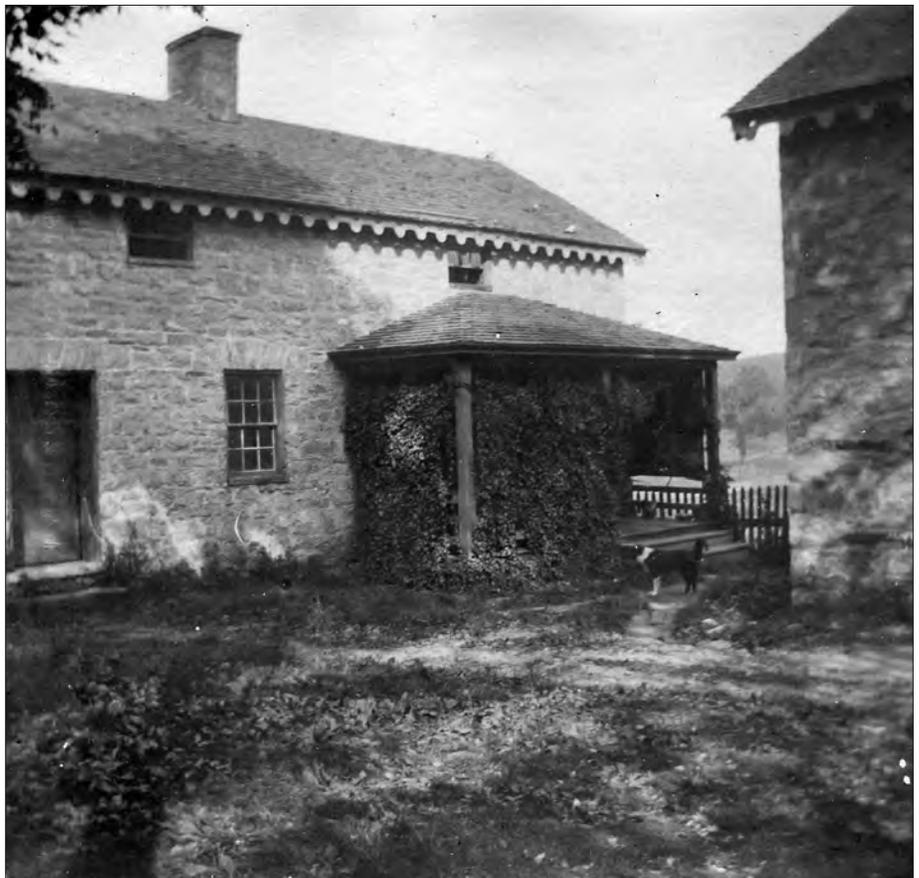
Figure 1.12. Gelatin print of Slave Quarters #2, including a wooden porch covered with vines. The corner of Slave Quarters #3 is visible at right. View looking northeast, c. 1897 (HAMP 44215).

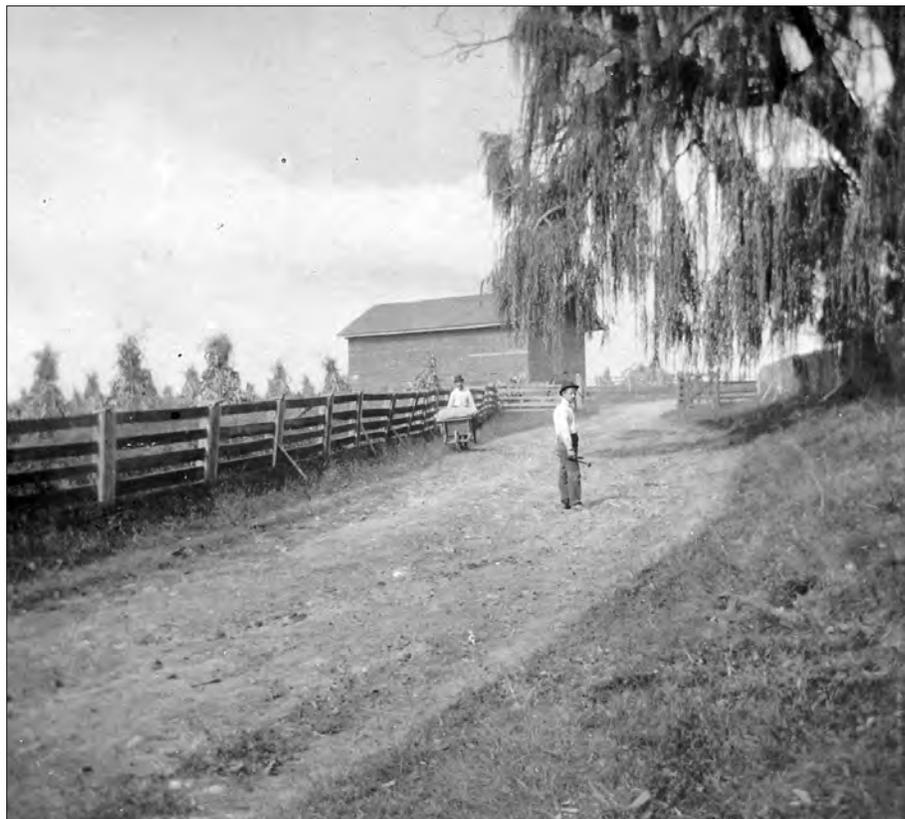
Figure 1.14. Gelatin print of the Farm Road showing the Corn Crib at center, the West Farm Field at left, and a weeping willow hanging over the road at right. View looking northwest, c. 1897 (HAMP 44216).

Throughout the late 1980s and 1990s, selective removal of volunteer vegetation and diseased and hazardous trees thinned the wooded landscape on the Farm property. In the 1980s, native flowering dogwood (*Cornus florida*) were removed due to severe decline. The trees were replaced with a dogwood anthracnose resistant hybrid called 'Constellation'. A major storm in 2004 caused damage to several trees within the Farm parcel. In an effort unrelated to storm damage, the park subsequently replaced select missing deciduous trees within the Farm House yard, including a pin oak (*Quercus palustris*), sugar maple (*Acer saccharum*), and flowering crabapple (*Malus* cv.). A weeping willow (*Salix babylonica*) was also replanted along Farm Road to replace a missing tree shown in a historic photograph of the Corn Crib (see Figure 1.14)

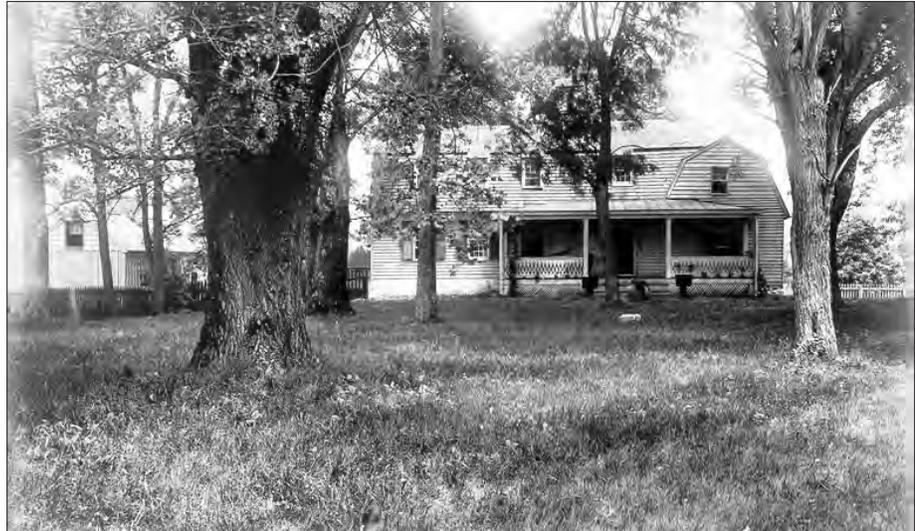
Figure 1.15. Gelatin print of the Farm House from the Farm House yard. View looking east, c. 1910 (HAMP 19370).

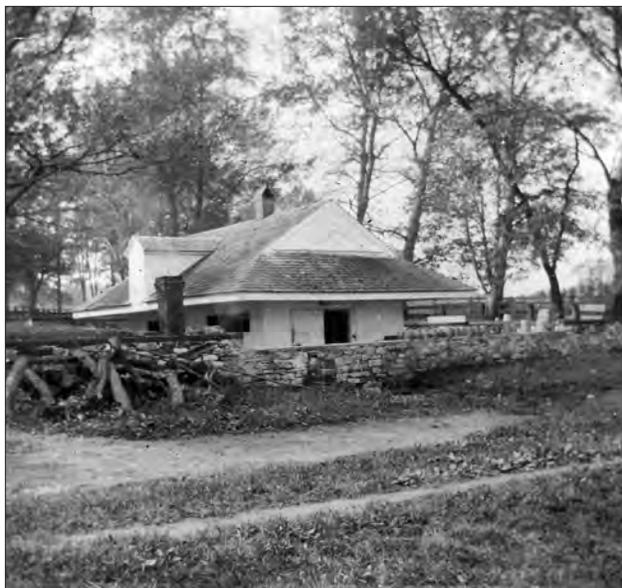
Figure 1.20. (above left) Gelatin print of the Hampton Dairy. View looking southwest, c. 1897 (HAMP 44210).

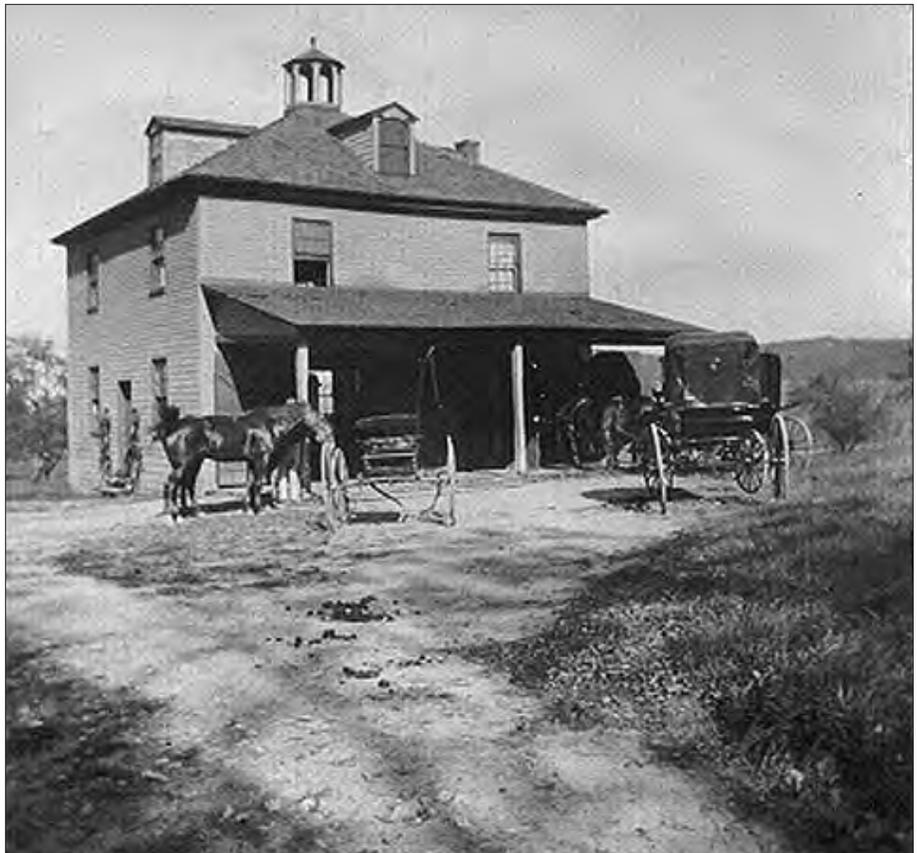
Figure 1.35. Hampton Carriage House. View looking northeast, c. 1897 (HAMP 44209).

Stables and paddocks/pastures on the North Lawn added an air of utility to the Mansion grounds. By the turn of the century, a carriage house, constructed in the 1850s, stood to the east of the stables (Figure 1.35). The pastures to the west and south of the stables were defined by post and rail fence, which is visible in the background of several photographs from the period (see Figures 1.32 and 1.36). After her husband's death, Margaretta Ridgely's tenure at Hampton saw an increase in the use of the grounds for active recreation. The predominately agricultural uses of the North Lawn in the early to mid-nineteenth century, including pasture and paddock, were slowly supplemented by recreational uses later in the century, including baseball.

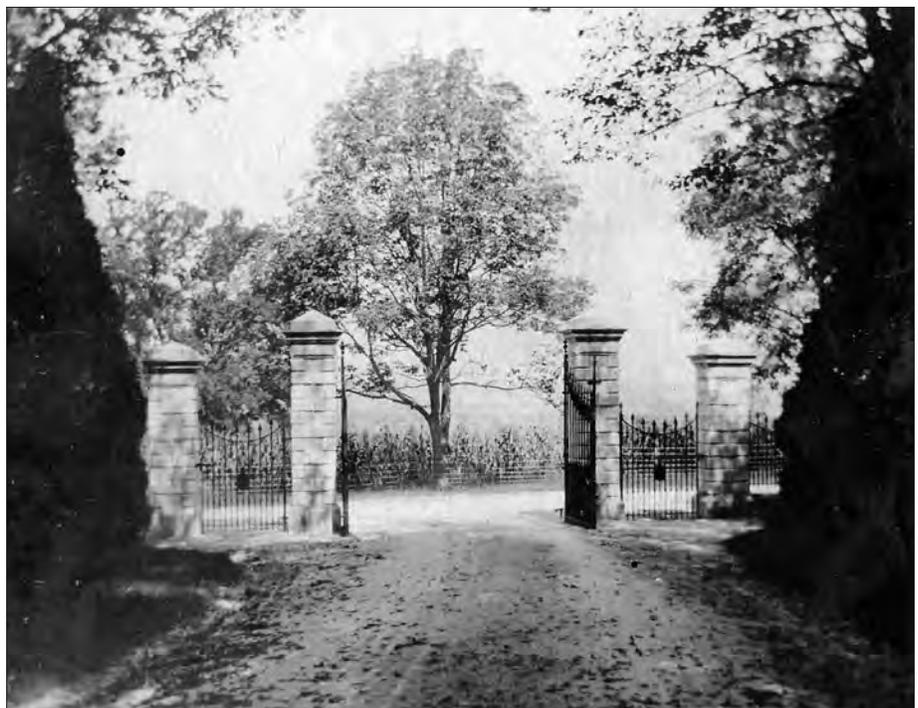
Figure 1.39. Gelatin print of the Mansion gates from the entrance road. View looking north, c. 1900 (HAMP 18575).

About 1875, a “lofty iron gateway flanked with massive pillars of white marble” was added at the entrance from Hampton Lane (Figure 1.39).¹⁷⁹ The gateway stands as an emblem of the estate at its most baronial. During the Civil War, the Marquess of Hartington, the heir to one of the greatest English estates,

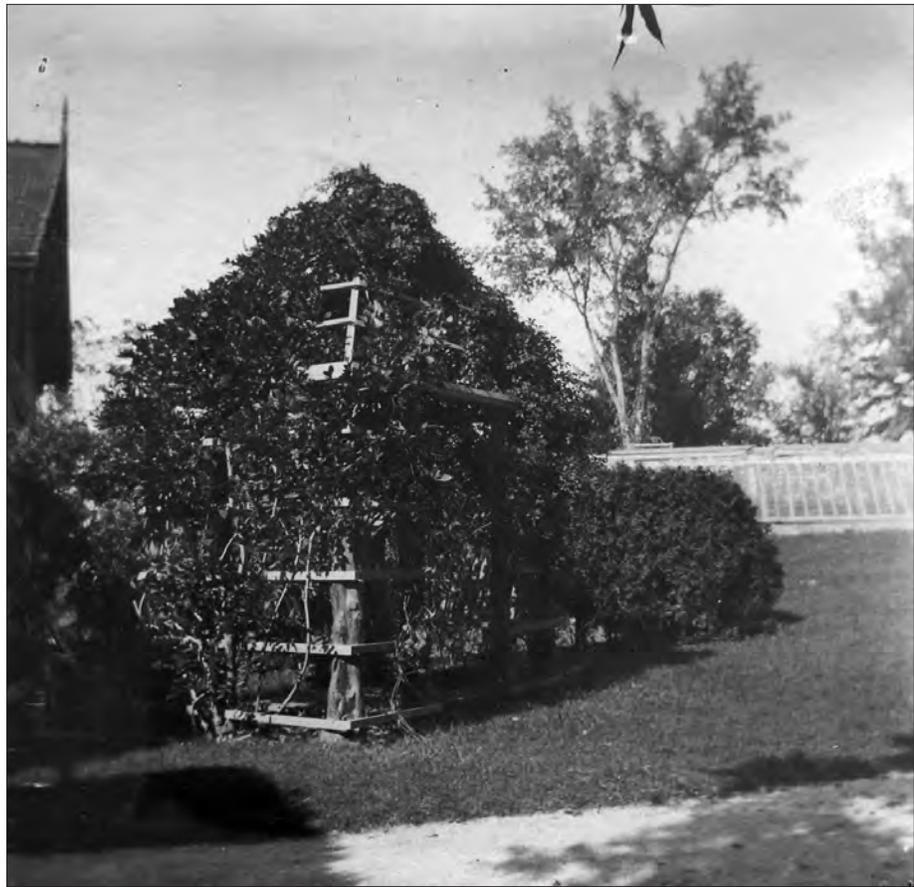
Figure 1.40. Gelatin print a grapery adjacent to the Garden Maintenance Building (at left). Greenhouse #2 is visible beyond. View looking northwest, c. 1897 (HAMP 44225).

The Mansion grounds incorporated noteworthy rustic furnishings as well, including the grapery adjacent to the Garden Maintenance Building (Figure 1.40) and benches along the northern precipice of the Great Terrace, overlooking the Falling Gardens (Figure 1.41). A painting bill surviving from 1882 reveals a remarkable assortment of articles, including various cast-iron items, as well as twenty “Pannel Tree boxes [sic]” and twenty-six “Tree boxes & Tubs,” a number of which were decorated in striking combinations of “Vermillion, bronze, & straw.”¹⁸¹ Boxed citrus trees graced the Great Terrace, in the summer, adding to the marble urns and the overall impression that Hampton represented the villa ideal (Figure 1.42). It is significant that by the second half of the nineteenth century, the “regulated order” of Hampton’s terraces and parterres was identified as an “Italian garden.” From mid-century in Britain, and in America as well, there was a revival of interest in Italianate garden forms, which allowed Hampton’s eighteenth century “villa” composition to be perceived as once again fashionable.¹⁸²

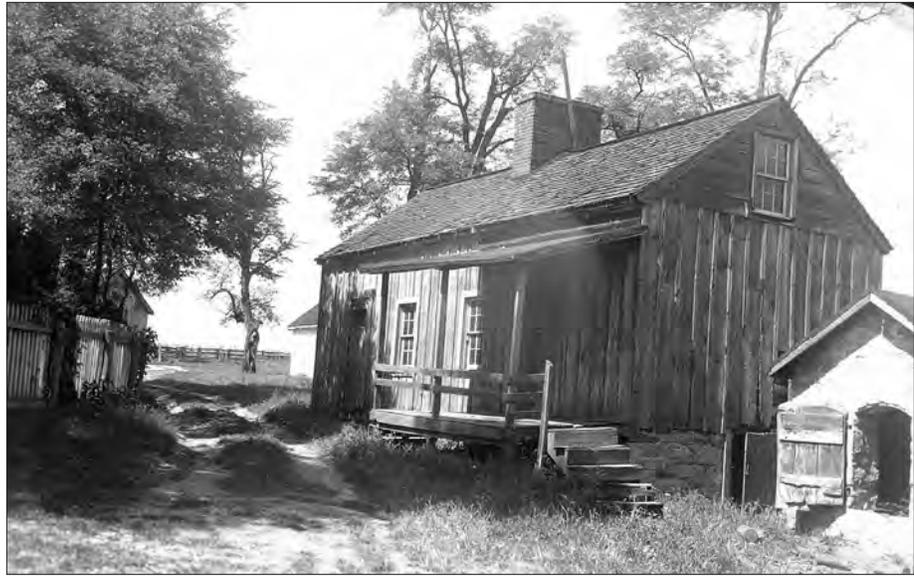
Figure 1.47. Farm House from adjacent yard. View looking east, 1936 (HABS MD-226-J, E.H. Pickering).

During the early twentieth century, repairs were made to the Farm House and a new slate roof was installed. The covered porch on the west façade of the building was removed in the late 1920s. A new cantilevered hood and stone steps replaced it in the 1930s. Sometime during the second quarter of the twentieth century, major interior renovations transformed the Farm House. A bathroom and new plumbing were added to the second floor and the building was wired for electricity. These ‘modern’ amenities may have been added between 1929 and 1938, after the death of Helen Ridgely, who refused to have electricity installed in the Hampton Mansion during her lifetime.¹⁸⁵

Black and white photographs from the 1936 HABS document the Hampton Farm, including the Overseer’s House (Farm House), Dairy, Cow Barn (now demolished), Mule Barn, Slave Quarters #2, Slave Quarters #3, Ash House, and Long Barn Granary (Long House Granary) (Figures 1.47 to 1.52). The picket fence surrounding the Farm House yard is in disrepair, although the foundation plantings along the west side of the Farm House appear to be well maintained.¹⁸⁶

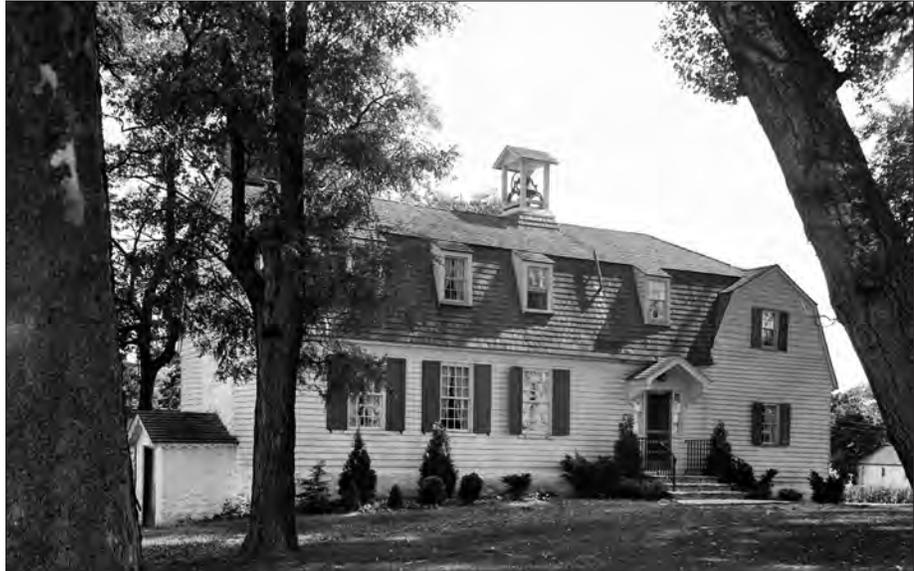
Figure 1.48. Farm House cluster from near the Dairy stream. View looking north, 1936 (HABS MD-226-J, E.H. Pickering).

Electrical and/or telephone wires are prominent in the HABS photographs, as they run from Hampton Lane to the north along the western edge of the Dairy and connect to a pole near the southeast corner of the Farm House. A rail fence surrounds the Mule Barn area, extending to include the Corn Crib to its south.

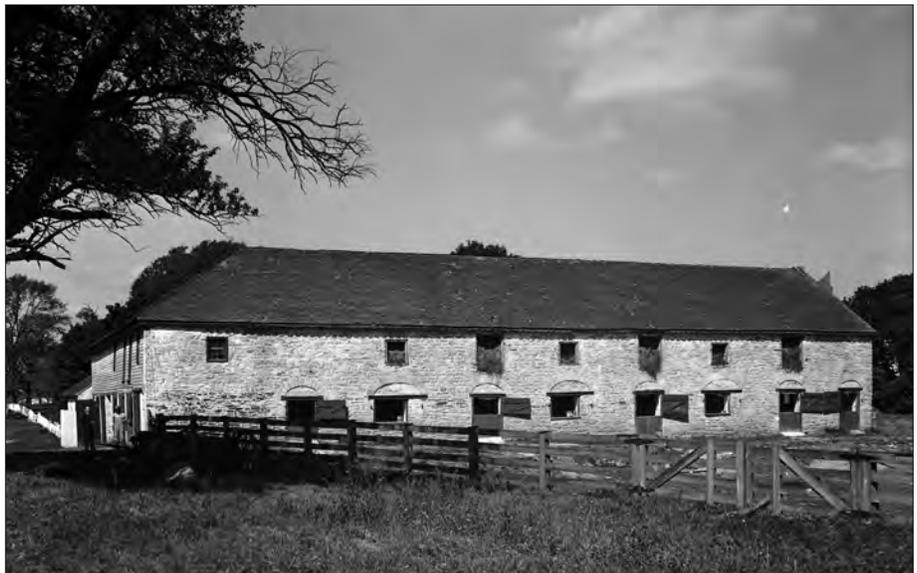
Figure 1.50. Cow Barn, with the Long House Granary visible beyond at left. View looking northwest, 1936 (HABS MD-22-6H, E.H. Pickering).

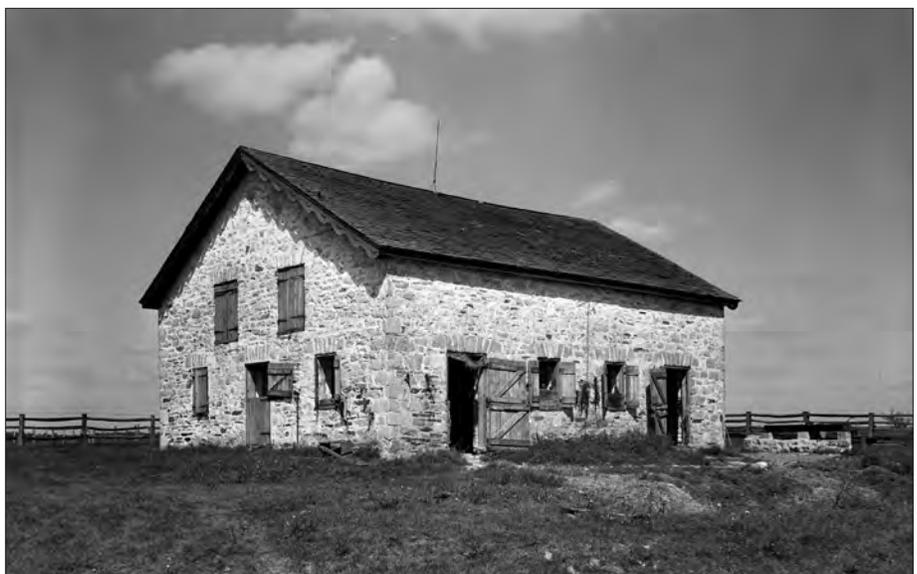
Figure 1.51. Mule Barn from Farm Road. View looking north, 1936 (HABS MD-226-O, E.H. Pickering).

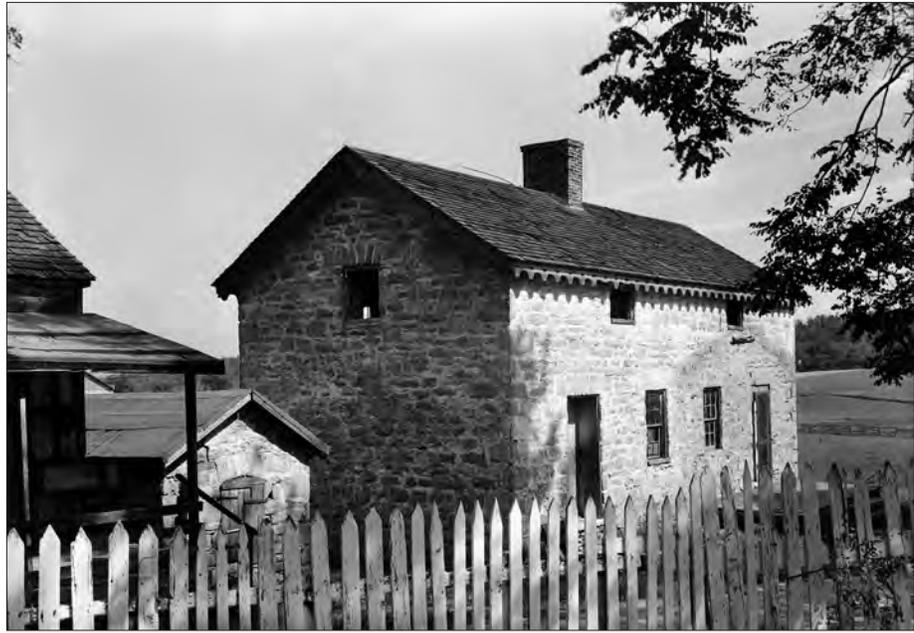
Figure 1.52. Slave Quarters #2 from the fenced yard behind the Farm House. View looking north/northeast, 1936 (HABS MD-226-L, E.H. Pickering).

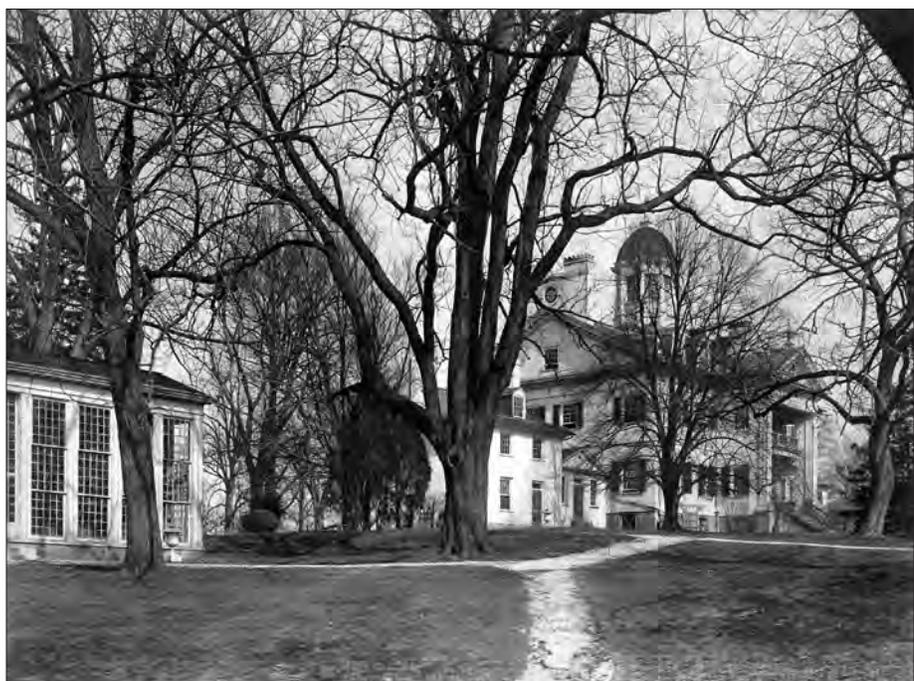
Figure 1.59. Gelatin print of the Orangery and Mansion from a path in the current vicinity of the upper parking lot. View looking northeast, c. 1908 (HAMP 20526 p. 05).

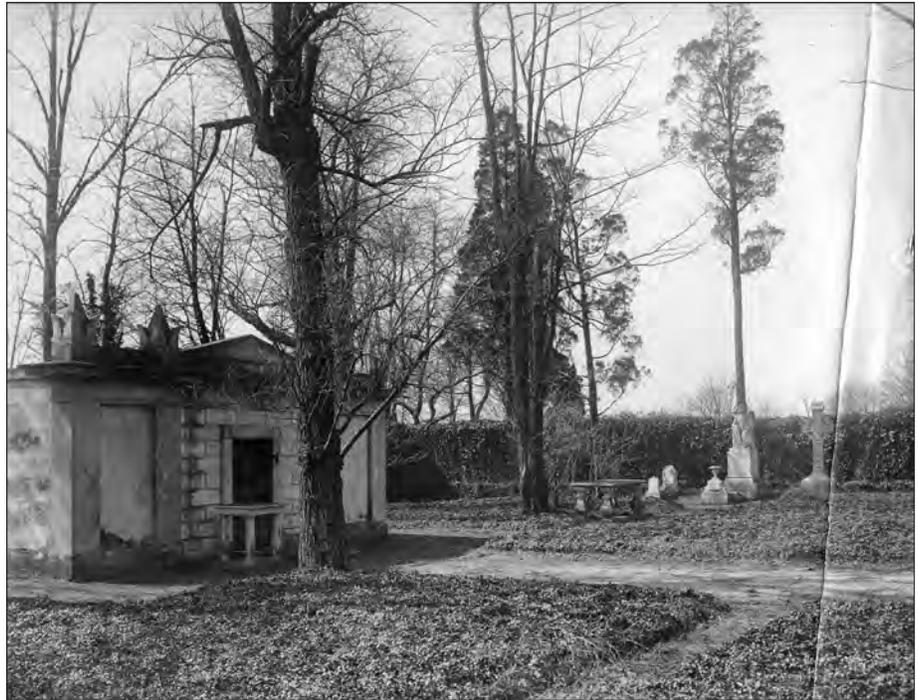
Figure 1.64. Gelatin print of the Ridgely Family Cemetery showing vegetation in and beyond the cemetery. View looking southwest, 1908 (HAMP 20526 p. 08).

path that led from the gates to the vault and a narrow perimeter path. English ivy (*Hedera helix*) covered the Cemetery Walls beyond which the grounds were forested to the north and open to the west (Figures 1.63 to 1.65). Helen Ridgely, who appreciated Hampton's history and sought to uphold its legacy, regularly shared the cemetery with guests, "...I took them through the gardens & to the vault, something I do with anyone who comes & asks to see them..."²⁰²

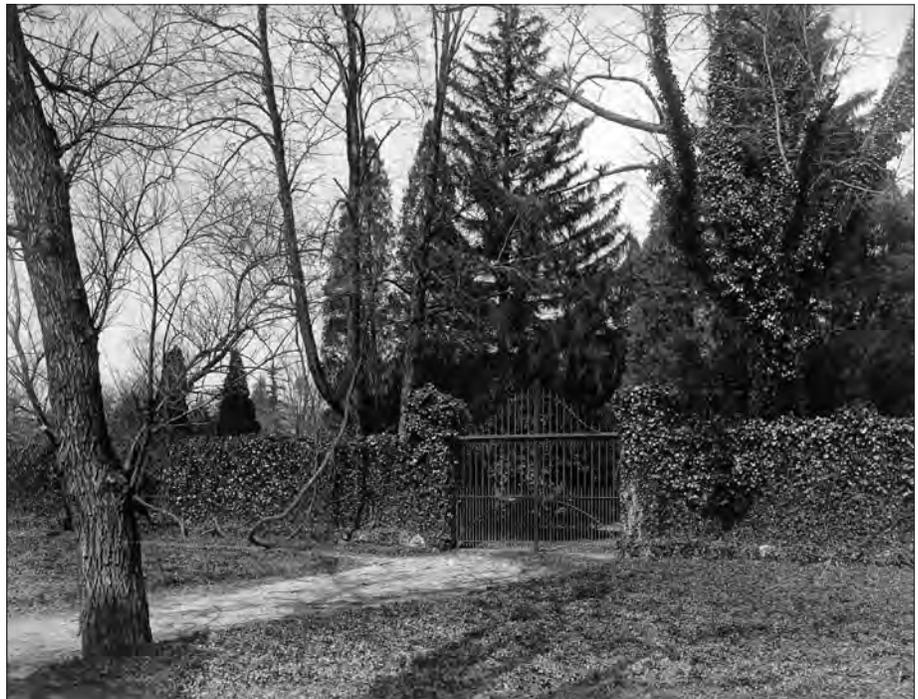
Figure 1.65. Gelatin print of the Ridgely Family Cemetery gate from the interior of the cemetery wall. View looking north, 1908 (HAMP 20526 p. 10).

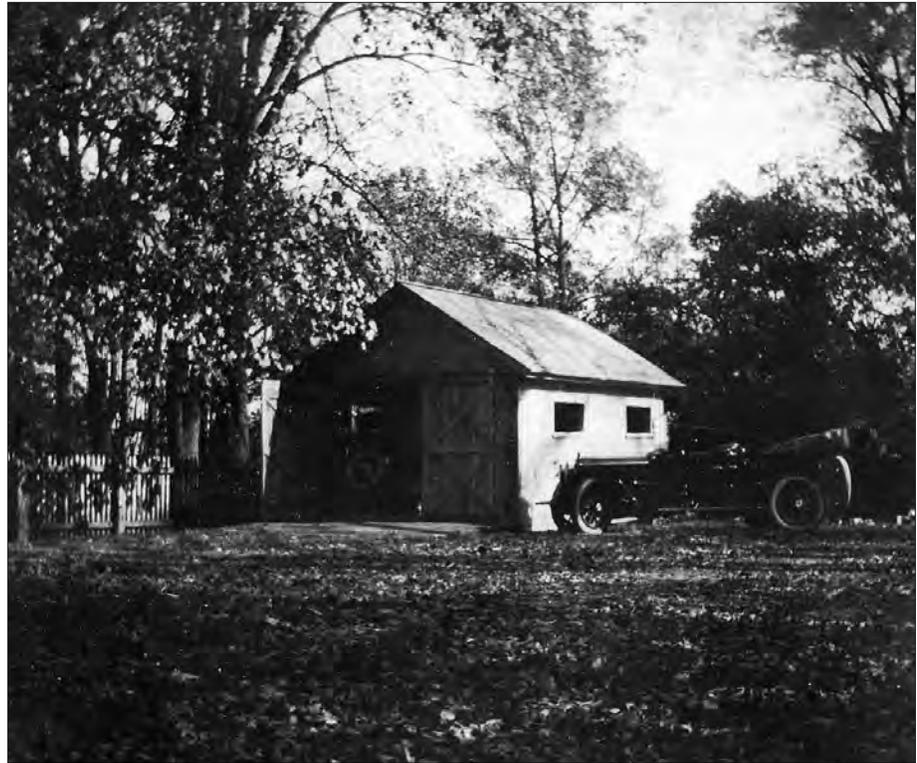
Figure 1.66. Gelatin print of the 1910 Garage. Note the picket fence beyond. View looking northeast, c. 1920 (HAMP 18624).

The early 1900s marked the arrival of the automobile at Hampton, and in 1910 the Ridgelys constructed the first garage on the property to house their new car (Figure 1.66). The 1910 Garage, located to the east of the East Terrace in the Domestic Service Cluster, was bordered by a white picket fence to its north, likely an extension of the fence that separated the East Terrace from the heart-shaped carriage drive. Historically, the East Terrace was a particularly active area, with the Summer Kitchen and the Octagon House, which housed servants at the time (Figures 1.67 to 1.69). The terrace was bordered by a lattice fence on the interior

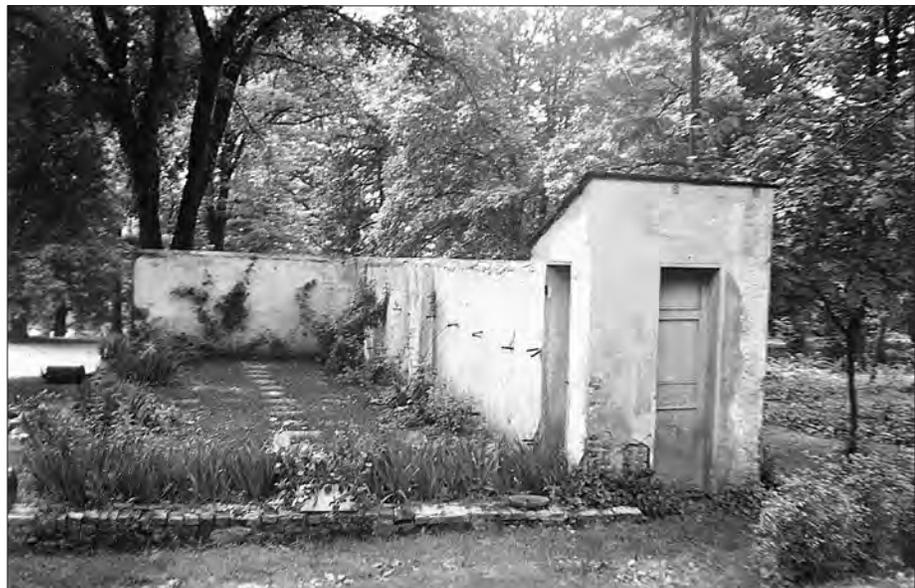
Figure 1.71. (right) Gelatin print of the remains of the Orangery after a 1926 fire. View looking west, 1934 (HAMP 6705).

and a picket fence on the exterior, adjacent to the bucolic scene across the North Lawn beyond the adjacent carriage drive (Figure 1.70). On the opposite side of the Mansion, the Orangery, constructed a decade earlier between 1928 and 1932, burned in 1926 (Figure 1.71).

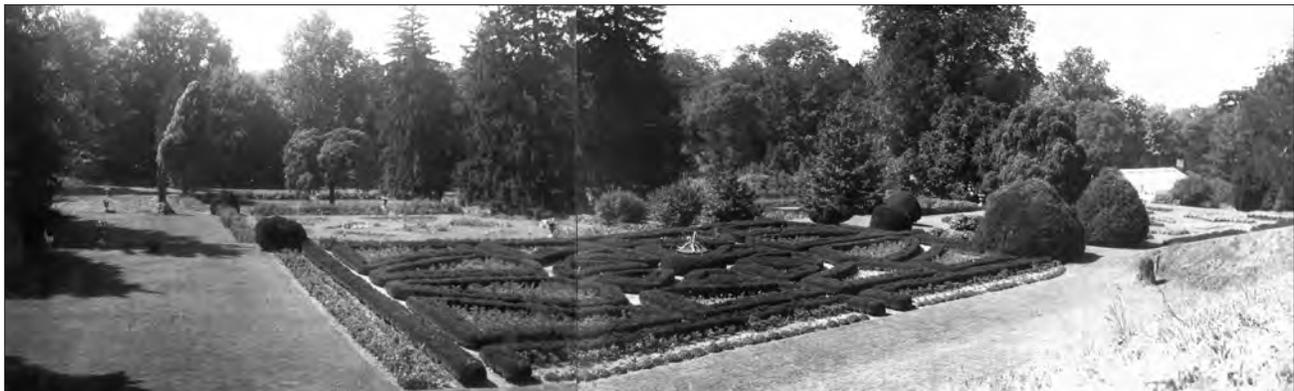
Figure 1.72. (below) The Falling Gardens and Greenhouse #2. View looking southwest, c. 1935 (HAMP 19240).

In the 1930s, after Helen Ridgely's death and the arrival of the recently widowed John Ridgely Jr. and his family to the Mansion, the grounds appeared in order but did not reflect the horticultural exuberance of decades before (Figures 1.72 and 1.73). The Falling Gardens were bedded-out and paths appeared well-raked, although the landscape beyond, near the Caretaker's Cottage, appeared less than well-tended (Figure 1.74).

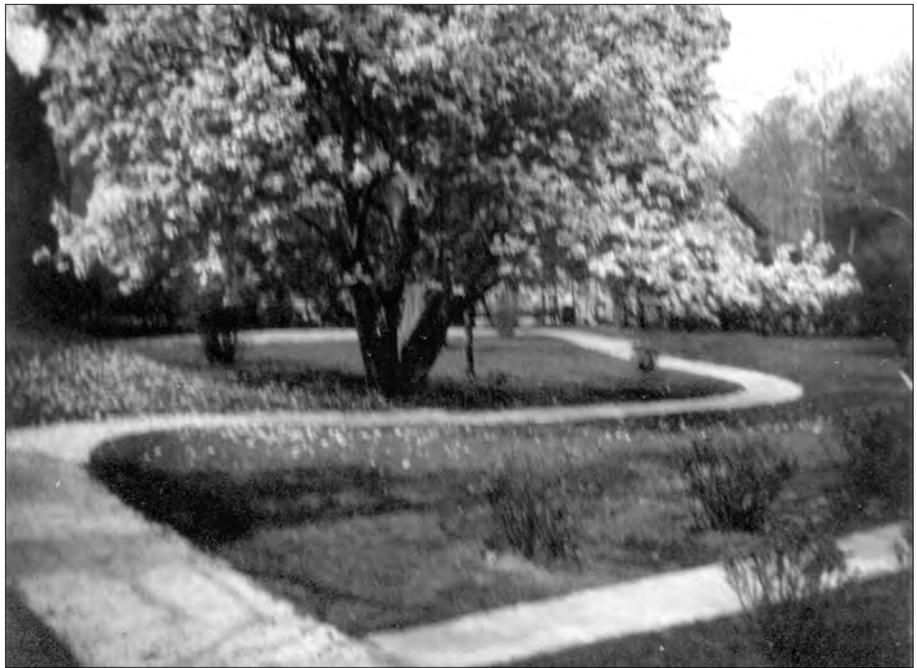
Figure 1.73. Saucer magnolia in bloom showing the extension of the cobblestone path, rose lined bluestone walk to Greenhouse #2 (to the right of the image frame), as well as the Garden Maintenance Building in the background. View looking southwest, c. 1920 (HAMP 9289).

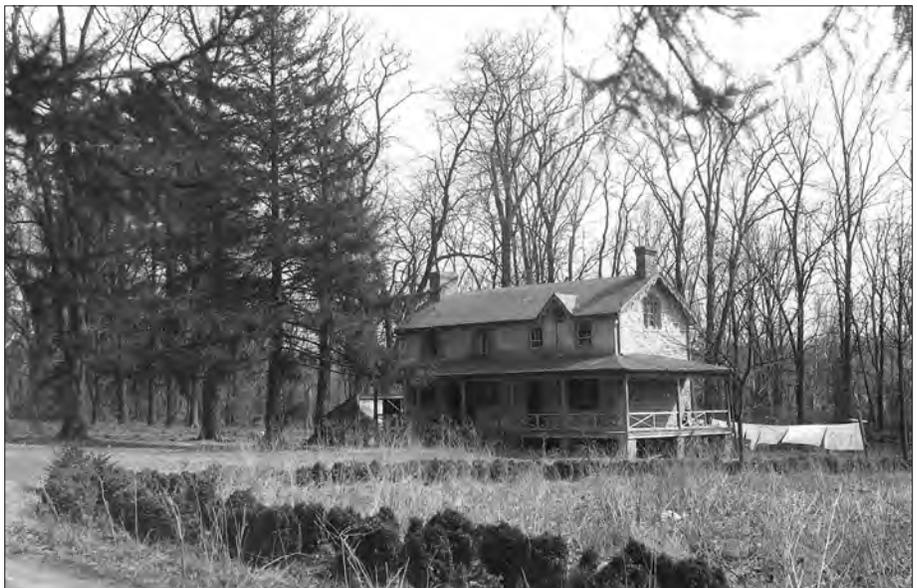
Figure 1.74. Gelatin print of the Caretaker's Cottage showing a distinct planting of boxwoods in the foreground. View looking southeast, c. 1935 (HAMP 20477).

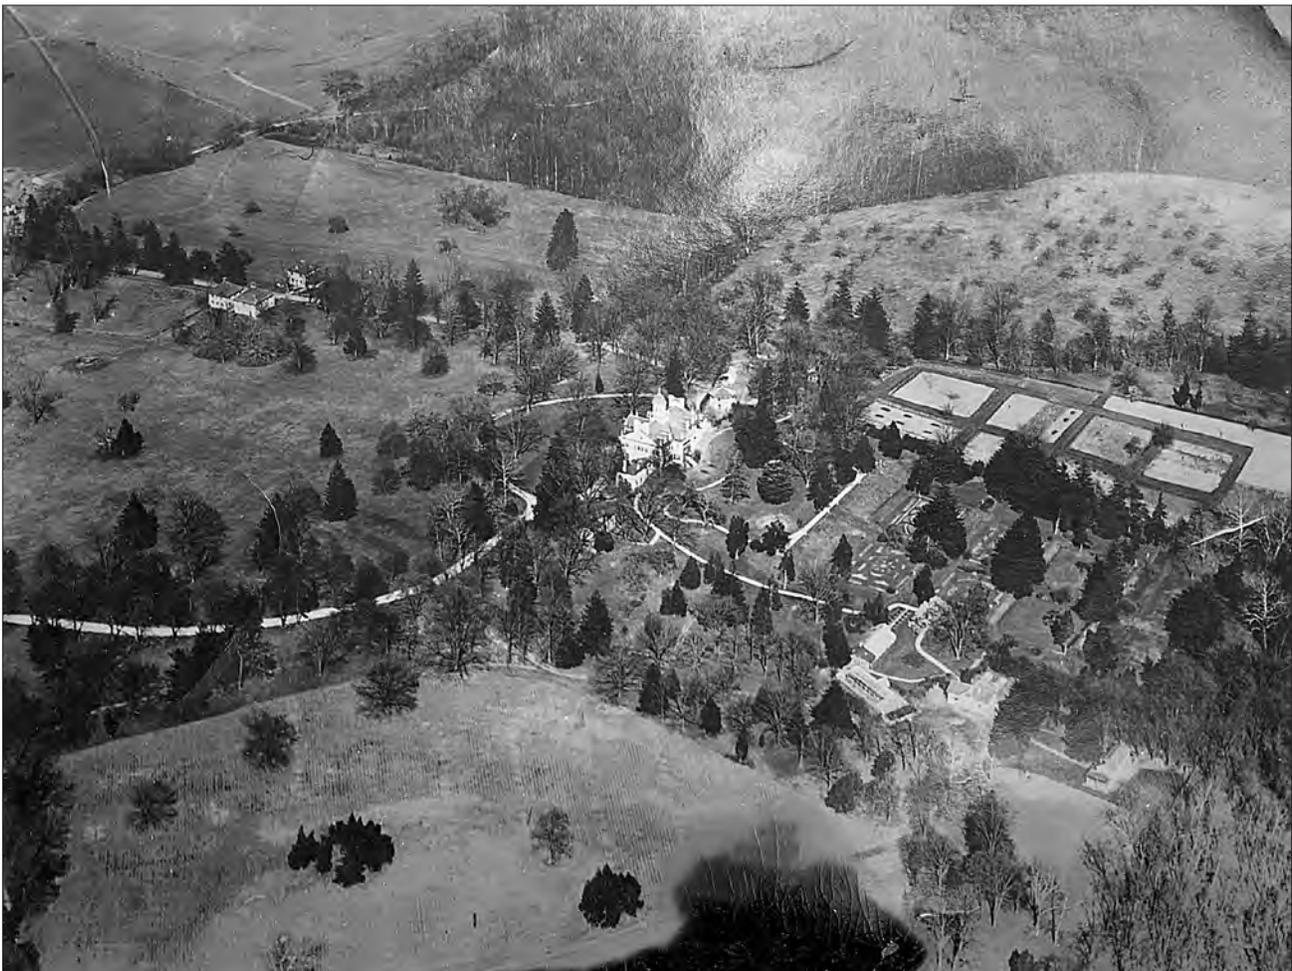
Figure 1.75. Hampton showing what appears to be tilled land in the foreground (lower left of image) and an orchard in the background (upper right of image). Aerial view looking northeast, c. 1920 (HAMP 18662).

of a 1920s aerial photograph of the Hampton area shows few houses in the immediate vicinity of the Mansion (Figure 1.75). By the 1950s, however, aerial photographs document that new houses constructed adjacent to Hampton exceeded one hundred (see Figures 1.99 to 1.101).

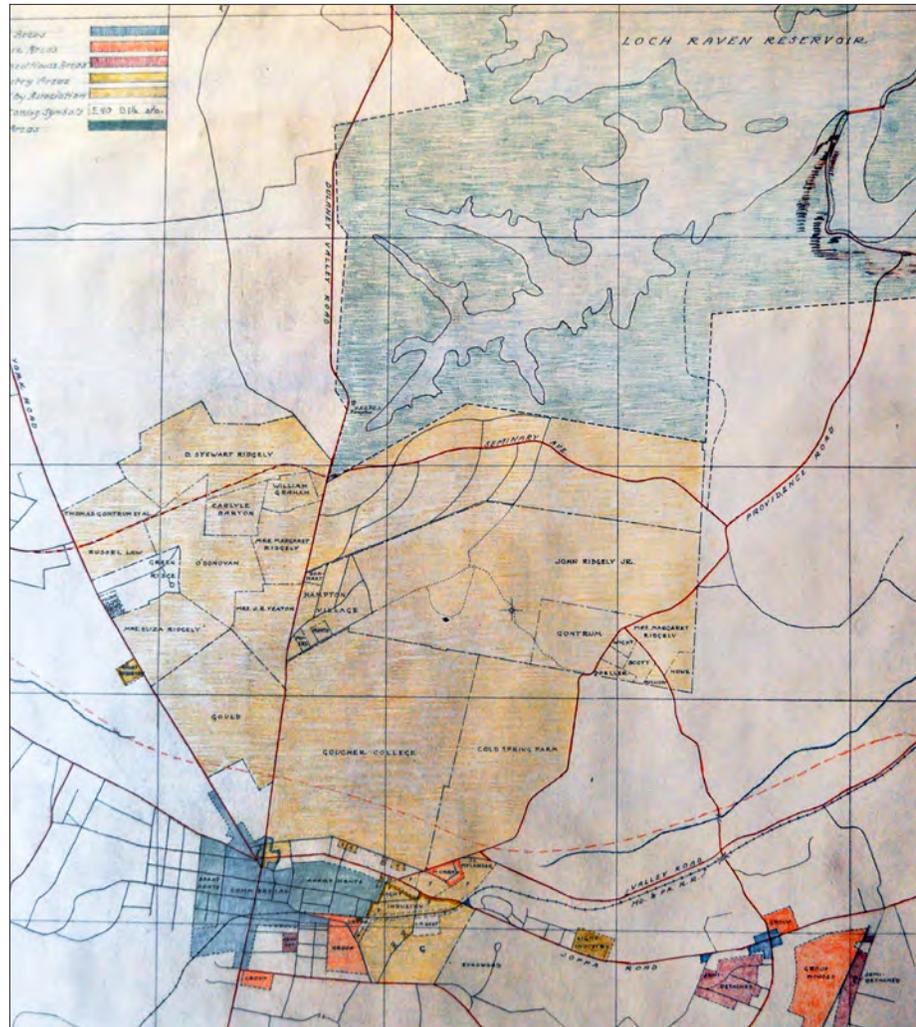
Figure 1.77. Olmsted Brothers' "Map of Land in the Vicinity of Towson, Maryland; compiled from various sources, showing present land uses, roads and railroads, and zoning, together with proposals by several agencies for extensions of major highways..." Plan view, January 1946 (courtesy of the National Park Service, Frederick Law Olmsted National Historic Site, job 09696, plan 16, print 1).

Residential development on the Hampton Farm property continued during John Ridgely Jr.'s tenure. By 1946, the subdivision of the land at the intersection of Dulaney Valley Road and Hampton Lane, noted on historic plans as "Hampton Village," was complete. Land between the Farm and Loch Raven Reservoir was similarly laid-out with roads designed for suburban development (Figure 1.77).

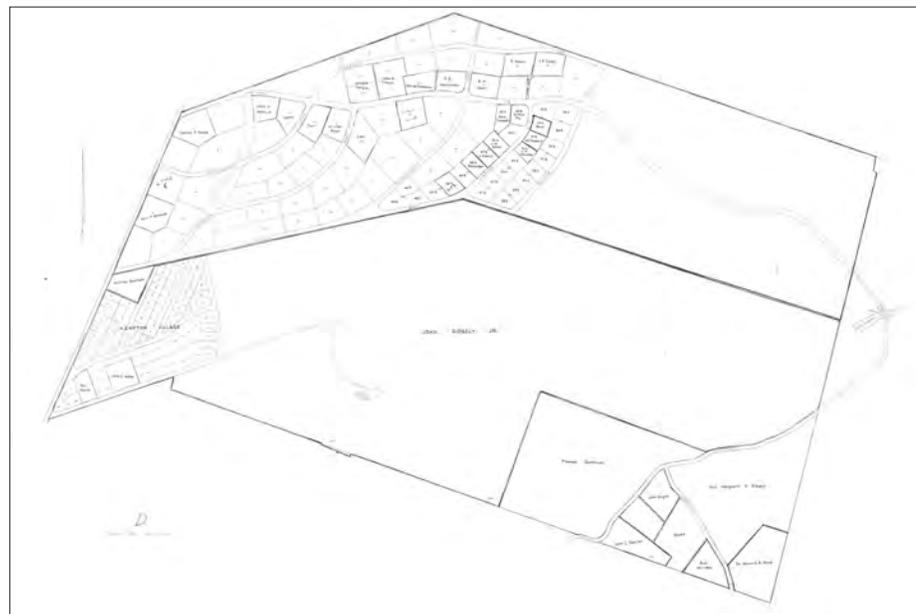
Figure 1.78. Portion of the Olmsted Brothers' base map for the Towson area showing dense residential development to the north and west of Hampton. Plan view, July 1945 (courtesy of the National Park Service, Frederick Law Olmsted National Historic Site, job 09696, plan 9).

Despite the short duration of the project, base maps prepared by the Olmsted Brothers firm document the extent of development in the vicinity of Hampton in the mid-1940s, including several notable road improvements (Figure 1.78): Seminary Avenue was extended between Dulaney Valley Road and York Road; Hampton Lane was formalized to the east of Hampton; and a proposed “freeway” to the south of Goucher College, which later became the Baltimore Beltway, was discussed at length. In October 1948, the Society for the Preservation of Maryland Antiquities requested a copy of the Olmsted Brothers’ base map in relation to their involvement with Hampton, as “the Society is making preparations to act as Custodian for the Hampton Mansion, which is now Federal property.”²¹⁰
