CULTURAL LANDSCAPE REPORT FOR HAMPTON NATIONAL HISTORIC SITE

VOLUME I: SITE HISTORY, EXISTING CONDITIONS, ANALYSIS &
EVALUATION

TOWSON, MARYLAND

Olmsted Center for Landscape Preservation
National Park Service, Boston, Massachusetts, 2014

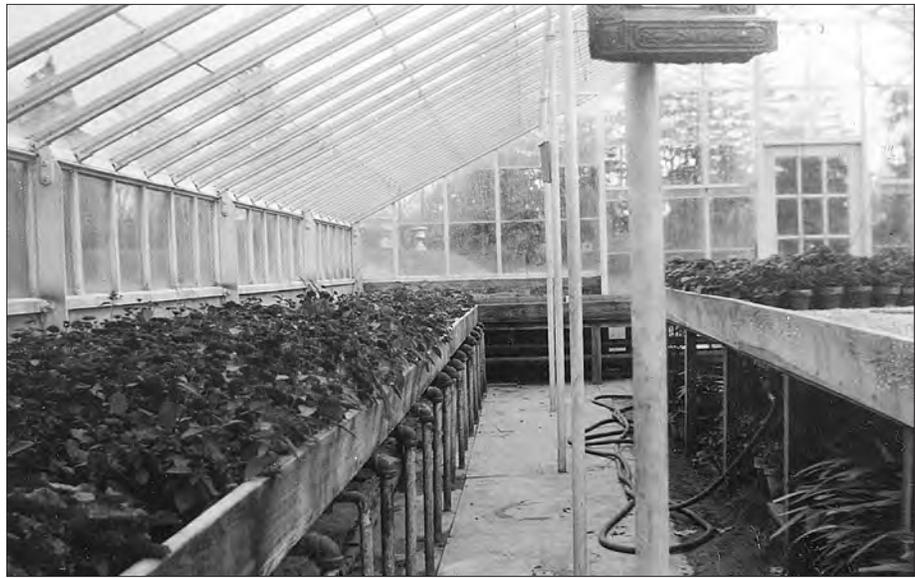
Figure 1.79. Gelatin print of the interior of Greenhouse #2. View looking east, c. 1940 (HAMP 4286).

From 1936 to 1940, Lillian Ketchum Ridgely served as the mistress of Hampton for three generations of Ridgely men, Captain John Ridgely, John Ridgely Jr., and her husband, John Ridgely III. She was responsible for management of the house and gardens. Like Ridgely women before her, Lillian Ketchum Ridgely was a knowledgeable horticulturist, avid gardener, and member of a local garden club. While no written evidence of her improvements remain, photographs from the 1940s show the Mansion grounds in order, with the Falling Gardens bedded-out annually from plants grown in the greenhouse, replanting much of the Falling Gardens herself (Figure 1.79).

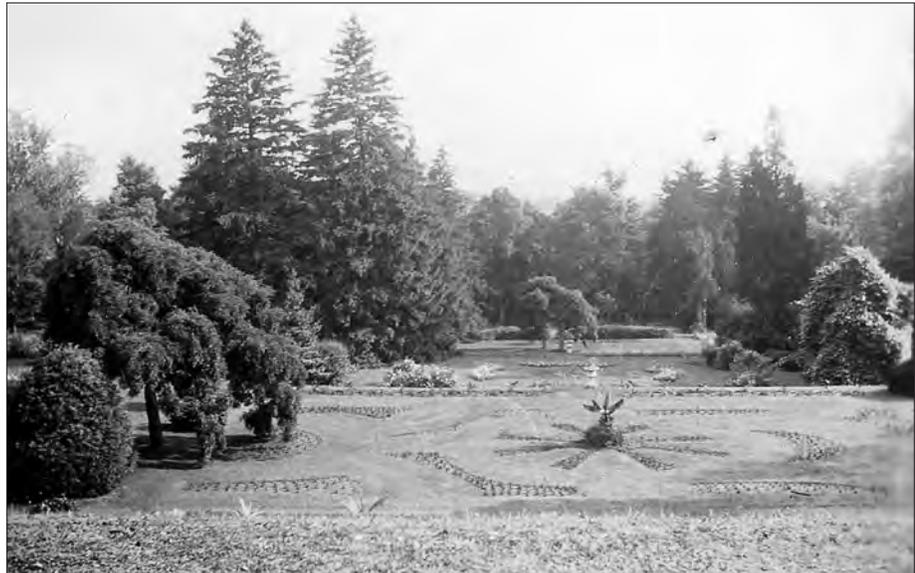
Figure 1.80. Gelatin print of Parterre II of the Falling Gardens. View looking south, c. 1940 (HAMP 20690).

Photographs from the 1940s show the Falling Gardens in good condition, with upper parterres planted with perennials annually. By the 1940s, spruces that framed the central walk of the Falling Gardens were of mature height and width, blocking southerly views along the central axis of gardens (Figures 1.80 to 1.82). The Great Terrace appeared in similar condition, with vines climbing the arborvitae at the precipice of the lawn and wisteria covering the south portico (Figures 1.83 and 1.84).

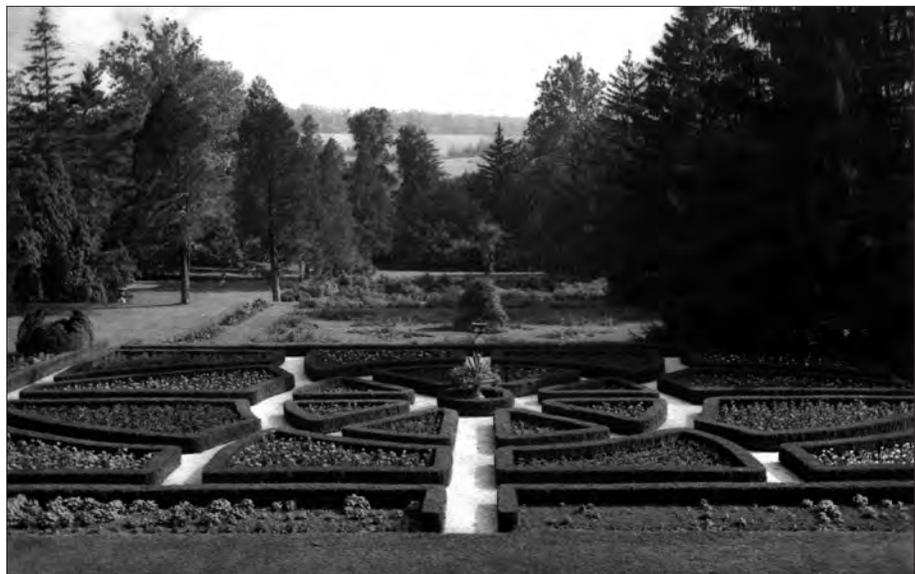
Figure 1.81. Eastern half of the Falling Gardens. View looking south, c. 1940 (HAMP 22557).

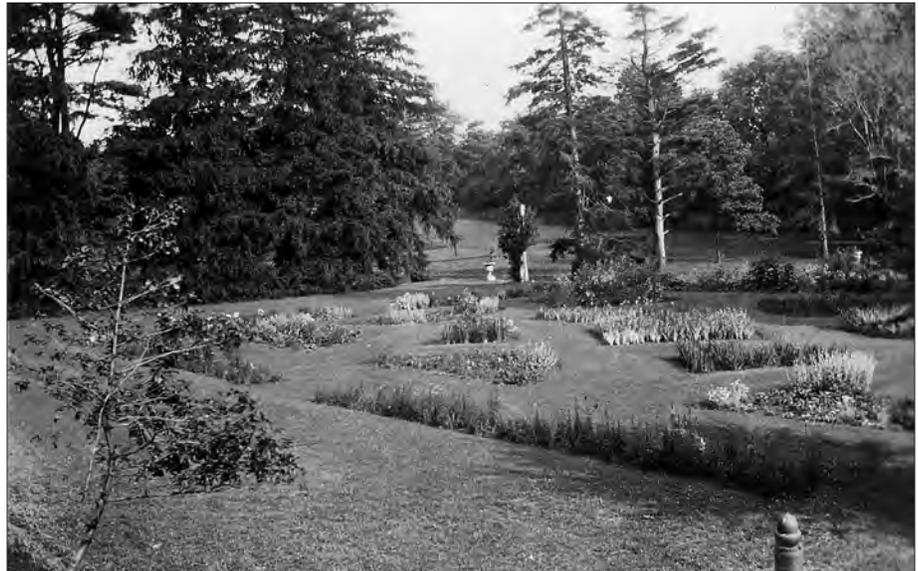
Figure 1.82. Gelatin print of Parterre III of the Falling Gardens. View looking southeast, c. 1940 (HAMP 20689).

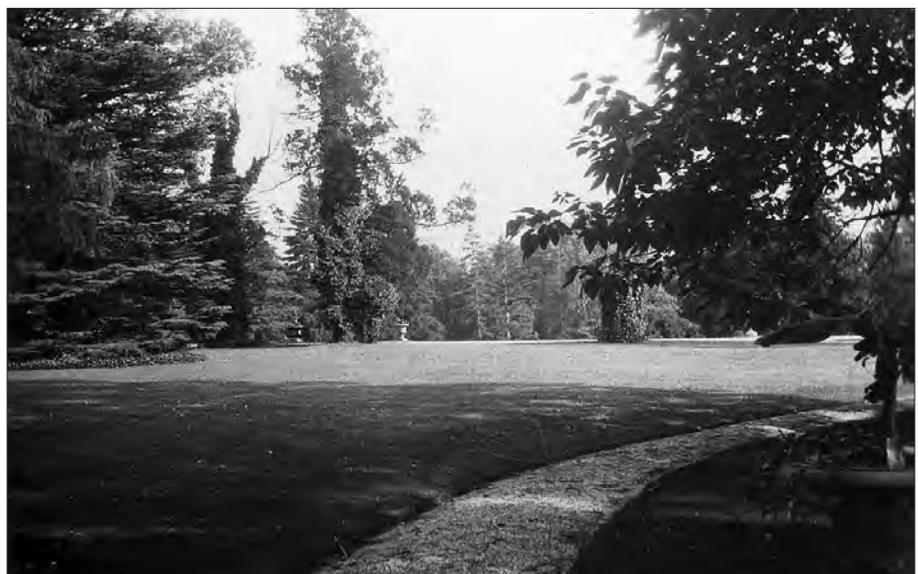
Figure 1.83. Lawn of the Great Terrace from the western side of the serpentine path. Several historic trees are visible, including the cedar of Lebanon at left. Note the English ivy below the cedar of Lebanon. It provided a solid groundcover until decimated by white-tailed deer in the early 1990s. View looking south, c. 1940 (HAMP 20684).

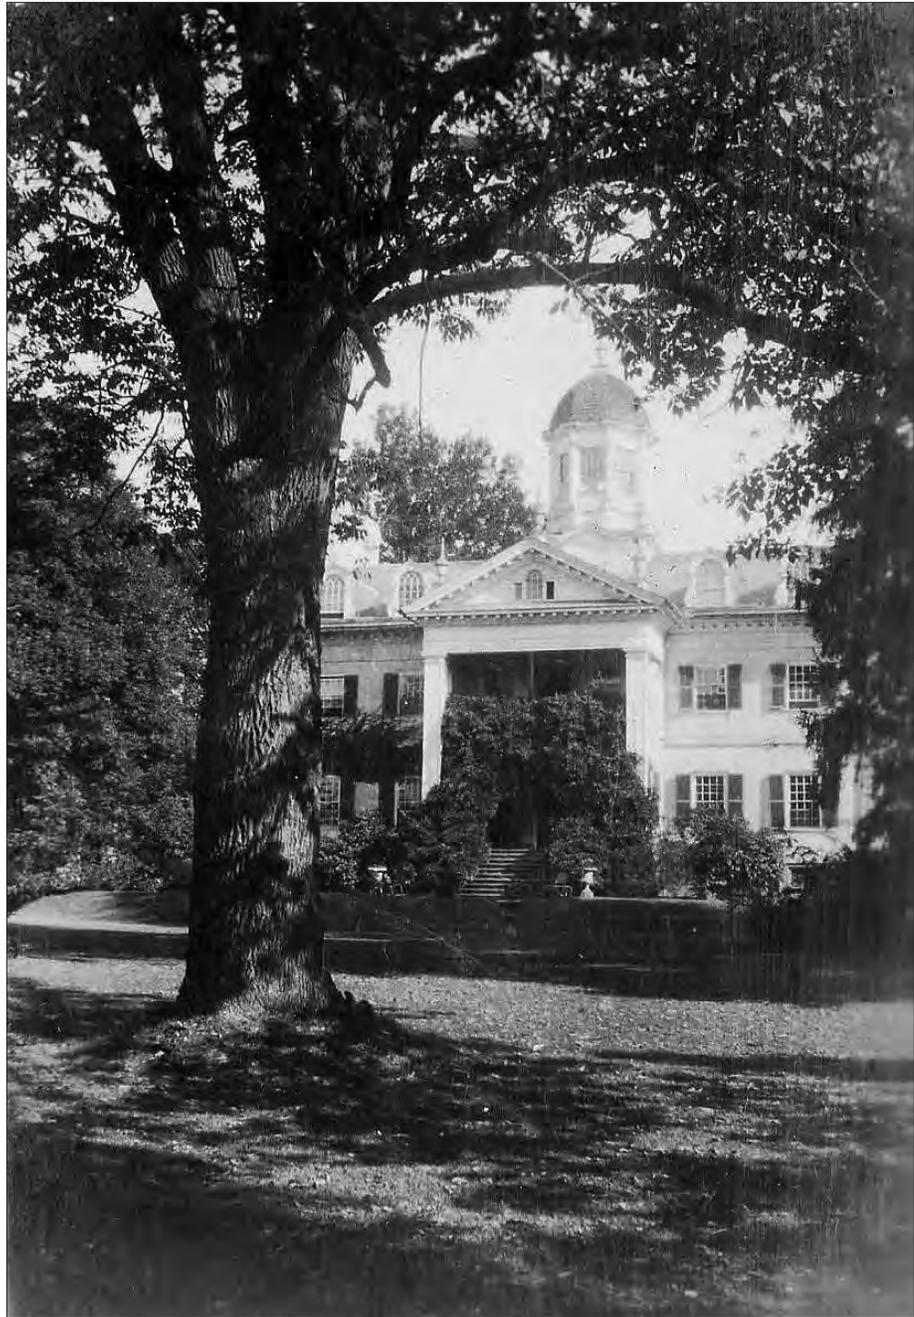
Figure 1.84. South portico of the Mansion, showing wisteria over the staircase. View looking north, c. 1940 (HAMP 20682).

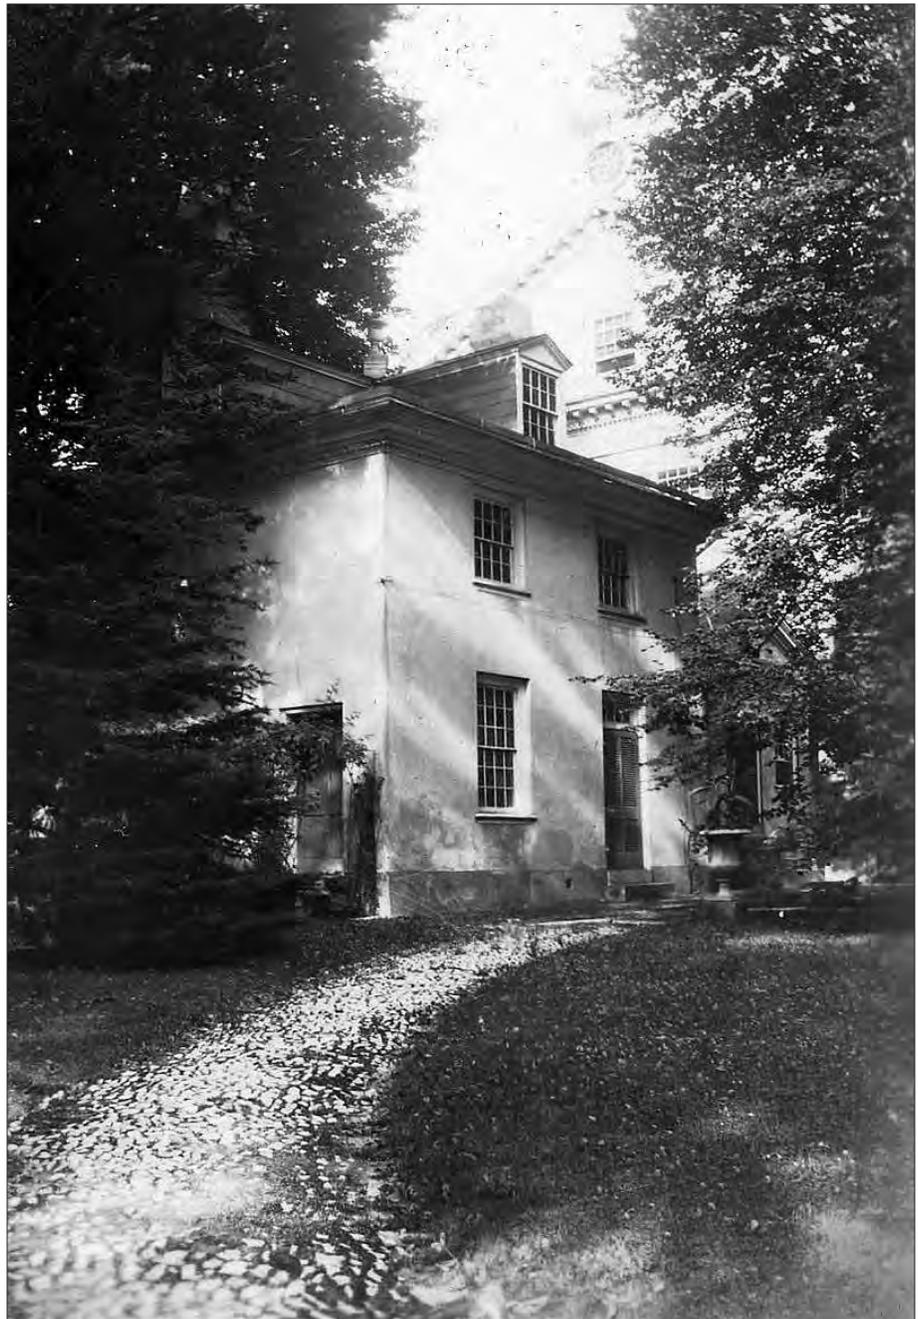
Figure 1.85. View of the west wing of the Mansion from the cobblestone path. A marble urn is visible on the terrace, the existing cedar of Lebanon is visible to the left, the beech damaged by the 1940 storm is seen in the upper left corner, and the existing European linden is visible to the right. View looking northeast, c. 1940 (HAMP 20685).

However, the cobblestone walk and other features showed signs of a lack of maintenance (Figure 1.85). A major storm in 1940 wrought damage to Hampton’s trees, including a large beech to the west of the Mansion. Photographs taken

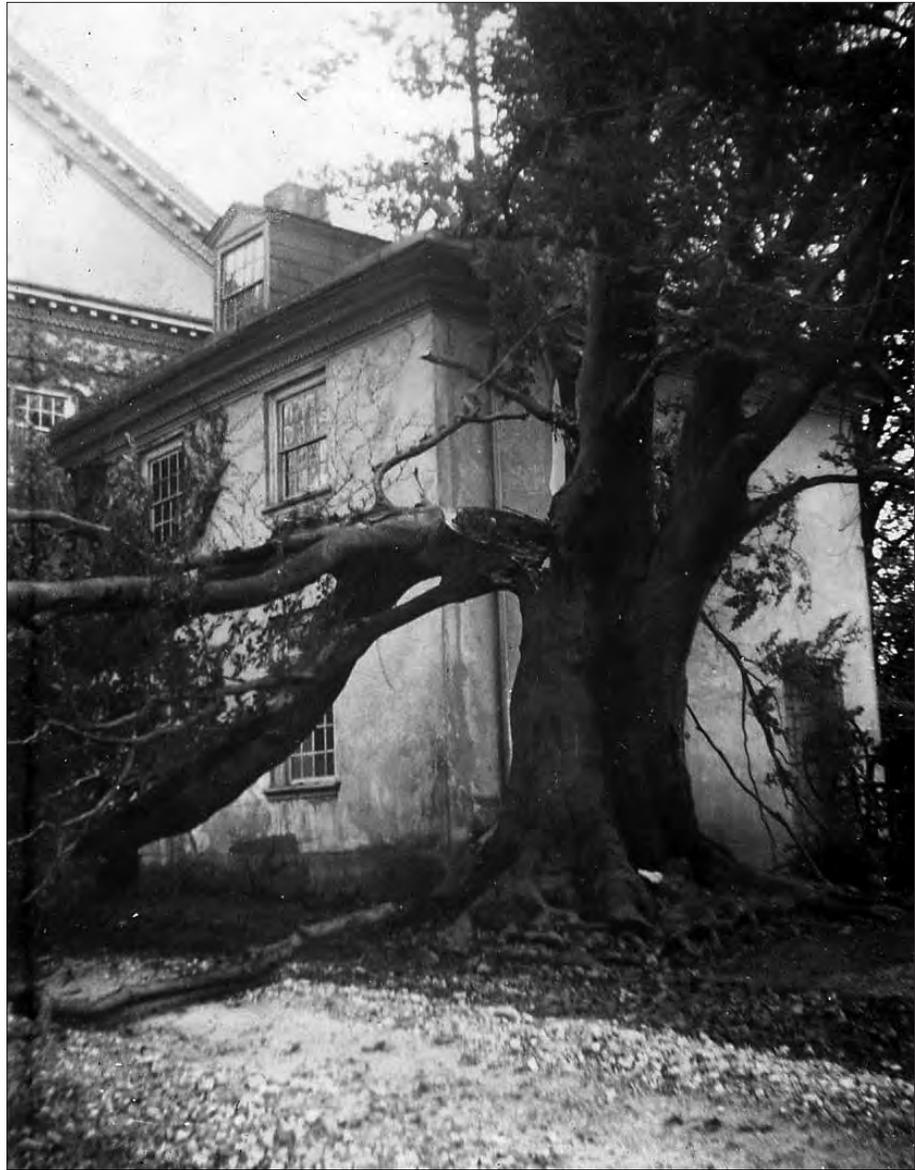
Figure 1.86. West wing of the Hampton Mansion showing a storm damaged purple-leaved European beech tree. View looking southeast, 1940 (HAMP 18146).

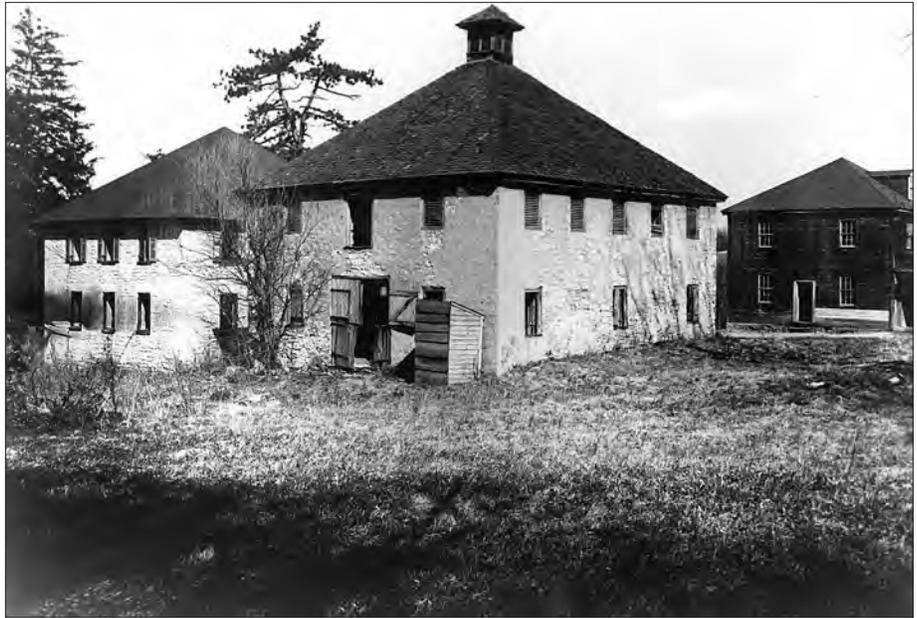
Figure 1.87. The stables with the Carriage House visible beyond Stable Drive. View looking northeast, c. 1940 (HAMP 14918).

shortly after the storm show that the loose aggregate surface of the heart-shaped carriage drive suffered from deferred maintenance and was possibly damaged as a result of fallen limbs as well (Figure 1.86). While the garden areas were well maintained, historic service areas, including the stables and Domestic Service Cluster, appear to have suffered from limited financial resources, with unmown lawns and façade damage to buildings (Figures 1.87 and 1.88).

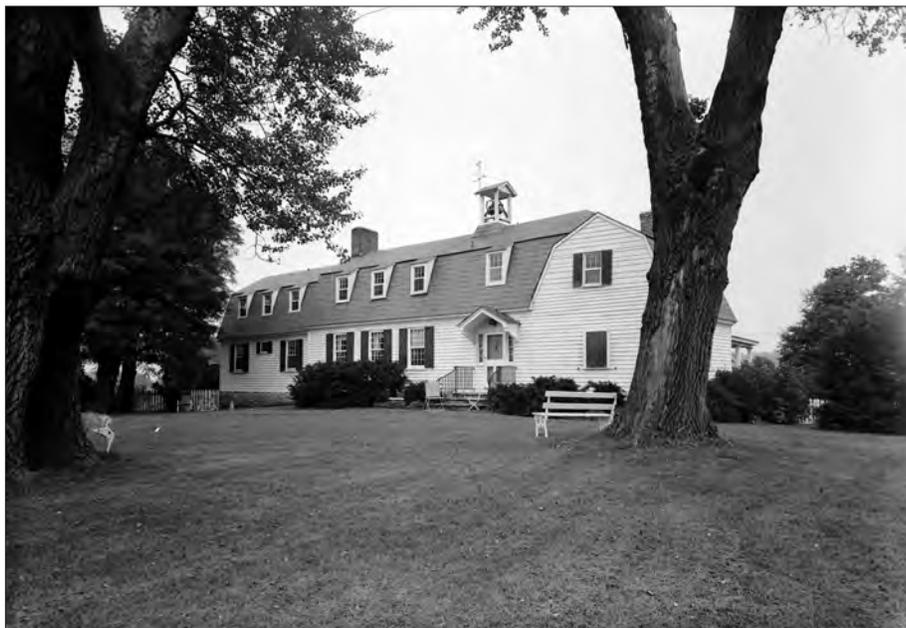
Figure 1.90. The Farm House from Farm House yard. View looking east, 1959 (HABS MD-226-J, Lanny Miyamoto).

north side of the house increased living space by about one quarter and consisted of a wood frame structure with clapboard siding and a stone foundation (Figure 1.90).

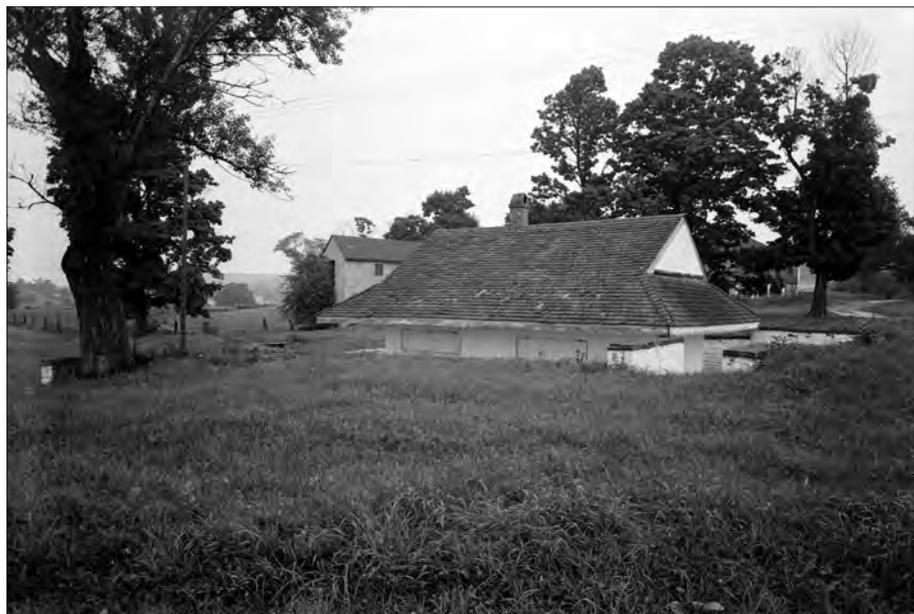
Figure 1.91. The Dairy from Farm Road. View looking east, 1959 (HABS MD-226-F, Lanny Miyamoto).

The HABS photographs also show that buildings and structures beyond the Farm House yard were overgrown with grass and weeds, and some had fallen into disrepair (Figure 1.91). Throughout the third and early fourth quarter of the twentieth century, the condition of the remaining buildings continued to deteriorate due to lack of use and maintenance.²¹³

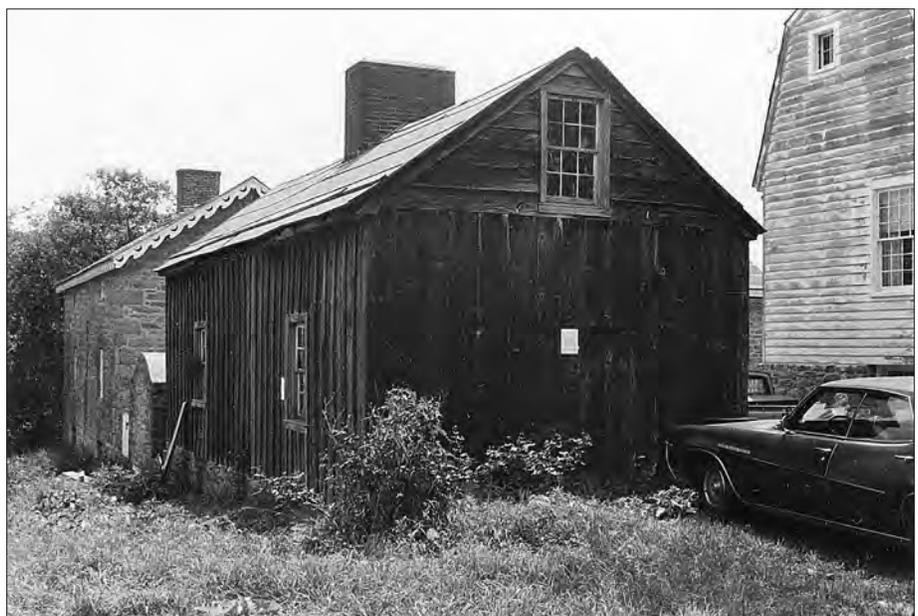
Figure 1.92. Log Farm Structure with the Farm House to the right and Salve Quarters #2 beyond. View looking south, c. 1970 (HAMP15482).

In 1982, and again in 1985, archeological investigations began at the Log Farm Structure (Figure 1.92). In 1986, an architectural preservation program focused on stabilizing the Log Farm Structure and restoring one wall of the Mule Barn that had been damaged by a failing roof during Jane Ridgely's tenancy. In 1984, archeologists continued investigations at the Dairy and the Long Barn, which were both subsequently repaired and renovated. During the late 1980s, exterior repair work was also completed on Slave Quarters #2 and Slave Quarters #3, including roof replacement. In addition, the Farm House Yard picket fence was repaired and a new wooden boardwalk and fence section was added between the Farm House, the slave quarters, and the Ash House.²²⁰

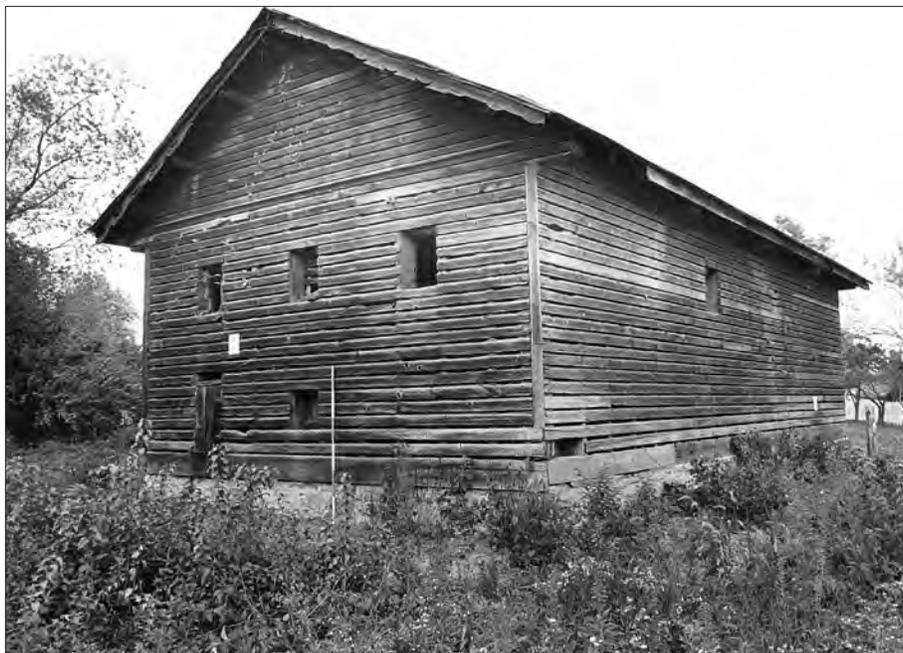
Figure 1.93. The Corn Crib prior to destruction by fire. The Farm House yard fence is visible on the right of the image. View looking northeast, c. 1980 (HAMP 28202).

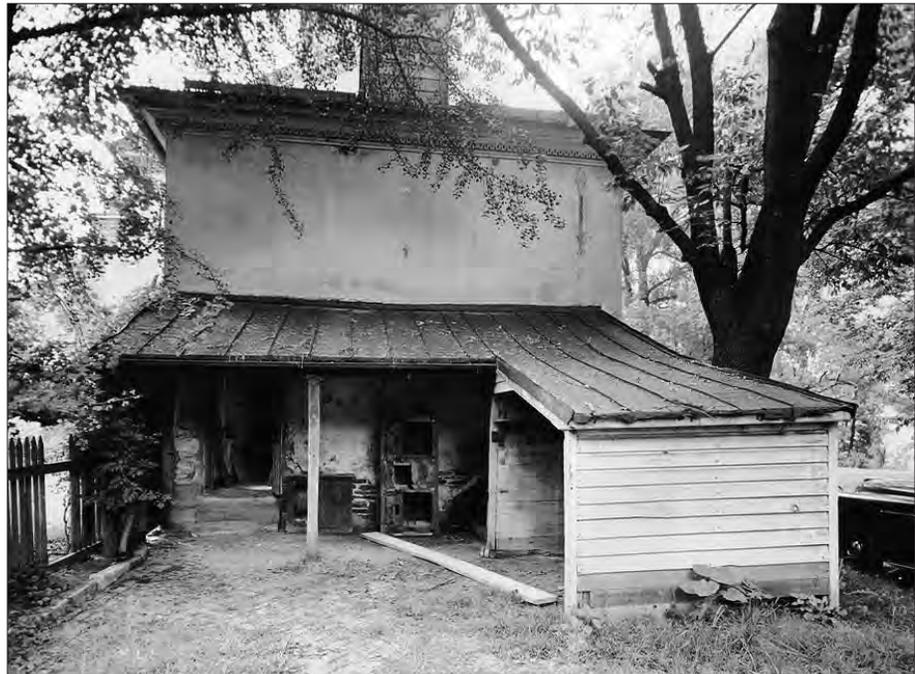
Figure 1.94. The Summer Kitchen from the East Terrace. The existing white ash is visible to the right. View looking west, 1949 (HAMP 20455).

When the National Park Service acquired the Hampton Mansion and many of its ancillary buildings from the Avalon Foundation in 1947, the buildings, structures and grounds had begun to suffer from deferred maintenance (Figures 1.94 and 1.95). Photographs from the end of Jane and John Ridgely Jr.'s tenure in the

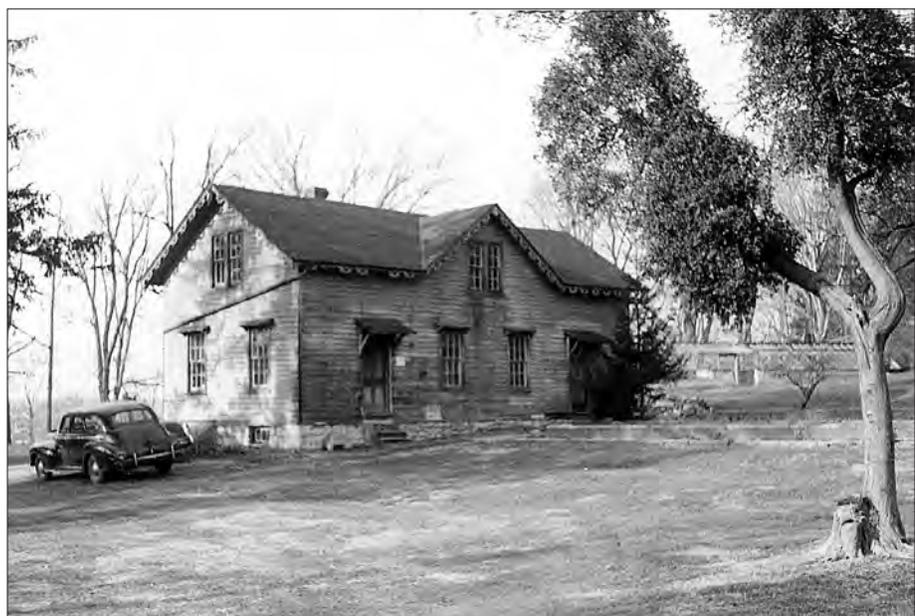
Figure 1.95. East facade of the Garden Maintenance Building. The cold frame foundations are visible in the middle ground and Greenhouse #1 is visible in the background. View looking northwest, c. 1950 (HAMP 20542_01).

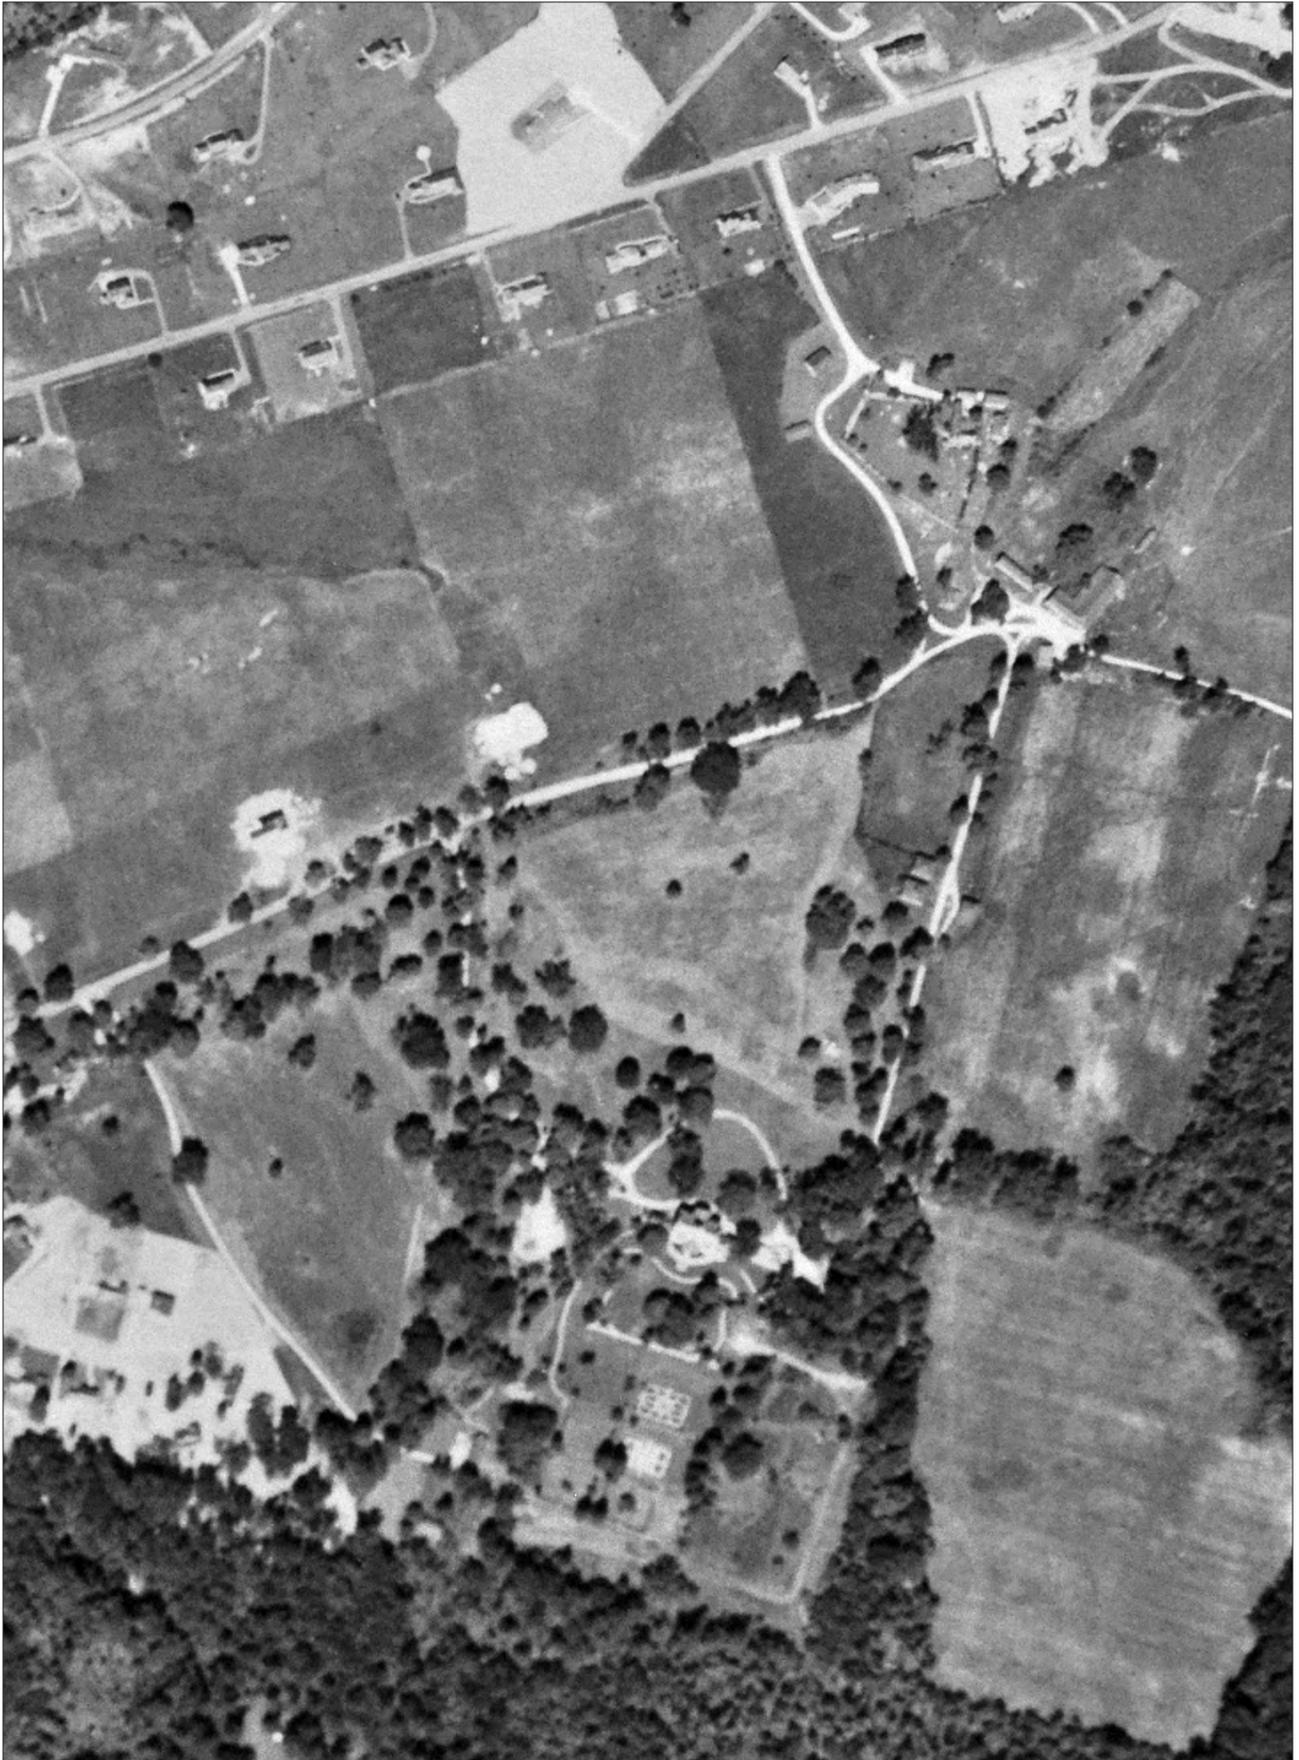
Figure 1.100. Aerial photograph of Hampton, August 28, 1952 (Baltimore County Soil Conservation District, Sheet K8, orig. 1:20,000).

Alden Hopkins had made a second visit to the site by June 30, when he submitted a formal proposal for landscape restoration plans.²²⁶ His proposal was accepted. In July 1949, Hopkins submitted “A Report on the Proposed Garden Restoration,” together with a general layout plan, and, eventually, detailed designs for five of the six parterres.²²⁷ Hopkins’ report stated that “the year 1830 has been selected as the ultimate date of reconstruction,”²²⁸ yet he proposed new parterre arrangements based largely on English precedents (Penshurst Place, Chevening House, Fragnall) from the late seventeenth and early eighteenth century.²²⁹ Elbert Cox, National Park Service Acting Regional Director, expressed concern over the “conjectural reconstruction” proposed by Hopkins. Therefore, Cox initially only recommended the restoration of Parterre I, the boxwood parterre on the east side of the upper terrace.²³⁰ In April 1949, Alden Hopkins also submitted his initial designs for a proposed parking lot adjacent to the site of the site of the Orangery.²³¹ Historic aerial photographs show that this parking lot was under construction or complete by 1952 (see Figure 1.100).

Between 1955 and 1956, three parterres on Terraces 1 and 2 were ‘reconstructed’ according to Hopkins’ plans, including Parterres I, II, and III (Figures 1.99 and 1.100). Parterre I was the recipient of the Garden Club of America Founder’s Fund Award. Work on Parterre II was supported by the Roland Park Garden Club. Reconstruction of Parterre III was funded by the Eli Lilly Foundation. In 1973, the National Park Service rehabilitated Parterre IV, with assistance from District III of the Federated Garden Clubs of Maryland.²³³ In 1976, the National Park Service also reconstructed the Orangery, which had burned to its foundation in 1926, in its original location.

of the grounds under the stewardship of the Society for the Preservation of Maryland Antiquities and the early years of the National Park Service (Figures 1.100 to 1.104).

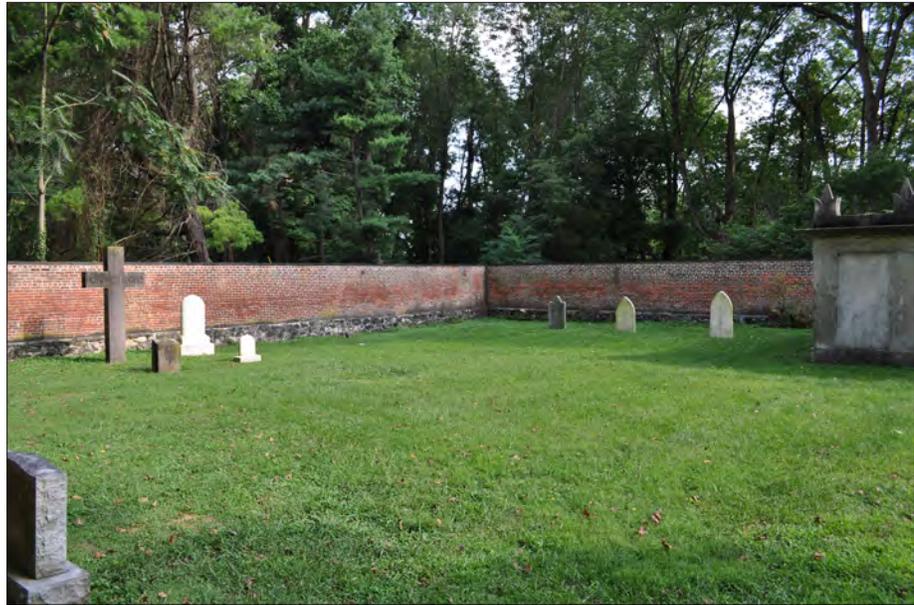
FARM LANDSCAPE

the inner perimeter of the brick wall. Broken headstones are evident, and there are more graves than are currently marked. Little vegetation remains within the cemetery, although two large Japanese yews (*Taxus cuspidata*) flank the exterior of the gated entrance (Figure 3.3).

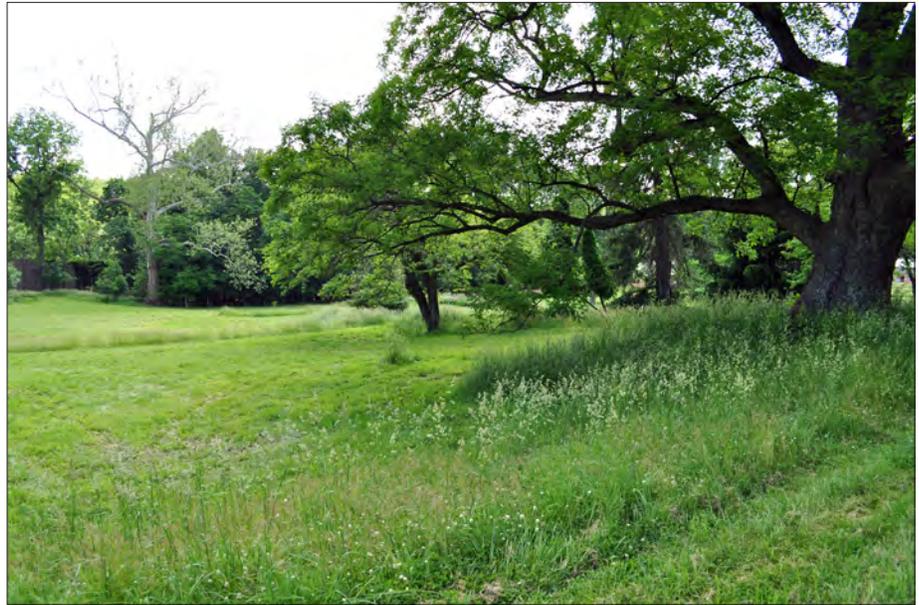
Existing Condition: The area directly east of the Falling Gardens is now a terraced meadow scattered with deciduous trees. The meadow is mown semi-annually. The remains of four terraces are evident in the gentle slope of the East Orchard. However, the last orchard specimen, a pear tree, died in the 1980s. The East Orchard is bound to the south by the highway, to the east by the Cemetery Woods, to the north by the Domestic Service Cluster, and to the west by the Great Terrace and Falling Gardens. Groupings of naturalized deciduous trees buffer the East Orchard from the highway fence (Figure 3.4).

Figure 3.4. East Orchard from the upper terraces. View looking southwest, 2012 (OCLP).

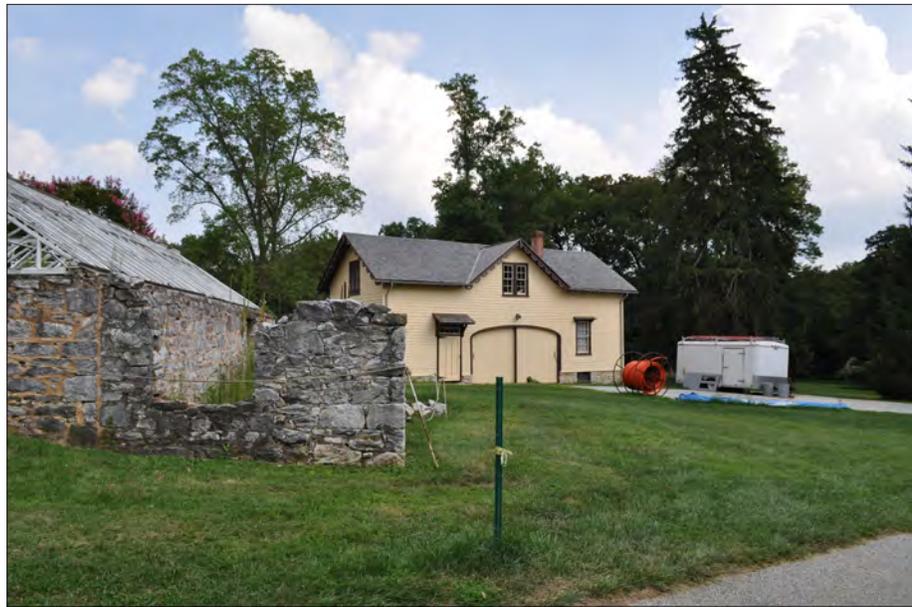
Existing Condition: Located to the west of the Falling Gardens, the Garden Maintenance Cluster has served as the core of garden maintenance activities for the estate throughout its history. The area continues to serve this function and was defined in the park *General Management Plan* as a “Support Zone” where new development could be located. The area consists of six loosely clustered buildings and their associated functional areas. The Caretaker’s Cottage is situated at the southern end, set back from other Garden Maintenance Cluster buildings. The Greenhouse #1 ruin, Greenhouse #2, and the Garden Maintenance Building are adjacent to the second and third garden terraces, on the east side of the Garden Maintenance Cluster. The contemporary Park Maintenance Building stands at

Figure 3.5. Garden Maintenance Area. View looking southeast, 2013 (OCLP).

the western end of the area, shielded from Ridgely-era structures with plantings. Access to the Garden Maintenance Cluster is currently by way of a paved road that leads to the area from the entrance road. Portions of a road trace are also evident on the western periphery of the area. Historically, this road connected the area of the Garden Maintenance Building, the Caretaker's Cottage, the Falling Gardens, the East Orchard, and fields to the east (Figure 3.5).

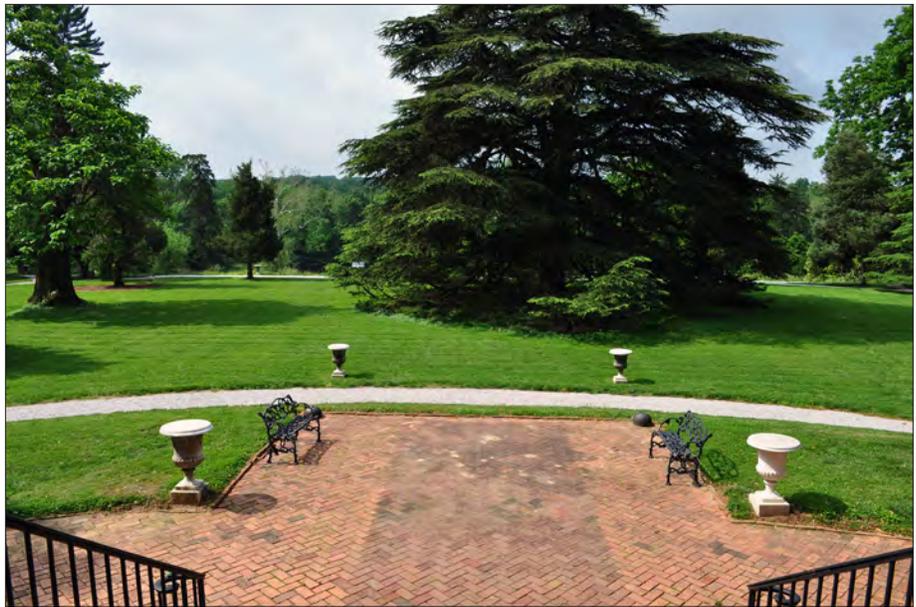
Figure 3.6. Great Terrace from the Mansion steps adjacent to the Brick Terrace. View looking south, 2012 (OCLP).

Existing Condition: The Great Terrace begins south of the Mansion's Brick Terrace and is predominantly lawn, with a variety of large deciduous and evergreen trees. An evenly spaced, circa 1840 planting of eastern redcedars (*Juniperus virginiana*) grows along the southern edge of the Great Terrace. A cedar of Lebanon is planted in the center of the lawn space, and a number of other specimen trees are planted in the Great Terrace. Southern catalpas (*Catalpa bignonioides*) along the west side of the terrace date to about 1775. It is possible they are the earliest trees planted in the gardens at Hampton. Circulation features on the Great Terrace include the Serpentine Walk, a gravel path that circles the area in a series of undulating curves. The cobblestone path leads from the western side of the Great Terrace to Greenhouse #2 and the Falling Garden terraces below (Figure 3.6). A grass ramp is located on the central axis of the Falling Gardens as well.

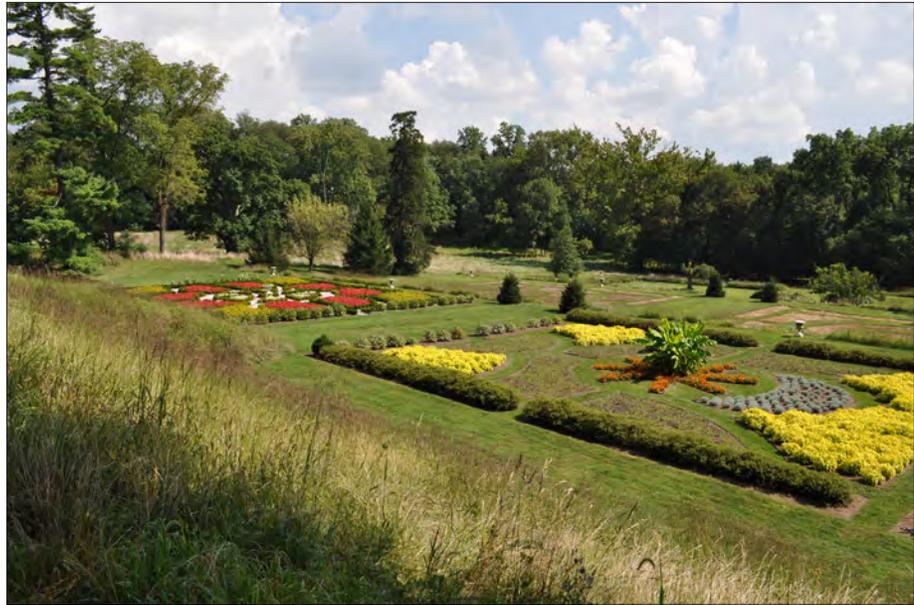
The Falling Gardens consist of a series of terraces that descend symmetrically along a strong north/south axis from the southern façade of the Mansion. The Great Terrace lies south of the Mansion. It measures approximately 160' by 240'. The lower terraces are wider at approximately 80' by 290'. Each successive terrace falls in decreasing height; the fall from the Great Terrace to Terrace 1 measures 18'-0", from Terrace 1 to Terrace 2: 6'-6", from Terrace 2 to Terrace 3: 5'-6", and from Terrace 3 to Terrace 4: 3'-0". Turf ramps connect the terraces. Regularly-

Figure 3.7. Falling Gardens from the Great Terrace. View looking southeast, 2013 (OCLP).

The layouts of the upper four parterres have been rehabilitated to reflect their appearance during Eliza Ridgely's stewardship. Parterres I and II are planted with perennials and annuals to reflect their historic appearance, while Parterres III and IV are defined but remain unplanted. Terrace 3 retains some historic plantings, including peonies planted by Lillian Ridgely and a Maryland state champion weeping Japanese scholar tree (*Sophora japonica* 'Pendula'), with only traces of the historic bed layout. Terrace 4 is surfaced in mown lawn. What is historically documented as a fifth terrace on the 1843 *Map of Hampton* is now located adjacent to the Baltimore Beltway sound barrier and is entirely forested. The entire Falling Gardens is bordered by evergreen plantings; a managed American arborvitae (*Thuja occidentalis*) hedge separates the Falling Gardens from the Garden Maintenance Area to the west, and a combination of Norway spruce (*Picea abies*), eastern white pine (*Pinus strobus*), and arborvitae divide the Falling Gardens from the East Orchard. A wooded area to the south of the Falling Gardens, consisting mostly of successional species, provides a buffer between Hampton National Historic Site and Interstate 695. The Falling Gardens are maintained by the National Park Service with support from the Federated Garden Clubs of Maryland (District III) and Historic Hampton, Inc. (Figure 3.7).

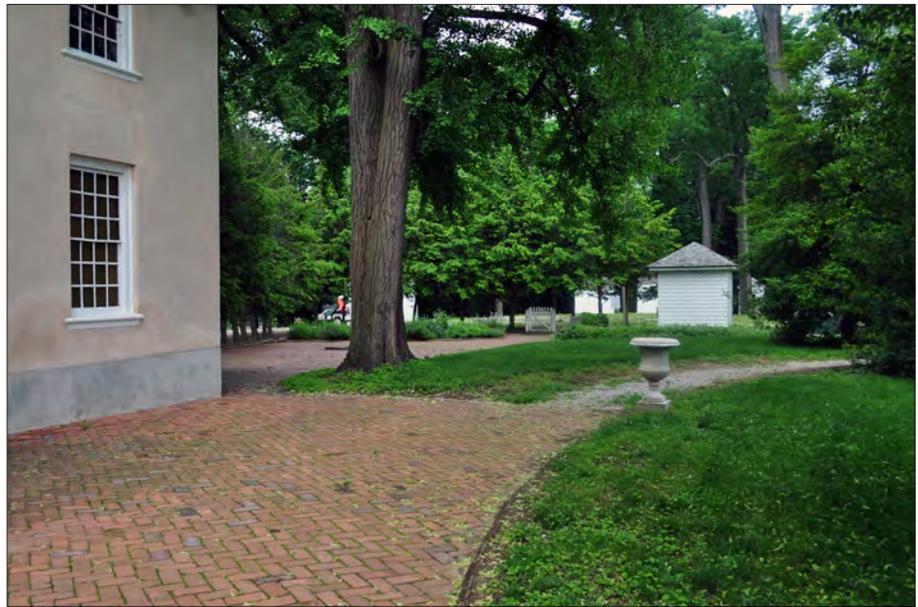
Figure 3.8. Domestic Service Cluster from the Brick Terrace at the southeast corner of the Mansion. View looking northeast, 2012 (OCLP).

Existing Condition: The Hampton Mansion commands the attention of visitors from the highest geographical point on the estate. The 1910 Garage, Coal Gas Storage ruin, Smoke House, Paint House, Privy #1, and Privy #2 are located to the east of Hampton Mansion, across what is now the geothermal well field, and are currently used for either storage or interpretation purposes. The Pump House is set closer to the Mansion, just south of the East Terrace, and is now used for storage. The reconstructed Orangery stands to the west of Hampton Mansion.

Historically used to grow fruit trees that would not otherwise survive in the local climate, the Orangery is now used to host meetings and public programming events (Figure 3.8).

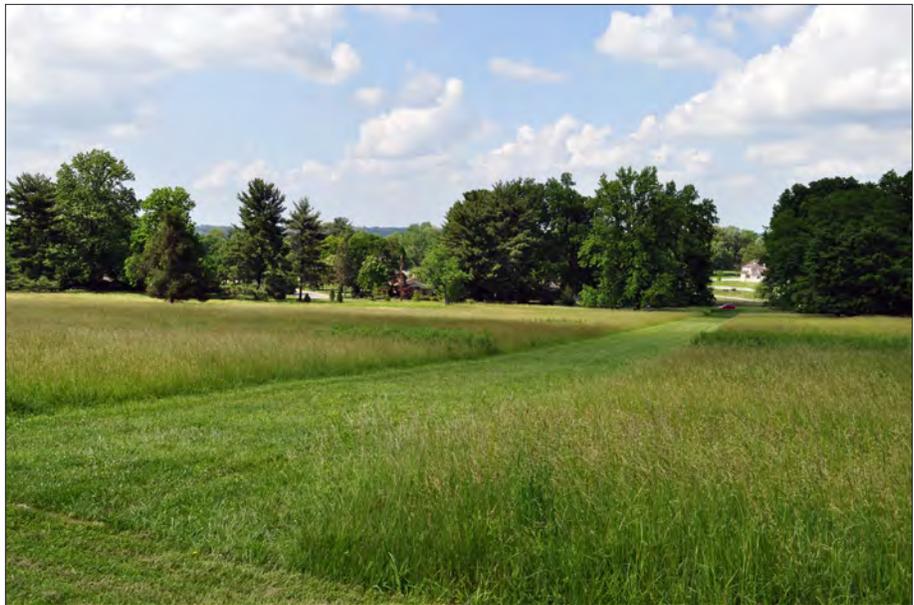
Existing Condition: The North Lawn has remained largely unchanged after the historic period. Clusters of specimen trees mark its boundaries, leaving the view to the Mansion and farm open. There is a significant transition point just beyond the heart-shaped carriage drive entry, where the lawn’s gentle slope steepens dramatically. The historic function of this ridge had not been confirmed, but it may have functioned as a ha ha, keeping animals from nearing the Mansion while maintaining the view without interruption. From the edge of this ridge to Hampton Lane, the lawn maintains a steady seven percent slope with an overall vertical change of approximately 40’. The North Lawn is mown semi-annually, whereas the formal area adjacent to the Mansion is maintained as mown lawn. A number of specimen trees fell to decline and were removed in the late twentieth century, including a pair of purple European beech (*Fagus sylvatica* ‘Atropunicea’) and one American beech (*Fagus grandiflora*) planted in the early nineteenth century (Figure 3.9).

Figure 3.9. North Lawn from the edge of the heart-shaped carriage drive. View looking northwest, 2012 (OCLP).

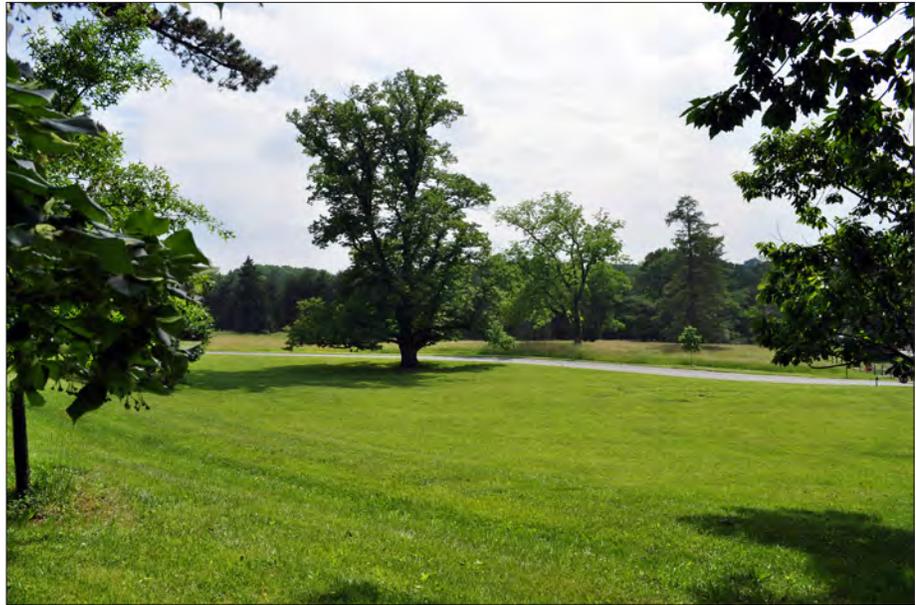
Existing Condition: The West Field is adjacent to the North Lawn, and is located to the north and west of the Mansion. The West Field underwent significant alterations near the end of the twentieth century. Few traces of the historic uses of this area have been found aside from groupings of hawthorn and apple (or serviceberry) that suggest the area was historically used as an orchard. The area has been regraded and new drainage patterns have been established to accommodate modern uses. A park entrance road, large paved bus parking pad, and additional parking area have been developed in the West Field area. Traces of the historic West Road remain, with one short section still in use near the Garden Maintenance Area. Other historic circulation patterns do not survive in the West Field. Views to the Mansion are obscured by mature vegetation. A drainage/sediment control swale, construction date unknown, extends through West Field, beginning about 200'-0" south of Hampton Lane and extending between the entrance road and the historic entrance drive. The swale extends south, passing through a culvert under the entrance road and continuing south along the western edge of the grass-paved overflow parking area, and eventually exits the southwest

Figure 3.10. West Field from the historic entrance drive. View looking southwest, 2012 (OCLP).

corner of the site (Figure 3.10). Post-historic features in the West Field, including the entrance road, parking, and drainage swale, are non-contributing, while the West Field area as a whole contributes to the park's significance.

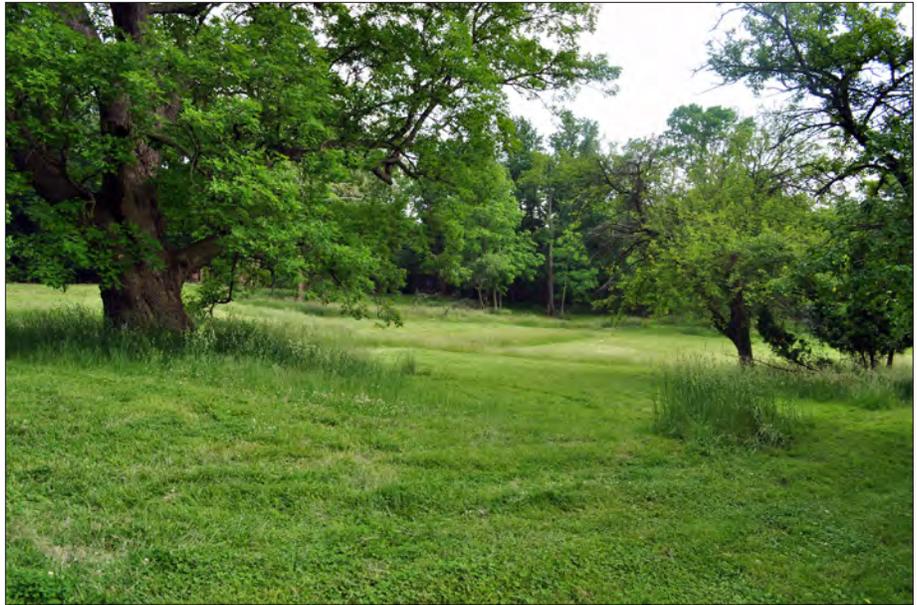
Existing Condition: Subtle remains of four terraces are evident on the East Orchard, mirroring the form of the Falling Gardens terraces. The flat areas of the East Orchard terraces are regularly mown, while the embankments between terraces are only mown semi-annually (Figure 3.11).

Figure 3.11. East Orchard terraces from the eastern edge of the Falling Gardens. View looking southeast, 2012 (OCLP).
