CULTURAL LANDSCAPE REPORT FOR HAMPTON NATIONAL HISTORIC SITE

VOLUME I: SITE HISTORY, EXISTING CONDITIONS, ANALYSIS &
EVALUATION

TOWSON, MARYLAND

Olmsted Center for Landscape Preservation
National Park Service, Boston, Massachusetts, 2014

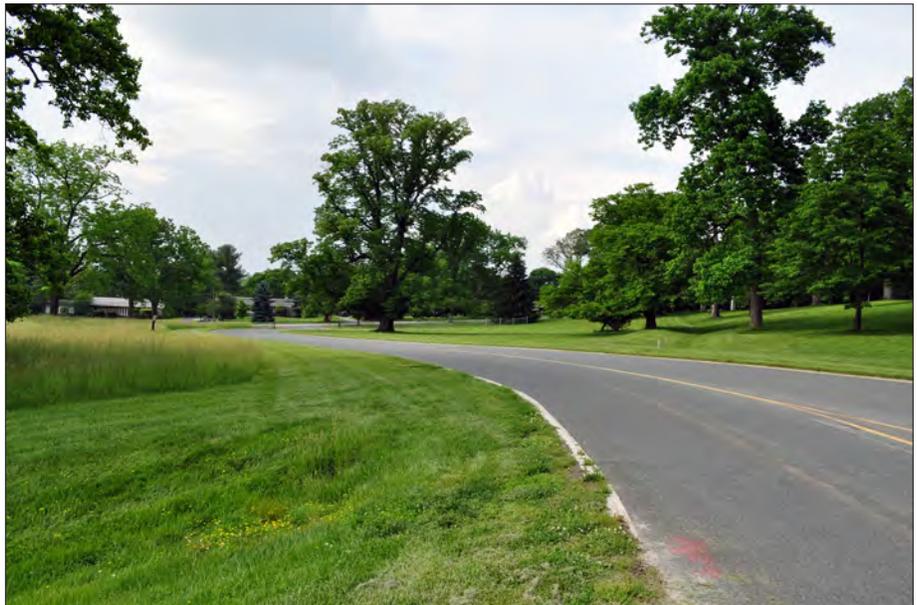
Figure 3.12. Drainage swale along the western side of the visitor entrance road. View looking northwest, 2012 (OCLP).

Existing Condition: Swales and culverts were placed along the entrance road for drainage and sediment control when it was constructed in 1988. The main swale begins between the historic entrance drive and the current entrance and extends through West Field. The swale is directed into a culvert under the current entrance drive, continues along the western edge of the overflow parking area, and enters a second culvert under the West Road trace to the east of the Park Maintenance Building (Figure 3.12).

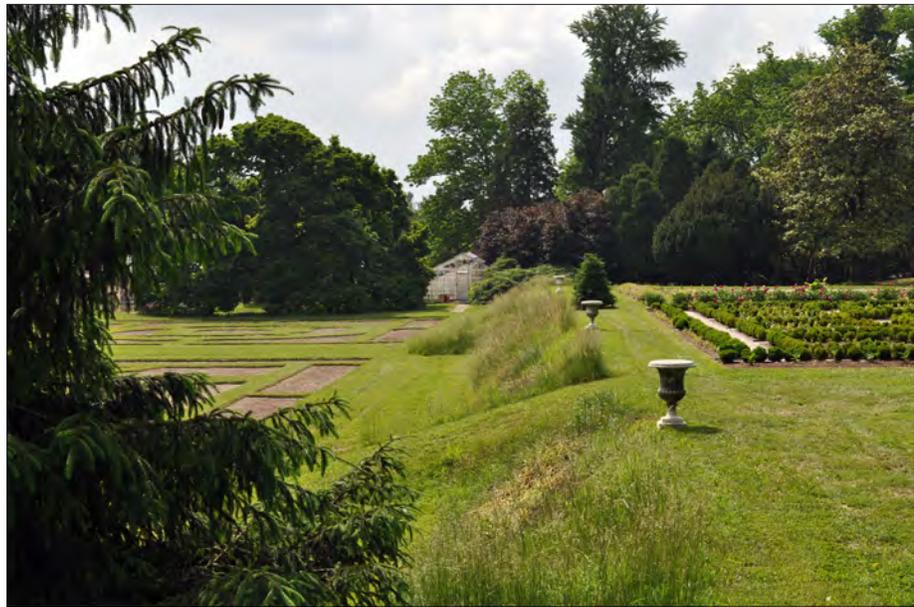
Figure 3.13. Falling Garden terraces showing the earthen embankment between Terraces 1 and 2. View looking west, 2012 (OCLP).

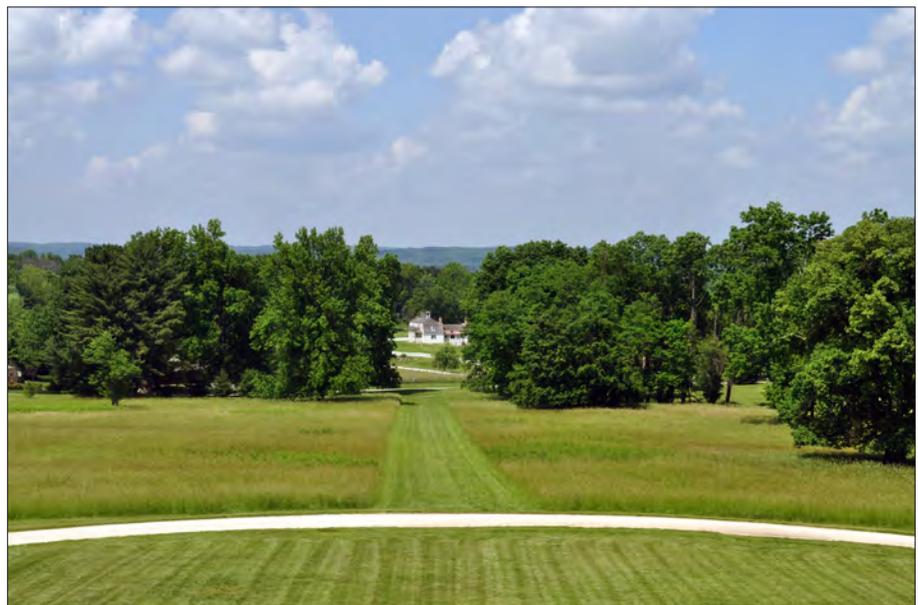
Existing Condition: The elevation of the Mansion emphasizes the view to the Farm House cluster. An opening in the plantings along Hampton Lane frames the view of the Farm House. An axial strip of the North Lawn is maintained as mown lawn, accentuating the line of sight to the Farm House from the Mansion, and vice versa. Despite suburban housing developments immediately surrounding Hampton, the historic view to the Farm House from the Mansion has been maintained and is intact. Vegetation in the foreground shields contemporary houses that border the park (Figure 3.14).

Figure 3.14. View across the North Lawn to the Farm House from the Mansion. View looking north, 2012 (OCLP).

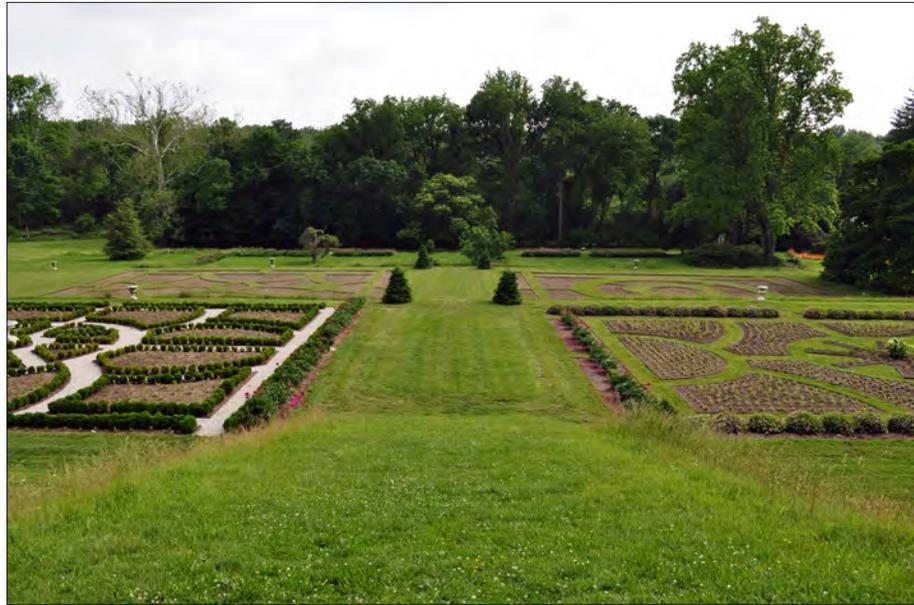
Figure 3.15. View along the central axis of the Falling Gardens from the Great Terrace. View looking south, 2012 (OCLP).

Existing Condition: The view along the central axis of the Falling Gardens extends along a mown lawn pathway that is flanked by symmetrical plantings of Norway spruce (*Picea abies*) and elaborate parterres. The view terminates in a wooded area at the southern boundary of the park, where a concrete sound wall separates the park from the Baltimore Beltway (Figure 3.15). A Chinese chestnut (*Castanea mollissima*) currently grows just to the east of the central axis on the edge of the woods at the south end of the Falling Gardens. The origin of the tree is unknown, but it appears to have been intentionally planted during the historic period.

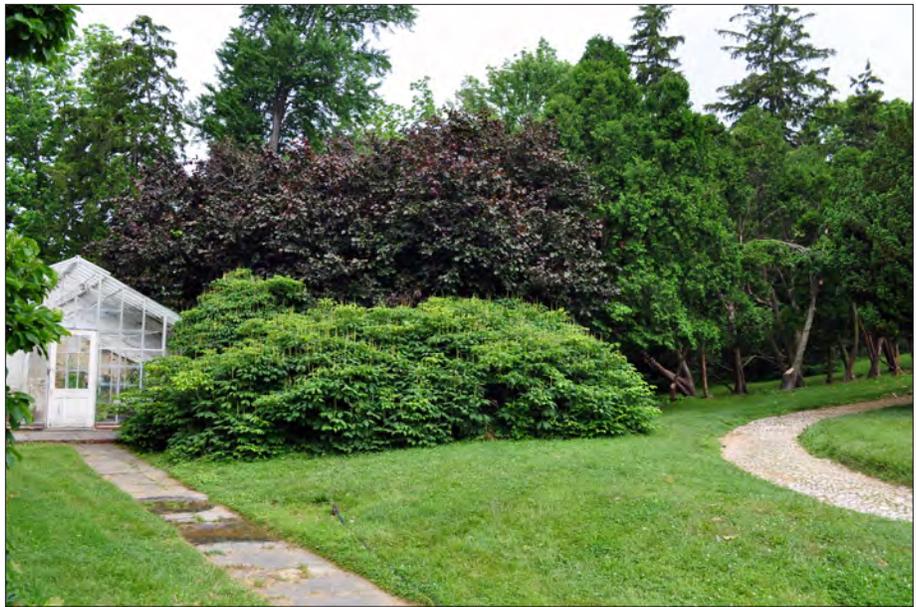
Figure 3.16. Bluestone walk to Greenhouse #2. The cobblestone path is also visible to the right. View looking northwest, 2012 (OCLP).

Existing Condition: A 3'-0" wide bluestone walk extends eastward from the entrance of Greenhouse #2 toward the grass walk on Terrace 2. The bluestone pavers vary in length between 12" to 24". Historically, the bluestone walk is documented connecting with the cobblestone path. However, it currently terminates short of this juncture (Figure 3.16).

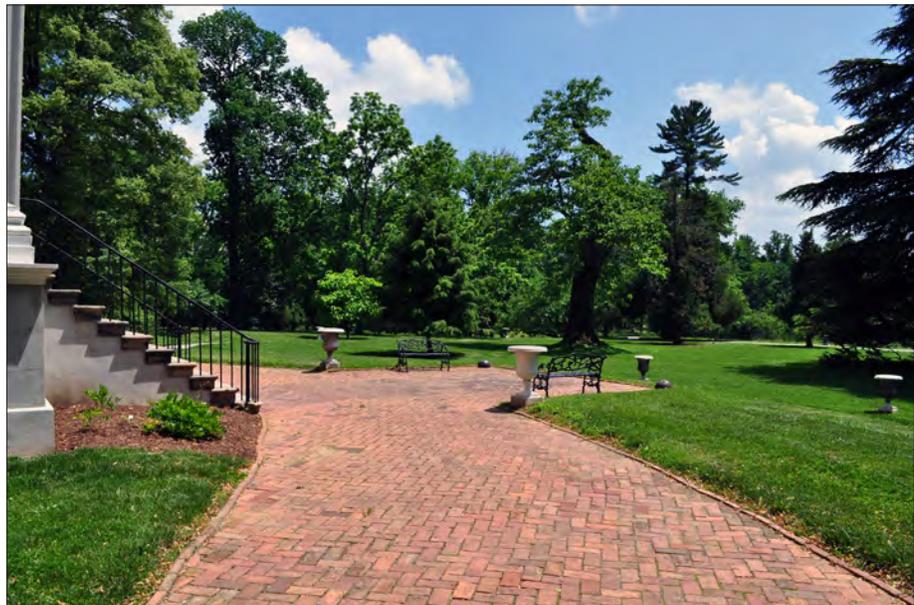
Existing Condition: The Brick Terrace, located on the south side of the Mansion, extends from the west hyphen to the east hyphen of the Mansion. The curvilinear edge of the terrace is defined by a light granite curb. The red brick surface is laid in a herringbone pattern (Figure 3.17).

Figure 3.17. Brick Terrace to the south of the Mansion, with the Great Terrace visible to the right. View looking east, 2012 (OCLP).

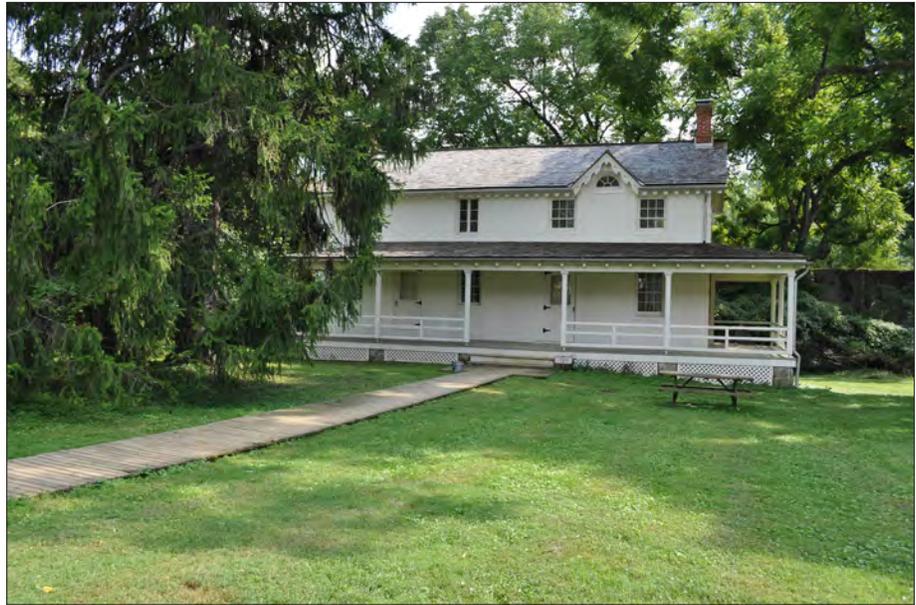
Figure 3.18. The non-contributing Caretaker's Cottage boardwalk. View looking south, 2013 (OCLP).

Existing Condition: The park constructed a wooden boardwalk from the front steps of the Caretaker's Cottage to the Garden Maintenance area parking lot sometime between 1981 and 1991. The 4'-0" wide walk consists of pressure-treated lumber (Figure 3.18).

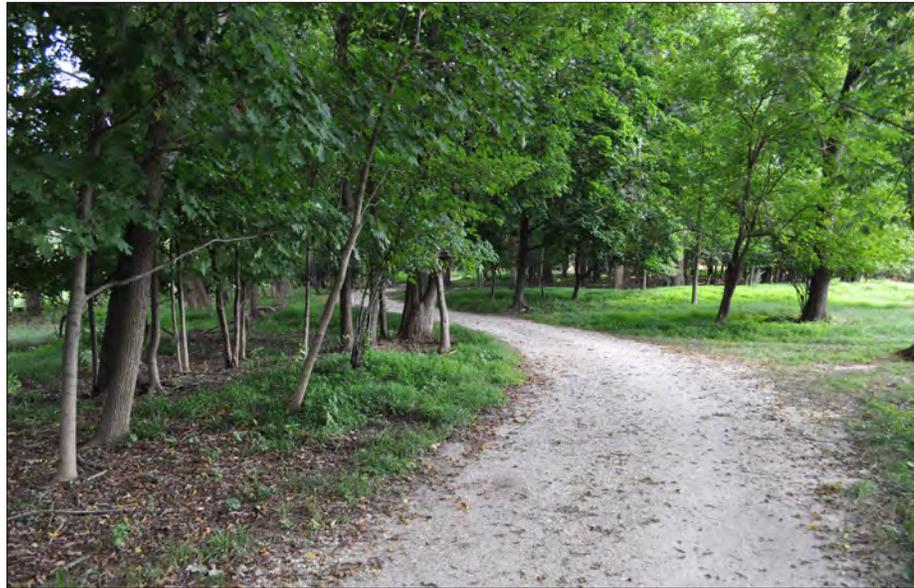
Existing Condition: The cemetery road is surfaced with compacted earth and crushed stone. It winds along flat terrain southeast of the mansion and ends in a circular loop at the cemetery gate. The road is approximately 10' wide and 1,000' long. The road was altered in 1949 (Figure 3.19).

Figure 3.19. Cemetery road, along the eastern park boundary. View looking southeast, 2013 (OCLP).

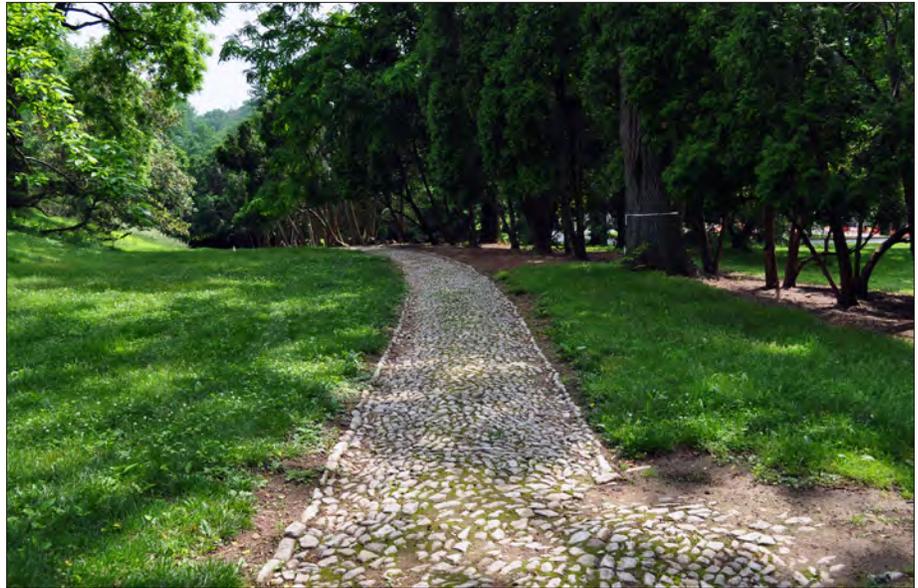
Existing Condition: The existing cobblestone path begins at the Brick Terrace and terminates just short of the bluestone walk to Greenhouse #2. The path is approximately 5'-6" wide and 376' long and has a surface of white quartz stones. Only 3' to 4' of the Orangery spur remains visible. The balance has likely been overgrown by turf. The main path ranges from being relatively clear to completely overgrown, with the southernmost section entirely overgrown by lawn. The portion of the cobblestone path that remains visible underwent preservation work in 2003 (Figure 3.20).

Figure 3.20. Cobblestone path from the south of the Orangery. View looking south, 2012 (OCLP).

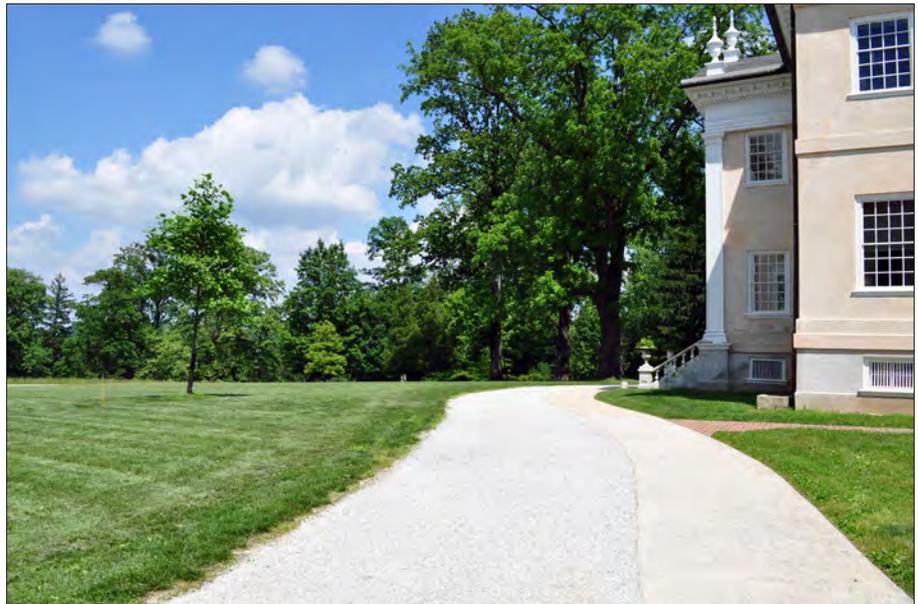
Existing Condition: The concrete walk to mansion is located on the north side of the Hampton Mansion and abuts the southern edge of the heart-shaped carriage drive. The walk provides an accessible route from the upper parking lot to the East Terrace, including access to the Mansion visitor entrance and front steps (Figure 3.21).

Figure 3.21. Concrete walk to the Mansion from the heart-shaped carriage drive. View looking east, 2012 (OCLP).

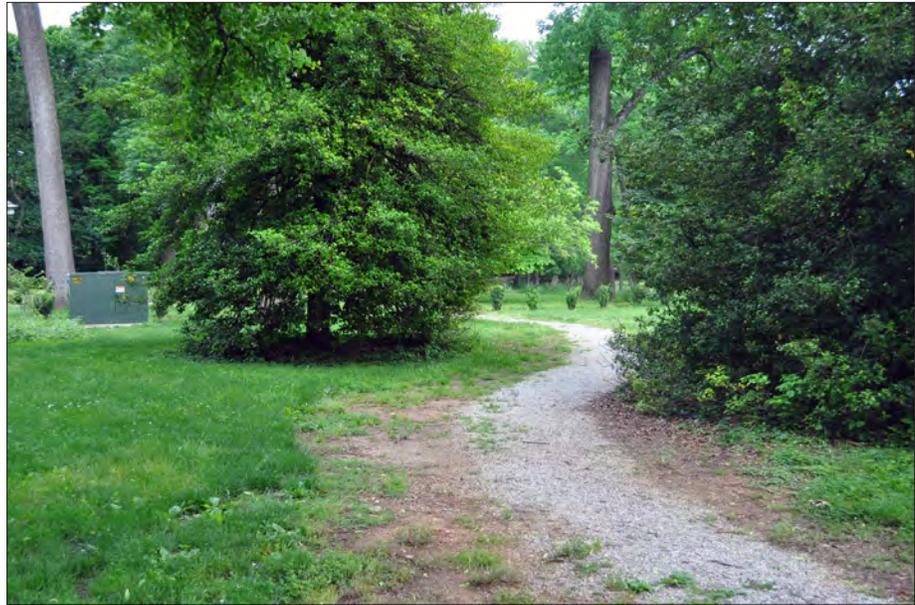
Existing Condition: The East Pathway begins at the Brick Terrace and winds in the direction of the privies under a tree canopy. The 5’-6” wide pathway is currently surfaced with white gravel. It terminates at the edge of the geothermal well field and does not continue to the domestic support buildings to the east. The East Pathway was restored in 1999–2000 (Figure 3.22).

Figure 3.22. East Pathway from the Brick Terrace. View looking east, 2012 (OCLP).

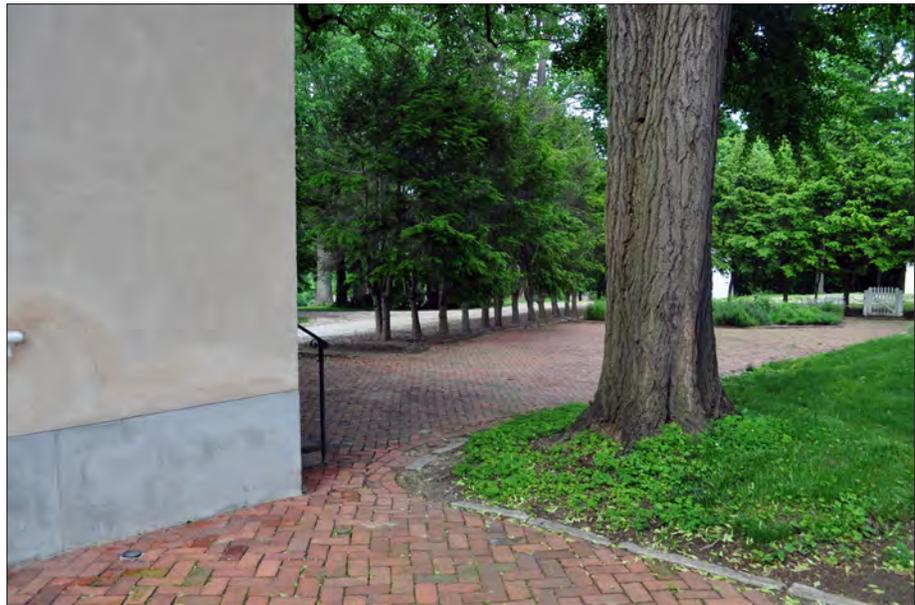
Figure 3.23. East Terrace from the Brick Terrace at the southwest corner of the Mansion. View looking northeast, 2012 (OCLP).

Existing Condition: The East Terrace is located to the east of the east wing of the Mansion. The brick surface is laid in a herringbone pattern and the edges are lined with a square, white, granite curb. The southern edge of the East Terrace is aligned with the Mansion façade. The north and east sides of the terrace are lined with overgrown hemlock hedges. The East Terrace gate marks the eastern entrance to the area. An octagonal herb garden is located in the northeast quadrant of the terrace and marks the historic location of servants' quarters (Figure 3.23).

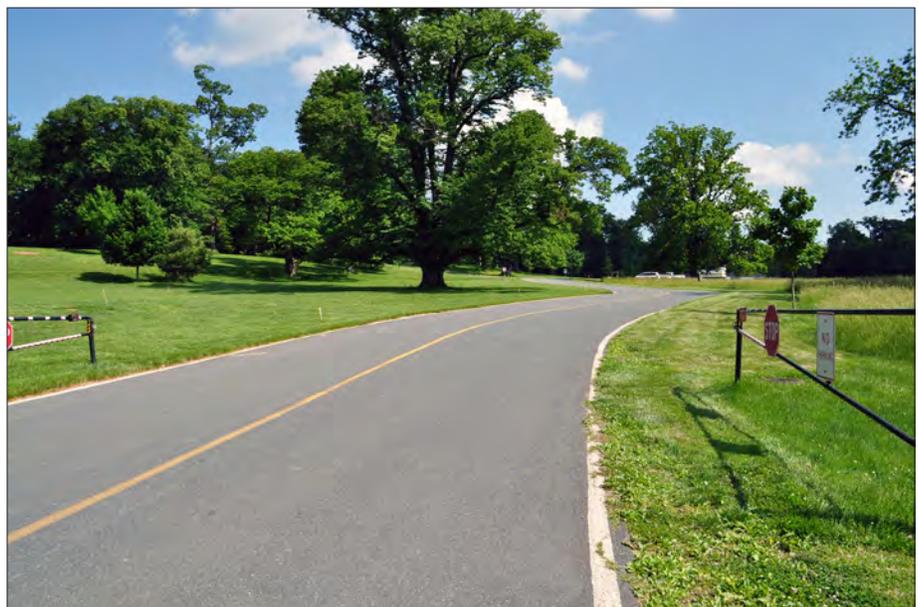
Existing Condition: The National Park Service constructed the entrance road in 1988. This bituminous concrete road is located southwest of the historic entrance drive and runs from Hampton Lane, through West Field, and uphill to the upper parking lot. In the West Field, the road is designed for two-way traffic. Access to the upper parking lot is a one-way loop. The portion of this road through the West Field is proposed for relocation to the west in conjunction with construction of a new park visitor center (Figure 3.24).

Figure 3.24. Entrance road from its intersection with Hampton Lane. View looking southeast, 2012 (OCLP).

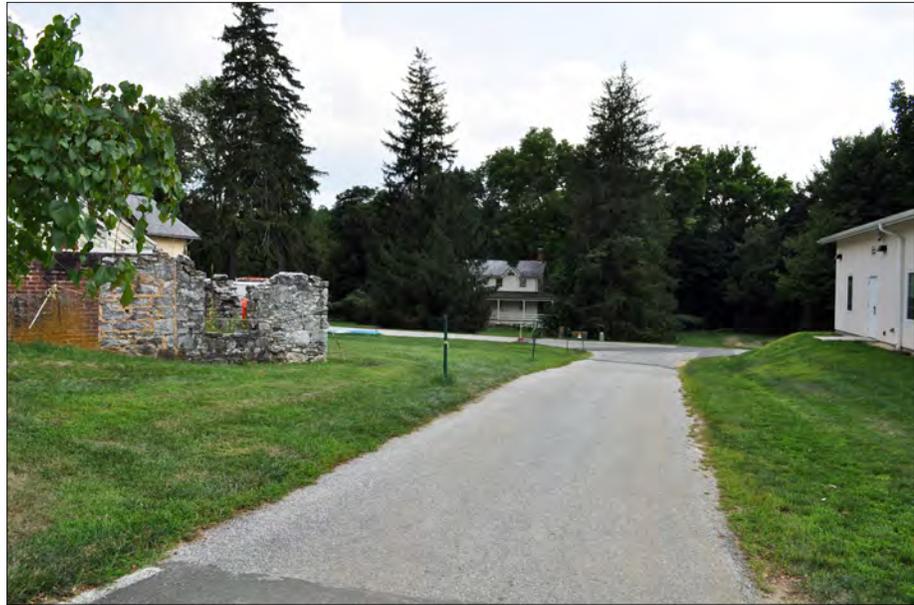
Figure 3.25. Garden Maintenance Area service road and parking.
View looking south, 2013 (OCLP).

Existing Condition: The Garden Maintenance Area service road intersects with the southernmost point of the entrance road and extends to the south to connect with the Garden Maintenance Area parking lot and to provide access to the Park Maintenance Building (Figure 3.25).

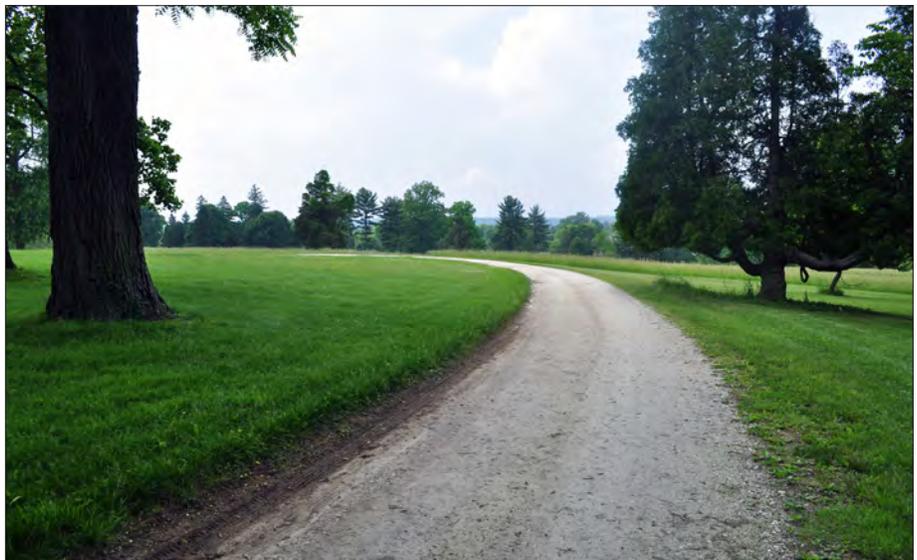
Existing Condition: The historic character of the heart-shaped carriage drive has been maintained since the end of the historic period, with the exception of the addition of a concrete walk along the Mansion front. The drive is surfaced with crushed stone. A drainage culvert crosses under the drive, although it is not known if it still provides drainage from the inside of the loop (Figure 3.27).

Figure 3.27. Eastern portion of the heart-shaped carriage drive. View looking north, 2012 (OCLP).

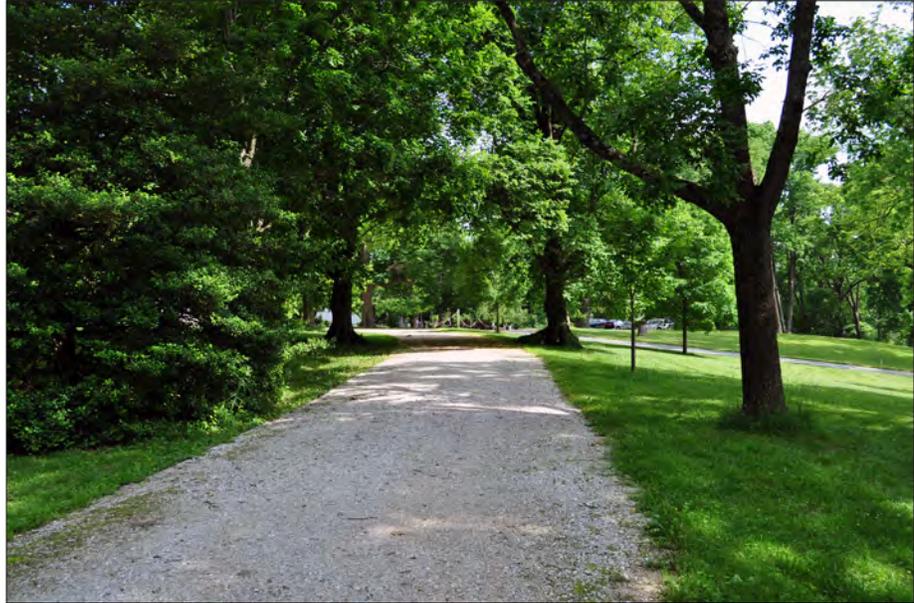
Figure 3.28. Historic entrance drive surfaced in crushed stone. View looking southeast, 2012 (OCLP).

Existing Condition: Intersecting Hampton Lane about 250'-0" to the east of the entrance road, the historic entrance drive leads south from Hampton Lane and curves east to meet the heart-shaped carriage drive to the north of the Mansion. The drive is surfaced with recycled crushed concrete and is bordered by steel edging in some areas. The historic entrance drive has not been used for vehicular circulation since the construction of the visitor entrance drive in 1988. However, it remains a well-traveled pedestrian route (Figure 3.28).

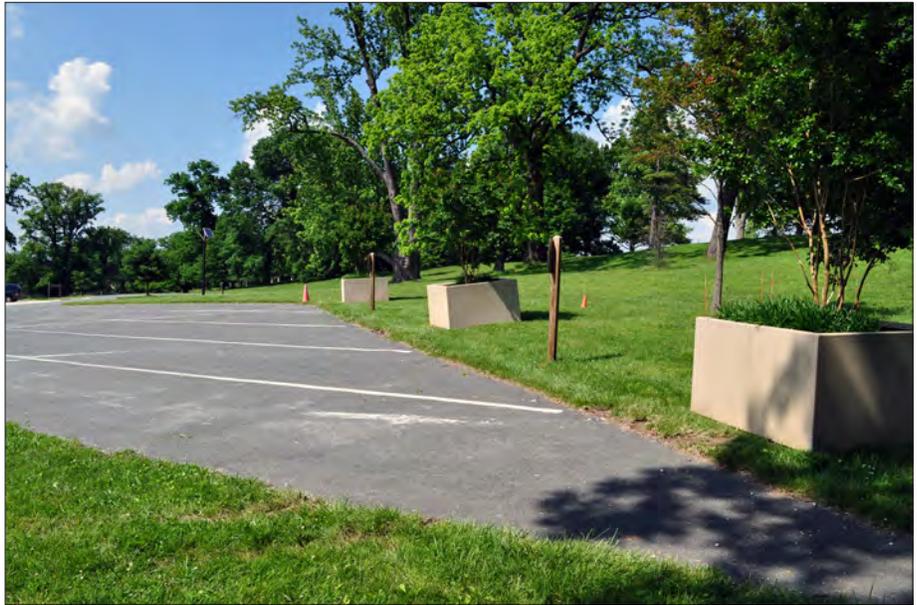
Figure 3.29. Lower parking lot, with bus parking area. View looking northwest, 2012 (OCLP).

Existing Condition: The park installed the lower parking lot to accommodate buses and overflow parking. Paved bus parking is located on the east side of the entrance road and overflow parking is located on the west side of the road on an areas surfaced with light colored gravel over interlocking plastic paving grid. This parking area is planned for removal, as a replacement lot is proposed in conjunction with the new park visitor center (Figure 3.29).

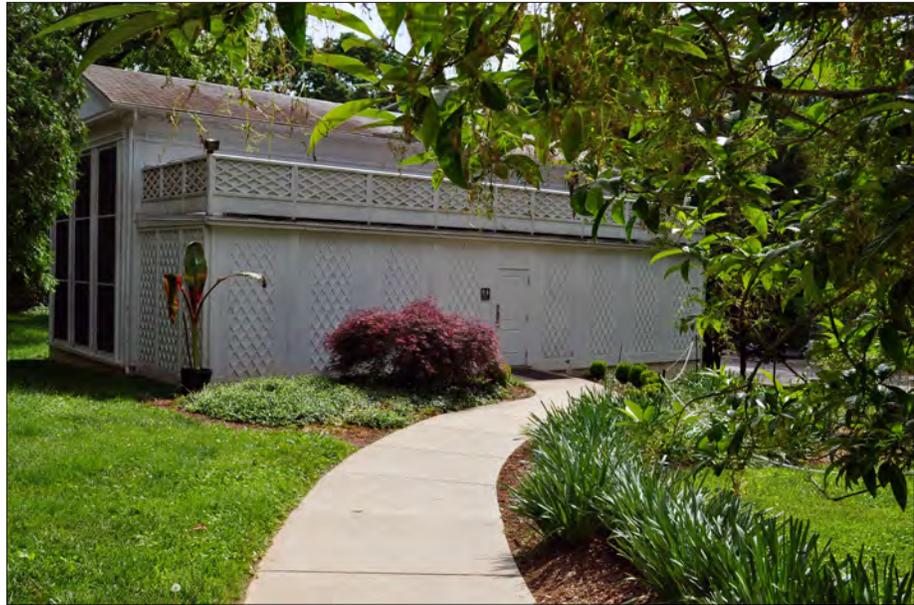
Existing Condition: Pedestrian access to the Orangery is provided by a concrete walk that connects the north side of the Orangery with the western side of the heart-shaped entrance drive. The alignment of the short walk includes two gentle curves at a universally accessible grade (Figure 3.30).

Figure 3.30. Concrete walk leading to the Orangerie from the historic entrance drive. View looking southwest, 2012 (OCLP).

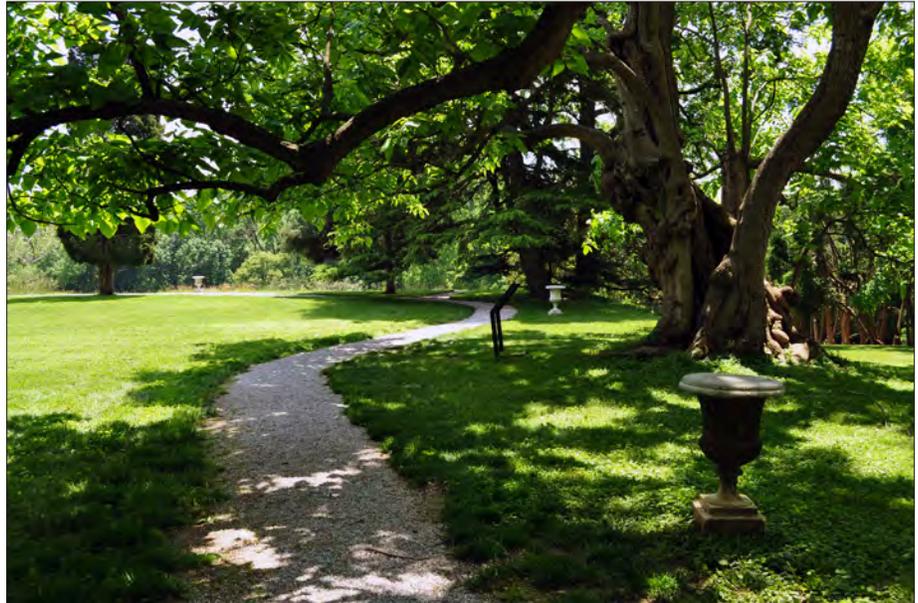
Existing Condition: The Serpentine Walk retains its historic alignment, a butterfly shape, along the perimeter of the Great Terrace. Along the north, west, and east sides, the walk is gently curving. On the south side the walk runs in an east-west alignment at the crest of the first slope of the Falling Gardens. The walk is surfaced with white gravel and is approximately 5'-6" wide and 800' long (Figure 3.31).

Figure 3.31. Western side of the Serpentine Walk on the Great Terrace as it leads under the limbs of a southern catalpa. View looking south, 2012 (OCLP).

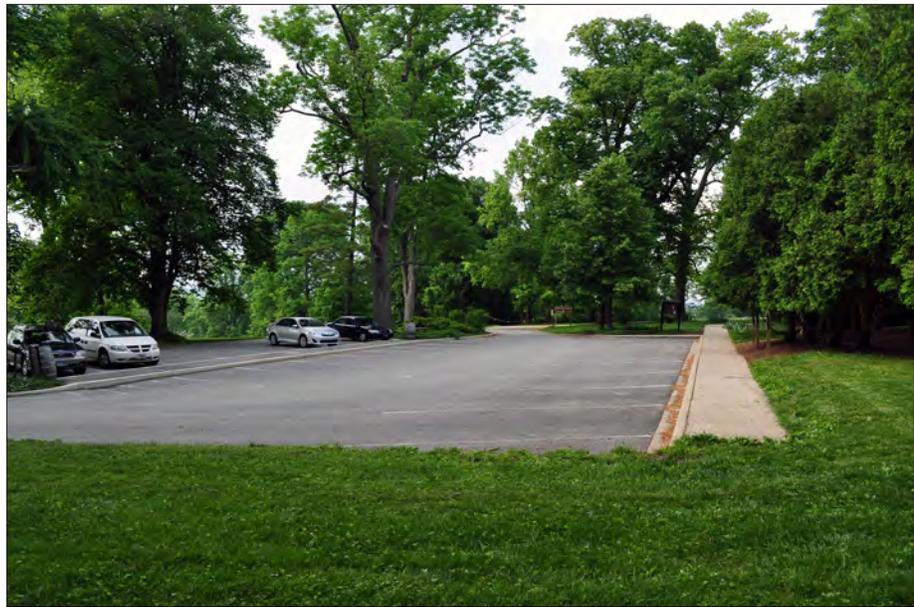
Figure 3.33. Upper parking lot showing the concrete walk to the Orangery. View looking north, 2012 (OCLP).

Existing Condition: The upper parking lot is the closest visitor parking lot to the Mansion, and is located directly to the west of the Orangery. The lot was designed by landscape architect Alden Hopkins in 1949. The lot was complete or under construction by 1952. It is paved with bituminous concrete and shaded by mature canopy trees. A universally accessible concrete sidewalk along the eastern side of the parking lot, constructed in 1995, accommodates pedestrian access to the Mansion (Figure 3.33).

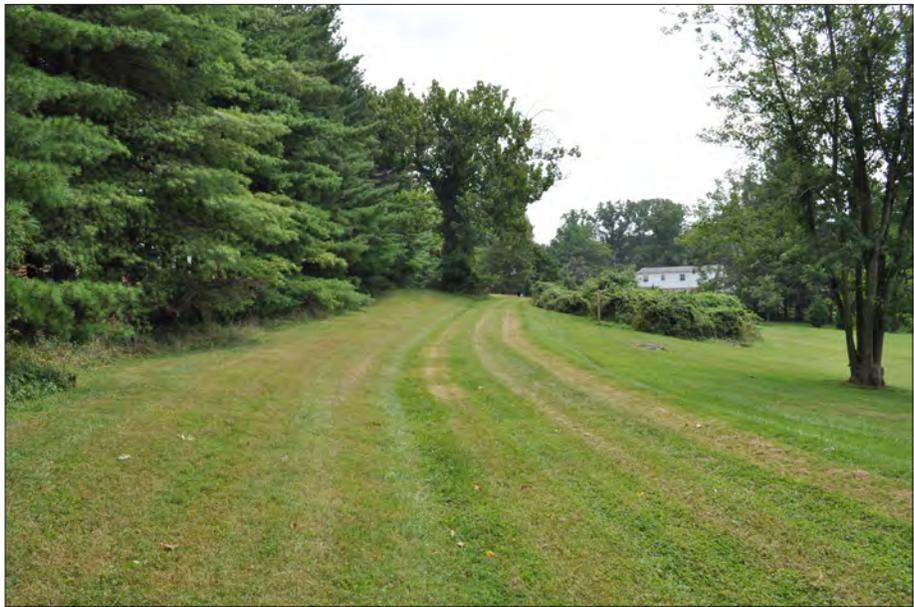
Existing Condition: The West Road trace runs along the western boundary of the mansion landscape. It extends from Hampton Lane, under the green metal Park Maintenance Building, to a small parking area adjacent to the Garden Maintenance Building. The road trace is approximately 10’-0” wide and 850’-0” long. The only section that is currently maintained and used for vehicular circulation lies within the Garden Maintenance Area. This portion of the road was

Figure 3.34. West Road trace along the western park boundary, now planted with a white pine screen. View looking southwest, 2013 (OCLP).

Along the east side of the road trace, white pines (*Pinus strobus*) provide a screen for adjacent residential development. Several large specimen trees border the road trace and are possible remnants of an earlier planting. The remainder of the road is visible only as a trace and is maintained as mown turf. The section of the road that extended eastward from the Garden Maintenance Area is missing, although traces of the road remain visible in some portions of the Falling Gardens and East Orchard (Figure 3.34).

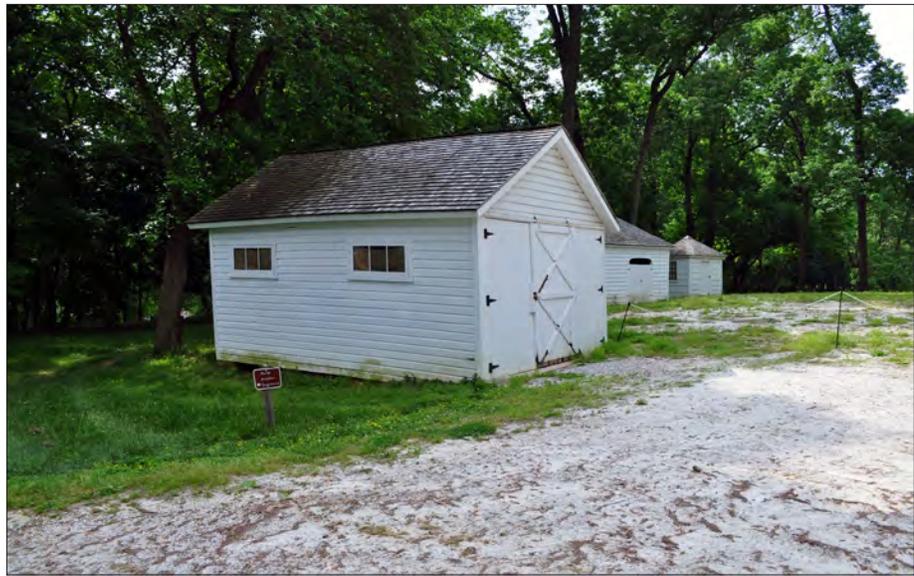
Figure 3.35. 1910 Garage showing the geothermal well field at right. View looking southeast, 2012 (OCLP).

Existing Condition: The garage is located approximately 200' from the east side of the Mansion. It is a 14'-8" by 20'-4" structure with white clapboard siding, a wood-shingled gable roof, and doors on its western face. The garage's placement on the north side of the graveled parking area provides enclosure for the Domestic Service Cluster. Windows on the north and south sides provide light, and the west wall has a central sliding door flanked by two hinged doors for vehicle access. The 1910 Garage underwent preservation work in 2007 and is currently used for storage (Figure 3.35).

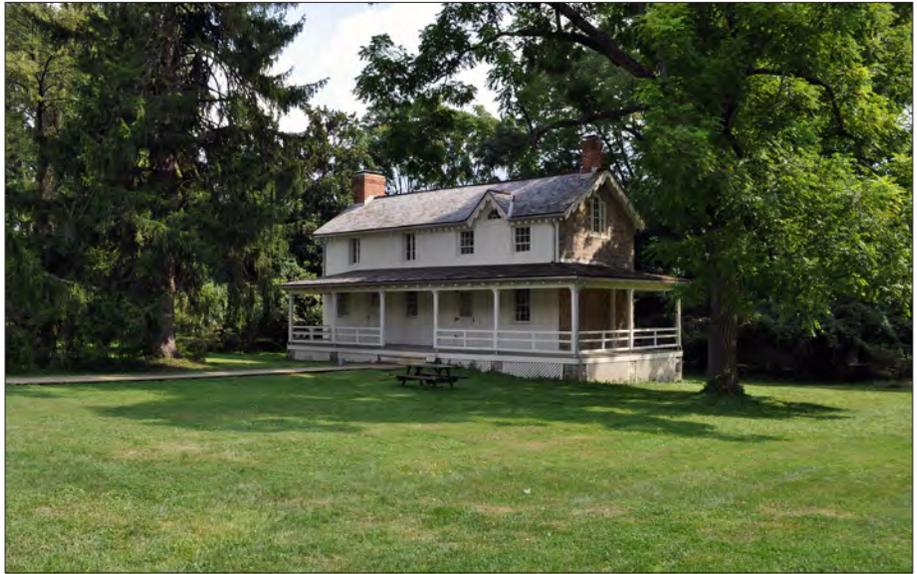
Figure 3.36. Caretaker's Cottage, with the non-historic walkway and southern park boundary beyond. View looking southwest, 2013 (OCLP).

Existing Condition: The Caretaker's Cottage is a two-story quarters comprised of two roughly equal parts. The west half is laid in stone and the east half in brick. The building is covered in stucco and painted white except for the west side and the western half of the south side, where the stone is exposed. The Caretaker's Cottage has undergone minor renovations since the end of the historic period. These include kitchen and bathroom fixtures, and carpeting. The door on the north side of the west structure is of modern, likely a replacement. The porch, located on the north side, has a replacement rail at the top of the stairway. Beveled caps on the porch columns are likely later additions to the porch as well. The building underwent preservation work in 1997–98 (Figure 3.36).

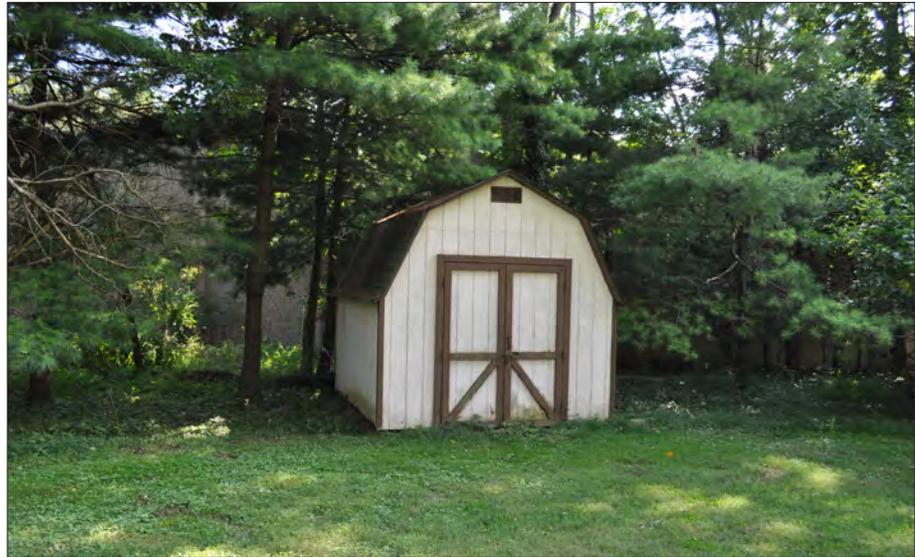
Existing Condition: The Caretaker's Shed is located southeast of the Caretaker's Cottage. It was constructed in 1985, and is planned for removal (Figure 3.37).

Figure 3.37. Caretaker's Shed. View looking south, 2013 (OCLP).

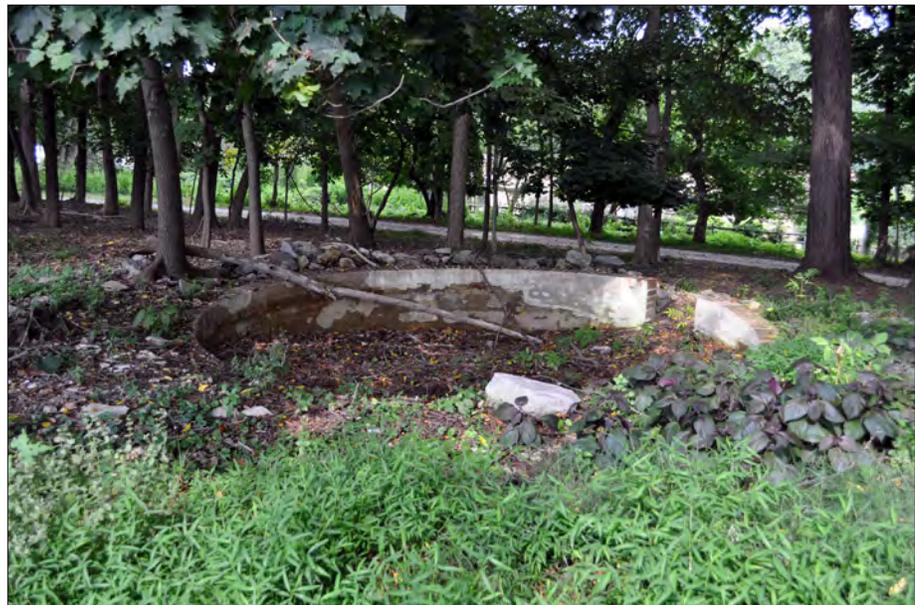
Figure 3.38. Coal Gas Storage ruin. View looking east, 2013 (OCLP).

Existing Condition: Portions of the circular brick wall of the Coal Gas Storage ruin remains visible. The brick walls are laid in common bond with sixth course header bond. The extant masonry underwent restoration work in 2009 (Figure 3.38).

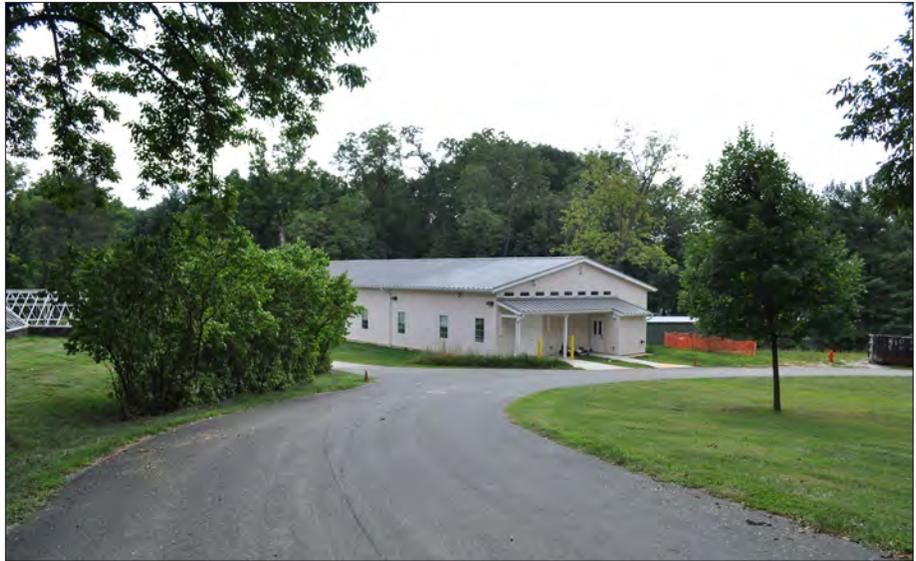
Figure 3.39. Collections Storage Building. View looking southwest, 2013 (OCLP).

Existing Condition: The Collections Storage Building is located to the east of the Park Maintenance Building and Green Metal Building. The rectangular building extends in a southerly direction from the entrance road. Construction of the Collections Storage Building began in 2012 and was completed in 2013. The building provides climate-controlled storage facilities for park collections (Figure 3.39).

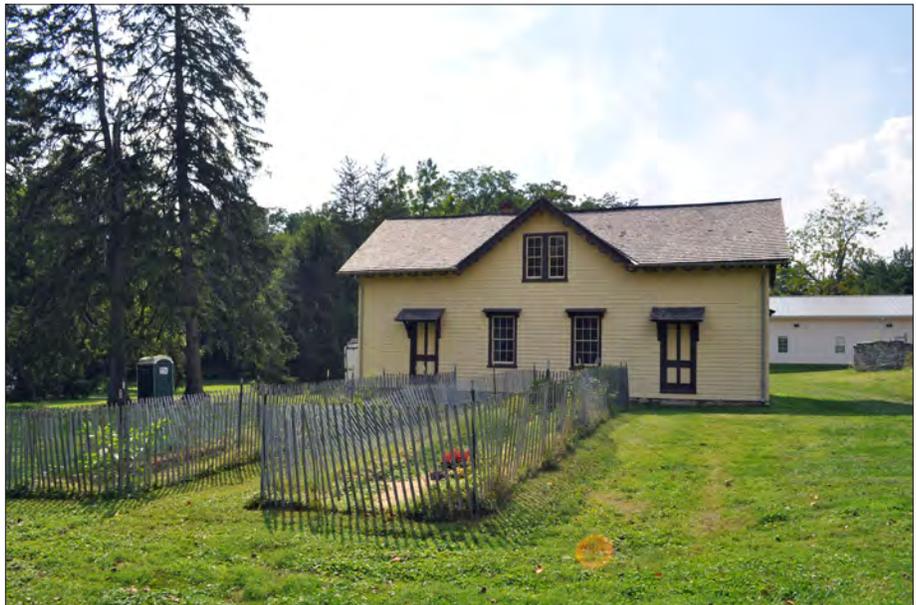
Figure 3.40. Garden Maintenance Building. Fenced cold frame foundations are visible in the foreground and the new Collections Storage Building is visible to the right. View looking west, 2013 (OCLP).

Existing Condition: Located on the west side of the Falling Gardens between the Caretaker's House and the greenhouses, the Garden Maintenance Building is accessible by a driveway that connects it to Hampton Lane. Following the historic period, the Garden Maintenance Building was likely used for storage. The building continues to serve as storage space today (Figure 3.40).

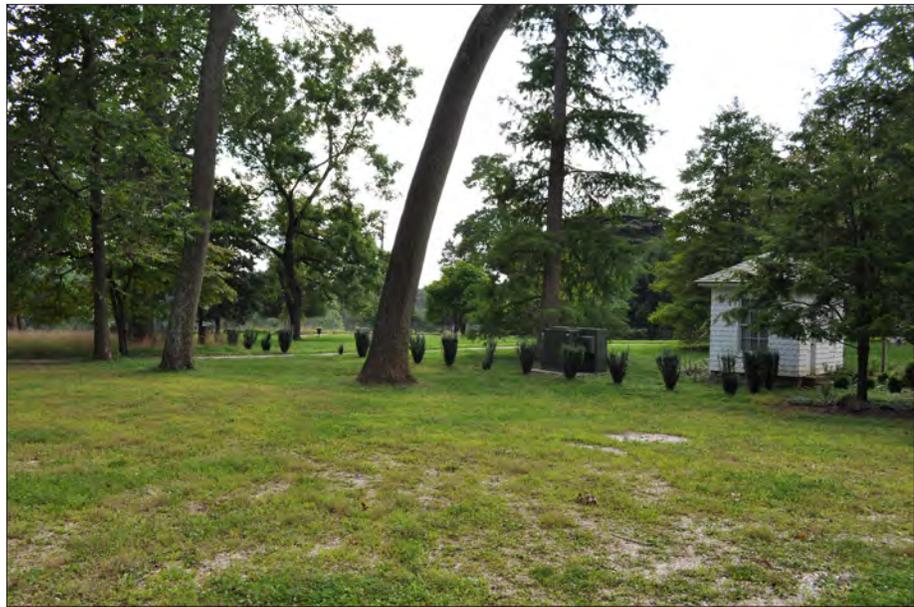
Figure 3.41. Geothermal well field in the foreground, with the Great Terrace in the background. The Pump House is visible on the right side of the photograph. View looking south, 2013 (OCLP).

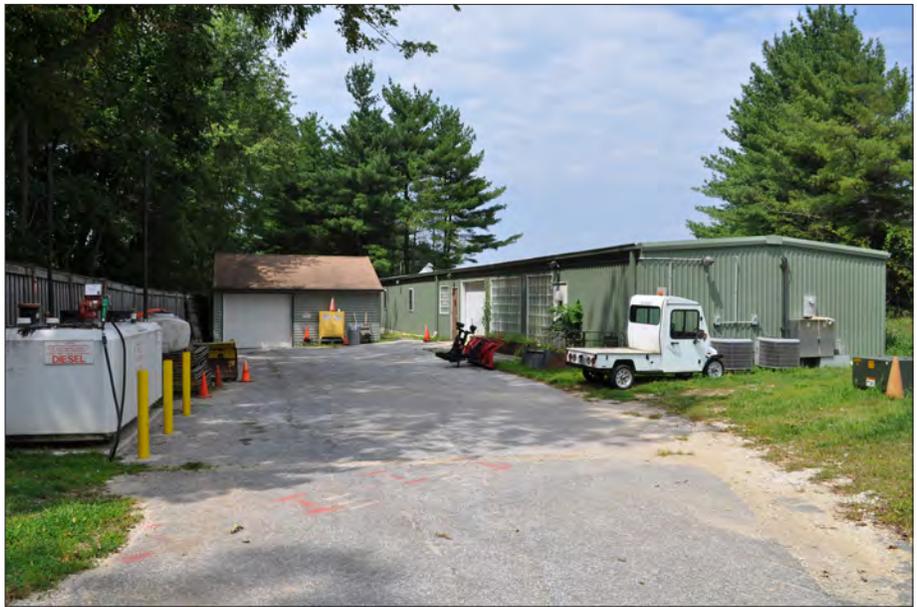
Figure 3.42. The Green Metal Building (on the right) and the Park Maintenance Building (with white garage door on the left) from the maintenance parking area. View looking northwest, 2013 (OCLP).

Existing Condition: The Green Metal Building is a long, narrow, rectangular single-story building with a low-pitch gabled roof. The walls are sheathed with vertical aluminum siding. The long axis of the building is oriented northwest to southeast. Once used for storing maintenance equipment, it was redesigned to store collection items (Figure 3.42).

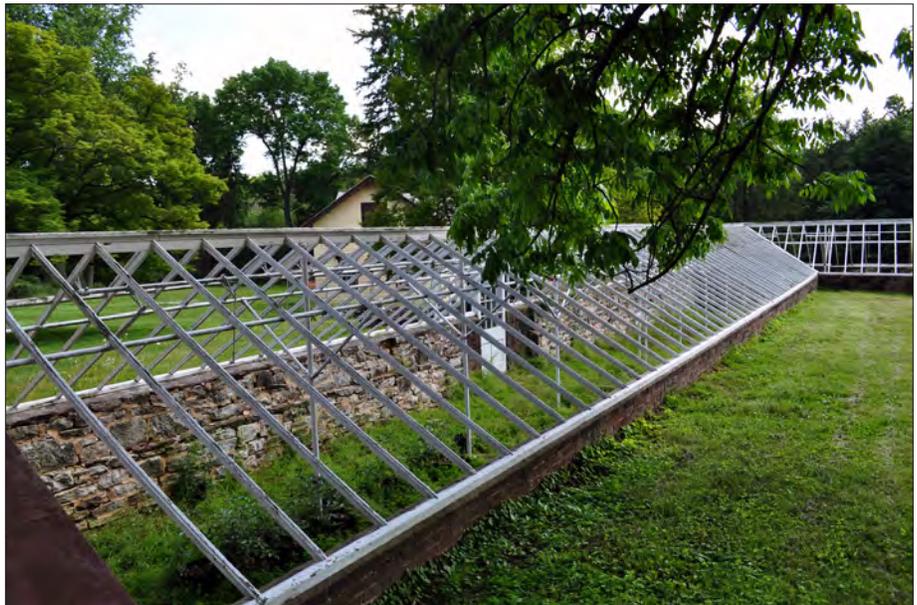
Figure 3.43. Greenhouse #1 ruin. View looking southwest, 2012 (OCLP).

Existing Condition: The Greenhouse #1 ruin consists of L-shaped remains of the gable-roofed structure with metal framework constructed over stone and brick walls, and a random range ashlar stone potting room. The greenhouse portion is missing all of the glass, and the potting room is without a roof. The walls of the potting room are approximately 5' high, and the floor may have been backfilled to raise it to the current level. For safety reasons, visitors are restricted from the greenhouse area (Figure 3.43).

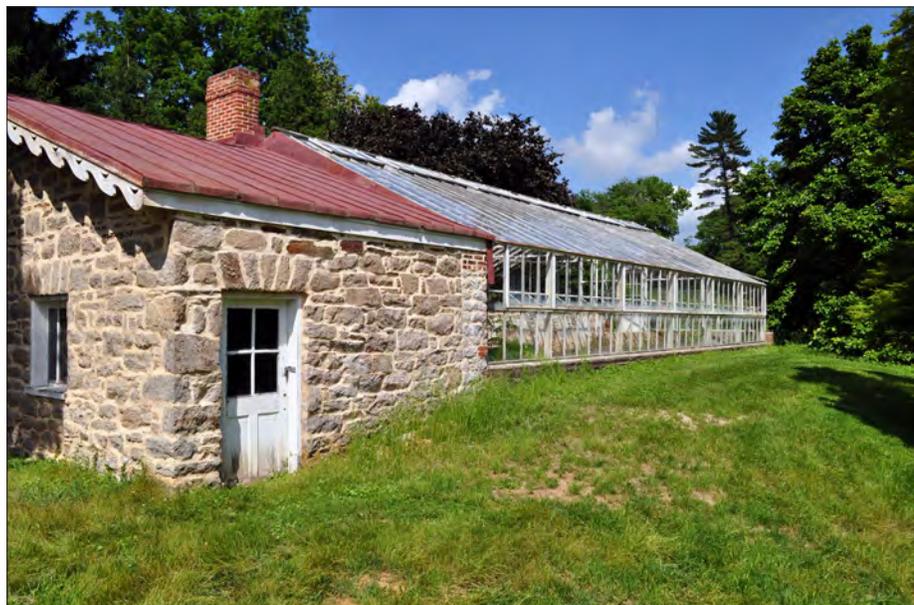
Existing Condition: Greenhouse #2 consists of a stone potting room with a gable roof and brick chimney on the west side and a longer glass-roofed greenhouse

Figure 3.44. Greenhouse #2 from the vicinity of Greenhouse #1 ruin. View looking northeast, 2012 (OCLP).

constructed on brick knee walls. It is located directly off the west end of the grass walk across the north side of Falling Garden Terrace 2. The entrance on the east façade has a bluestone stoop that is approximately 6'-0" deep and 12'-0" wide bordered by brick.

The National Park Service replaced the standing-seam tin roof on the potting room in 1999. The greenhouse portion underwent a significant restoration in 2000 that included repointing of the foundation, stabilizing the metal frame, replacing glazing, and repairing the ventilation system of operable glass louvers. However, today, glazing is failing and glass panes are coming loose. The original furnace and clay pot racks remain in the stone potting room (Figure 3.44).

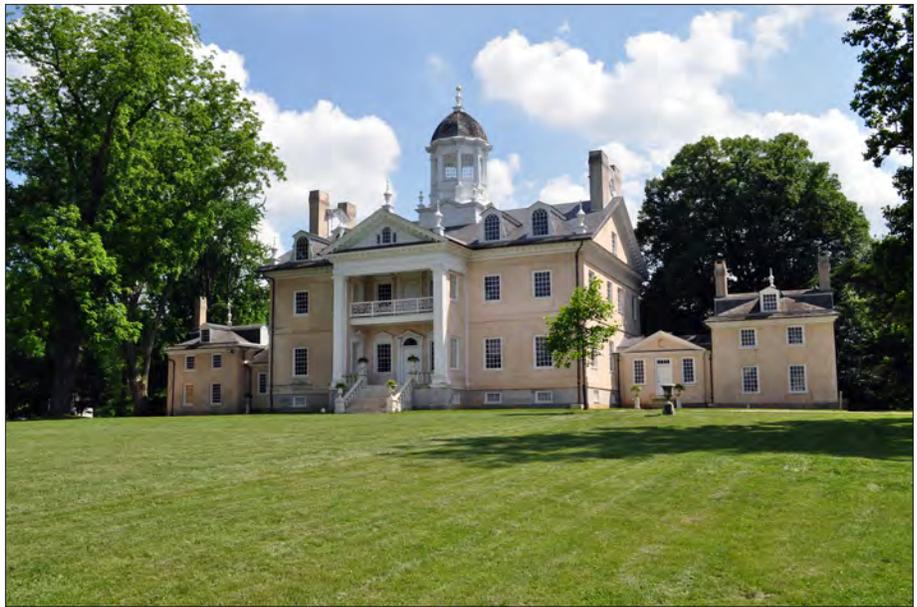
Figure 3.45. North facade of the Hampton Mansion from the lawn defined by the heart-shaped carriage drive. View looking south, 2012 (OCLP).

Existing Condition: Hampton Mansion is an outstanding example of late Georgian architecture in America. It has a symmetrical, five-part linear plan composed of a large central structure connected to two wings by hyphens, and is constructed of rubble stone covered with stucco, embellished with wood-framed projecting porticoes, dormer windows, and a large cupola. The three-story building is approximately 177' in length. The Mansion was restored and renovated immediately after Hampton was acquired by the National Park Service. This work included repair of the exterior stucco and windows, reinforcement of flooring, and adding restrooms in the basement, caretakers' quarters on the upper stories, and a tearoom in the east hyphen and wing (closed in 1998). In the 1960s, the cupola was restored, selected window frames reconstructed, and stucco patched. In the 1980s, the stucco was completely replaced. The roof was replaced in 1998. Extensive interior work was completed in 2005–08 to restore rooms to their character during various historic periods of occupancy. Hampton Mansion is now used primarily for interpretation and visitor services. A visitor reception room is located in the west hyphen and a gift shop in the west wing (Figure 3.45).
