CULTURAL LANDSCAPE REPORT FOR HAMPTON NATIONAL HISTORIC SITE

VOLUME I: SITE HISTORY, EXISTING CONDITIONS, ANALYSIS &
EVALUATION

TOWSON, MARYLAND

Olmsted Center for Landscape Preservation
National Park Service, Boston, Massachusetts, 2014

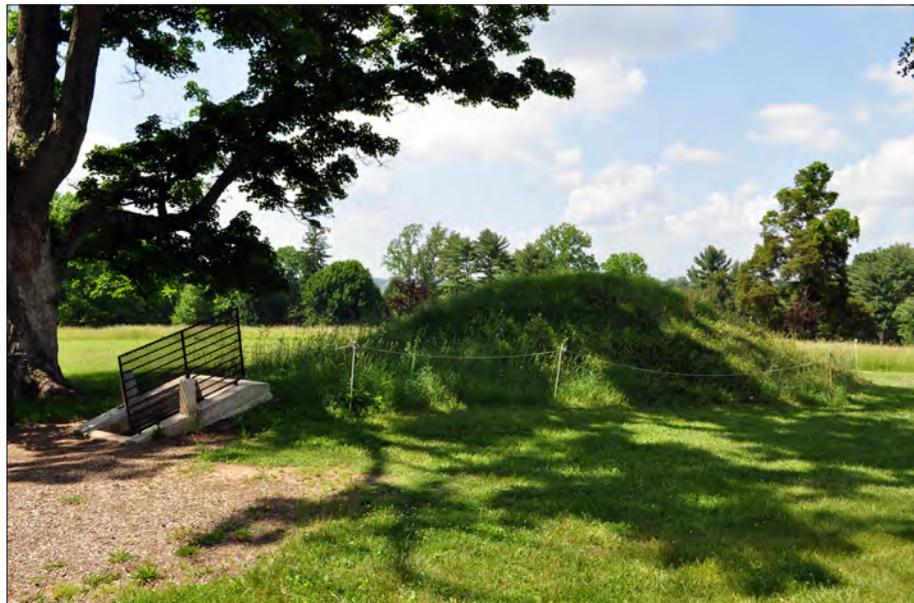
Figure 3.46. Ice House from the heart-shaped carriage drive. View looking northwest, 2012 (OCLP).

Existing Condition: The Ice House is a subterranean structure located in the front lawn, northwest of the heart-shaped carriage drive. It is constructed of rubble stone with a brick dome roof, which is covered in a thick layer of earth. The interior of the structure consists of a tapered shaft measuring 16'-0" in diameter at the top and 7'-0" diameter at the bottom. It extends approximately 30' below grade. The Ice House is visible from the outside as an oval mound of earth measuring approximately 10' high and 47' in diameter along its north/south axis and 42'-0" along its east/west axis. A narrow, stone-lined passage historically used for loading ice is cut into the north side of the mound. About 20'-0" south of the mound, an entrance to the brick-vaulted tunnel used for retrieving ice provides access to the structure. The entrance to the tunnel is composed of an iron door set into a concrete frame, and leads first to a flight of stone steps, then the tunnel. A small interpretive sign stands to the right of the entrance. The National Park Service restored the Ice House in both 1997–98 and in 2008, including installation of lighting and a handrail (Figure 3.46).

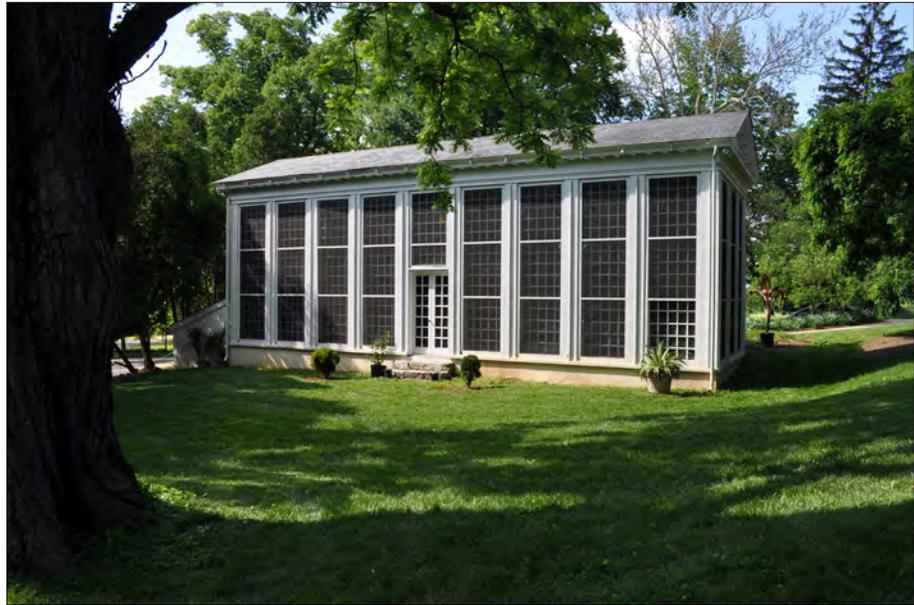
Figure 3.48. Orangery from the cobblestone path. View looking north, 2012 (OCLP).

Existing Condition: The Orangery is a single-story brick and frame structure with a rubble stone foundation. The current building was reconstructed in 1975–76 on the foundation of the original Orangery. Historic photographs and archaeological evidence were used to guide reconstruction. The building is nine bays long and three bays wide, with a brick lean-to on the west side. It was designed in Grecian

temple form in the Classical Revival style. The original core of the building walls was brick; however, concrete blocks were used in the reconstruction. Inside the building on the north side, a modern addition provides accessible restrooms, a small kitchen, and a storage room. The gable roof is covered in slate, and there are full-length windows on the south and east façades. The Orangery is currently used to host meetings, public programs, and special events (Figure 3.48).

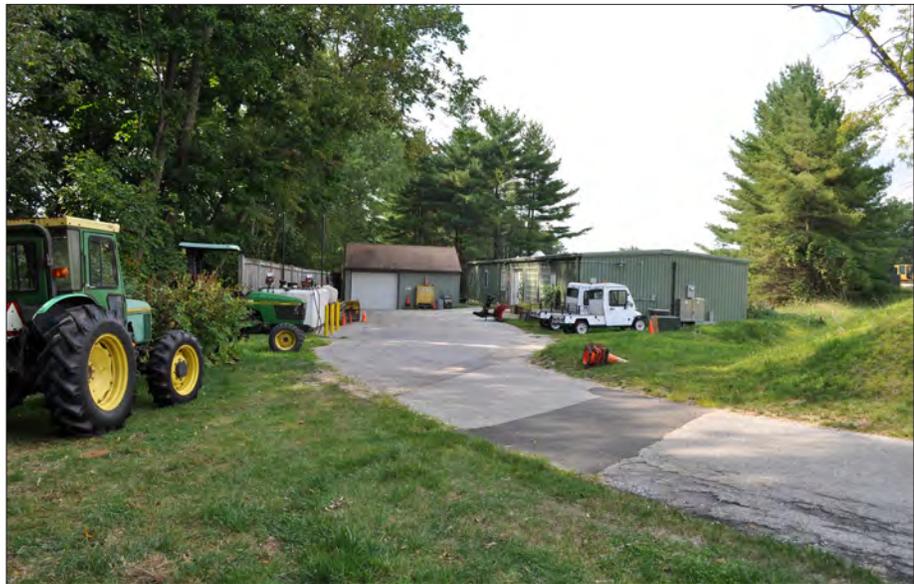
Figure 3.51. Site of the Pole Barn foundation. View looking west, 2013 (OCLP).

Existing Condition: The remnants of what is believed to be the historic Pole Barn foundation have been identified to the southeast of Privy #1. The foundation is a rectangle approximately 8' wide and 12' long (Figure 3.51).

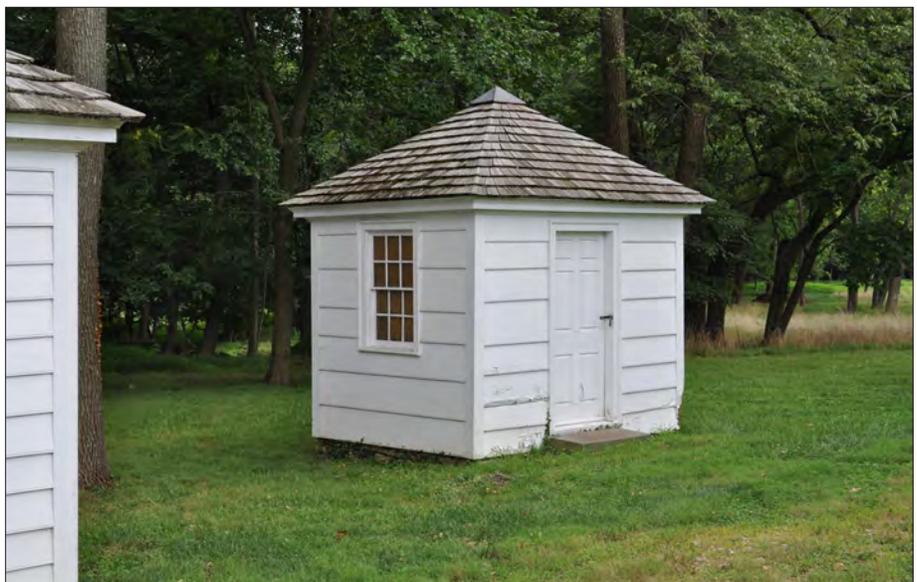
Existing Condition: Privy #1 is a single-story building with a hipped, wood shingle roof and white clapboard siding. The building measures 8'-0" by 10'-0" with the long axis running north to south. A single door provides access on the western façade. Windows on the north and south façades allow light to enter the structure. Privy #1 is currently used for interpretation (Figure 3.52).

Figure 3.52. Privy #1. View looking southeast, 2013 (OCLP).

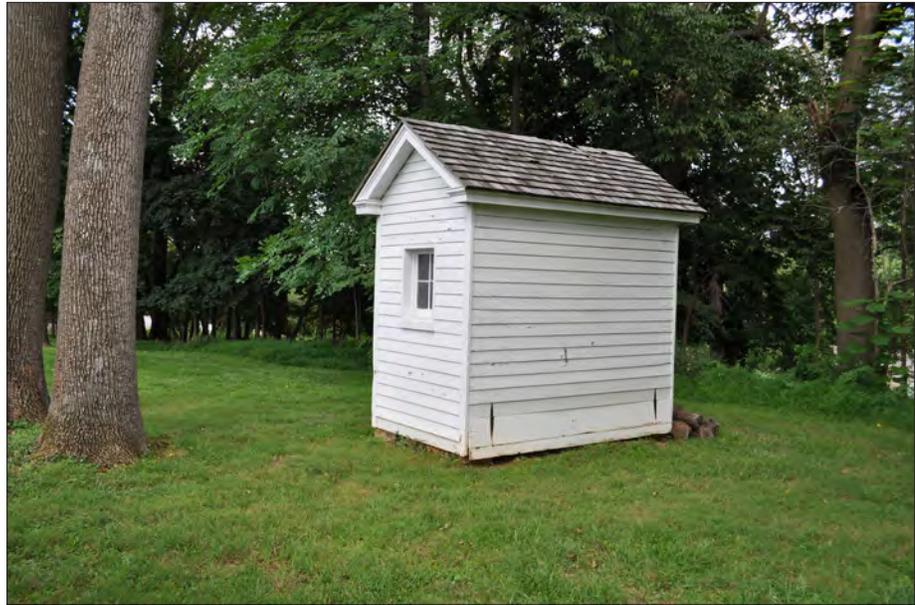
Figure 3.53. Privy #2. View looking northeast, 2013 (OCLP).

Existing Condition: Privy #2 is located to the northeast of Privy #1. It is a single-story with a gabled, wood shingle roof and white clapboard siding. The east and west walls each have fixed four-light windows, and there are two doors on the north side (Figure 3.53).

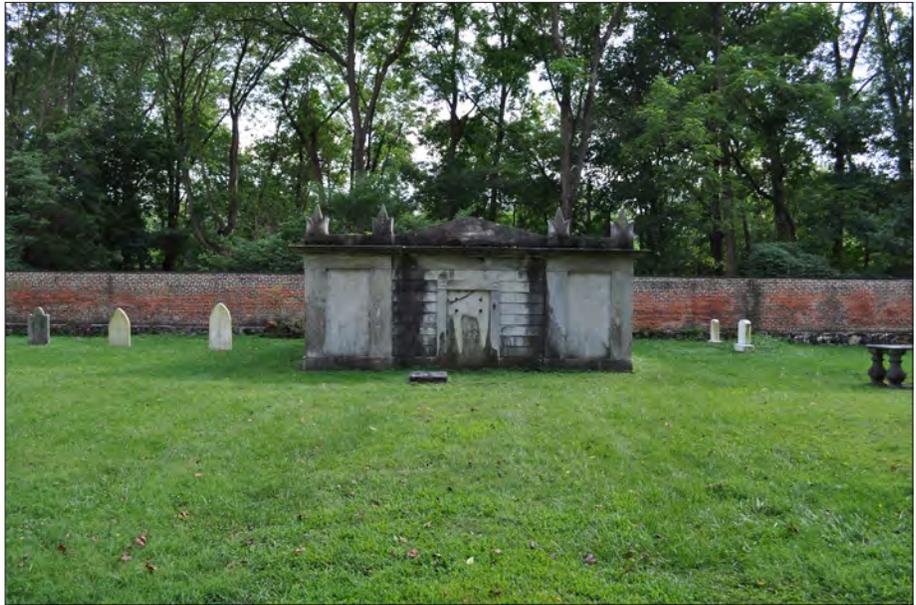
Figure 3.55. Ridgely Family Vault from the cemetery gate. View looking south, 2013 (OCLP).

Existing Condition: The Ridgely Family Vault is located at the southeast corner of the property within the Ridgely Family Cemetery. It is a single-story structure constructed of gray marble masonry on the north, east, and west sides. The north

side is faced with brick. The vault is surrounded by narrow brick walkway laid in a herringbone pattern, which is overgrown with grass. A pathway from the gate to the vault is also concealed by grass. A marble plate now seals the entrance on the center of the north wall, and the decorative iron gate that once covered the entrance is now in storage. The vault was restored in 1992 (Figure 3.55).

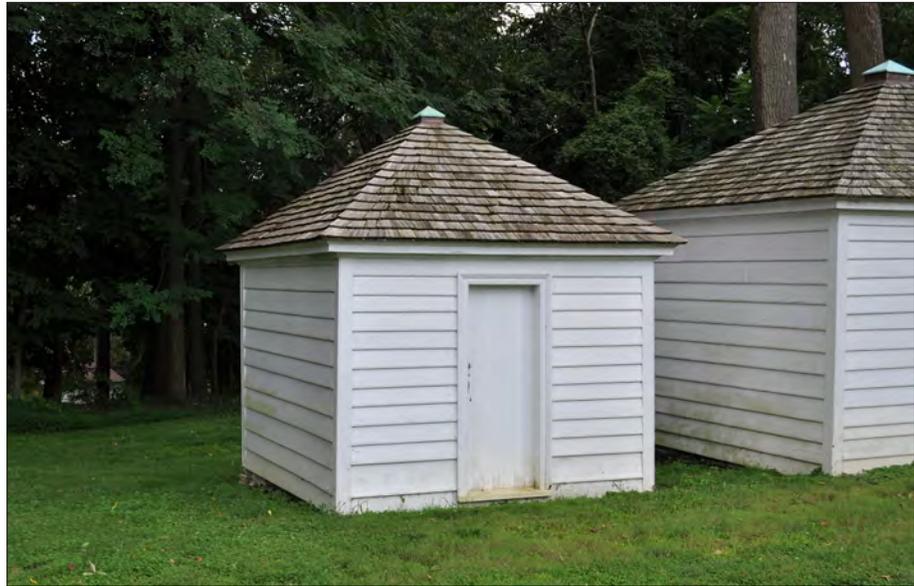
Figure 3.56. Smoke House (left), adjacent to the Paint House (right). View looking southeast, 2013 (OCLP).

Existing Condition: The Smoke House is located on the east side of the Hampton Mansion in a grouping of three buildings organized in a row oriented north to south. The Smoke House is one of two smaller buildings that flank the larger center building, the Paint House. The Smoke House is a single story building with weatherboard siding and a pyramidal shingled roof. Inside, the Smoke House has a single room with a random-width tongue and groove pine floor. Following the historic period, the building was restored in 1968. Work included restoration of the finial at the roof apex, removal of three windows, and removal of vent holes in the siding. The Smoke House is currently used for storage (Figure 3.56).

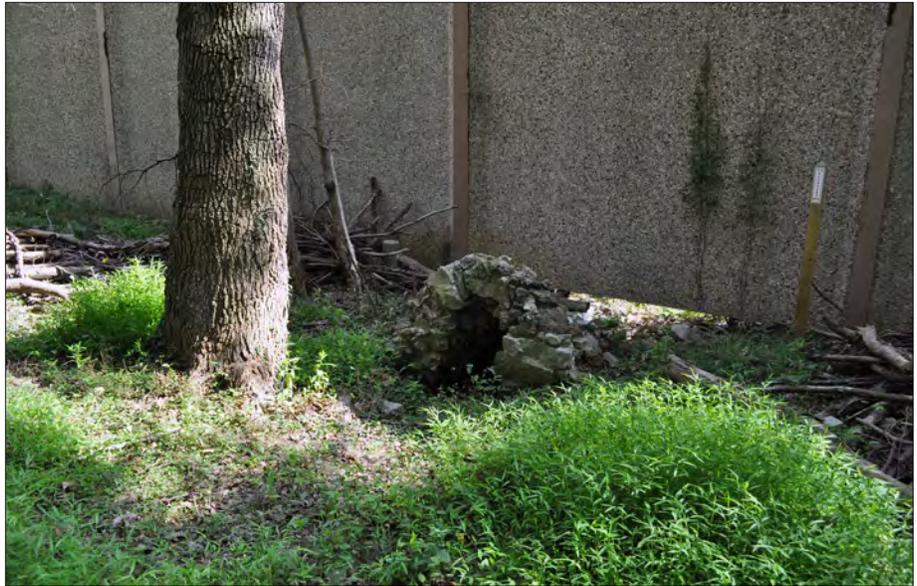
Figure 3.57. South Spring ruin.
View looking south, 2013 (OCLP).

Existing Condition: The South Spring is in disrepair. The top is damaged and lies next to the structure. The remnants of the structure are in a grouping approximately 5' by 5' wide and 3'-6" high. Water no longer surfaces at the South Spring; although the land near the South Spring ruin is often damp. The structure was stabilized in 2009 (Figure 3.57).

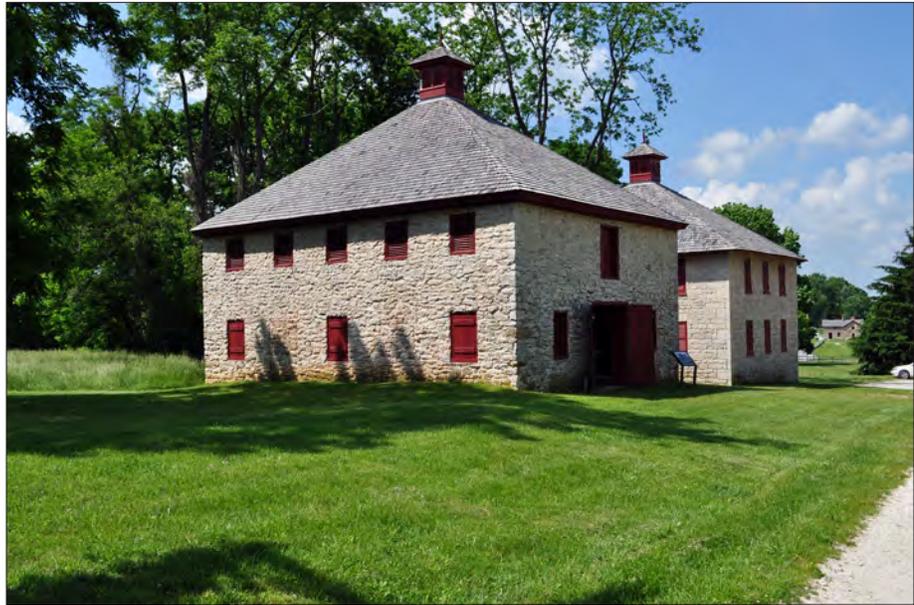
Existing Condition: Stable #1 is located on the west side of the Stable Drive and is immediately south of Stable #2. It is a two-story stone building with a wood-shingled roof. The roof was historically topped with a wooden cupola (now in storage). There are now pairs of double doors open to the west and to the east. The inside of the building is open space on both stories; the original stalls were removed due to termite damage during extensive restoration efforts in 1963–64.

Figure 3.58. Stable #1 from Stable Drive. View looking northwest, 2012 (OCLP).

The original compacted earth floor has been replaced with soil-cement mixture. This stable currently houses a display of carriages, bridles, yokes, and other equestrian equipment, which is visible to visitors through the east doors. Exterior preservation work was completed in 2004 (Figure 3.58).

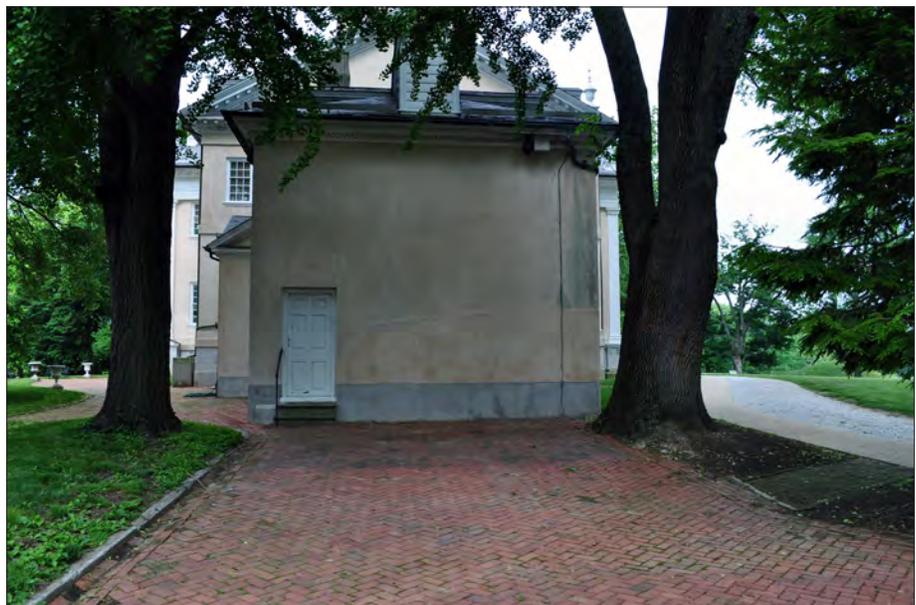
Figure 3.60. Historic location of the Summer Kitchen on the East Terrace. View looking west, 2012 (OCLP).

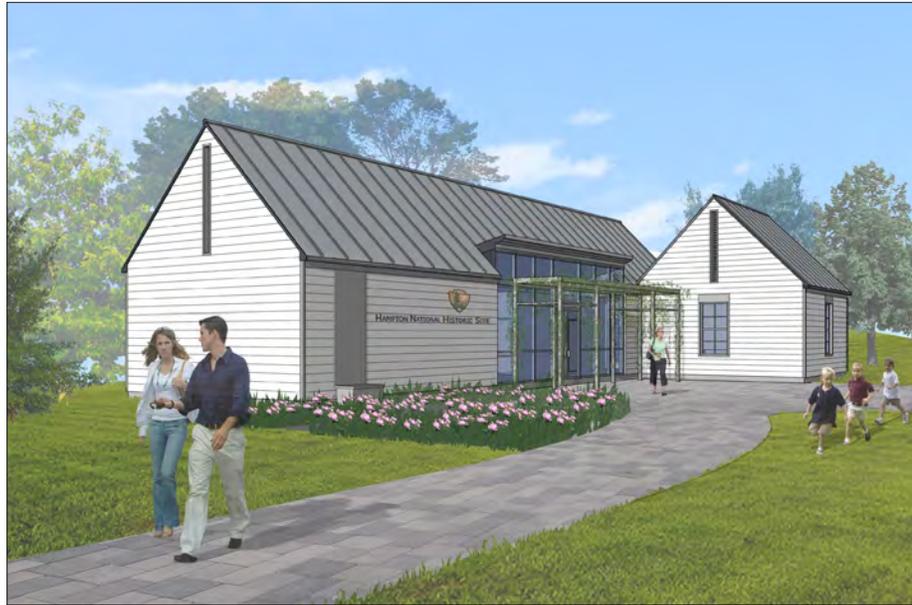
Figure 3.61. Rendering of the Visitor Contact Station. View looking west, 2012 (HAMP).

Existing Condition: The Visitor Contact Station is currently under construction along the western property boundary. When complete, this building will provide visitor orientation services and office space for park staff and partners. A new entrance road and associated lower visitor parking area are also under construction to replace the existing, outdated facilities (Figure 3.61).

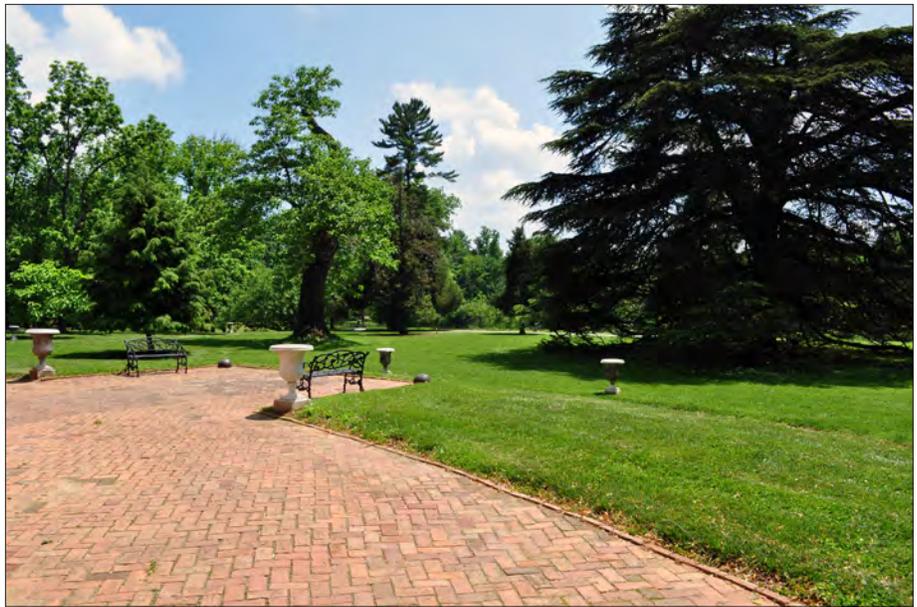
Figure 3.62. Cast metal benches on the Brick Terrace. View looking southeast, 2012 (OCLP).

Existing Condition: Ornate, contemporary metal benches are placed on the Great Terrace for both functional as well as aesthetic qualities. The benches are contemporary replicas of the original benches, now in storage and in the Orangery (Figure 3.62).

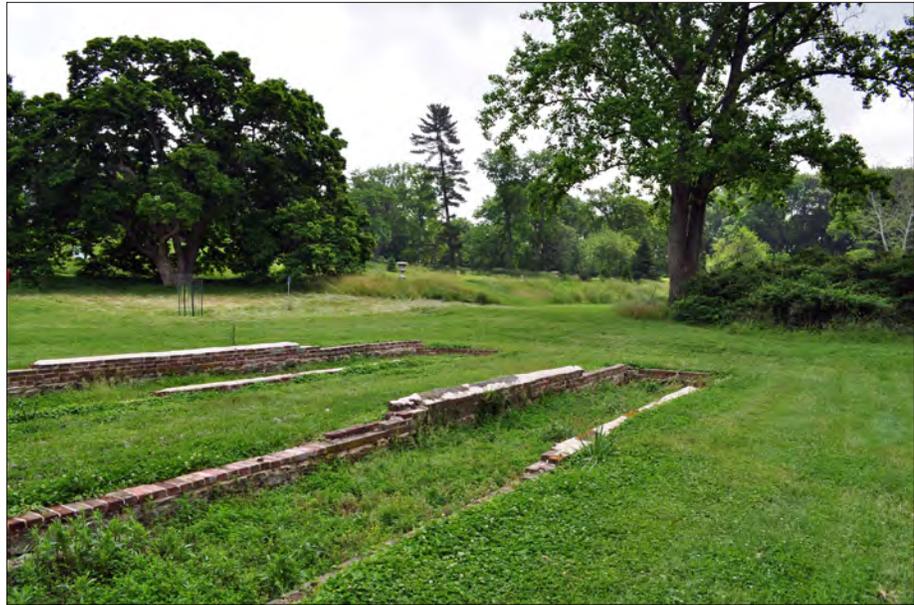
Figure 3.63. Cold frame foundations to the east of the Caretaker's Cottage. View looking east, 2012 (OCLP).

Existing Condition: The cold frame foundations fell to disrepair following disuse; all that remains are the brick foundation remnants of two long, rectangular, cold frames located on the east side of the Garden Maintenance Building. Each foundation is 37'-6" long. The east foundation is 7'-8" wide, and the west foundation is 6'-8" wide. The National Park Service stabilized the foundations in 2010–11 (Figure 3.63).

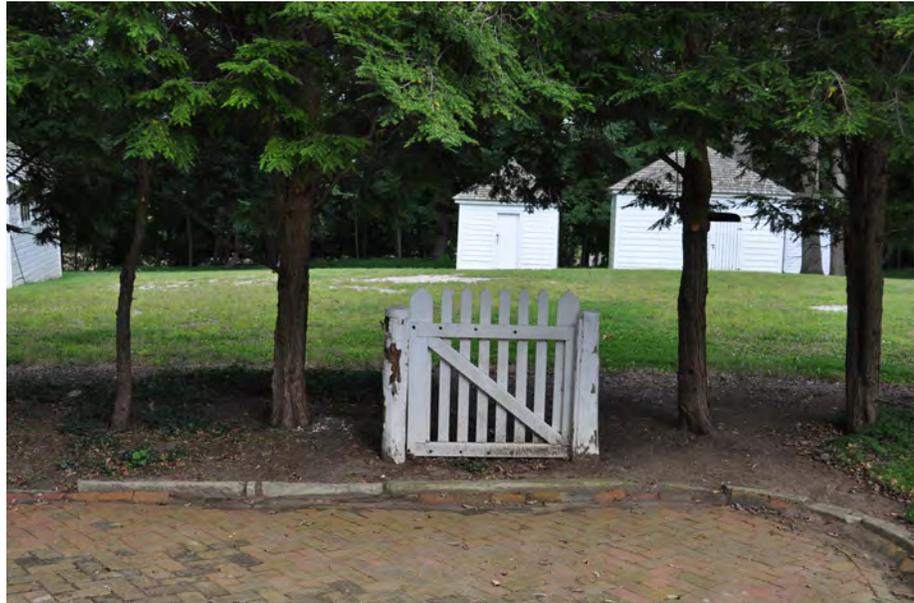
Figure 3.64. East Terrace gate from the terrace. View looking east, 2013 (OCLP).

Existing Condition: The East Terrace gate is a white, freestanding gate at the eastern end of the East Terrace. It is flanked by two hemlock trees, once part of the hedge surrounding the terrace. A mulched pathway leads to the gate from the west (Figure 3.64).

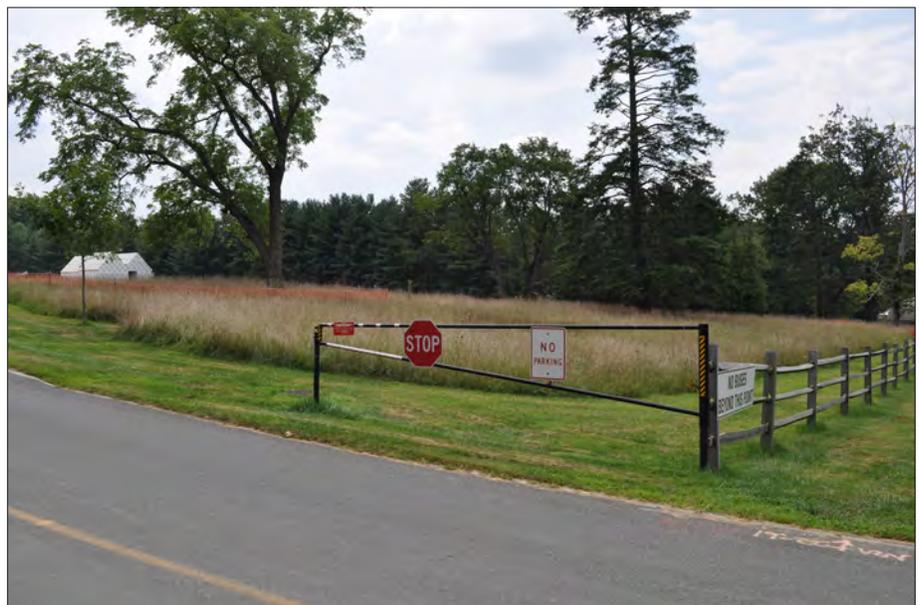
Figure 3.65. Entrance road gate.
View looking southeast, 2013
(OCLP).

Existing Condition: The entrance road gate is located at the intersection of the entrance road and Hampton Lane, blocking visitor access to the site when it is closed. The gate is composed of contemporary hinged metal gates placed in line with the wooden farm fence. Contemporary signage directs visitor traffic and displays when the grounds are open to the public (Figure 3.65).

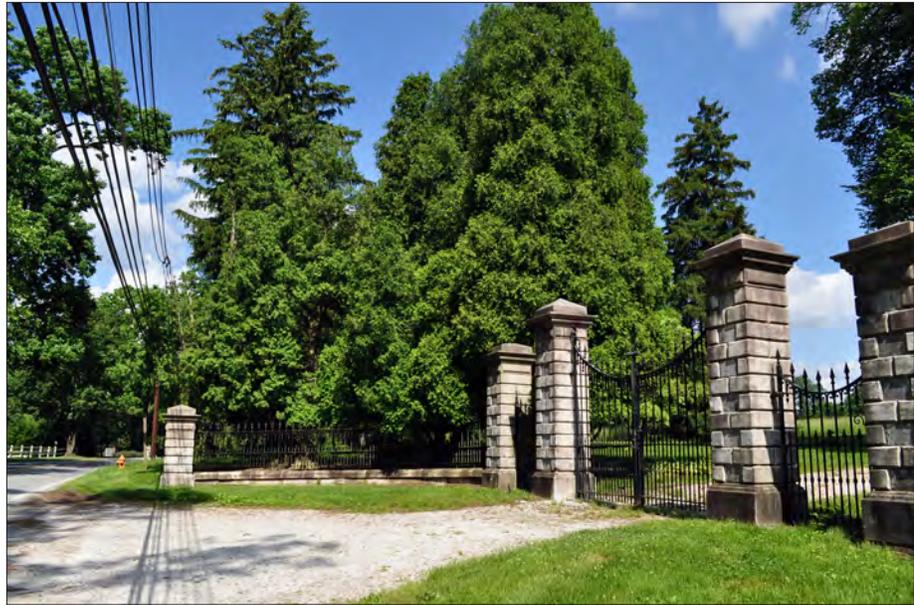
Figure 3.66. Mansion gates from Hampton Lane. View looking east, 2012 (OCLP).

Existing Condition: The Mansion gates remain at the intersection of the historic entrance drive and Hampton Lane, and have not undergone any major changes since the historic period. A row of arborvitae forms a backdrop beyond the curved walls. The gates were restored in 1999–2000 and are still functional, but are not currently used (Figure 3.66).

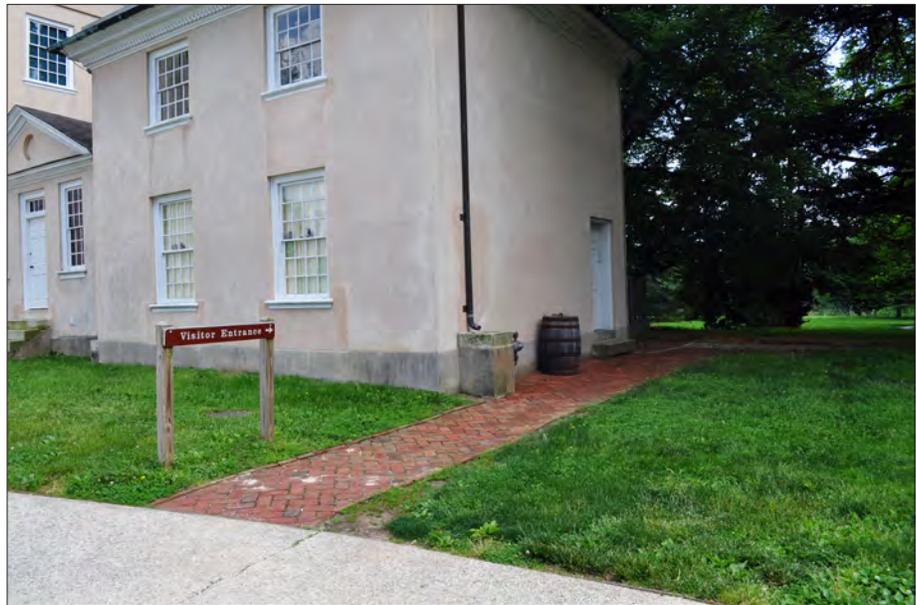
Figure 3.67 Mansion landscape signage along the walk to the visitor entrance. View looking south, 2012 (OCLP).

Existing Condition: Various forms of contemporary signage are placed throughout the property to aid in visitor interpretation, resource protection, and wayfinding (Figure 3.67).

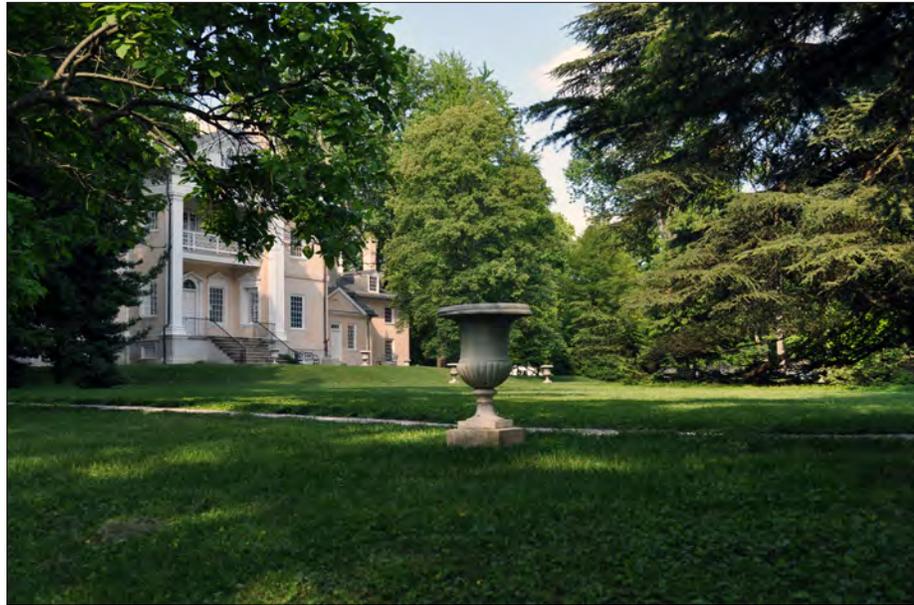
Existing Condition: Forty-two marble urns remain on the mansion grounds and the majority are used as decorative elements within the Great Terrace and Falling Gardens. The balance of the urns are located on the north side of the Mansion, in the lawn defined by the heart-shaped entrance drive, and flanking building entrances. They have a classic krater form, without handles. The urns resemble an inverted bell with a flared rim and decorative scallops at the bottom of the bowl. The neck of the bowl is a simple turned design with a flared bottom. The urns in the Falling Gardens have a plain square pedestal as a base, those at the Mansion's

Figure 3.68. Marble urn on the Great Terrace. View looking northeast, 2012 (OCLP).

main entry are set directly on the balustrade, and others by the Mansion have a cylindrical base. The urns are 36” high, excluding the pedestals. The urns are fitted with fiberglass lids to keep out trash and debris that lead to blocking drain holes, collecting water, and damage due to freezing and thawing. The urns underwent significant conservation treatment in the 1980–90s and again in 2010 (Figure 3.68).

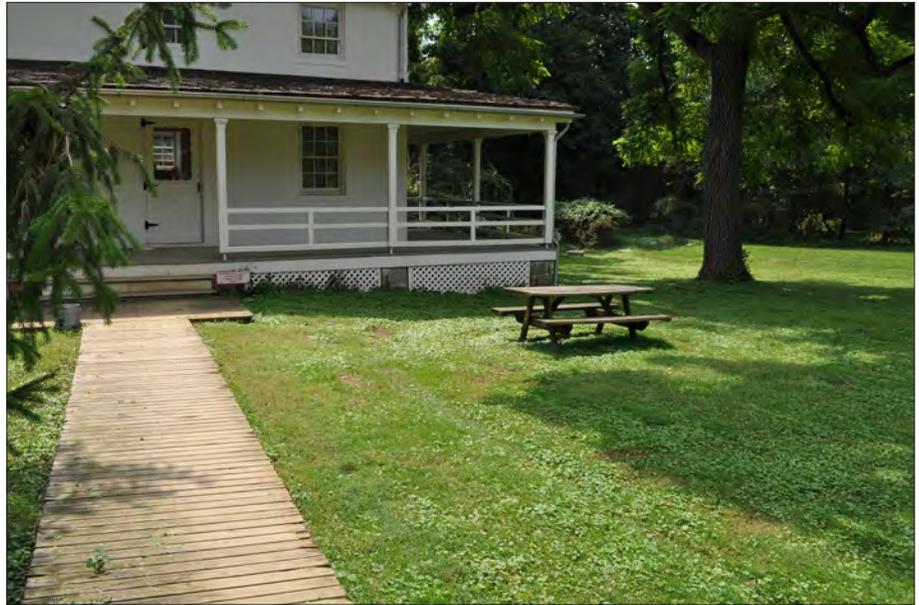
Existing Condition: Various contemporary wooden picnic tables are placed on the mansion grounds for visitor and staff use. Tables are located in the tree grove adjacent to the lower parking area and in the vicinity of the Caretaker’s Cottage (Figure 3.69).

Figure 3.69. Picnic table near the Caretaker's Cottage. View looking southwest, 2013 (OCLP).

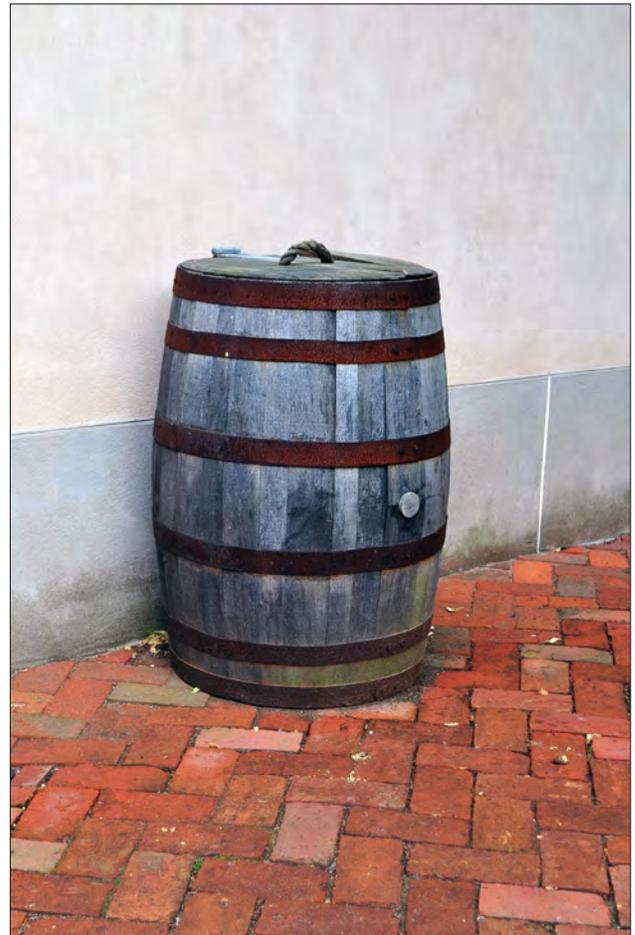
Figure 3.70. Refuse barrel along the western facade of the Mansion. View looking southeast, 2012 (OCLP).

Existing Condition: The wooden wine barrel refuse barrels placed throughout the property are contemporary additions to the mansion grounds. The barrels are comprised of wooden staves held together with metal hoops. A circular wooden head tops the barrel, and a hinge allows the cap to be opened for waste to be deposited inside (Figure 3.70).

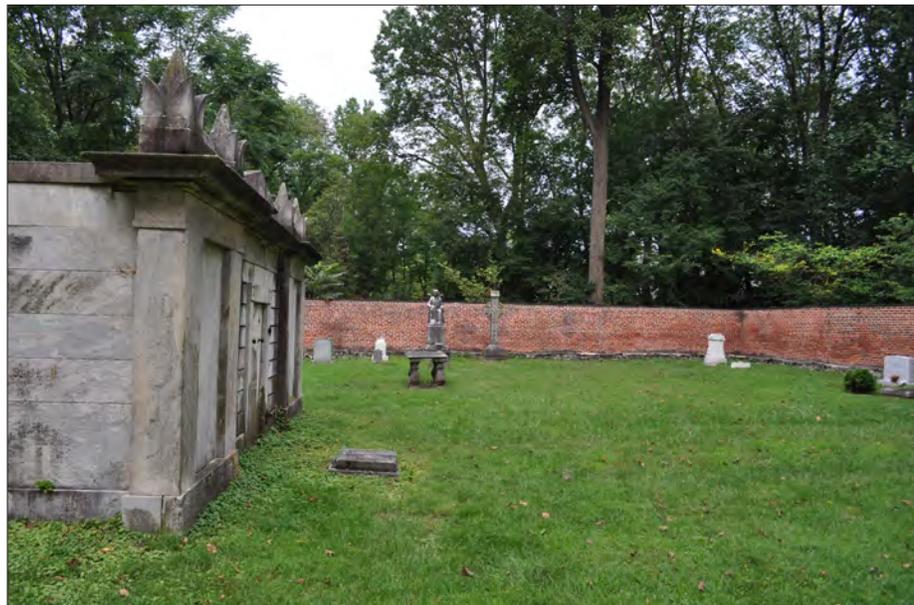
Figure 3.71. (right) Ridgely Family Cemetery grave markers. View looking west, 2013 (OCLP).

Existing Condition: A variety of grave markers in the form of granite headstones, markers, and small monuments indicating the burial locations of various Ridgely family members stand within the walls of the Ridgely Family Cemetery. Some markers have deteriorated over time, and there are more graves than there are markers, including several unmarked graves outside of the cemetery wall on the north and west sides (Figures 3.71 and 3.72).

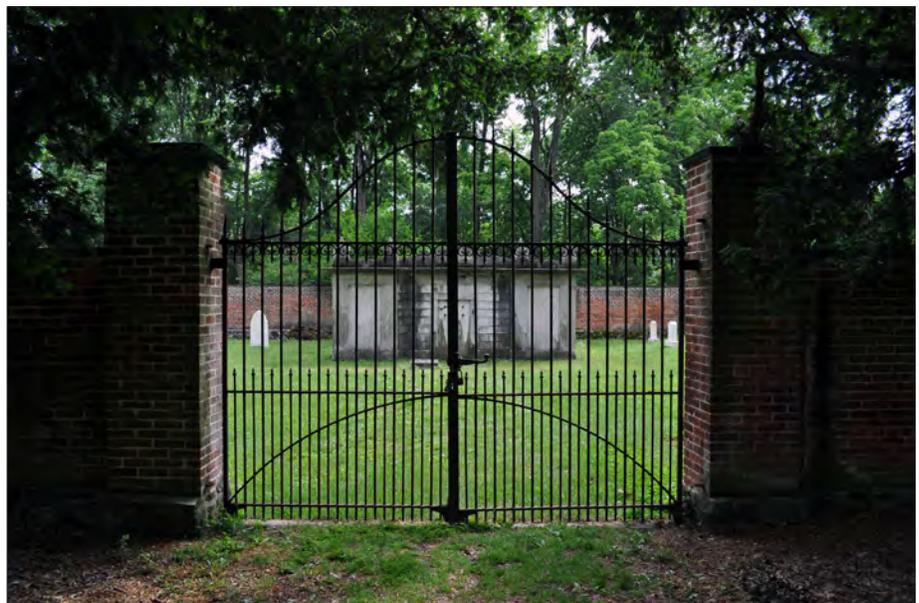
Figure 3.73. Ridgely Family Cemetery wall and gate. View looking south, 2012 (OCLP).

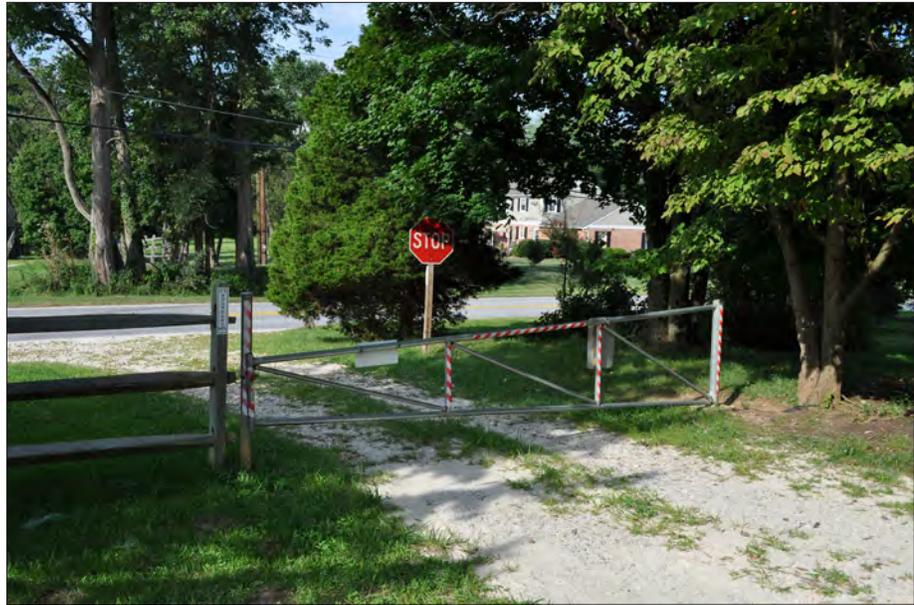
Figure 3.74. Stable Drive entrance gate. View looking north 2013 (OCLP).

Existing Condition: The Stable Drive entrance gate is located at the intersection of Stable Drive and Hampton Lane, and is comprised of contemporary hinged metal gates placed in line with the wooden fence along the property boundary and perpendicular to the adjacent vegetative border that runs along the eastern boundary of the property (Figure 3.74).

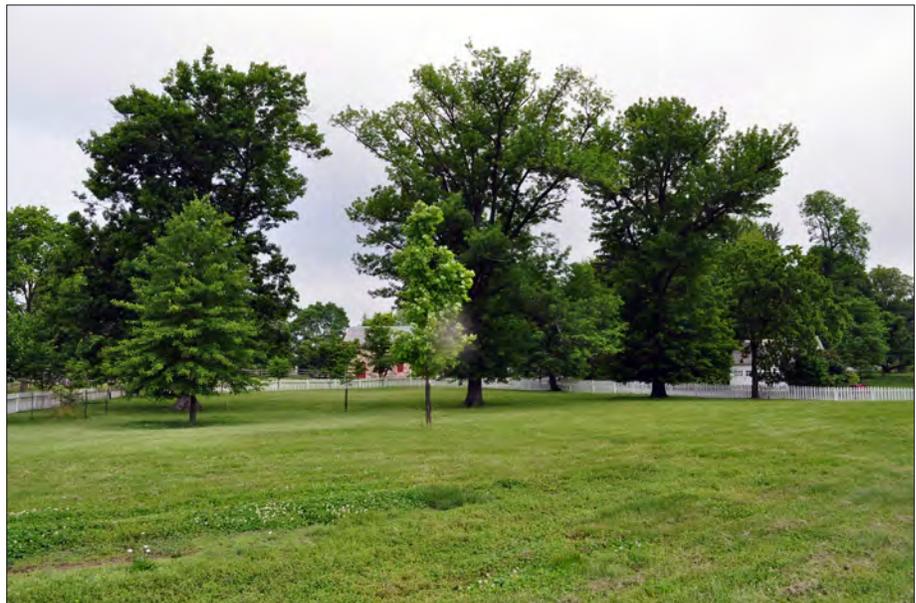
Figure 3.75. Farm House yard. View looking northwest, 2012 (OCLP).

Existing Condition: A white picket fence surrounds the Farm House yard, an area to the east of Farm Road. The only building within the fence is the Farm House, at the northeast corner of the yard. The L-shaped Farm House contributes to the boundaries of a small, grassy courtyard area at the very northeast corner, defined by the Log Farm Structure (c. 1835–69), Ash House (c. 1845–60), Slave Quarters #2 (c. 1845–60) and Slave Quarters #3 (c. 1845–60). To the south and west of the Farm House is a tree-shaded lawn which gently slopes down to the south from the Farm House (Figure 3.75).

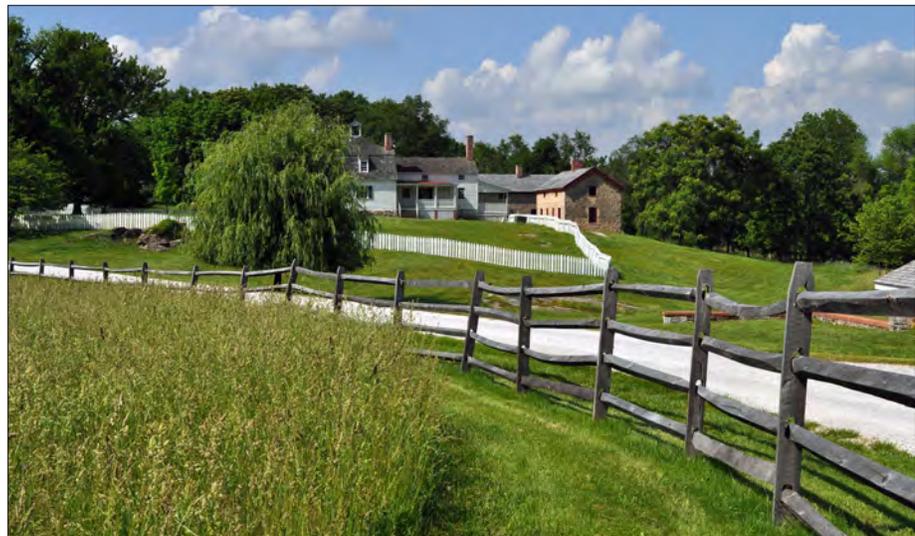
Figure 3.76 West Farm field (to left). View looking north, 2012 (OCLP).

Farm House Cluster to a low point at the northern-most extent of Hampton National Historic Site. This area was treated for invasive species and to remove selected non-historic trees in 2010. To the south of the Farm House Cluster, the Farm Landscape consists of trees over mown lawn, with the West Farm Field bordering the east side of Farm Road. The West Farm Field is planted with seasonal ryegrass, oats, and/or corn annually and surrounded by post and rail fencing. To the west, adjacent development is screened by a contemporary planting of evergreen and deciduous trees. The majority of the field is mown once or twice per season, and the edges of the field are mown weekly (Figure 3.76).

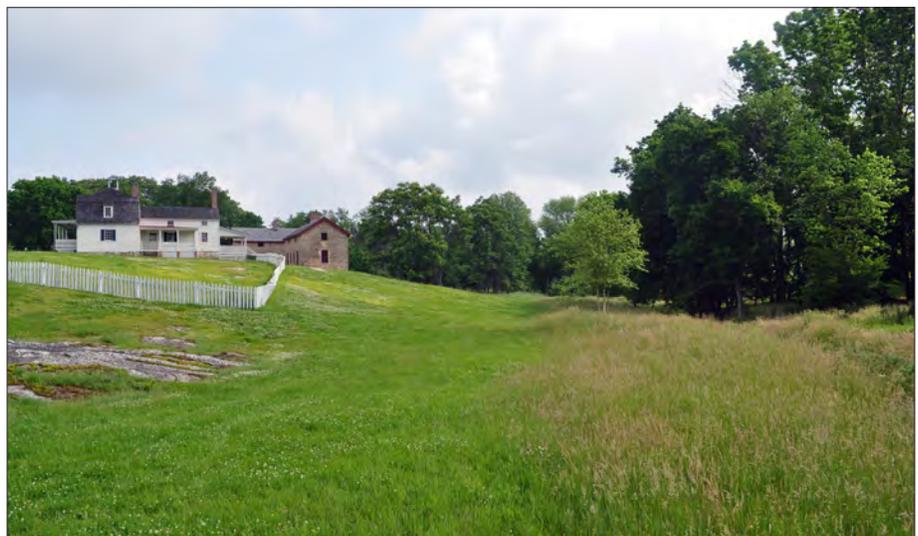
Figure 3.77. Dairy stream (to right).
View looking northeast, 2012
(OCLP).

The southern end of the stream is bordered by unmown meadow grass, while the northern end of the stream is surrounded by woodland. The National Park Service established a riparian buffer to protect water quality. The stream exits park land across the eastern property boundary and enters an underground channel through a concrete culvert (Figure 3.77).¹⁰

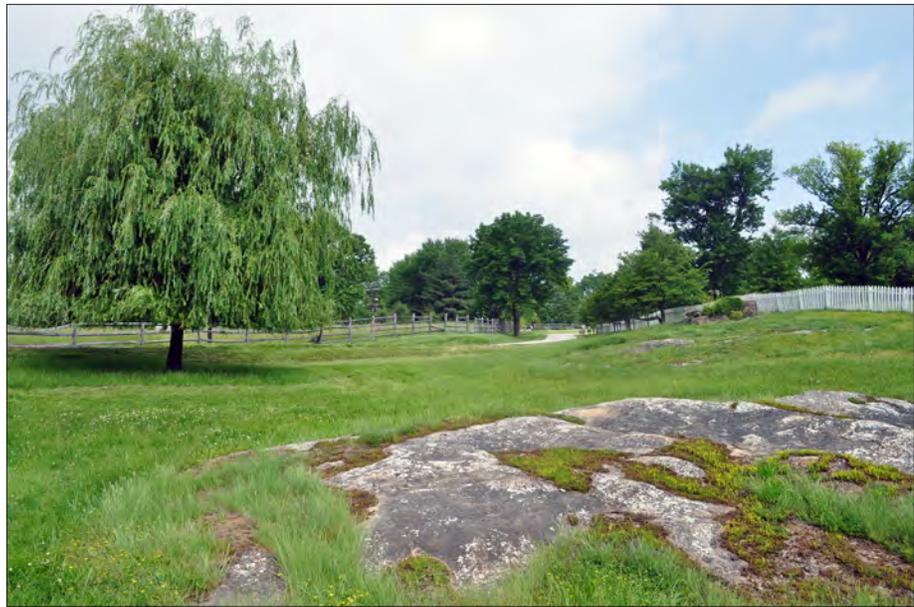
Figure 3.78. Rock outcropping from the vicinity of the Dairy stream. View looking northwest, 2012 (OCLP).

Existing Condition: Various rock outcroppings perforate the ground plane in the middle of the farm landscape, where the topography rises to a slight hillock. The most prominent rock outcropping is located south of the Farm House, more or less at grade level. Vertical drill holes and evenly spaced horizontal grooves on the rock surface show signs of deliberate alterations to reduce the size of the rock outcropping (Figure 3.78).

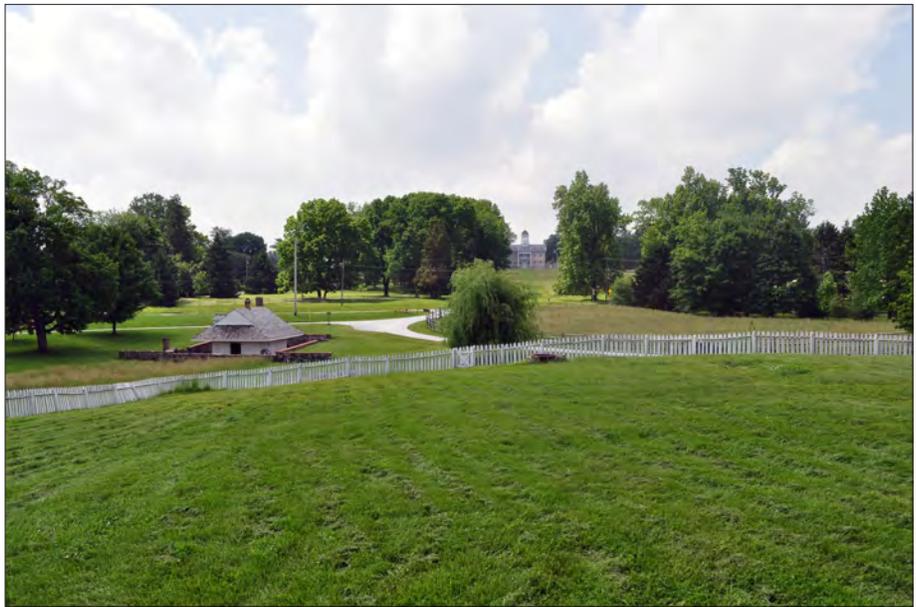
Figure 3.79. View to the Mansion from the Farm House. View looking southwest, 2012 (OCLP).

Existing Condition: The view to the Mansion from the Farm House is largely unobstructed, with the exception of overhead utility lines that parallel Hampton Lane. Vegetation in the northern end of the North Lawn, along Hampton Lane, poses the greatest threat to maintaining the visual connection between the two buildings (Figure 3.79).

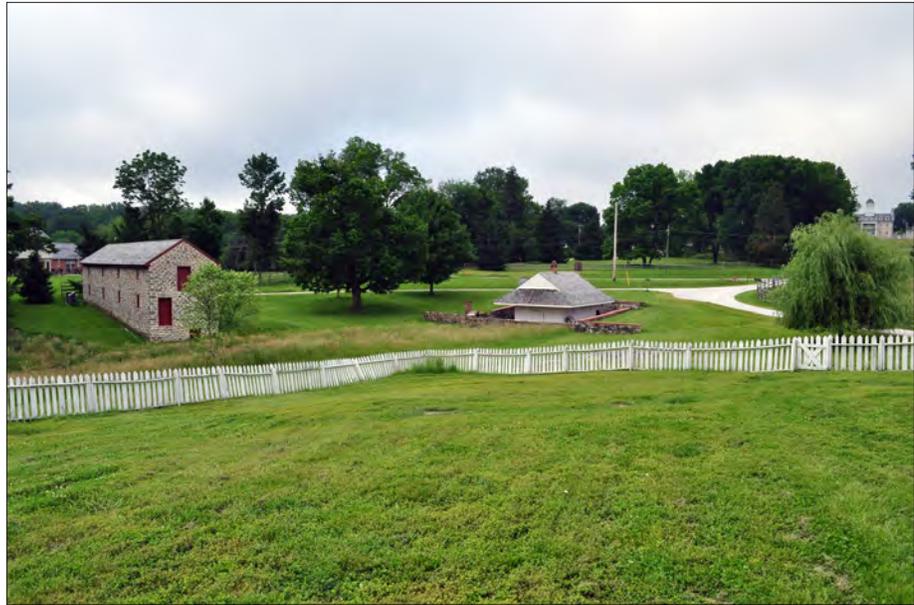
Figure 3.80. View within the Farm House yard. View looking south, 2012 (OCLP).

Existing Condition: The Farm House yard affords clear views of the farm landscape due to its elevation. Views to the south and east are composed of the Farm House yard lawn and white picket fence in the foreground, with a variety of landscape features beyond throughout the Farm. In the northern and westerly directions, a stand of trees within the yard limits views beyond (Figure 3.80).

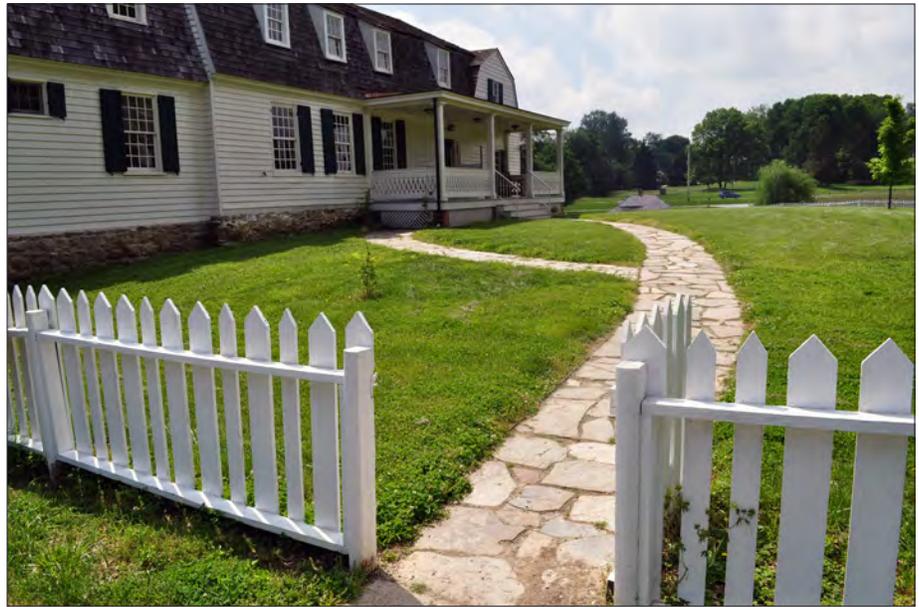
Figure 3.81. Farm House flagstone walk. View looking south, 2012 (OCLP).

Existing Condition: The Farm House flagstone walk begins at the west entrance of the Farm House and makes a wide curve north to pass through a gate in the white picket fence along the northern side of the Farm House yard. The flagstone walk is comprised of irregular paving stones and is bordered by mown lawn (Figure 3.81).

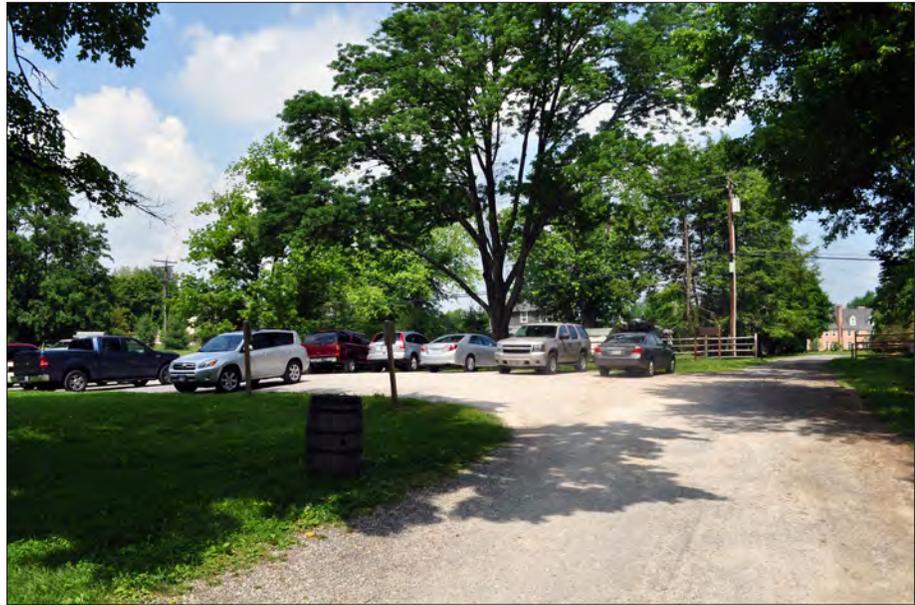
Existing Condition: The farm parking area is a rectangular, crushed stone surfaced area at the northwest corner of the farm property. Its long axis runs east to west and connects to Farm Road at the eastern end. The parking area is approximately 130' by 50' and can accommodate approximately twenty-six vehicles. This parking area is shaded by trees along its north and west sides (Figure 3.82).

Figure 3.82. Farm parking area from Farm Road. View looking northwest, 2012 (OCLP).

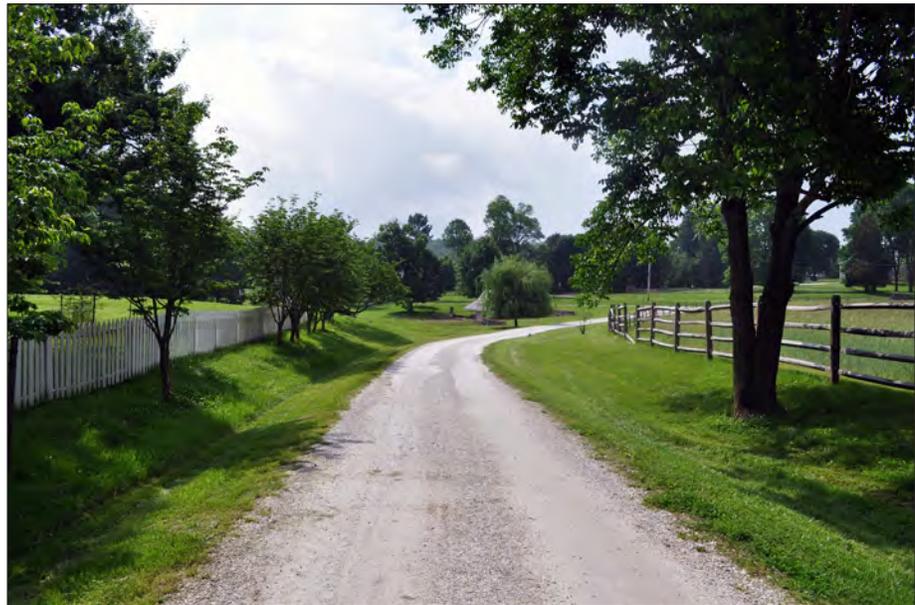
Figure 3.83. Farm Road, with the Farm House yard to the left and the West Farm Field to the right. View looking south, 2012 (OCLP).

Existing Condition: The remaining portion of Farm Lane runs north from Hampton Lane, through the Farm, and to St. Francis Road. The Farm Road is surfaced with crushed stone. The Farm Road was resurfaced in 2003 and rehabilitated in 2010 to provide visitor safety improvements at intersections near the Dairy and Corn Crib foundation. Spurs still lead to the Farm House and Long House Granary (Figure 3.83).
