CULTURAL LANDSCAPE REPORT FOR HAMPTON NATIONAL HISTORIC SITE

VOLUME I: SITE HISTORY, EXISTING CONDITIONS, ANALYSIS &
EVALUATION

TOWSON, MARYLAND

Olmsted Center for Landscape Preservation
National Park Service, Boston, Massachusetts, 2014

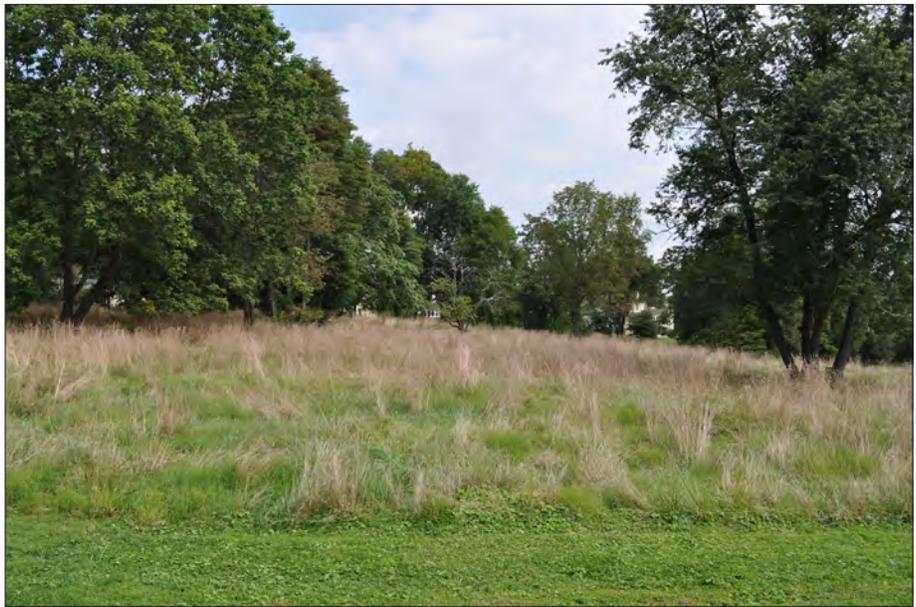
Figure 3.84. Location of the field access drive trace from the Farm Road, visible in the foreground. View looking north, 2013 (OCLP).

Existing Condition: The field access drive trace extends from the northern end of Farm Road into the North Farm Field. The trace is unmown and its alignment is only evident upon close inspection (Figure 3.84).

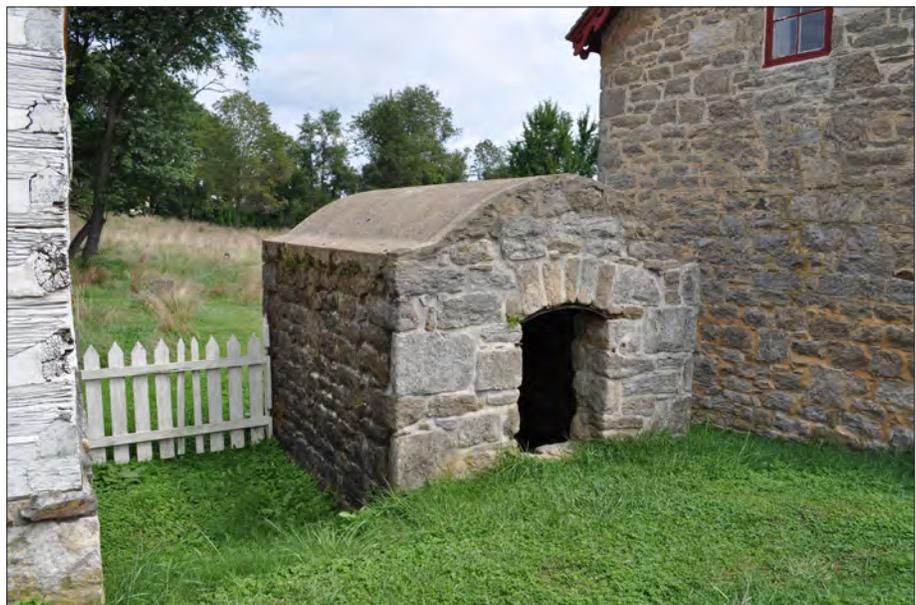
Figure 3.85. Ash House, with the Log Farm Structure to the left and Slave Quarters #2 to the right. View looking north, 2013 (OCLP).

Existing Condition: The Ash House is a 5' by 7' structure constructed of rubble stone with a brick vault roof. The vault is parged with mortar on the exterior, and the brick roof is a replacement of a former peaked roof. Following the historic period, the Ash House was rehabilitated in 1979, stabilized in 1985, preserved in 1997, and restored in 2006. The Ash House is currently used for interpretive purposes (Figure 3.85).

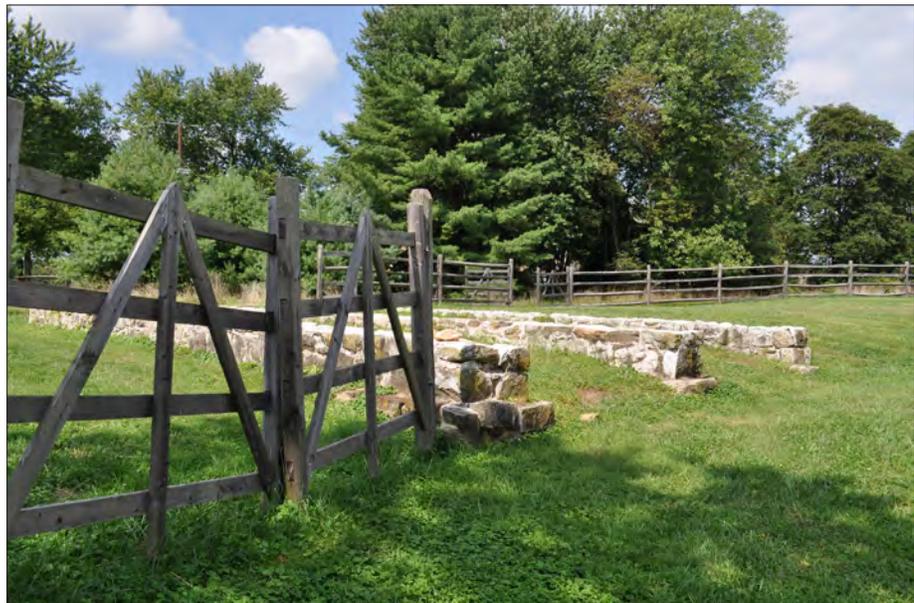
Existing Condition: Ruins of the Corn Crib's stone masonry foundations are located to the southwest of the Dairy. The structure was destroyed in 1988 by arson. The foundation walls were stabilized and capped in 1997–98. The structure awaits reconstruction (Figure 3.86).

Figure 3.86. Corn Crib foundation, with the West Farm Field fence visible to the left. View looking northwest, 2013 (OCLP).

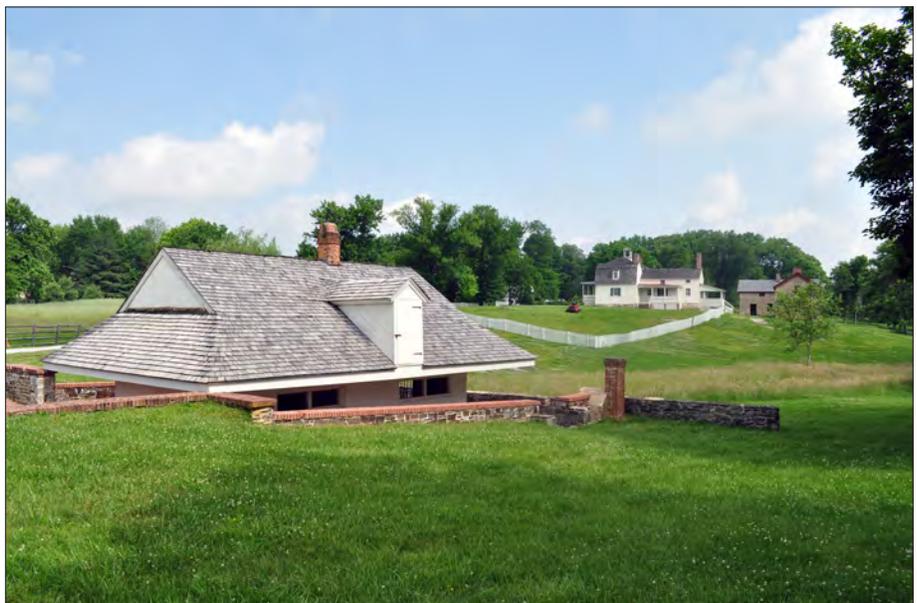
Existing Condition: The Dairy is the first structure encountered by visitors entering the Farm from Hampton Lane. It is located to the east of Farm Road at the source of the Dairy stream. It is a single-story structure with a unique gable and hip roof, and stucco walls. The structure is surrounded by a brick terrace, with stone retaining walls topped with brick coping. The Dairy is currently used for interpretive programming. Following the end of the historic period, the Dairy was stabilized in 1981 and again in 1997–98 (Figure 3.87).

Figure 3.87. Dairy, with the Farm House visible beyond. View looking northwest, 2012 (OCLP).

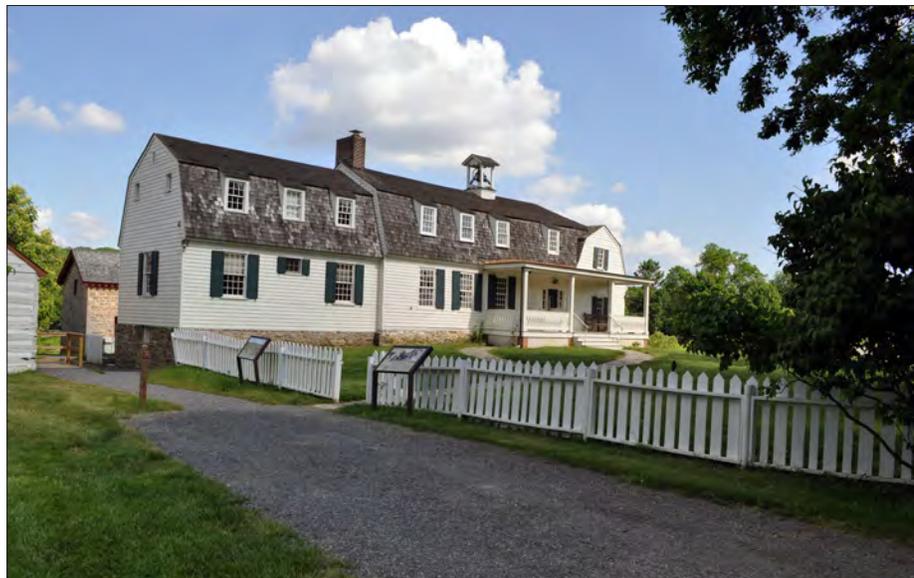
Existing Condition: The Farm House, located in the center of the farm property, is an L-shaped building with a stone foundation, wood frame, and a slate gambrel and gable roof. Following the historic period, the Farm House was expanded to the north during 1948–49 to accommodate Jane and John Ridgely, Jr. after the mansion Landscape was turned over to the National Park Service. The Farm House was known as the Ridgely House until the death of Jane Ridgely in 1978.

Figure 3.88. West facade of the Farm House from Farm Road. View looking southeast, 2012 (OCLP).

Since acquisition by the National Park Service, work on the exterior included a new wooden roof, restoration of the bell tower, rehanging of the original bell, reconstruction of the west porch, repointing the foundations, and the addition of accessibility features. Restoration on the interior included addition of a modern HVAC system, provisions to make the first story accessible, and the creation of a classroom space (Figure 3.88).

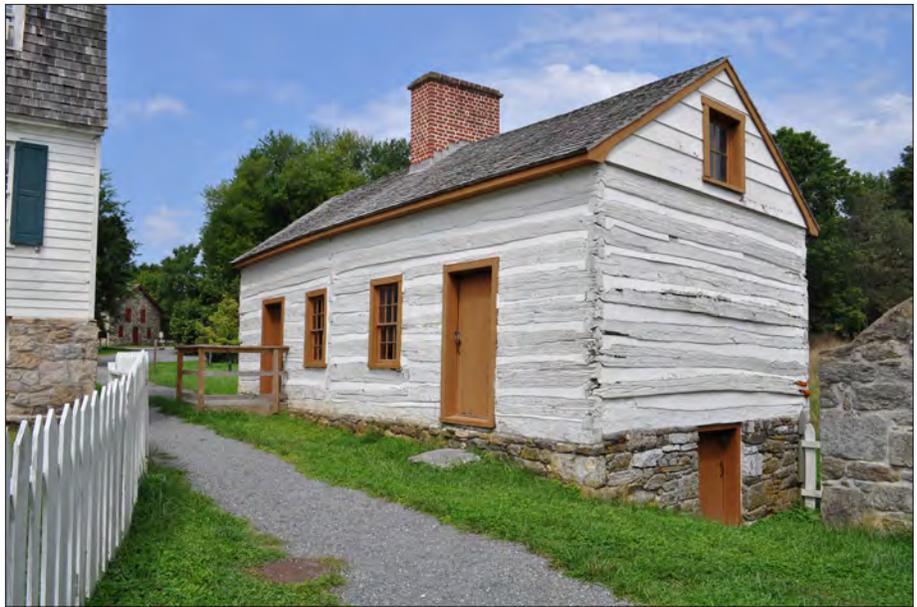
Figure 3.89. Log Farm Structure from the vicinity of Slave Quarters #3. View looking northwest, 2013 (OCLP).

Existing Condition: The Log Farm Structure, also known as Slave Quarters #1, is part of the Farm House Cluster. Located directly north of the Farm House, the Log Farm Structure is four bays long, one bay wide, and one and a half stories high. It is constructed of log plank walls on a rubble stone foundation, and a wood-shingled gable roof with a central chimney. The Log Farm Structure is currently used for interpretation (Figure 3.89).

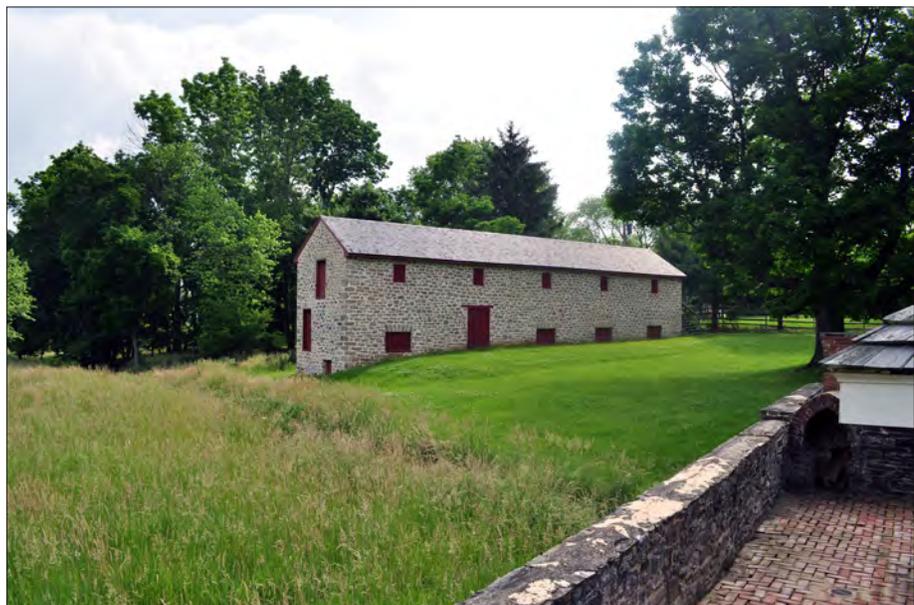
Existing Condition: The Long House Granary is located southeast of the Farm House Cluster and is accessed by a short spur off the main Farm Road. It is constructed of stone walls and wood shingle roof. It is five bays long, with the long axis running from northwest to southeast. The Long House Granary underwent significant renovation work to the interior in 1983–85, and was rehabilitated in 1987. It is now used for archival storage (Figure 3.90).

Figure 3.90. Long House Granary from the Dairy. View looking northeast, 2012 (OCLP).

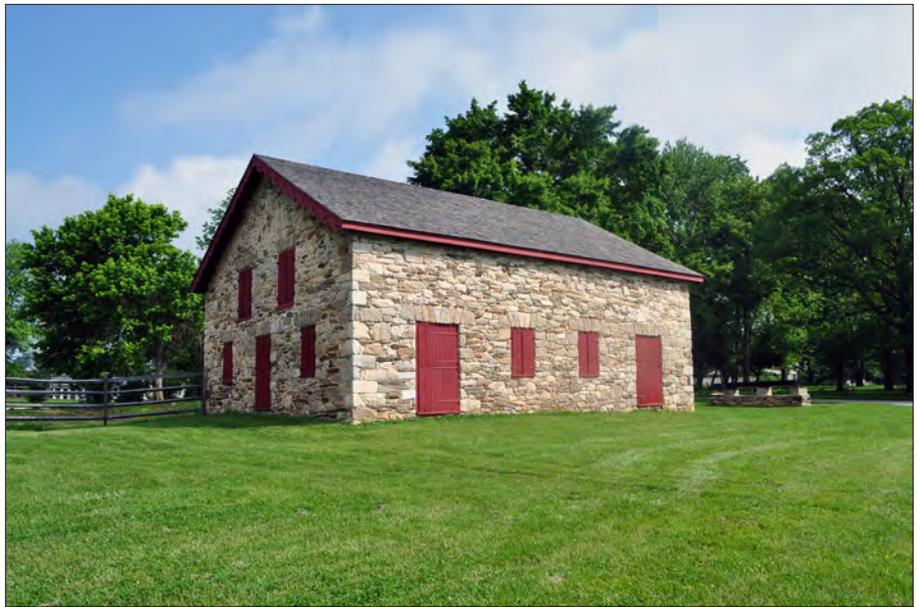
Figure 3.91. Mule Barn from Farm Road. View looking northwest, 2012 (OCLP).

The two-story building consists of granite walls on a rubble stone foundation, is four bays long and three bays wide. The Mule Barn was rehabilitated in 1985, and preserved in 1999–2000. The structure is currently used for storage (Figure 3.91).

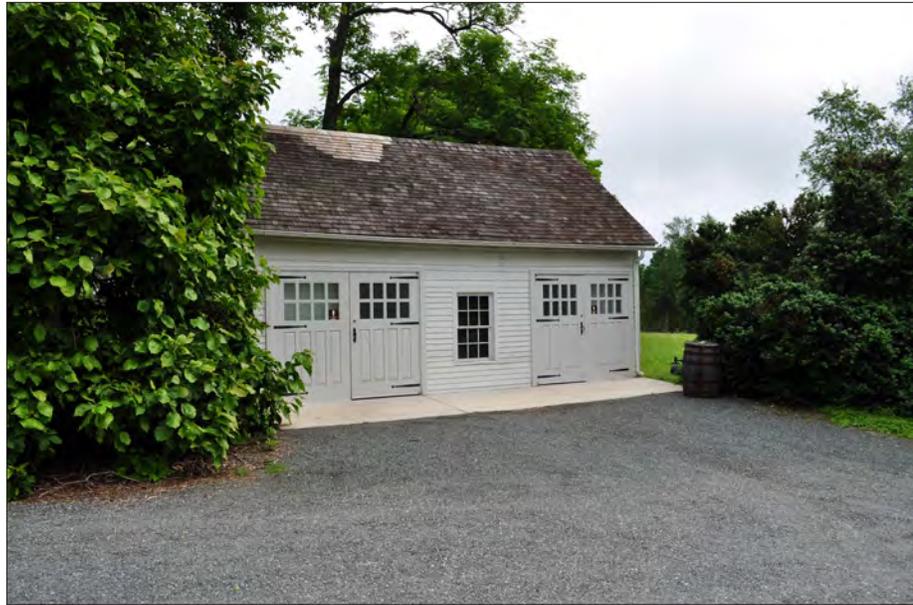
Existing Condition: The North Farm Garage is a single-story structure building with clapboard siding and a shingled roof constructed on a stone foundation. It is located northwest of the Farm House, and is partially shielded by adjacent plantings. The North Farm Garage was rehabilitated in 1979, rehabilitated in 2009, and currently serves as a restroom (Figure 3.92).

Figure 3.92. North Farm Garage from Farm Road. View looking north, 2012 (OCLP).

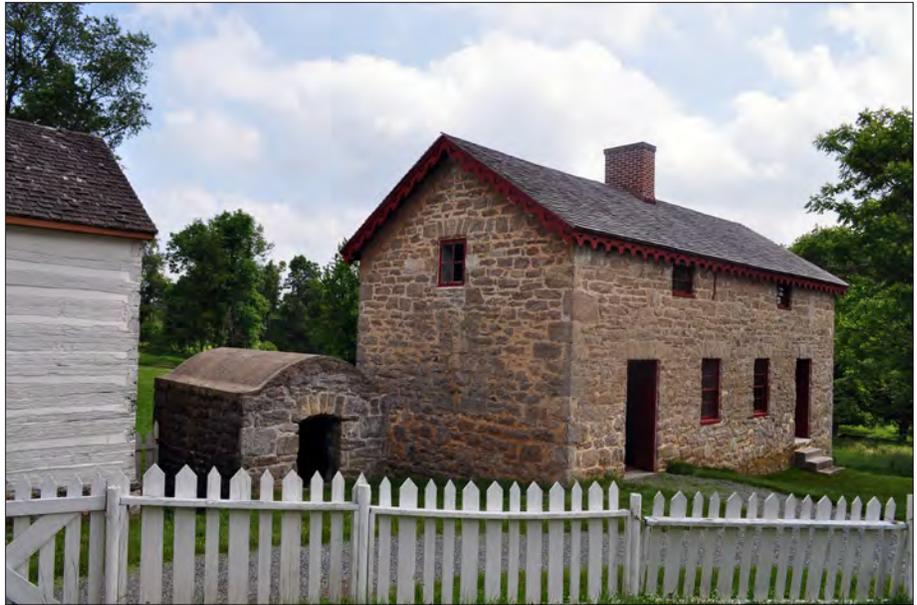
Existing Condition: Slave Quarters #2 is located northwest of the Farm House and directly to the east of the Ash House. It is a two-story building constructed of granite masonry on a rubble stone foundation, with a wood-shingled gable roof and a central chimney. It is four bays wide and one bay deep. Slave Quarters #2 is currently used for as part of the park interpretive program to show the residential quarters for slaves and tenant farmers on the estate (Figure 3.93).

Figure 3.93. Slave Quarters #2 from the rear of the Farm House. View looking northeast, 2012 (OCLP).

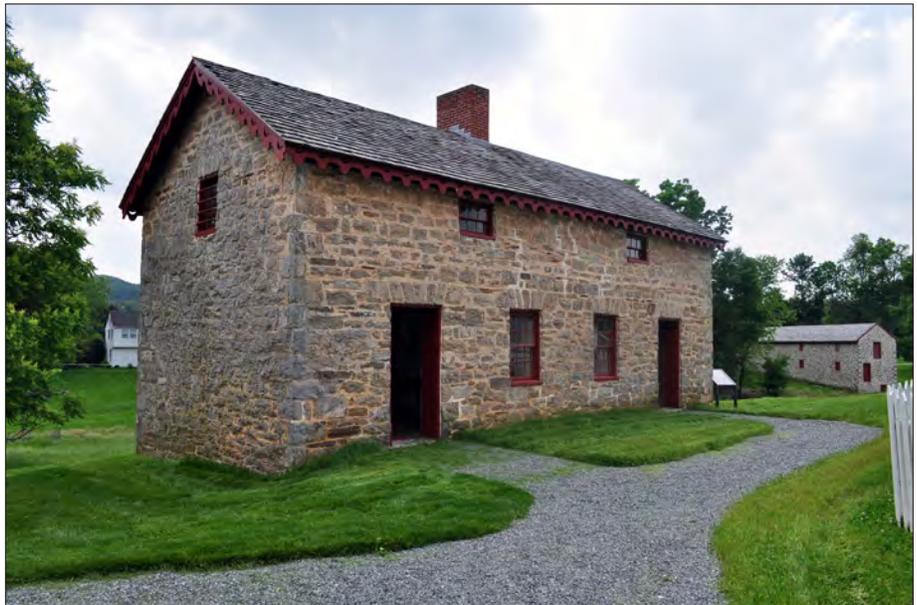
Existing Condition: Slave Quarters #3 is constructed with granite masonry walls on a rubble stone foundation with a wood-shingled gable roof. Slave Quarters #3 was rehabilitated in 1985, underwent restoration work in 2006 and 2009, and is currently used for storage and interpretative purposes (Figure 3.94).

Figure 3.94. Slave Quarters #3, with the Long House Granary visible beyond. View looking south, 2012 (OCLP).

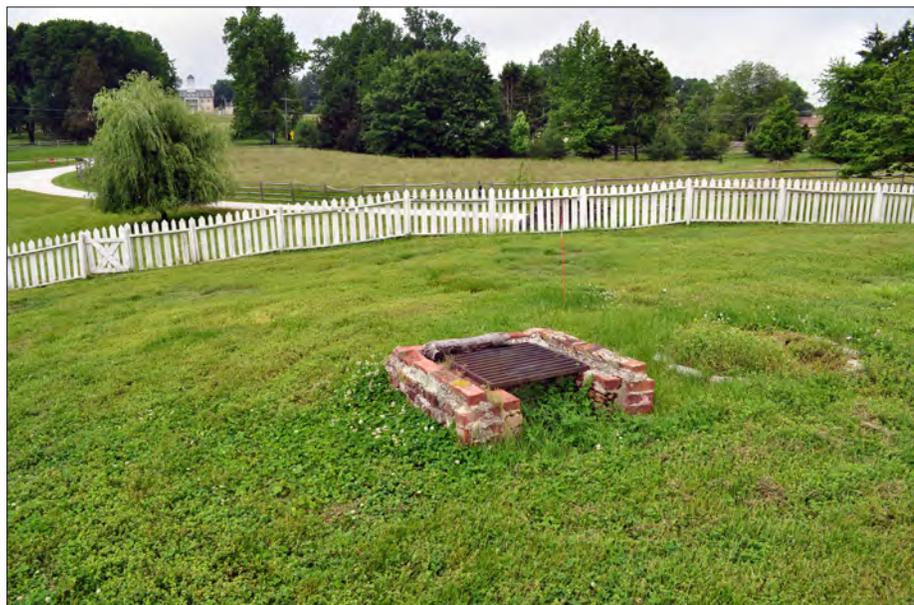
Existing Condition: A brick barbeque is located near the southern corner of the Farm House yard. This U-shaped brick structure is about 14” high, with a 24” by 24” metal grate cooking surface set atop the brick. The Farm House barbeque was constructed by the Ridgelys during their occupation of the Farm House post-1948 (Figure 3.95).

Figure 3.95. Farm House barbeque, with the Mansion visible beyond. View looking southwest, 2012 (OCLP).

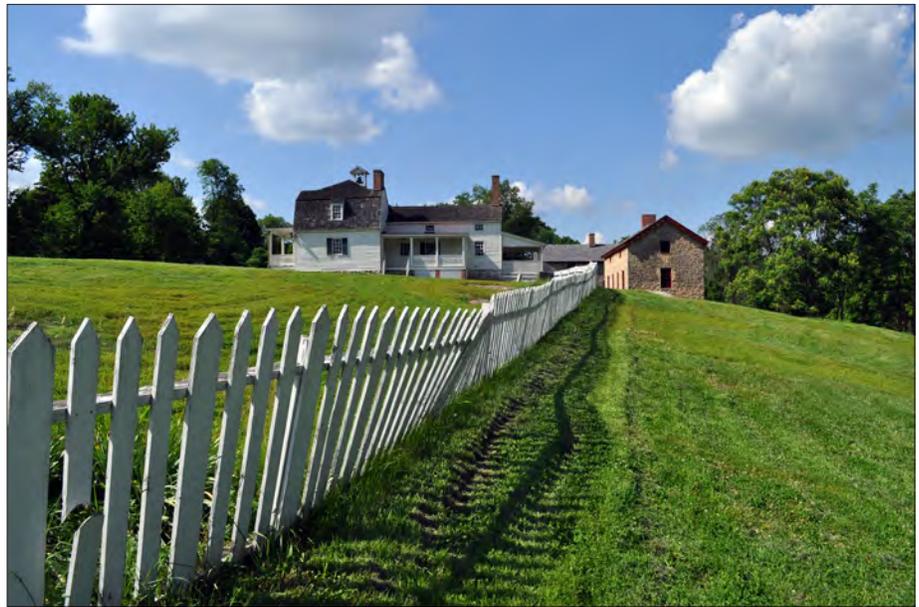
Figure 3.96. Farm House yard picket fence, with the Farm House (left) and Slave Quarters #3 (right) visible beyond. View looking north, 2012 (OCLP).

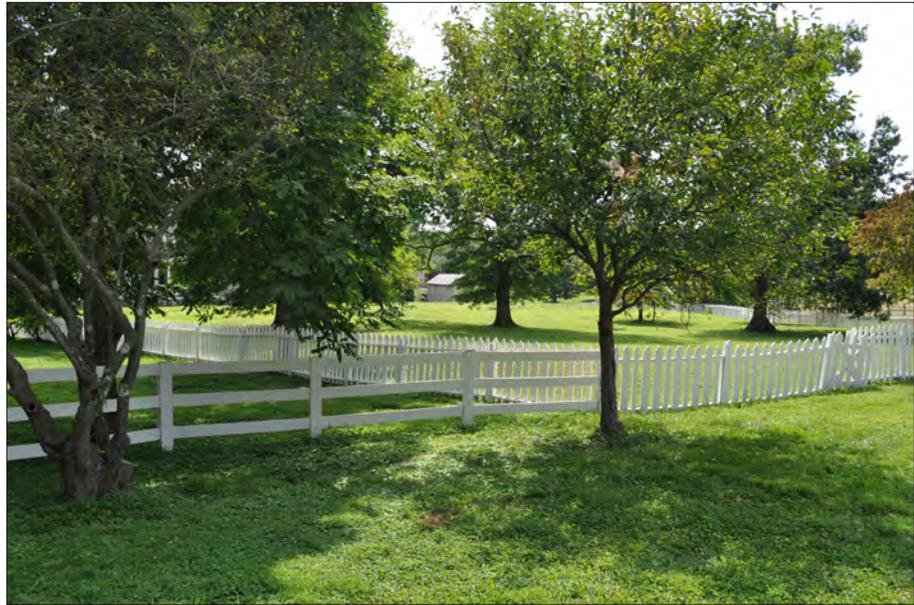
Existing Condition: A short section of post and rail fence extends north from the northwest corner of the Farm House yard picket fence. It is painted white and terminates before it reaches the Farm Road spur, which runs east towards the Farm House. Another section of rustic post and rail fence borders the West Farm Field and Farm Road (Figure 3.97).

Figure 3.97. Farm House post and rail fence, with the Farm House yard visible beyond. View looking southwest, 2013 (OCLP).

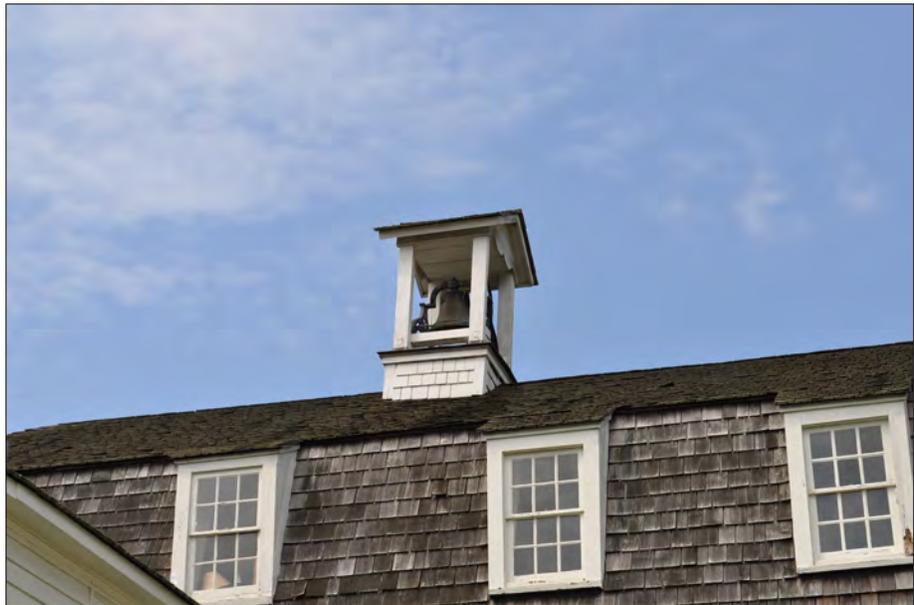
Figure 3.98. Farm House tower bell. View looking west, 2013 (OCLP).

Existing Condition: The bell still hangs in the Farm House tower. A rectangular cast-in sign that is embossed, ‘Register & Webb./Balto. MD’ is located at the bell’s shoulder. The clapper has an oval ball and tassel-shaped end and is controlled by a large pulley and a grooved wheel located at one side between the arch and Y-support (Figure 3.98).

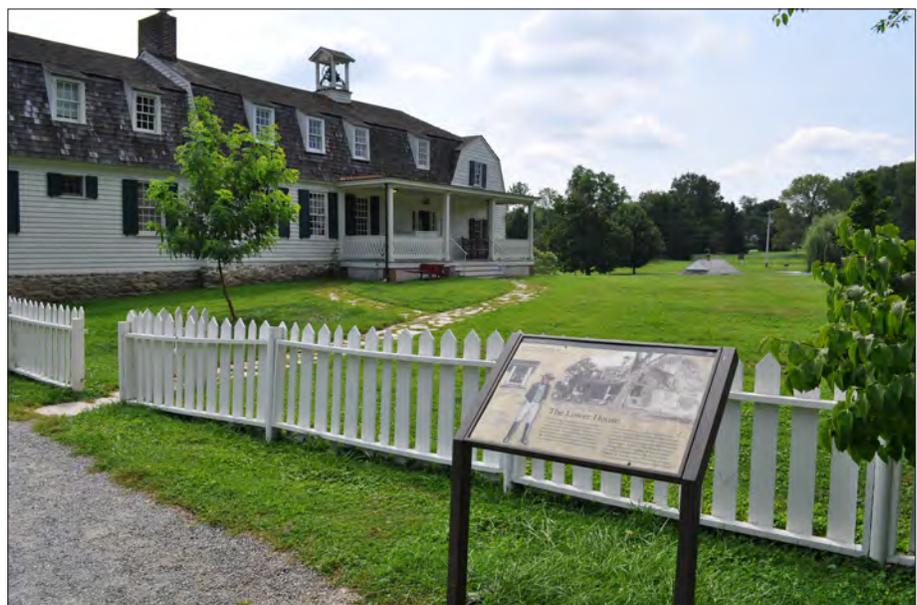
Existing Condition: Various contemporary signs are located throughout the farm landscape to aid in visitor way-finding (Figure 3.99).

Figure 3.99. Farm landscape signage. View looking south, 2013 (OCLP).

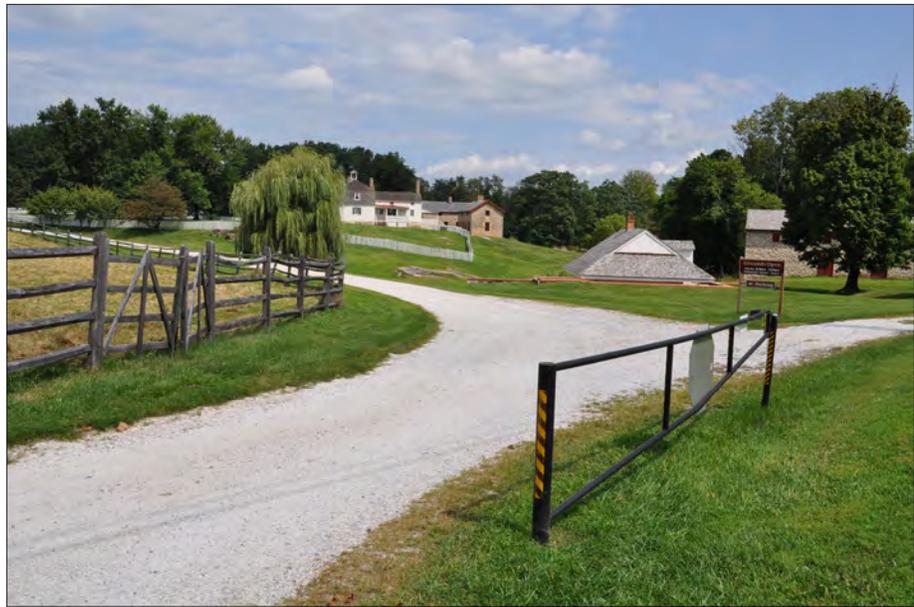
Existing Condition: The Farm Road entrance gate is set back from the intersection of Farm Road with Hampton Lane, and is composed of a contemporary hinged metal gate installed in-line with the wooden field fence. Contemporary signs direct visitors to park entrances and displays park hours. Small rock outcroppings flank the road entrance and gate (Figure 3.100).

Figure 3.100. Farm Road entrance gate. View looking north, 2013 (OCLP).

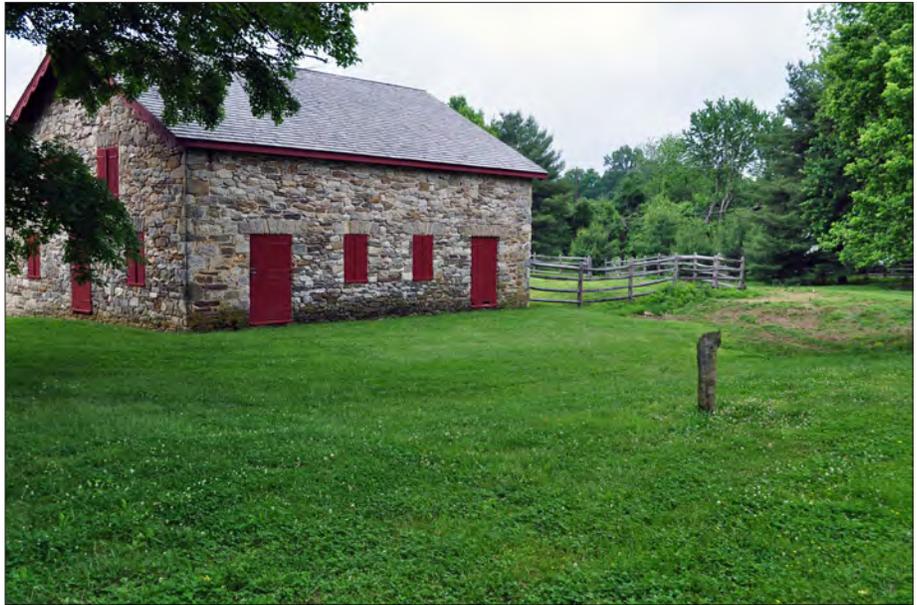
Figure 3.101. Mule Barn barbed-wire fence remnant (post in foreground). View looking southwest, 2012 (OCLP).

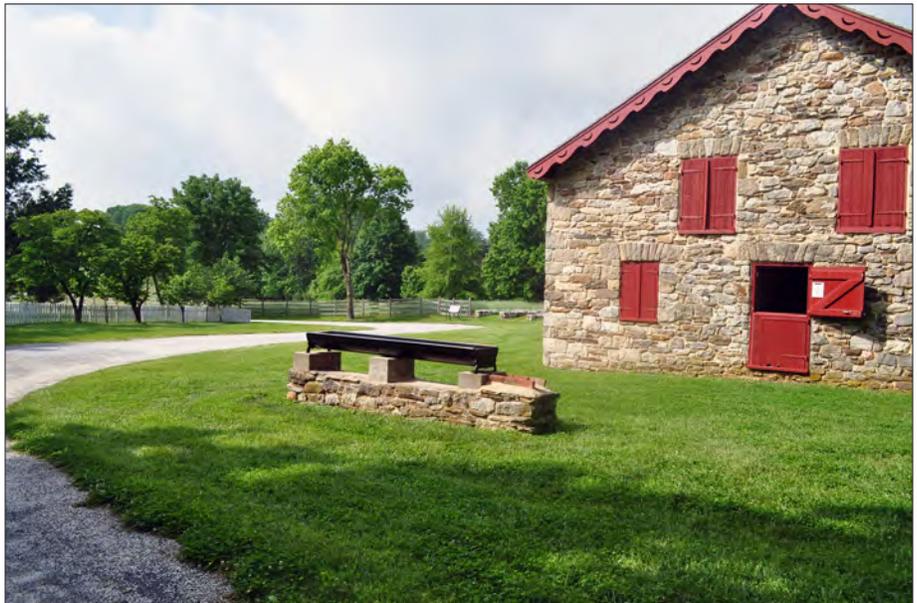
Existing Condition: The Mule Barn trough is located to the northeast of the Mule Barn. It consists of a cast iron watering trough supported by three piers that rest on a granite foundation with a brick drain weir at one end (Figure 3.102).

Figure 3.102. Mule Barn trough, with the Mule Barn visible to the right. View looking southwest, 2012 (OCLP).

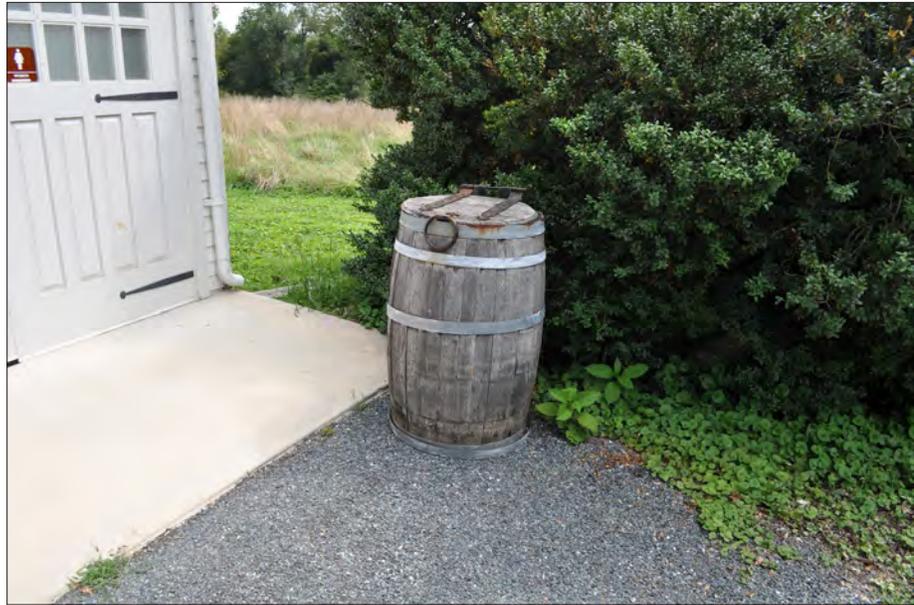
Existing Condition: The wooden wine barrel refuse barrels placed throughout the property are contemporary additions to the Farm grounds. The barrels are comprised of wooden staves held together with metal hoops. A circular wooden head tops the barrel, and a hinge allows the cap to be opened for waste to be deposited inside (Figure 3.103).

Figure 3.103. Refuse barrel. View looking north, 2013 (OCLP).

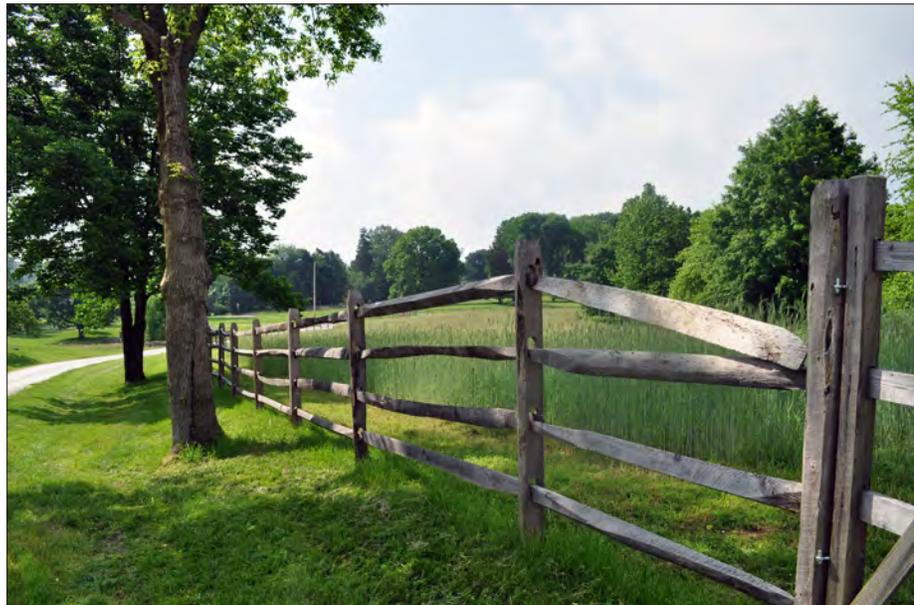
Figure 3.104. West Farm Field fence, with rye growing beyond. View looking southeast, 2012 (OCLP).

split log posts connected by four rails (contributing). Additional contemporary post and rail fences border sections of the farm property line, primarily within the southern half of the farm parcel (non-contributing, Figure 3.104).
