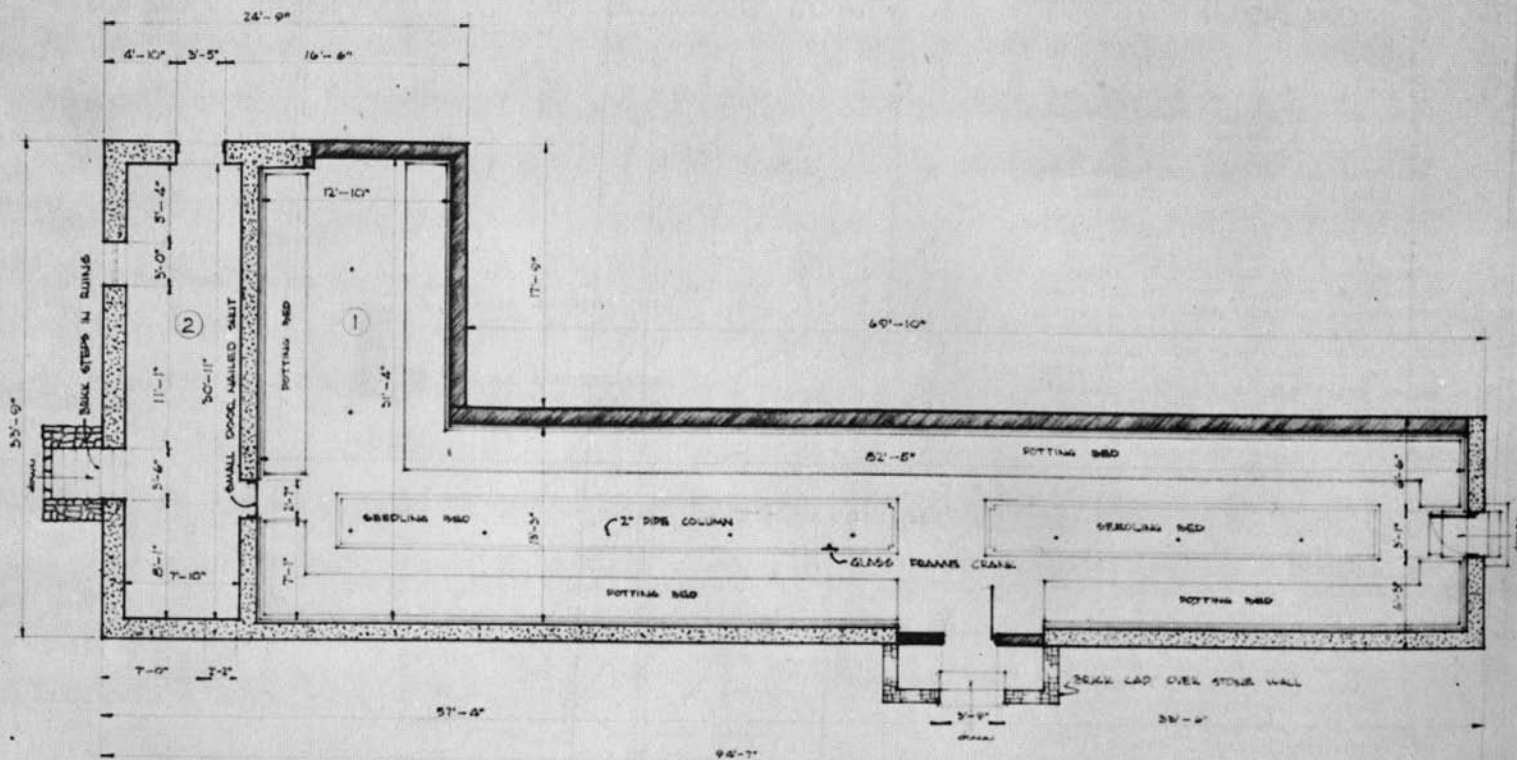
FLOOR PLAN
 SCALE: 3/8" = 1'-0"

NOTE:
 THE WALL BETWEEN ROOMS 1 & 2 IS PERFORATED WITH
 NUMEROUS CLOSED OPENINGS WITH BRICK ARCHES AND WOOD
 & IRON LINTELS; WOOD PLATES AND ROLLED IRON SOCKETS.
 BECAUSE OF THE DESTRUCTION AND OVERLAPPING OF THESE ELEMENTS
 IT IS IMPOSSIBLE TO DETERMINE THE ORIGINAL STATE AND
 FUNCTION OF ROOM NO. 2.

FRAGMENTS OF STUCCO REMAIN IN
 INTERIOR CORNER ON WALLS, OTHERWISE
 EXPOSED BRICK AND STONE SURFACE.
 FLOOR IS BRICK TAVING IN ROOM REPAIR.
 EAST FLOOR OTHERWISE
 NO CEILING
