U.S. DEPARTMENT OF THE INTERIOR
NATIONAL PARK SERVICE

**ACCOMMODATION
of
HANDICAPPED VISITORS
at
HISTORIC SITES**

**Volume II
TECHNICAL MANUAL**

October, 1979

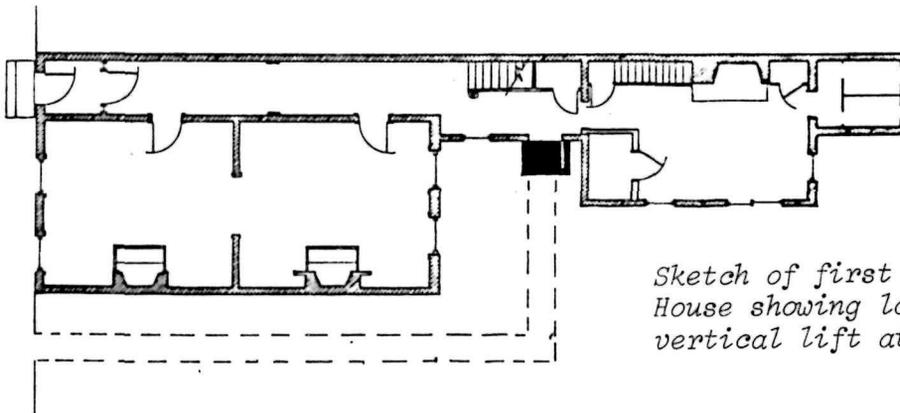
Sketch of first floor of Bishop White House showing location of proposed vertical lift at side entrance.

Analysis of the solutions to the entrance problem indicates that option #4: Install a vertical lift at the side entrance, provides favorable access. This entrance is reasonably accessible through the garden, and because the garden is walled, installation of a lift would not be a visual intrusion to visitors at the front. It is important to note that a lift requires that a 5 foot by 5 foot platform be built over the existing stairs. This could be designed to be reversible and not damage the stairs. The lift would then raise individuals in wheelchairs up to the platform so they could roll through the doorway.

A ramp at this side entrance was considered to be less desirable because of its length; 18 inches of rise requires 18 feet of length. Because the garden wall is not much more than 18 feet from the doorway, the ramp would have to bend at a right angle and extend along the garden walk in either direction.

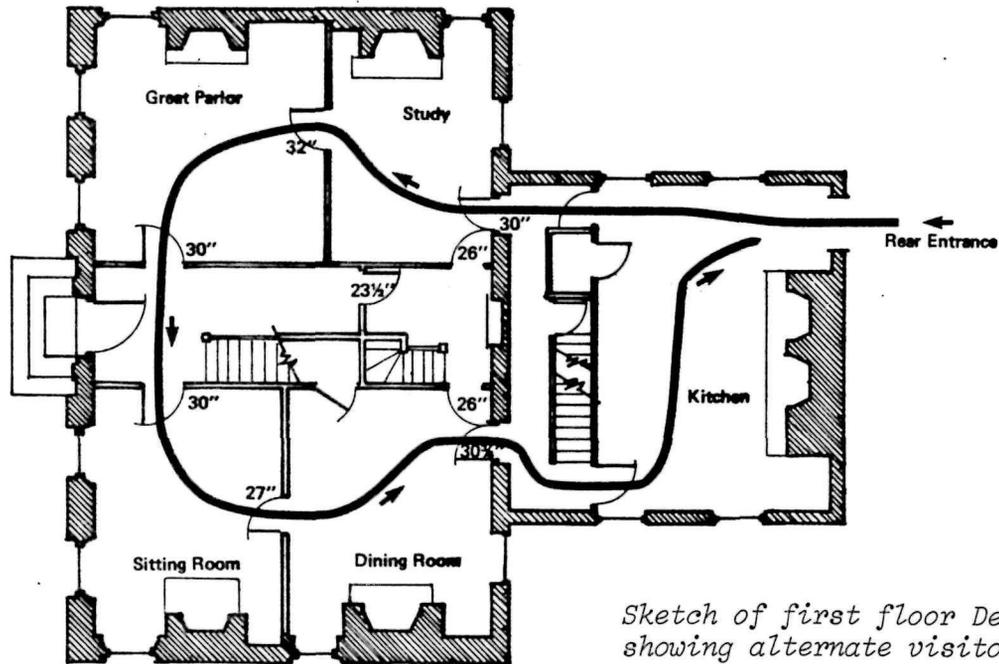
As noted below in the sketch of the first floor, the second solution calls for the tour to go from the kitchen through a 30 inch doorway (normally kept closed) to the study. Visitors in wheelchairs would then be permitted to travel the length of the study, pass through a 32 inch doorway and enter the great parlor. Thirty inch doorways at the hallway would allow wheelchairs to pass through into the sitting room. From there a 27 inch doorway might prove inaccessible to some individuals in wide wheelchairs. Those in standard wheelchairs would have to be pushed through the opening, so as not to hurt their knuckles while propelling themselves through the narrow opening. Travel through the dining room and back to the kitchen would complete the tour. Those visitors who found the 27 inch doorway to be a barrier would have to retrace their route in order to return to the kitchen.

When presented with the above two solutions to the narrow center doorway problem, the second option is clearly superior. It achieves access by changing the tour route and has negligible effect on the historic fabric when individuals in wheelchairs, and possibly accompanying visitors travel over the well worn floor boards. The second option would necessitate changing the tour and accompanying interpretation, but it is felt that if all visitors in the group were given this modified tour, no segregation or separate treatment of a handicapped person would result. Since the tour is always guided, staff assistance to push wheelchairs is available.

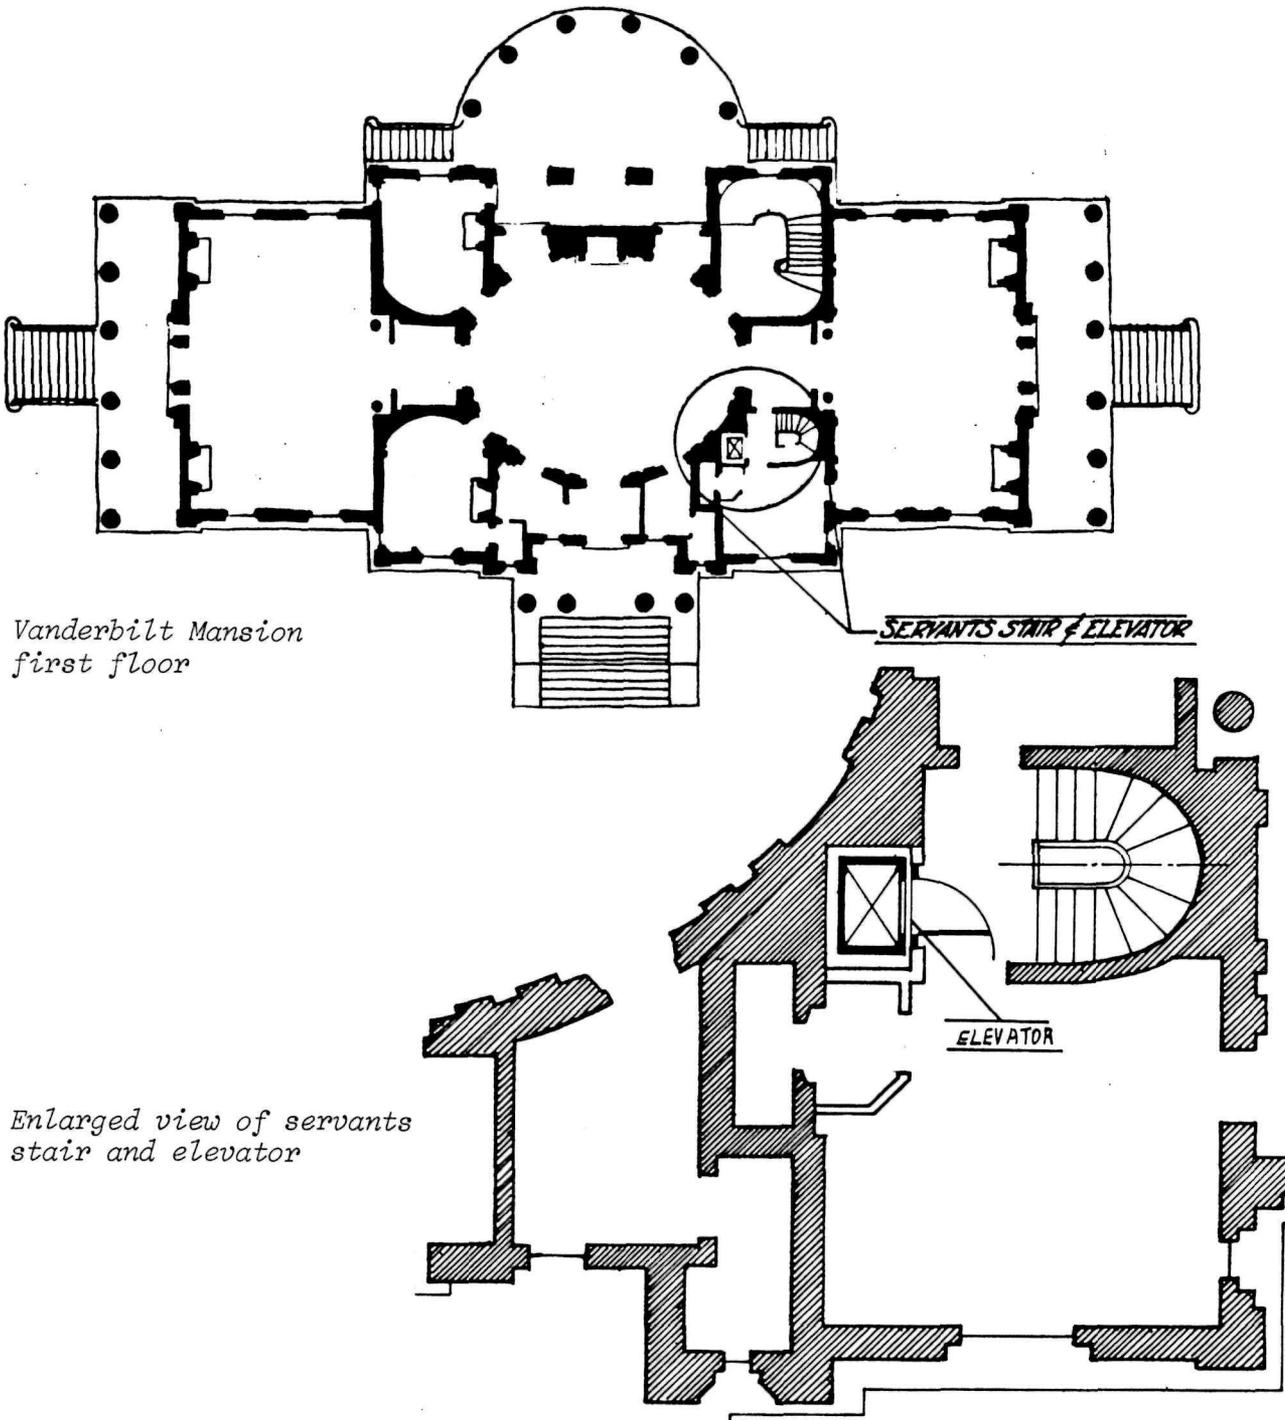
A sketch of a portion of the first floor below reveals some detail about the existing servant's staircase and the residential elevator. Further field measurements by elevator consultants would be required to determine the adequacy of the open center well which houses the present staircase. Modification of the elevator shaft would involve removal of a small percentage of the stone pier surrounding the elevator.

1. Remove the entire servant's stairway and install a large elevator for the public.
2. Enlarge the shaft of the existing residential elevator and install a new and larger car for elderly and handicapped visitors.
3. Install a closed circuit television system that would allow visitors to view other floors from the basement or from the visitor center.
4. Create an audio-visual presentation which depicts inaccessible areas with accompanying narrative. Locate this presentation in an accessible location.
