National Park Service  
Cultural Landscapes Inventory  
2004

Ainahou Ranch House and Gardens  
Hawaii Volcanoes National Park

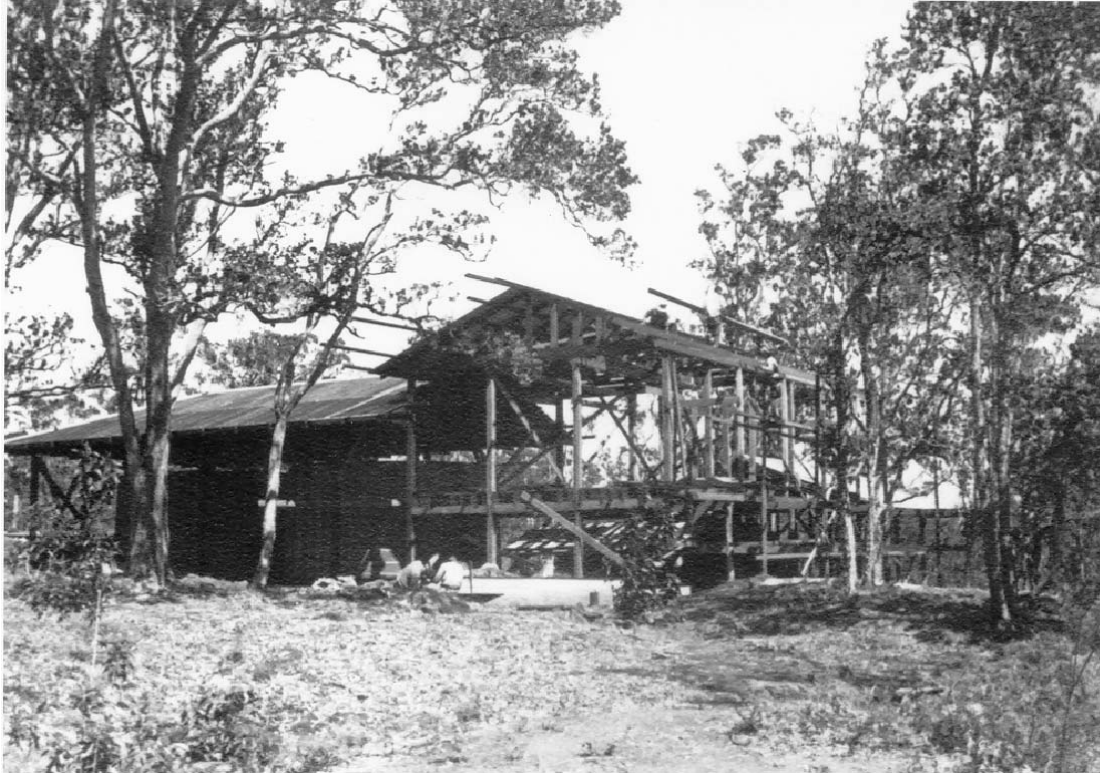
*Physical History # 1: Historical photo of the construction of the 'Ainahou Ranch House (courtesy of Samuel M. Lowrey, 1941).*

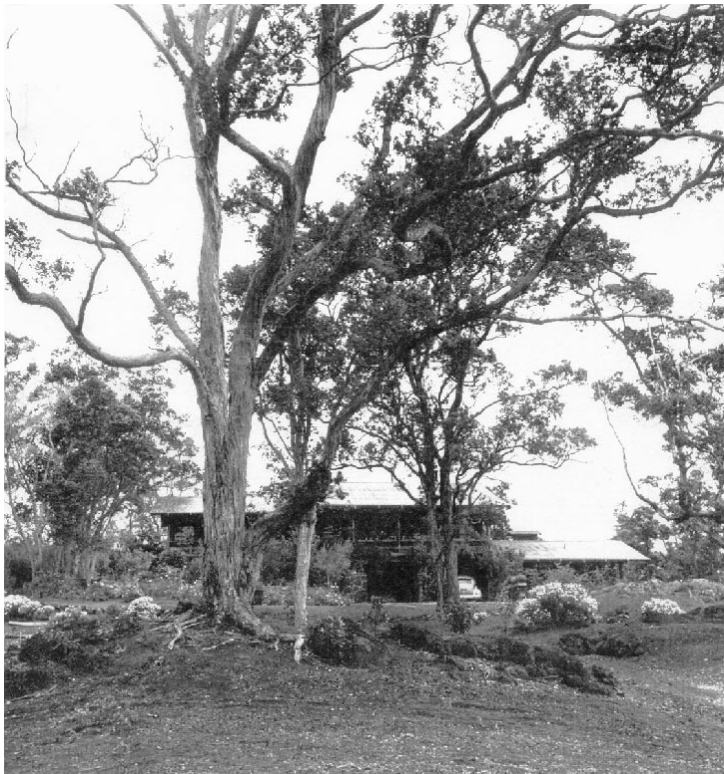
*Physical History # 2: Historical photo of the front view of the 'Ainahou Ranch House (courtesy of Shipman LTD, 1949).*

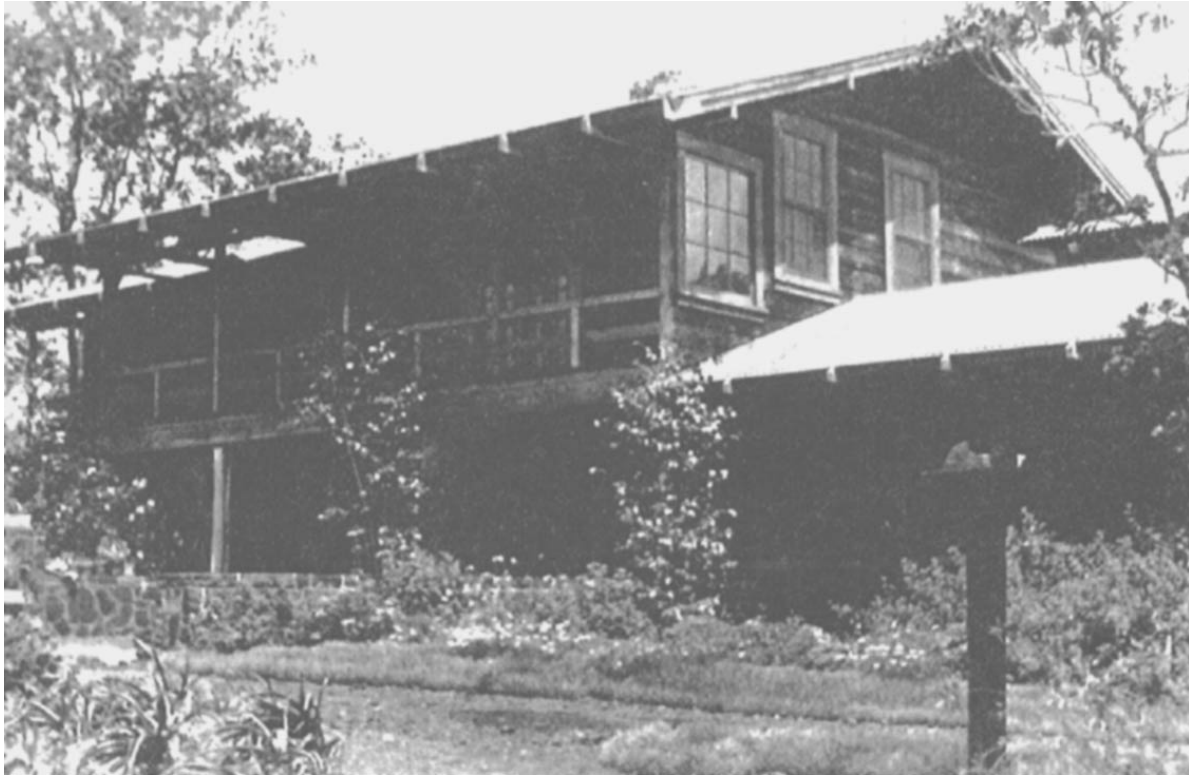
*Physical History # 3: Historical photo of the 'Ainahou Ranch House with the kitchen to the right and the garage to the left (courtesy of Shipman LTD, 1949).*

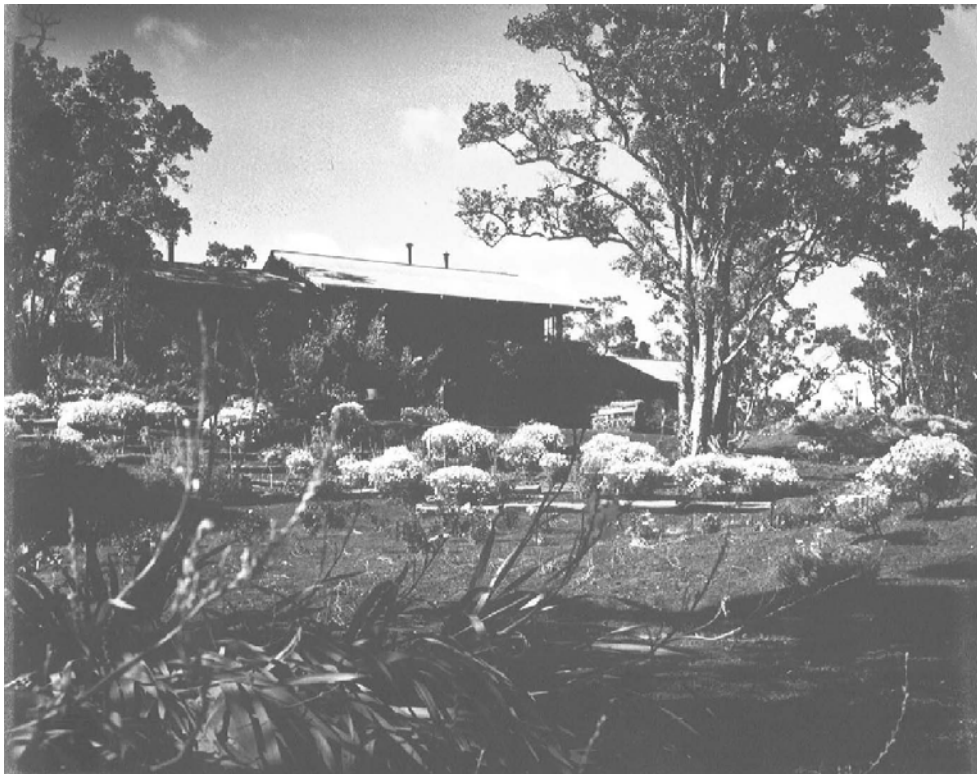
*Physical History # 4: Historical photo of the 'Ainahou Ranch House and Gardens (courtesy of Shipman LTD, date unknown).*

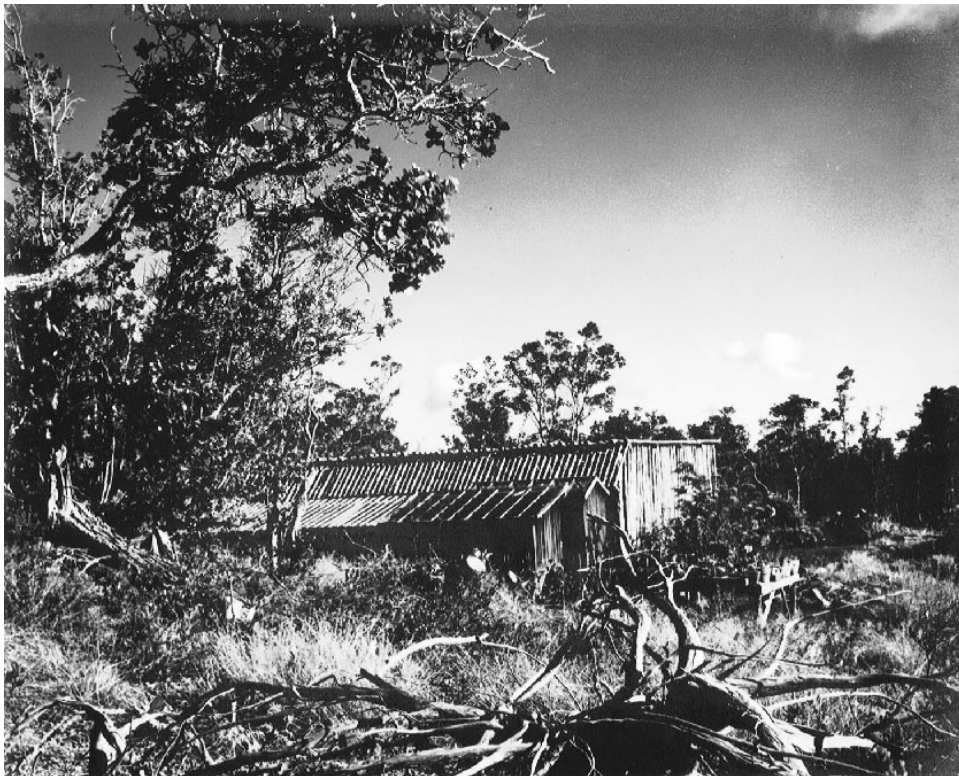
*Physical History # 6: Historical photo of the 'Ainahou Ranch nursery (courtesy of Shipman LTD, date unknown).*

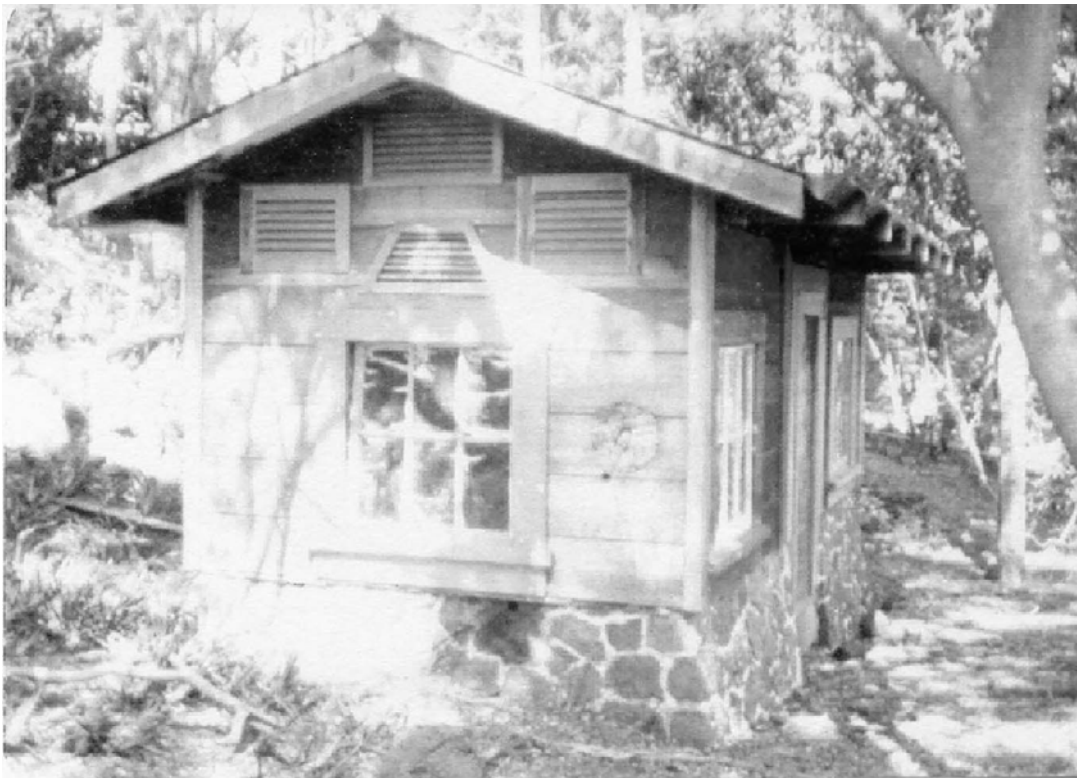
*Physical History # 8: Historical photo of the generator shed located to the east of the ranch house (PWR, HAVO, CLI files, 1970s).*

The mortared stone foundation of Shipman's generator shed remains approximately seventy feet east of the ranch house (at the bottom of the hill). The dimensions are approximately 10' x 20' x 2'6" high. Remains of an old generator can still be seen within the structure. The wooden portions of the structure are now missing.

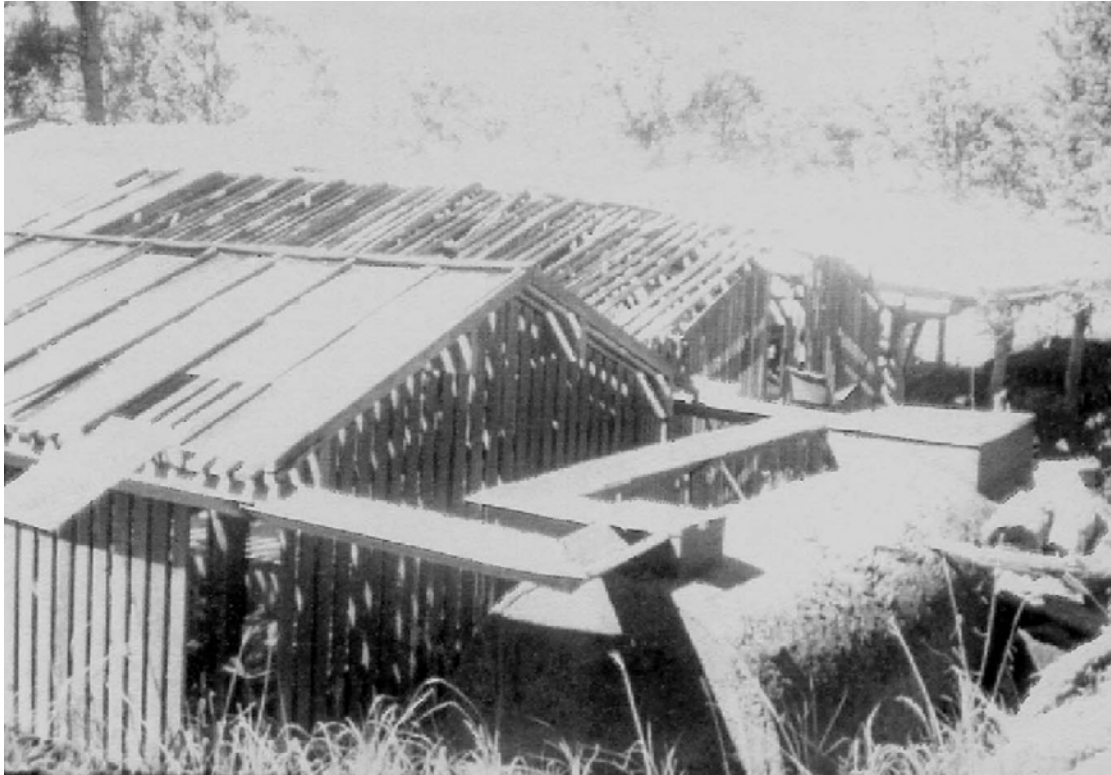
*Physical History # 9: Historical photo of the glass hothouses in the nursery area. Note the retrieval of rainwater from the roof of the structures (PWR, HAVO, CLI Files circa 1973).*

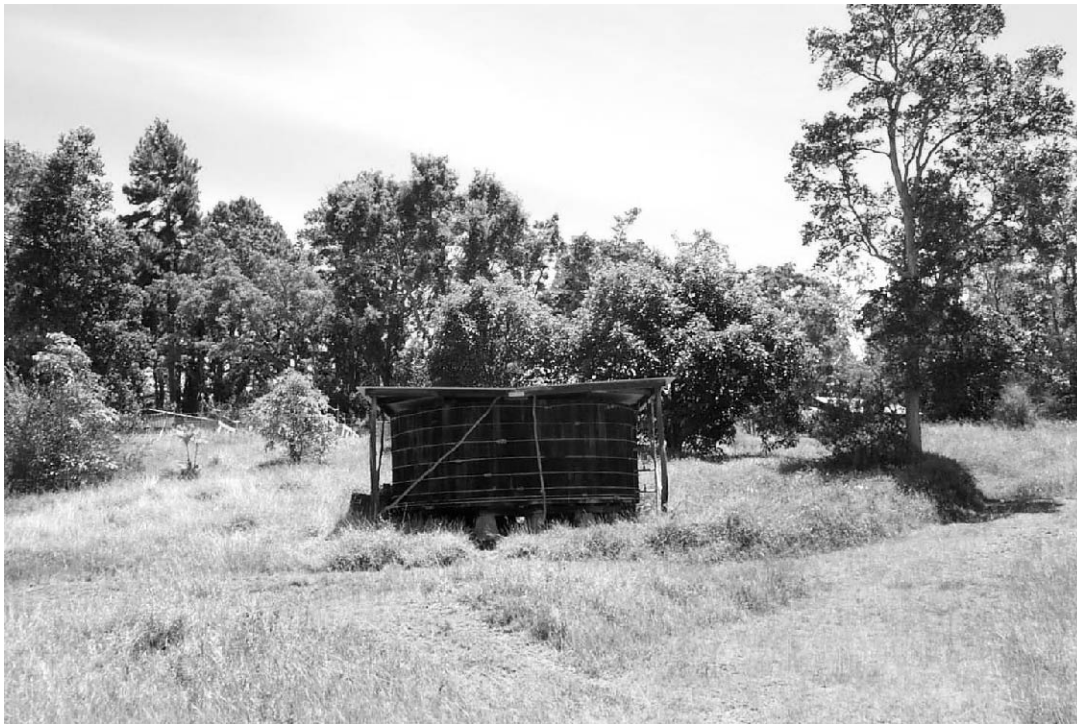
*Topography # 1: In Shipman's gravity-powered water system, this water tank a few feet down from the nursery area collected water from the roofs of the hothouses, and serviced the livestock facilities down slope (PWR, HAVO, CLI files, 2003).*

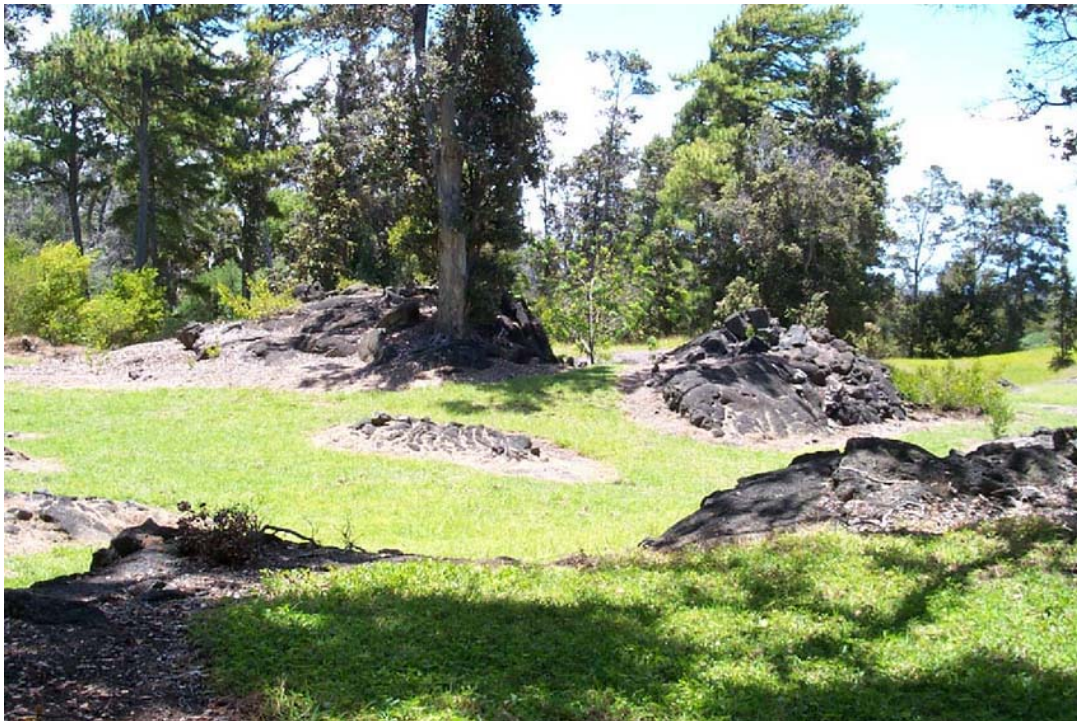
*Topography # 2: Lava outcrops are topographic features that contribute to the character of the landscape (PWR, HAVO, CLI files, 2003).*

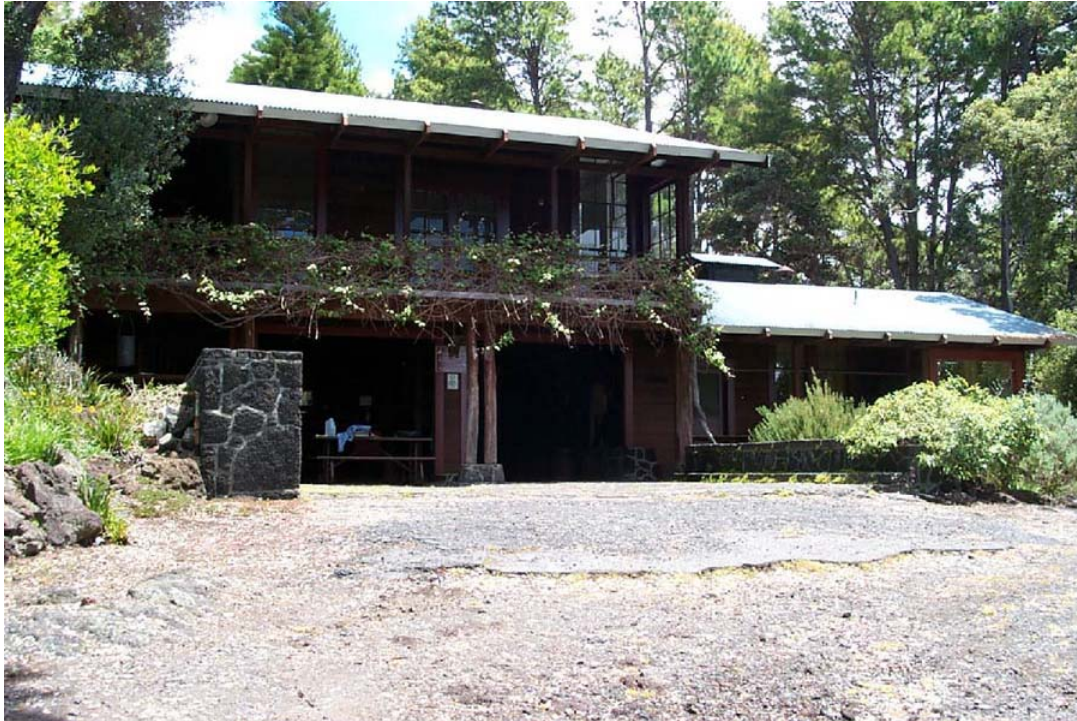
*Buildings and Structures # 1: Contemporary photo of the front view of the 'Ainahou Ranch House (PWR, HAVO, CLI files, 2003).*

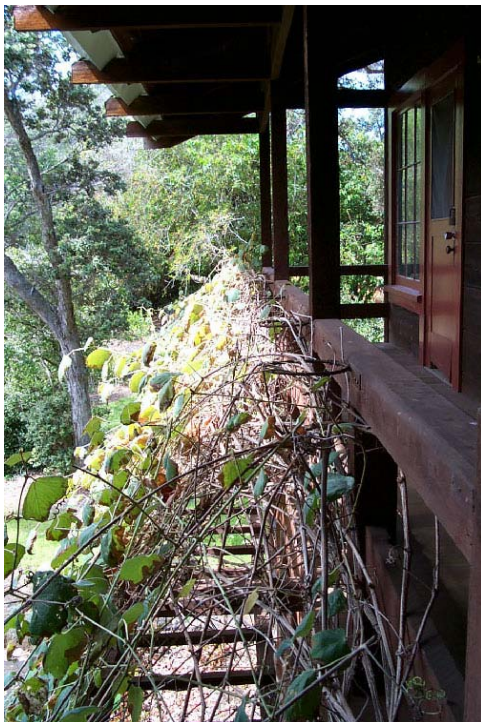
*Buildings and Structures # 2: Contemporary photo of the grape trellis located on the south side of the ranch house (PWR, HAVO, CLI files, 2003).*

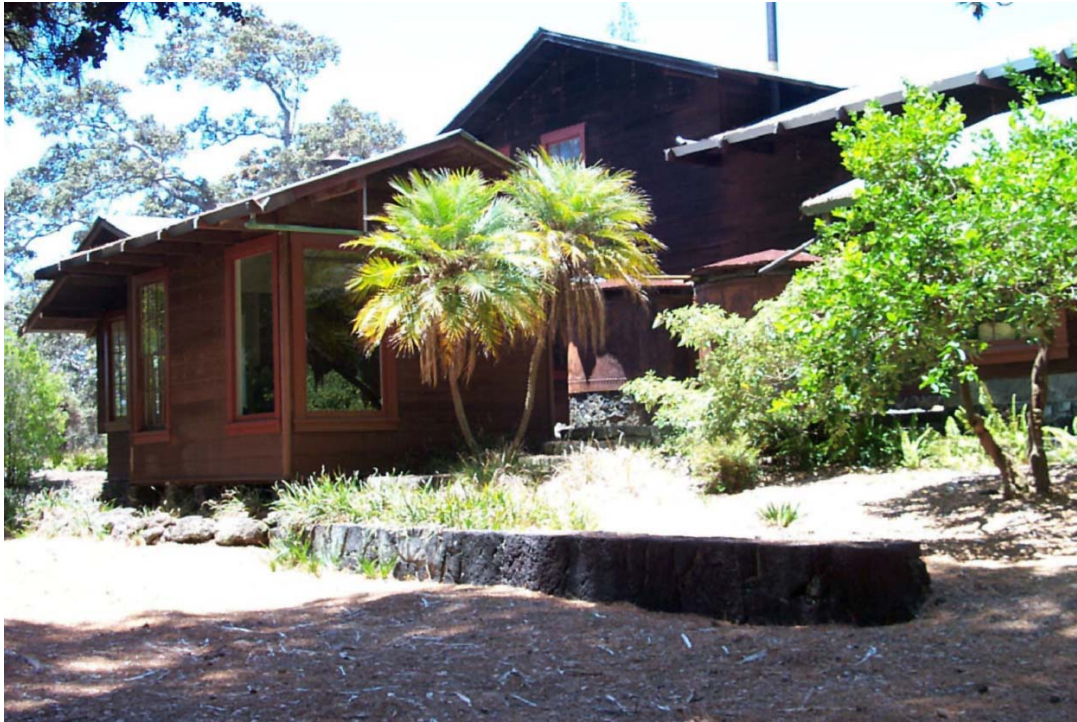
*Buildings and Structures # 3: Contemporary photo of the east side of the ranch house (looking SW)(PWR, HAVO, CLI files, 2003).*

Two small metal water tanks once used for drinking water are nestled in on the east side of the house (see photo, Buildings and Structures # 3). The roof of the ranch house served as the rain shed for these two tanks, which were not issued separate LCS numbers due to their close association with the ranch house. The two large water storage tanks that were contained within the ranch house building are no longer present, but their concrete foundations are still intact. These foundations are also considered part of the ranch house and therefore do not have separate LCS numbers.

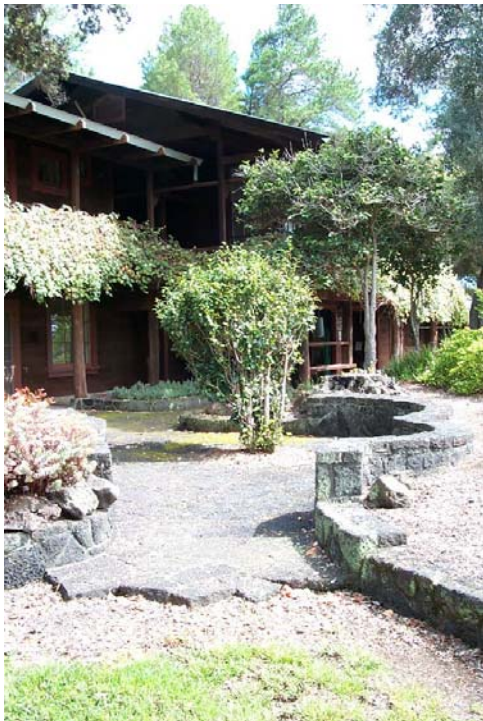
*Buildings and Structures # 4: Contemporary photo of the serpentine rock wall framing the outdoor patio area (PWR, HAVO, CLI files, 2003).*

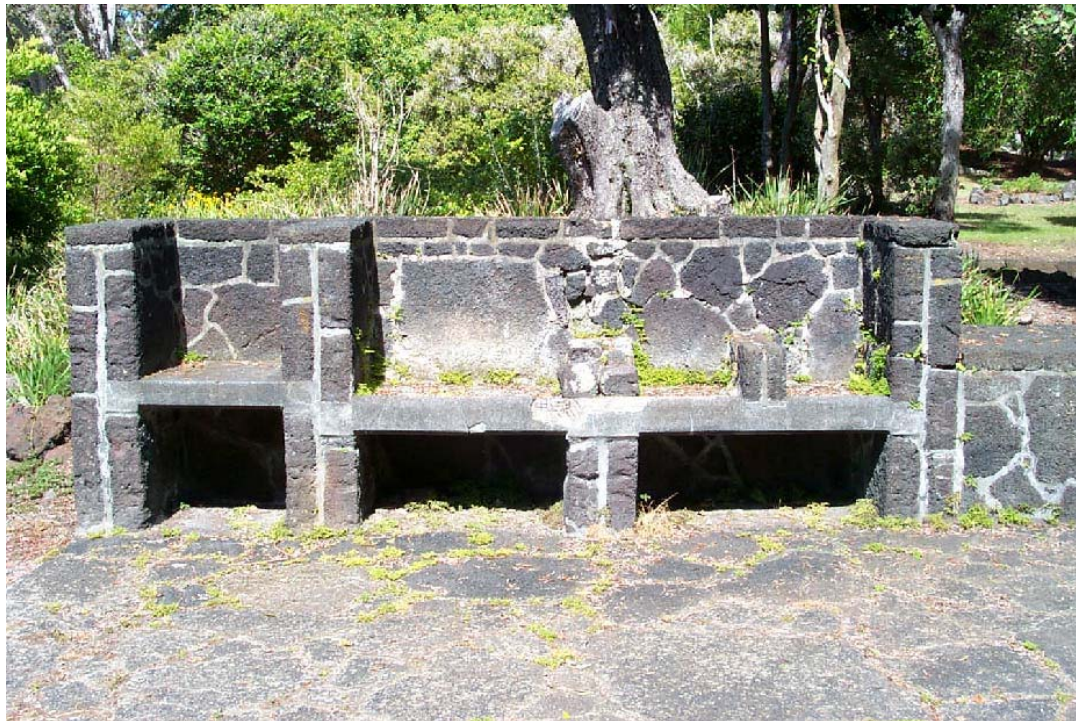
*Buildings and Structures # 5: Contemporary photo of the barbecue pits built with lava rocks in a mosaic pattern (PWR, HAVO, CLI files, 2003).*

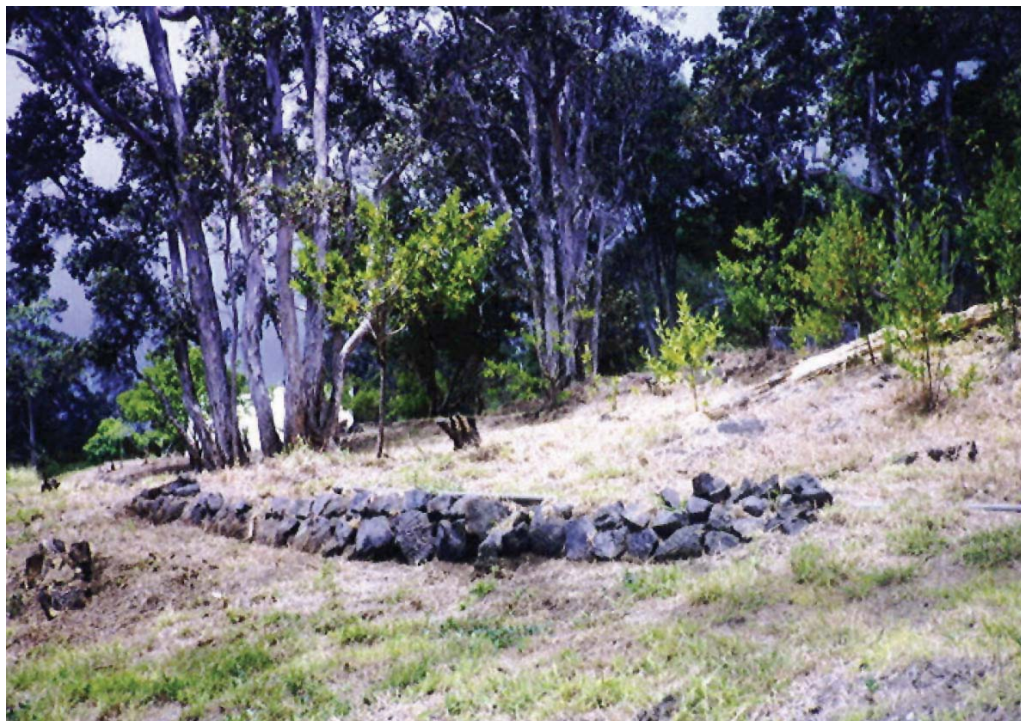
*Buildings and Structures # 6: A dry-laid lava rock retaining wall located between the nursery area and the ranch house (PWR, HAVO, CLI files, 2003).*

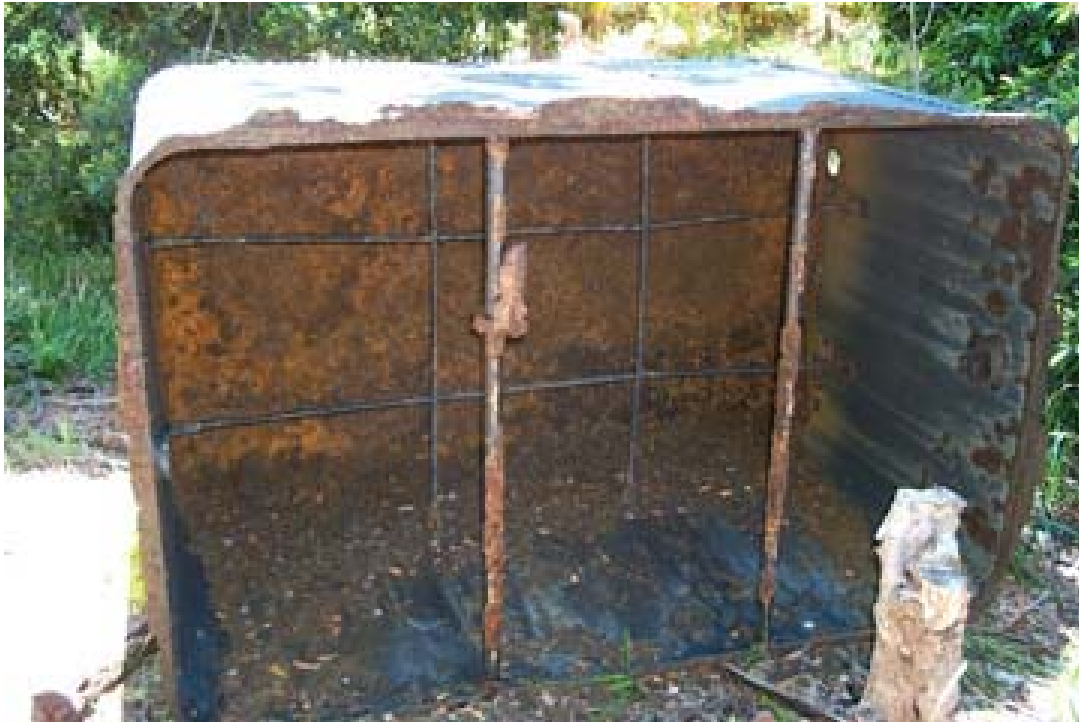
*Buildings and Structures # 7: A rusty metal container near the generator shed foundation. Historical function unknown (PWR, HAVO, CLI files, 2003).*

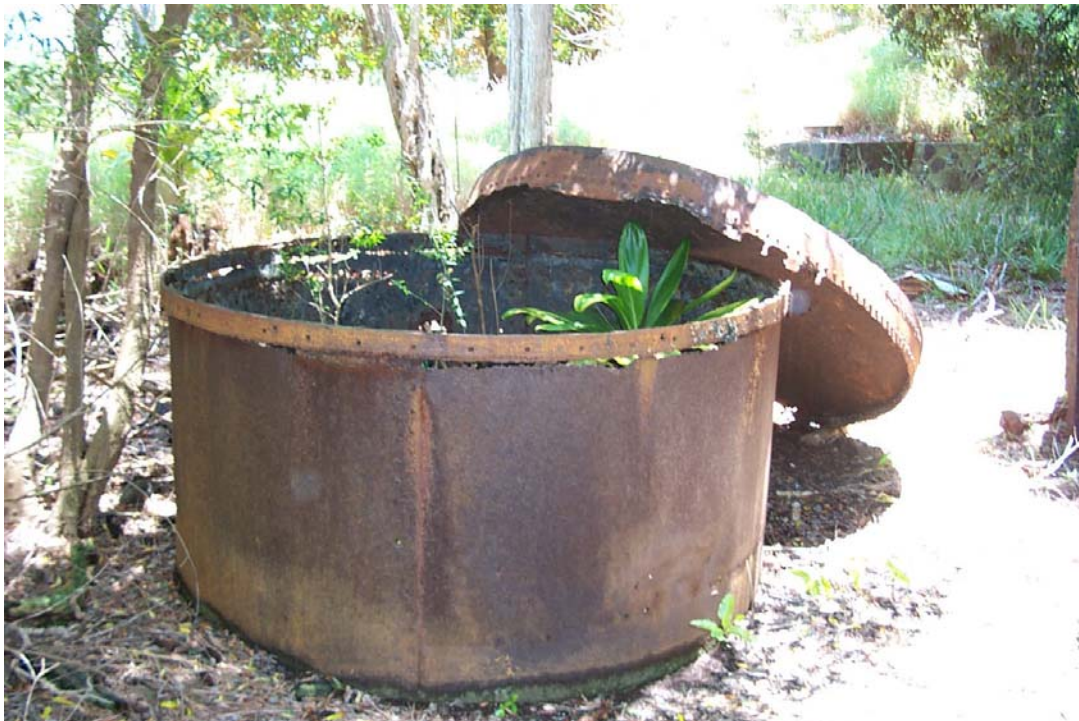
*Buildings and Structures # 8: A rusty metal container w/ lid near the generator shed foundation. Historical function unknown (PWR, HAVO, CLI files, 2003).*

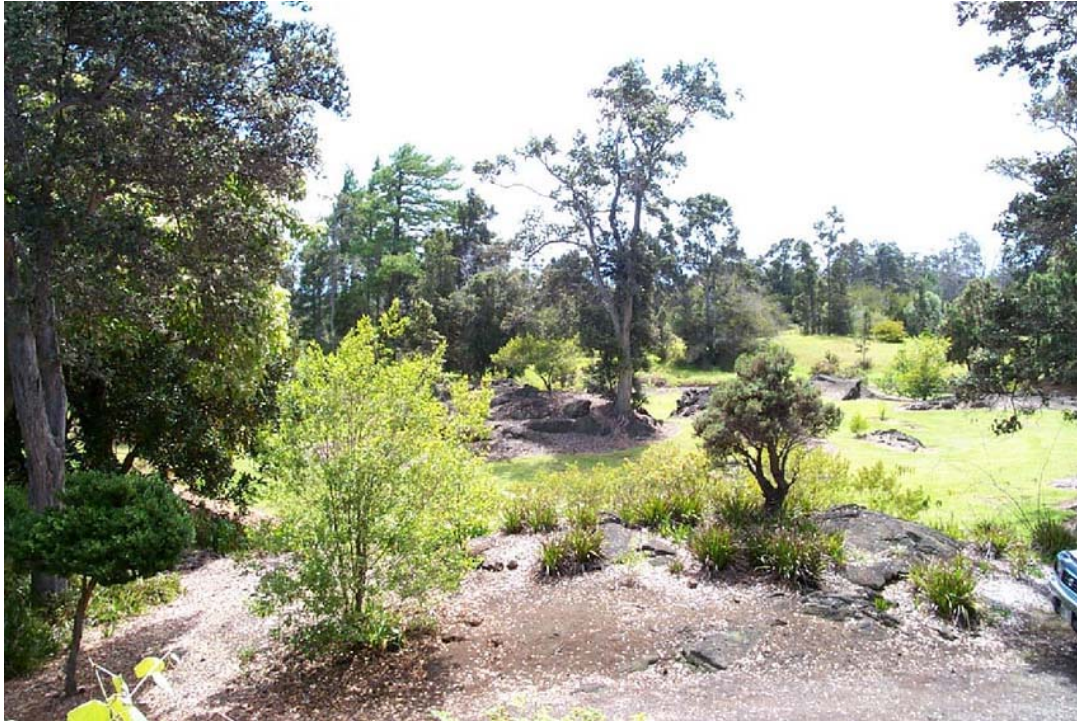
*Spatial Organization # 1: From balcony looking south. Note influence of small-scale topography on aesthetics and spatial organization of vegetation (PWR, HAVO, CLI files, 2003).*

The spatial organization of the ranch house gardens is highly irregular, resulting from the integration of existing native vegetation and small-scale topographic features such as lava outcrops (see photo, Spatial Organization # 1). Throughout the component landscape there are subtle reminders that Shipman attempted to create a landscape that was complementary with the surrounding natural beauty: the ranch house is nestled at the edge of the forest and not a central feature, exotic plants and native plants are often arranged together in clusters defined by existing topography, and cattle fences were often supported by large 'ohi'a trees. With the exception of the cork oak grove, there is generally a lack of distinct sections and grid patterns in the planted exotic vegetation, making it less incongruous with the wilderness surroundings. Incorporation of lava outcrops and ubiquitous native species (particularly 'ohi'a which thrives on rock outcrops) within the component landscape accomplishes harmony and unity in the garden design, which might otherwise appear chaotic given the great variety (and lack of patterning) of exotic species. Curvilinear patterns of hedges, palms, and pine trees complement circulation patterns (see Circulation section) and natural escarpments in several instances (see photos, Spatial Organization # 2, Spatial Organization # 3). The pattern of open spaces within the component landscape is also highly asymmetrical, which helps to blend the component landscape with the natural forest surroundings (see photo, Spatial Organization # 4).

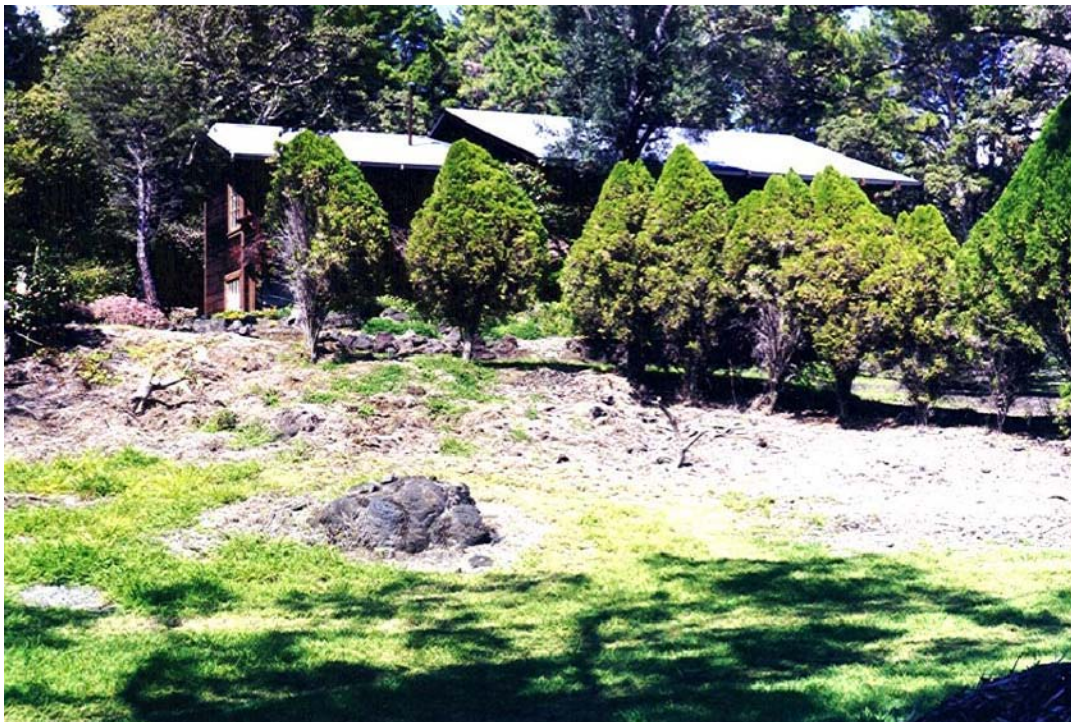
*Spatial Organization # 2: Hedge of arborvitae lines the driveway (hidden from view) and the shallow end of a natural escarpment (PWR, HAVO, CLI files, 1999).*

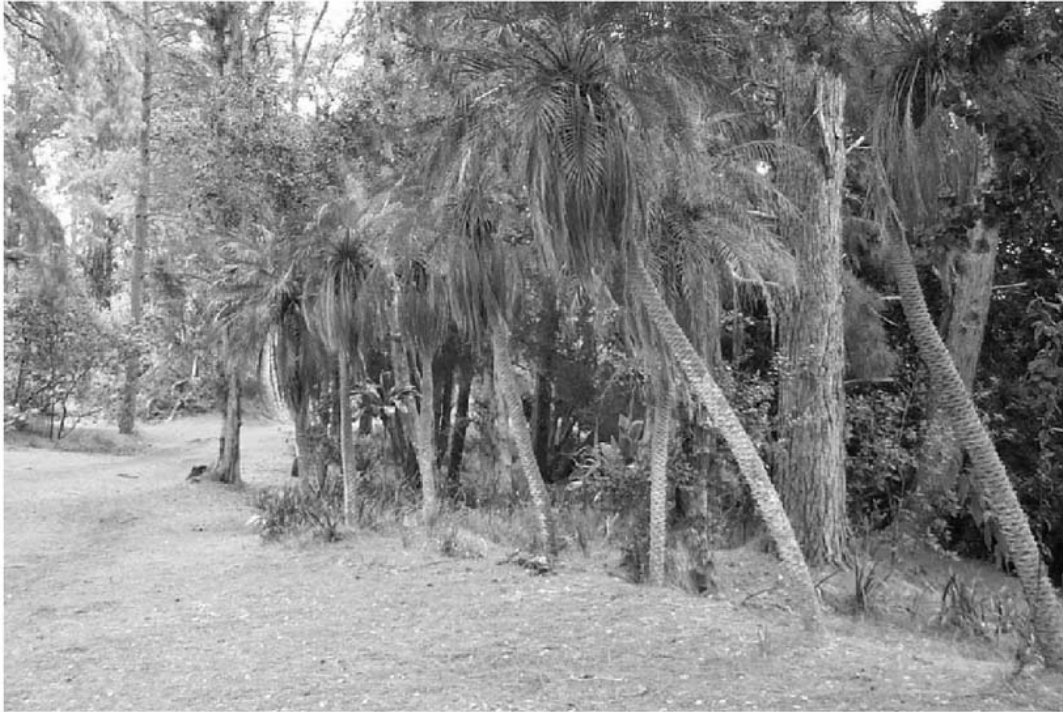
*Spatial Organization # 3: Row of dwarf date palms lines the driveway near the east side of the ranch house (PWR, HAVO, CLI, 2003).*

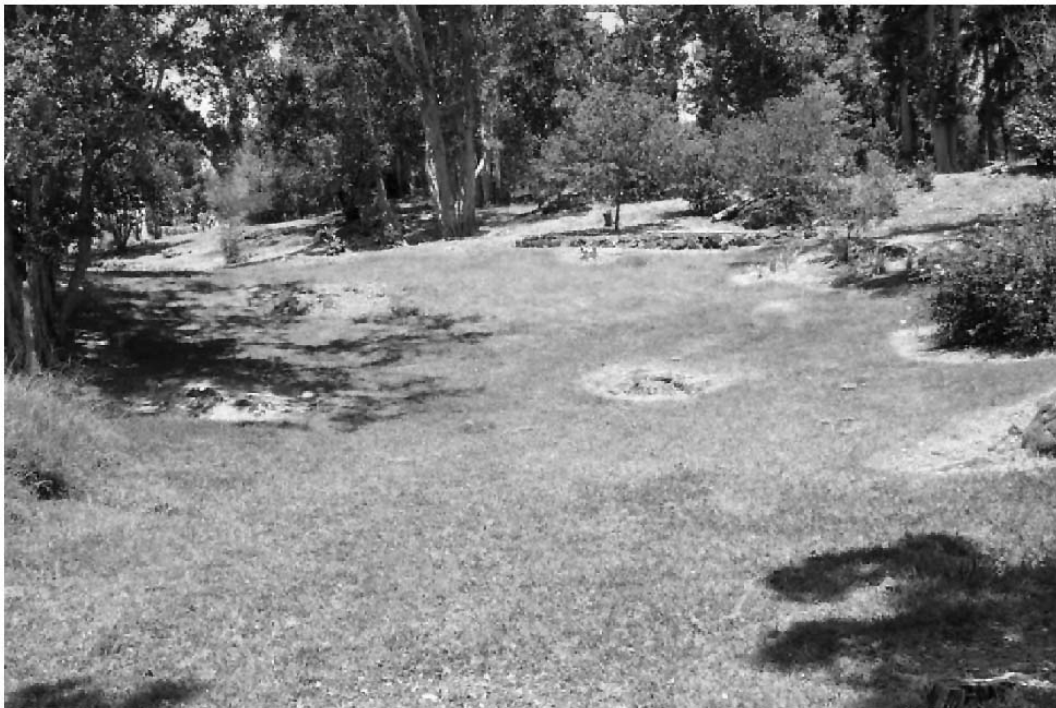
*Spatial Organization # 4: An open space creating an informal corridor between the ranch house and the nursery area (PWR, HAVO, CLI files, 2003).*

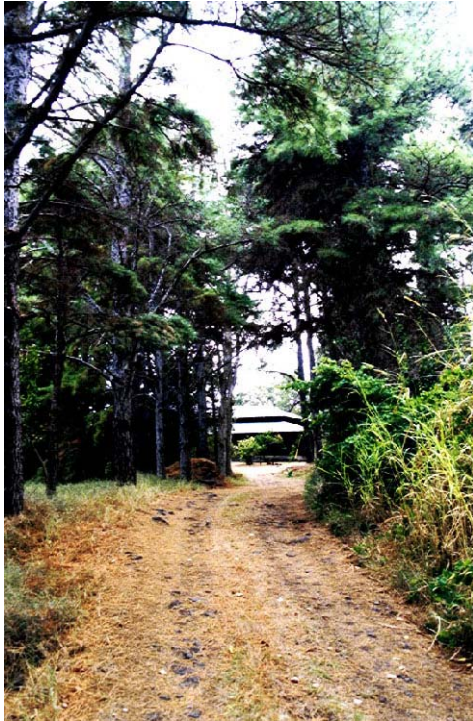
*Circulation # 1: Northern portion of the driveway loop, looking southwest towards the ranch house (PWR, HAVO, CLI files, 1999).*

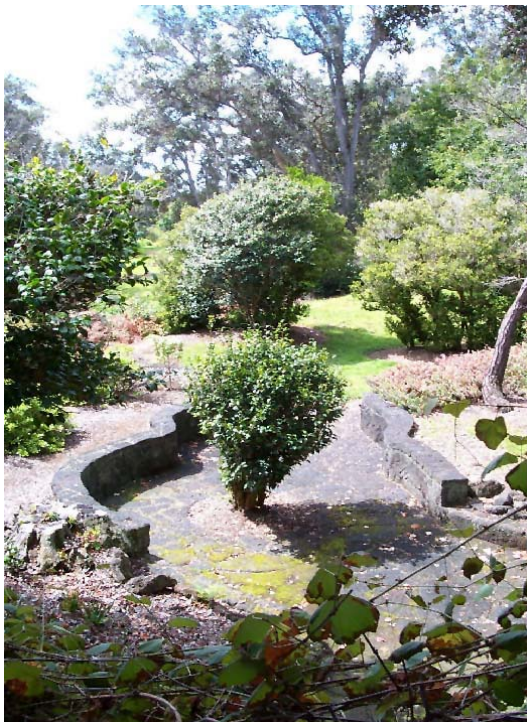
*Circulation # 2: Formal walkway / patio on the south side of the ranch house gives way to multiple grass corridors through the gardens in the western lawn area, looking west (PWR, HAVO, CLI files, 2003).*

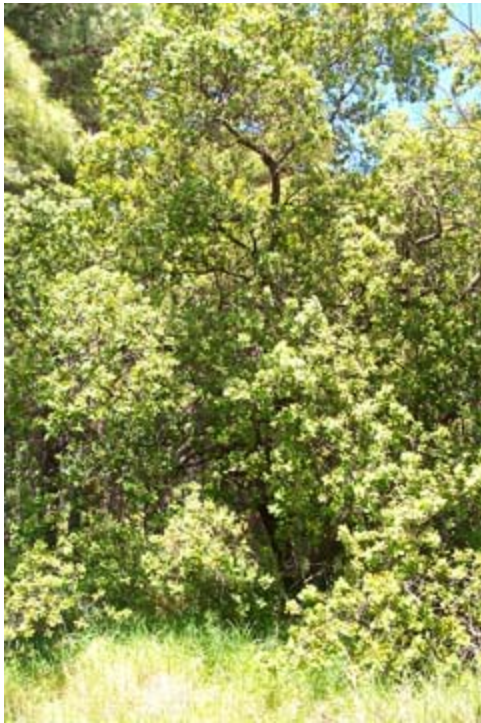
*Vegetation # 1: Large native sandalwood north of driveway loop (PWR, HAVO, CLI files, 2003).*

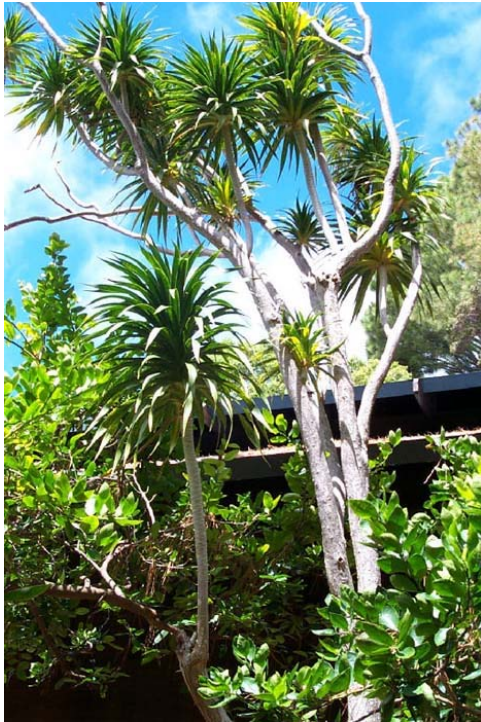
*Vegetation # 2: Hala pepe tree fronting the east side of the ranch house (PWR, HAVO, CLI files, 2003).*

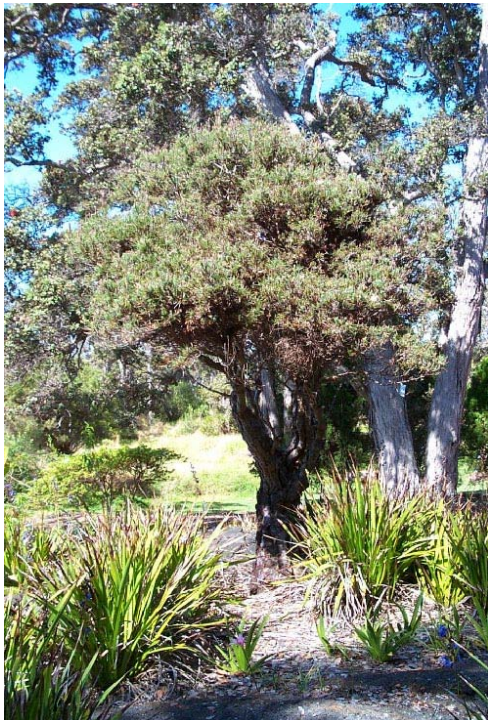
*Vegetation # 3: Italian stone pine with native 'ohi'a in the upper background and neomarica lilies in the foreground (PWR, HAVO, CLI files, 2003).*

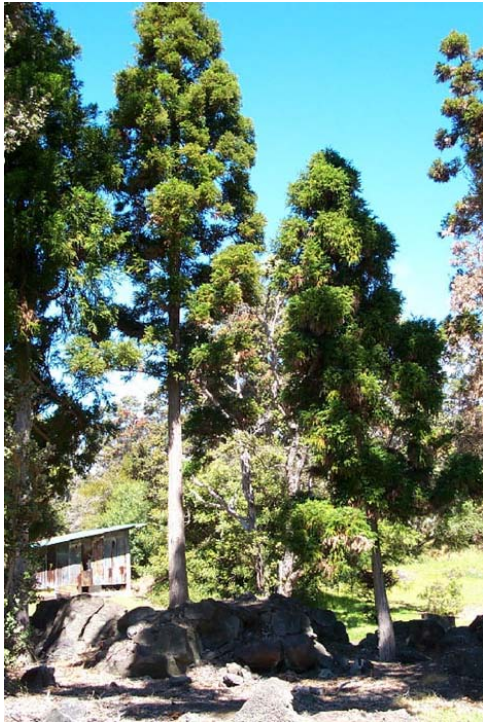
*Vegetation # 4: Row of tsugi pines running parallel with natural rock formations (PWR, HAVO, CLI files, 2003).*

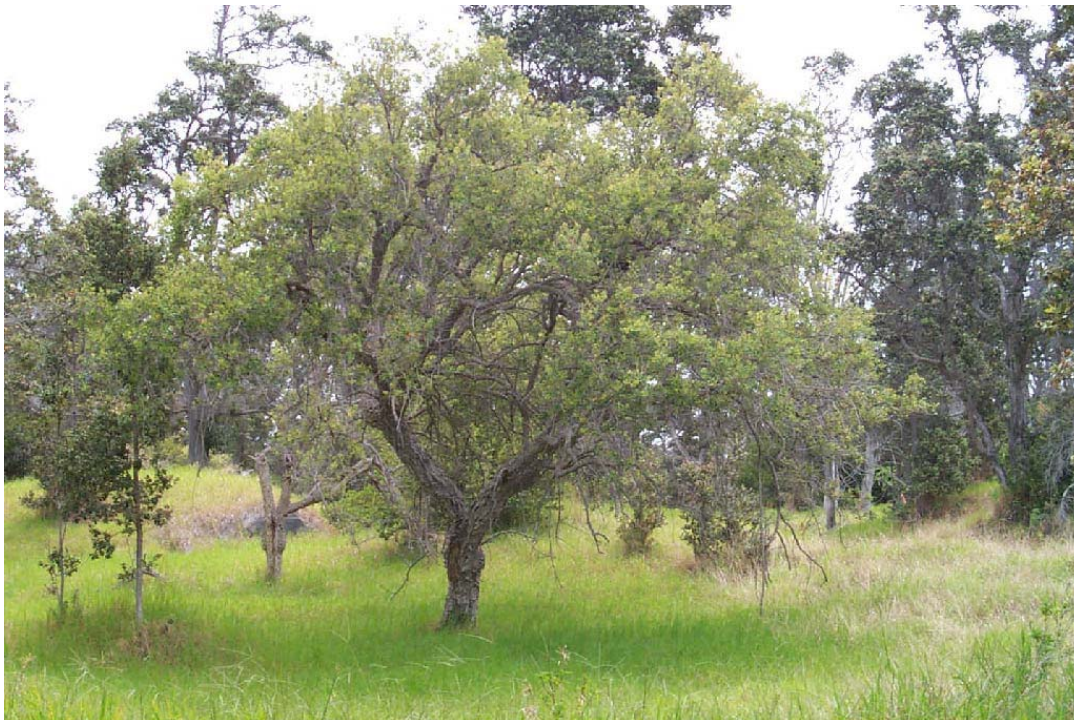
*Vegetation # 5: One of the Cork oaks in the grove. Tall 'ohi'a in background (PWR, HAVO, CLI files, 2003).*

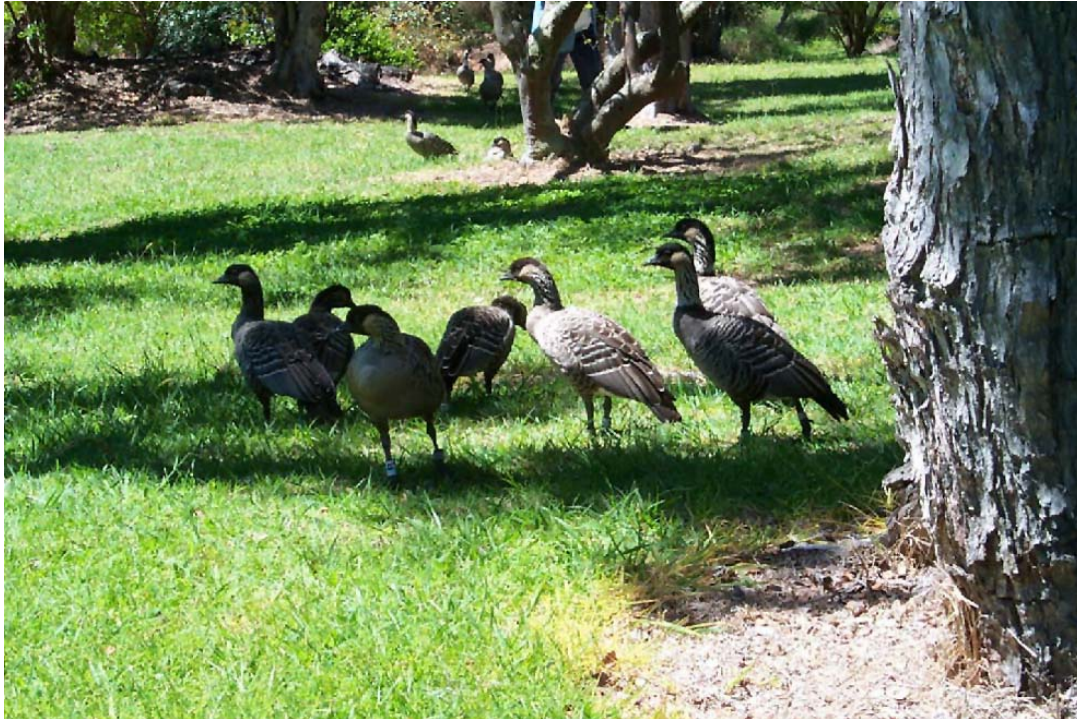
*Land Use # 1: Contemporary photo of Nene feeding on grass at the 'Ainahou Ranch House grounds (PWR, HAVO, CLI files, 2003).*

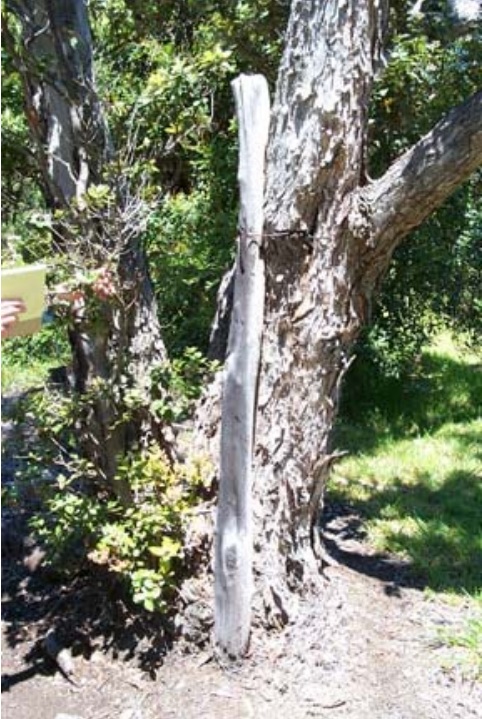
*Small-Scale Features # 1: Remnant fence post displaying use of live 'ohi'a trees (PWR, HAVO, CLI files, 2003).*

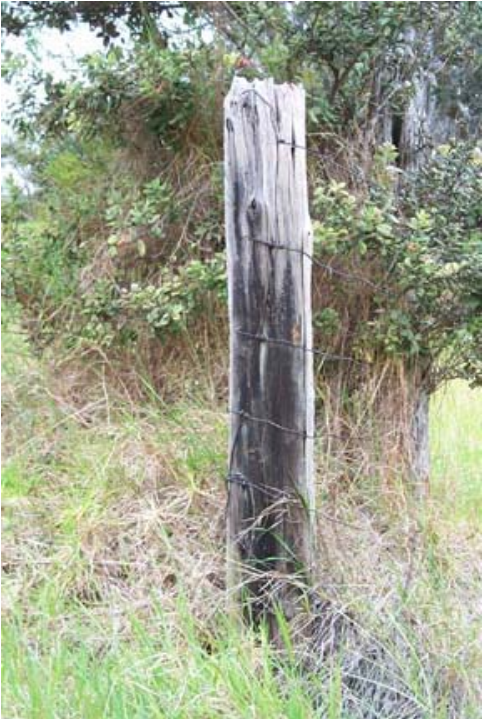
*Small-Scale Features # 2: Remnant conventional-type 'ohi'a fence post (PWR, HAVO, CLI files, 2003).*
