**National Park Service
Cultural Landscape Inventory
2006**

**Kilauea Administration and Employee Housing Historic District
Hawaii Volcanoes National Park**

CULTURAL LANDSCAPES INVENTORY (CLI) PROGRAM
2011 Condition Assessment Update for:

CONDITION ASSESSMENT: **GOOD**

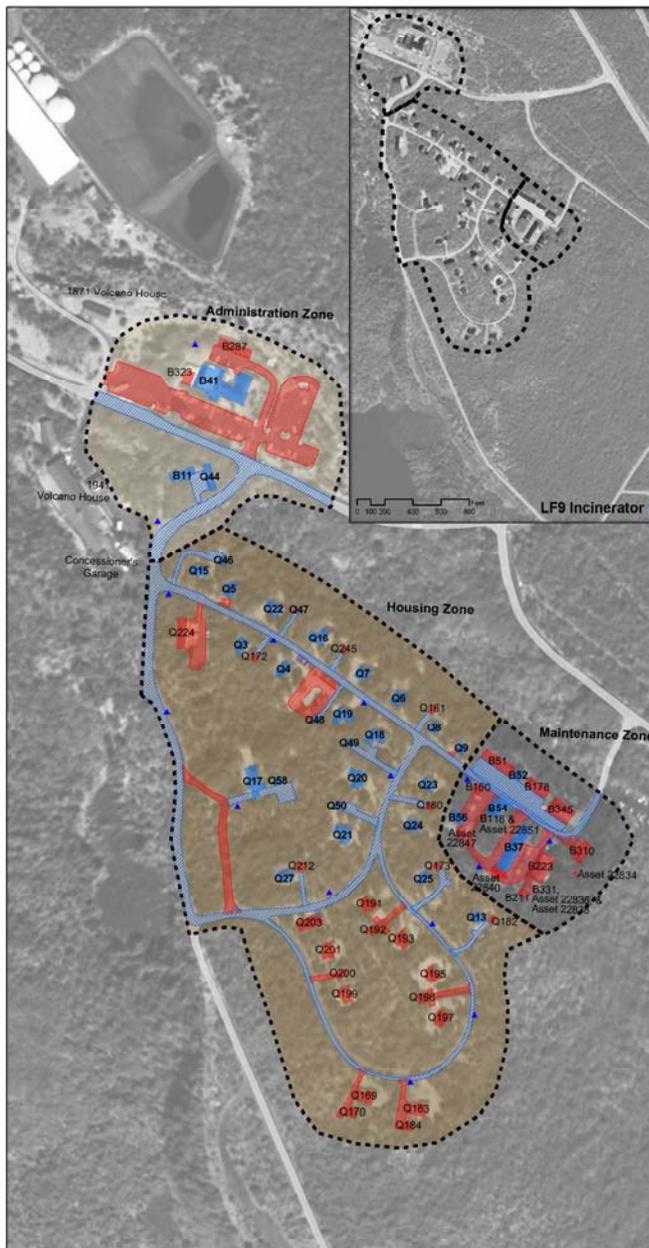
Site Map 1. Buildings and Structures
 Kilauea Administration and Employee Housing Historic District

Site Plan #1: Buildings and Structures, Kilauea Administration and Employee Housing Historic District. See Supplemental Information for a full-sized map.

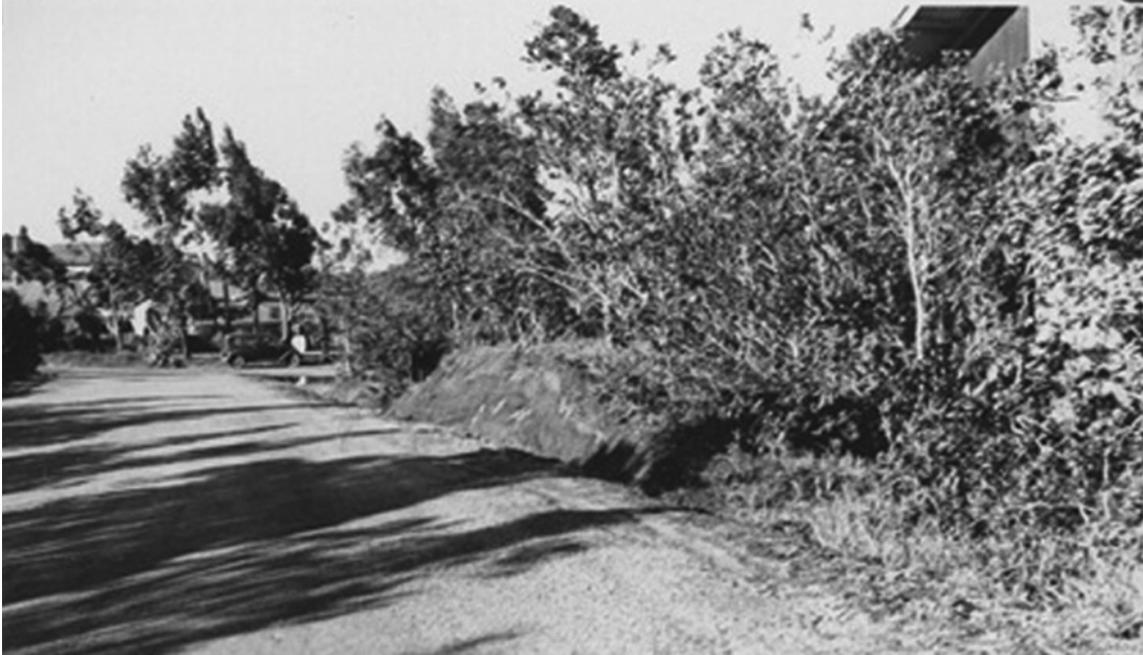
Figure 1. Photograph from the 1939 landscape architect report showing rounding of road banks (1939 Landscape Architect Report, HAVO Archives).

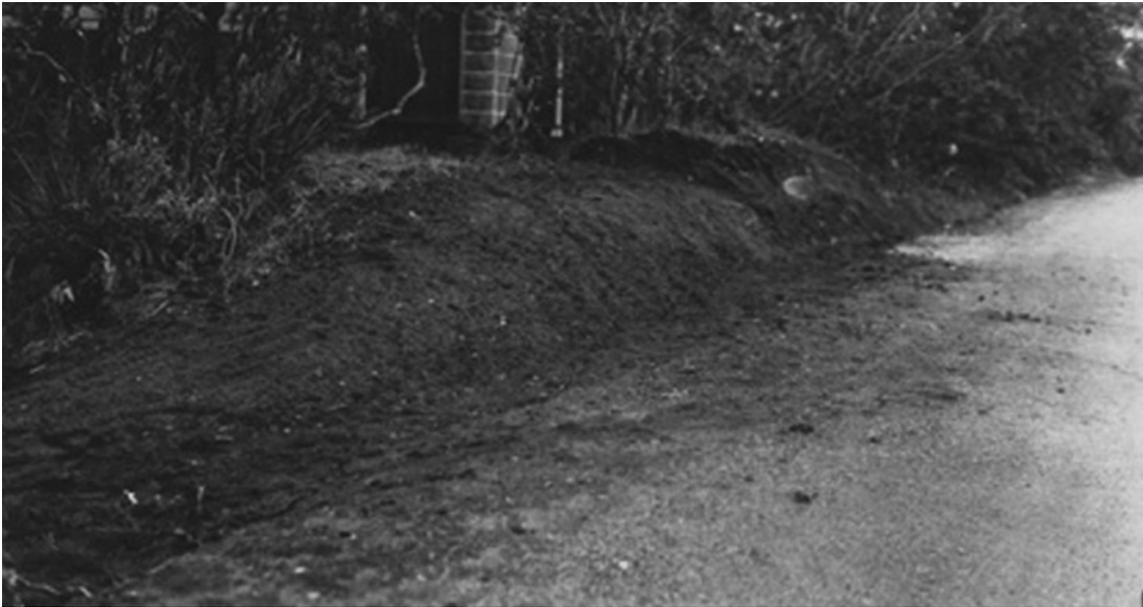
Figure 2. Photograph from the 1939 landscape architect report showing rounding of road banks (1939 Landscape Architect Report, HAVO Archives).

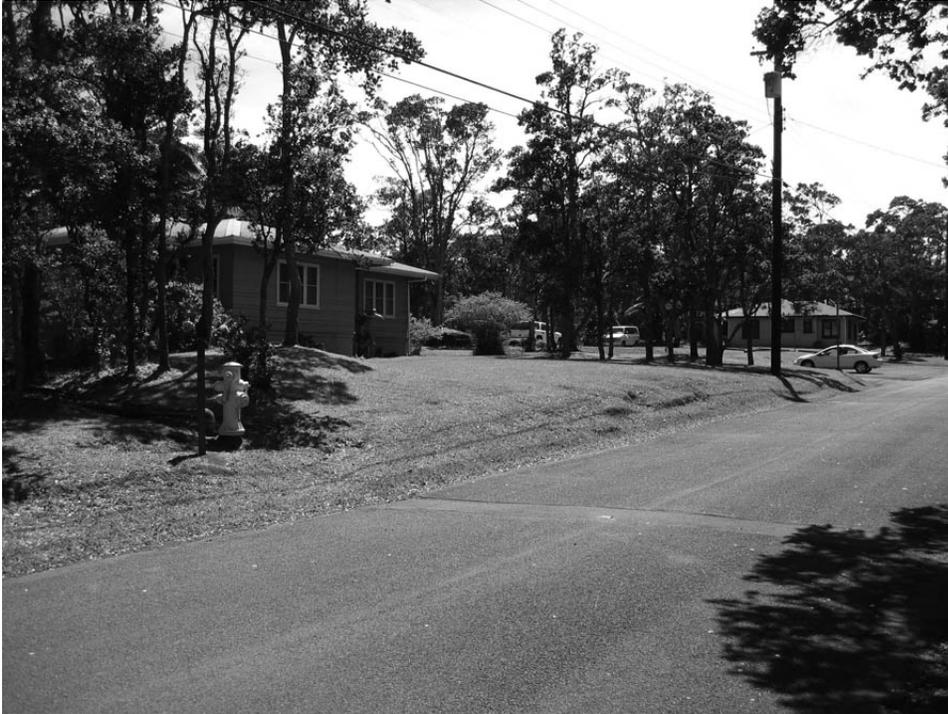
Figure 3. Lots were graded to create boundaries between the units—Employee Quarters No. 19 (PWR Staff—2005).

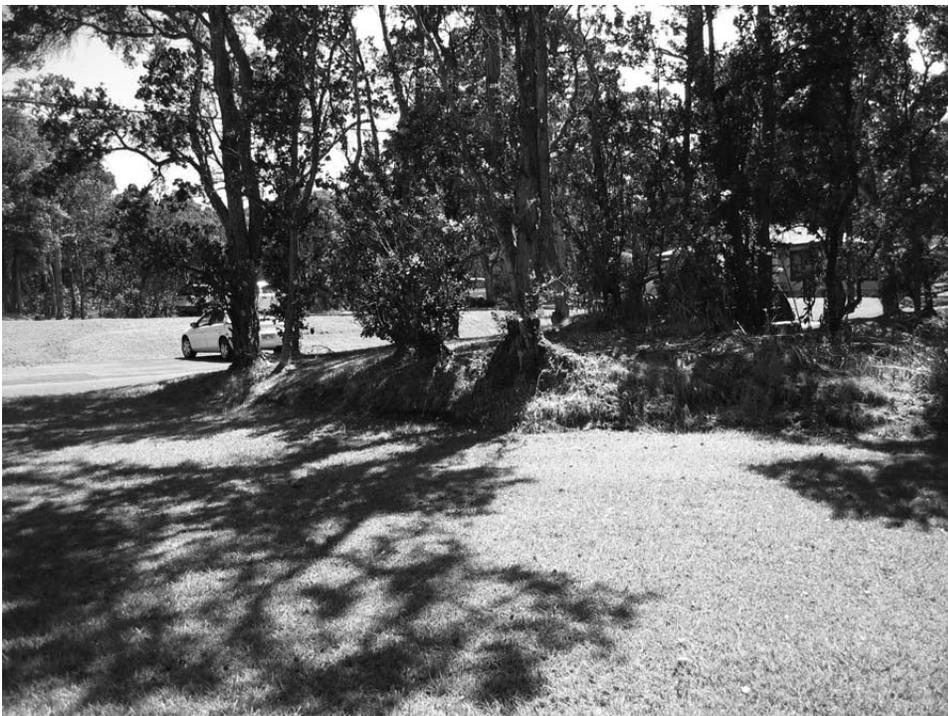
Figure 4. Change in elevation between two residences. The grading and lot boundaries are further accentuated with vegetative screening (PWR Staff—2005).

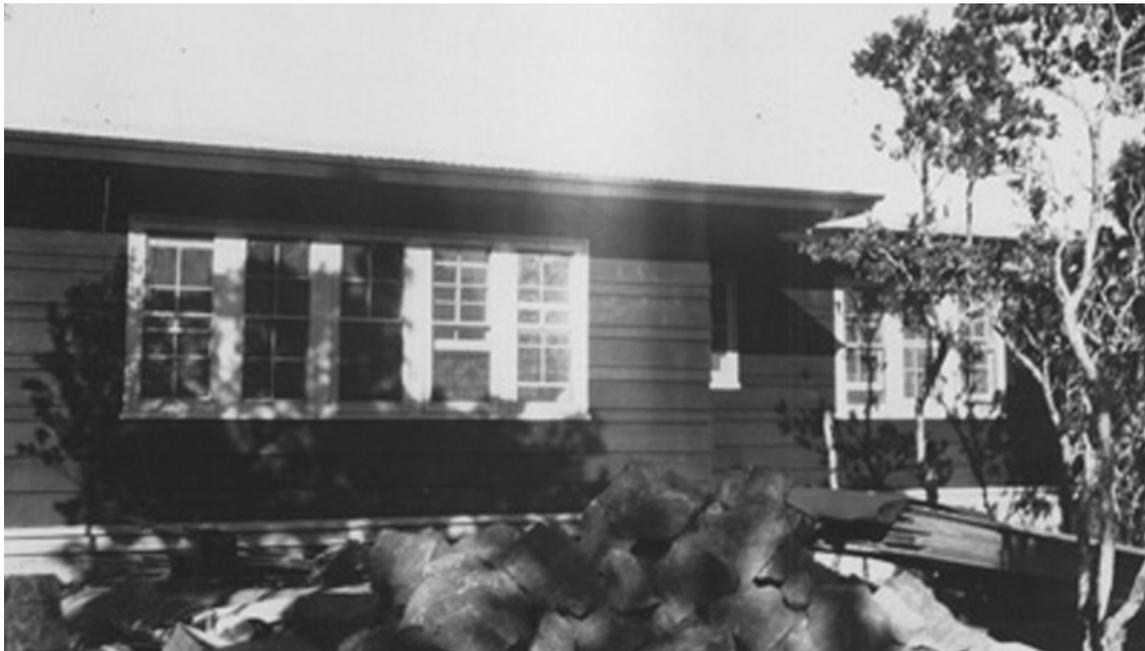
Figure 1. Employee Residence being built (1945 NPS Travelogue, HAVO Archives).

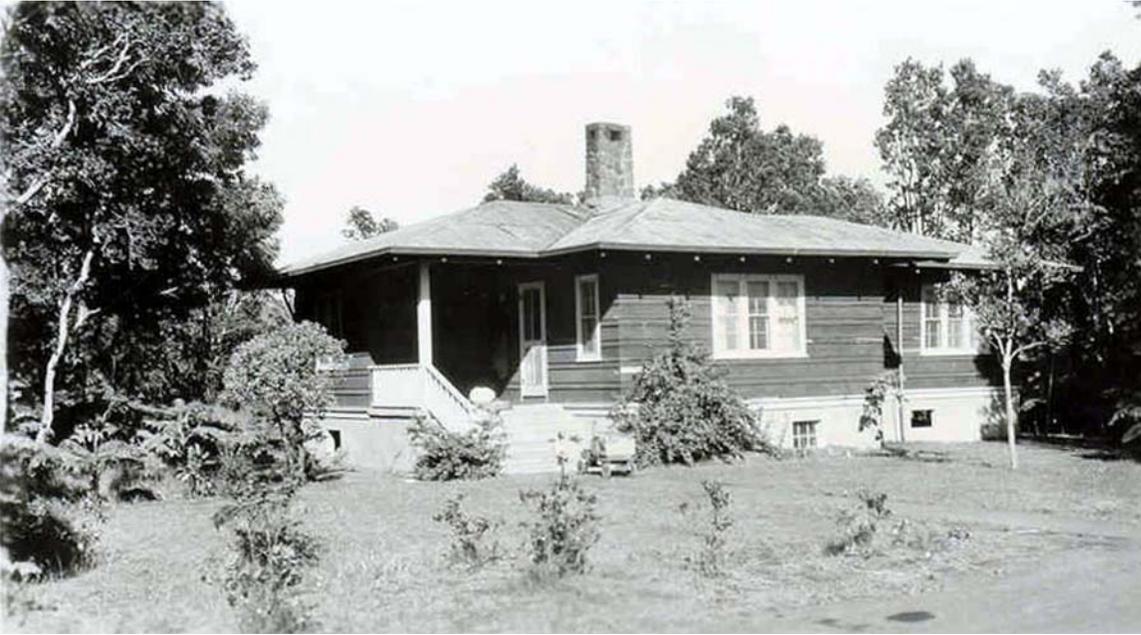
Figure 2. Example of a typical residence (Employee Quarters No. 22) ca. 1945, approximately six years after it was built. The building was designed to blend in with the surrounding native vegetation. (1945 NPS Travelogue, HAVO Archives).

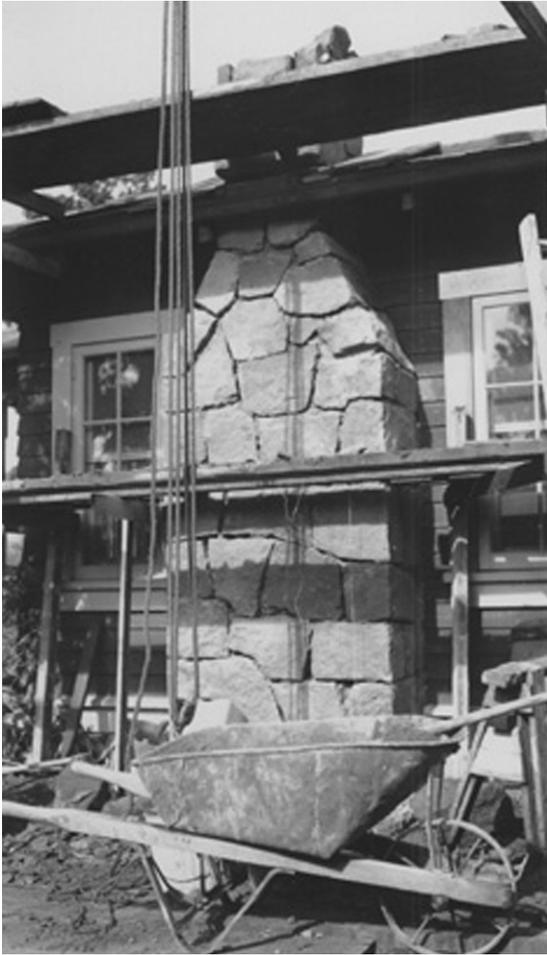
Figure 3. Stone chimney being added to Employee Quarters No. 5 in 1934—six years after the residence was built (1934 Landscape Architect Report, HAVO Archives).

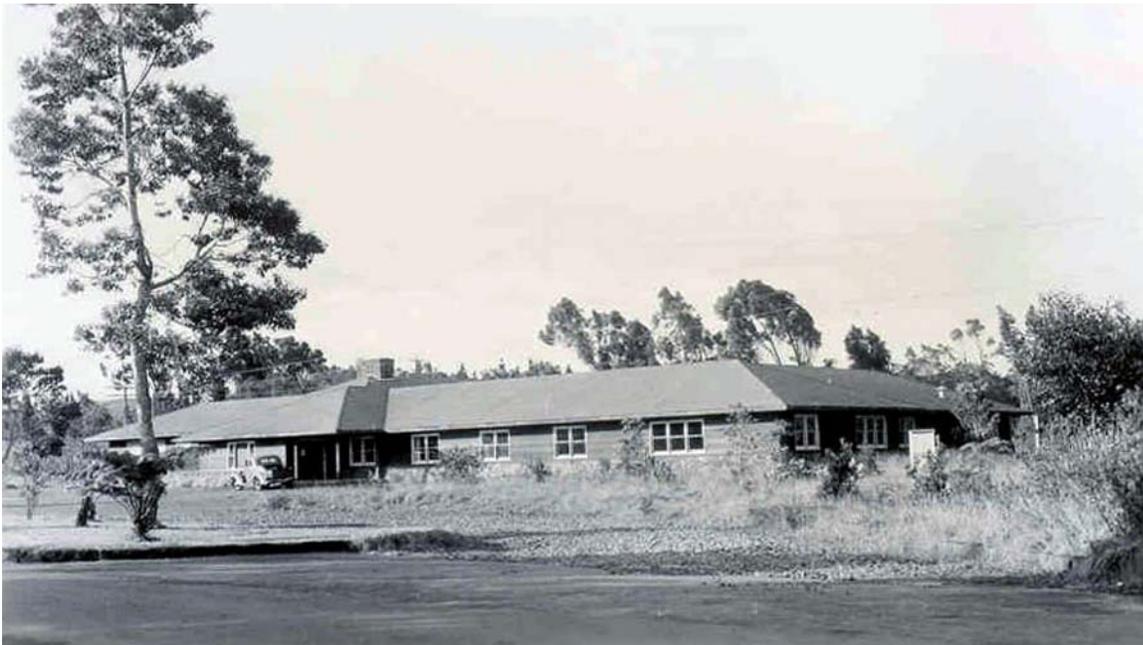
Figure 5. Administration Building after completion in 1942 (1945 NPS Travelogue, HAVO Archives).

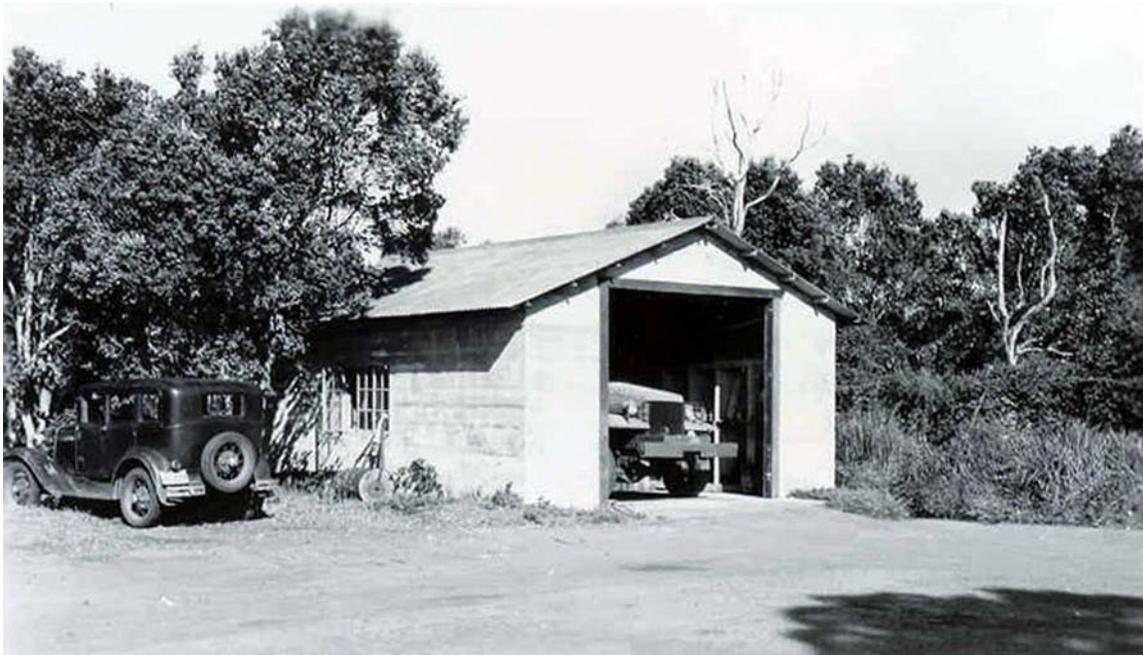
Figure 8. Building No. 52 after completion in 1934. (1934 Landscape Architect Report, HAVO Archives).

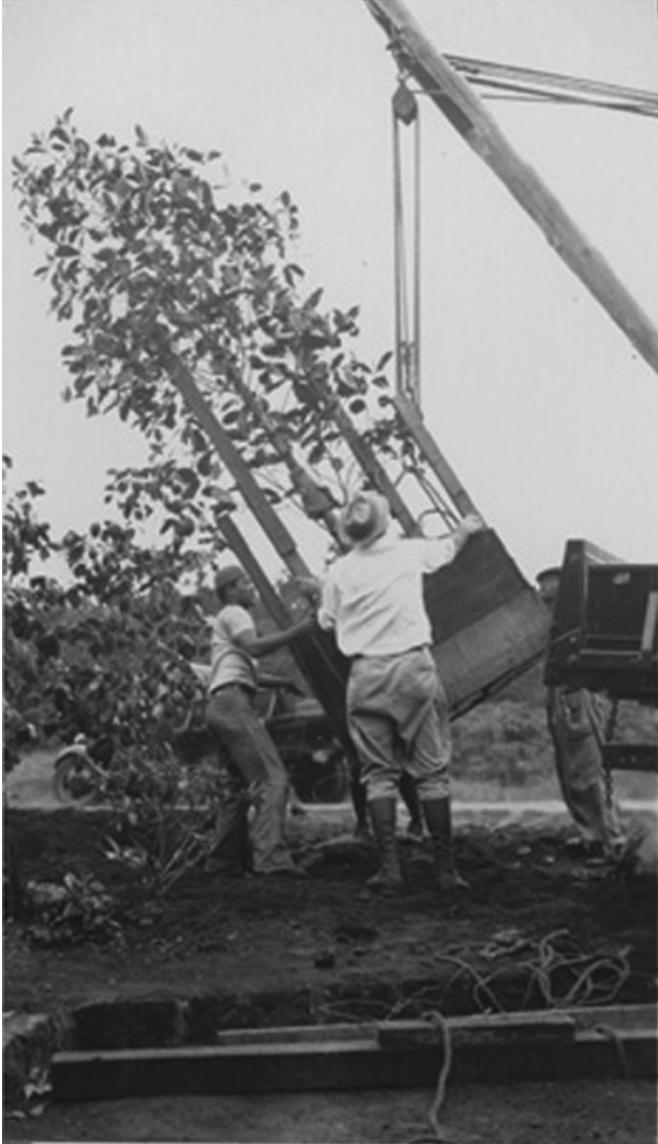
Figure 6. Transplanting *kopiko* trees in front of the Administration Building (1934 Landscape Architect Report, HAVO Archives).
