Hubbell Trading Post National Historic Site

Hubbell Trading Post Furnishings Report and Plan

Prepared By: Hubbell Trading Post National Park Service Staff &
Heritage Conservation, Drachman Institute
College of Architecture and Landscape Architecture
University of Arizona Tucson, Arizona

September 20, 2011

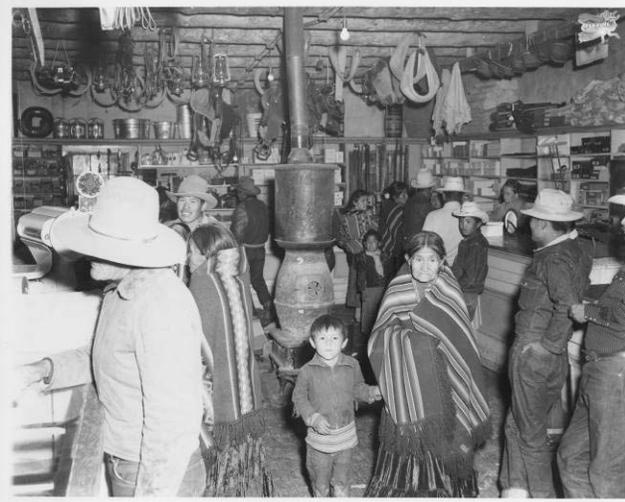
Figure 8. Historic photograph of Bullpen showing members of community and goods in background. circa 1949 (Mullarky Collection 824 / RP-187).

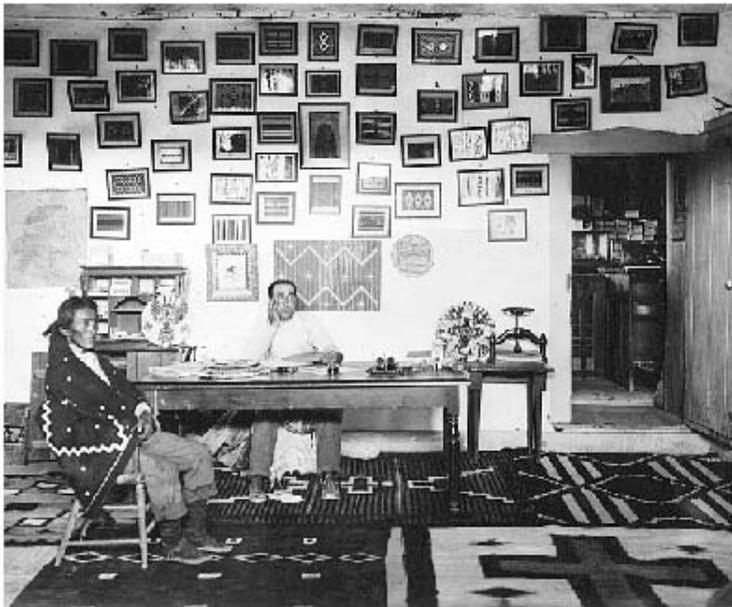
Figure 10. J.L. Hubbell’s office, showing the openness of the room for conducting business and the rug paintings on the wall. (HUTR RP-013).

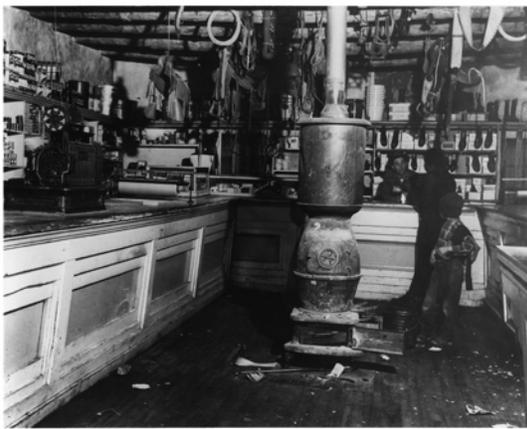
Figure 12. The Bullpen showing the variety of goods and open Bullpen area, circa 1949 (Mullarky Collection 13 / RP-189).

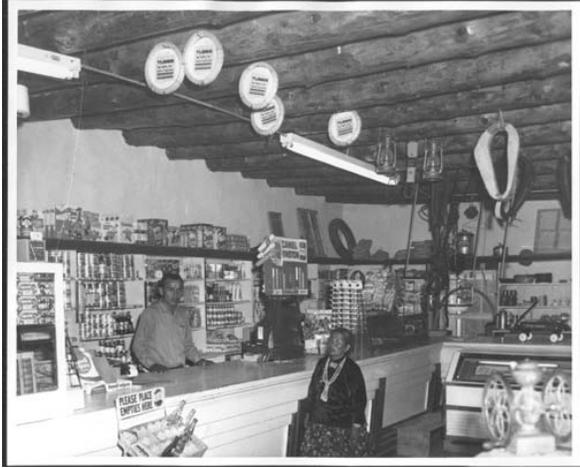
Figure 14. The Bullpen showing the variety of goods and modern fixtures including freezer and cash register, circa 1955 - 1960 (McNitt Collection 6947 / RP-387).

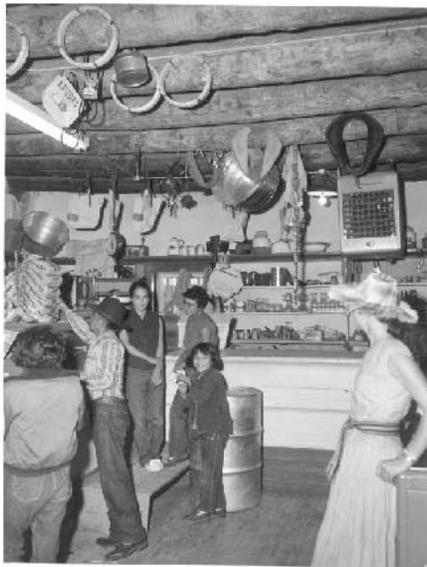
Figure 15. The Bullpen showing customers and the merchandise layout on shelves and ceiling, circa 1960 (HUTR 8686).

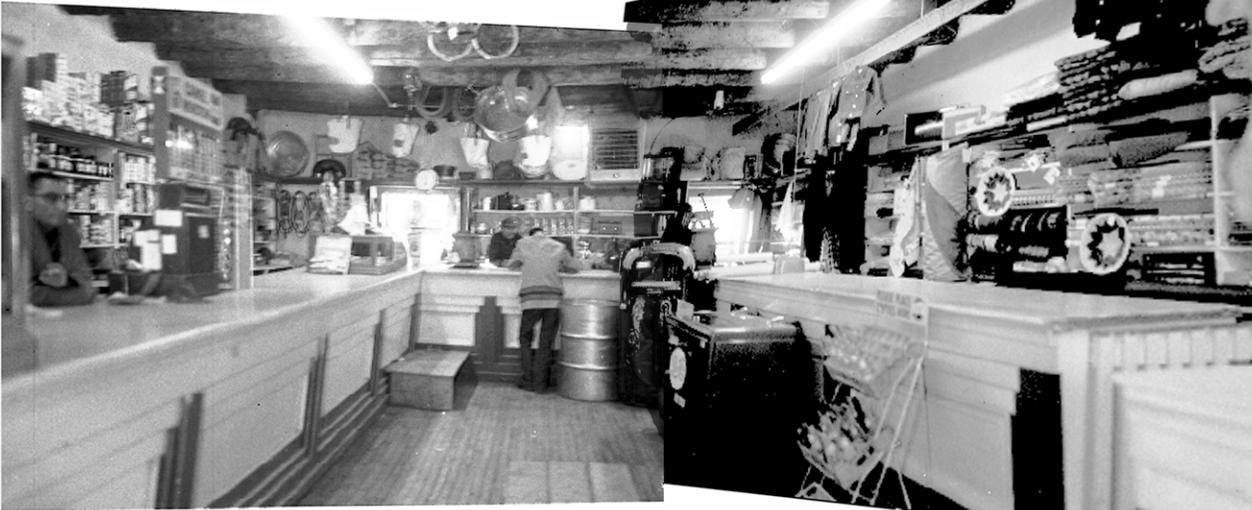
Figure 16. Panoramic view of the Bullpen. 1960 (HUTR Negative No 44-45).

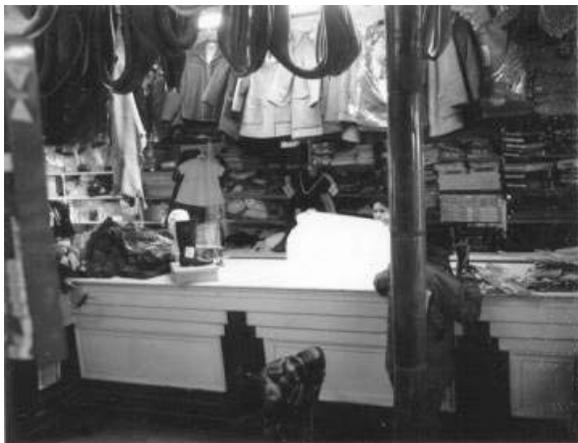
Figure 17. North wall of Bullpen showing modern merchandise on shelves and ceiling. 1969 (HUTR 23371A).

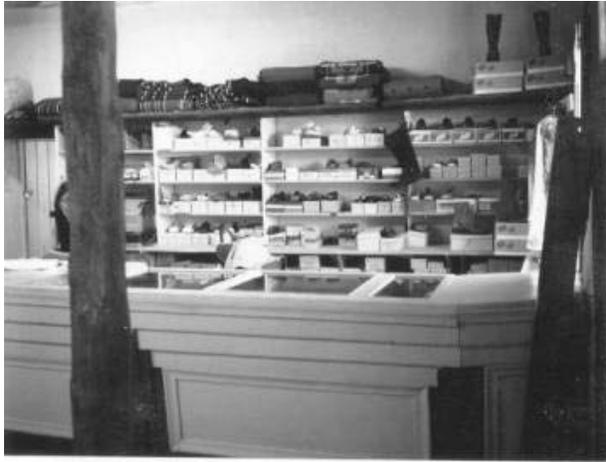
Figure 18. NE corner of Bullpen showing merchandise layout on shelves and counter. 1970 (HUTR 23370A).

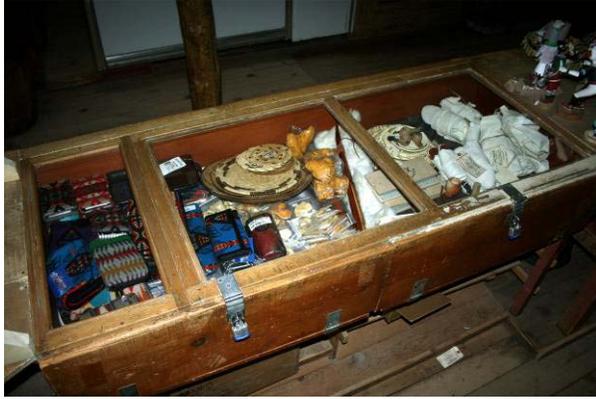
Figure 34. North counter display cases. April 6, 2010 (Photograph by Ed Chamberlin).

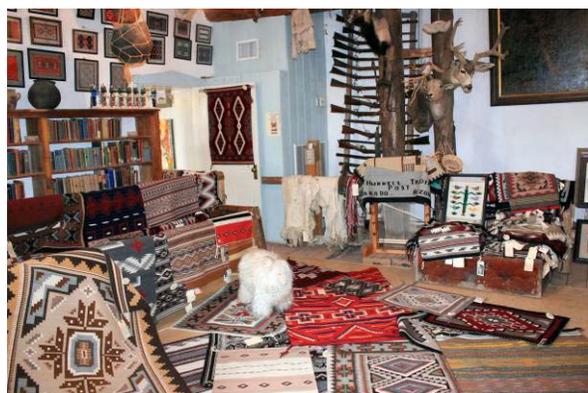
The floor is covered in linoleum. There are two horizontal rails that support rugs and bookshelves along the east wall and a partial rug rail along the south wall in front of the gun rack that leans against the wall. Just to the south of partial rug rail are two log posts. One of the posts supports two animal heads and the other is displays traditional basketry. In front of the rug rails on the east side and along the west wall are pallets that hold piles of rugs. Bare light bulbs hang from the ceiling on chains. A cabinet that is in the southeast corner of the room shields the HVAC system from view.

The room is used to display both the rugs for sale and the museum artifacts. At various times, there may be paintings for sale in this room, but set on the floor or leaning against the walls, not displayed on the walls. All objects suspended from the vigas, hung on the walls and posts and behind the rug rails are museum objects.

Figure 42. Rug Room January 28, 2005.
(HUTR Digital IMG_2015 Photograph by Ed Chamberlin).

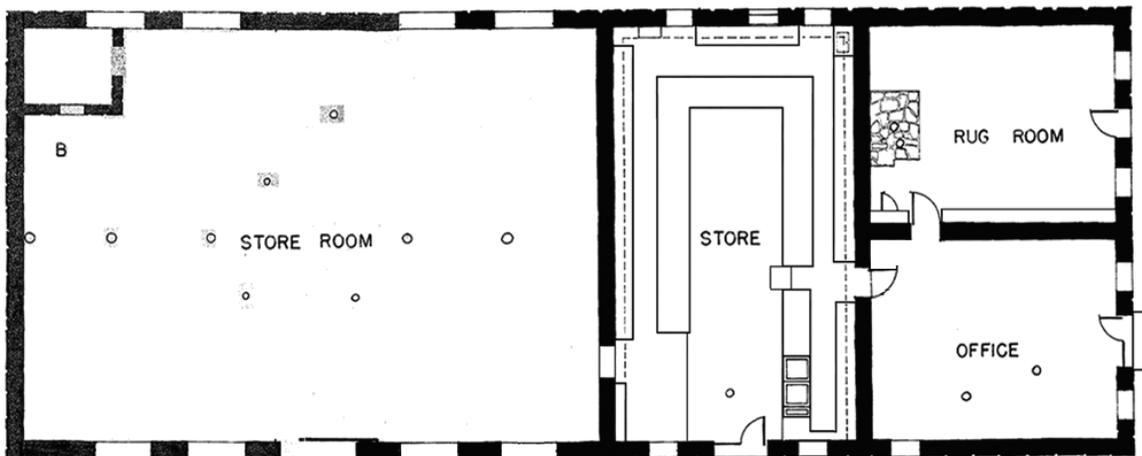
Figure 47. Circa 1889

Based upon dendrochronological evidence, in approximately 1889 the new Trading Post building was expanded to include the Bullpen and the Wareroom. It is assumed that the wide counters in the Bullpen were built-in when this room was added on, clearly defining this room as the "Store". At this point using the attached Trader's Office as an office makes logical sense. How the Rug Room" was used at this time is only an assumption since there is no physical evidence showing its use.

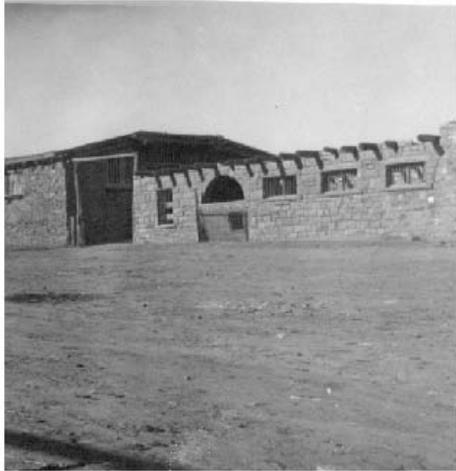
The last room added to the building was the Wareroom extension (HB09) which was built in the 1920s, but never completed or used through 1964, when it was roofed and used as a laundromat. In the 1970s, a renovation of the interior was done to house museum storage and the curator's office and in 2004, the space was remodeled into its current configuration for offices for National Park Service staff. (See Appendix J. for the remodeling progression from 1974 – 2010.)⁶⁴

Figure 52. The Wareroom extension. 1944 (HUTR 8692).

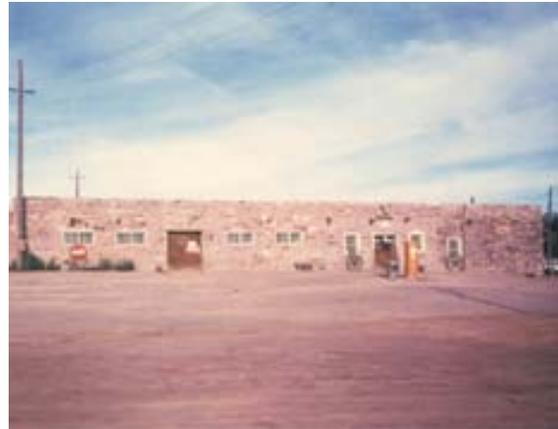
Figure 53 Gas pumps in front of the Trading Post. circa 1960 (HUTR 8689).

the roofless Wareroom extension is distinguishable from the rest of the building because of its arched doorway entrance. The color photograph above shows one of the gas pumps in front of the door to the bullpen. The gas pumps were installed in 1945 and removed in 1966.

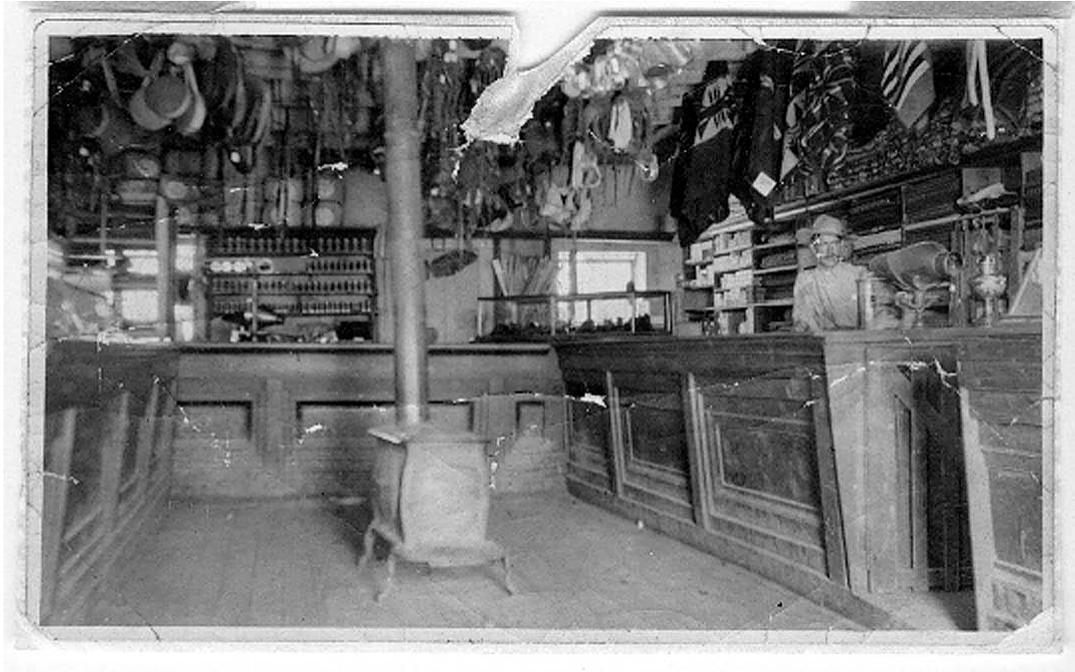
Figure 54. *The Bullpen*. circa. 1910 (HUTR 7071).

The earliest interior comprehensive photographic image available for this part of the building is the following photograph of the Bullpen taken after the turn of the century. Unfortunately, there is no date or photographer identified for this image, however, certain clues, such as the completed winged painting on the exterior door, identifies it as being later than the 1908 Burbank painting.

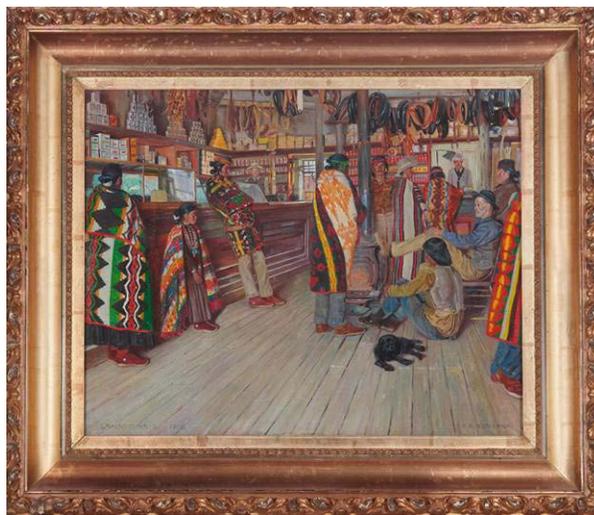
Figure 55. *Oil painting of Bullpen* by E.A. Burbank, 1908 (HUTR 3457).

A detailed image of the Bullpen is the oil painting by Elbridge Ayer Burbank. This wonderful image was painted in 1908 and provides a color view of the interior of this room. The shelves are stocked and miscellaneous merchandise hang from the ceiling. The woodstove is heating the room and oak and pine planking cover the floor. One of the glass display cases is visible on the counter in the southwest corner. It appears that the northeast counter is still parallel with the northwest counter judging by where the man wearing the Pendleton robe is standing. The walls are not painted. The counters are not painted and appear as they do in the present day. It is easy to discern the two funnel shaped scales and the glass display case on the counter, the Pendleton-like blankets and canteens hanging from the ceiling, and the woodstove in the center of the room. Some time after 1908 the shelves along the west wall were built across the top of the door. The northeast section of the counter is aligned with the northwest counter rather than slightly south as it is currently.

The wood floor was constructed of six-inch wide planks laid east to west. In the center was an area without flooring upon which stood a small rectangular cast iron stove. The surrounding counters appear to be the same as those currently in place painted partly with a mahogany stain and partly dark green. A paint chip indicates that the mahogany color was covered with the green. Two log posts were set upright in the inside corners of the counters in the southwest and northwest. Gaps resulting from the removal of these posts are still visible in the present-day flooring. There were also two log posts behind the counter near the shelves on the west wall.

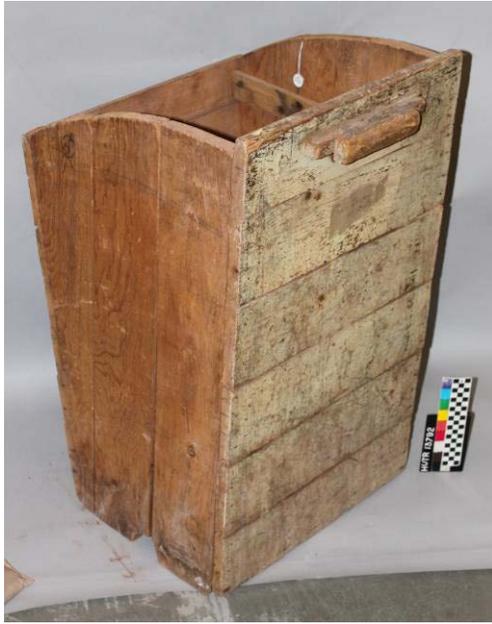
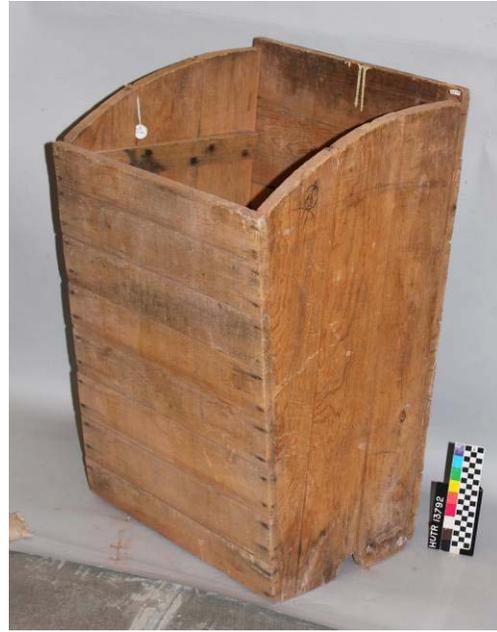
Joe Tippecanoe, who began work in the Store in 1911 and was an employee of the Hubbell's for many years, mentions candy, particularly stick candy, and tobacco as being in the glass show cases. He says that on the south side toward the door the shelves contained dishes and coffee pots. On the north side were the shoes. Under the counters lard, potatoes, sugar and corn were kept, some of those things in bins.⁶⁸ One of the old bins previously stored in the Barn; now stored in the Museum, has a paper label, "Navajo Corn 7¢ lb. Two more of those bins were still under the south counters in 1972 but are now stored in the Museum.

Figure 56. Storage Bin front. (HUTR 13792 front).

Figure 57. Storage Bin back. (HUTR 13792 back).

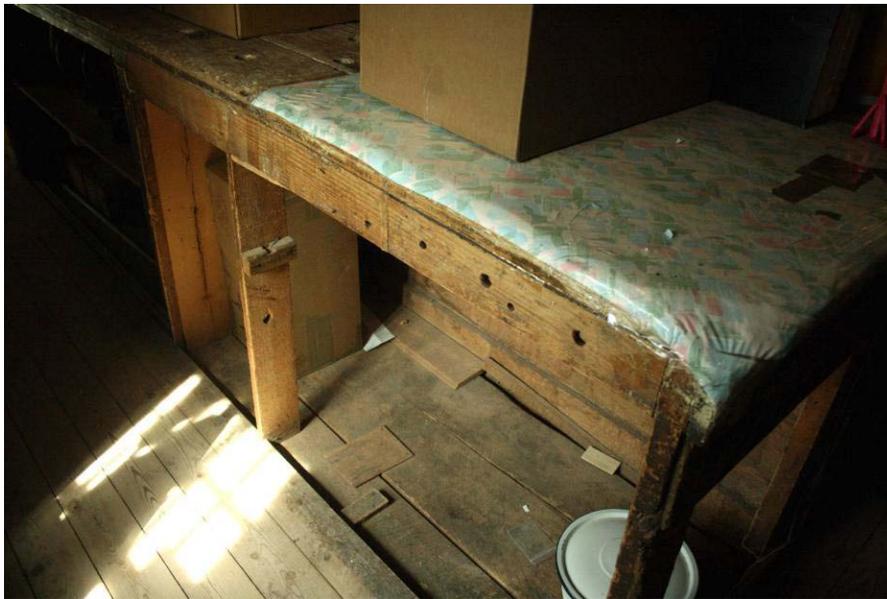
Figure 58. Cord and Rope Holes (HUTR Digital File SW Corner Counter Rope Holes).
Photographs 56 – 58 by Ed Chamberlin March 2010).

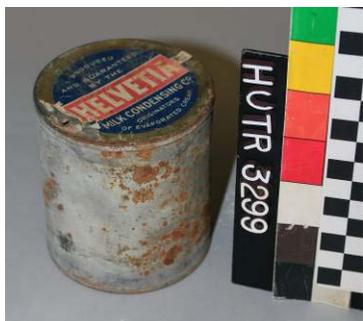
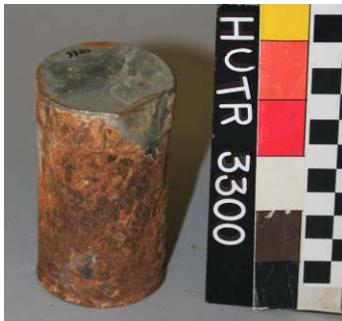
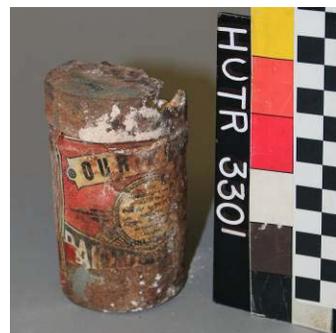
Additional sources of information, relatively minor but highly accurate, are labels from baking powder cans and an evaporated milk can (HUTR 3299, 3300, and 3301) found under the floor during stabilization of the west wall in 1971.

The baking powder, packed by C. N. Cotton, was guaranteed under the Food and Drugs Act of June 30, 1906. The other label lacks any date. In addition, a salt bag, with a patent date of 1889 (Catalogue Number 3294) was recovered with this lot of material, as well as a match box with trade mark registered in 1874 (HUTR 3309) and a mouse trap patented in 1894 (HUTR 3288).

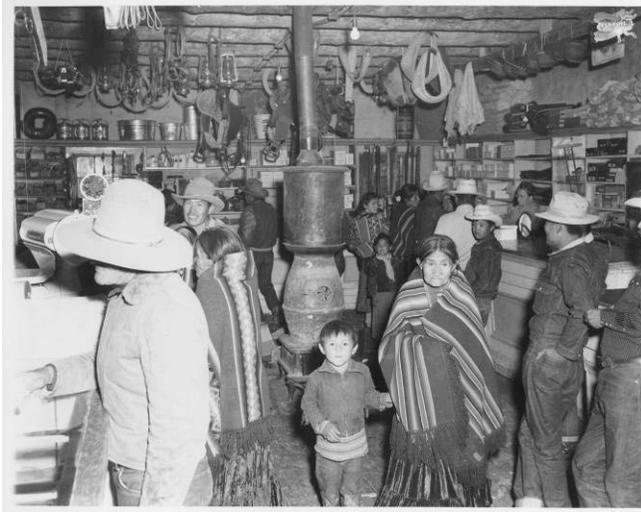
Figure 65. Bullpen, 1949 (RP-187).

The next series of extant photographs of the bullpen are from 1949. Surprisingly, the room has not changed considerably from Burbank's painting in 1908. There is a different woodstove in the center of the room and plenty of food items in boxes and jars on the south-side shelves. The shelves along the west wall of the room are now clearly stocked with hardware (stove pipes, buckets, coffee pots, etc.) and fill the west wall between the windows. Cloth, perhaps shawls, and boxes of shoes are displayed in the shelves along the north wall behind the counter.

The face of the counters and most of the shelves are now painted a light color. A new white scale is located on the south counter in the left side of two of the images. A fancy cash register sits on the south counter while the space west of the cash register is open, without the glass display cases that are currently present. The face of the counter has been painted, but the walls are not painted. Image RP-189 shows the corner of the northeast counter which has been moved southward. Therefore sometime between 1908 and 1949 the northeast counter was relocated. Also in 1949 there are horse collars, saddles, ropes and hats hanging from the ceiling.

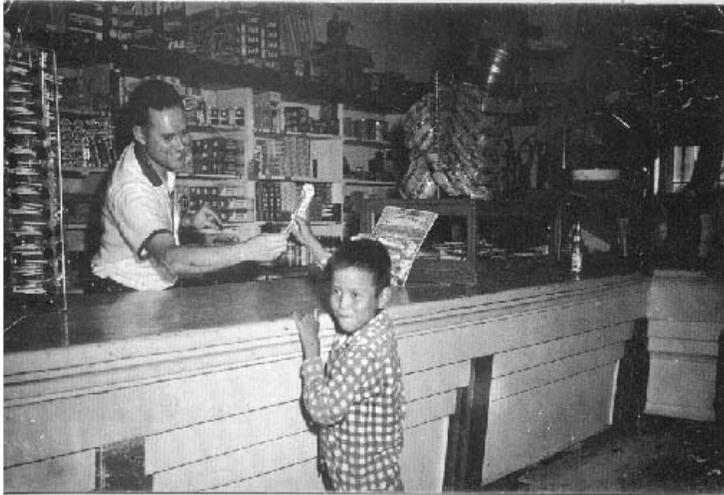
Figure 68. Painted counter top and fronts. 1960 (HUTR 8683).

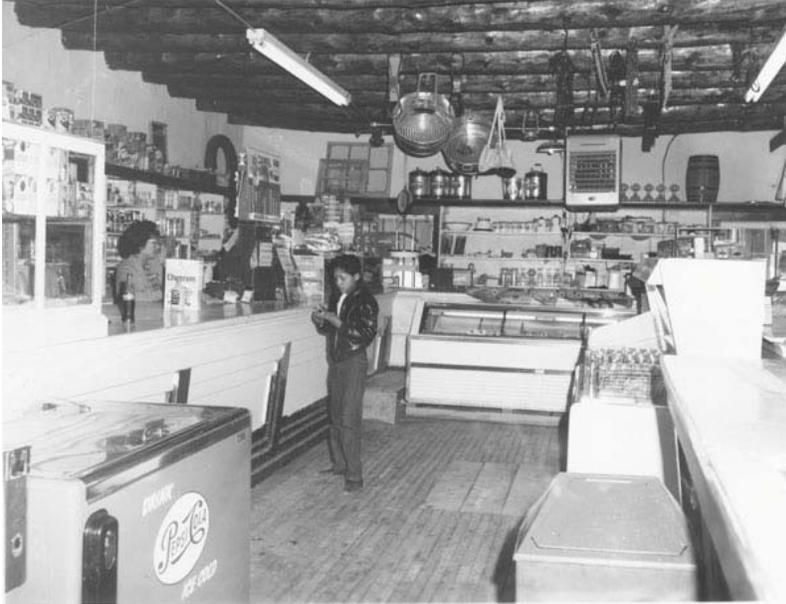
In the next two photographs, both taken in 1966, the woodstove in the center of the room has been removed. The gas heater hanging from the ceiling at the west end is clearly visible. The shelving on the west wall still fills the space between the two windows. Although both of these images were probably taken in the same year, the furnishings on the floor are considerably different between the two images. A Pepsi Cola, "soda" cooler has been placed in the bullpen, as well a square trash can, a juke box, a barrel, an ice cream freezer dispenser and a return-bottle case holding rack. Long florescent lights hang from the ceiling and the single incandescent light bulbs are not visible. The face and top of the counters are painted white and the top of the counters have been cleared of almost everything. All four walls have been painted. The color could be turquoise or beige rather than white. The remains of a turquoise color paint has been discovered beneath the current white paint on the south and north walls. The following furnishings are located on the south counter, from east to west: the white-frame glass-front display box, the brown cash register, and the candy display case. The wooden, candy-box step is still located in the southwest corner on the floor.

Figure 71. Photograph showing the south and west sides of the Bullpen. 1966 (HUTR Negative No. 196).

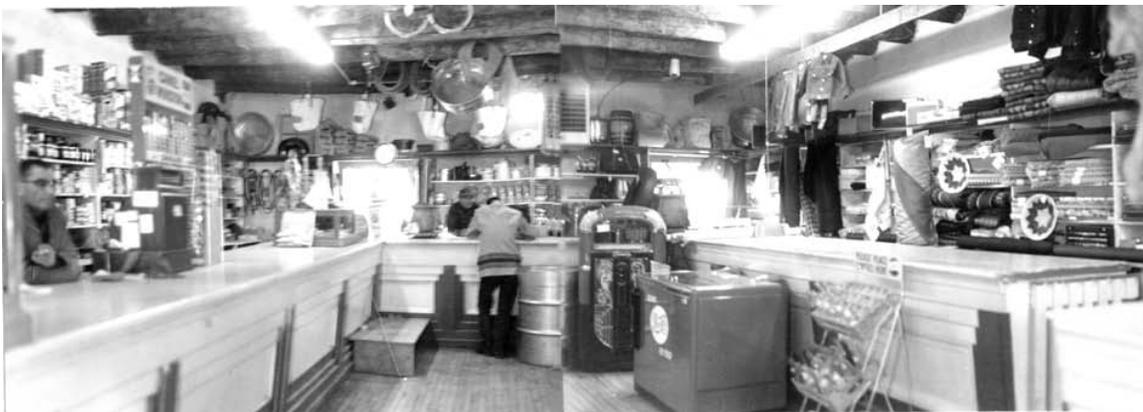
Figure 72. Photograph showing the south, west and north sides of the Bullpen. 1966 (HUTR Negative No 44-45).

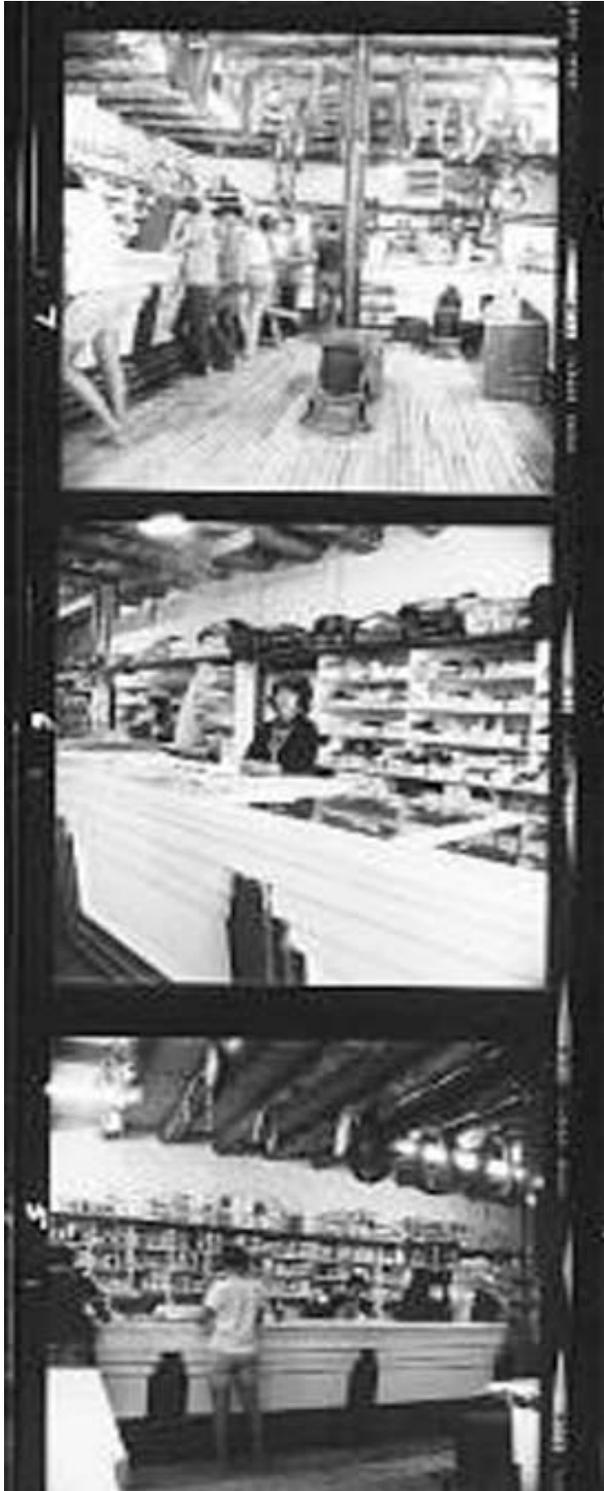
The next three photographs show that the woodstove has been brought back into the Bullpen and the counters are still painted white with black accents. The three visible walls (south, west, and north) are painted. It is unknown if these wall are white or turquoise. The wooden, candy-box step is located in the southwest corner on the floor. A square trash can is located on the floor near the counter pass-through on the north side of the bullpen. A barrel is located at the west end of the room on the floor. The northeast corner shelving is being used to display moccasins and Pendleton blankets. Florescent light tubes hang from the ceiling along with horse collars and other livestock tack. On the shelves in the southwest corner is a large Camel-Winston cigarette display. The curved glass-front candy display case is in place at the right side of the image on the west end of the counter.

*Figure 73. Photographs of Bullpen
by Fred Mang Jr., 1969 (HUTR 25708)*

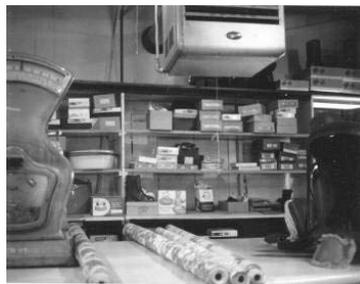
Figure 78. Center of west wall.
Shelving still blocks the west door.
1969 (HUTR 22373)

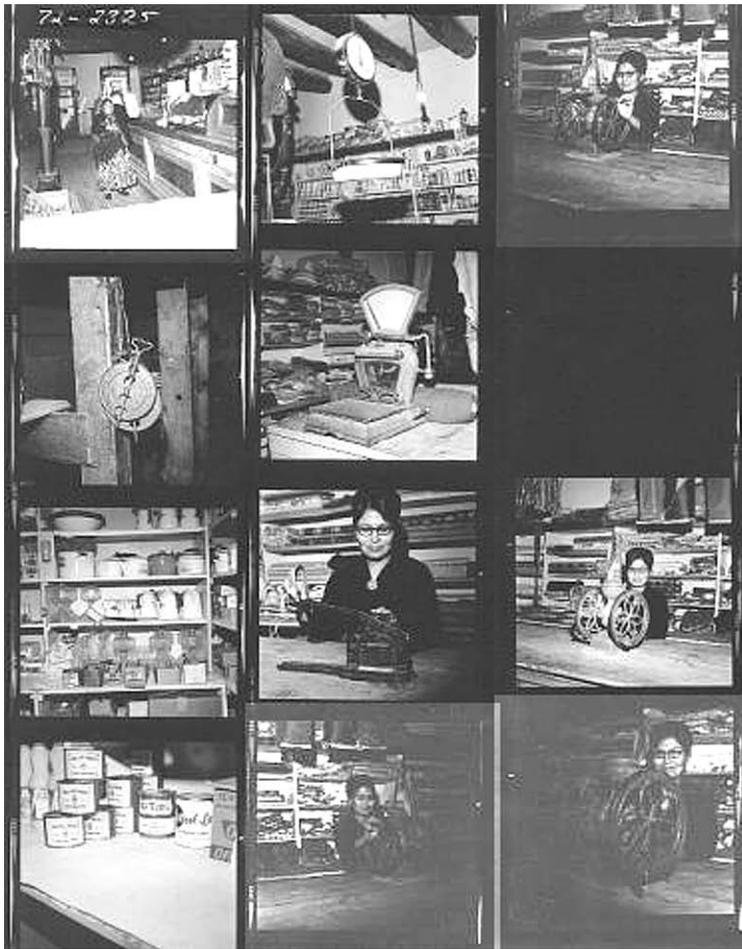
The contact print in the top left corner shows that in 1972 the counters are no longer painted white. Sometime between 1970 and 1972 the paint was stripped off the tops of the bullpen counters, although both dark and light paint is on the face. Also in this image, the front door is visibly being used as a bulletin board and the curved glass-front and square candy display cases are located at the west end of the south counter. Moving clockwise around the room, the scale is located at the west end of the north counter. An SMPA employee, Ms. Loraine Dalgai demonstrates how to use the coffee mill and the tobacco cutter on the north counter. Bolts of velveteen cloth are displayed from the ceiling above the north counter. These photographs show that merchandise on the shelves has not changed to any great extent from the previous decade.

Figure 83. Series of contact prints highlighting details of the Bullpen. 1972 (HUTR 25701).

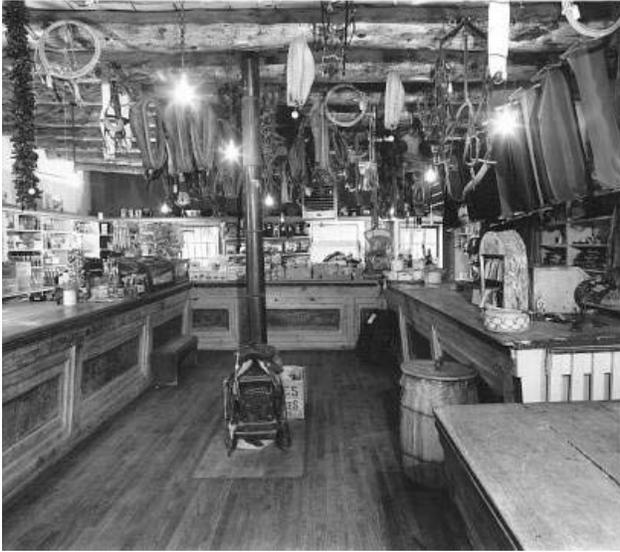
In 1989 a new floor was placed atop the existing floor in this room, the Trader's Office and in part of the Wareroom. The south wall is painted but the west wall is not. Noticeable changes from the 1970s are that the west counter is now used to display snack food chip products and that the north counter is holding tourist-type items. The northeast counter in the foreground does not have anything on it.

Figure 84. Bullpen. 1991 (HUTR 25658).
Photo by George Huey

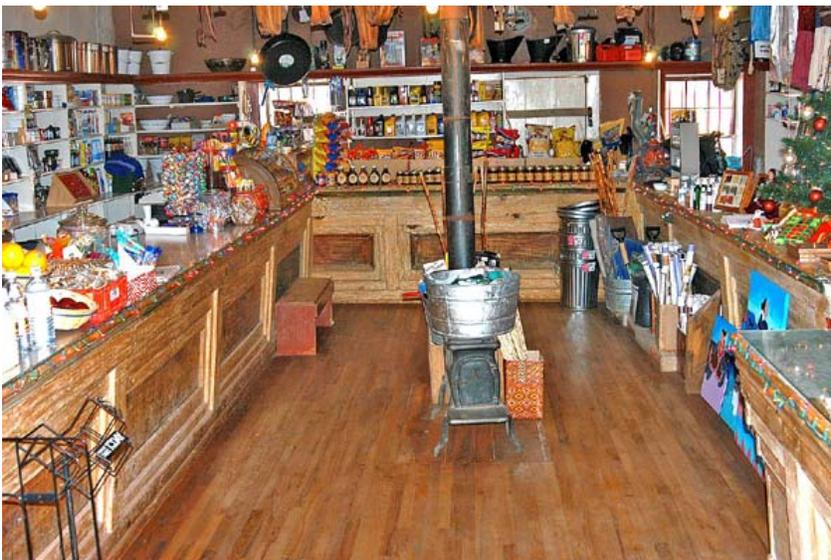
Figure 96. Hubbell Trading Post Bullpen, 2005 Photo by John Vinck (25658new).

This 2005 re-shoot of photograph 25658 is provided to show the changes to the room since 1991. Primarily and most visibly the changes are merchandise for sale and the use of the room to display those items.

Rows of jams and honey are still on the west counter. Stacks of trash cans, buckets, shovels and rolls of paper are along the north counter and the northeast counter has a square of glass on the corner.

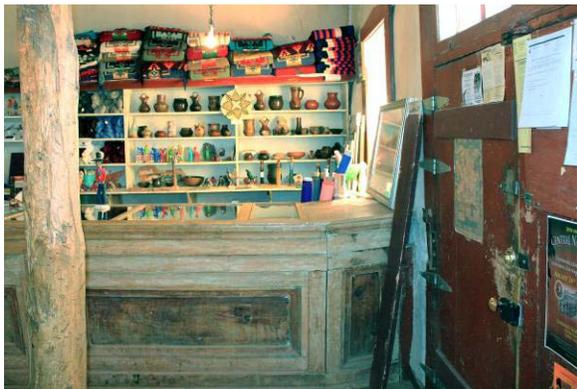
Figure 105. Glass-topped north counter.
(HUTR Digital File IMG2046).

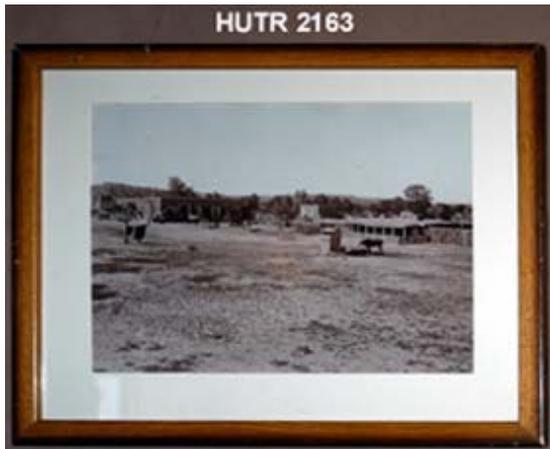
Further evidence of the interior is actually available from exterior photographs. The Ben Whittock photo, taken prior to 1902 (HUTR 2163), indicates two stone chimneys; one on the east wall of the Trader's Office and the other on the south wall of the Rug Room. A subsequent photo from c.1905 shows the office chimney, but not the Rug Room chimney (HUTR 4397). The photograph below shows the office chimney. David Brugge noted that a drawing by Burbank in 1912 (Burbank, 1946 p. 63) shows the office chimney. Photograph HUTR 8654 had previously been identified as c. 1910, but must date after 1912.

Figure 109.
(Ben Whittock – prior to 1902. HUTR 2163).

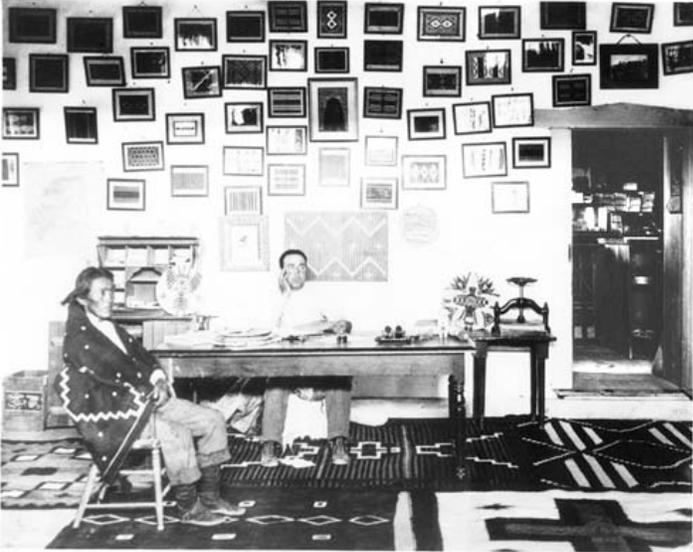
Figure 113. Trader's Office with door into Bullpen.
(Vroman 1904. RP - 013).

The earliest are several pictures taken by Adam Clark Vroman in 1904. RP - 13 shows the south wall of the Office before the large desk was set against the wall. The other (HTP-PP-43) is a remarkably good picture of the original fireplace (now removed) against the east wall. The copies were acquired from the Los Angeles Museum of Natural History and were printed from Vroman's original glass negatives.

As noted above on the basis of exterior photos showing chimneys, the fireplace existed throughout all or most of the period from 1900 to 1912. The Vroman photo shows it in great detail. It was plastered with adobe and rectangular in cross section, the chimney being equal in horizontal dimensions to the fireplace proper. An American flag design textile with 12 stars hangs over the hearth opening. This textile looks like it could be a Navajo weaving. The textile obscures the opening but enough is visible on one side to suggest an arched top. A depressed dirt floored area in front of the hearth doubtless served to prevent sparks from reaching the wooden flooring. A wood frame formed a sort of façade about the opening for the hearth. An empty fireplace tool bracket is mounted to the wooden frame on the south vertical rail with a pot holder hanging from it. Above this were three shelves appearing rather like a triple mantel. These were filled with pottery, most of which was of modern Hopi manufacture although included was at least one prehistoric Anasazi jar, a rectangular bas-relief of a Navajo weaver, a few stone artifacts including an ax head, a small stone bowl, a knobby stone artifact that might have been a club, a porcelain vase and some unidentifiable bric-a-brac. Above these on the front of the chimney were hung eight of the small rug paintings and what appears to be a Burbank painting of an elderly Navajo or Hopi man. The location of this painting today is unknown. A series of small rectangular wooden shelves on each side of the fireplace and chimney complete the structure. On the north side these are filled with books, account books on the lower two shelves and unidentified published sets on the upper four. On the south side the lower two shelves hold business papers in cardboard files and boxes and the top shelf is vacant. The other three shelves hold pottery, some of which is Hopi, but also including pieces that appear to be from Zuni, Acoma or from other pueblos even further east. On the south part of the façade a small Hopi bowl or dipper hangs from a nail and a two-pronged metal bracket provides a place for leaning pokers and other tools.

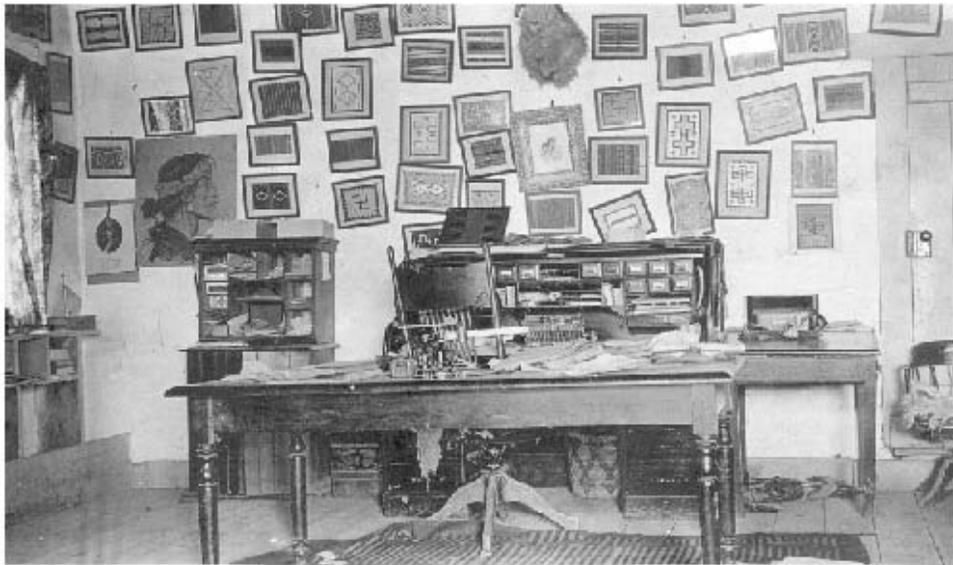
Next is another photograph of the south wall taken in the summer of 1906 by Virgil Huff White (HUTR 8702). In this picture the large desk is set against the wall and there have been some minor changes in the decoration on the wall.

*Figure 115. Trader's Office south wall.
(White 1906. (HUTR 8702).*

Alterations visible in the White photo taken two years later in 1906 are numerous. Most notable is the large roll top desk which was still used in the Office until 2009, when a replica was substituted and the original moved to the Museum storage facility.. The simple wooden chairs have been replaced with two swivel chairs, both with pelts to soften the seats. The wooden crate has been moved to a position between the cabinet and the desk. Various boxes and papers covered the available surfaces of the cabinet.

A wastebasket in coiled Indian basketry, possibly Mescalero Apache origin, is under the desk. The letterpress is no longer on the small table by the door. In its place is a small unidentified object. The table itself appears to be a replacement, although of similar size. The pictures on the wall have been shifted around somewhat. Present are Sawyer's painting of a Yei'bi'chei rite hanging above the door, a plaque similar to the weaver plaque that once hung on House patio wall , the photograph of Don Lorenzo's two daughters now on the east wall of the Office, and the large sketch of a Navajo in profile by Maynard Dixon, now in the Museum, and an unidentified picture of an individual with long loose hair, probably a painting or photograph of an Indian girl.

Office equipment shows some advance in the picture. While the letterpress is no longer visible, a typewriter on the desk indicates that it was no longer needed. It should be noted that the latest letterpress in the Hubbell Papers ends in 1904, with a few late entries in 1914.⁸² On the table is a heavy glass inkwell and a small balance scale and numerous papers, account books and a clip board, a rolled up concho belt, and a beaded belt are on the small table by the door, but the dark objects under the table are not identifiable. Aside from the account books and a couple of cigar boxes, most of the papers and containers on the office furniture cannot be described in specific terms. A simple striped rug (Moqui Style) lies on the floor under the table.

moved into the Rug Room. In 2009, the roll top desk (HUTR 4211) against the wall in photograph HUTR 8702 and the table (HUTR 4212) in the foreground in both images were relocated to the Museum storage facility and replaced with replicas. The smaller, square leg table on the right side is possibly a school desk now in Museum storage with catalog number HUTR 13636. The goat head (HUTR 5988) hanging in the center of the rug paintings is still hanging in the Trader's Office, but now it is on the west wall above the door that opens into the rug room. Another change from these photographs to the present is the way the door to the bullpen opens. In the images below the door opens to the right. In approximately 1950 the hinges were moved to the other side of the door so now the door opens to the left.⁸³

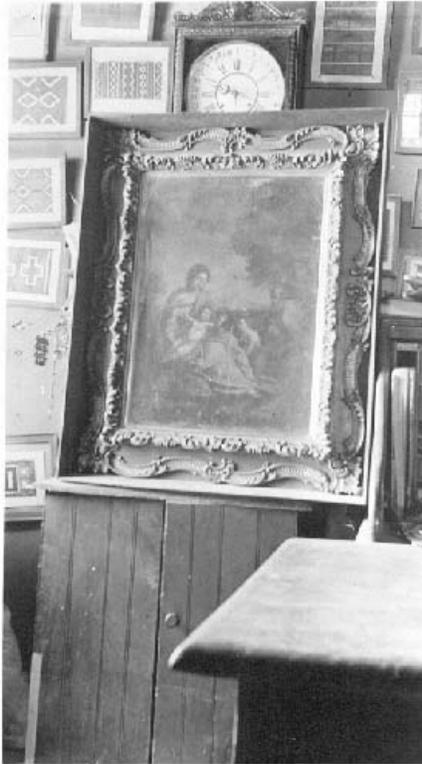
Figure 116. Trader's Office southeast corner.
(Assumed after 1910 and prior to 1920. HUTR 8704).

Finally, an undated close up photograph of the Italian Madonna painting was taken in the Office and enough objects show around the edges to help in documenting rug paintings and clock furnishings (HUTR 8704). A note on the back of this picture, probably by Wescoat Wolfe, former NPS superintendent at Hubbell, suggests a date of "Circa 1920." The only record of photographs being made of the Italian painting dates from 1912 (Hubbell to Cornelia Stuart Cassady-Davis, 7 June 1912, HUTR Historical Files). This strongly suggests that the picture may date in that year, but is by no means certain proof. The photograph is part of a set which includes HTP PP 55, dated on the basis of the fact that it was taken during Charles Hubbell's employment at the Oraibi Trading Post from about 1911 – 1916. (Brugge, 1972, p.104). Thus a date considerably prior to 1920 is indicated.

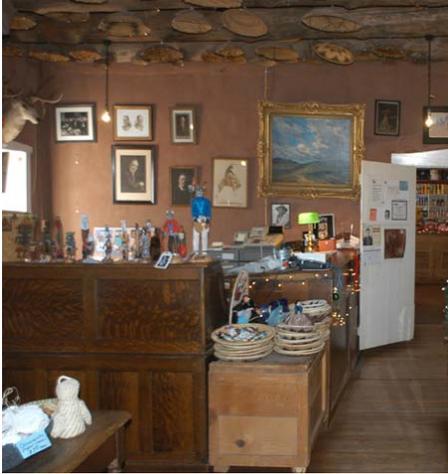
Figure 117. (HUTR 8702 new).

This 2005 photograph shows the same location as documented in RP 13 and HUTR 8702 above. A most notable difference between 1906 and 2005 is the shift in the way business is conducted. The relaxed atmosphere seen in 1906 has changed to a business oriented, increase in work-load atmosphere one hundred years later in 2005.

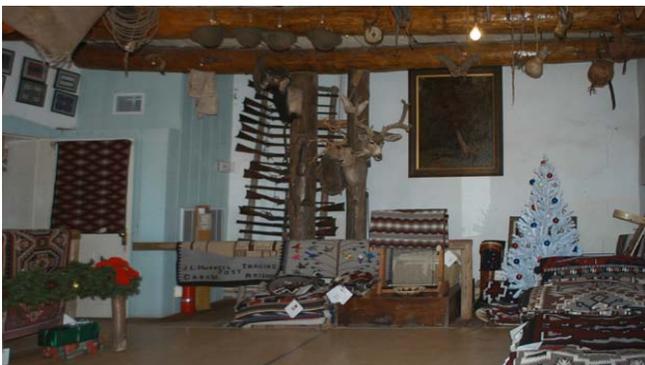
Figure 193. Rug Room south wall. 2005. (HUTR Digital File Rug Room South Wall).

The closet in the southeast corner of the room was expanded to hide an HVAC unit installed in 2005. The gun display rack was moved a couple feet to the west because of the new, larger closet.

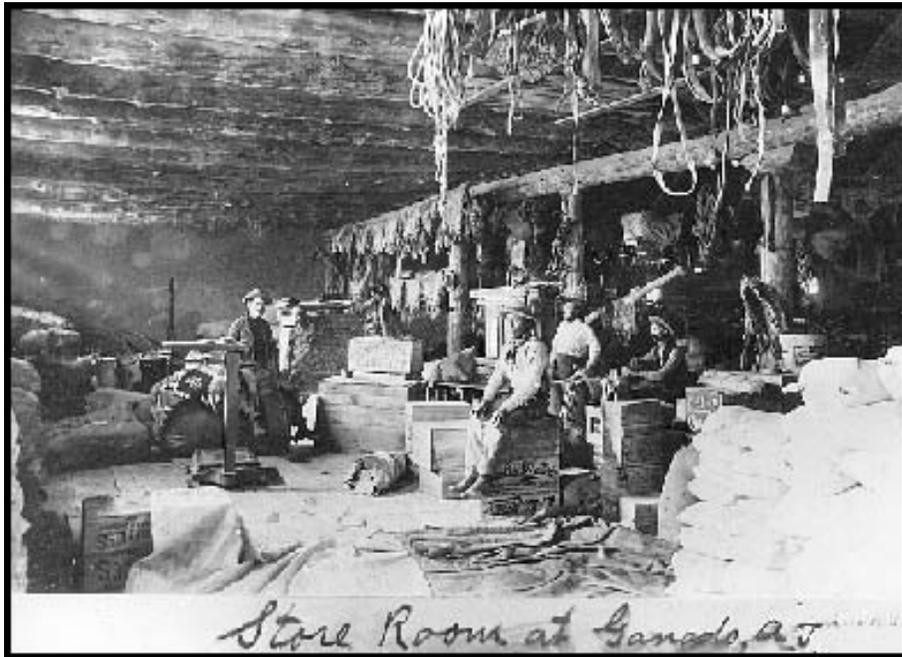
Figure 199. Hubbell Trading Post Wareroom, 1897 (HUTR 2178).
Photo by G. B. Wittick (Ben Wittick).

By as early as 1895 the wareroom was completed and stocked with supplies. This photograph provides good documentation of the room and its contents. The entire 1968 furnishing plan for this room was based on this photograph.

The volume of space was necessary for traders to stock pile wool fleeces in the spring before bundling them and shipping them to markets.

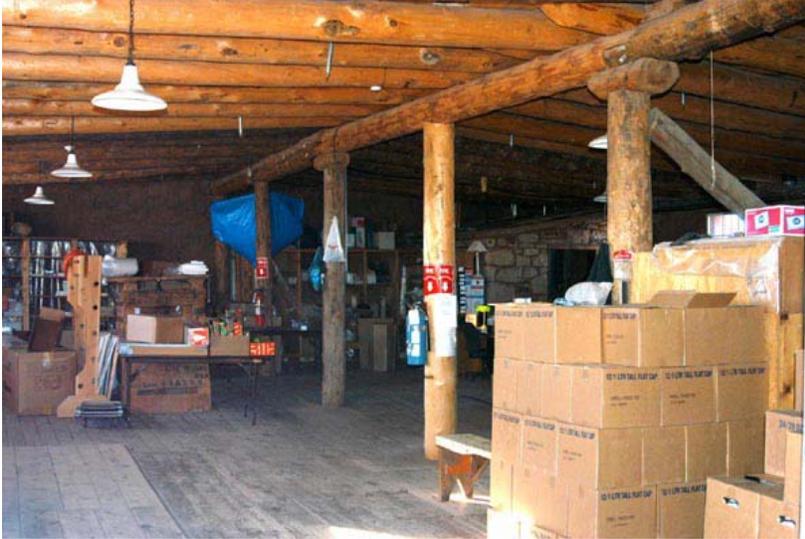
Figure 200. Wares room. 2005. (2178new. Photograph by John Vinck).

Dorothy Hubbell recalled that around 1930, after a very rainy summer, the center log rafter broke. They tried to keep as much of the original ceiling up as possible. The small stone structure in the southwest corner housed a Kohler gasoline engine generator up until sometime in the 1930s when a diesel engine was installed in the Utility Building (HB-08).¹¹⁹

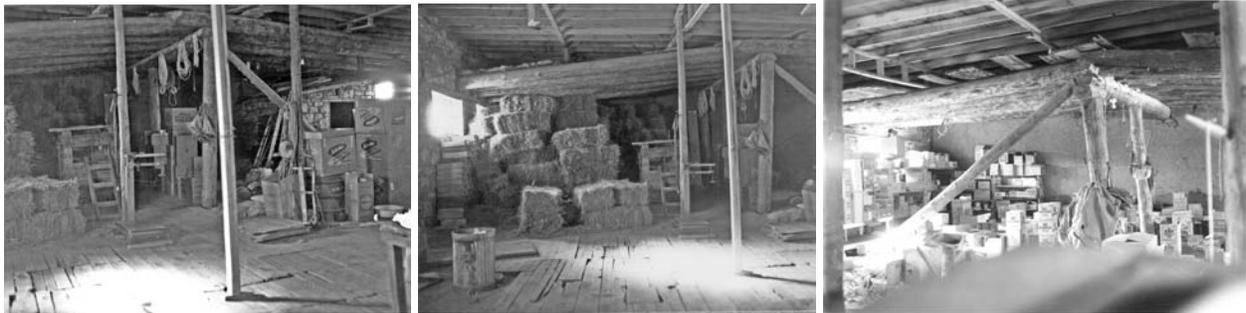
Figure 202. 1966. (HUTR Negative No 40). Figure 203. 1966. (HUTR Negative No 41) Figure 204. 1966. (HUTR Negative No 236).

The following three images were taken in 1966 to illustrate the historic structures report. They provide an excellent look at this room at that time. In 1966, the ceiling was constructed with a slanted roof from east to west across the top of the vigas as shown in Figure 203 below. NPS Plans from 1972 indicate the missing vigas would be replaced and the slope returned to its original configuration as shown in Figures 205 – 207.

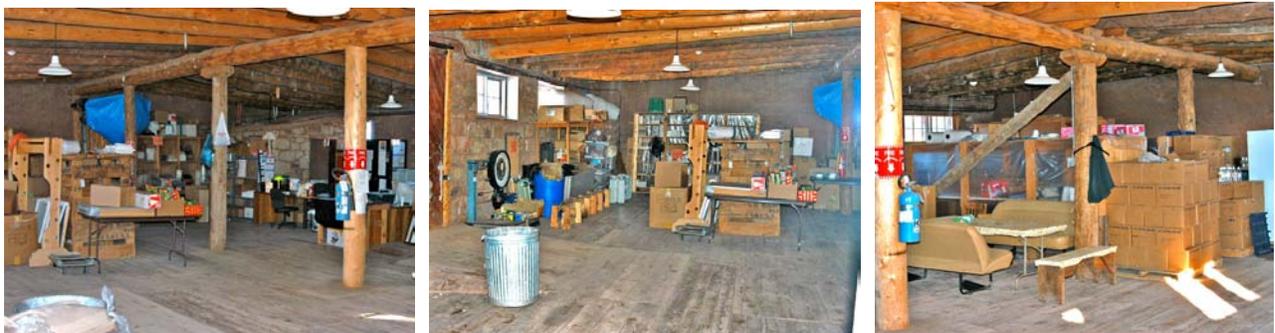
Figure 205. 2005. (HUTR Negative No 40 new).

The same views in 2005 show that the contents of the room changed from 1966 due to a change in community needs reflecting a reduction in livestock products and more reliance on packaged goods.
