National Park Service
Cultural Landscapes Inventory
2009

Cant Ranch Historic District
John Day Fossil Beds National Monument

MANAGEMENT CATEGORY: B: Should be preserved and maintained

CONDITION ASSESSMENT: Good

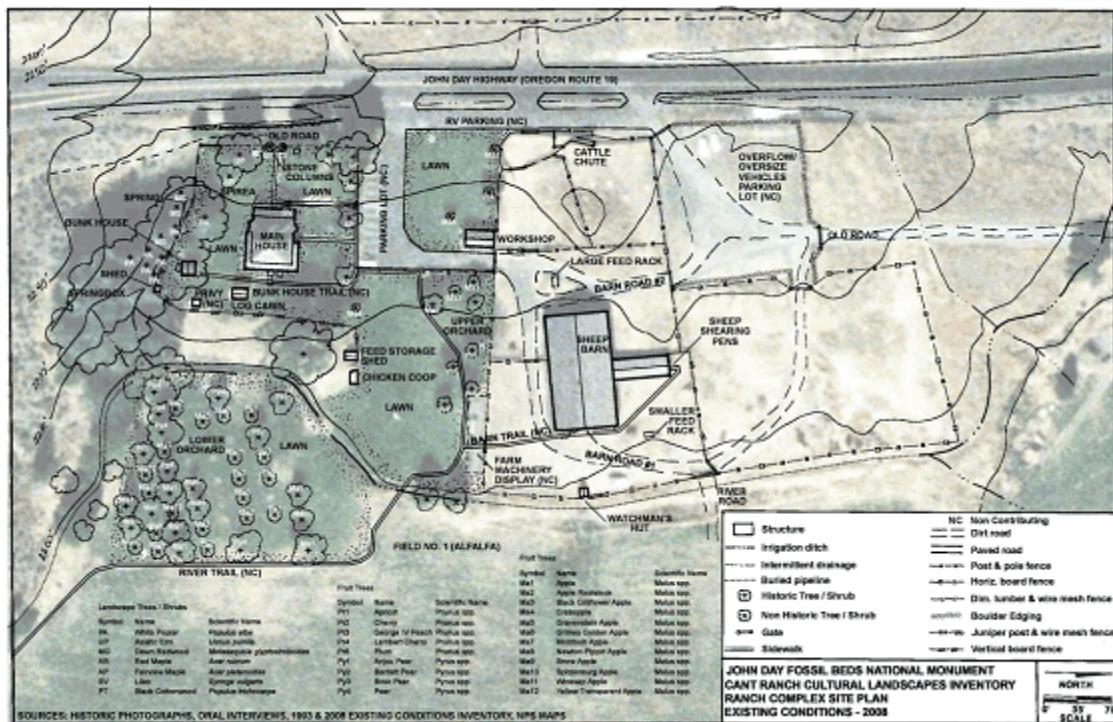
Site Plan

See the Supplemental Information section for a full 11"x17" version of site plan.

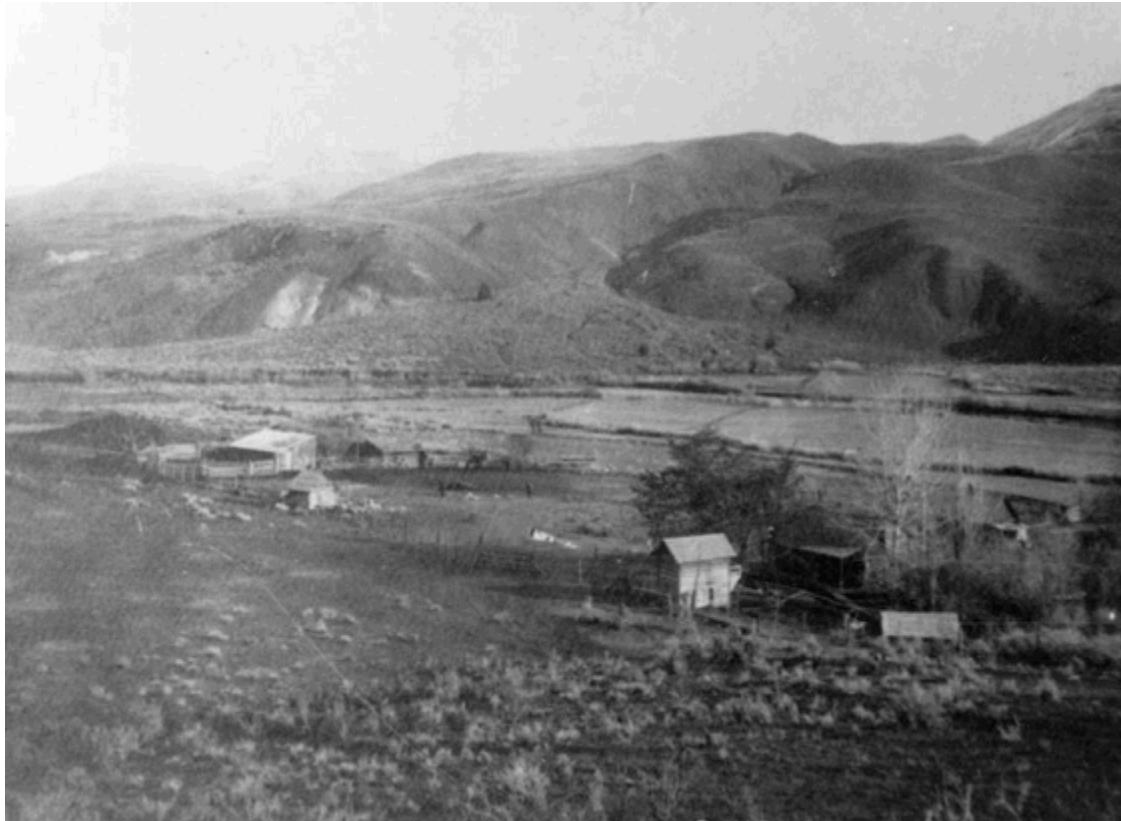
The ranch complex as established during the Officer Homestead Era, divided into a residential area to the right and a work area to the left. The division is retained into the present. (Unknown photographer, JODA archives, no neg. #.)

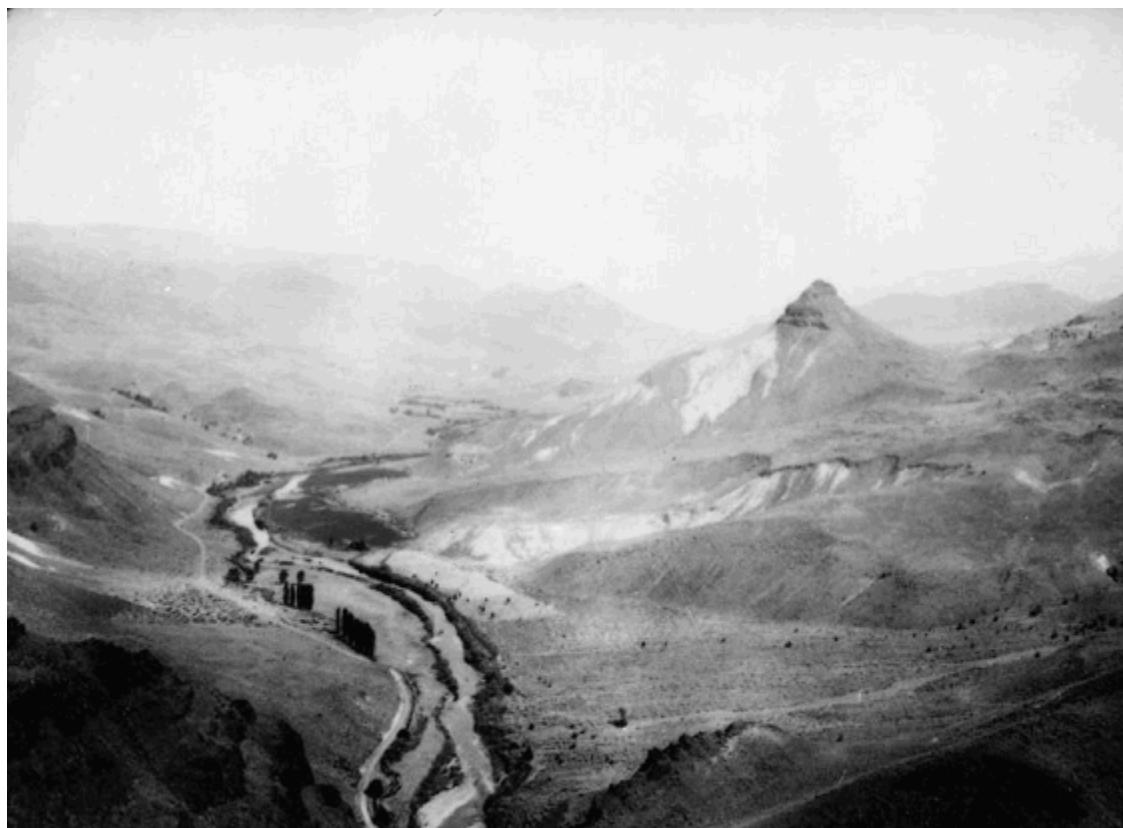
Looking N from Picture Gorge towards Cant Ranch (circa 1925). Field #2 is visible on the left side of John Day River. Field #3 had been recently added on the right side of the river N of Field #2. (Unknown photographer, JODA archives, neg. # 417.)

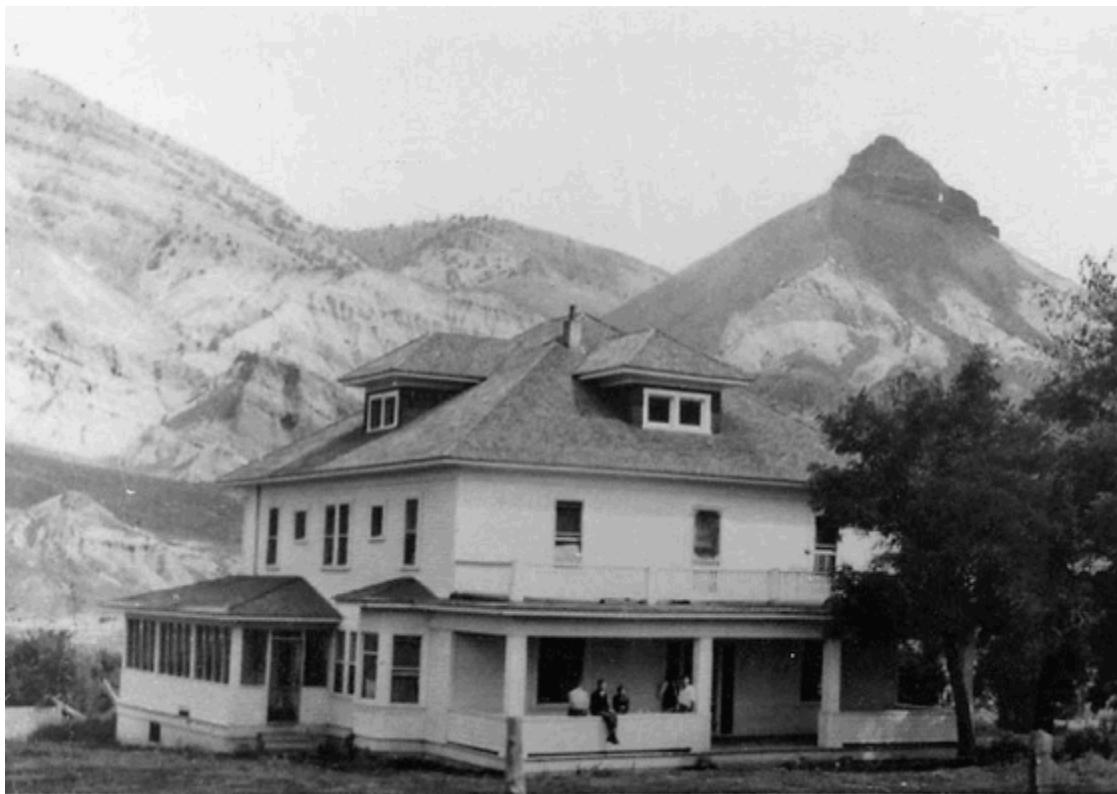
Looking SE towards the main house, constructed 1917-18. The photo probably was taken in the early 1920s. Note the open porch on the 2nd floor. Note the use of shade trees on the SW side of the house. (Unknown photographer, JODA archives, neg. # 65.)

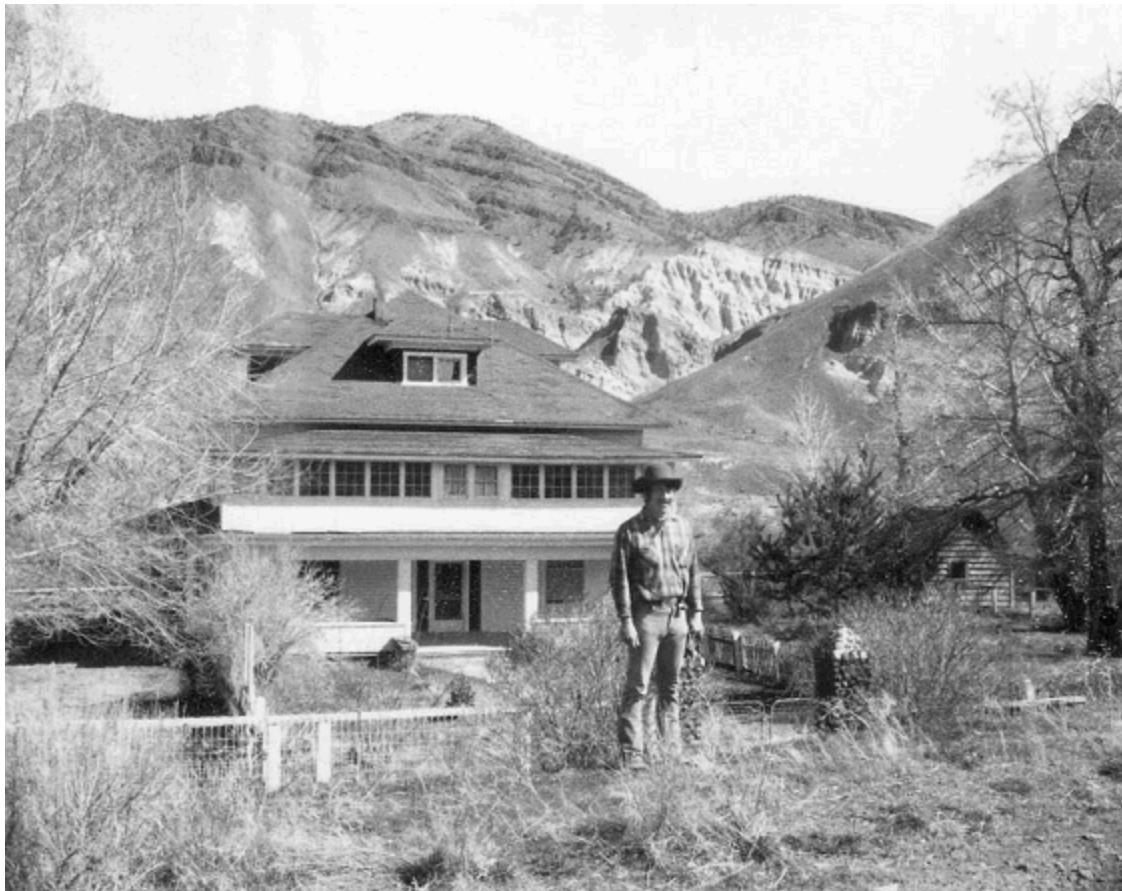
Main house (1976). Elms, black locusts, & white poplars enclose house. Visible are the post & wire fence, stone columns, lilacs and entrance walk. Bunk house behind house. Ranch hand in photo. (Unknown photographer, JODA archives, unknown neg. #.)

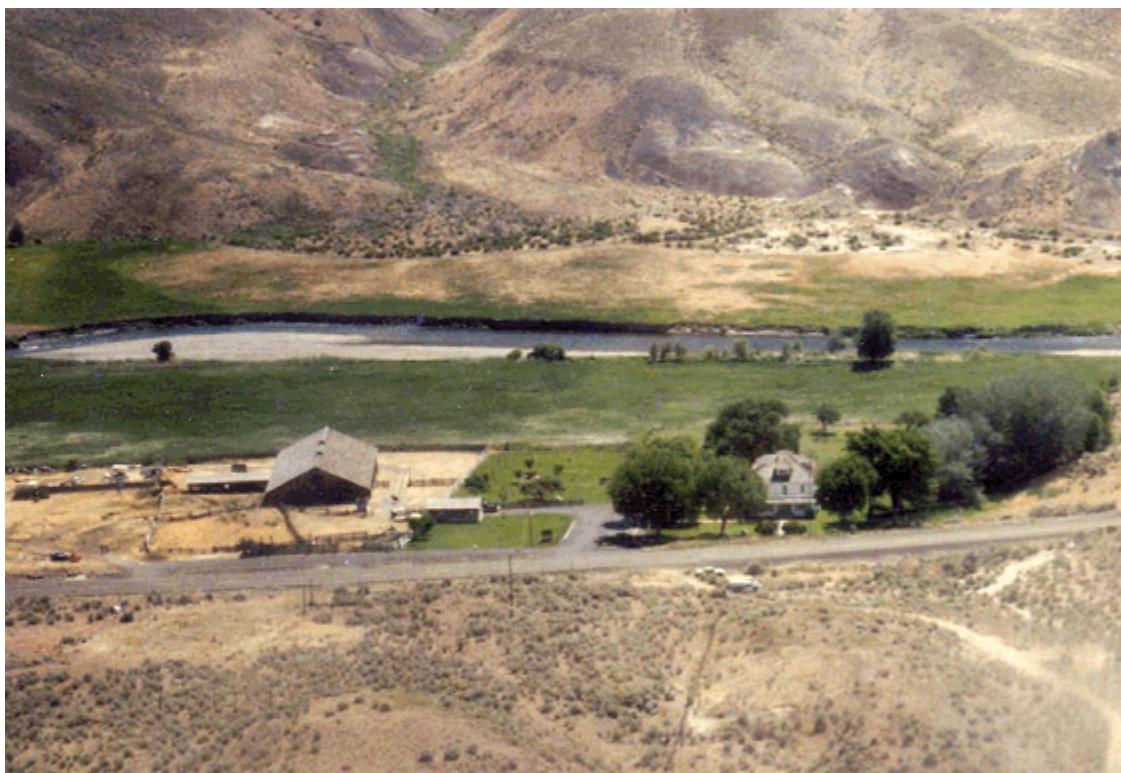
Ranch complex (1985) taken from W side of the ranch. Note shade trees & residential cluster on right . Note work area on left . Field #1 is behind ranch complex and Field #4 is on the far side of John Day River. (J. Morris, JODA archives, neg. #7298.)

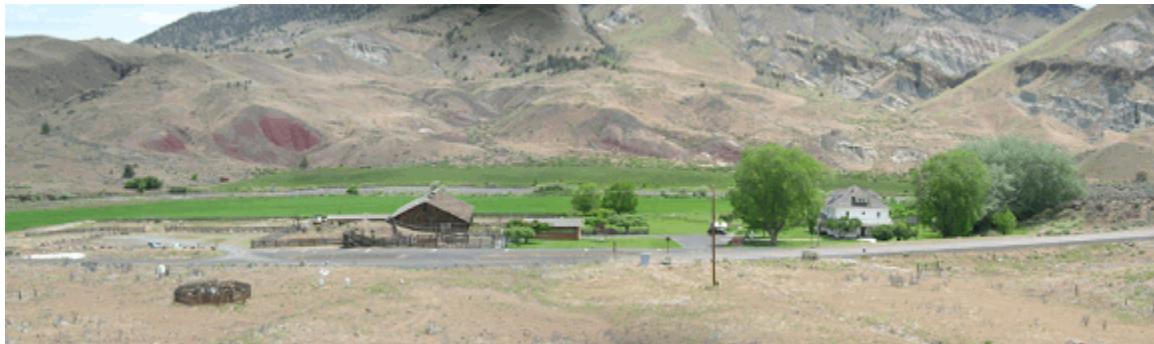
Ranch complex. The main house and ornamental trees dominate the residential area on the right. The sheep barn and corrals dominate the work area on the left. Fields #1 & #4 are visible beyond the ranch complex. (PWRO staff 2008)

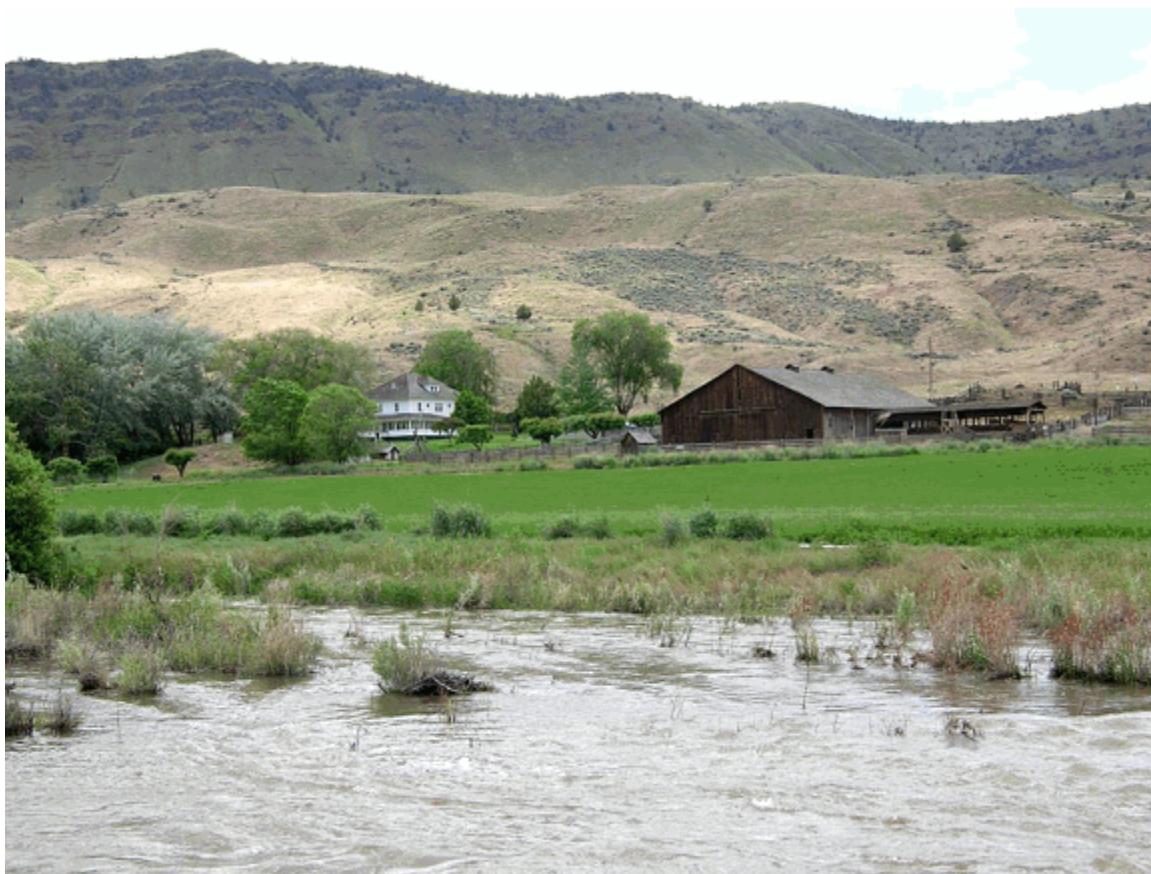
The John Day River cuts through the center of the historic district. The ranch complex is upslope and out of the floodplain. Field #1, between the river and the ranch complex, takes advantage of the deposited soils of the floodplain. (PWRO staff 2008)

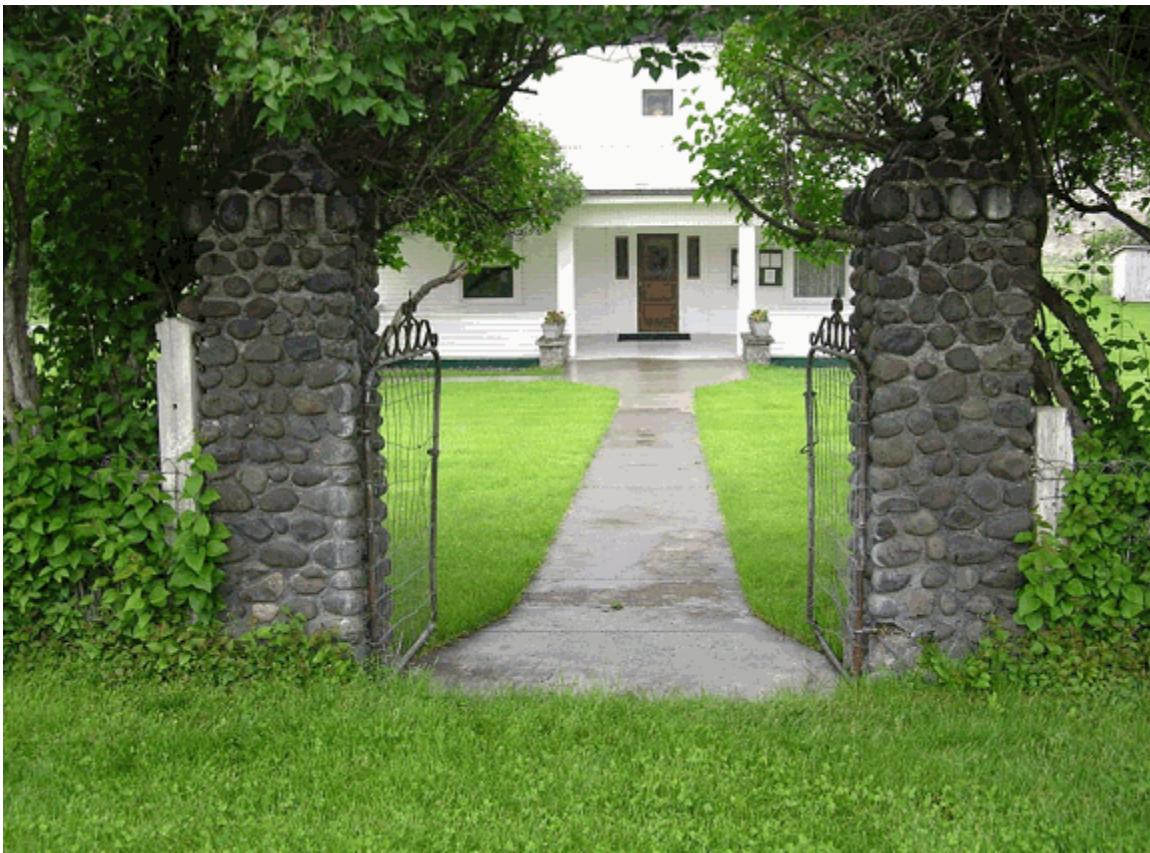
Entrance walkway #1, the primary pedestrian access to the main house until the John Day Highway was constructed in the 1920s. Note the stone columns (Park # CR-17; LCS # 100426; contributing) and lilacs which framed the entry gate. (PWRO Staff 2008)

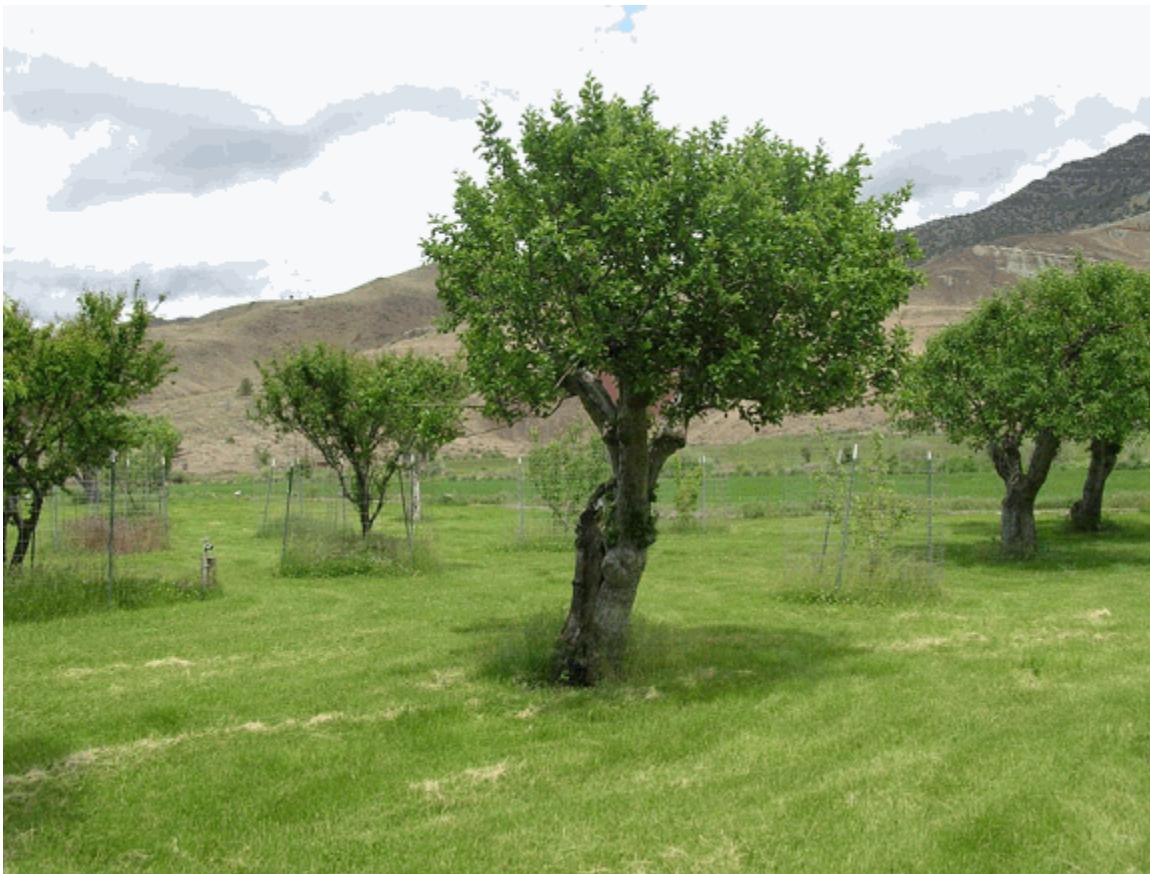
Lower orchard (contributing) with rows of fruit trees dating to the Officer Homestead era. Note the new fruit trees planted by the NPS to recreate the rows that existed during the period of significance. (PWRO staff 2008)

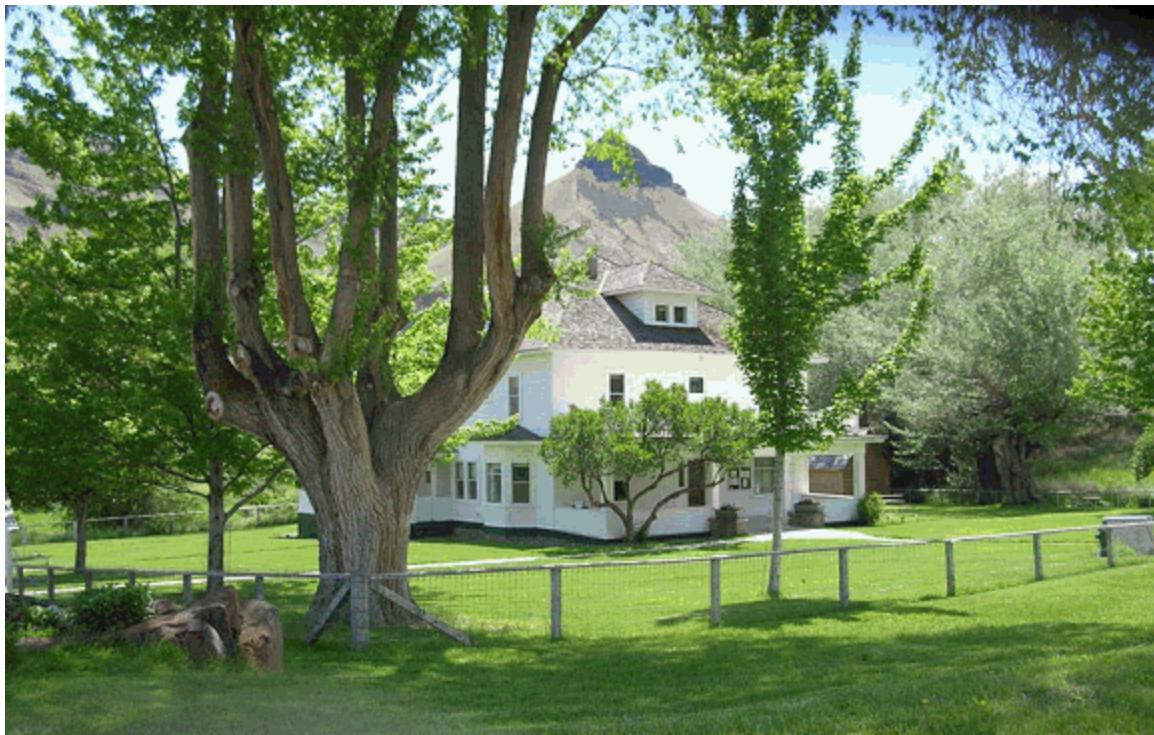
Main house (Park # CR-11; LCS # 023381; contributing). The Asiatic elm on the left and the lilac beside the front porch both date to the Sheep Ranching era. The dimensional lumber and wire mesh fence follows its historic alignment. (PWRO staff 2008)

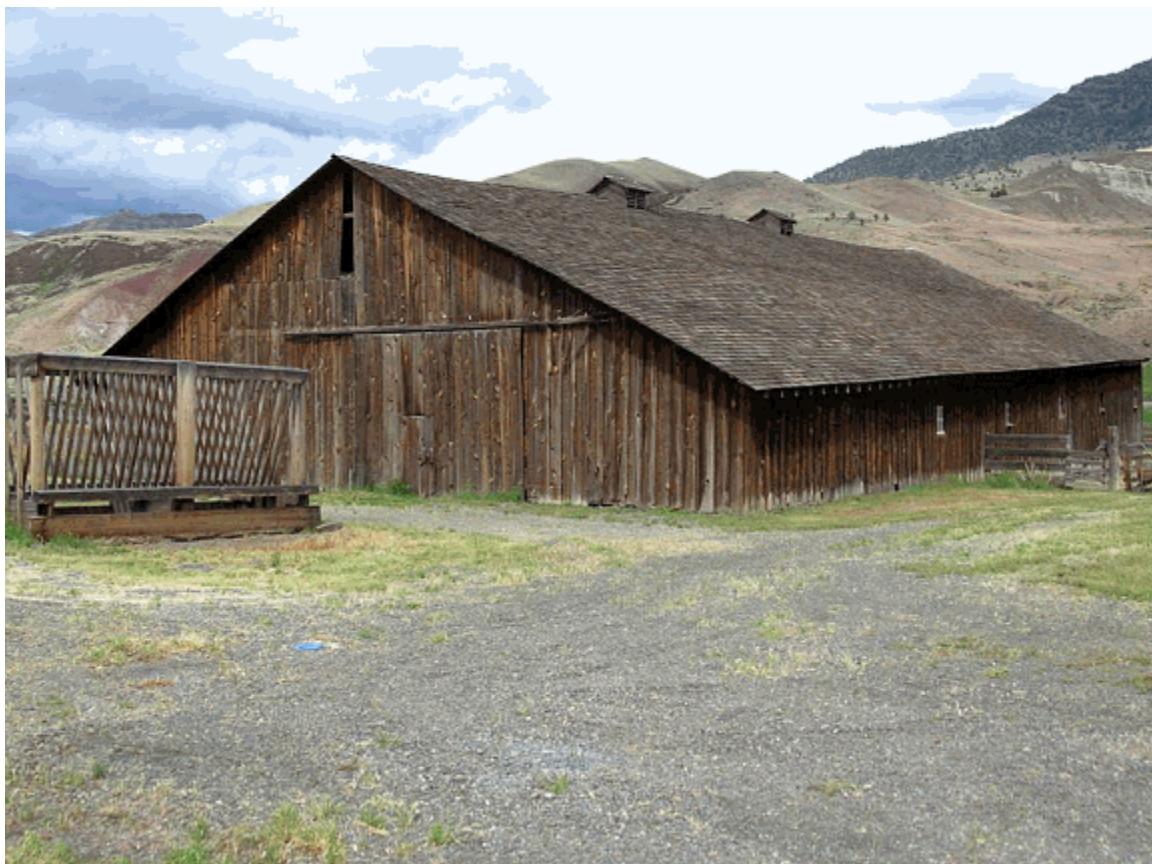
South and west facades of the Sheep Barn (Park # CR-1; LCS # 100275; contributing). Note the large feed rack (Park # CR-16; LCS # 100425; contributing) to the left. Barn roads are visible in the foreground. (PWRO staff 2008)

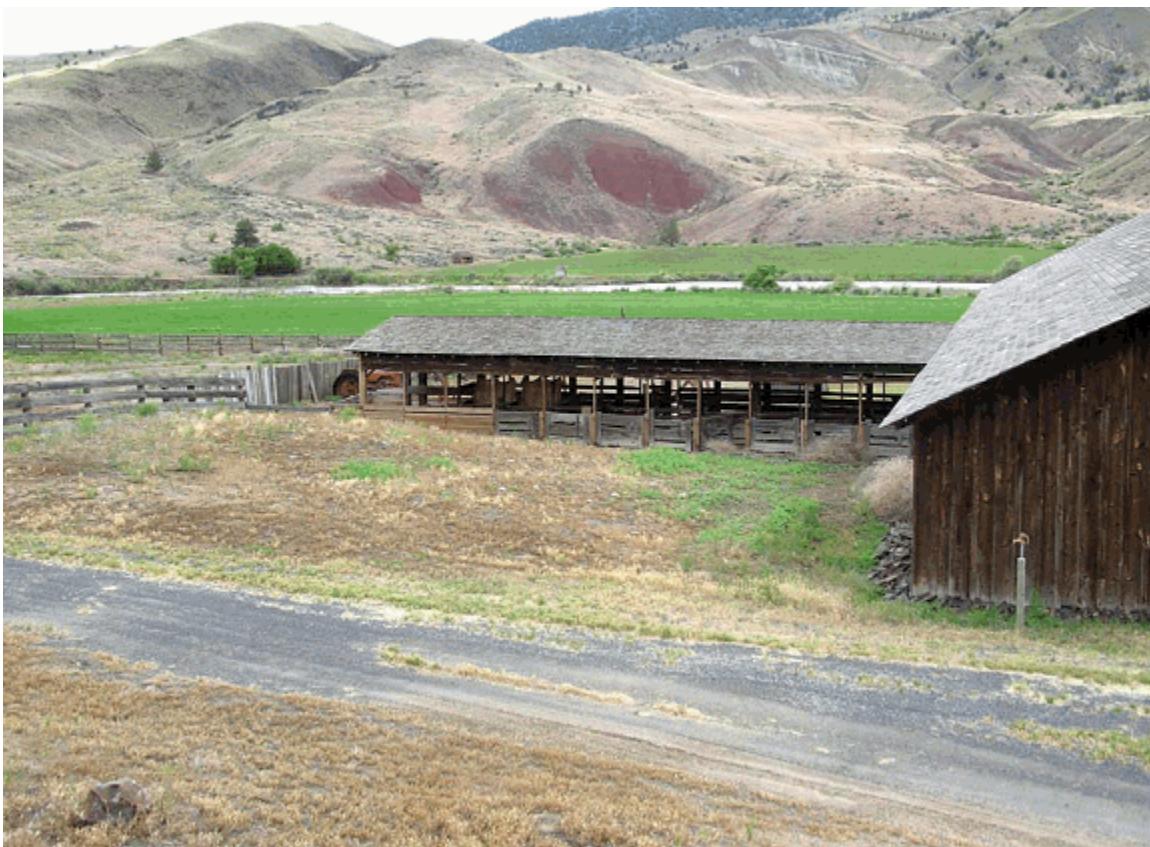
West façade of the sheep shearing pens (Park # CR-3; LCS # 100277; contributing) that project from the north façade of the barn. A simple barn road is in the foreground. Behind the pens are Fields #1 & #4 divided by the John Day River. (PWRO staff 2008)

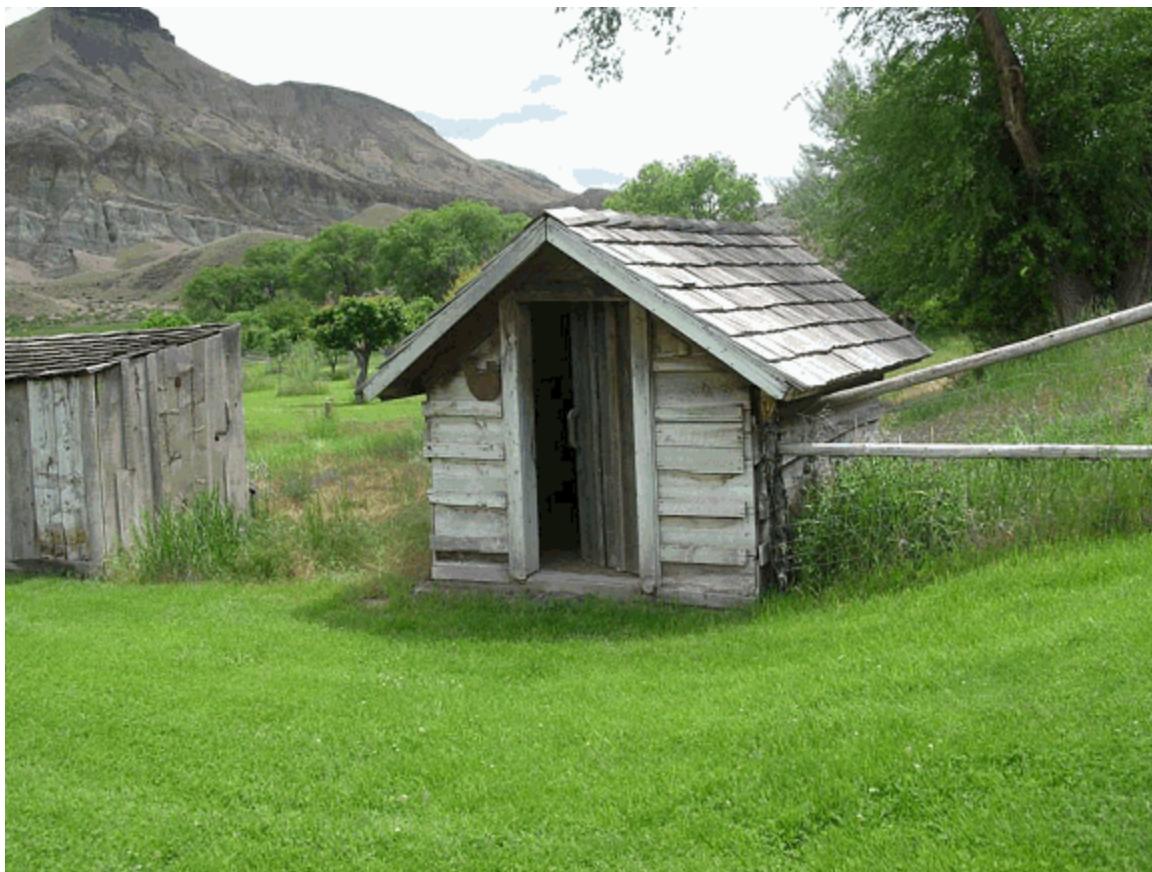
Feed storage shed (Park # CR-13; LCS # 100426; contributing) located downslope from the house. The west end of the chicken coop (Park # CR-6; LCS # 100278; contributing) is on the left. The lower orchard is visible in the background. (PWRO staff 2008)

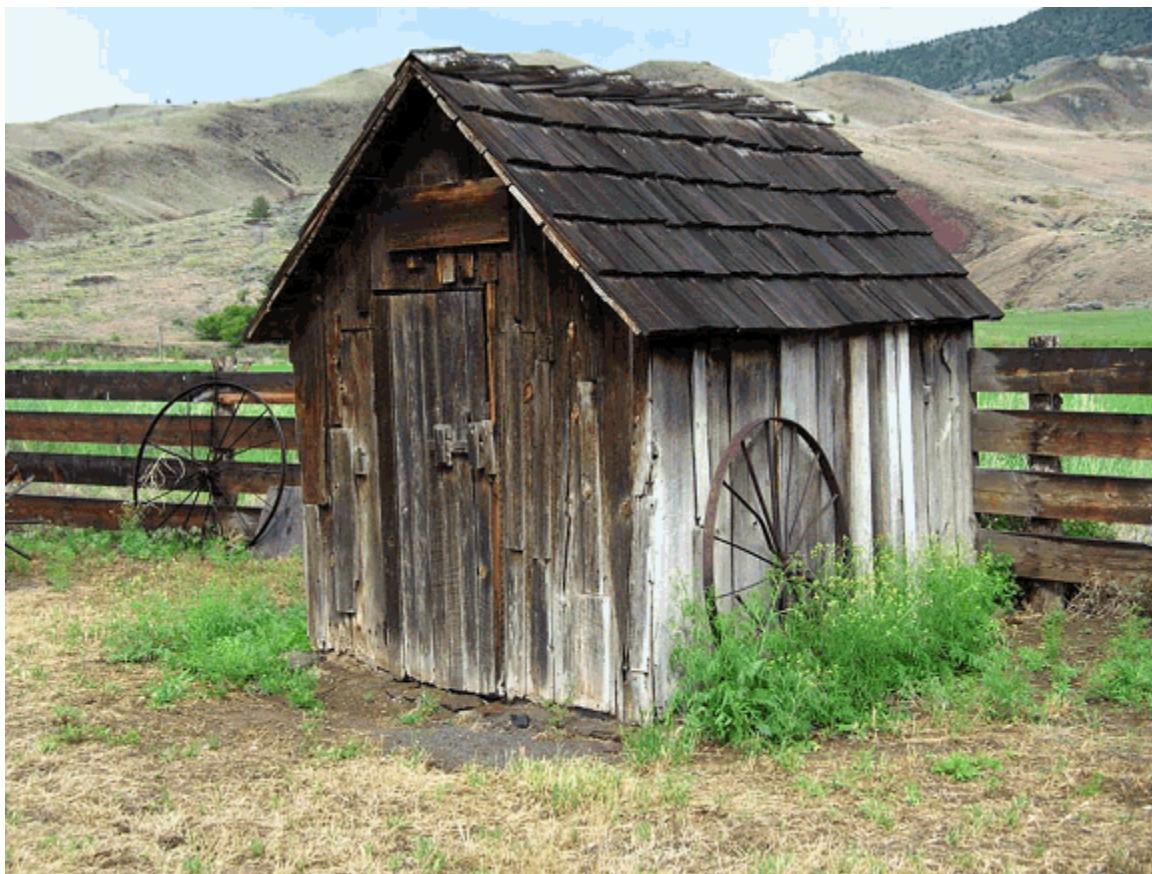
The Watchman's Hut (Park # CR-7; LCS # 023377; contributing) located east of the sheep barn. Note the horizontal board fence behind the structure. (PWRO staff 2008)

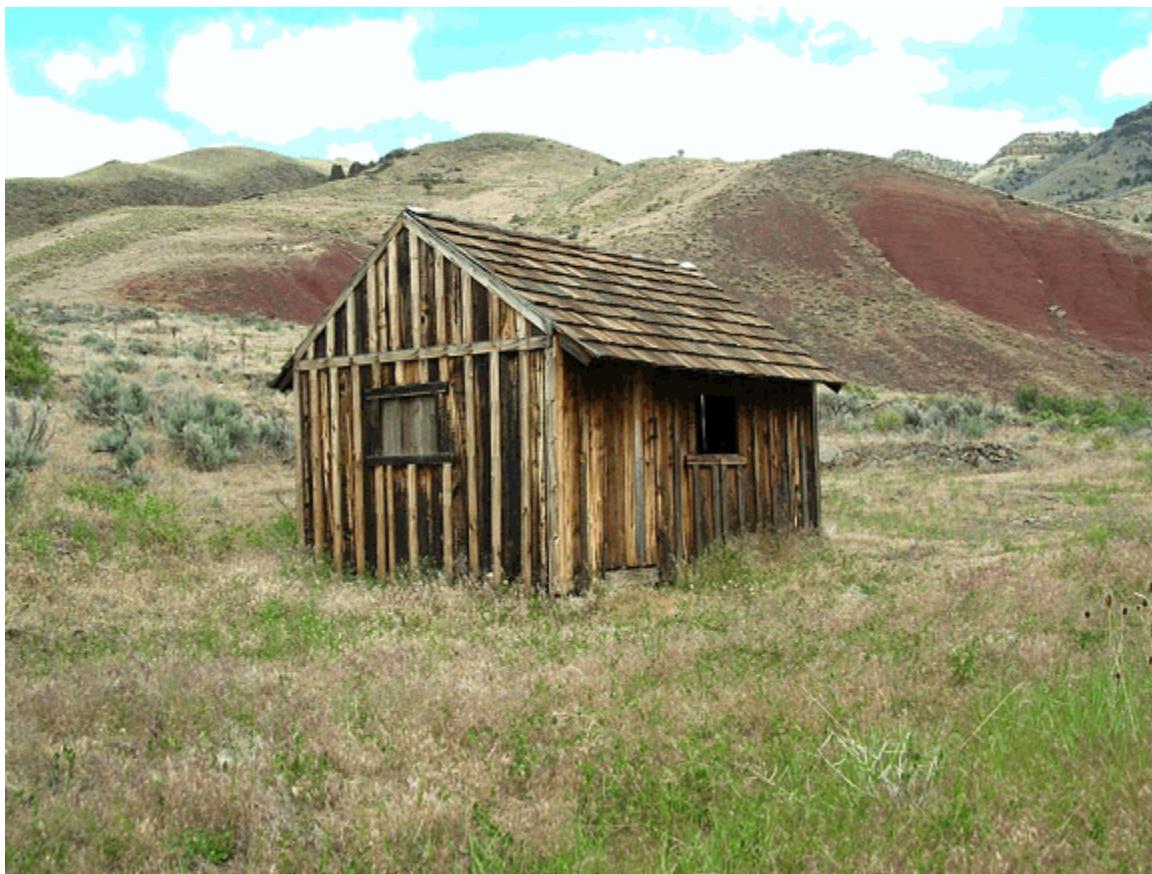
Christina's Cabin (Park # CR-4; LCS # 023374; contributing) located on the northern edge of Field #4. (PWRO staff 2008)

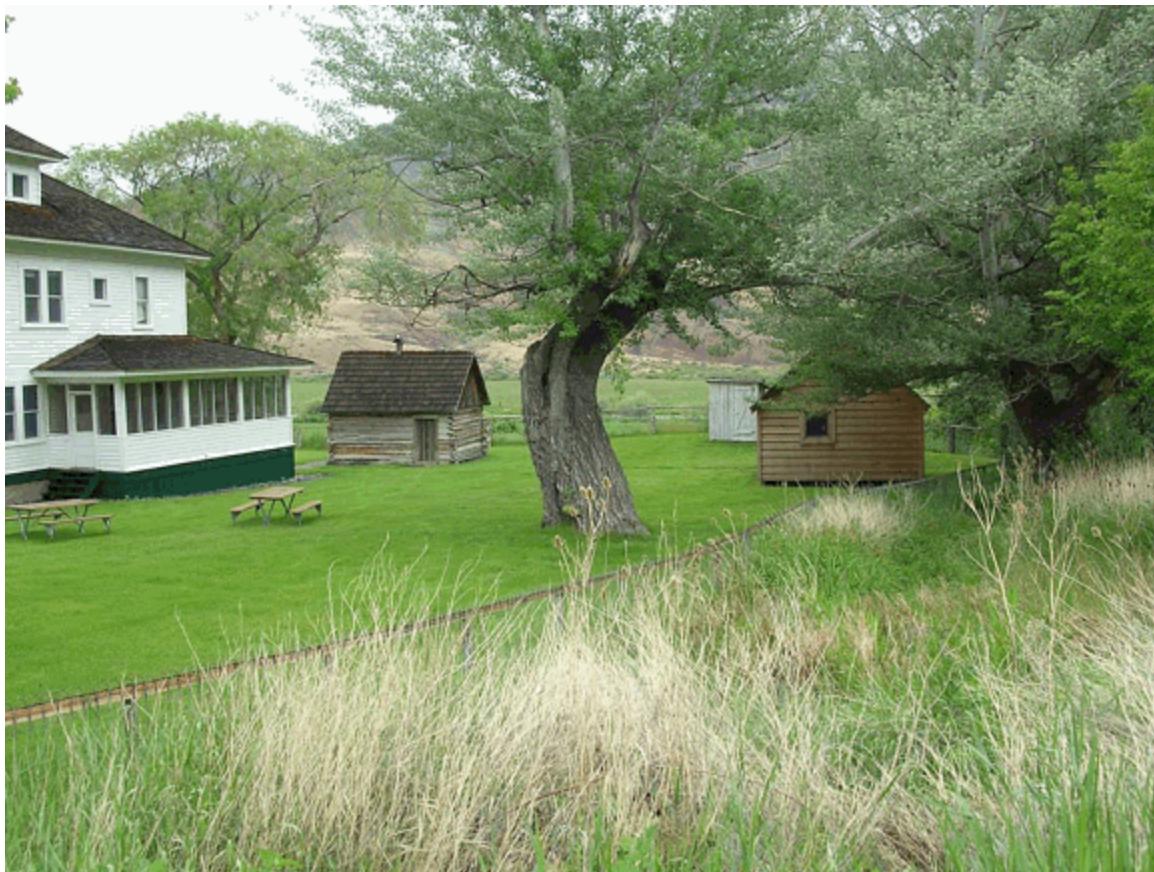
Residential area. To the right of the main house are the log cabin (Park # CR-10; LCS # 023380; contributing), replica privy, and bunk house (Park # CR-8; LCS # 100279; contributing). Also visible are the riparian area & a white poplar. (PWRO staff, 2008)

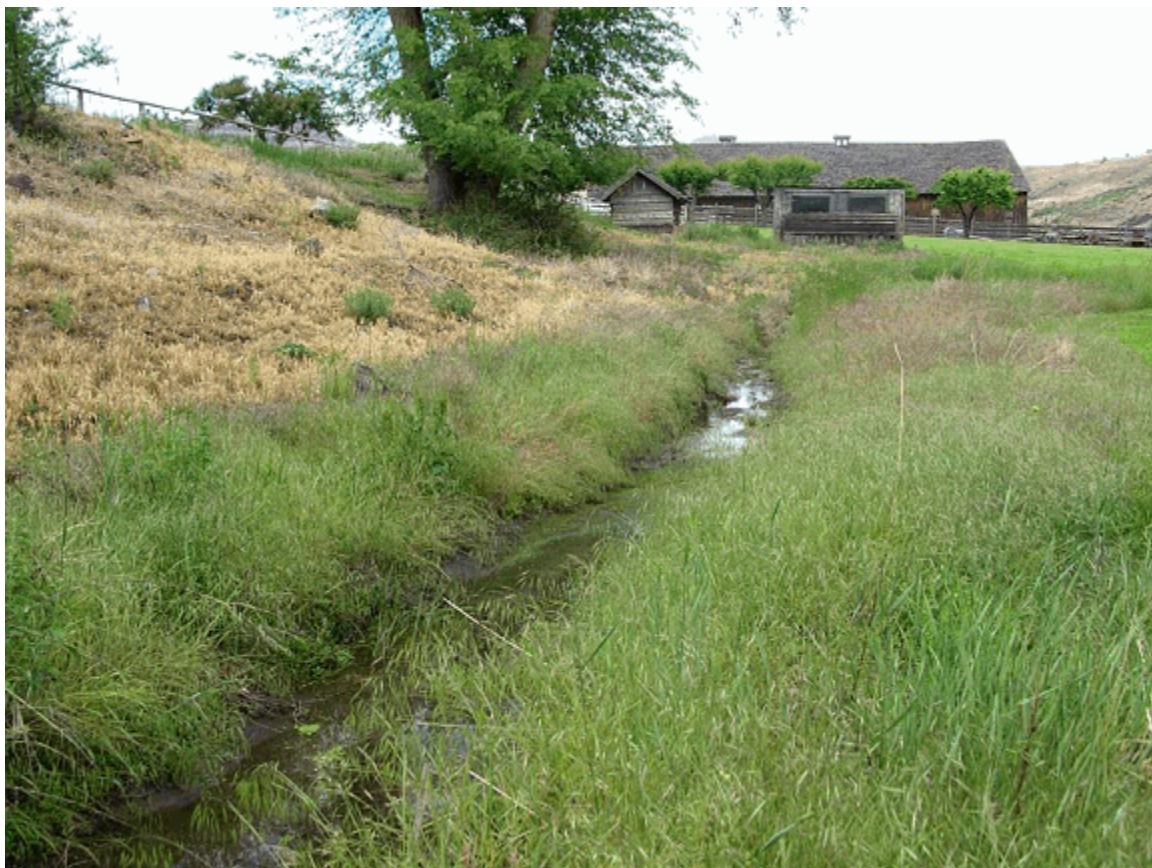
The contributing segment of the Rock Creek Irrigation Ditch below the main house. The sheep barn is visible in the background. (PWRO 2008)

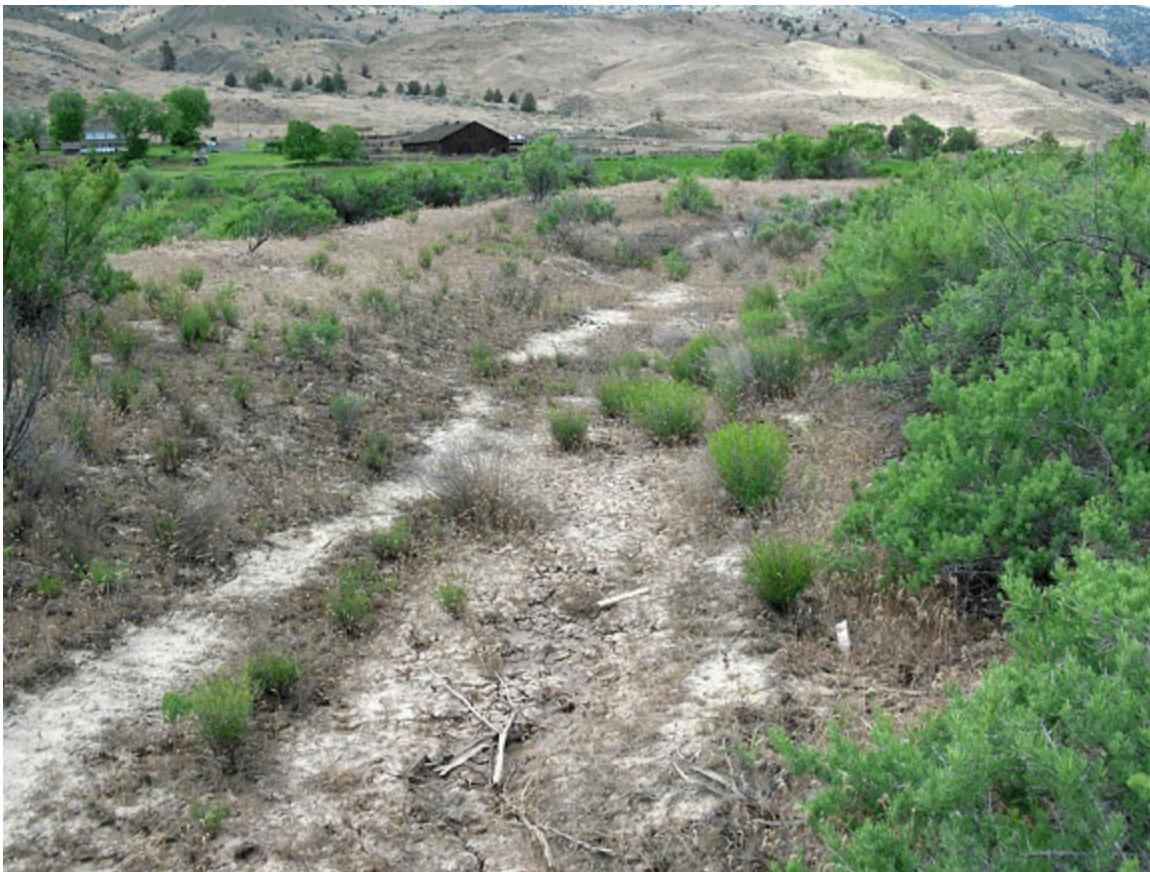
The Titanic Ditch running along the eastern edge of Field # 4. The light colored soil marks the base of the irrigation ditch. Though abandoned, substantial portions of the ditch remain. In the background are the main house and the sheep barn. (PWRO 2008)

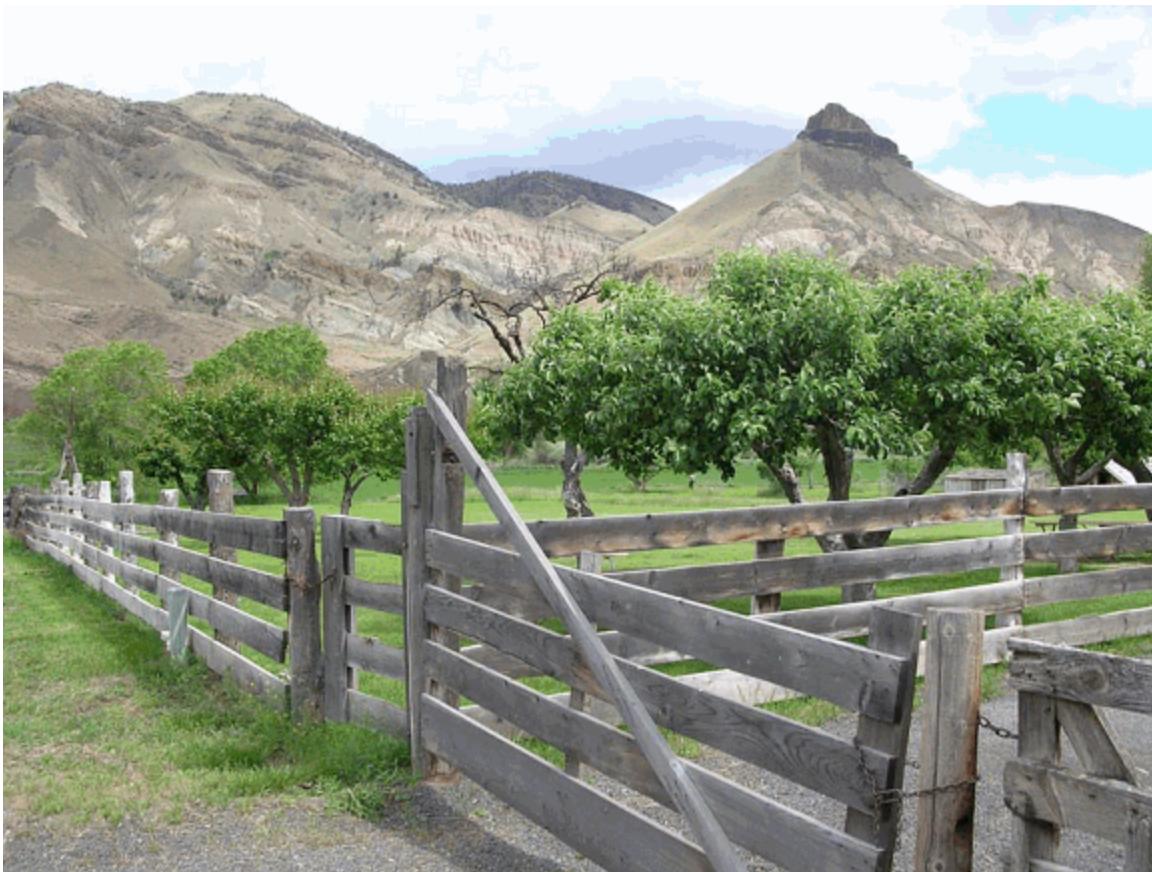
Horizontal board fence, the most common historic fence type at the ranch complex. The historic upper orchard is visible behind the fence. (PWRO 2008)
