National Park Service
Cultural Landscapes Inventory
2009

Cant Ranch Historic District
John Day Fossil Beds National Monument

MANAGEMENT CATEGORY: B: Should be preserved and maintained

CONDITION ASSESSMENT: Good

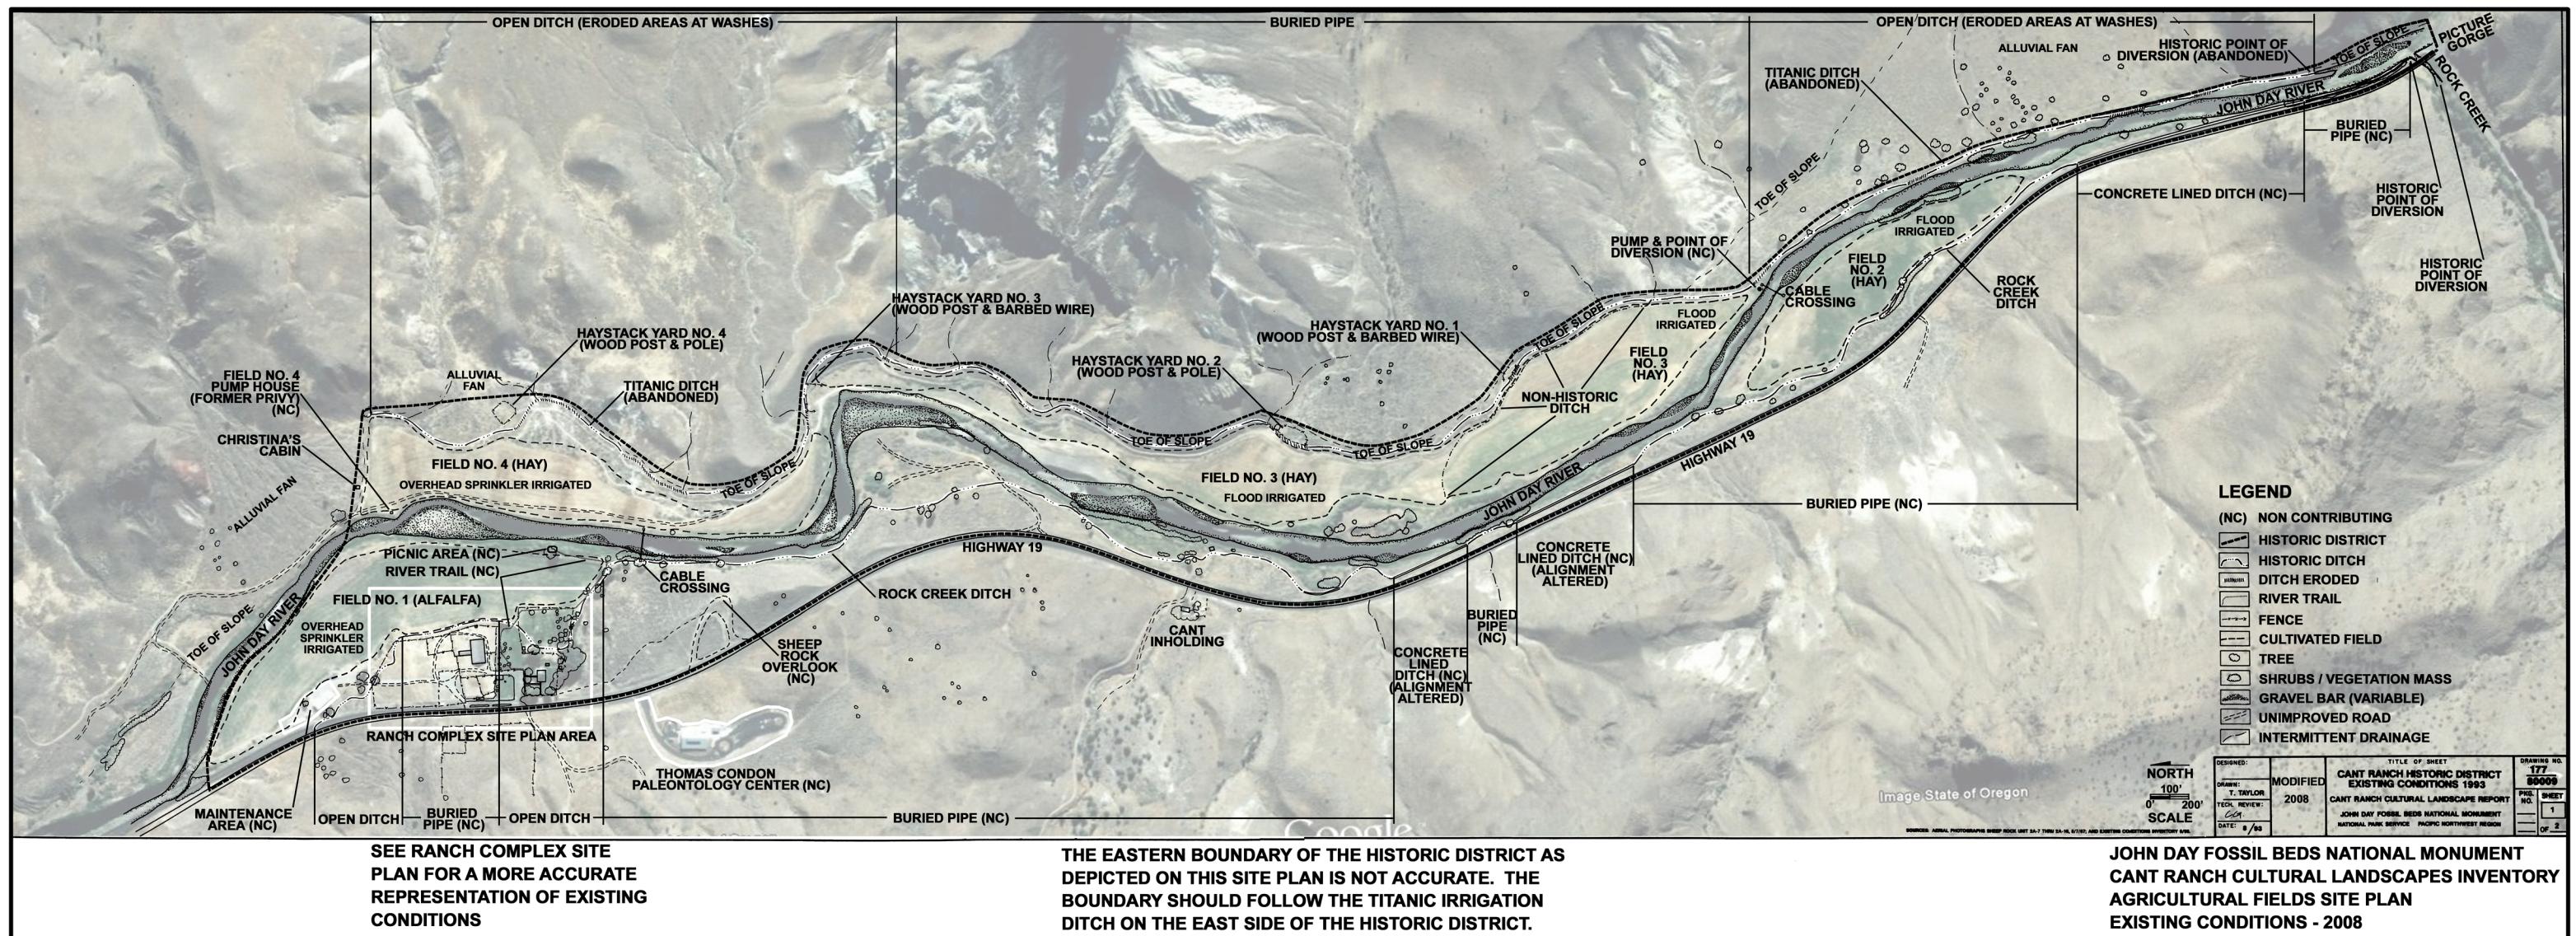
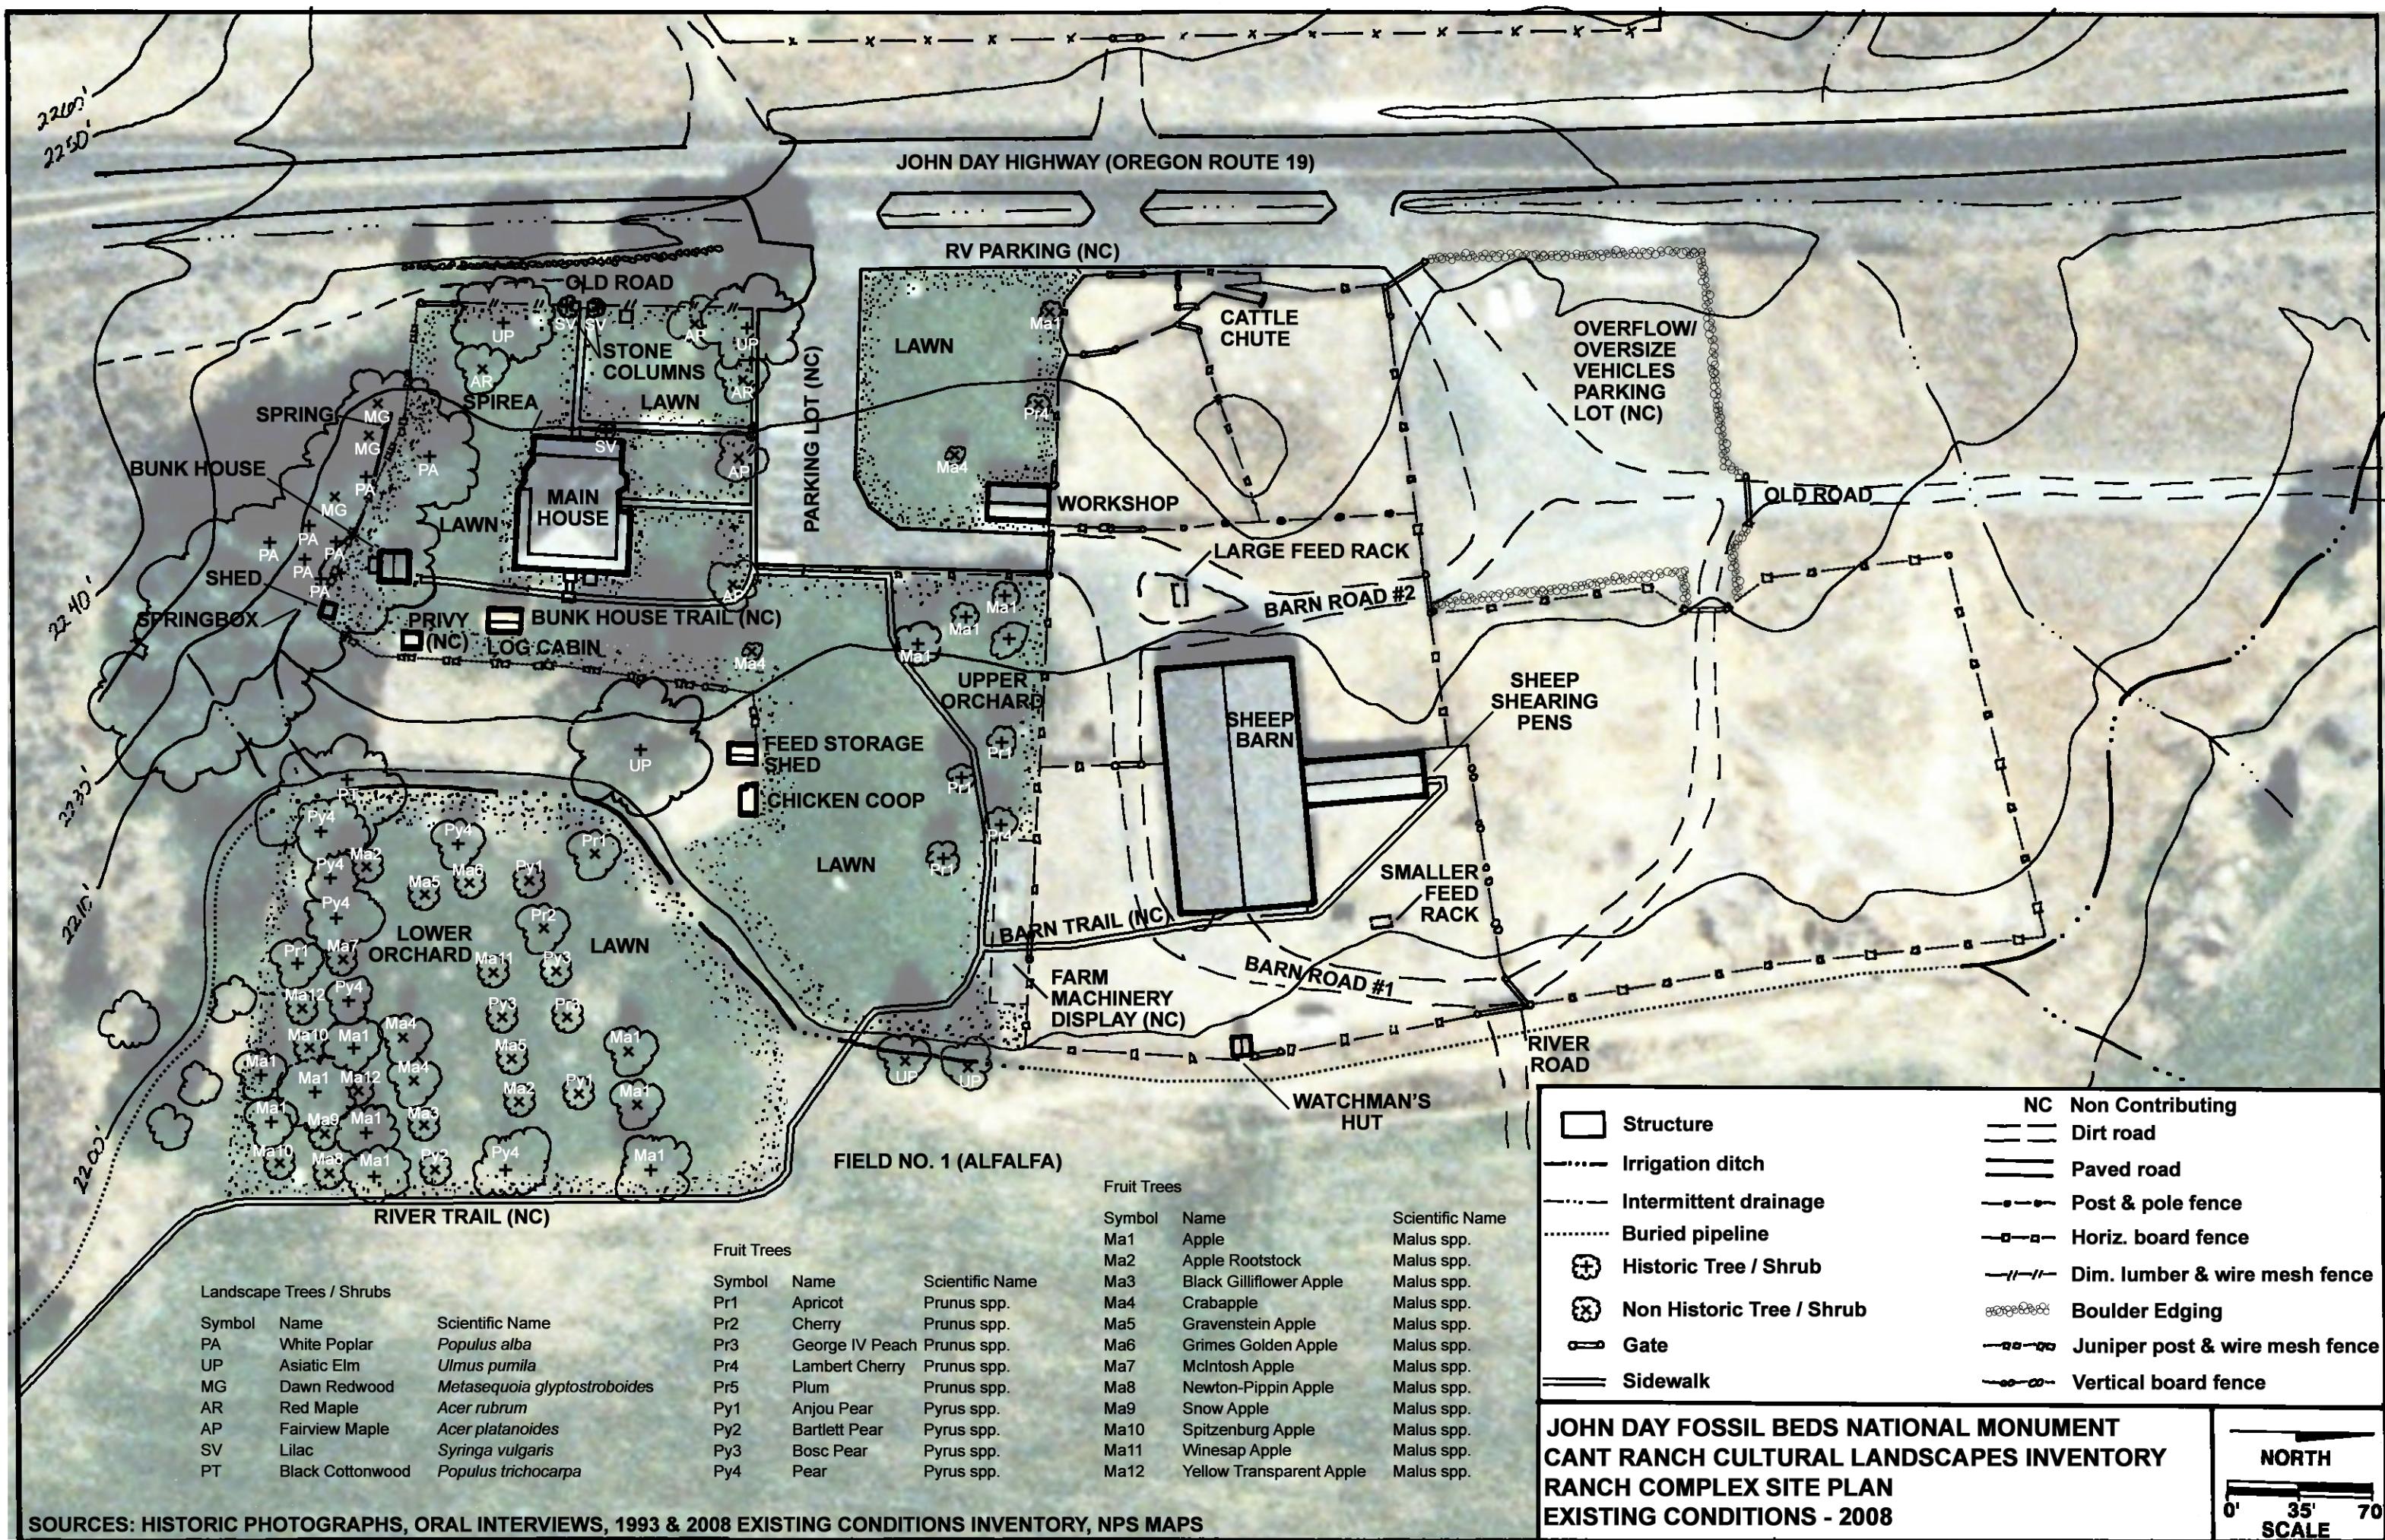
Description: A larger version of the Ranch Complex Site Plan is available from the JODA resource manager or the Pacific West Region's CLI coordinator.
