Kennesaw Mountain National Battlefield Park  
Georgia

# Signal Hill and Field Hospital at the Wallis Farm Cultural Landscape Report Environmental Assessment

November 2021

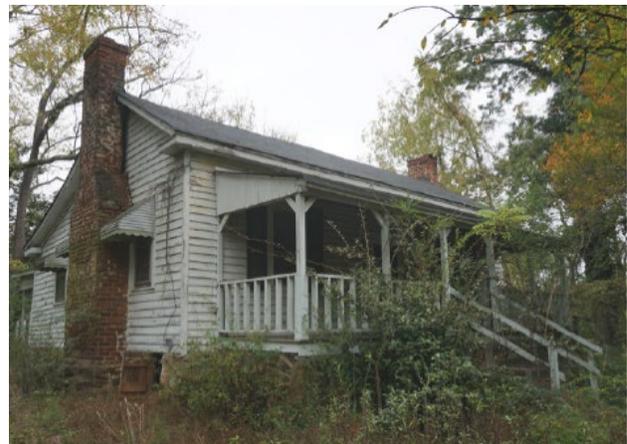
The Wallis House, looking northeast (QE 2021)

The Wallis House is a single-story, side-gabled frame dwelling with rear additions situated on a level knoll approximately 35 feet north of Burnt Hickory Road. The original portion of the house, likely constructed ca. 1853, consists of a center-hall plan with a symmetrical central front entryway flanked by equally sized rooms on the east and west. Two brick chimneys are located on the east and west sides of the structure. A porch with wood deck, oriented toward Burnt Hickory Road on the south side of the structure, shelters the front entry to the house. The residence sits on a mortared fieldstone foundation, is clad in white-painted weatherboard siding, and is topped with an asphalt shingle roof. Two shed-roofed rear additions and a gable-oriented porch are situated on the north end of the structure, and date to the late nineteenth or early twentieth century and the mid-twentieth century (CRA 2020).

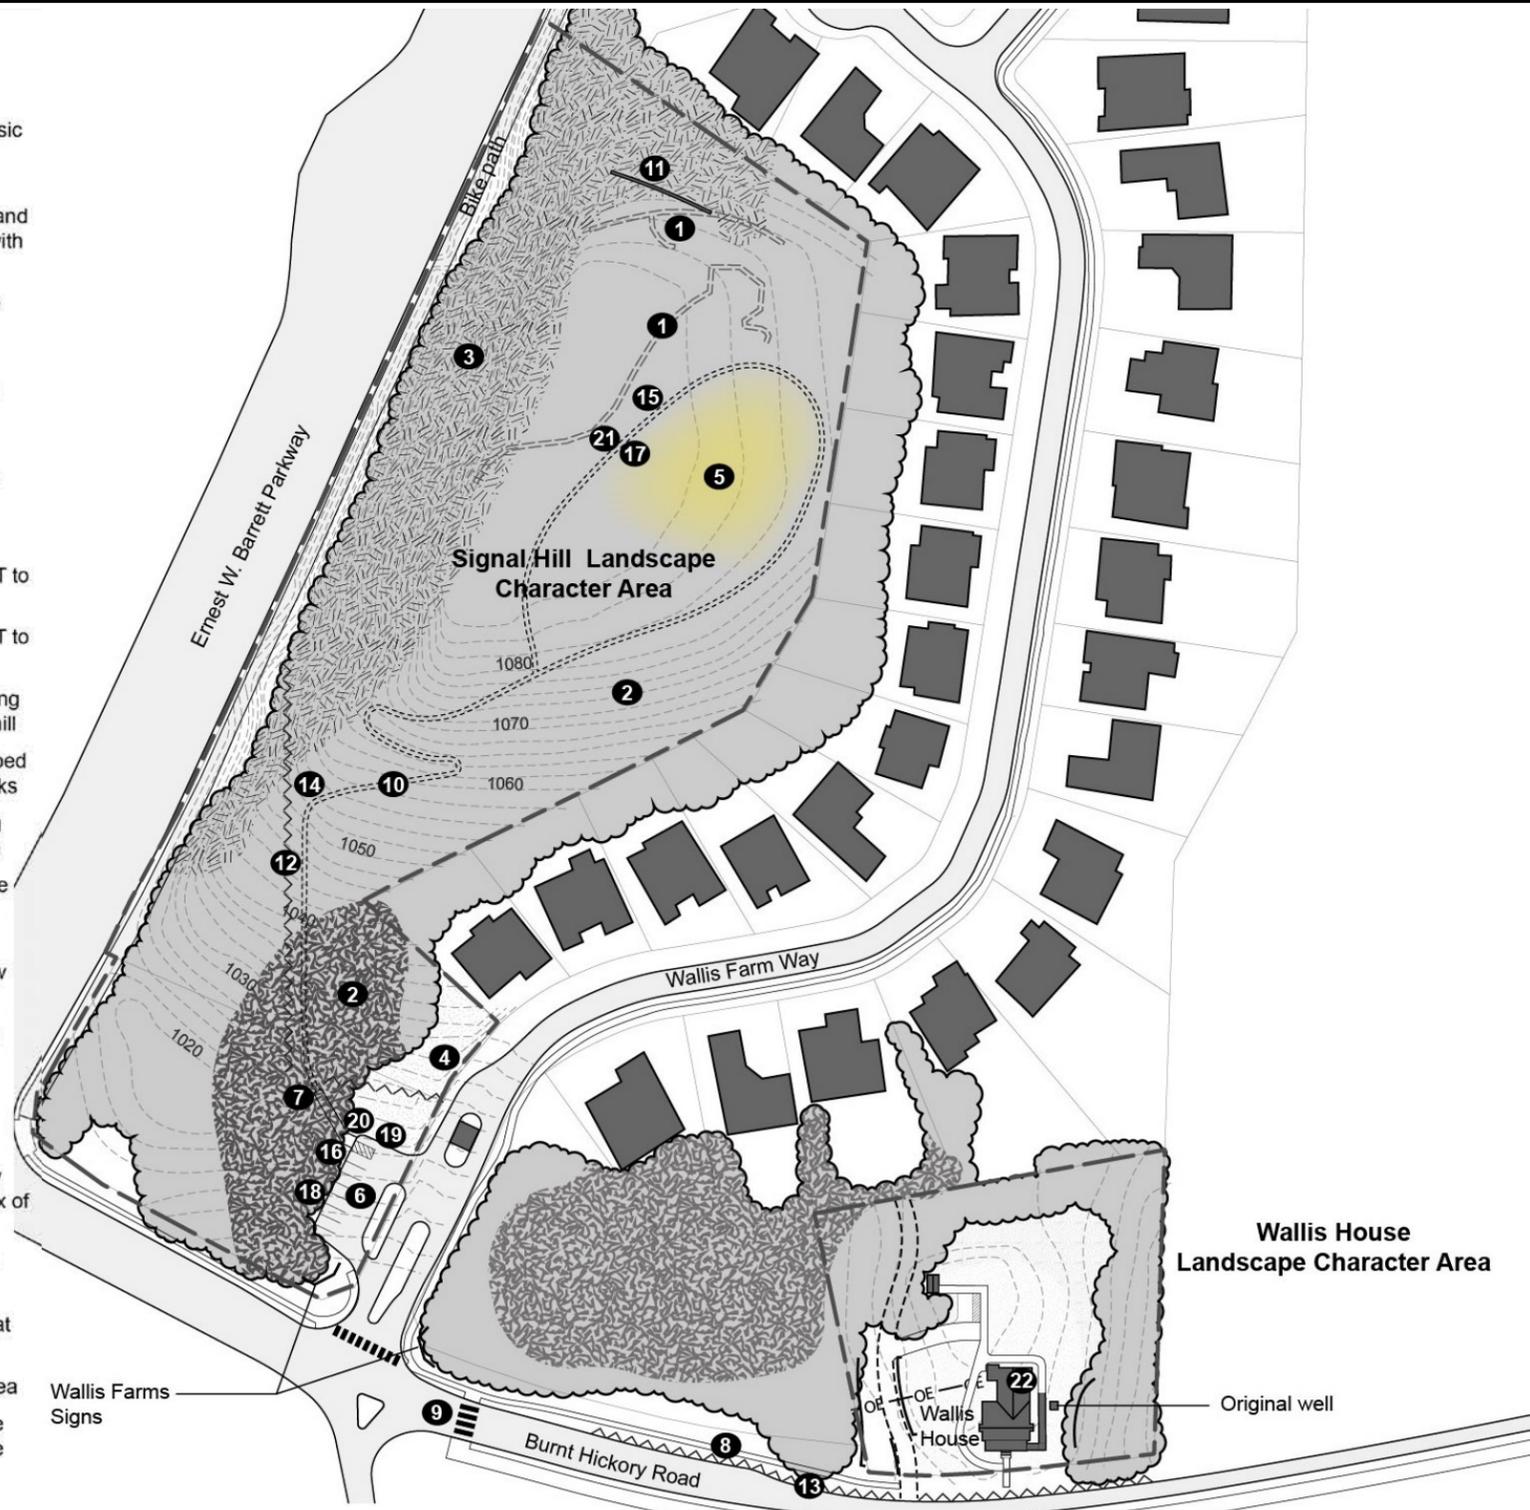
- 17 Install "See Something? Say Something!" wayside at apex of signal hill
- 18 Add NPS fee signage at the parking area
- 19 Add park identification sign at the parking area

- 20 Add bench at the parking area
- 21 Add bench along interpretive trail near the waysides at the apex of signal hill

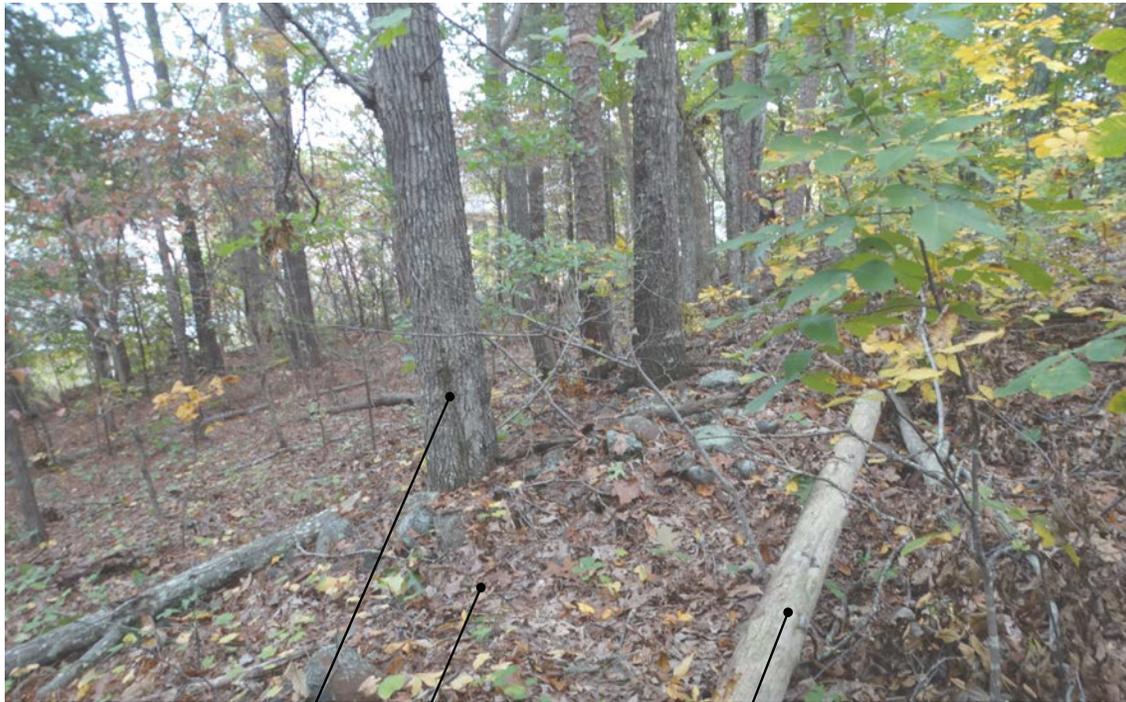
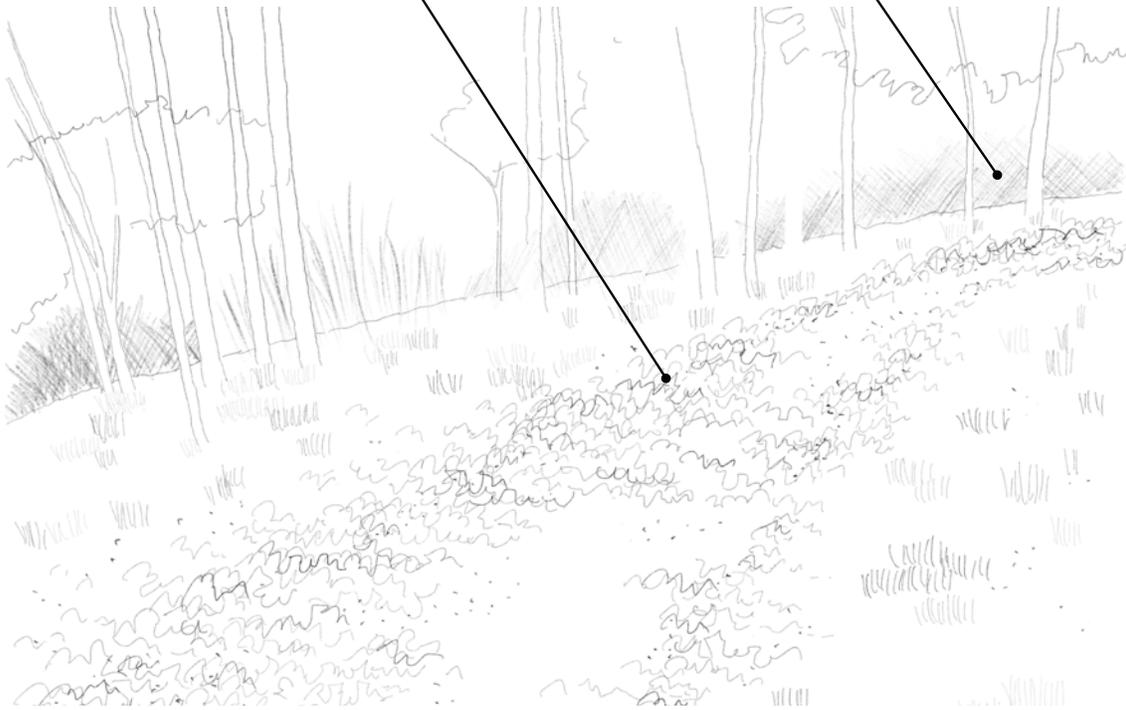
FIGURE 8  
Alternative 2: Proposed Action,  
Confederate Earthwork Remnants

Remove trees from slopes of earthwork

Maintain protective cover of leaf litter

Selectively clear underbrush to expand view along earthwork

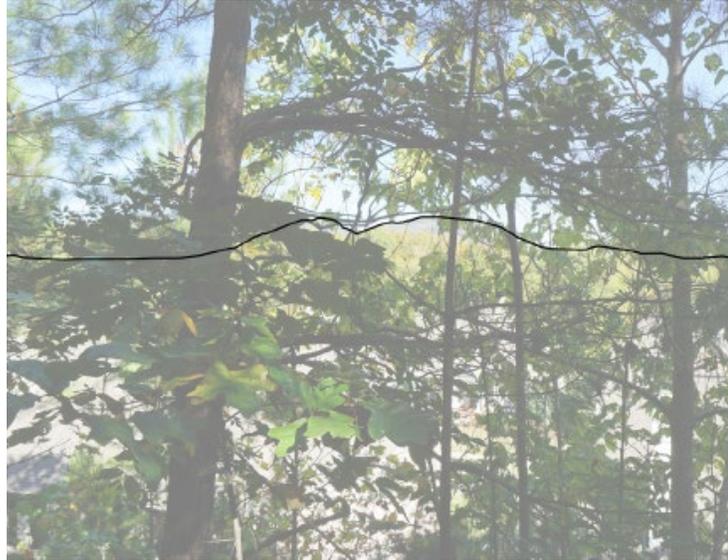
Existing view east from signal hill. The overlaid line identifies the approximate topography of Big and Little Kennesaw Mountains (QE 2021)

Other interpretive materials would be installed to highlight the view toward Big and Little Kennesaw Mountain, such as semi-transparent signage to convey the relationship between the historic viewshed and existing conditions. Additionally, the NPS would add interpretive messaging at Big Kennesaw Mountain or Pigeon Hill to interpret the view from those locations toward the signal hill.

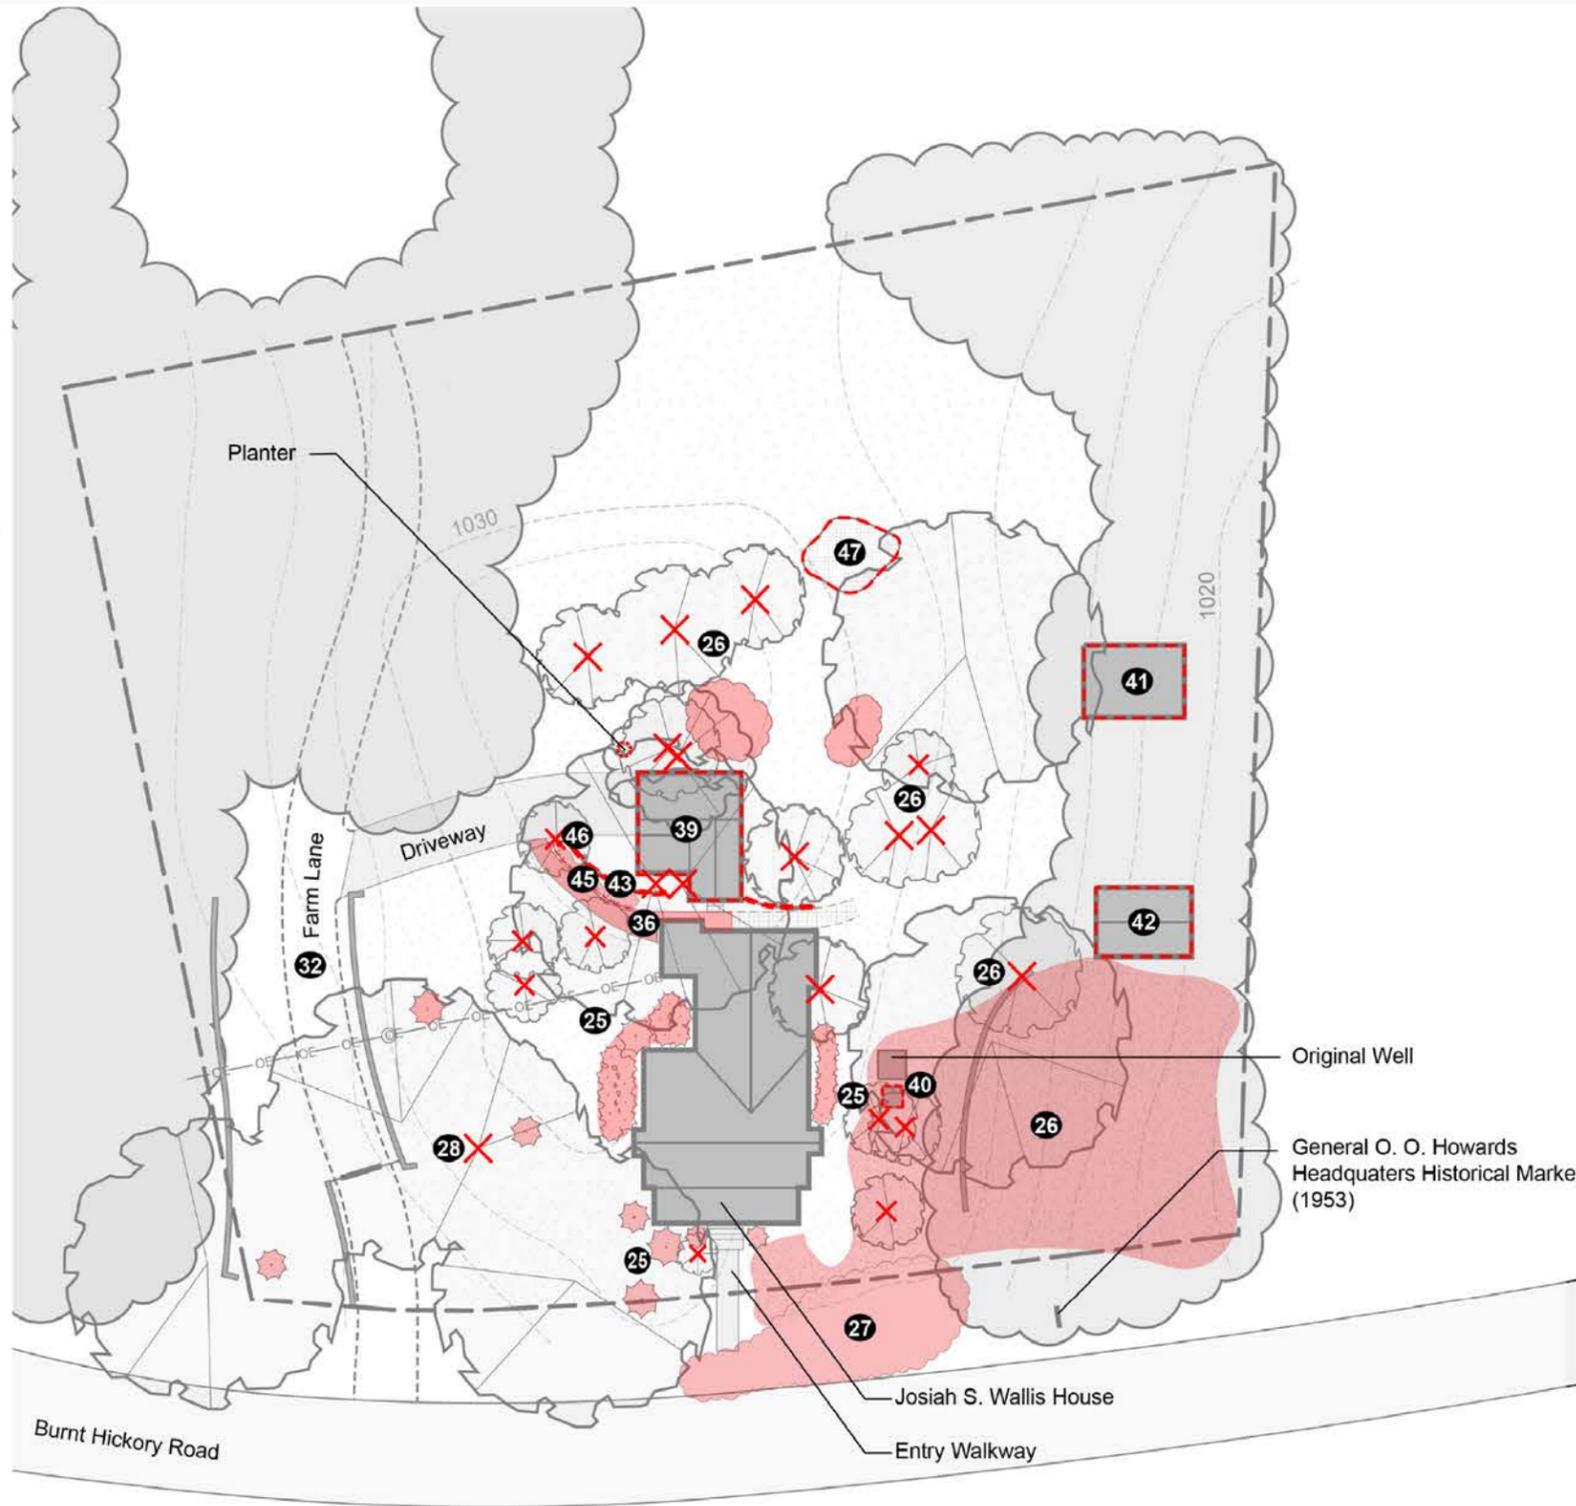
- 42 Remove non-contributing south chicken coop
- 43 Remove the non-contributing stone retaining walls between the Wallis House and smokehouse/garage
- 45 Remove non-contributing post-and-board fence

- 46 Remove non-contributing light post
- 47 Remove non-contributing debris pile

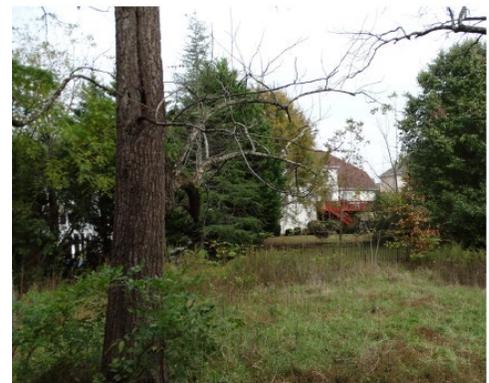
Obscured view from the Wallis House toward the signal hill (QE 2021)

Woodland vegetation obscures views from the Signal Hill Landscape Character Area. Adjacent homes are visible along the southeast and northeast edges of the property. Due to the elevation of the property above the Wallis Farms subdivision, portions of the surrounding rolling wooded landscape are visible from the signal hill. Of particular importance is the vista northeast from the signal hill. From this point, both Big and Little Kennesaw Mountains are partially visible through vegetative growth. Within the Wallis House Landscape Character Area, views are enclosed by dense vegetation on the east, south, and west sides of the property. To the north are partial views of the adjacent Wallis Farms subdivisions. See figure 16 for a graphic depiction of historic views both extant and lost within the project area.

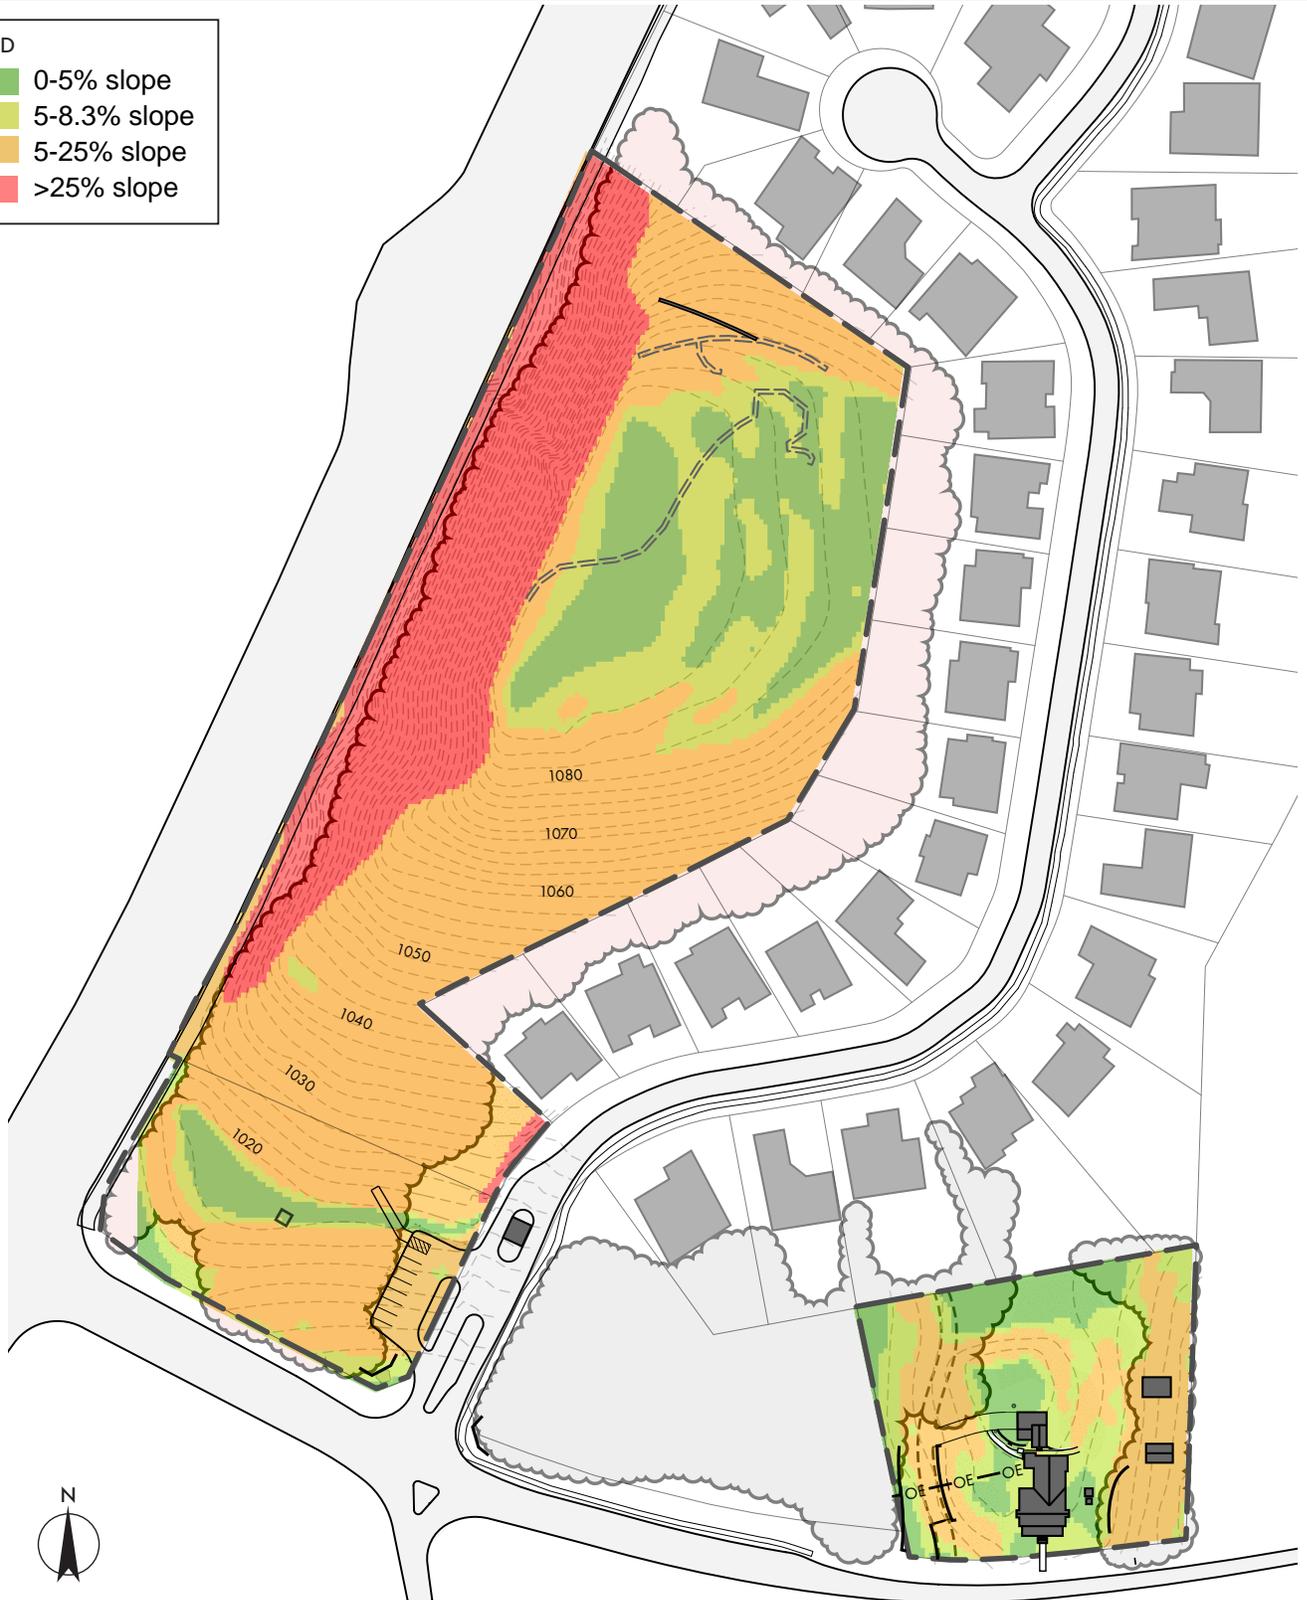
FIGURE 14  
Existing Conditions: Slopes

A range of slopes are present within the project area (see figure 14). Gentle slopes, below 8.3 percent, can be easily mown. These slopes are typically located at the top of the knoll surrounding the Wallis House and at the southern end of the hill to the west of the house. Moderate slopes are identified as those between 8.3 and 25 percent. Moderate slopes typically occur on the north, east, and south sides of the signal hill, and at lower elevations near the base of the hill. Steep slopes greater than 25 percent are located along the west side of the hill and are vulnerable to erosion and sloughing. Erosion is also evident at the base of the hill to the west of the parking lot where runoff water has carved stream channels into the landscape.

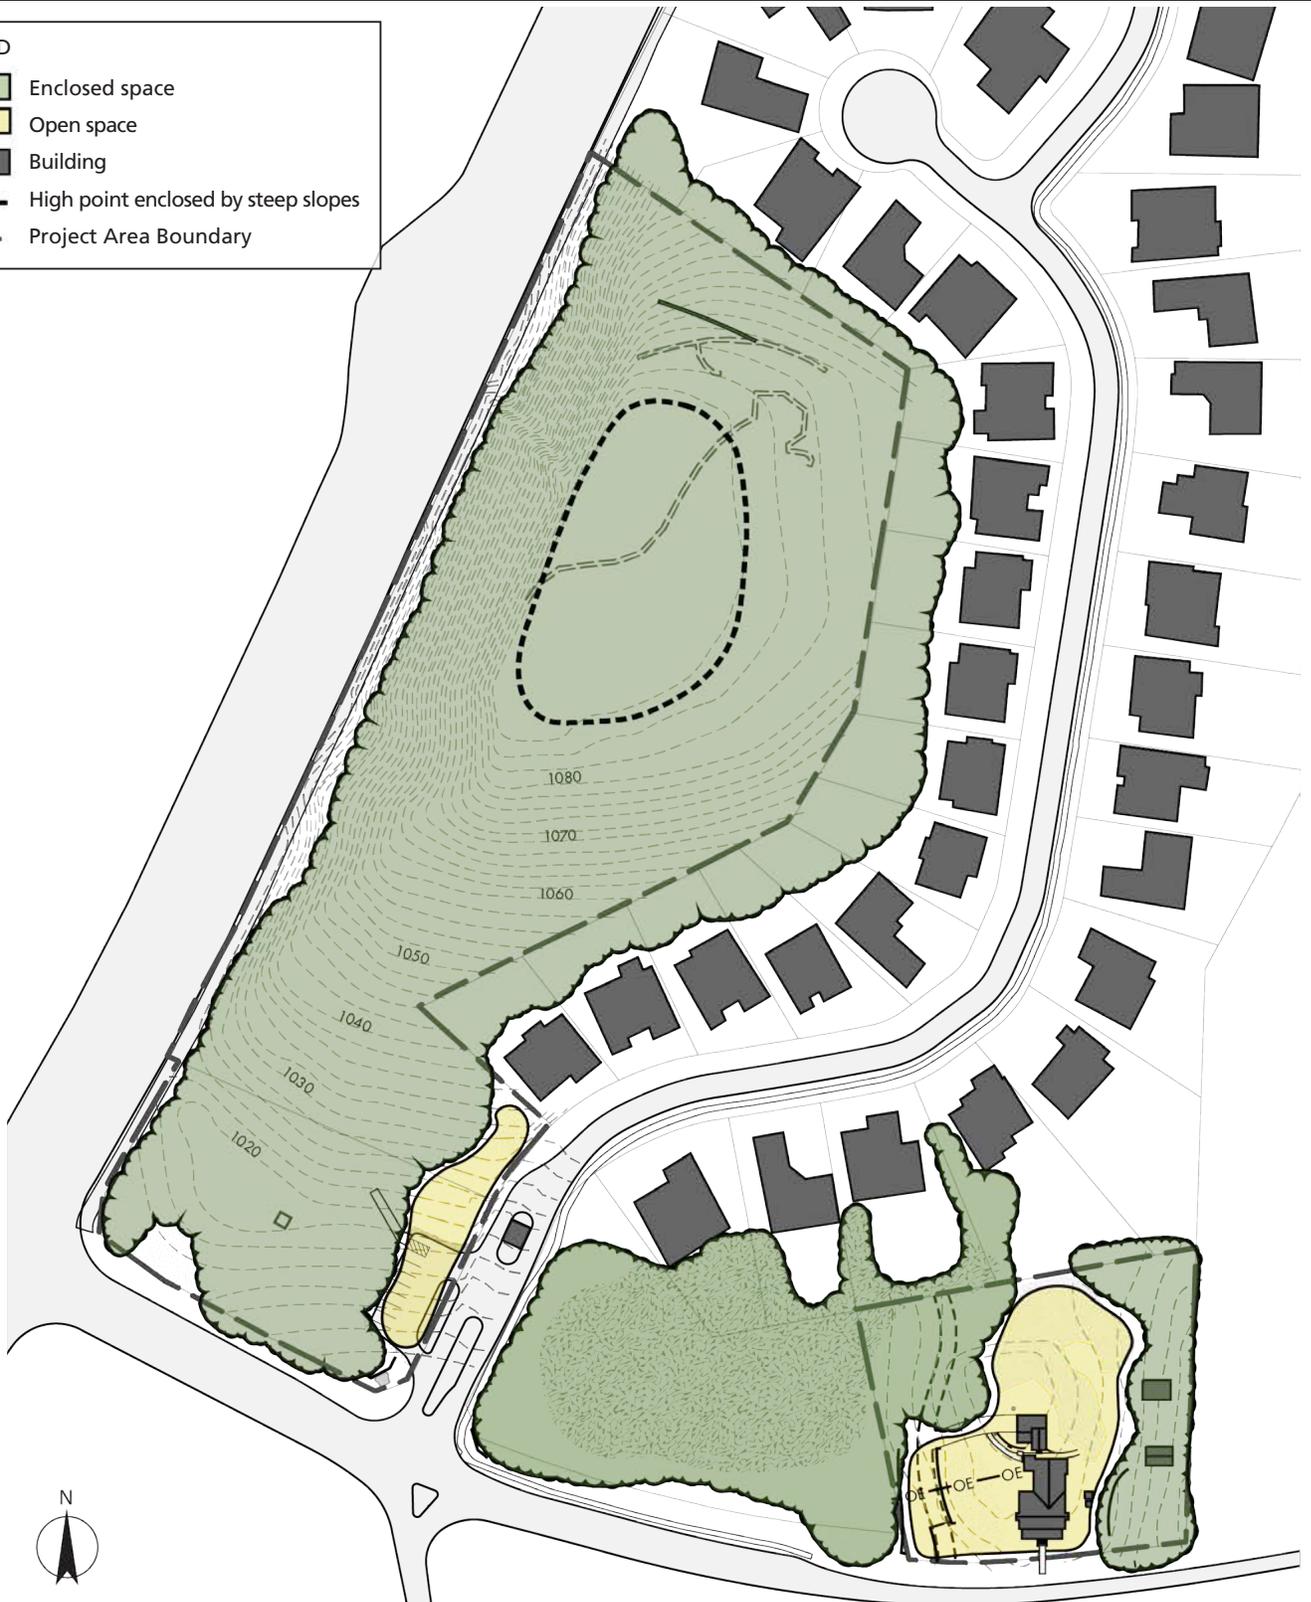
FIGURE 15  
Existing Conditions: Spatial Organization

Spatial organization of the Signal Hill Landscape Character Area is dominated by a large hill sloping down on all sides from its high point in the north-central portion of the parcel (see figure 15). The top of the hill is relatively flat and enclosed by the surrounding steep topography. The site is almost entirely forested except for a small parking area located at the southeast corner of the site accessed from Wallis Farm Way and a mown retention pond located near the southwest corner of the site. Remnants of Confederate earthworks are arranged in two lines along the north and west aspects of the hill, near its apex. Although the dense woodland vegetation spatially separates the interior of the landscape character area from surrounding suburban development, traffic noise from Ernest W. Barrett Parkway is prevalent along the western side of the property.

Spatial organization of the Wallis House Landscape Character Area is centered around the Wallis House, which is situated near the center of the parcel on a low knoll (see figure 15). The house is part of a cluster of buildings that includes the smokehouse/garage, the original well, the well house, and two chicken coops. The parcel is accessed on its west side where a gravel-paved farm lane enters the property. Woodland vegetation encloses the east and west sides of the knoll, surrounding a clearing that extends from the Wallis House to the northern end of the parcel. Ornamental domestic plantings concentrated along the southern side of the parcel spatially separate the Wallis House and outbuildings from the road, although road noise is still noticeable within the interior portions of the small site.

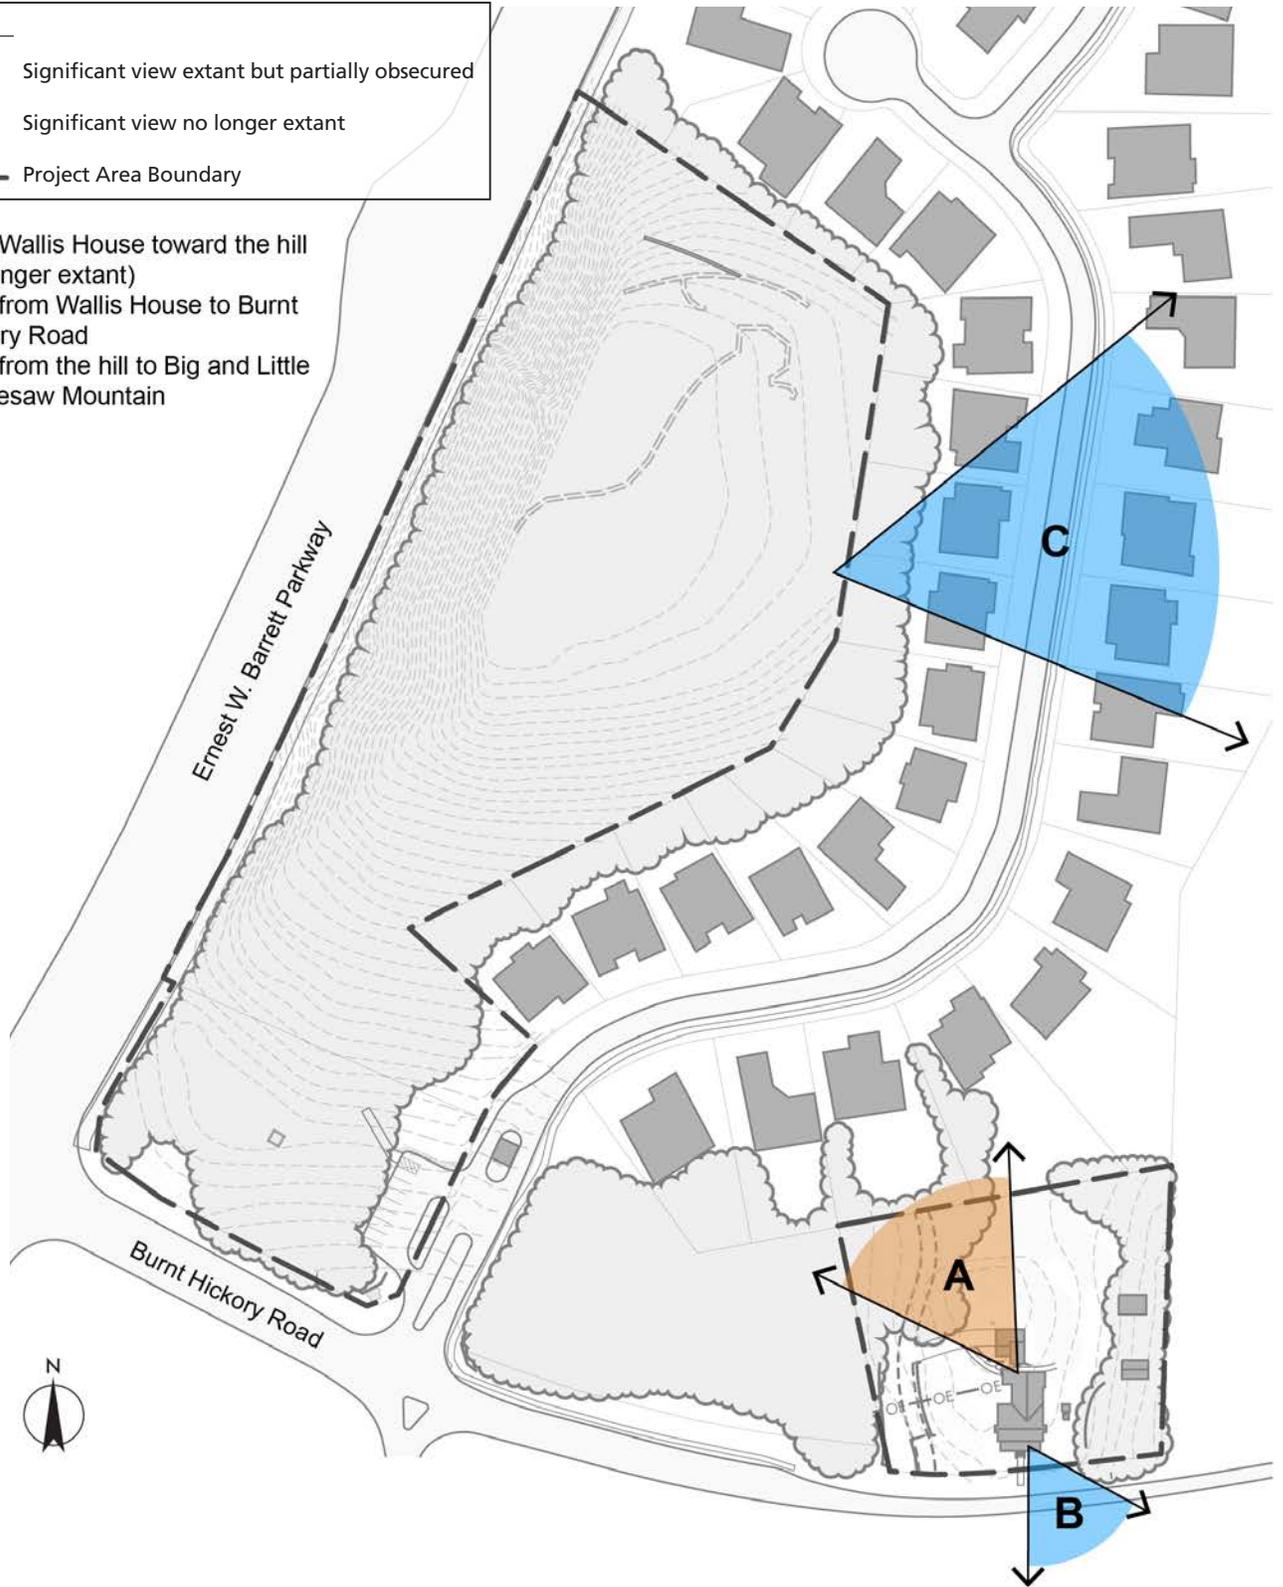
FIGURE 16  
Existing Conditions: Historic Views

- A** View Wallis House toward the hill (no longer extant)
- B** View from Wallis House to Burnt Hickory Road
- C** View from the hill to Big and Little Kennesaw Mountain

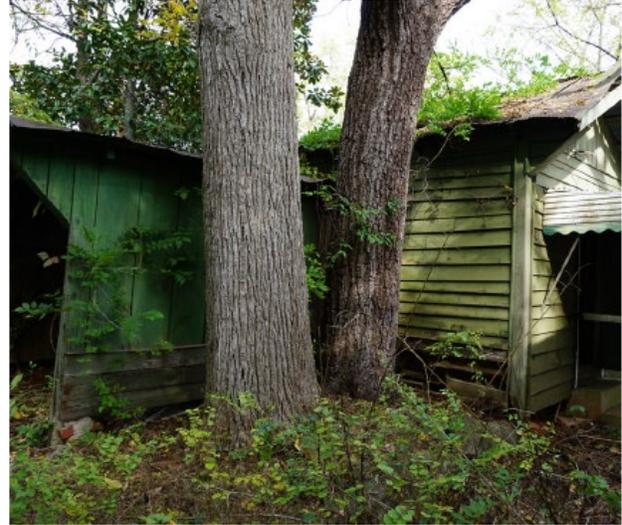
Hazard walnut and elm trees adjacent to the smokehouse (QE 2021)

Individual trees identified as hazards to buildings, structures, or other historic resources are also noted within the Wallis House Landscape Character Area. A walnut tree is located immediately adjacent to the southwest corner of the smokehouse/garage, with branches extending over the building. An elm is located south of the west addition to the smokehouse/garage, approximately 2 feet west of the walnut tree. The trunk is located adjacent to the building foundation, and branches extend over the structure. A large post oak is growing within the retaining wall at the west side of the farm lane. Dead and live branches extend over the utility line. One branch of an elm tree to the west of the Wallis House extends over the west chimney. Roots of an elm are located immediately adjacent to the foundation of the Wallis House at its northeast

corner. A dogwood to the south of the well house and original well has dead branches extending over the structures. The tree is overgrown with poison ivy and leaning to the north. An elm located to the south of the well house and original well is topped and has the potential to impact the adjacent structures. A poor condition dogwood is growing from the retaining wall to the east of the Wallis House. A large red oak (*Quercus rubra*) to the southeast of the Wallis House is in poor condition. Branches are damaged, the tree is overgrown with ivy, and the tree exhibits evidence of a hollow trunk. A large post oak to the west of the farm lane has a large scar and rot on the north side of the trunk and is growing with poison ivy. Volunteer magnolia and walnut trees are impacting the north side of the smokehouse/garage.

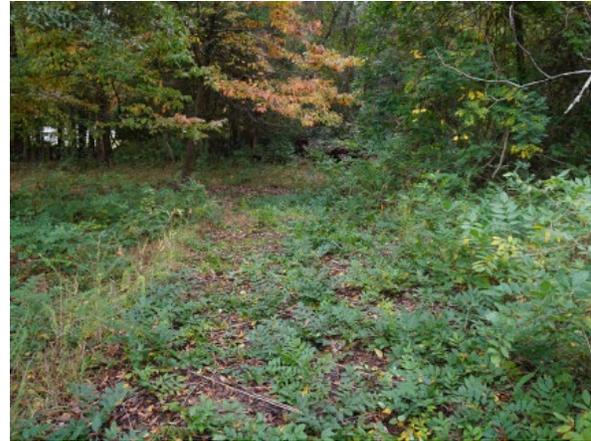
Concrete driveway overgrown with vegetation  
(QE 2021)

Approximately 80 feet north of the Wallis House Landscape Character Area parcel boundary, a concrete driveway extends east from the farm lane to the garage. The concrete driveway is approximately 60 feet long, and measures between 13 feet 10 inches and 10 feet 2 inches wide. Extensive cracking, spalling, and vegetative growth are present on the concrete driveway, which is in poor condition.

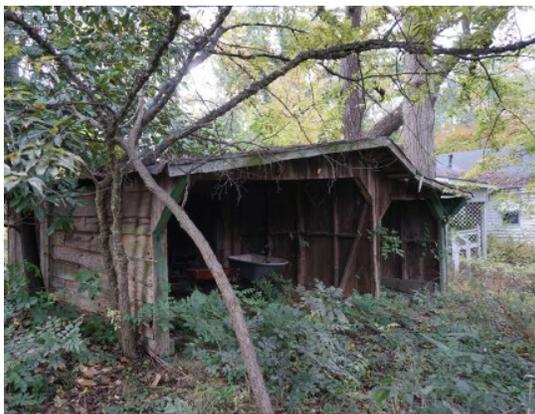
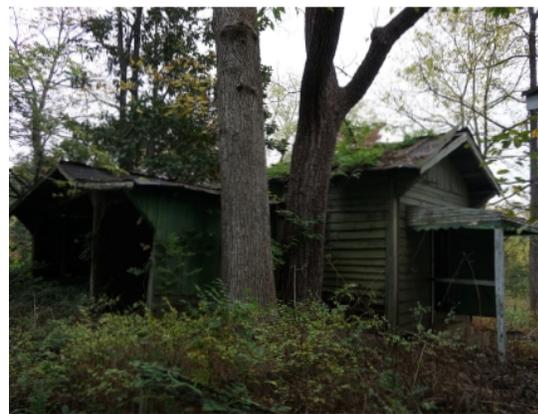
Views of the smokehouse/garage (QE 2021)

*Smokehouse/Garage.* The smokehouse/garage is located approximately 10 feet north of the Wallis House. The structure incorporates a single-story front gable frame portion on the south side, a single-story shed-roof carport spanning the rear (north) elevation, and a smaller shed roof frame carport located on the west side of the structure at the terminus of the driveway. The smokehouse is set on a stone pier foundation, clad in weatherboard siding, and topped by a corrugated metal roof (CRA 2020). The entrance to the gabled portion of the structure is accessed by two concrete steps; entrances to the carports are on grade. The smokehouse is in poor condition due to deterioration of the envelope and the presence of hazard trees in close proximity to the structure.

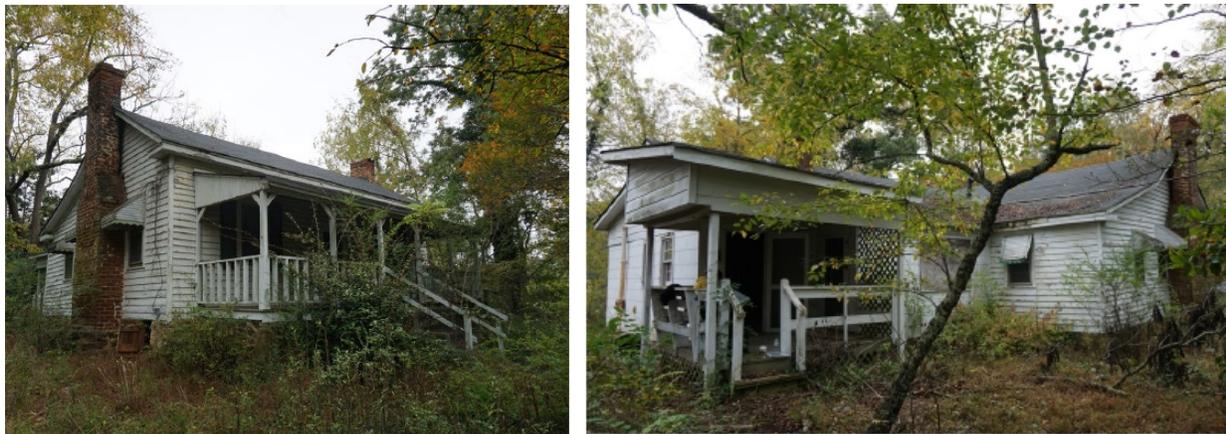
Views of the Wallis House front (left) and rear (right) (QE 2021)

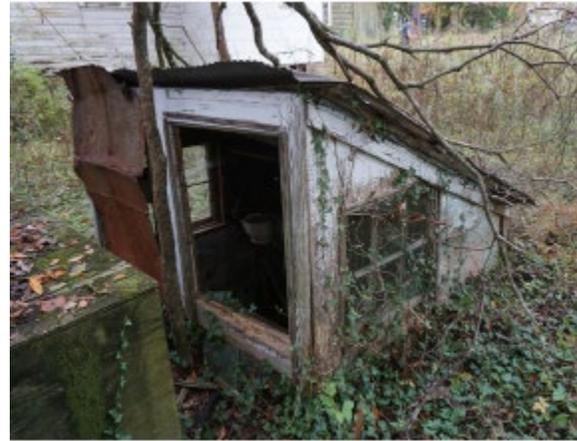
View of original well (QE 2021)

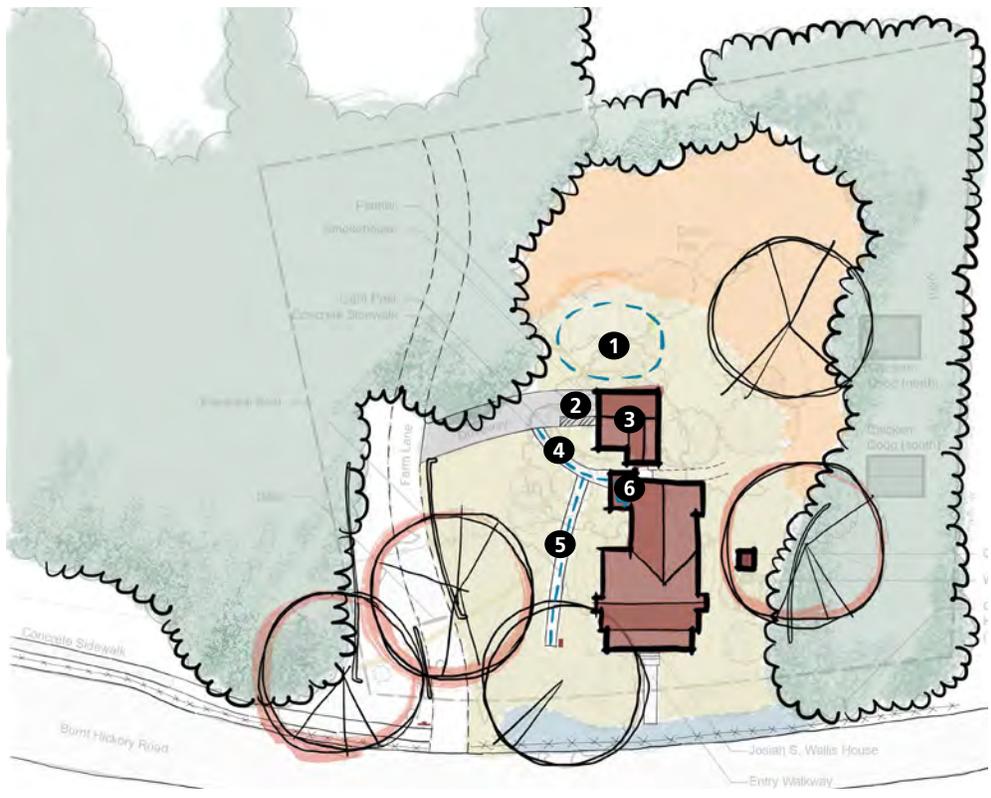
- 1 Outdoor education space
- 2 Parking at existing driveway
- 3 Smokehouse/ garage converted to comfort station
- 4 Repaired existing sidewalk
- 5 New accessible walkway
- 6 Accessible entrance to Wallis House

**Option 1** recommends renovating the existing smokehouse/garage as a comfort station. In this option, the east end of the existing driveway would provide an accessible parking space, and existing walkways north of the house would be repaired to provide universal access to the site and into the north (rear) portion of the house. A new accessible walkway would extend along the west side of the house to the "Homestead, Hospital, Headquarters" wayside.

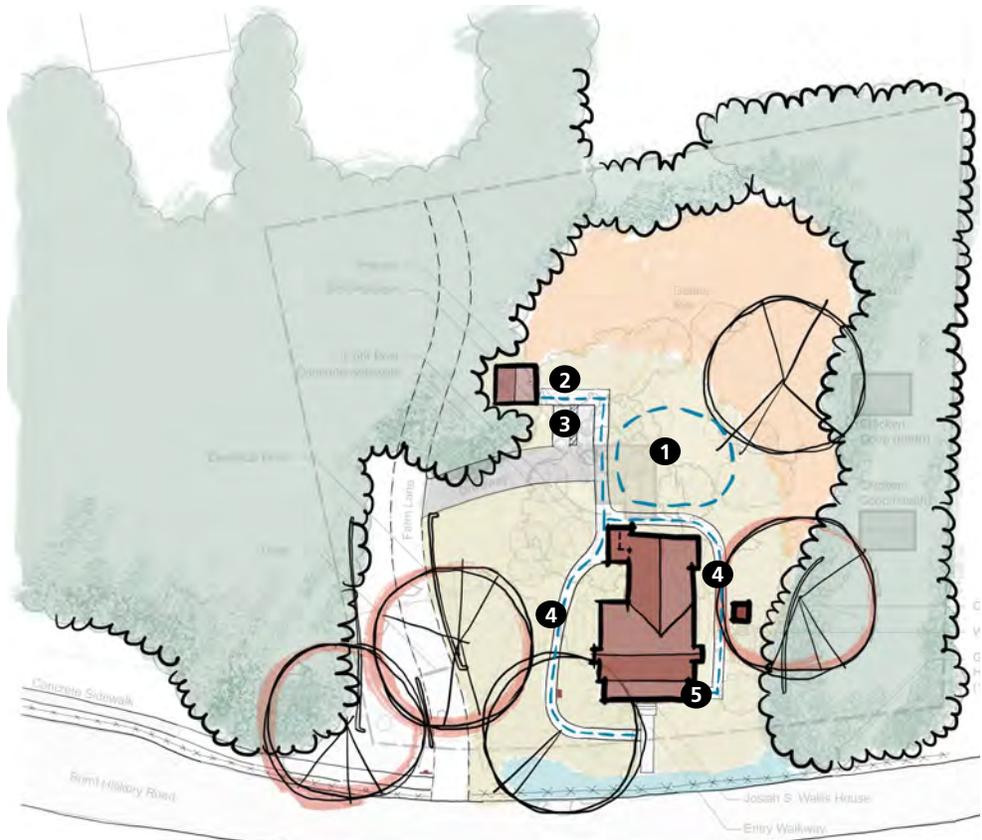
- 1 Outdoor education space
- 2 New comfort station
- 3 New accessible parking space
- 4 New accessible loop walkway
- 5 Outdoor lift to Wallis House front porch

**Option 2** recommends constructing a new comfort station northwest of the house. An accessible parking space would be provided on the north side of the existing driveway. New accessible walkways would form a loop around the exterior of the Wallis House, and a lift would connect to the east side of the front porch, on the opposite side of the structure from the primary view of the house.
