The Union Building: History and Architecture

Keweenaw National
Historical Park

Introduction

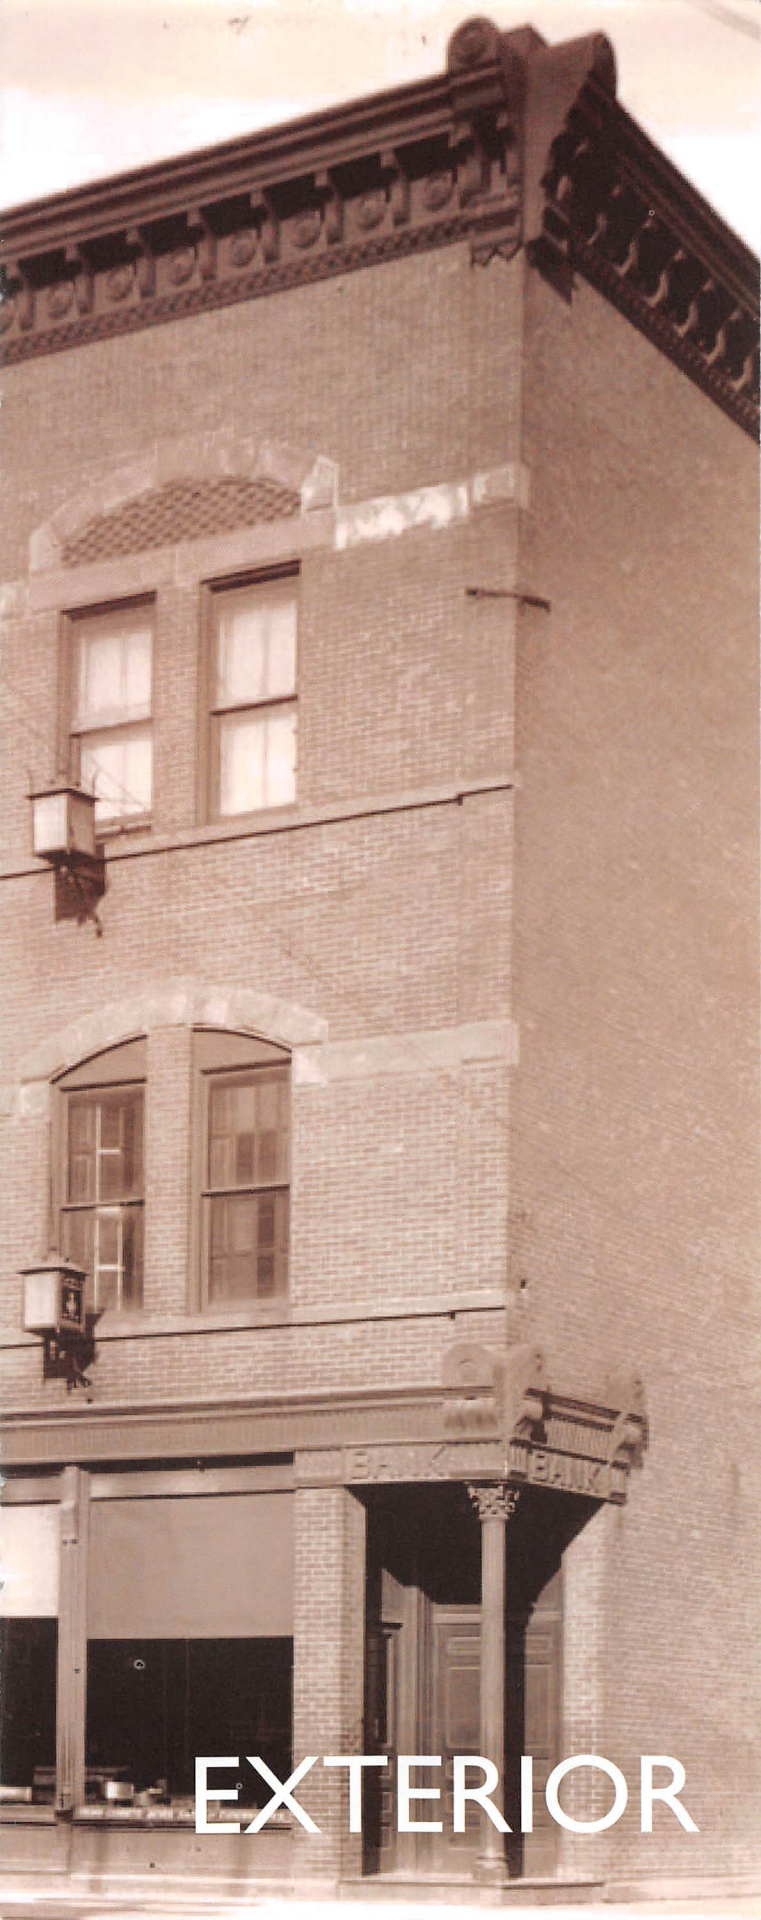
Cornice

A pressed metal cornice caps the top of the Union Building's brick masonry wall on the south and west facades. It is attached to a wood frame, serves to protect the top of the wall, and adds architectural distinction to the building's exterior. At the time of the building's construction in 1889, pressed metal cornices could be ordered from a catalog, and because they were shipped and installed in pieces, they were an affordable alternative to the wood or stone which they were intended to simulate. When the NPS acquired the building in 1998, the south cornice was in disrepair and the west cornice had been completely removed. As part of the 2005 exterior rehabilitation, the existing cornice was restored and repainted, and a new cornice was installed on top of the west façade. The reproduction was based on an analysis of historic photographs and molds made from the existing cornice's brackets and rosettes.

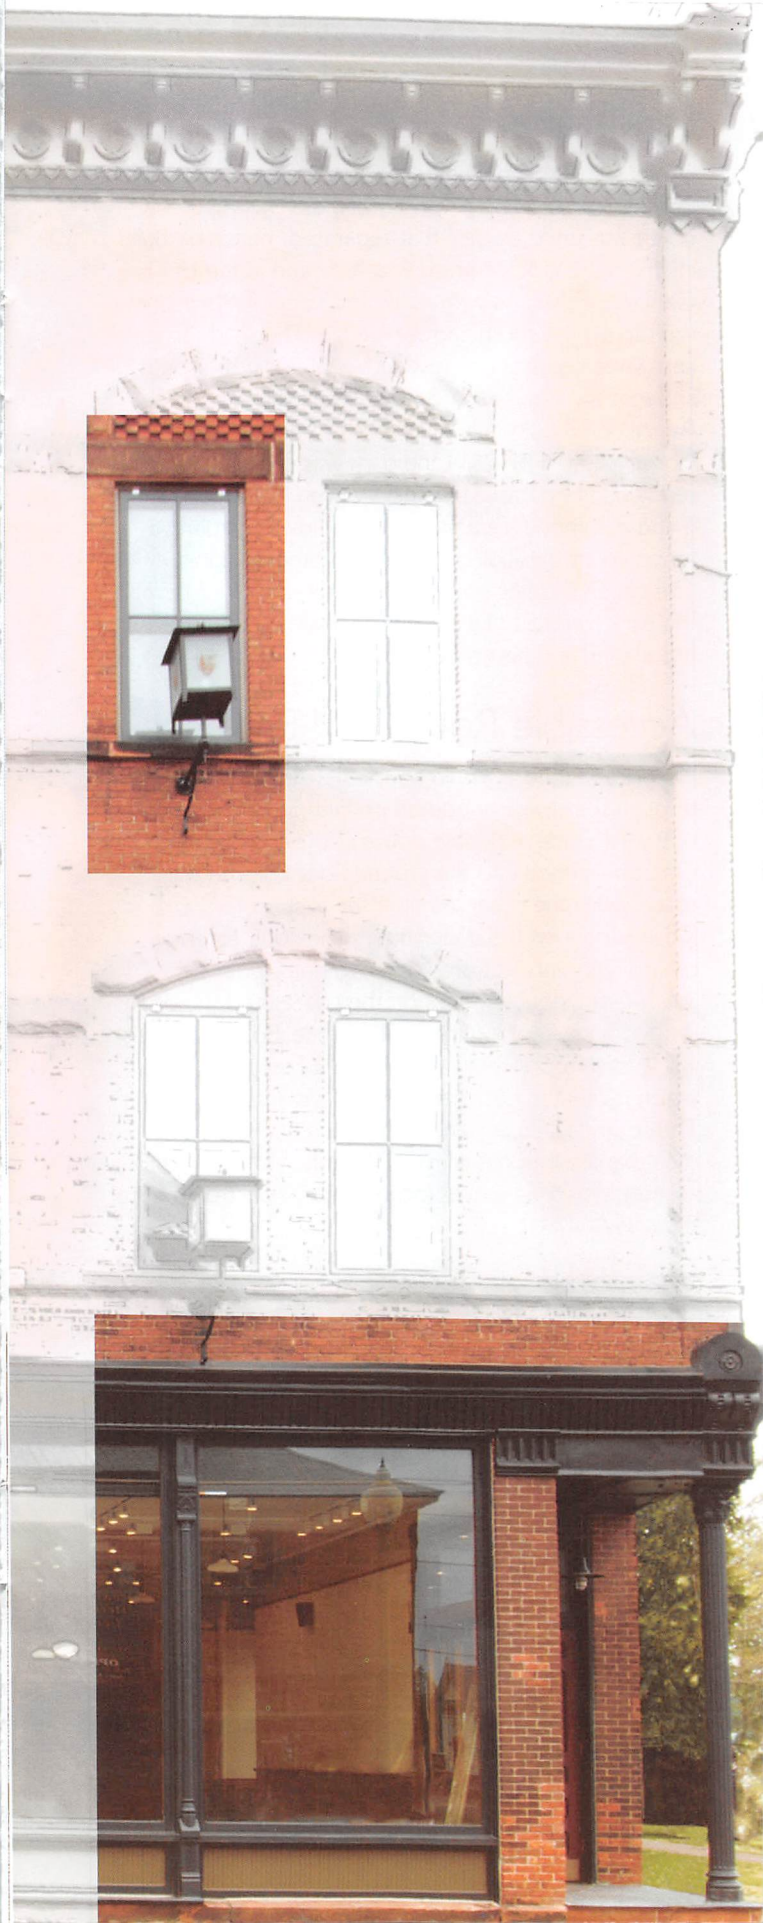
Cast Iron Storefront

In addition to the large expanse of plate glass and wood framing, the Union Building's storefront is characterized by its cast iron columns and entrance platforms. Similar to pressed metal building parts, these components could be ordered from a catalog, and came in a variety of sizes, styles, and configurations. Note that the columns on the two storefronts have an identical arrangement and spacing, with the exception that the south storefront does not incorporate a recessed entrance. Rather, the south commercial space is entered at the corner which is supported by a free-standing cast iron column with flutes and a Corinthian capital.

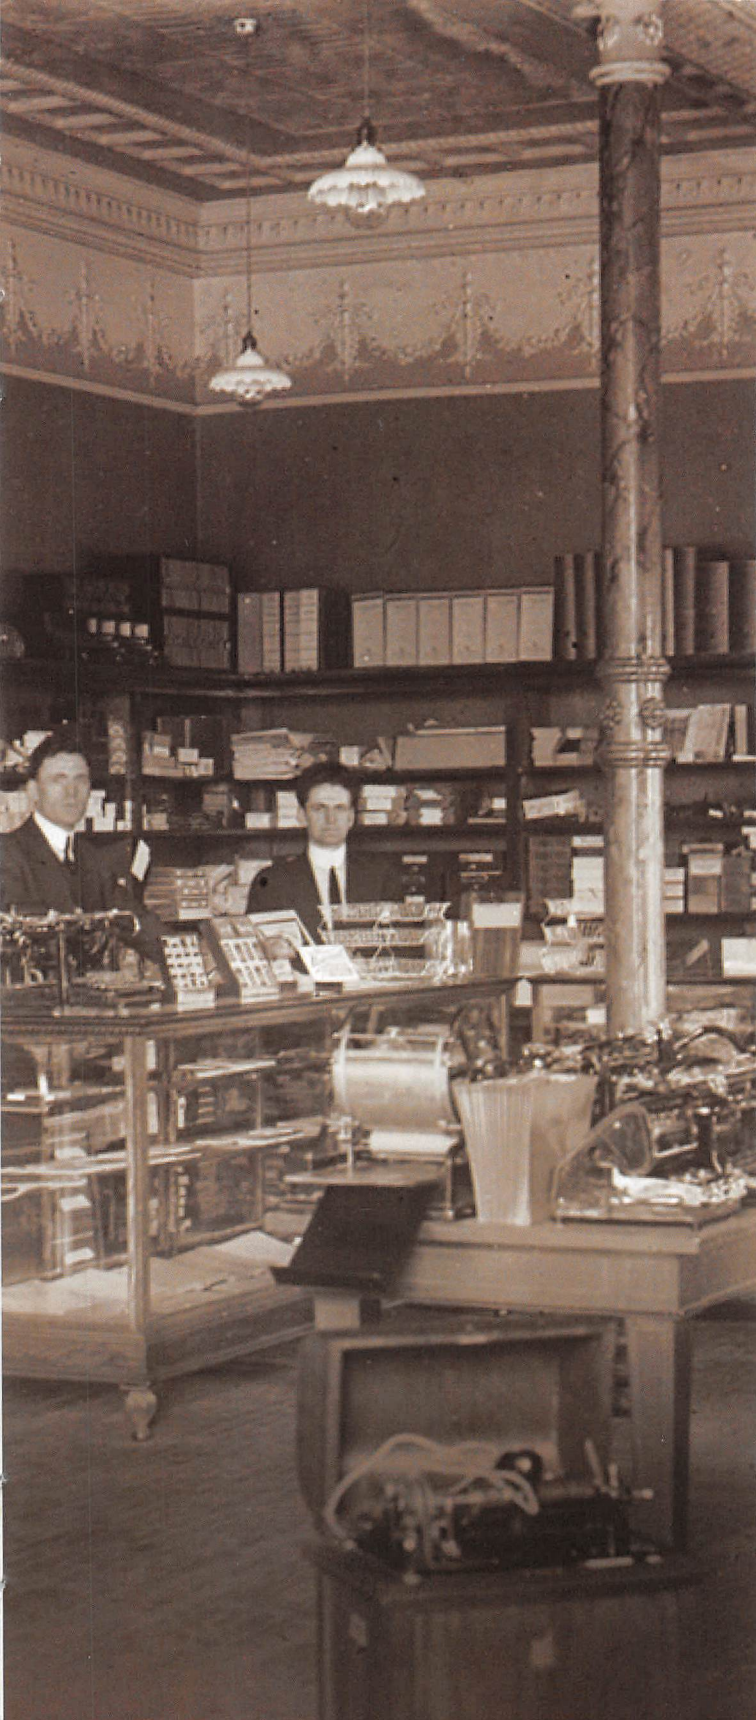
FIRST FLOOR

- 1 South storefront pressed metal ceiling
- 2 Faux marble painting on iron column
- 3 Floor tile
- 4 Lincrusta border and pressed metal cornice and ceiling
- 5 New and modified interior wall openings
- 6 Parquet floor
- 7 Light fixtures
- 8 Elevator and second stair

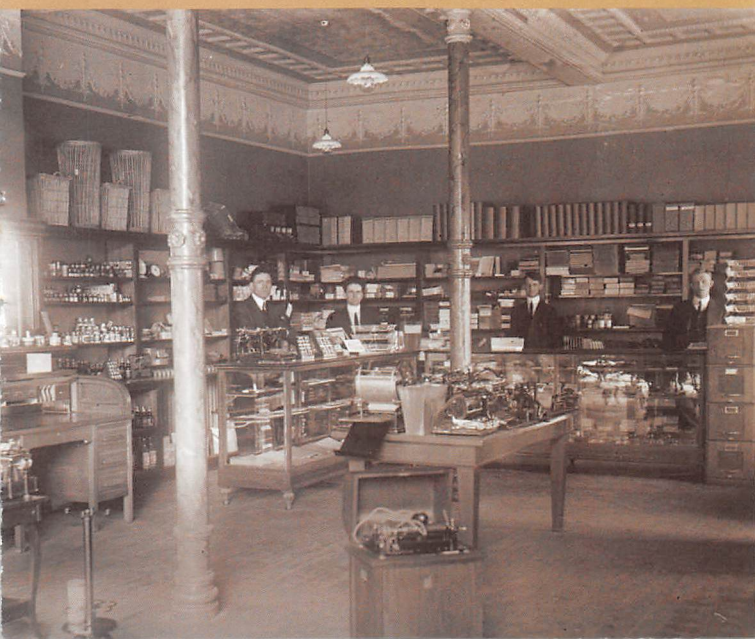
South storefront pressed metal ceiling

The ceiling in the South Storefront is covered in interlocking pressed metal panels. At the time of the Union Building's construction, manufacturers produced pressed metal ceilings in a variety of patterns and designs. The pressed metal ceiling complemented the paneled oak wainscot to create a higher level of finish as befitting a bank interior.

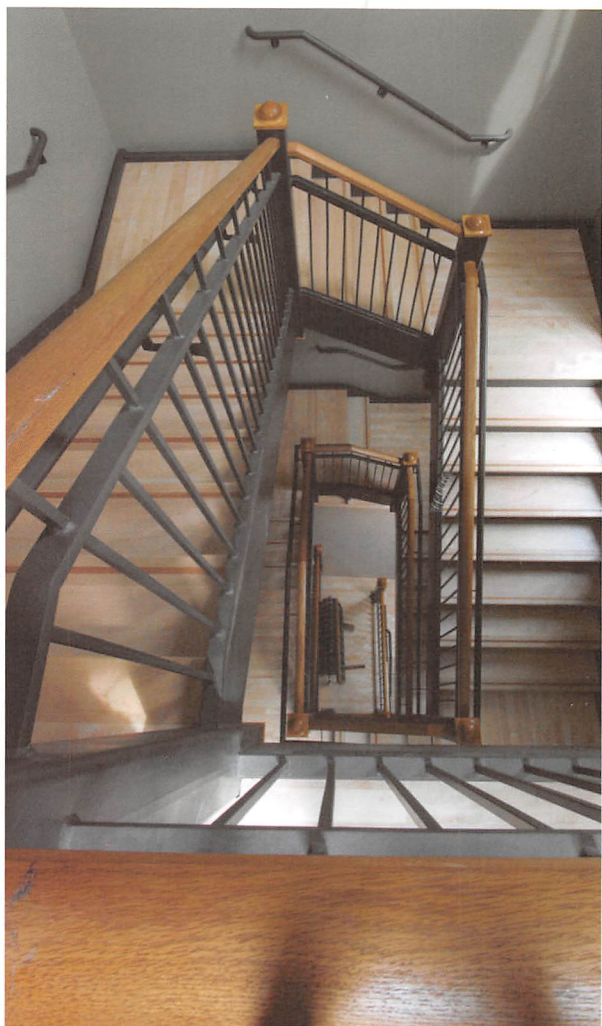
Elevator and second stair

During the interior rehabilitation, the most significant alteration was the installation of an elevator and second stair for improved access and egress. Floor joists and partition walls were removed, and the Union Building's southeast corner was reconfigured to provide vertical circulation, connecting all levels. This change was made only after analyzing conceptual alternatives that included, among others, an exterior building addition. In the end, it was decided that the most efficient and cost effective approach involved consolidating these new features within the building footprint. On the first floor, the space now occupied by the elevator and new stair had at one time served as an art gallery and later a work shop for the Keweenaw Printing Company. Directly above, the second and third floor each had a small kitchen that served lodge hall gatherings.

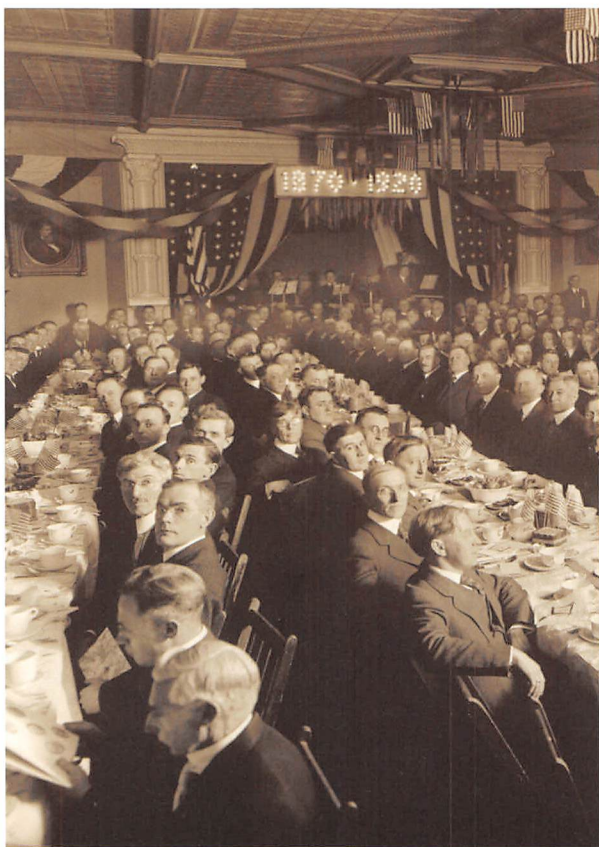
Stage

Drama appears to have been the primary consideration when the Masons' lodge hall was modified to include a full theatrical stage, complete with an elevated platform, footlights, overhead stage rigging, backstage area, and decorative proscenium and backdrop. Unfortunately, the historic stage was situated directly under the failed roof and incurred significant damage before the building was acquired by the NPS. By then, the stage floor was buckled and rotted, the ceiling had collapsed, and mold had worked its way up the stage backdrop. The interior rehabilitation included a complete reconstruction of the stage platform and walls and incorporated a new stair and platform lift for stage access. The backdrop and proscenium that featured Classical and Babylonian designs has been recreated and printed on durable wall panels. Some elements, such as stage rigging and footlights, were not recreated, but the original components have been accessioned into the park's museum collection and saved as a record of the stage's early use.
