The Union Building Historic Structure Report (Draft)

Part 1: Developmental History

April 2002

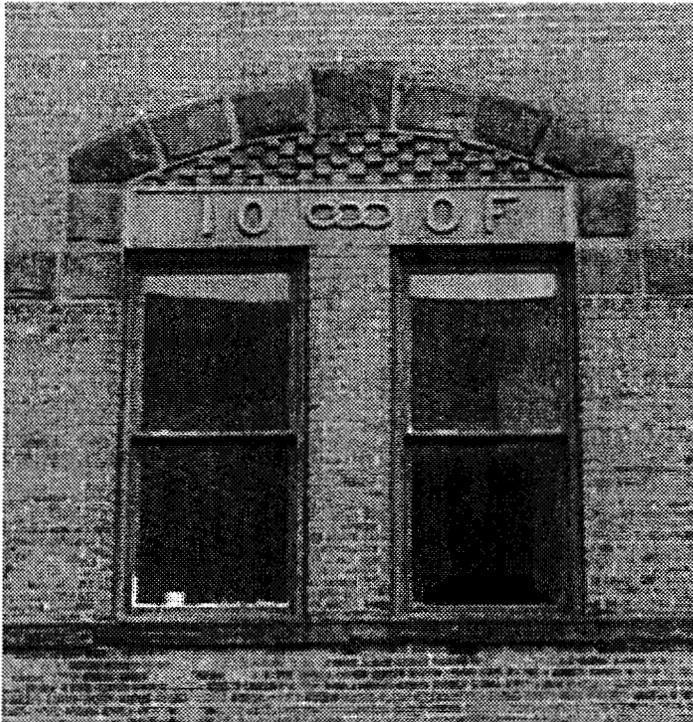
The second floor of the building was designed as a lodge for the Independent Order of Odd Fellows, Hecla Lodge, No. 91. The insignia of the group appears on a terra cotta plaque above the center windows on the building's second story. NPS Photo.

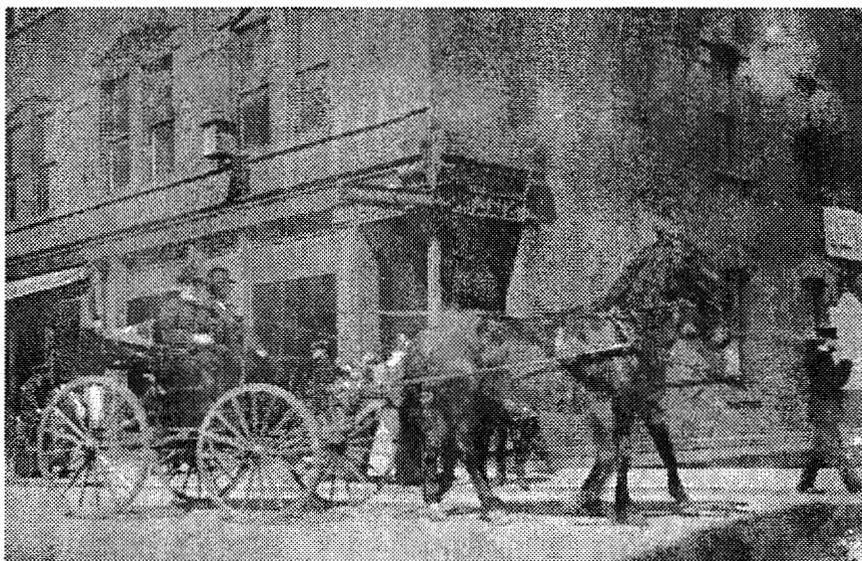
View of the southwestern corner of the Union Building while the Merchants and Miners Bank occupied the commercial storefront. The bank, the building's first commercial tenant, moved to a new location on Fifth Street in 1907.

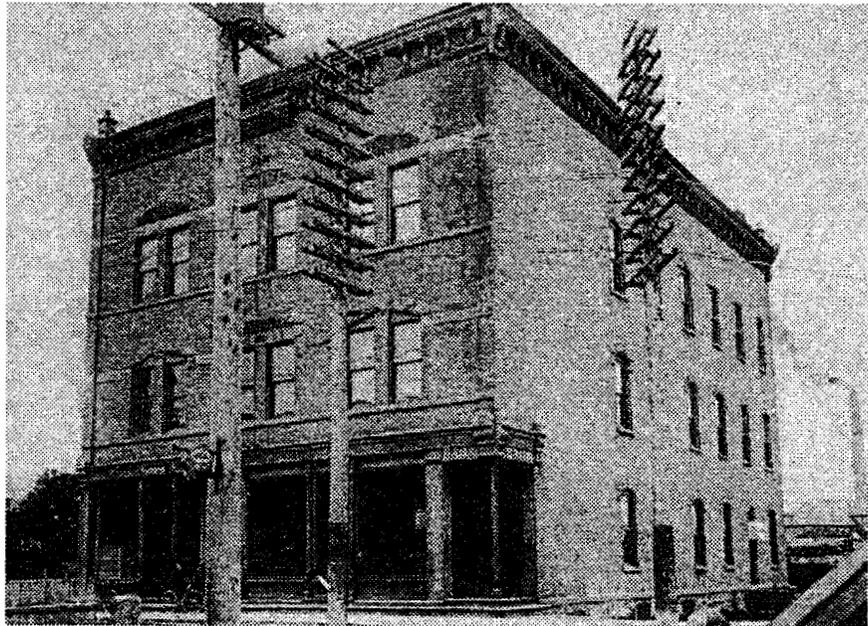
Early view of the building's façade prior to the construction of the YMCA building to the north. Source: Coppertown Mining Museum.

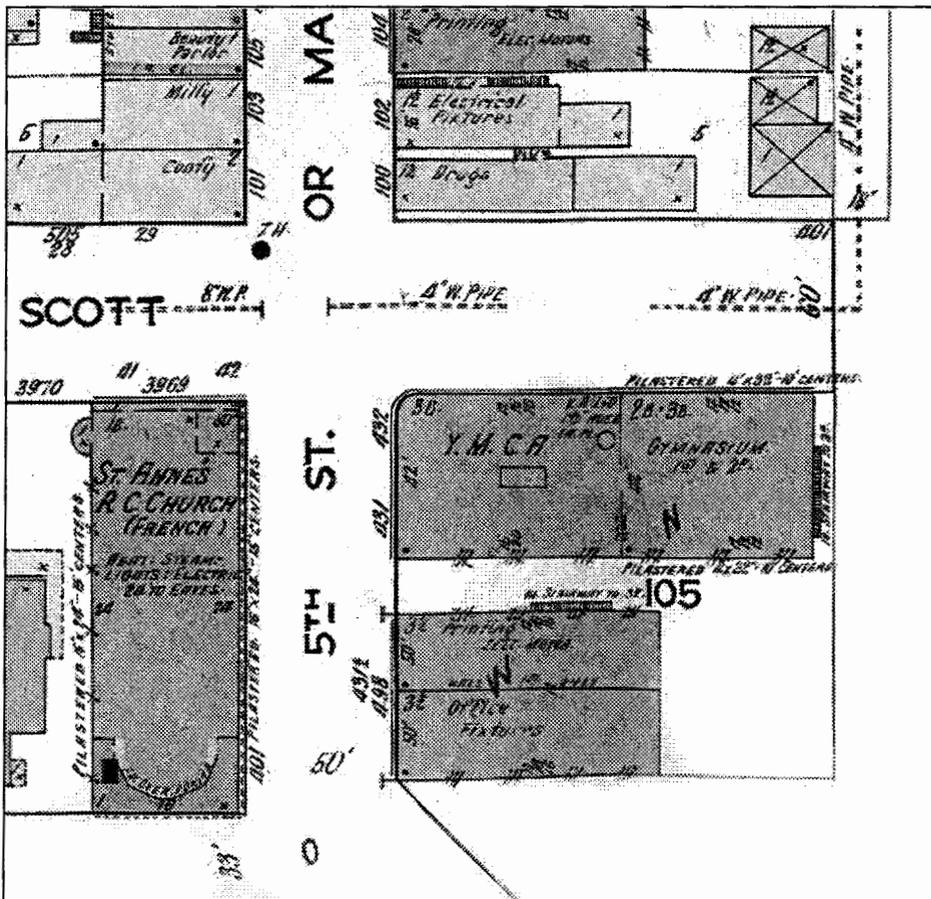
Union Building footprint from a Sanborn Fire Insurance Company Map, 1917. On the map, the YMCA building lies adjacent to the Union Building on the north, while St. Anne's Church is situated across the street to the west. Source: Village of Calumet.

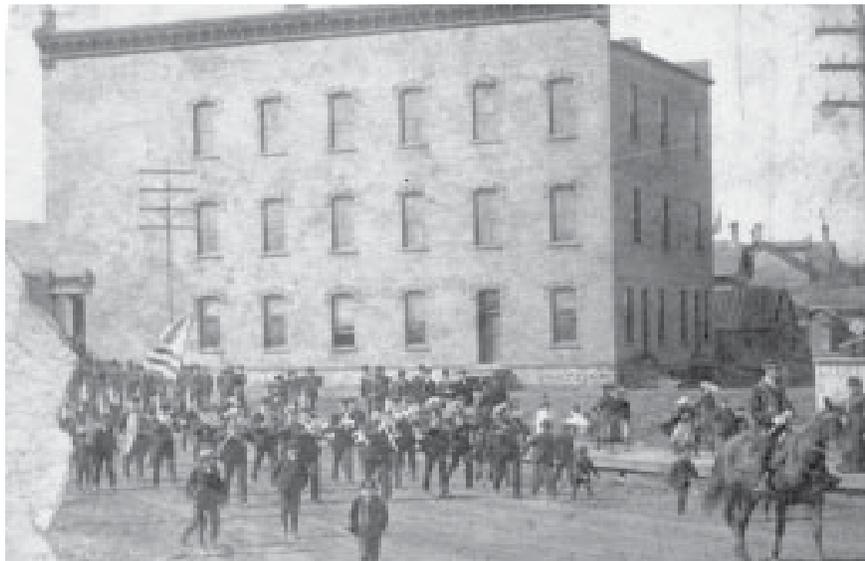
An early view of the building's south elevation including a parade group on Red Jacket Road. Source: Keweenaw NHP Archives

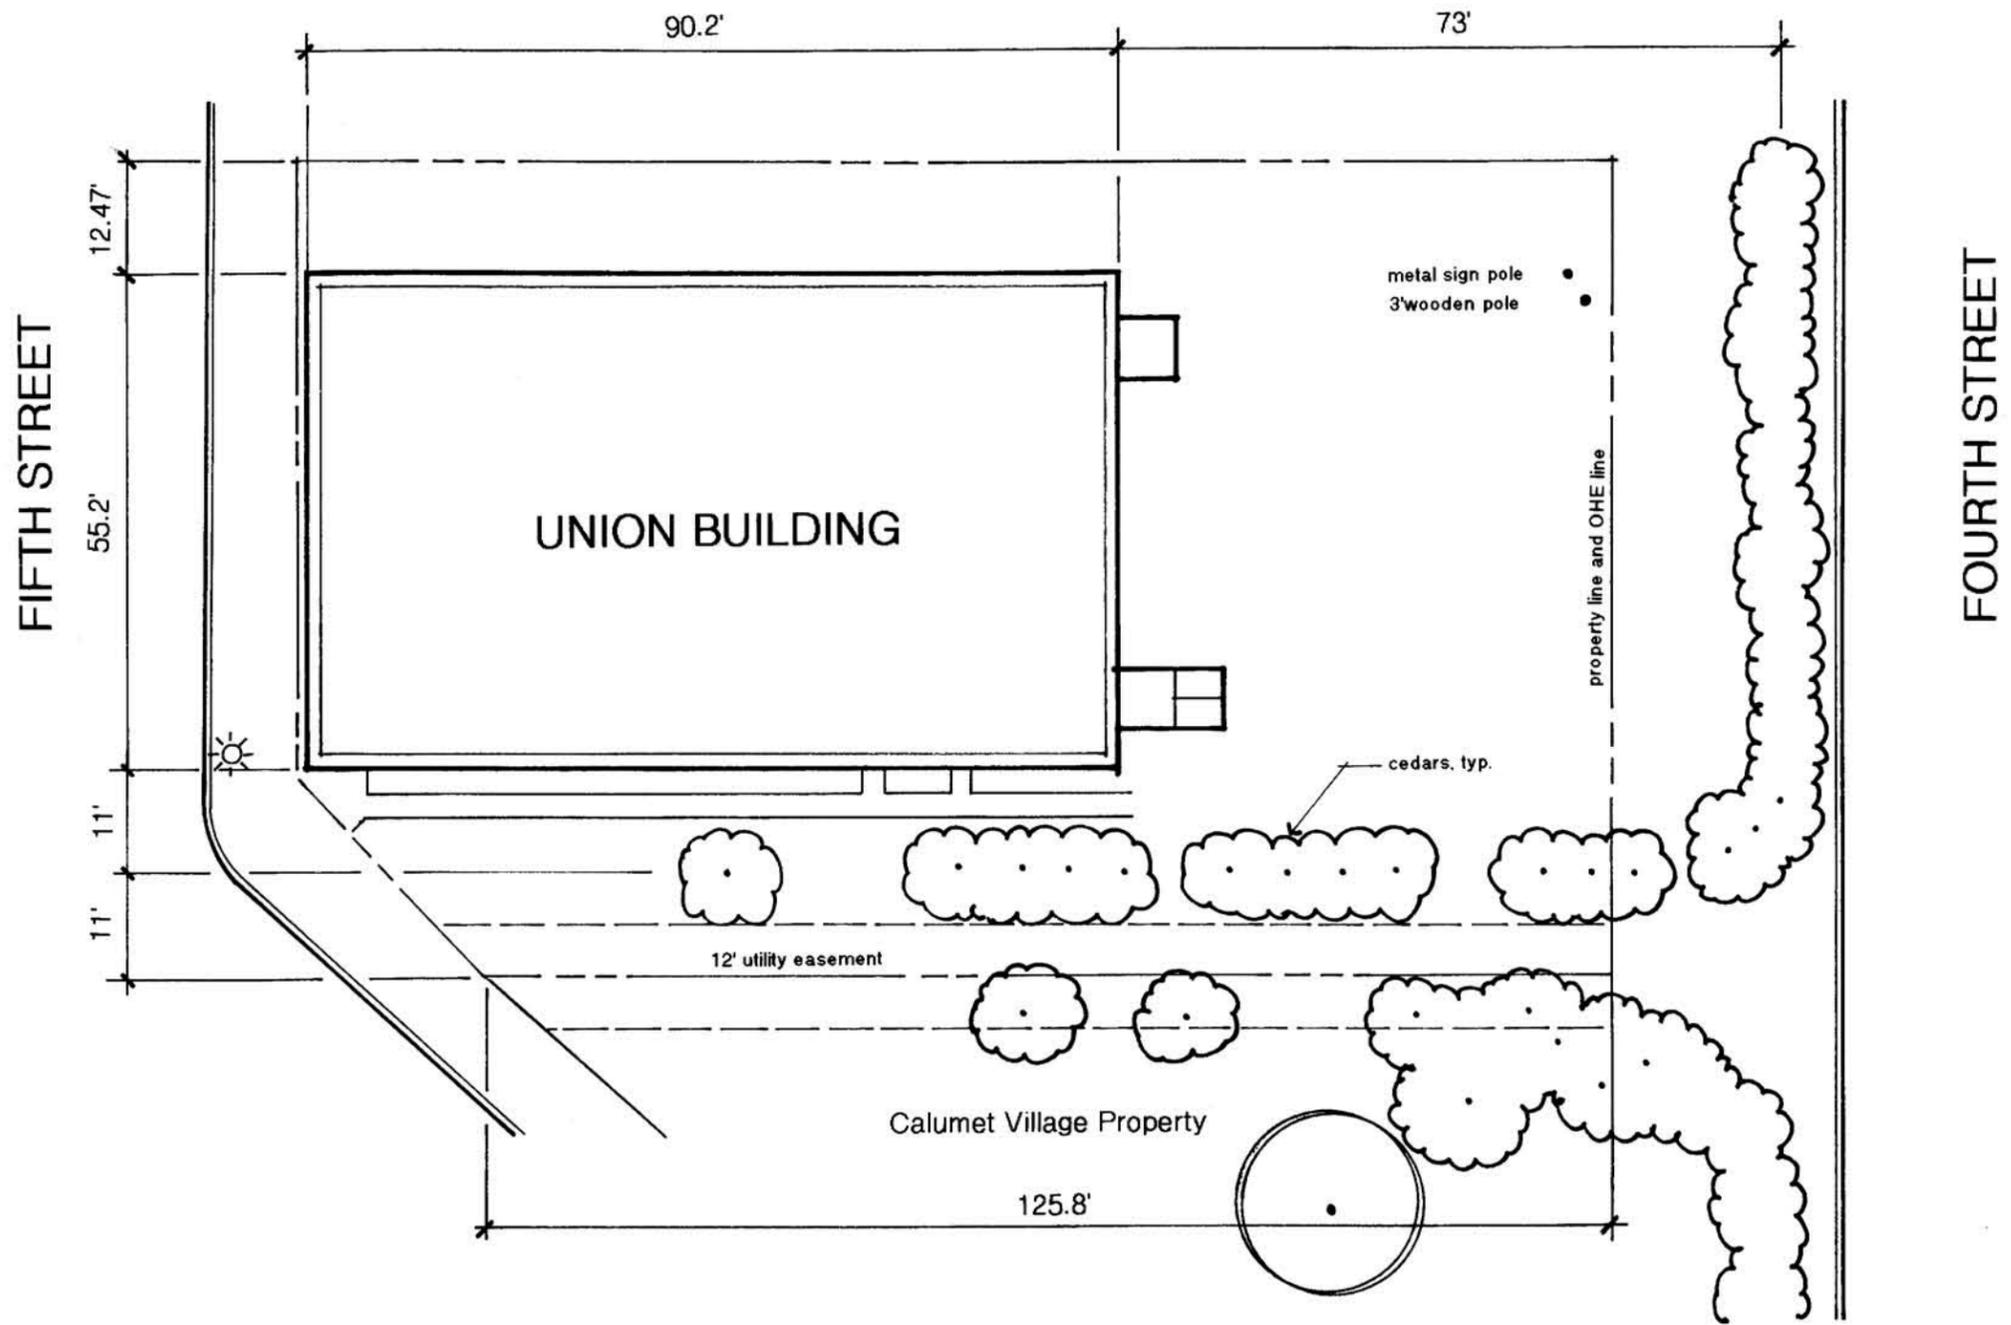
SITE PLAN
 EXISTING CONDITIONS March, 2002
UNION BUILDING Calumet, Michigan

Pedestrian traffic occurs primarily on a concrete sidewalk adjacent to Fifth Street. From this walk a smaller two-foot-wide concrete walk extends into the site along the south elevation of the building. This smaller walk connects to two doorways in the southeast corner of the building before continuing toward the east yard where it terminates. The walk along Fifth Street was replaced in the summer of 2001 while the smaller one is original. Both are in serviceable condition.

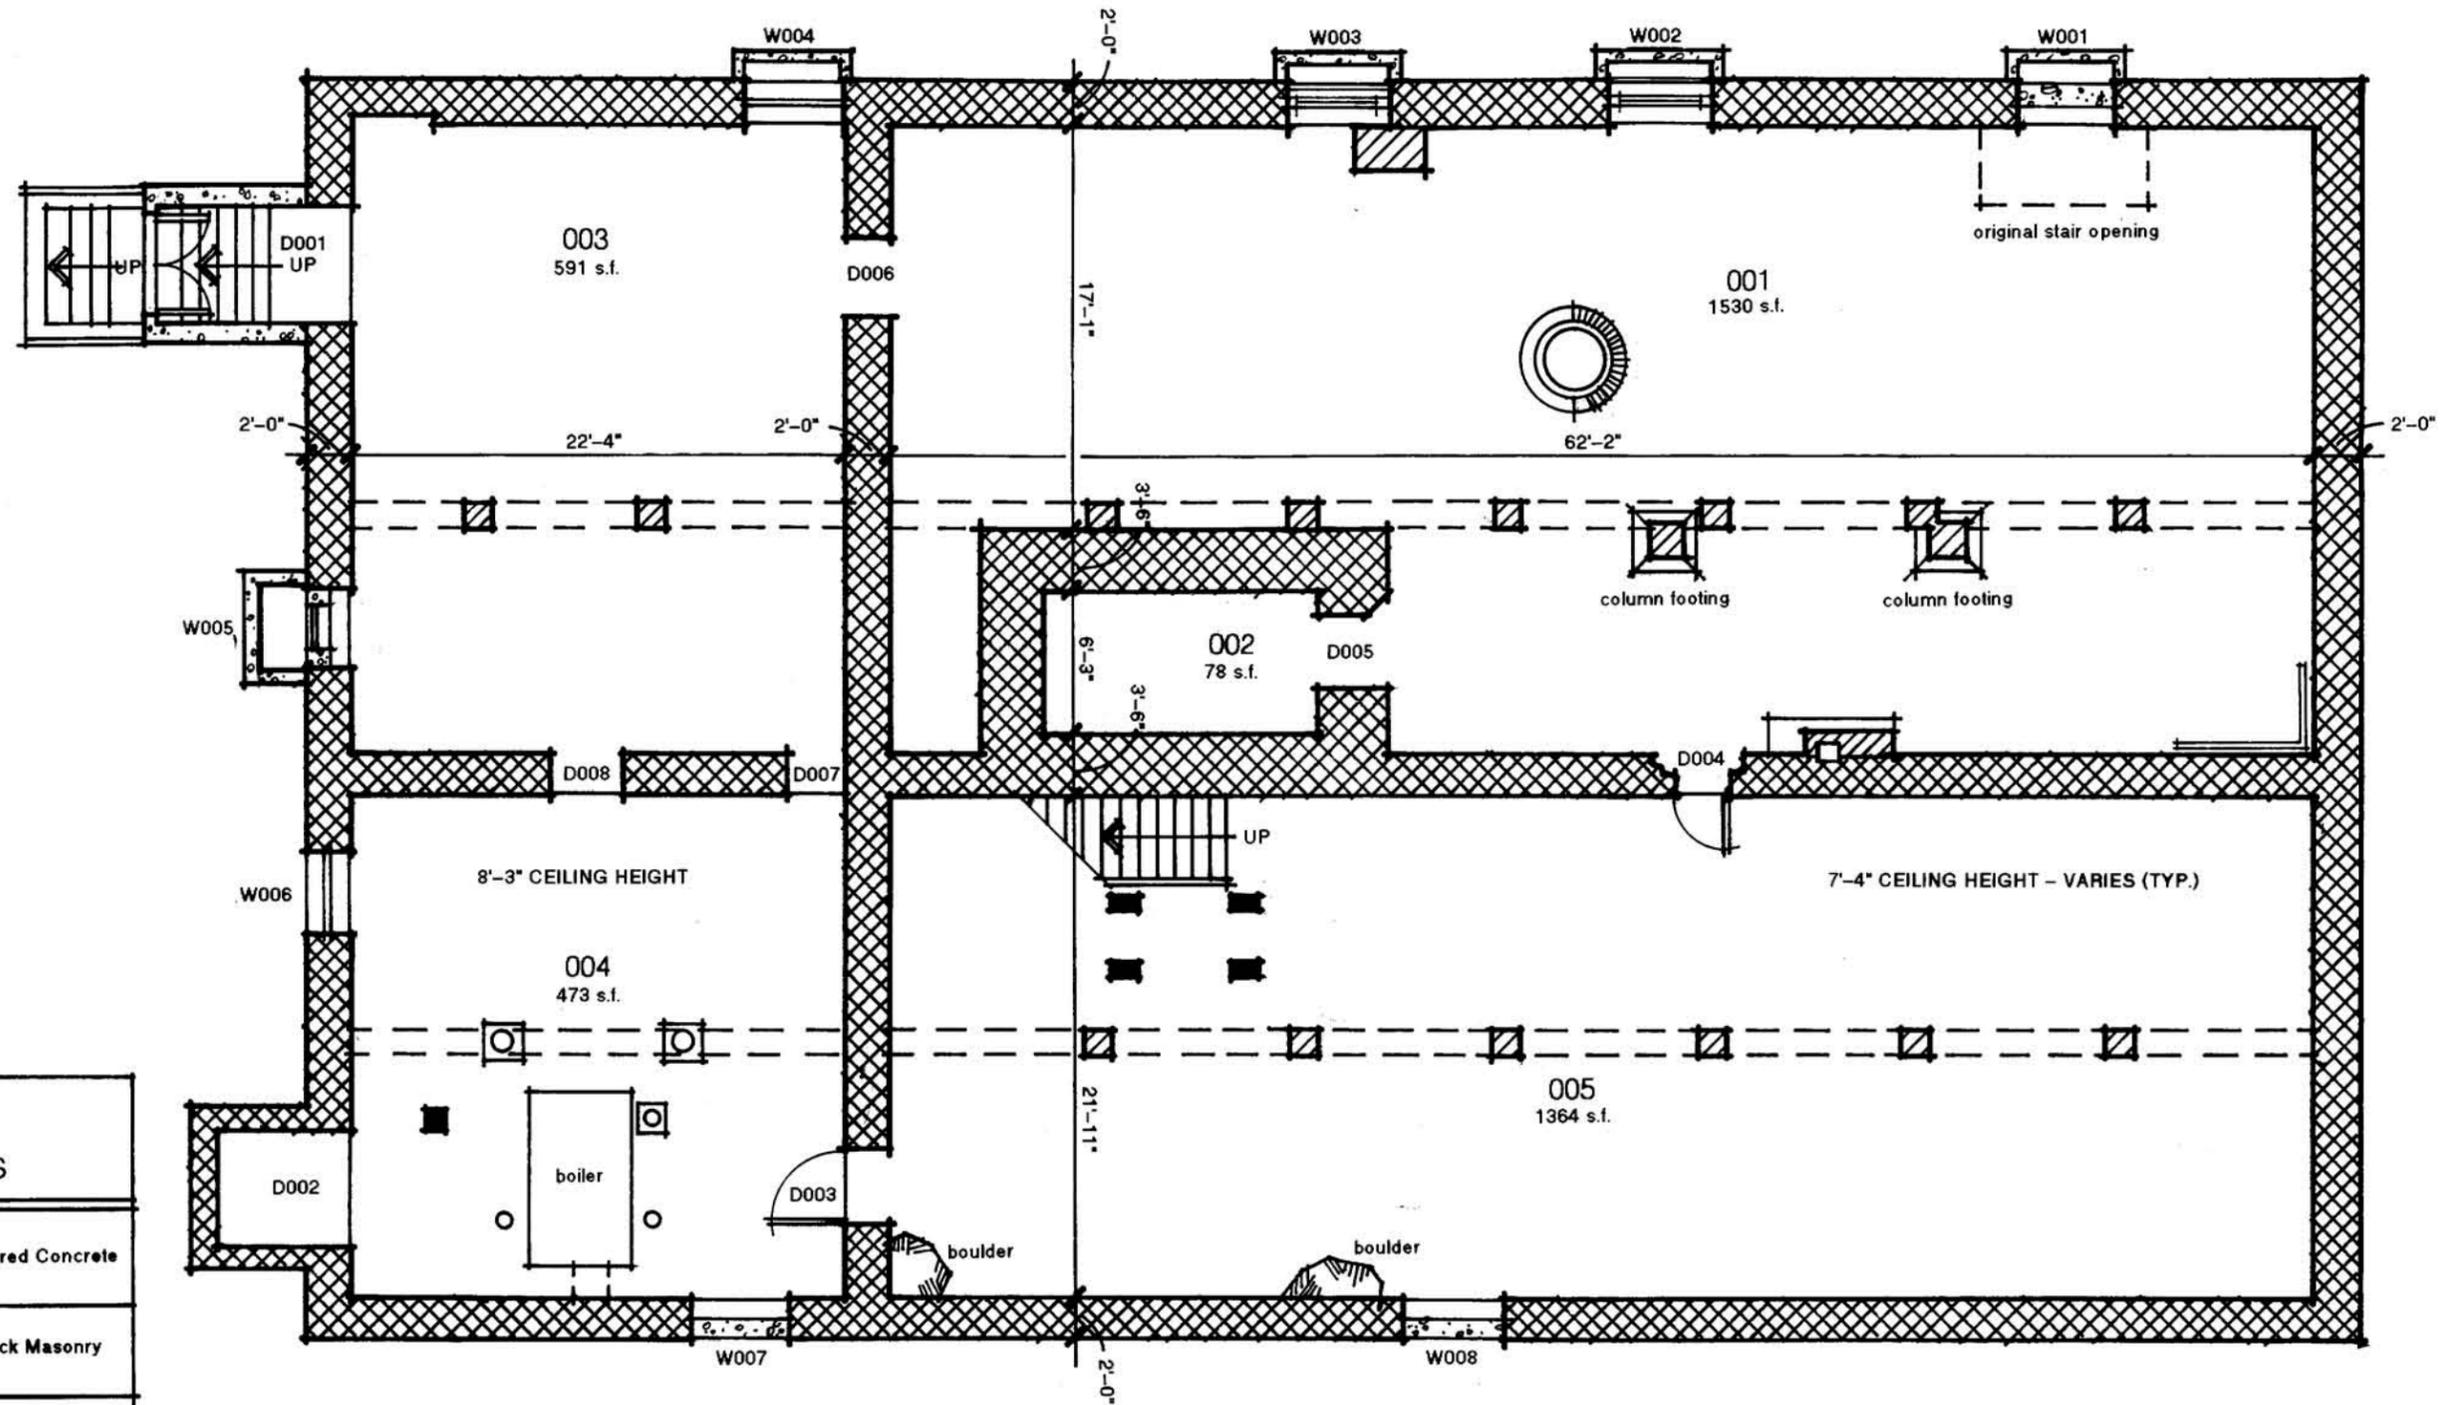
BASEMENT PLAN
 EXISTING CONDITIONS 2002
UNION BUILDING Calumet, Michigan

The basement foundation walls are constructed of exposed mine rubble masonry approximately two feet thick. A load-bearing stone rubble wall divides the Union Building’s full basement lengthwise. A secondary, non-load-bearing stone rubble wall intersects the center wall forming a cross in plan. The foundation for a first floor safe is located along the south side of the longitudinal interior masonry wall. Window openings are typically blocked-in with concrete or wood cover panels.

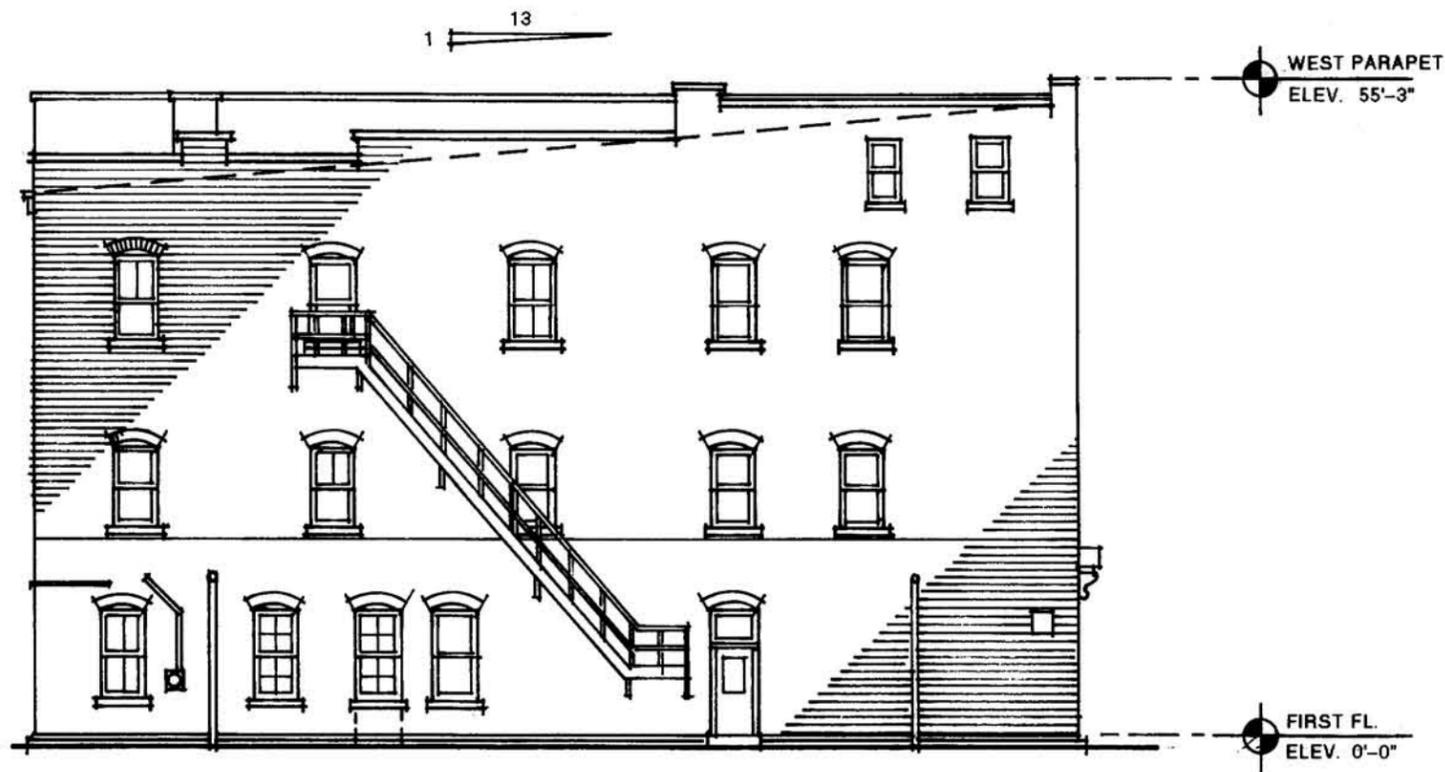
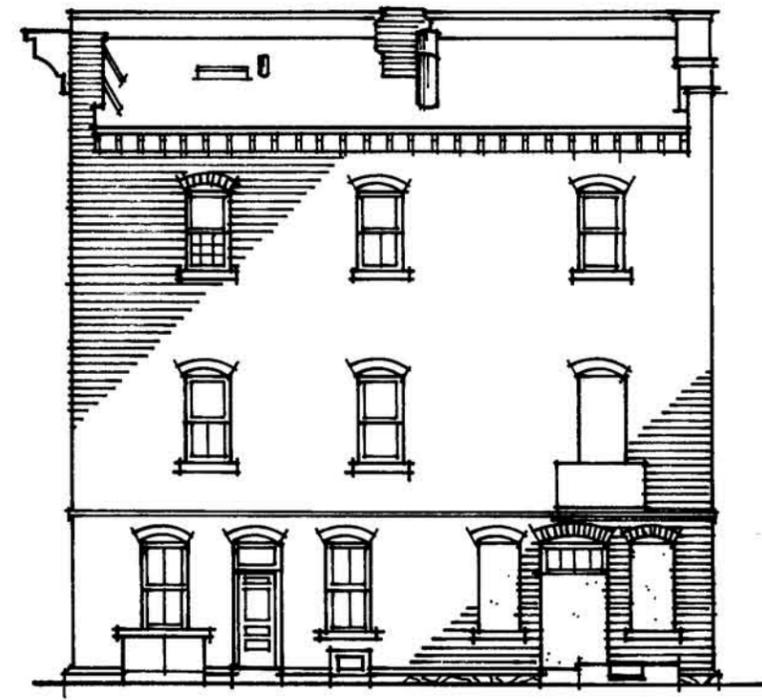
EAST ELEVATION

The east elevation originally faced a back alley (now Fourth Street) and is functional in character. There is a flat-roofed concrete basement entrance enclosure in the lower south corner. Also attached here is a recently constructed bulkhead enclosure in poor condition. A double service door opening and a single door opening, both with transoms, and four window openings punctuate the first floor but do not align with the two rows of three window openings on the second and third floors.

- The brick masonry displays extensive failure particularly under the window sills, under the eaves, and at the bottom of the wall. In areas, deformation has occurred as the brick has separated from the wall. Large areas will require replacement. A section of masonry below the north second floor window has been covered with sheet metal to prevent collapse.
- Three window openings have been fitted with plywood window panels.
- The double service doors are missing and covered with painted plywood panels.
- The ends of the exposed rafter tails are cut with a decorative profile and do not appear to be extensions of roof structure. Historic photographs do not depict this feature.

- Rust stains on the brick masonry are visible under the metal fire escape.

- There is pronounced spalling and cracking in the brick masonry at the base of the wall and in the east and west upper corners.

- The configuration of the exposed metal fire escape does not comply with current egress requirements. Corrosion has weakened its structural integrity.

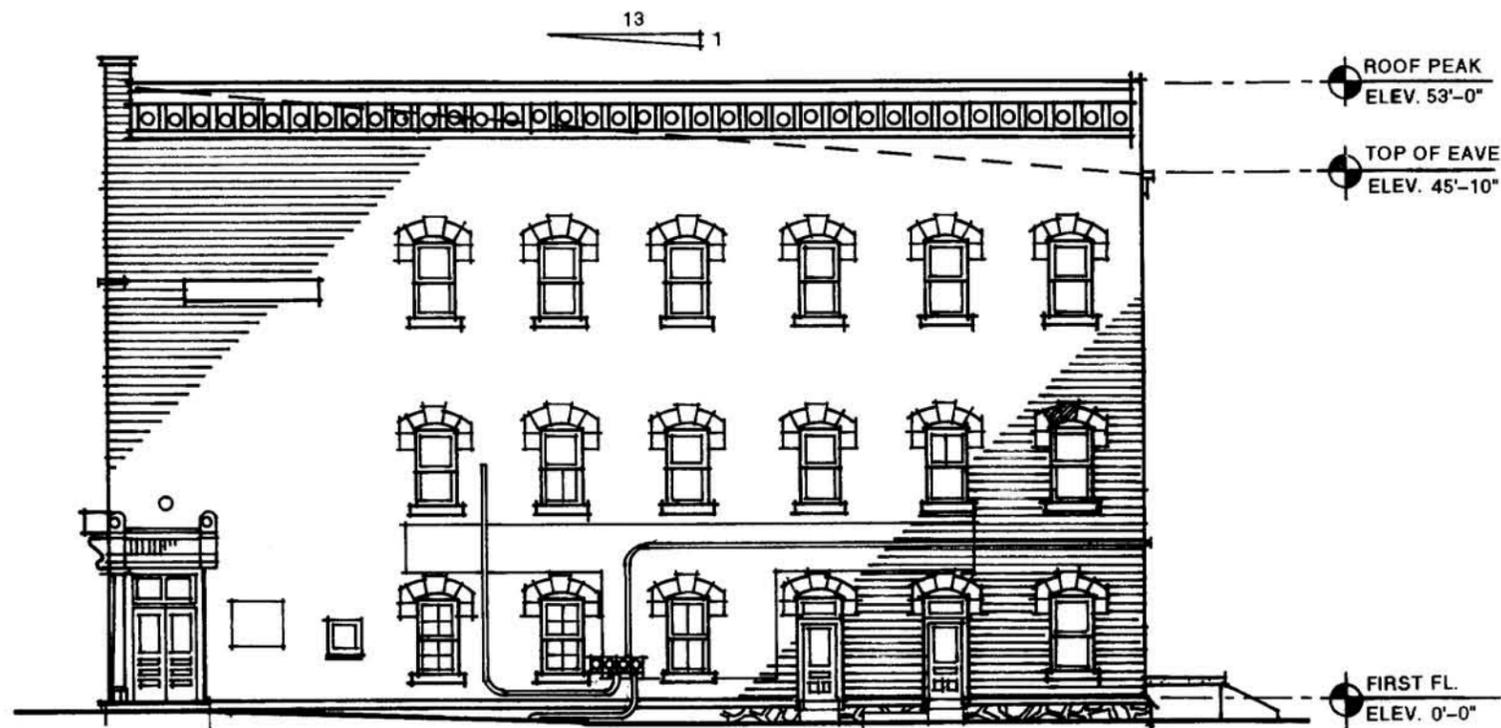
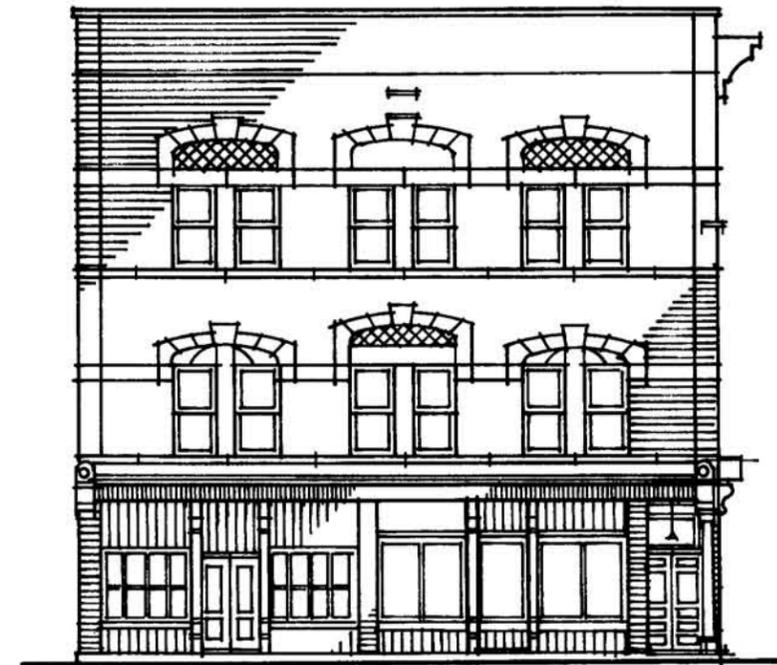
SOUTH & WEST ELEVATIONS
 EXISTING CONDITIONS 2002
UNION BUILDING Calumet, Michigan

- The water table on the west elevation and under the southwest corner entrance has been painted in an apparent effort to arrest deterioration. The water table here is substantially eroded.

- The brick masonry at the bases of the three masonry piers along the storefront is particularly deteriorated with open mortar joints and spalling.

- Cast iron stoops are installed in both the north and southwest corner recessed entrances. Although early photographs do not reveal an entrance between the iron pilasters of the south storefront, the edge of a cast iron stoop is visible here. The stoop assembly at the southwest corner entrance has settled unevenly. The cast iron stoops are in good to fair condition with limited deterioration.

- The iron column in the southwest corner is missing decorative elements (acanthus and volute components) from its Corinthian capital. Corrosion has deteriorated the column base resulting

- A decorative rosette is missing from the west corner bracket of the pressed-metal storefront cornice. The word “BANK” is ghosted on the frieze of the cornice over the southwest corner entrance.

- The paint finish has failed on the pressed-metal storefront cornice, exhibiting extensive flaking and peeling.

- There is a painted metal and neon sign mounted near the west corner of the third floor façade that reads: “MASONIC TEMPLE”. The paint is faded and peeling. Elements of the neon glass are missing.

- The original pressed-metal cornice is in good to fair condition. Corrosion and loss of material is evident. Original pressed-metal corner brackets and finials are missing.
