Subject: Determination of Eligibility for the National Register of Historic Places for Canyon City Cabin (Mile 7.5) and Sheep Camp Cabin (Mile 13) of the *Chilkoot Trail and Dyea National Historic Landmark* within the Klondike Gold Rush National Historical Park and Preserve

National Register of Historic Places Registration Form

Historic name: Canyon City State Cabin

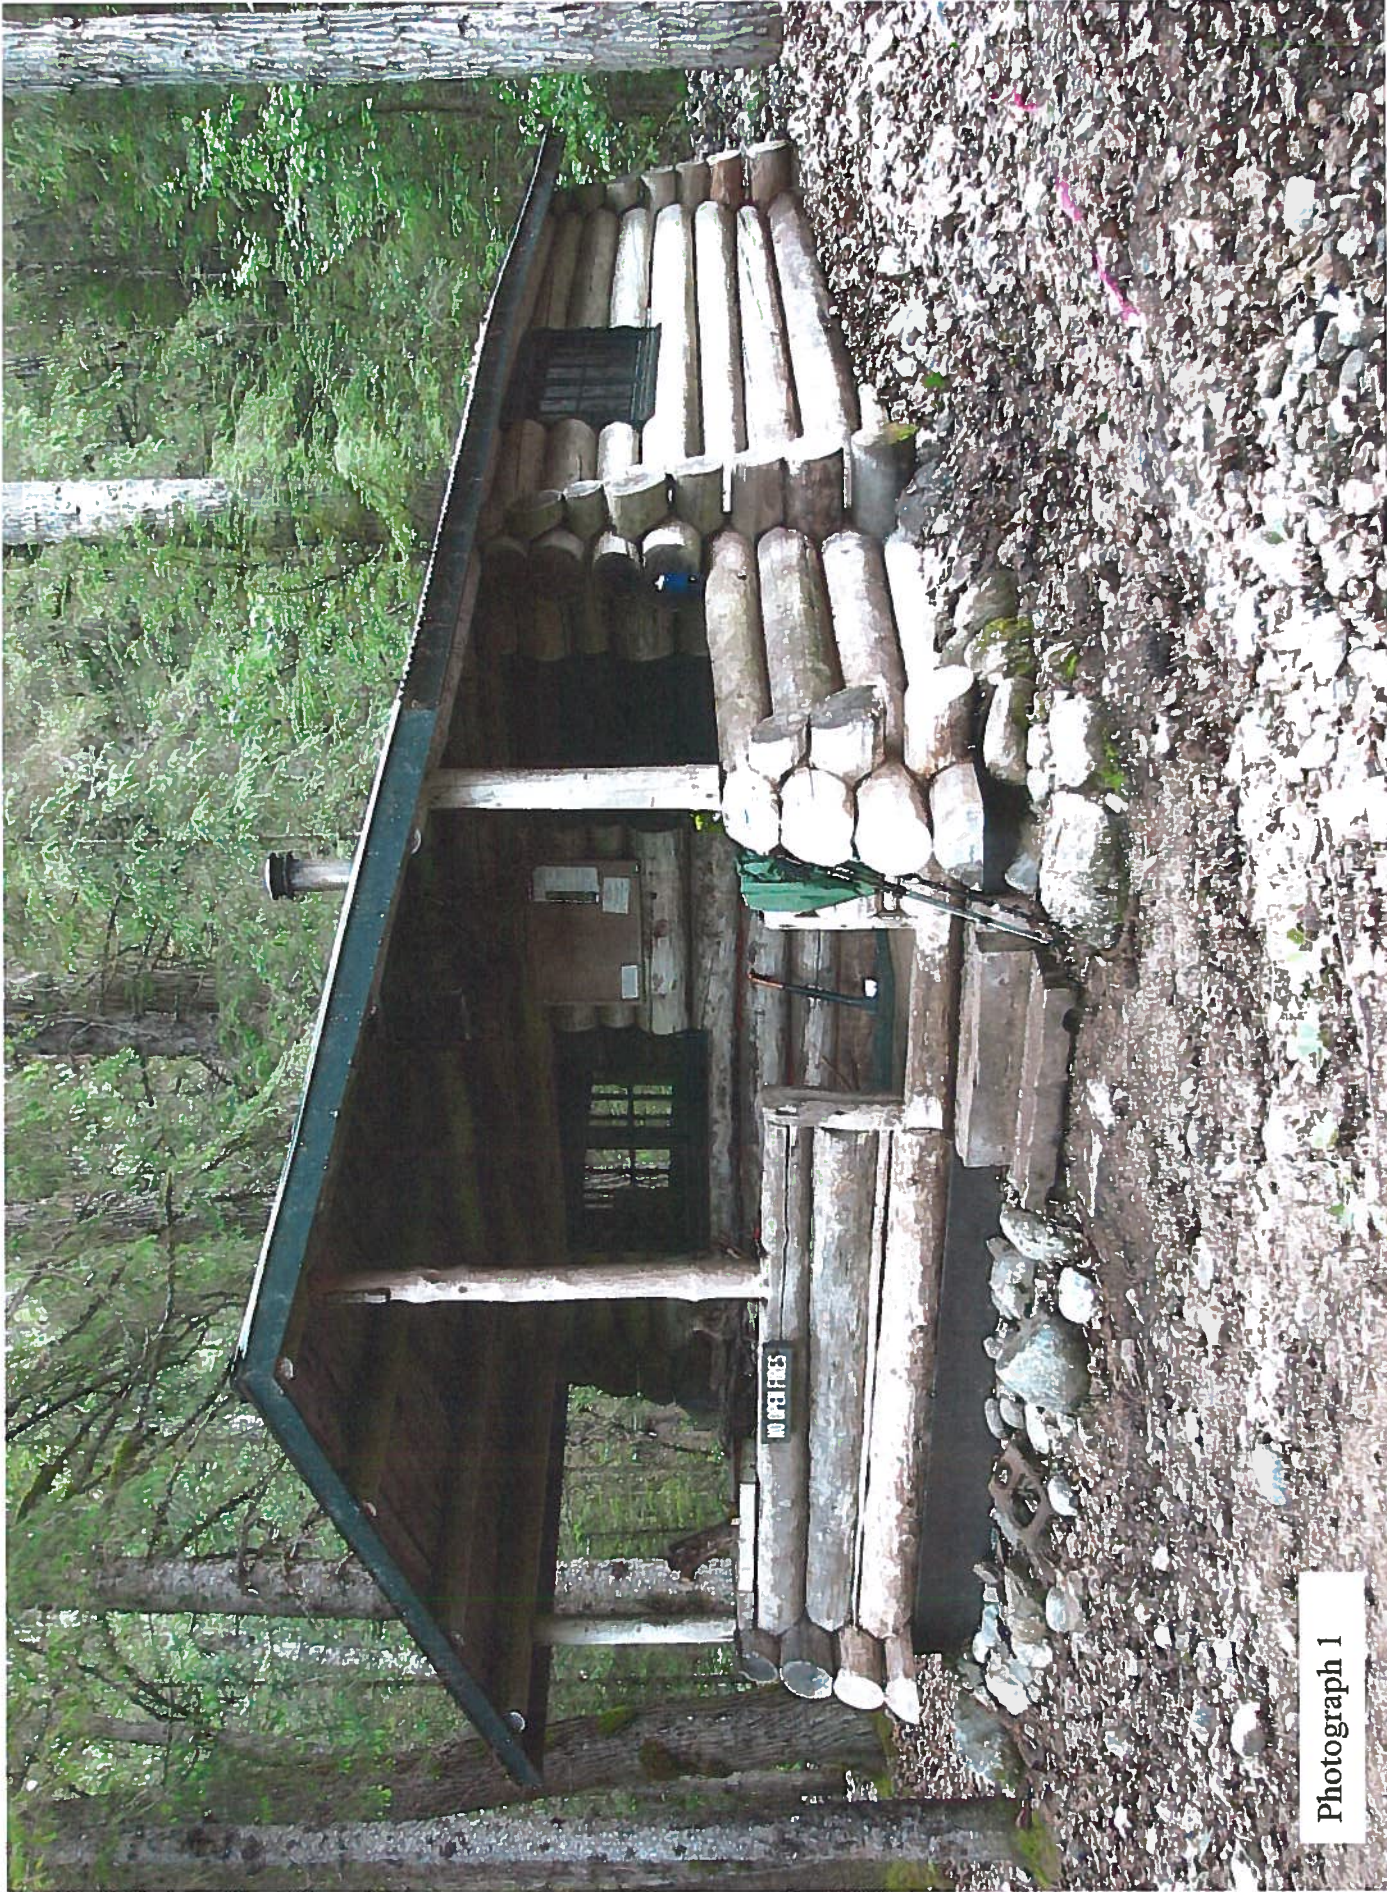
Photograph 1

Canyon City State Cabin, Mile 7.5, Chilkoot Trail, Front and side view, west and south façades. Susannah Dowds, Klondike Gold Rush National Historical Park, Site Visit, June, 2017.

The west facing Canyon City State Cabin is centrally situated in a wooded area, tall black cottonwood (*Populus balsamifera*) and spruce trees (*Picea sitchensis*) surround the cabin. The site slopes slightly south to north, and a stream runs to the north of the cabin. Other amenities related to the campground including a warming tent, picnic table, two composting outhouses, and eleven campsites are in the vicinity (Photographs 1-4).

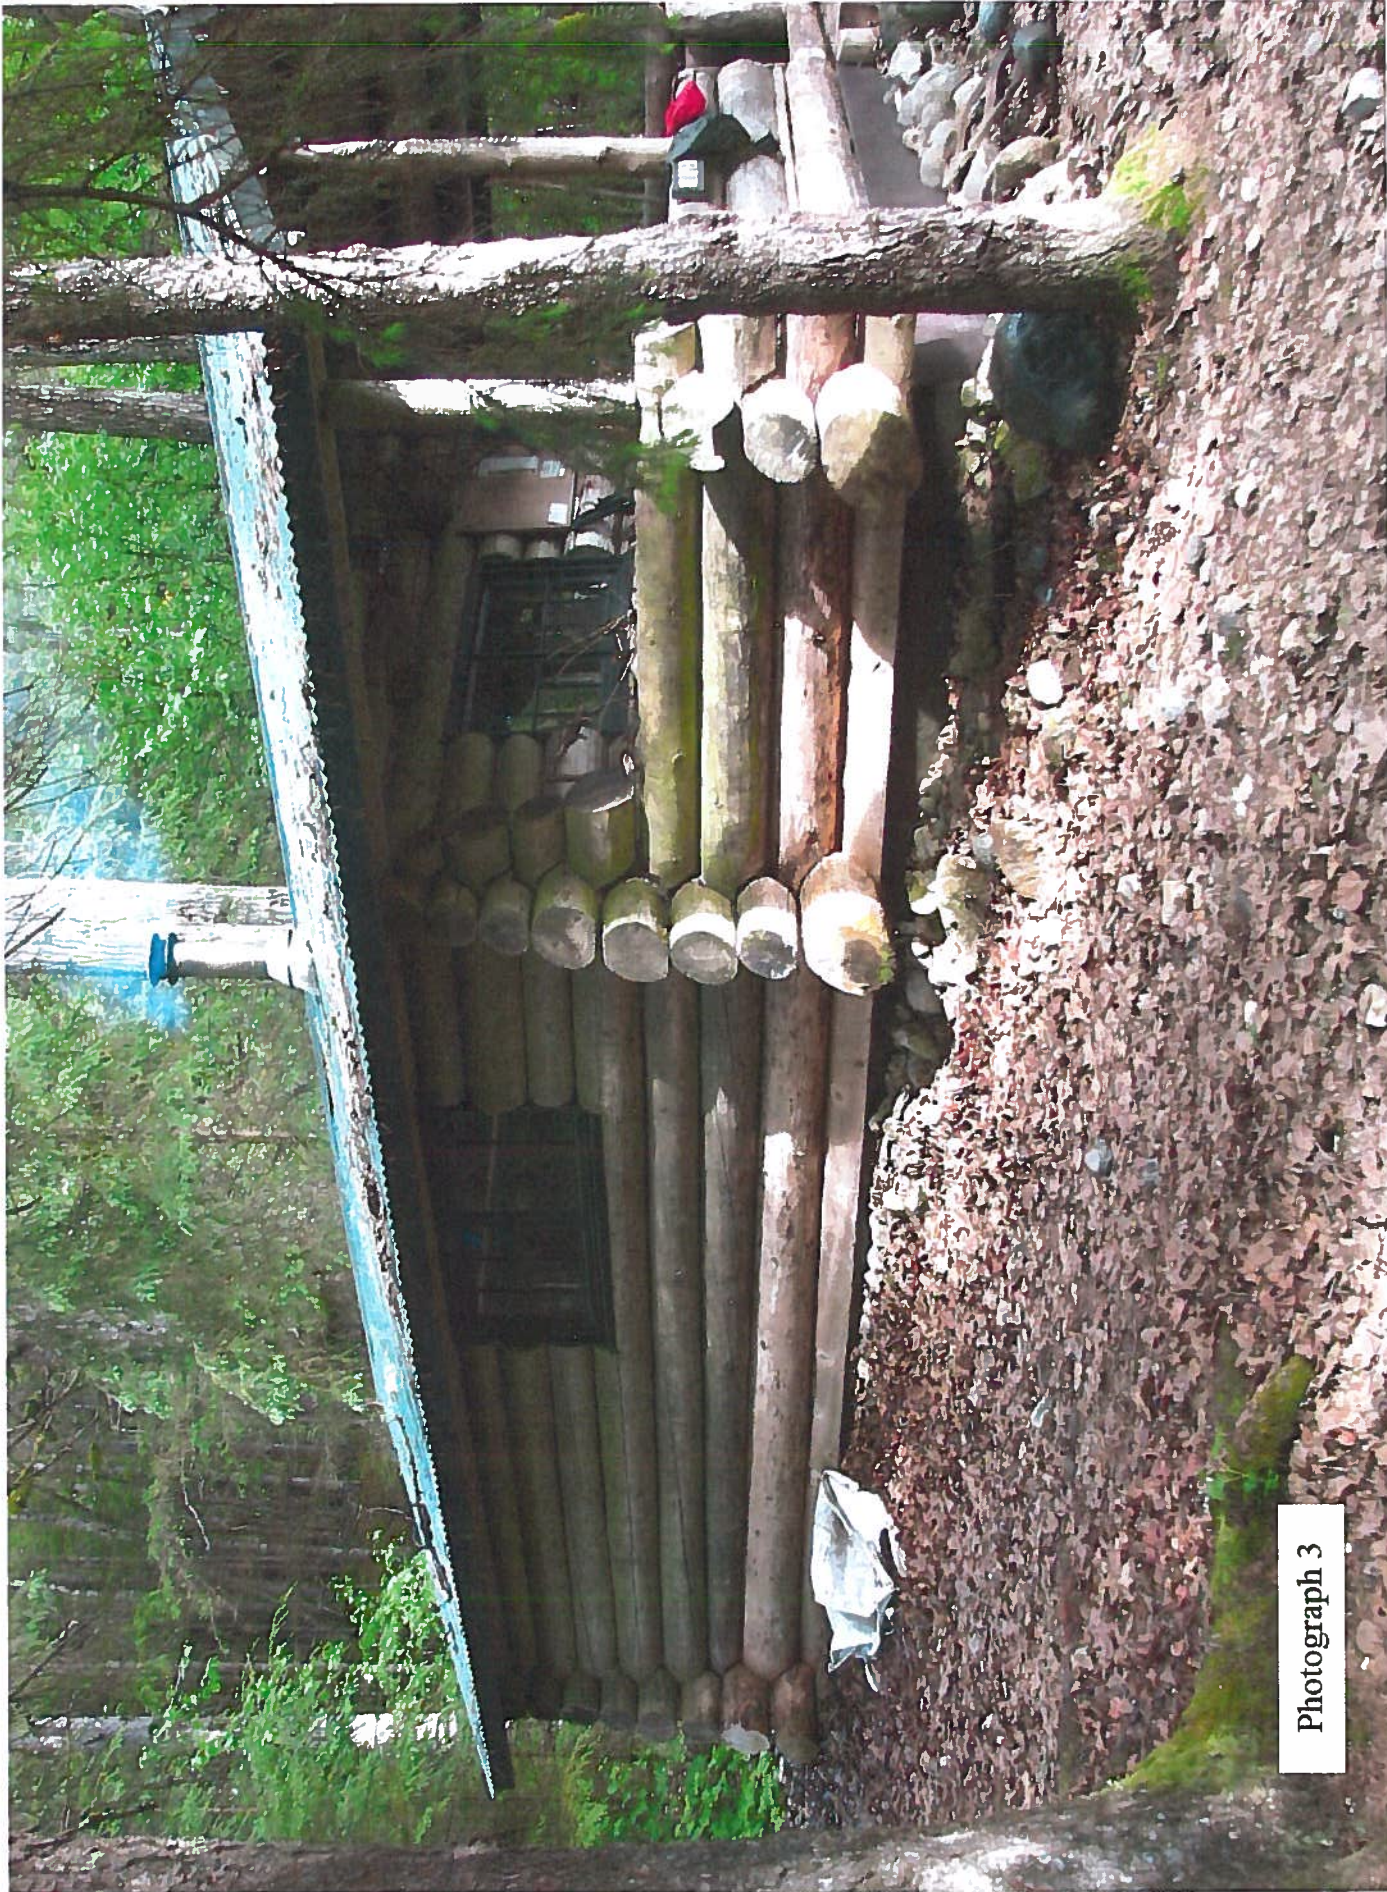
Photograph 3

Canyon City State Cabin, Mile 7.5, Chilkoot Trail, Side and partial front view, north and west façades. Susannah Dowds, Klondike Gold Rush National Historical Park, Site Visit, June, 2017.

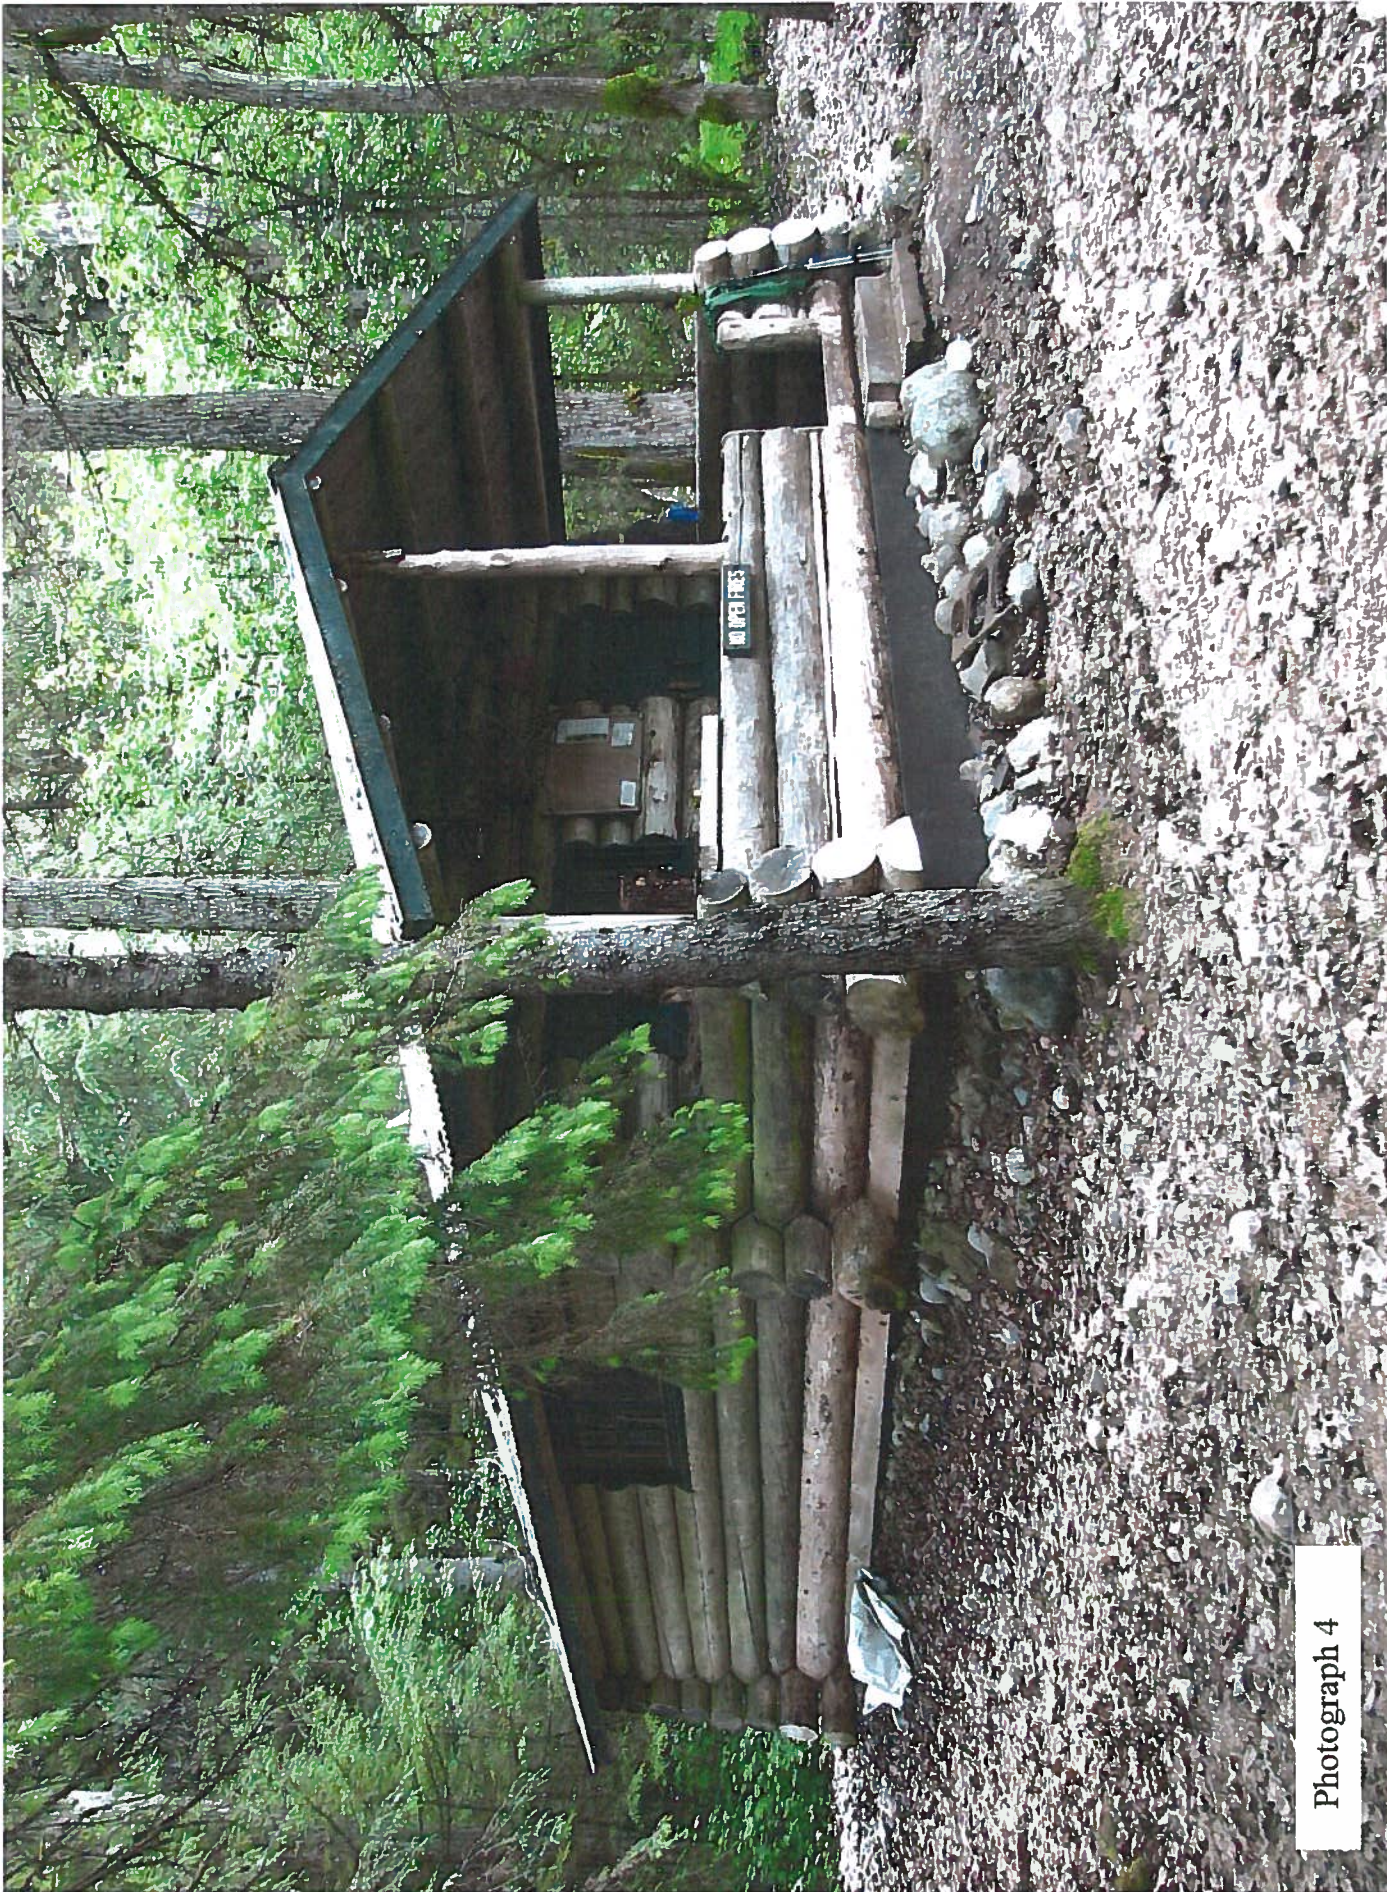
Photograph 4

Canyon City State Cabin, Mile 7.5, Chilkoot Trail, Side and front view, north and west façades. Susannah Dowds, Klondike Gold Rush National Historical Park, Site Visit, June, 2017.

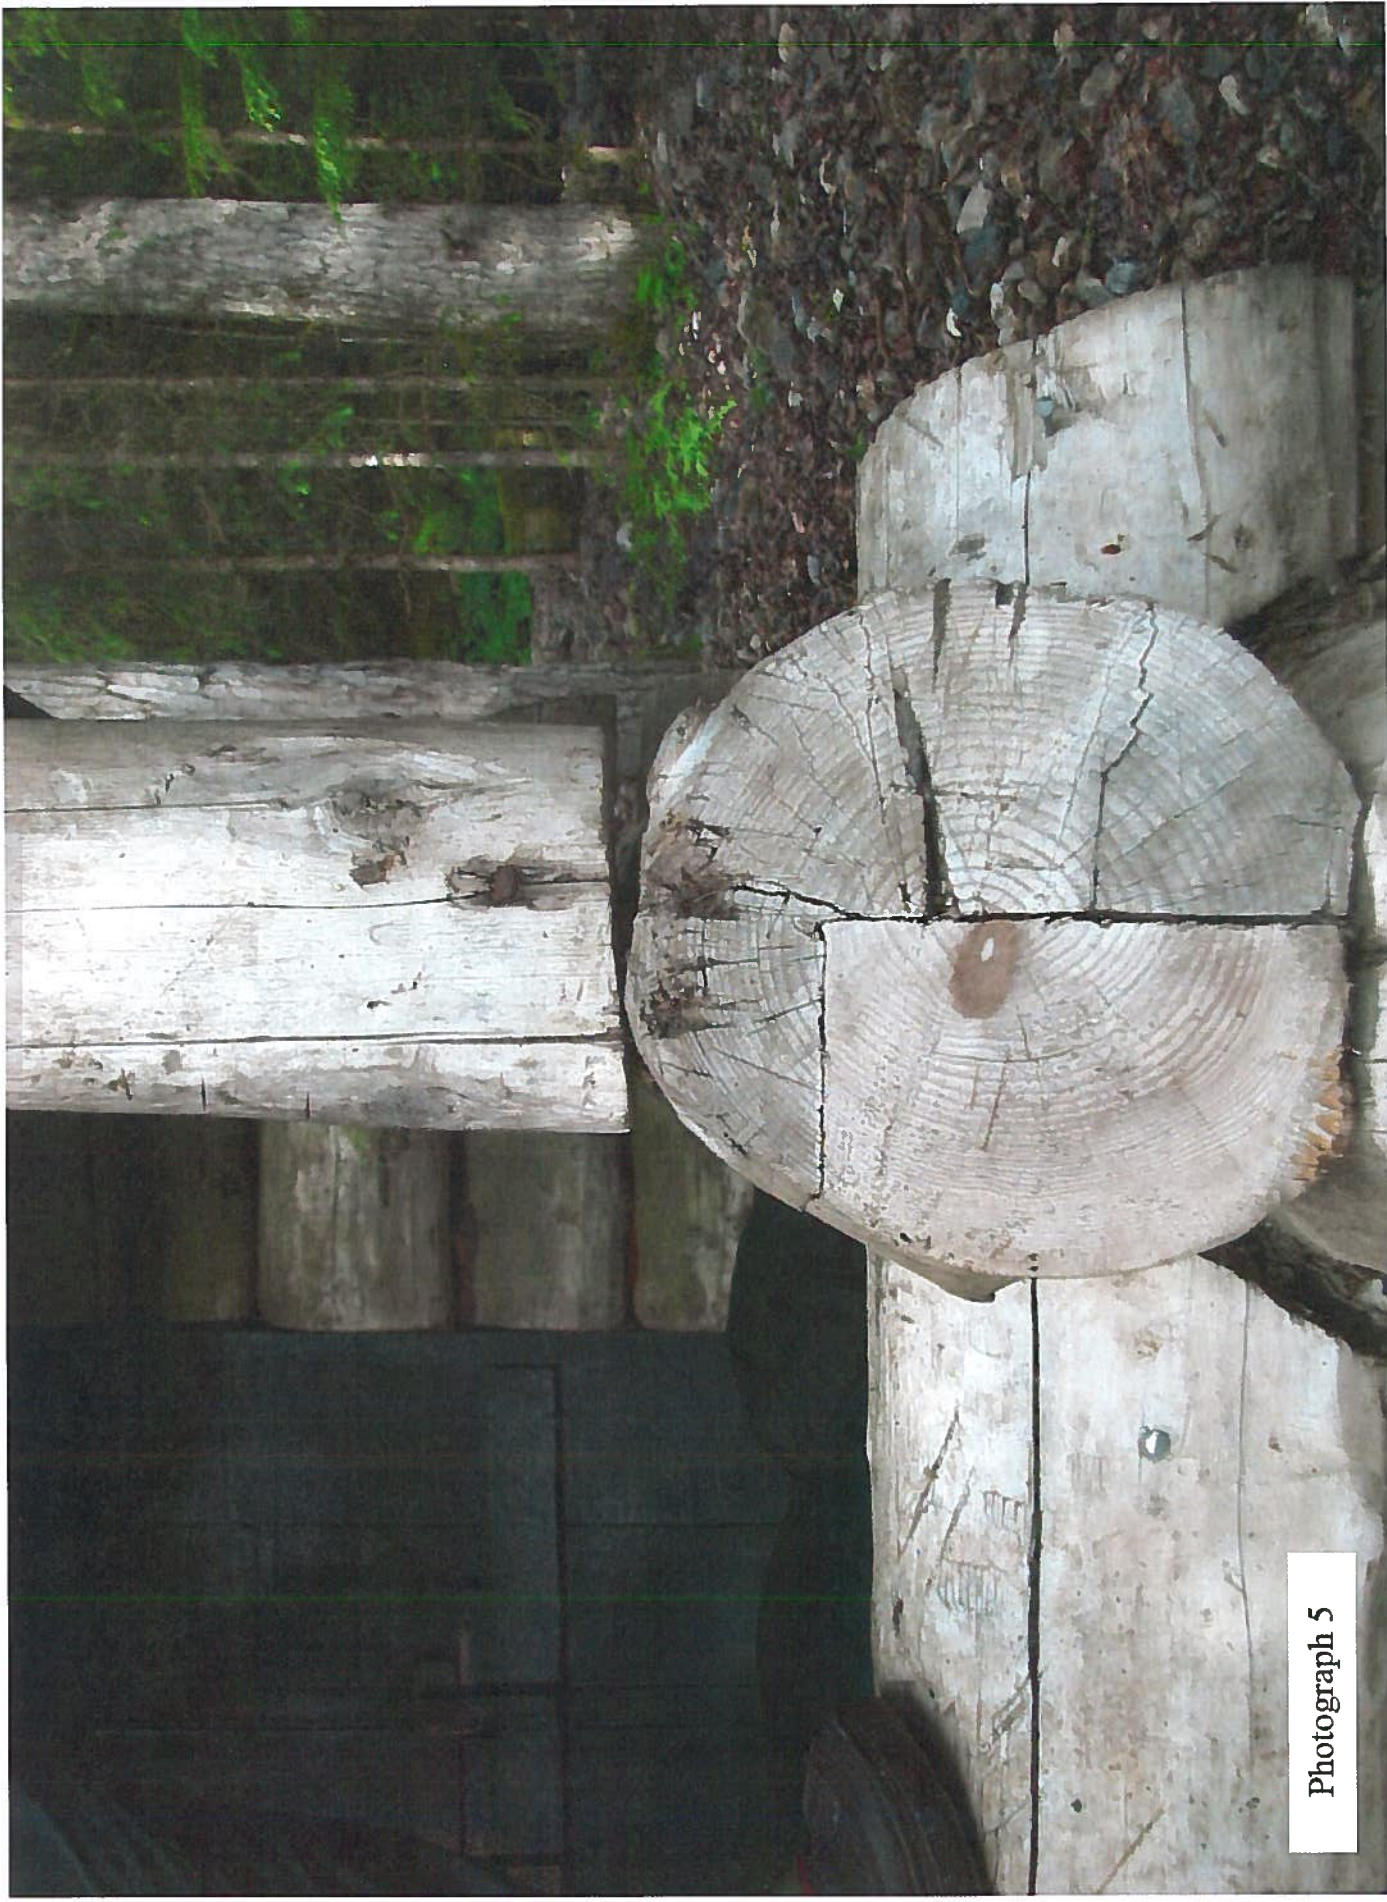
Photograph 5

A ridge log and two purlins on each slope compose the roof framing and 1" dimensional lumber boards varying in width from six to twelve inches runs from the ridge board to the drip edge of the roof to support the corrugated roofing. At the west and east gable ends, 2x6" barge boards, painted green, partially cover the purlins of the projecting roof. On the north and south sides of the roof, 2x4" fascia boards, also painted green, are attached to the dimensional lumber boards running from the ridge board. The roof rests on two wall plate logs at the top of the north and south façades, wall plate logs extend the full 27'-10" length of the building. Three vertical, wood posts support the roof over the porch (Photograph 5).

Canyon City State Cabin, Mile 7.5, Chilkoot Trail, Southwest corner of porch showing bottom of porch post (exterior).
Susannah Dowds, Klondike Gold Rush National Historical Park, Site Visit, June, 2017.

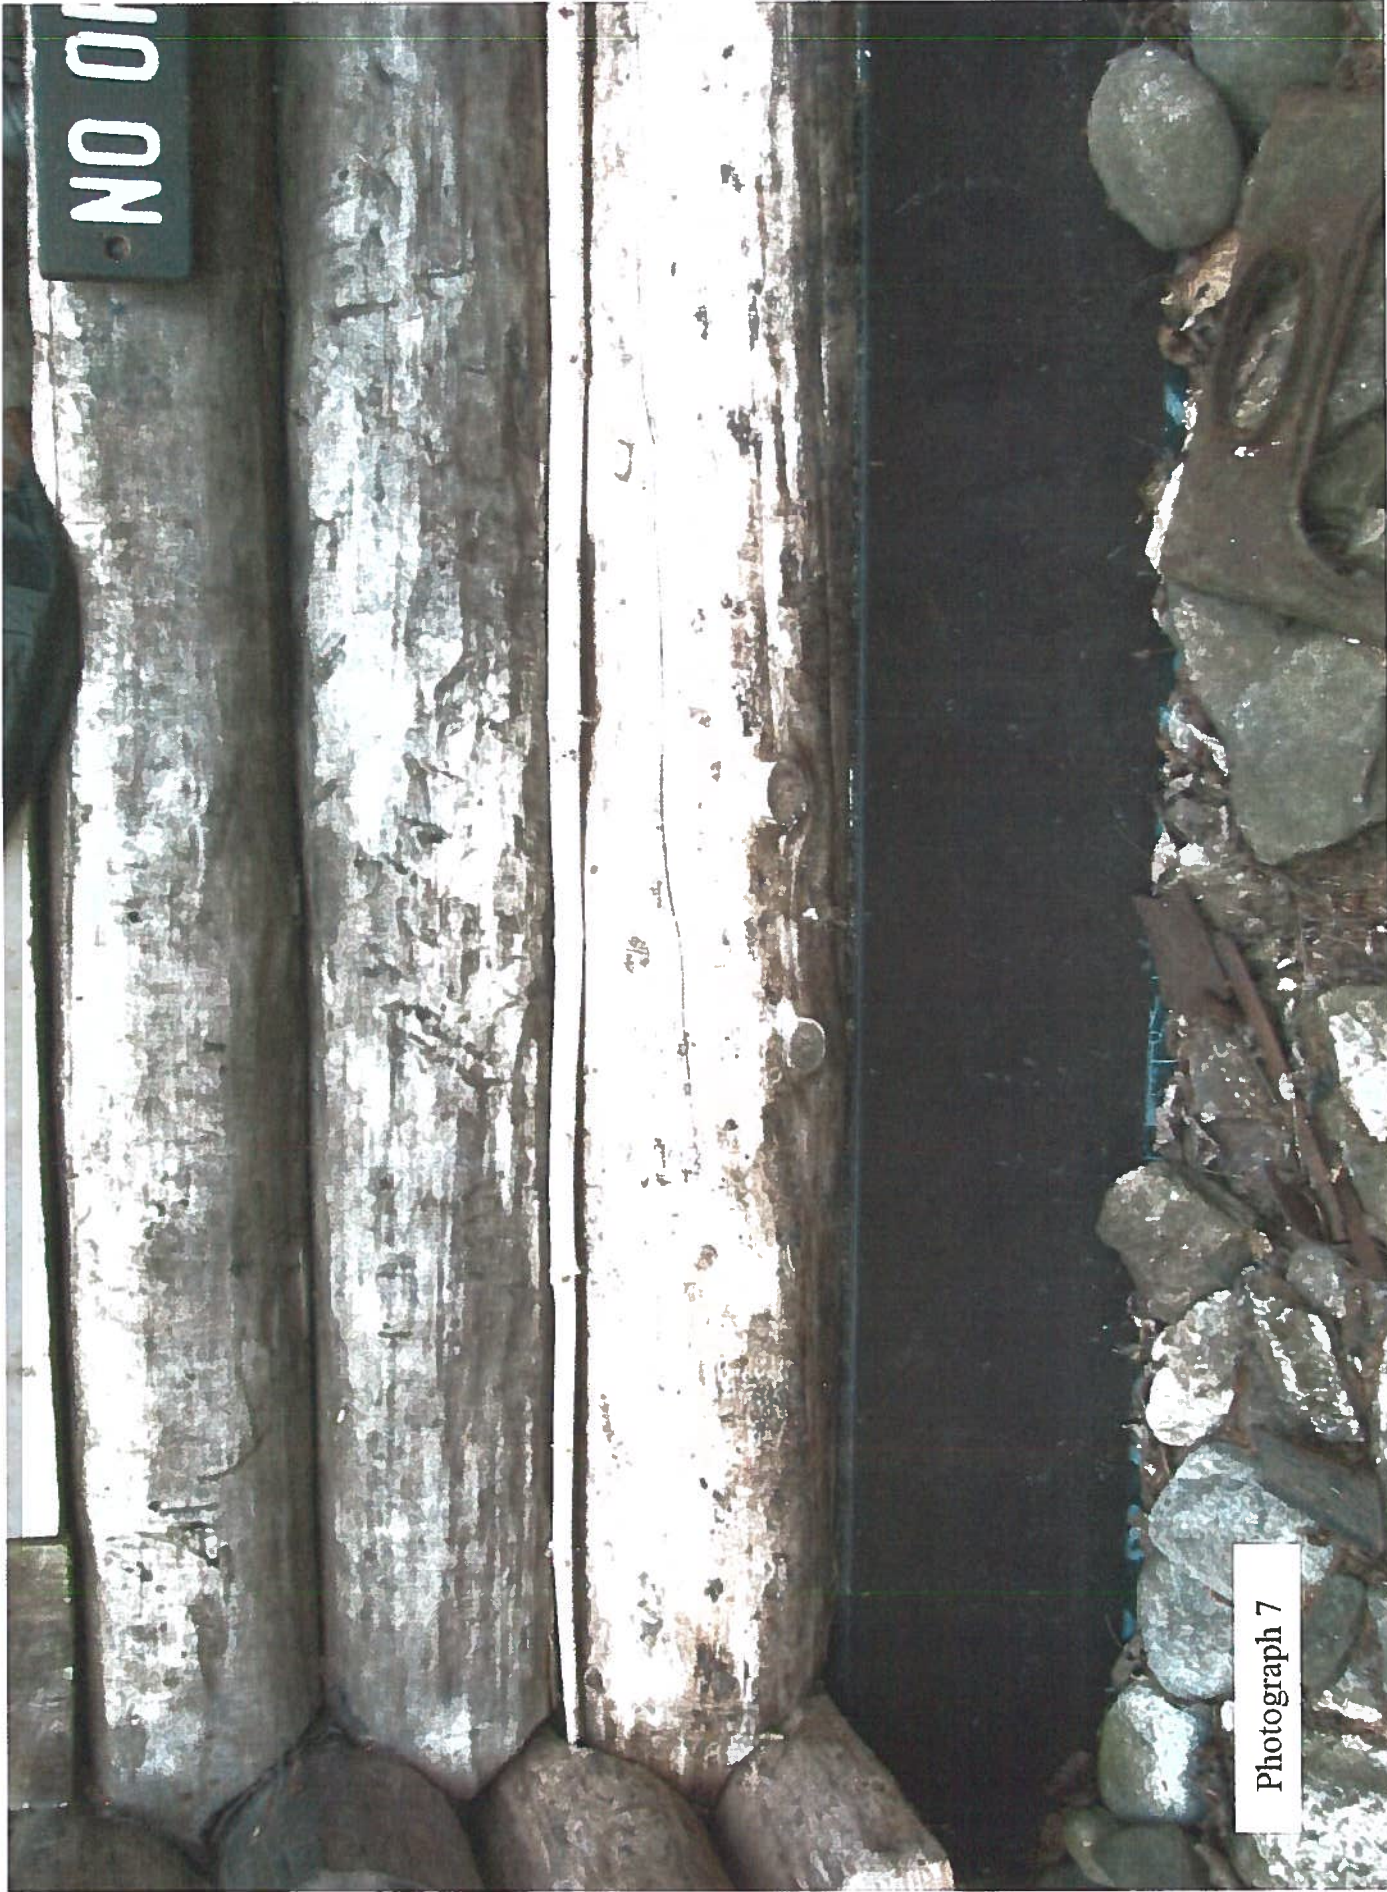
Photograph 7

The building has a dimensional wood foundation, with large stones laid loosely around the porch to assist with recurring drainage issues (Photograph 7).

Canyon City State Cabin, Mile 7.5, Chilkoot Trail, Cabin foundation. Susannah Dowds, Klondike Gold Rush National Historical Park, Site Visit, June, 2017.

the porch between 1977 and 1985.¹ In 2009 and 2010, NPS maintenance staff made a number of repairs, replacing the roof sheathing and adding a dimensional wood foundation. Workers also installed new interior flooring and replaced the bottom three cottonwood wall courses with spruce (*Picea sitchensis*) logs. Lead paint present on the wood trim was removed in 2011.

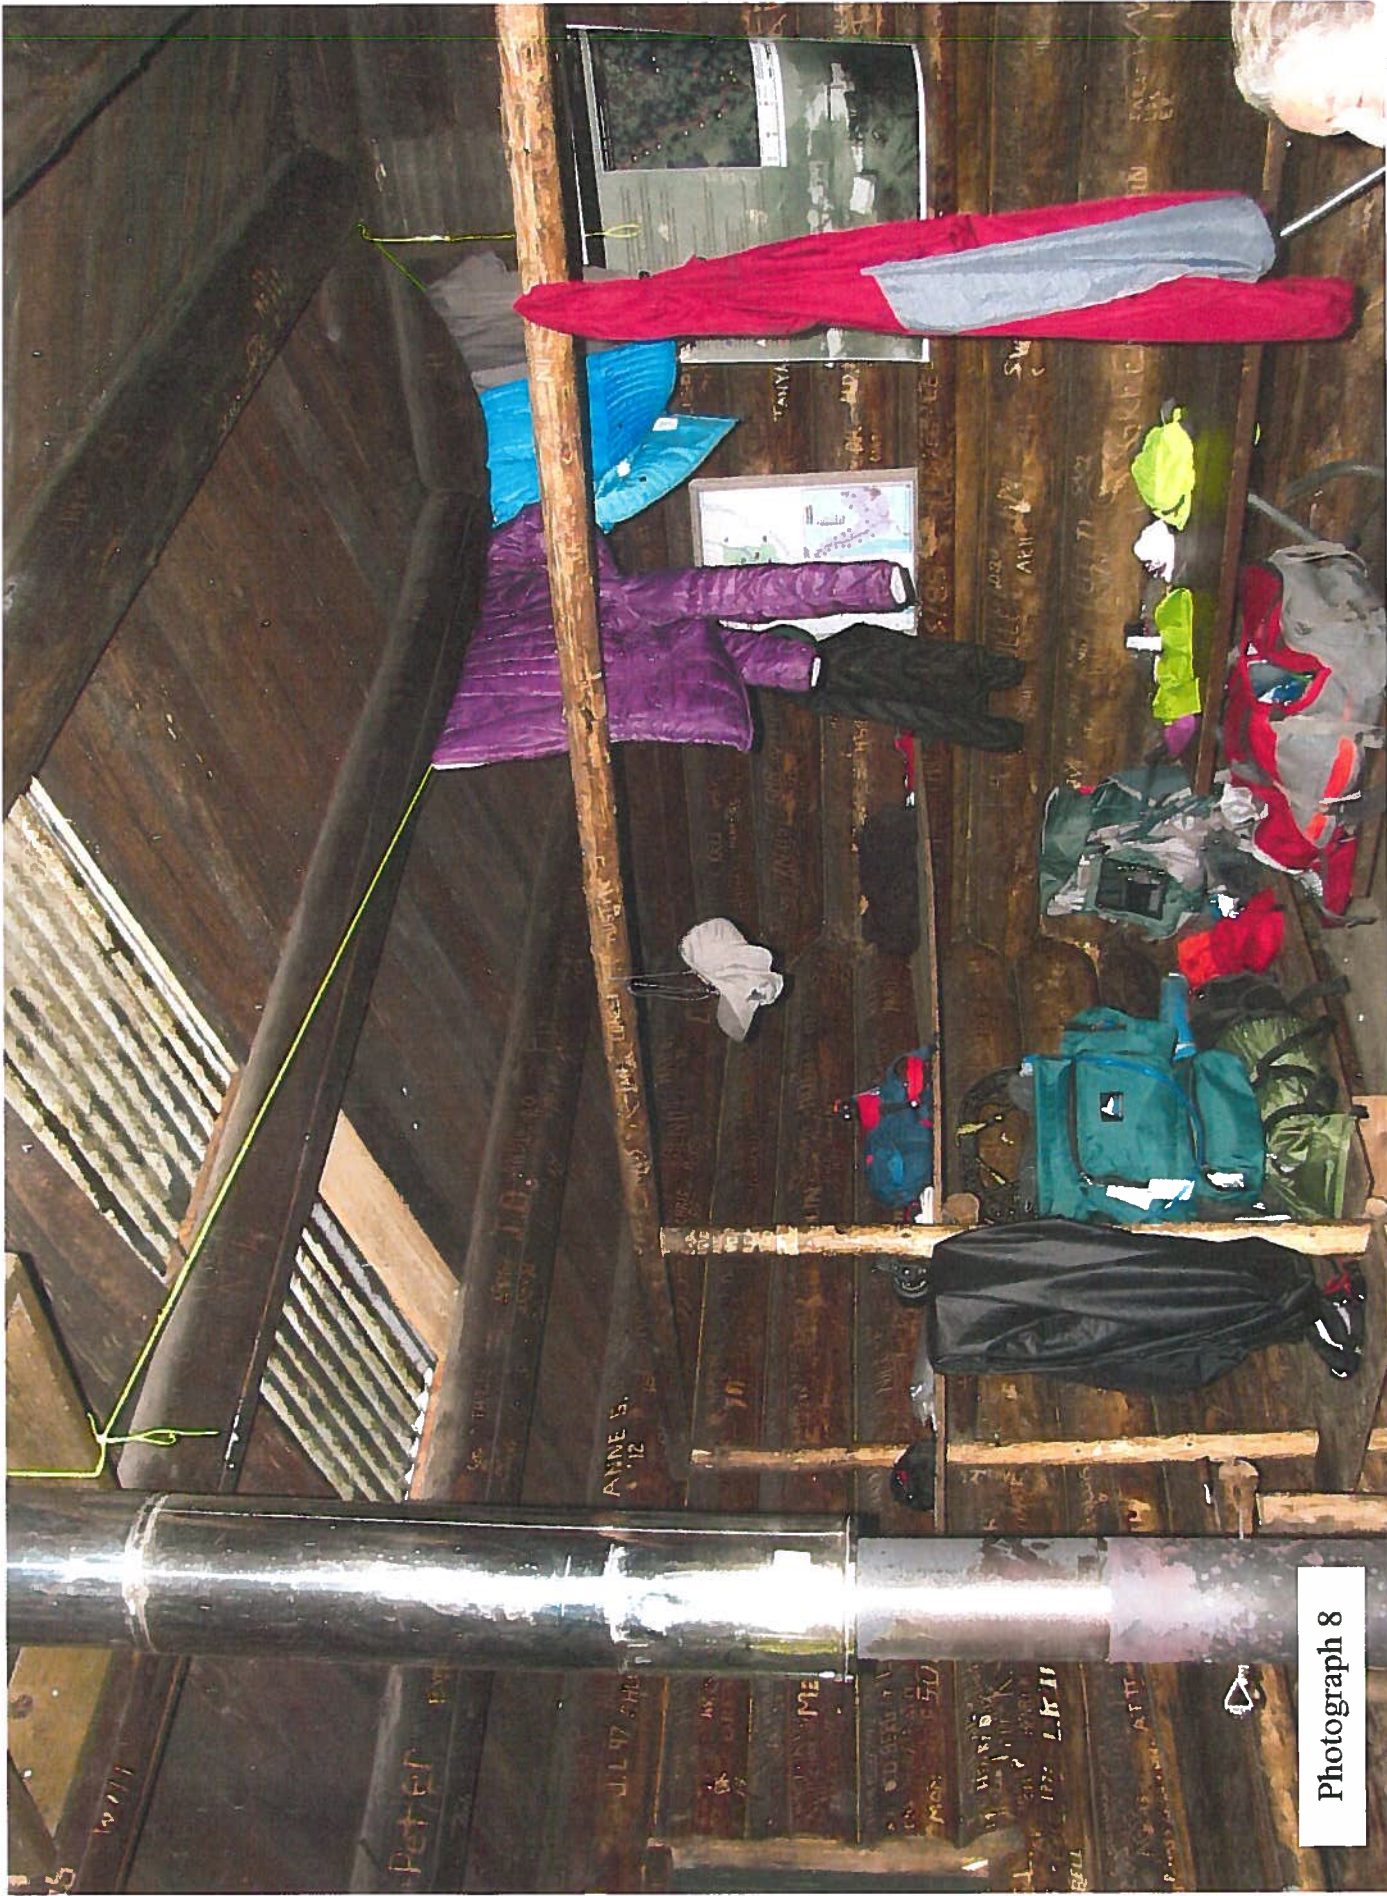
Photograph 8

The building interior consists of one open room with a heat stove, carved wood chairs, bunk beds, and shelving. The wood floorboards are 7" wide, running east to west. Single bunks on the north and south walls on the west end of the room are constructed of stripped log posts with plywood sleeping surfaces. One table, under the window on the north wall, and wall shelves along the west wall have a similar, simple round log construction technique. A "Smart Stove" brand wood burning heat stove sits west of center. It has a corrugated roof hearth surrounded by 5x5" rough cut lumber. Three chairs carved out of tree stumps surround the stove.

Canyon City State Cabin, Mile 7.5, Chilkoot Trail, Interior view from southwest corner showing side (north) and back (east) walls, stovepipe of central warming stove, bunks, graffiti, clothesline for drying hiking gear, skylight, ridge log and two purlins. Susannah Dowds, Klondike Gold Rush National Historical Park, Site Visit, June, 2017.

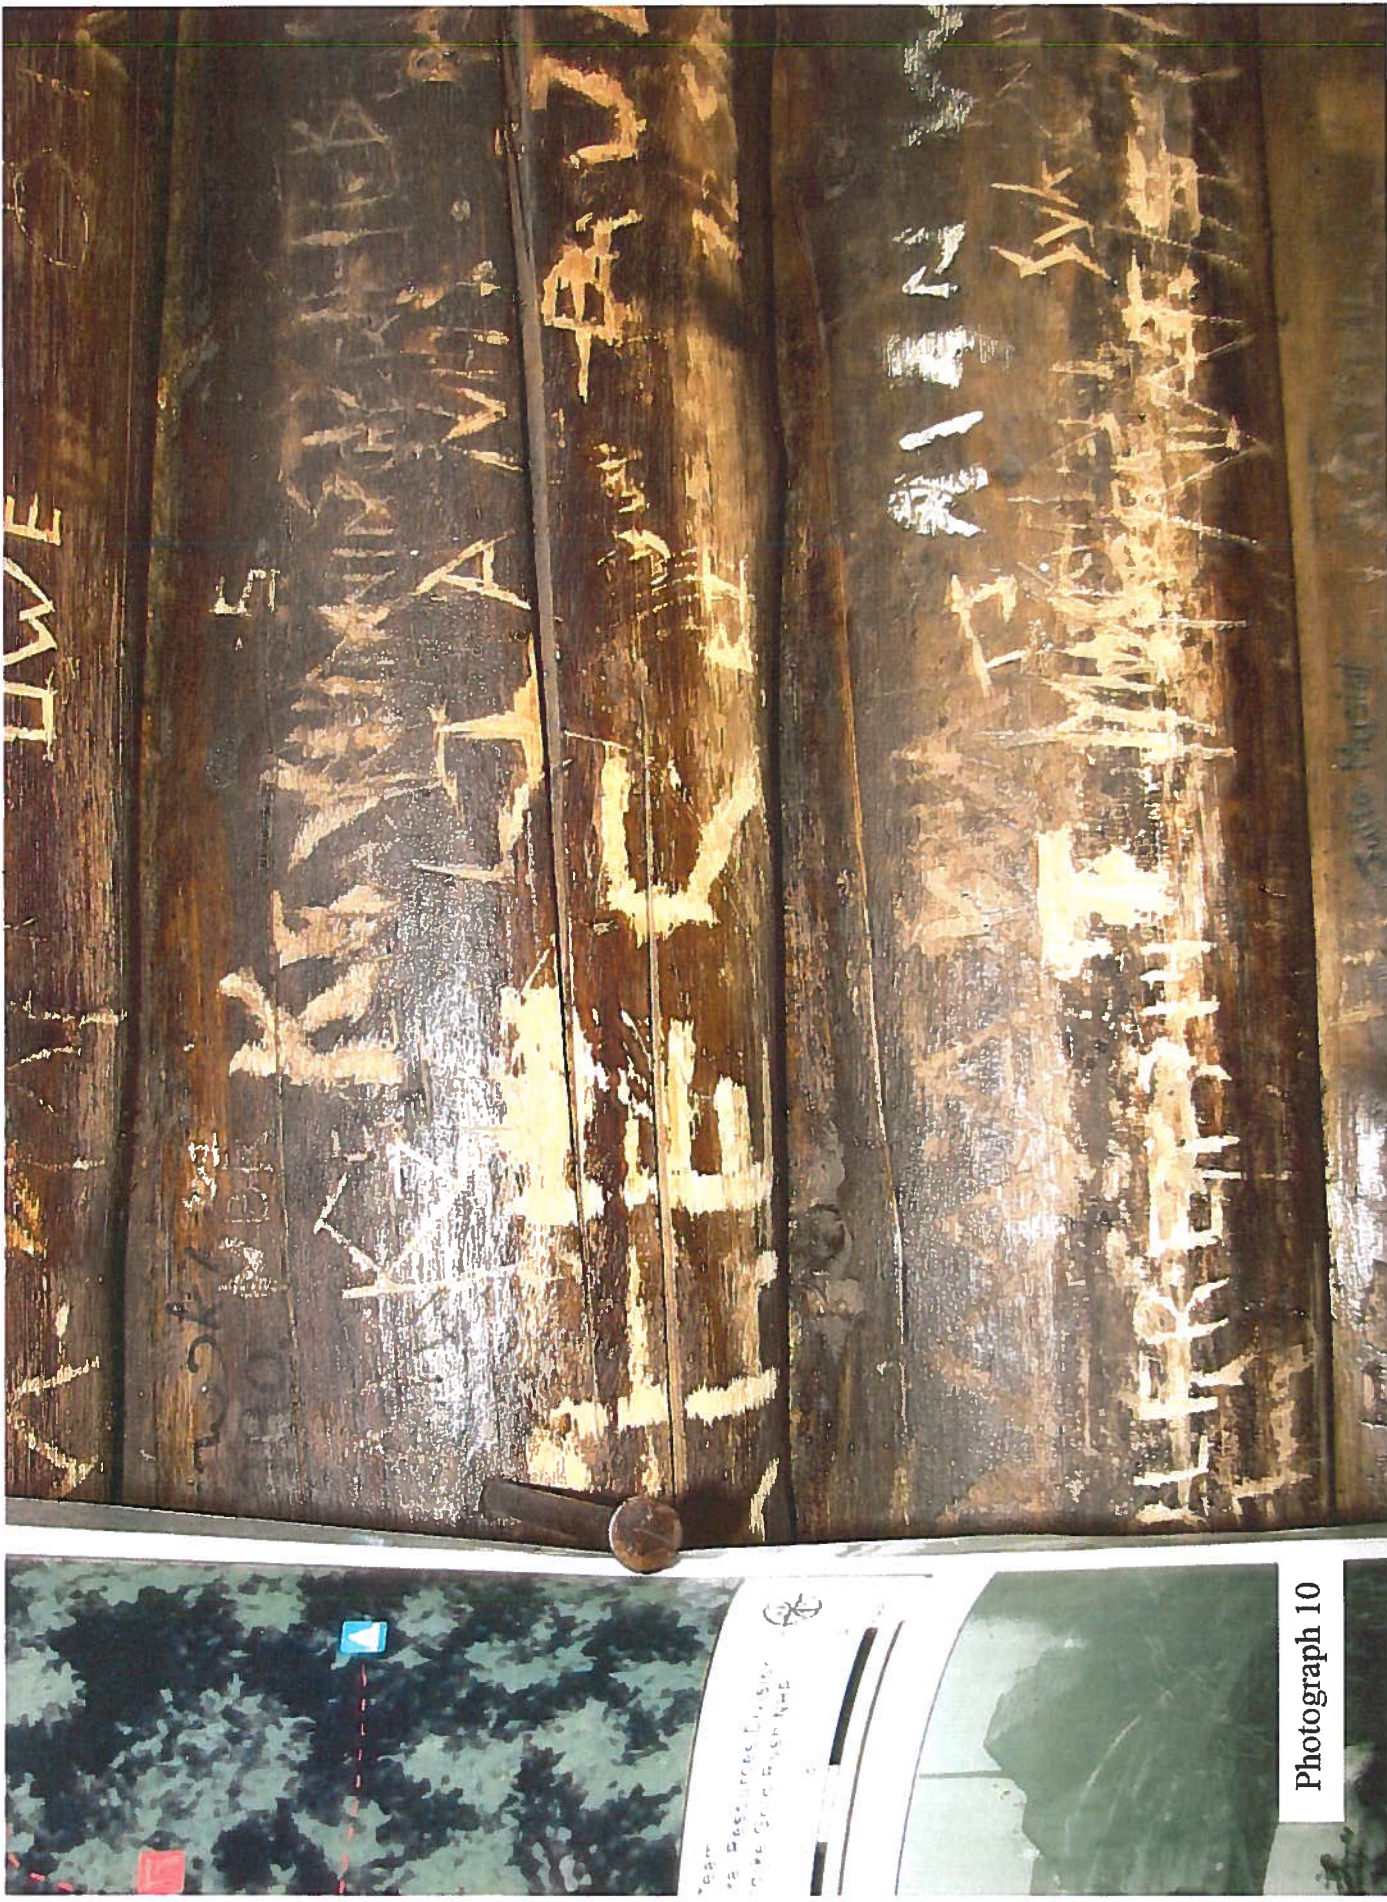
Photograph 10

Almost every surface of the cabin features names, dates and messages, carved or written in marker, by hikers who have visited the site in the past fifty-five years. Additionally, abundantly and conveniently located around the cabin interior are large nails, hooks, and strings for hanging hiking gear and drying wet clothes (Photographs 8-12).

Canyon City State Cabin, Mile 7.5, Chilkoot Trail, Interior, close-up view of carved graffiti. Susannah Dowds, Klondike Gold Rush National Historical Park, Site Visit, June, 2017.

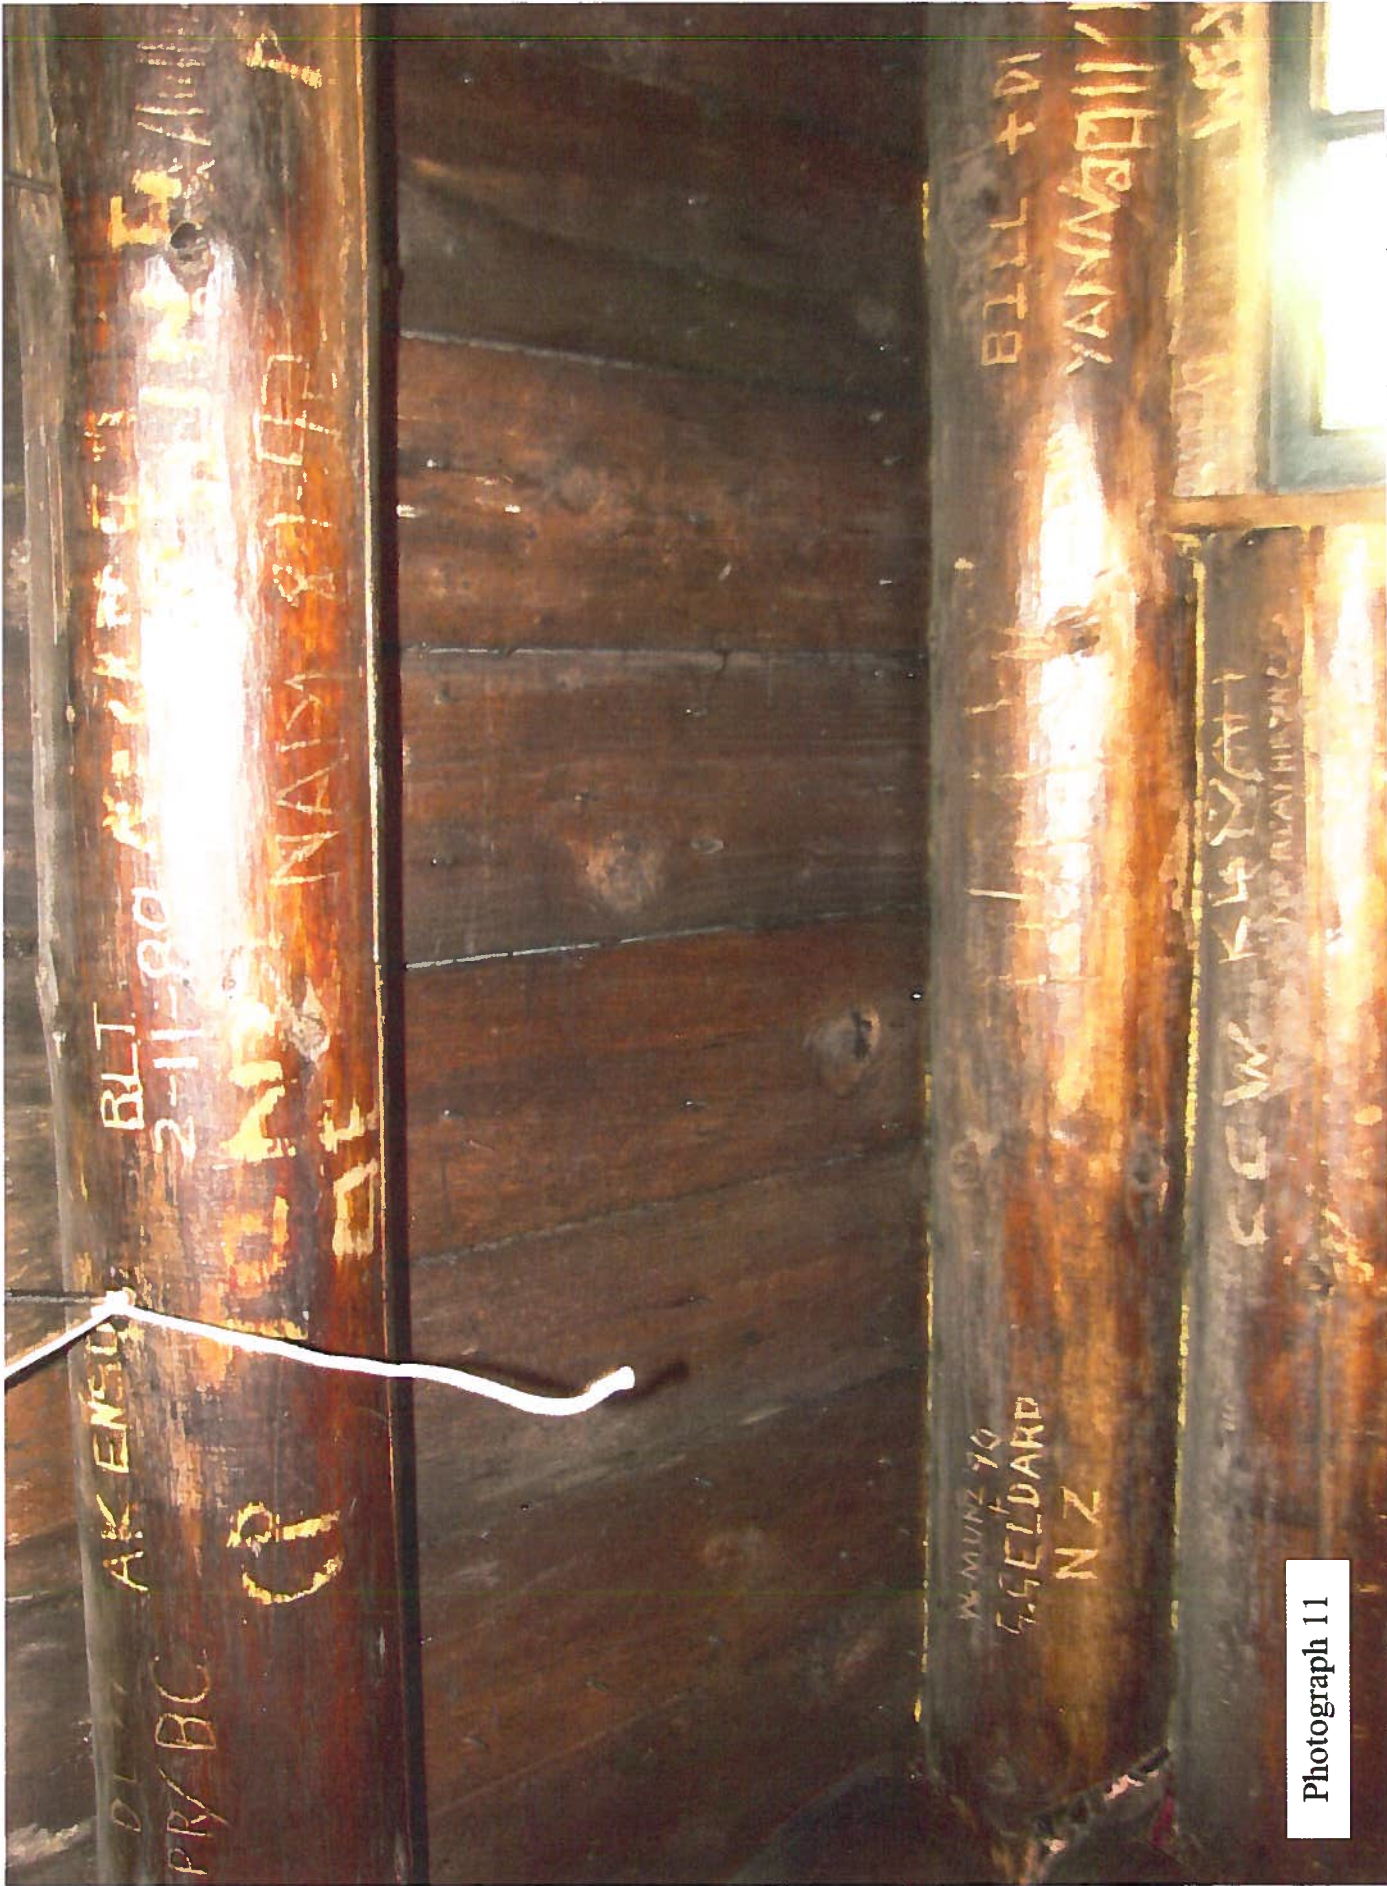
Photograph 11

Canyon City State Cabin, Mile 7.5, Chilkoot Trail, Interior view of clothesline and graffiti on purlines, dating as early as 1989. Susannah Dowds, Klondike Gold Rush National Historical Park, Site Visit, June, 2017.
