Subject: Determination of Eligibility for the National Register of Historic Places for Canyon City Cabin (Mile 7.5) and Sheep Camp Cabin (Mile 13) of the *Chilkoot Trail and Dyea National Historic Landmark* within the Klondike Gold Rush National Historical Park and Preserve

National Register of Historic Places Registration Form

Historic name: Canyon City State Cabin

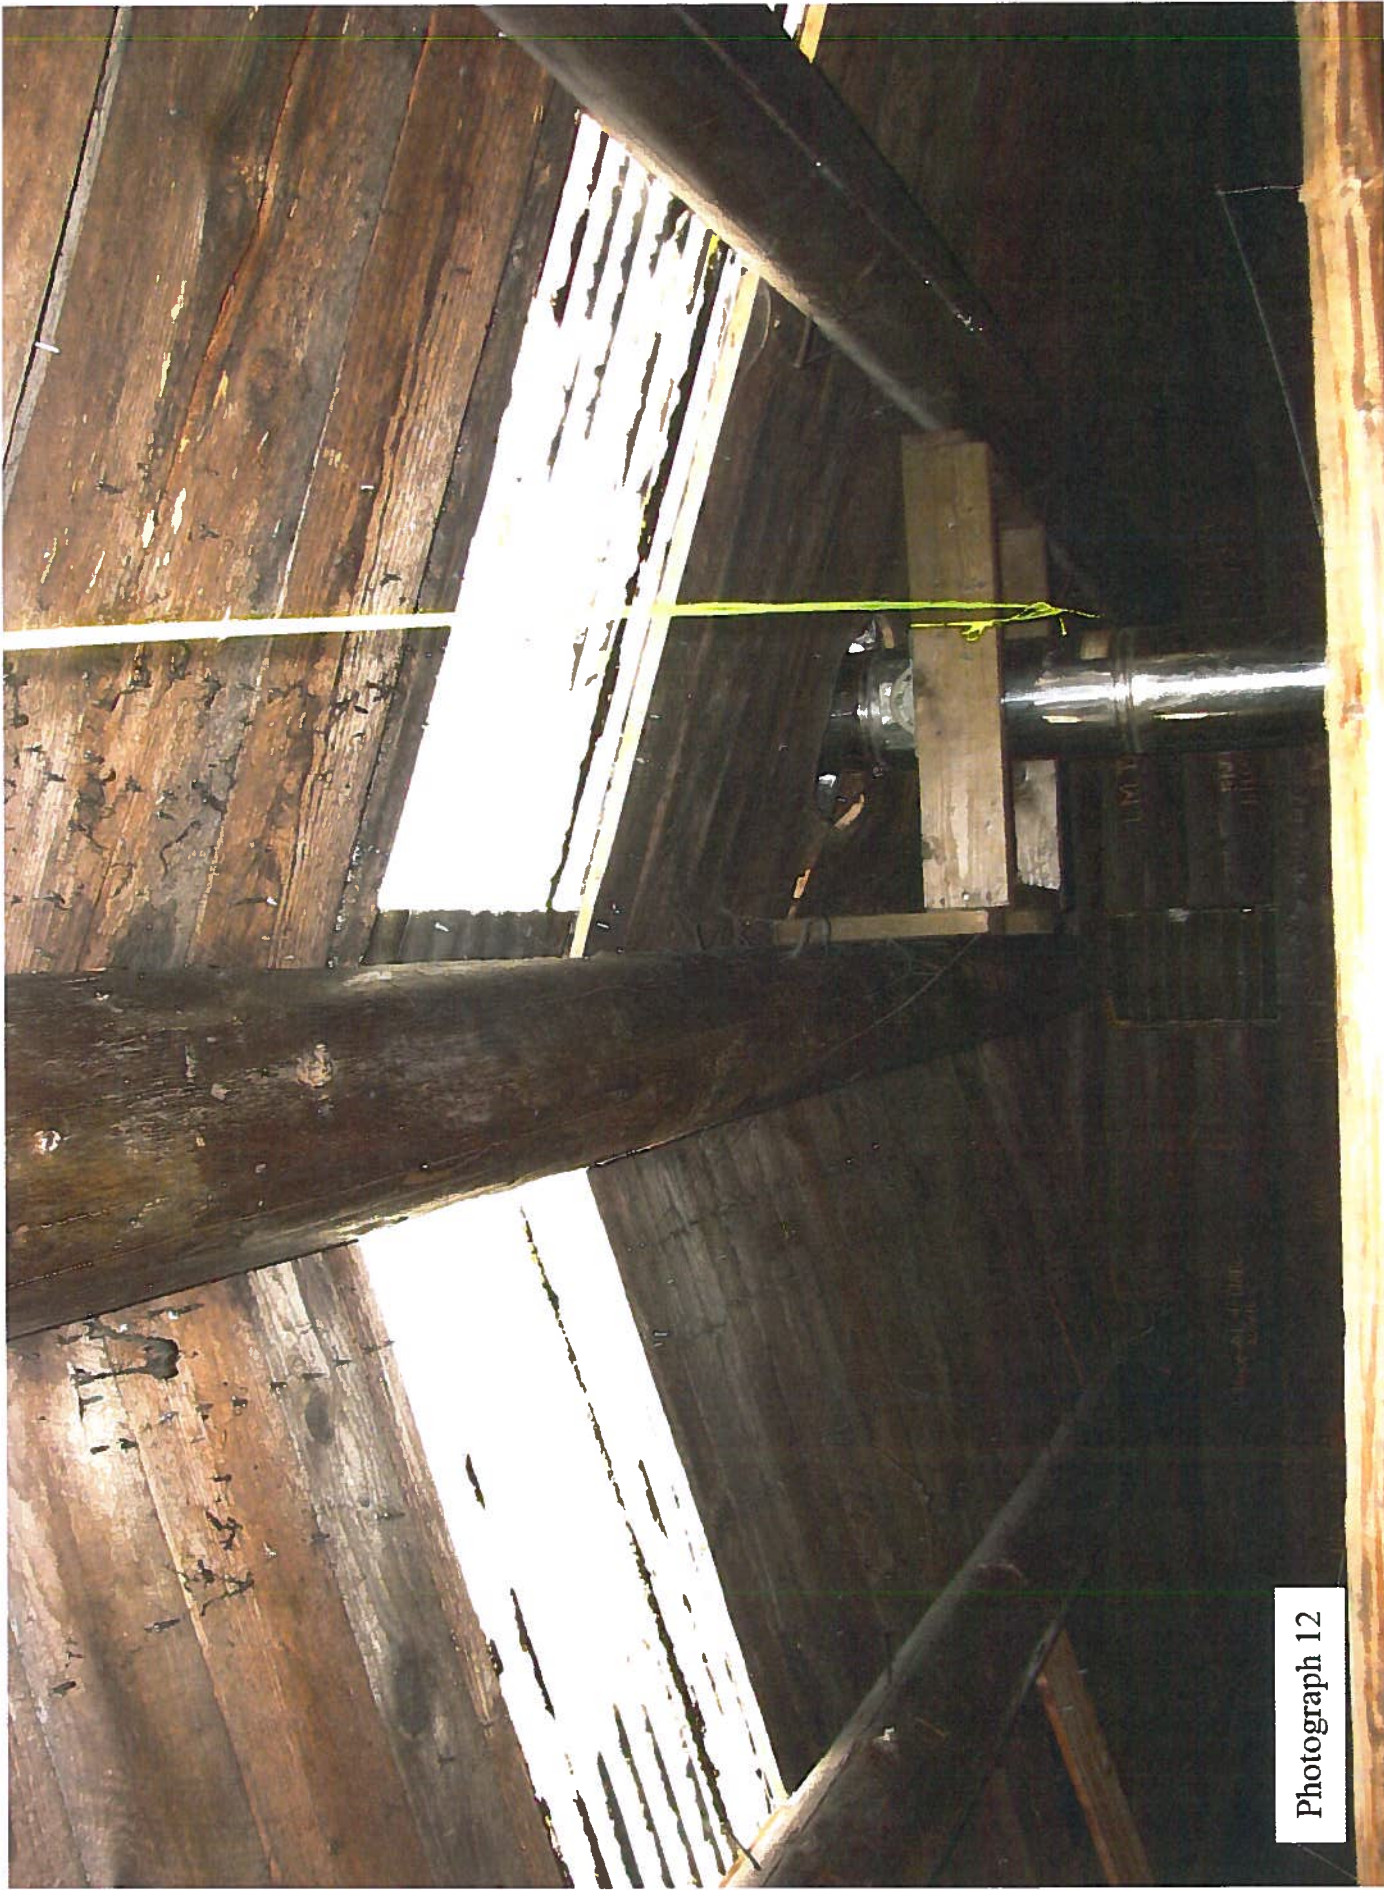
Photograph 12

A ridge log and two purlins on each slope compose the roof framing and 1" dimensional lumber boards varying in width from six to twelve inches runs from the ridge board to the drip edge of the roof to support the corrugated roofing. At the west and east gable ends, 2x6" barge boards, painted green, partially cover the purlins of the projecting roof. On the north and south sides of the roof, 2x4" fascia boards, also painted green, are attached to the dimensional lumber boards running from the ridge board. The roof rests on two wall plate logs at the top of the north and south façades, wall plate logs extend the full 27'-10" length of the building. Three vertical, wood posts support the roof over the porch (Photograph 5).

Canyon City State Cabin, Mile 7.5, Chilkoot Trail, Interior view of ceiling taken from the back (east) wall, shows top of west wall, ridge log and purlins, beams, skylight, metal louvered opening, clothesline and top of support for bunks.

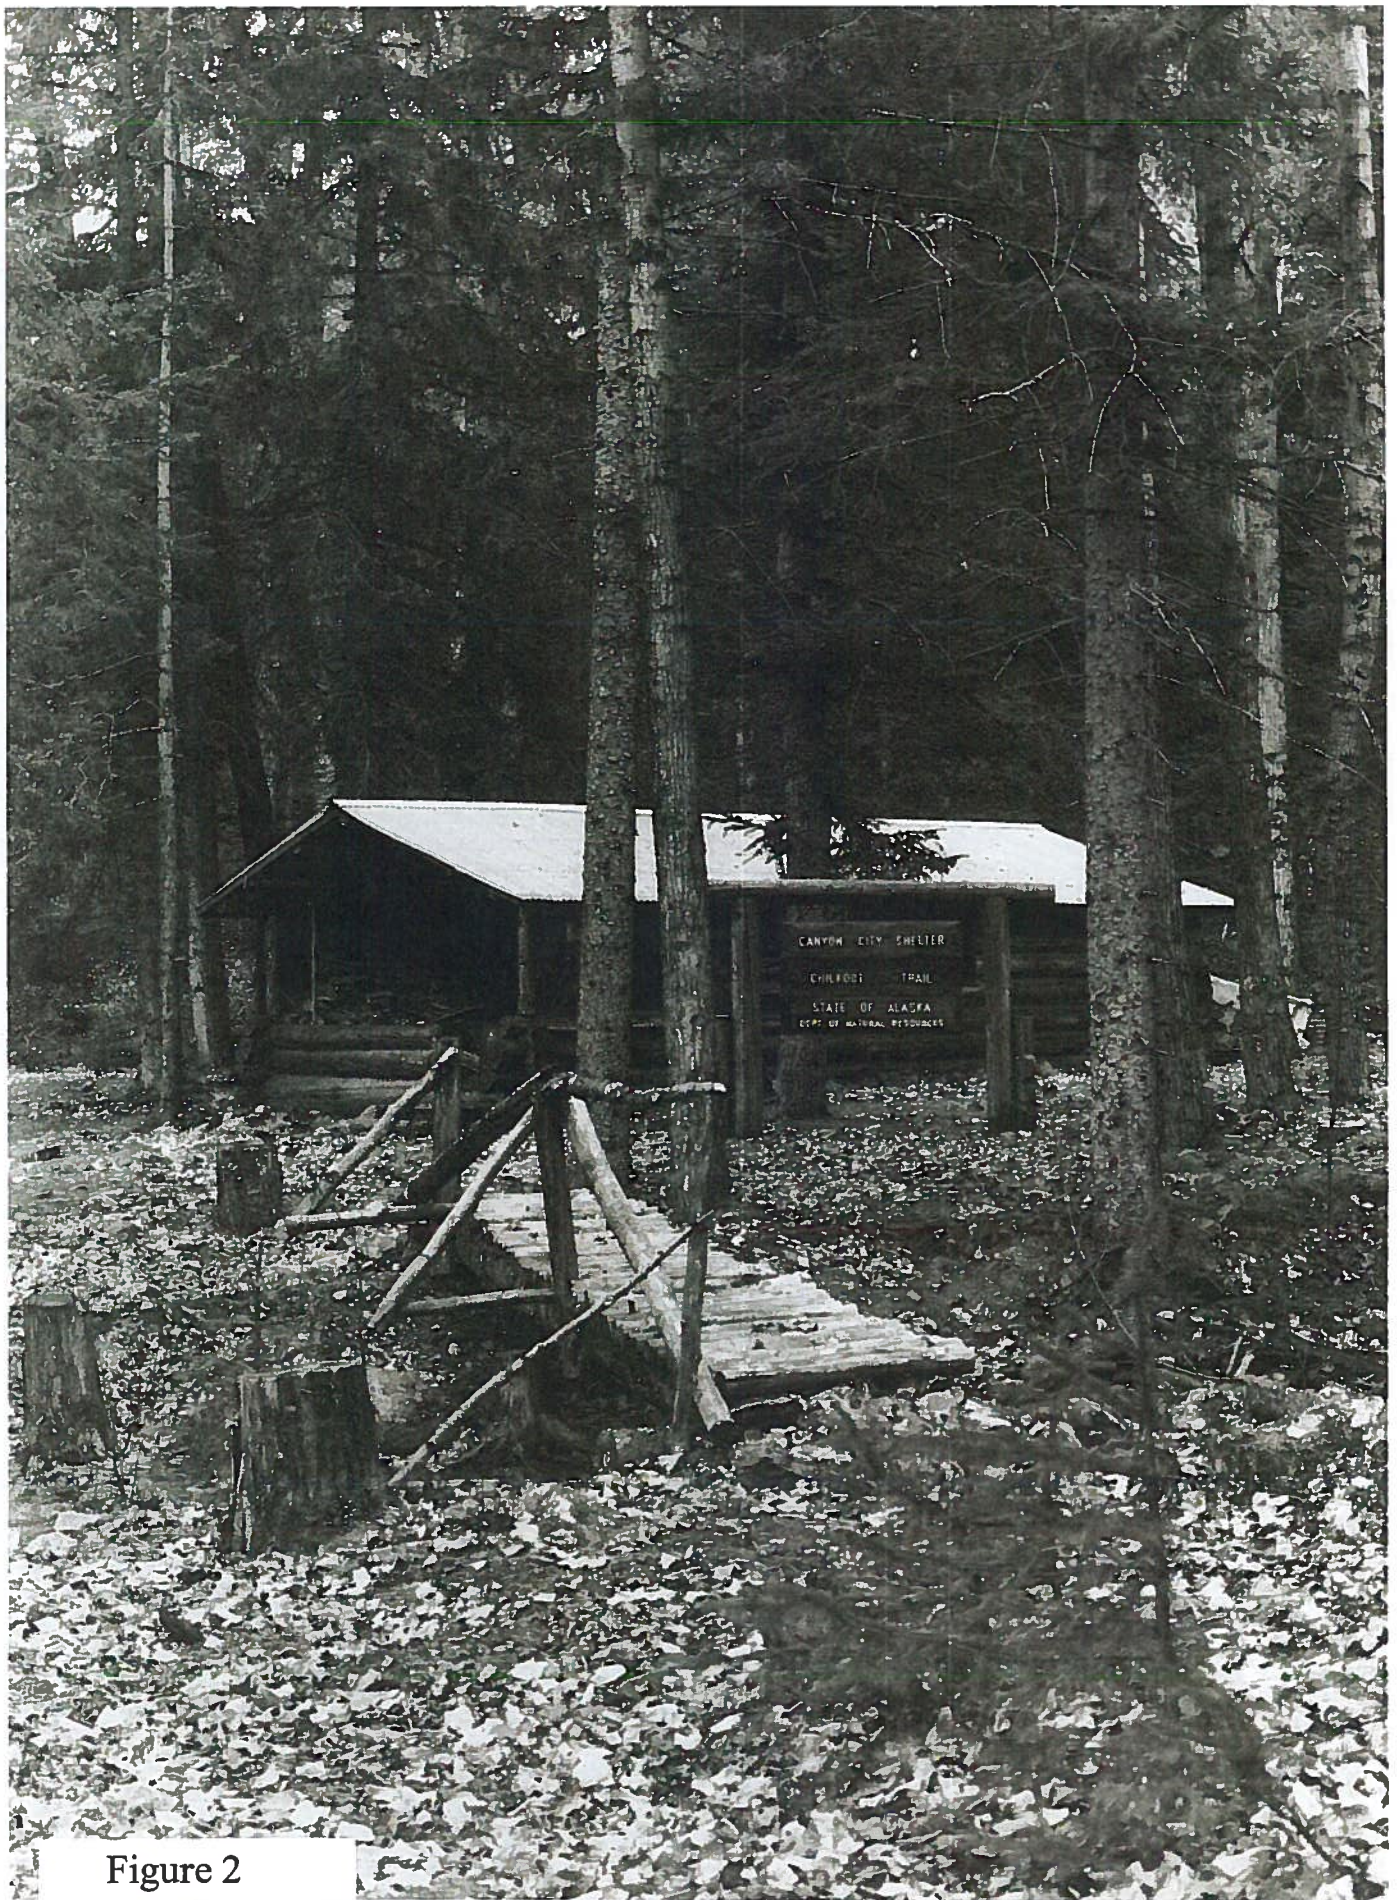
Figure 1

Canyon City State Cabin, Mile 7.5, Chilkoot Trail, west (front) façade, view looking east.
Unknown photographer, NPS 1977 (NPS, KLGO, Administration Maintenance File, 02.06.338.46666).

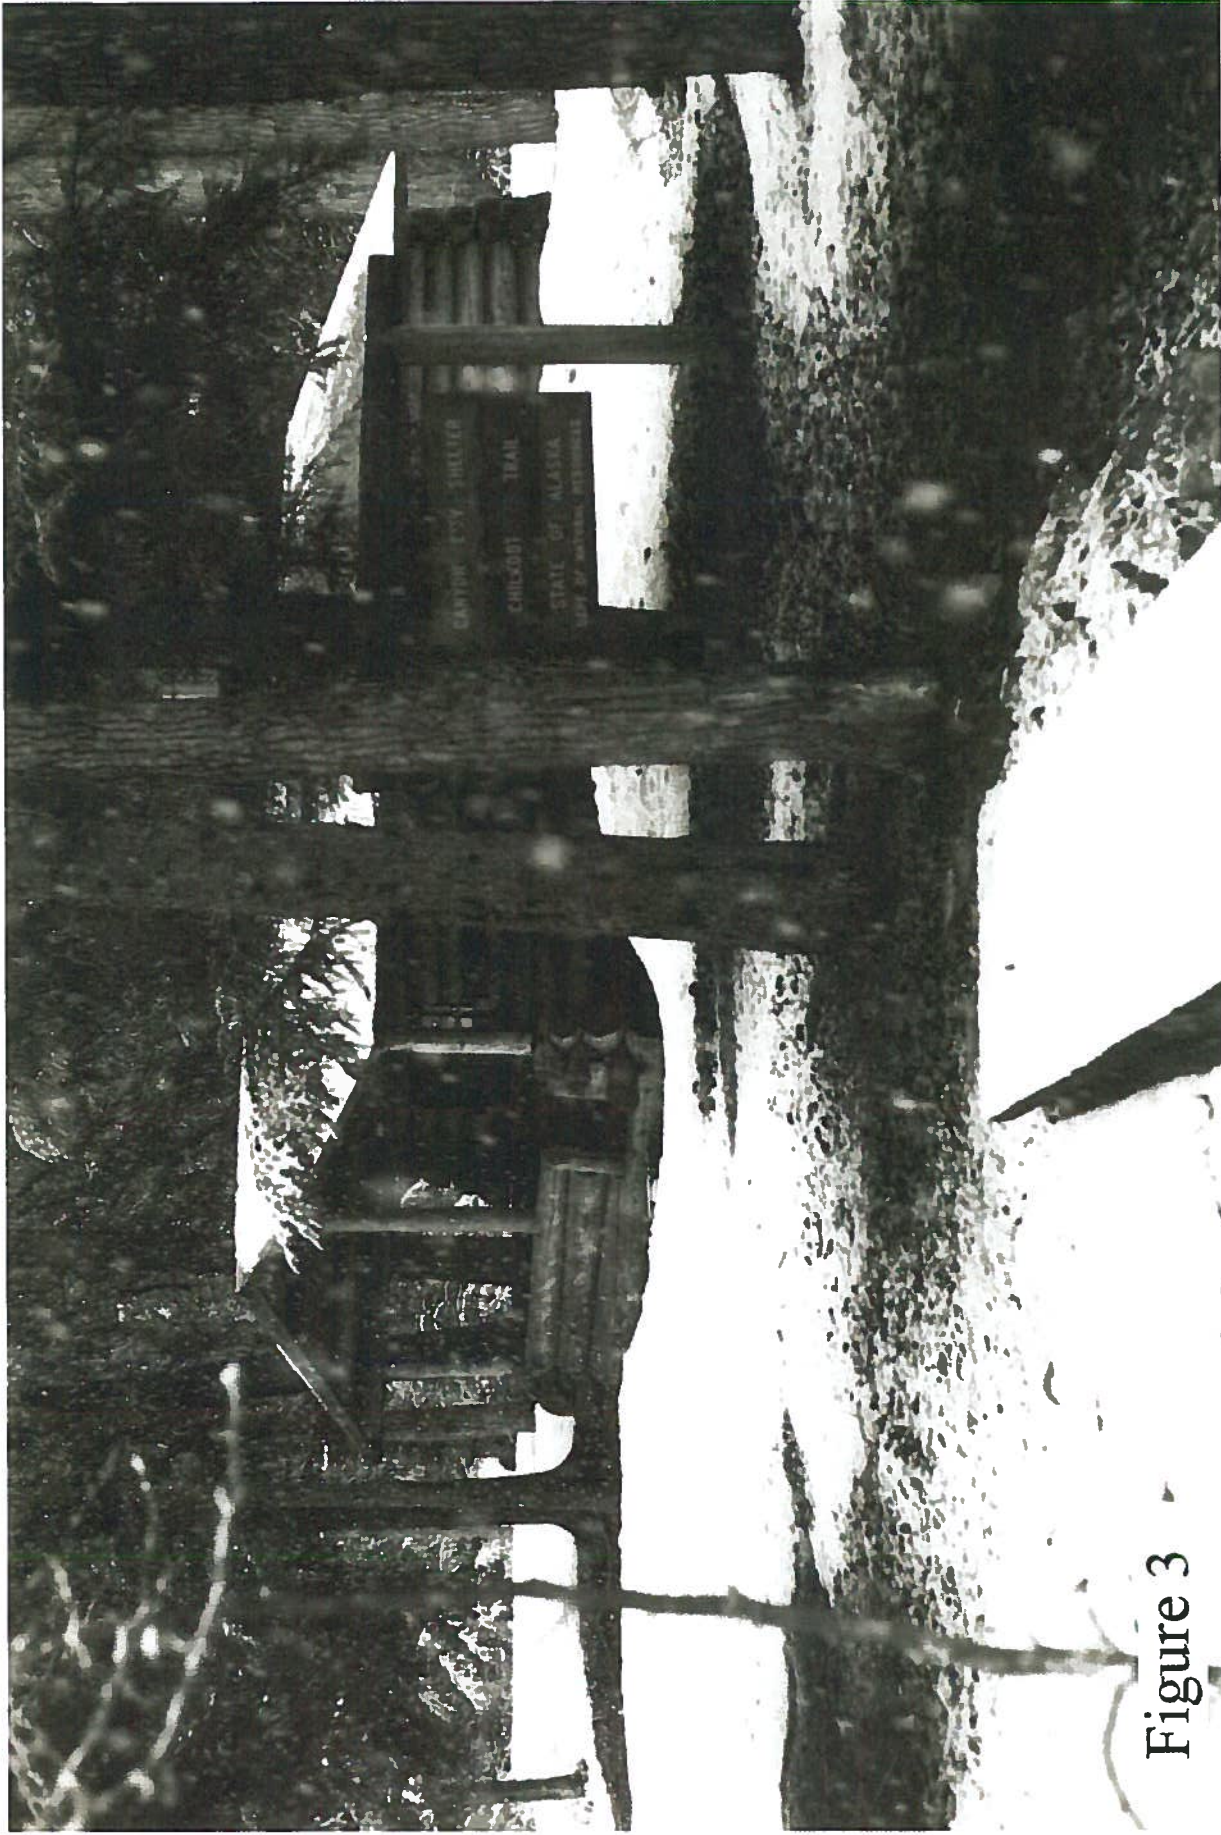
Figure 3

A 2004 report, by building conservator Harrison Goodall, rated the cabin as being in good to fair condition. By comparing historic images of the cabin, it is evident that a king post was added to

Canyon City State Cabin, Mile 7.5, Chilkoot Trail, West (front) and south (side) façades, view looking northeast. Unknown photographer, NPS 1985 (NPS, KLGO, Administration Maintenance File, 02.06.338.43882).
