Knife River Indian Villages National Historic Site

Natural Resource Condition Assessment

Natural Resource Report NPS/ NPS/KRI/NRR—2014/775

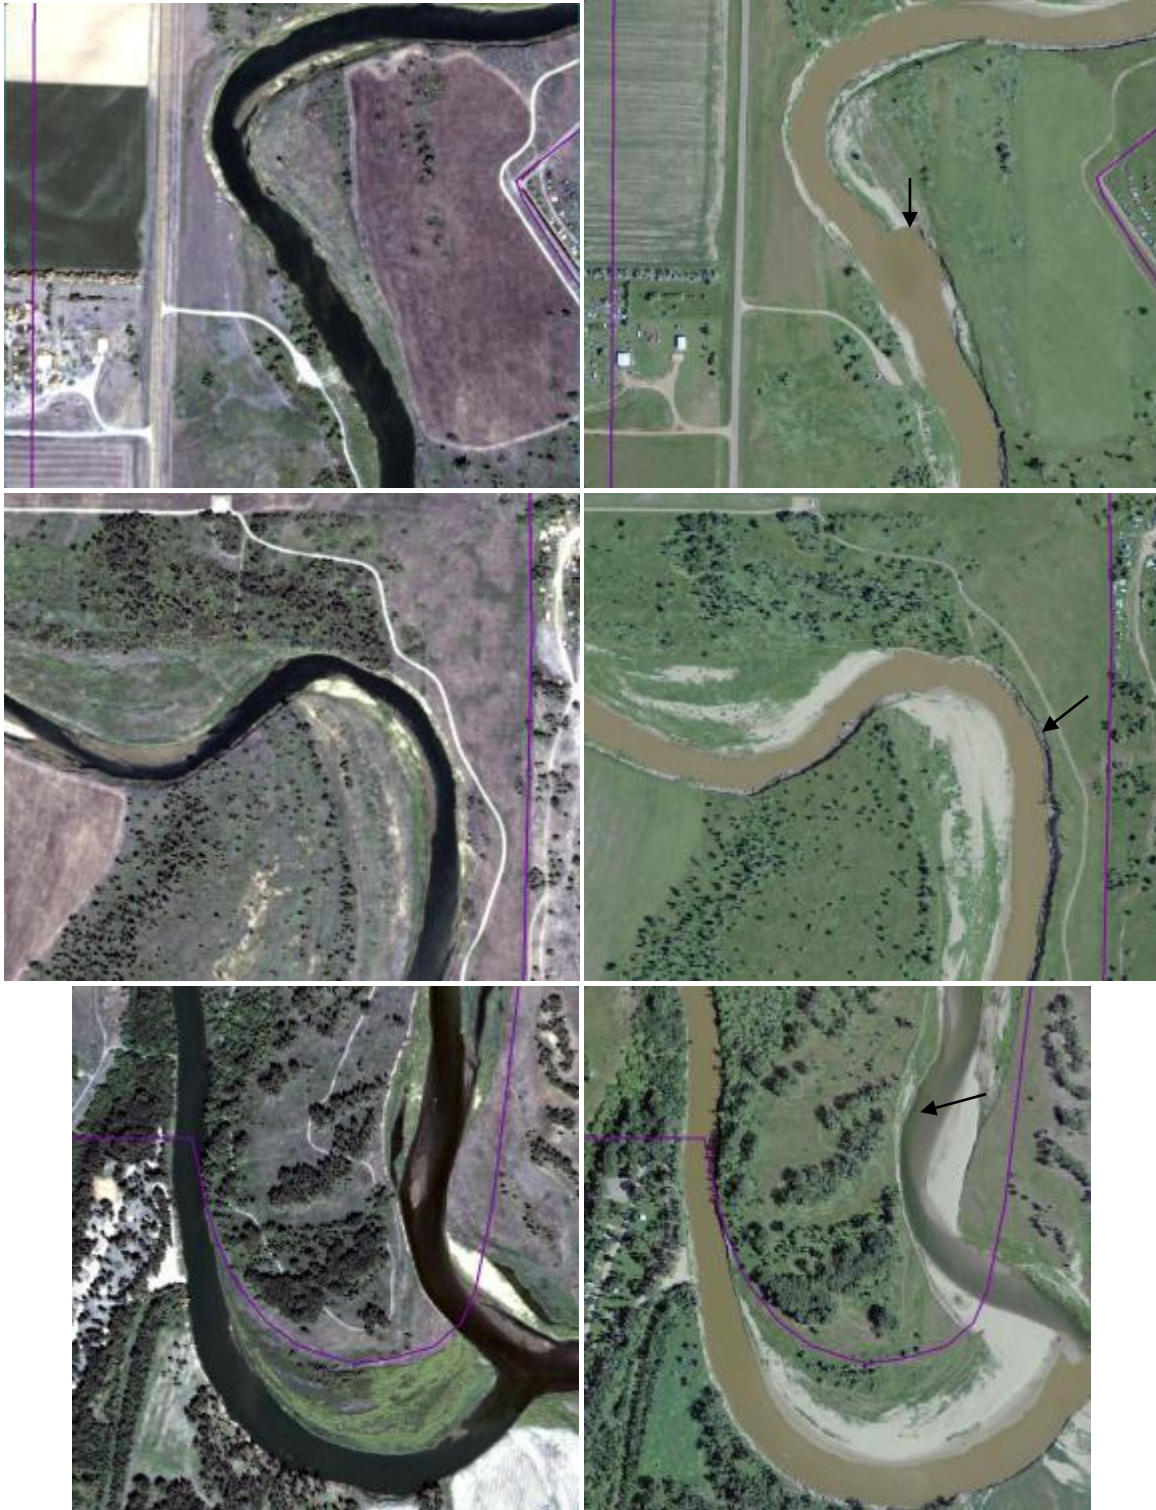
Figure 6. Examples of recent river migration in KNRI (2004 to 2009): 27 July 2004 QuickBird Satellite imagery (left), and 24 July 2009 United States Department of Agriculture (USDA) National Agriculture Image Program (NAIP) aerial photography (right). Image pairs (2004/2009) are left to right. Arrows identify some of the visual evidence of river migration between photo pairs.

Morphological changes in the river result in changes to the land cover of KNRI. Providing a quantification of these changes is beyond the scope of this assessment. However, given the bank changes measured by Sexton (2012), changes in land cover have been occurring since 1965; 2002 aerial photography (Salas and Pucherelli 2003) also shows evidence of land cover change occurring from 2002 – present in the park. Sexton (2012) measured bank movement along each major bend in the Knife River (except Peninsula Bend in the southern portion of the park) from 1965 to 2009. The author found mean distances of river bend bank movements from 1965 to 2011 ranged from 14 to 77 m (48 ft to 253 ft), and in some sections of river bends, the bank moved nearly 91 m (300 ft). Sexton (2012) offers a repeatable set of methods to measure future river bank movement. Although not mapped in the Sexton (2012) study, park staff indicates that the Peninsula Bend in the area referred to as “Peninsula Woods” has also experienced notable morphological change. This area is a strip of land between the Missouri and Knife Rivers containing riparian woodlands. Some of the recent changes due to migration of the Missouri and Knife Rivers (i.e., erosion and deposition processes) are illustrated in paired aerial photos from 2004 and 2009 (Figure 6). Further, detailed illustrations and measurements of river bend migration from 1965 to 2011 are found in Sexton (2012).

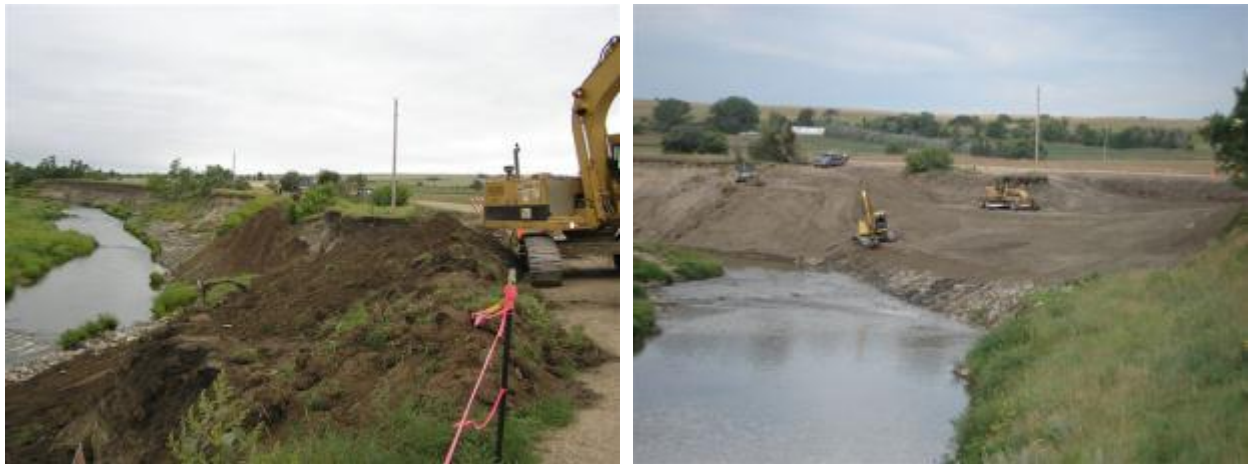
Figure 7. Photos of riverbank repair along Taylor's Bluff in KNRI, August 2009. On the left, Taylor's Bluff prior to major excavation, fill, and rip rap installation; on the right, Taylor's Bluff in the process of rip-rap installation.

Erosion associated with periods of increased flow is a concern to park management because of the threat it poses to archeological sites in the park. It is important to note that while much of the Knife River migration is likely occurring naturally, bank stabilization features (rip-rap) have altered natural erosion and deposition in some areas of KNRI. Bank stabilization was installed along the Sakakawea Village by the USACE in 1979 (Ahler 1984), then additional bank stabilization was installed at Taylor's Bluff in 1984-85 (Clambey 1985). In a 2009 spring flooding event, portions of the Tri-lock bank stabilization system failed. In response, riverbank stabilization restoration work was completed on approximately 183 m (600 ft) of river bank along Taylor's Bluff, repairing damage by filling and installing rip-rap (Figure 7). The Taylor Bluff bank is now a combination of rip-rap and tri-lock, and the stabilization features at Sakakawea Village are comprised of rip-rap.

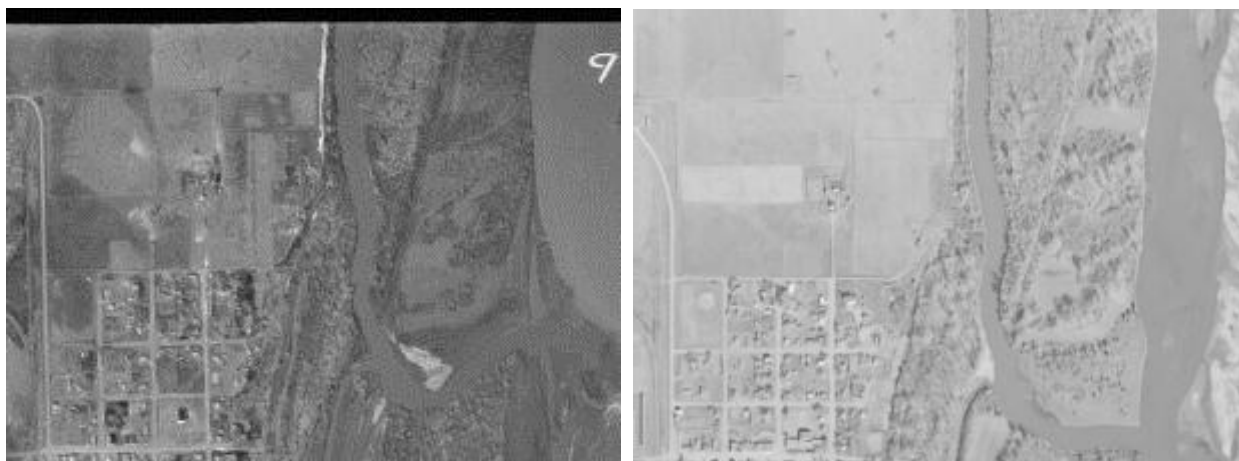
Figure 8. Portion of an aerial photo of Stanton/Knife River area captured 4 April 1943 (left), and 8 October 1965 (right) (Digital Horizons 2012).

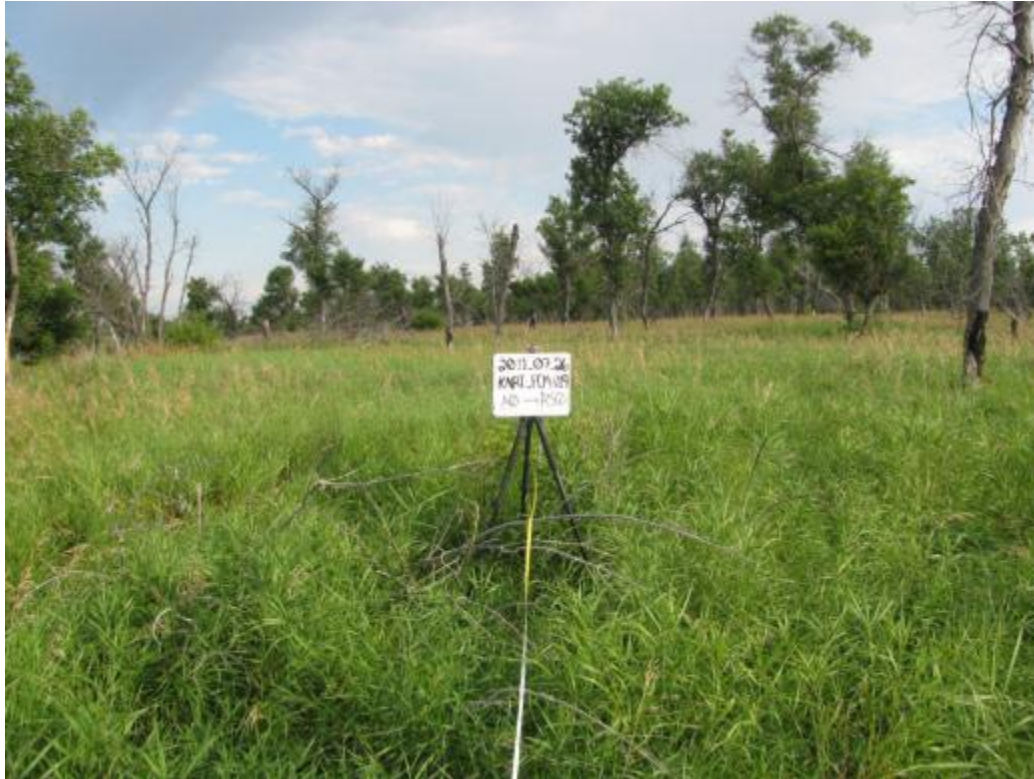
Photo 5. A forested plot in KNRI showing evidence of tree mortality (photo from Ashton et al. 2011).

Ashton et al. (2011) found only three sample plots that contained evidence of tree and tall shrub species. At these sites, no saplings were observed, and only five living trees were documented. These trees were not in optimal health, as two of the five trees exhibited more than 10% mortality on their branches. Snag trees with high amounts of dieback were common across these plots (Photo 5). Across two sites (KNRI_PCM_002 and KNRI_PCM_020), seedlings were observed for boxelder, green ash, chokecherry, and silver buffaloberry (*Shepherdia argentea*) (Table 14).

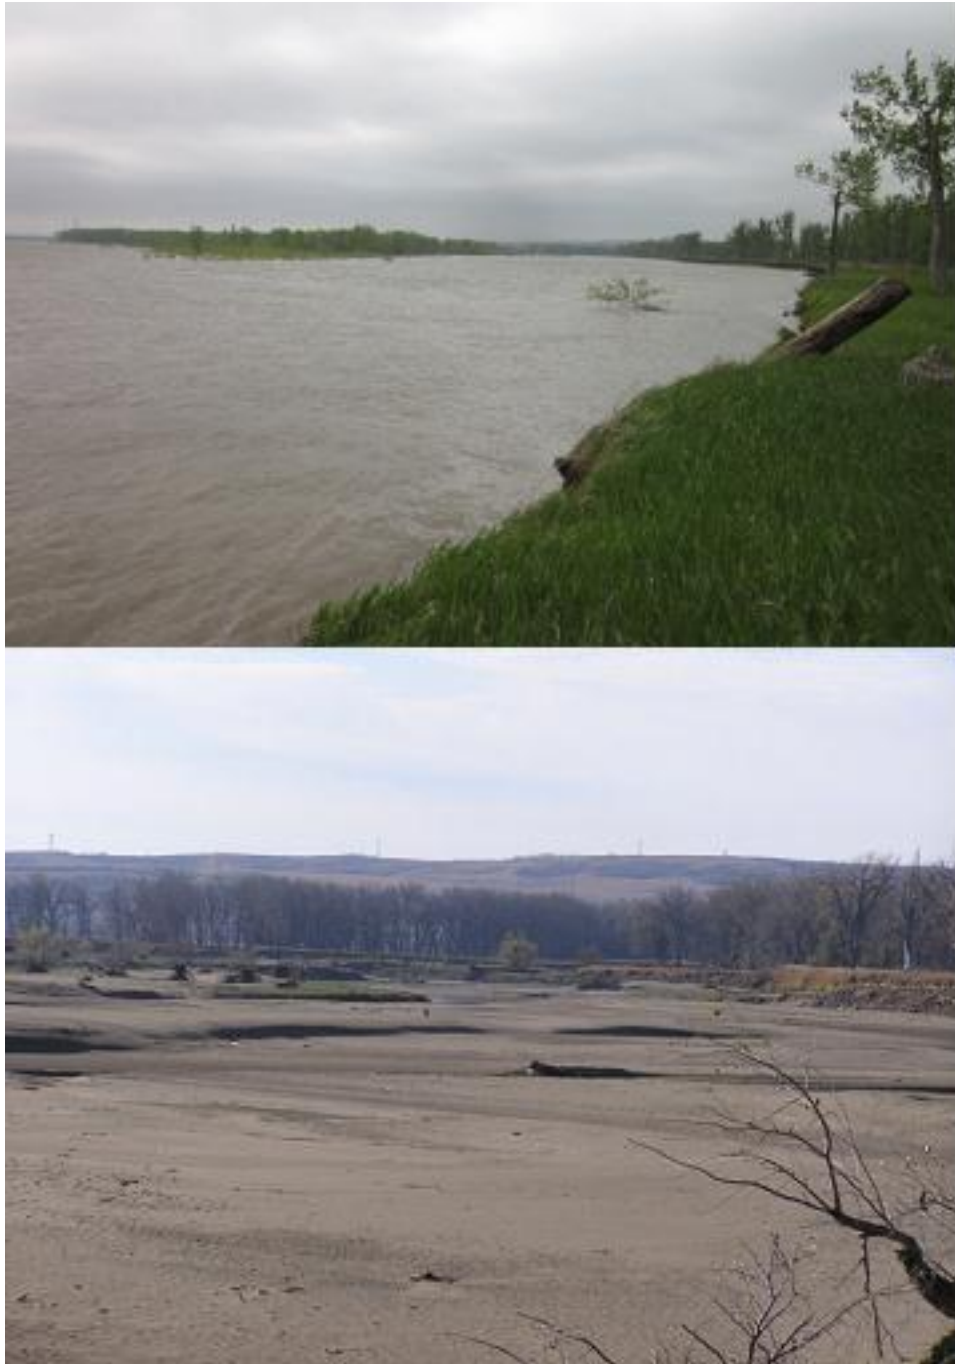
Photo 6. Missouri River byway near KNRI during the prolonged 2011 flood event (top), and Missouri River byway filled in with silt and sand after the prolonged 2011 flood event (bottom) (photos from John Moeykens, NPS).

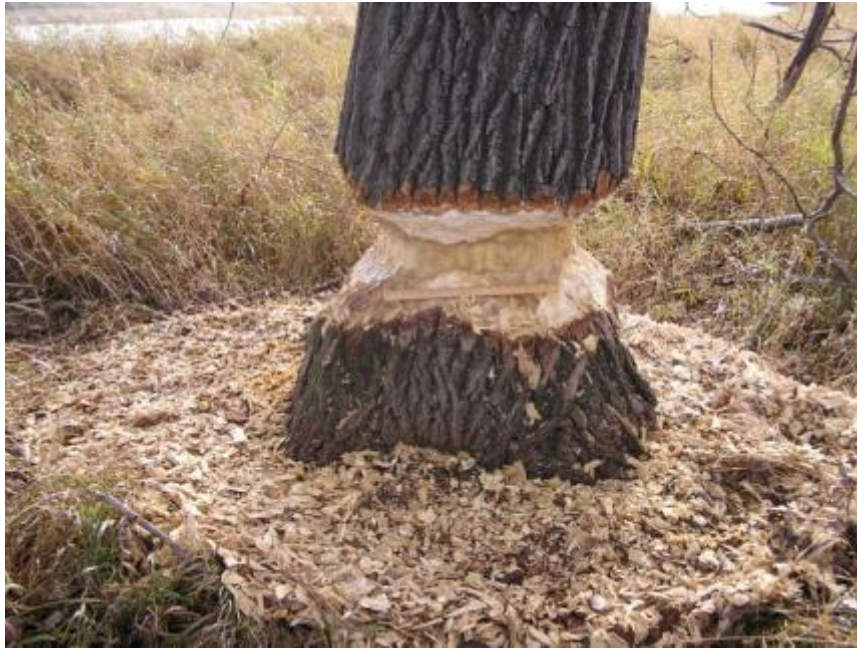
Photo 7. Example of a fresh beaver cut in KNRI. An 18-inch ruler is located in the cut to provide context for how large the cut/tree are (photo by John Moeykens, NPS).

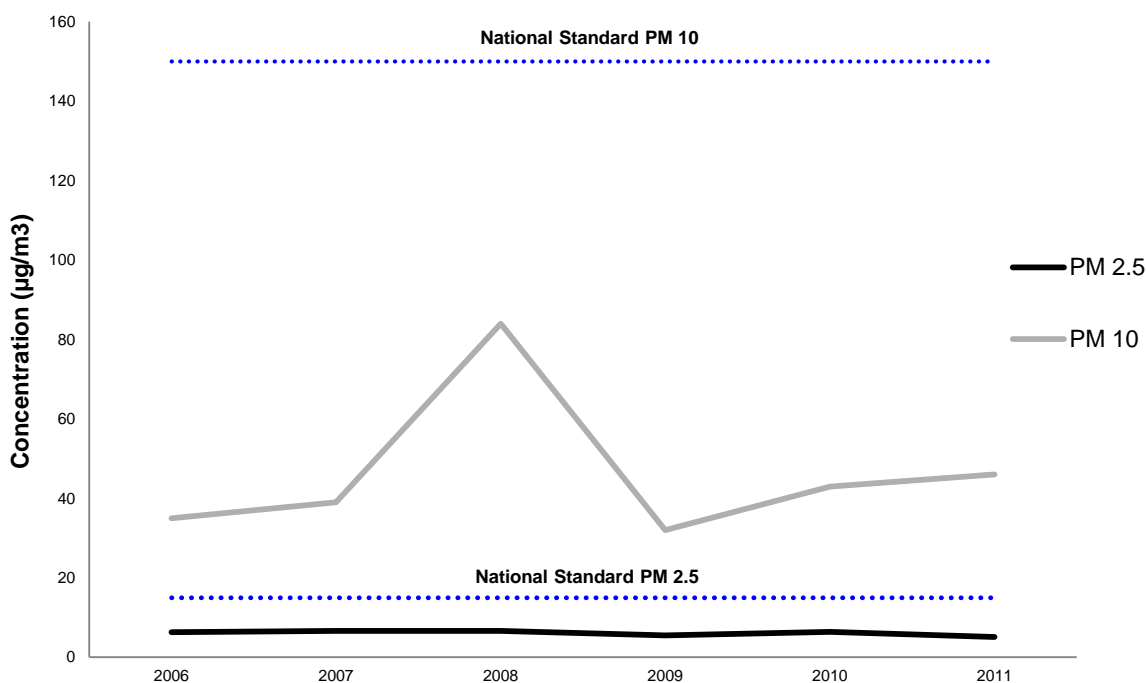
Figure 18. Average annual particulate matter concentration (PM_{2.5} and PM₁₀) near KNRI, 2006-2011 (EPA 2011).

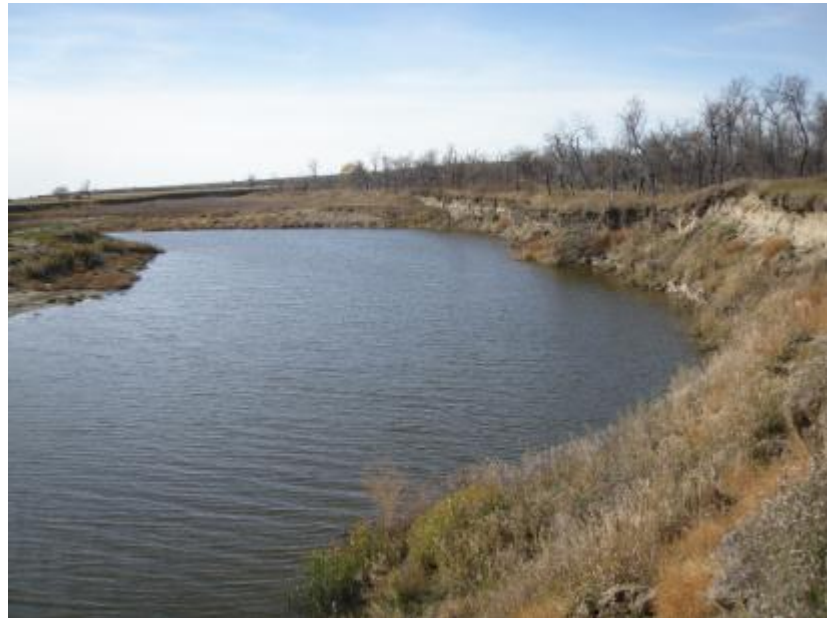
Photo 16. Example of outer bank erosion of the Knife River in KNRI (SMUMN GSS Photo).

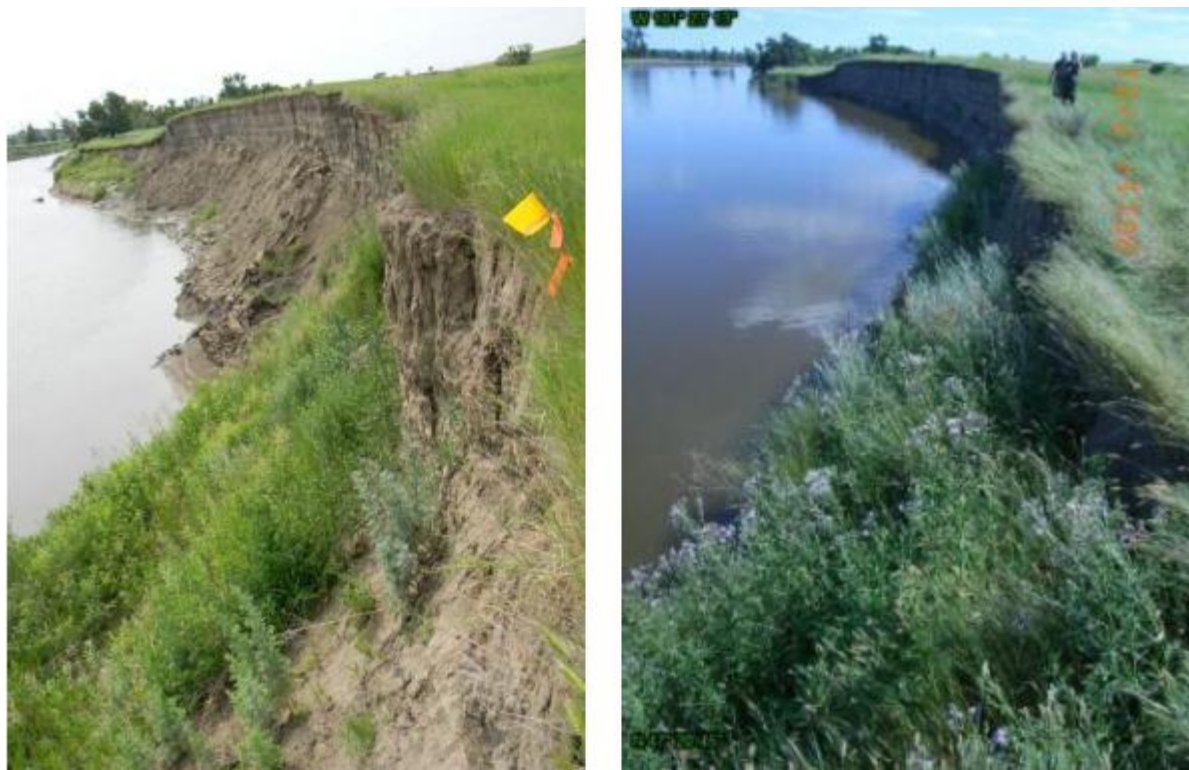
Figure 21. The Knife River, under flood waters, at the Elbee Bluff site looking downstream. On the left is June 2010, and on the right is July 2011 (Images from Cummings 2011).

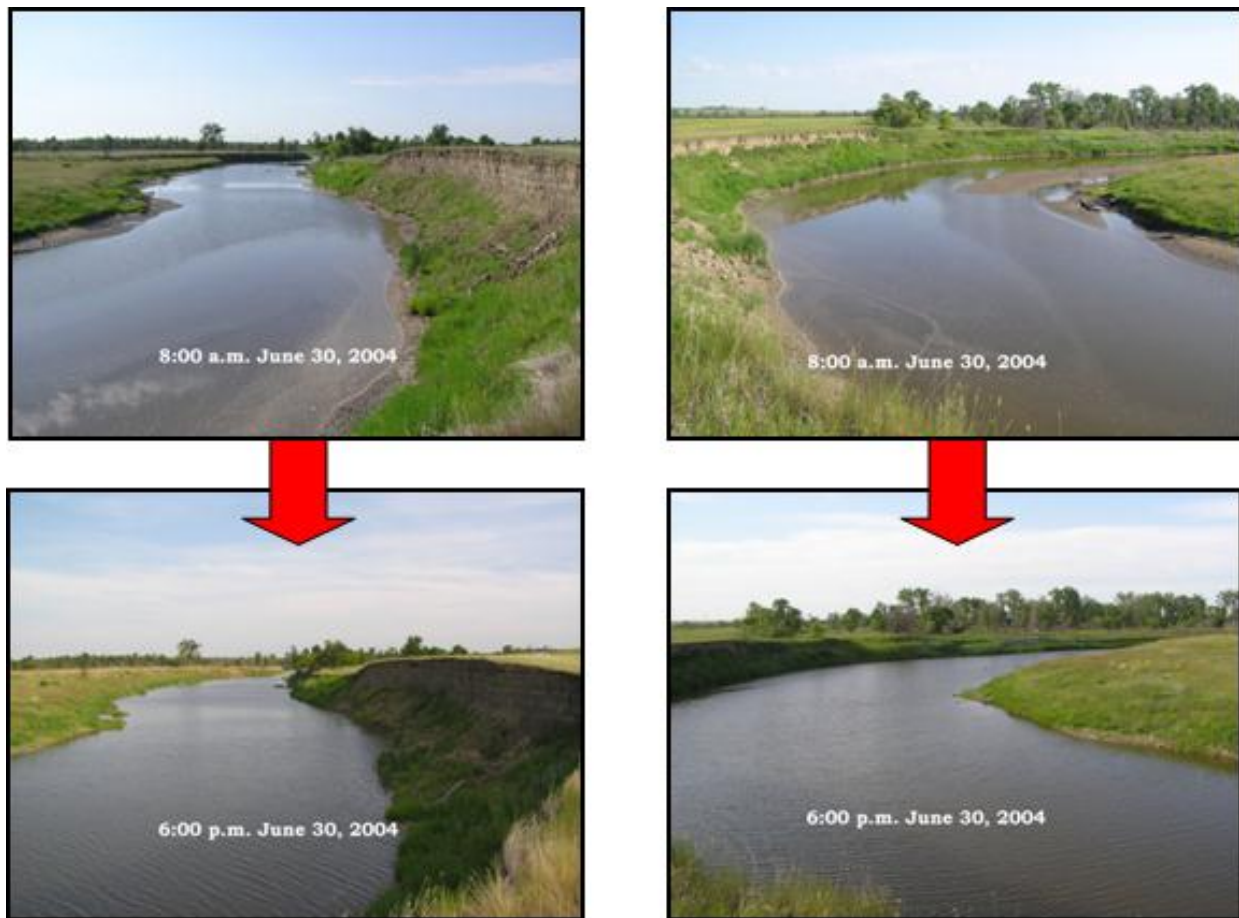
Figure 22. An example of the backwater effect at the Elbee Bluff site due to elevated flow release from the Garrison Dam. Figure reproduced from Ellis (2005).

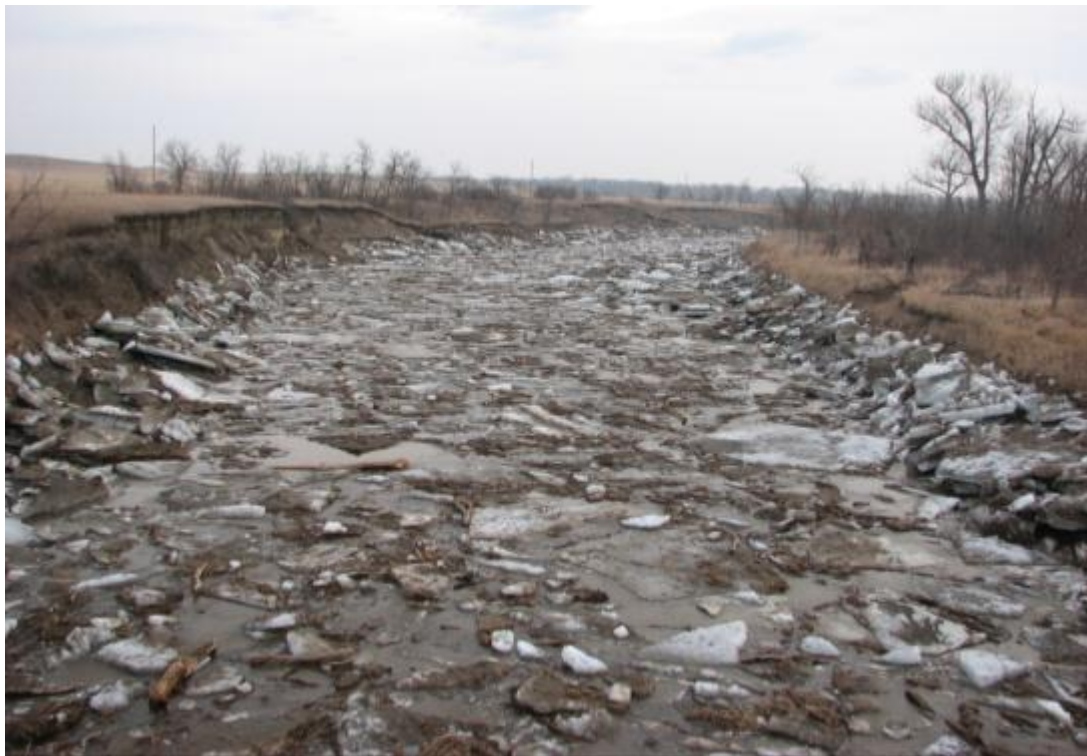
Photo 17. Ice jam on the Knife River. Photo taken by John Moeykens, NPS.

An increase in the frequency of high precipitation events could correlate to an increase in bank erosion along the Knife River. While erosion and deposition of sediment are natural processes along the river, an increase in precipitation or groundwater seepage could accelerate the process. Ice jams, while natural, result in bank gouging and an acceleration of bank erosion rates. An increase in the frequency of major ice jams and floods could result in a dynamic shift in the erosion rates of the river and could accelerate the natural meander process of the river. Furthermore, the size and duration of these ice jams has increased the erosion rates near several archeological sites; examples of severe ice jams are seen in Photo 17, Photo 18, and Photo 19.

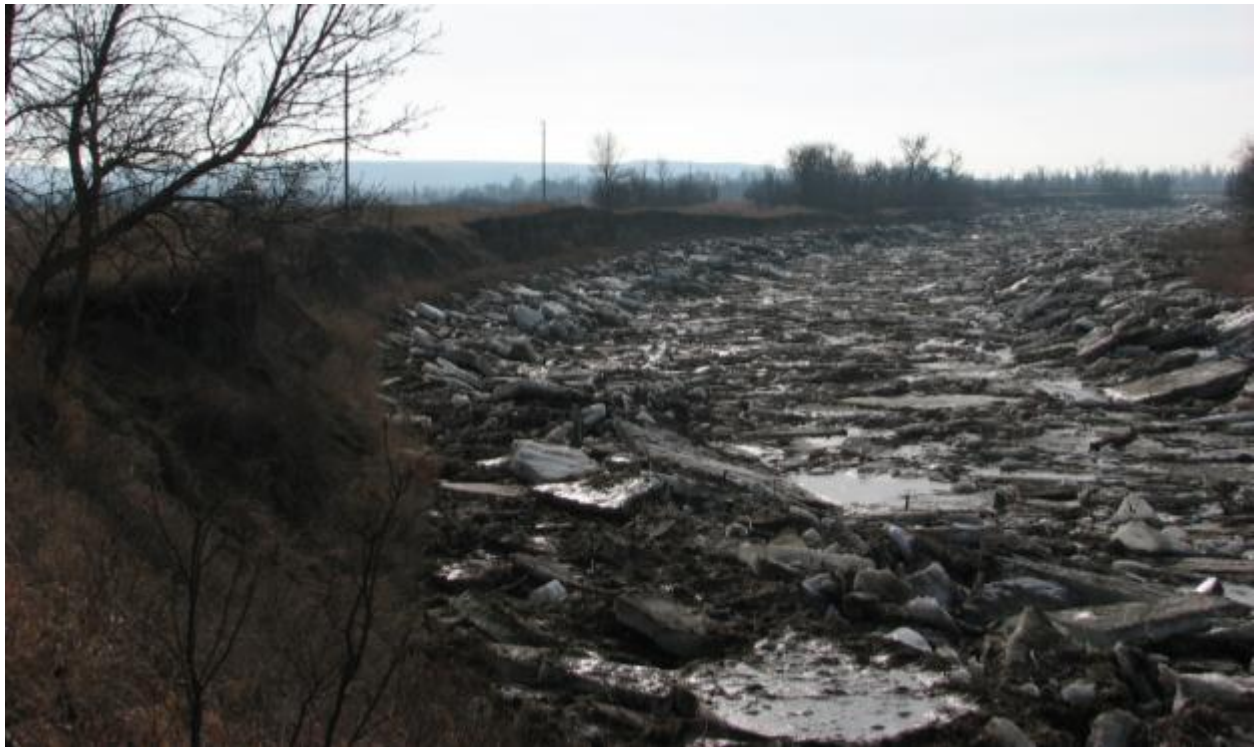
Photo 18. Ice jam along a bend of the Knife River. Photo taken by John Moeykens, NPS.

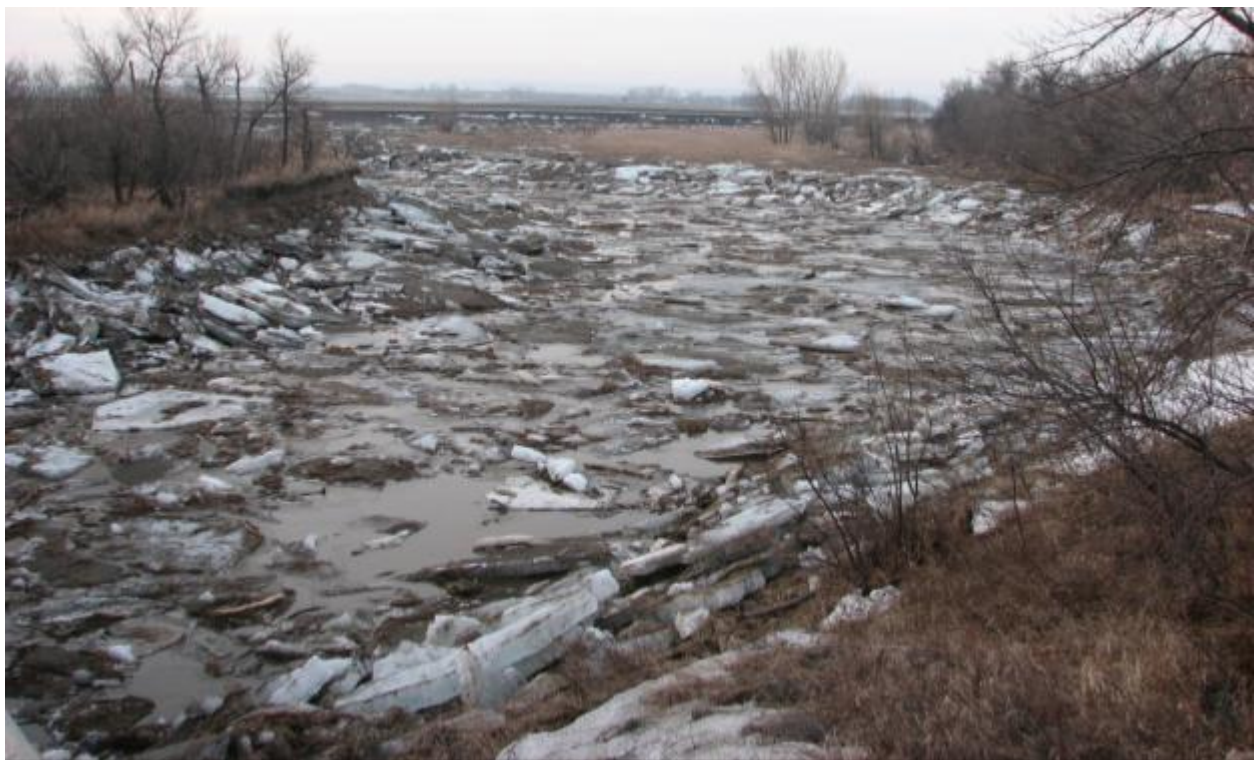
Photo 19. Ice jam along a bend of the Knife River; evidence of ice build up along the shoreline is clearly visible. Photo taken by John Moeykens, NPS.

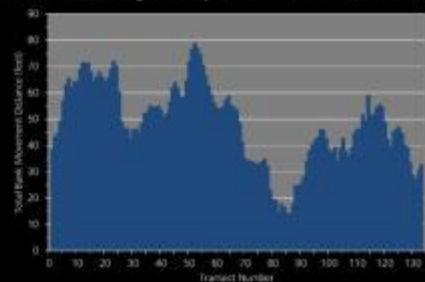
Plate 11. Taylor Bend bank movement from 1965-2011. Plate created by Chad Sexton, THRO GIS Analyst.
