# THE HISTORIC LANDSCAPE OF FORT SPOKANE: A PRELIMINARY STUDY SPRING 1984

COULEE DAM
NATIONAL RECREATION AREA

## THE HISTORIC LANDSCAPE OF FORT SPOKANE: A PRELIMINARY STUDY

CATHY ANN GILBERT LANDSCAPE ARCHITECT

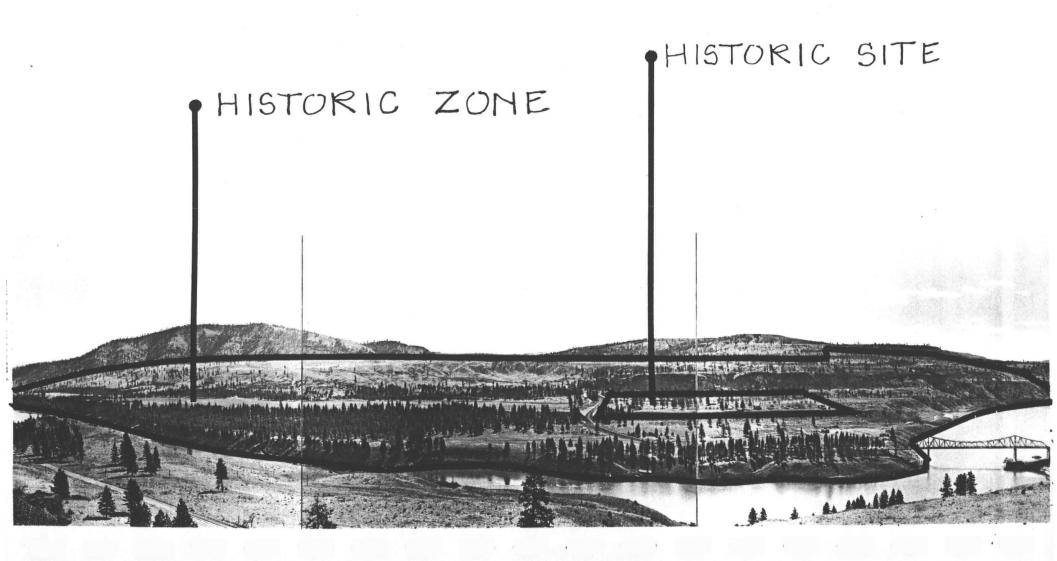
VIEW TO THE SITE-ACROSS THE SPOKAME RIVER. FROM THE MORTH (PHOTOGRAPH A, CD. 1935)

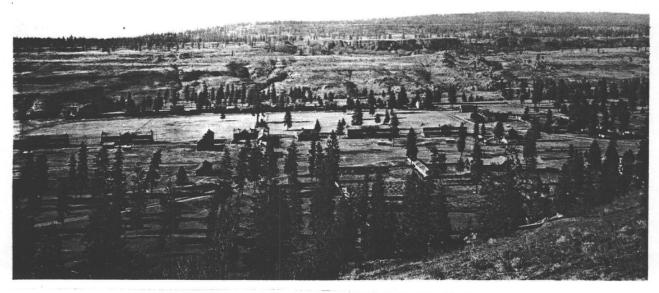
B. Historic view of fort at its peak, ca. 1893, looking northeast.

After President Chester Arthur formally declared Fort Spokane a military reservation in 1882, construction at the fort accelerated. By the summer of 1884 there were approximately 25 buildings on the post, including six, two-story, wood-frame barracks, a schoolroom, and a two-story administration building. Other structures followed and, by 1888, most of the buildings were in place. The layout of the fort was typical of many other posts of the period and reflected in its layout the routine and the social structure of the military system during that era (see photograph B).

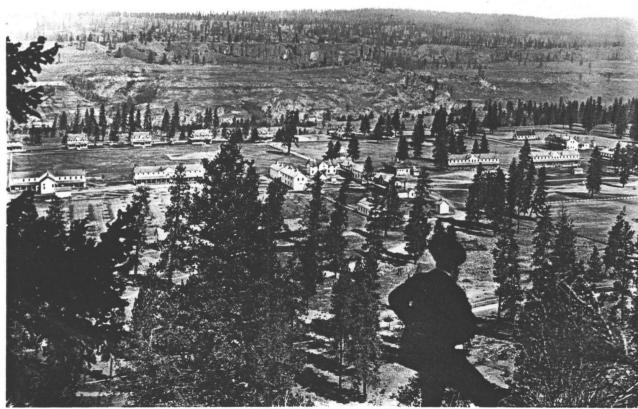
D. View of site during Indian Agency School era, 1905-1908, looking north. Large orchard and young box elder along boardwalk.

The school officially opened its doors April 2, 1900. It had an average yearly attendance of 75 children. The philosophy regarding the education of Indian children at this time centered on acculturation. In the early 1900s that philosophy meant that the girls learned the duties of 'homemaking' while the boys learned mechanical and agricultural techniques (see photograph D).

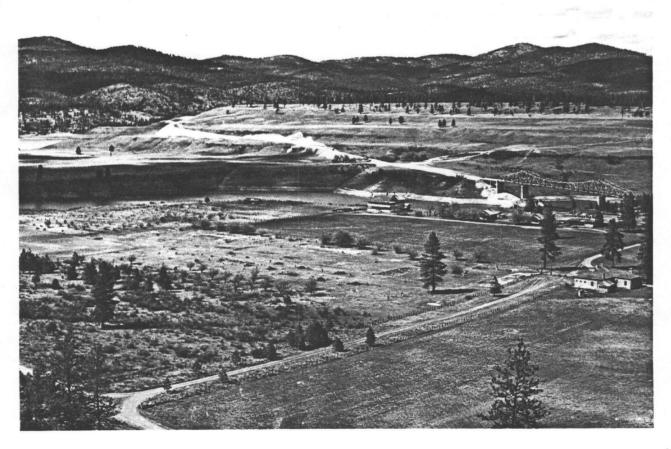
F. Historic Fort Spokane ca. 1940, showing the northwest corner of the grounds. The guardhouse is at the far right and several officers' quarters are just off center.

From 1899 to 1929 the fort served as a school and agency headquarters, then as a school and hospital, and finally as a hospital for Indian patients suffering from respiratory ailments. For the next thirty years, the complex sat vacant and neglected. During these years, many of the buildings were destroyed or dismantled and sold. Finally, in 1960, the National Park Service assumed jurisdiction of the site. Only five standing buildings, a number of foundation ruins, and the large grass field that had been the military parade grounds remained at that time (see photographs F and G).

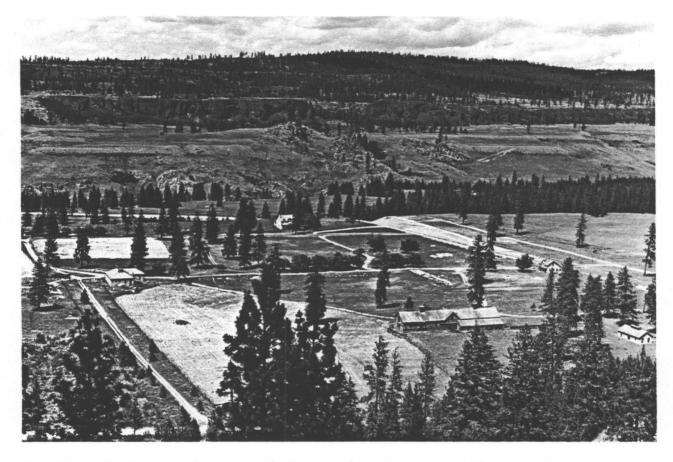
G. Historic Fort Spokane ca. 1940, northeast corner. The guardhouse, quartermasters and two officers' quarters are visible.

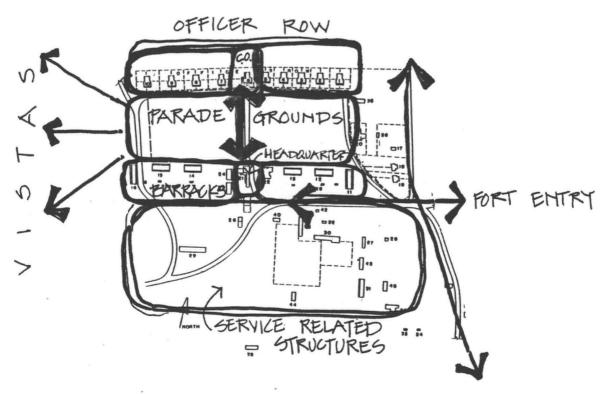
Schematic of military structure

A strong element of symmetry was clearly evident in the axial layout of the grounds at Fort Spokane (see site map one). The Commander's house, located along the northern edge of the site, was flanked on both sides by officers' quarters. Most of the officers lived in duplex or double quarters. Higher ranking officers lived in single houses. Altogether there were ten such houses delineating the north edge of the complex. Directly south of the Commander's house across the parade ground and centered in the complex was the administration building which served as headquarters for the post. A stately two-story building with a glass-sided cupola, this structure and the Commander's house echoed each other and created a primary axis, dividing the site into a series of quadrants.

Directly east of the administration building was one of only a few brick buildings, the guardhouse. This was the second guardhouse built on the post. The first was south of the administration building. On an east-west axis on both sides of the administration building were six, two-story, wood-frame barracks. One of these buildings contained a kitchen, mess hall, reading room, and rooms for non-commissioned officers on the ground floor, and a long

The large open area between officers' row and the barracks constituted the parade grounds. Used for drills and roll calls (and later in this period, baseball), the east side of these grounds fronted a road and formed the east edge of the parade. The fort hospital and chapel sat across the road on the boundary of the site. In contrast there were no structures along the western edge of the parade, the plateau terminated at a bluff overlooking the river and the eye was left to drift far beyond the boundaries of the fort into the Columbia Valley.

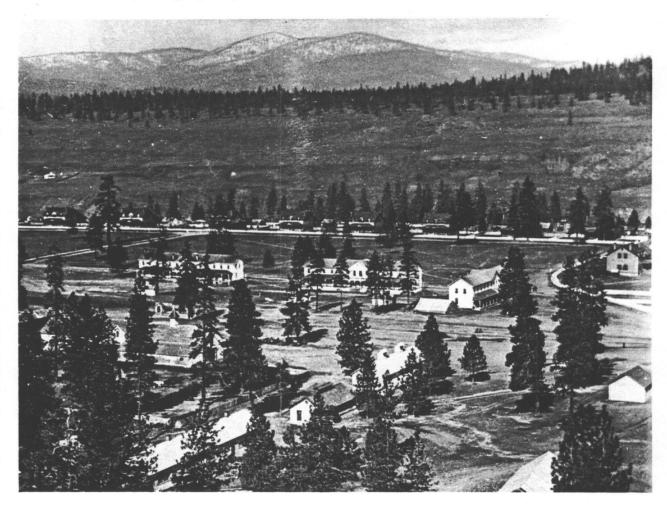
H. View from the southeast, ca. 1890, showing entry road, barracks and service buildings.

In addition to these primary facilities, another large cluster of service-oriented buildings were sited south of the barracks. A sawmill, stables, wagon shed, powder magazine, ice house, quartermaster shops and woodhouse, among other facilities, provided shelter for many of the needs of the fort (see photograph H).

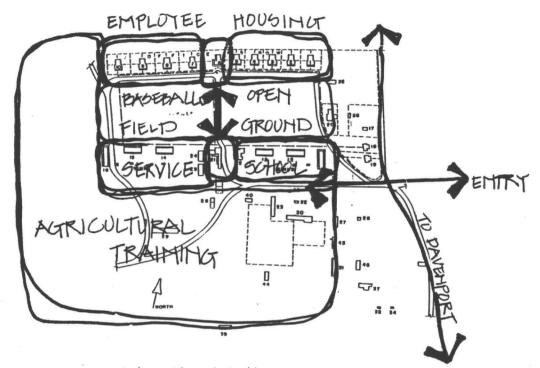
Schematic of Indian era structure

Directly across from the superintendent's house in the old administration building was the school office, assembly hall, and quarters for older boys. The former guardhouse was used as a bath house and sewing room. The six barracks on either side of the administration building were used in a variety of ways. Initially, the three buildings east of the old guardhouse housed support facilities for the school and one was converted to the main dining room and kitchen for the entire school.

This spatial structure, with students clustered in the west, staff and employees along the north, administration in the center, and the other facilities to the east remained until the school and hospital closed in 1908 and 1910 respectively.

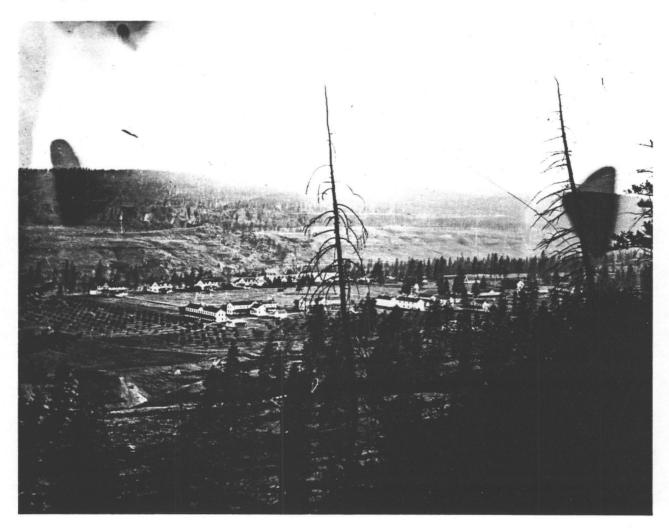
I. View of the complex during the Indian Agency period, ca. 1912, looking north.

One of the most significant additions to the fort complex during this era was the large fruit orchard, vegetable garden and other vegetation planted by the students as part of the agricultural teachings of the school (see photograph I).

On the west and southwest quadrants of the grounds, approximately 700 fruit trees were planted on a grid that elbowed around the edge of the complex. In addition, a substantial vegetable garden produced roughly 275 bushels of potatoes and associated garden produce. Ultimately, it was hoped that the profits from these efforts might help defray the costs of maintaining the boarding school. Not all plantings however, were profit-oriented. Several pines established themselves around the old barracks and administration building.

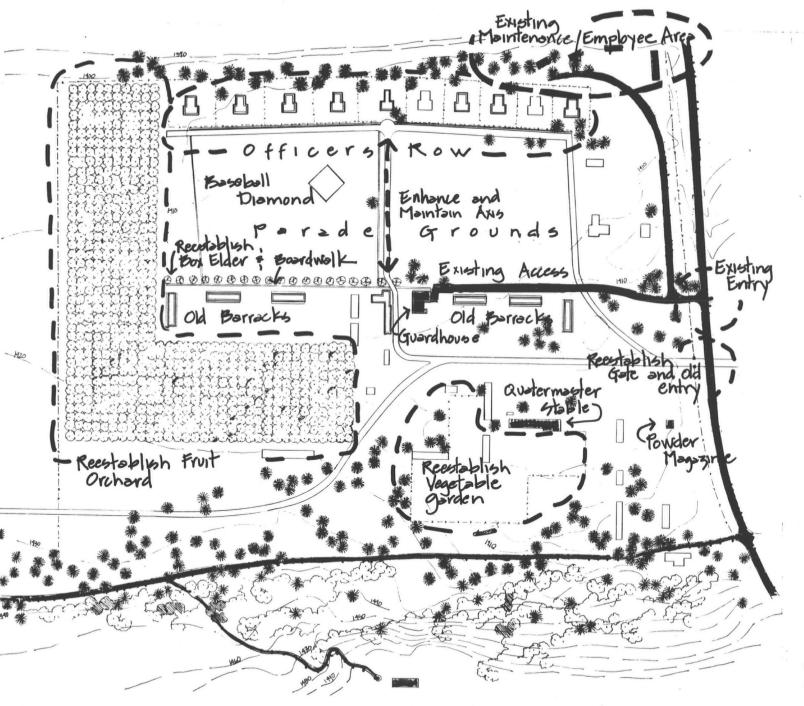
SITE MAP THREE

Site map 3 depicts the general layout and arrangement of landscape elements from both historic periods. It was derived by documenting functional patterns from each historic period and by overlaying site map 1 and 2, to determine those elements and patterns significant in each era.

Basically the plan proposes attention be focused on reestablishing overall patterns rather than isolated components. It is important to note that while individual elements (boardwalk, buildings, fences, plantings) are significant, their value lies primarily in the relationships they create and their ability to delineate and communicate the historic landscape as a whole. The goal of these recommendations is to provide guidelines aimed at allowing greater flexibility in site interpretation, current uses on the grounds and future park needs while maintaining the integrity of the historic site.
