**HISTORIC SITE MASTER PLAN
& FEASIBILITY STUDY**

LOCK 2 EAST OF THE MORRIS CANAL

Robert Street
Hugh Force Park
Wharton, Morris County, New Jersey

Project No. 0616H

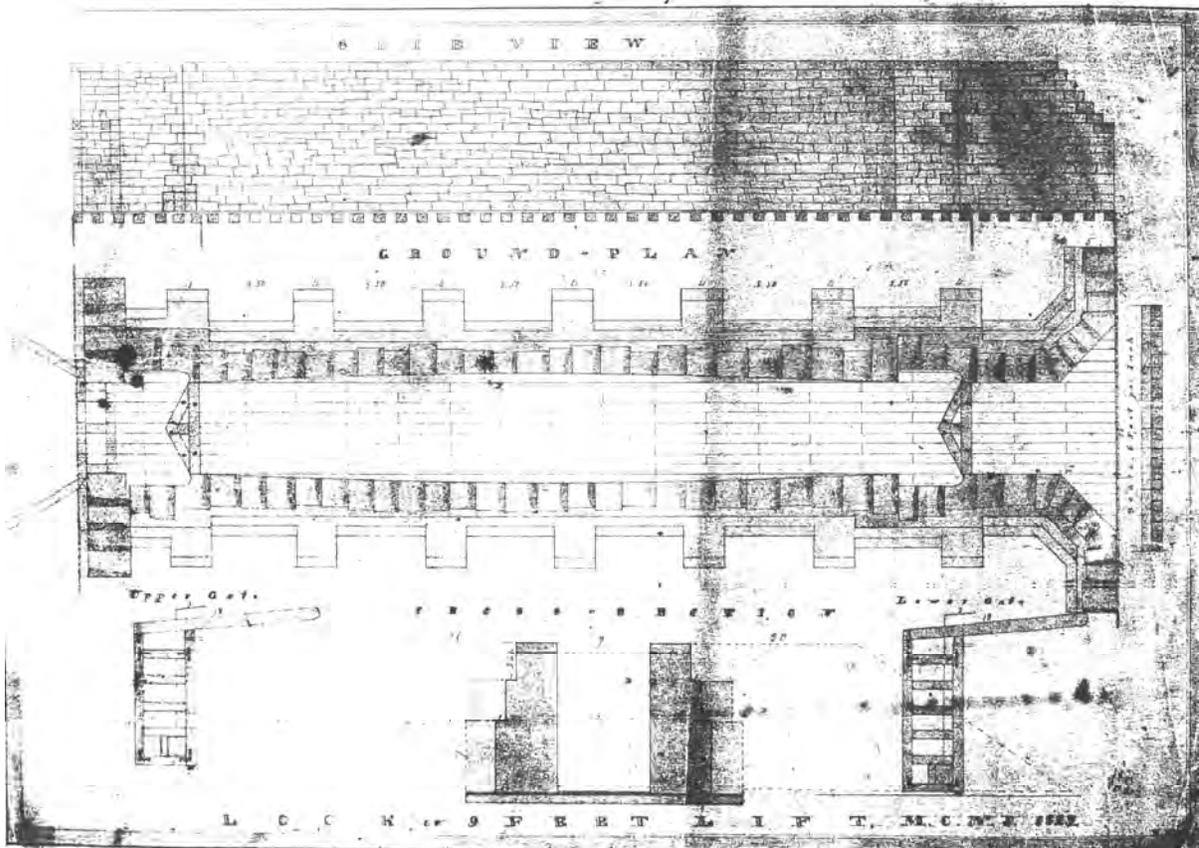
Figure No. 5

1823 Plan, Elevation and Sectional Diagram of Original Lock Construction, 1823.

This series of drawings show the original locks along the Morris Canal in section, ground plan and elevation.

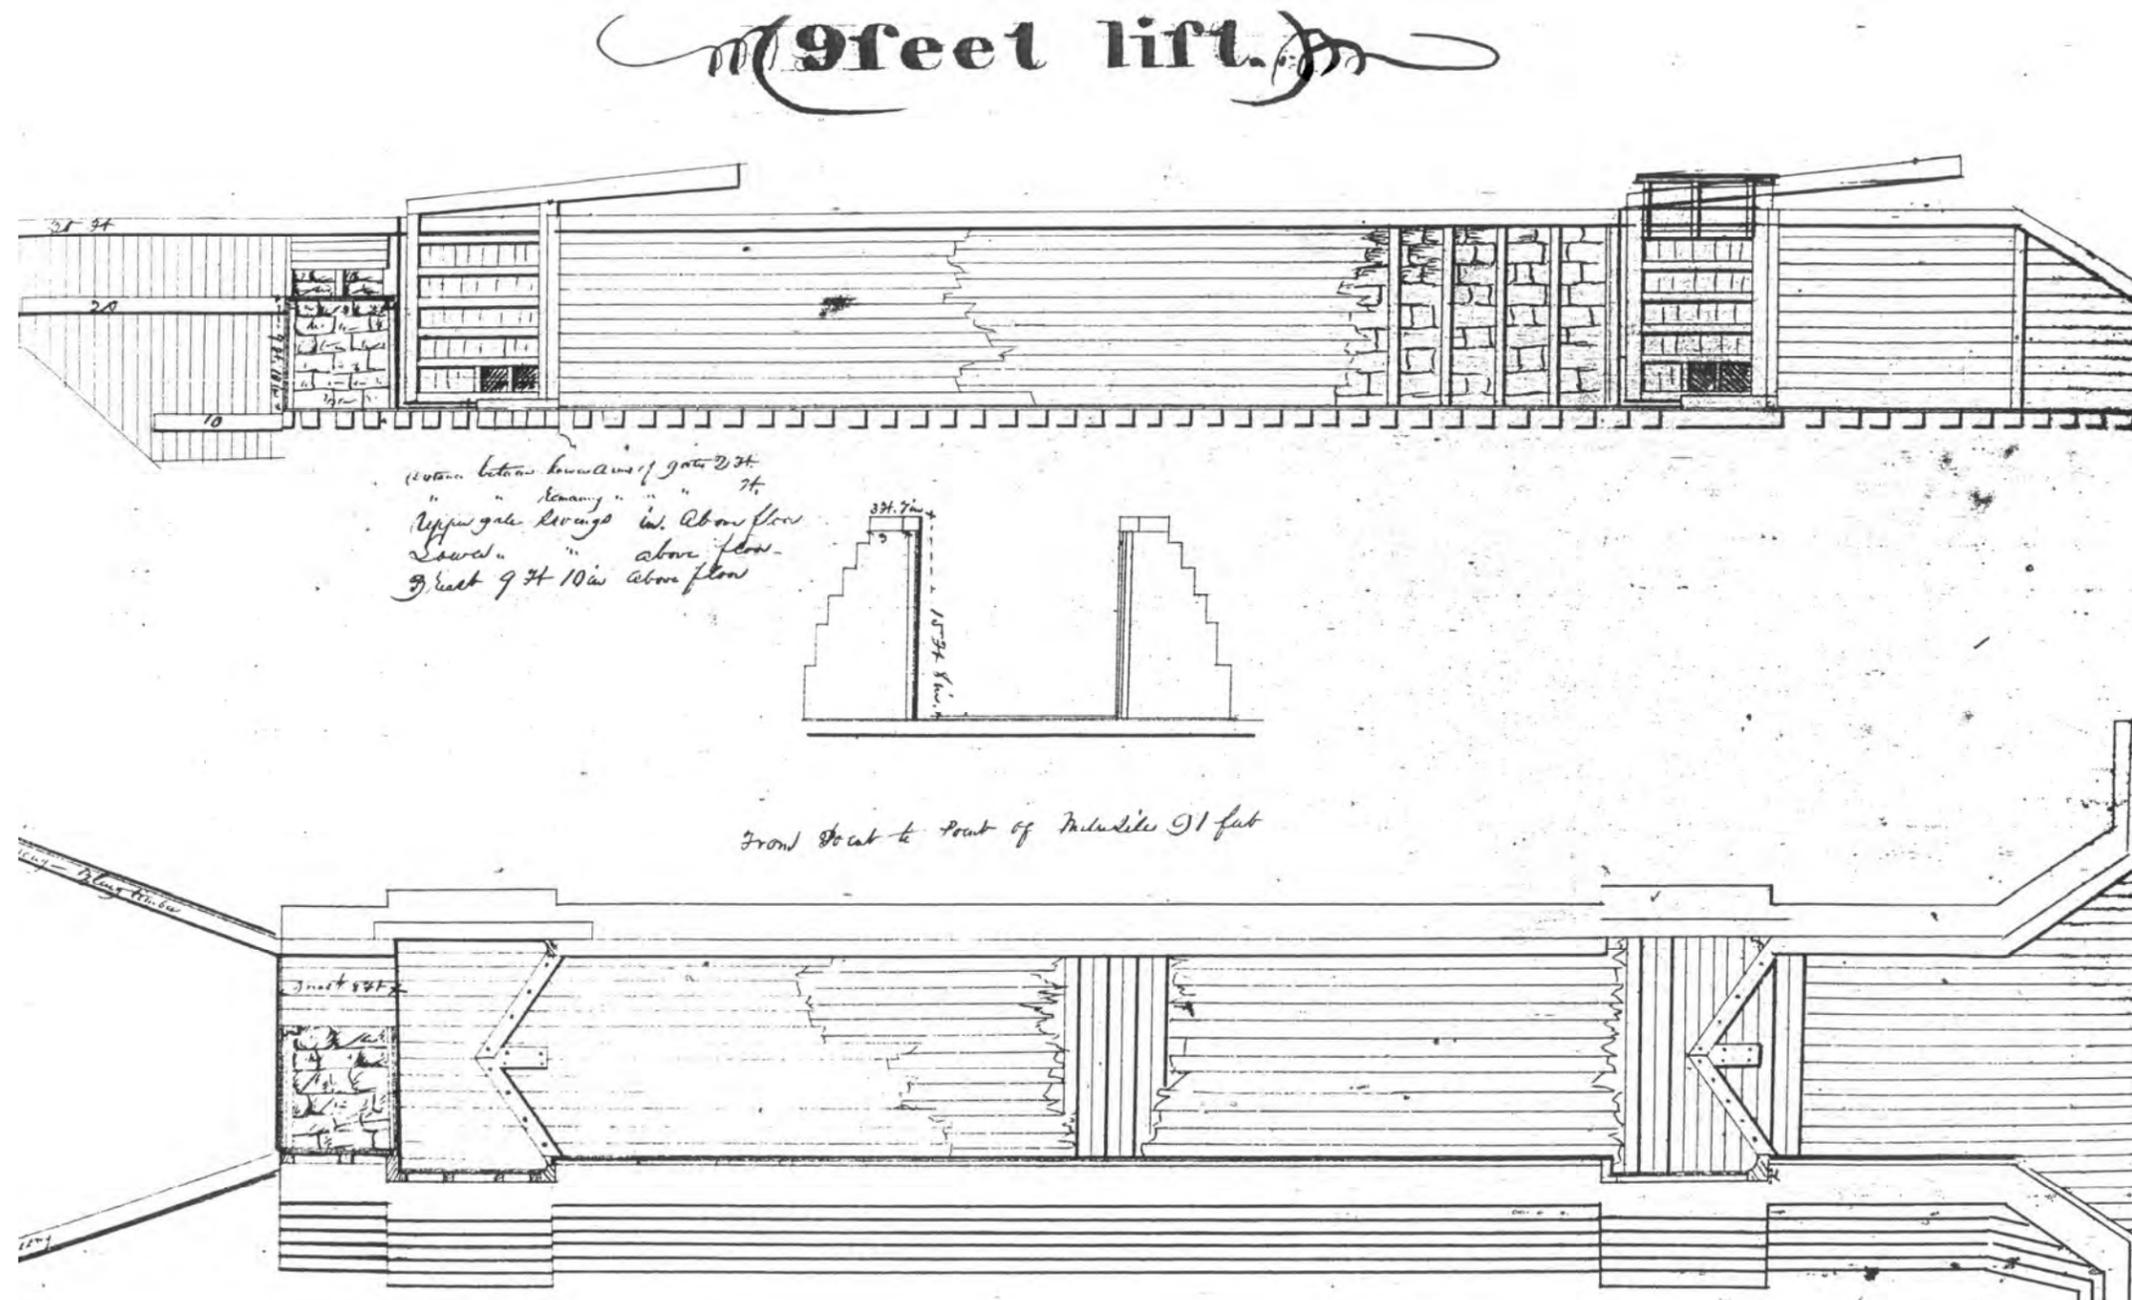
Figure No. 8

Plan, section and elevation Diagram of Lock Construction after 1845

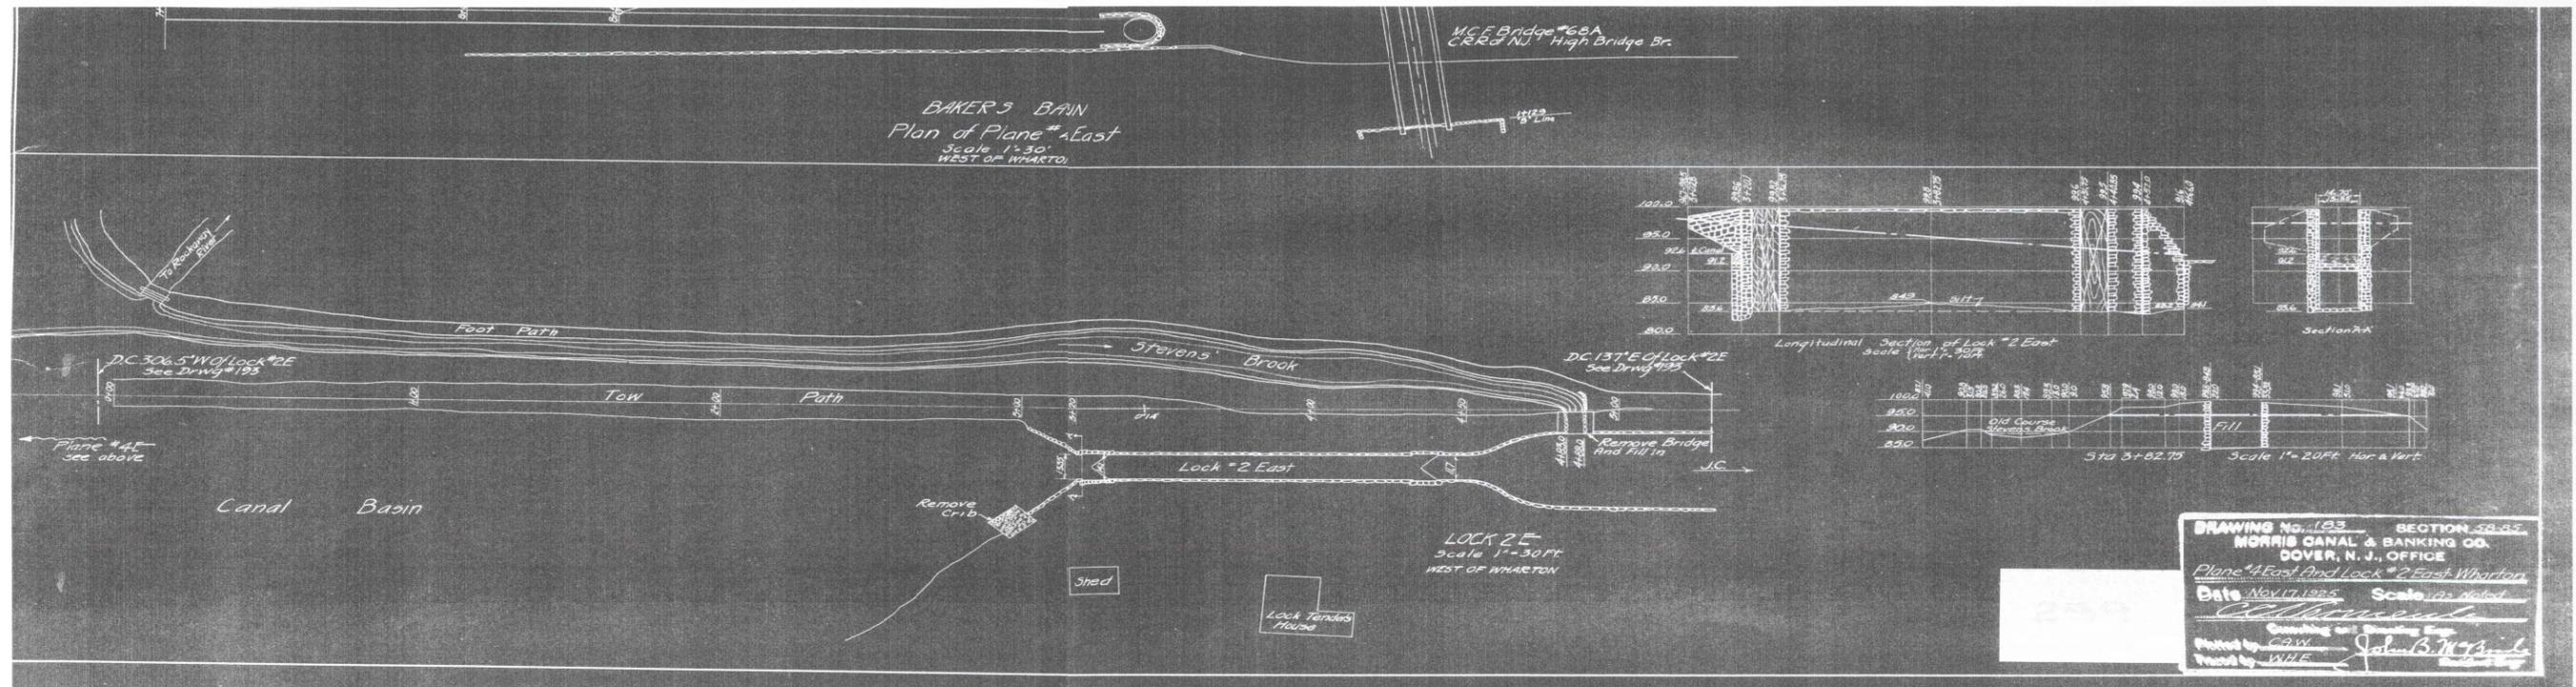
Figure No. 9

1925 Dismantling Plans prepared by C. Vermeule of Lock 2 East

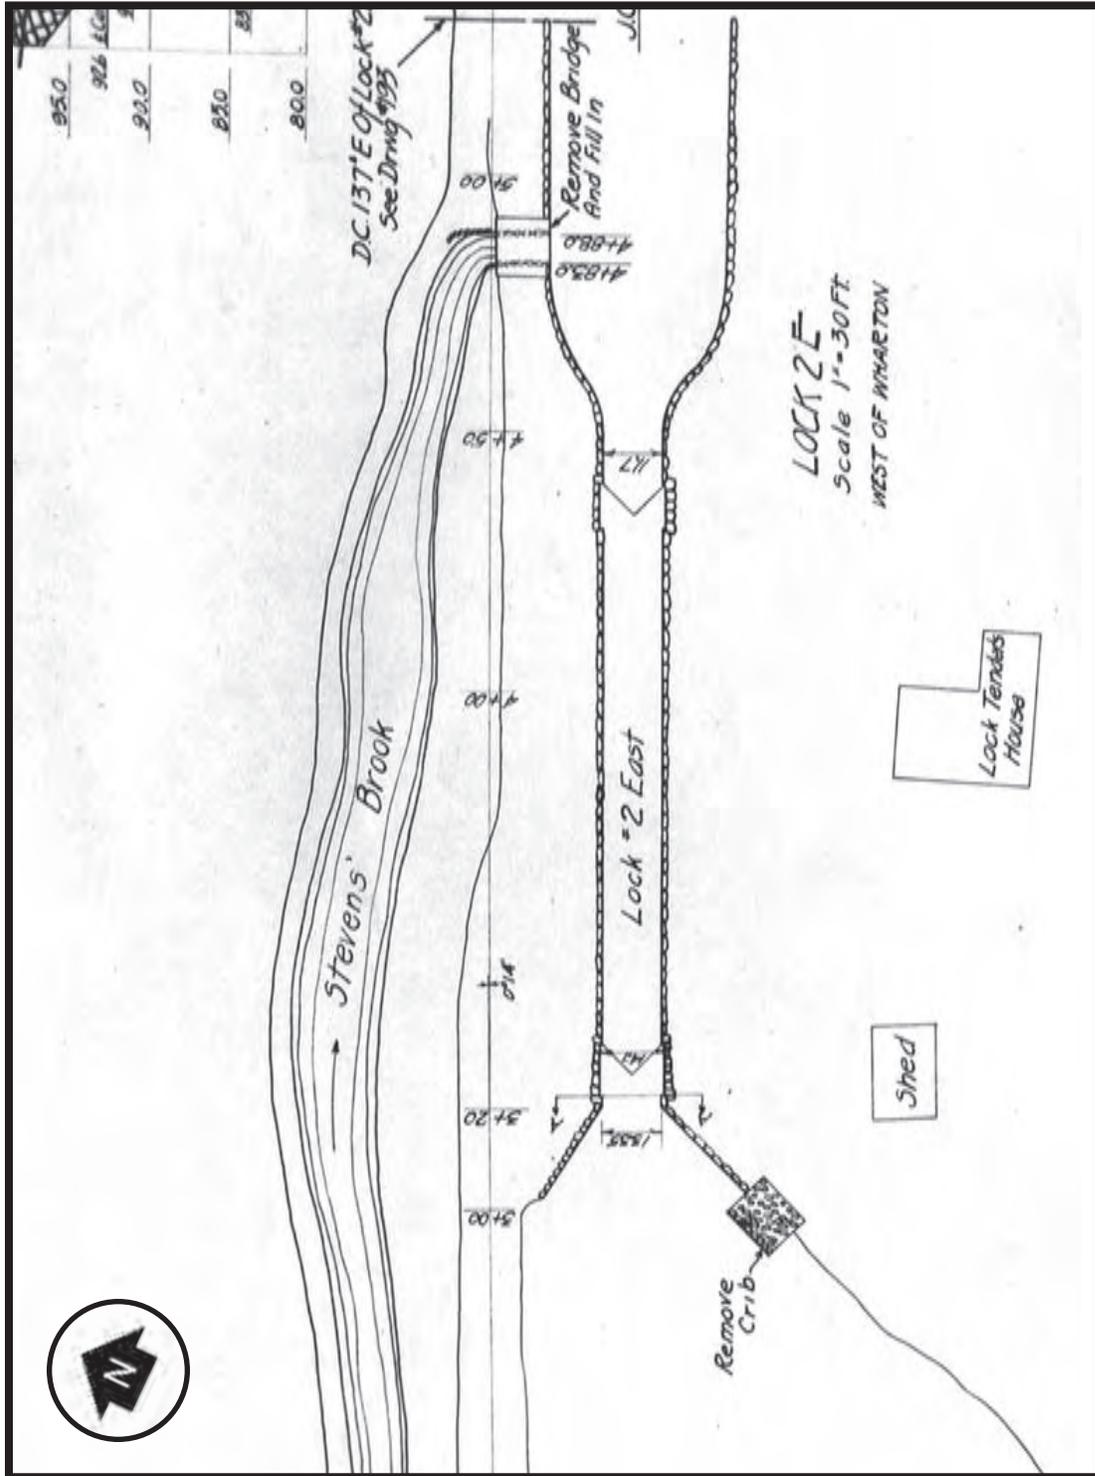
Figure 4. Vermeule, C. Jr. Plan View. "Plane #4 East and Lock #2 East – Wharton, Drawing No. 183." 1927.
Scale: 1 inch = 36 feet.

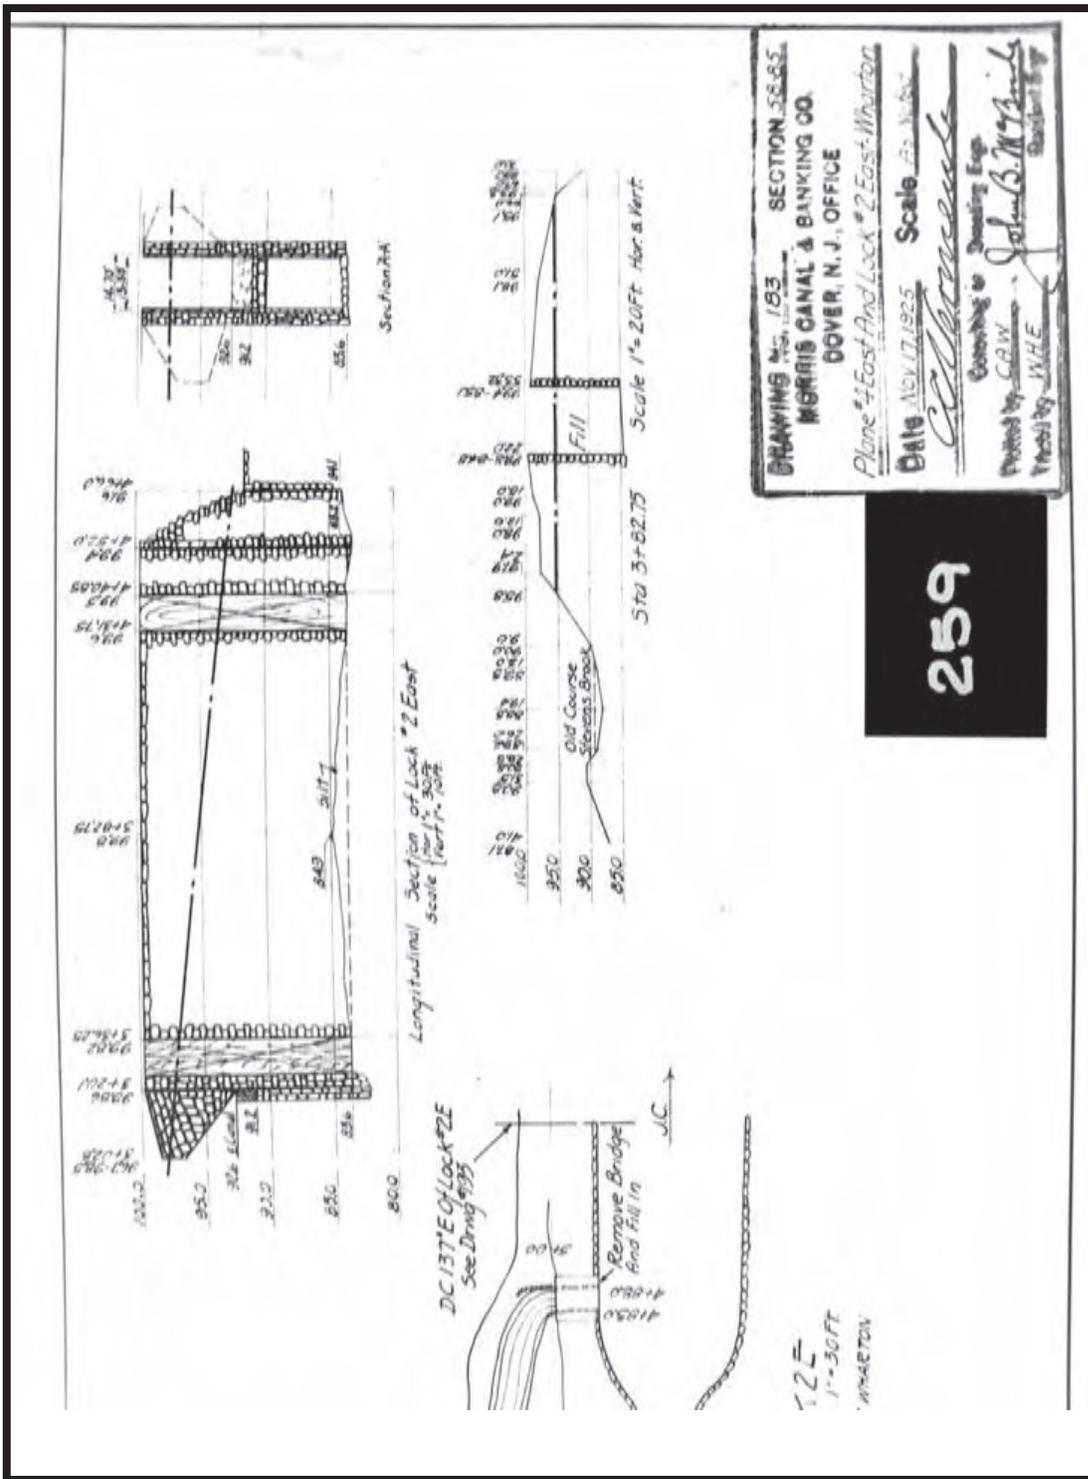
Figure 5. Vermeule, C. Jr. Profile View. "Plane #4 East and Lock #2 East - Wharton, Drawing No. 183." 1927. Vertical scale: 1 inch = 15 feet.

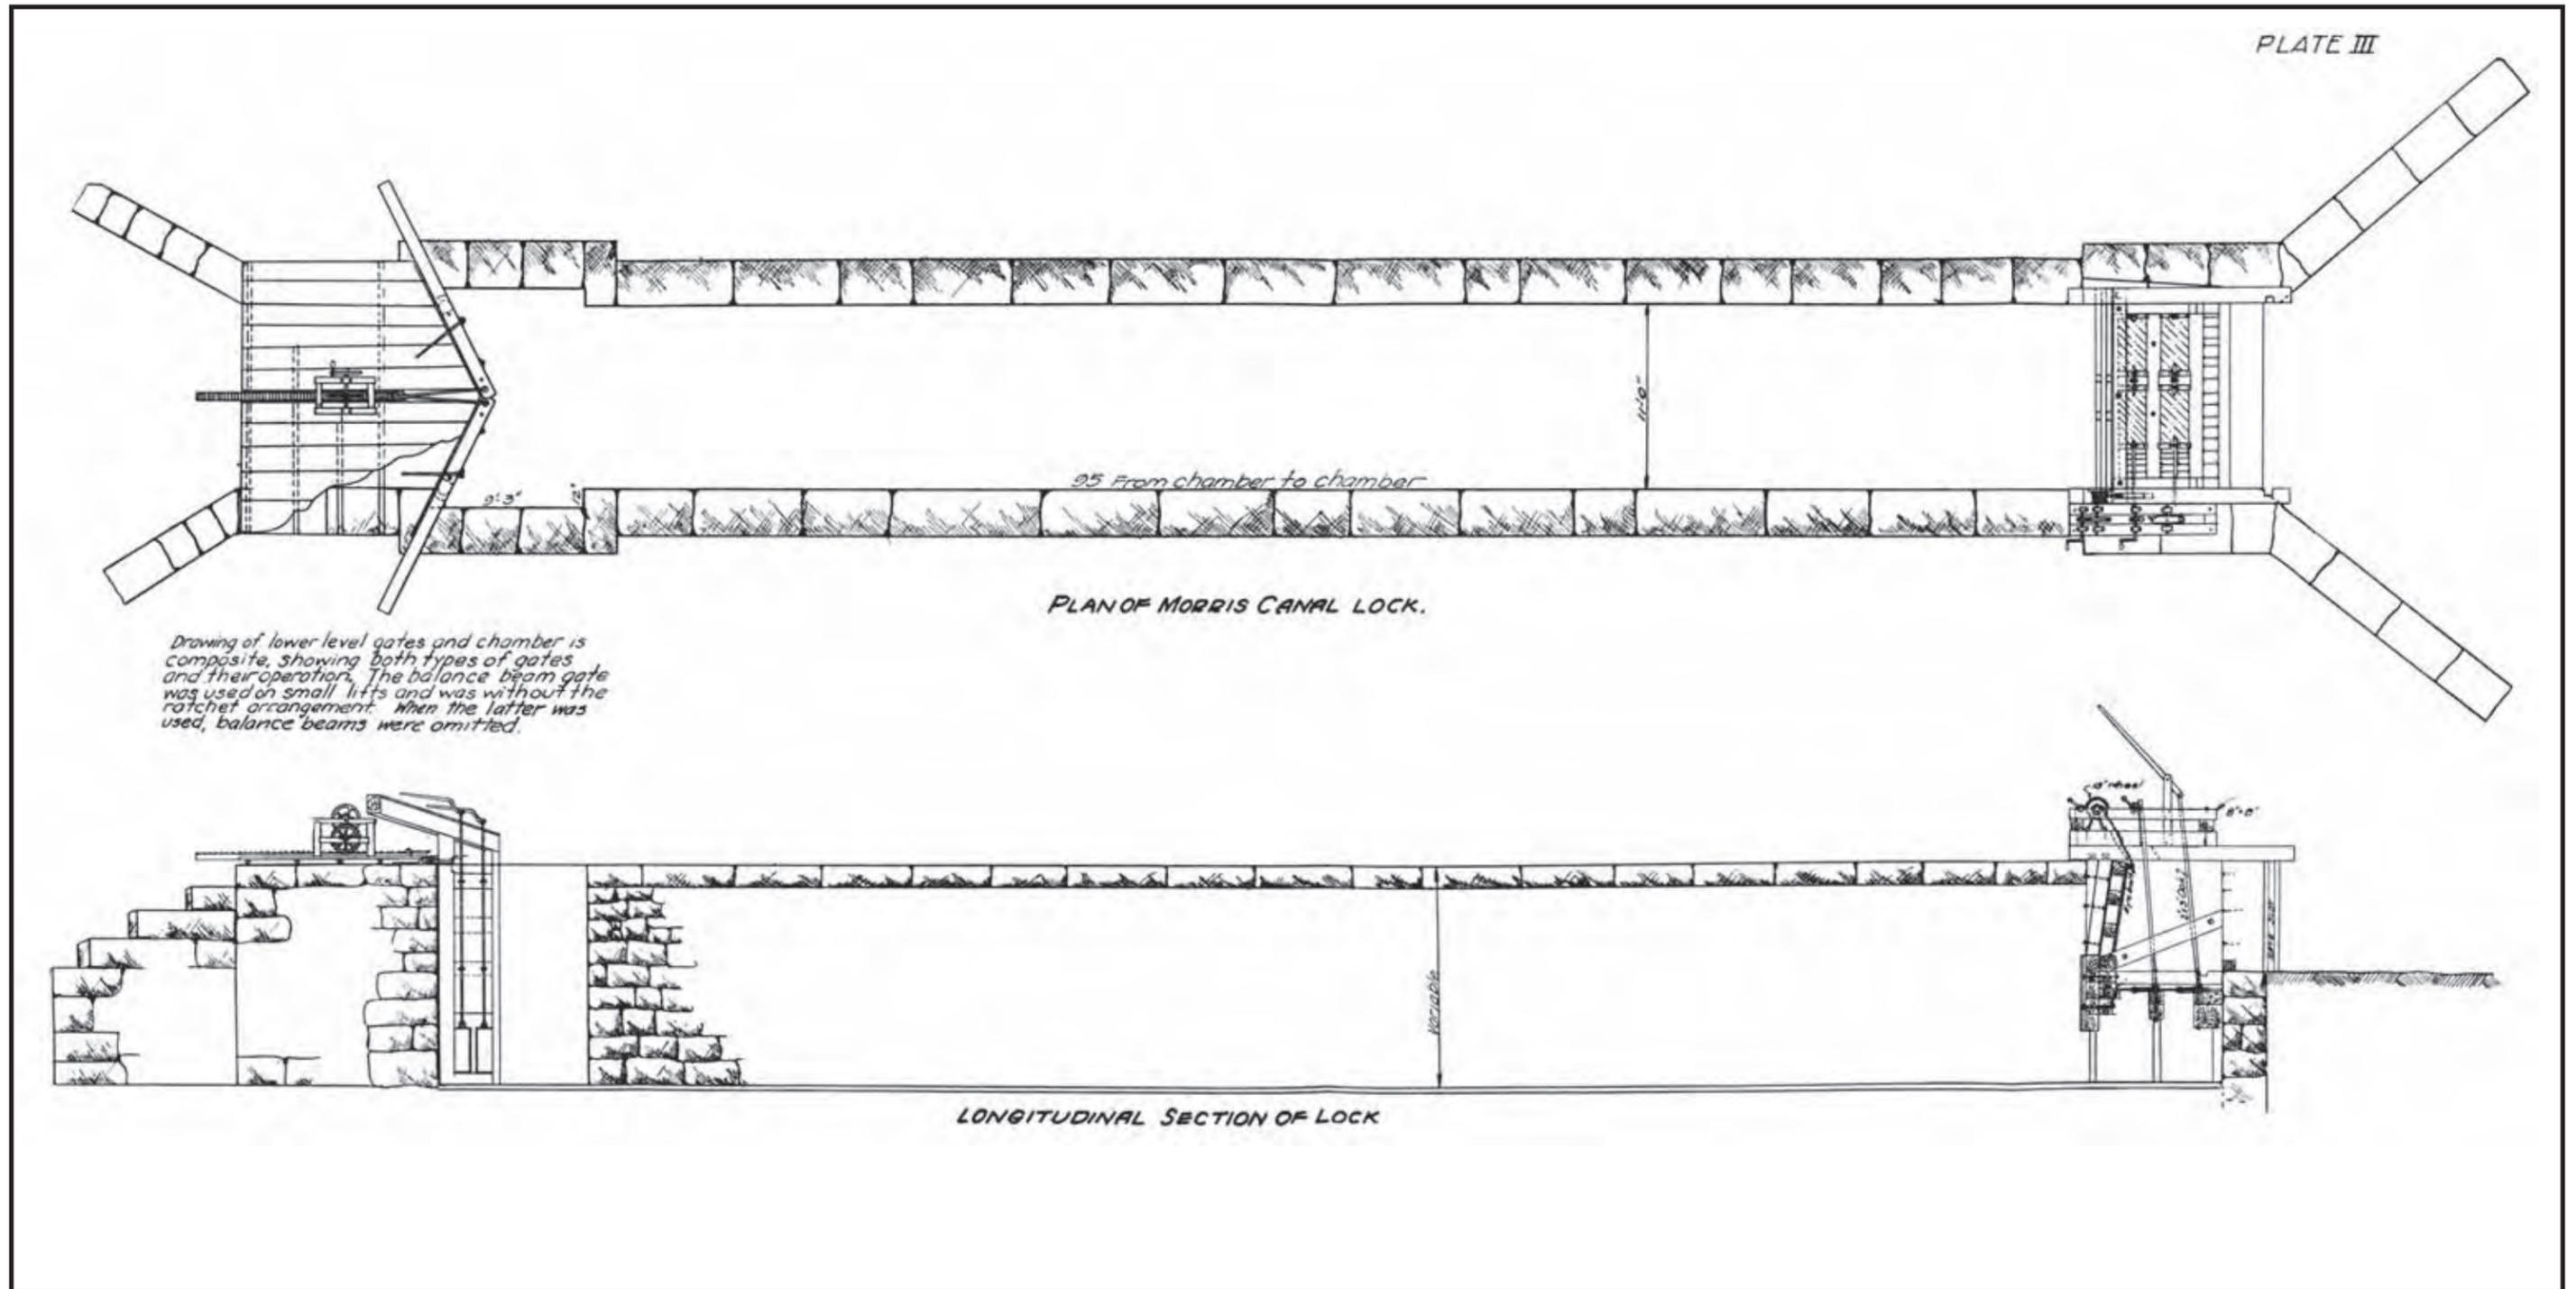
Figure 6. General Plan of a Morris Canal Lock. Source: Cornelius C. Vermeule, Jr 1929.

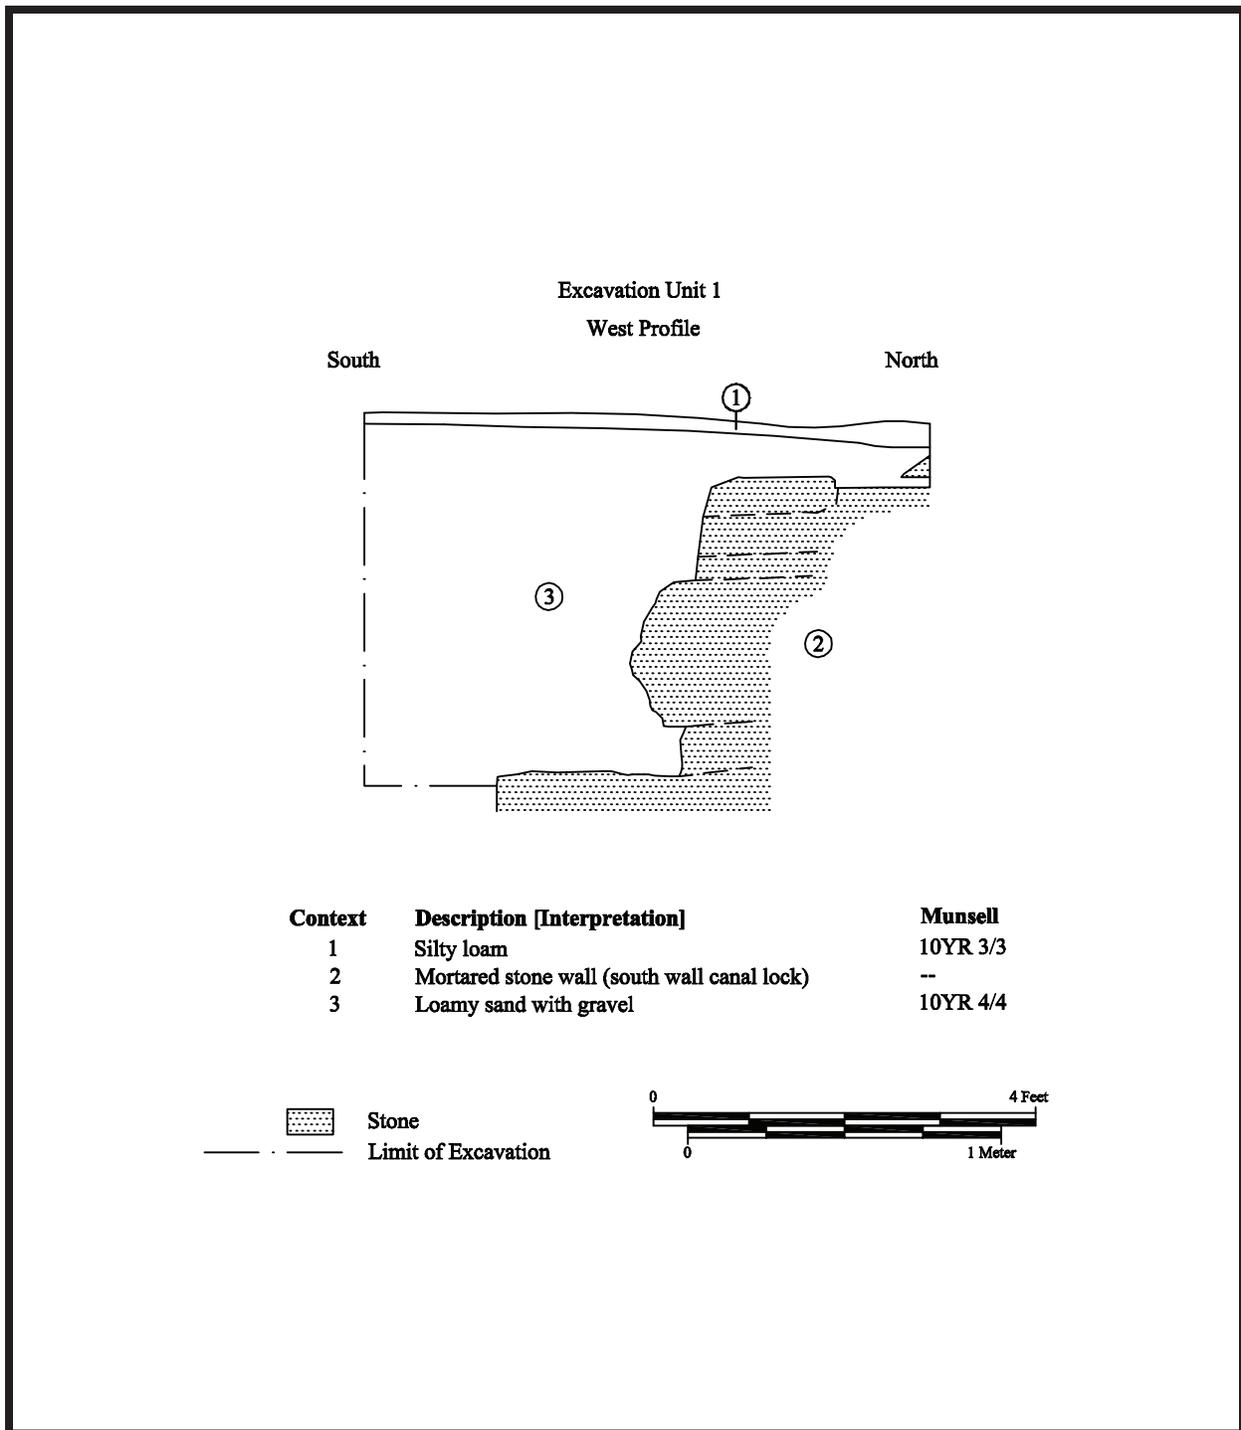
Figure 9. Excavation Unit 1, West Profile.

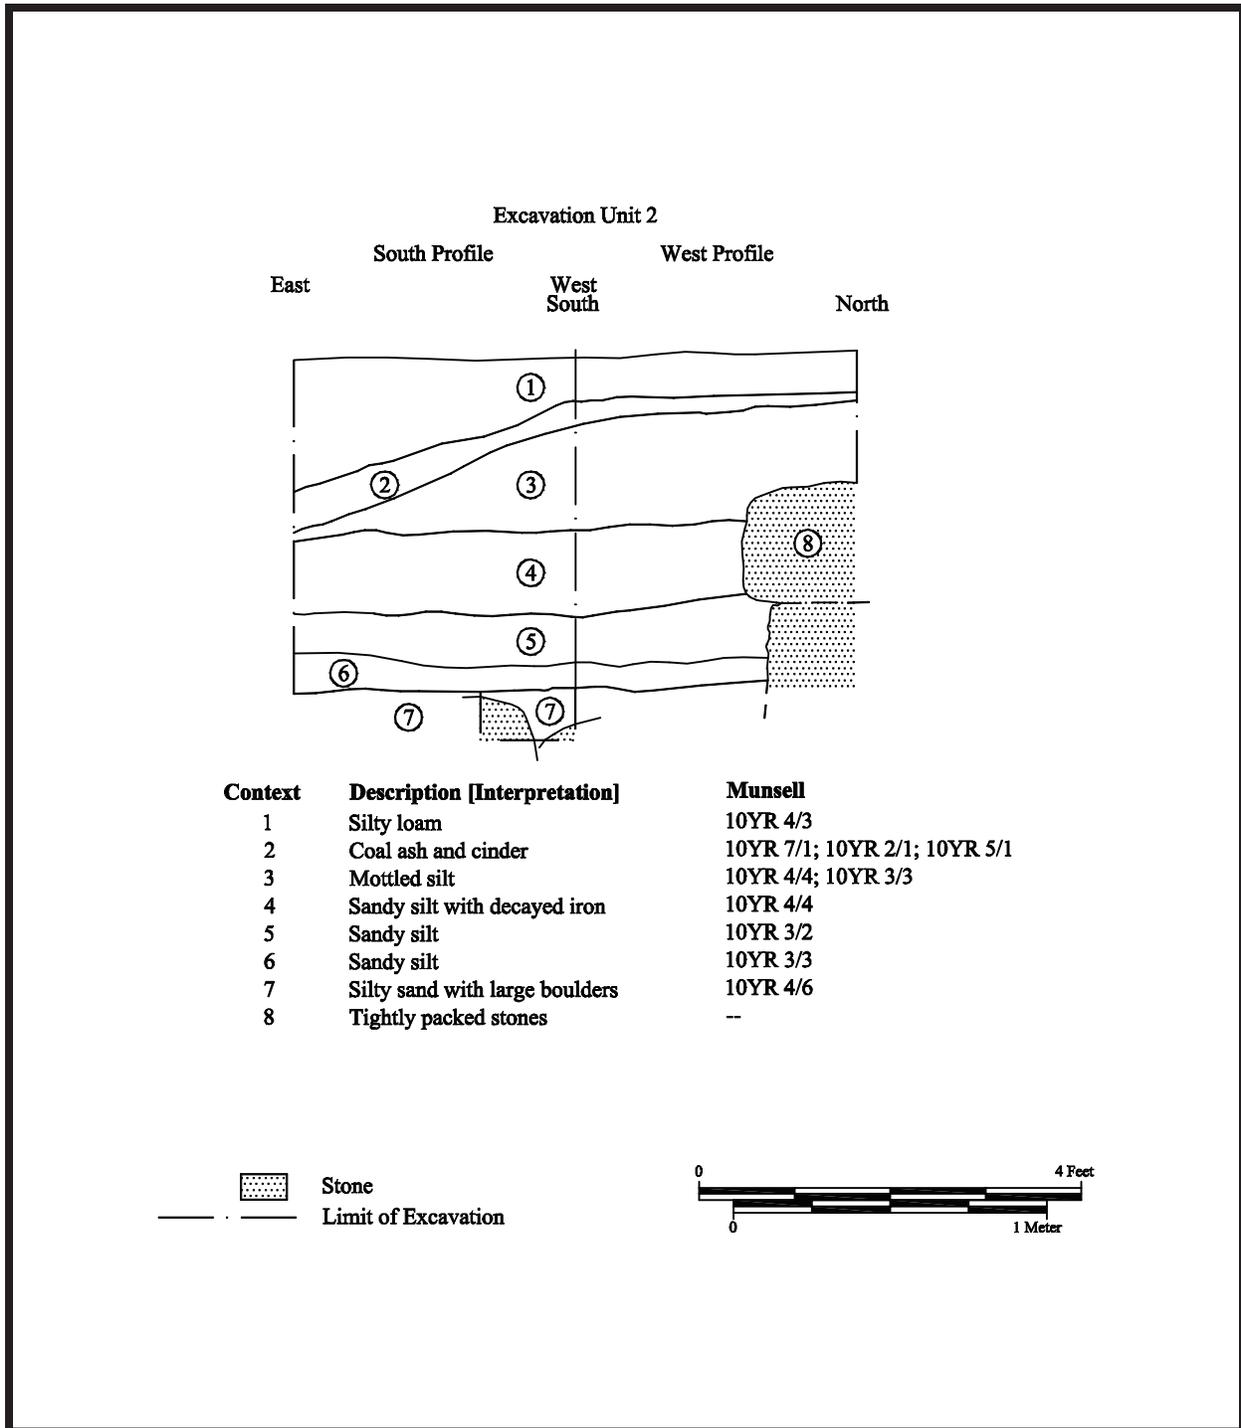
Figure 10. Excavation Unit 2, South and West Profile.

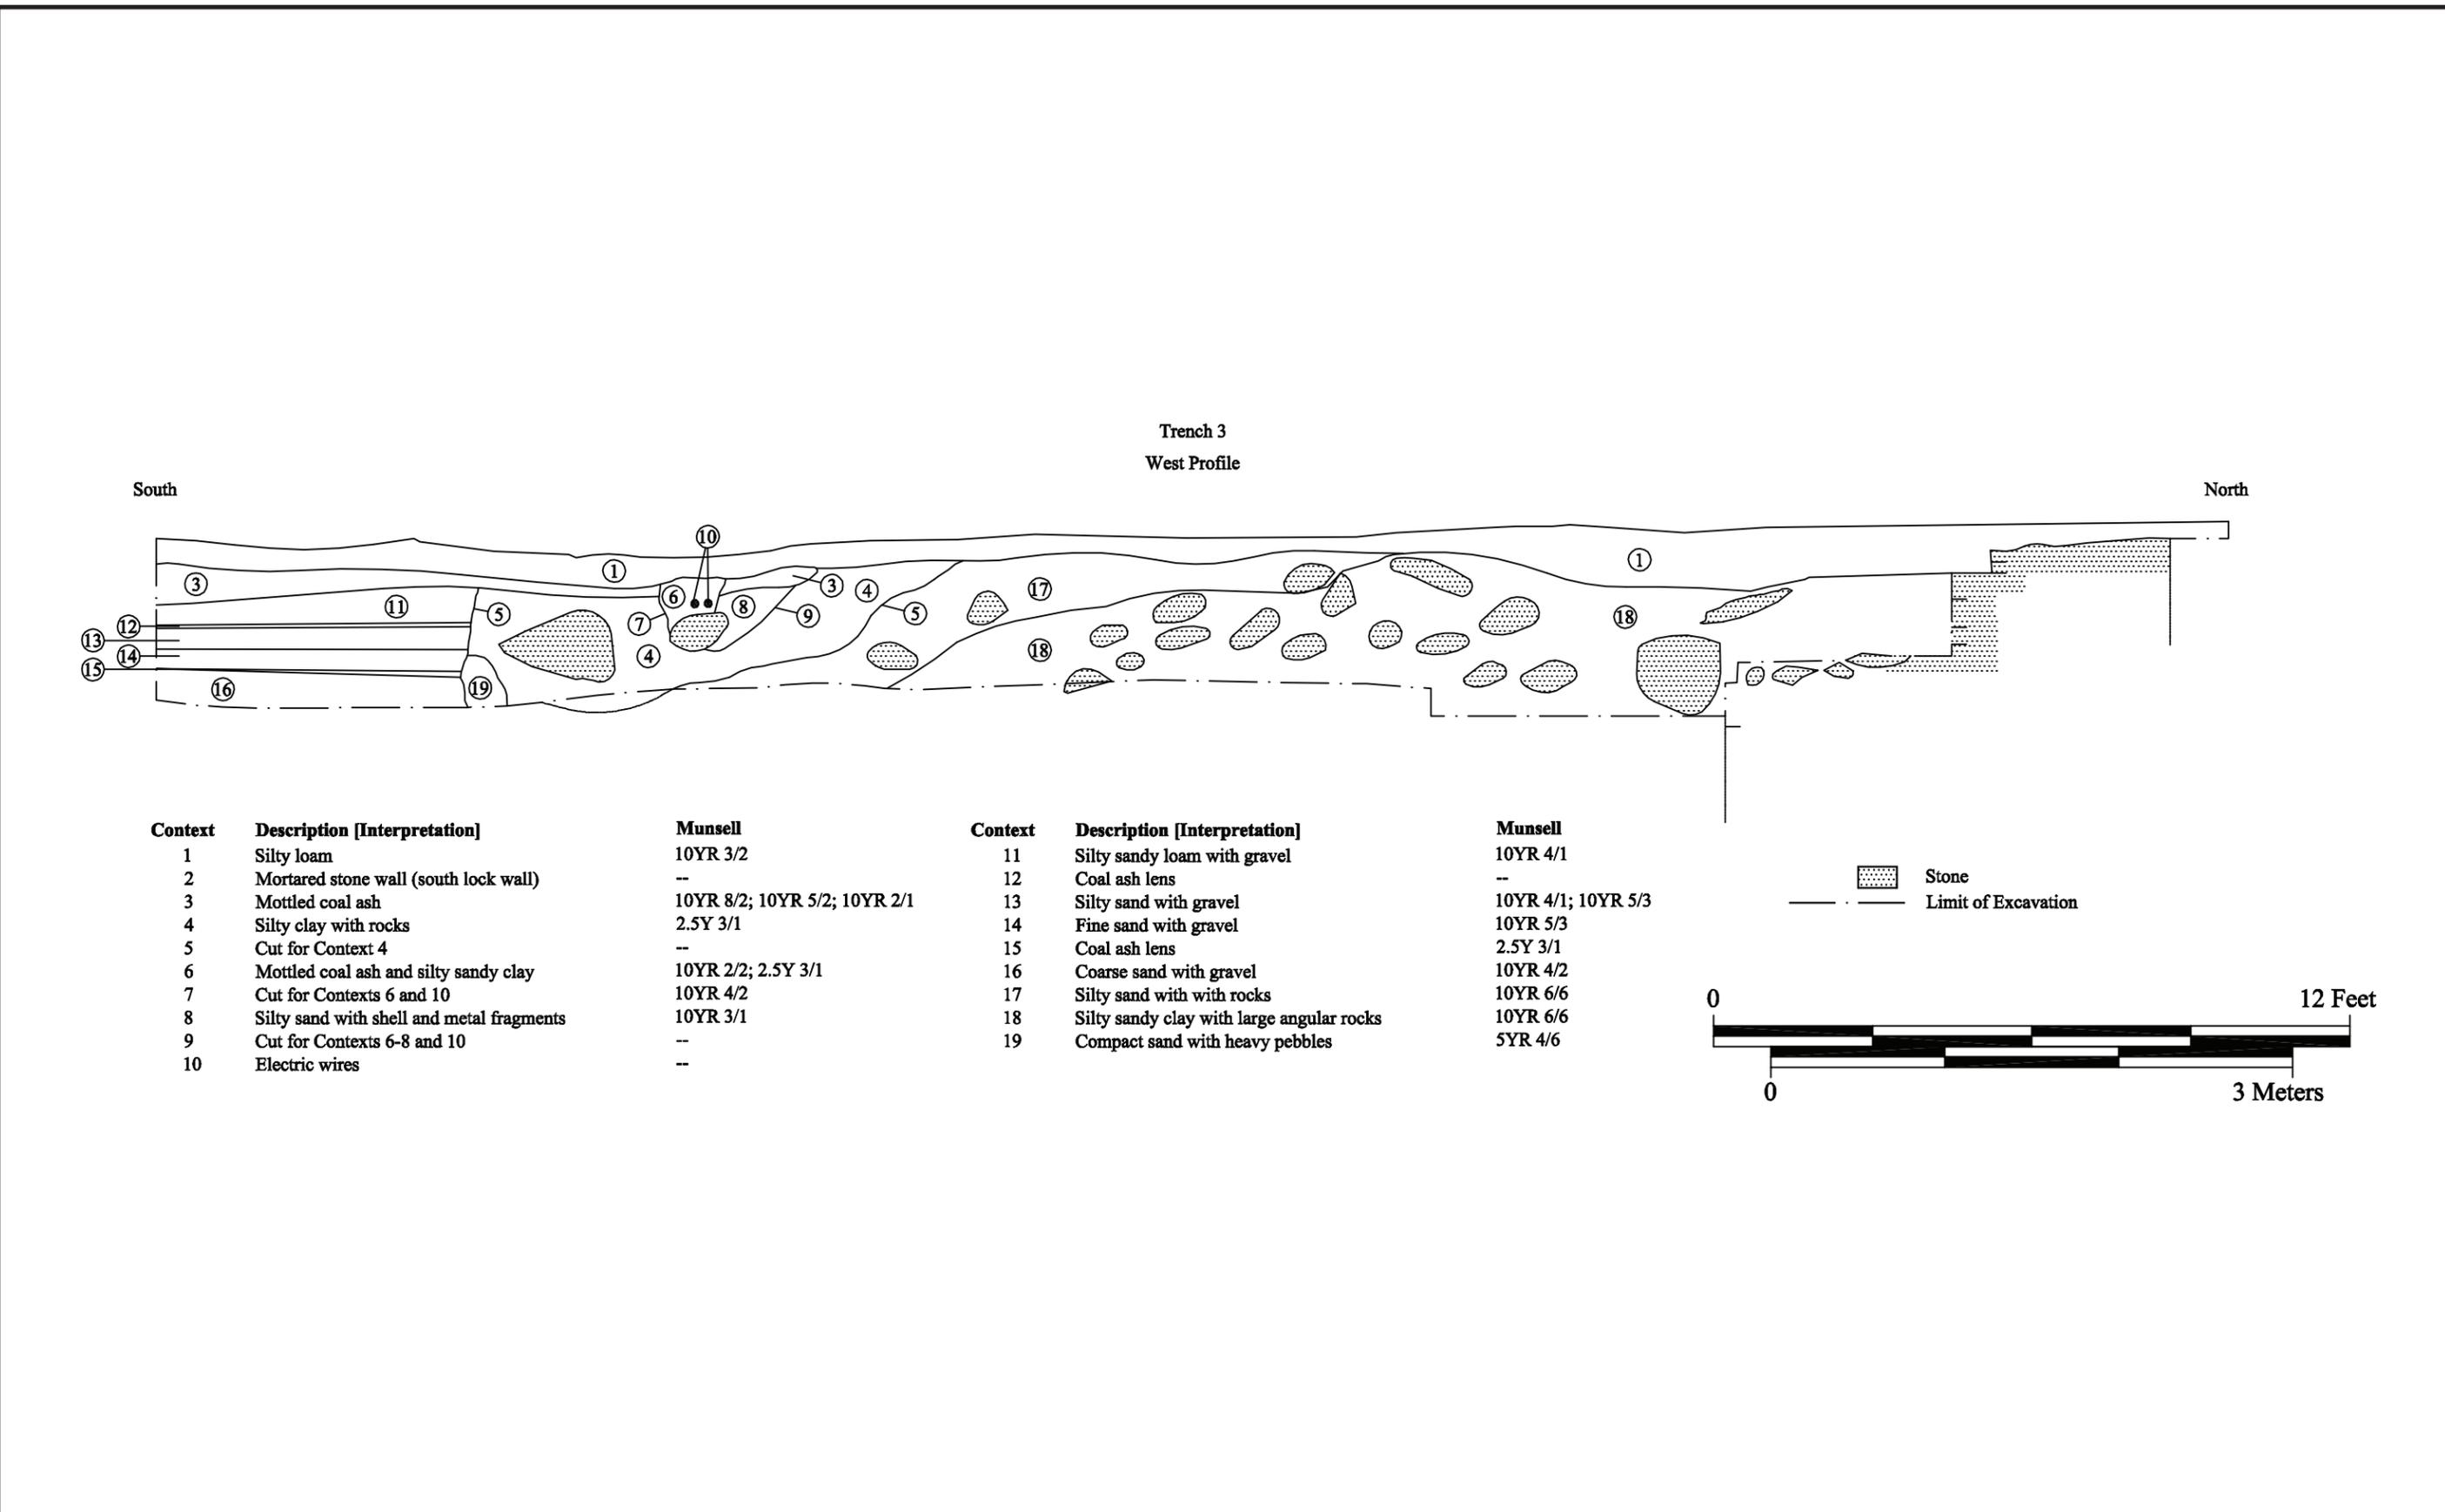
Figure 14. Trench 3, West Wall Profile.

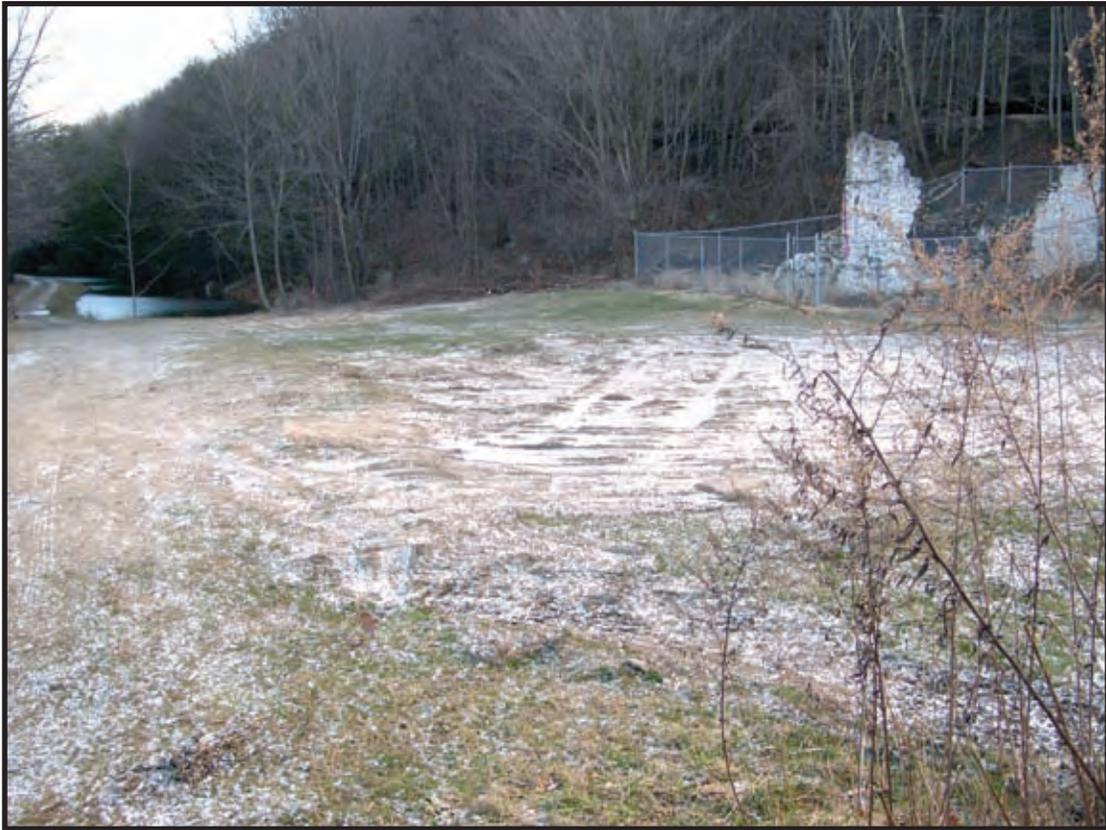
Plate 1. View looking east of the project site; the buried lock extends from the foreground to the left and the lock tender's house ruin is visible at the top right (Photographer: James Lee, January 2007) [HRI Neg.#06052:D5:17].

The following technical report describes and interprets archaeological investigations carried out at Morris Canal Lock 2 East, in Wharton Borough, Morris County, New Jersey (Figures 1 and 2; Plates 1 and 2). The document also broadly defines areas of likely archaeological sensitivity within the property and includes recommendations for archaeological resource management procedures in the event of planned alterations and modifications to the property that may entail ground disturbance. This report is intended as a supplement to the Historic Site Master Plan created for the project by HJGA Consulting, Architecture & Historic Preservation, Inc., which contains a detailed history of the project site.

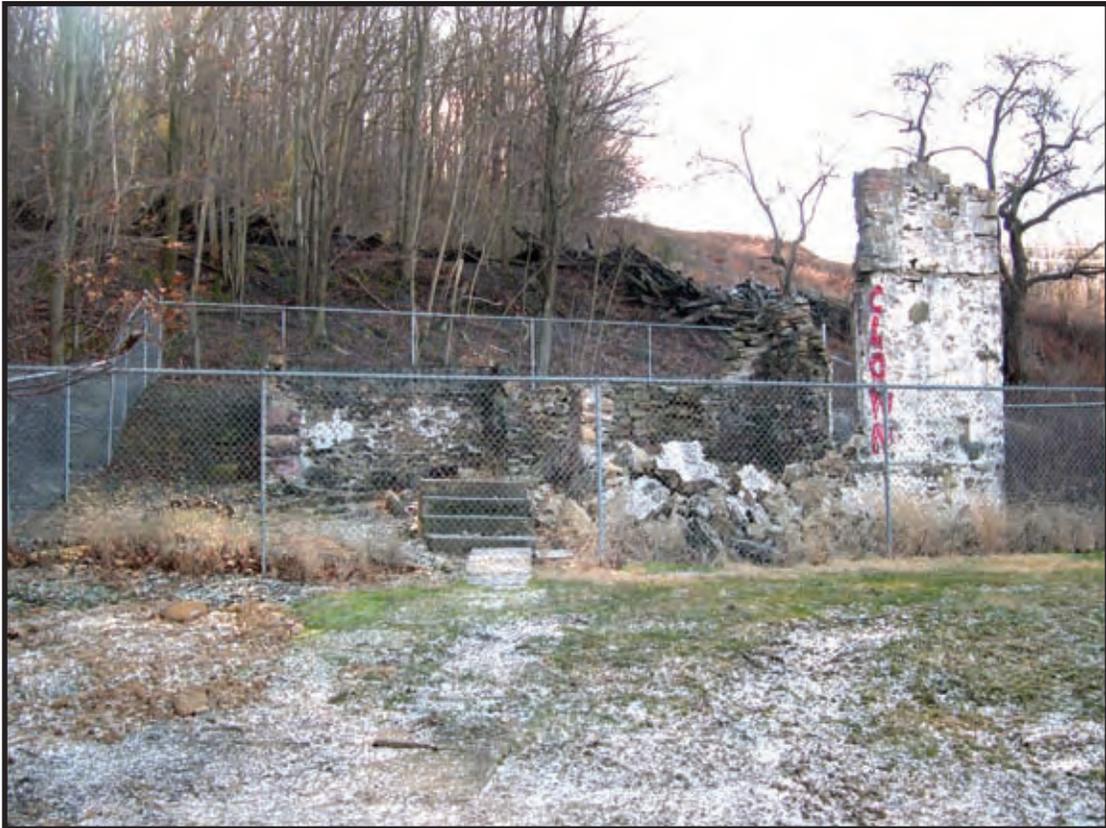
Plate 2. View looking south of the lock tender's house ruin (Photographer: James Lee, January 2007) [HRI Neg.#06052:D5:57].

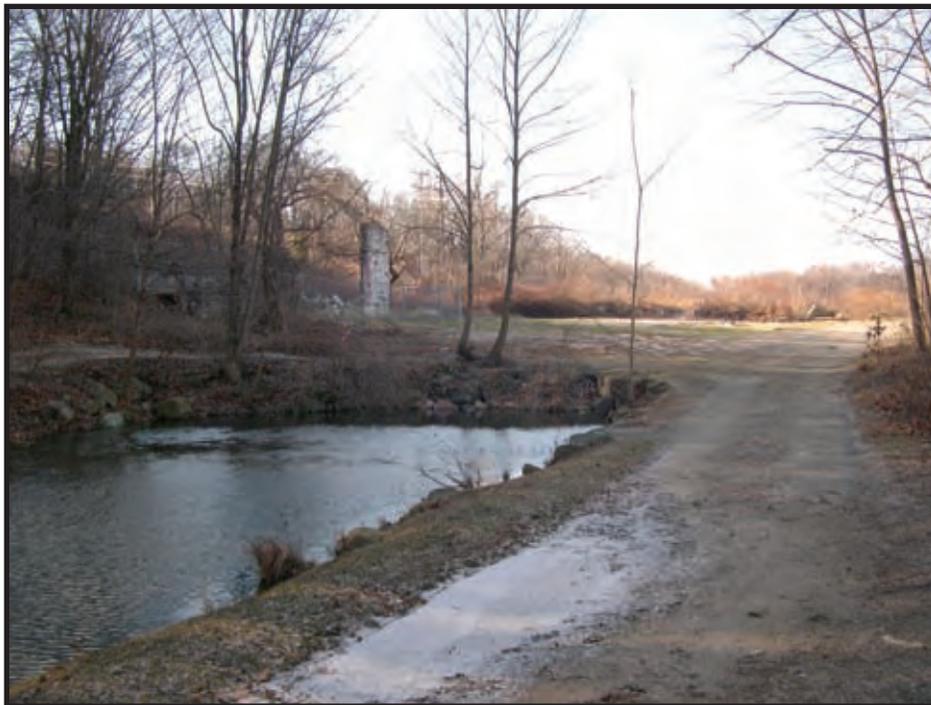
Plate 5. Modern view looking west of the Lock 2 East project site (Photographer: James Lee, January 2007) [HRI Neg.#06052:D5:77].
