**HISTORIC SITE MASTER PLAN
& FEASIBILITY STUDY**

LOCK 2 EAST OF THE MORRIS CANAL

Robert Street
Hugh Force Park
Wharton, Morris County, New Jersey

Project No. 0616H

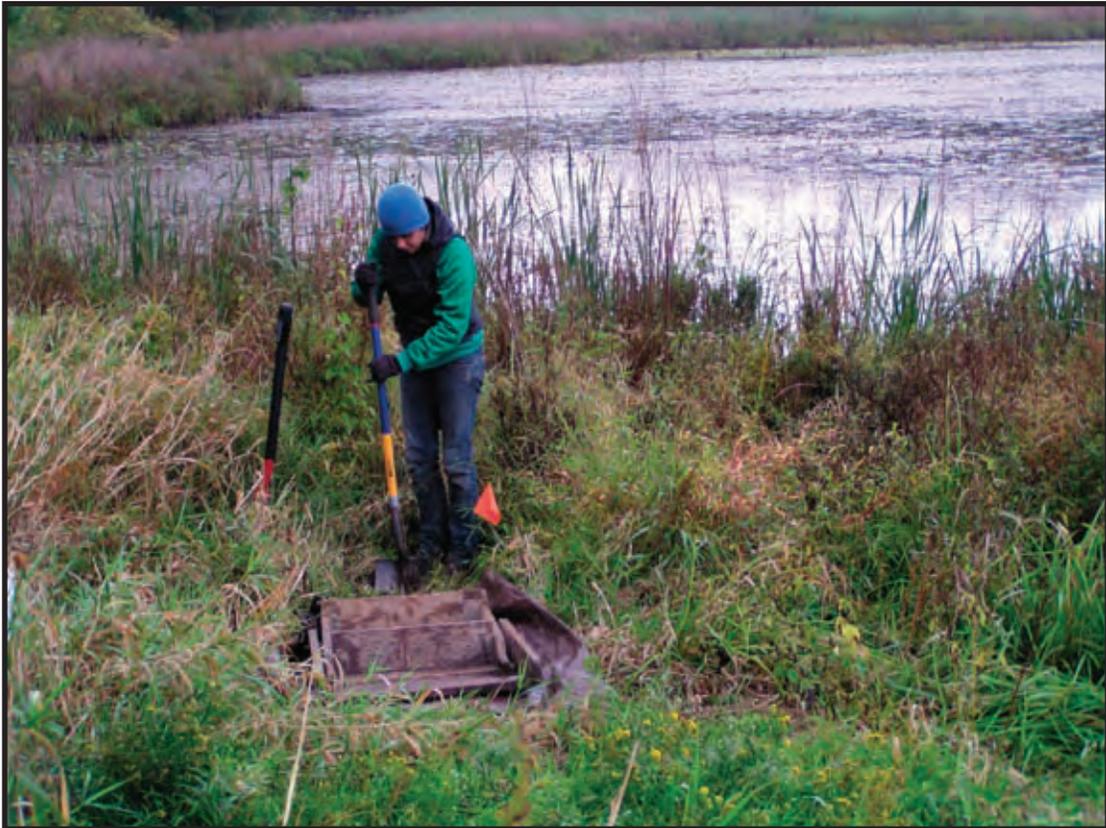
Plate 14. View looking west of an archaeologist shovel testing along the western edge of the project site (Photographer: Joshua Butchko, October 2006) [HRI Neg.#06052: D2:21].

Also, since the closure of the canal, a substantial amount of fill has been brought to the site and dumped into the basin and canal at the western end of the lock, moving the edge of the basin to the west and leaving piles of fill material (Figure 7; Plate 14). No pre-1920s ground surfaces were identified within this area. The few artifacts recovered from this area are likely derived from the fill and do not relate to the occupation of the site. This fill and associated disturbance extends into the southwestern corner of the project site where a few outbuildings are visible in historic photographs (Plates 7 and 8). Because of the apparent surface disturbance the former location of these structures could not be ascertained through inspection or shovel testing.

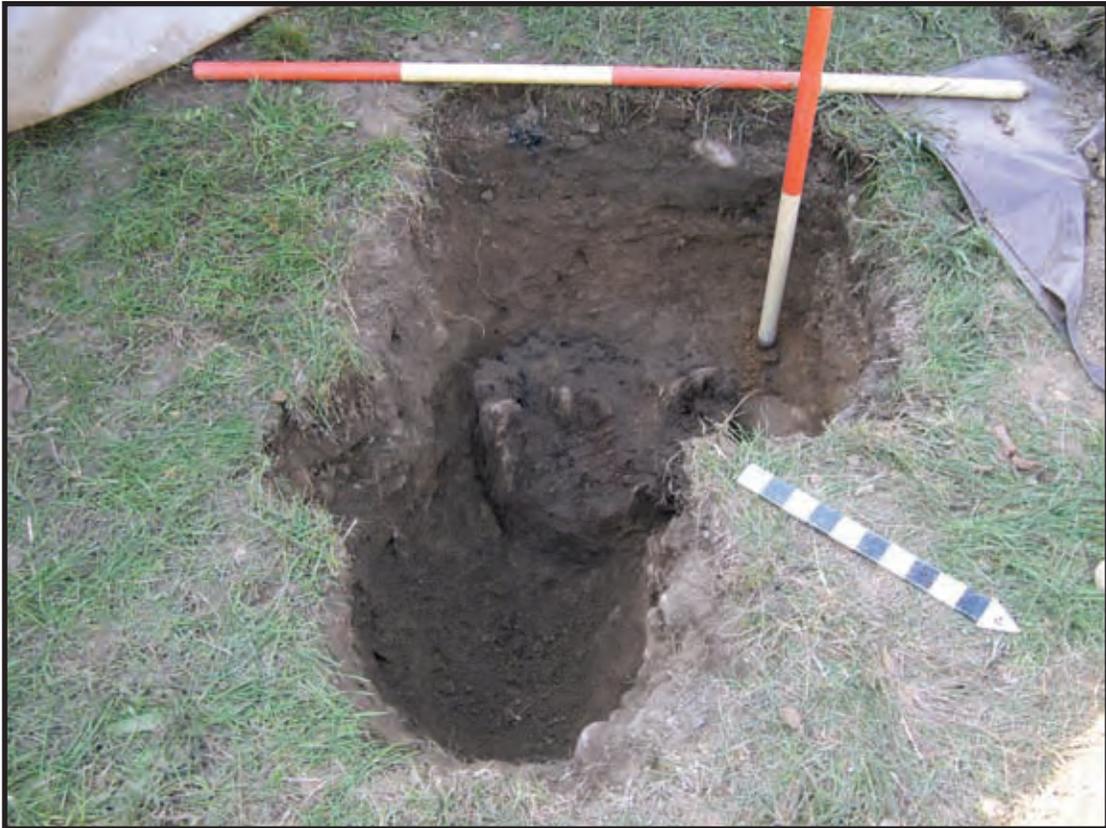
Plate 16. View looking southwest showing the base of a snubbing post identified in Shovel Test 61 (Photographer: James Lee, October 2006) [HRI Neg.#06052:D3:44].

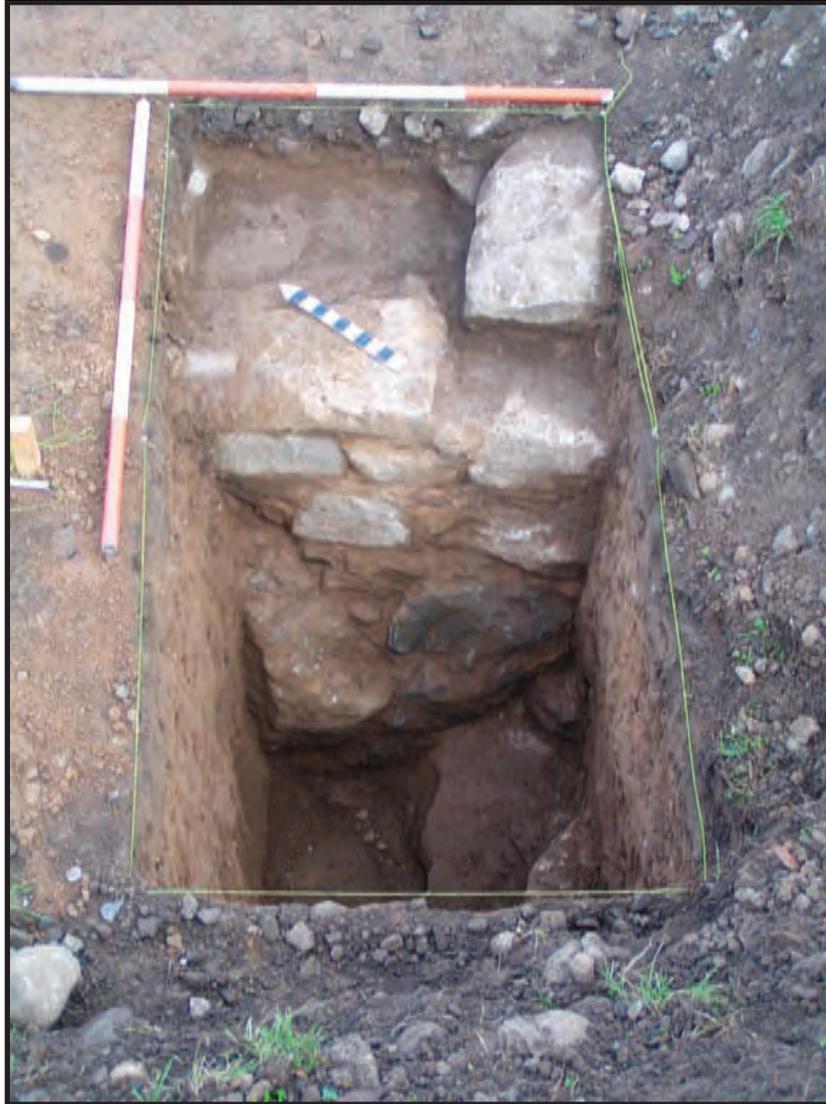
Plate 17. View looking north of Excavation Unit 1 showing the outside of the southern lock wall (Photographer: James Lee, October 2006) [HRI Neg.#06052:D2:29].

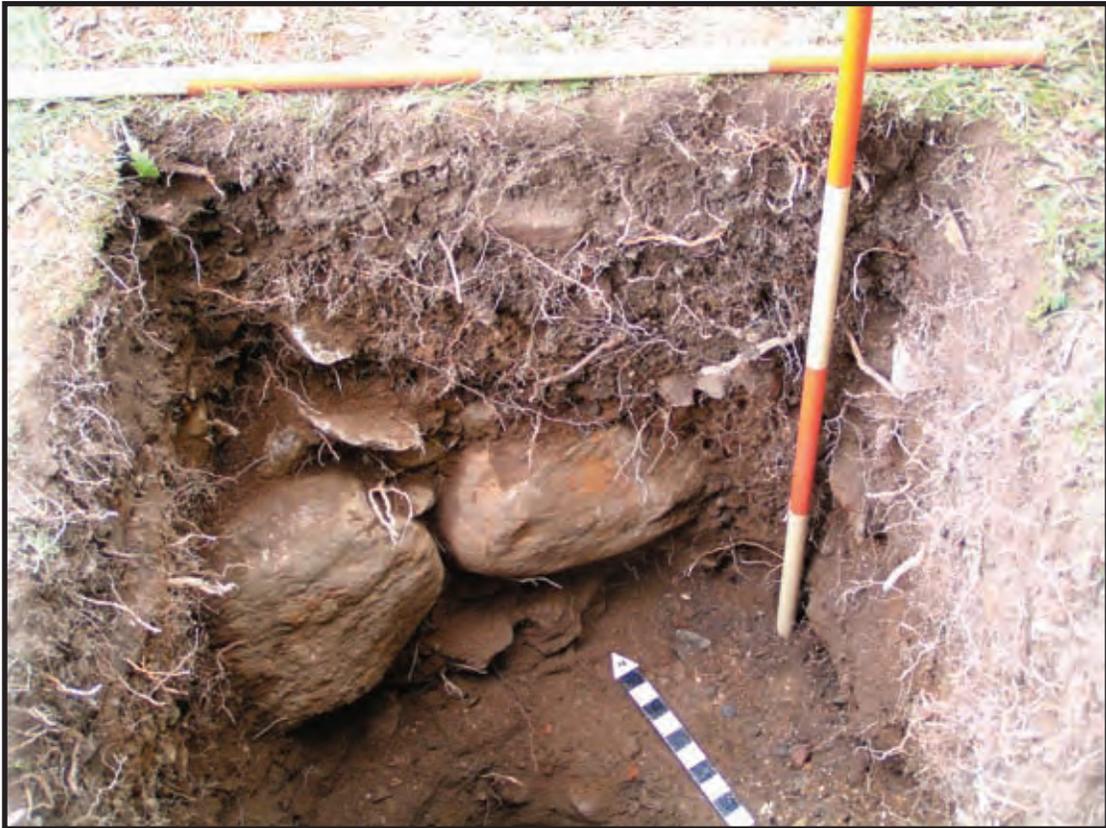
Plate 18. View looking north of Excavation Unit 2 (Photographer: Joshua Butchko, October 2006) [HRI Neg.#06052:D2:34].

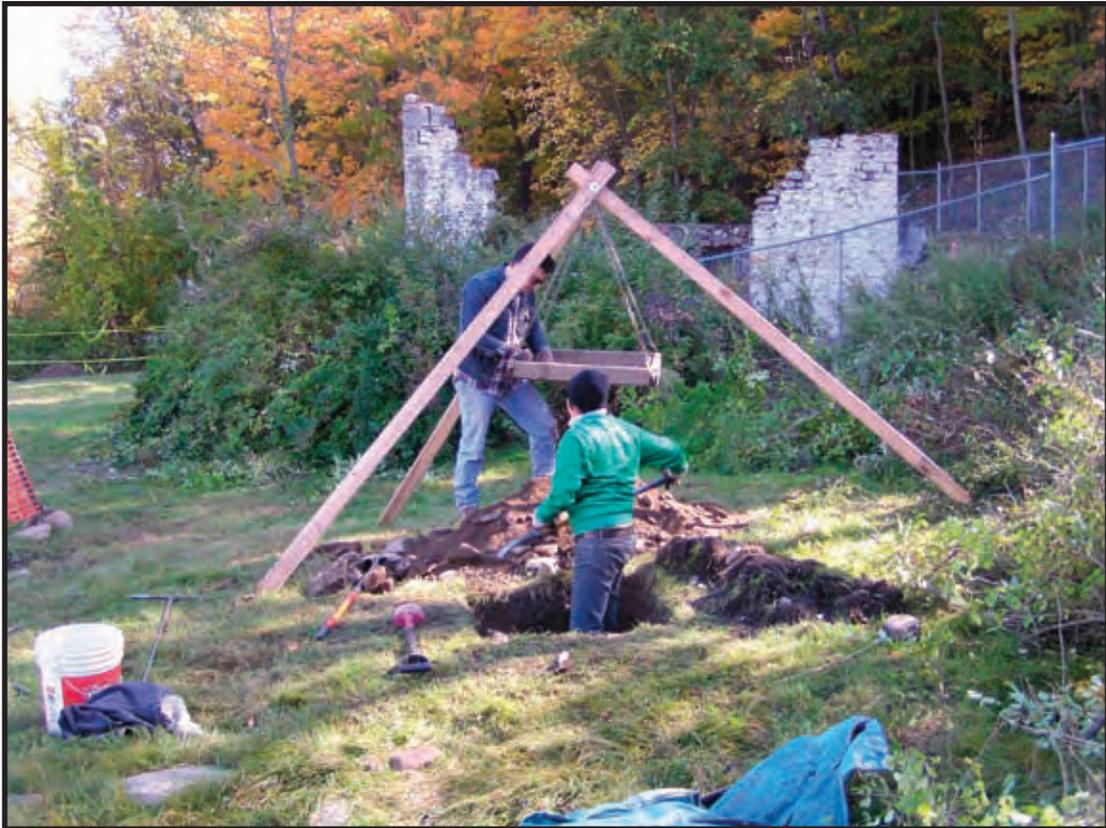
Plate 19. View looking east of Excavation Unit 3 in progress (Photographer: Joshua Butchko, October 2006) [HRI Neg.#06052:D2:48].

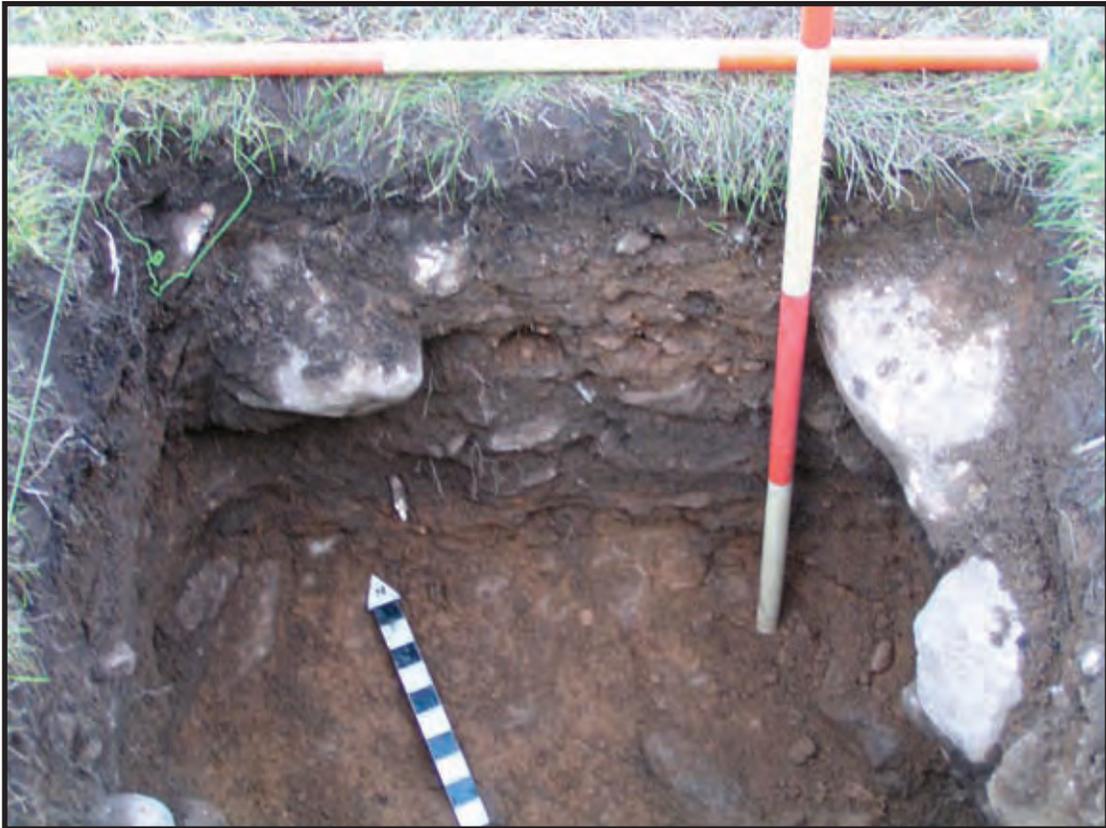
Plate 20. View looking north of Excavation Unit 3 (Photographer: Joshua Butchko, October 2006) [HRI Neg.#06052:D2:51].

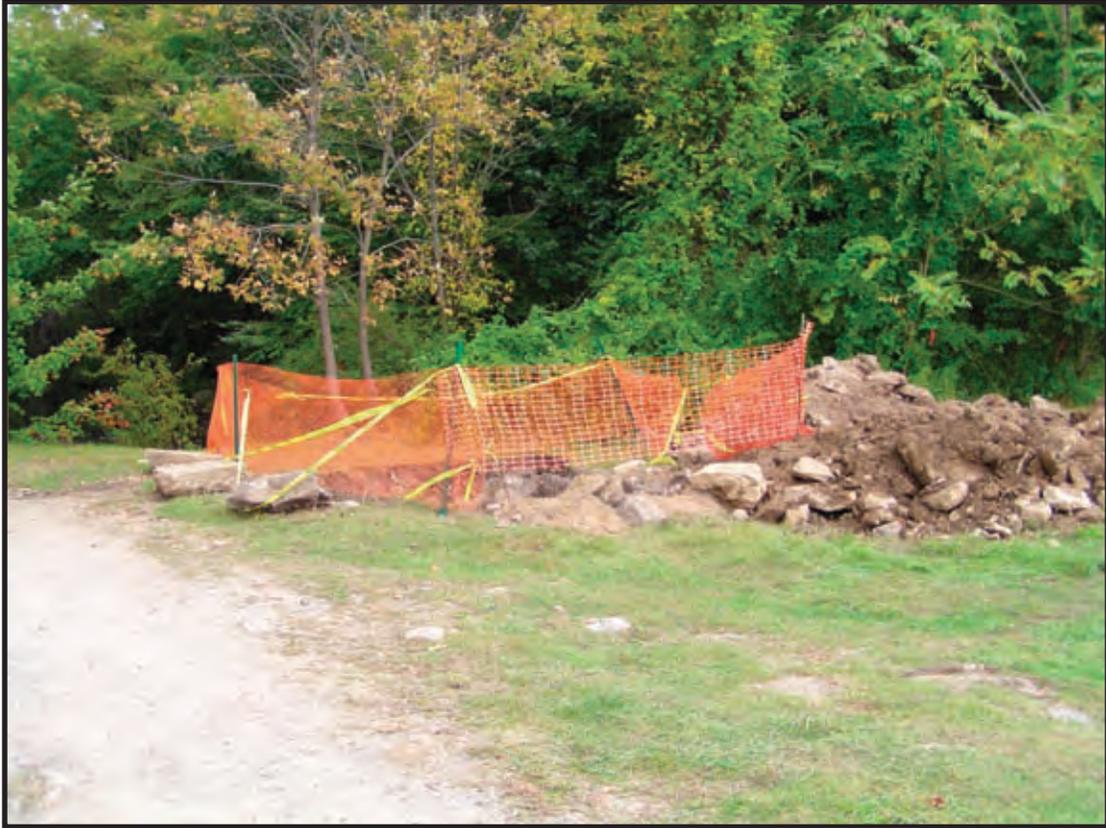
Plate 21. View looking east towards the location of Trench 1 at the eastern end of the lock (Photographer: James Lee, October 2006) [HRI Neg.#06052:D2:17].

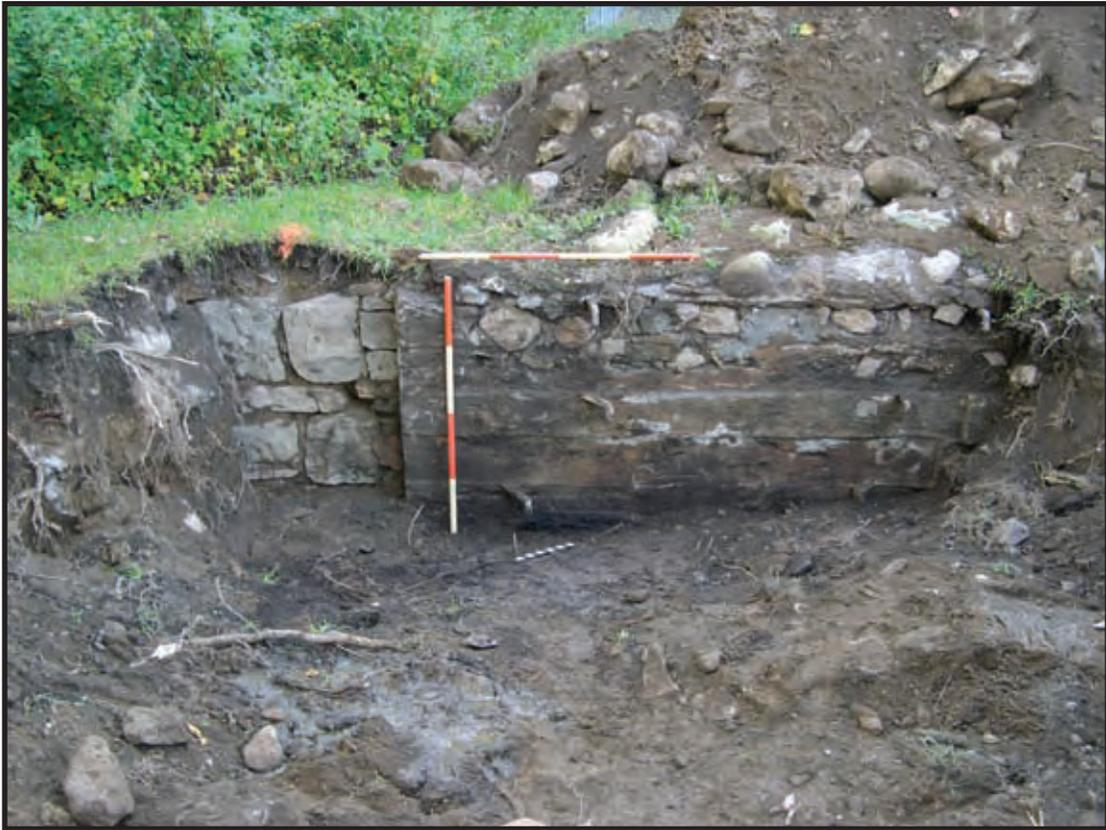
Plate 22. View looking south of the south wall of the lock exposed in Trench 1; note the recess for the miter gate (Photographer: James Lee, October 2006) [HRI Neg.#06052:D3:50].

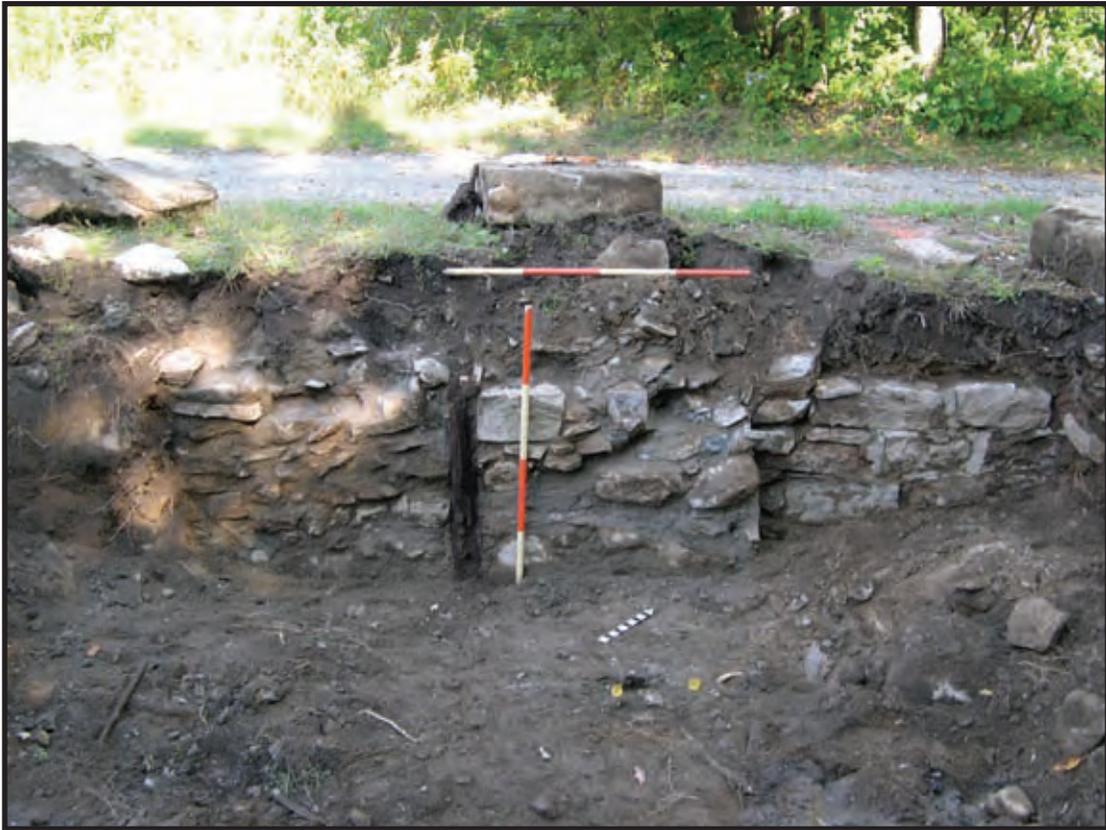
Plate 23. View looking north of the north wall of the lock exposed in Trench 1; note the upright timber still in place alongside of the scale rod (Photographer: James Lee, October 2006) [HRI Neg.#06052:D3:10].

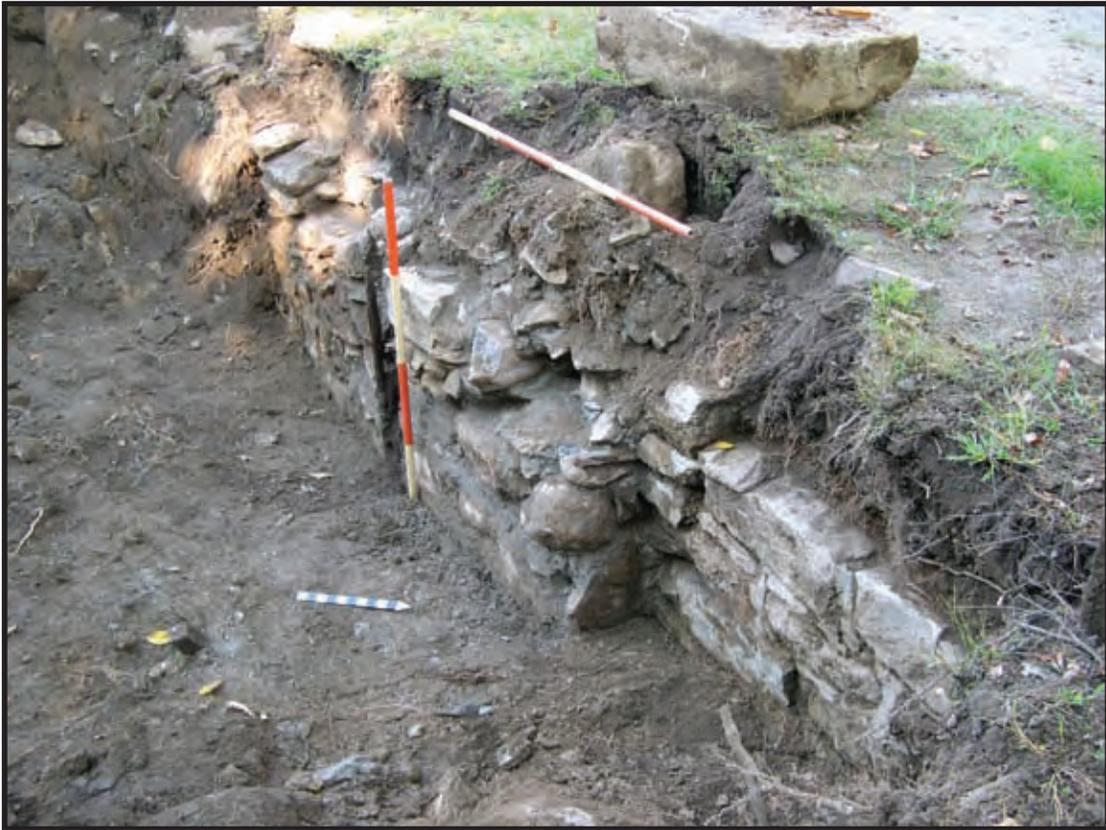
Plate 24. View northwest of the north wall of the lock in Trench 1. The recess for the miter gate is visible in the foreground and the surviving vertical timber from Plate 26 is visible next to the upright scale rod. Approximately three to four feet of the top of this wall was removed when the lock was dismantled (Photographer: James Lee, October 2006) [HRI Neg.#06052/D3:11].

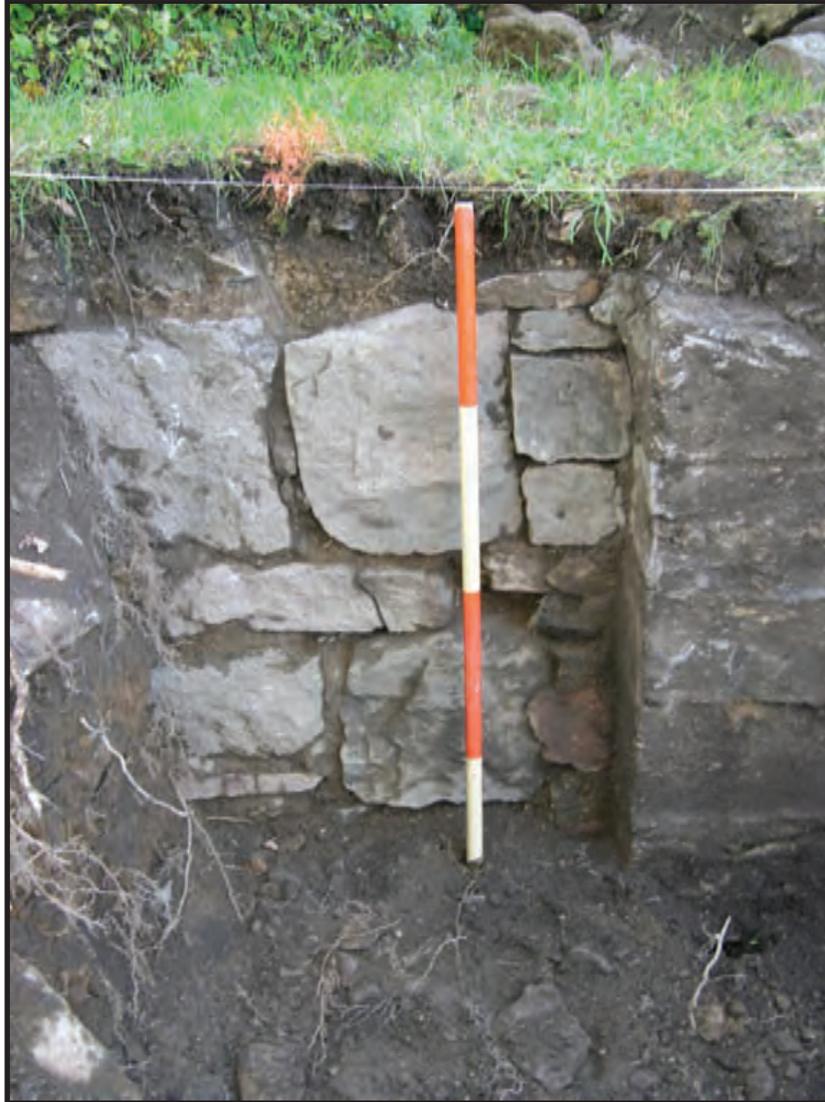
Plate 25. View south of the recess for the miter gate on the southern wall of the lock in Trench 1. Note the change from stone within the recess to concrete extending to the right. This concrete has horizontal timber impressions possibly indicating that concrete was added as a repair behind the timbers (Photographer: James Lee, October 2006) [HRI Neg.#06052/D3:12].

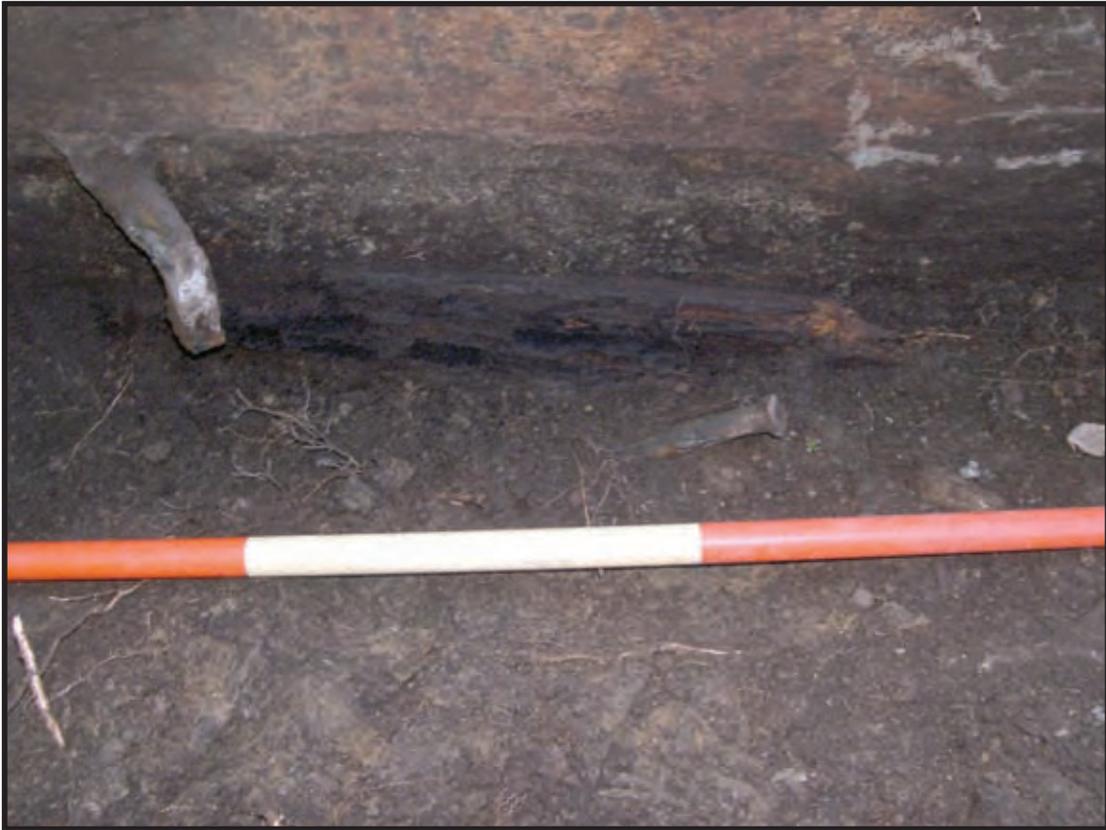
Plate 26. View south along the bottom edge of the trench against the south wall of the lock in Trench 1. A surviving horizontal timber with concrete poured behind it. The large, square spikes held the timber sheeting to the lock walls (Photographer: James Lee, October 2006) [HRI Neg.#06052/D3:15].

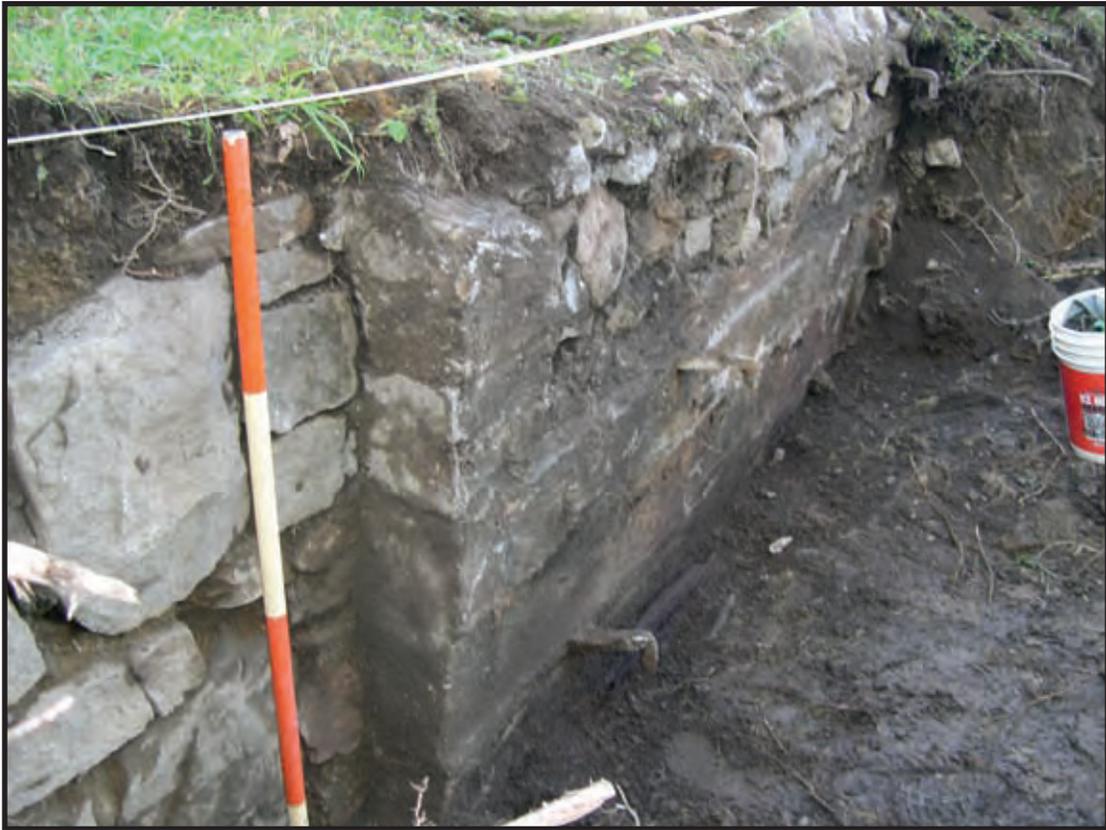
Plate 27. View looking southwest of the south wall of the lock in Trench 1 showing the mortar repairs poured behind the locks missing timber sheeting; note the horizontal timber sheeting visible along the wall at the base of excavation (Photographer: James Lee, October 2006) [HRI Neg.#06052:D3:14].

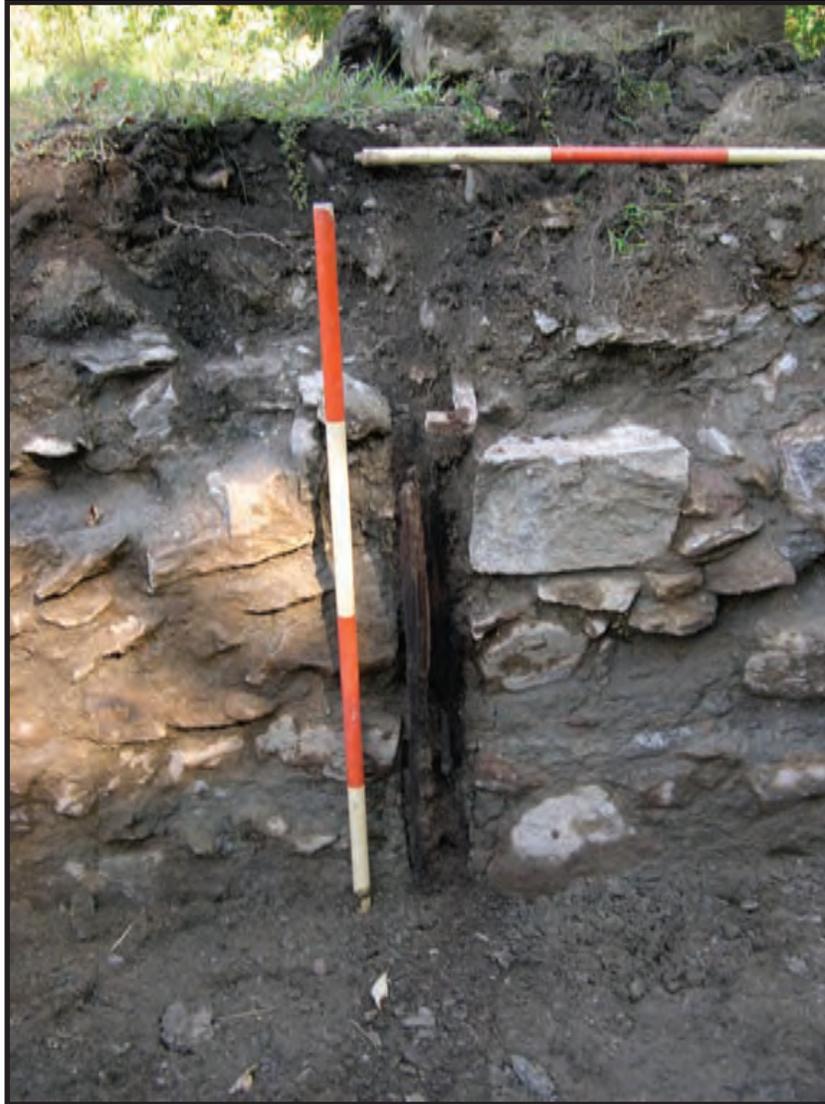
Plate 28. View north showing a surviving timber recessed into the north wall of the lock in Trench 1. This timber likely a nailer that anchored the horizontal timber sheeting that lined the lock (Photographer: James Lee, October 2006) [HRI Neg.#06052/D3:16].

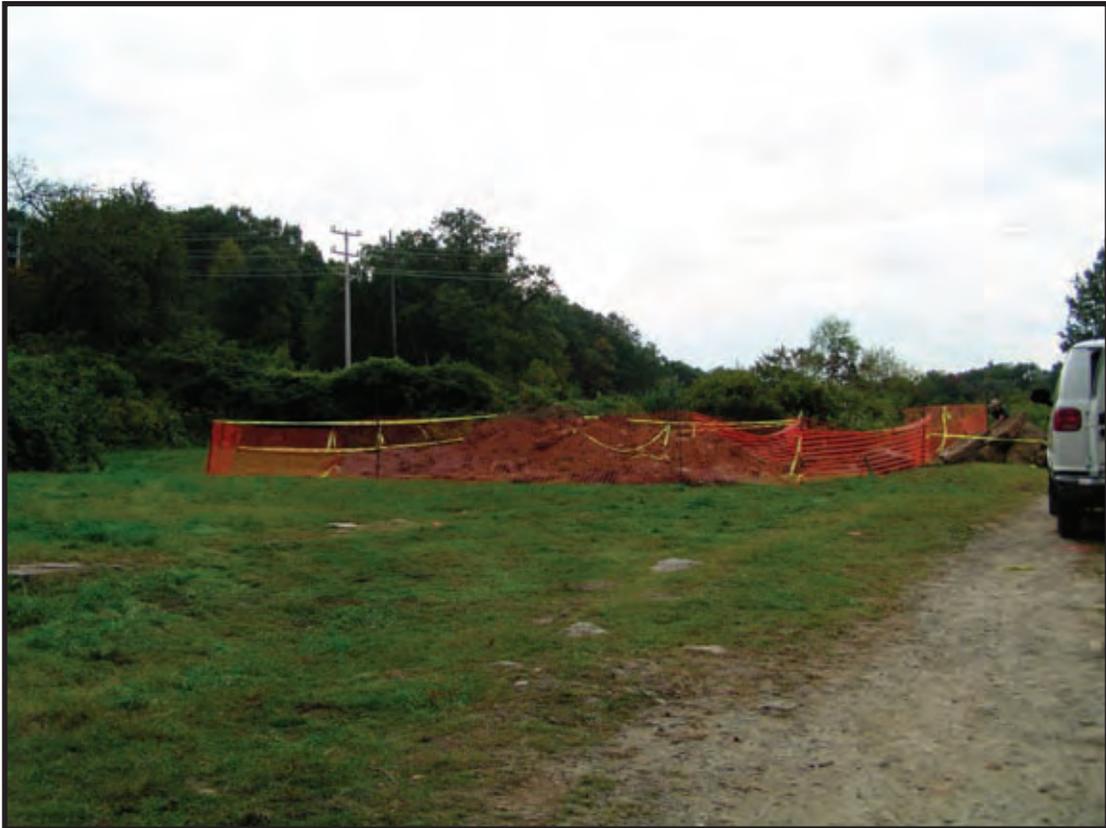
Plate 29. View looking southwest towards the location of Trench 2 at the western end of the lock (Photographer: James Lee, October 2006) [HRI Neg.#06052:D2:19].

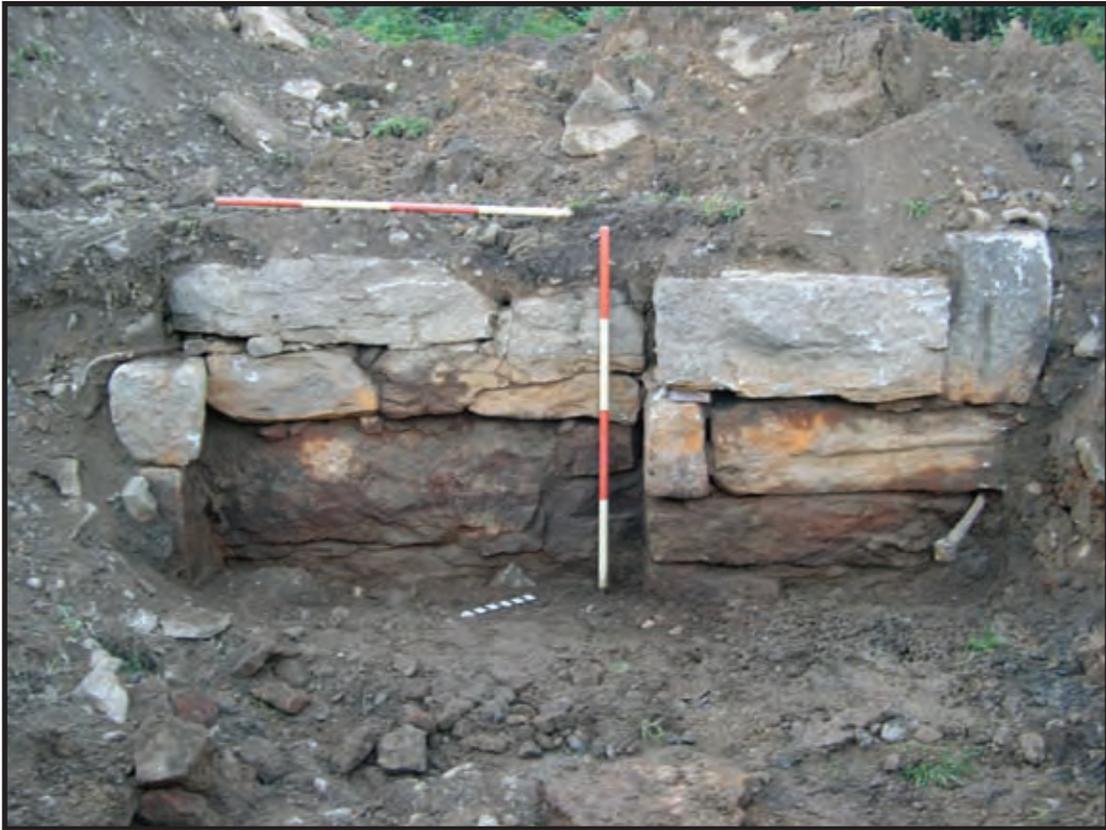
Plate 30. View looking south of the south wall of the lock exposed in Trench 2; note the recess for the drop gate mechanism (Photographer: James Lee, October 2006) [HRI Neg.#06052:D3:29].

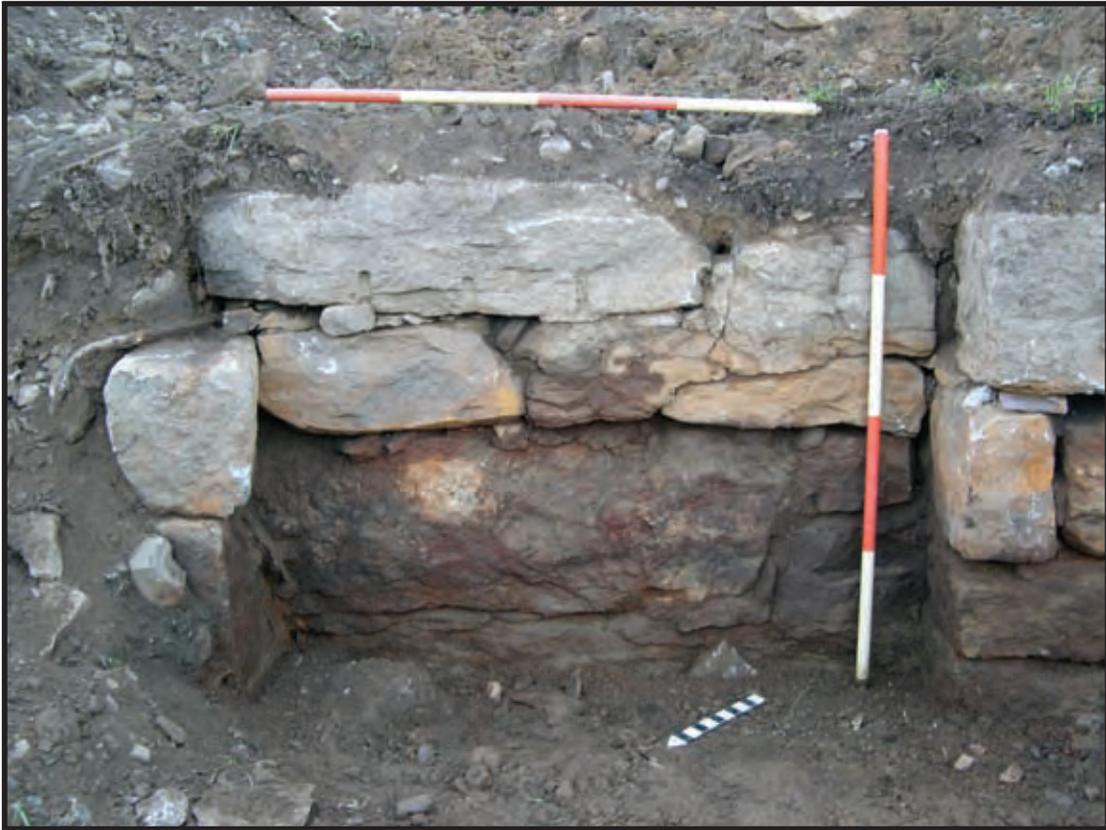
Plate 31. View south of the recess in the south wall of lock to accommodate the lever for the drop gate that was located just below the bottom of this trench (now below the water line) (Photographer: James Lee, October 2006) [HRI Neg.#06052/D3:31].

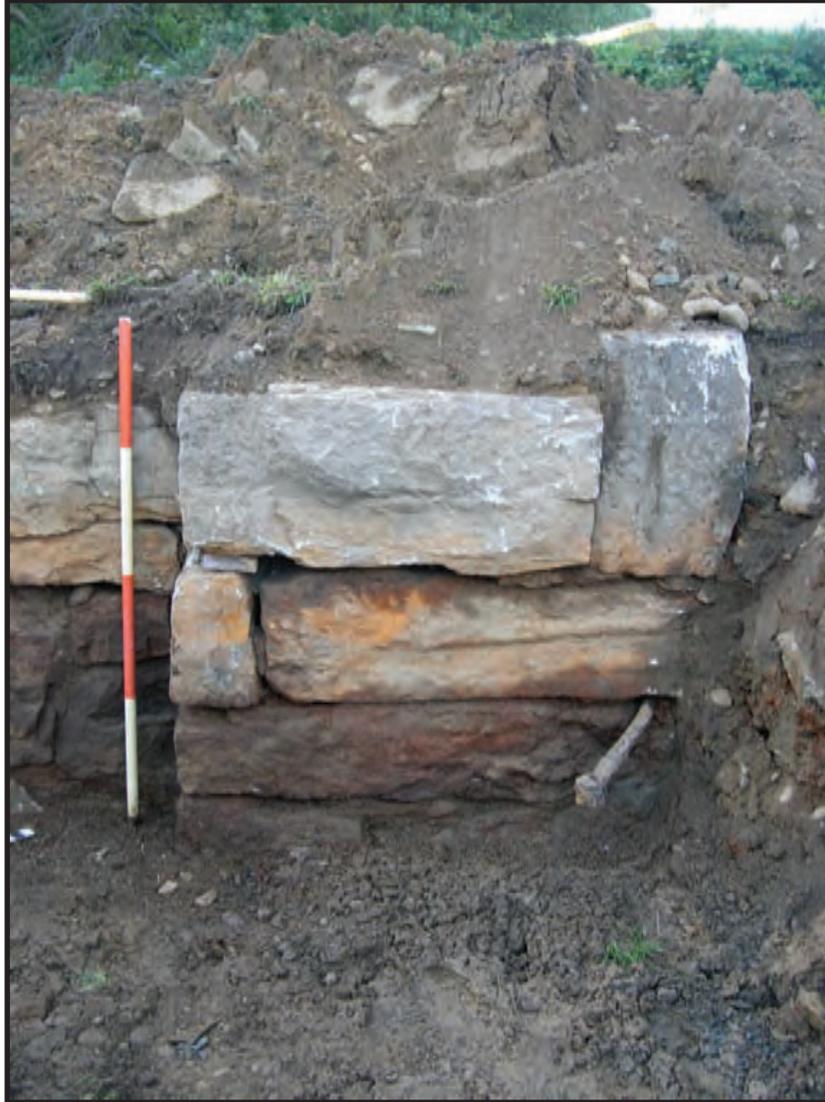
Plate 32. View south of the south wall of the lock showing an iron tie-rod that probably held timber bumpers used to guide the boat into the lock (Photographer: James Lee, October 2006) [HRI Neg.#06052/D3:33].

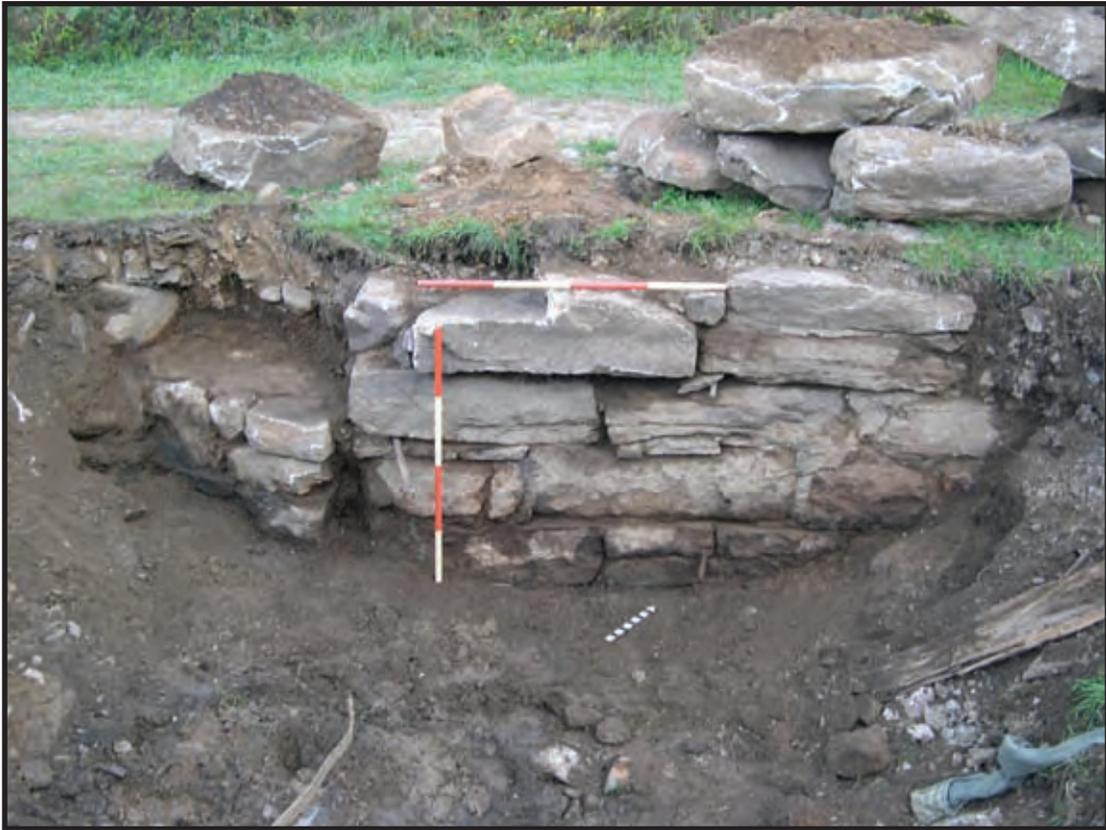
Plate 33. View looking north of the north wall of the lock exposed in Trench 2. The flaired, upstream headwall of the lock is visible at the left end of this section. Unlike the wall opposite this one (Plate 30), there is no recess to accommodate the drop gate mechanism, which is only necessary on one side. Also, the original top of this wall was removed when the lock was dismantled. The large flat coping stones which had run along the top of this wall were found in the lock and are visible lying on the ground above this wall (Photographer: James Lee, October 2006) [HRI Neg.#06052/D3:24].

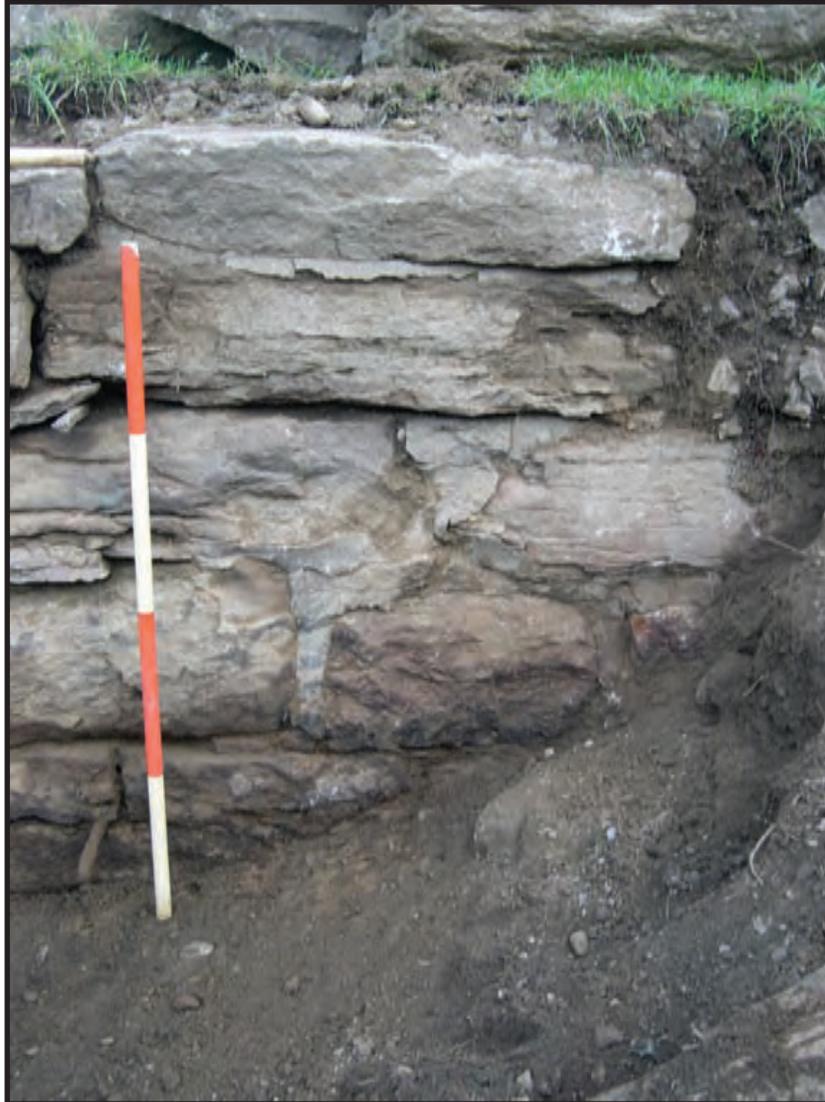
Plate 34. View north of the north wall of the lock in Trench 2 showing the mortar patching (Photographer: James Lee, October 2006) [HRI Neg.#06052/D3:27].

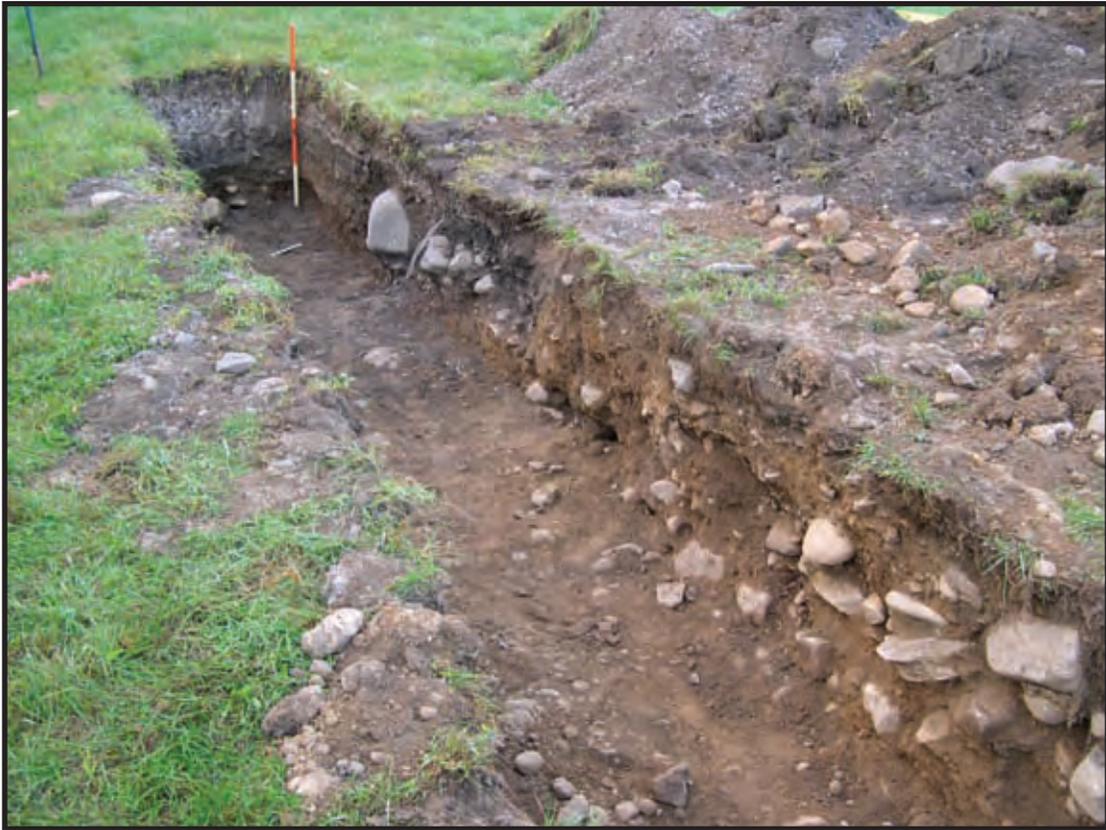
Plate 35. View looking southwest of Trench 3 (Photographer: James Lee, October 2006) [HRI Neg.#06052:D3:36].

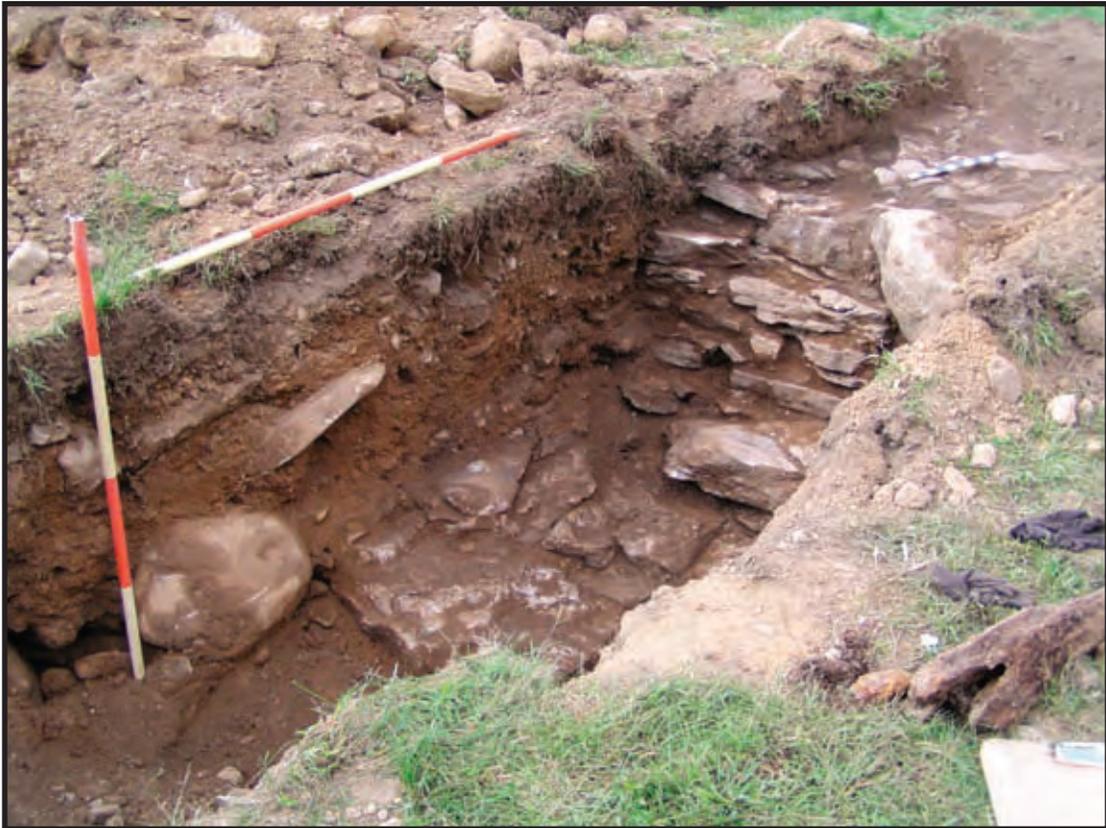
Plate 36. View looking northwest showing the exterior of the southern wall of the lock exposed in Trench 3; note the step out at the bottom of the trench where the wall widens (Photographer: James Lee, October 2006) [HRI Neg.#06052:D2:09].

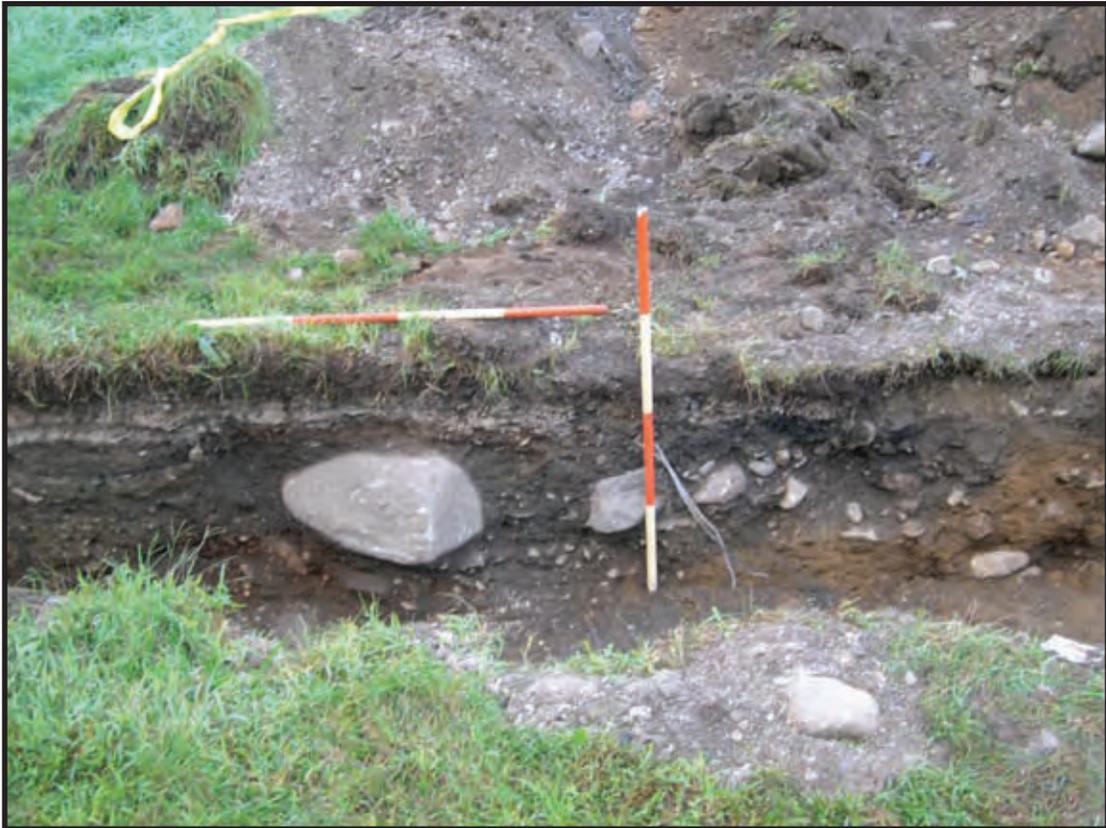
Plate 37. View looking west of the profile of Trench 3 showing the filled ditch that ran between the lock and the house (Photographer: James Lee, October 2006) [HRI Neg.#06052:D3:38].
