**HISTORIC SITE MASTER PLAN
& FEASIBILITY STUDY**

LOCK 2 EAST OF THE MORRIS CANAL

Robert Street
Hugh Force Park
Wharton, Morris County, New Jersey

Project No. 0616H

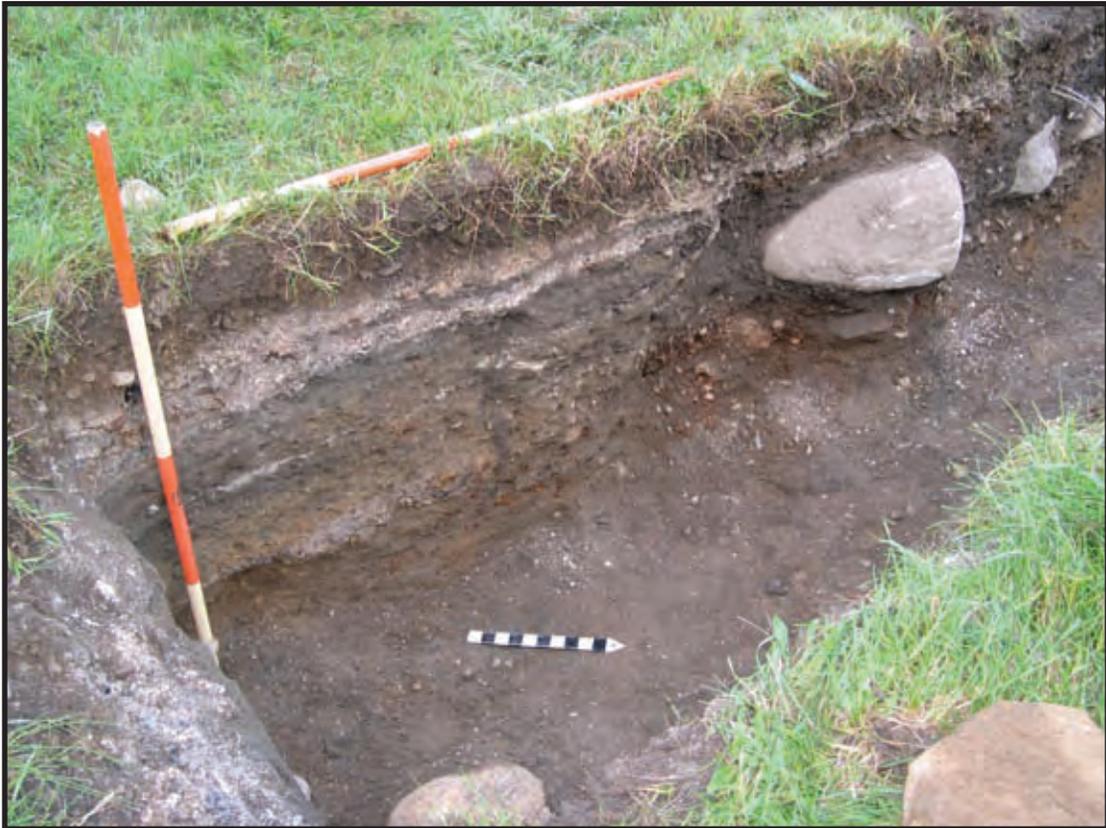
Plate 38. View looking northwest of the profile of Trench 3 showing the stratified yard deposits that post date the filling of the ditch (Photographer: James Lee, October 2006) [HRI Neg.#06052:D3:41].

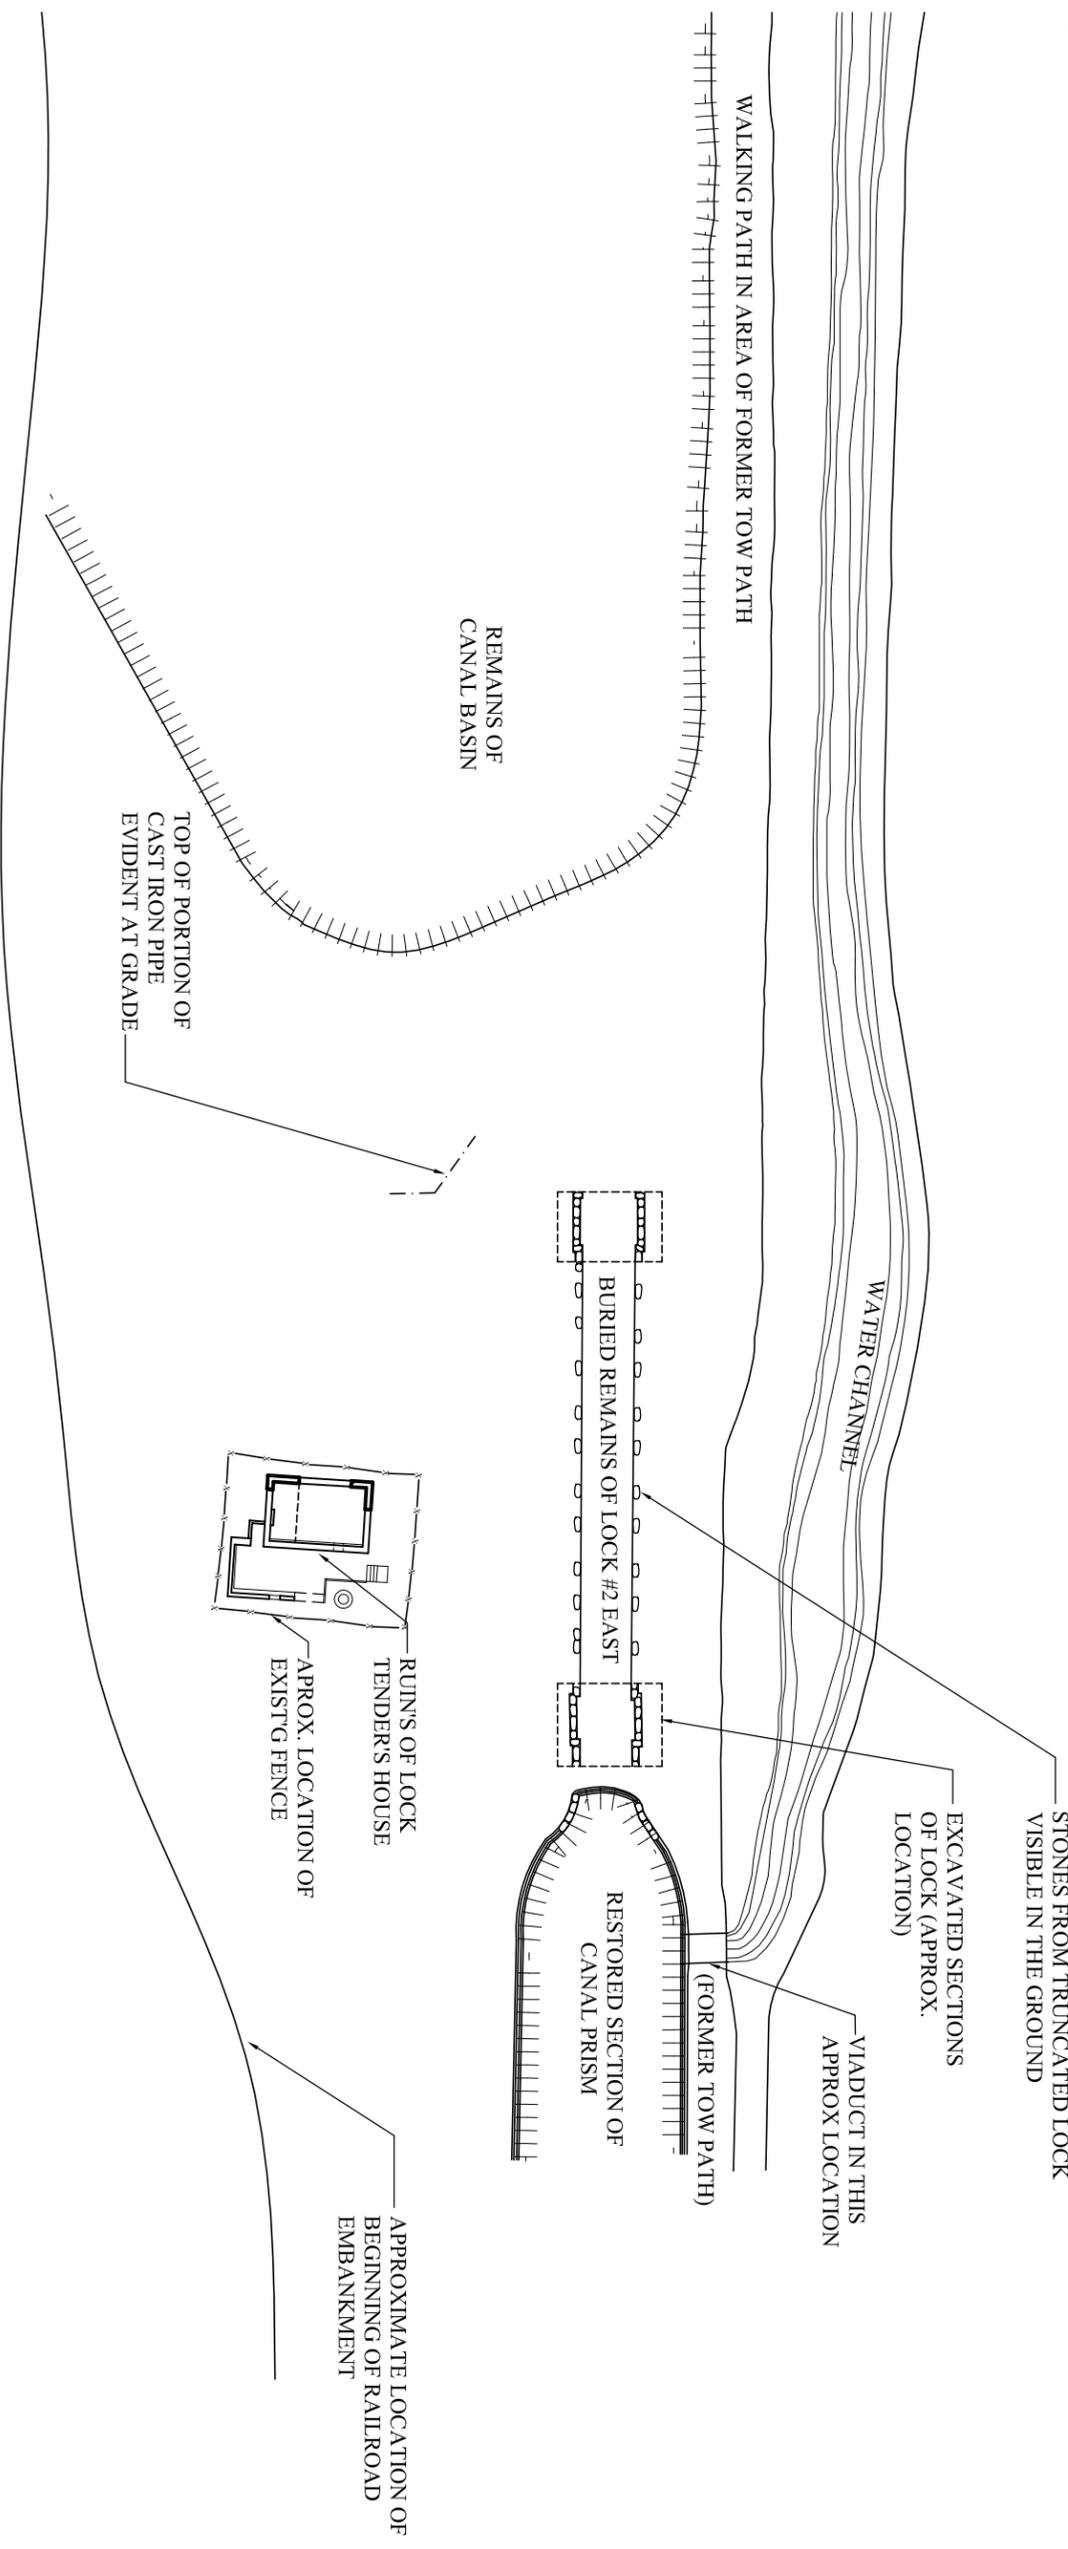
LOCK 2 EAST - EXISTING CONDITIONS
NOT TO SCALE

(Drawings based on C. Vermeule Abandonment Plans and
in-field assessment of existing conditions)

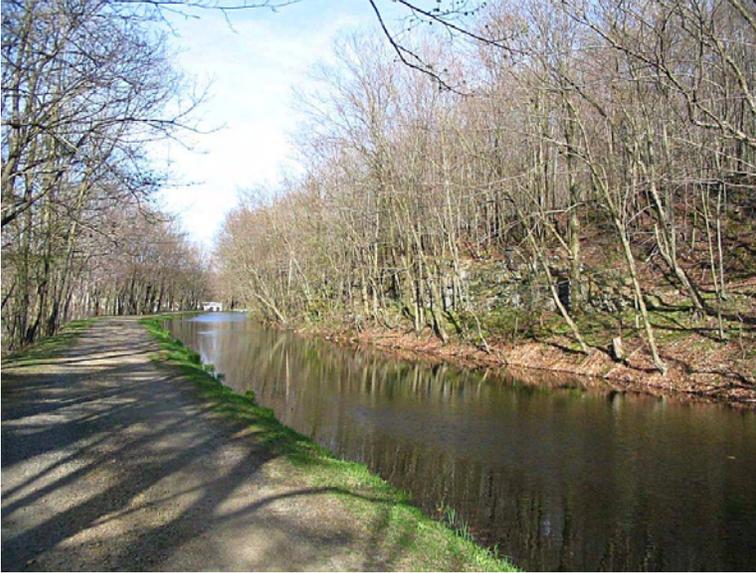
Photo 1

View of watered section of the canal prism looking east. Note the tow path on the left side of the photograph and the railroad embankment on the right.

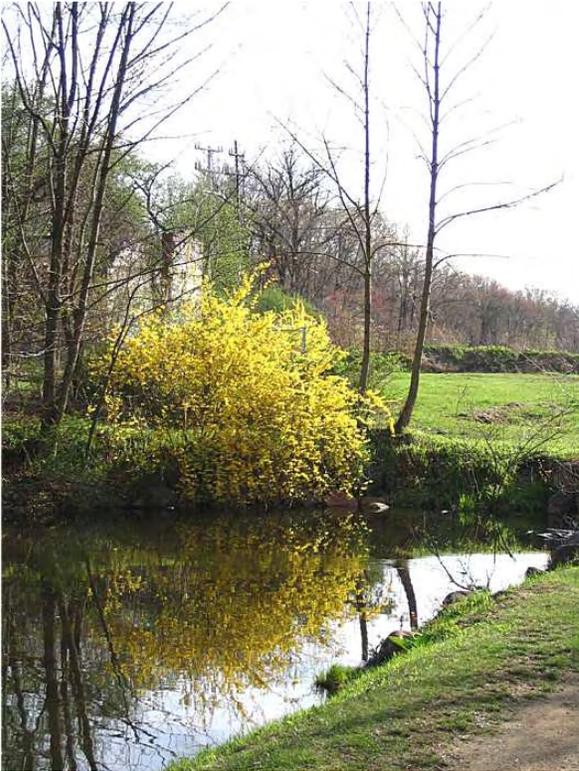
Photo 3

View of canal prism at the transition between the canal and remaining portions of the lock's splayed headwall at the east end of the lock.

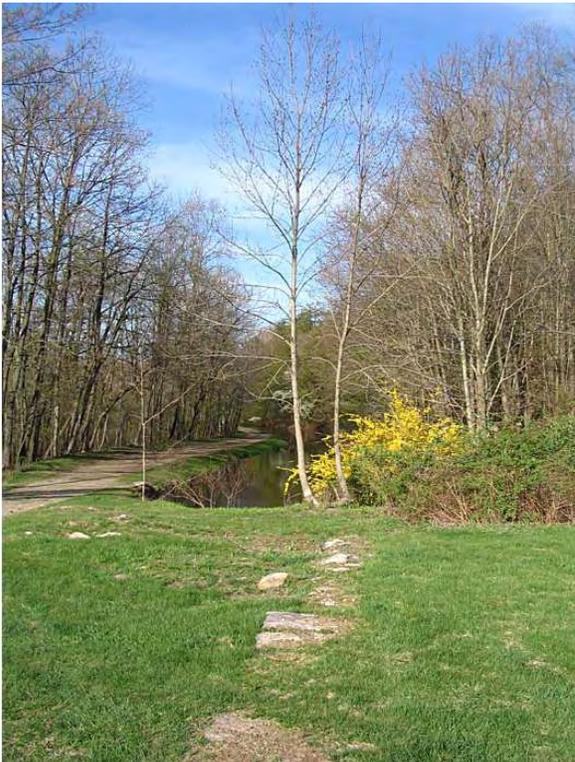
Photo 4

View of Lock 2 East looking east from the remains of the lock toward the canal prism. The stones visible in the ground form the outline of the remains of the lock.

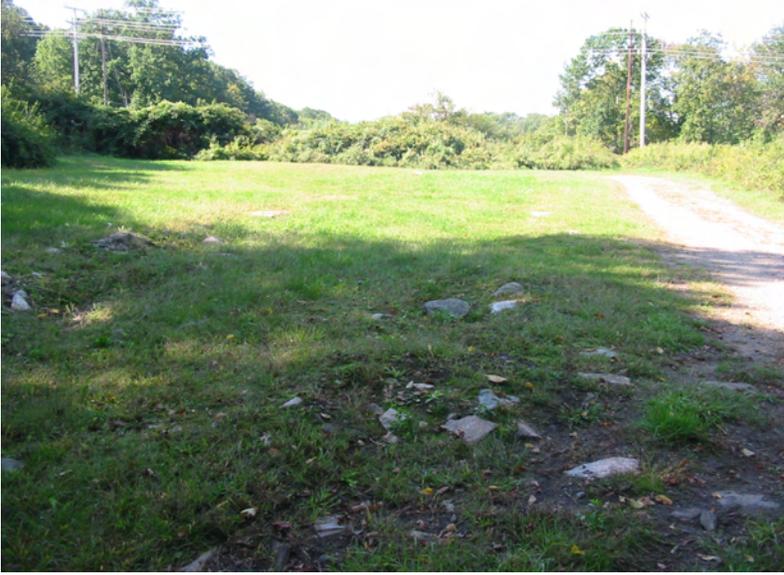
Photo 5

View of the Lock 2 East site looking west towards the canal basin which is hidden by brush. The line of stone visible on the surface shows where the lock remains are buried. The top two to three feet of the lock were removed and the grade cut and leveled.

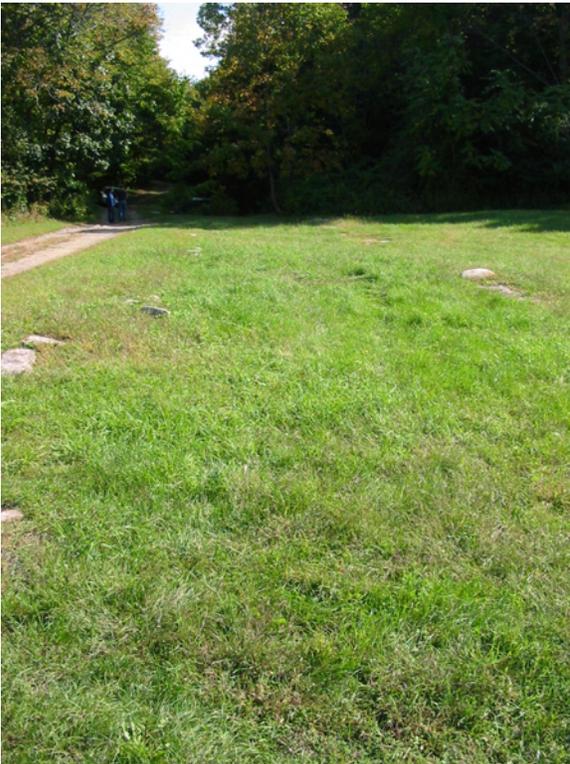
Photo 6

View of the Lock 2 East site looking east at the top of the lock walls. The path on the left connects the tow paths along the prism and basin.

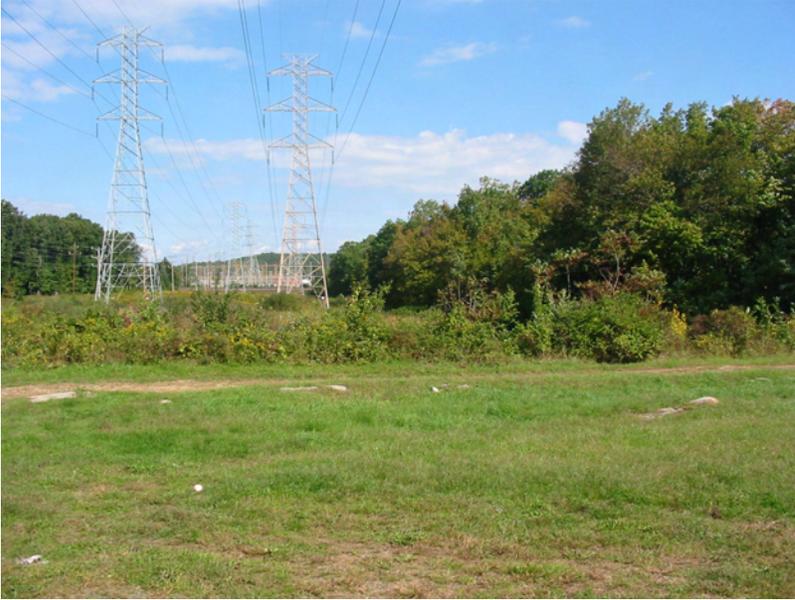
Photo 7

Overall view of the Lock 2 East site looking north. Beyond the line of vegetation along the path is Stephens Brook which feeds the canal prism.

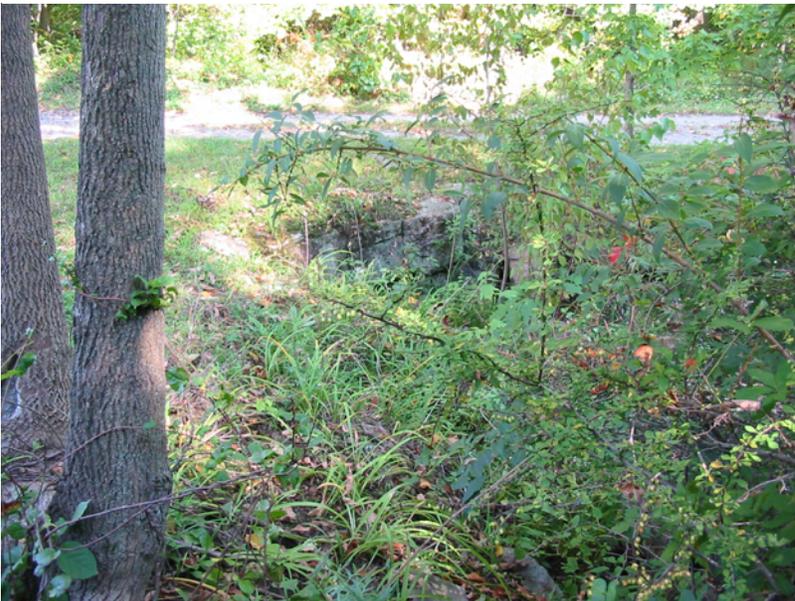
Photo 8

Detail view of the remains of the splayed headwall at the east end of the lock at the connection with the canal prism.

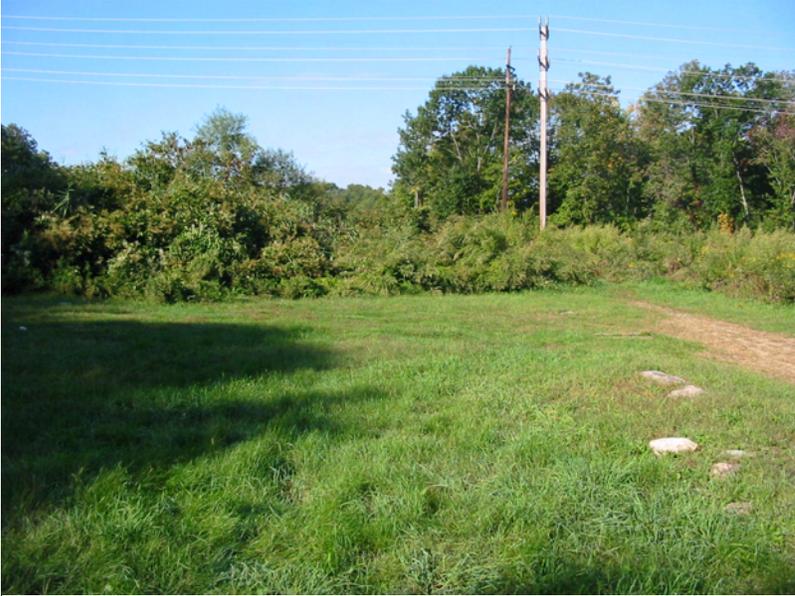
Photo 9

View of the brush separating the former lock from the location of the former canal basin beyond.

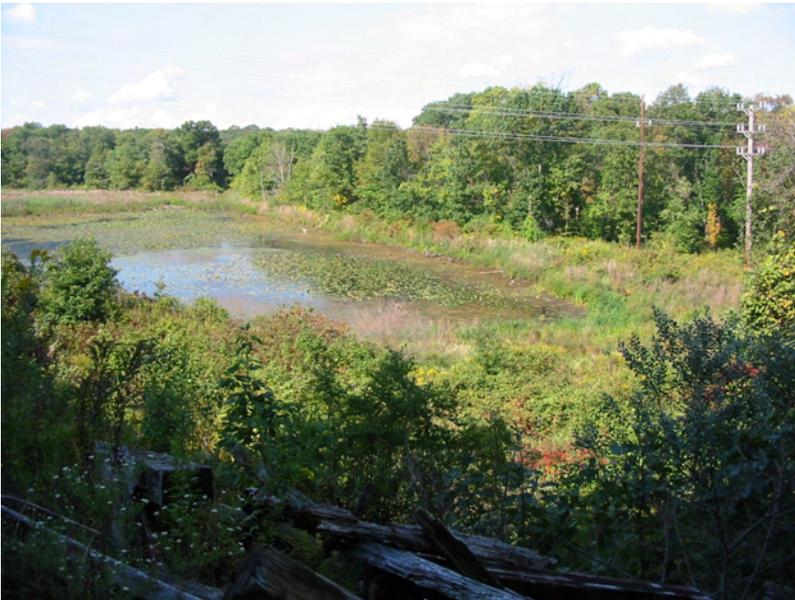
Photo 10

Overall view of the former canal basin, now a pond, to the west of the former Lock 2 East. The configuration of the basin has been modified since the canal abandonment. View taken from the railroad embankment above the lock tender's house.

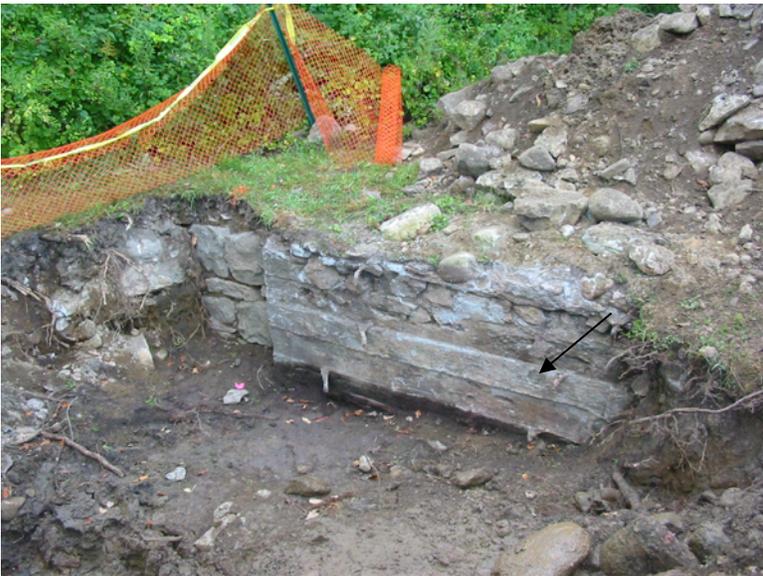
Photo 11

Detail view of one of the excavations of the lock. This is the east end showing some of the repairs to the stone walls with cast-in-place concrete.

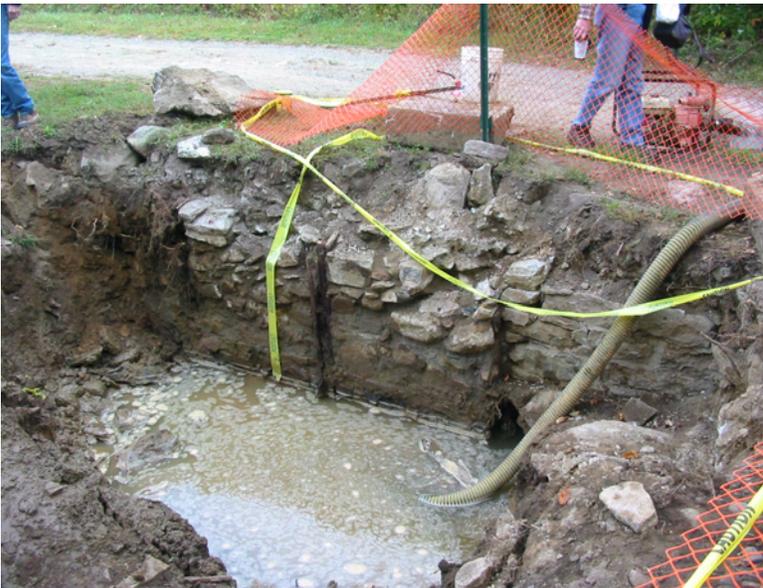
Photo 12

View of the east excavation at the lock showing the stone walls including cast iron hardware attached to the side walls.

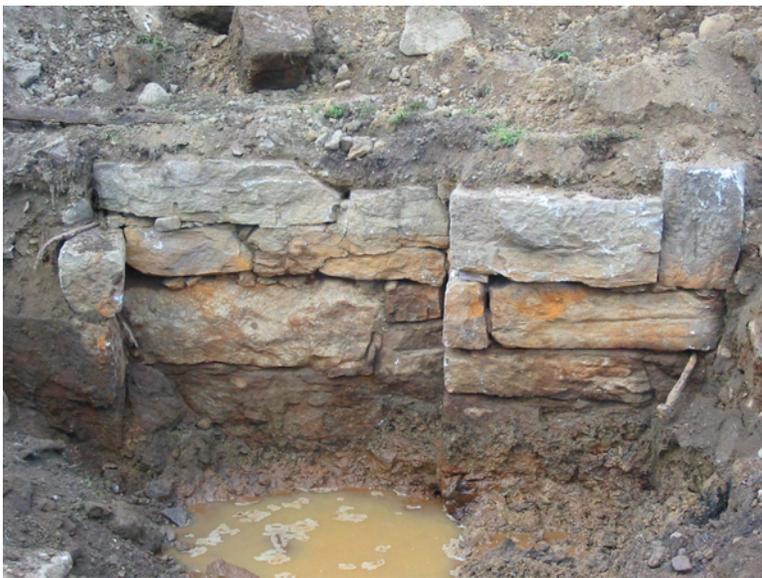
Photo 13

Detail view of one of the west excavations of the lock; the south wall of the lock. Note the clear indication in the walls for the recess for the free operation of the miter gates in this location.

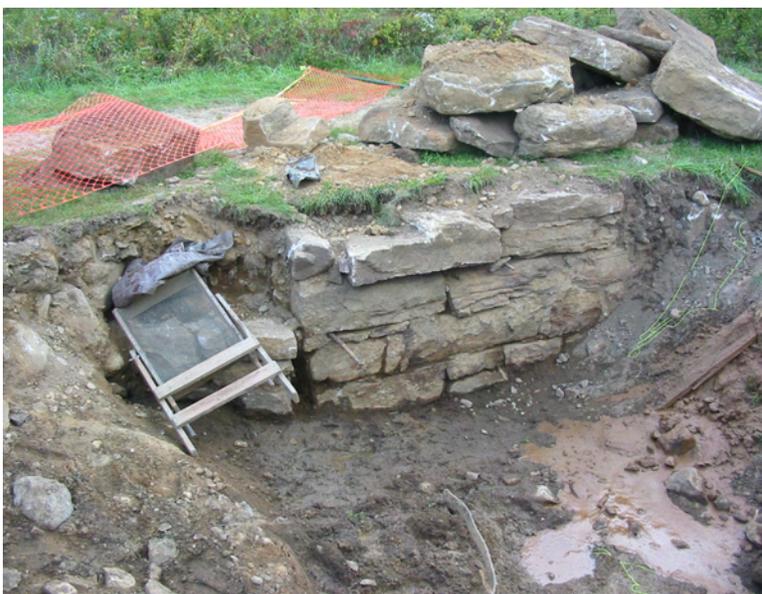
PHOTOS 13 & 14

View of the north wall of the west lock excavation. Note the overall good condition of the stone composing the walls. Only four feet of the lock walls were revealed due to the presence of ground water in the bottom of the lock.

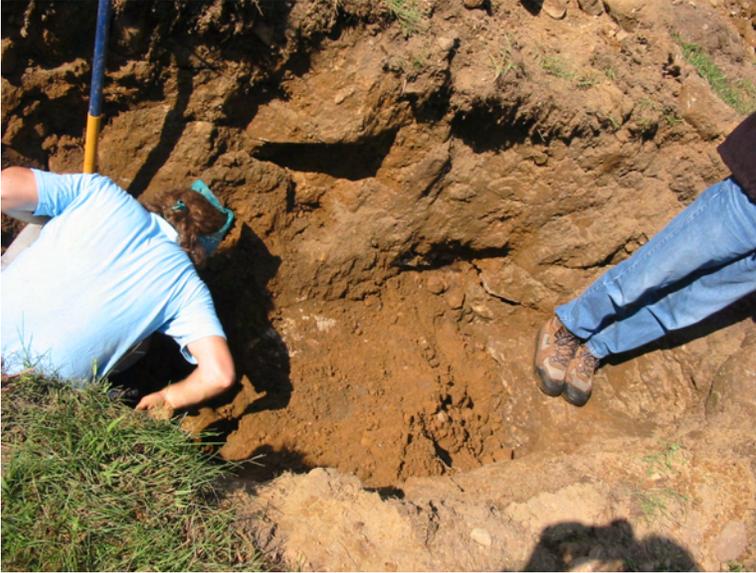
Photo 15

View of a third excavation at the south side of the lock showing the gradual thickening of the lock walls from top to bottom.

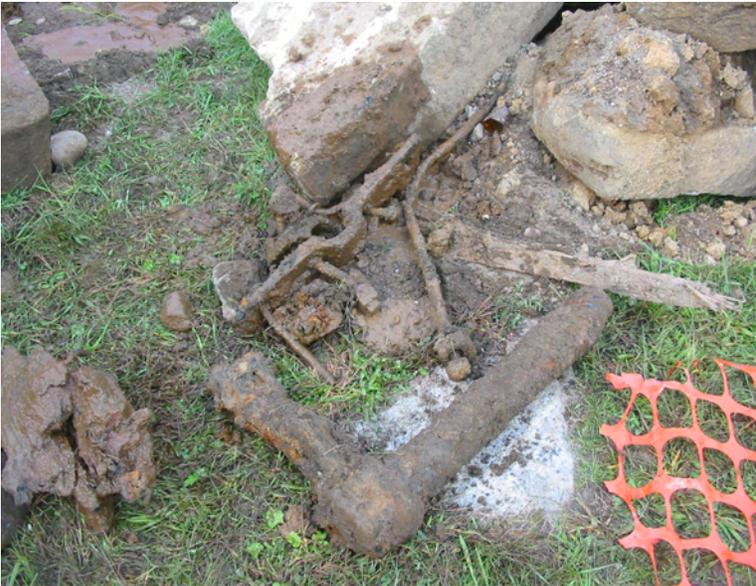
Photo 16

View of iron spikes, hinges and other pieces of ironwork that appear to be associated with the miter gates located at the west end of the lock.

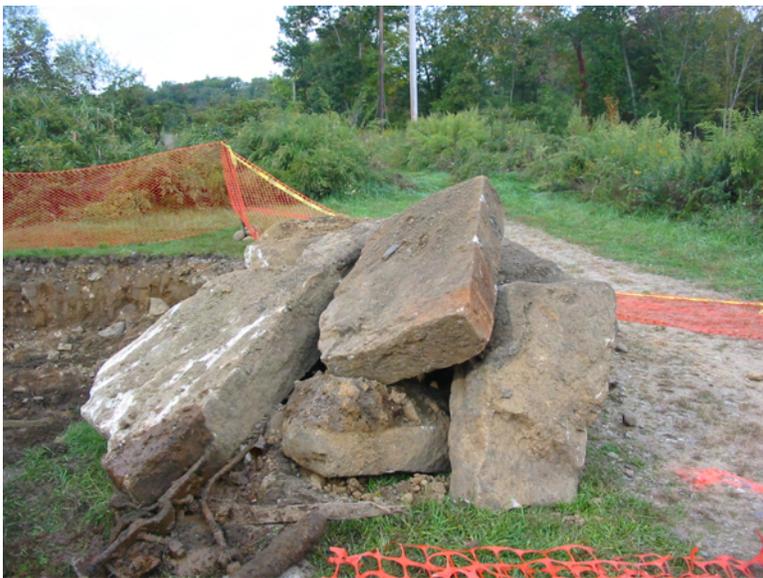
Photo 17

View of coping stones removed from the filled in sections of the lock. These stone appear to be the top layers of the lock walls that were removed during the canal's abandonment. It will be critical to examine each stone for clues to their original location based on scarring, bedding joints, and other features prior to reinstallation.

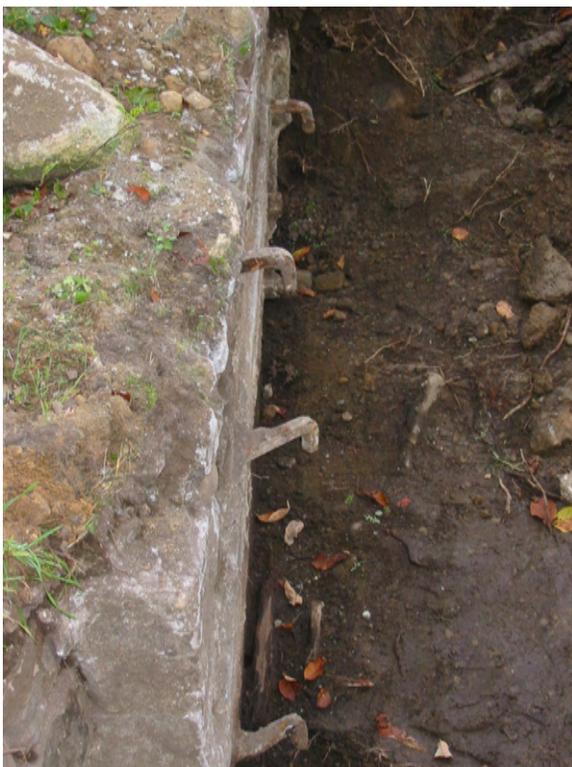
Photo 18

Detail of iron spikes that appear to have been used to attach the timber sheathing to the lock walls.

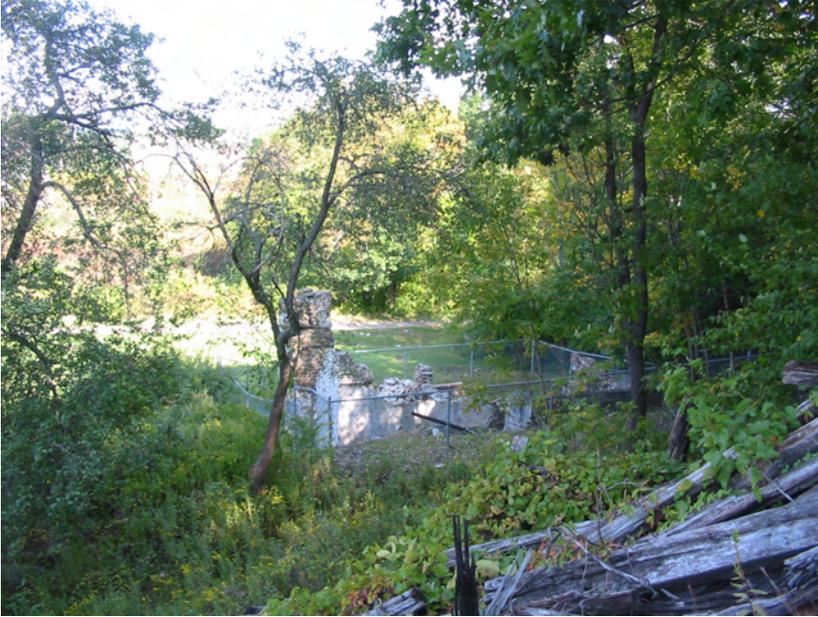
Photo 19

Overall view of the Lock 2 East site facing northeast, specifically showing the ruins of the lock tender's house and the surrounding brush. Photograph was taken from the railroad embankment above.

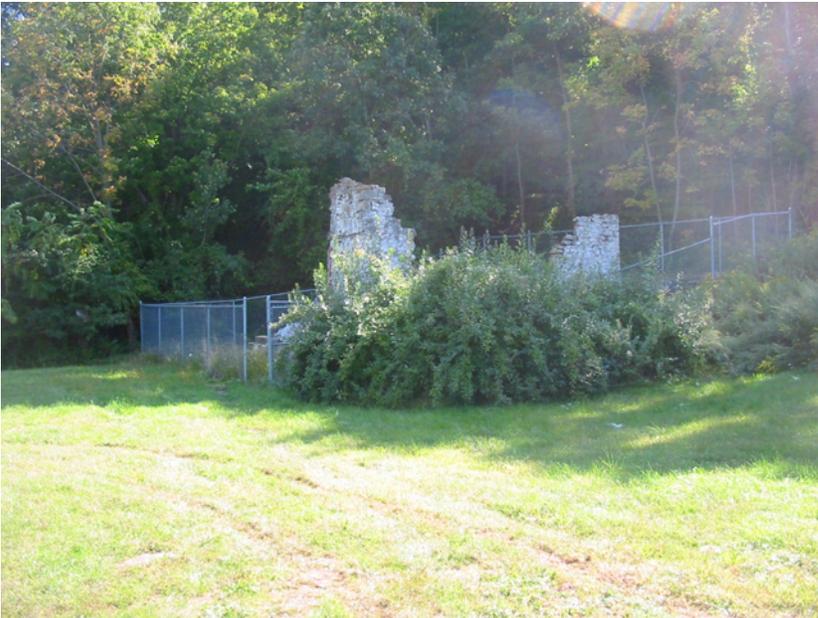
Photo 20

Overall view of the lock tender's house ruin looking southeast.

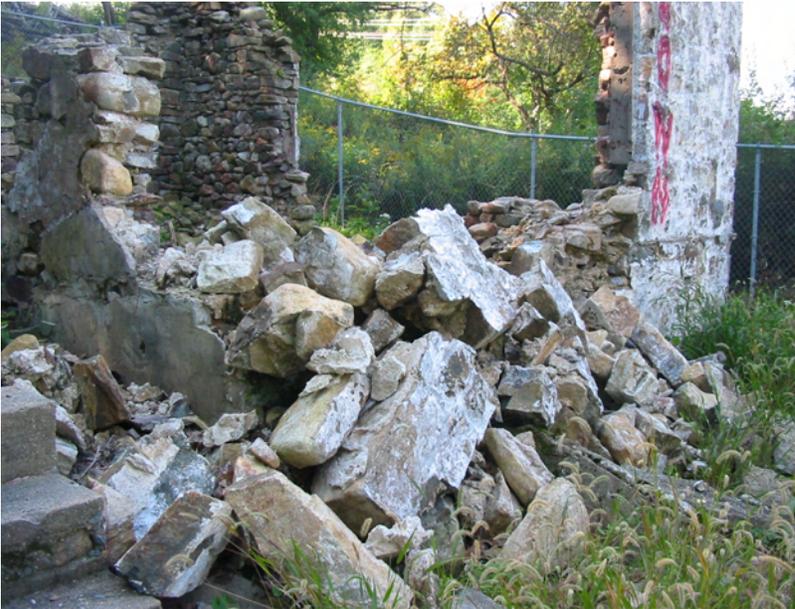
Photo 21

Detail view of the ruins of the lock tender's house looking southwest at the northeast corner.

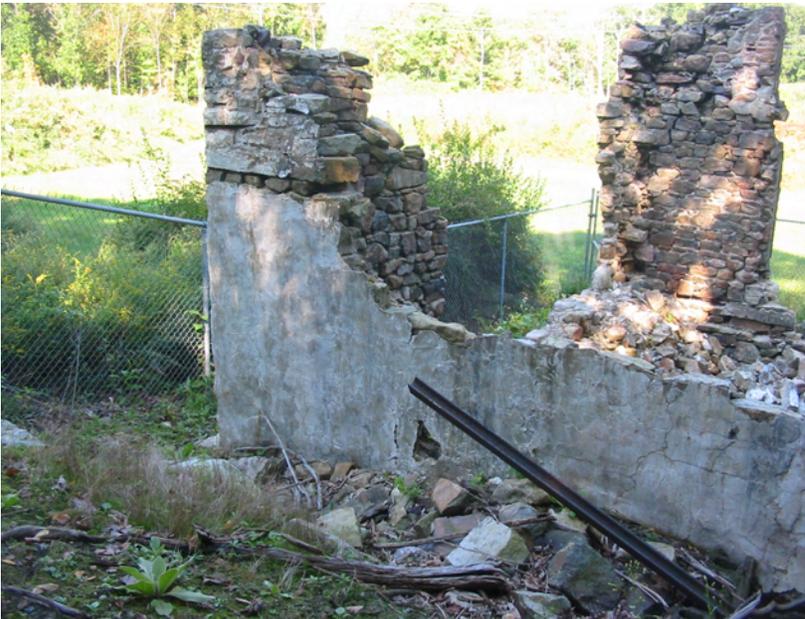
Photo 22

Partial view of the remaining south wall of the main building of the lock tender's house; the northwest corner is also visible beyond.

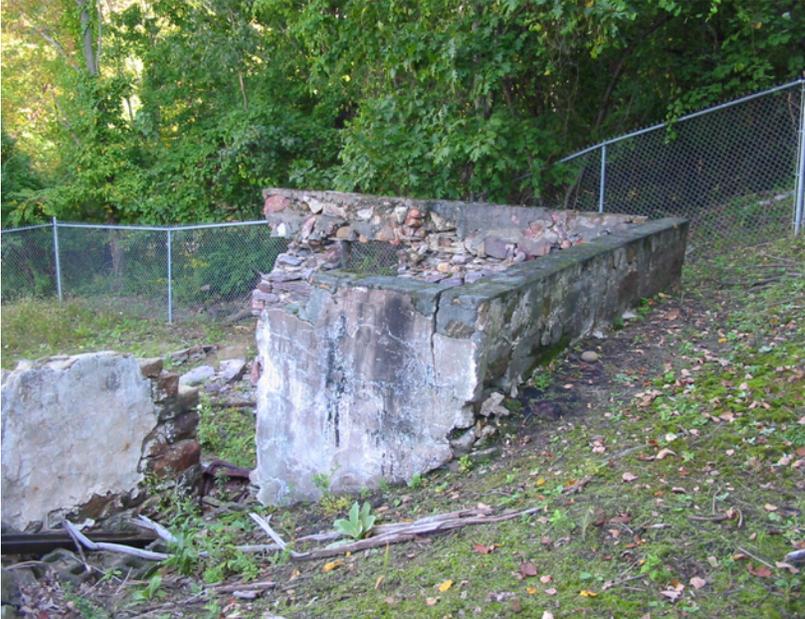
Photo 23

View of the lock tender's house looking northeast at the kitchen wing.

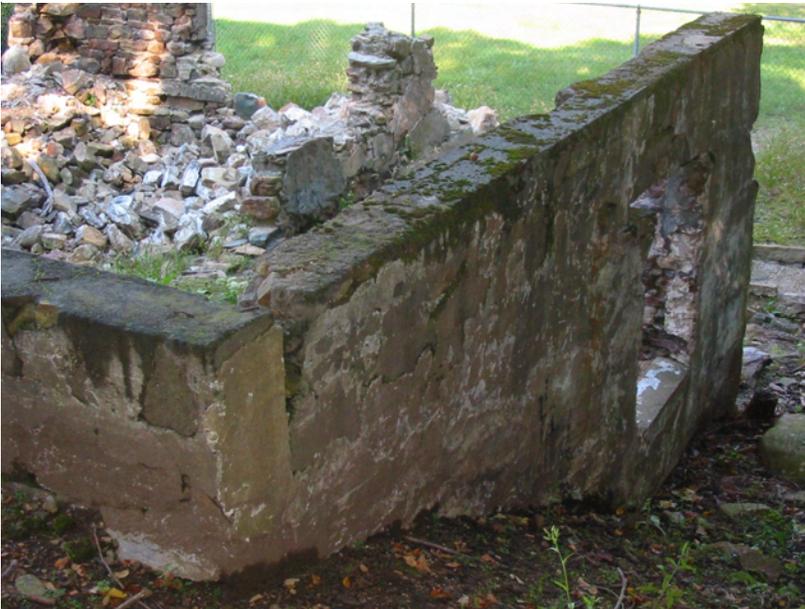
Photo 24

View of the southeast corner of the kitchen wing. Note the well-preserved rough opening to the window in the east wall.

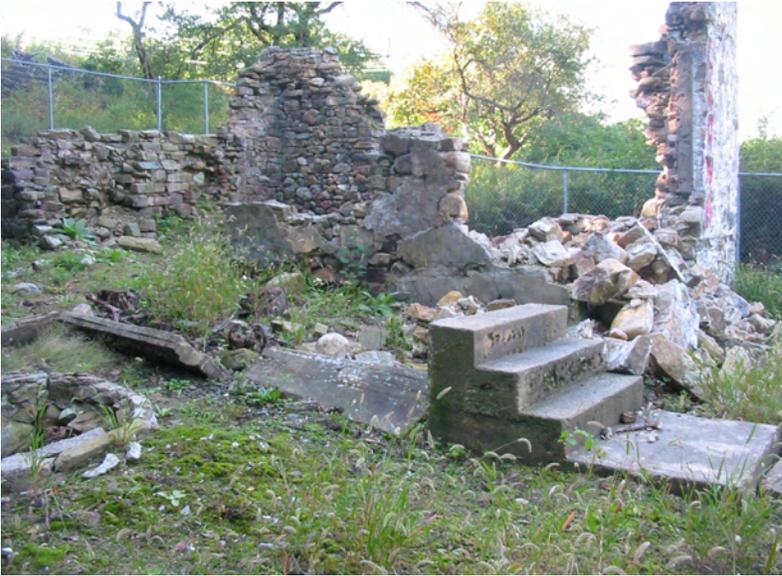
Photo 25

View looking southwest at the ruins of the lock tender's house.
Note the former well/cistern to the left of the picture, as well as the
remains of the steps to the right.

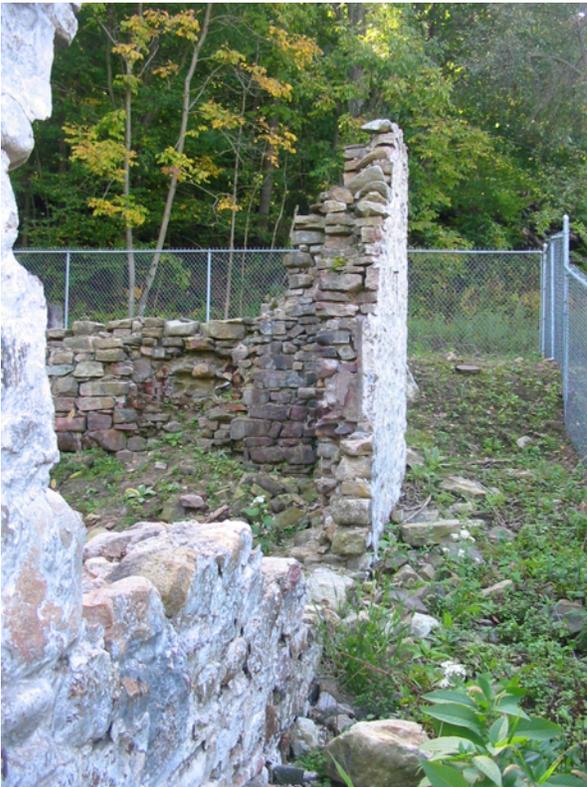
Photo 26

View looking south at the west exterior wall of the
lock tender's house.

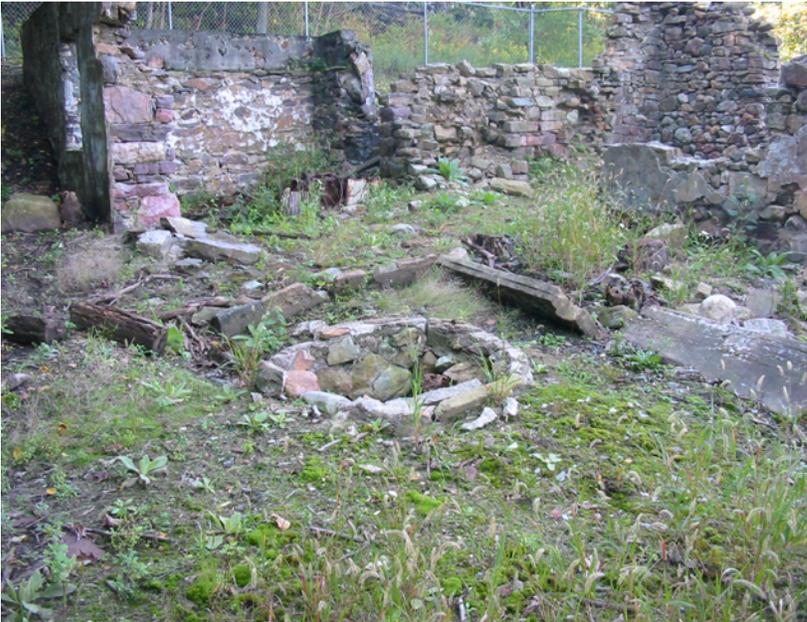
Photo 27

View looking southwest showing the interior of the lock tender's house and the juxtaposition of the kitchen wing to the main house. Note the former well in the foreground.

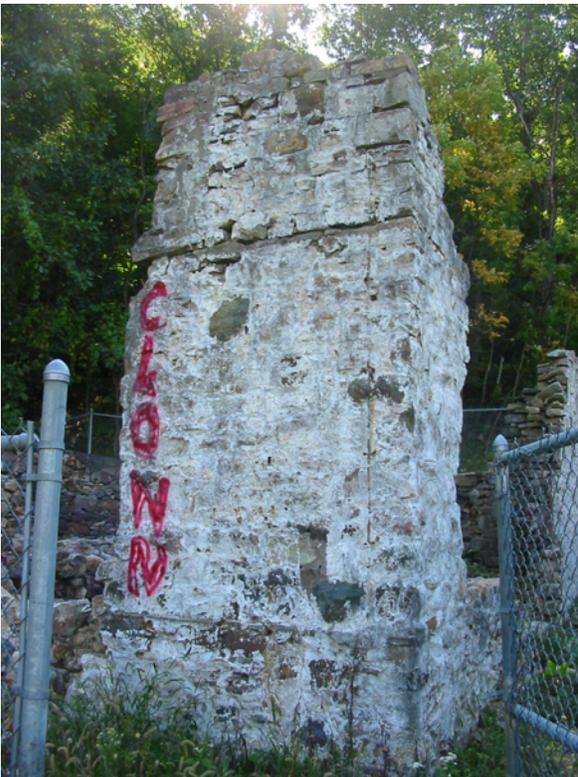
Photo 28

Detail view of vandalism on the northwest corner of the lock tender's house. This is the tallest section still standing and therefore is highly unstable.

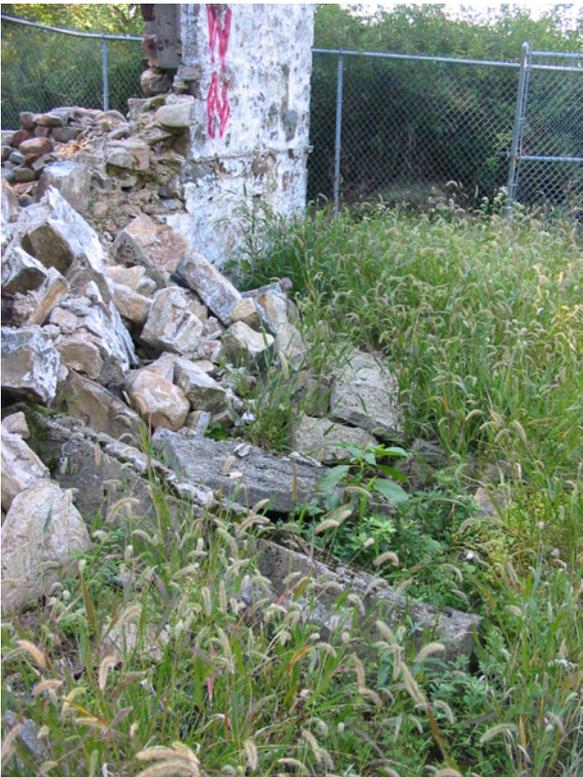
Photo 29

Detail view of the ruins of the lock tender's house looking west. View shows vandalism of the crumbled north wall of the house, as well as overgrowth of brush around the site.

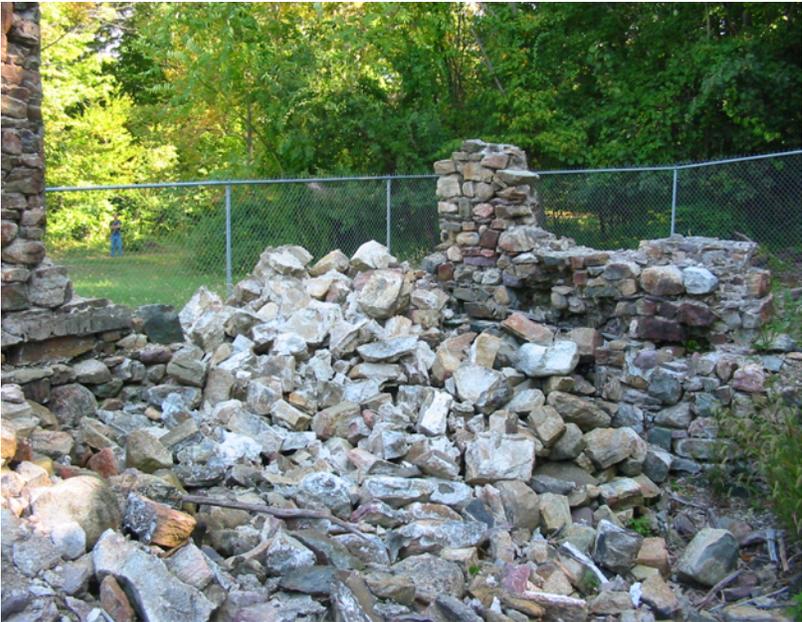
Photo 30

Overall view of the pile of stone rubble lying within the interior of the lock tender's house.

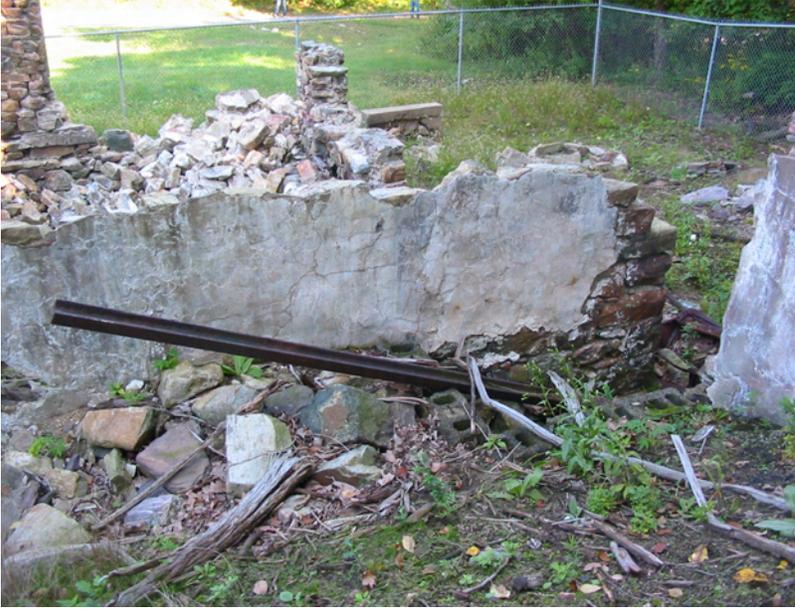
Photo 31

Detail view of stone rubble and other debris behind the south elevation of the house.

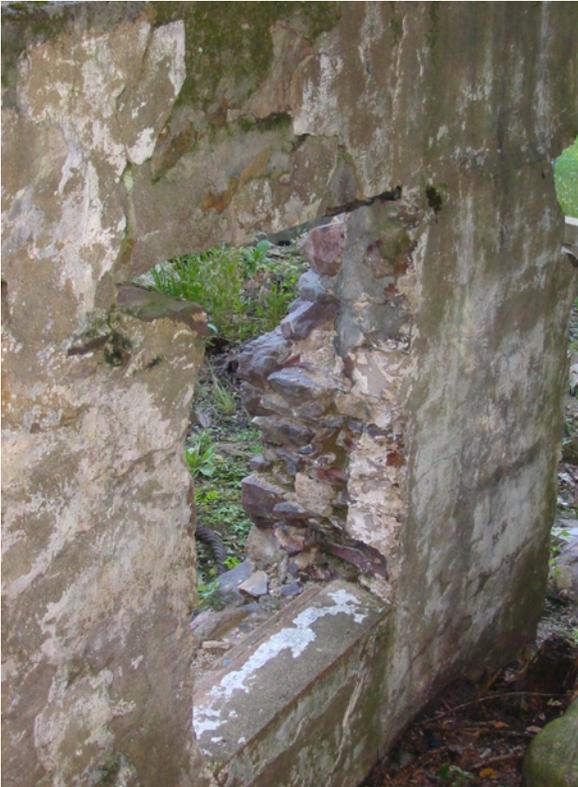
Photo 32

Detail of the opening in the east elevation of the kitchen wing.

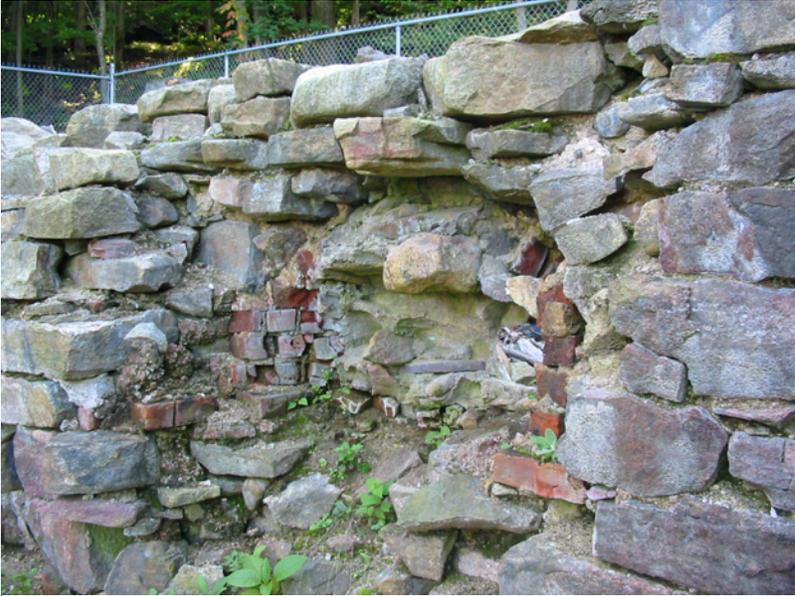
Photo 33

Detail view of the brick and stone in the area of the former fireplace on the first floor in this location, the south exterior wall of the main house.

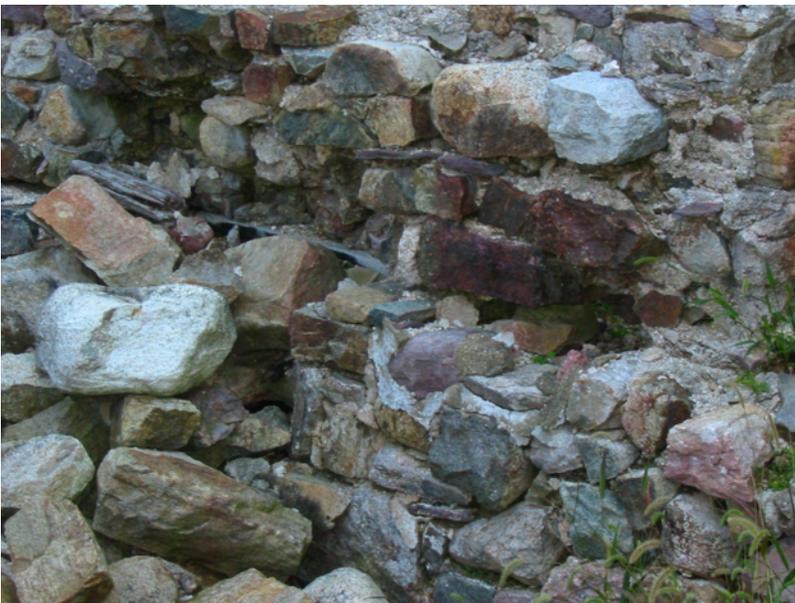
Photo 34

View of the exterior stone wall at the transition between the basement and first floor level showing the ledge where the first floor framing would have been placed.

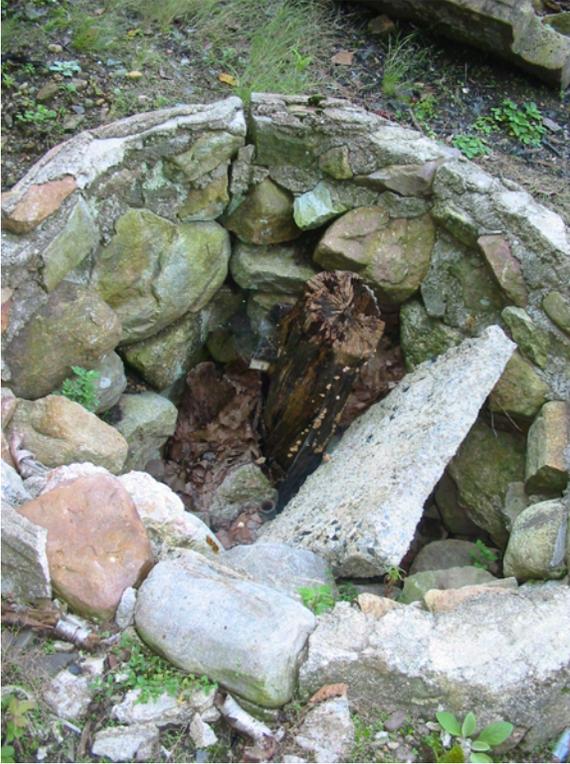
Photo 35

Detail view of the well/cistern in the northeast corner of the lock tender's house. Galvanized pipes leading to the house are seen in the opening .

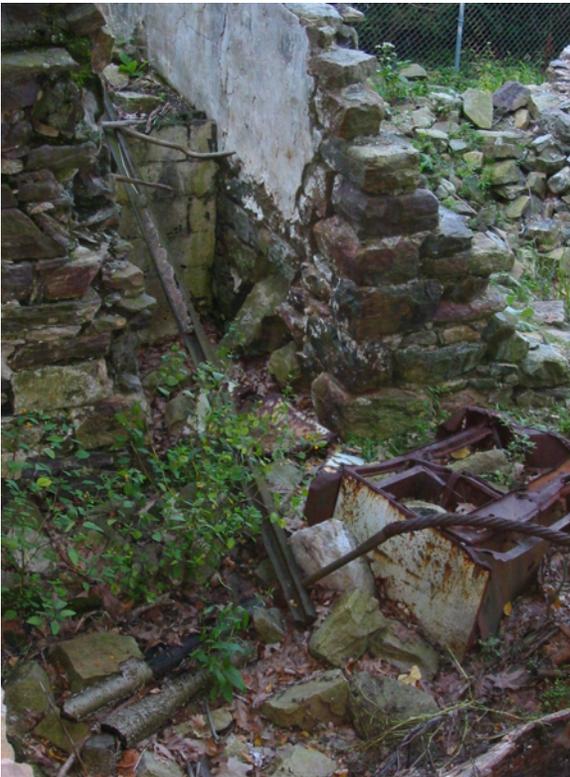
Photo 36

Detail view of debris within the lock tender's house, including portions of the rail and cables that were once used to brace the exterior walls of the main building.

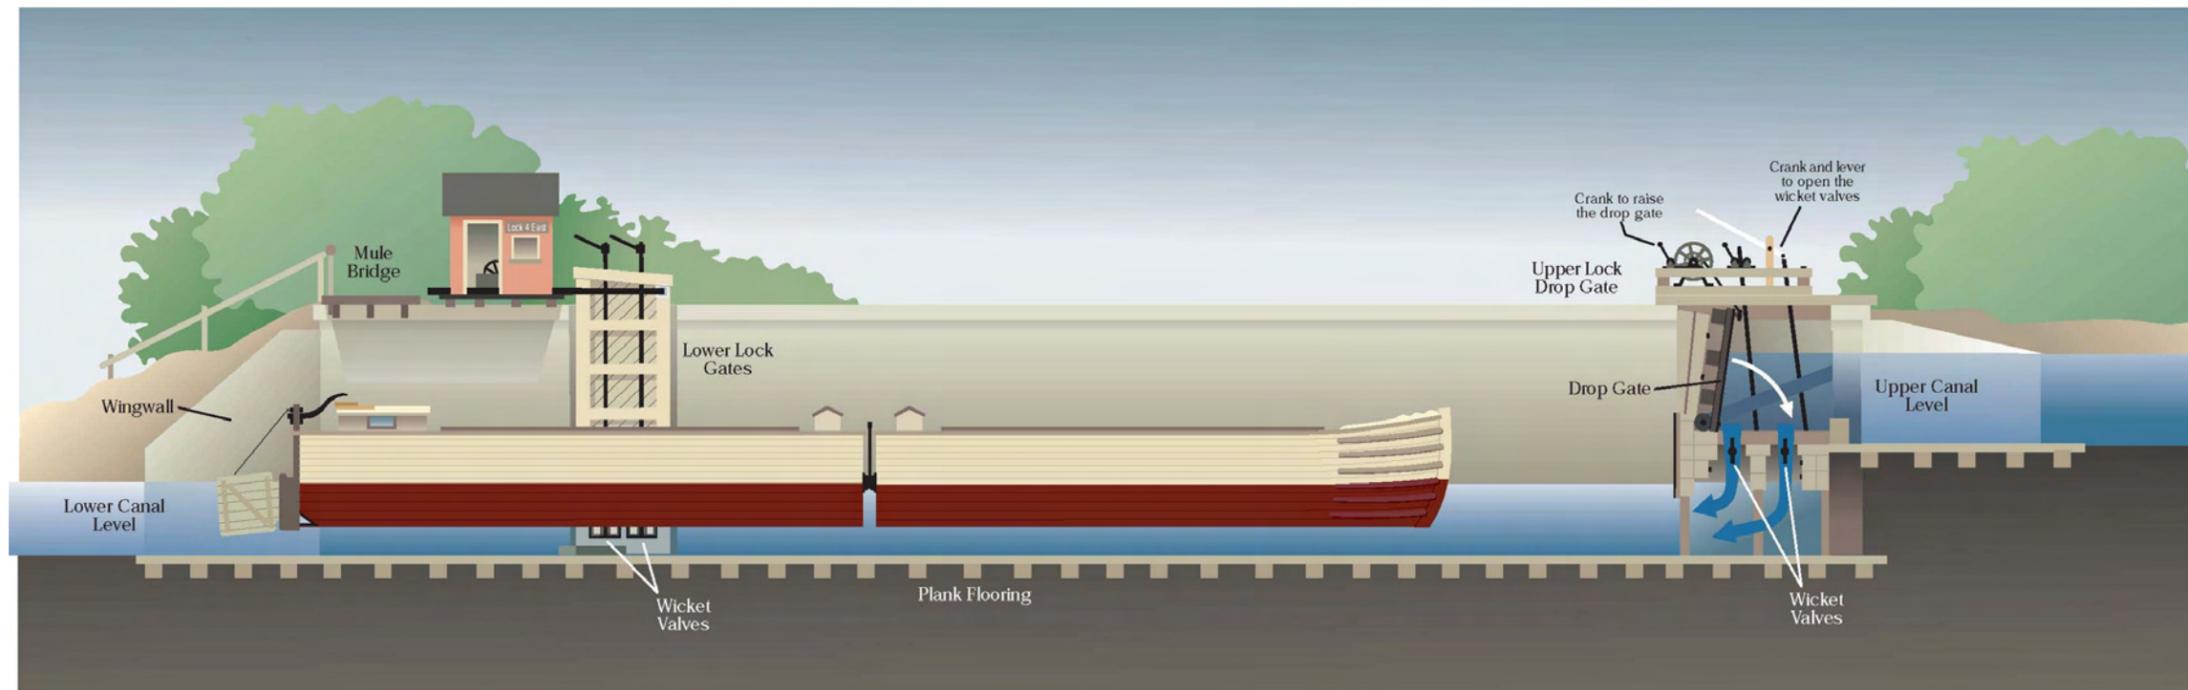
Supplemental Materials 3

Color diagram showing the operation of a lock.
