CULTURAL LANDSCAPE REPORT FOR THE MANSION GROUNDS

MARSH-BILLINGS-ROCKEFELLER NATIONAL HISTORICAL PARK

VOLUME III: TREATMENT

Olmsted Center for Landscape Preservation
National Park Service, Boston, Massachusetts, 2005

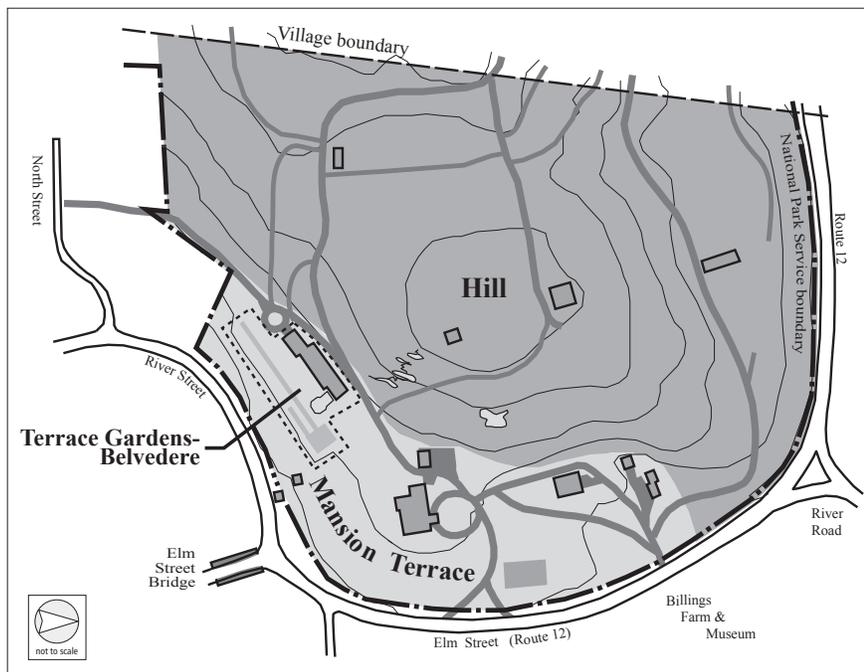
Figure 2: Diagram of the Mansion grounds illustrating three areas used to organize landscape features: Mansion Terrace, Terrace Gardens-Belvedere, and Hill. SUNY ESF.

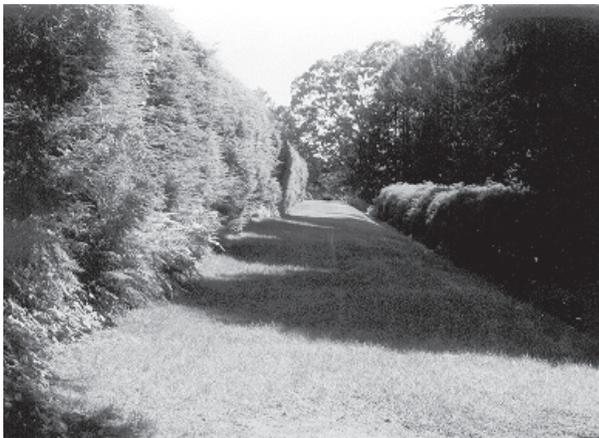
Figure 3: Historic view looking east through the Long Terrace space (SO-4) illustrating enclosed character defined by large perimeter hemlock hedges (V-49) during the late Rockefeller era, summer 1994. Olmsted Center for Landscape Preservation.

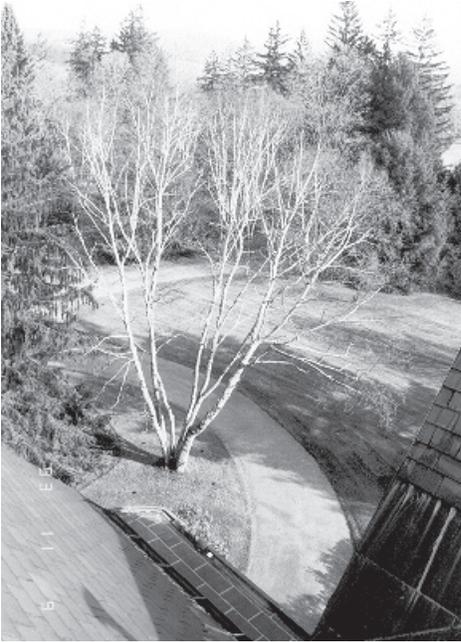
Figure 4: Historic view of the main entrance drive (C-1) looking northeast from the Mansion roof showing sharp lawn/road edge during the late Rockefeller era, November 1993. Olmsted Center for Landscape Preservation.

C-1: *Main Entrance Drive*: Maintain uniform appearance of drive across both inactive (between circle and Elm Street) and active (circle) sections, and maintain historic drive edge aligned with the outside edge of the catch basins (the edges were restored in 2002 by removing approximately one foot of encroached turf). Consider addition of inconspicuous steel edging (similar to that used on the Secondary Entrance Drive) in order to retain and mark the sharp edge between the lawn and graded roadbed that was characteristic of the Rockefeller era. [Figure 4]

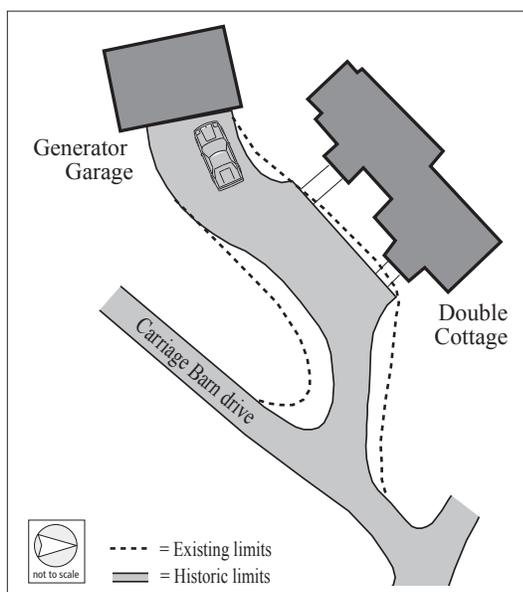
Figure 5: Recommended general limits of Double Cottage drive (C-3), based on extent documented on 1978 plan by Bryan J. Lynch entitled "Secondary Entrance Drive / The Mansion." SUNY ESF.

C-3: *Double Cottage Drive*: Re-establish historic limits of drive with adjoining lawn/planted areas. [Figure 5] Consider the addition of inconspicuous steel edging to retain and mark the limits of the drive, which have expanded since the historic period, likely due to a combination of infrequent or imprecise grading and vehicle encroachment. Consider limiting parking on the drive during the visitor

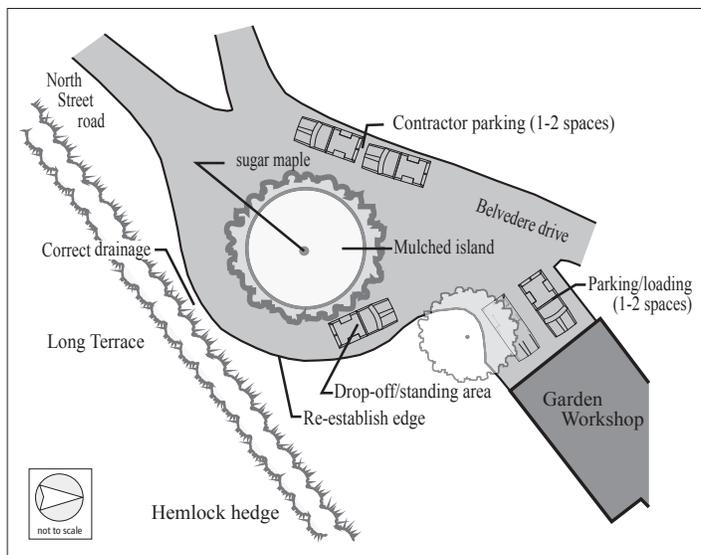
Figure 6: Recommended general limits and organization of the Belvedere drive circle (C-4) at the Garden Workshop. SUNY ESF, based on Bruno survey (2002).

Garden Workshop for parking of maintenance vehicles. Enforce staff parking in Billings Farm & Museum lot and limit vehicles to delivery drop-off and other necessary maintenance purposes. Space for parallel parking of one or two contractor vehicles may be appropriate on the north side of the circle. The circle is not wide enough to accommodate staff parking and vehicular access (notably on south side of circle), thus causing vehicles to encroach beyond the edges of the drive onto the adjoining lawn and compacting the root system of the sugar maple, which is showing signs of decline. Excessive parking in the circle also detracts from the historic setting of the adjoining Terrace Gardens, from which the cars are visible.

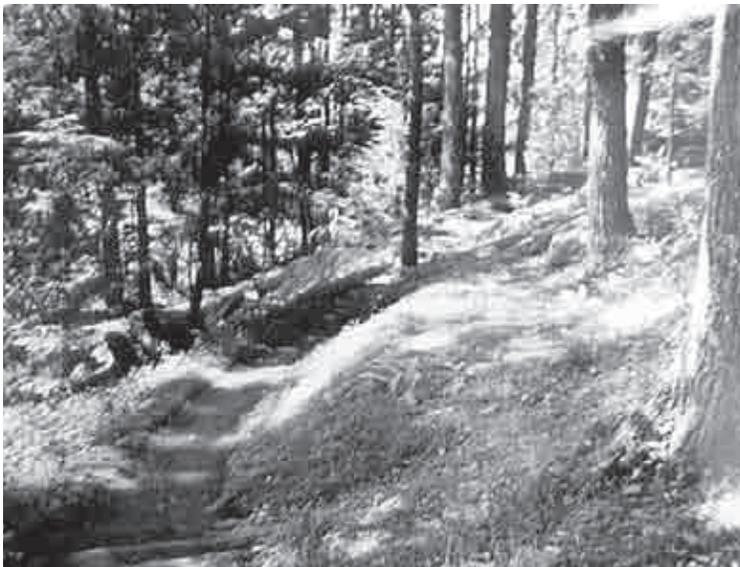
Figure 7: Historic view of the Waterfall Garden path (C-29), illustrating well-maintained condition and open understory in the Hillside Gardens characteristic of the Rockefeller era, c.1992. Courtesy of Mimi Bergstrom, Woodstock, Vermont.

Paths: C-27 *Lily Pond Path*, C-28 *Waterfall Garden Path*, C-29 *Lily Pond Waterfall Path*, C-30 *Upper Hillside Path*, C-31 *Arboretum Path*: Keep paths clear of encroaching vegetation and path surfaces clear of leaf litter and other debris. This will most likely require regularly scheduled clearing throughout the summer and fall (rather than just annual clearing). Where paths have a moss-covered surface or moss edges (primarily in the Waterfall Garden), pedestrian use should be restricted to avoid damage to the mosses. Repair deteriorated stone and log steps, and replace in-kind when deteriorated beyond repair. During the Rockefellers' tenure, the hill paths were well maintained with raked or swept surfaces and little encroaching vegetation [Figure 7].

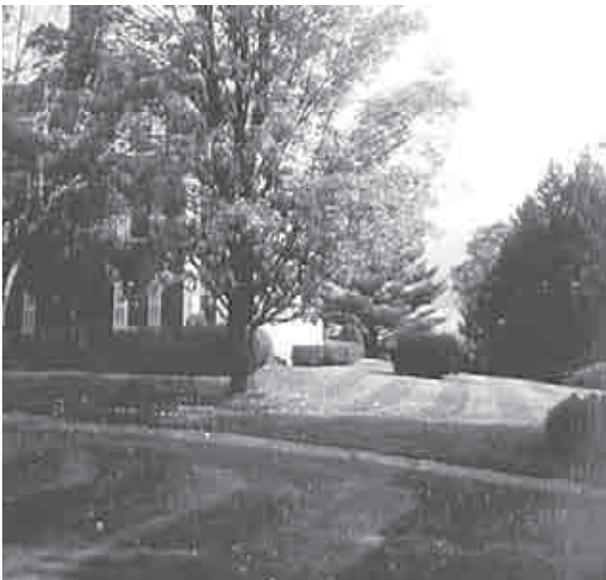
Figure 8: Historic view looking east across the Mansion lawn (V-1) illustrating class ‘A’ level of maintenance characteristic of the Rockefeller era, c.1992. Courtesy of Mimi Bergstrom, Woodstock, Vermont.

level of maintenance of the Mansion and swale lawns, in keeping with conditions during the Rockefeller era. [Figure 8] Maintenance should minimize the use of pesticides, in keeping with the park’s Integrated Pest Management (IPM) program. In summer 2002, the lawn was restored to its class “A” level of maintenance. If in the future class “A” cannot be maintained sustainably (without extensive use of ecologically damaging products and/or practices), a lower level of maintenance would be appropriate provided the historic height and coverage of the lawn is maintained. The lowering of the level of maintenance would be a reversible change, allowing for potential future restoration to “Class A,” but should be restricted, if possible, to less visible areas of lawn. These areas would include the outer (southern and eastern) portions

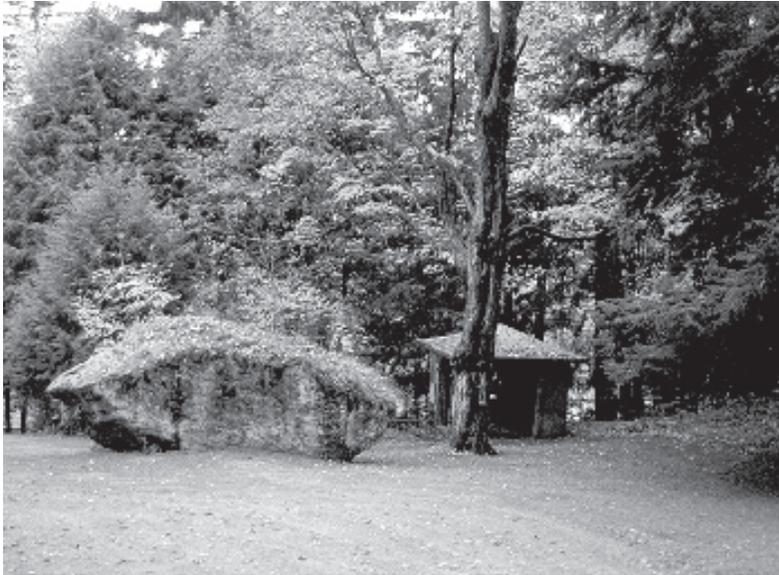
Figure 9: View south of the sugar maple in the Mansion lawn grove (V-3) adjoining the Mansion lawn boulder (NS-1), October 2000. The tree was removed in fall 2000. SUNY ESF.

V-3: *Mansion Lawn Grove*: Plant a sugar maple (*Acer saccharum*) off the southwest corner of the Mansion lawn boulder, with exact location to be determined through examination of remains from the historic tree. [Figure 9] This sugar maple was removed in fall 2000. A mature red oak in this grove was recommended for removal at the same time, but remains standing. Preservation of this tree is the preferred treatment, given that it does not pose a significant threat to surrounding buildings

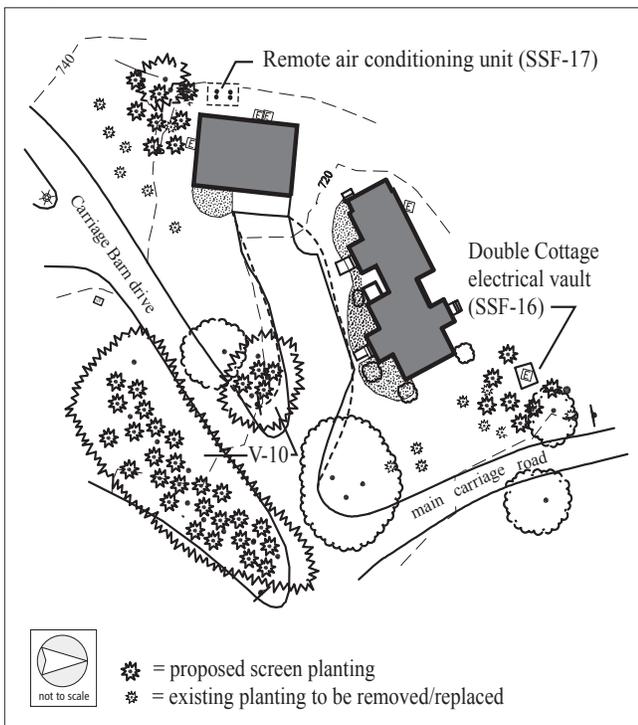
Figure 10: Preferred treatment for vegetative screening (V-10) at Carriage Barn and Double Cottage. SUNY ESF, based on Bruno survey (2002).

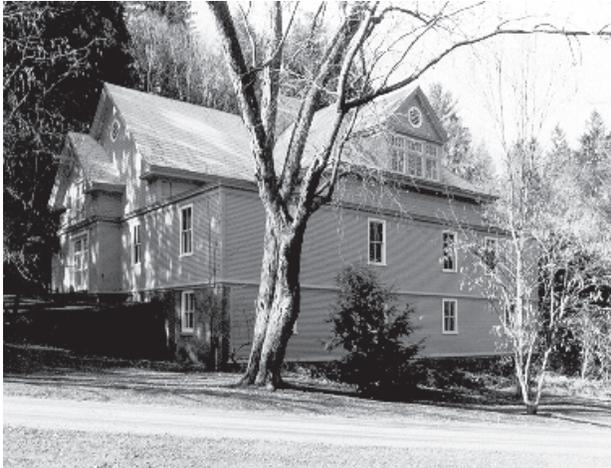
Figure 11: Historic view of the mature silver maple (V-22) along the Secondary Entrance Drive during the late Rockefeller era, November 1993. The tree was removed in c.1998. Olmsted Center for Landscape Preservation.

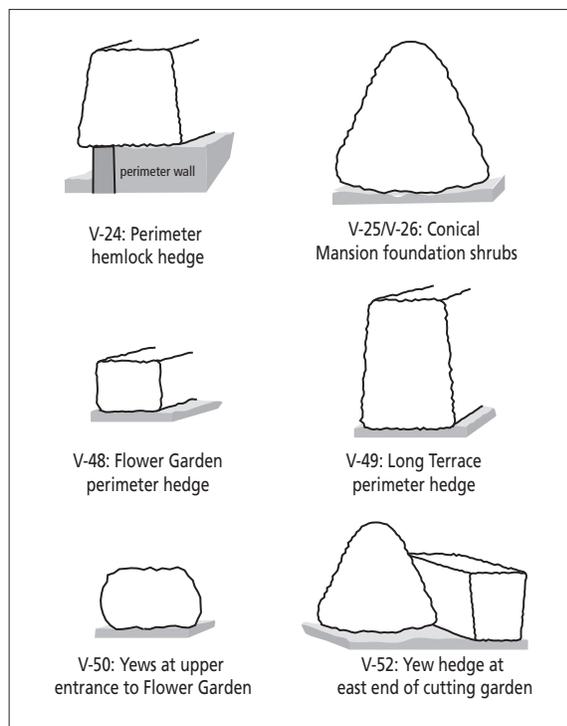
Figure 12: Diagram of recommended forms for clipped hedges on the Mansion grounds. SUNY ESF.

V-24: *Perimeter Hemlock Hedge*: Maintain hemlock (*Tsuga canadensis*) hedge at uniform shape, characterized by a flat cap, inwardly canted sides [Figure 12], and an overall height of 6'-7', tapering down to 4'-5' under the shade of the perimeter plantation (V-4) south of the Mansion. One hundred and eighty linear feet of the hedge east of the Lower Summerhouse were replaced in spring 2002, along with a short section within the old hedge. These new plantings, including those adjoining the main entrance drive planted in 1997, should be allowed to mature into a shape and size that is consistent with the adjoining historic plants. A consistent shape and size between old and new plants may also in part be achieved through limited renewal pruning of the historic plants.

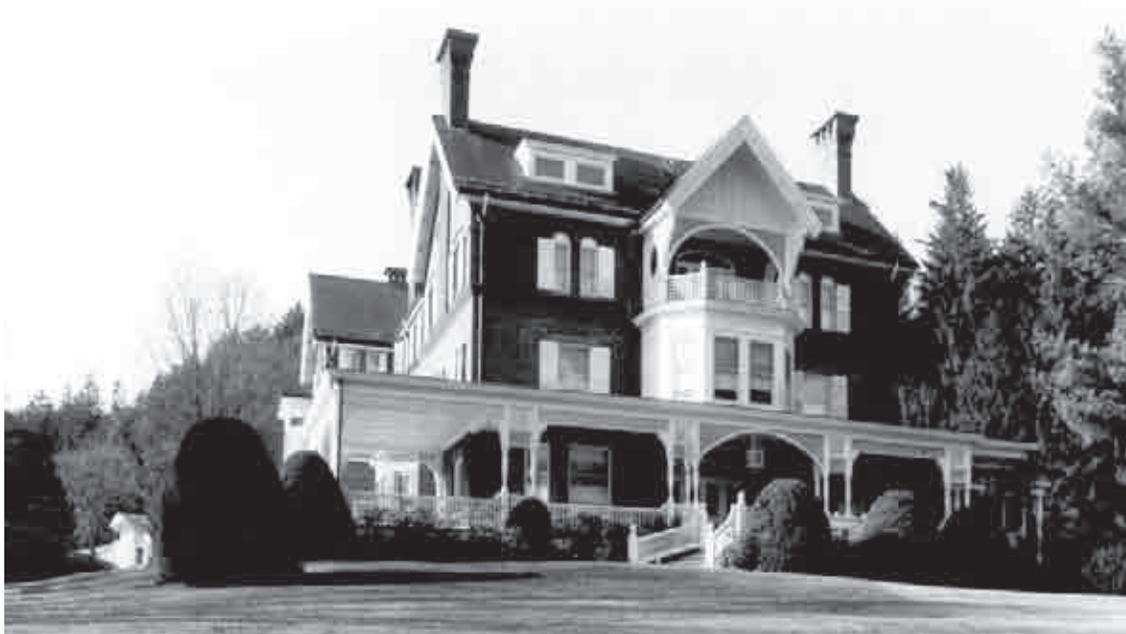
Figure 13: Historic view of the foundation shrubs (V-25) and lawn yews (V-26) along the east front of the Mansion during the late Rockefeller era, November 1993. Olmsted Center for Landscape Preservation.

V-25: *Mansion Foundation Shrubs*: Maintain manicured appearance and existing size and shape of clipped and natural-form deciduous and evergreen shrubs, allowing recent replacement plant material to reach a size no greater than that present during the 1992-1997 period. [Figures 12, 13, and 14] In general, keep shrubs below the height of the verandah railing (east/south

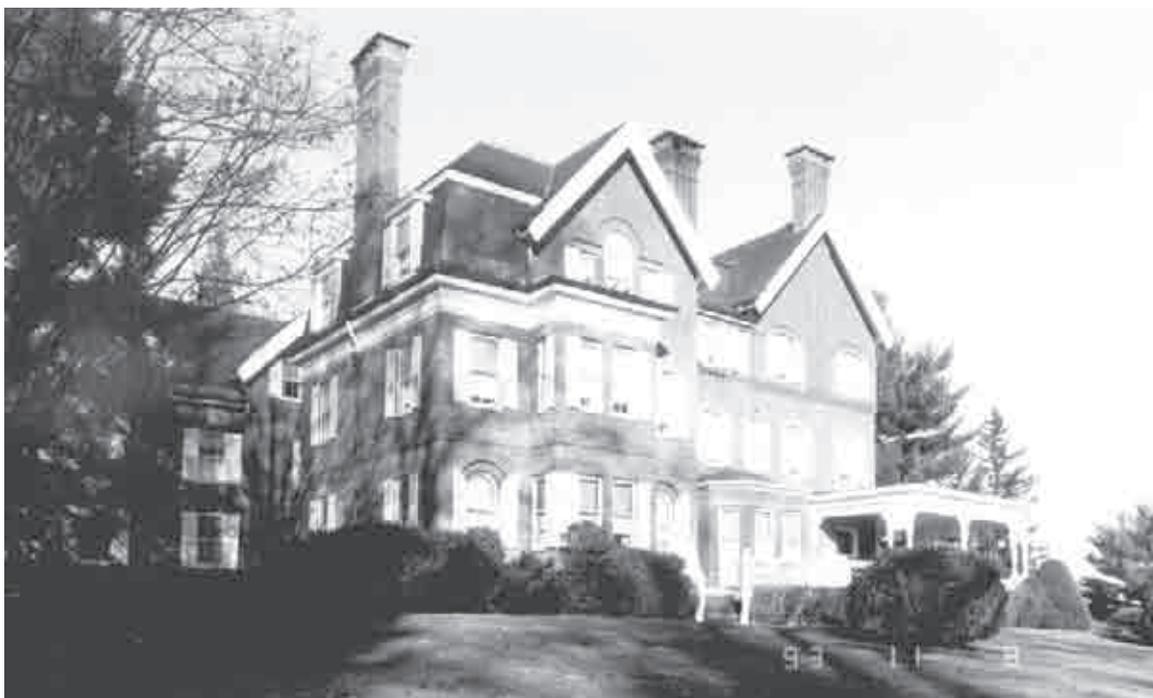
Figure 14: Historic view of the foundation shrubs (V-25) and lawn yews (V-26) along the south and west sides of the Mansion during the late Rockefeller era, November 1993. Olmsted Center for Landscape Preservation.

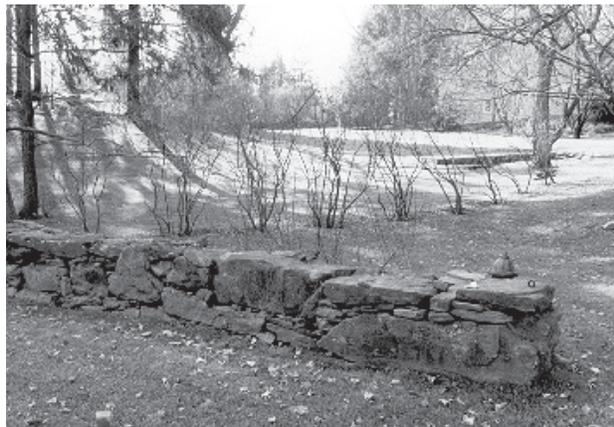
Figure 15: Historic view looking south of the lilac hedge (V-30) at bottom of swale during the late Rockefeller era, November 1993. Olmsted Center for Landscape Preservation.

V-30: *Lilac screening at bottom of the Swale*: Remove rectangular mulched bed and re-establish turf, maintaining small mulched areas around the stems. Maintain plants as individuals and extend plantings in-kind (*Syringa vulgaris*) approximately 10’ to the east and west to re-establish character extant during the Rockefeller era. [Figure 15] If lilacs continue to decline due to poor growing conditions (shade), replace with a shade-tolerant shrub having a similar form and habit, such as Burkwood viburnum (*Viburnum burkwoodii*).

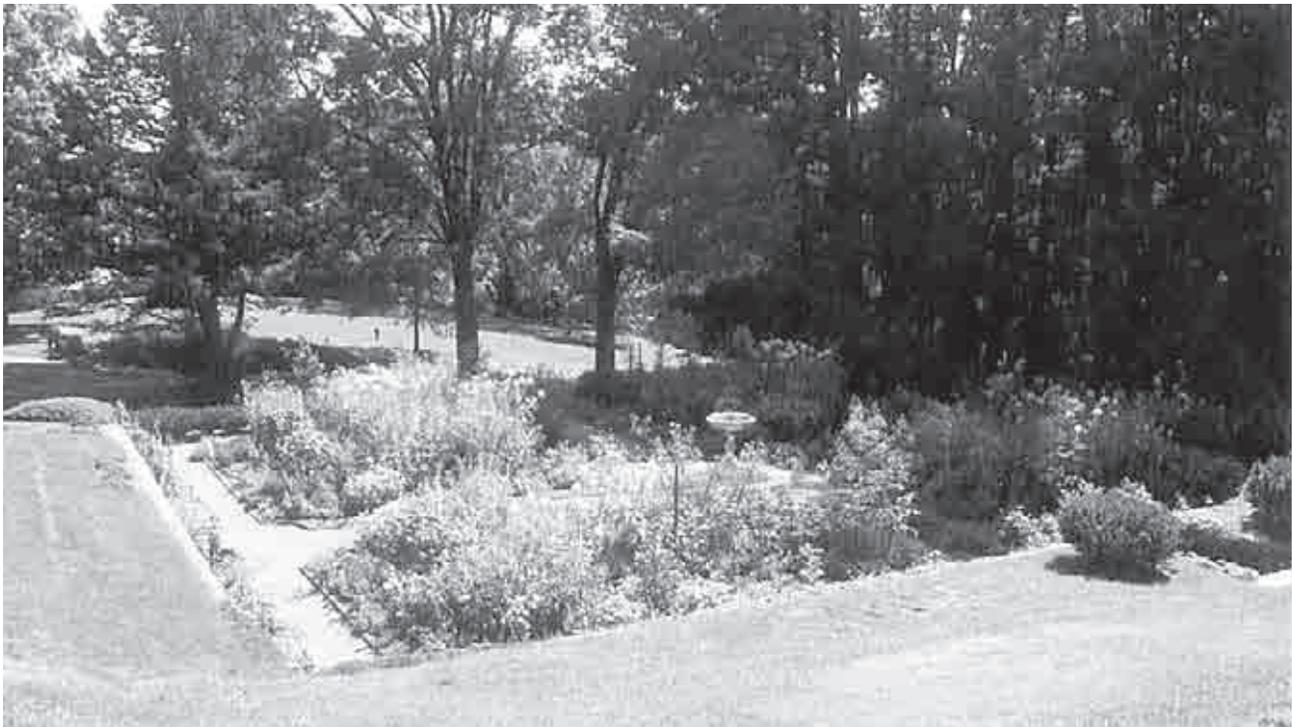
Figure 16: Historic view of the Flower Garden (V-55) looking southeast during the late Rockefeller era, summer 1994. Note shade from hemlocks along south (right) side of garden. Olmsted Center for Landscape Preservation.

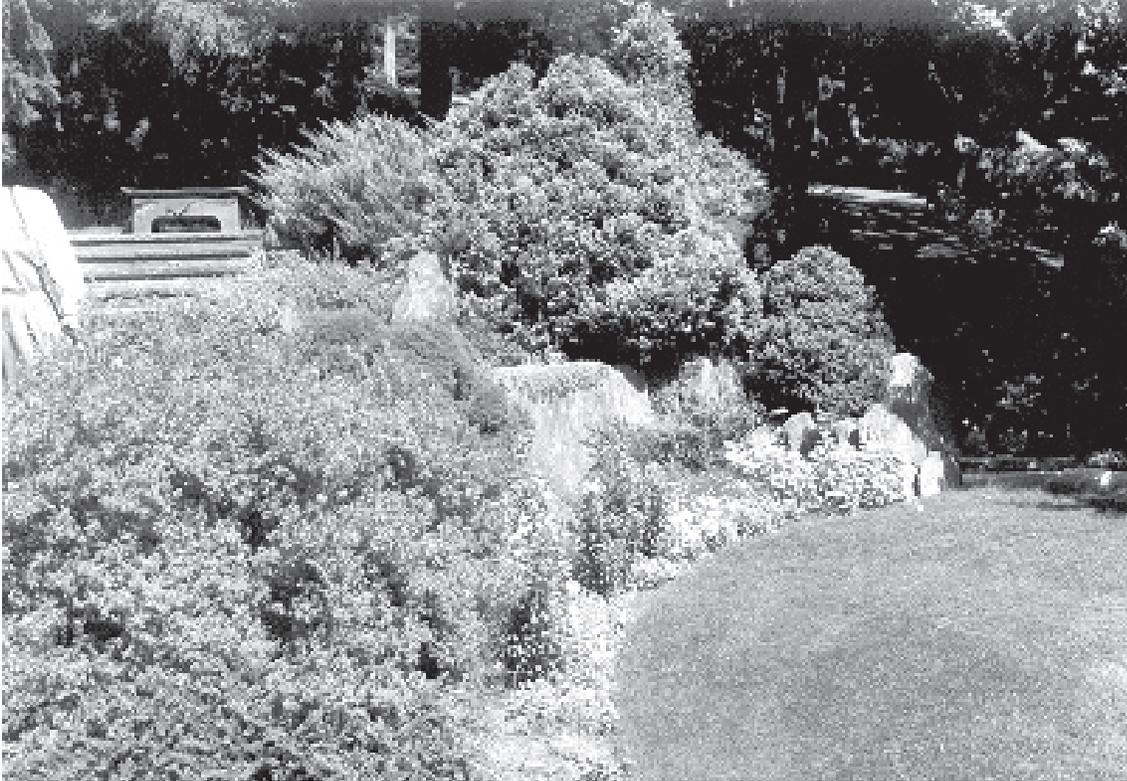
Figure 21: Historic view of the rock garden (V-58) along the upper pool terrace steps during the late Rockefeller era, summer 1994. Olmsted Center for Landscape Preservation.

V-58, V-61, V-62: *Rock Gardens*: Develop planting plans for all rock gardens. Retain existing configuration of beds, rock placement, woody plant material, and alpine character. [Figure 17] Maintain existing size of woody plant material. Replace herbaceous plants in-kind as necessary. Typical herbaceous plant material used during the late Rockefeller era included: *Aruncus*, *Astilbe*, *Asarum*, *Campanula*, *Epimedium*, *Iris*, *Phlox*,

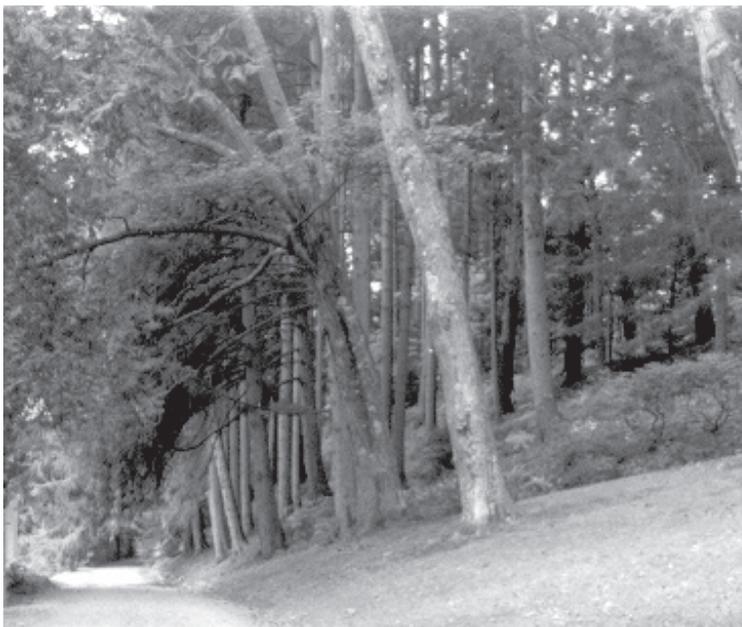
Figure 18: Historic view looking west from the Belvedere drive through the c.1874 Norway spruce plantation (V-68) showing open understory characteristic of the late Rockefeller era, November 1993. Olmsted Center for Landscape Preservation.

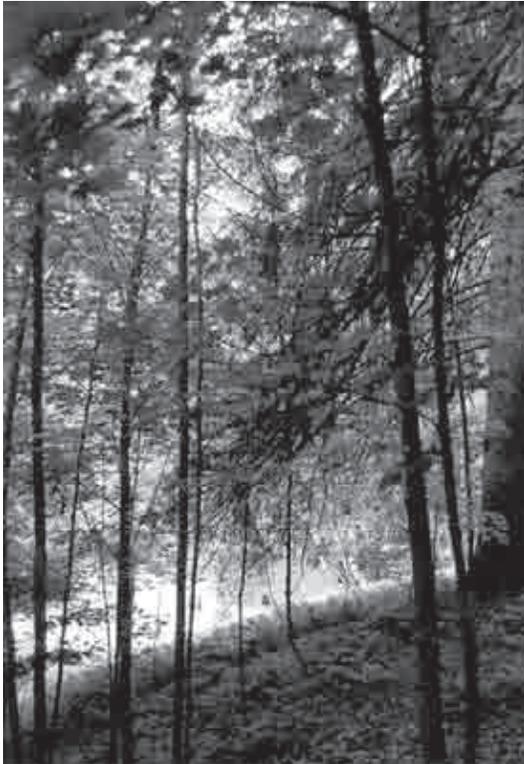
Figure 19: View southeast through the plantation on the east hillside below the Lily Pond illustrating heavy successional hardwoods growth and death of lower limbs on historic Norway spruces due to shading, September 2002. SUNY ESF.

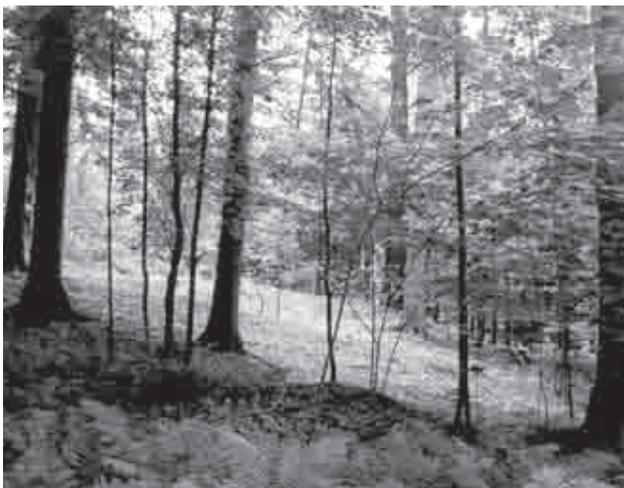
Figure 20: Naturalized plantation on hillside east of Bungalow where historic white pines have been removed, leaving sufficient space for replacement planting, September 2002. Note successional hardwoods that have grown up along the edges of the open space. SUNY ESF.

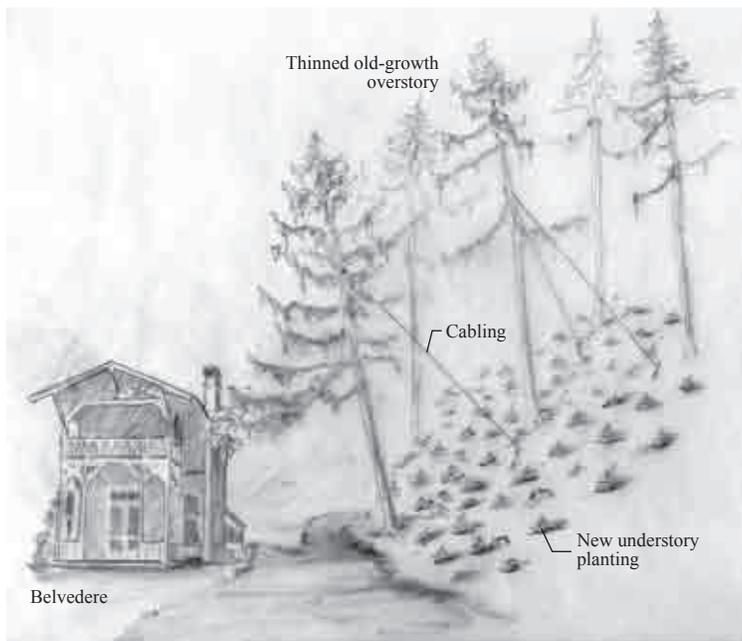
Figure 21: Illustration of possible long-term replanting strategy for Stand 42b, the c.1874 Norway spruce plantation on the south hillside showing retention of widely-spaced old-growth and an understory of new plantings. SUNY ESF.

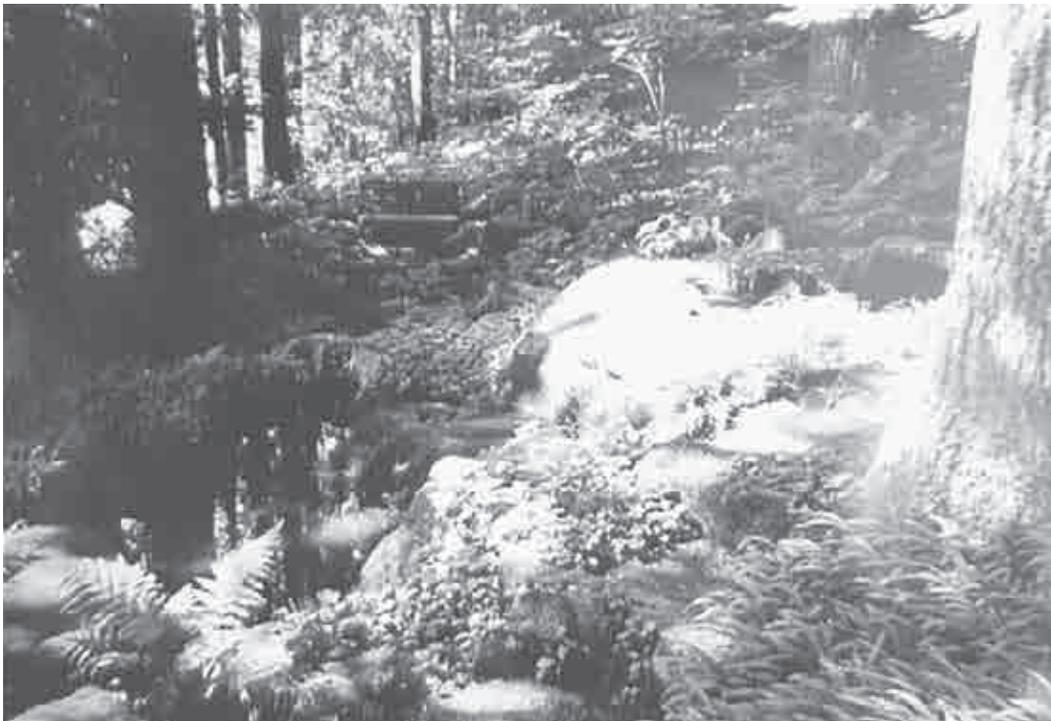
Figure 22: Historic view looking west across the upper part of Waterfall Garden showing historic character of woodland plantings (V-78) and sunlight-dappled conditions during the late Rockefeller era, c.1992. Courtesy of Mimi Bergstrom, Woodstock, Vermont.

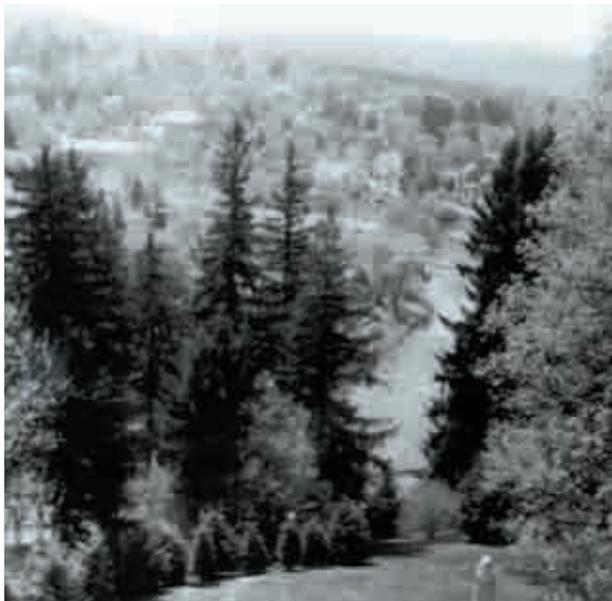
Figure 23: The Ottawaquechee River vista (VV-2) showing historic condition with view of river through the perimeter plantations, view south from Mansion, May 1977. Billings Family Archives.

visible from the second and third floor rooms (including the Rockefellers' bedroom) on the south side of the Mansion. Maintain sufficient height on the vegetation within the vista clearing to screen the view of River Street from the Mansion. The vista clearing was maintained during the Rockefeller era as a narrow opening in the perimeter plantation, with hemlocks and other shrubs used to screen River Street. This vista became more enclosed in later years, but the river probably remained visible. [Figure 23]

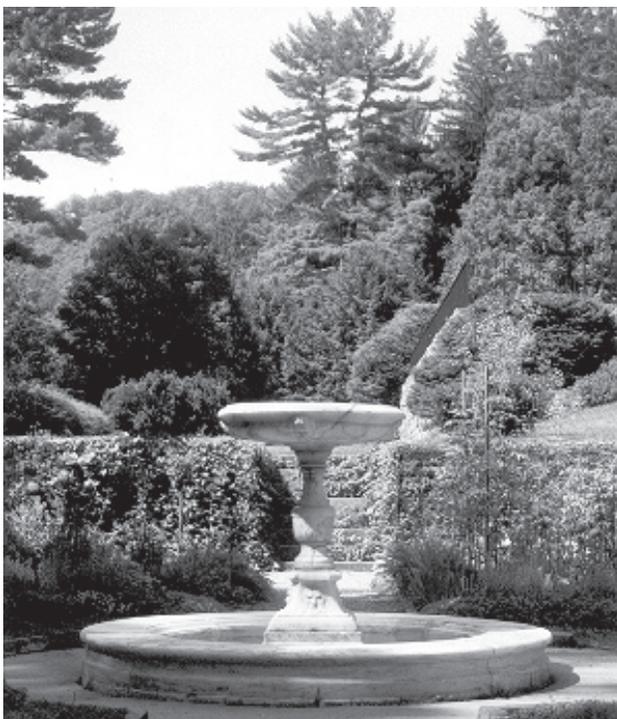
Figure 24: Historic view of the Mount Tom vista (VV-4) during the late Rockefeller era, summer 1994. Mount Tom is the ridge visible to the left of the double-leader white pine. Olmsted Center for Landscape Preservation.

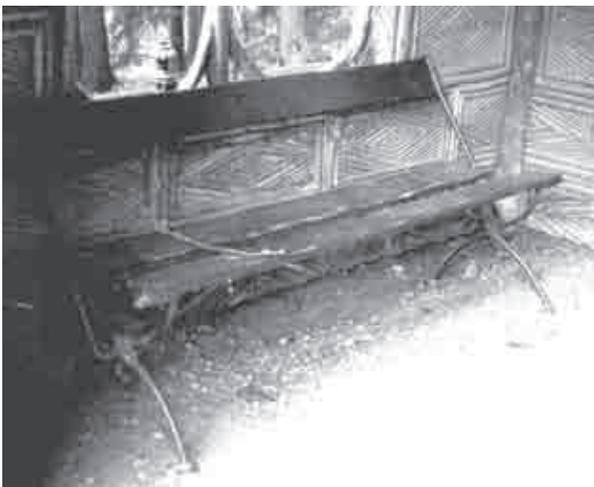
Figure 25: A historic lawn seat in the Upper Summerhouse, a model for the general lines of new benches that would be compatible with the historic character of the landscape, 2001. This particular seat has an unusual movable back. SUNY ESF.

The historic lawn seat in the Upper Summerhouse provides a good model for a compatible design (the Rockefellers set out several benches similar in overall form and detail to this example, which probably dates from the late nineteenth or early twentieth century). [Figure 25] Designs similar to this, with simple rod frames and painted wood-slat seats and backs, would be most appropriate when sited adjacent to plantings or buildings (such as the Carriage Barn) and not as isolated features. Where benches must be placed in an open area, such as in the lawn along the Mansion-Flower Garden walk, the backs should be omitted in order to make the benches less conspicuous.

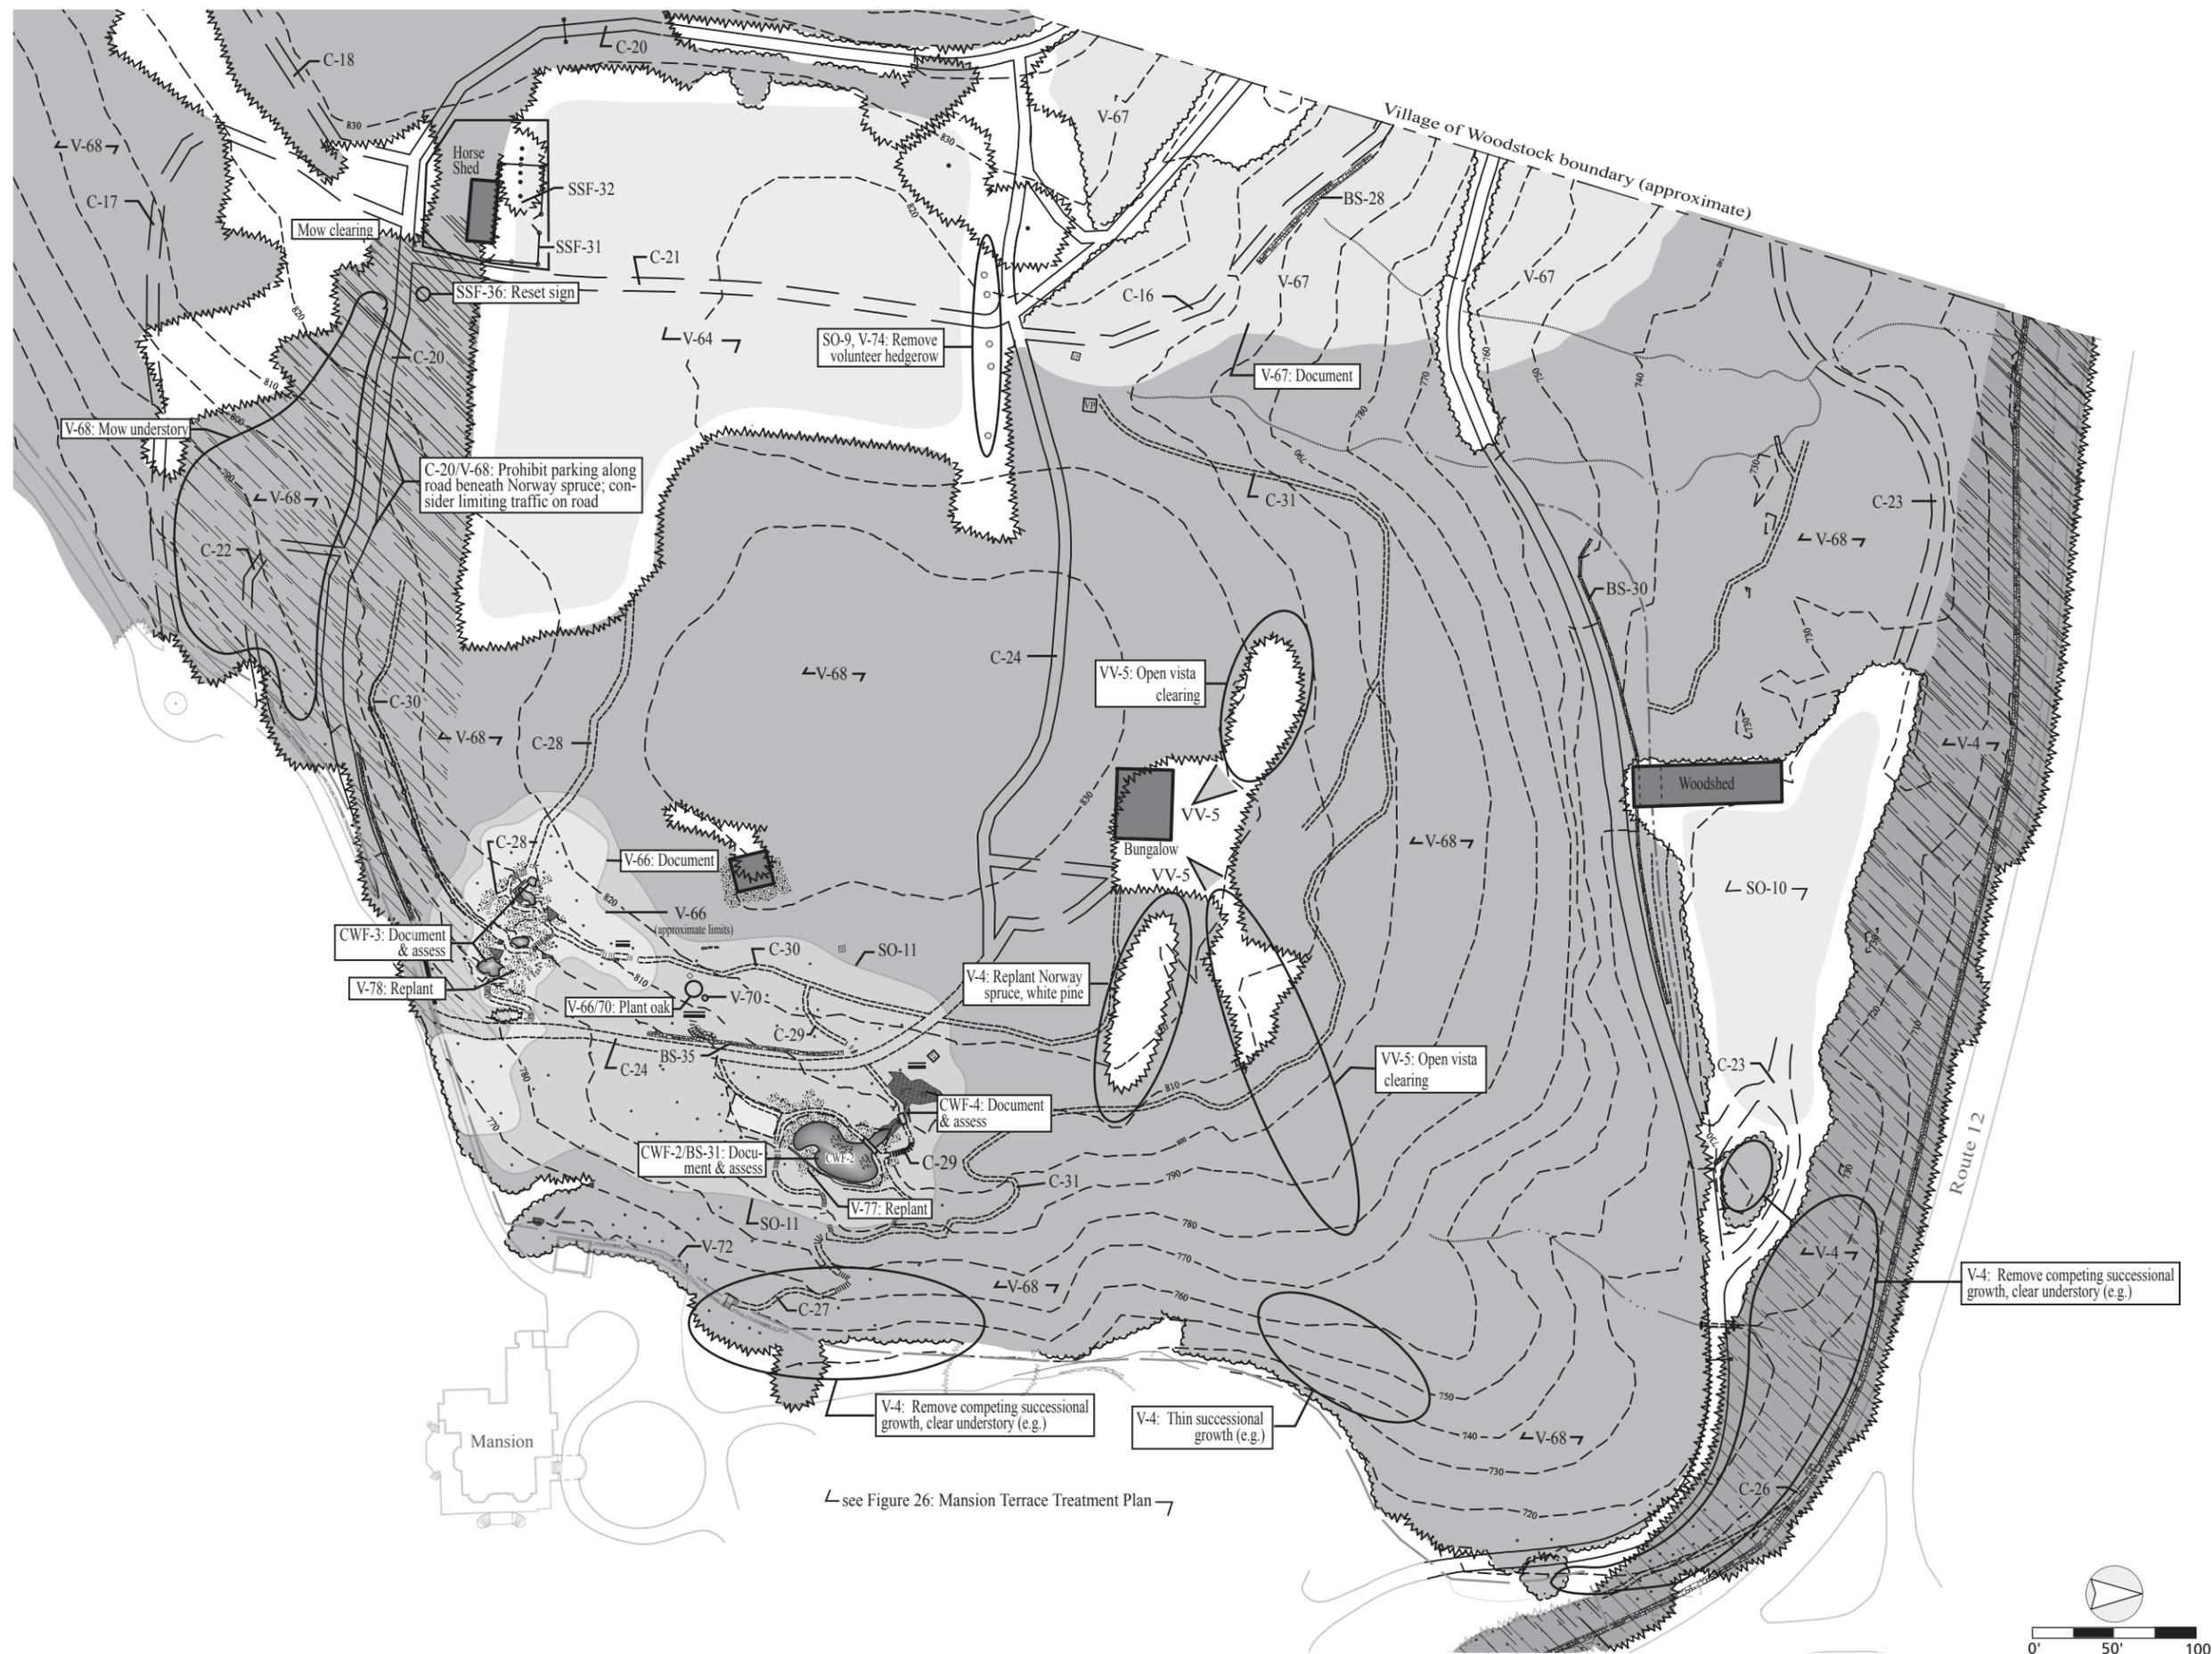
Figure 29

see Figure 26: Mansion Terrace Treatment Plan
