National Register of Historic Places  
Registration Form

historic name Mammoth Cave Historic District  
other names/site number see sec. 7 for individual site numbers

Historic Resources of Mammoth Cave National Park, MPS  
Edmonson, Hart, and Barren Counties, Kentucky,  
Mammoth Cave Historic District

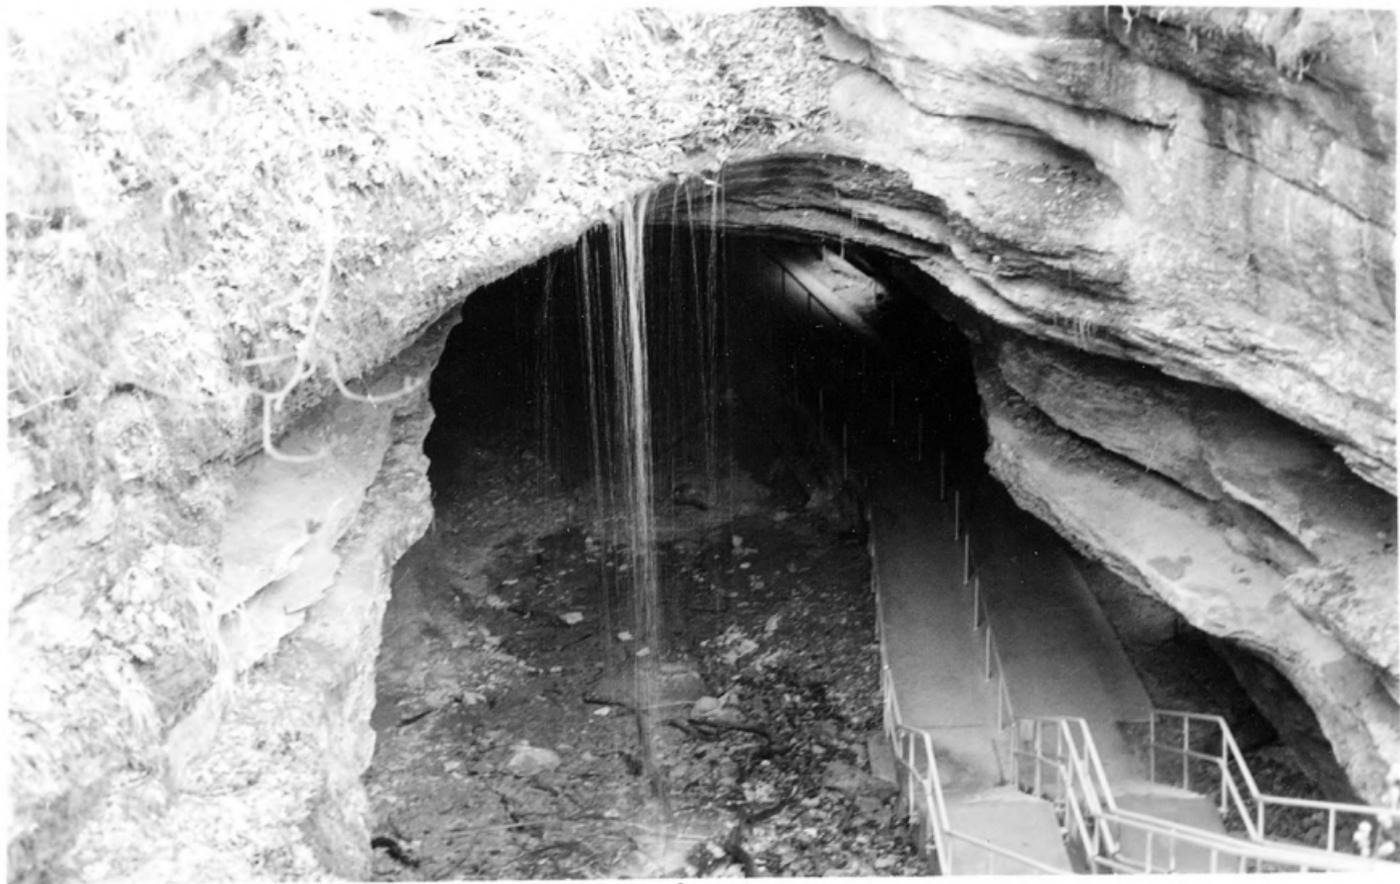
1. Historic Entrance (E-01)  
Mammoth Cave National Park, Kentucky

The historic entrance, the only known natural entrance to Mammoth Cave, is a large sinkhole, approximately 30' wide by 30' high. A steady flow of waters constantly drips from the top of the opening to the entrance floor. A steep double concrete stairway with metal handrails leads to the steel entrance door and turnstile, all of which were added in the past two decades and are non-contributing elements. The immediate setting has been somewhat altered with the recent addition of rock walls, concreted steps, and park benches in the entrance's gathering yard. These alterations do not adversely affect the integrity of the immediate setting, which is essential for integrity of feeling and association. The opening itself is original and stable, as are the rock walls of the sinkhole one encounters when entering the cave. Integrity of location, immediate setting, feeling, and association are intact.

7. Though the Historic Entrance itself is a contributing resource, the double concrete stairway with metal handrails leading to the cave from the surface, as well as the steel entry door and turnstile found at the cave's opening, were all added in the past two decades and are thus non-contributing elements.

Historic Entrance (E-01)  
[photo #1]

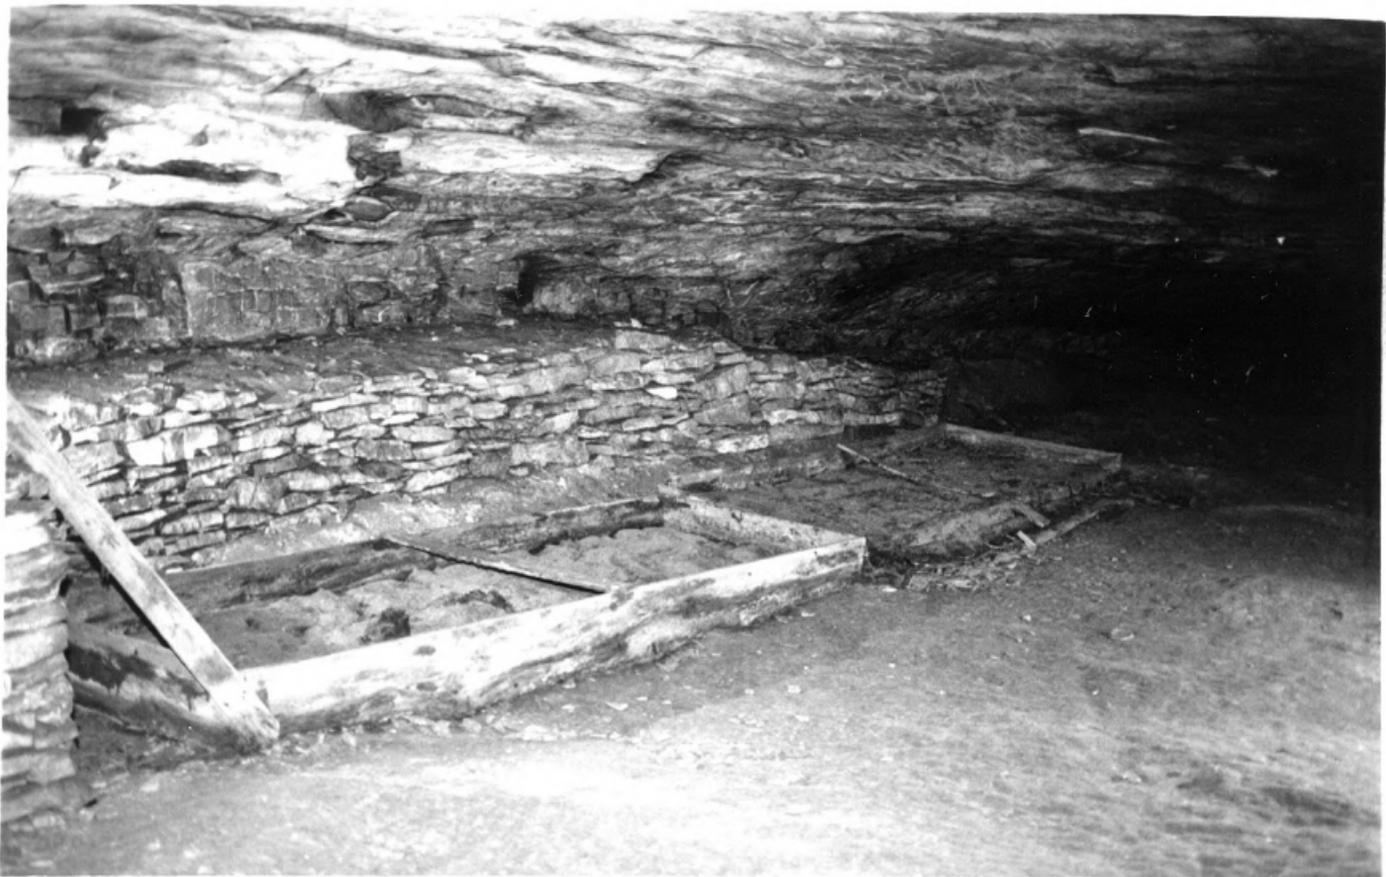
2. Mushroom Beds (IL-02)  
Mammoth Cave National Park, Kentucky

In 1881-82 the Mammoth Cave Mushroom Company attempted to grow mushrooms in a remote portion of Audubon Avenue. Though the experiment was a failure, the somewhat deteriorated remnants of the mushroom beds remain in their original location. The six mushroom beds each measure approximately 4' wide by 12' long. The soil of the beds is contained within bottomless boxes made

with 12" wide wooden planks. Three of the beds are elevated on 3' on dirt-filled limestone rubble platforms. The other three sit directly on the cave floor. Though the wood boards supporting the beds are deteriorated, integrity of location, setting, design, materials, feeling, and association are intact.

Mushroom Beds (IC-02)  
[photo #2]

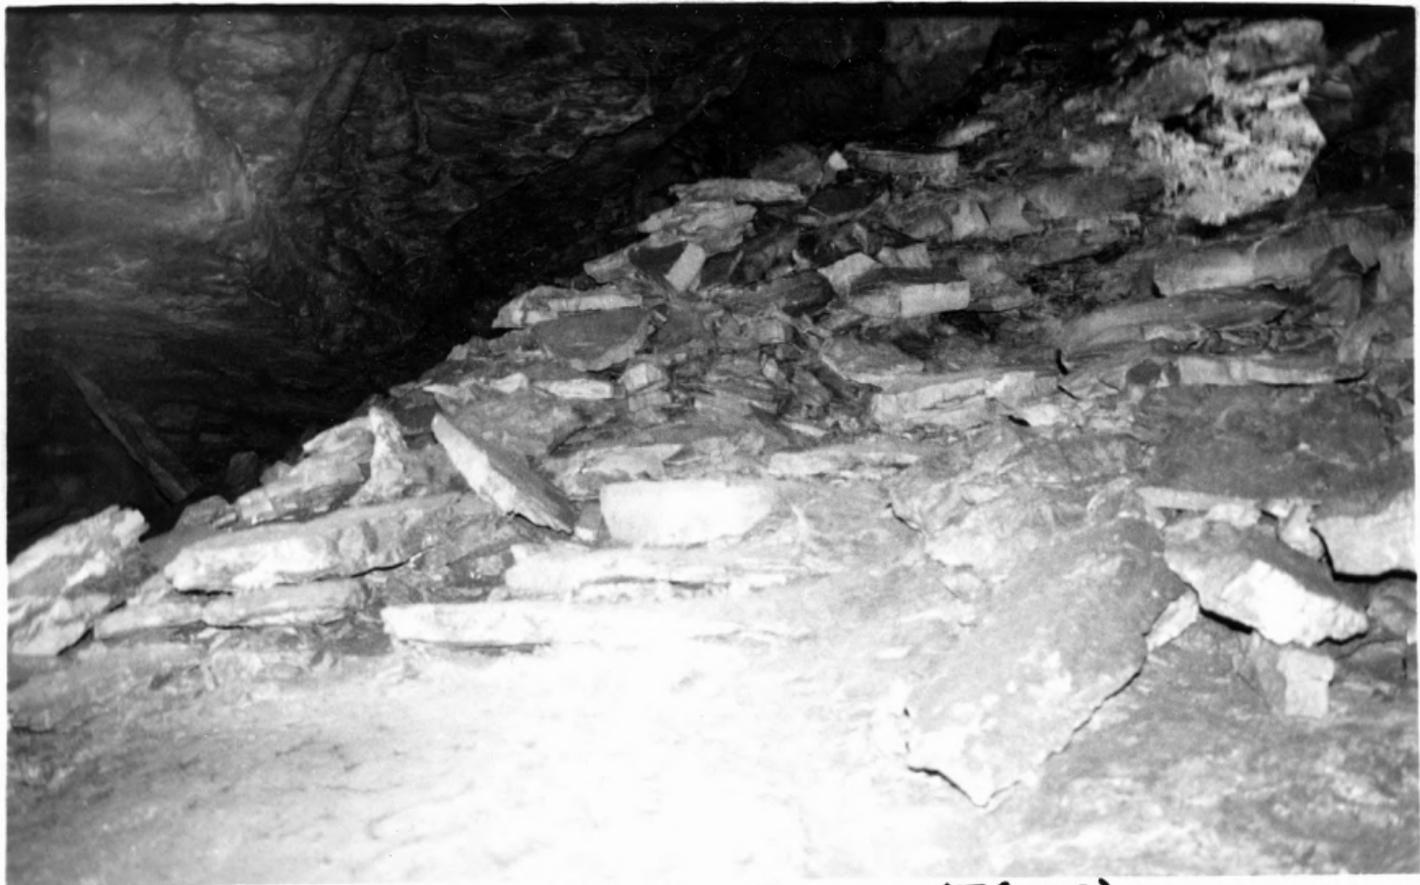
3. Rock stairs to Olive's Bower (IC-03)  
Mammoth Cave National Park, Kentucky

Leading to the area of the cave named "Olive's Bower," the rock stairs and walls are believed to have been constructed sometime in the late nineteenth century. They consist of stacked limestone rocks and slabs. Beginning at Audubon Avenue, the 14 stairs ascend approximately 10 feet to the trail leading to Olive's Bower. The limestone rubble walls, which were stacked when the path was being cleared, line the trail for about forty yards from the end of Audubon Avenue to Olive's Bower. Both are in good condition. Integrity of location, setting, design, materials, workmanship, feeling, and association are intact.

Rock Stairs and Walls to Olive's Bower (IC-3)  
[Photo # 3]

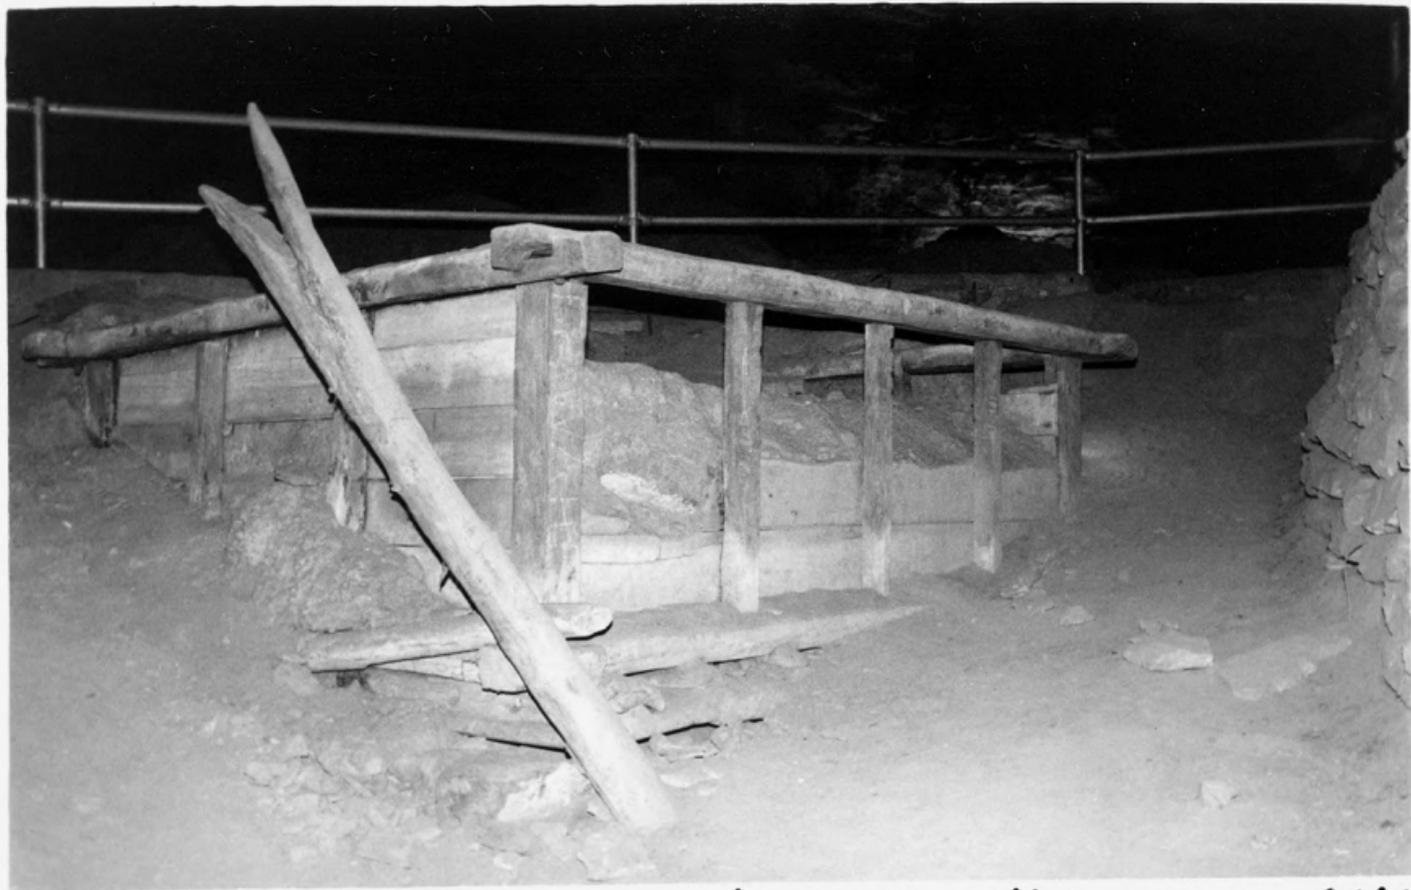
4. Leaching Vat, Rotunda, Saltpetre Mining Works (452A)  
Mammoth Cave National Park, Kentucky

Located in the Rotunda, along Broadway, and at Booth's Amphitheatre in Mammoth Cave are a system of wooden leaching vats, pipes, and collecting tanks used in the mining and processing of the cave dirt for saltpetre, a major component of gunpowder, during the War of 1812.

The rectangular leaching vats (3 in the Rotunda and 6 in Booth's Avenue) with sides measuring between 9' and 12' and stand approximately 3 1/2 feet high, are constructed of hand hewn and sawn oak and poplar and rest on low stone walls. Water was drained through cave dirt placed in these vats to extract calcium nitrate, which could be converted to saltpetre. The vats in the Rotunda are somewhat obscured by piles of discarded cave dirt. The features of those in Booth's Avenue are more visible. These show mortise and tenon frames, tongue and groove siding, and hand hewn nailing studs.

Saltpetre Mining Works (HS2A & B)  
[photos 4, 5, 6]

The remains of the mining operation are in fair condition. All wood which has been in extended contact with the cave dirt is deteriorated. The leaching vats are in their original locations. Though they remain in the passages in which they were used, most of the pipes were moved from their original positions decades ago--and relocated many times since. The park staff has layed out an extension of pipes end to end along the Broadway. Around the Methodist Church area is one section of pipes believed to be in their original positions. Despite deterioration and instances of relocation, integrity of location, setting, design, workmanship, materials, feeling, and association are maintained.

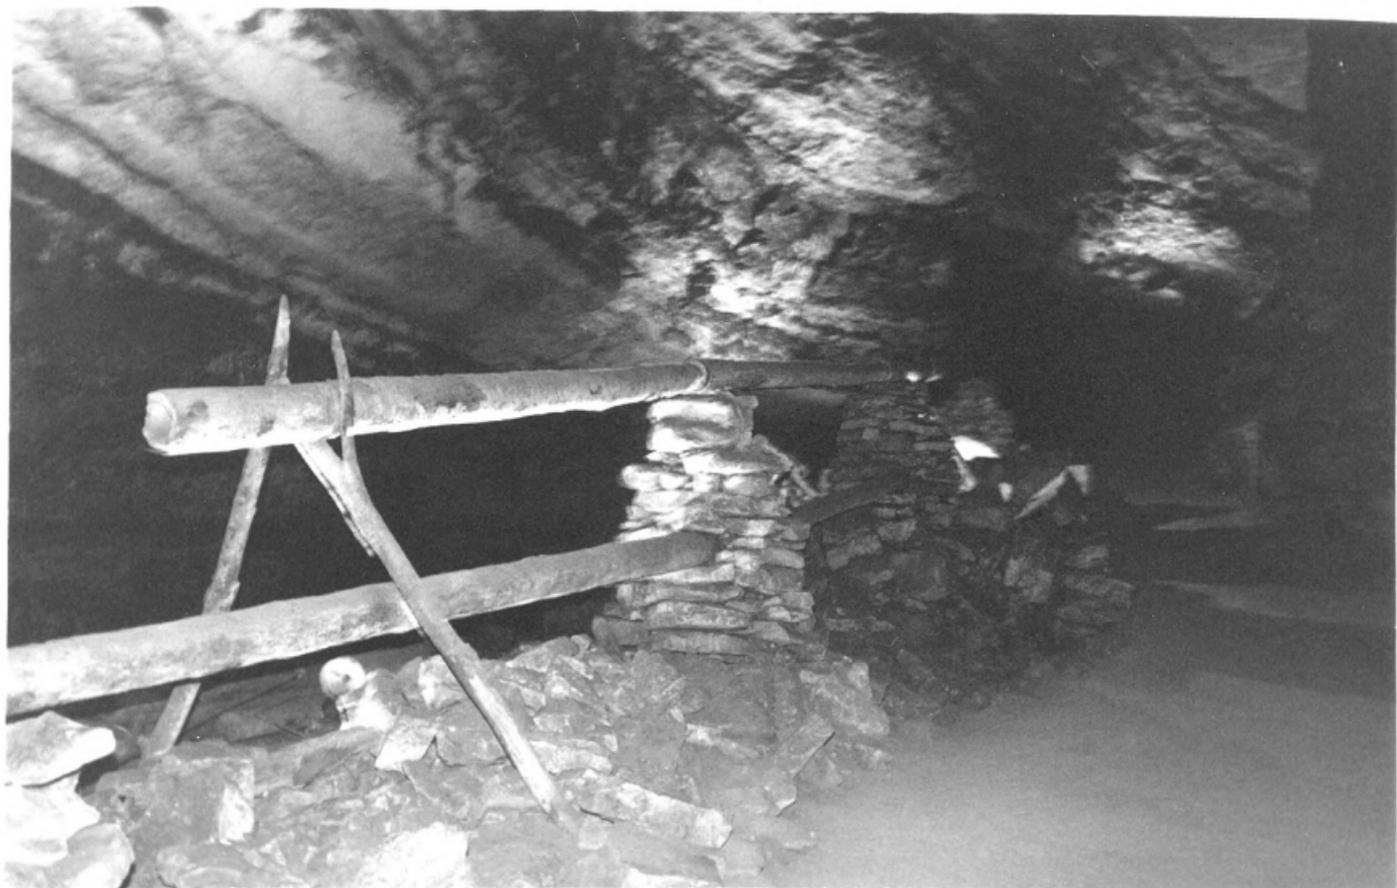
5. pipes near Methodist church, salt petre Mining works  
Mammoth Cave National Park, Kentucky (H52B)

The wooden collecting tank in the Rotunda, which "collected" the mineral-rich water after it had been leached through the cave soil, measures approximately 3' by 10'. The fifty sections of log pipes, used to transport water to and from the cave, located along Broadway range in size from 3' to 26' long. The logs were hollowed out and tapered at one end so that they fit together.

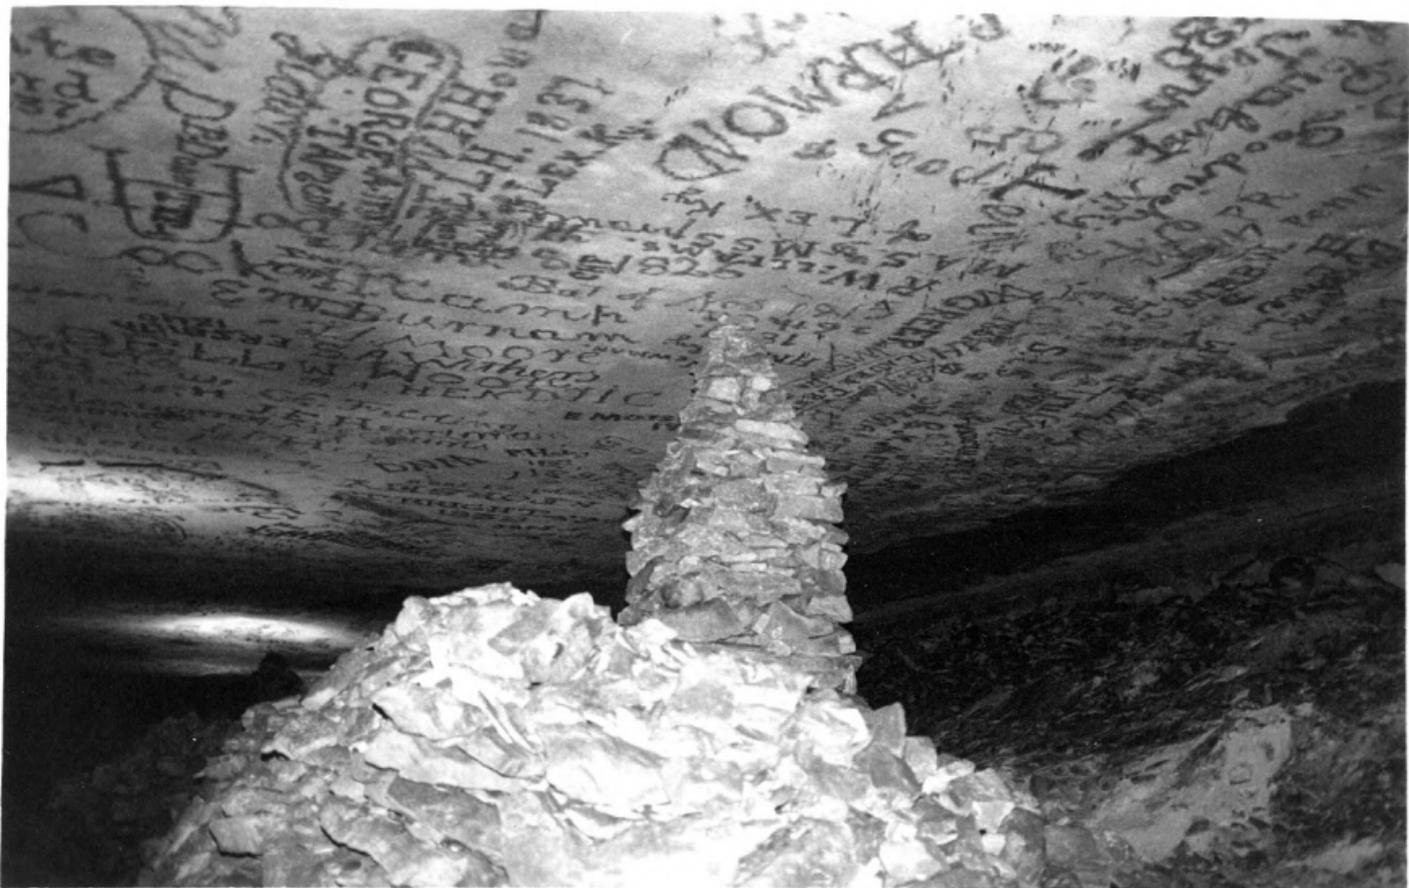
7. Rock Monuments and signatures (IC-10)  
Mammoth Cave National Park, Kentucky

The rock "monuments," stacks of limestone rubble put together by visitors to the cave in the nineteenth and early twentieth century, take on various shapes and sizes and sometimes bear the name of the state or group of visitors that constructed them. Local tradition holds that early cave guides encouraged this practice in order to quicken the arduous process of clearing trails. The rock walls, also made of rubble which once blocked the trails, vary in size from two to five feet. The signatures of visitors and dates of their visits were inscribed with candle smoke on the ceilings and walls of Gothic Avenue. Though monuments and signatures are found in various other portions of the cave, the largest intact collection of both are found in Gothic Avenue. Integrity of location, setting, design, workmanship, materials, feeling, and association are maintained.

Rock Monuments, Walls, and Signatures in Gothic Avenue  
(IC-10) [photo # 7]

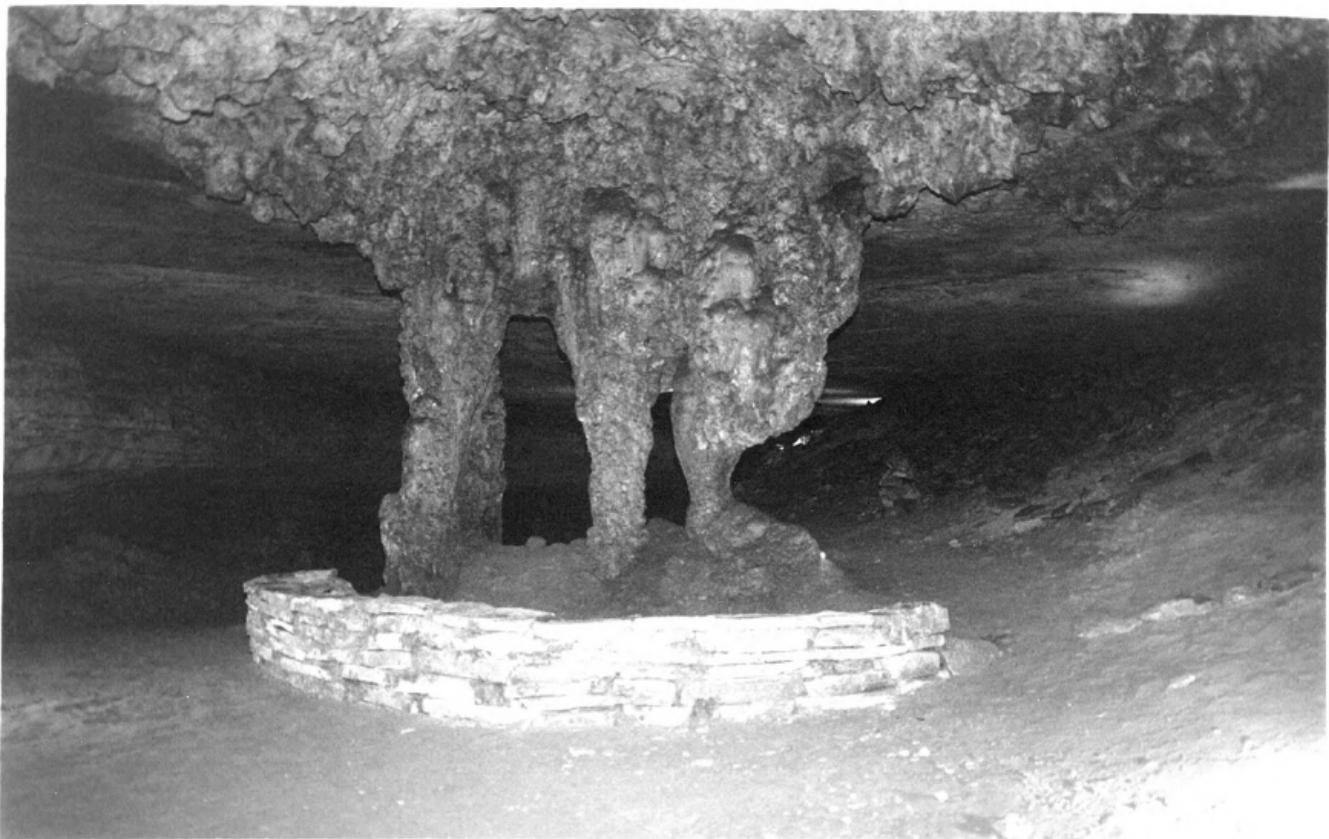
8. Rock wall at Bridal Altar (IC-05)  
Mammoth Cave National Park, Kentucky

Constructed by the Civilian Conservation Corps in the 1930s,

this semi-circular, cut and cemented limestone wall measures approximately 2' high and 21' long and surrounds the formation known as the bridal altar. The wall is a good example of the rock work done by the CCC at Mammoth Cave. Integrity of location, setting, design, materials, workmanship, feeling, and association are intact.

Rock Wall at the Bridal Alter (IC-05)  
[photo #8]

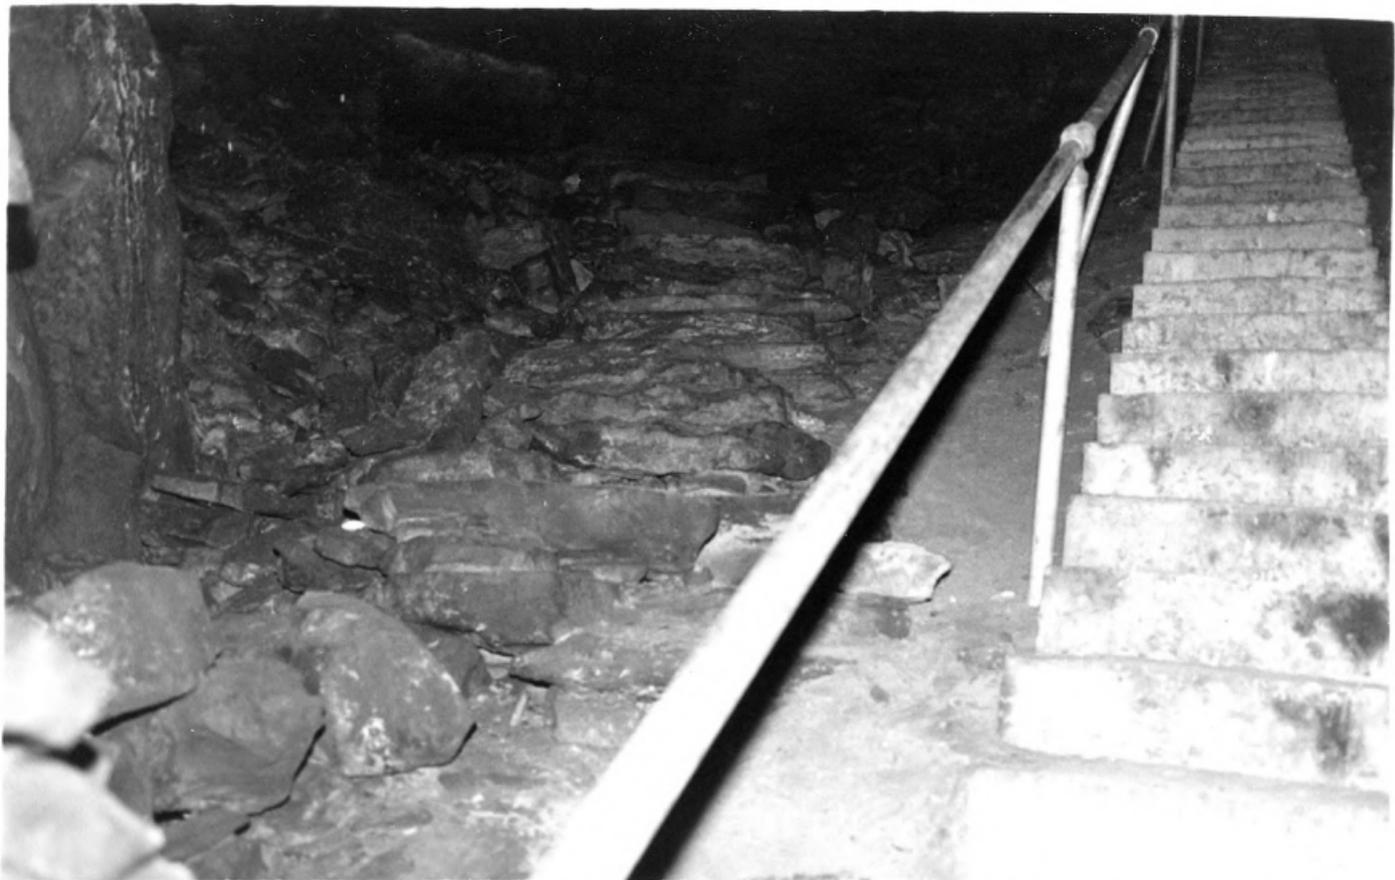
11. Rock stairs at end of Gothic Avenue (IC-04)  
Mammoth Cave National Park, Kentucky

Constructed in the late nineteenth century, approximately 27 irregularly shaped limestone slab steps lead from the end of Gothic Avenue through the "Elbow Crevice." Park officials estimate that up to 45 steps were part of the original stairway, some of which have been destroyed with the construction of the concrete stairway next to it. Though the setting and design have been somewhat altered, integrity of location, materials, workmanship, feeling, and association are intact.

Rock Stairs at End of Gothic Avenue (IC-04)  
[photo #11]

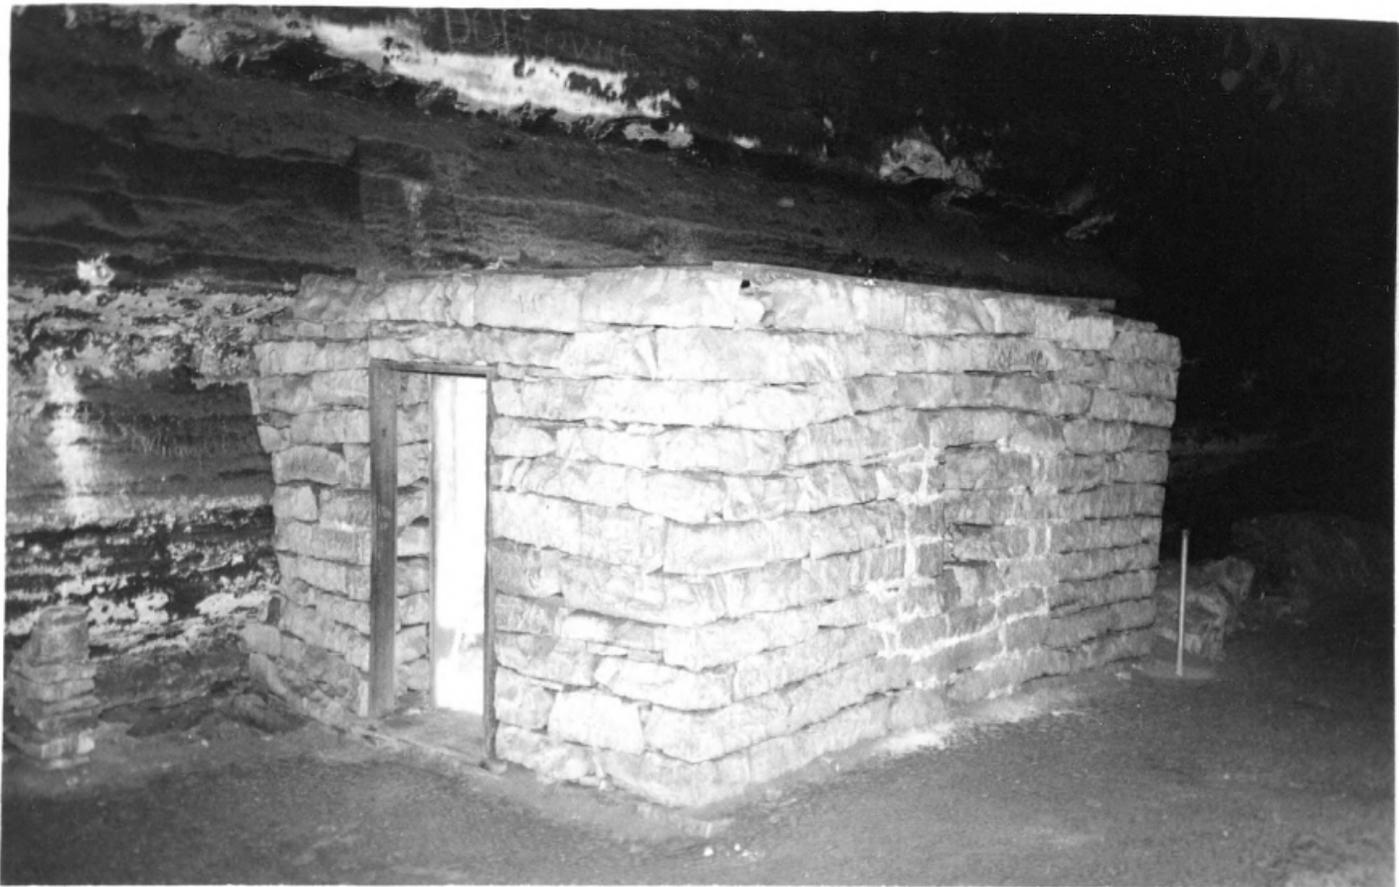
12. Tuberculin Huts (H53A)  
Mammoth Cave National Park, Kentucky

Located along Broadway, the two remaining tuberculin huts were constructed of loosely fitted limestone blocks measuring about two feet thick. The original canvas roofs no longer exist. The plank floor of the most intact hut (HS3A) remains, although the floor of HS3B is no longer present.

The walls of HS3A, the first hut one encounters when traveling down Broadway from the Historic Entrance, are approximately 7'8" tall, although the height varies slightly due to the uneven terrain. The cave wall serves as the rear wall of the structure. The front wall, parallel to the cave wall, has an unglazed window and measures approximately 17' long. The wall closest to the second structure measures approximately 12' long. The final wall, which has the structure's wood framed doorway, is just over 10' long.

Tuberculin Huts (HS3A and HS3B)  
[photos #12 & #13]

One of the tuberculin huts is in fair condition and the other is deteriorated. Despite the structural deterioration, integrity of location, setting, design, materials, feeling, and association are intact.

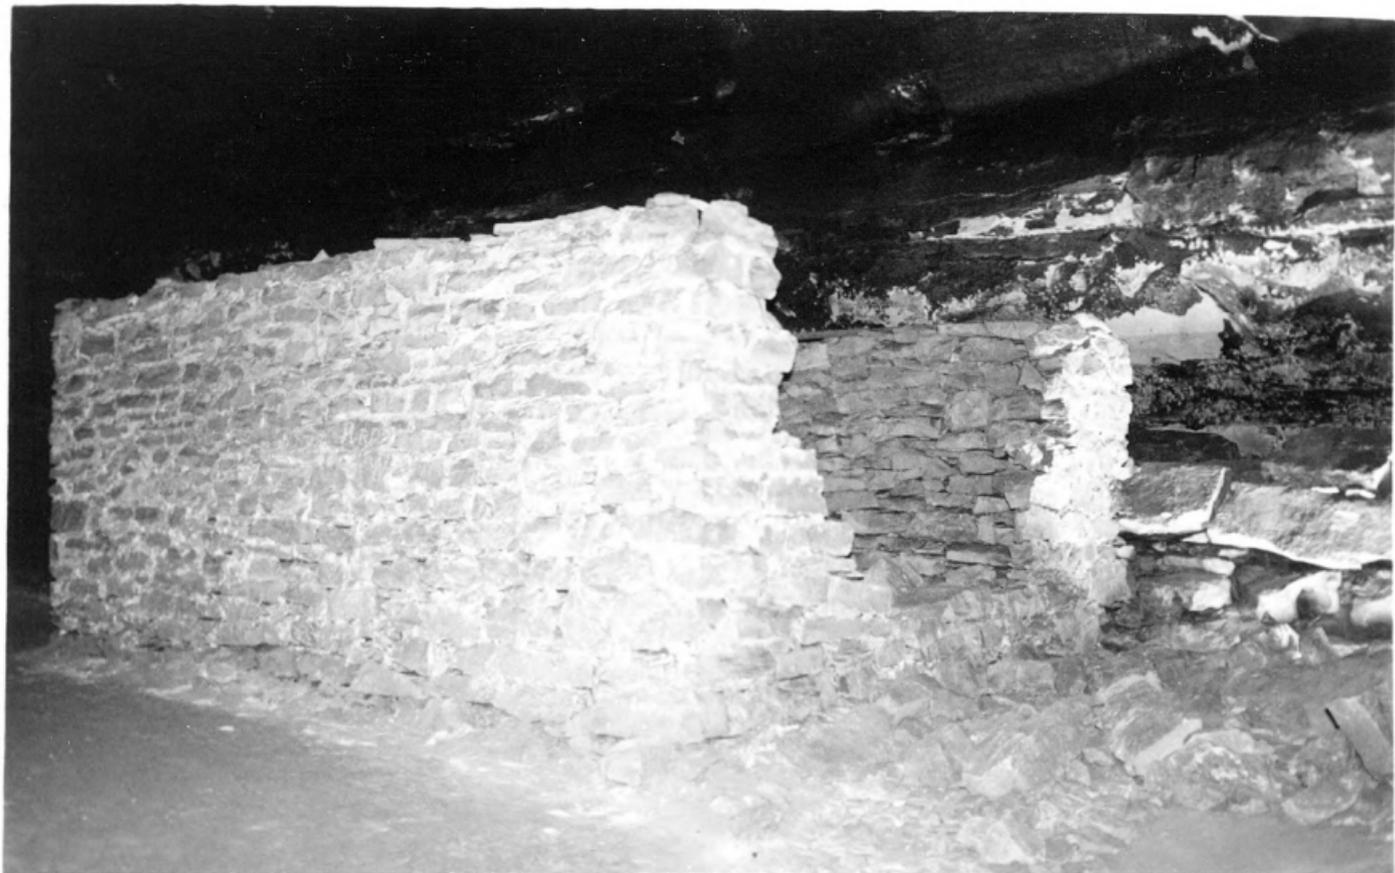
13. Tuberculin Hut (HS3B)  
Mammoth Cave National Park, Kentucky

HS3B, the larger of the two huts, is believed to have been used as a common dining hall for the tuberculin patients. Measuring approximately 8' high, 20' 6" long, and 16' wide, the structure has one door on the wall closest to HS3A. The wall opposite the door is partially collapsed.

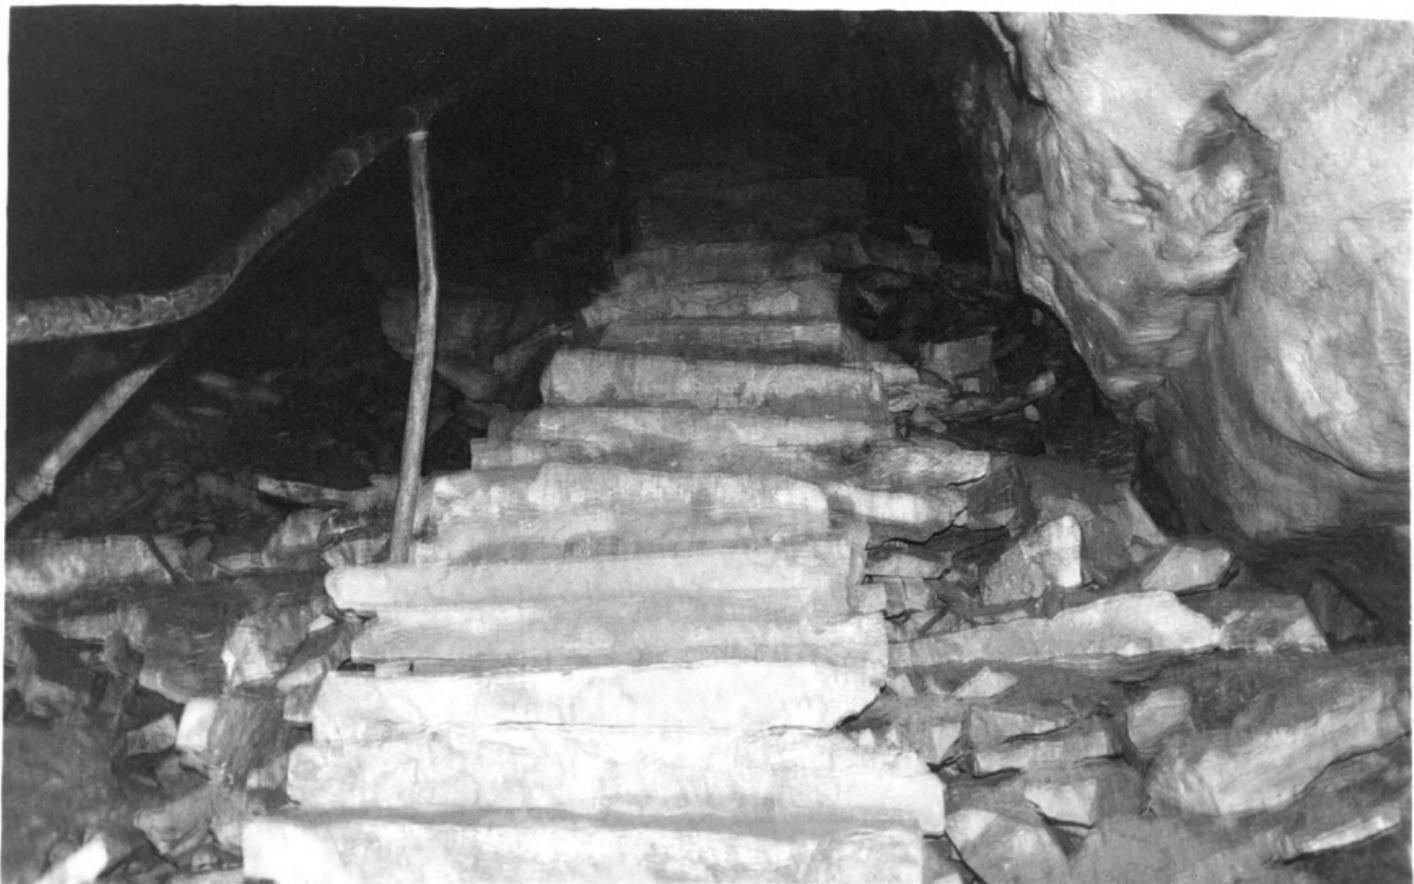
14. Albert's Stairway (IC-11)  
Mammoth Cave National Park, Kentucky

Constructed around 1908, Albert's Stairway consists of 52 limestone rubble stairs located along the right wall of Eliza-

beth's Dome (from the view of one climbing the steps). A metal railing was added to the stairway for safety, probably during the 1930s when the Civilian Conservation Corps was working in the cave. The structure is in good condition. Aside from the addition of the railing, the site is unaltered. Integrity of location, setting, design, materials, workmanship, feeling, and association are maintained.

Albert's Stairway (IC-11)  
[photo #14]

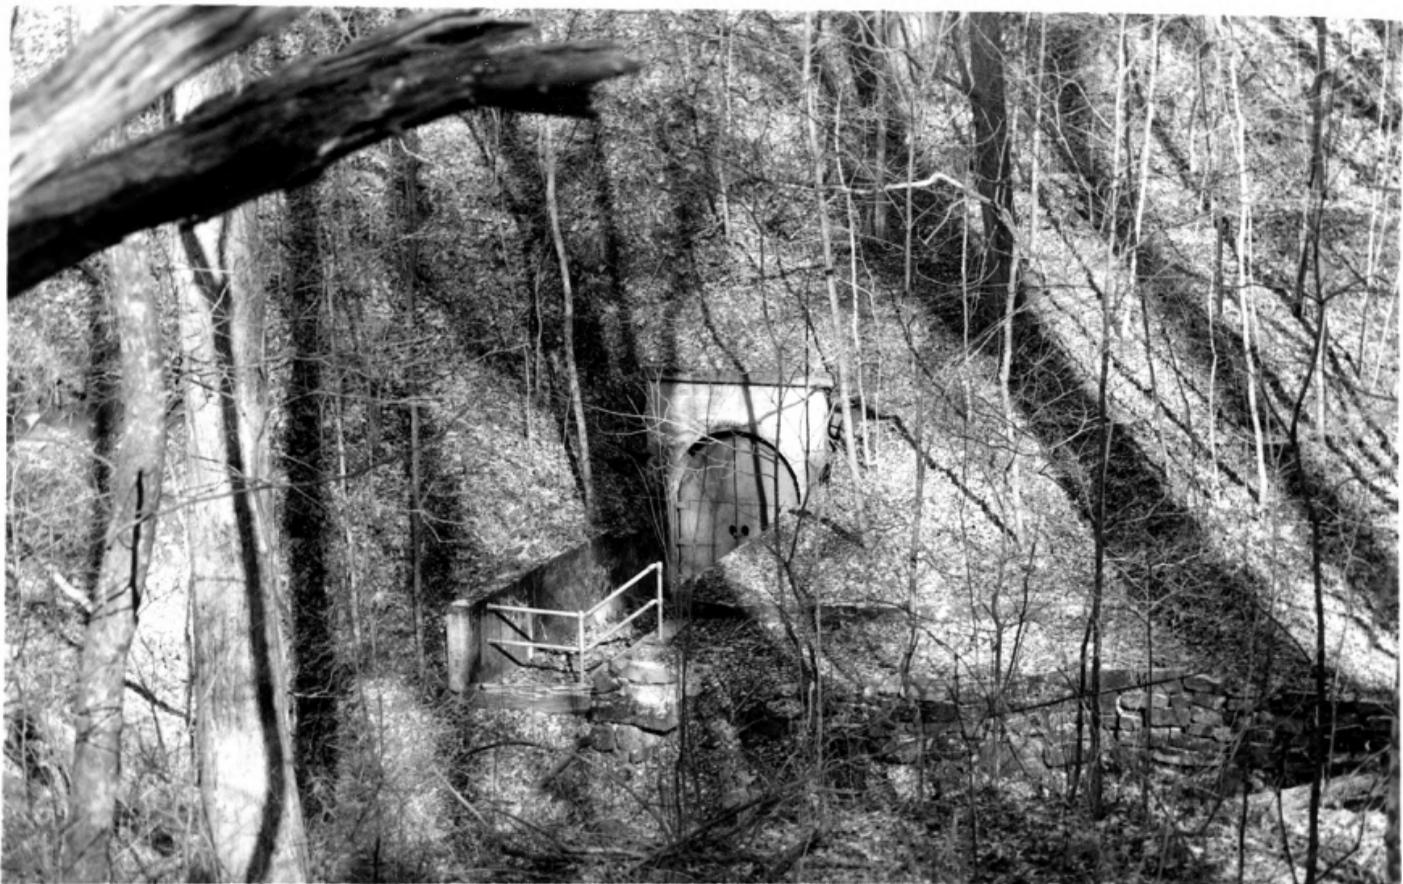
15. Violet City Entrance (E-20)  
Mammoth Cave National Park, Kentucky

Reached by a limited access road which continues the westerly route of state road 255 (old Highway 70) after its intersection with the park entrance road, Violet City Entrance was constructed in 1931 by George Carmichael, an engineer with Kentucky Asphalt Company, just prior to the park's development. The entrance was named after Violet Blair Janin, the last of the Croghan heirs and Mammoth Cave trustees. Built into a hillside, the entrance has a concrete gathering yard, concrete outer walls, and gothic shaped double iron doors with strap-like hinges. The entrance currently serves as the exit for the park's Lantern Tour. Though the immediate setting was slightly altered with the addition of metal handrails near the entrance, integrity of location, setting, design, materials, and workmanship, feeling, and association are intact.

Violet City Entrance (E-20)  
[photo #15]

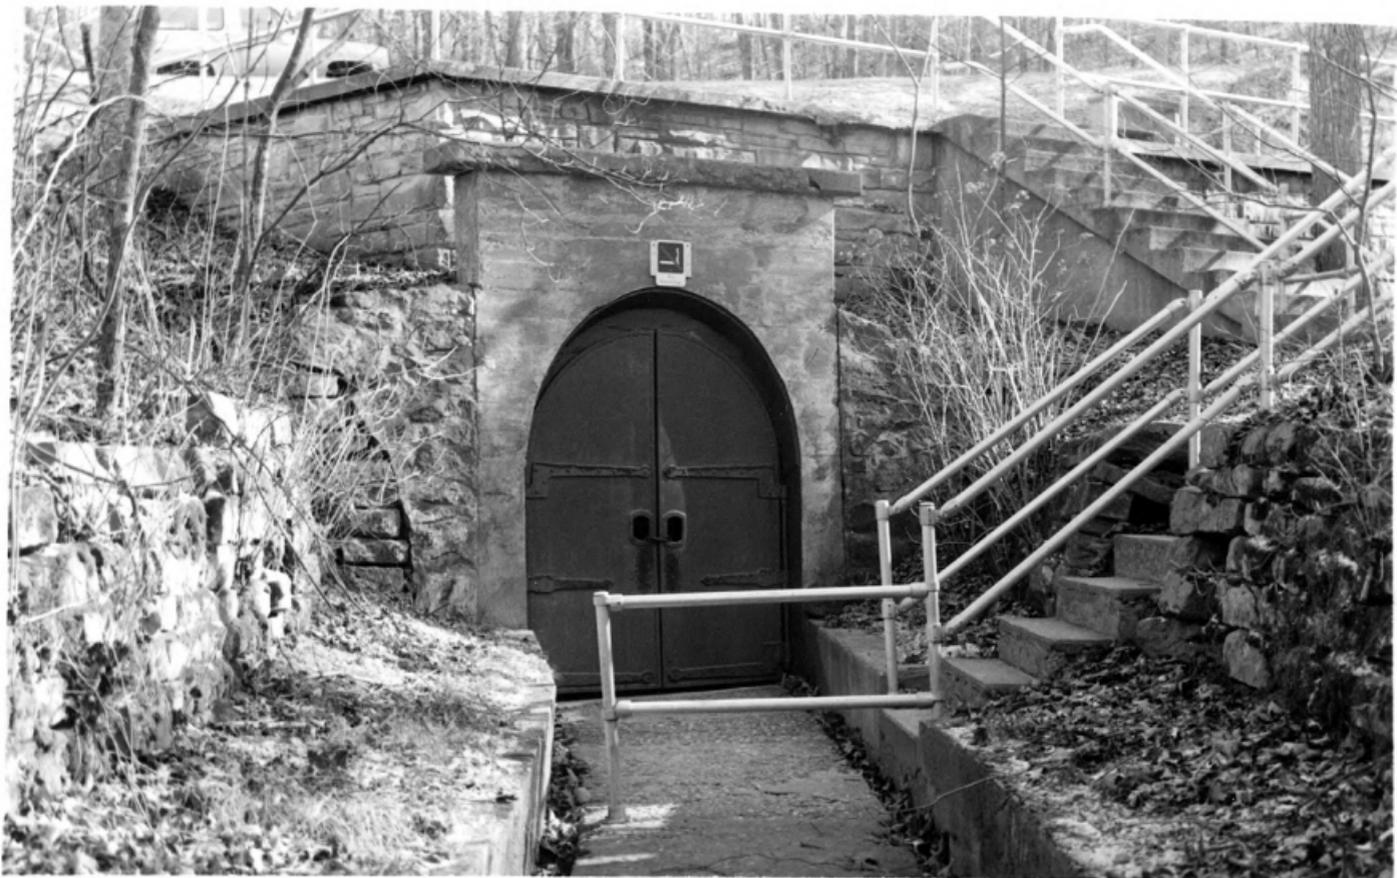
14. Carmichael Entrance (E-21)  
Mammoth Cave National Park, Kentucky

Carmichael Entrance was constructed in 1931 by George Carmichael, an engineer with the Kentucky Asphalt Company, just prior to the park's development. The entrance, which was named after Carmichael, is reached by a limited access road which continues the westerly route of State Road 255 after its intersection with the park entrance road. Concrete stairs descend from the access road to the double, iron, Gothic shaped doors with strap-like hinges, which are set into concrete outer walls. Though the original doors were taken out in the 1970s, they were replaced with exact copies of the ones removed. The opening currently serves as the entrance for the park's Half-day Tour. Though the immediate setting was altered with the addition of

metal handrails and concrete steps, integrity of location, design, materials, and workmanship are intact.

Carmichael Entrance (E-21)  
[photo #16]

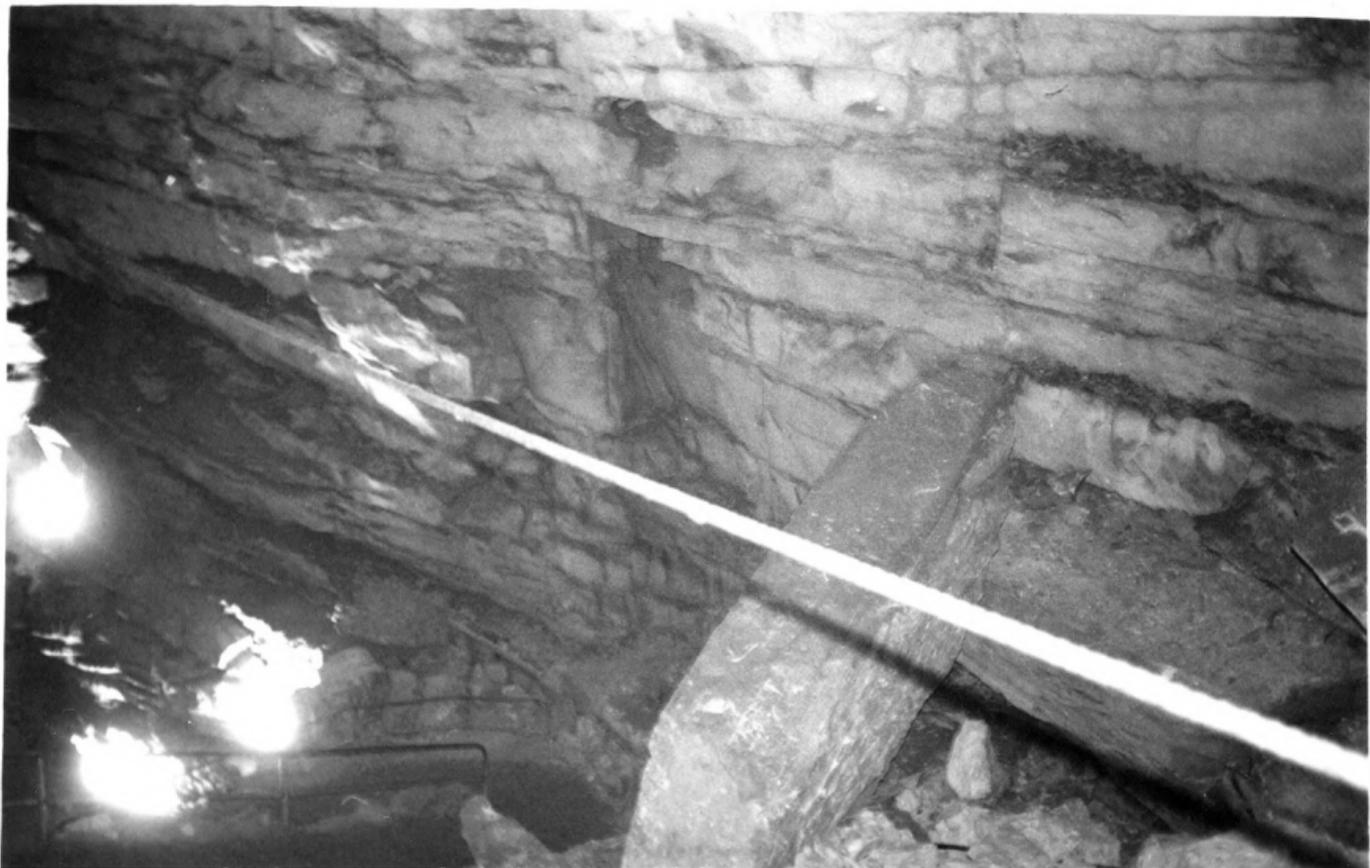
17. Cable at Aerobridge Canyon (IC-04)  
Mammoth Cave National Park, Kentucky

In 1921 and 1922 this 1" steel cable, measuring approximately 200' in length, supported a wooden cable car which transported visitors to the New Entrance Cave across the length of the canyon. The cable car and wooden loading platforms have been dismantled. Integrity of location, setting, materials, feeling, and association are intact.

Cable at Aerobridge Canyon (IC-06)  
[photo #17]

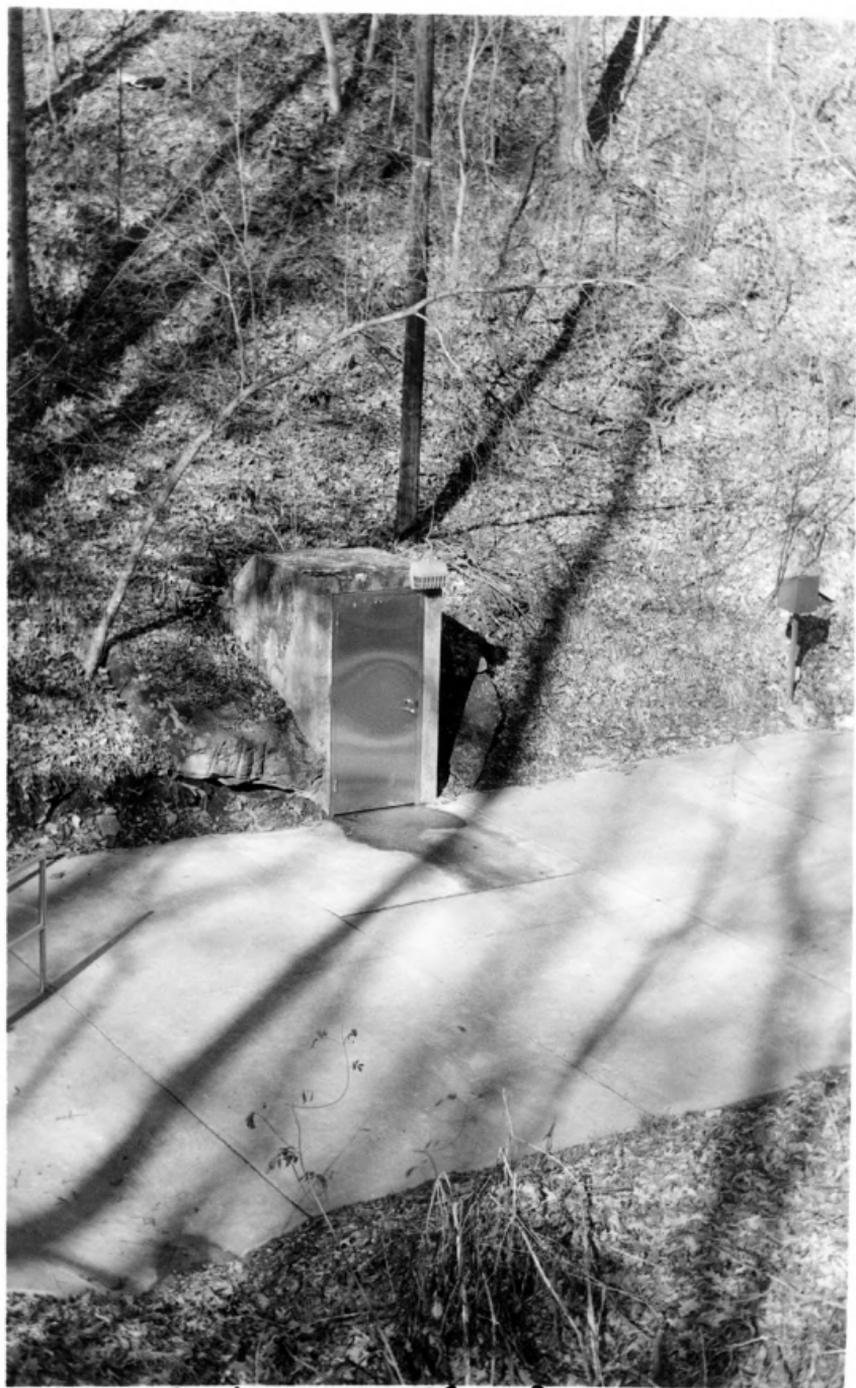
18. New Entrance (E-10)  
Mammoth Cave National Park, Kentucky

6. Located on the south slope of Mammoth Cave Ridge on an access road entered from Old Highway 70 (State Road 255), the New Entrance to Mammoth Cave (E-10, see photo #18) was constructed by the employees of George Morrison in 1921. In the early 1960s a new door and concrete shelter were added to the entrance, though it was closed in 1967 for safety reasons. In the early 1980s the door was again replaced, as was an interior stairway, and the entrance was reopened for tours. New Entrance is currently used for the Frozen Niagara Tour. Though its location is original and

its construction was important in the history of Mammoth Cave, the New Entrance is considered a non-contributing site because of its lack of integrity of immediate setting, design, materials, and workmanship.
