National Register of Historic Places  
Registration Form

historic name Mammoth Cave Historic District  
other names/site number see sec. 7 for individual site numbers

Historic Resources of Mammoth Cave National Park, MPS  
Edmonson, Hart, and Barren Counties, Kentucky,  
Mammoth Cave Historic District

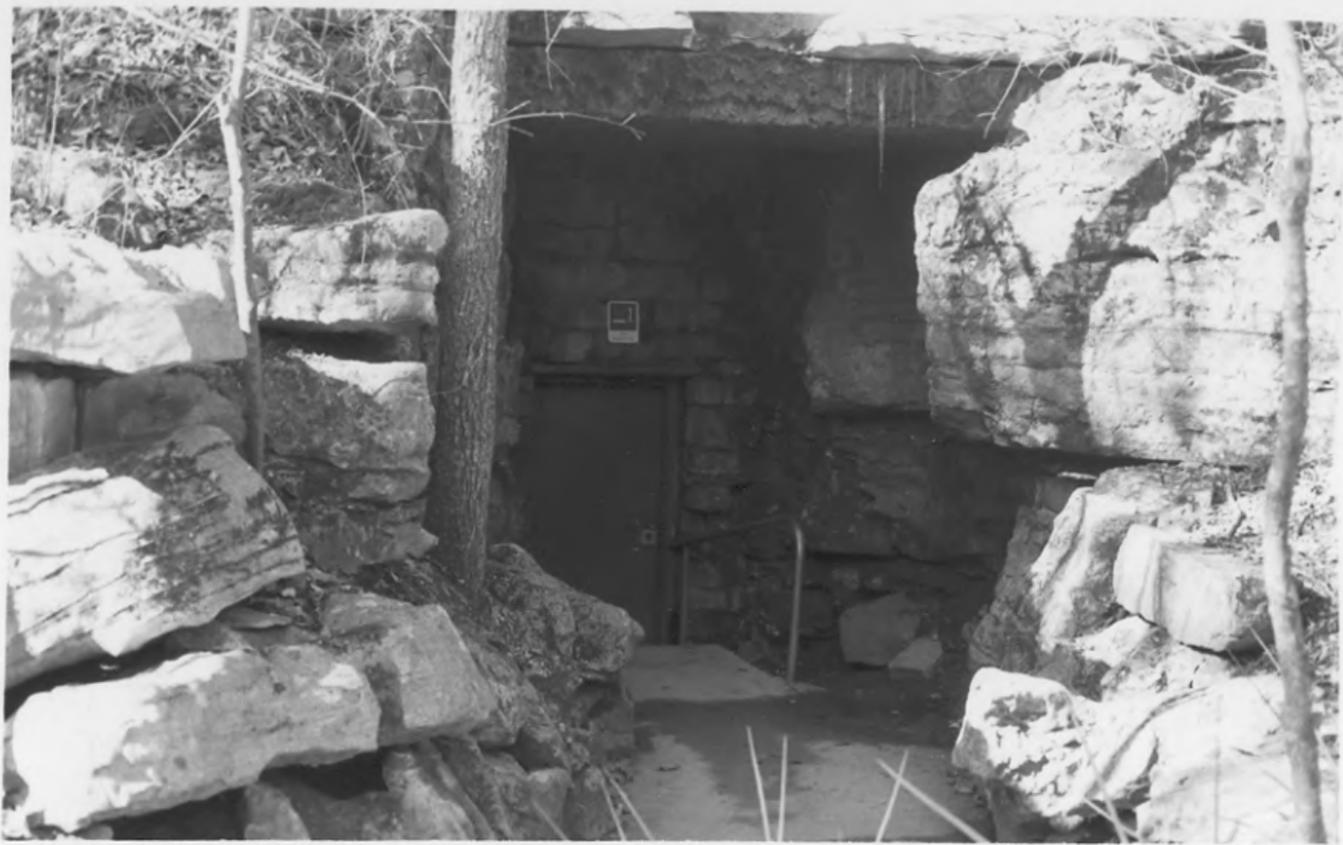
20. Frozen Niagara Entrance (E-4)  
Mammoth Cave National Park, Kentucky

Located on the south slope of Mammoth Cave Ridge on an access road entered from Old Highway 70 (State Road 255), the Frozen Niagara Entrance was constructed by the employees of George Morrison in 1924. The exterior tunnel that originally led to the cave's entrance was dismantled in the late 1920s. Limestone boulders were added around the entrance, probably in the 1930s, to give the entrance a more natural appearance. The original wooden door, set into a sandstone retaining wall, was replaced with a metal door in the late 1970s. Inside the door 10 concrete steps lead to the cave. Because the most prominent alterations were made within a decade of the entrance's construction, the current appearance of the Frozen Niagara Entrance does not vary much from its most well-known historical appearance. Integrity of location, immediate setting, the majority of materials, feeling, and association are intact.

Frozen Niagara Entrance (E-11)  
[photo #20]

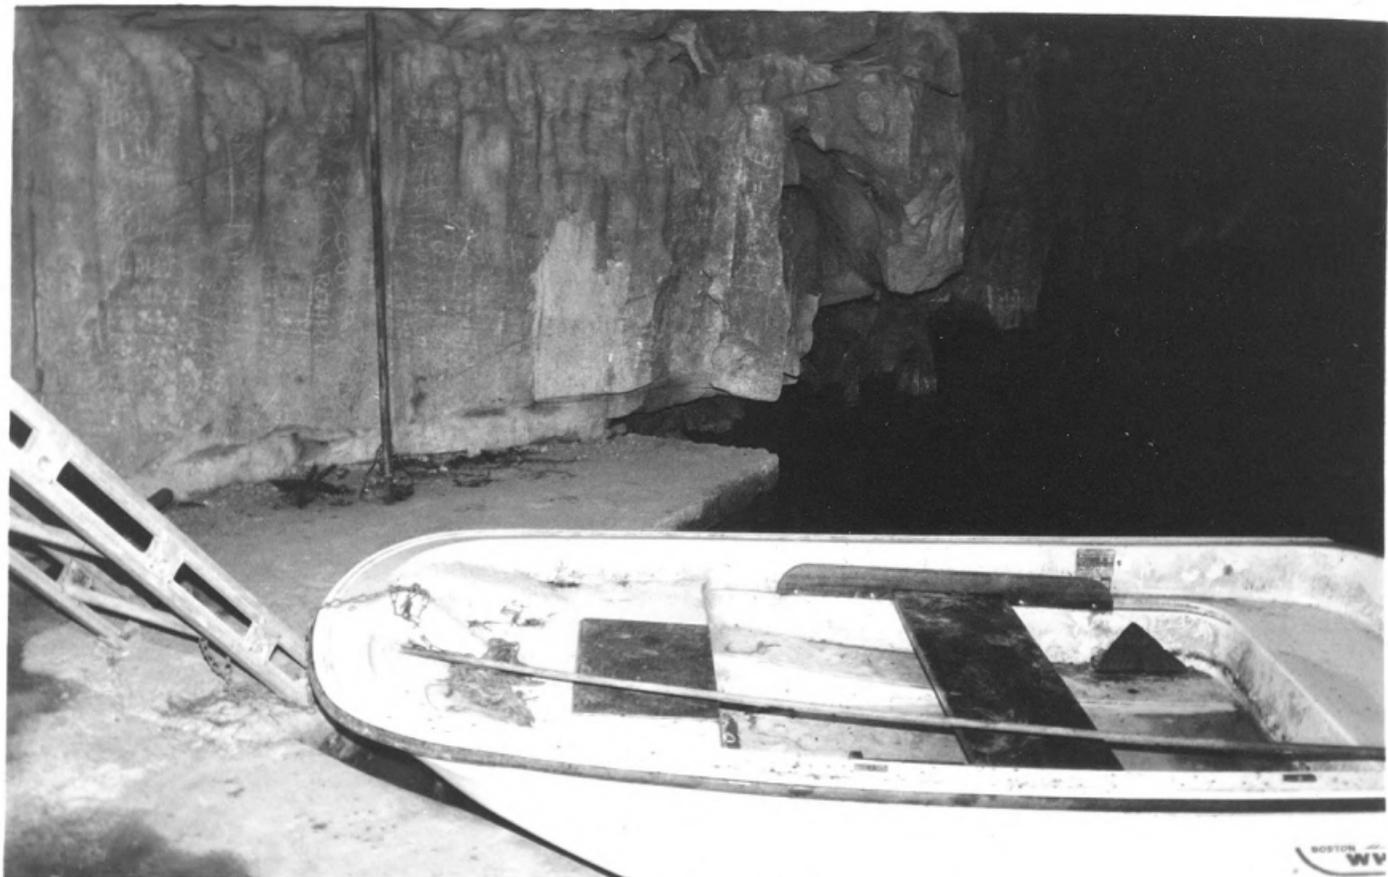
19. Landing at Crystal Lake (IC-08)  
Mammoth Cave National Park, Kentucky

This concrete boat landing was built in 1923 for the loading and unloading of passengers touring the Frozen Niagara portion of the cave. The landing, which was used until 1955, measures approximately 11' by 3'. A small boat is still docked at the site. Across the small lake are four concrete stairs associated with the landing. Integrity of location, setting, design, materials, workmanship, feeling, and association are intact.

5. There is one non-contributing metal bridge crossing Crystal Lake which replaced the original deteriorated wooden structure in the 1950s or 1960s.

Landing at Crystal Lake (IC-08)  
[photo #19]
