National Park Service  
Cultural Landscapes Inventory  
2004

Manzanar National Historic Site  
Manzanar National Historic Site

CULTURAL LANDSCAPES INVENTORY (CLI) PROGRAM  
2010 Condition Assessment Update for:

**Manzanar National Historic Site**

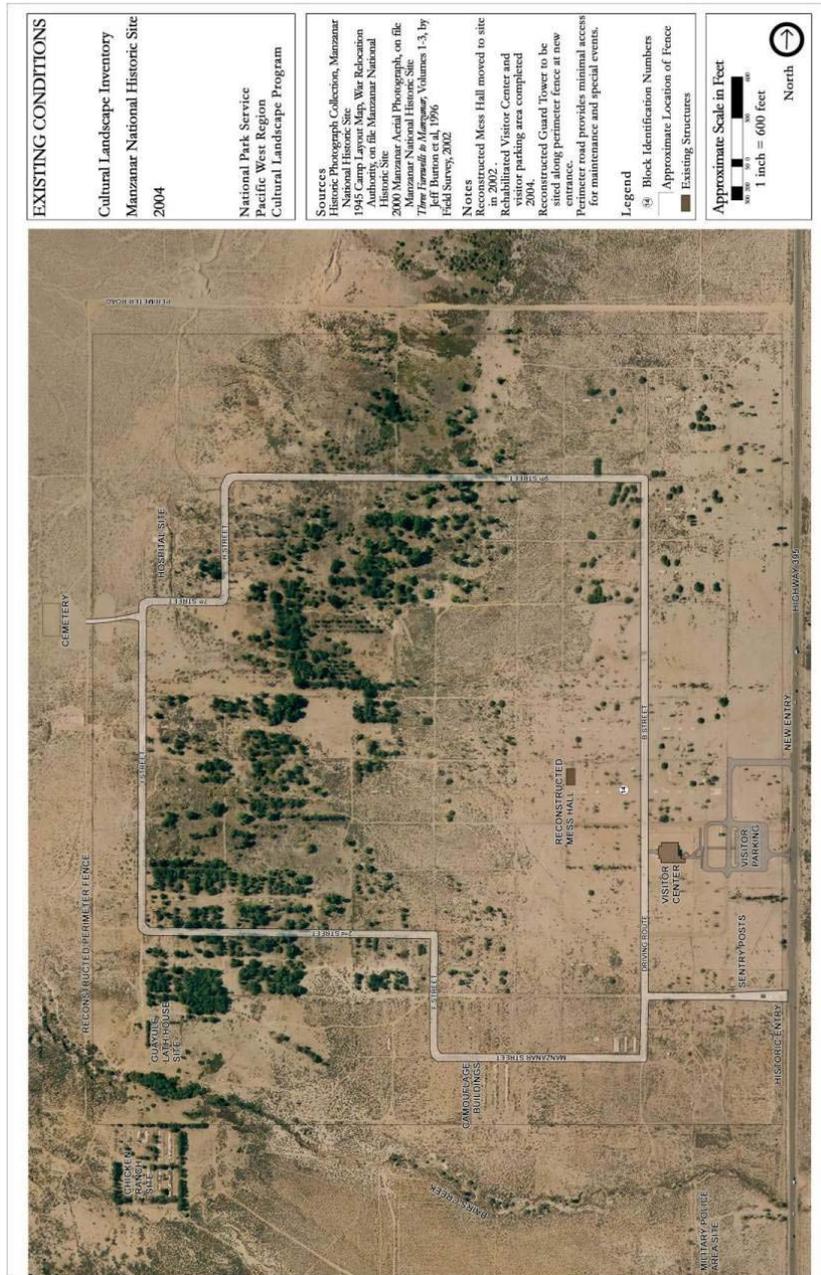
An existing conditions site map of Manzanar National Historic Site. A larger version is located in the Appendix. (CLR, 2004)

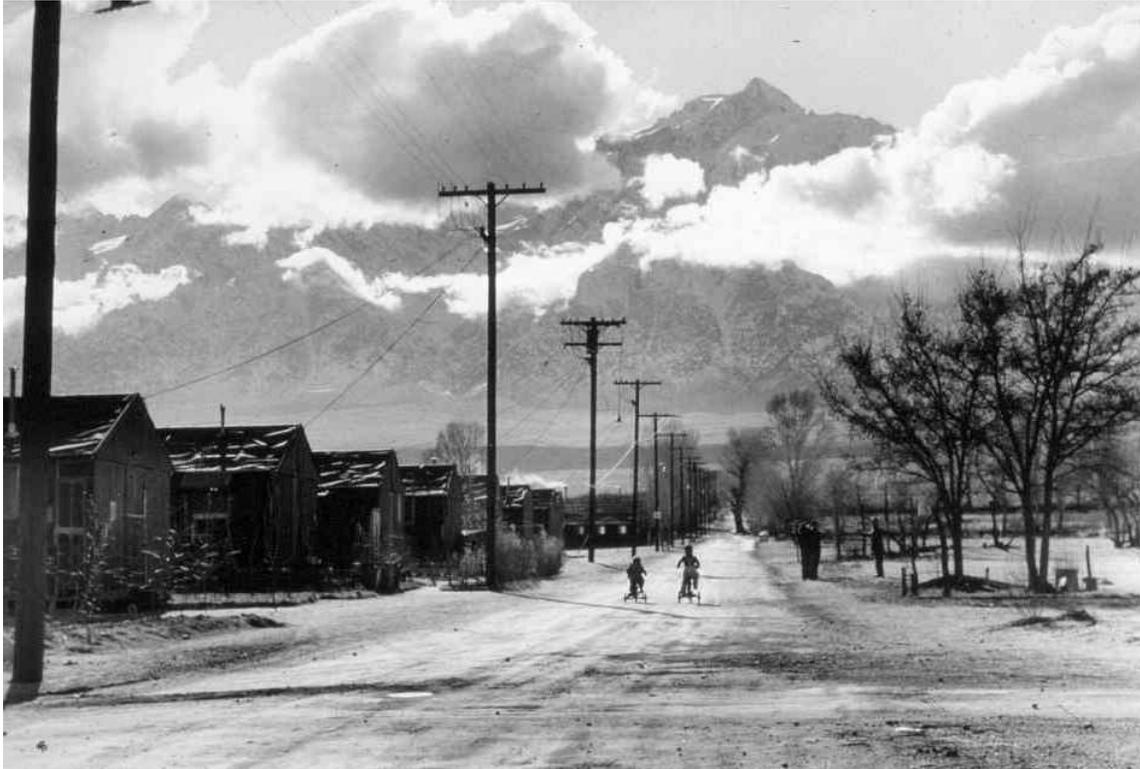
*View westward of Sixth Street; barracks are located on the left and the firebreak is to the right. (CLR, 2004)*

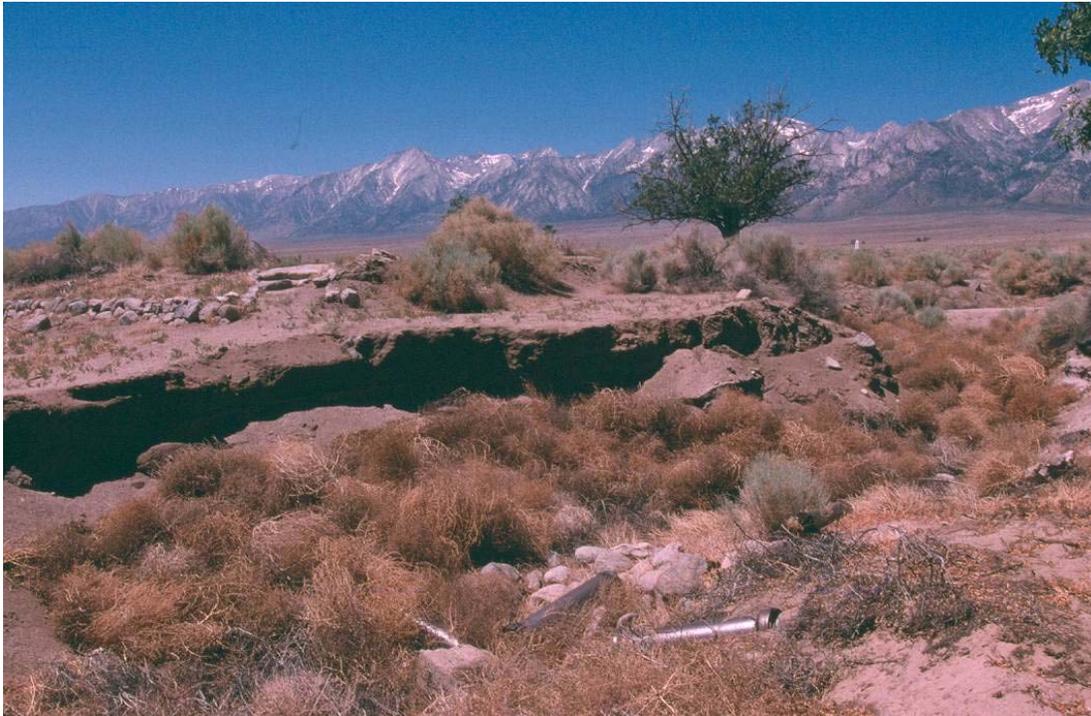
*Natural Systems and Features: Gulying, resulting from the distribution of high flows from the spring melt, have exposed archeological resources and disrupted the native Shadscale Scrub plant community and historic vegetation. (PWRO, 2004)*

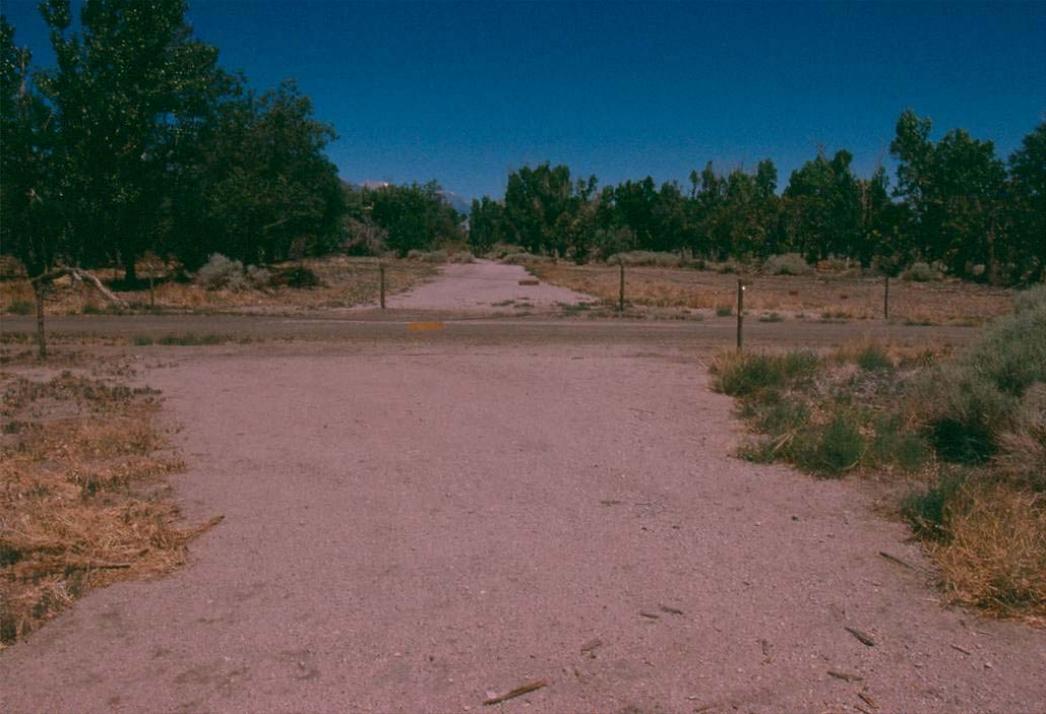
*Spatial Organization: The camp organization into a grid of thirty-six uniform blocks was reinforced by the roads, which ran generally north-south, and east-west. The intersection remains, seperating blocks. (PWRO, 2004)*

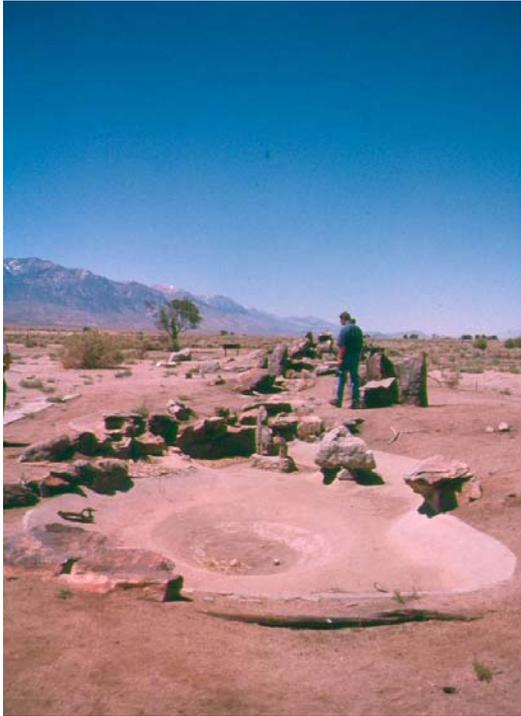
*Cultural Traditions: San-shi-en, the Block 34 mess hall garden, was built in the tradition Momoyama style, like many of the gardens at the camp. The large concrete pond, built in a traditional Japanese gourd shape, was excavated in 1999. (PWRO, 2004)*

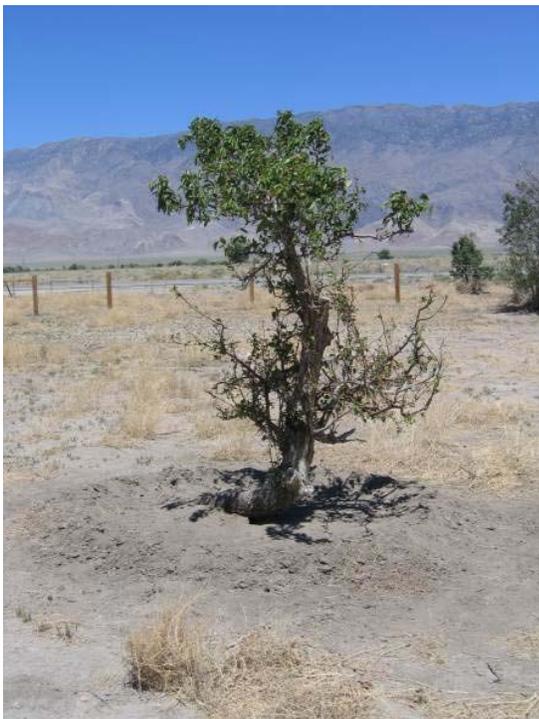
*Vegetation: A remnant pear trees from the Hatfield Orchard, like many of the fruit trees at the site, has been neglected since the camp closed. Park stabilization efforts include mulching and building a “dish” around the base to hold water. (PWRO, 2004)*

Recent stabilization efforts including irrigation and the removal of dead limbs and sucker growth and general pruning have significantly improved the condition of the trees.

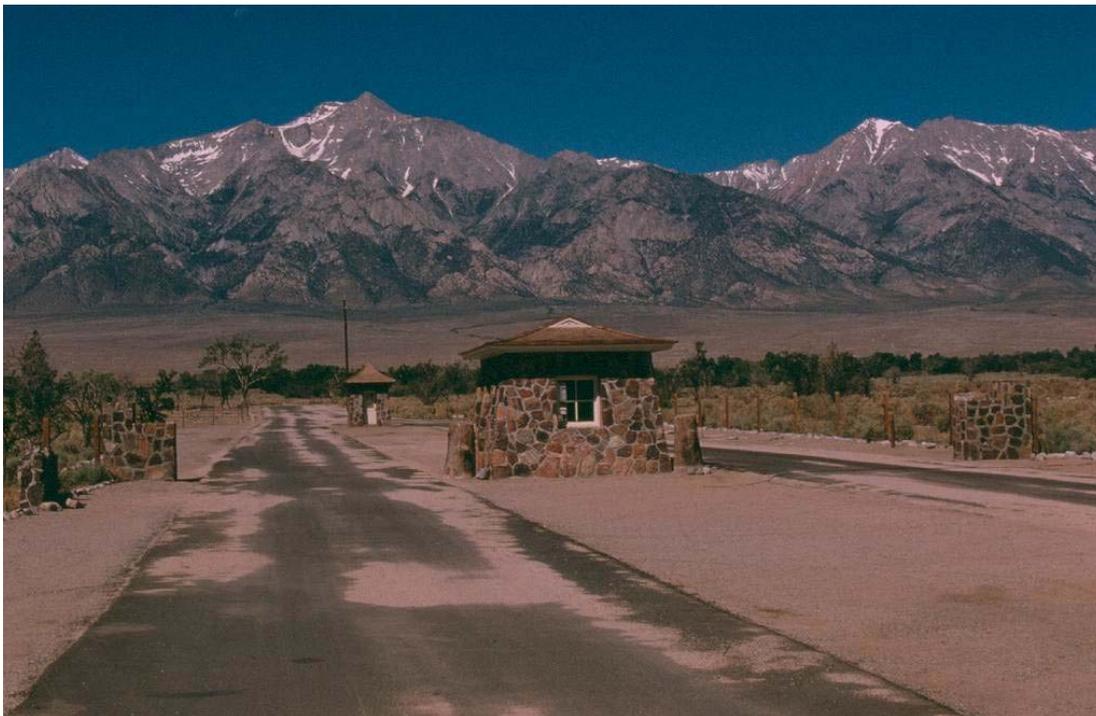
*Circulation: Two, one-lane roads divided by an open median with two sentry posts controlled access to the camp. Unlike other camp structures, the sentry posts had a Japanese influence. A historic parking lot is on the right side of the entry. (PWRO, 2004)*

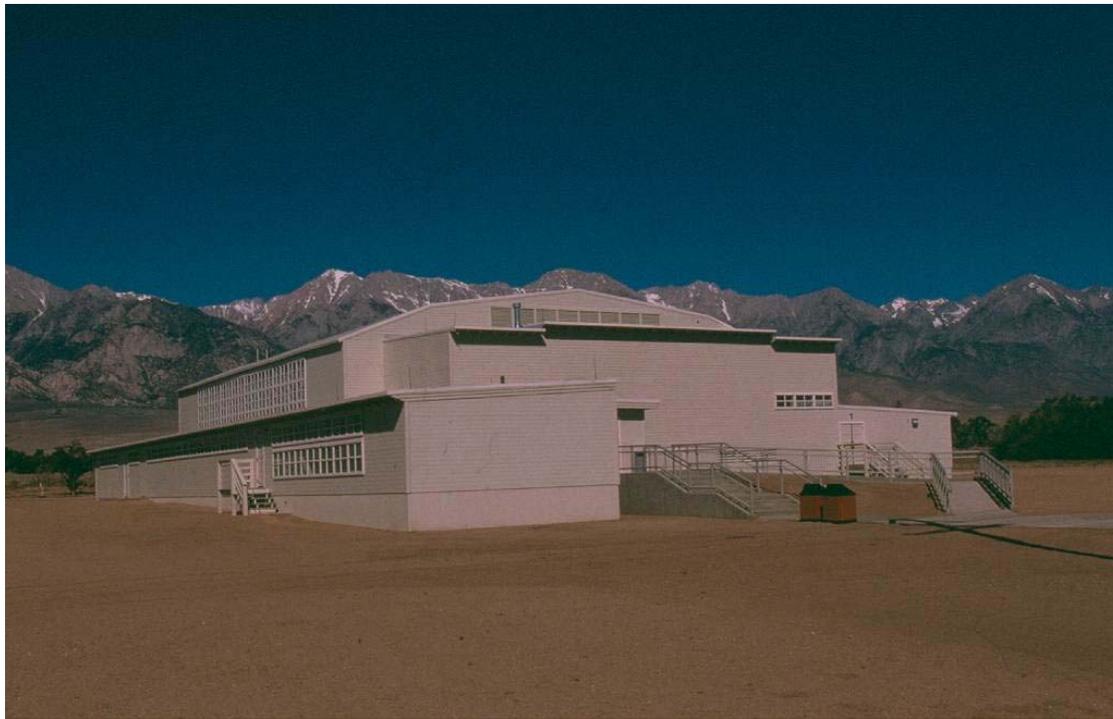
*Buildings and Structures: The auditorium was recently rehabilitated into the park Interpretation and Administration Center. The south wing that had been removed from the site was reconstructed as part of the rehabilitation. (PWRO, 2004)*
