ARCHEOLOGICAL  
COLLECTIONS MANAGEMENT  
AT  
MINUTE MAN  
NATIONAL HISTORICAL PARK

MASSACHUSETTS

VOLUME 3

ACMP Series No. 4

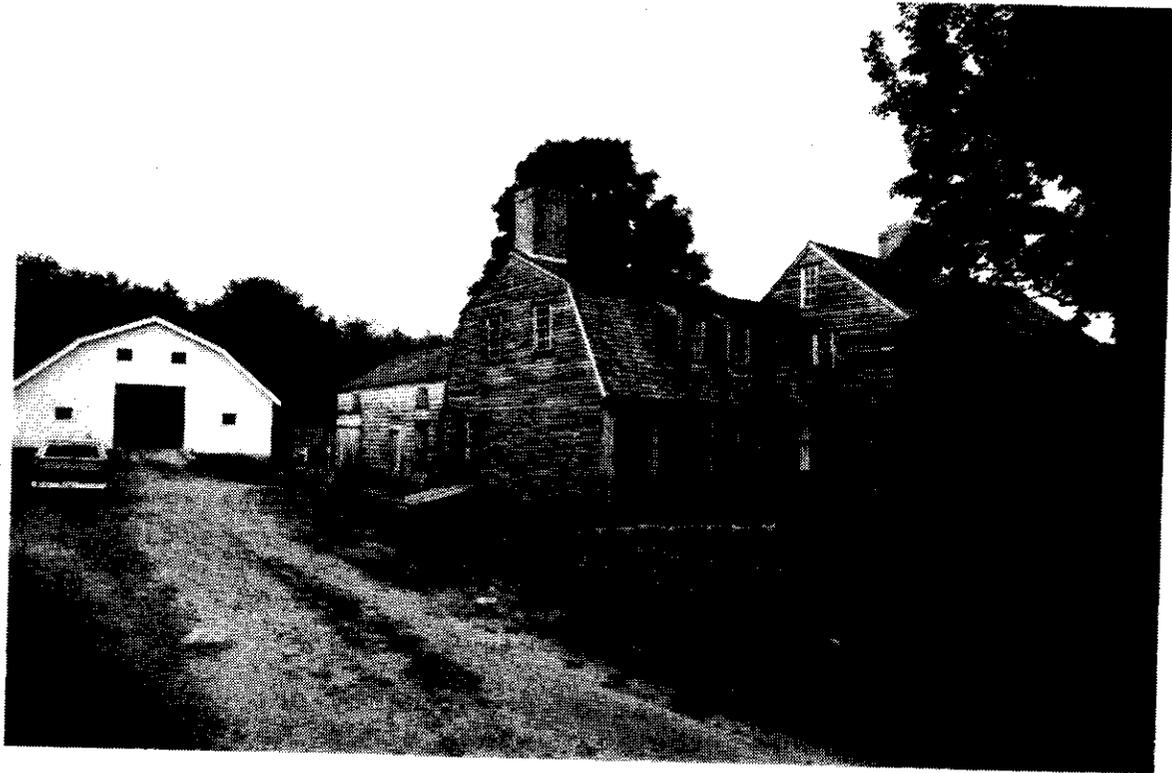
14.1. ACMP photograph of the Hartwell Tavern, 1986.

Today the inn structure still stands, and has recently been restored by the National Park Service (Figure 14.1). It has come to be known as the Ephraim Hartwell Tavern. The title of Tavern is somewhat of a misnomer, since the license for keeping an inn was different from that for keeping a tavern, and to date no contemporary account has been found documenting the name of Ephraim's establishment as a Tavern.

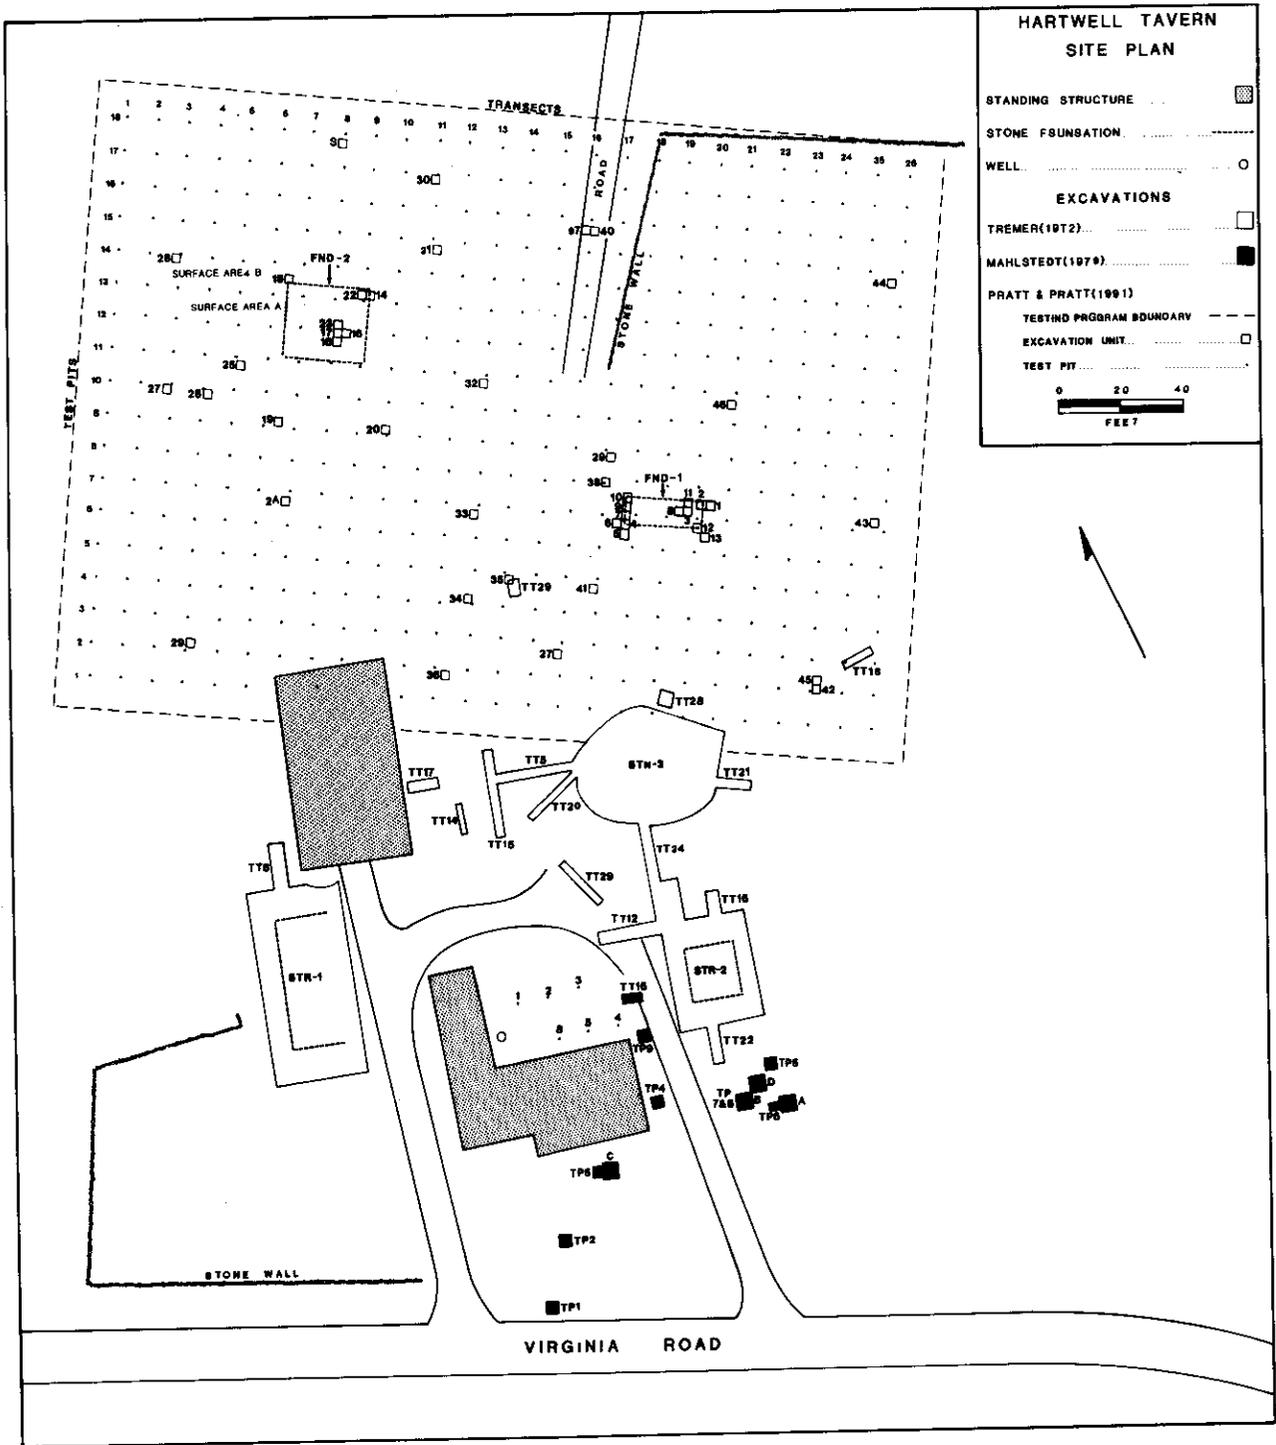
14.2. ACMP composite site plan, Hartwell Tavern excavations.

The subsequent archeological testing took place in the summer of 1980, utilizing essentially the same study area (Figure 14.2). Marjorie and Peter Pratt directed the fieldwork, and Marjorie prepared the final project report. Through their testing program, Pratt and Pratt were able to identify two foundations, a road, and several refuse areas. The foundations were those which had been discovered by Tremer in his 1973 survey. Marjorie Pratt provided generally detailed discussions of their findings in the final report (1981), and contrasted the results of the survey with those of the preceding geophysical survey (1981:52-66).

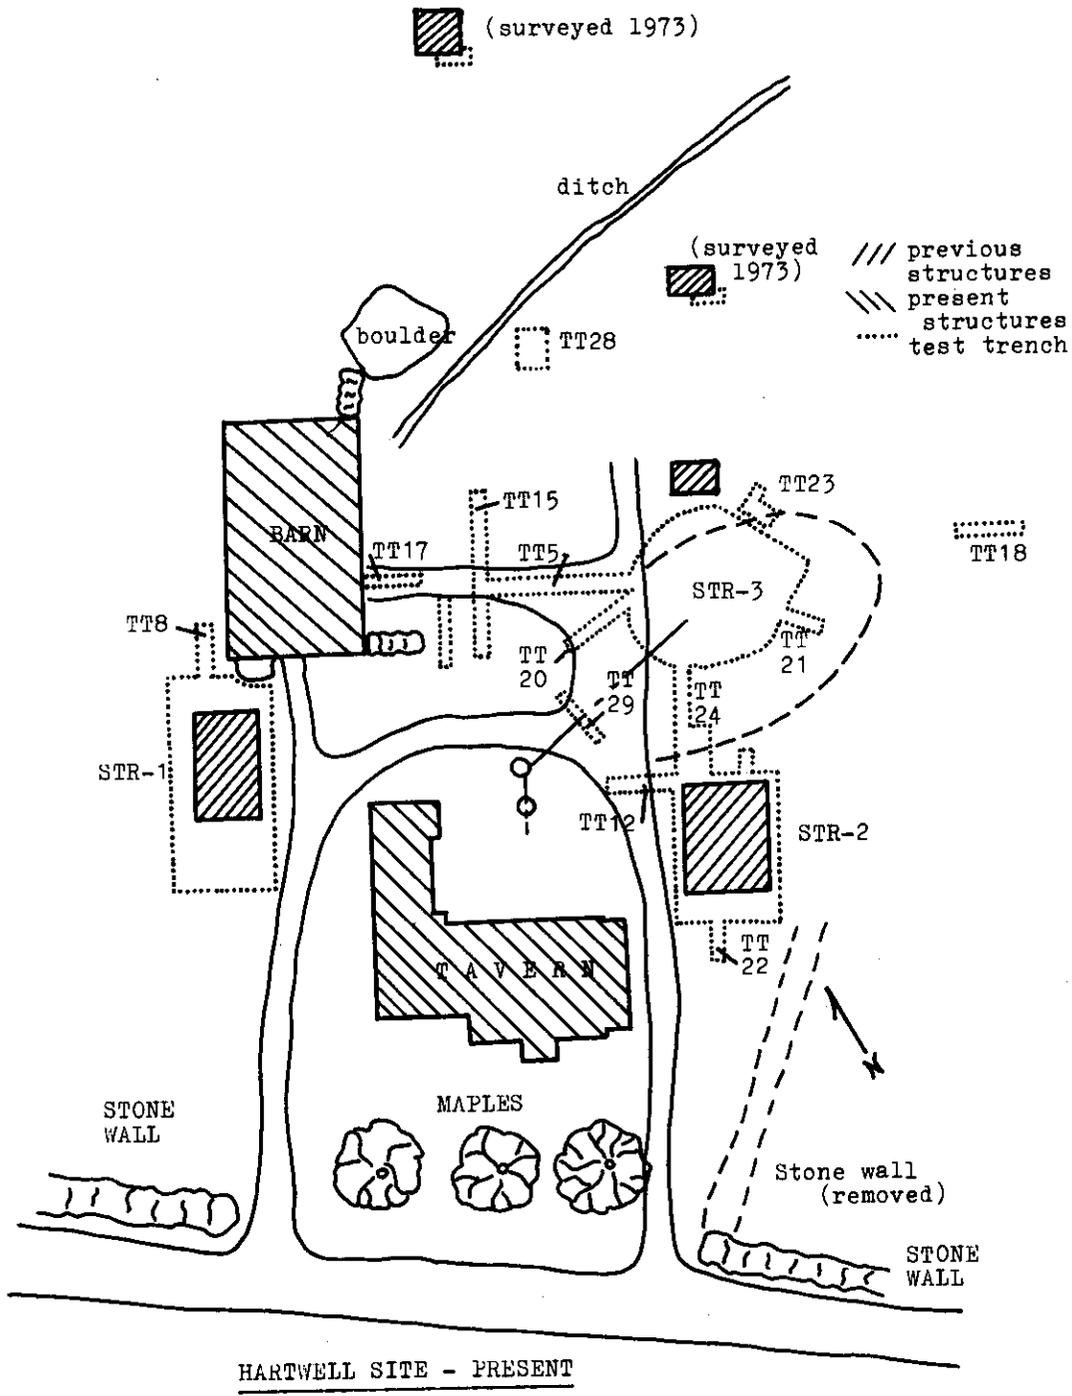
14.3. Tremer's original site plan (1973:5).

Tremer's site map did not include a scale. The ACMP calculated a scale of 1 in. = 40 ft. using known dimensions of the barn and tavern. This scale was then used to compare the measurements of test trenches and features documented in Tremer's report to the mapped dimensions. Of the eight test trenches with documented measurements, three had mapped dimensions significantly different from those stated in the report. STR-1 and STR-2 were also mapped differently from their documented dimensions.

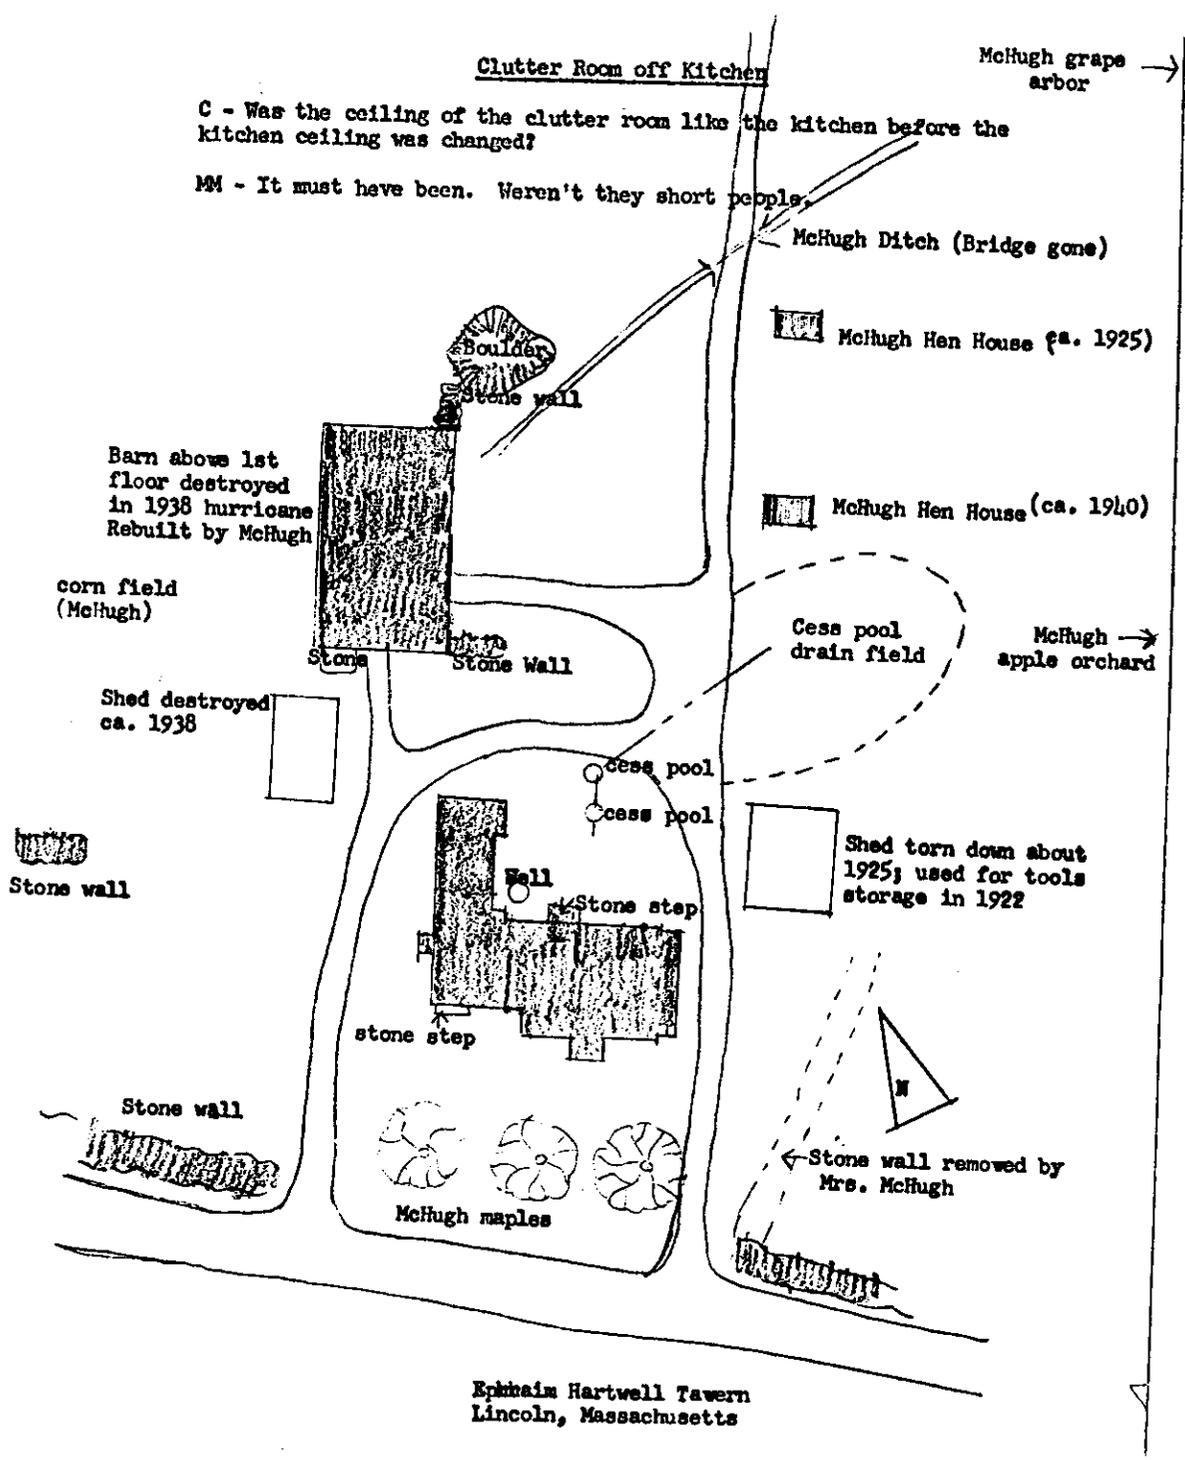
14.4. Luzader's schematic grounds plan, Hartwell Tavern (1972:15, drawn from Carroll n.d.).

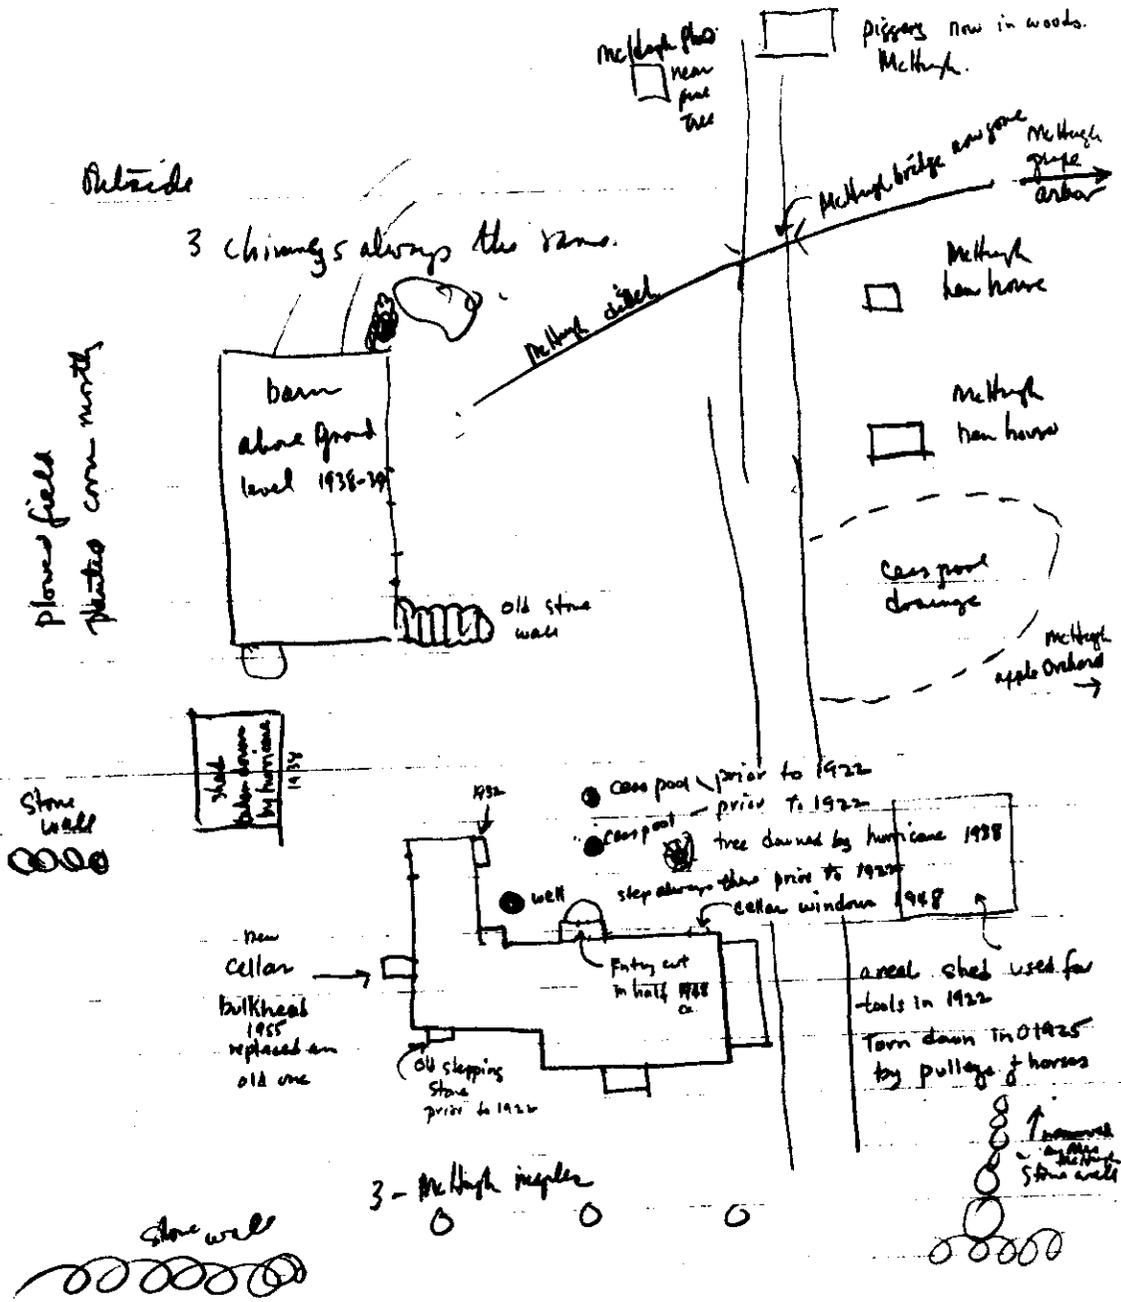
14.5. Carroll's sketch plan of grounds during McHugh years, based upon oral history interview with Mary McHugh, last tavern occupant (Carroll n.d.). Note "piggery" in upper right corner, and "McHugh Shed" immediately to the left. Also shown are the cesspool and sheds excavated by Tremer near house, and hen houses. Plan is not to scale.

The ACMP located Carroll's sketch in a file at MIMA. It was obvious from this map that Foundation 2, located north of the barn (Figure 14.2), could not have been part of the piggery, which was much farther east. The piggery would have been essentially due north of the hen houses and on the east side of the access road. Structures associated with the piggery appeared in a ca. 1932 photograph from Mary McHugh's photo album (Figure 14.16). The photograph probably faces east, and shows three small hog sheds and the corner of another structure. Apparently the Pratts found no evidence of these foundations, and their precise location is uncertain.

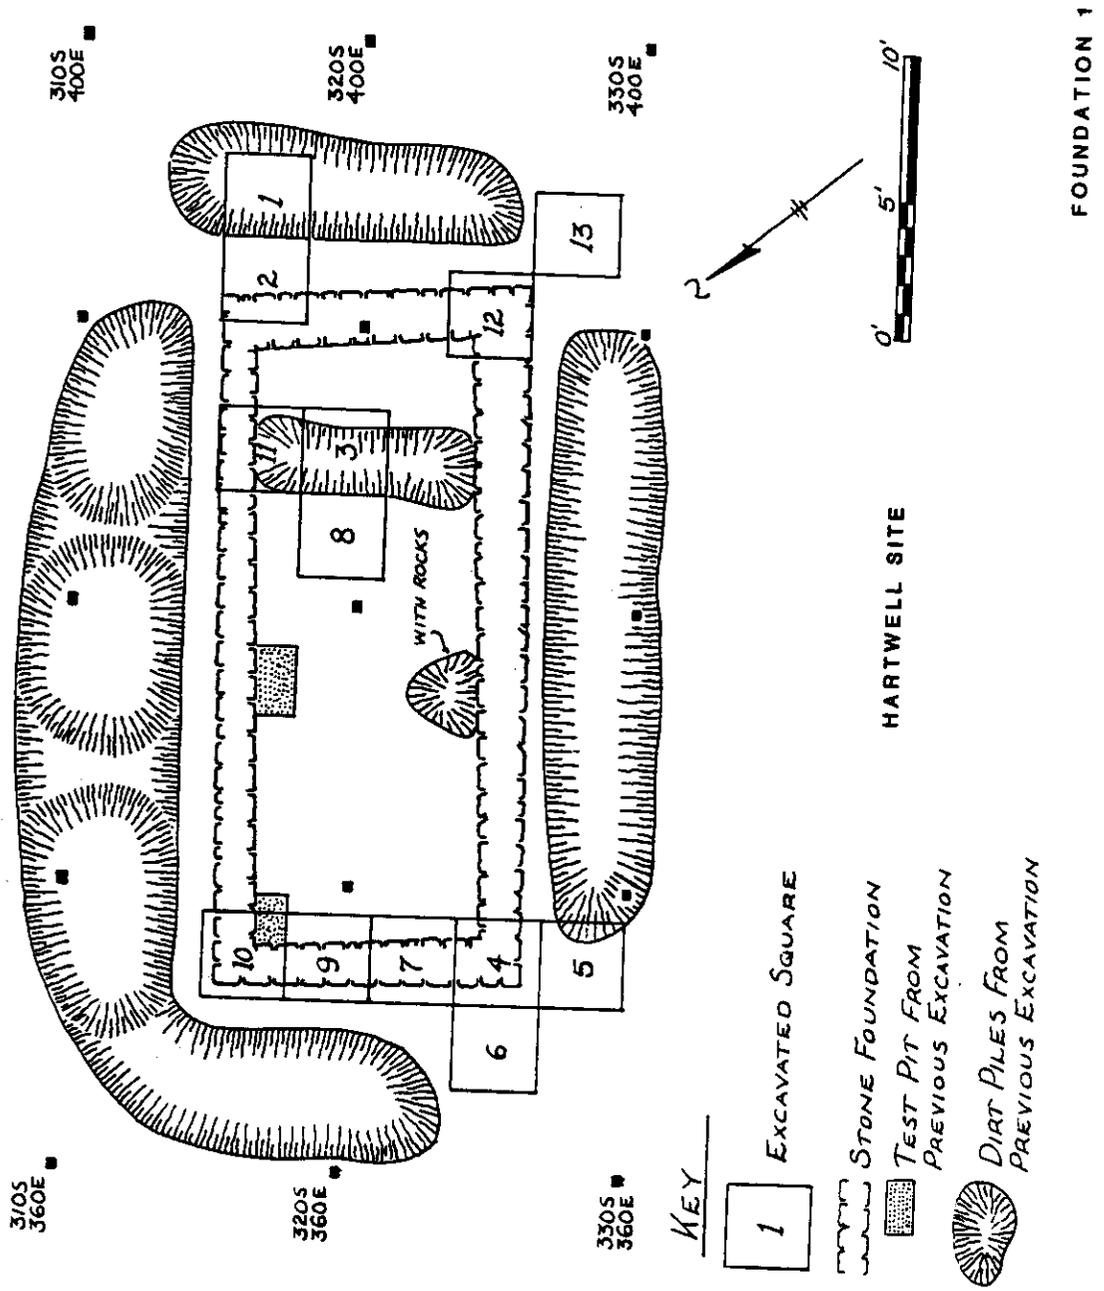
Figure 14.6. Pratt plan of Foundation 1 (1981:Figure 7).

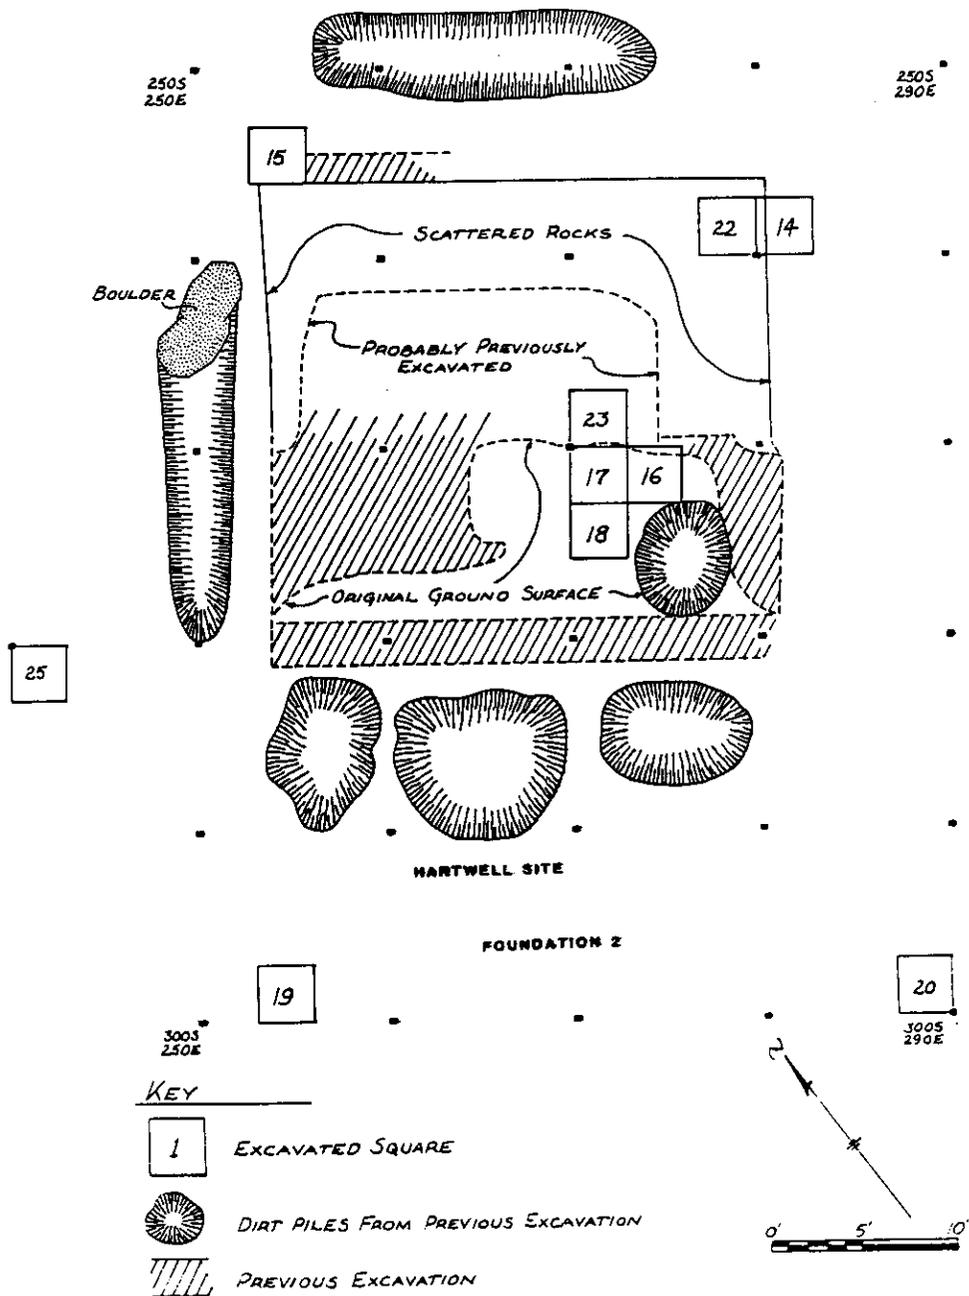
14.7. Pratt plan of Foundation 2 (1981:Figure 11).

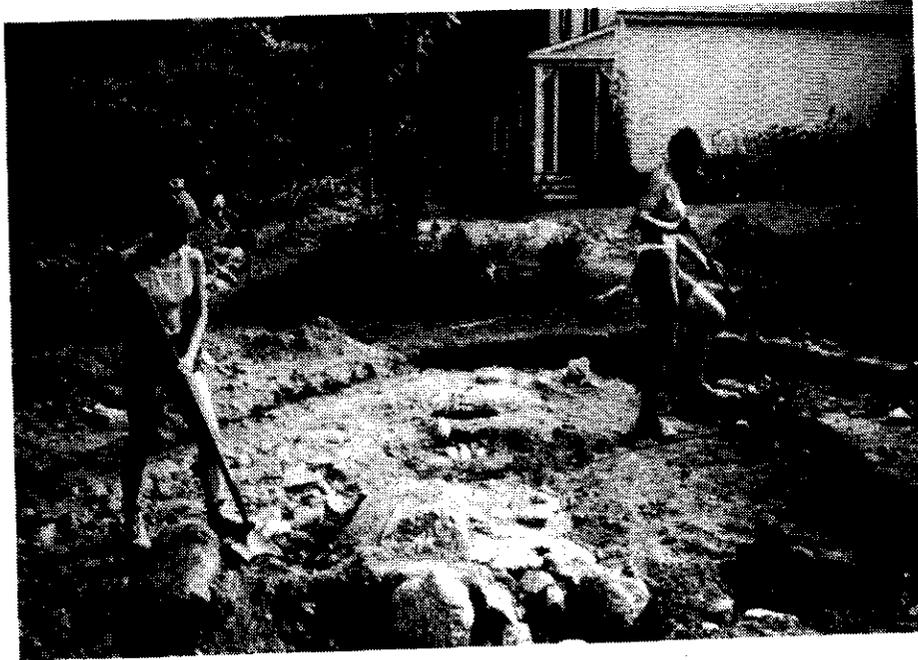
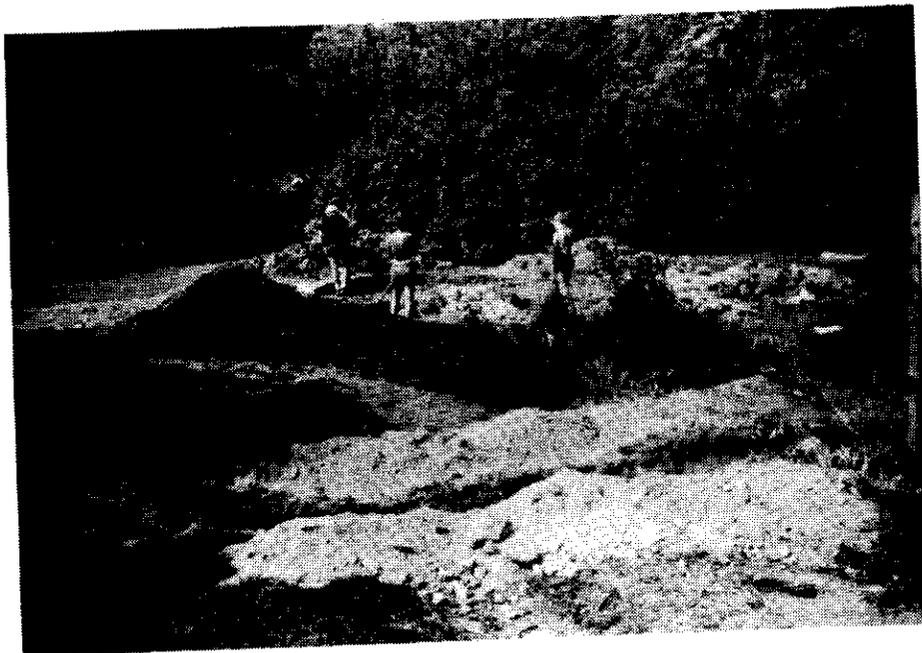
14.8. Tremer's excavation photographs, Hartwell Tavern, showing work on Structure 2 (MIMA.CS.HT.3., MIMA.CS.HT.4).

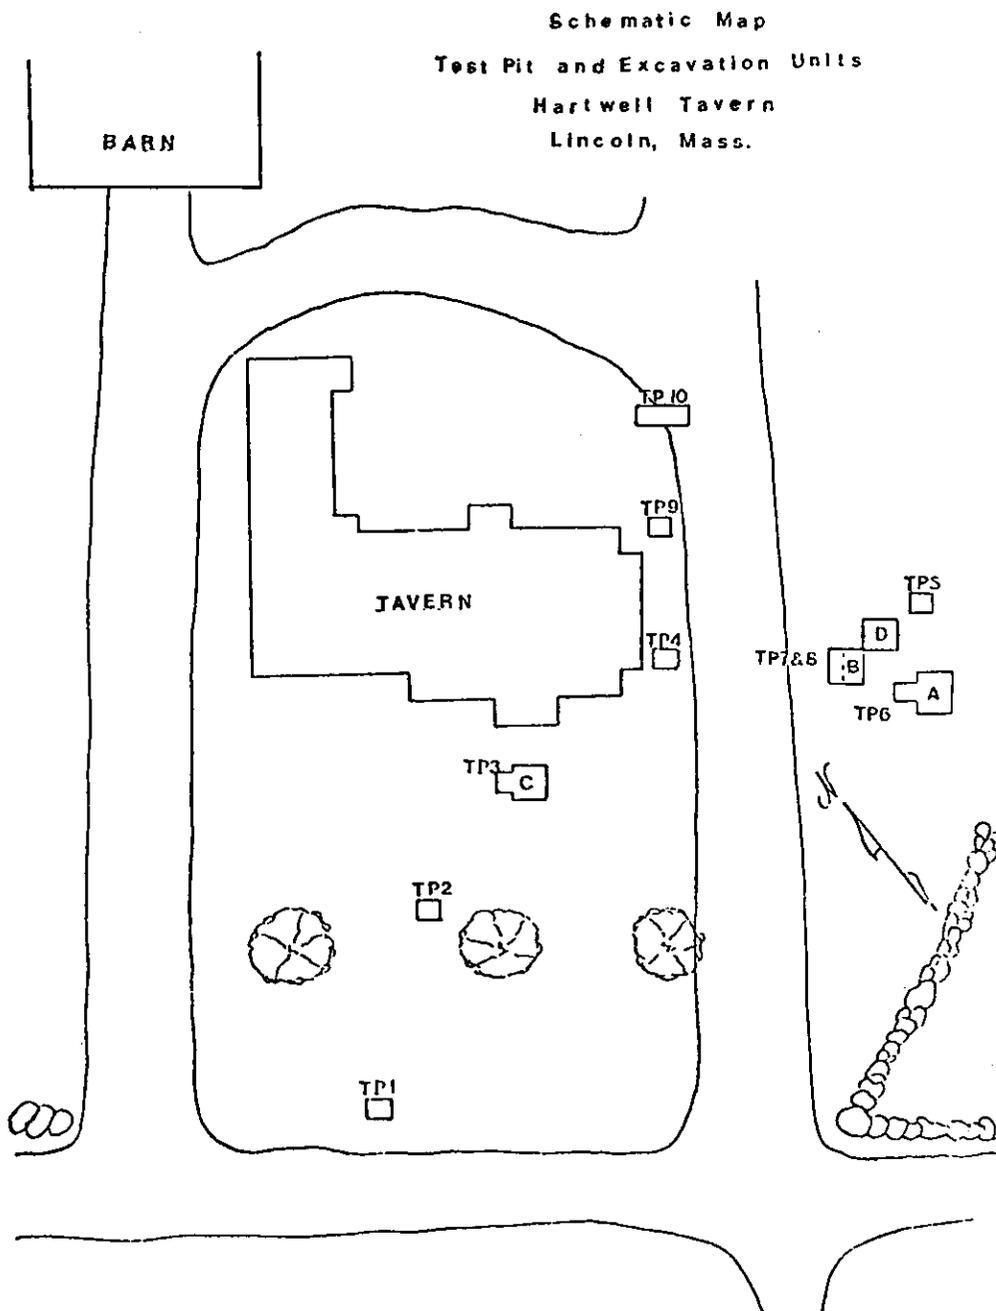
14.9. Mahlstedt's original site plan (1979a:Figure 2).

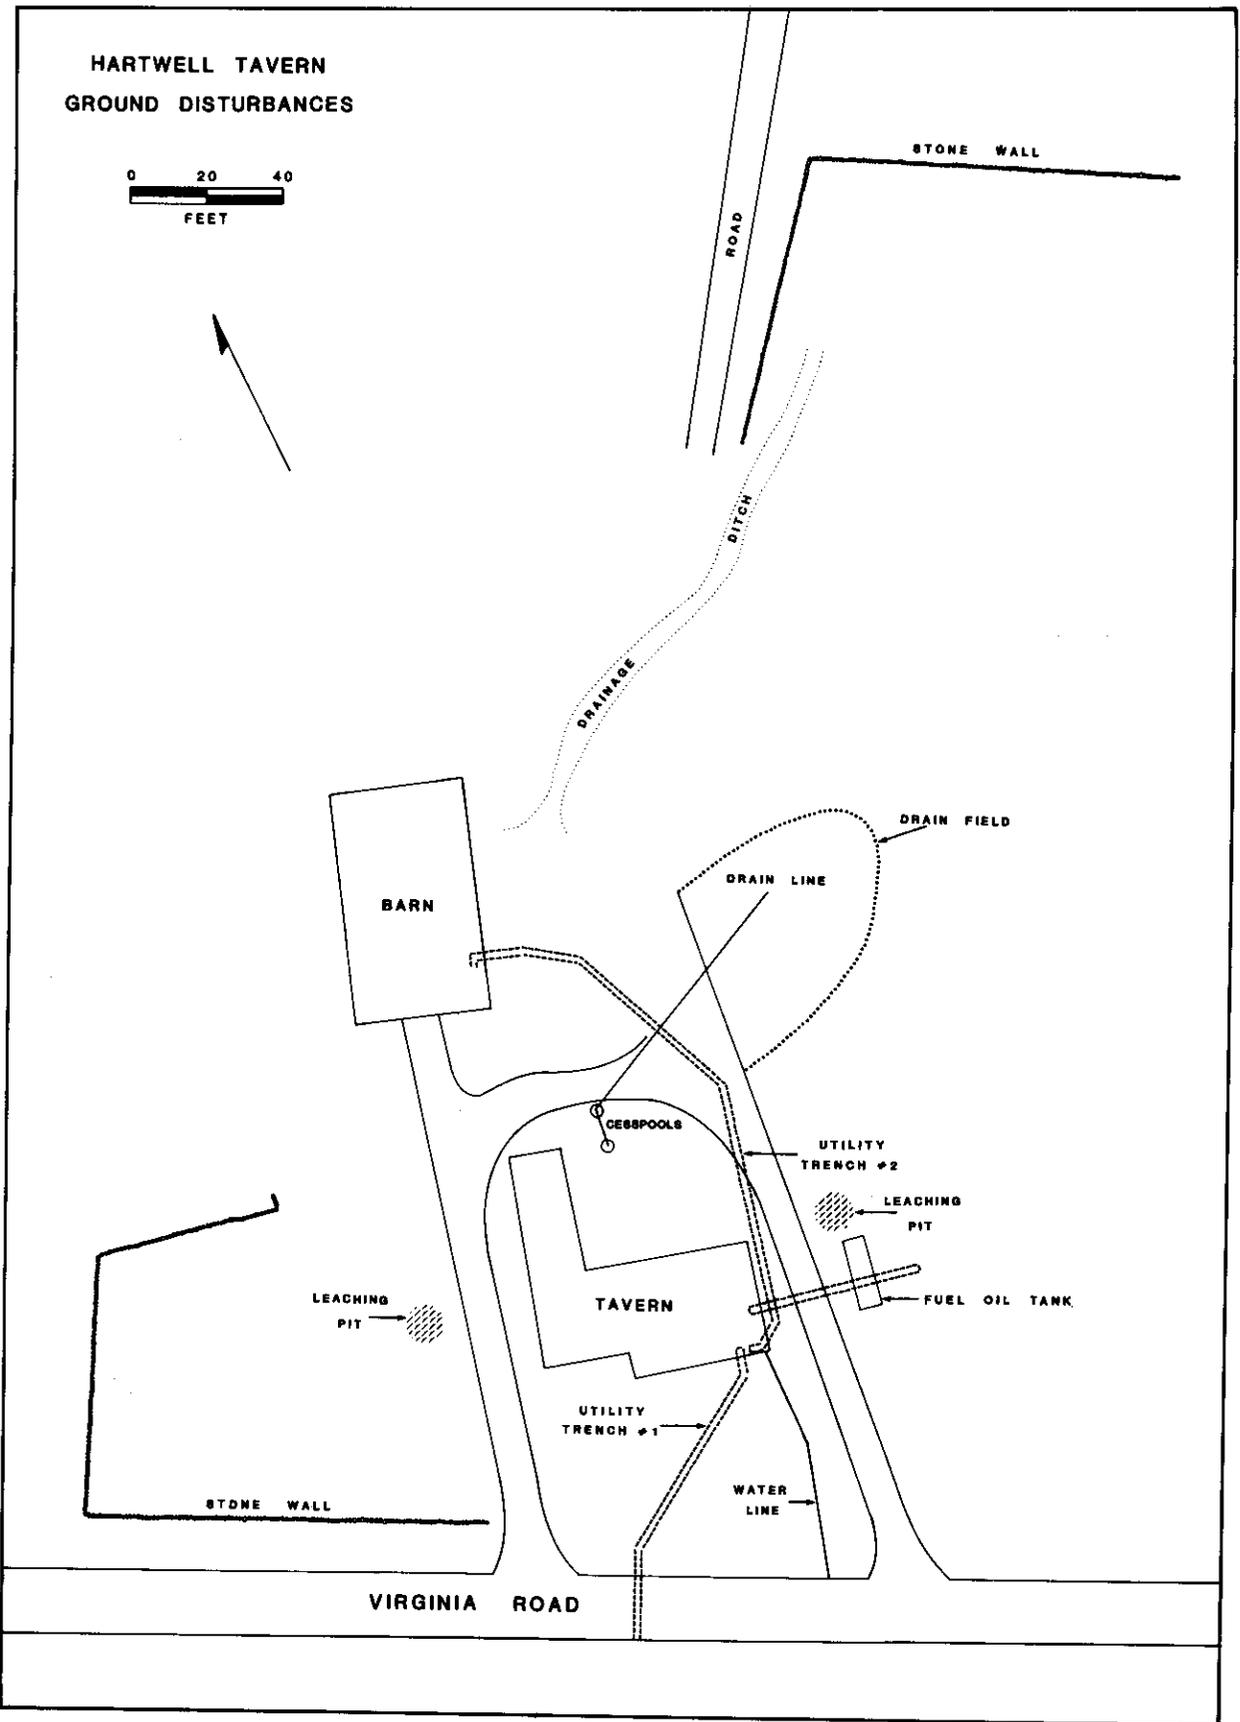
14.10. ACMP composite map of non-archeological ground disturbances, Hartwell Tavern.

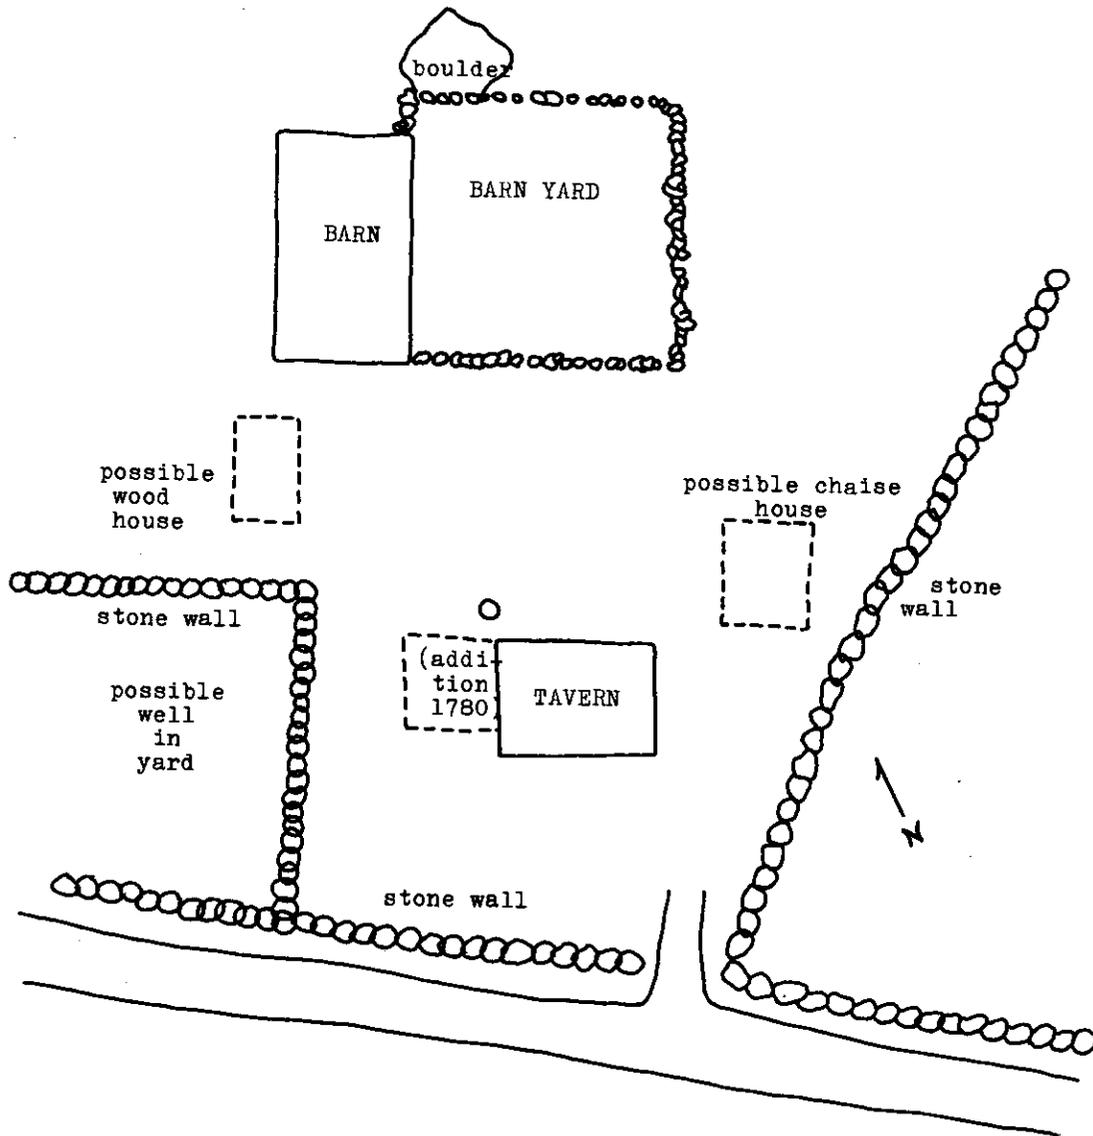
14.11. Luzader's speculative site plan of Hartwell Tavern grounds ca. 1775 (1972:14).

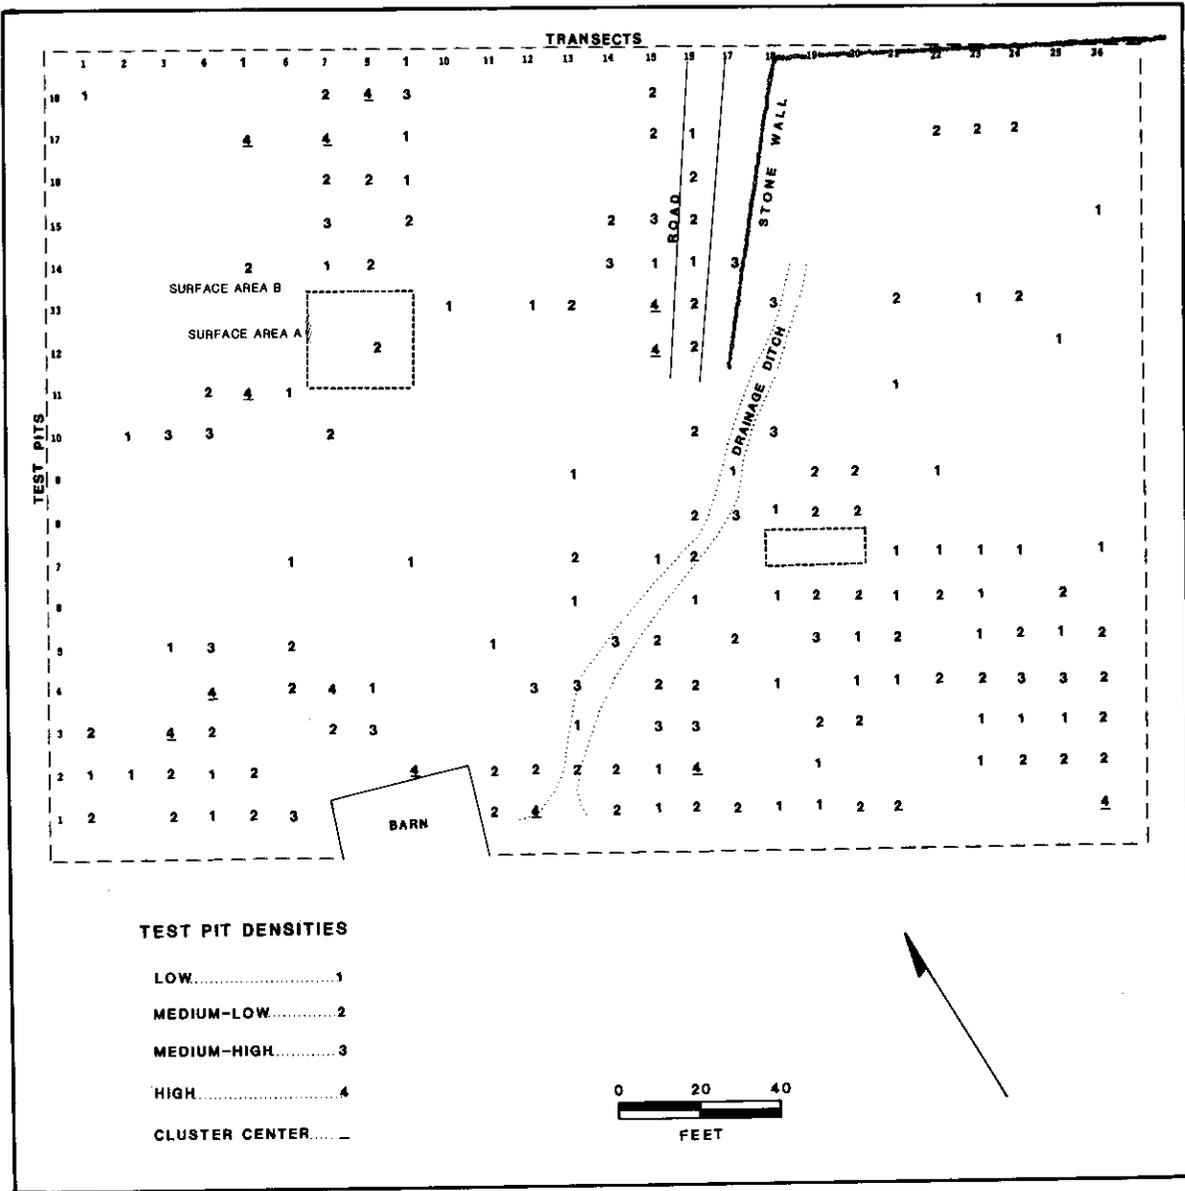
14.12. ACMP revised map of Pratt test pit artifact densities.

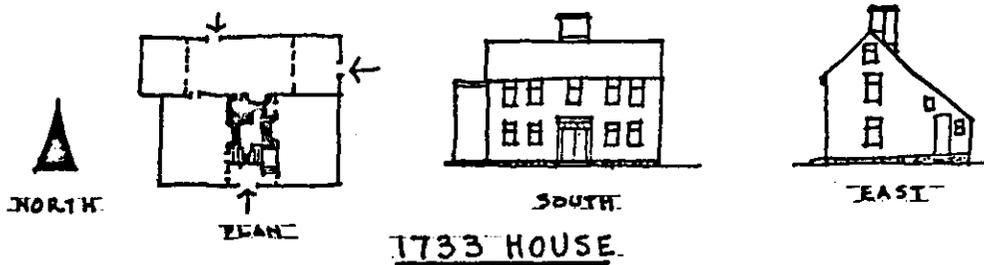
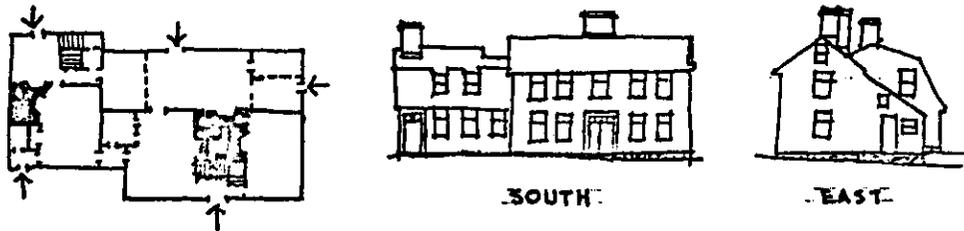
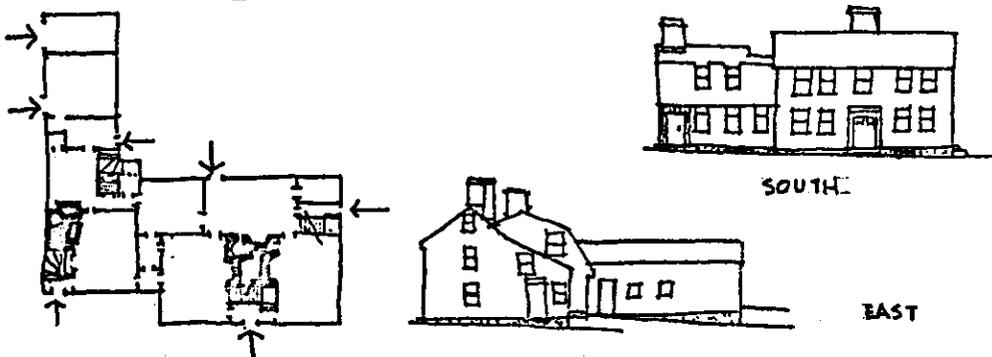
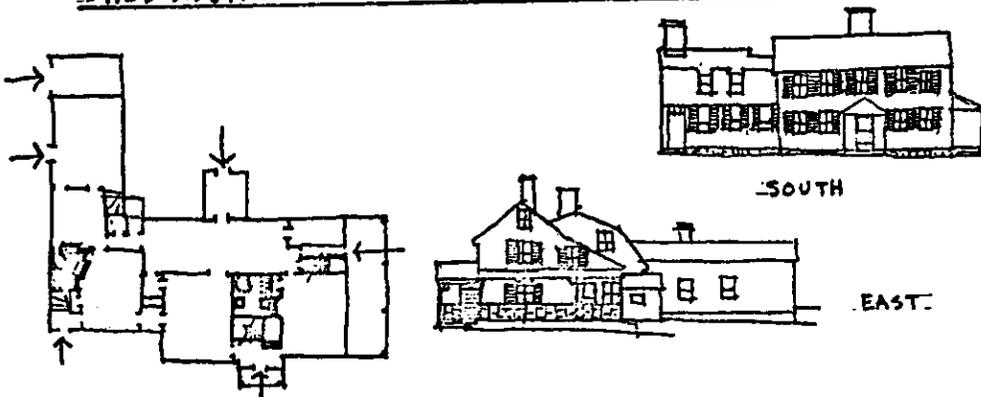
1733 HOUSE.

GAMBREL ADDITION OF CA. 1763

SHED ADDITION OF CA. 1830 + LEAN-TO REBUILT

CA. 1900 REMODELING WITH PORCHES

14.13. Hartwell Tavern architectural changes (Mulhern and Carroll 1975:ix).

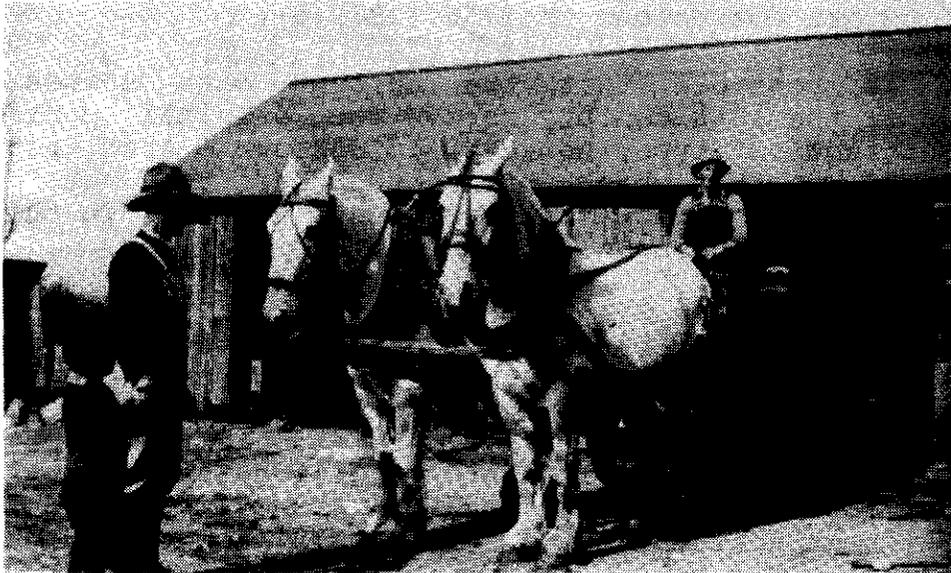
14.14. Photograph of McHugh shed, 1932 (MIMA 67-8).

through the shed's open doors. It seems most likely that the McHughs used the shed for storage of agricultural equipment and tools. As to its age, the earliest available photograph showing the shed was taken sometime prior to 1900 (located in the Farrell Collection, Lincoln Public Library; ACMP Historic Photographic Catalog: Volume 1, Virginia Road Area).

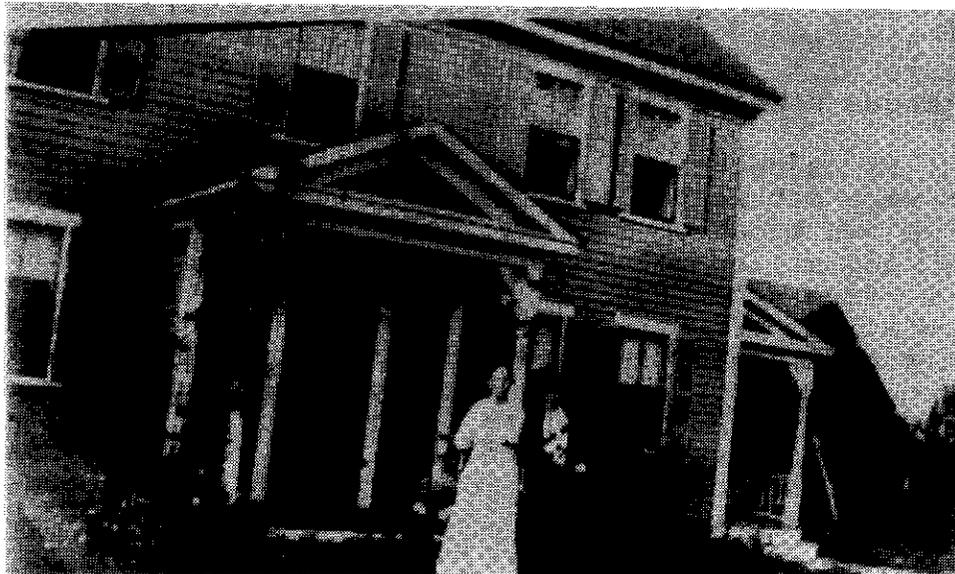
14.15. Photograph of McHugh house with tool shed to the right, ca. 1925 (MIMA 67-9).

Structure 2 was in use during Mary McHugh's occupation. The McHugh family stored their tools in this building in 1922, and tore it down with pulleys and horses in 1925 (Figure 14.5). Portions of the shed are visible in several photographs taken during this time (Figure 14.15), but no photographs were available from earlier years. The known date for the structure was pushed back to 1906 by evidence from the Walker's Atlas. This map depicted three structures on the

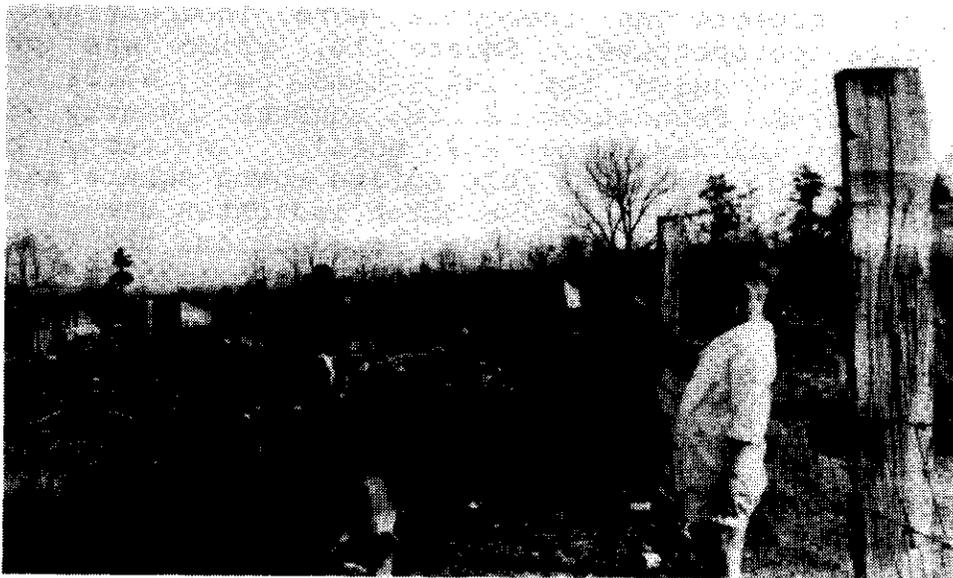
14.16. Photograph of McHugh piggery, ca. 1932 (MIMA 67-3).

There is thus little doubt that the Pratts' speculation about the outbuilding was incorrect. Carroll's sketch plan indicated a shed west of the piggery, which may suggest an alternative hypothesis. The shed did not appear to be far enough west to account for Foundation 2, but Carroll could not recall how approximately he had sketched the location (personal communication 1984).

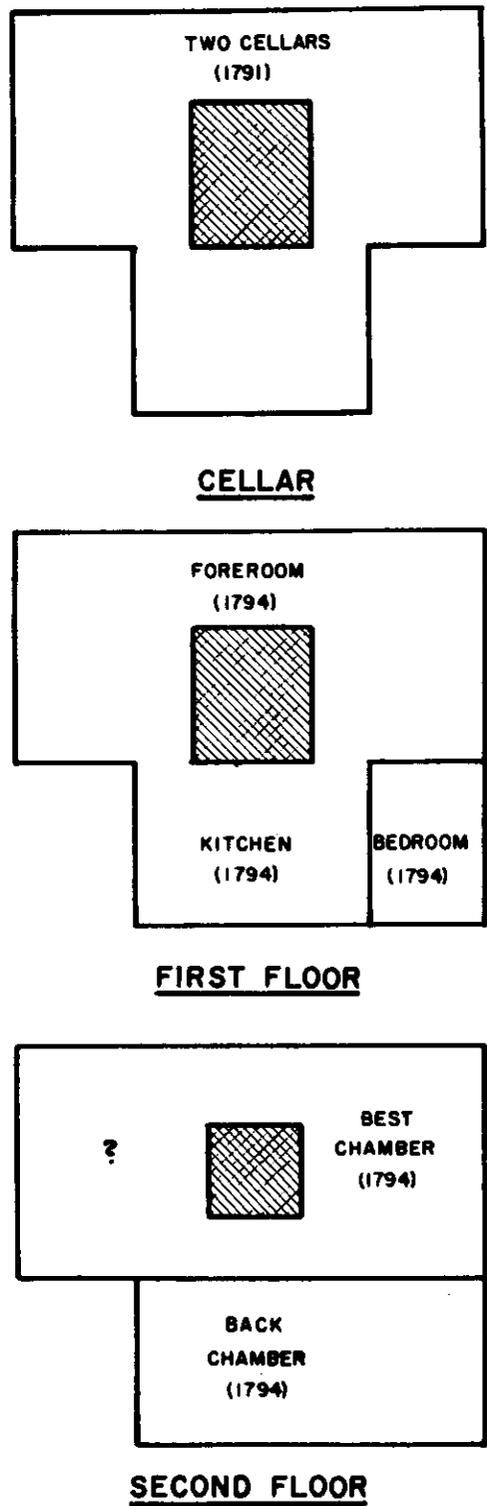
Figure 15.2. Keune's conjectural sketch of 18th century floor plan, Job Brooks house, showing possible lean-to configuration (Keune 1963:Illustration #11).
