ARCHEOLOGICAL  
COLLECTIONS MANAGEMENT  
AT  
MINUTE MAN  
NATIONAL HISTORICAL PARK

MASSACHUSETTS

VOLUME 3

ACMP Series No. 4

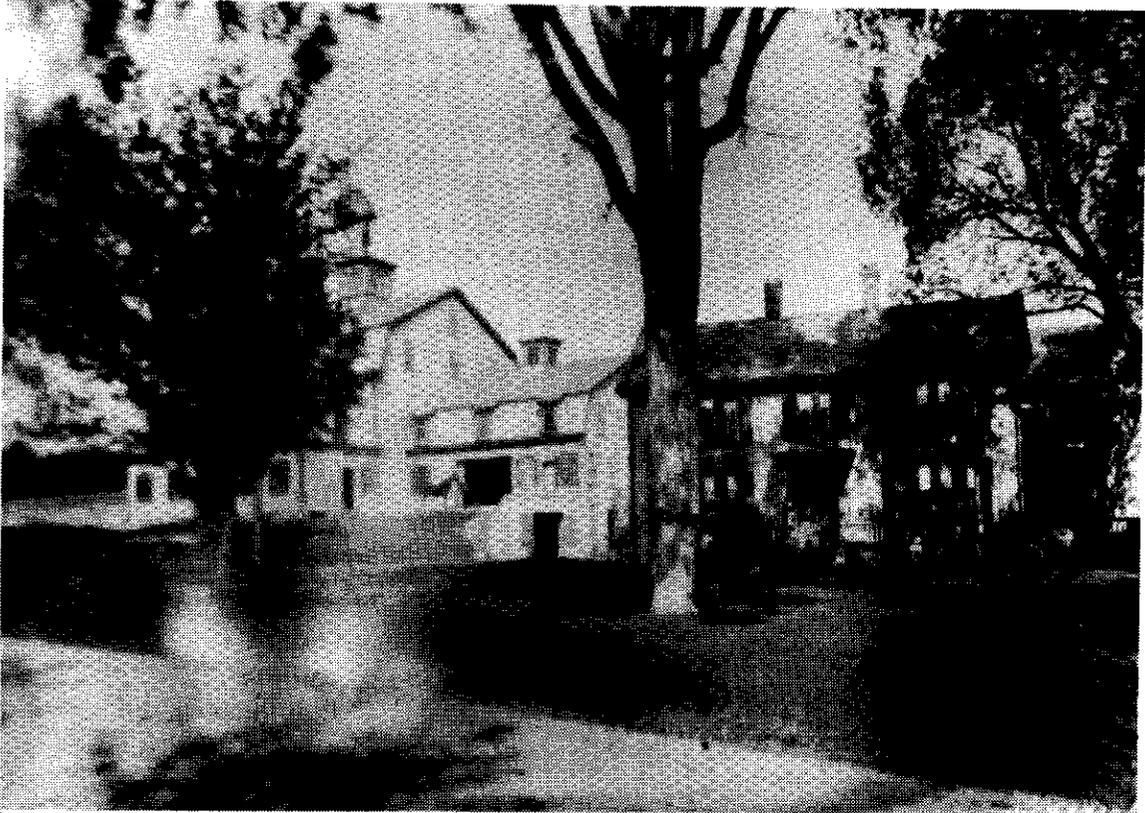
Figure 15.3. Photograph of the Job Brooks property in 1890 showing extensive ells and large barn (Keune 1963:Illustration #3).

The presence of earlier outbuildings is documented in some of the historic deeds (Sullivan 1963:14-15). At least four barns have been built on the property, and possibly more, with the last three documented during the late 19th and 20th centuries (Sullivan 1963:14-15). Historic photographs provide evidence of the extensive ells and huge barn which existed on the property in the late 19th century (Figure 15.3).

Thus, even though the history of the site and its occupants provide a number of interesting research possibilities, extensive ground disturbances may have ruled out the possibility of intact archeological deposits. Disturbances which occurred during the late 19th and the mid-20th centuries are evident in the photographic and photogrammetric record (Figures 15.3, 15.4). It may be that the yard areas in front of the extant house remain relatively undisturbed if testing of a limited nature was desired.

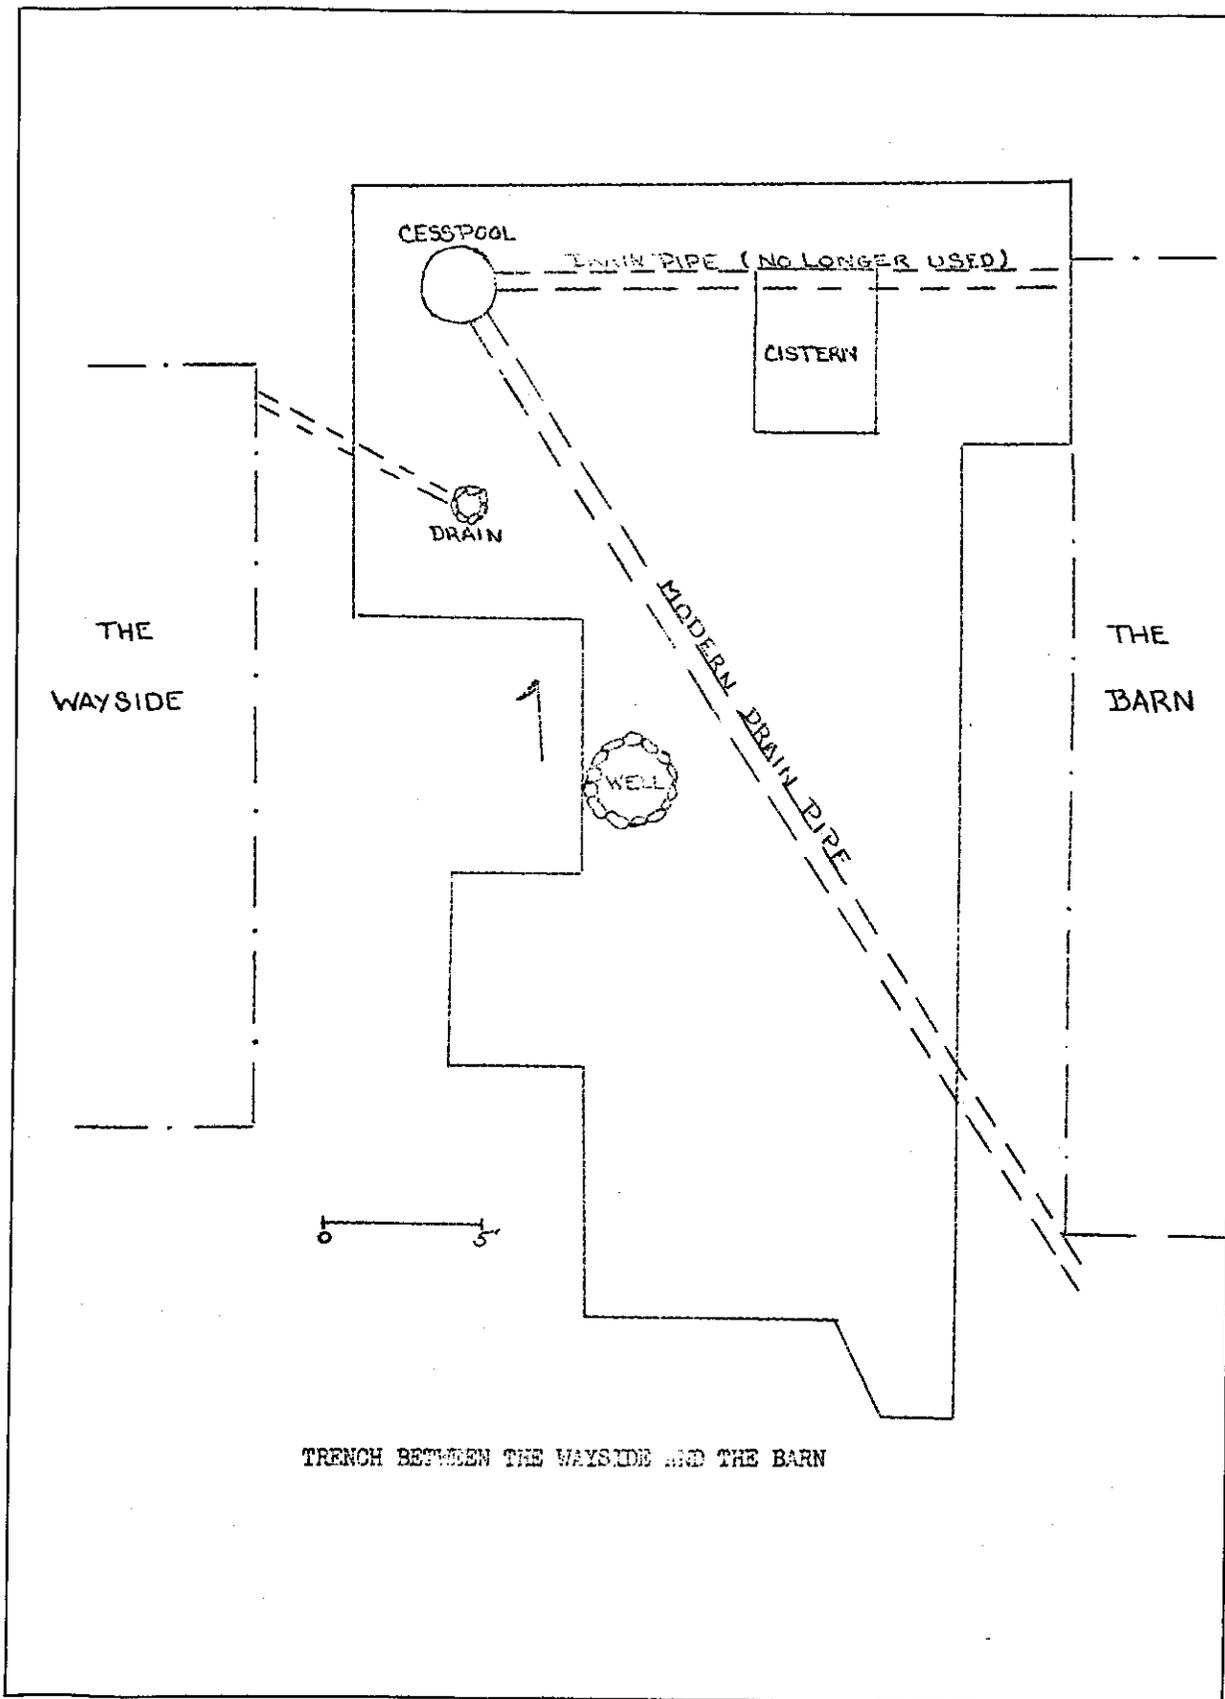
Figure 16.2. Snow's site plan: east of house (1969b:19).

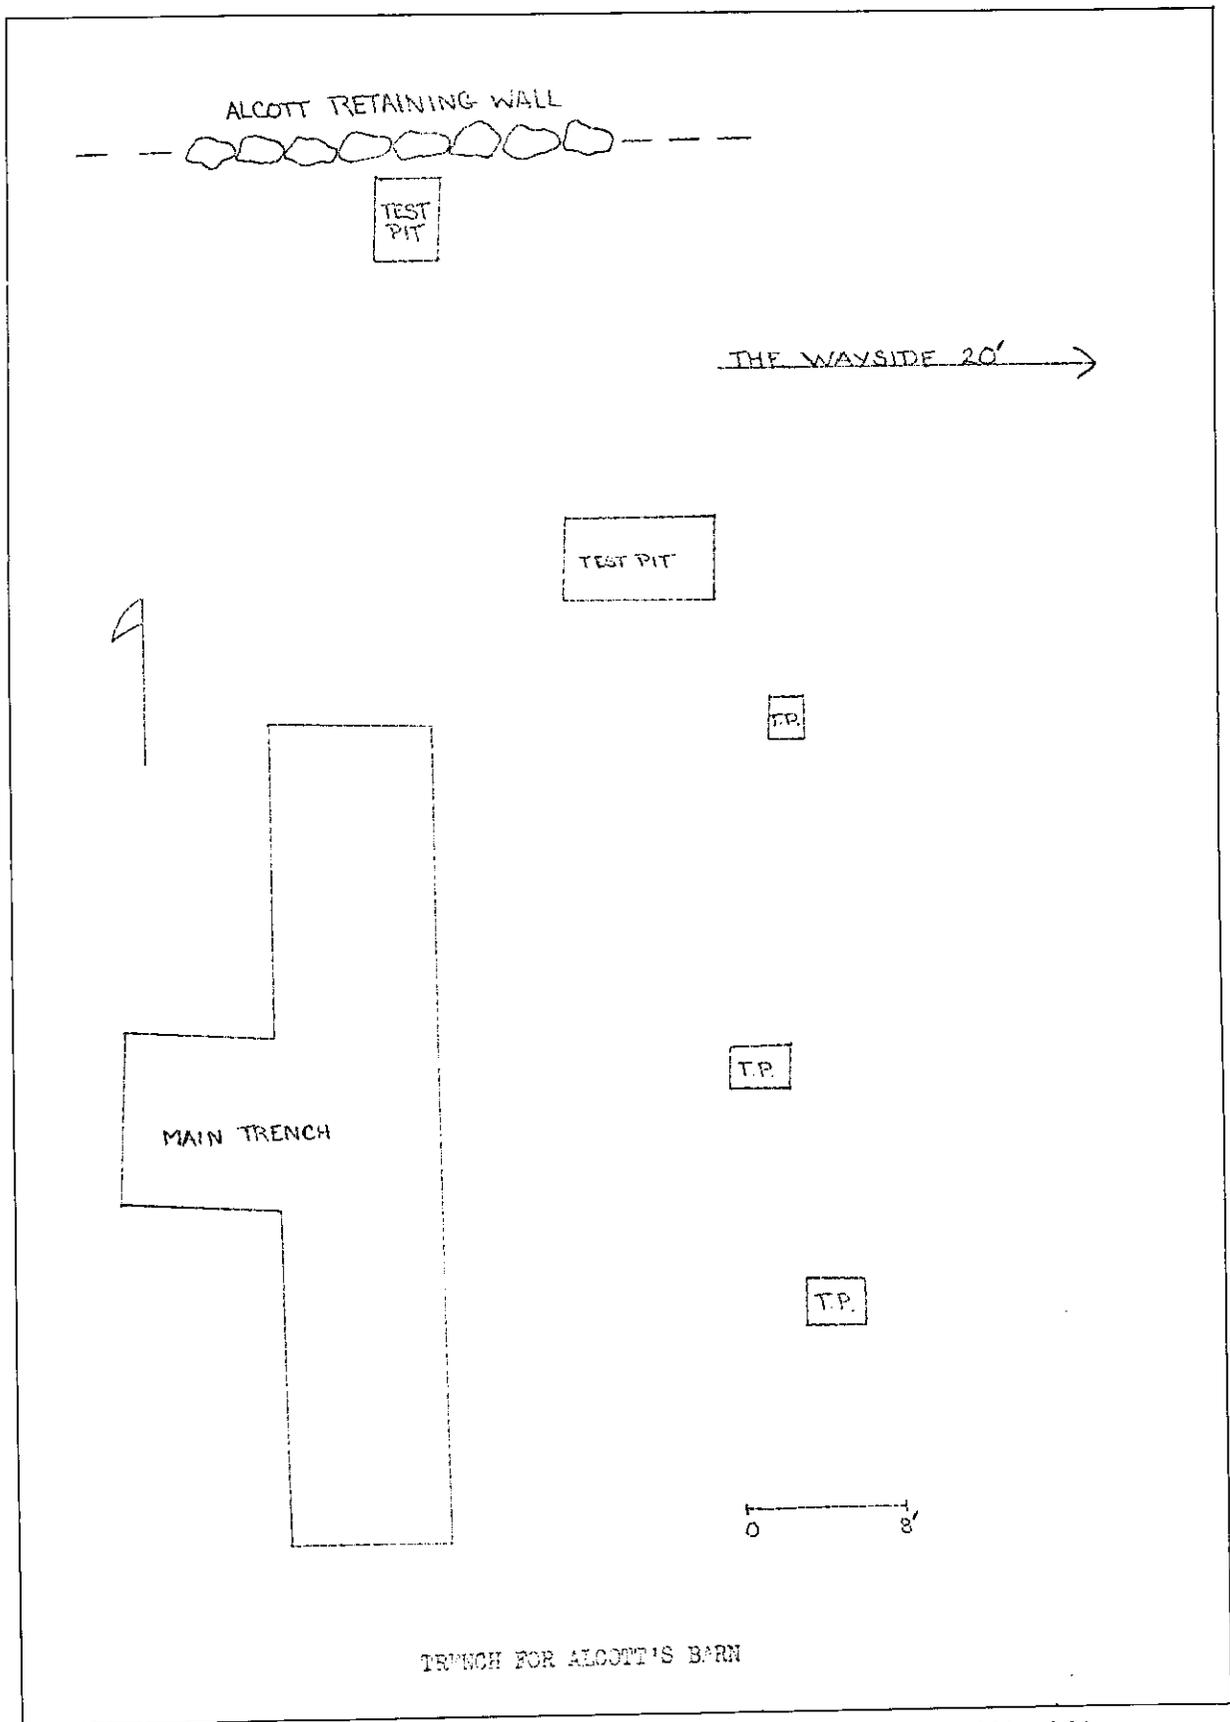
Figure 16.3. Snow's site plan: west of house (1969b:20).

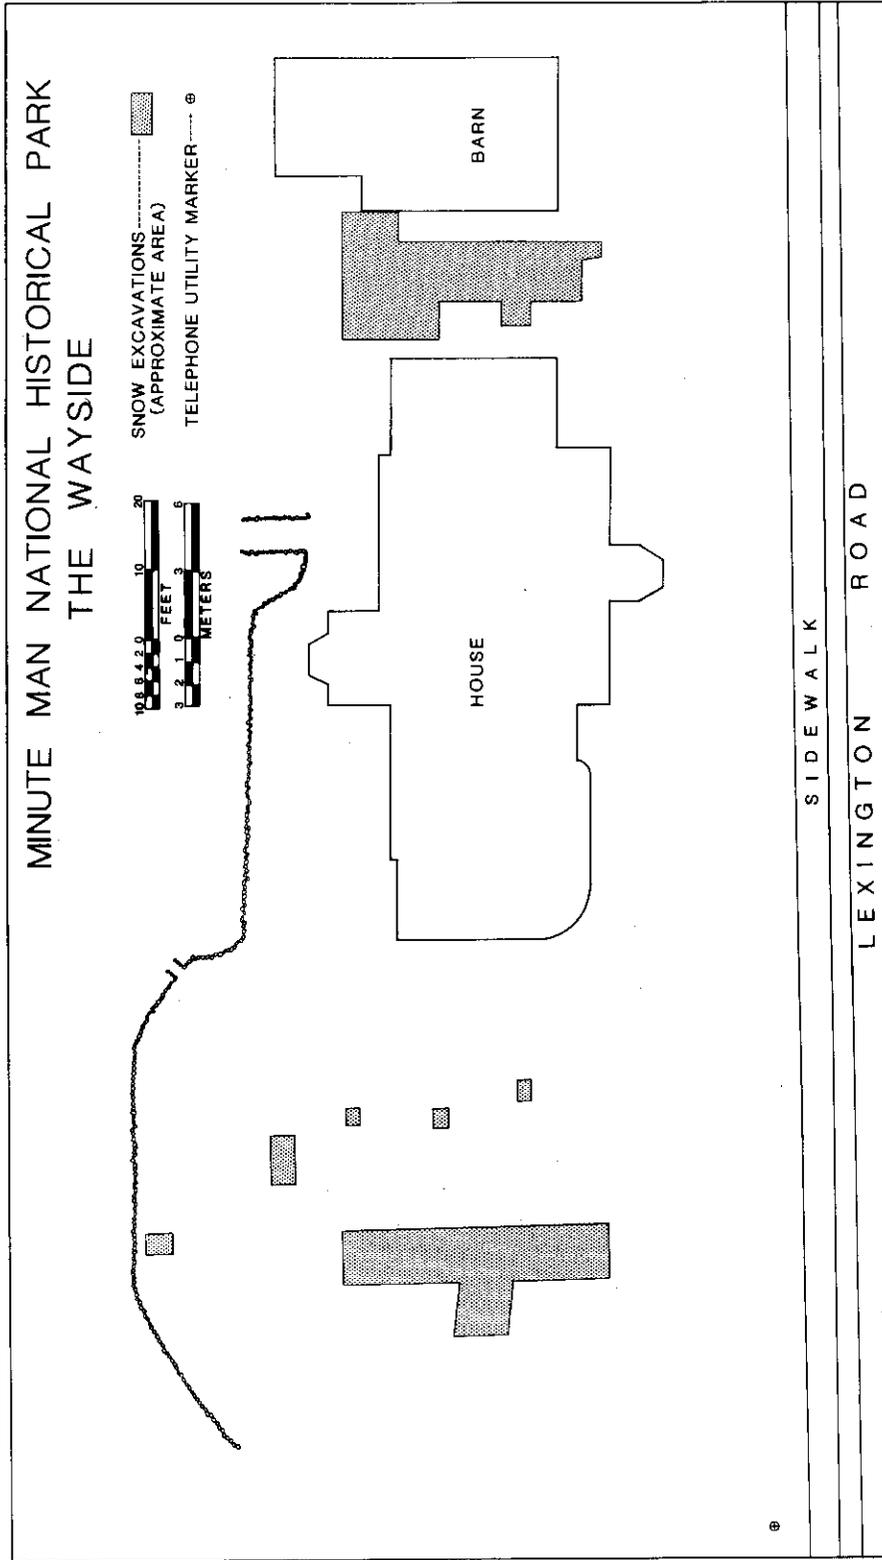
Figure 16.4. ACMP composite site plan of Wayside excavations.

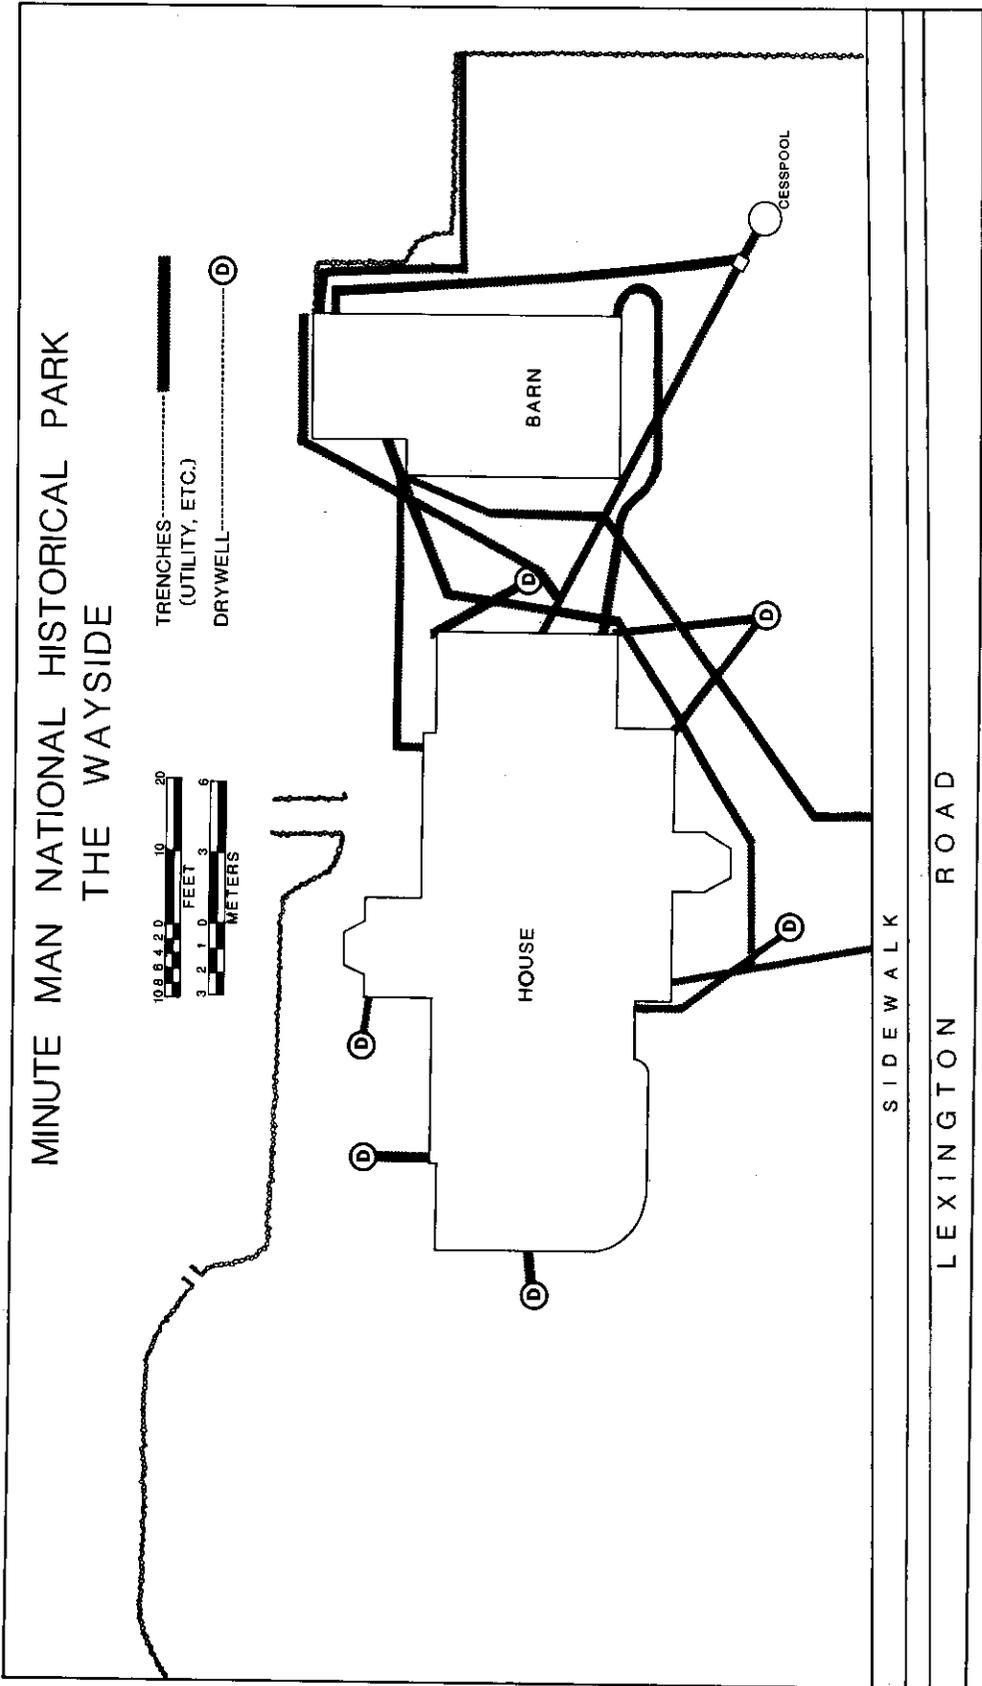
Figure 16.5. ACMP composite map of Wayside restoration ground disturbances.

The second map constructed by the ACMP was the ground disturbance map (Figure 16.5). Information for this map came from two sources. The first was the "Rehabilitation of the Wayside Barn" project drawing (NPS/NARO Engineering Microfilm Map #M25000, 11/75). This map contained information about the location of trenching for underground utilities (water, electricity and sanitation facilities). The other source was a map which provided the location of trenching for six dry wells, a gas main and fire alarm utilities (Carroll 1973:66). Although both of these maps were drawn at a fairly large scale (1 inch equals twenty feet), the ACMP felt that the resultant map (Figure 16.5) represented an accurate depiction of the disturbance on the grounds of the Wayside.

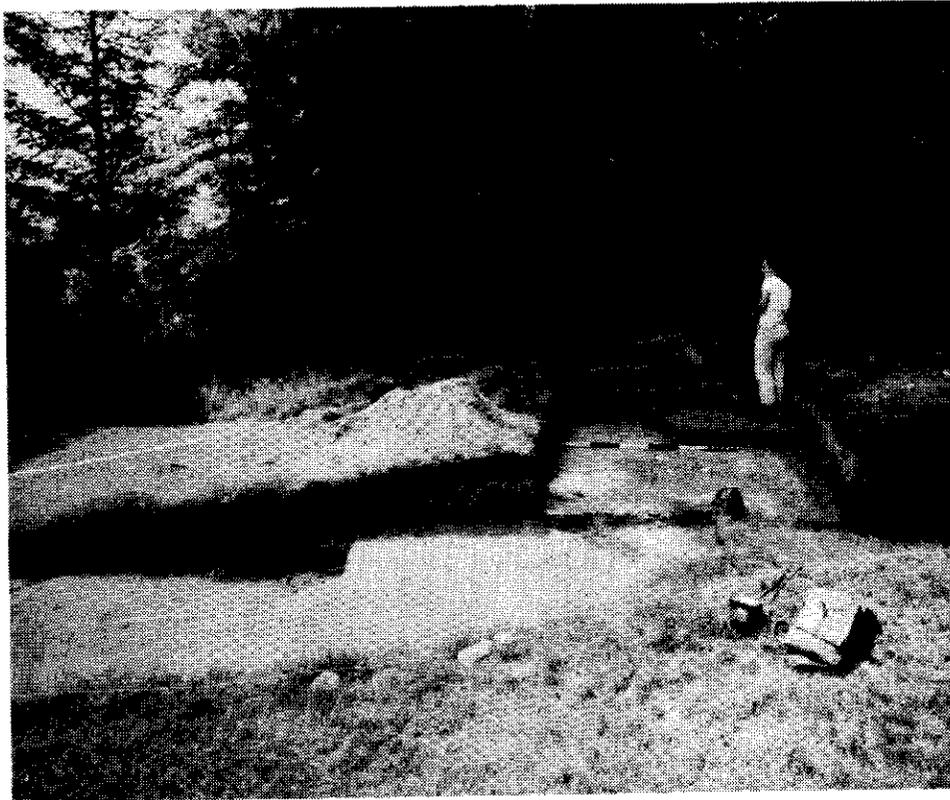
Figure 16.9. Snow's field photograph of Trench B excavation; note stratigraphic profile showing at least three distinct soil strata (1969b:Figure 4) (MIMA.BWP.WS.9).

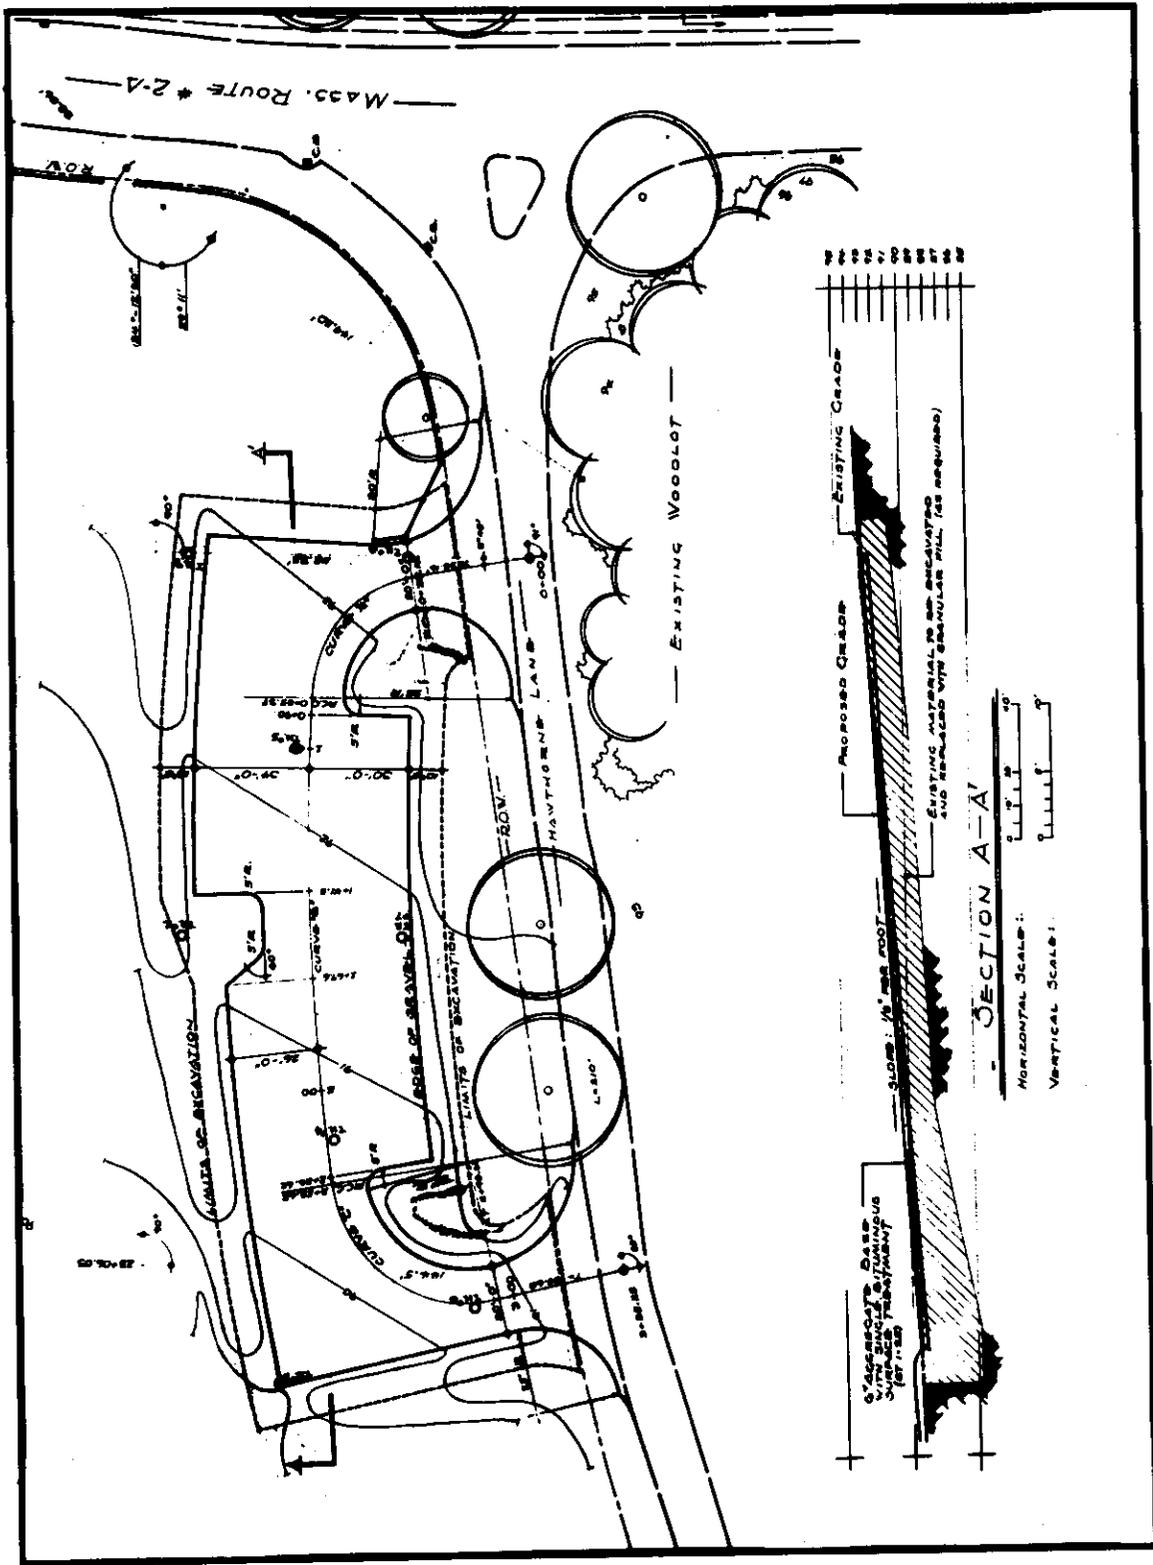
Figure 16.10. Plan and profile of Wayside parking area ground disturbance (NPS/NARO Engineering Microfilm Map #S41001, 9/68).

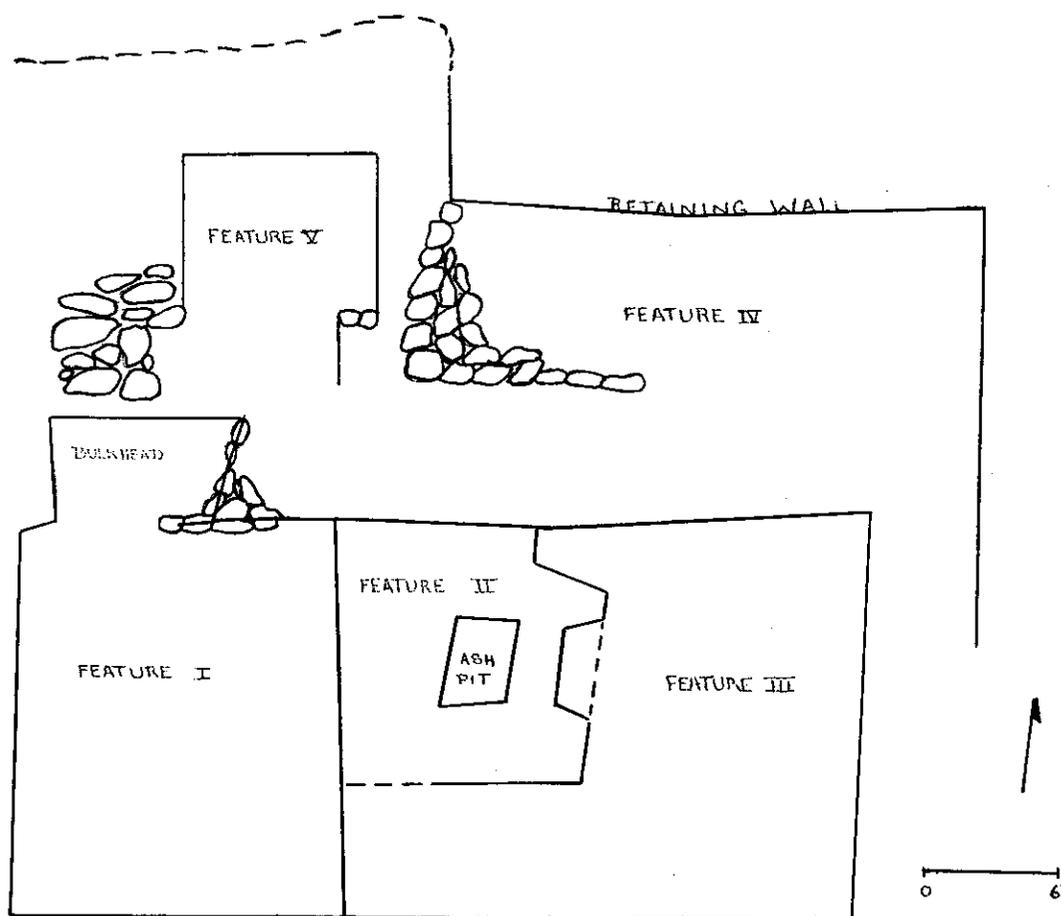
Figure 17.2. Snow's site plan (1969a:35).

Cordelia Snow's site map of the Casey house excavations (Figure 17.2) contained both a North arrow and a scale.

Snow's site map was considered essentially accurate and as such it was reproduced and is included in this report (Figure 17.2). The discrepancies between Bleacher's two site plans prompted the ACMP to construct a composite site map which combined the most accurate elements of each plan with those of Snow's site plan (Figure 17.3). Since Feature 2 as illustrated by Bleacher differed from that illustrated by Snow, and since the trench drawn by Bleacher on Snow's site map did not accurately reflect the limits of excavation, it was necessary to rely not only upon the illustrations Bleacher provided, but also on the dimensions of the trench and the photographs documented in her report. Using this information, the ACMP located Bleacher's test trench on Snow's site map. The trench detail provided by Bleacher (1979:27) was included as a blowup on the resulting composite site map (Figure 17.3).

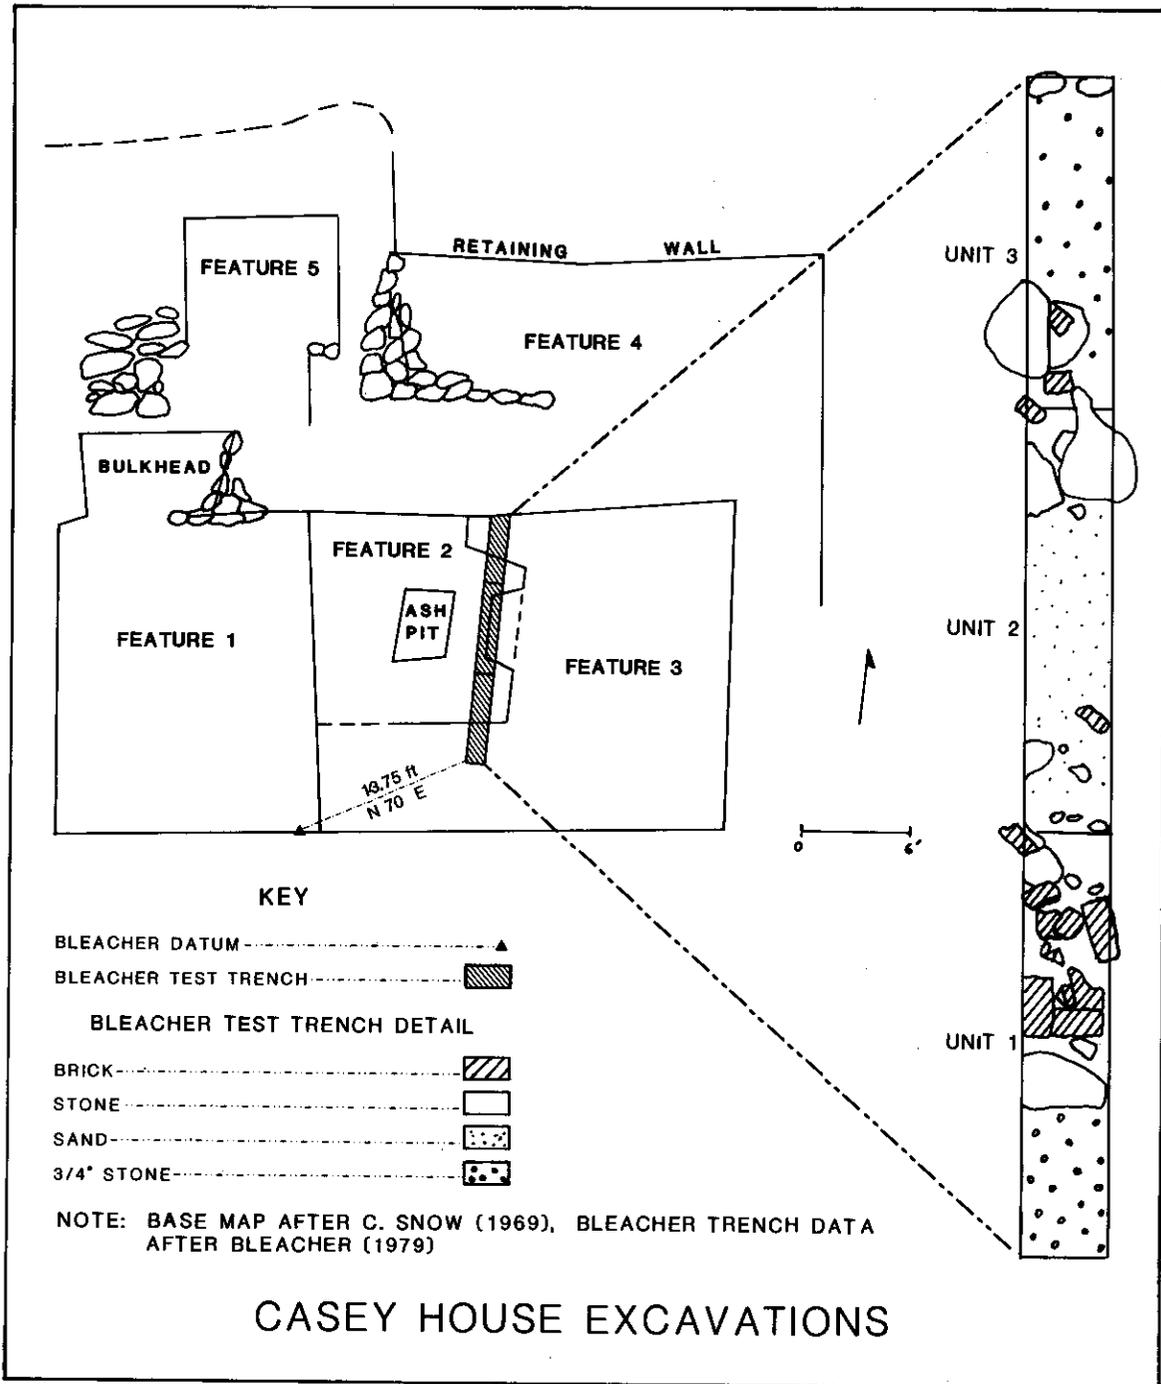
Figure 17.3. ACMP version of Bleacher's site plan.

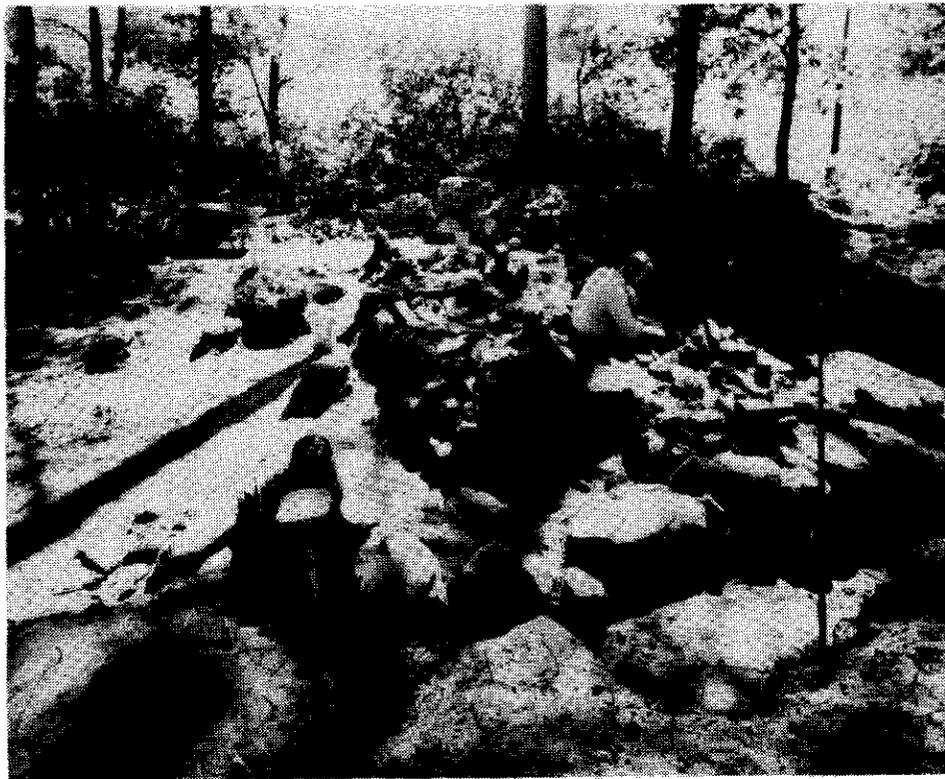
Figure 17.4. Snow's field photograph facing south showing: Feature 1 (cellarhole) to the right; Feature 2 (chimney base) in the center; and the general area of Feature 3 (east parlor) to the left (MIMA.BWP.CS.16).

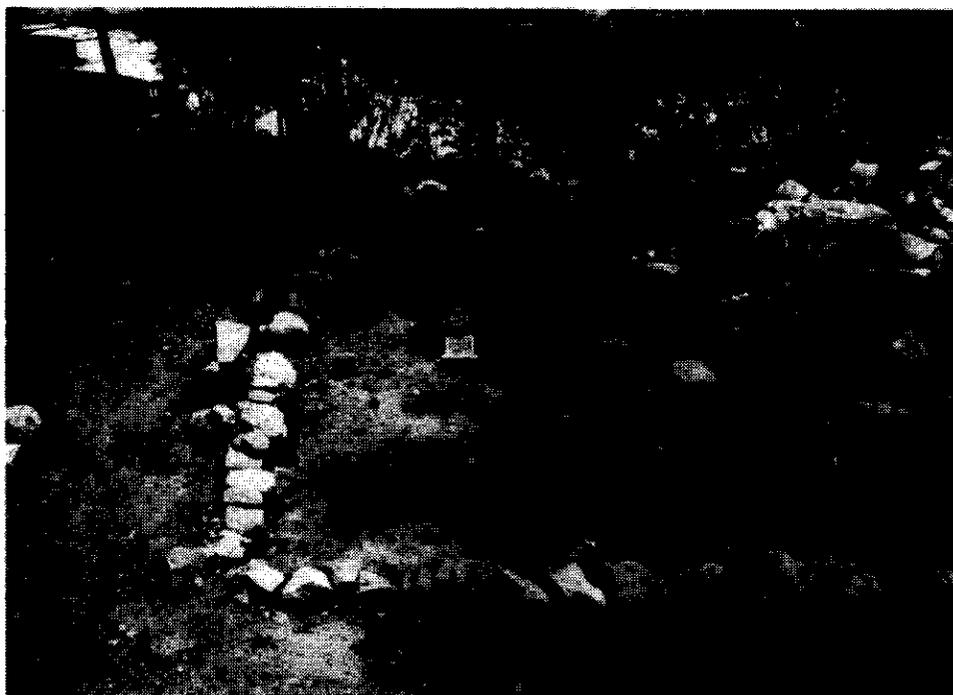
Figure 17.5. Snow's field photograph facing south showing the foundation stones for Feature 3 (east parlor) and a portion of the excavated chimney base (Feature 2) to the right. Note also the two stones to the extreme left which indicate the southern extent of Feature 4 foundations (1969a:Figure 3) (MIMA.CS.CS.1).

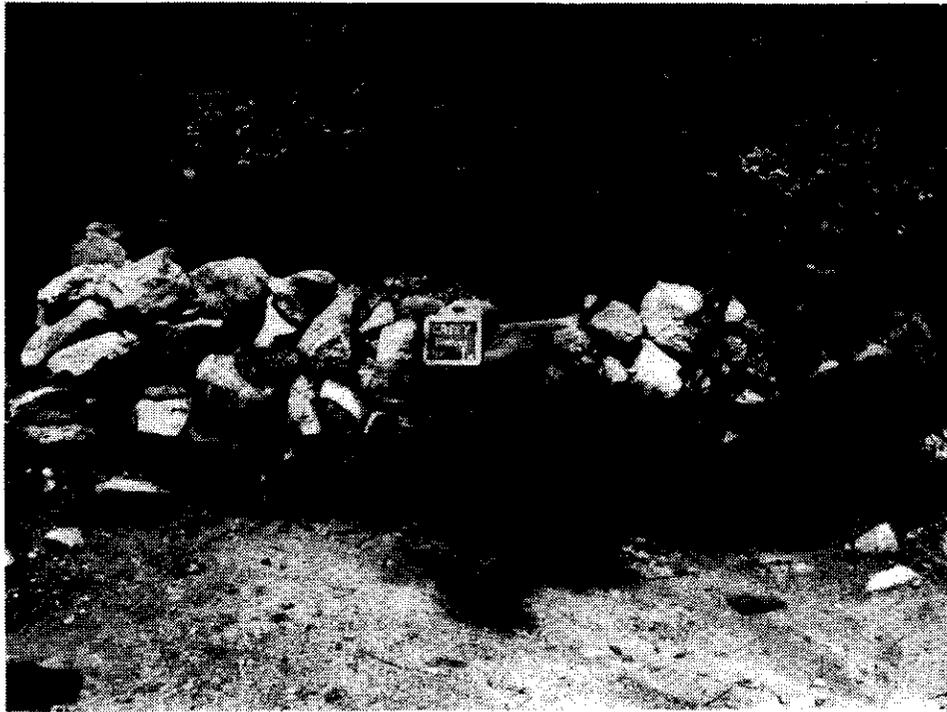
Figure 17.6. Snow's field photograph showing retaining wall which Snow defined as the northern boundary of Feature 4 (1969a:Figure 4) (MIMA.CS.CS.2).
