ARCHEOLOGICAL
COLLECTIONS MANAGEMENT
AT
MINUTE MAN
NATIONAL HISTORICAL PARK

MASSACHUSETTS

VOLUME 4

ACMP Series No. 4

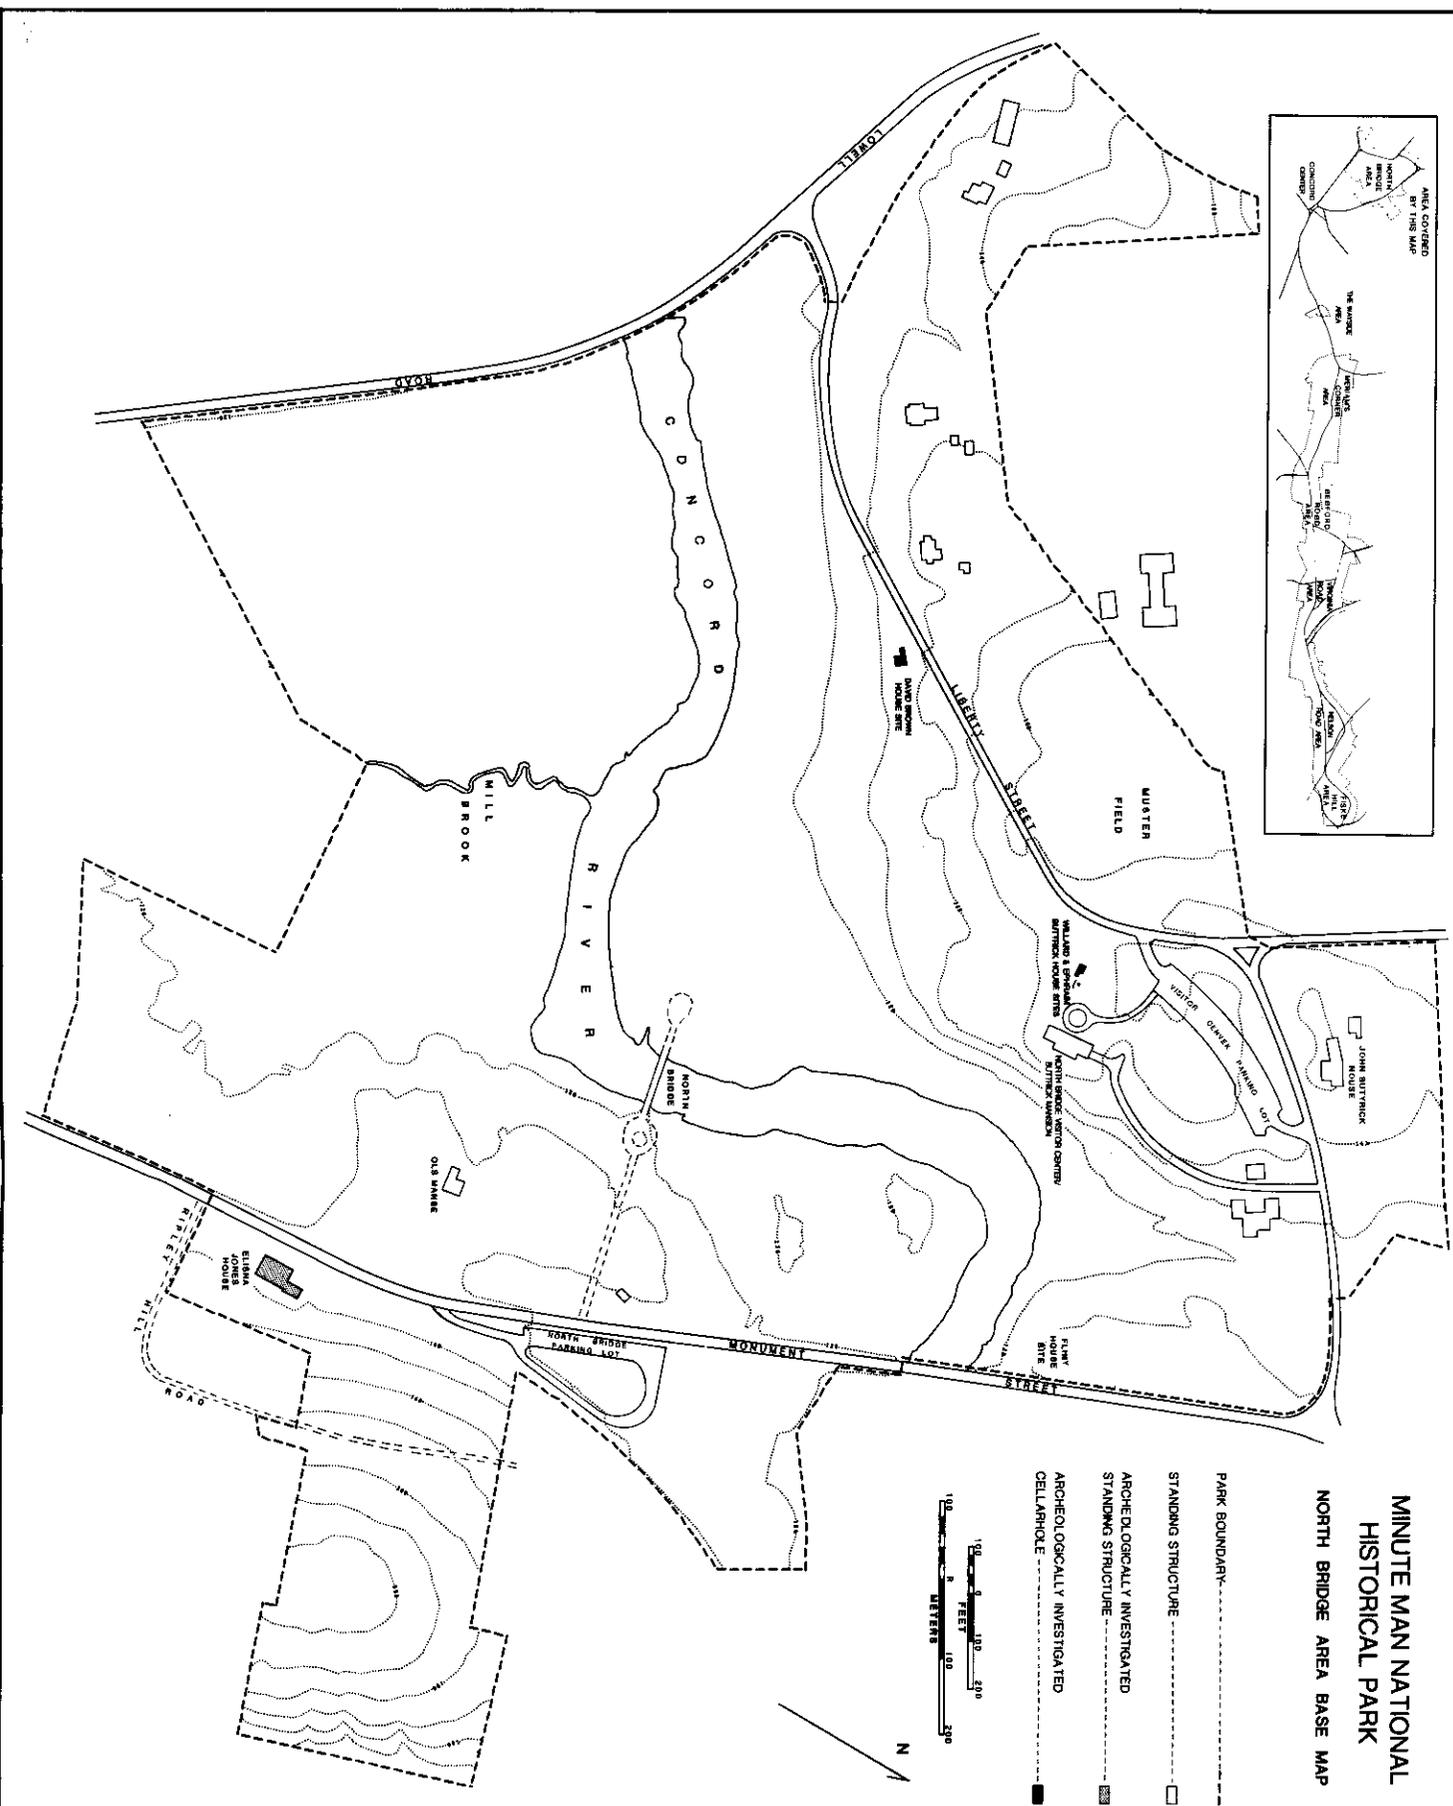
VI.1. ACMP base map of the North Bridge area.

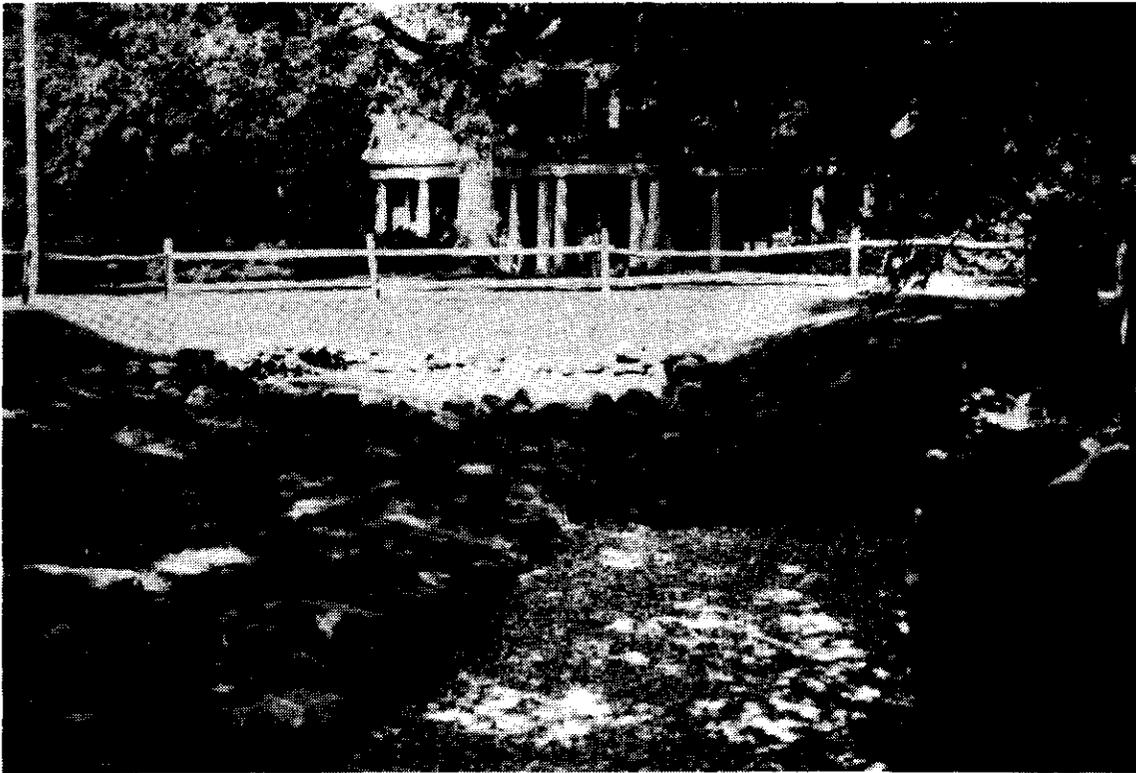
Figure 18.1. Photograph of Buttrick foundations after stabilization (Bleacher 1979:Roll 3, Frame 2).

Although successful stabilization measures had previously been undertaken at this site [i.e., parts of the southern and western wall of the west foundation had been rebuilt and concrete poured into trenches behind the walls (Bleacher 1979:3)], poor drainage in the western foundation required additional attention. The following stabilization methods were implemented:

Vegetation was removed by hand using kitchen and garden shears. Using wheelbarrows, shovels and rakes, 3/4" stone was placed within the western foundation. The stone is 4 to 6" in depth at the western end where drainage has been the poorest. In the remainder of the foundation, stone is 2 to 3" deep...and approximately 1" below the top of the standing walls at their lowest elevation (Bleacher 1979:12).

Although Bleacher did not record any artifact collection (1979), the foundation reconstruction certainly altered the original site disposition (Figure 18.1).

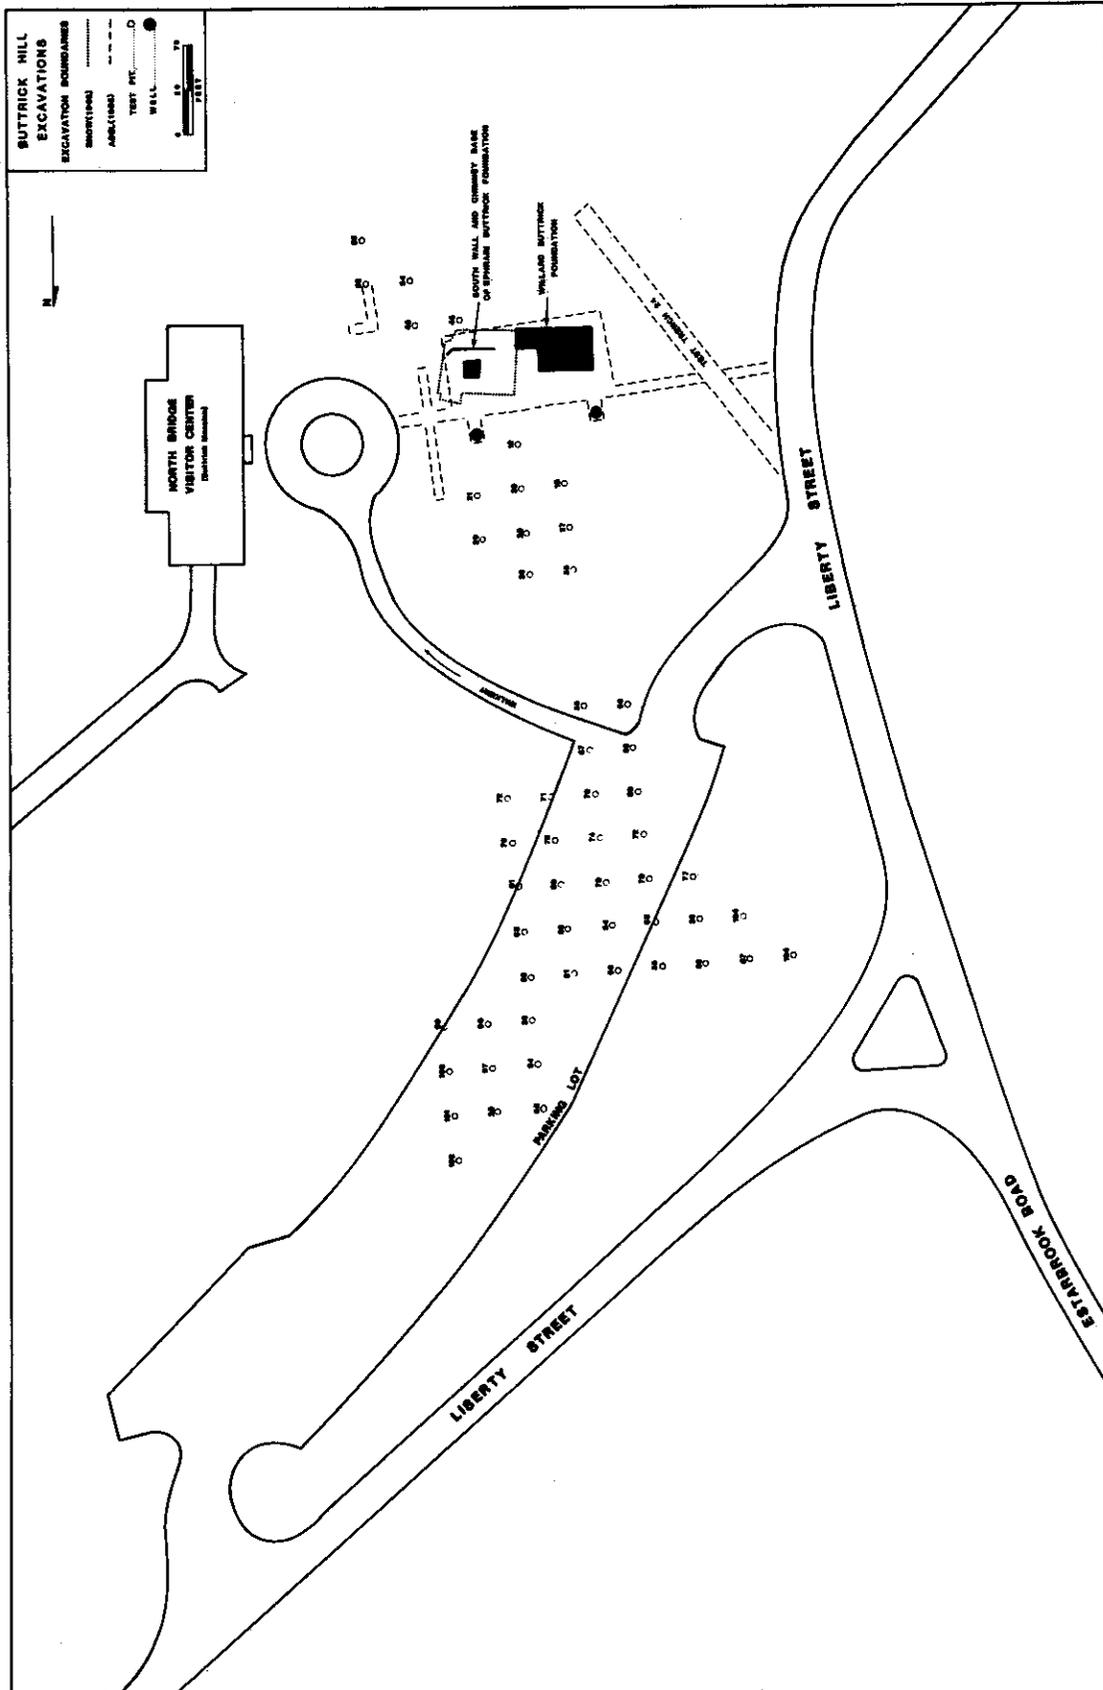
Figure 18.2. ACMP composite site map of excavations by Abel and Snow at the Ephraim-Willard-Stedman Buttrick site.

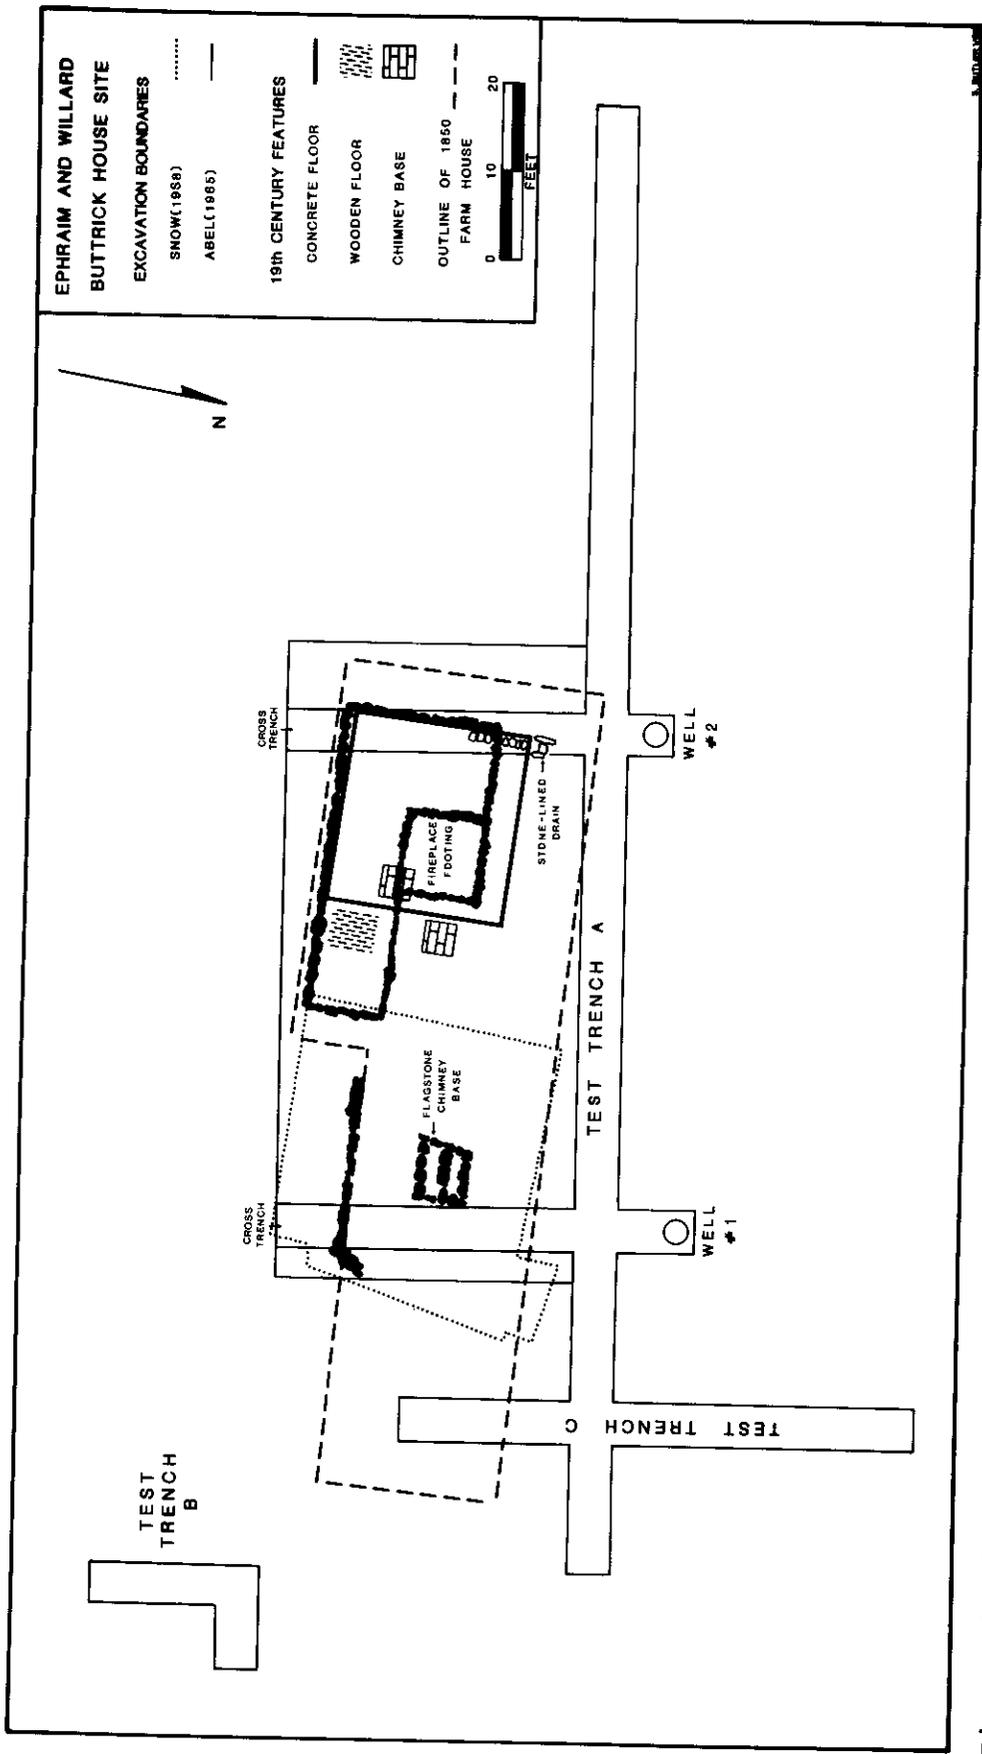
Figure 18.3. ACMP map showing structural features at the Ephraim-Willard-Buttrick site.

The outline of the 1850 farmhouse was also shown on this map. The location and dimensions of this structure were

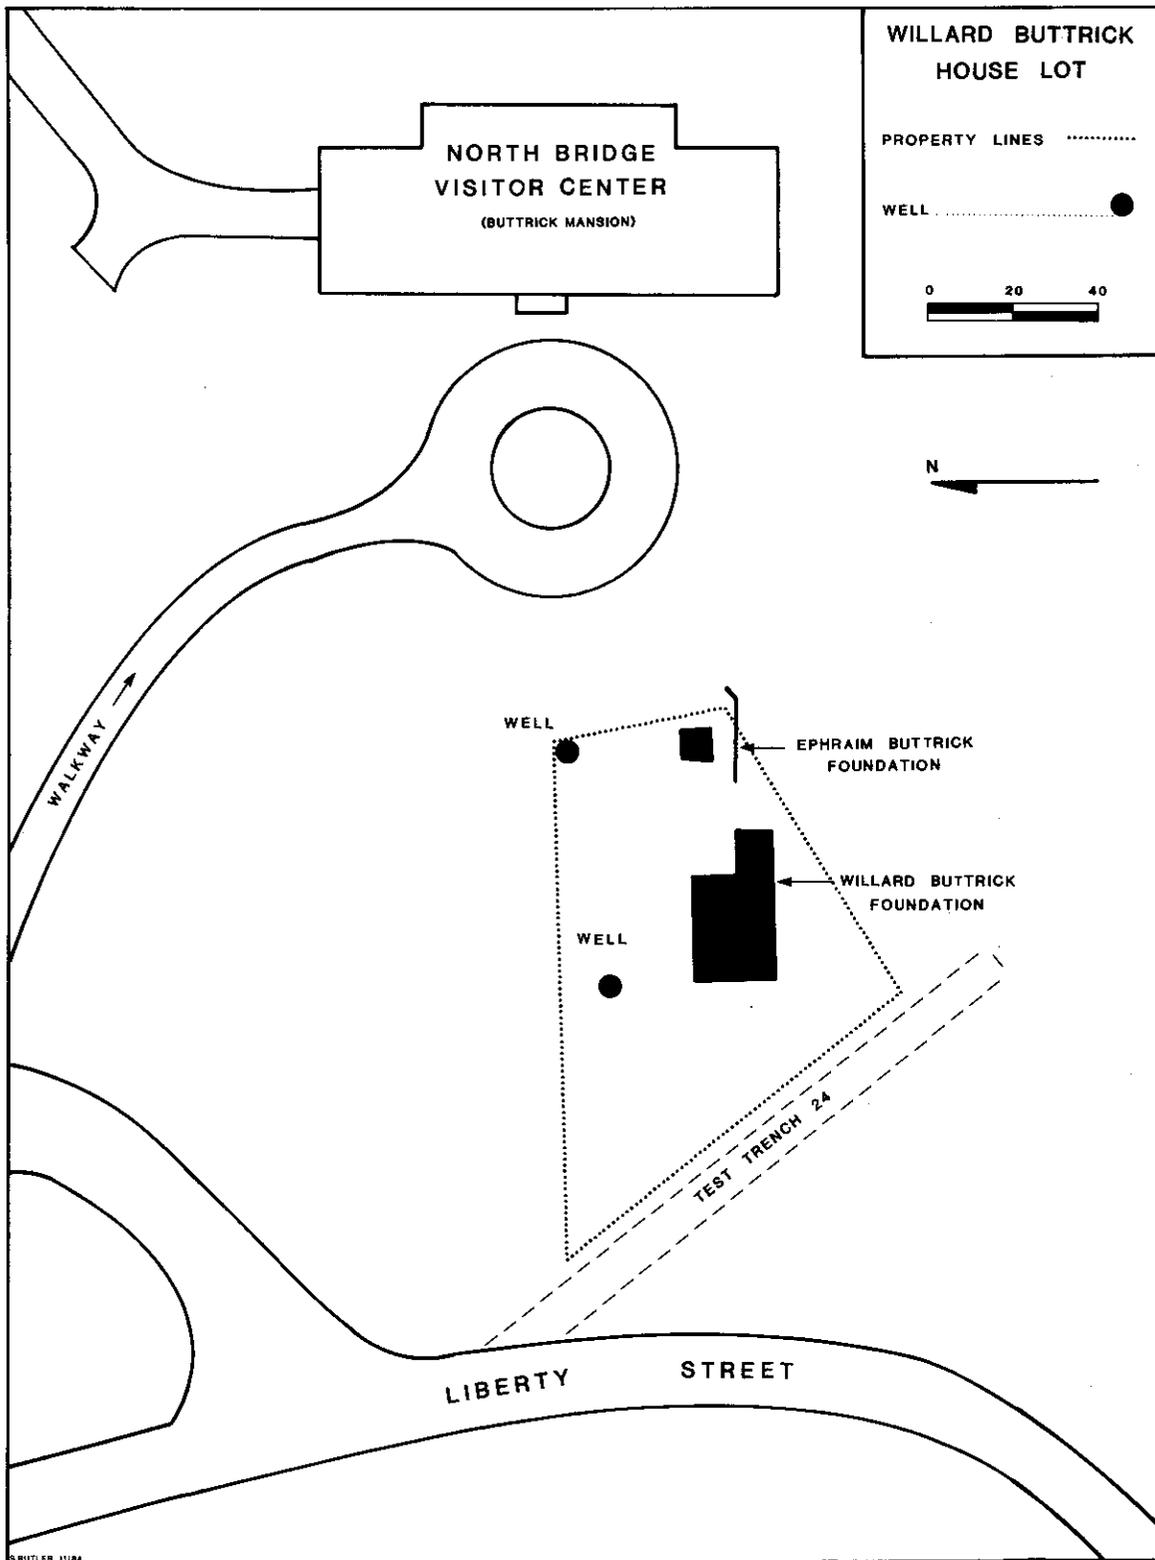
Figure 18.4. ACMP map showing Snow's proposed property boundaries for Willard Buttrick property.

The dimension and location of the property boundary was determined from the 1786 deed describing the Willard Buttrick house lot (Luzader 1968a:12). The plotting of the property lines was based on the assumptions that test trench 24 revealed evidence of Groton, or the county, road and that well #1 was the well noted in the deed. From these descriptions, the approximate lengths and orientation of the property lines were determined and illustrated.

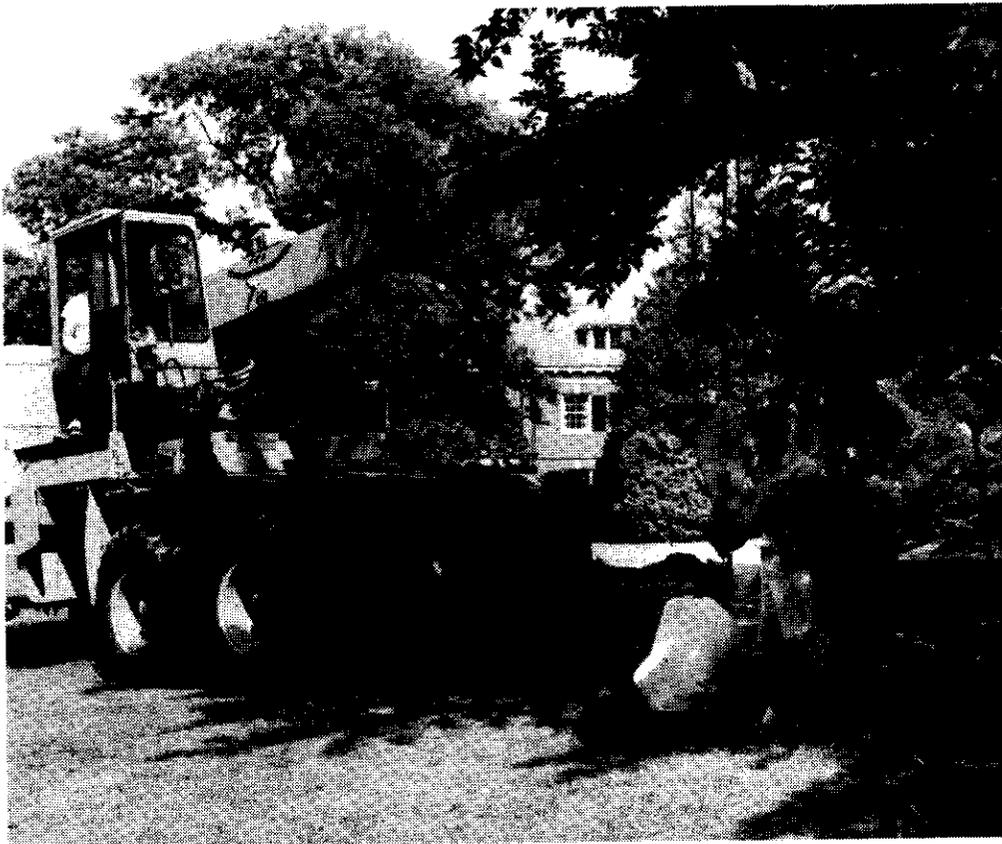
Figure 18.6. Crane removing heavy stone fill from well during Abel's 1965 excavation (MIMA.BWP.BM.6).

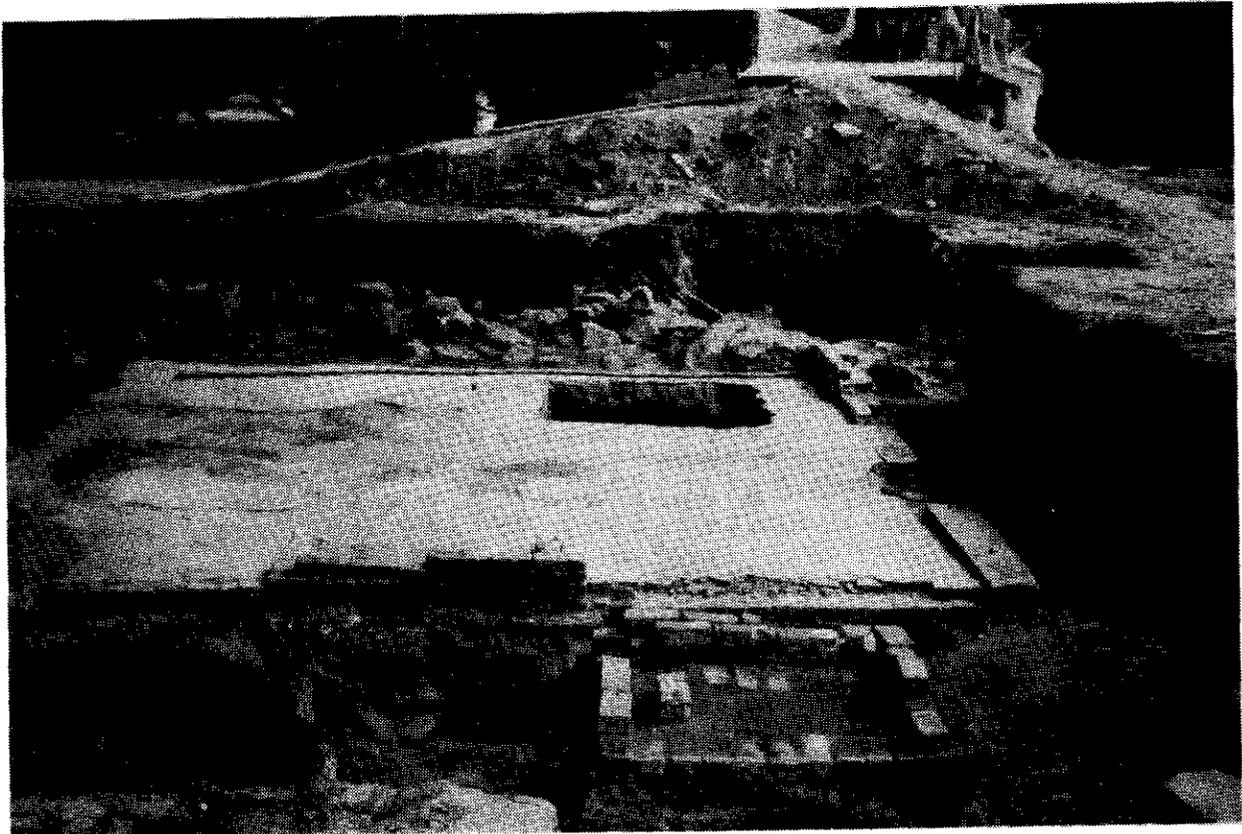
Figure 18.8. Abel's photograph of concrete floor of 19th century Buttrick farmhouse with brick chimney base in foreground, exposed during 1965 excavation (MIMA.BWP.BM.40).

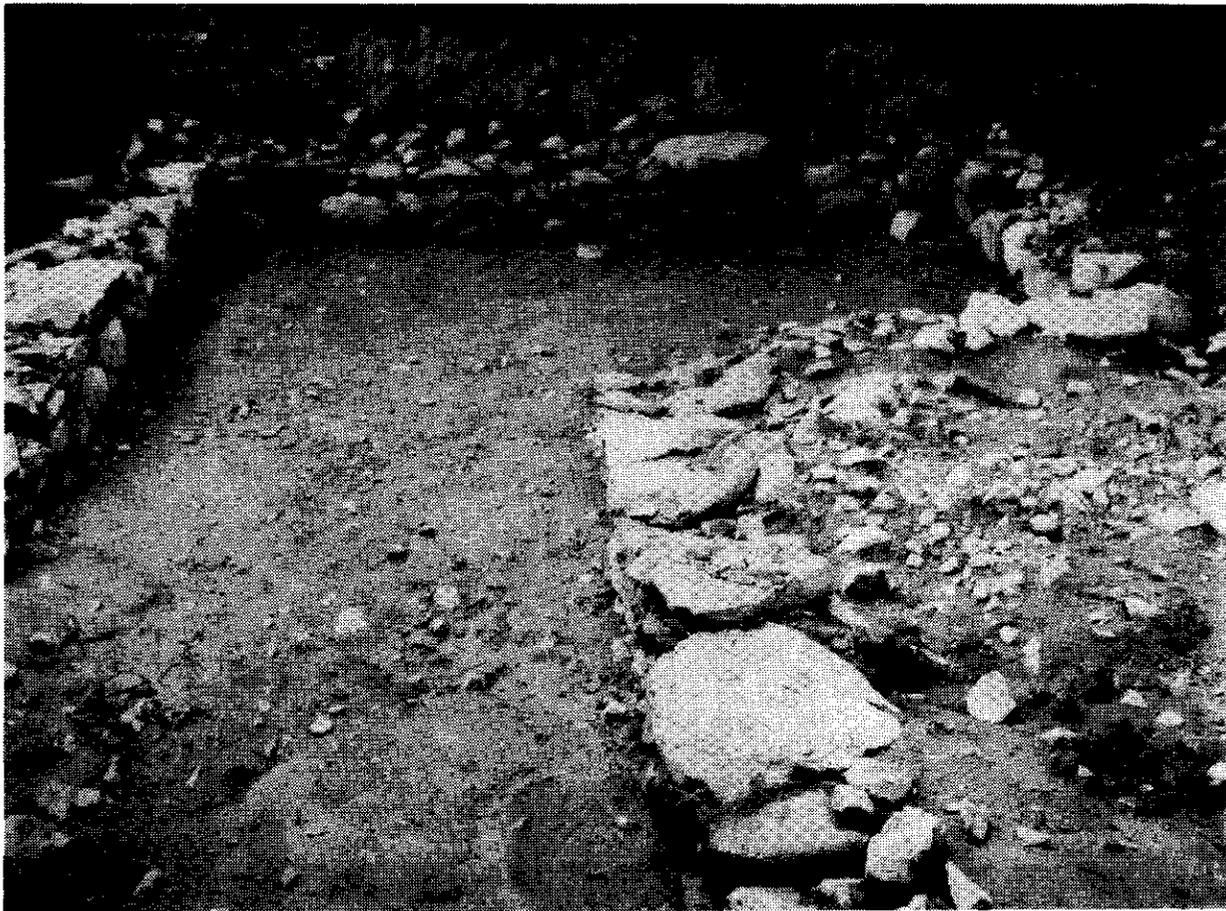
Figure 18.10. Foundation of L-shaped structure, looking west. Chimney base in lower right. From Abel's 1965 excavation (MIMA.BWP.BM.28).

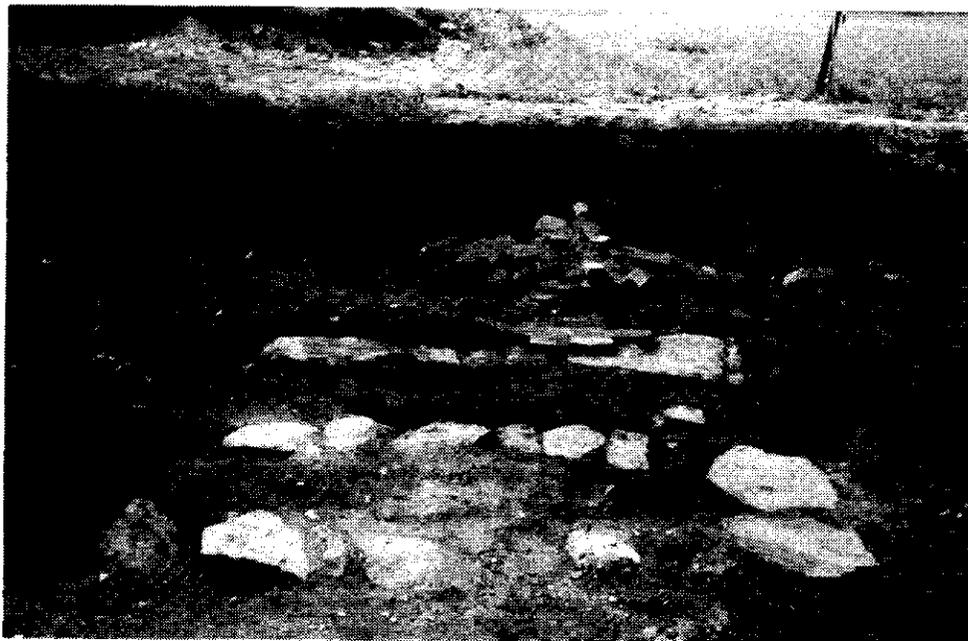
Figure 18.11. Chimney base of Ephraim Buttrick structure, with 3 rows of flagstones and brick rubble, from Snow's excavation (MIMA.BWP.BM.8).

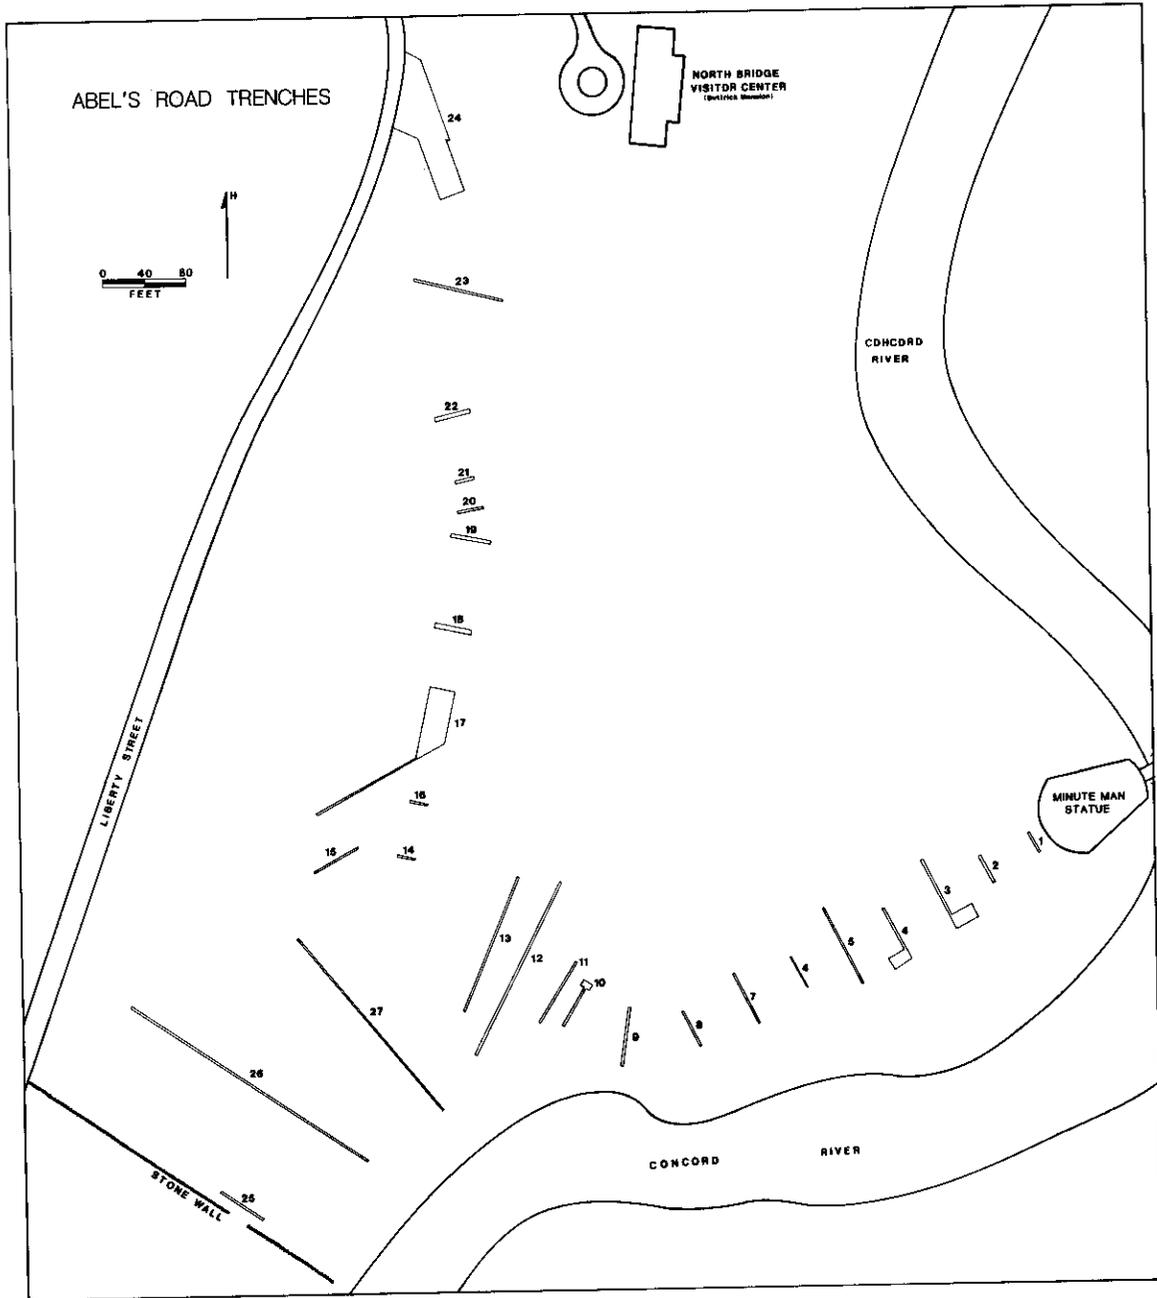
Figure 19.1. ACMP map of area west of the North Bridge, showing the location of Abel's test trenches (Abel 1965).

This fieldwork, confined to land owned by MIMA, concentrated on two parcels (Figure 19.1): (1) 34 acres of the Buttrick estate, bounded on the east and south by the Concord River, and on the west and north by Liberty Street; and (2) 3.76 acres of the "Muster Field," lying west of Liberty Street and across the road from the Buttrick Mansion (Abel 1965:14).

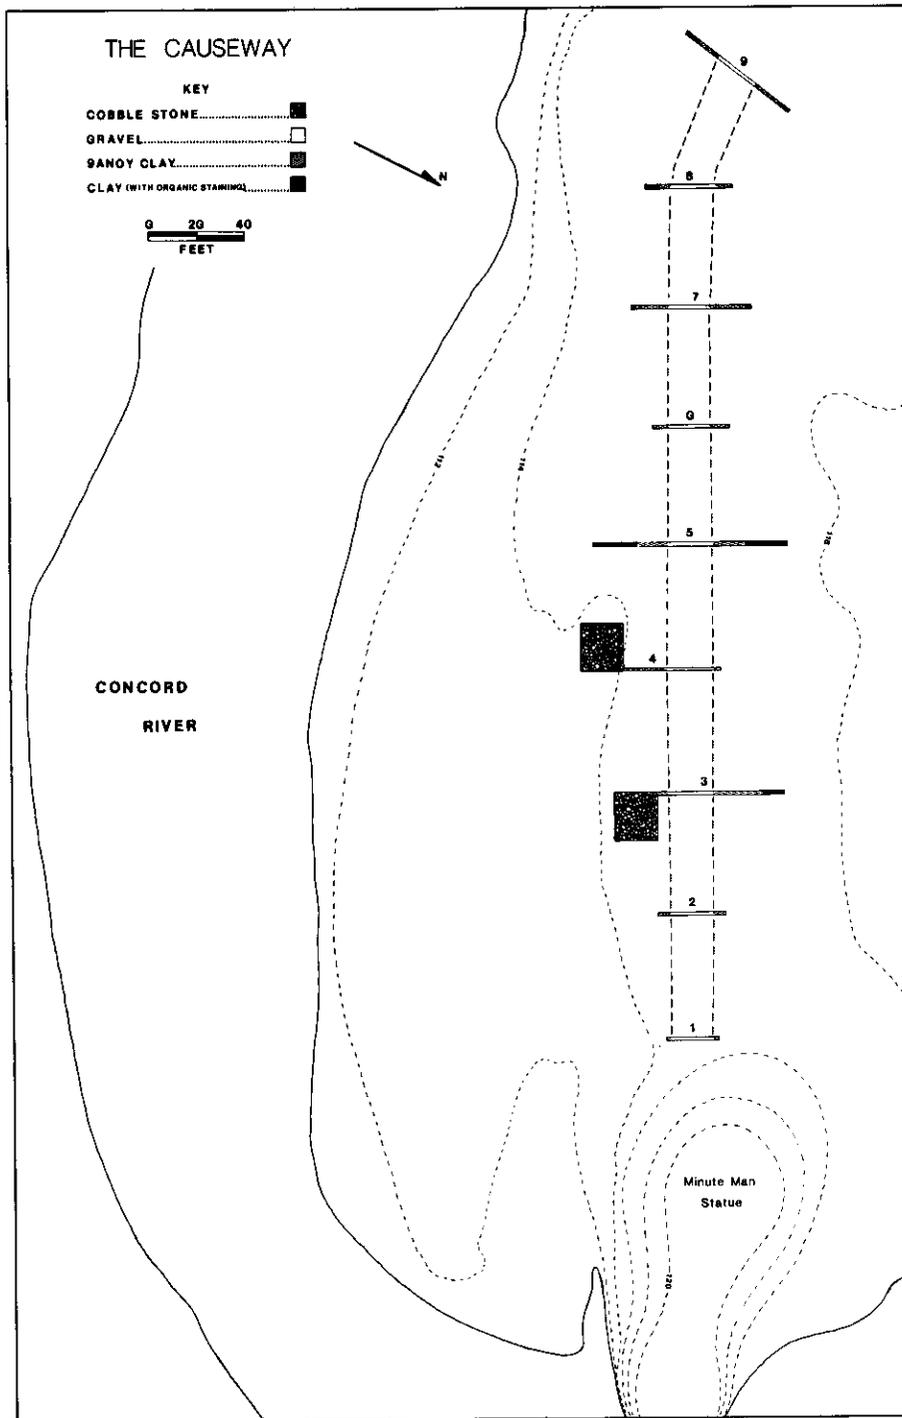
Figure 19.2. ACMP map showing location and results of Abel's trenches #1-9, along the causeway.

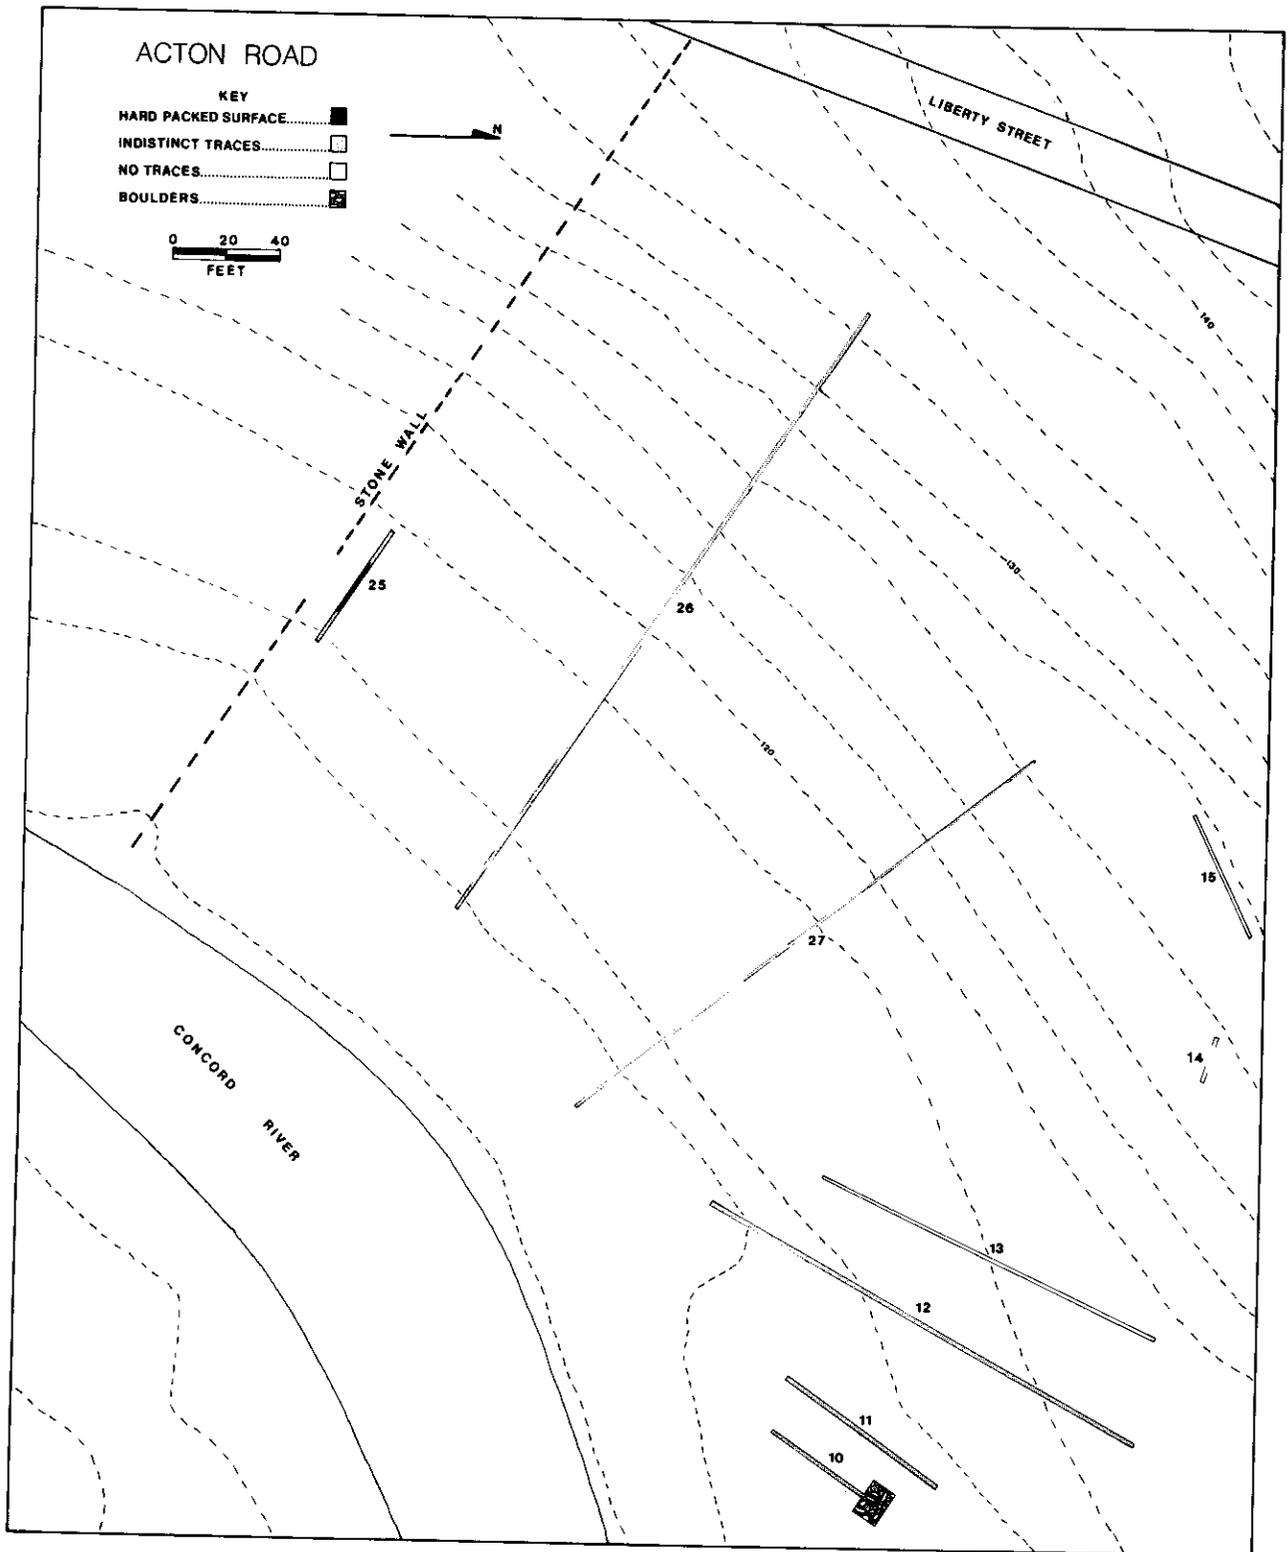
Figure 19.3. ACMP map showing the location and results of Abel's trenches #10-15 and #25-27, at the fork of Acton and Groton Roads.

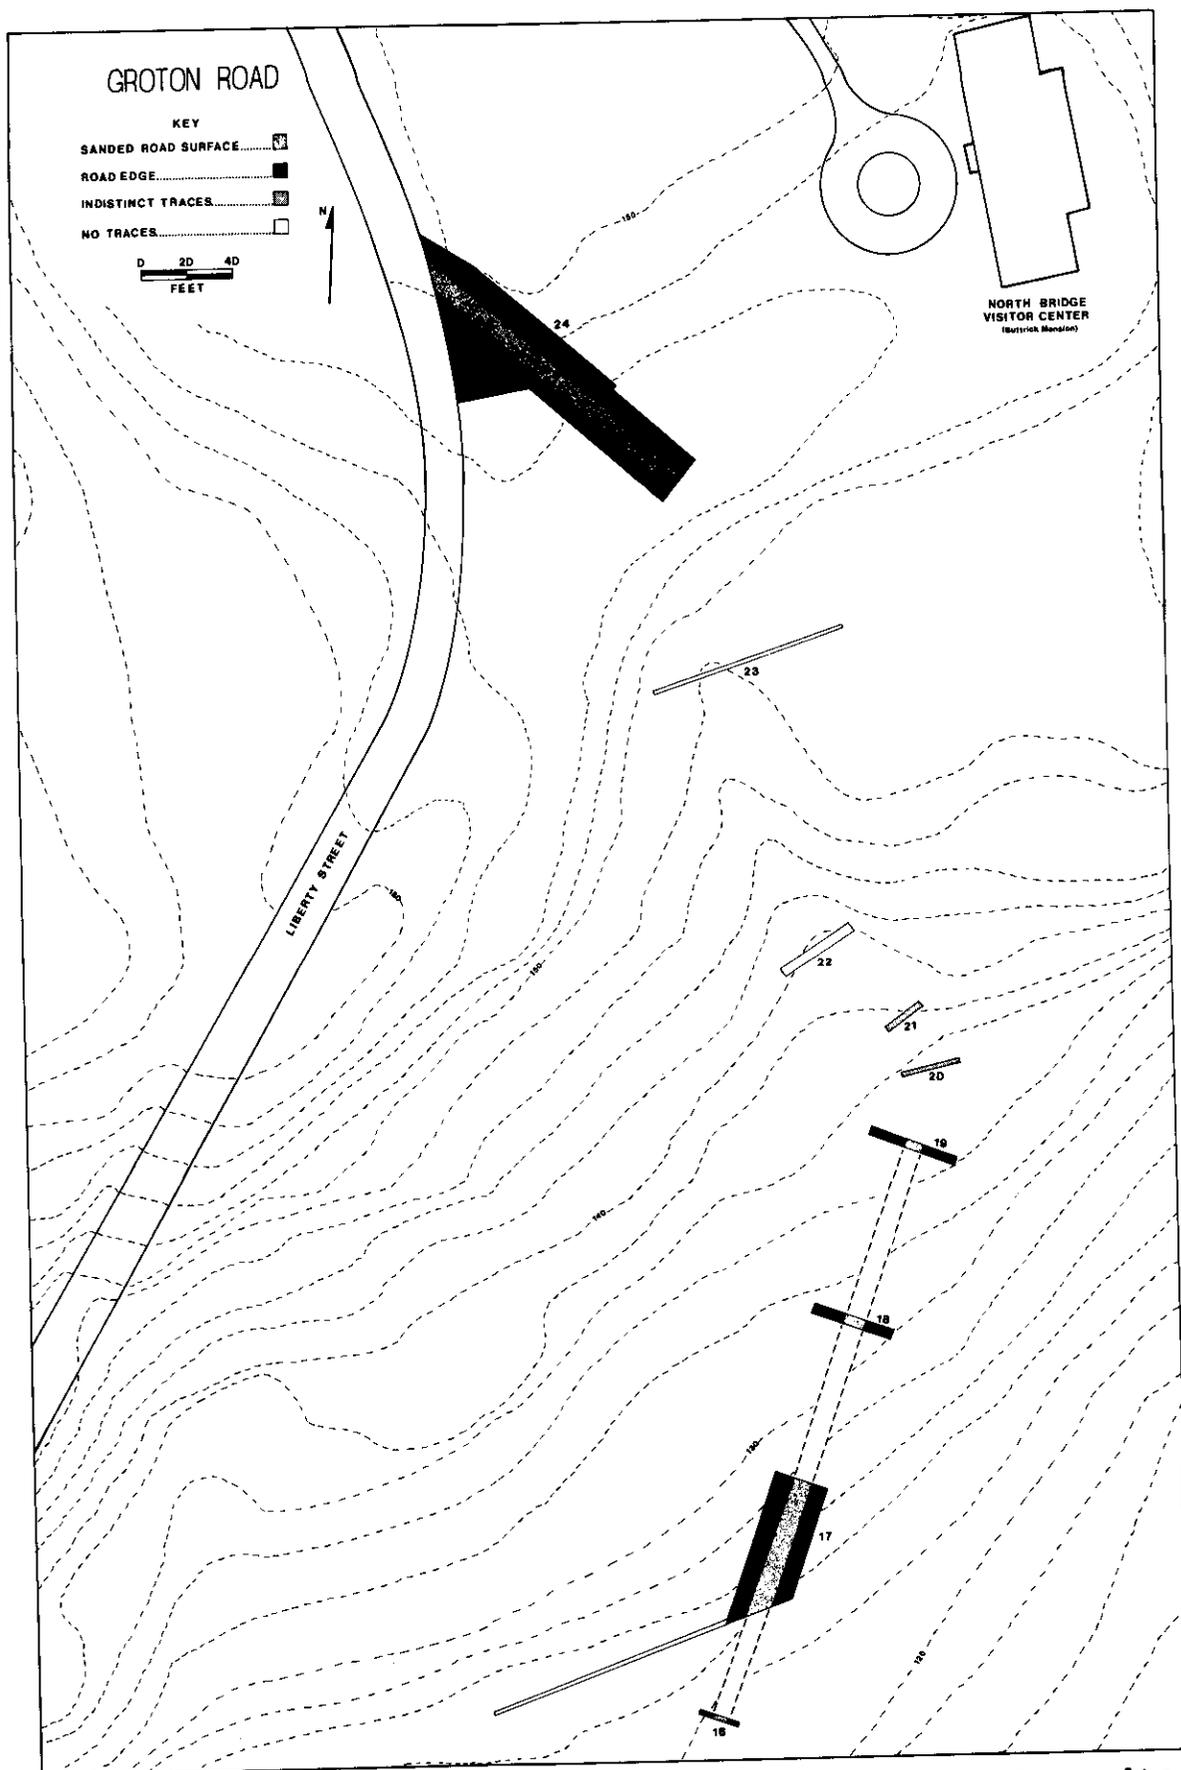
Figure 19.4. ACMP map showing the location and results of Abel's trenches #16-24 on Groton Road.

Evidence of Groton Road was represented by a sanded road surface located in trenches 16, 17, 18, 19 and 24. Trenches 22 and 23 had no traces of a road. A dashed line was placed through trenches 16 through 19 on both sides of the sanded road surface to indicate the definite presence of a roadway.

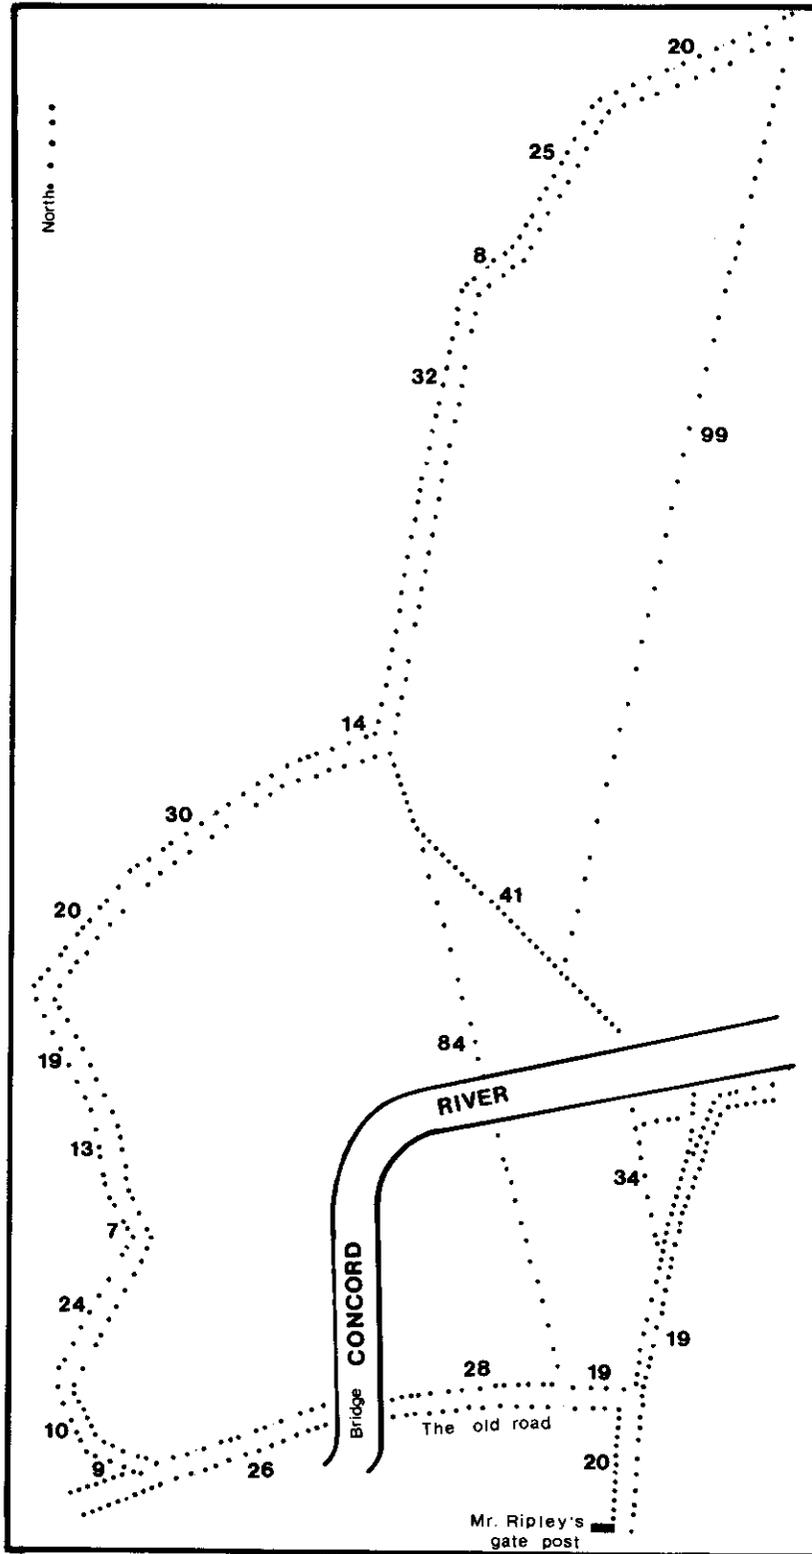
Figure 19.7. ACMP tracing of "Map of roads in vicinity of the Great North Bridge, probably drawn in 1792" (from Abel 1965:Plate 3). The numbers indicate the distance in rods between various points.

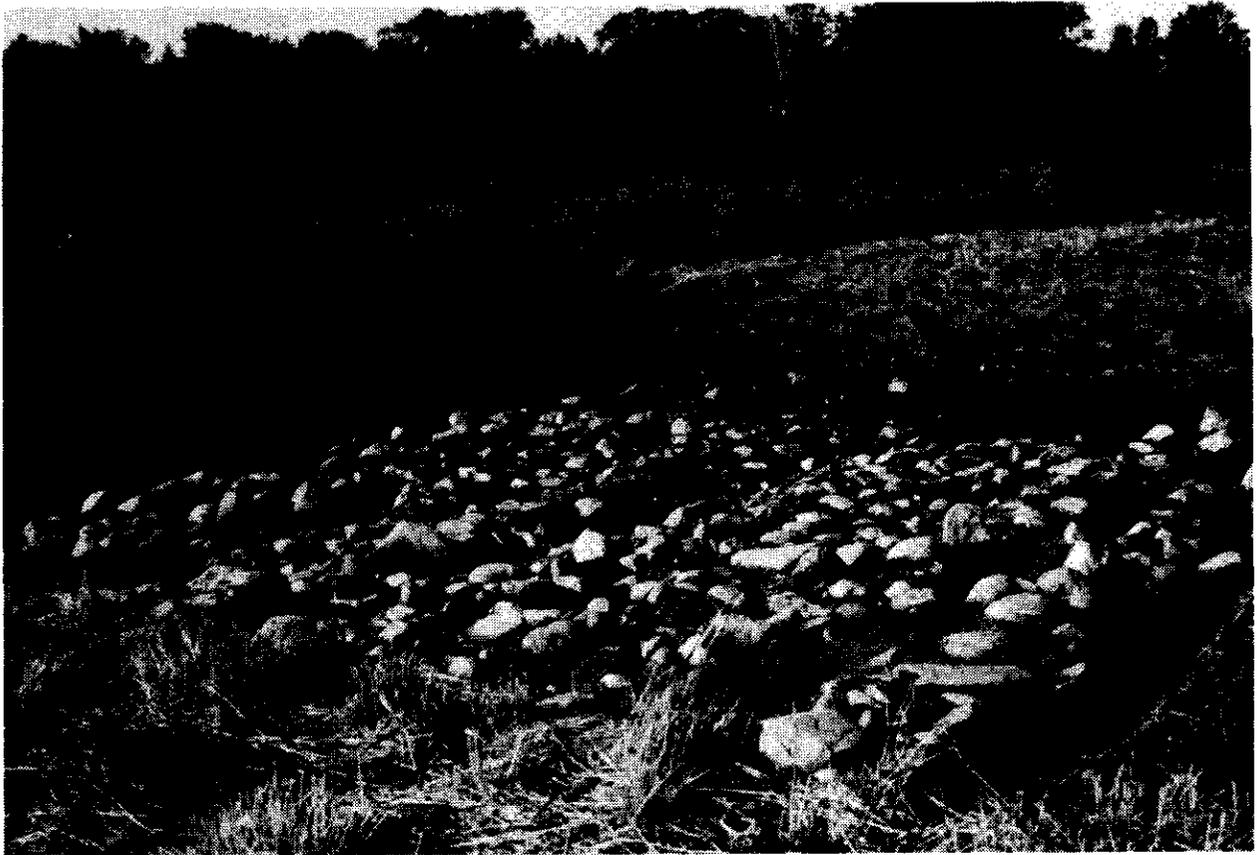
Figure 19.8. View to the southwest across an exposed section of a stone roadbed in the swamp west of the North Bridge. This roadbed was probably constructed between 1635 and 1650, and was abandoned in 1750 or '51 when an improved causeway was built alongside it on the north (Abel 1965:Plate 7).
