ARCHEOLOGICAL
COLLECTIONS MANAGEMENT
AT
MINUTE MAN
NATIONAL HISTORICAL PARK

MASSACHUSETTS

VOLUME 4

ACMP Series No. 4

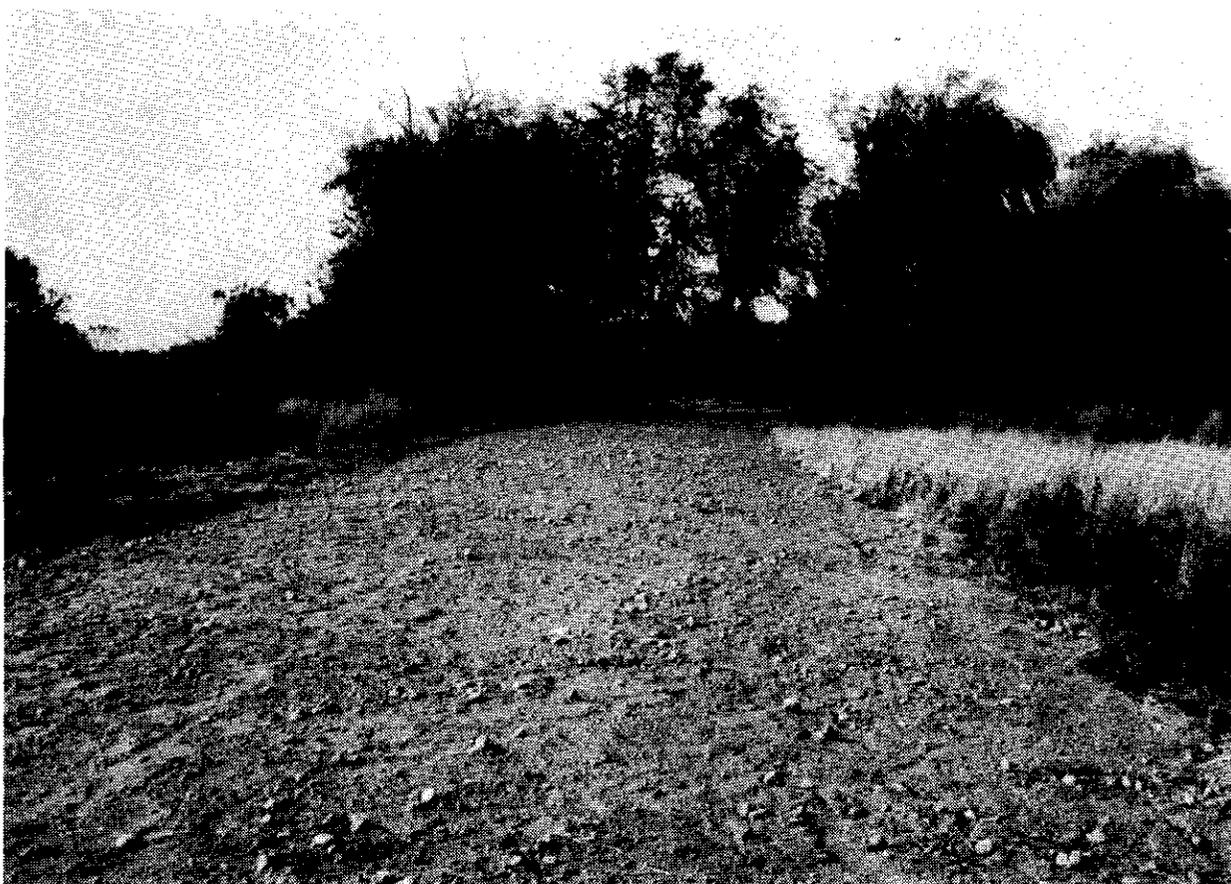
Figure 19.9. The 1750 causeway after a thin layer of gravel was spread over the original gravelled surface. At the extreme left can be seen a small section of the pre-1750 roadbed which had been exposed (Abel 1965:Plate 10).

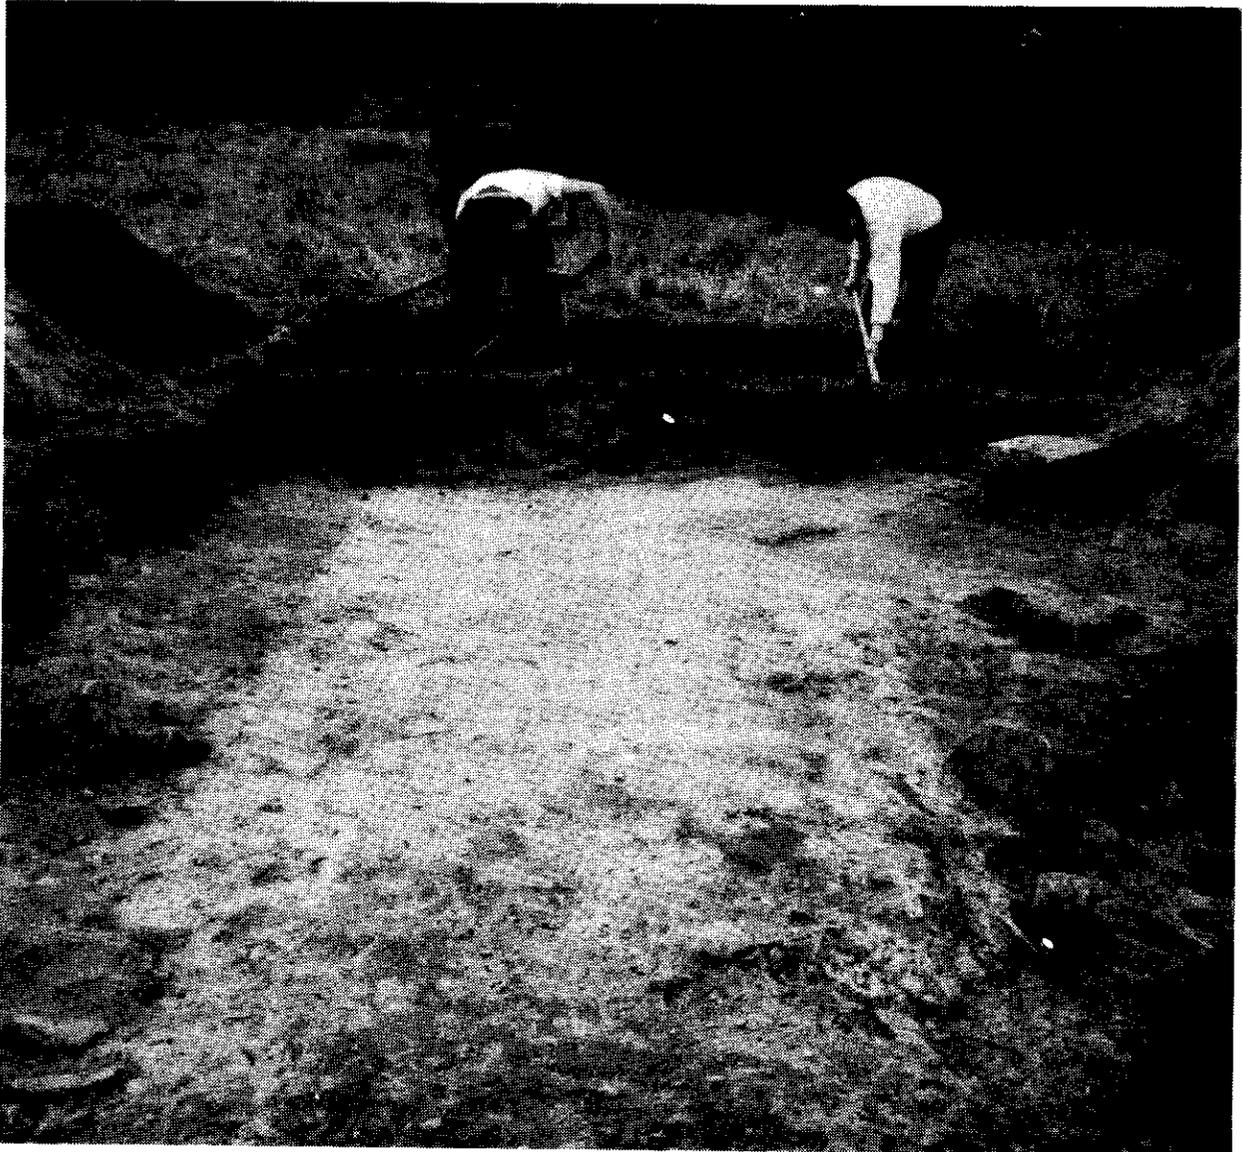
Figure 19.10. Excavation northward along the Groton Road from the point where it was discovered in trench 17. The road surface is the light area in the center of the picture (Abel 1965:Plate 8).

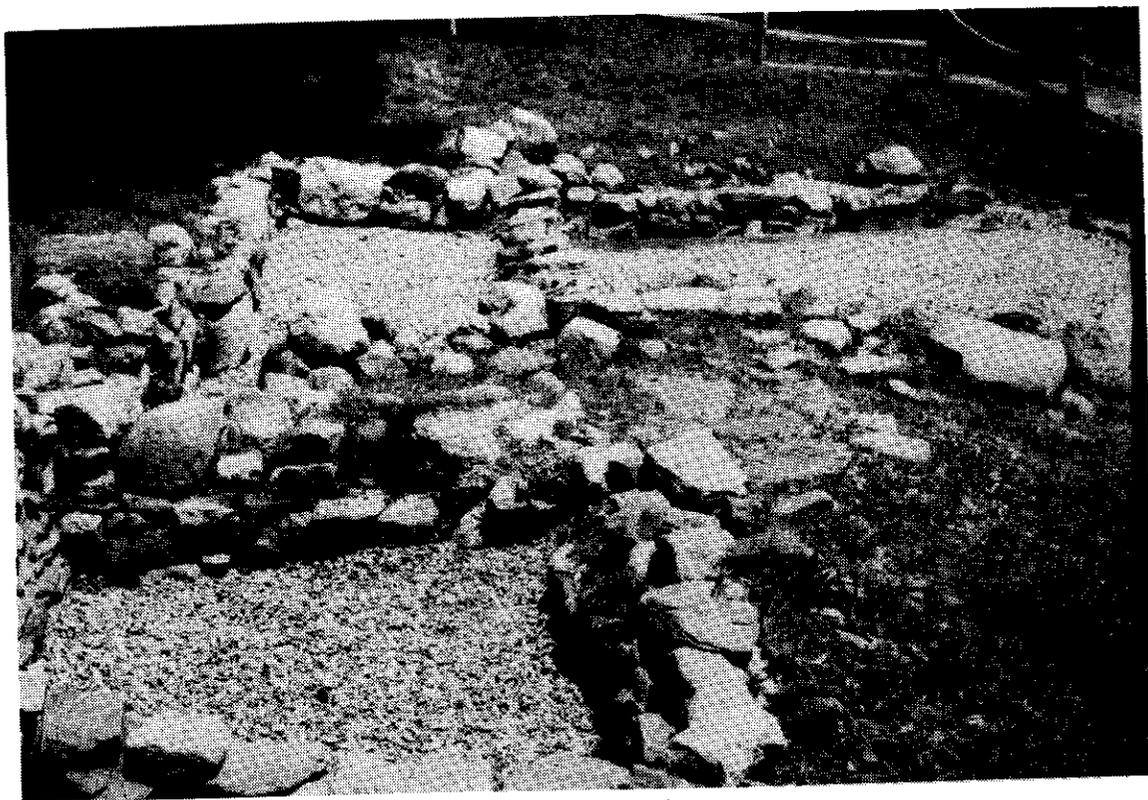
Figure 20.1. The David Brown site after stabilization by Bleacher (Bleacher 1979:Roll 3, Frame 5).

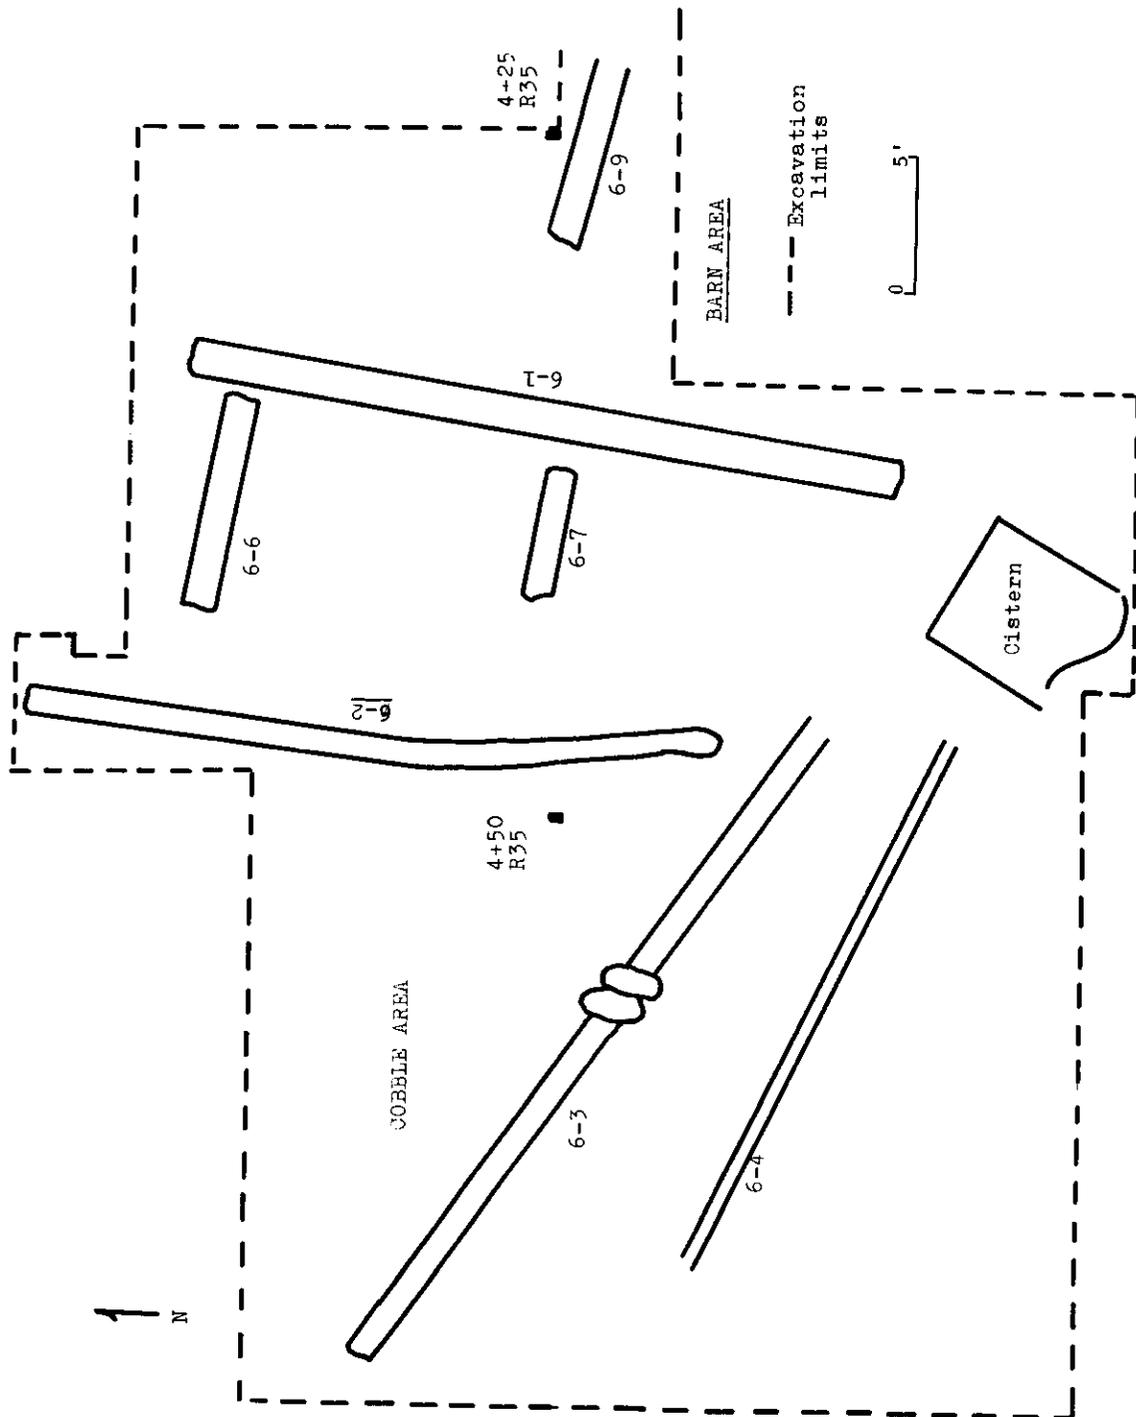
Figure 20.4. Tremer's final site map of barn area (1973a).

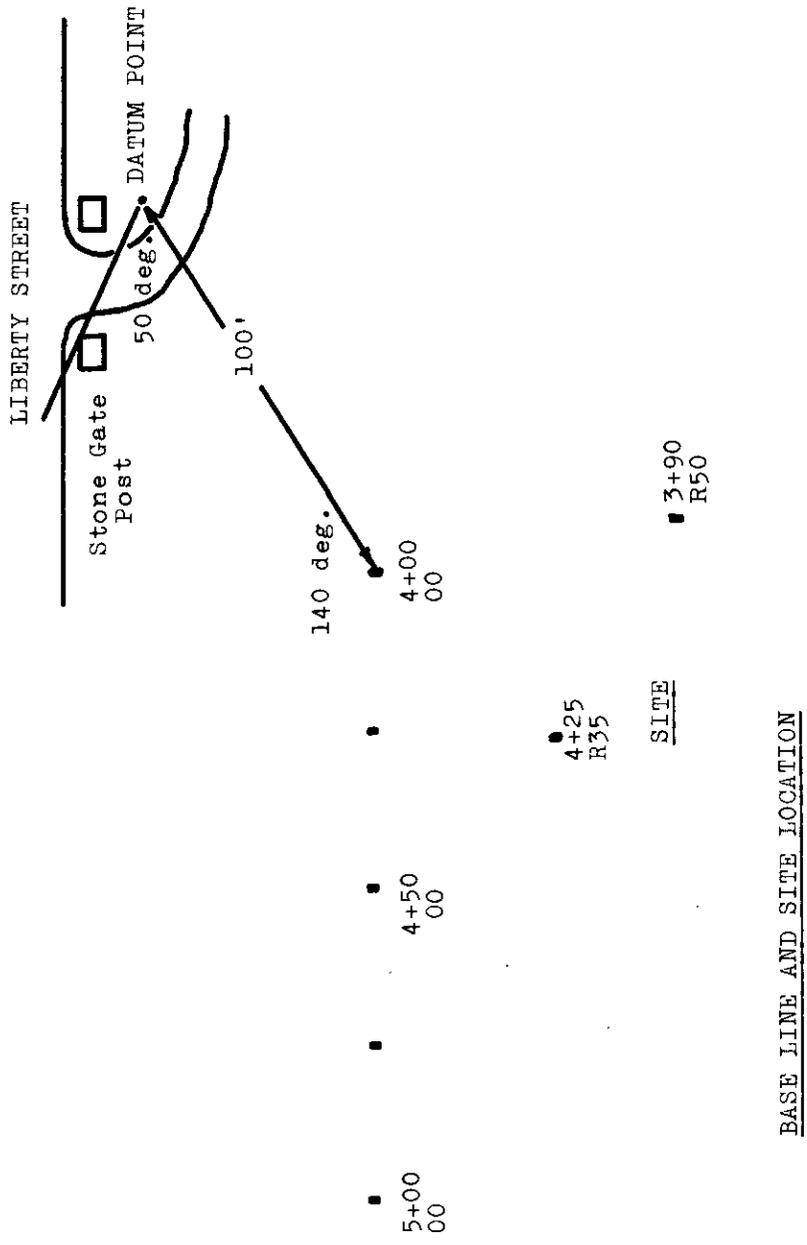
Figure 20.5. Tremer's map of the base line and grid system (1973a:3a).

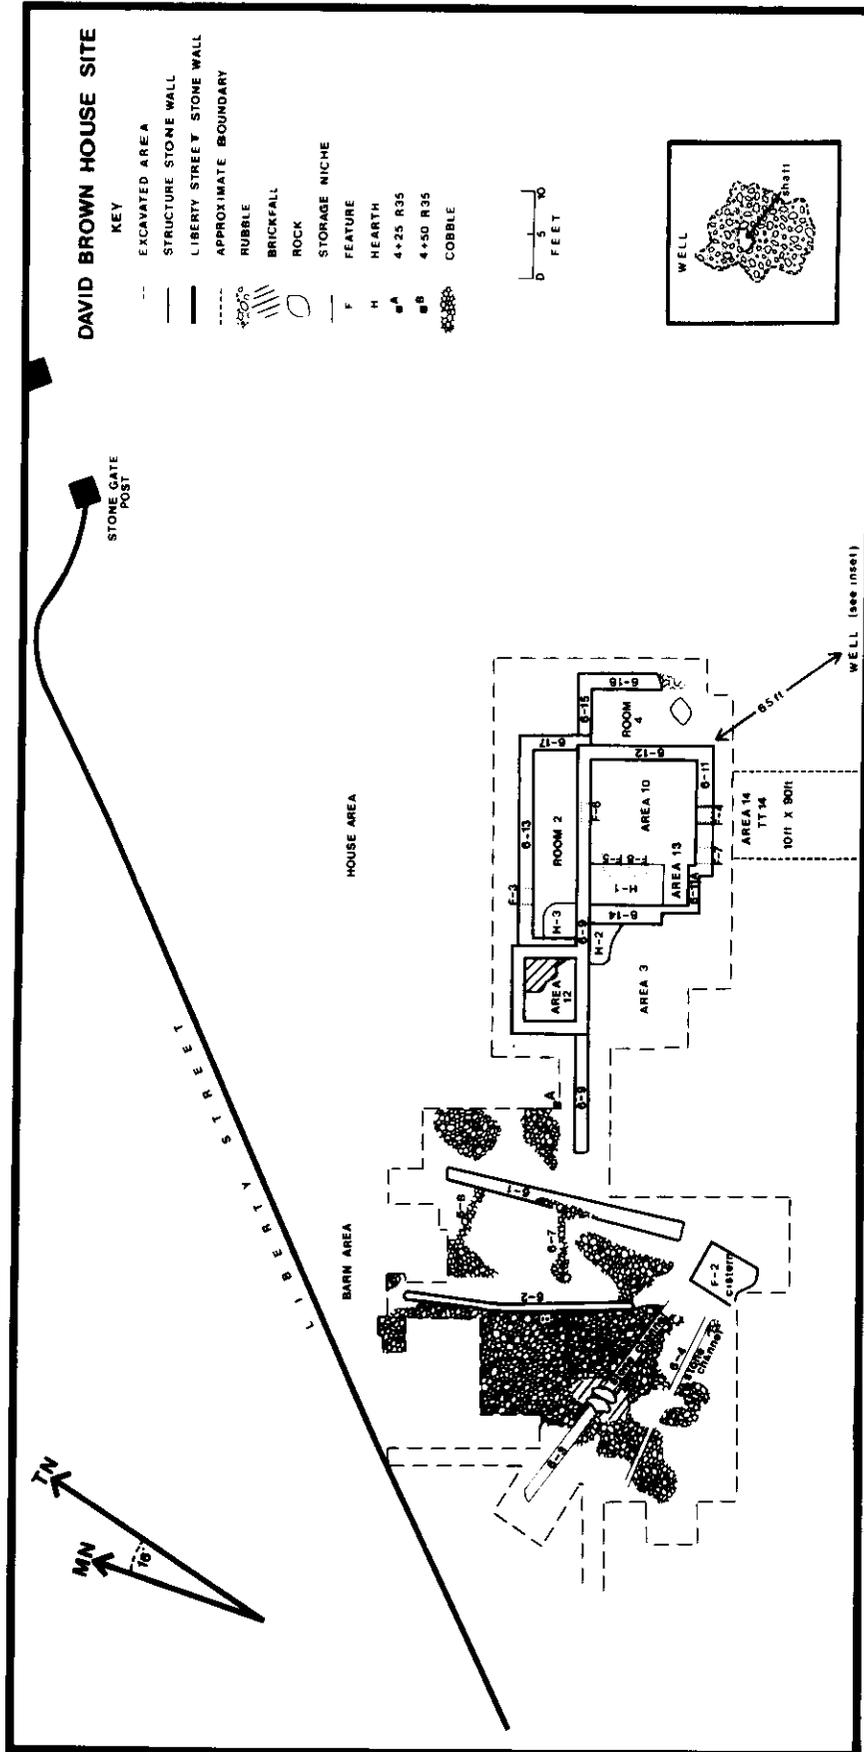
Figure 20.6. ACMP composite site map for the David Brown site.

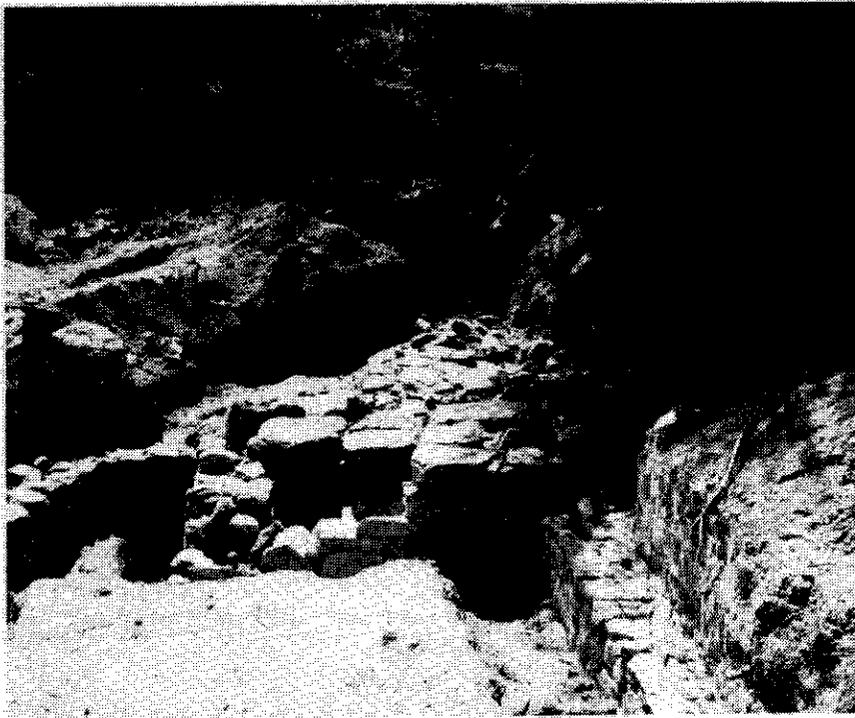
Figure 20.8. Looking west across house foundation. Wall 6-9 is in lower right; hearth complex is in foreground; stairwell is to left of hearth base (MIMA photo 72-350).

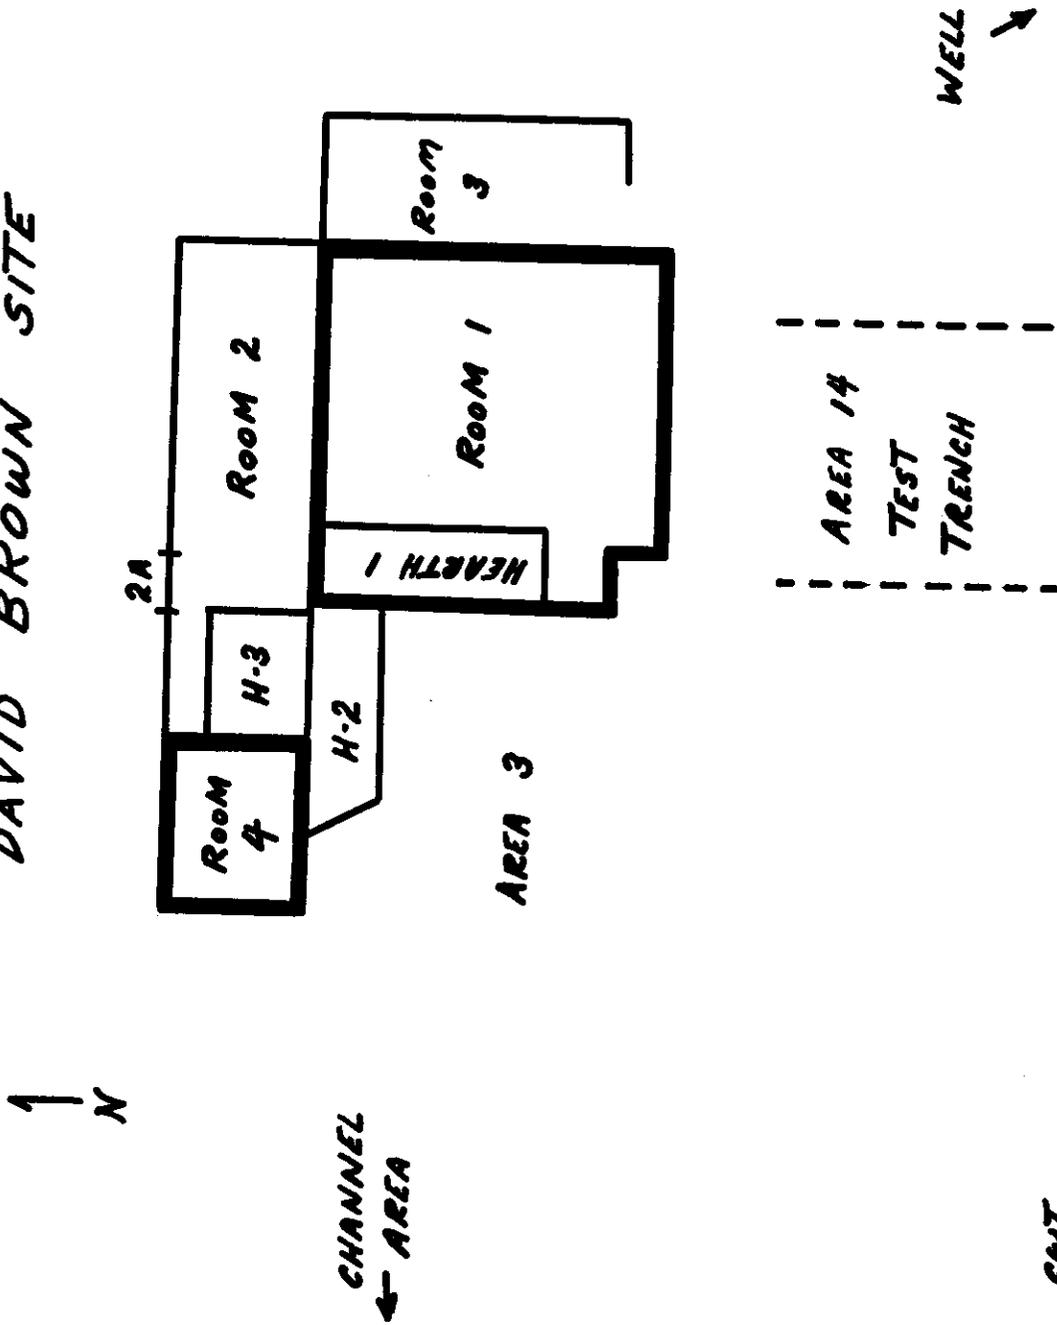
Figure 20.17. Tremer's map showing his interpretation of the structural features at the house site (1971).

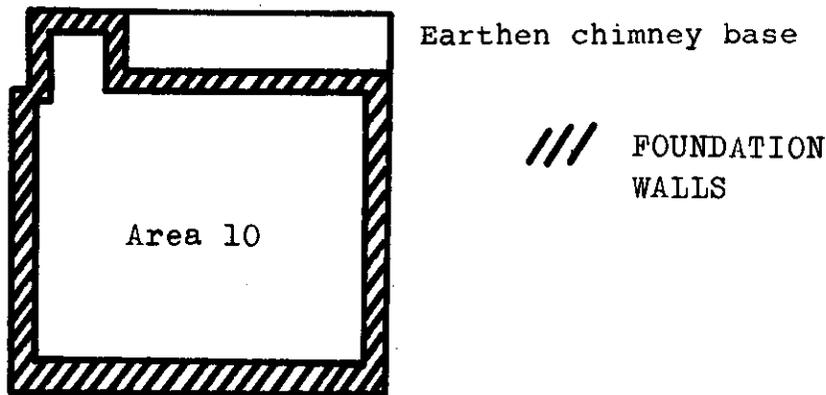
Figure 20.19. Tremer's illustration of house foundations with earthen base for chimney (Tremer 1973a:14).

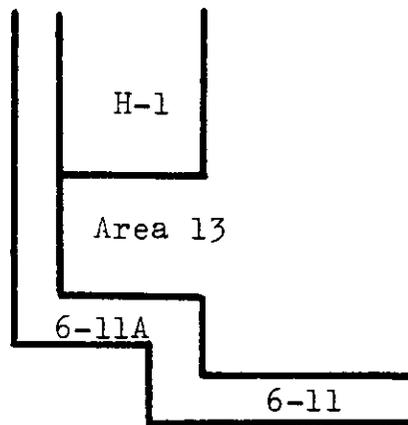
Figure 20.20. Tremer's illustration of stairwell area (Area 13) in southwest corner of house foundation (Tremer 1973a:21).

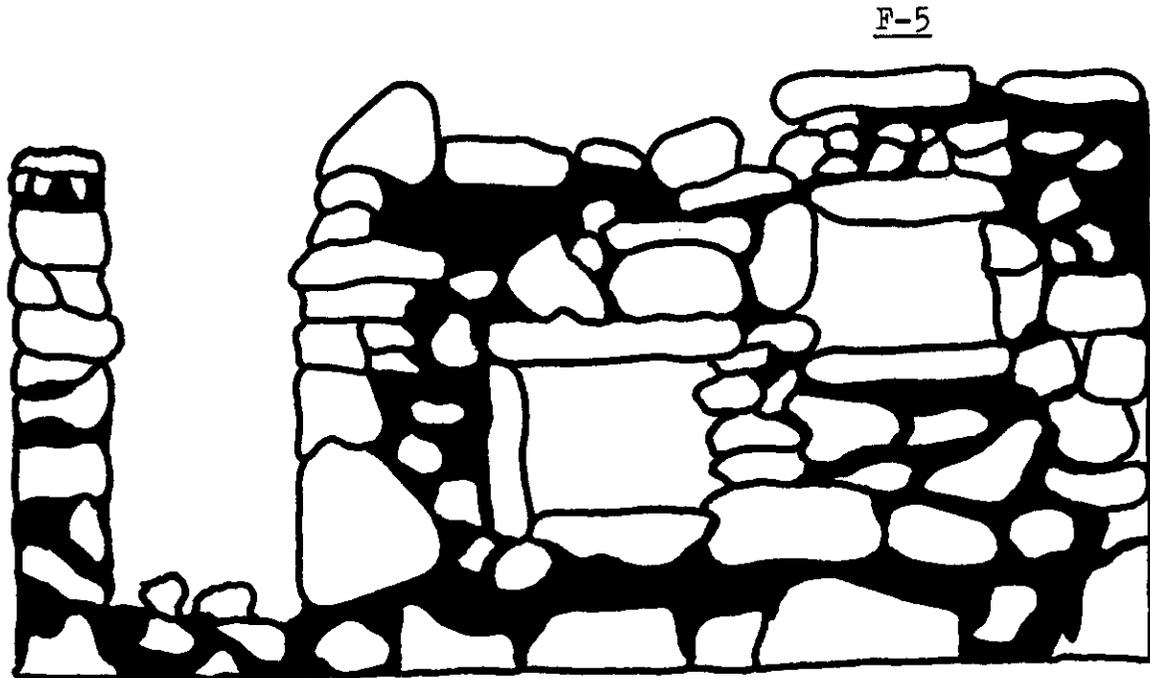
Figure 20.21. Tremer's illustration of storage niches in chimney base (Tremer 1973a:16a)

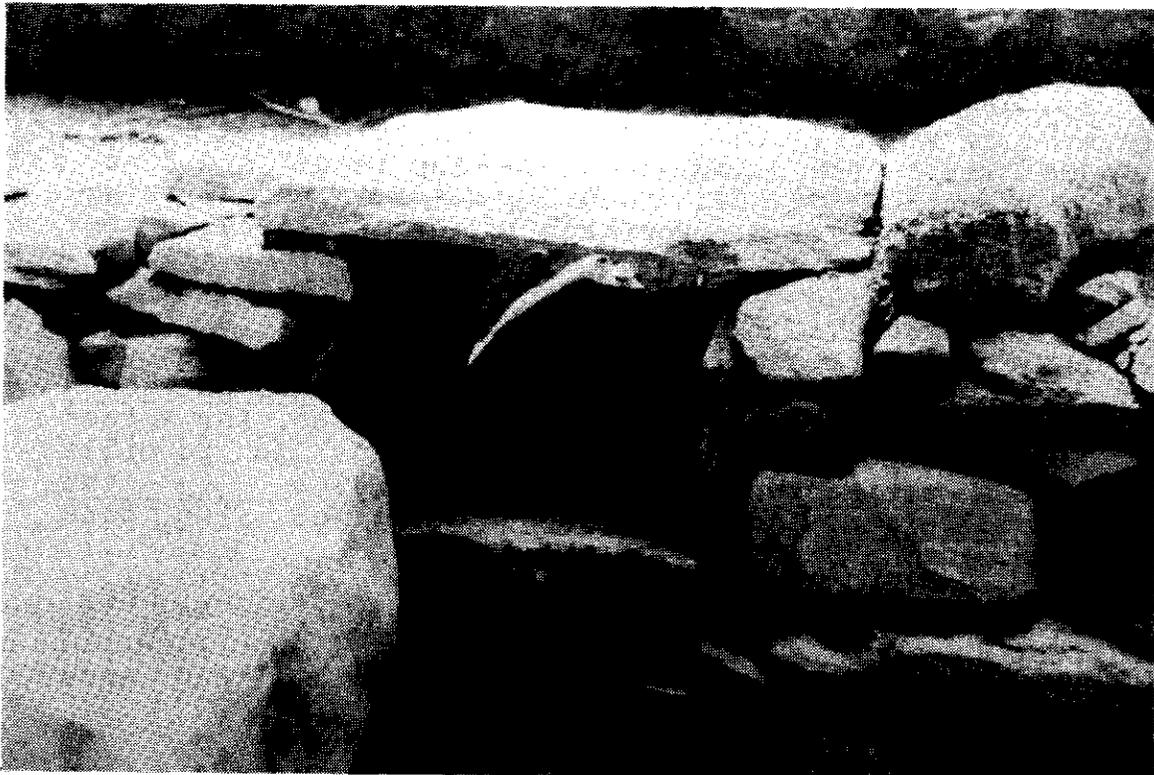
Figure 20.24. Niche F-4, under doorsill (Tremer 1973a:#11).

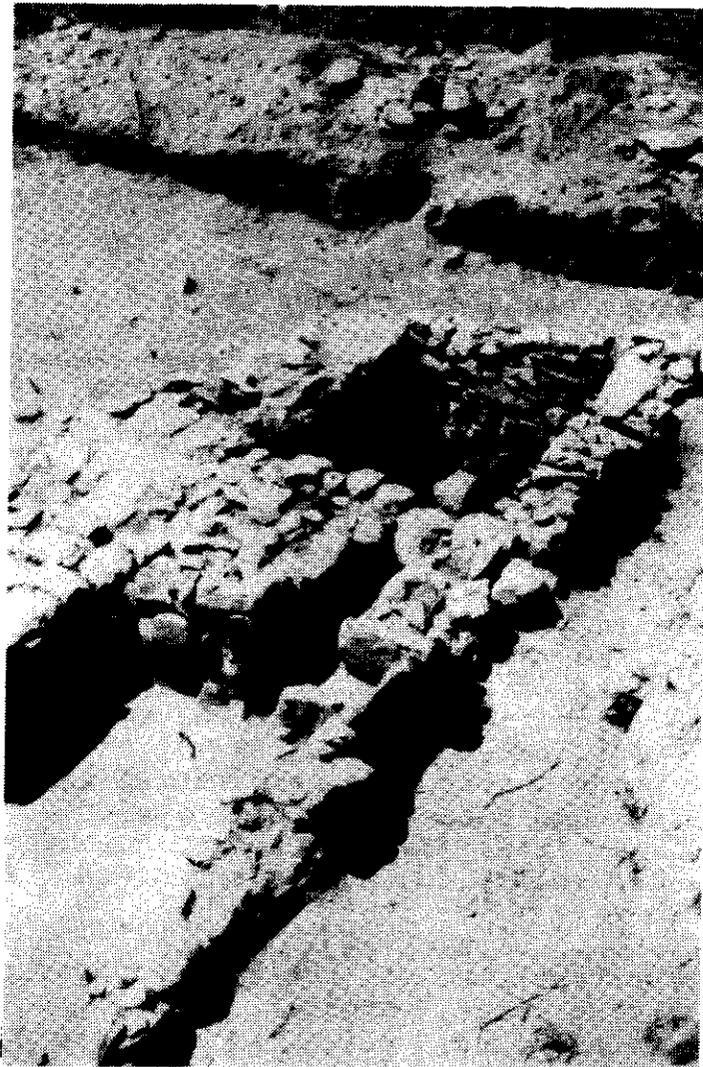
Figure 20.25. Storehouse foundation, Area 12 (Tremer 1973a:30).

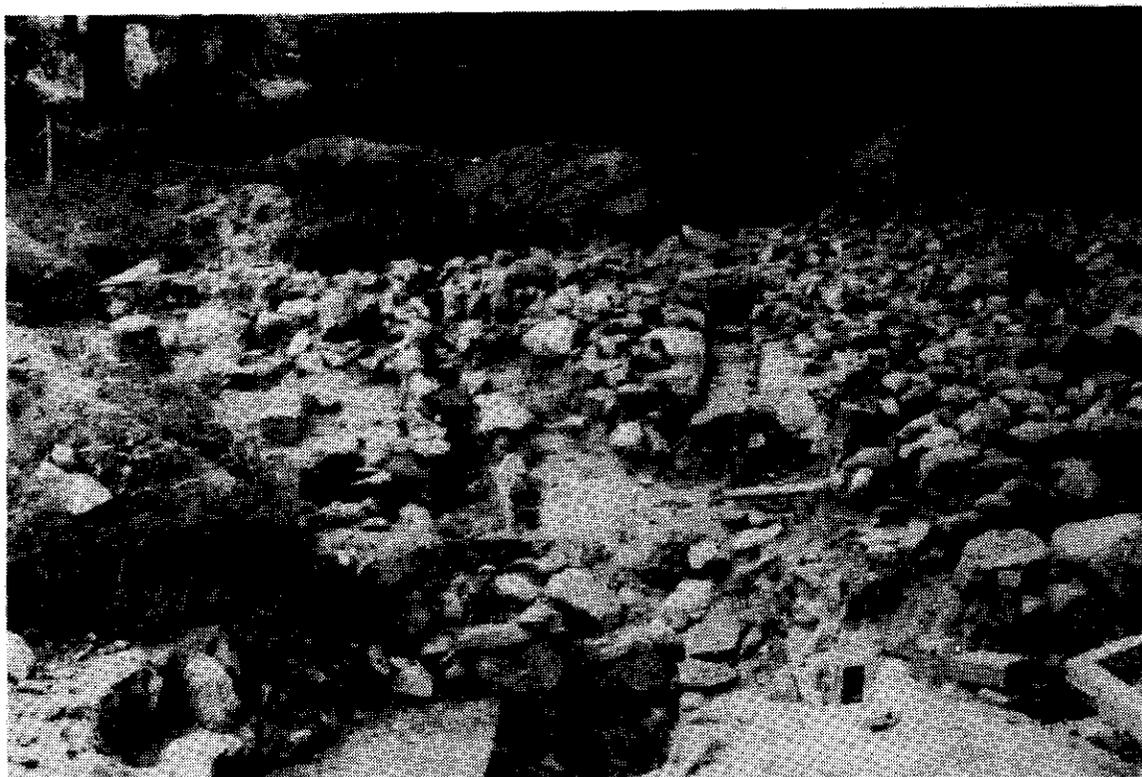
Figure 20.26. Barn area showing convergence of two channels toward cistern (Tremer 1973a:#38).

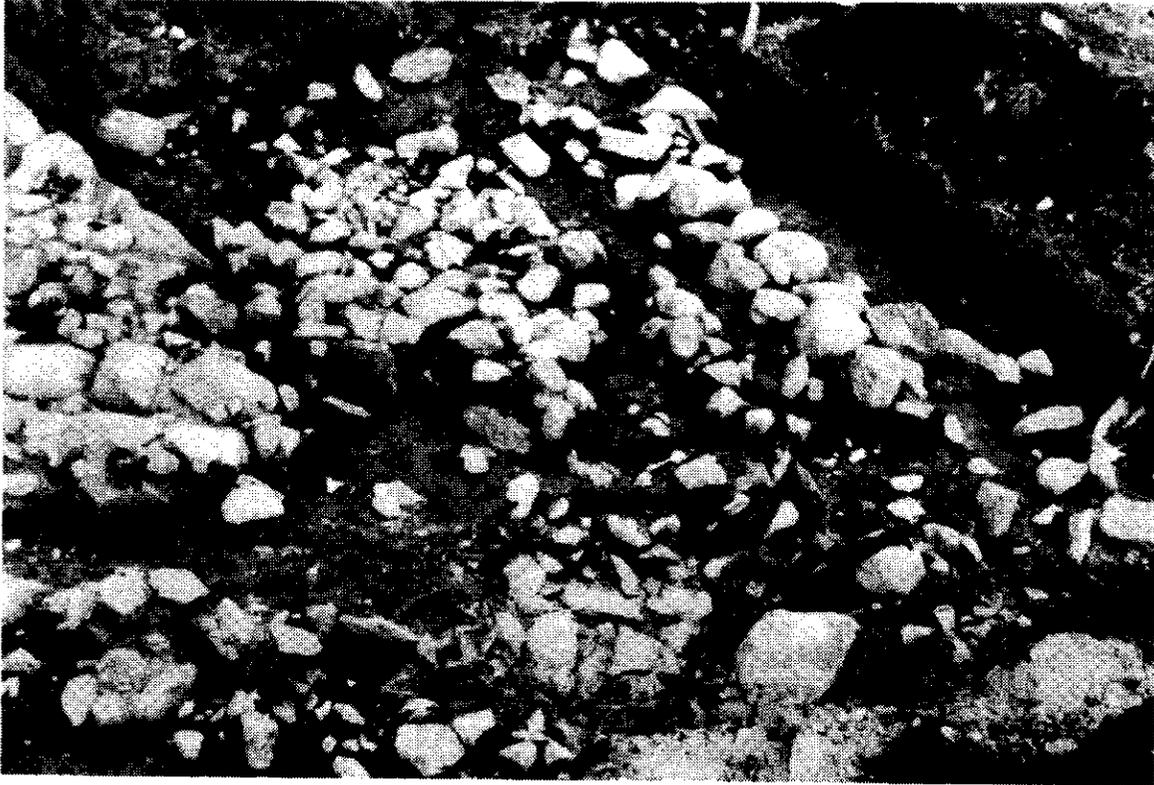
Figure 20.28. Rubble area with cistern area in lower right (Tremer 1973a:#37).

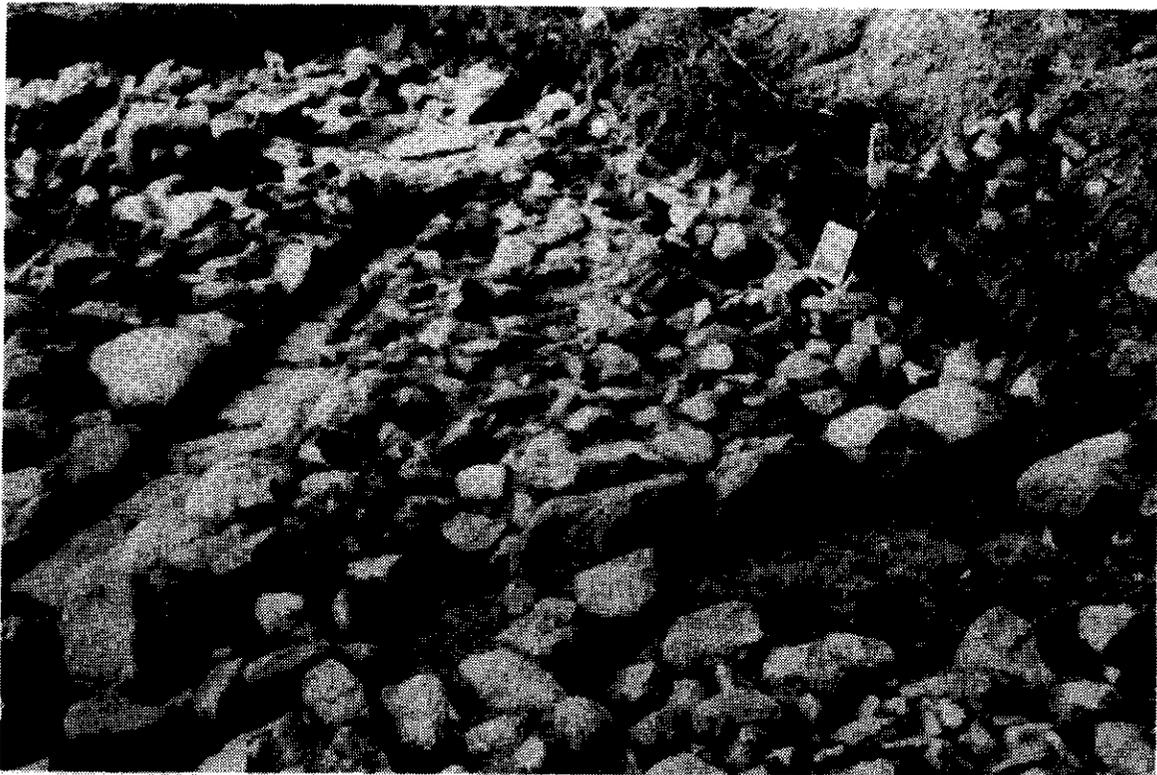
Figure 20.29. Barn area, showing cobble area, wall 6-2, and large stone channel (Tremer 1973a:#34).

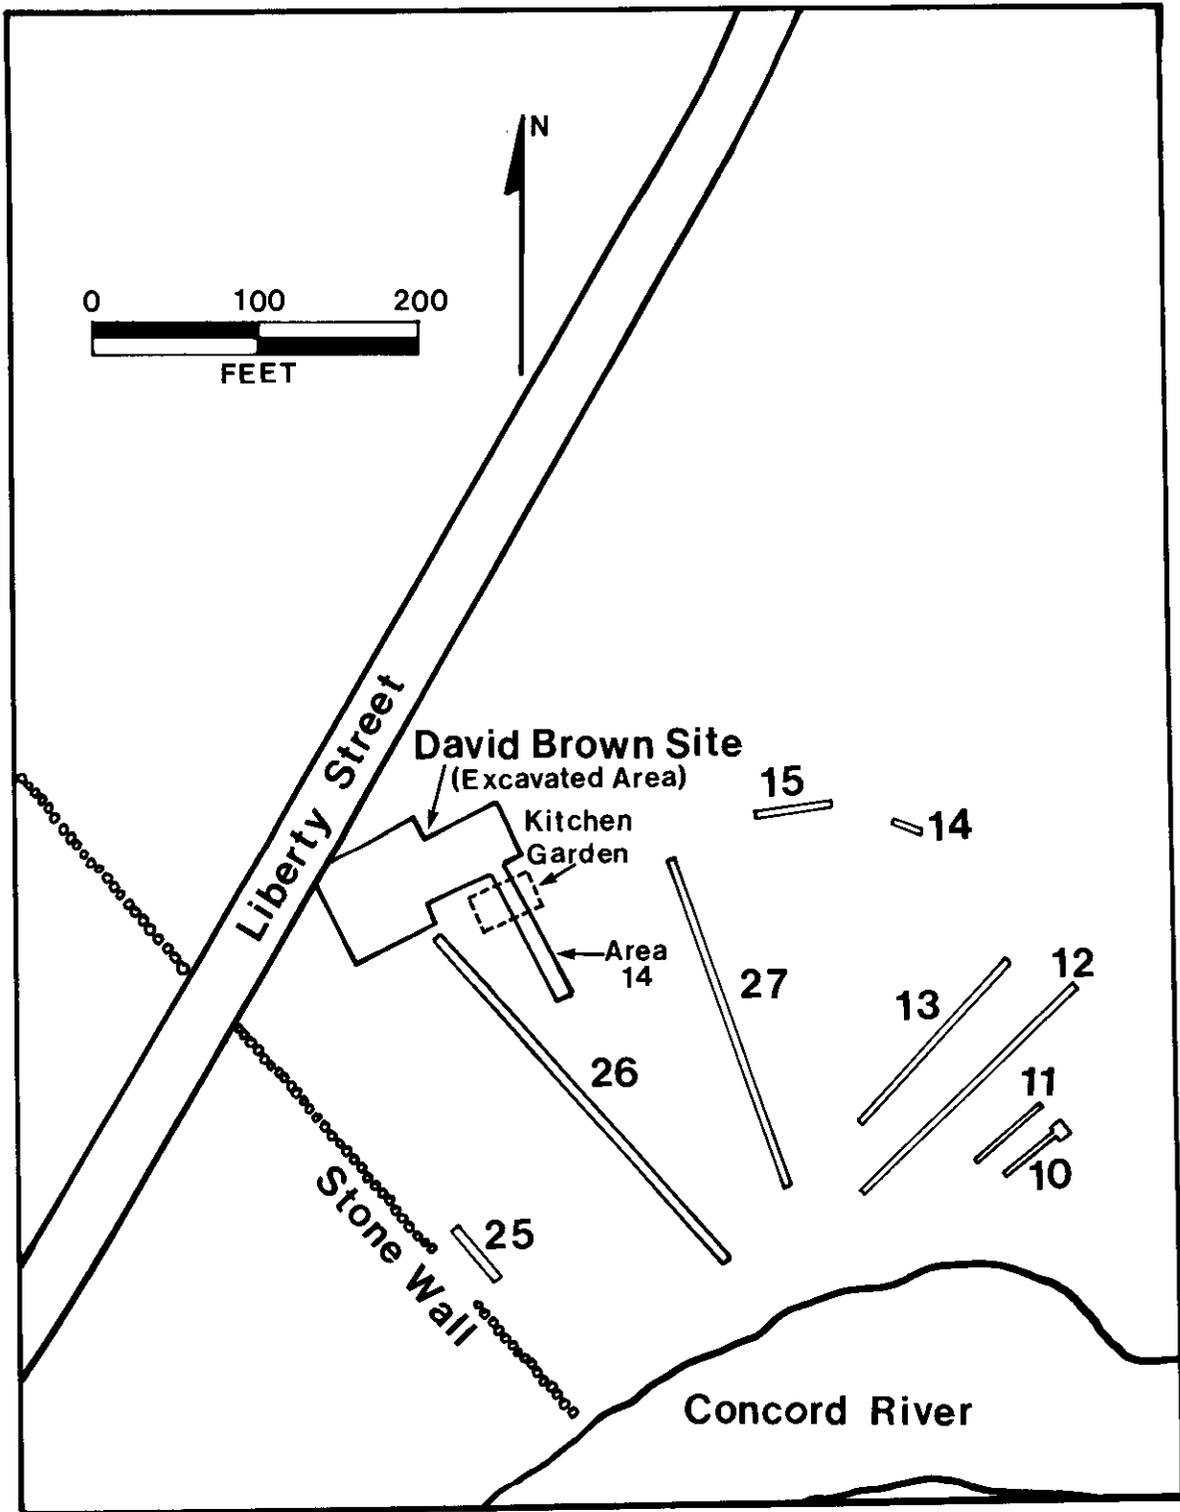
Figure 20.36. ACMP map showing locations of Abel's test trenches for the Acton Road.

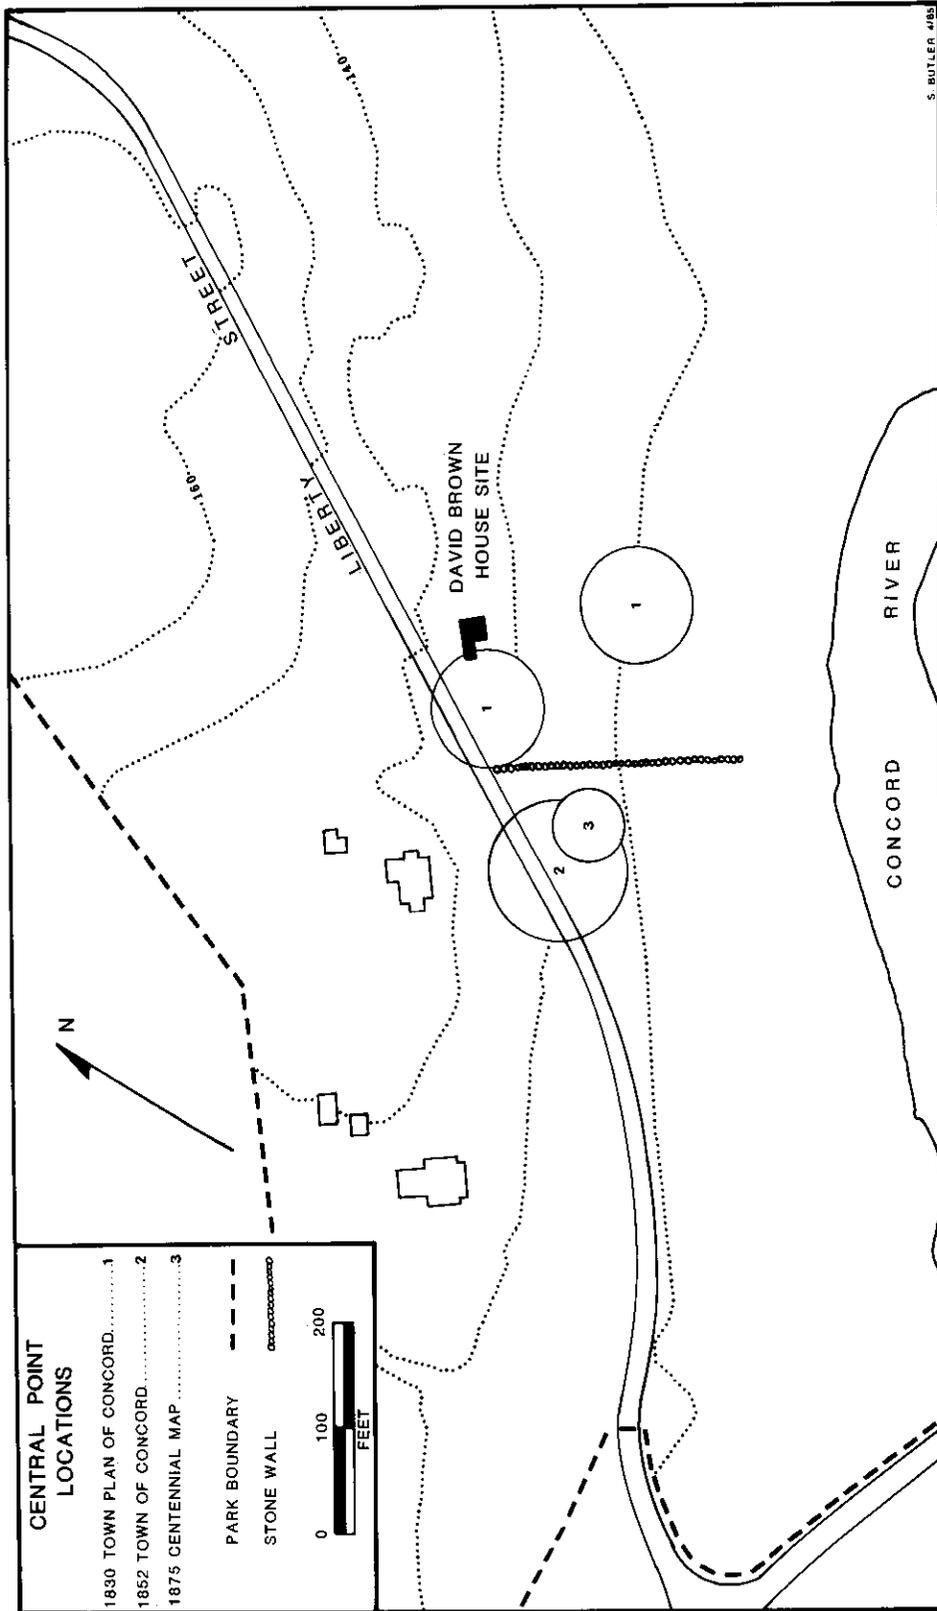
Figure 20.41. ACMP map showing results of triangulations to locate the David Brown house.

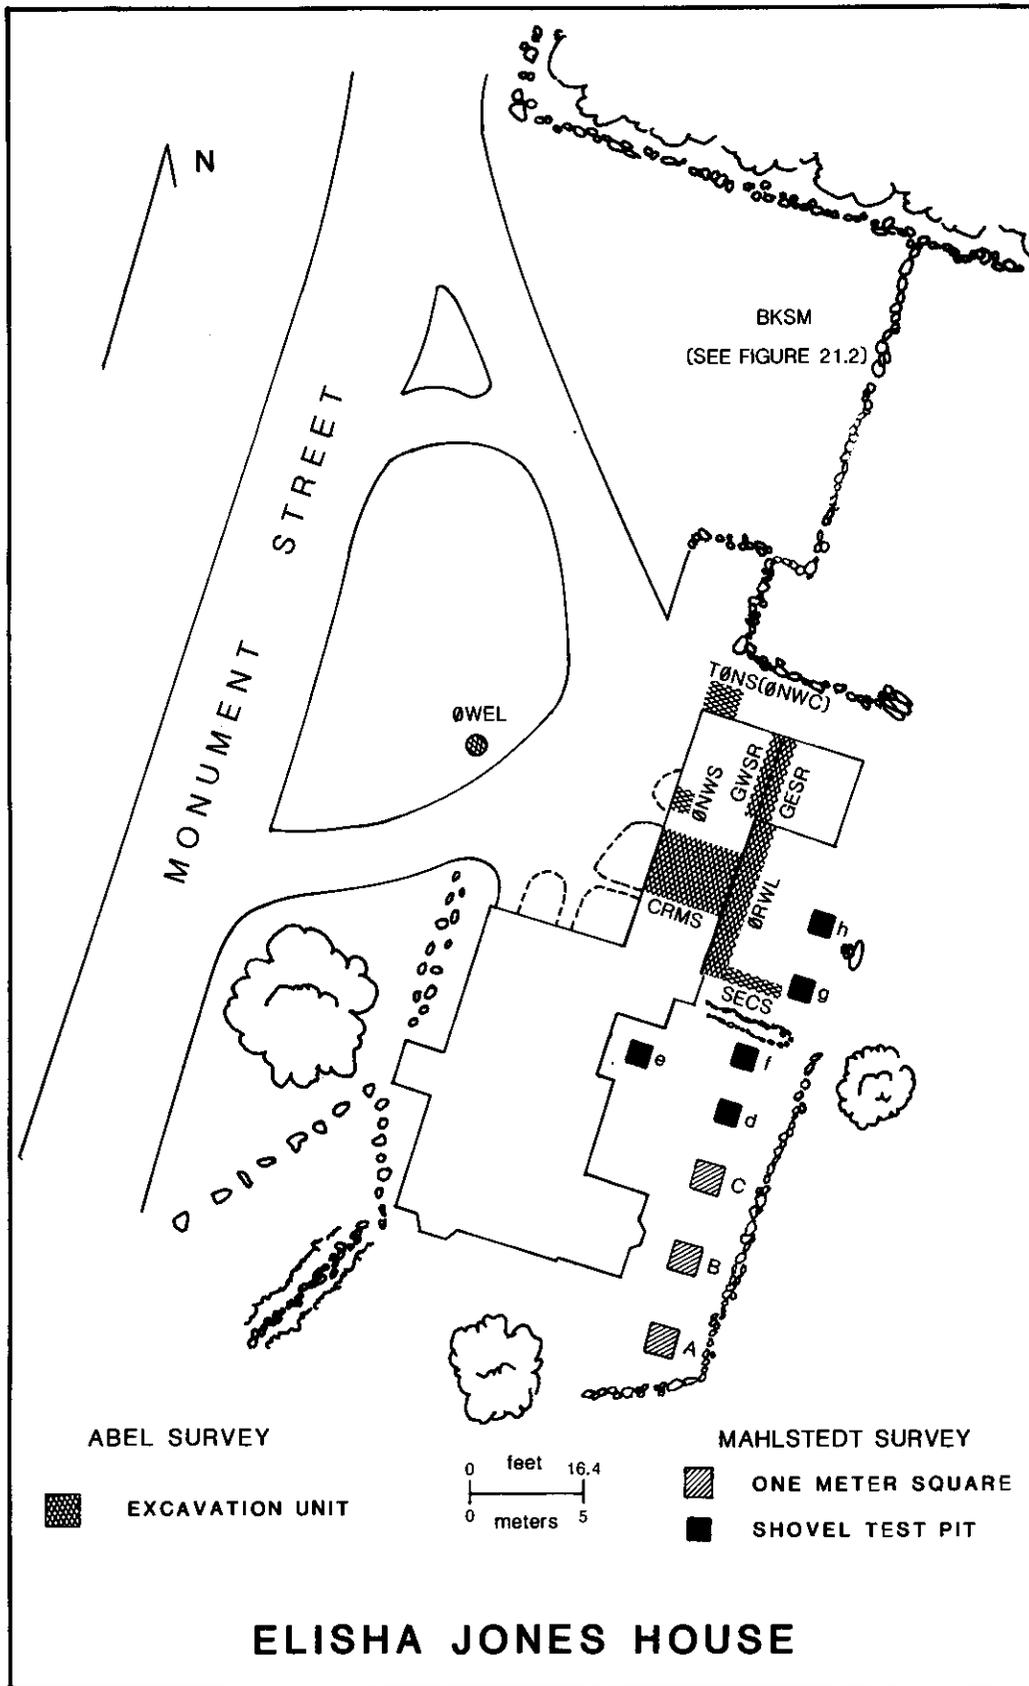
Figure 21.1. ACMP draft of Mahlstedt's site map (1979:10), to which Abel's excavation units have been added.

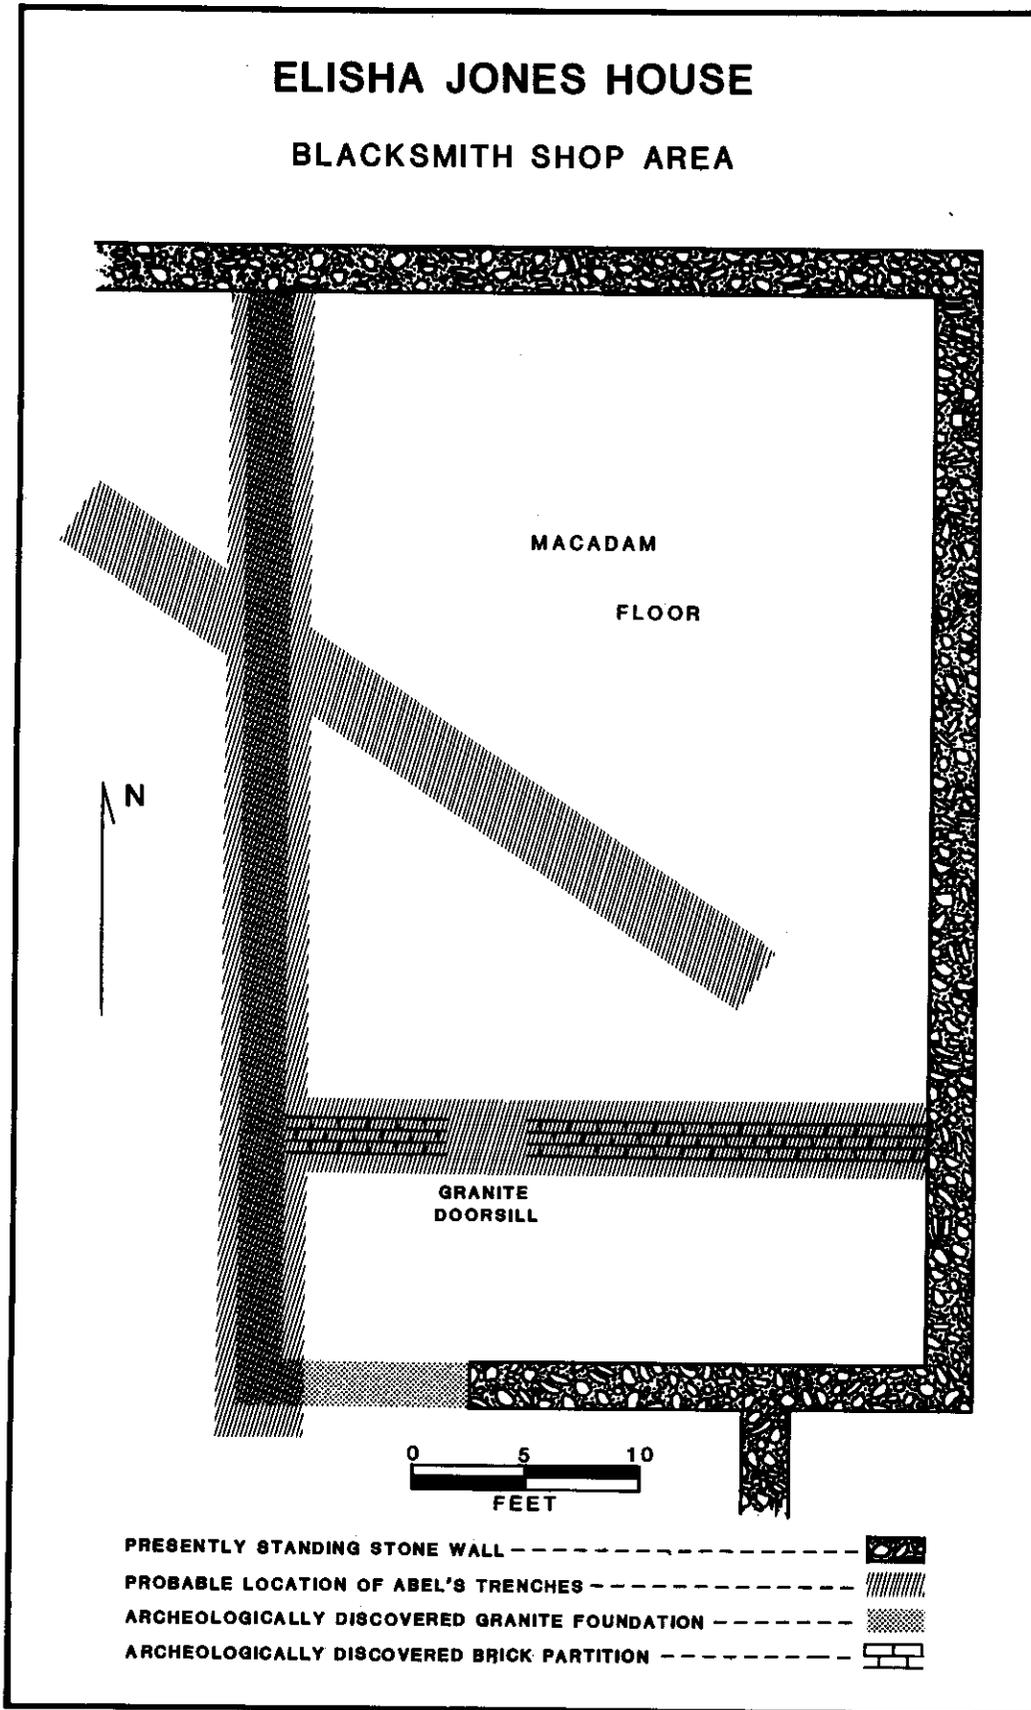
Figure 21.2. ACMP reconstruction of Abel's trenches in the blacksmith shop.
