ARCHEOLOGICAL
COLLECTIONS MANAGEMENT
AT
MINUTE MAN
NATIONAL HISTORICAL PARK

MASSACHUSETTS

VOLUME 4

ACMP Series No. 4

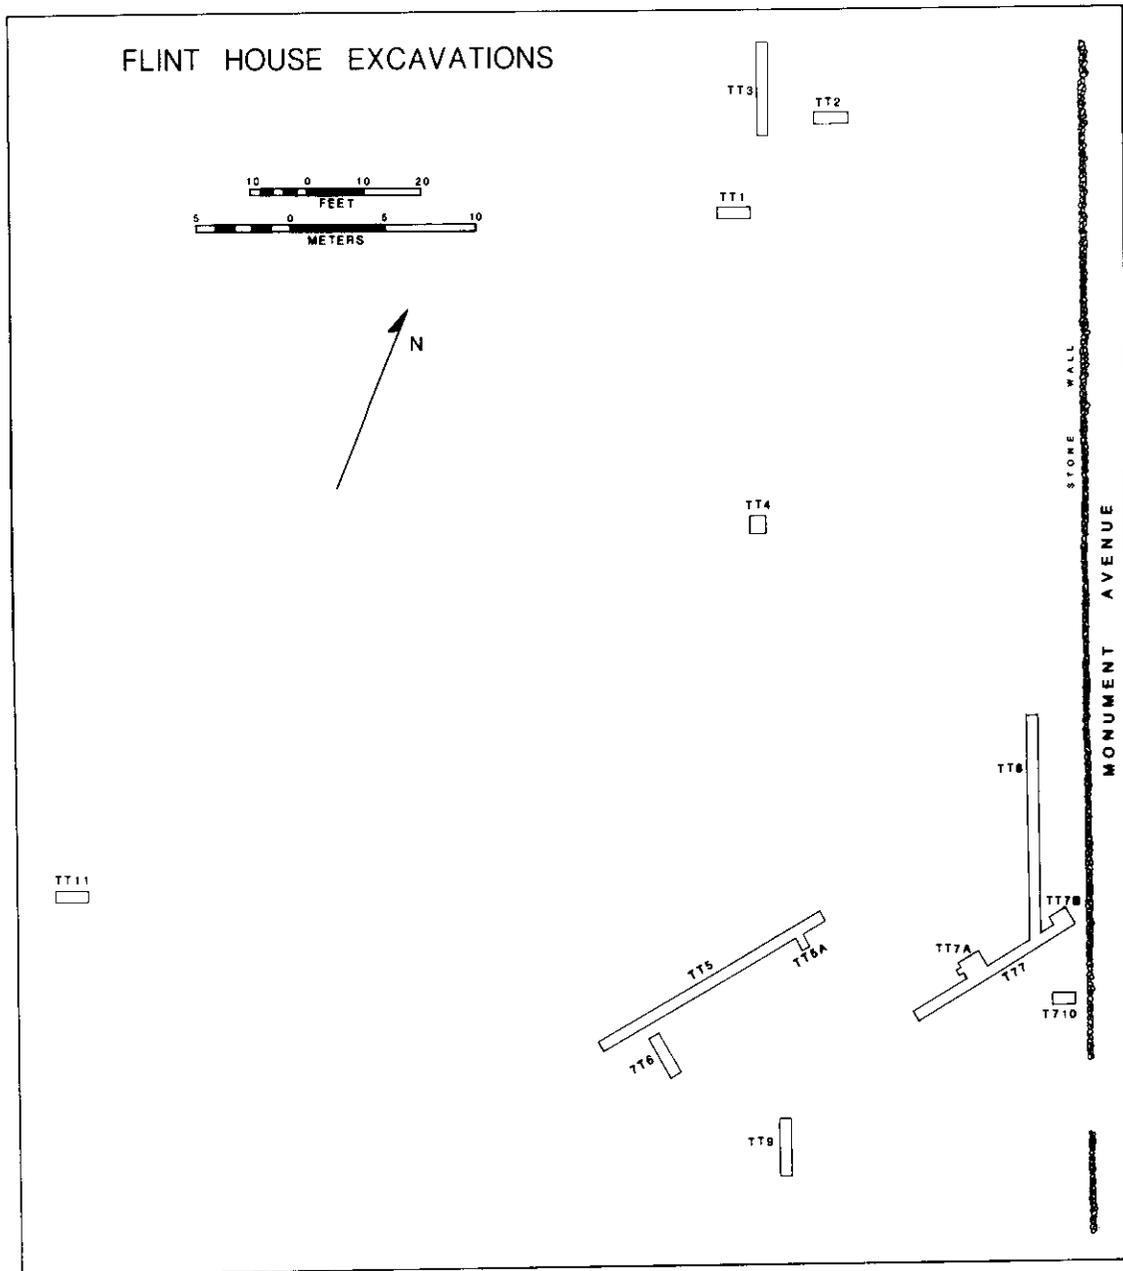
Figure 22.1. ACMP map showing approximate location of Tremer's excavation units (from Tremer 1973b:6).
