National Park Service
Cultural Landscapes Inventory
2009

Thomas Farm (Araby)
Monocacy National Battlefield

Inventory Summary

Inventory Unit Description:

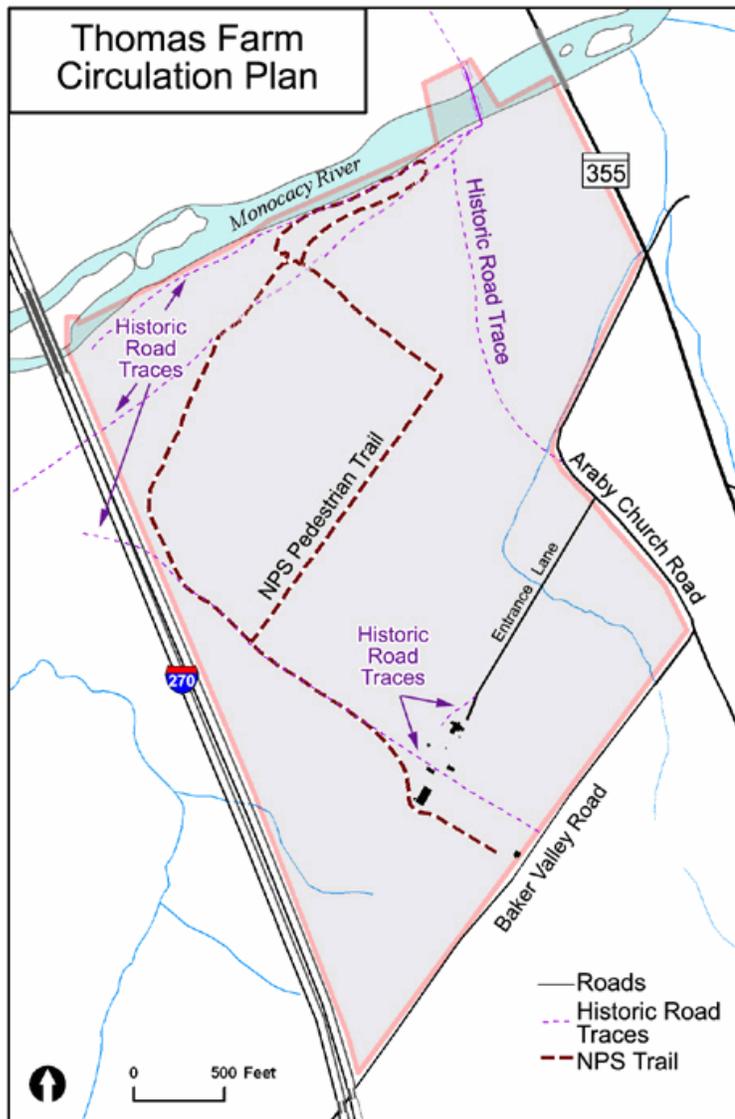
Thomas Farm Circulation

Modern circulation features on Thomas Farm include various internal farm lanes, a pedestrian trail put in by the NPS in 2006 and the parking area located east of the main house. Brick pathways that were installed by the Clapp family in the 1950s are found in the rear domestic yard and in front of the main house. As more recent additions to the landscape, these modern

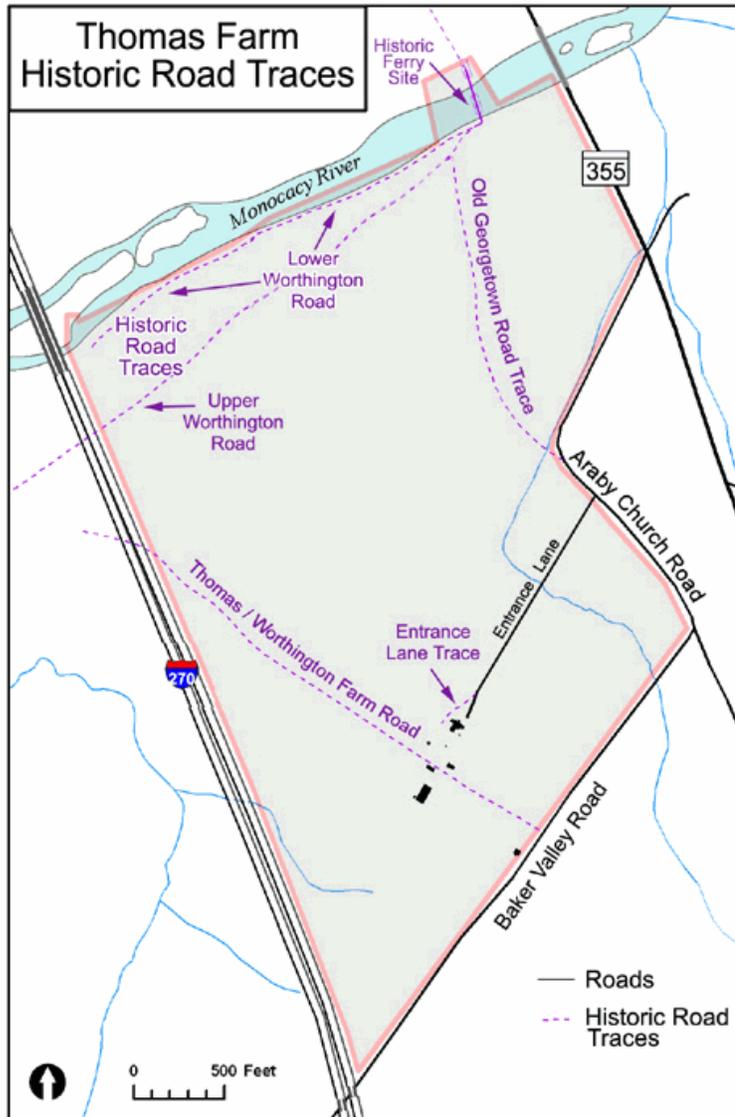
*Thomas Farm
Historic Road Traces*

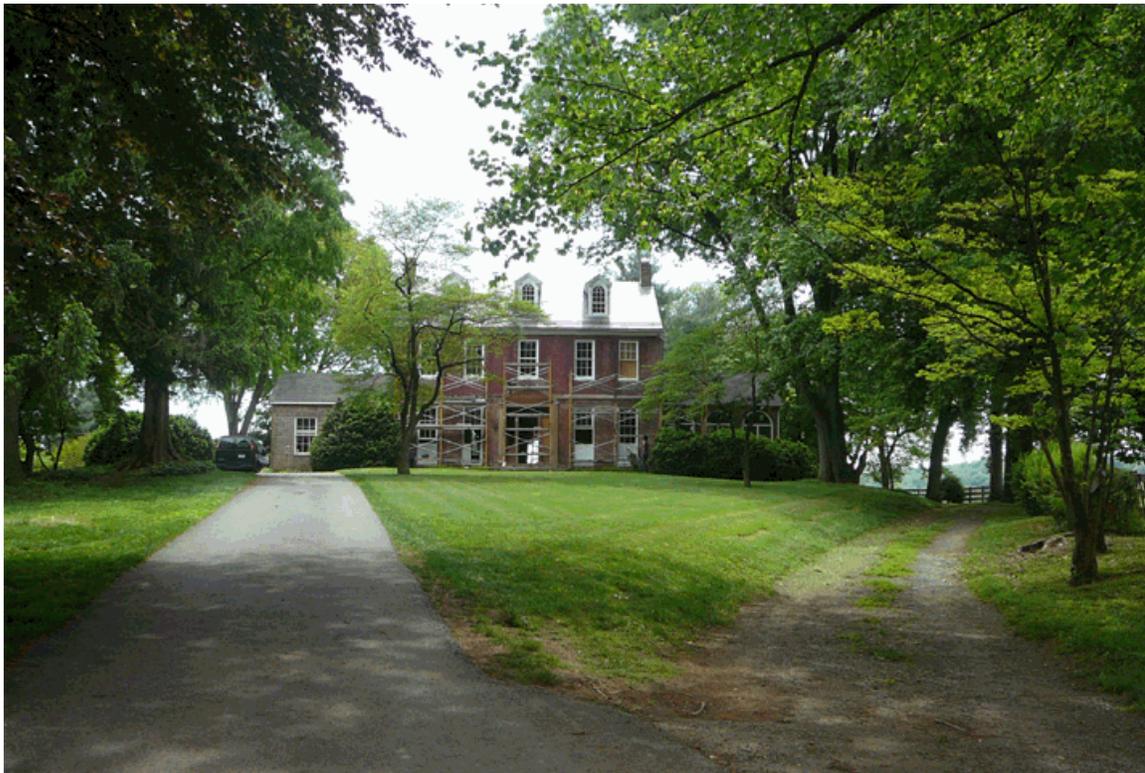
Thomas Farm Entrance Lane with the Entrance Lane Trace to the right (NCR/CLP 2009).

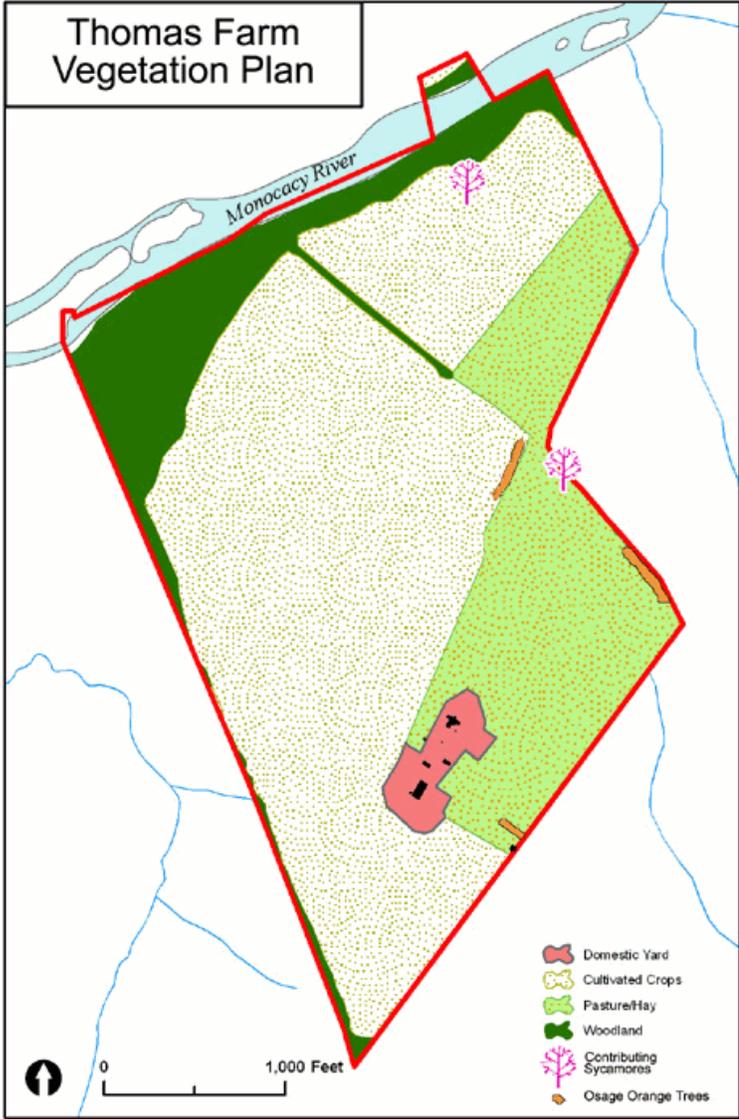
Thomas Farm: Vegetation Plan

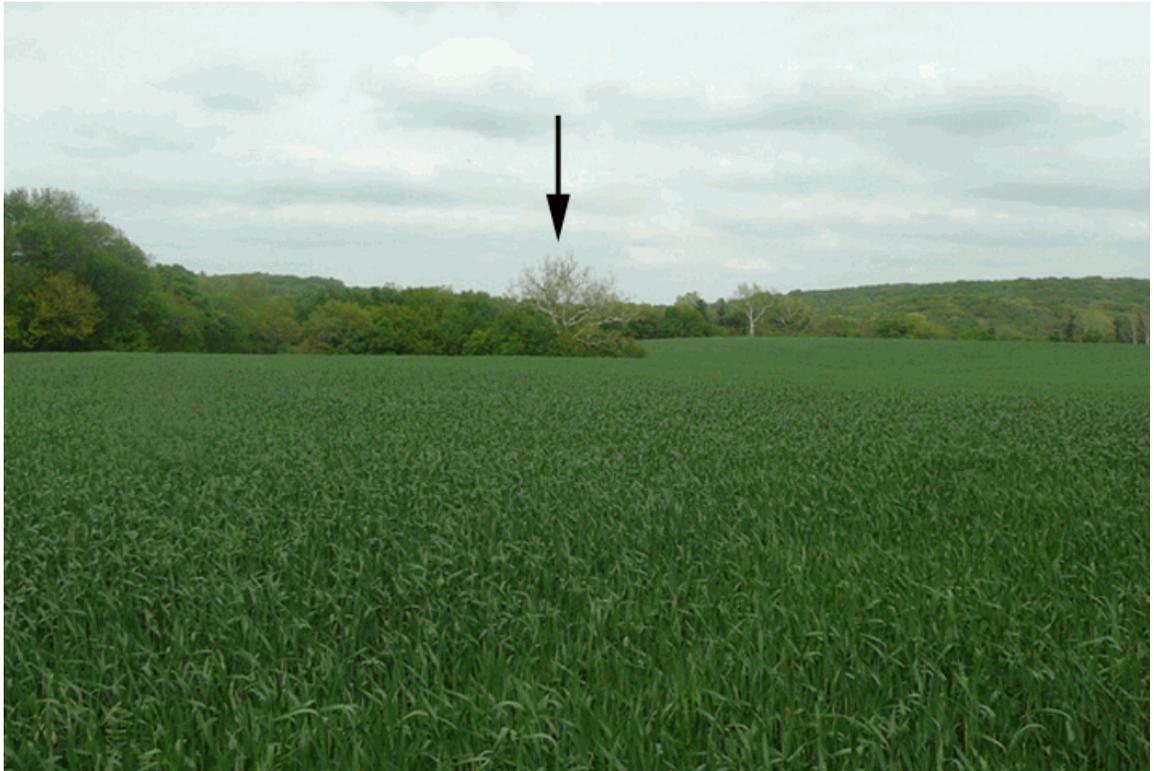
Thomas Farm: View across cropped field towards the river. The 300 year old sycamore can be seen in the center of the photo (NCR/CLP 5/2009).

At least two trees located on the Thomas Farm are known to date to the period of significance. They are both sycamores (*Platanus occidentalis*). One - estimated at over 310 years old - stands slightly south of the tavern site, on the east side of the Georgetown Road trace. This tree has been documented by the Historic American Landscape Survey as an historic tree. The other is found along the original Georgetown Road/Pike trace adjacent to Araby Church Road.

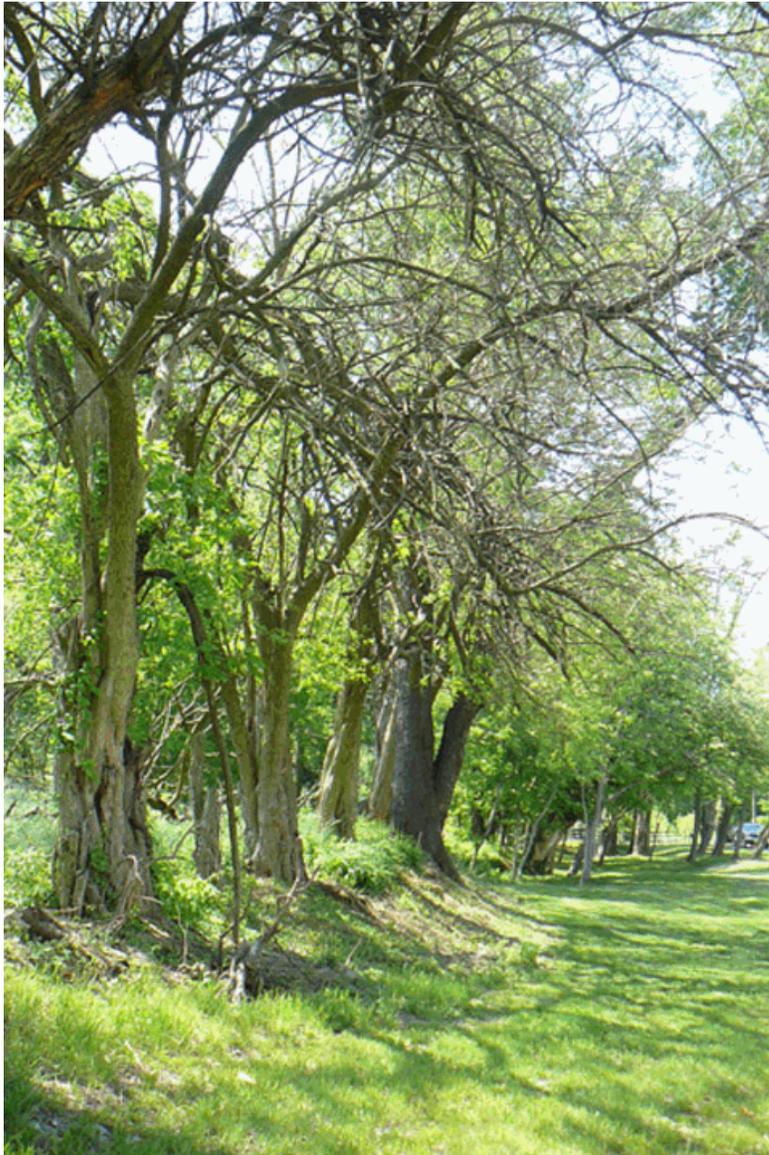
Line of Osage Orange trees along Araby Church Road (NCR/CLP, 4/2009).

In the nineteenth century, the agricultural press promoted living fences as a replacement for expensive post and rail fencing. Living fences were praised for their beauty, for the protection and shelter they provided, and for their effect on the temperature and moisture levels of the climate. Osage orange (*Maclura pomifera*) discovered growing on the plains of the mid-west, was brought east in 1803 to Philadelphia. Once recognized for its suitability as hedging, in the 1840s, growers were motivated to make it available commercially some time after 1850. For example, Warder's 1858 edition of "Hedges and Evergreens" promoted it as the hedge standard for the United States. Osage orange trees were planted on the Thomas Farm, as remnants still stand today.

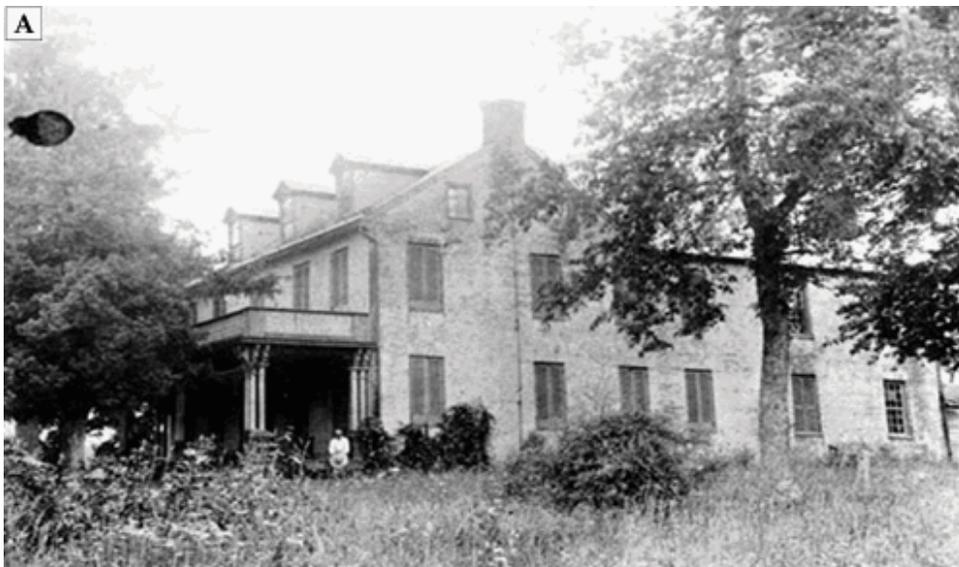
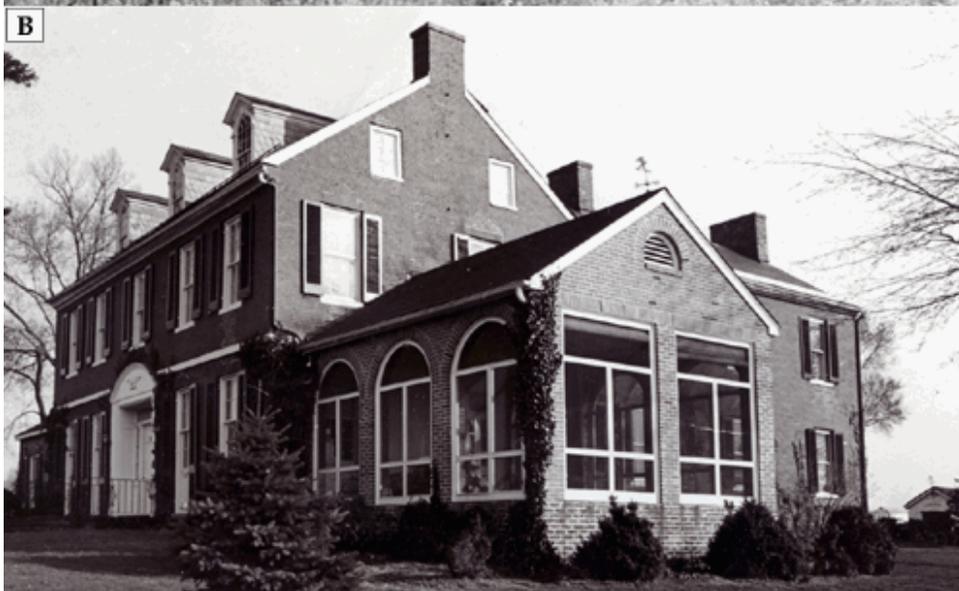
View of the Thomas Farm Main House

A: 1893 (Davis)

B: 1962 (Clapp Family)

The main house on the Thomas Farm was constructed in several phases and has been significantly altered from its original historic appearance. Major repairs and changes to the building have also been made since the time of the Battle of Monocacy; however, the Thomas House retains a high level of architectural integrity. While the original date of construction is not precisely known, historians generally agree that it was constructed by 1780.

The L-shaped, two-story brick structure has a slate roof and is oriented to face the historic Georgetown Road (Araby Church Road). The historic main block features fourteen rooms, an attic, and a partial cellar. Historical and architectural evidence suggest at least six distinct periods of construction: initial construction before 1795; expansion ca. 1795; expansion and remodeling between 1812 and 1847; additional expansion ca. 1860; repair and remodeling after the Battle of Monocacy in 1864; and mid-20th century renovation and alteration.

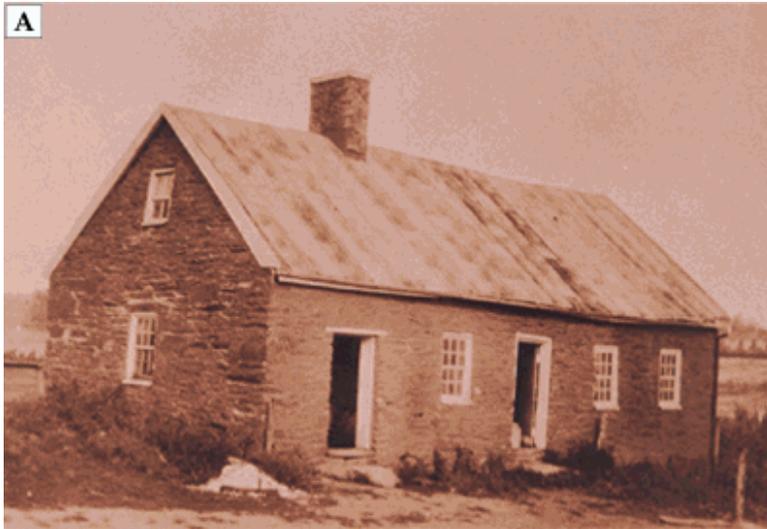
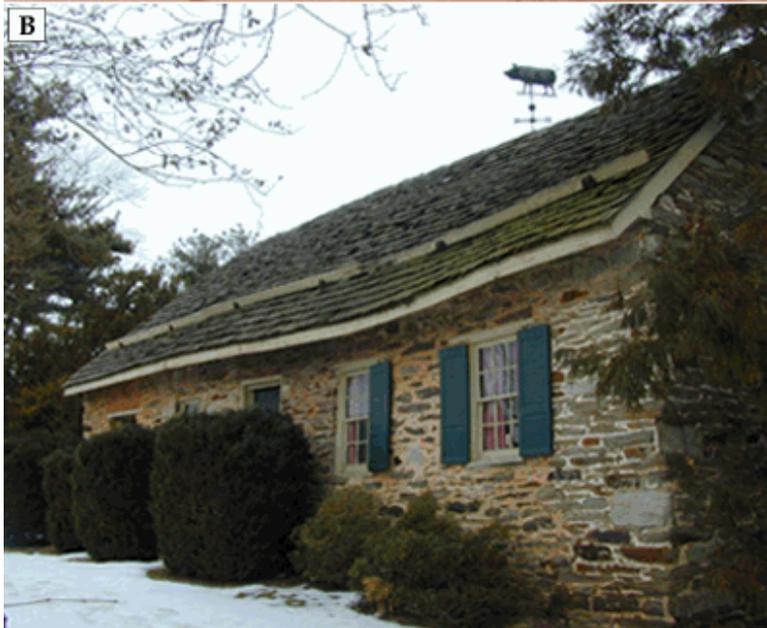
Thomas Farm Stone Tenant House

A: 1931 (Fred Cross)

B: 1999 (NCR/LCS)

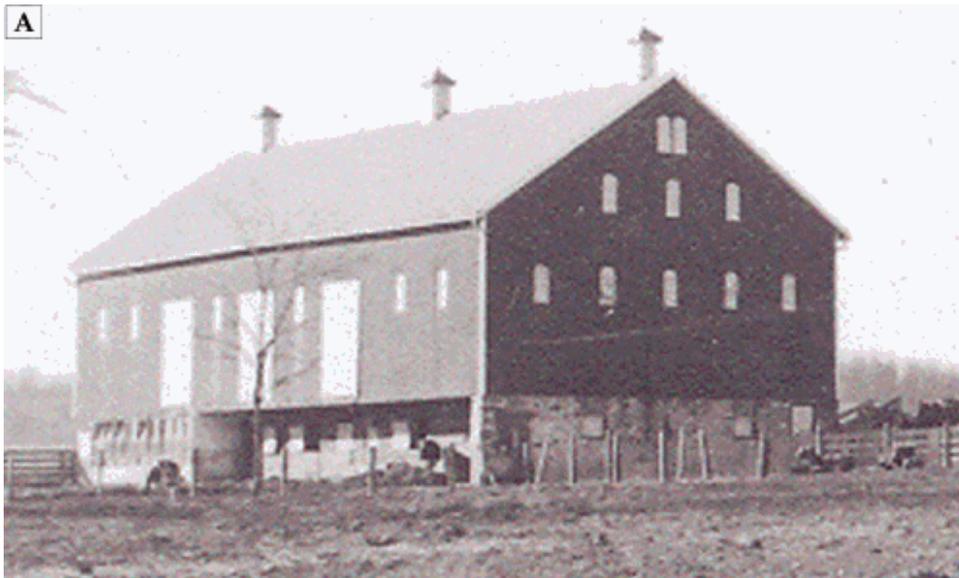
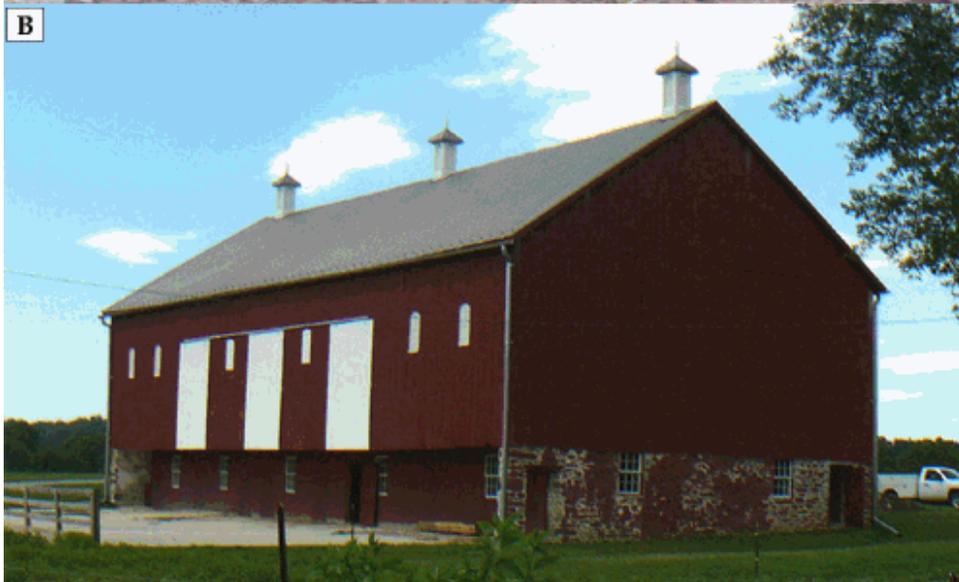
Thomas Farm Bank Barn
A: 1949 (Hilgenberg)
B: 2009 (NCR/CLP)

The Thomas barn is a Pennsylvania-style timber frame bank barn that faces east, with a ramp at the back and a closed-side cantilevered forebay. A fenced-in barnyard is located immediately east of the building. Historic fabric investigations indicate that this structure dates from the early 20th century, which means that it was likely constructed to replace the earlier brick barn shown in the Scharf engraving and described in the 1899 sale bill. The brick barn may have dated to the 1830s; it was certainly constructed well before 1847, since it is described in the insurance list with an "old" roof. "[S]outh of the corn cribs about 105 feet stands the barn sized 75 feet 2 inches long and 49 feet deep including the overjut on the east side, the basement story is built of stone, the other part is built of brick, and has 2 division walls runing [sic] a cross the barn, as high as the square of the building built of brick 14 inches thick. Barn is covered with oak shingles. The roof is old, lightning rod at the North end." There may also have been an even earlier barn dating from the 18th century. As pictured in the Scharf illustration, the brick barn had three square cupolas projecting from the gable and granary outshots on either side of the threshing floor. Geometric brick ventilators pierced the brick gable walls.

The present barn is constructed of timber frame on the same foundation that supported the brick barn, although the foundations were expanded to support the much larger bank barn. Vertical board siding sheaths the current barn's frame and the roofing material is sheet metal. The barn underwent a multi-year restoration that began with emergency stabilization in 2003. The restoration project was completed in 2009 and the barn is now used by the NPS for vehicle and equipment storage.

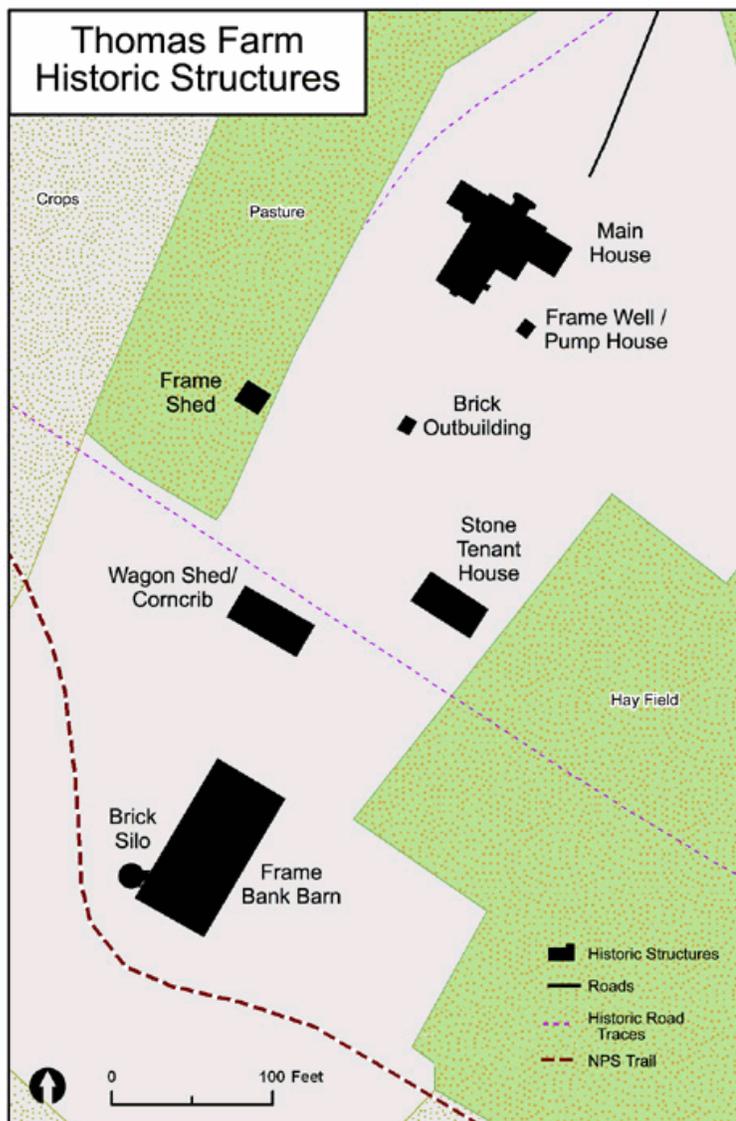
Thomas Farm: Historic Structures

The extant buildings of the Thomas Farm today are an 18th-century brick main house, an 18th-century stone tenant house, a 19th-century brick outbuilding, a 19th-century frame equipment shed, a 20th-century frame well/pump house, a 20th-century timber frame bank barn constructed on the foundation of an earlier brick barn, and a 19th-century timber-frame wagon shed/corn crib.

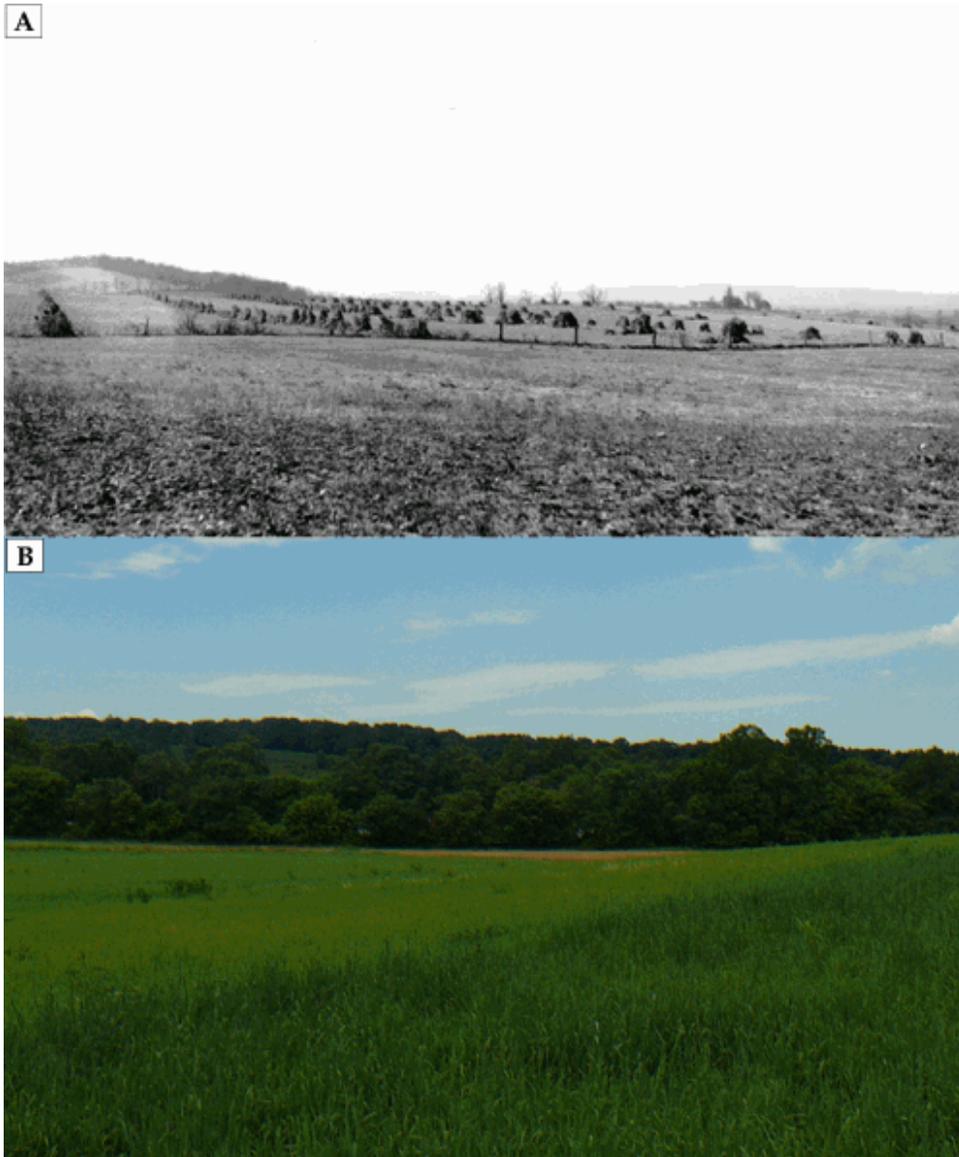
View from the Thomas Farm towards the Worthington Farm

A: circa 1930. Fence line in the middle distance is the Thomas/Worthington boundary (MONO CLI).

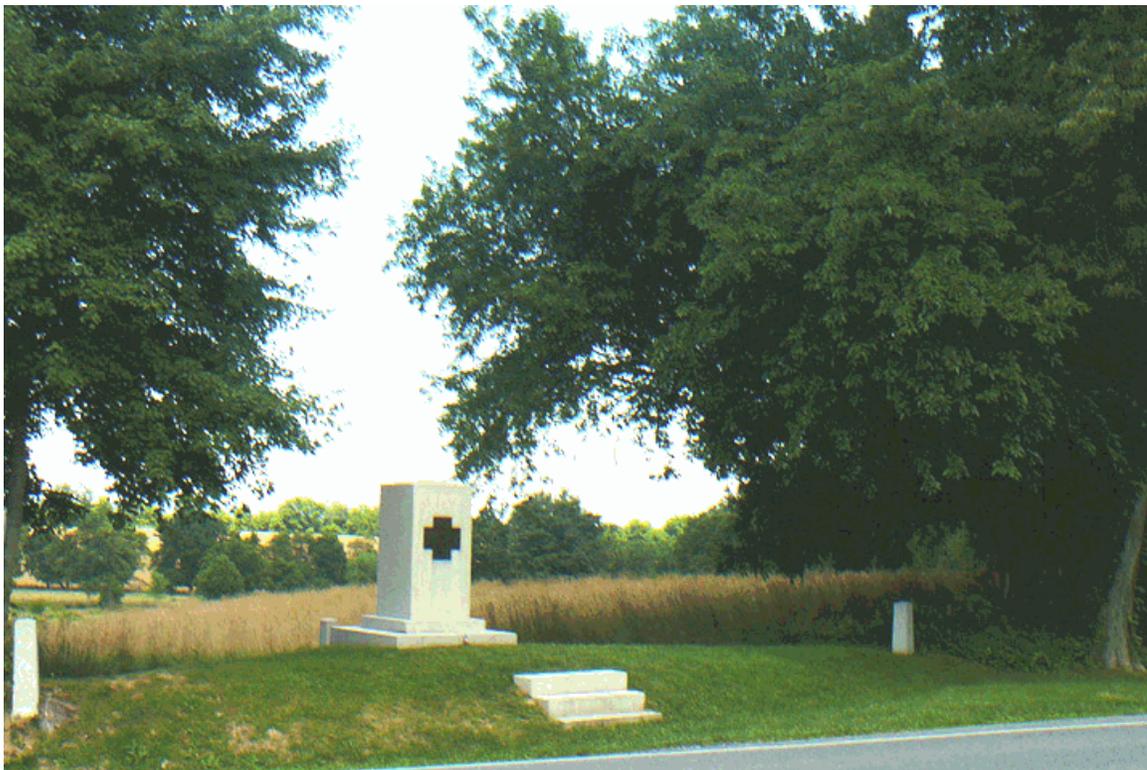
Vermont Monument
(NCR/CLP 7/2009)

The Vermont Monument remains in its original location, is in excellent condition and retains a high degree of integrity. As such, it contributes to the historic character of the Thomas Farm cultural landscape.

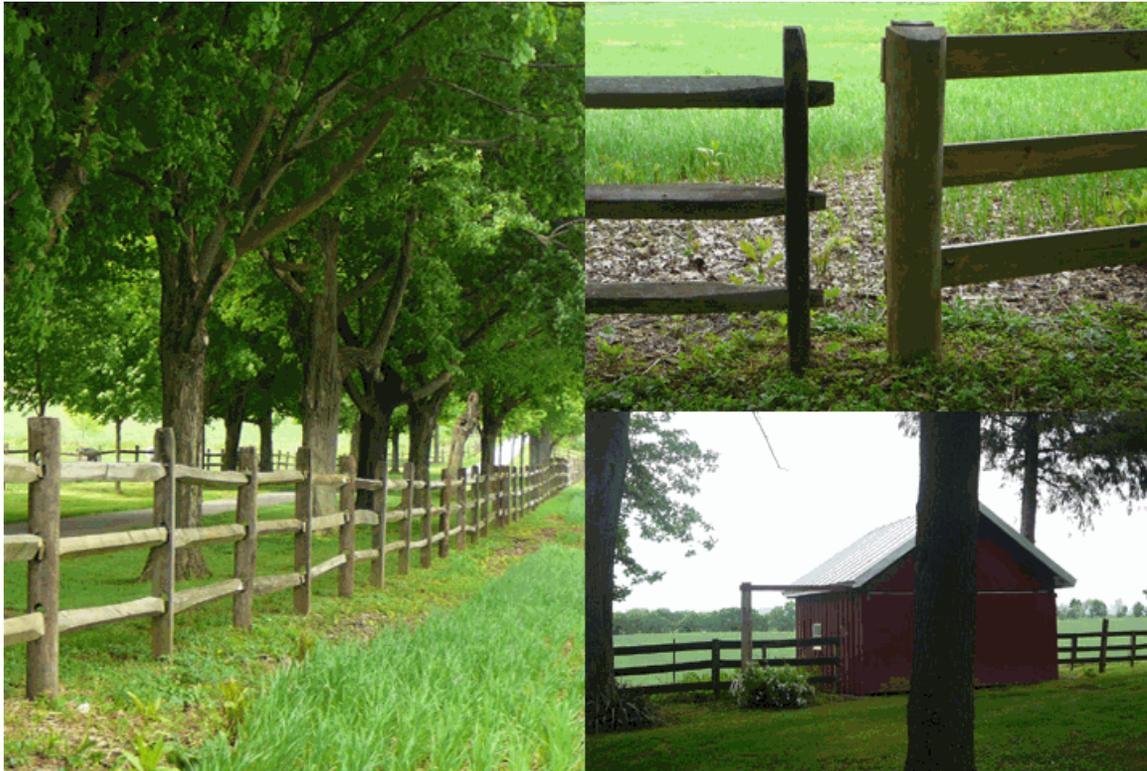
Thomas Farm Fences
3-rail fence along Entrance Lane, two types of 3-rail fence, 3-rail board fence near the
Frame Shed (NCR/CLP 2009)

Several types of fences can still be found on the Thomas Farm area. They include board fencing, two types of high-tensile wire fence, three-rail administrative fence, and post and bale barbed wire fencing.
