National Park Service  
Cultural Landscapes Inventory  
2005

East Side Highway  
Mount Rainier National Park

CULTURAL LANDSCAPES INVENTORY (CLI) PROGRAM  
*2010 Condition Assessment Update for:*

**East Side Highway**  
Mount Rainier National Park

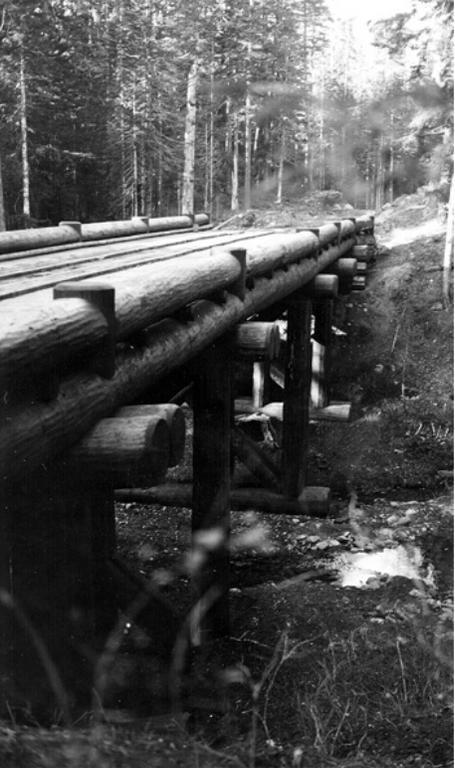
*Historic photo showing log stringer bridge over Cougar (Panther) Creek, 1935. (MORA Archives, twc278)*

Two of the original bridges built in the construction of the East Side Highway have been replaced since the historic period. The original bridge over Panther Creek (MP05.215), a log stringer bridge that began to show signs of decay by 1947, was replaced with a reinforced concrete and steel girder bridge in 1957. Built in conjunction with the Mission 66 rehabilitations, the design of the bridge reflects the aesthetic sensibilities characteristic of the 1950s, with simple, modern lines and a lack of ornamentation. The steel guardrails are composed of three horizontal rails that curve down into the curb at the ends.

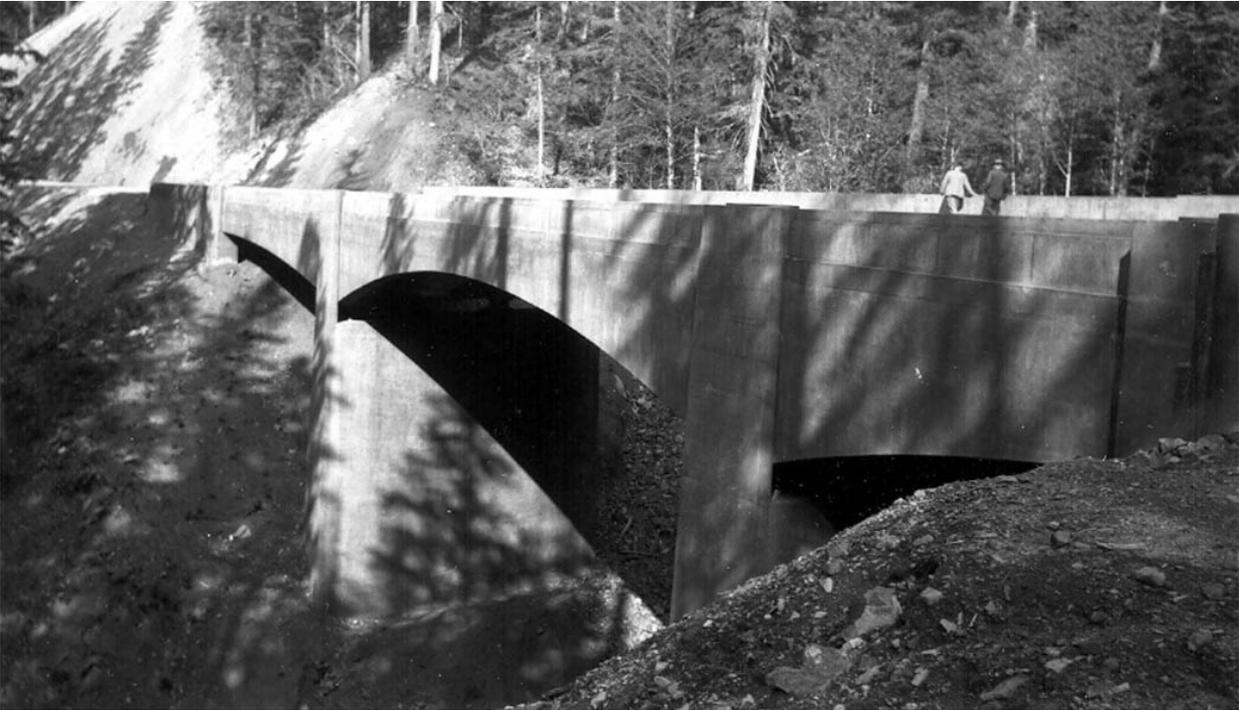
*Historic photo showing the bridge over Laughingwater Creek after completion in 1935. (MORA Archives, ps2017)*

The first bridge spanning Laughingwater Creek (MP05.215), completed in 1935, was a reinforced concrete bridge designed as a three-span, tee-beam structure with granite guardwalls facing the road. Tests performed during the 1980s revealed chemical precipitants leaching from the bridge, with exfoliation and cracks in the tee-beams. The failing bridge was replaced in 1995 with a 396-foot-long reinforced concrete bridge. The new bridge has simulated stone guardwalls made of cast concrete using

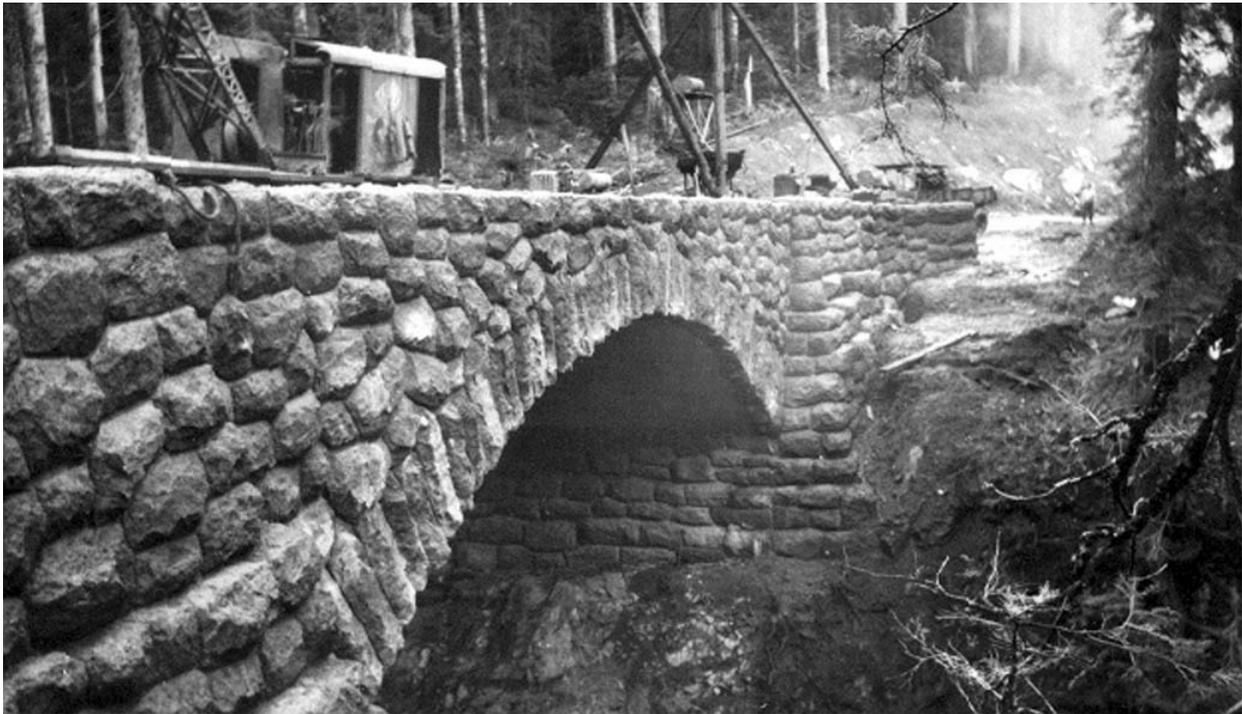
*Historic photo showing Deer Creek Bridge during construction, 1939. (MORA Archives, ps4056)*

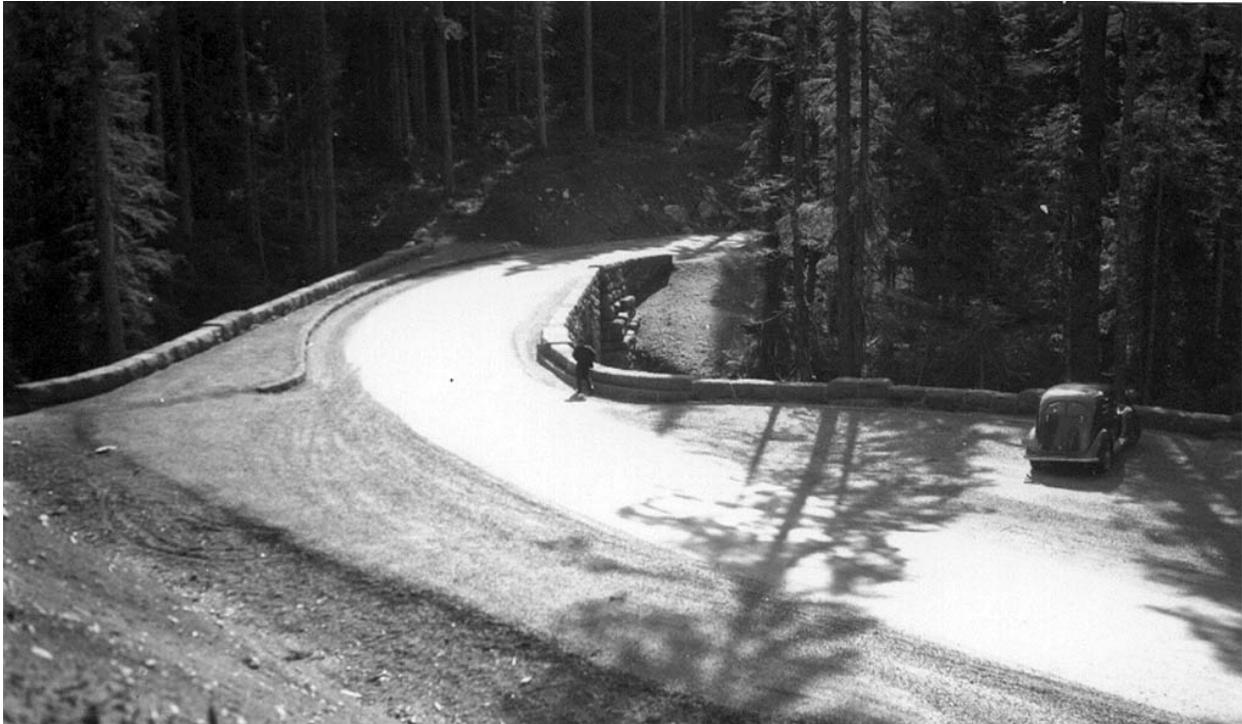
*Historic photo showing Deer Creek Bridge. The turnout at right provided visitors a view of the bridge, 1940. (MORA Archives, ps 2288)*

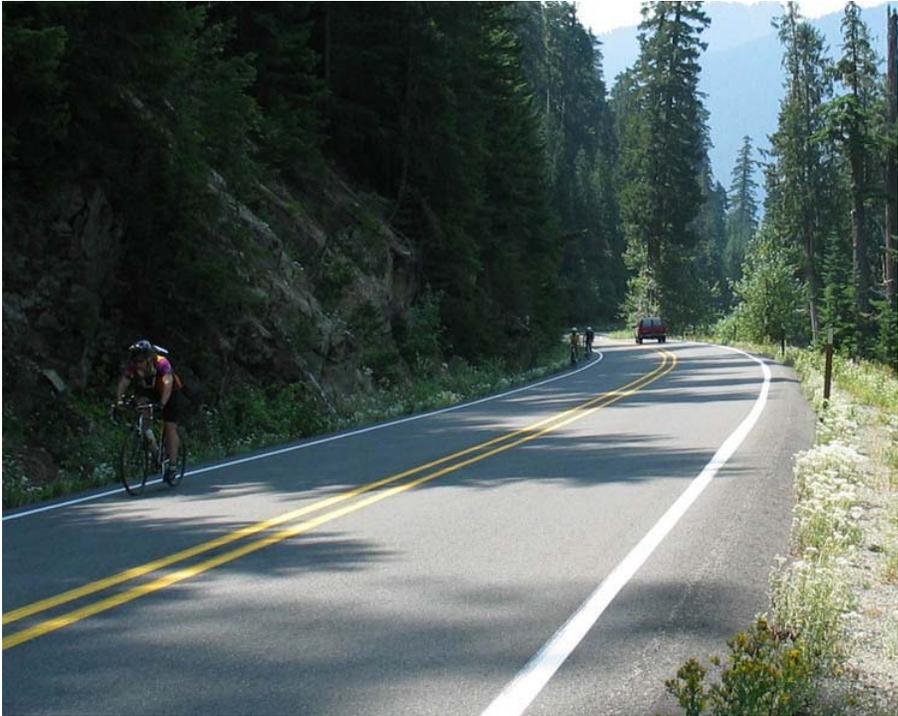
*Contemporary photo showing road with paved travel lanes, paved shoulders, and painted lines. The road serves both vehicular and bicycle travel. (MORA, 2004)*

Since the historic period, the road has been paved and widened in places to a uniform width of 24 feet, including two 11-foot travel lanes and two 1-foot paved shoulders. Travel speed in the southern portion of the road has increased from 35 miles per hour to 45 miles per hour. On the northern portion, however, the tight curves and dramatic character of the road keep speeds relatively low. Despite an increase in average speed along the road, the overall patterns of vehicular speed and traffic control remain and contribute to the cultural landscape.

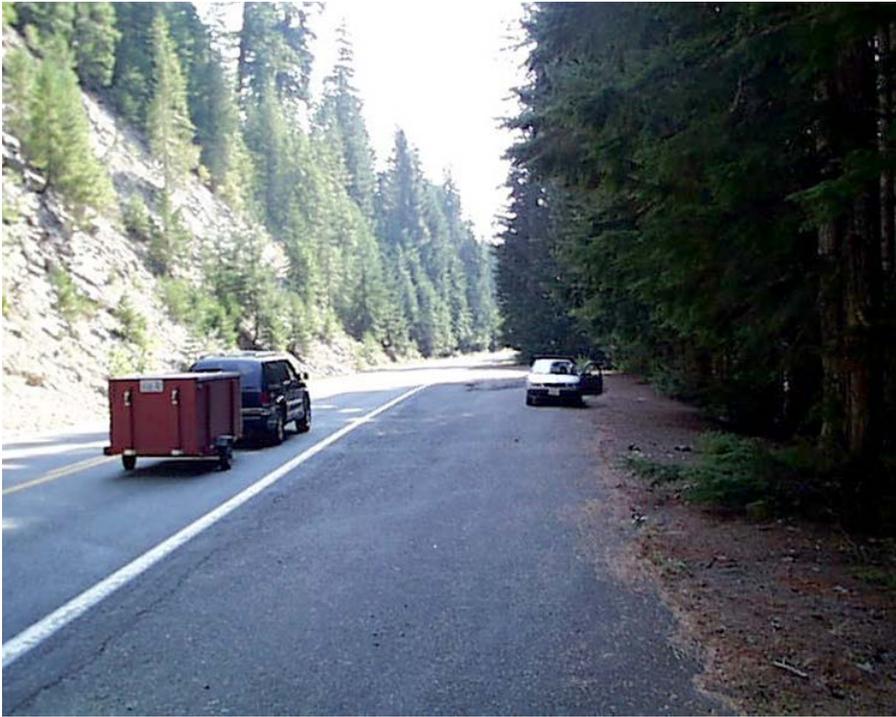
*Contemporary photo showing a turnout that has been widened and lengthened since the historic period. (MORA, 2003)*

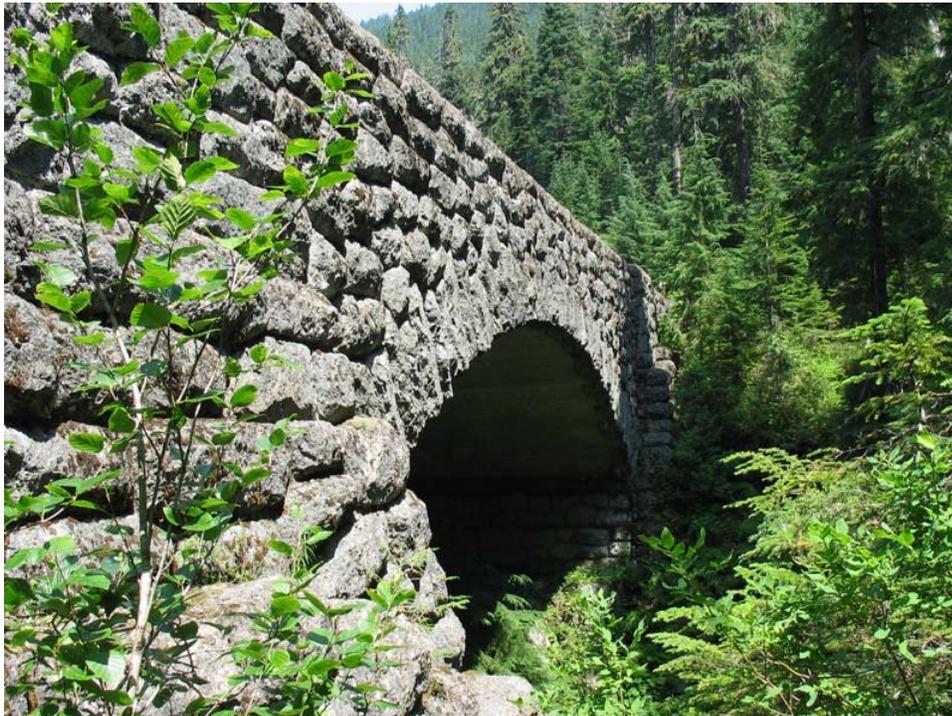
*Contemporary photo of Deer Creek Bridge. (MORA, 2004)*

Deer Creek Bridge (located at MP09.738) was designed by NPS landscape architects in 1936 and was completed by 1939. The bridge, measuring approximately 268 feet long and 39 feet wide, is a concrete-arch deck design with native volcanic stone facing on the arch, parapet, and abutment walls. The stepped concrete abutments, also veneered in masonry, rest on solid stone foundations. The bridge facing comprises rough-cut stones of various sizes and shapes mortared with recessed joints approximately 1 inch wide. The arch ring stones were individually specified with regard to size and shape, ensuring an irregular, hand-crafted effect. The overall character of the bridge is that of a substantial and grounded structure, integrated with, and growing out of, the natural landscape.

Since the historic period, the bridge has undergone minor updates, primarily to the road surface. In 1958, the East Side Highway, including Deer Creek Bridge, was paved with asphalt and painted with yellow center lines and white fog lines. It was likely at this time that the original sidewalk and stone curb on the west side of the bridge were removed. The periodic resurfacing of the road for maintenance and safety reasons does not adversely affect the integrity of the structure. In some places, the stone facing is becoming separated from the concrete core and is need of repair. Despite this, the bridge, including the concrete arch, the stone facing, the stepped abutments, and the foundations, is overwhelmingly intact and contributes to the historic character of the road.

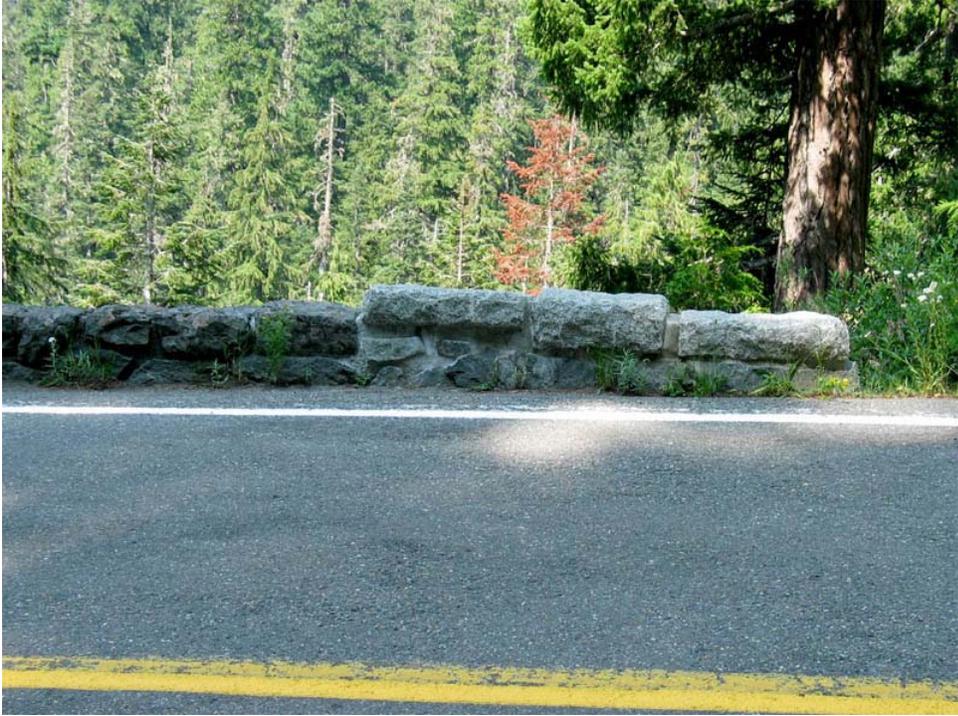
*Contemporary photo of a guardwall on the East Side Highway showing modern repairs using incompatible stone. (MORA, 2004)*

Today, the historic guardwalls and retaining walls are generally in good condition, retaining most of their original fabric and design integrity. Over the years, the stones have weathered and discolored and have grown moss and lichens on their mottled surfaces, contributing to the naturalistic effect and increasing the cohesion with the natural surroundings. In some places, however, repairs have been made to the walls with incompatible materials such as granite and bright white mortar. While these repairs are generally successful in replicating the scale, dressing, and overall design of the original fabric, the imported materials contrast sharply with the darker, mottled native stone, detracting from the historic scene of the road. More repairs are needed in other places, as some of the stones have loosened or rotated outward, threatening the structural integrity of the walls. Despite these changes, the guardwalls and retaining walls retain their historic integrity and help convey the significance of the cultural landscape.

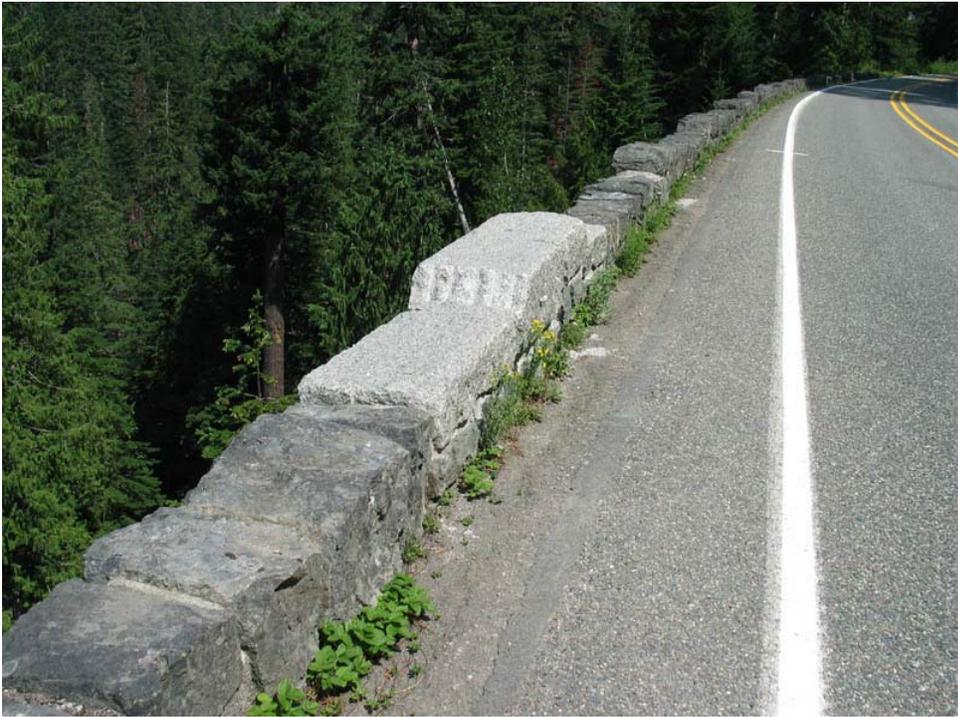
*Contemporary photo of a guardwall on the East Side Highway showing recent repairs using incompatible granite. (MORA, 2004)*

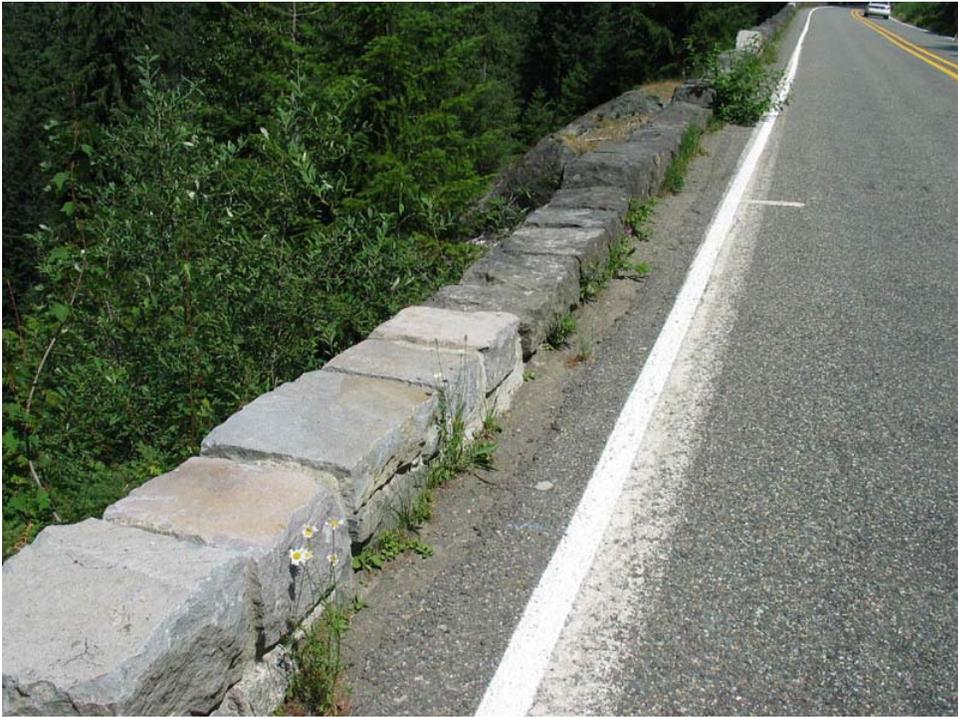
*Contemporary photo of a guardwall on the East Side Highway showing a recent repair with compatible stone material. (MORA, 2004)*

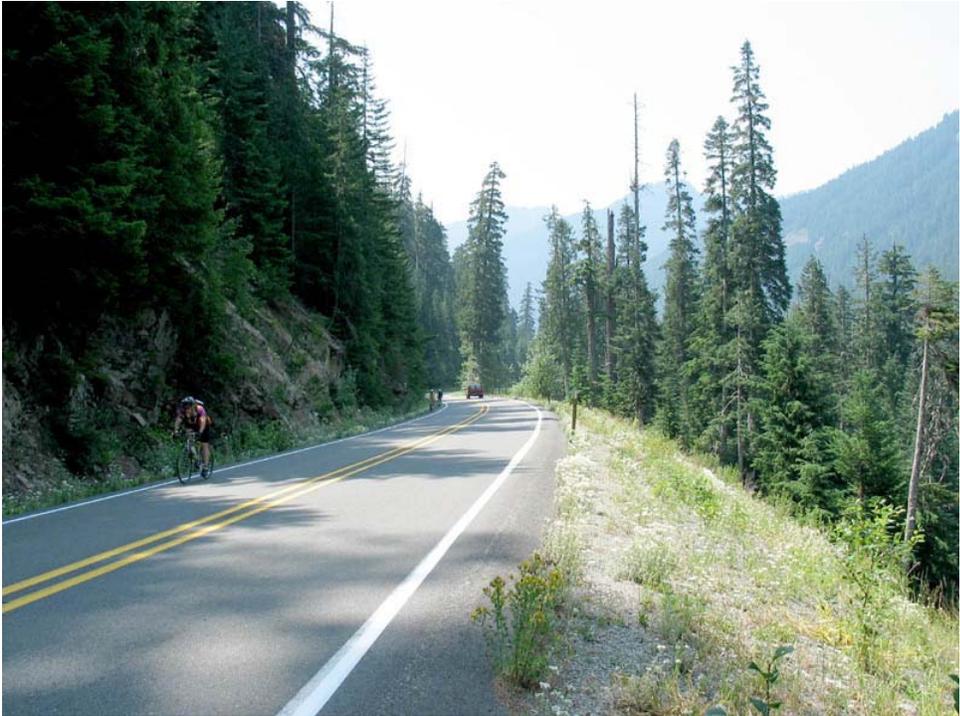
*Contemporary photo of the East Side Highway showing a typical half-bench cross section. (MORA, 2004)*

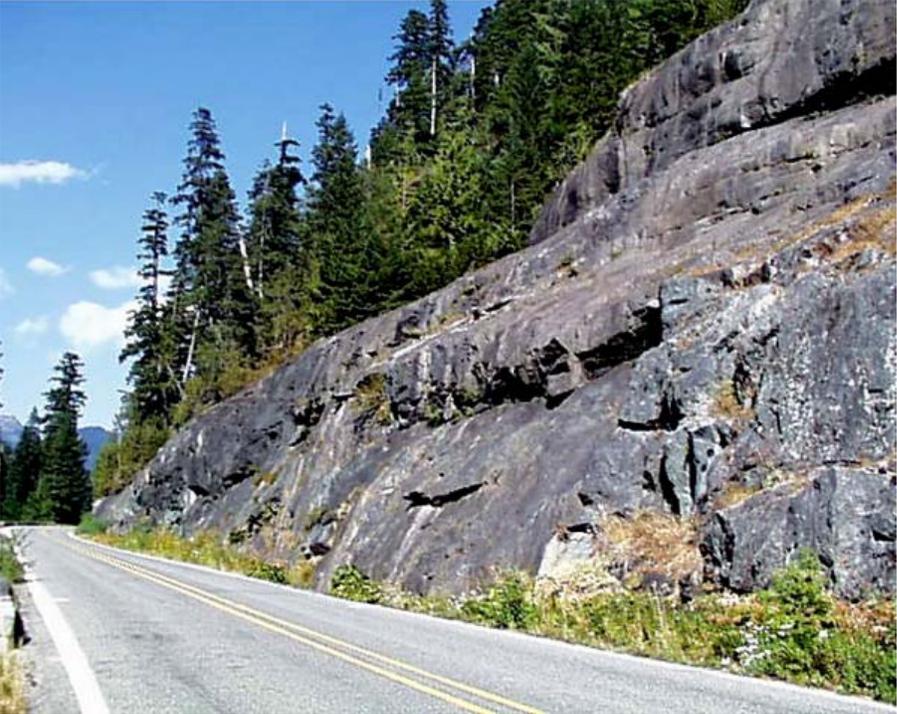
*Contemporary photo showing a battered rock cut on the East Side Highway. (MORA, 2004)*

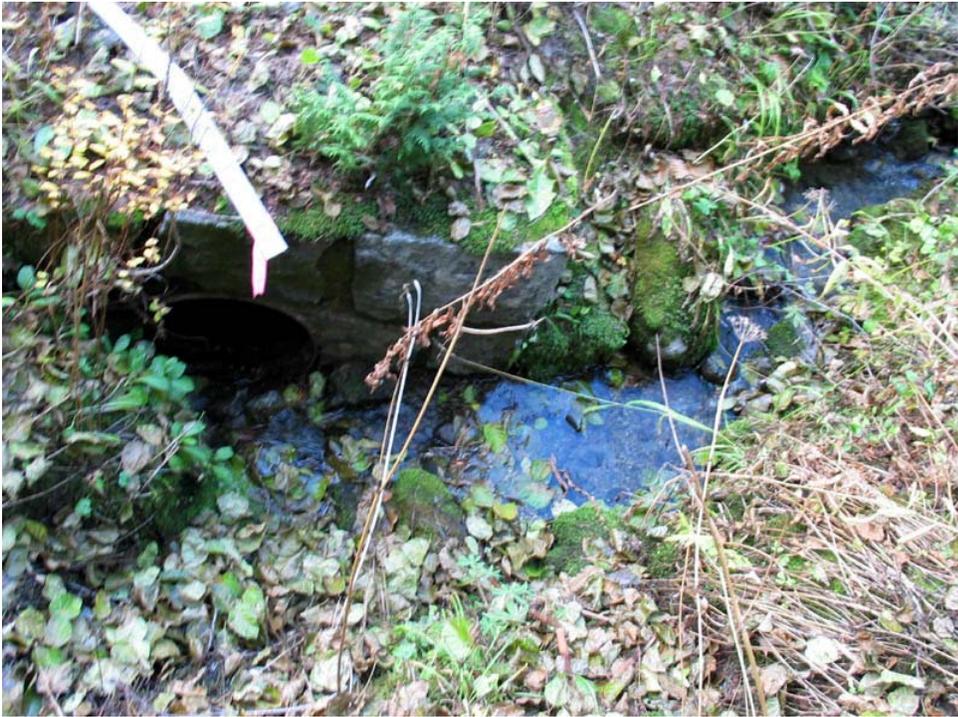
*Contemporary photo showing water conveyance in a ditch on the East Side Highway. The water is diverted just before the culvert to trap sediment and debris. (MORA, 2004)*

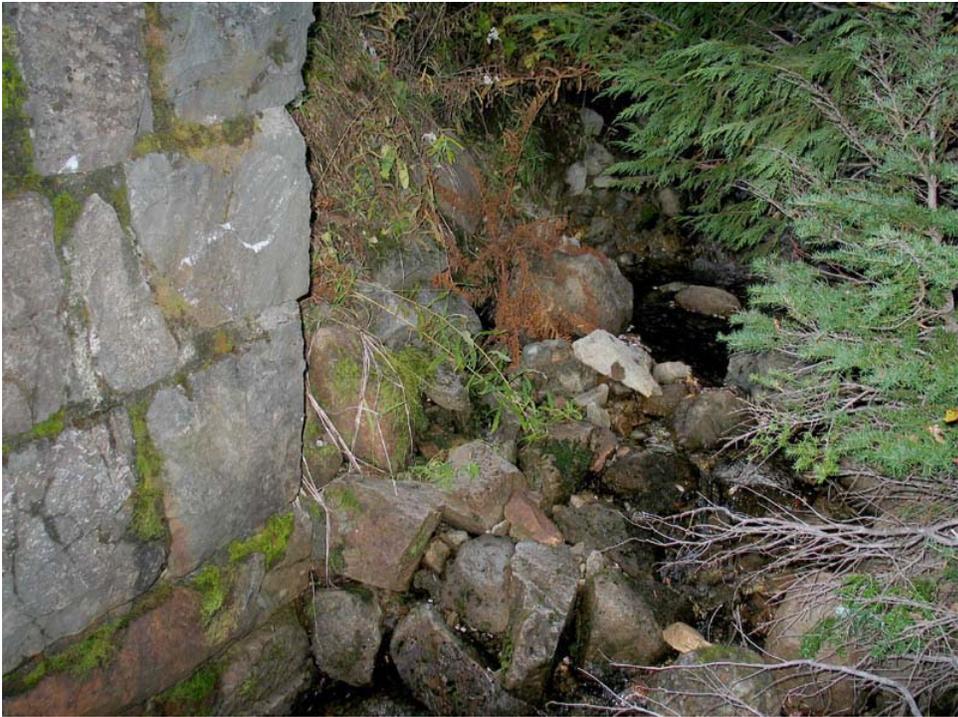
*Contemporary photo of a ditch and culvert on the East Side Highway. Constrictions in the ditch create small pools to trap sediment and debris. (MORA, 2004)*

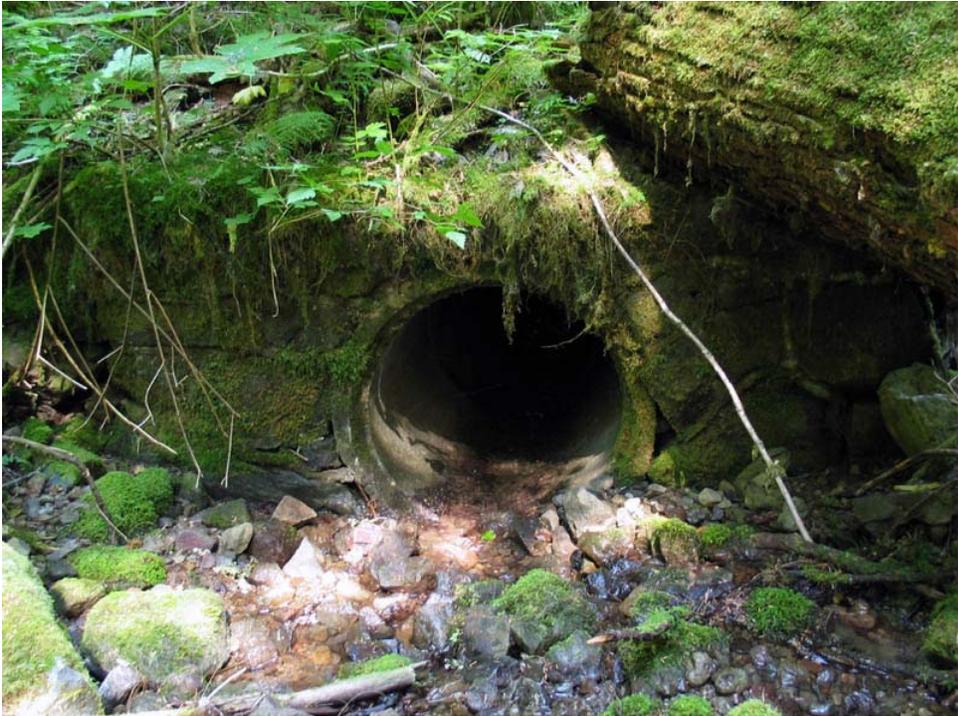
*Contemporary photo showing a typical culvert and stone headwall on the East Side Highway. (MORA, 2004)*

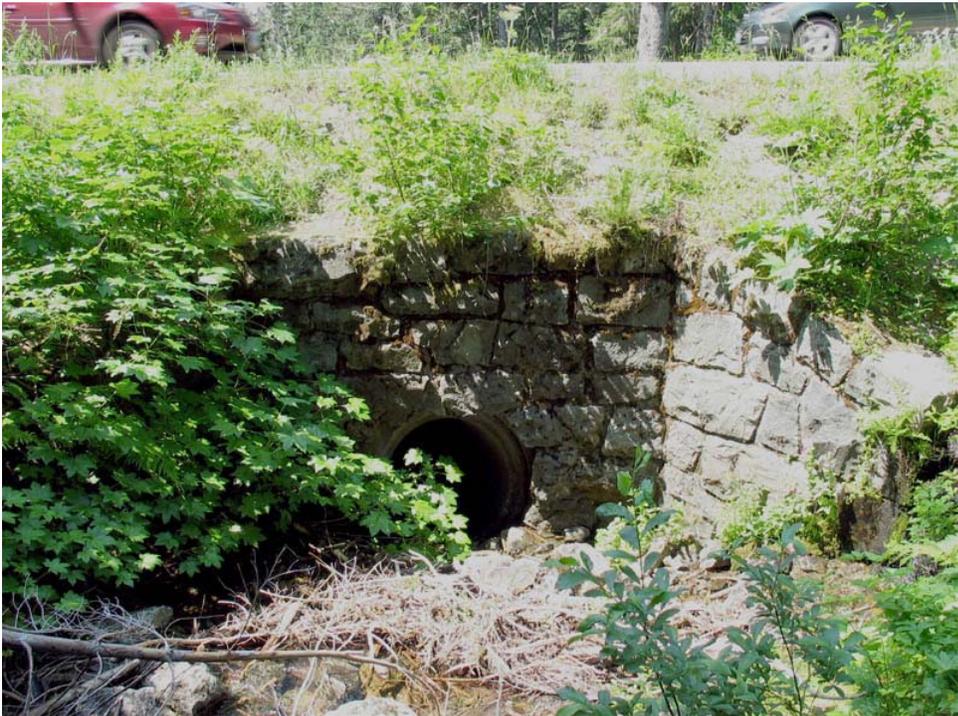
*Contemporary photo showing a culvert headwall with angled wing walls. (MORA, 2004)*

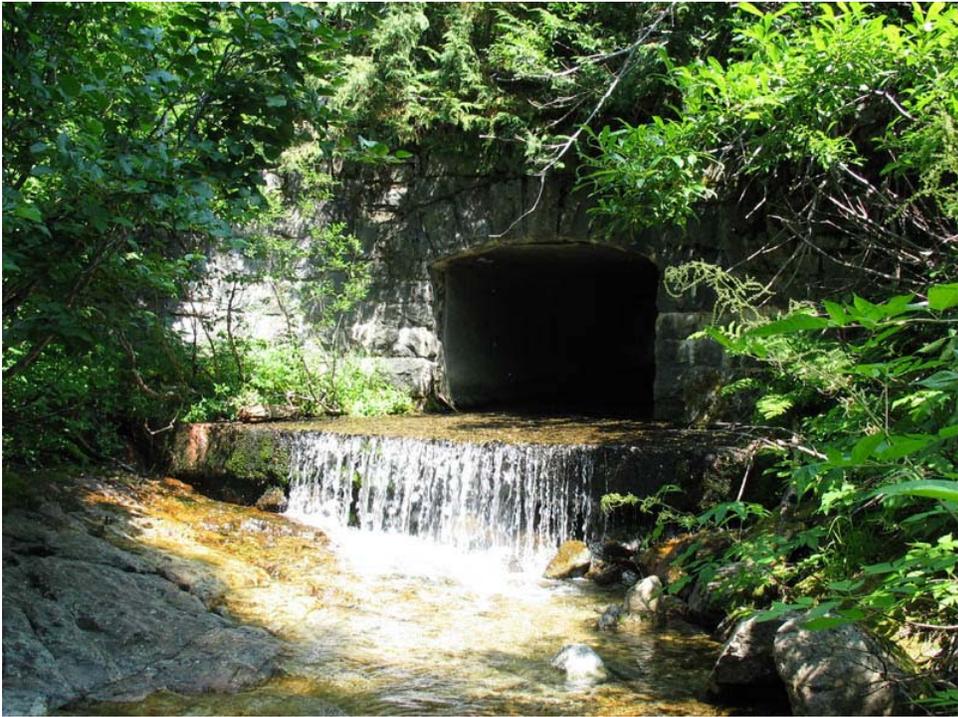
*Contemporary photo showing the box culvert and headwall of the Dewey Creek culvert. (MORA, 2004)*

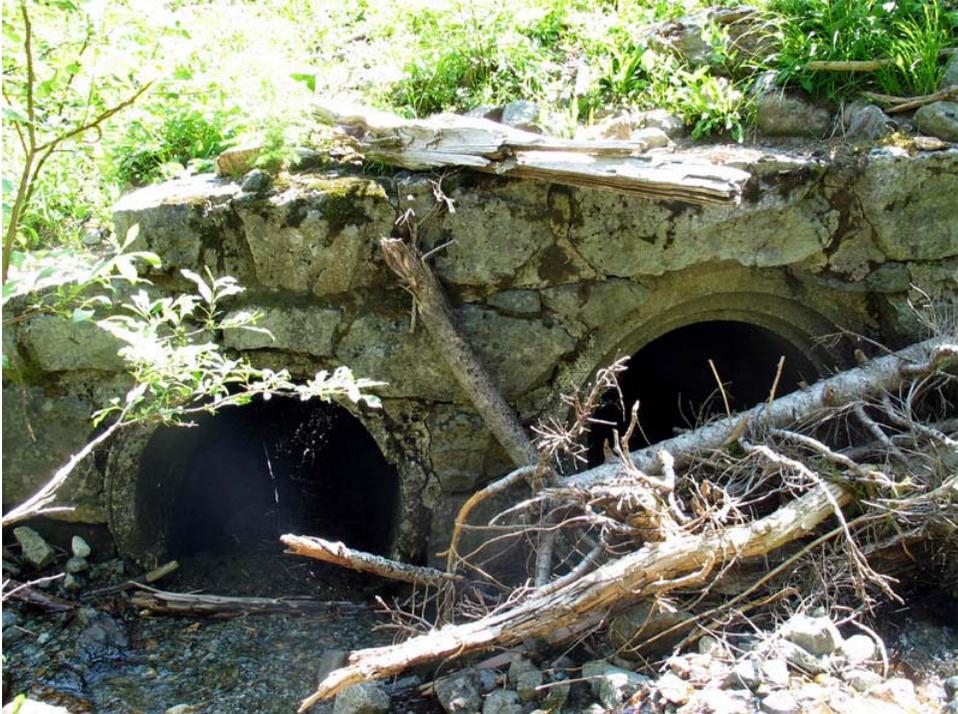
*Contemporary photo showing the double culvert at Chinook Creek on the East Side Highway. The culvert is being obstructed by debris. (MORA, 2004)*
