National Park Service
Cultural Landscapes Inventory
2004

Nisqually Entrance
Mount Rainier National Park

Proposed Revisions in the CLI Database for: MORA - Nisqually Entrance

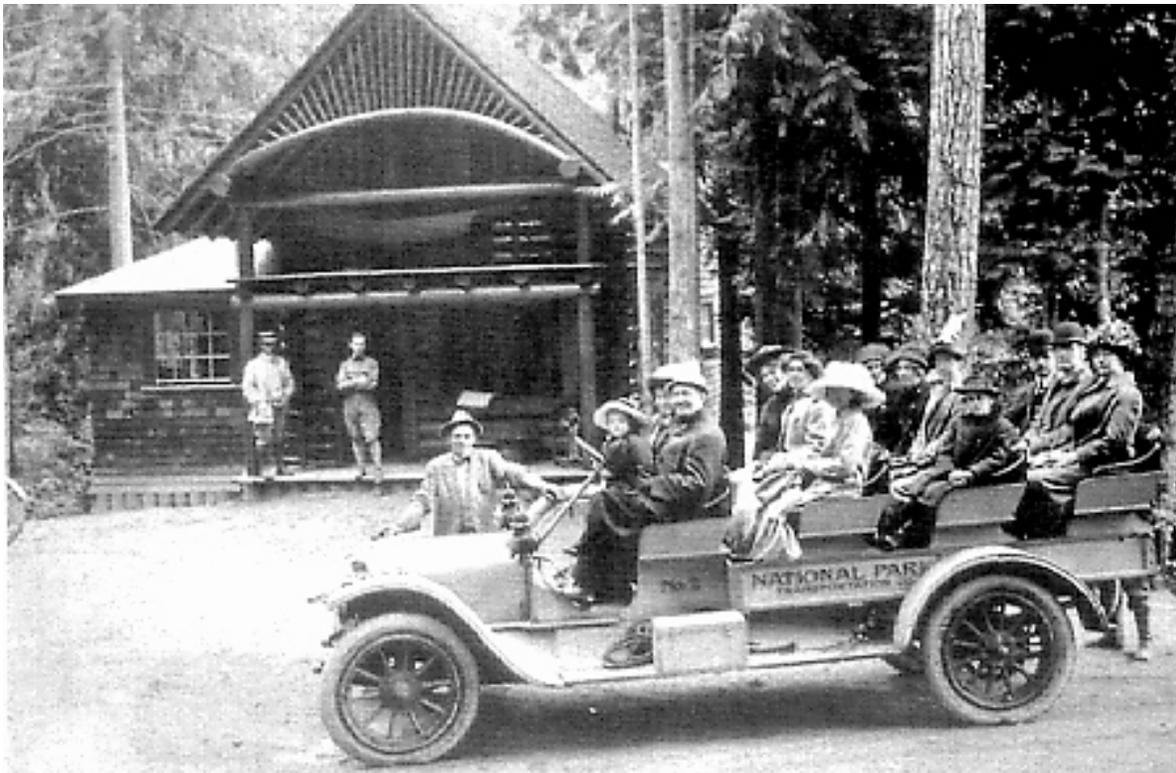
1912 photograph of Oscar Brown cabin, showing visitors arriving on a motorcade tour. Note the gravel parking area in front of the cabin, indicating a greater visibility of the cabin from the road than there is today. (MORA photo file, neg. 4543.)

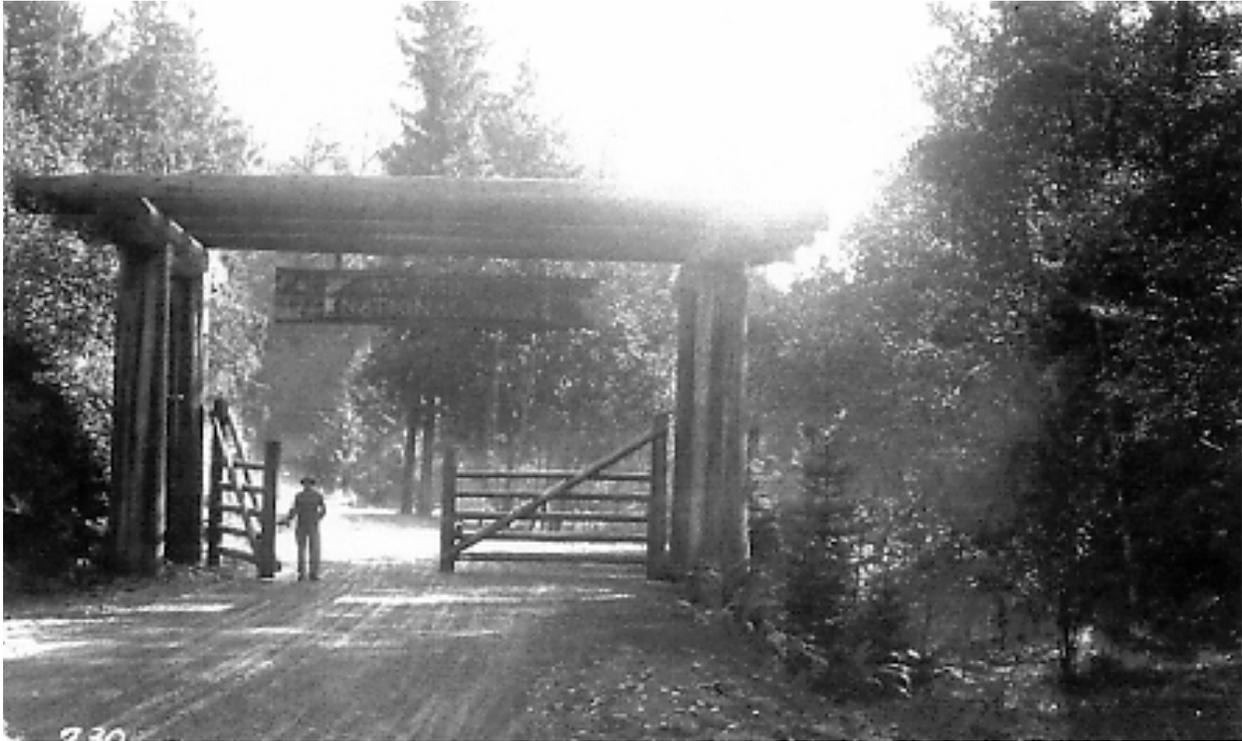
Nisqually Entrance arch, looking into the park, 1927. (MORA photo file, neg. 1280.)

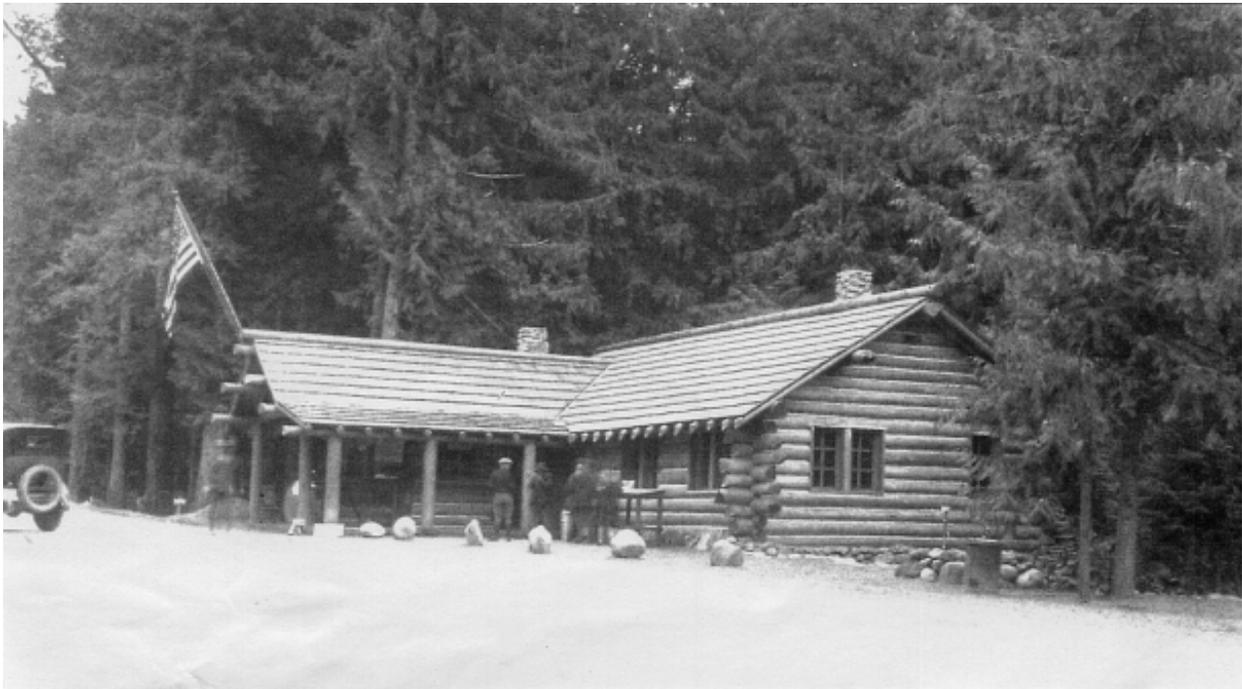
Nisqually Entrance checking station in the late 1920s, before the porte-cochere and booth were added. (MORA photo file, neg. 1594.)

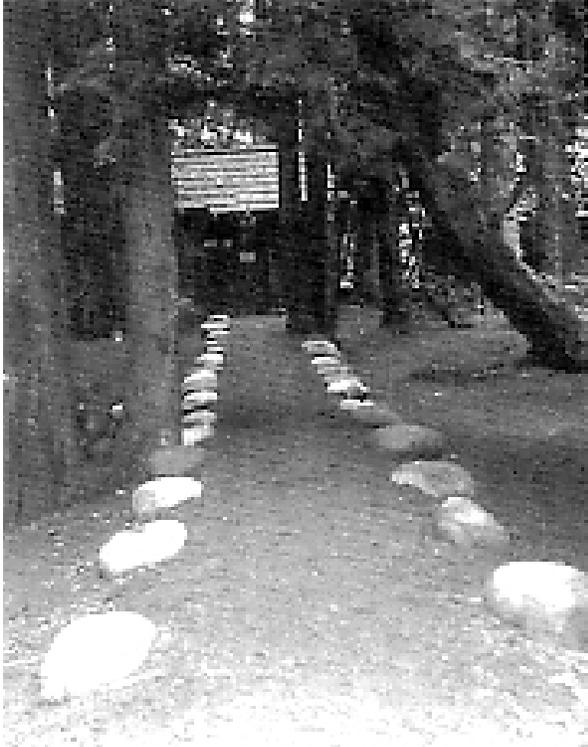
New path to the women's comfort station, built and rock-lined by the CCC. This photo was taken prior to planting, in 1935. (MORA photo file, neg. 4543.)

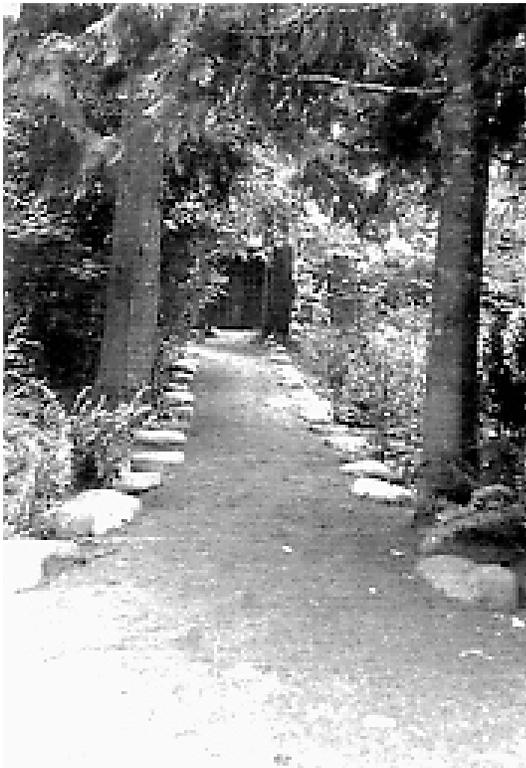
New path to the women's comfort station, after planting in 1935. (MORA photo file, neg. 4543.)

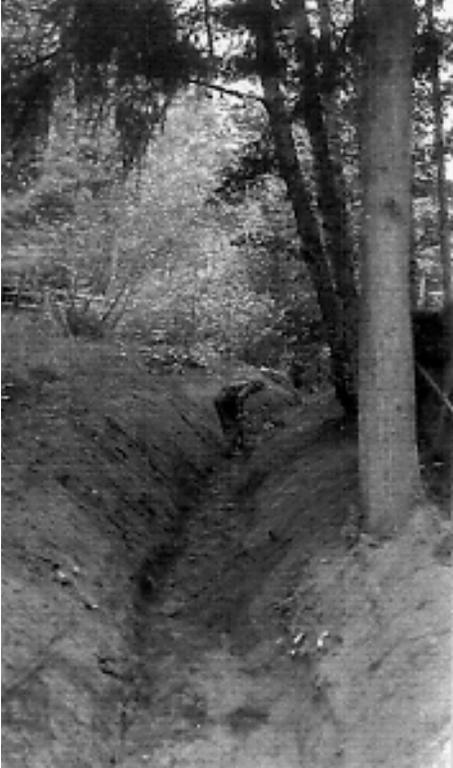
Drainage swale at Nisqually Entrance under construction by the CCC in 1935. (MORA photo file, neg. 4546.)

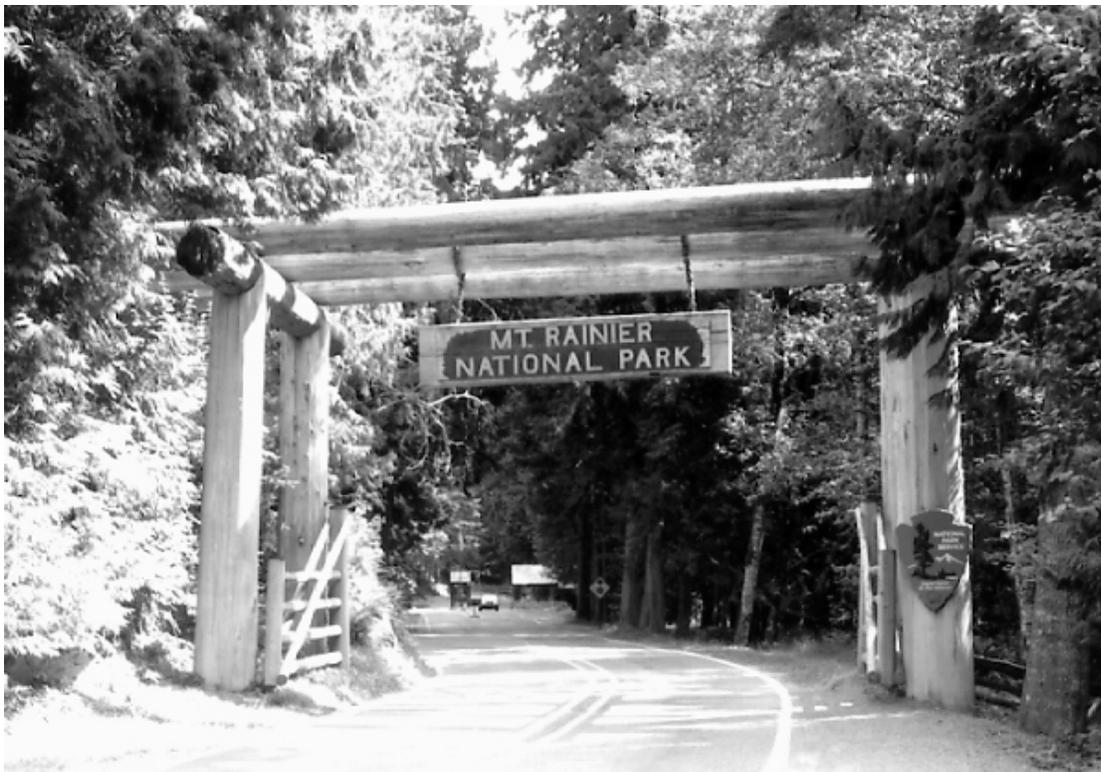
The reconstructed Nisqually Entrance arch, looking east. Note the entrance station and one of the kiosks approximately 500 feet along the Road to Paradise from the arch. (CCSO, 1994.)

Nisqually Entrance arch (CS-3) is distinguished as a historic structure, rather than a historic building. The original arch was constructed in 1911. Made of massive peeled logs, the structure reflected the scale and materials of the surrounding forest. With its rustic carved sign hanging by chains from the crossbeam, the arch became an icon for Mount Rainier National Park, symbolizing the entry into a unique landscape experience. The arch was rebuilt with wider dimensions in 1924, as part of the widening of the Road to Paradise. Albert Good featured the arch in his 1935 study "Park Structures and Facilities" (Good, 17, 23: 1935). Good noted that such overhead structures were no longer popular in park construction in the 1930s. While he thought entrance gates sometimes suggestive of the entrance to a "burial park," he conceded that the Nisqually Entrance arch was particularly appropriate, as the "huge cedar logs used are doubtless representative of the size of the timber that features the region." The arch persisted for almost 50 years, until 1973, when it was reconstructed with in-kind materials and original design, however, the historic half-log sign was incorporated into the reconstruction, and still announces "Mt. Rainier National Park" to visitors.

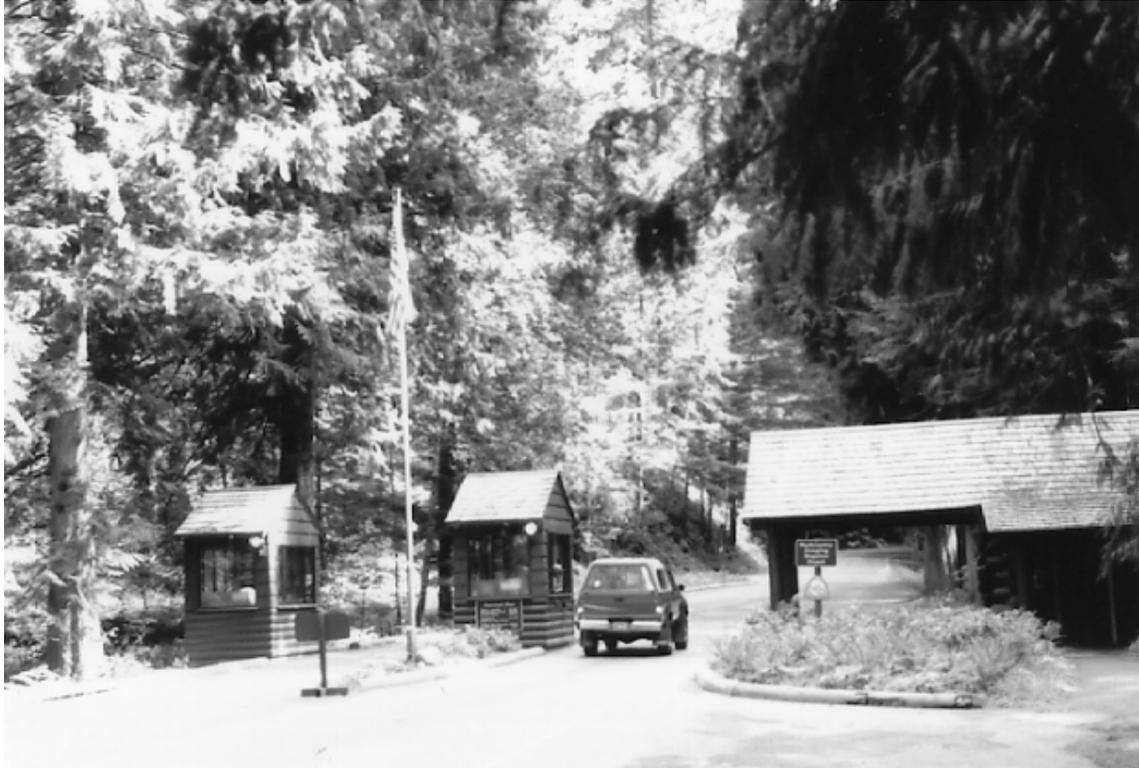
Nisqually Entrance entrance station, with two kiosks dating from 1985 (far left), and 1962 (middle). Also note the new plant bed in front of the 1930s porte-cochere, sealing this route off to vehicles. CCSO, 1994.

The Nisqually Entrance entrance station and residence (N-001), built in 1926, is an excellent example of the rustic style of architecture and log construction. A rock foundation was added in 1936, and a porte-cochere and kiosk were added in 1937. The rustic style of the building was maintained through two subsequent additions in 1962 and 1985. New plant beds established in 1985 redirected traffic flow toward each kiosk, and reinforced the abandonment of the porte-cochere as an entry portal to the park.

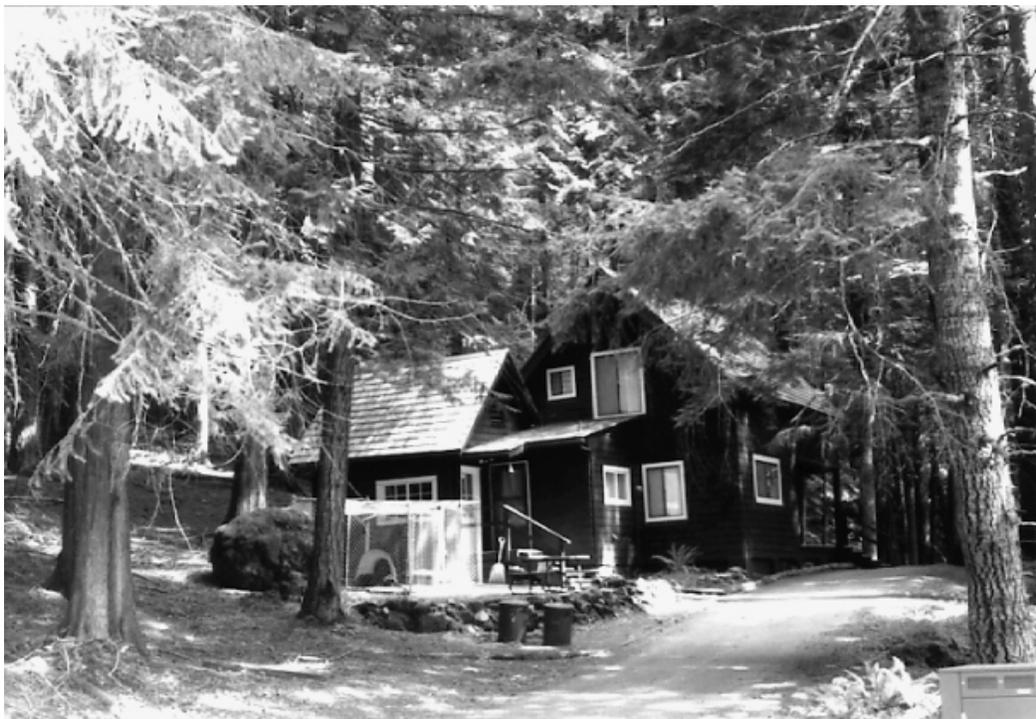
Photograph of the Ranger's residence, built in 1915, viewed from the west. Note the driveway to the residence was added after the historic period. (CCSO, 1994.)

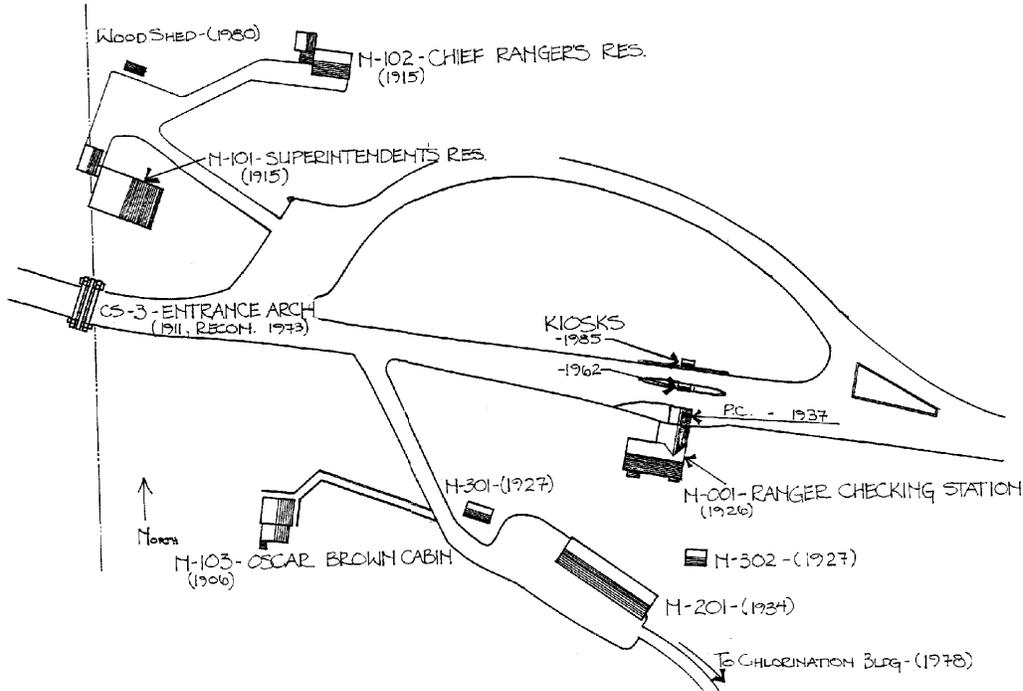
Plan showing the seven historic buildings and one historic structure at Nisqually Entrance, along with the recent additions of the woodshed, garage, kiosks, and chlorination house. (CCSO, 1994.)

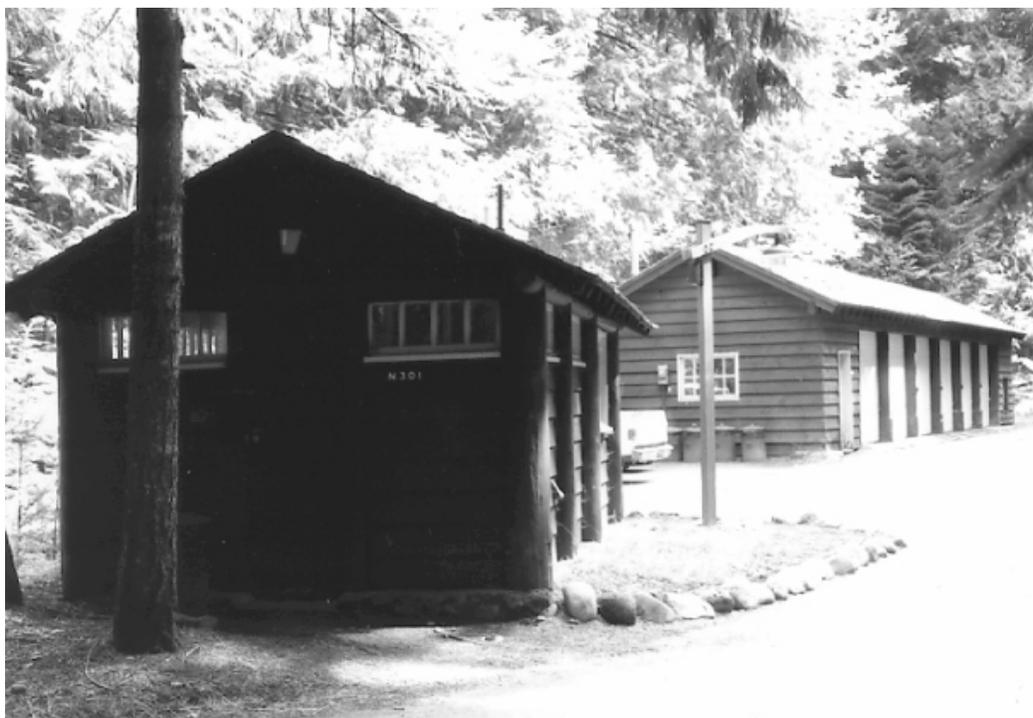
Photograph of the equipment building, constructed in 1934. Note the parking area behind the building, and one of the original comfort stations in the foreground. This comfort station is currently being used as a work station. (CCSO, 1994.)

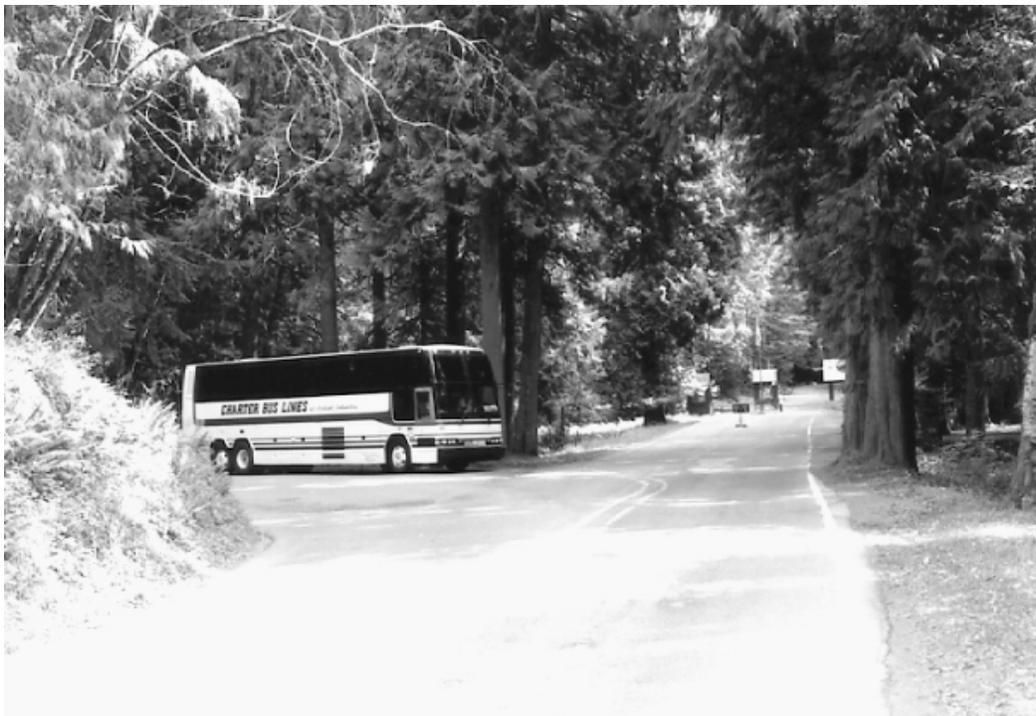
Photograph showing a tour bus about to turn towards Nisqually Entrance arch, where the exit and entry lanes of the Road to Paradise reconverge. Note the kiosks at the entrance station in the distance. (CCSO, 1994.)

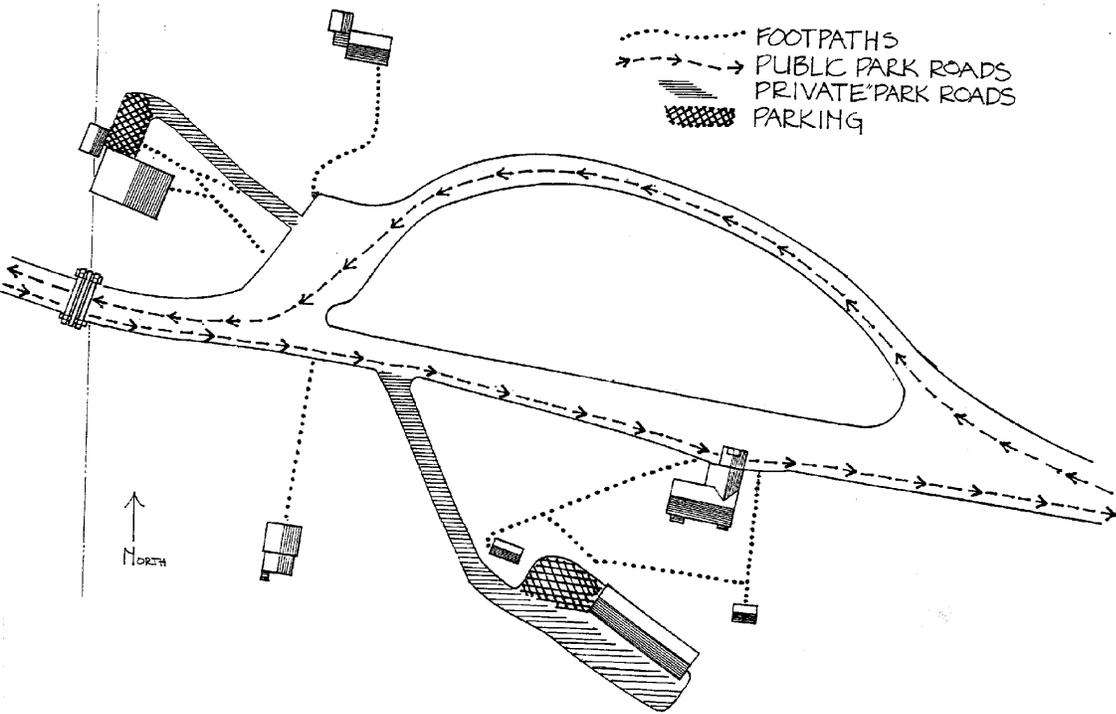
Plan showing circulation at Nisqually Entrance during the historic period. Note the single entry lane to the entrance station, the path linking the two comfort stations, and the path from the road south to Oscar Brown cabin. (CCSO, 1994.)

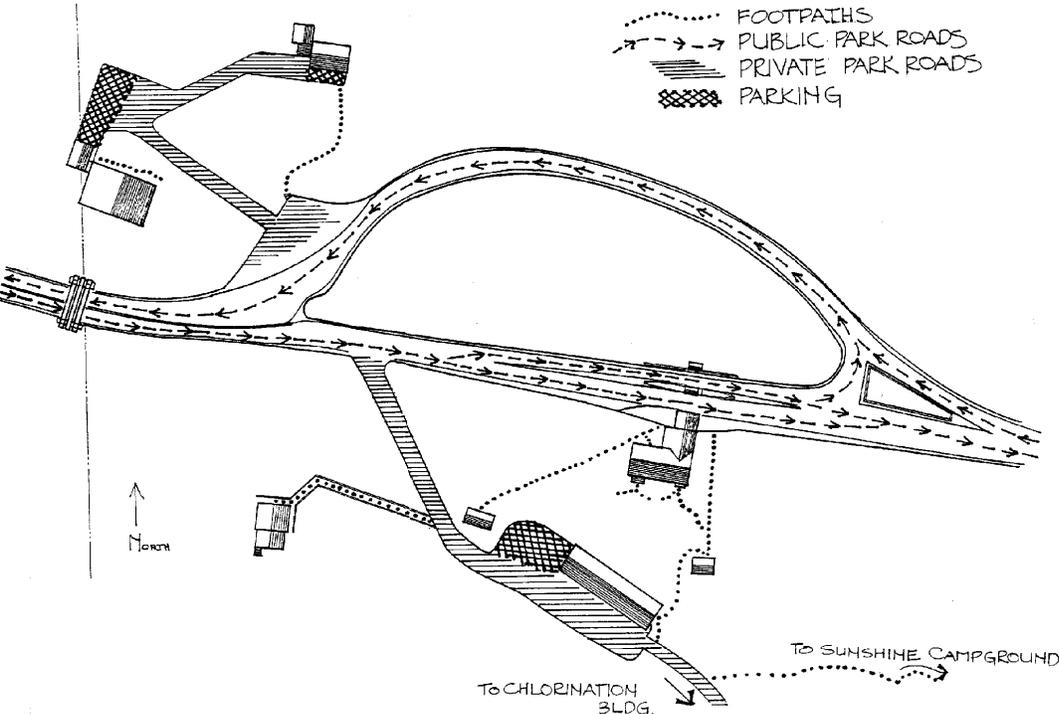
Plan showing current circulation at Nisqually Entrance. Note the addition of a second entry lane at the entrance station, the extended driveway to the Ranger's residence, and the new path to Oscar Brown cabin. (CCSO, 1994.)

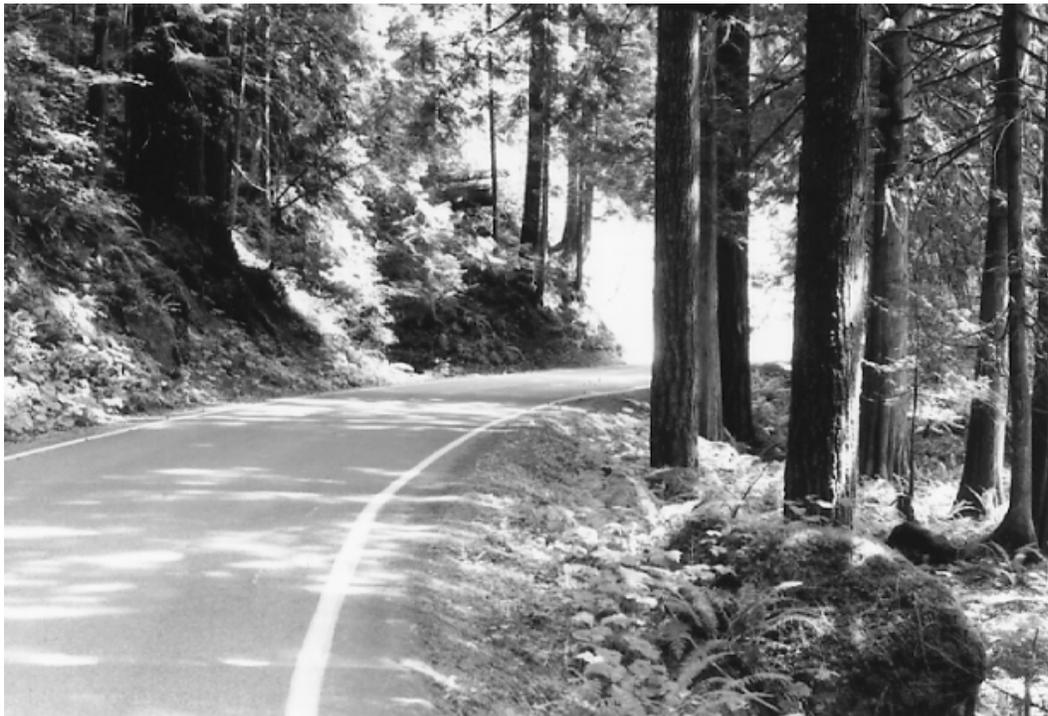
Today, these drainage features still remain, and reflect a response to natural features at Nisqually Entrance. In some cases, the efficacy of drainage features has been reduced through lack of maintenance. Where drainage swales have been allowed to fill with forest debris and vegetation, and where culverts have not been cleaned out, the drainage system does not efficiently conduct water and pooling of storm water occurs.

Photograph looking east along the exit lane at Nisqually Entrance, showing the depression in the central vegetated island to the right, or south side. (CCSO, 1994.)

The east side of the Entrance Station needs a subtle re-grading in order to ensure positive drainage of water away from the foundation.

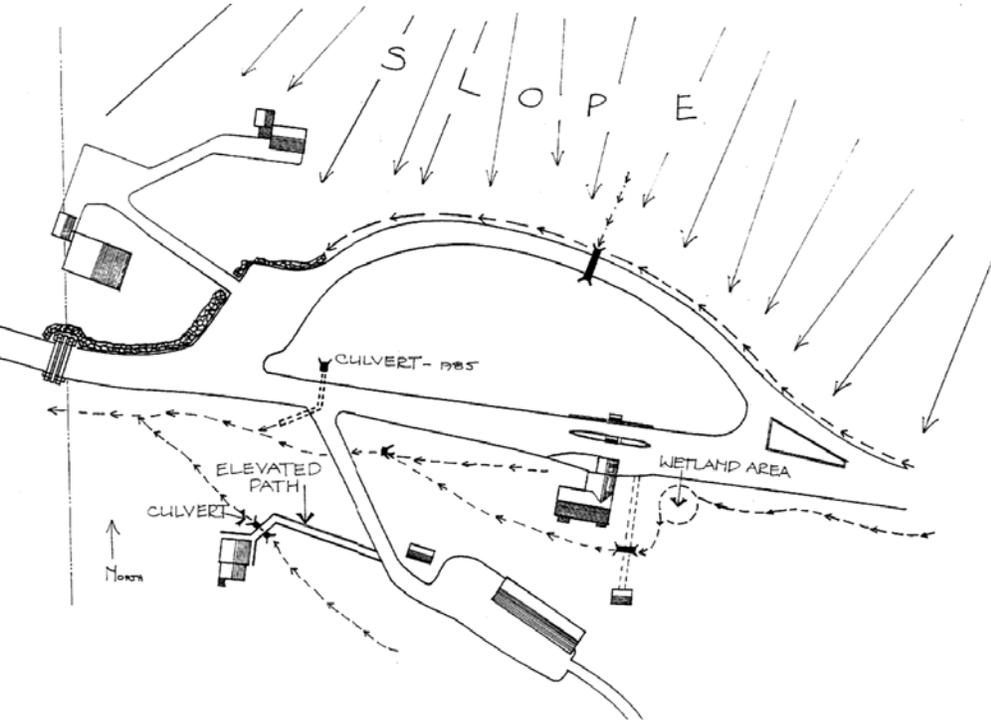
Diagram showing the existing conditions of drainage infrastructure at Nisqually Entrance. (CCSO, 1994.)

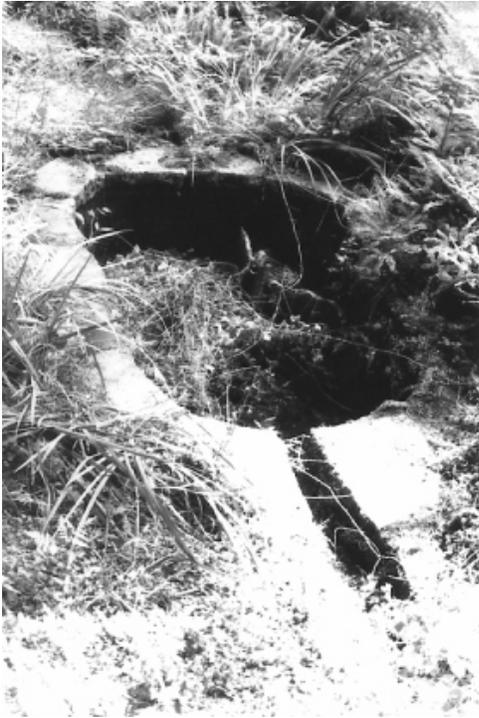
Photograph showing the fish pond near the Superintendent's residence. The concrete fish pond is capped with stone, and is fed by a water channel. The pond is surrounded by a rockery, with both native and ornamental plants. (CCSO, 1994.)

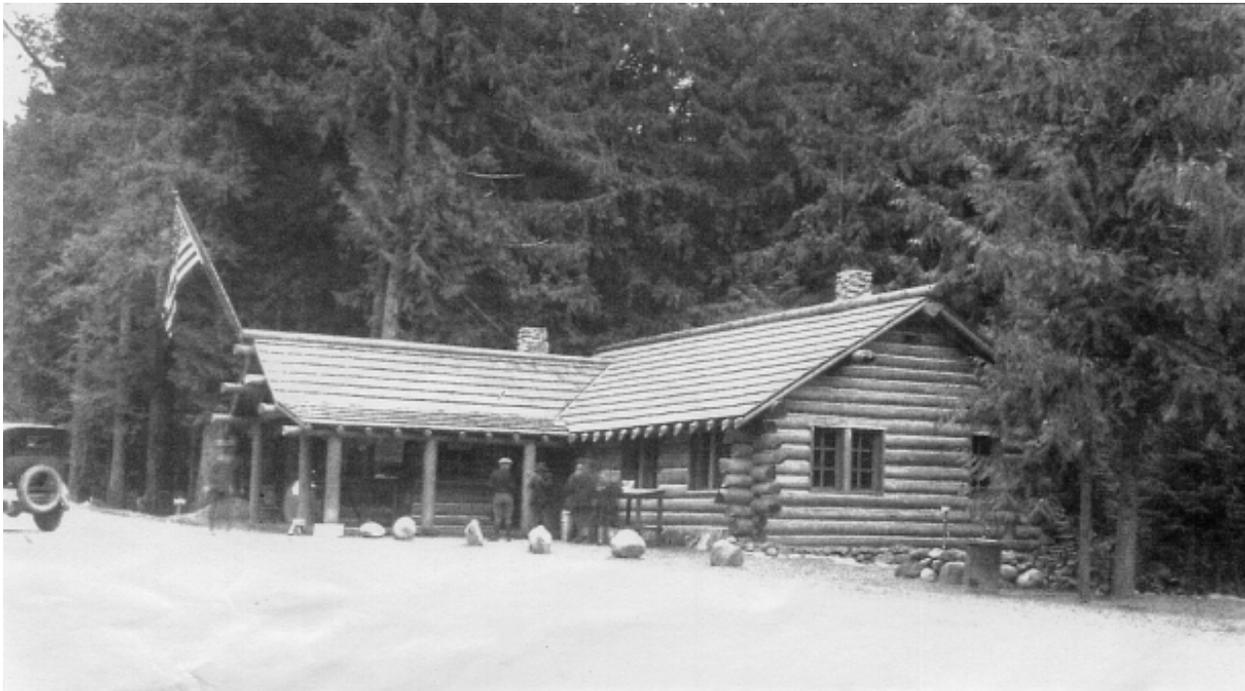
Photograph showing the location of the flag pole on the Nisqually Entrance station in the late 1920s. (MORA photo file, neg. 1594)

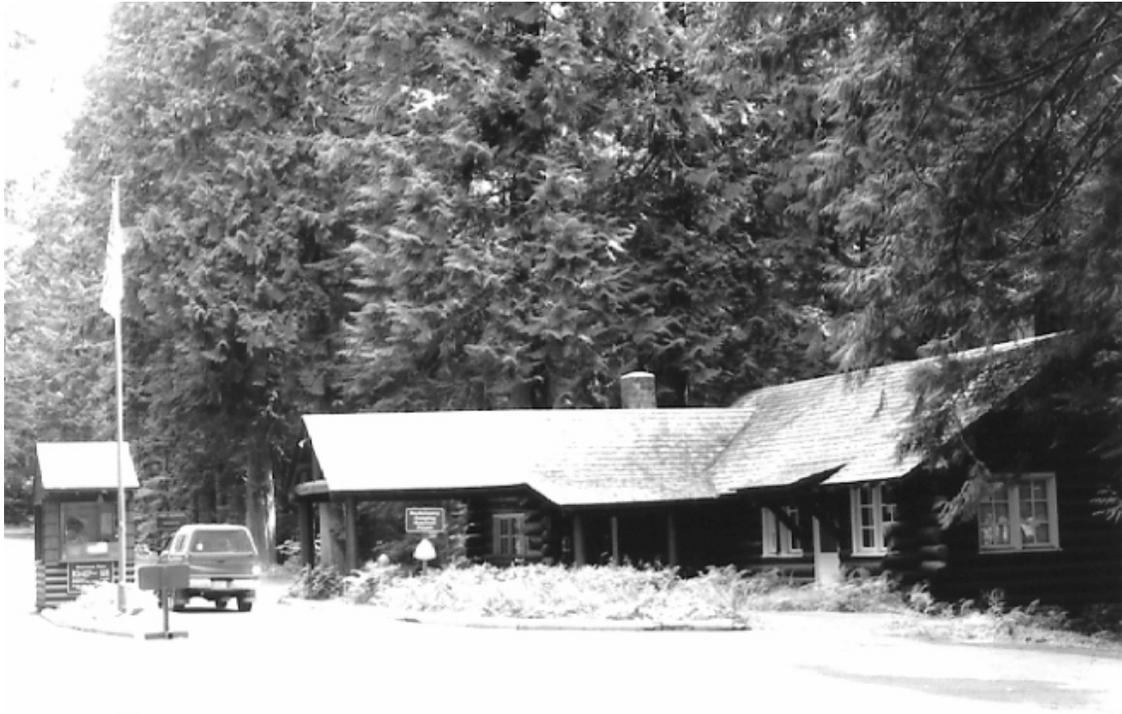
Photograph showing the contemporary location of the flag pole, now sited in front of a kiosk built in 1962. (CCSO, 1994.)

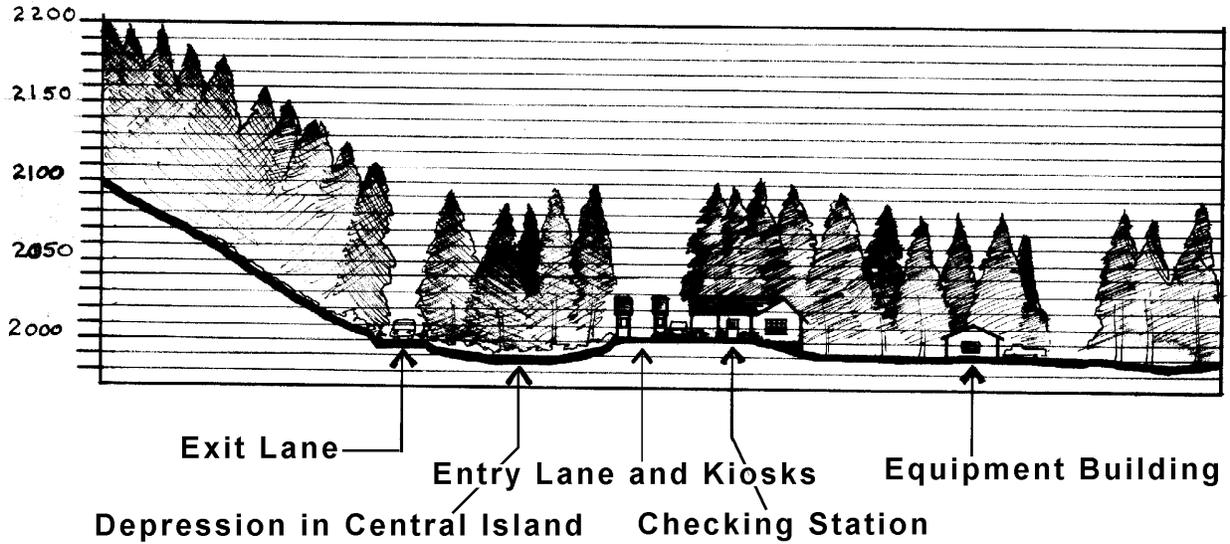
SITE TOPOGRAPHY - SECTION / ELEVATION

Diagram indicating the topographic position of the Nisqually Entrance station in relation to equipment building, the entry and exit lanes of the Road to Paradise, and the central island separating the two lanes. (CCSO, 1994.)

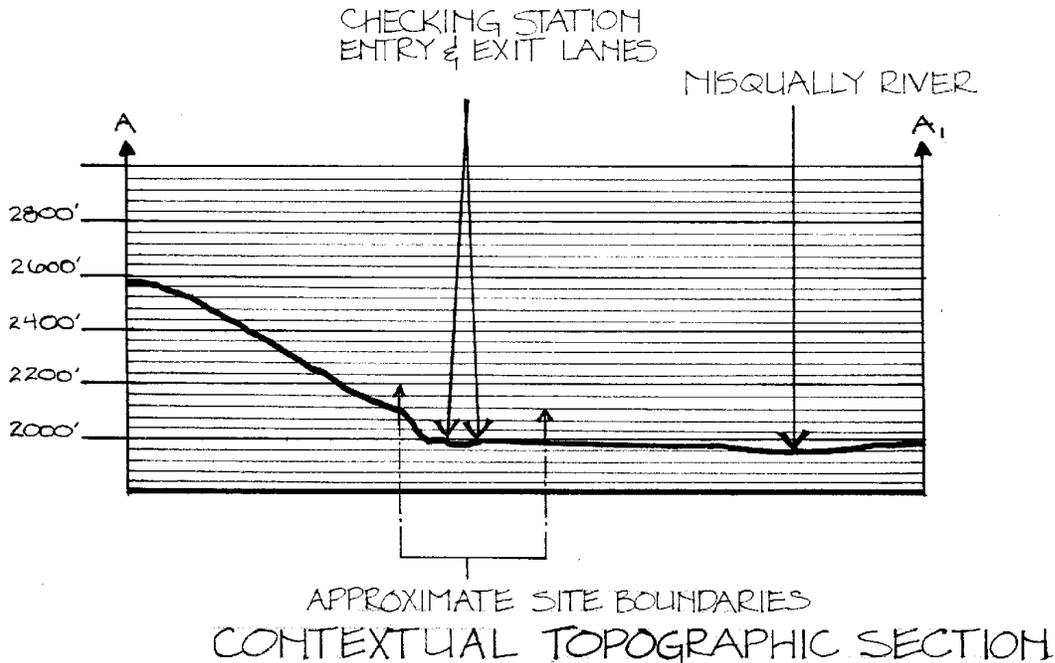
Diagram to show the topographic position of Nisqually Entrance station in relation to the north slope above the site, and the Nisqually River to the south. (CCSO, 1994.)

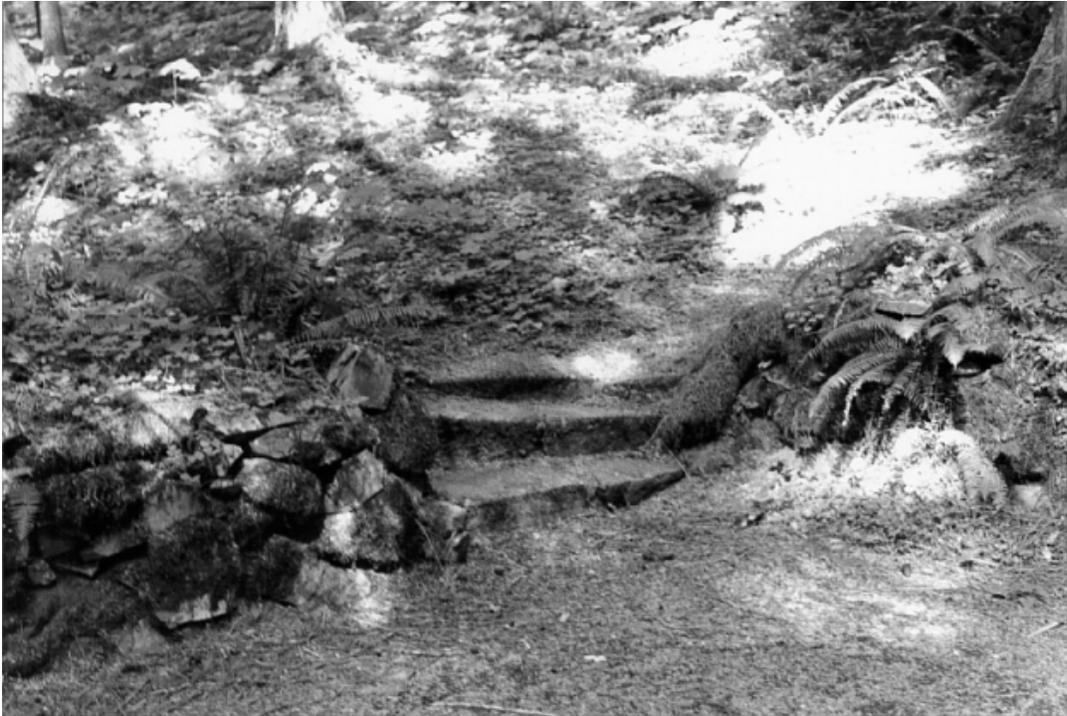
Photograph showing a dry-laid stone wall covered with herbaceous plants, and a set of stone steps leading to a building at Nisqually Entrance. (CCSO, 1994.)

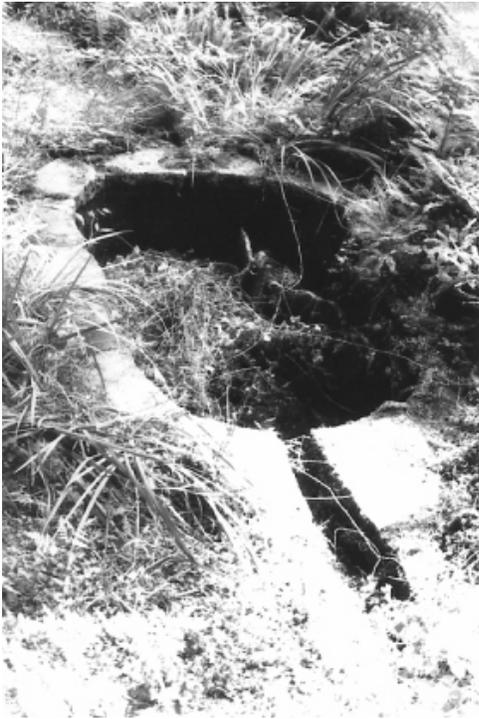
Photograph showing a variety of grasses and irises surrounding a stone-lined concrete pond and water channel in the rockery at the Superintendent's residence.

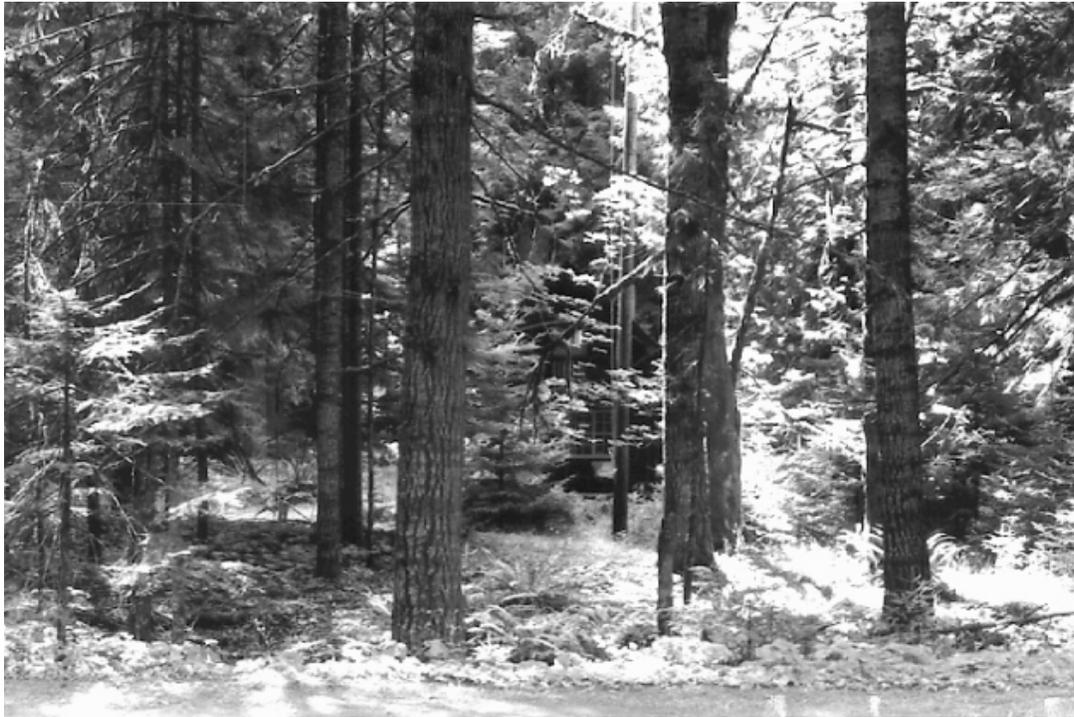
Photograph showing a cedar grove south of the Road to Paradise with Oscar Brown cabin barely visible in the distance. When compared to a historic photo of Oscar Brown cabin in 1912, the density of present vegetative cover is evident. (CCSO, 1994.)

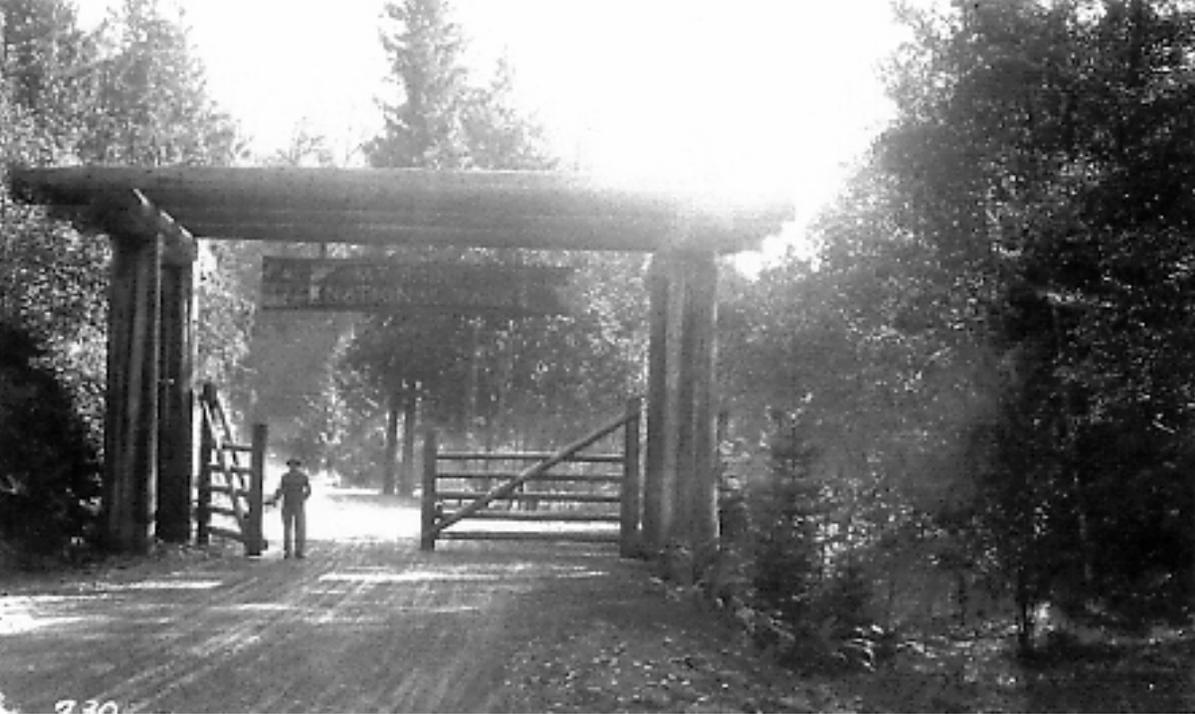
Photograph showing the renowned view of the Nisqually Entrance arch in 1927. (MORA photo file, neg. 1280.)

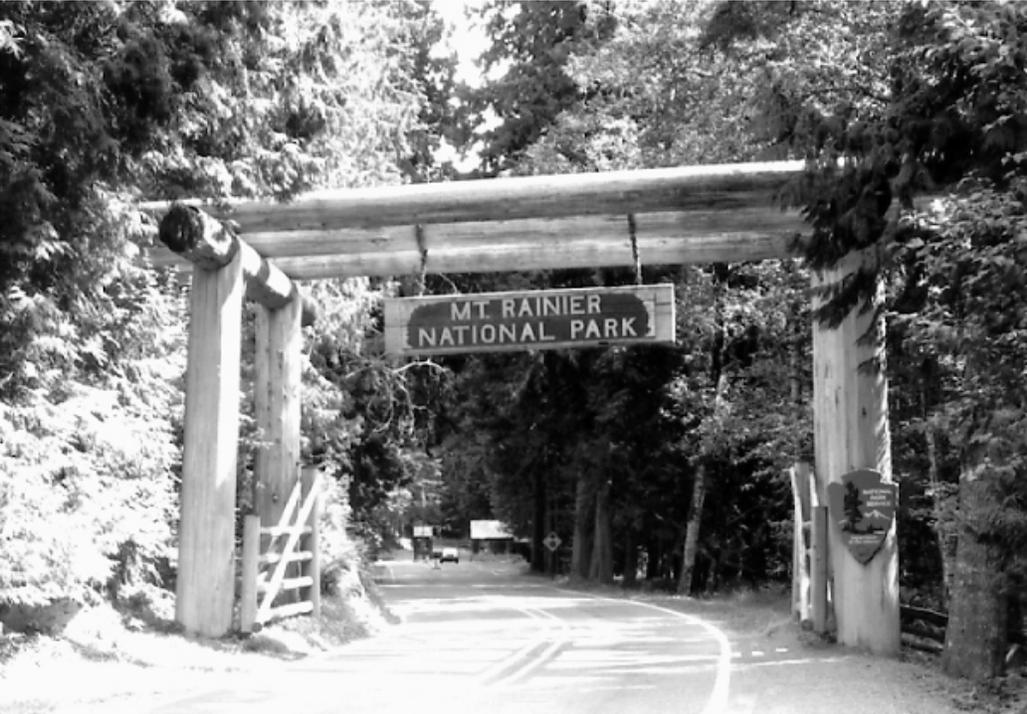
Photograph showing the view of Nisqually Entrance arch in 1994. (CCSO, 1994.)
