Road to Paradise
Mount Rainier National Park

CULTURAL LANDSCAPES INVENTORY (CLI) PROGRAM
2010 Condition Assessment Update for:

CONDITION ASSESSMENT: **FAIR**

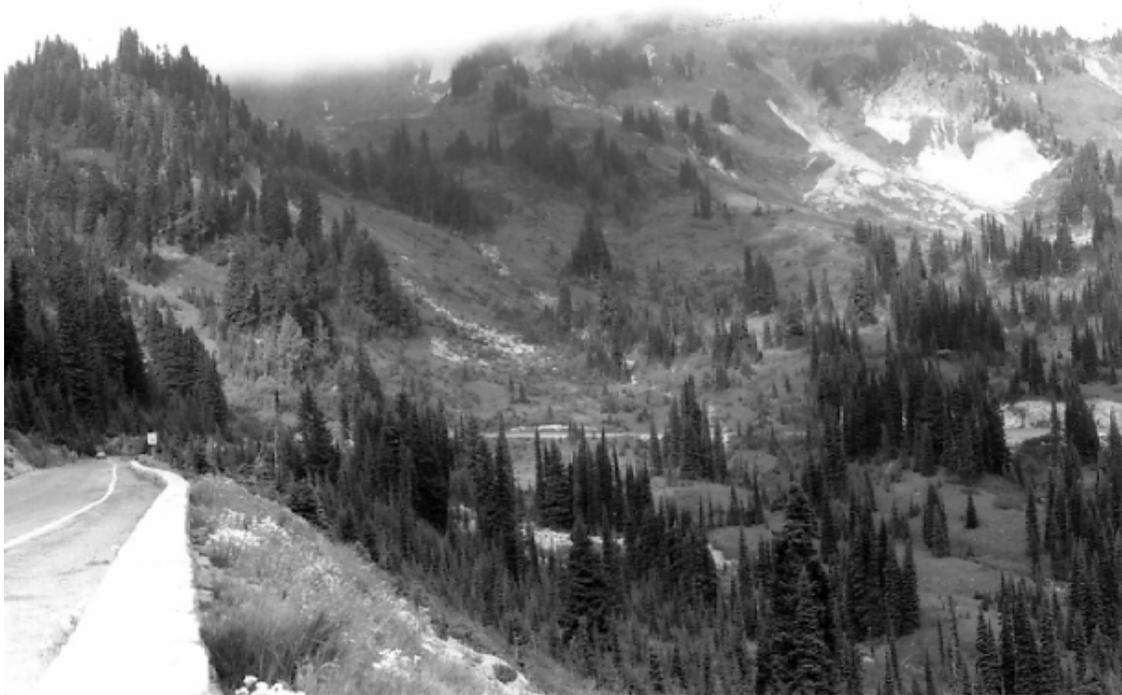
Photograph of the Road to Paradise as it climbs through high elevation forest at the upper reaches of the Paradise Valley. CCSO, 1994.

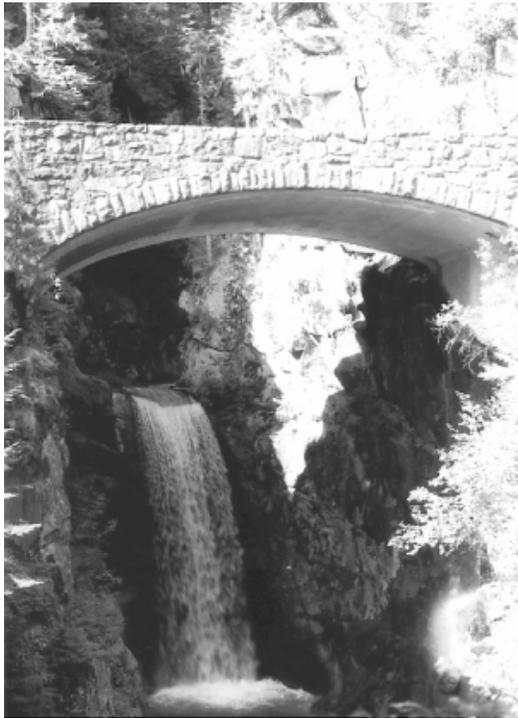
Photograph of Christine Falls bridge, looking north from the scenic overlook. CCSO, 1994.

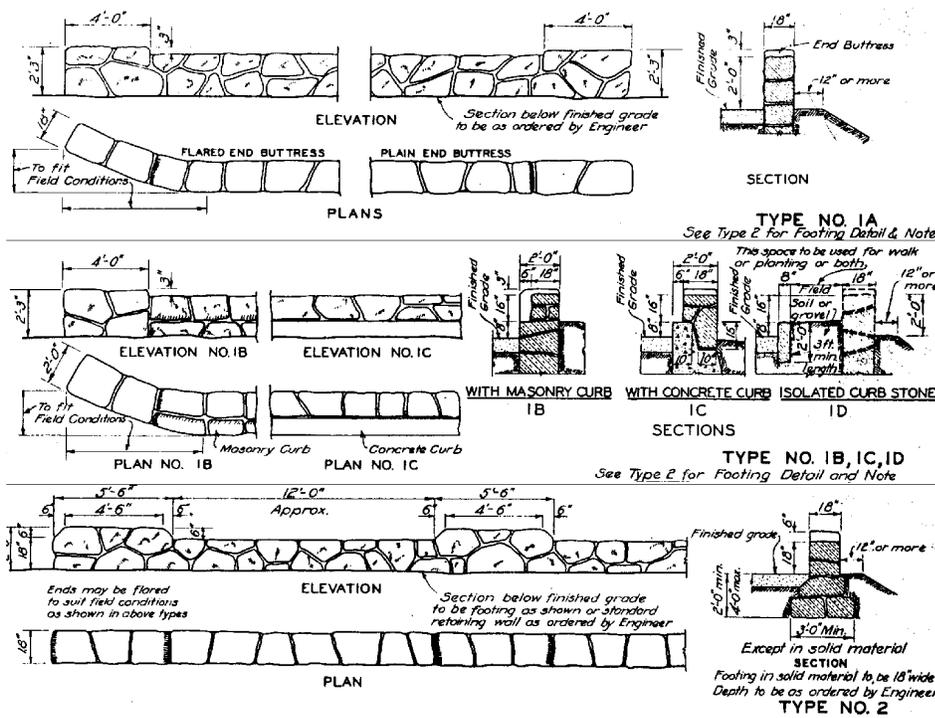
Standard detail drawings for rock walls, developed by the Bureau of Public Roads and the NPS, and used extensively along the road. This drawing dates from 1935.

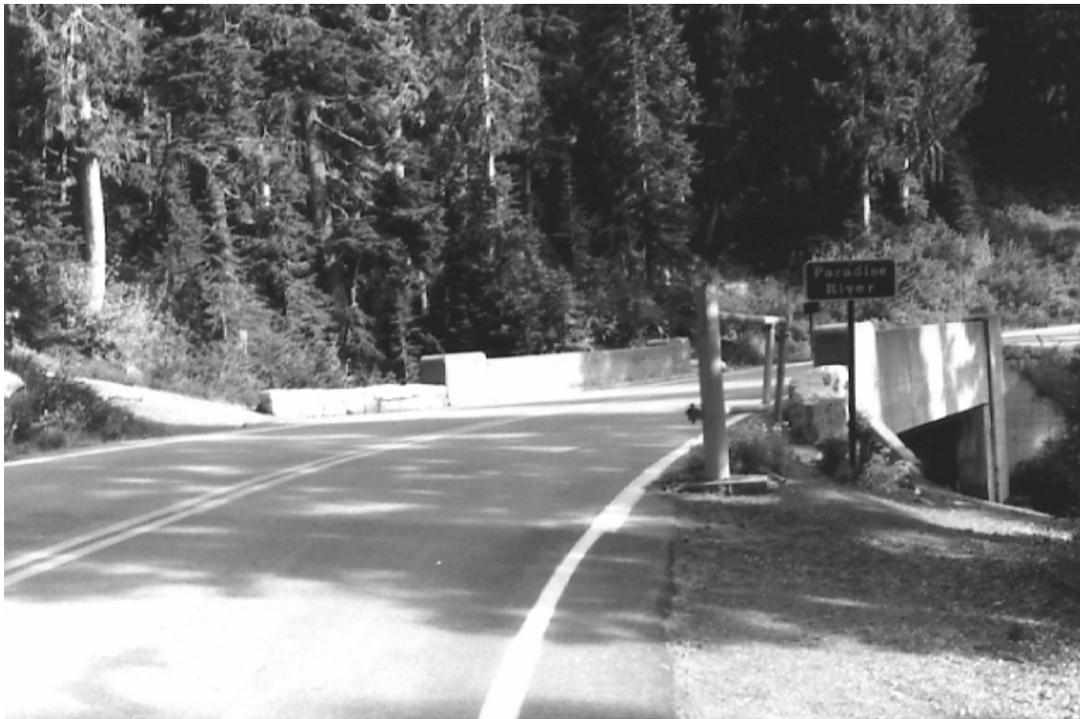
Photograph of the concrete bridge at the first crossing of the Paradise River, which was constructed in 1927 and still remains today. CCSO, 1994.

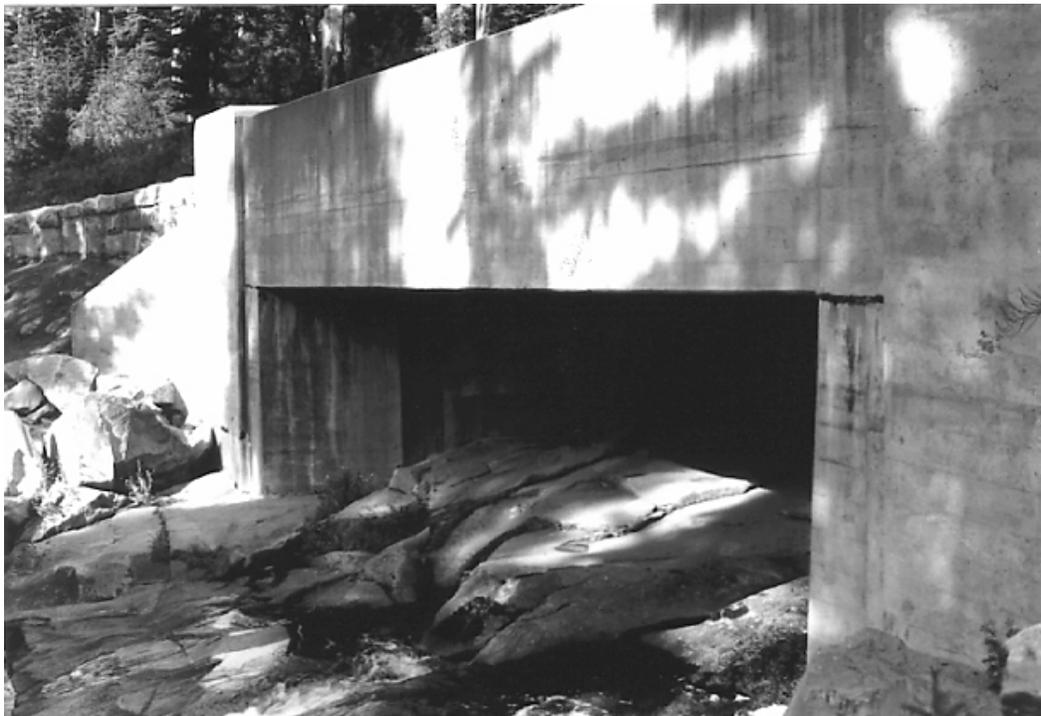
Close-up photograph of the 1927 concrete bridge at the first crossing of the Paradise River. CCSO, 1994.

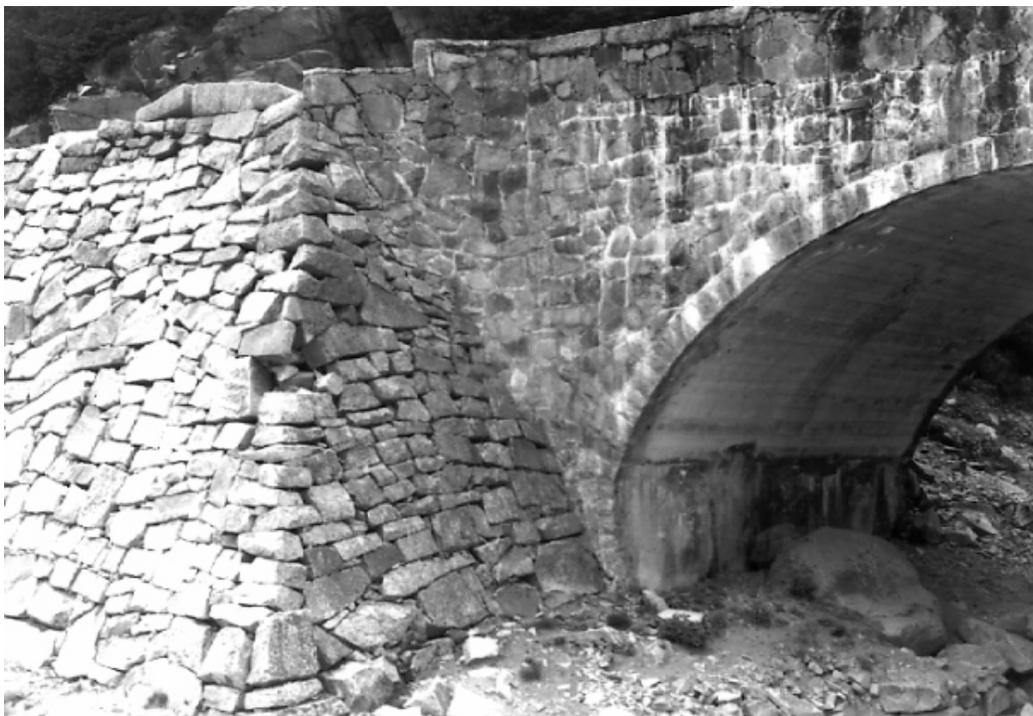
Photograph of the rock abutment at Edith Creek bridge, which retains a fill-area, and serves as a pullout for vehicles. CCSO, 1994.

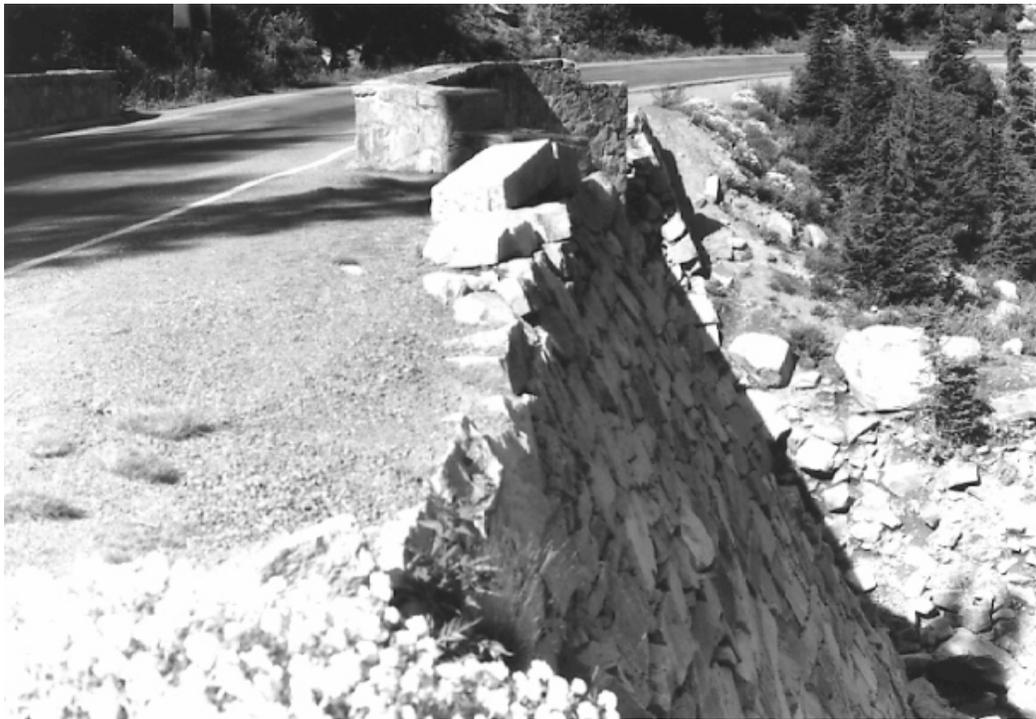
Photograph of the vehicular pullout retained by a rock abutment at Edith Creek bridge. CCSO, 1994.

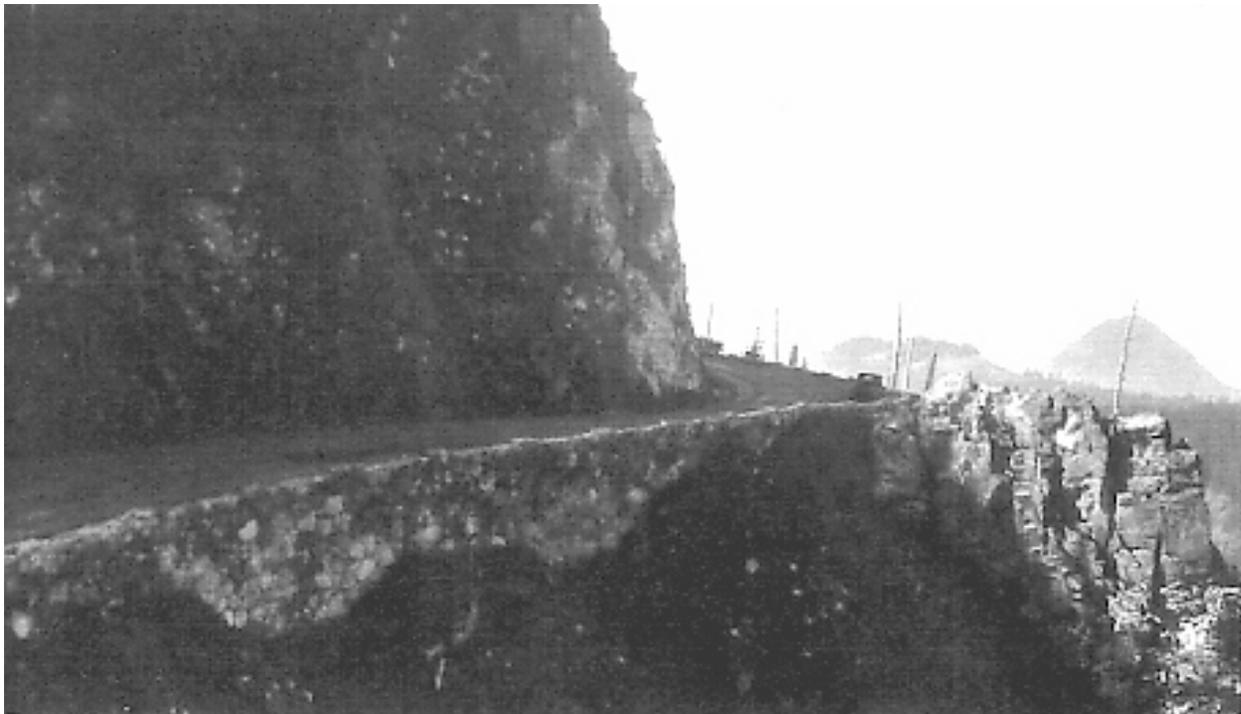
Photograph of the masonry retaining wall along the Road to Paradise at Ricksecker Point, constructed in the 1920s. MORA photo files, neg. 1484.

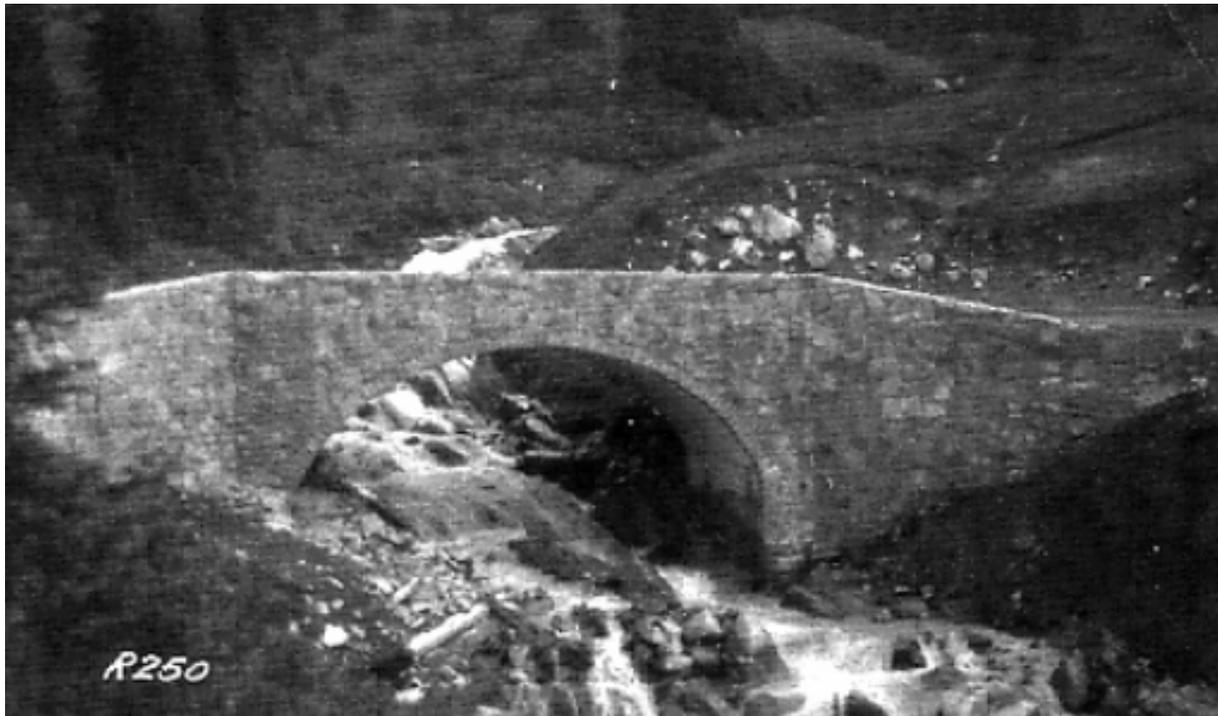
Photograph of the bridge at the fourth crossing of the Paradise River in 1927. MORA photo files, neg. 1298.

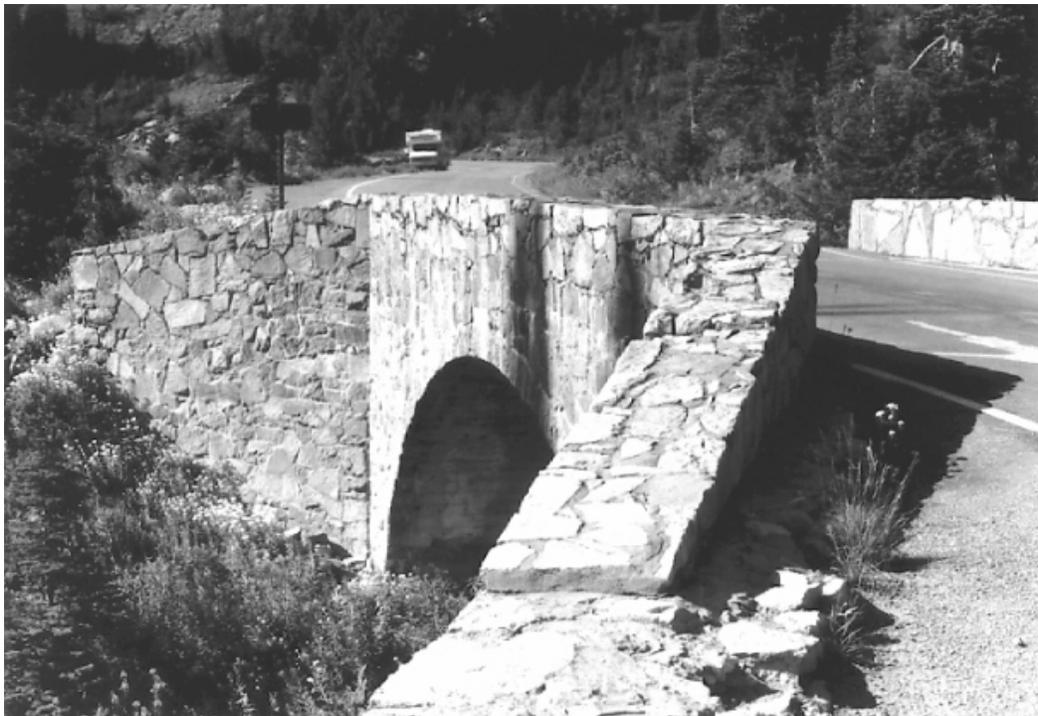
Photograph of the original bridge at the fourth crossing of the Paradise River, looking north. CCSO, 1994.

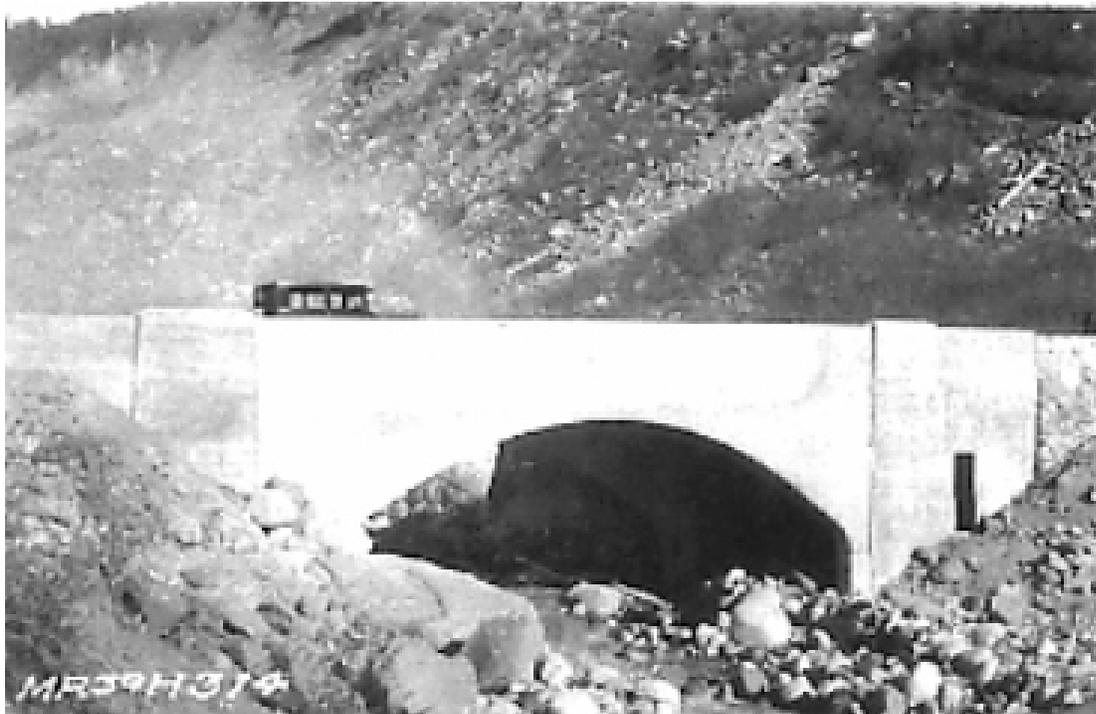
Historic photograph of the Nisqually River bridge, which was constructed in 1933. MORA photo files, neg. 2913.

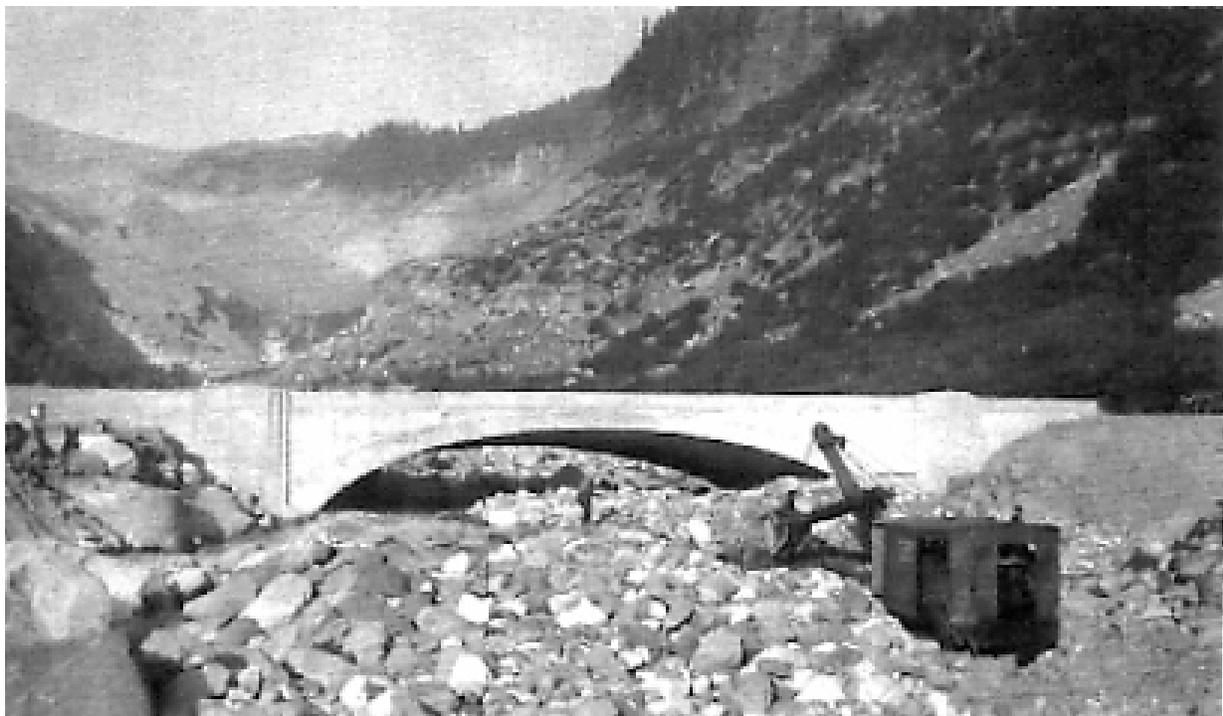
Photograph of the Nisqually River bridge constructed in 1936. This bridge was damaged in a 1947 flood, and finally destroyed in the late 1950s. MORA photo file, neg. 2265.

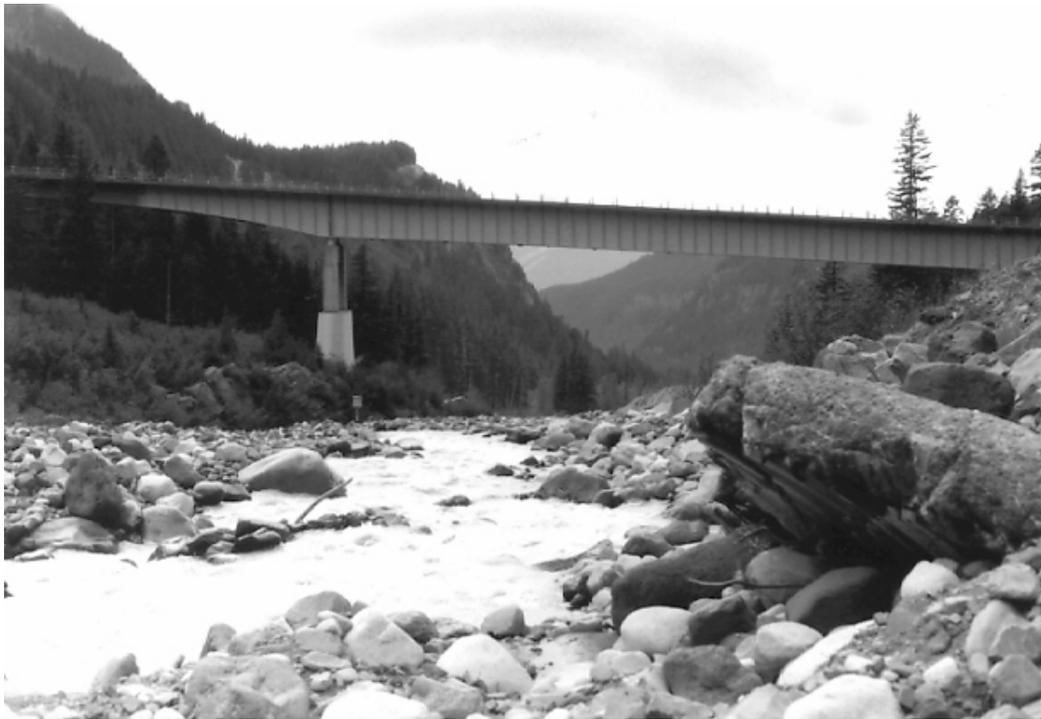
Photograph of the current Nisqually River bridge, which was constructed in 1961. This bridge is located approximately 300 feet downstream from the original bridge site, and is considerably higher. CCSO, 1994.

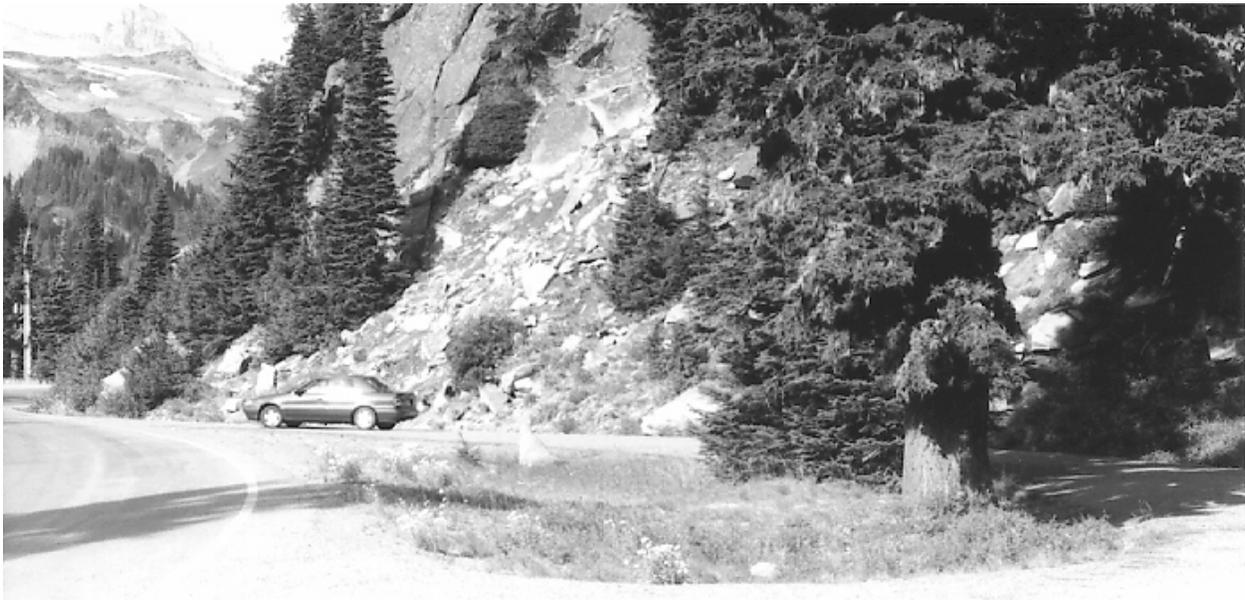
Photograph of a loop turnout on the old Paradise access road, with a planting bed designed to integrate the developed area with the larger landscape. CCSO, 1994.

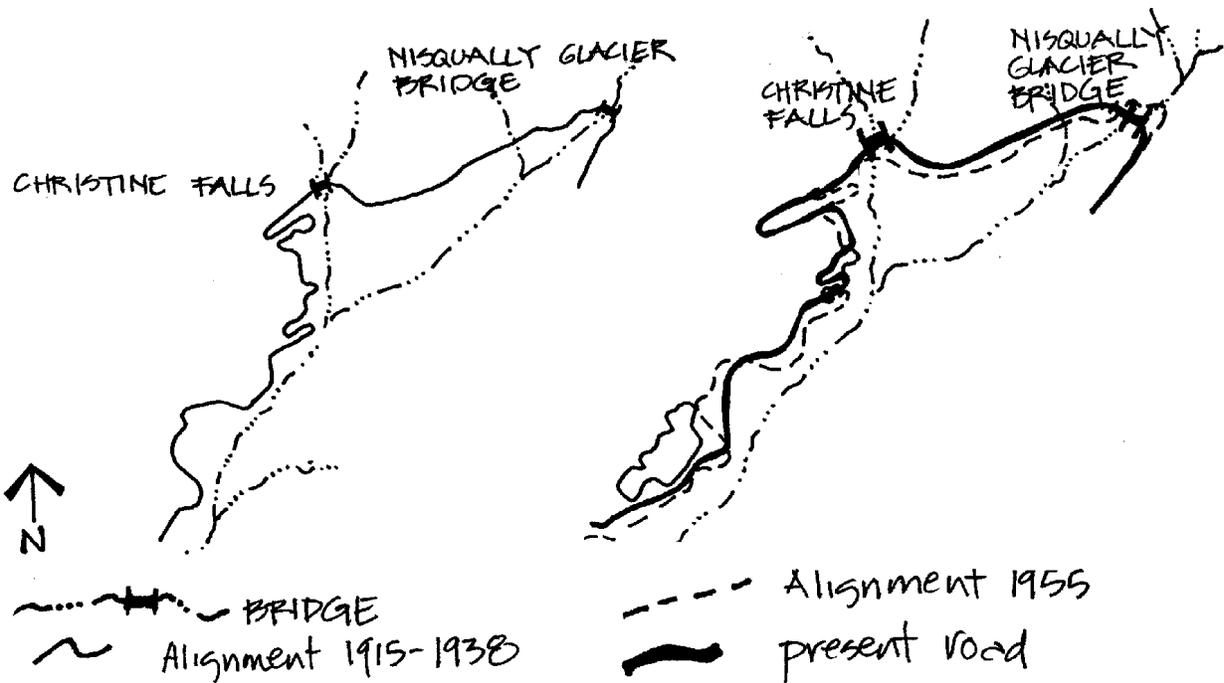
Diagrams indicating circulation changes in road alignment at the Christine Falls approach and Nisqually Glacier bridge, between 1915 and present day.

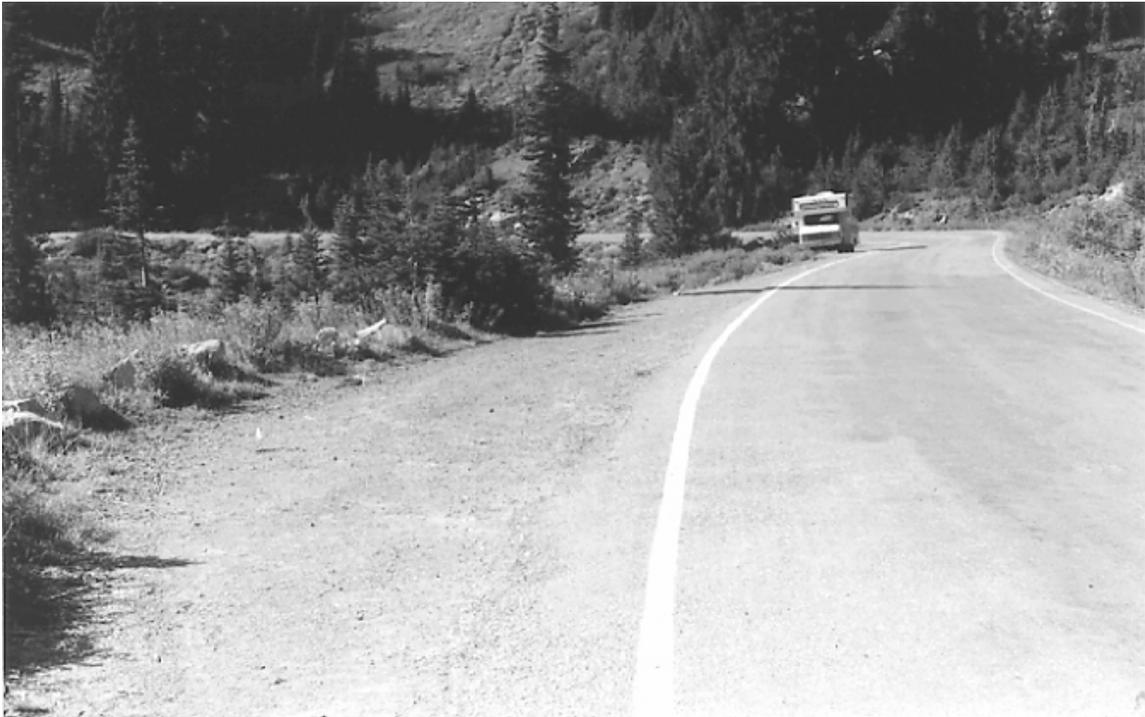
Photograph of an informal pullout on the road shoulder, historically designed to provide a variety of viewing-places. Many original pullouts have been paved, but they remain in the same location. CCSO, 1994.

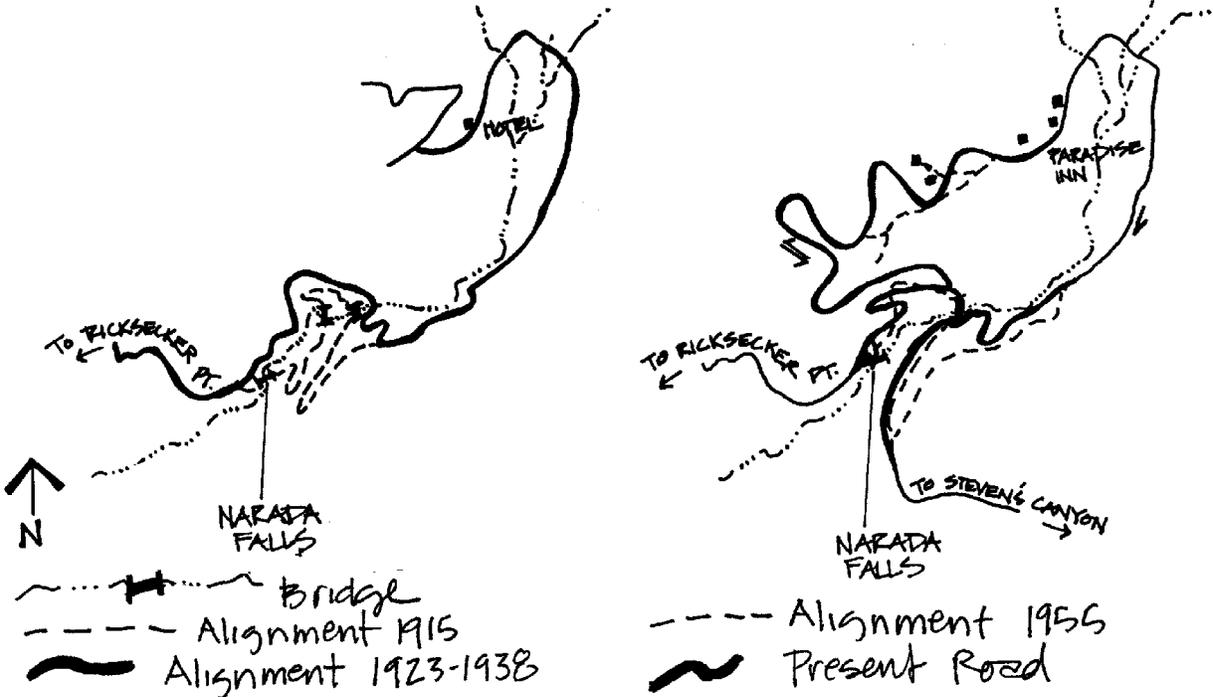
Diagrams indicating circulation changes in road alignment from Narada Falls to Paradise, between 1915 and present day.

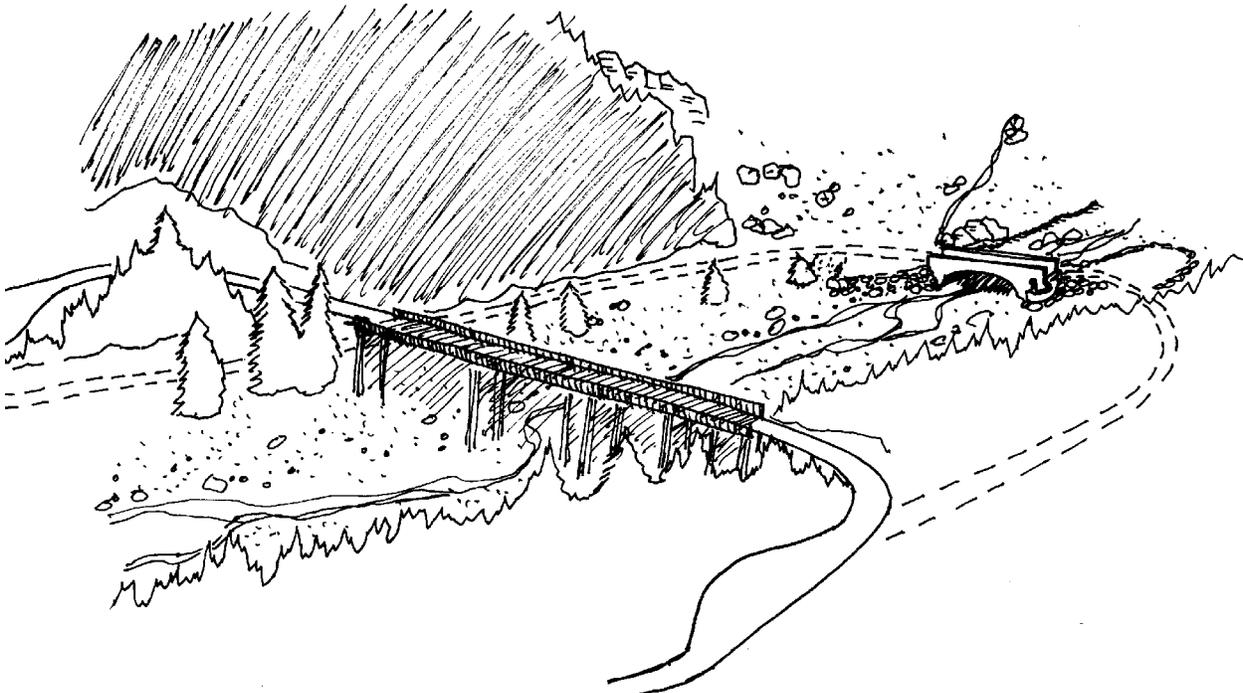
Sketch showing the location and approximate alignment of the early road and bridge across the Nisqually River Valley.

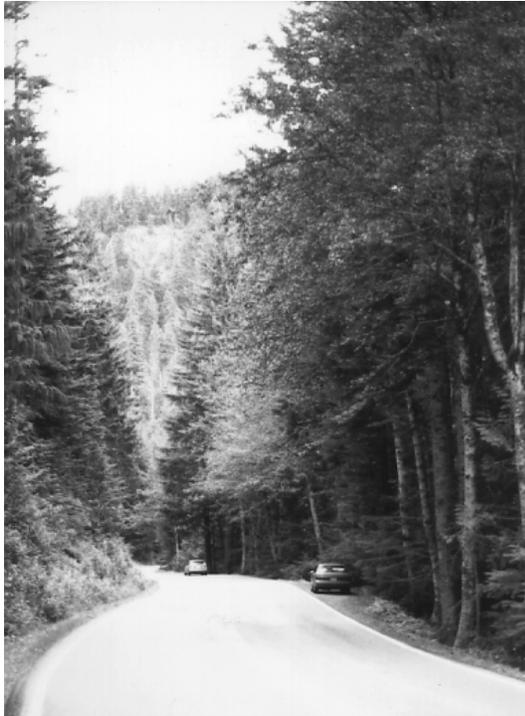
Photograph illustrating the rounding-off of cut and fill slopes at the side of the road. CCSO, 1994.

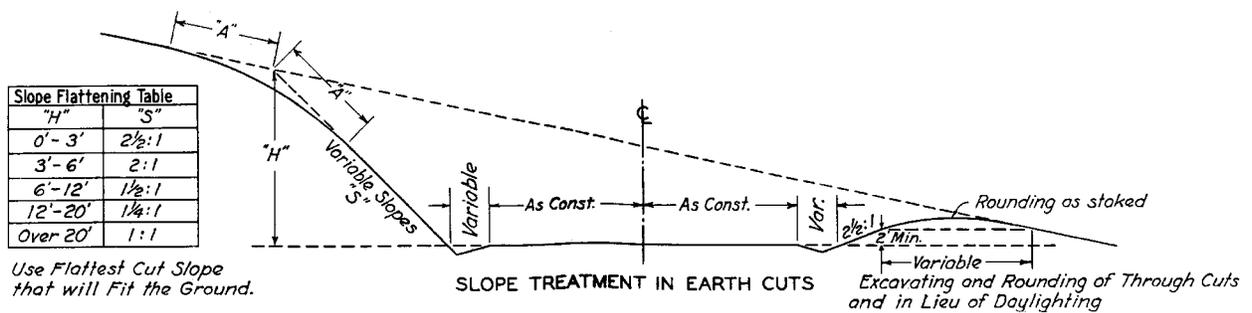
Cut and fill slopes along the road were graded to blend with the landscape. (MORA, no date.)

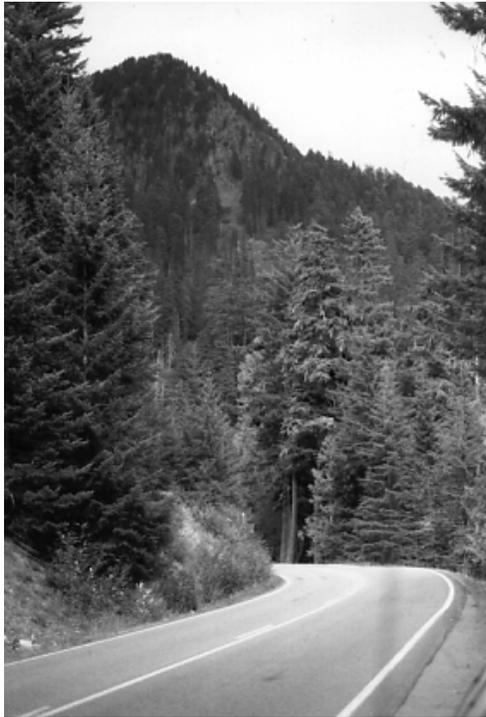
Another photograph illustrating the rounding-off of cut and fill slopes on a segment of the road above Longmire. CCSO, 1994.

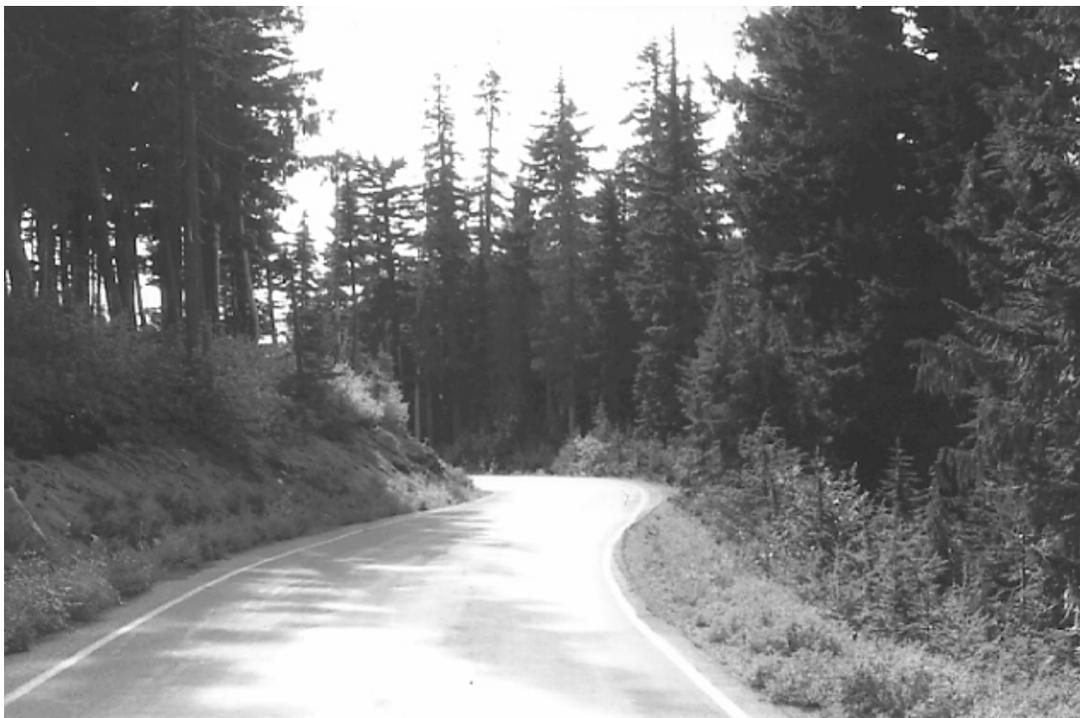
Photograph illustrating how the design of the road followed natural contours, in order to minimize the need for cut and fill, and further intrusions into the natural environment. CCSO, 1994.

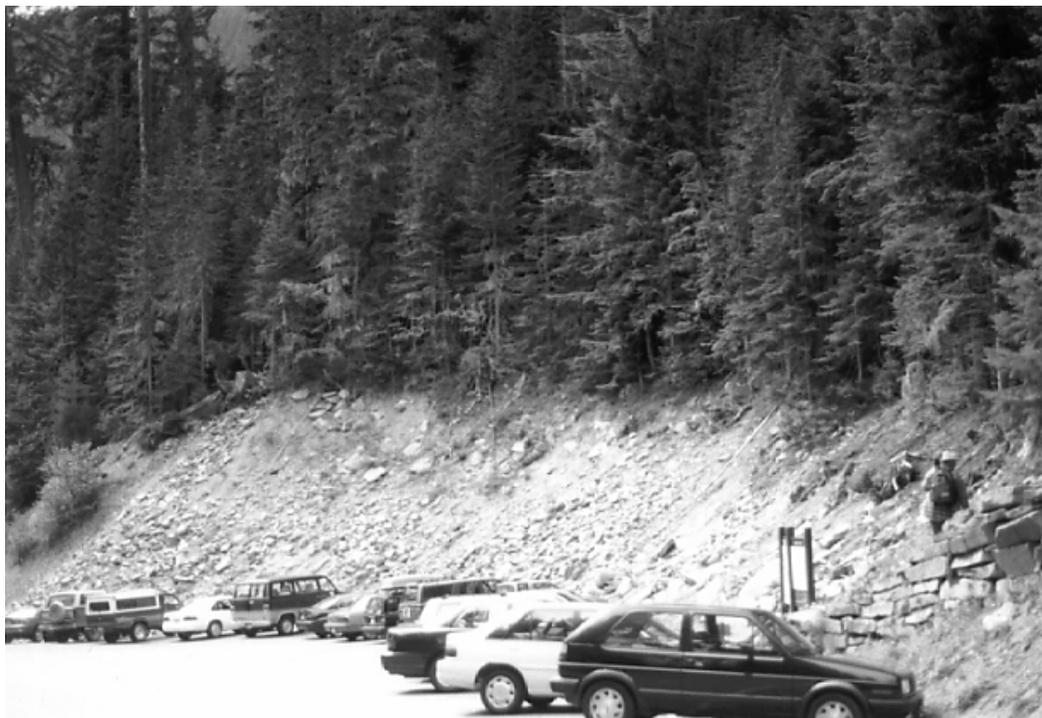
Photograph showing a steep slope at the Comet Falls trailhead, where slope stabilization is a concern to park managers. The trailhead was built in 1985. CCSO, 1994.

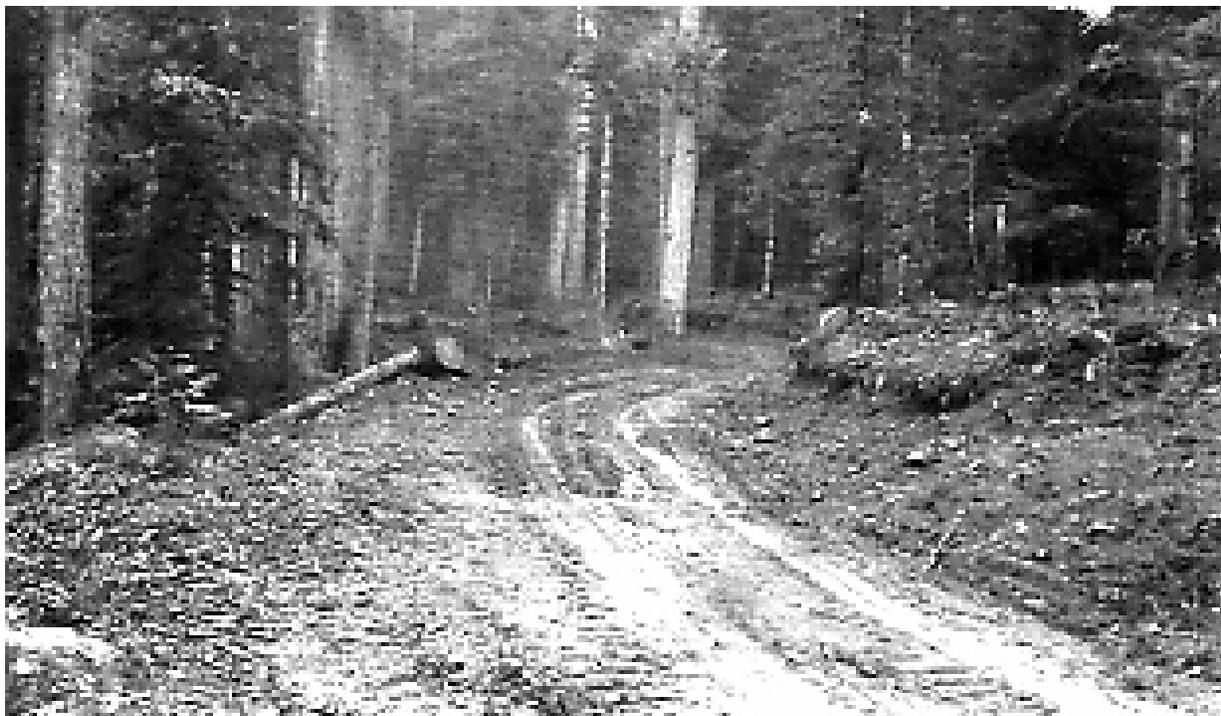
Historic photograph showing a view of the Road to Paradise below Longmire in 1928. MORA photo files, neg. 4075.

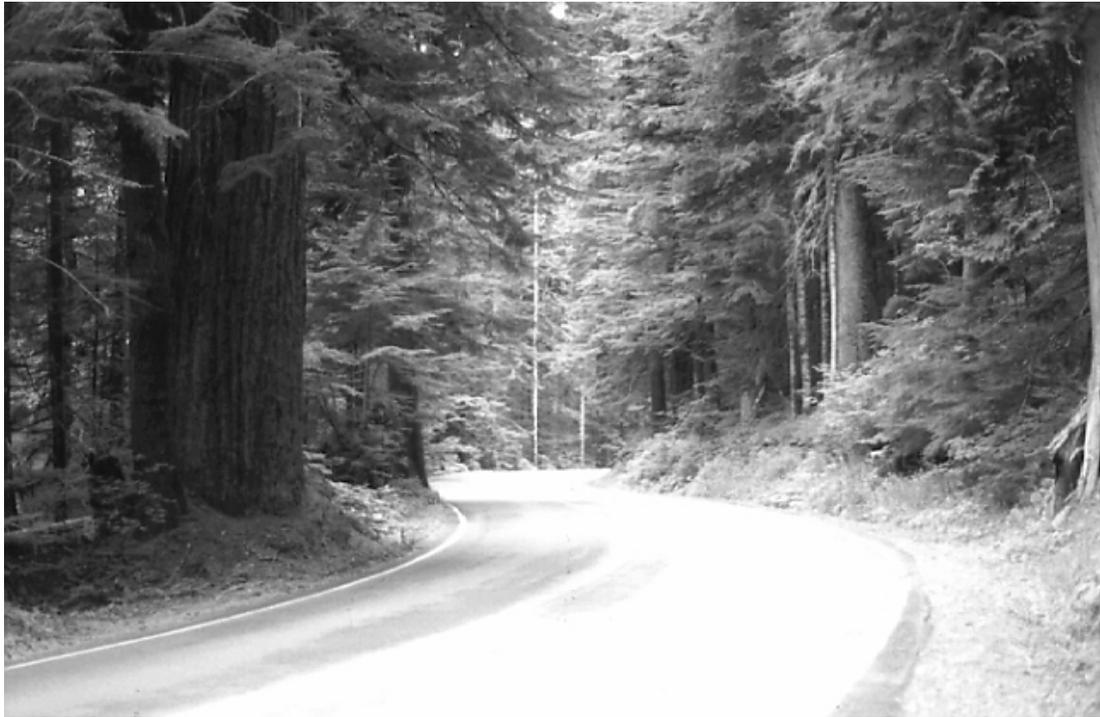
Photograph of the Road to Paradise below Longmire in 1994, showing the road winding through the lowland forest. CCSO, 1994.

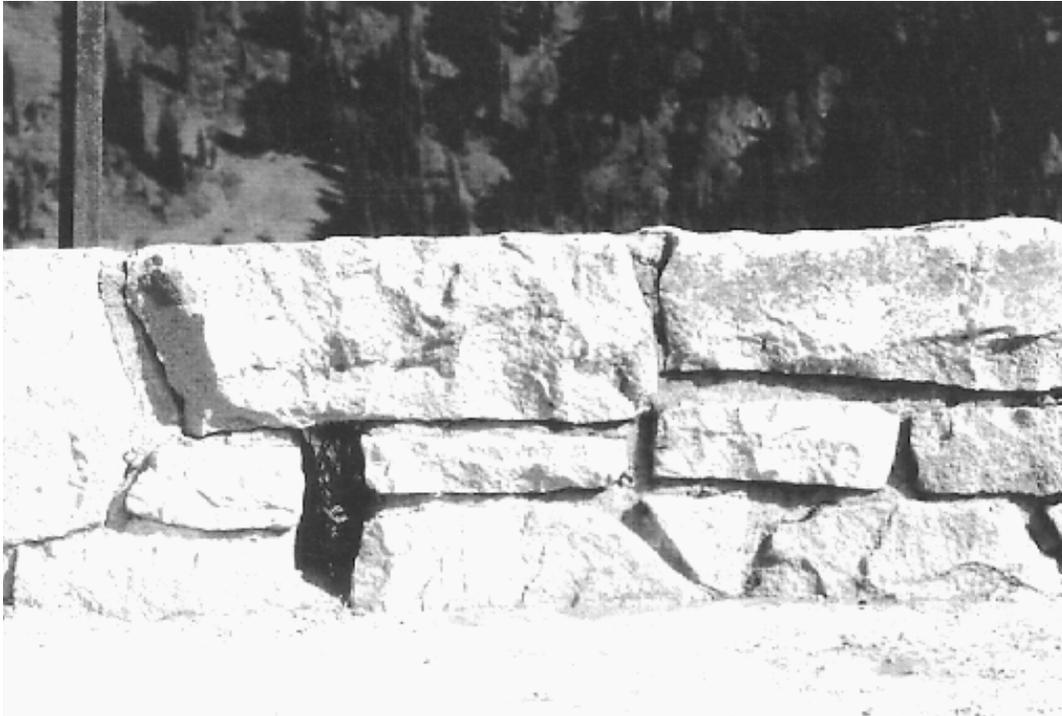
Photograph showing a stone wall with a weep hole. This is a typical detail in a wall near Paradise. (CCSO, 1994.)

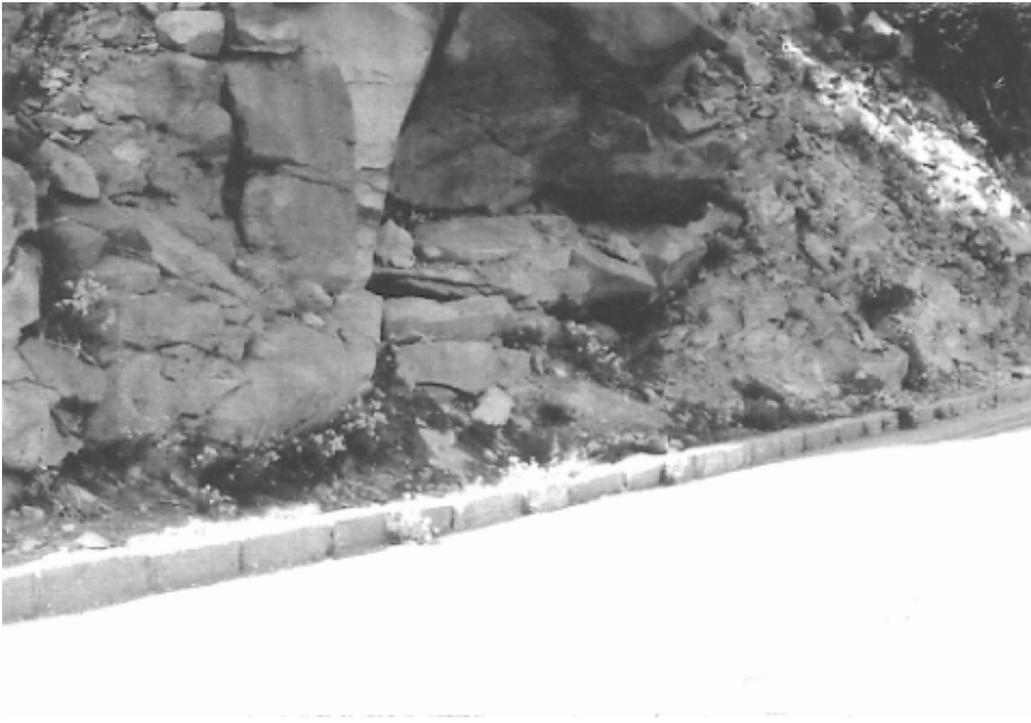
Photograph showing a stone curb along the edge of the road near Paradise. (CCSO, 1994.)

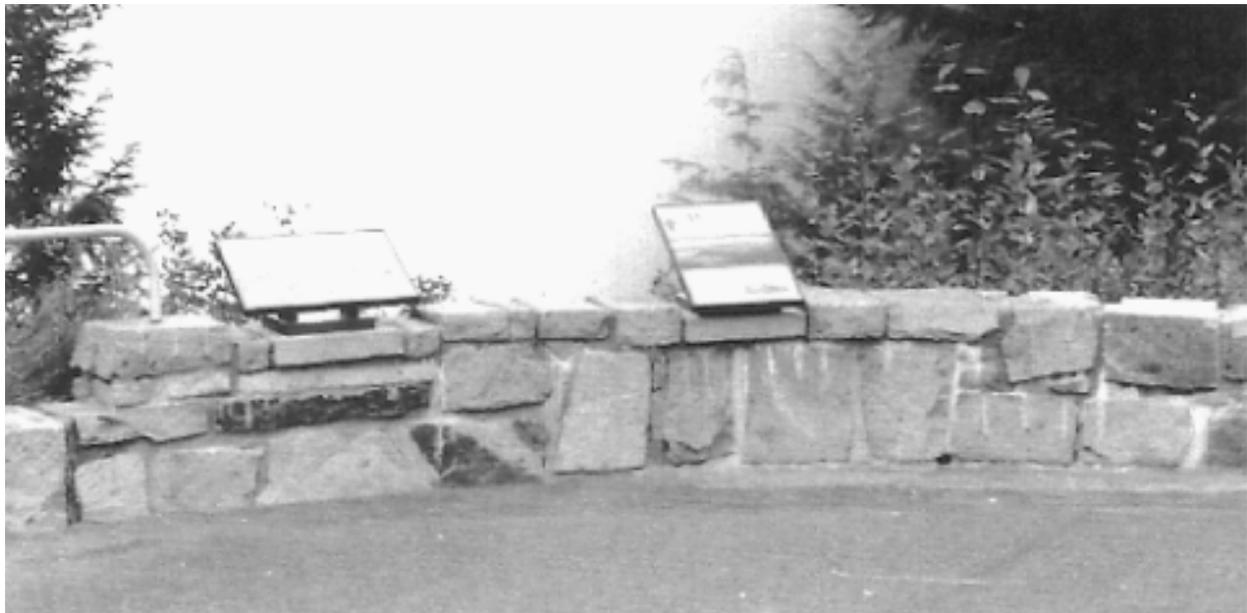
Photograph showing a contemporary wayside exhibit along the road near Ricksecker Point. (CCSO, 1994.)

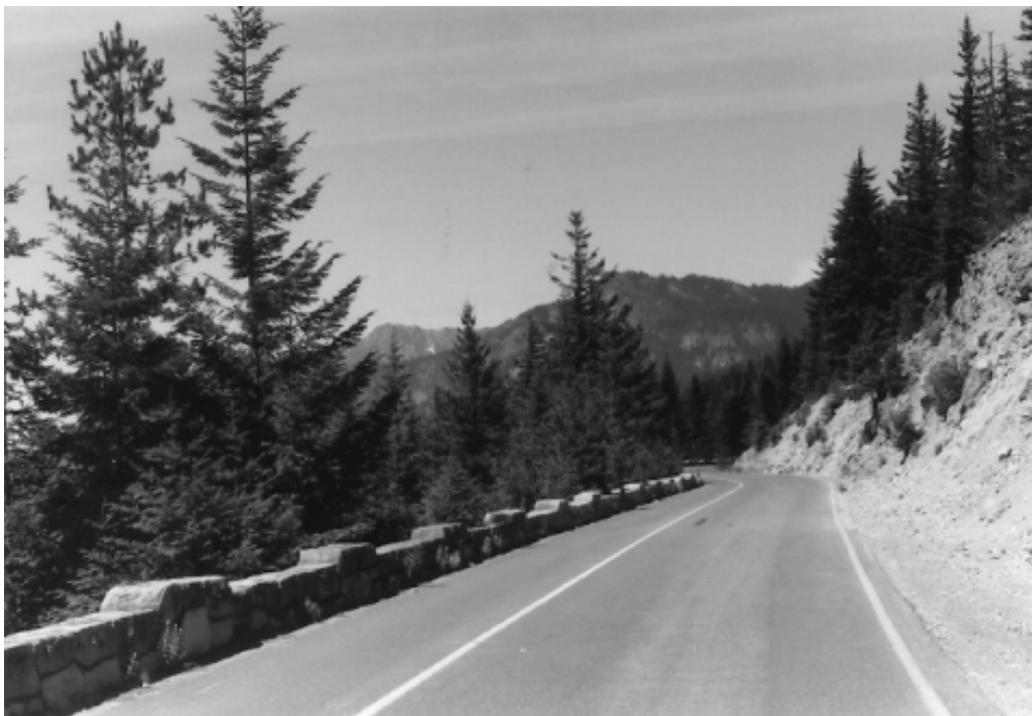
Photograph showing a stone guardrail with crenelations at the edge of the road near Paradise.

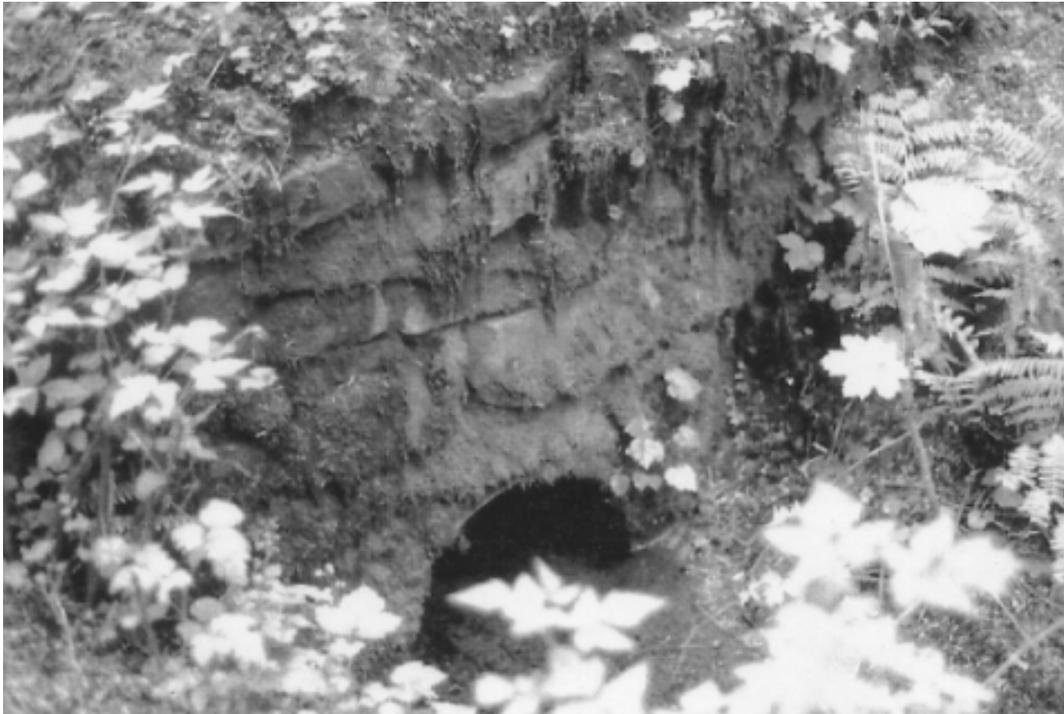
Photograph showing a stone culvert along the lower portion of the road, between Nisqually Entrance and Longmire. (CCSO, 1994.)
