Road to Paradise
Mount Rainier National Park

CULTURAL LANDSCAPES INVENTORY (CLI) PROGRAM
2010 Condition Assessment Update for:

CONDITION ASSESSMENT: **FAIR**

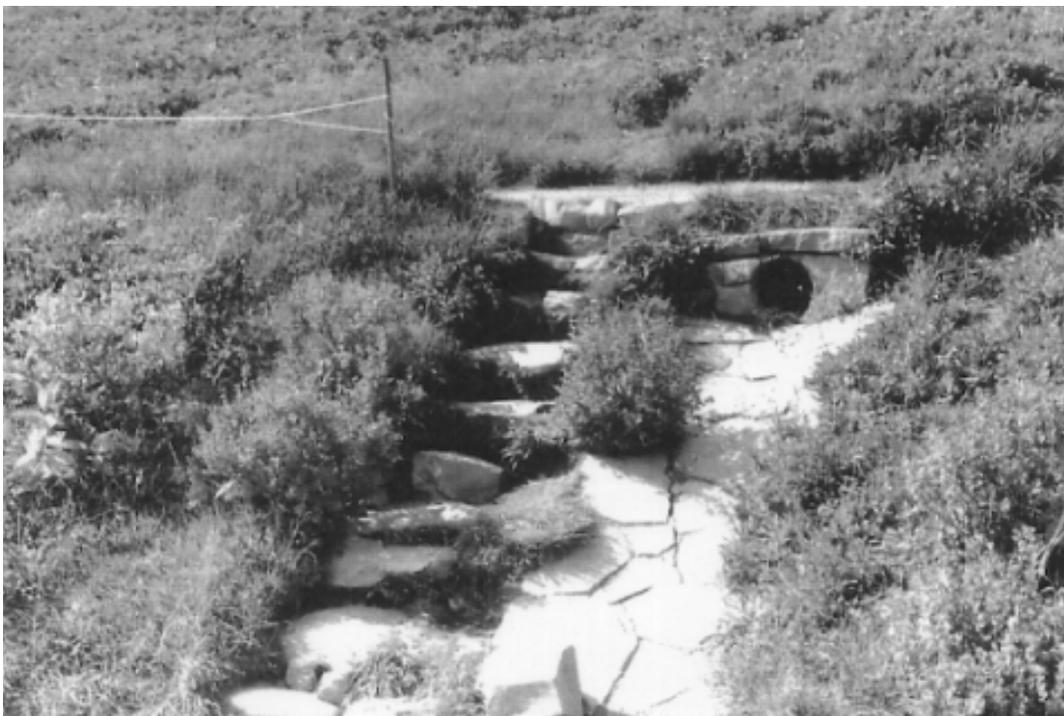
Photograph showing a stone culvert, drainage wall, and stairs leading to Paradise area footpaths from the west end of the main parking lot. (CCSO, 1994.)

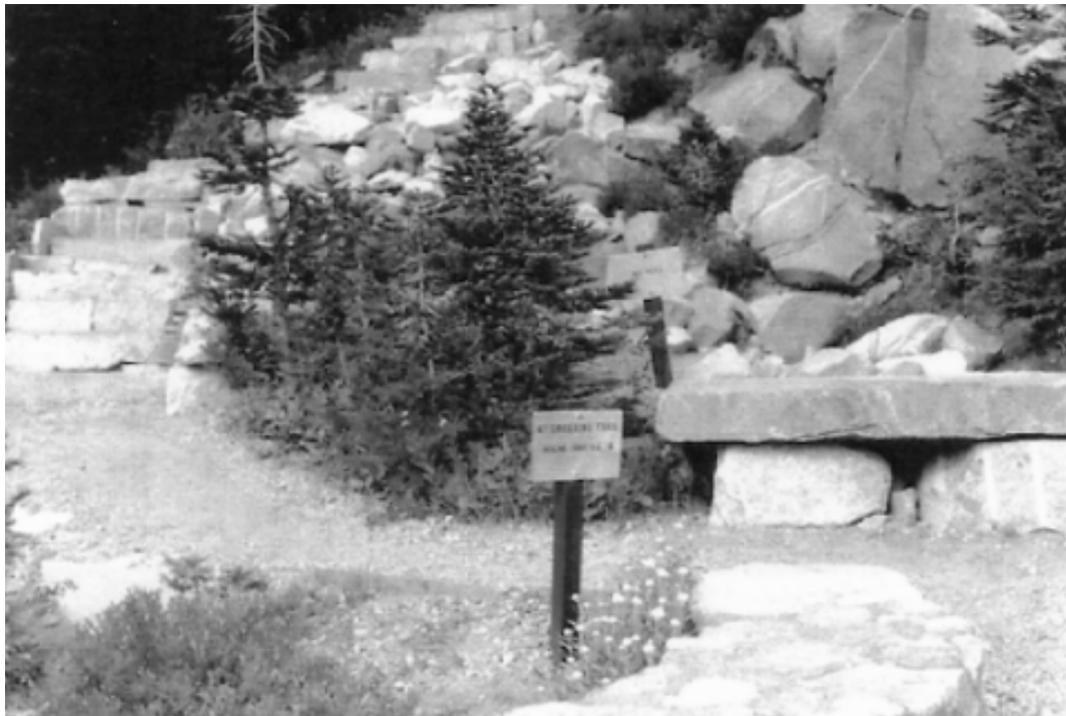
Photograph showing an example of a contemporary, engraved metal trail sign. (CCSO, 1994.)

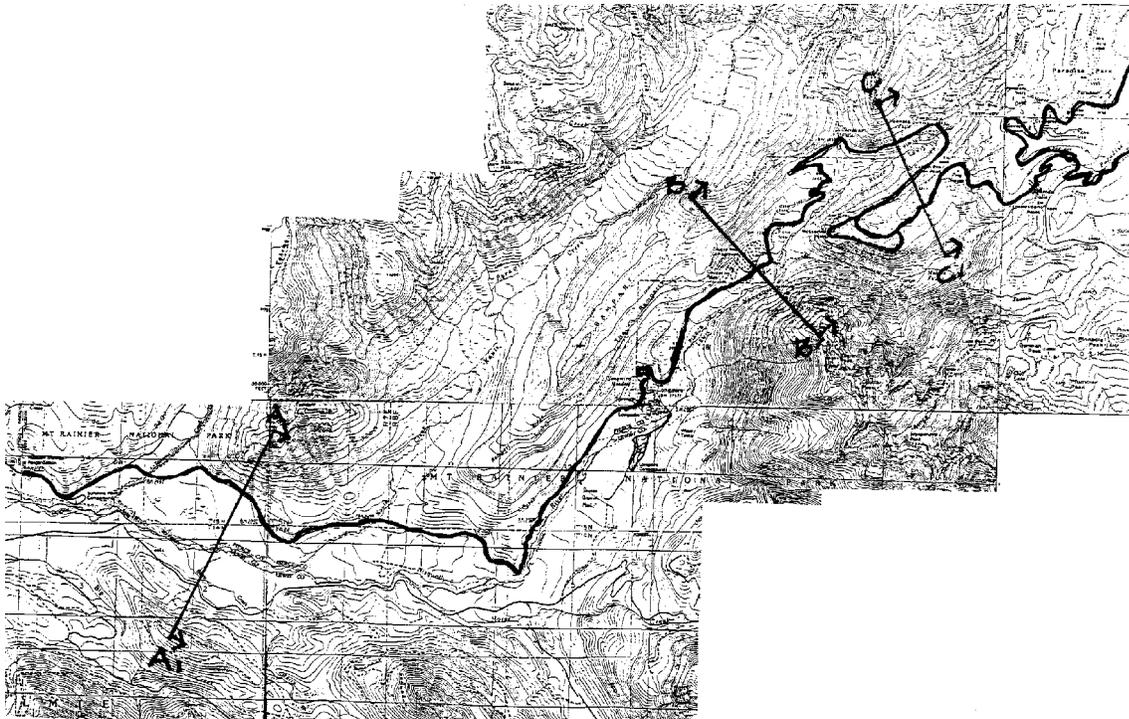
Plan of the Road to Paradise indicating the topography of the road. Three cross sections following this plan, A-C, are keyed.

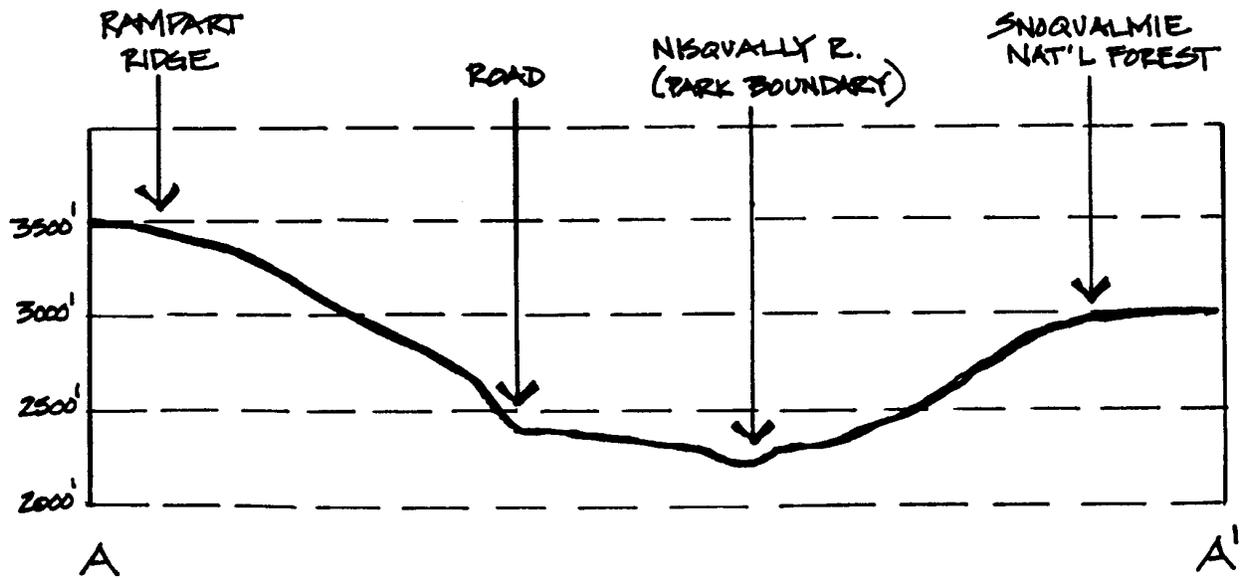
Cross section A-A', indicating the topography surrounding the Road to Paradise at a point not far from the Nisqually Entrance, where the road is following along the Nisqually River valley.

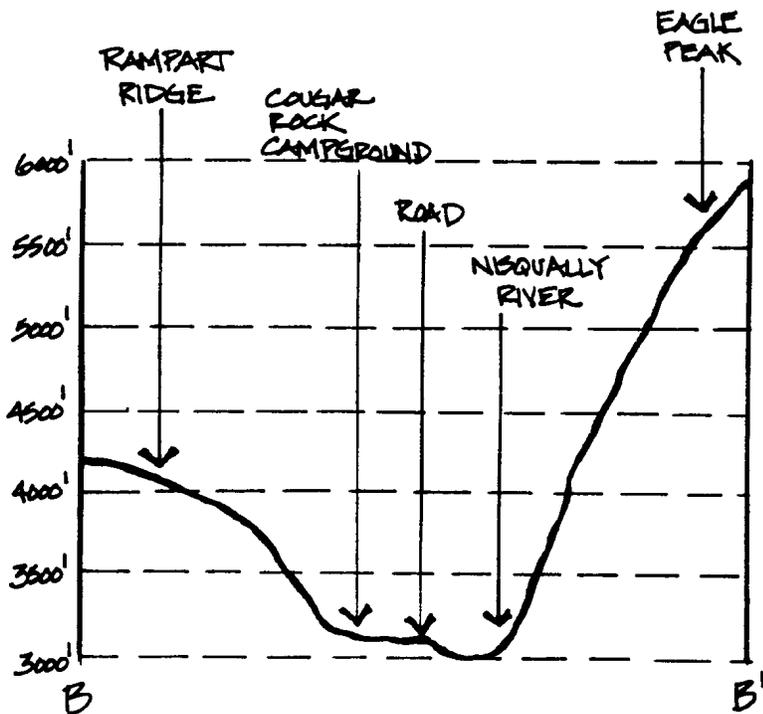
Cross section B-B', indicating the topography surrounding the Road to Paradise near Cougar Rock Campground, where the road follows along the Nisqually River valley, between Rampart Ridge and Eagle Peak.

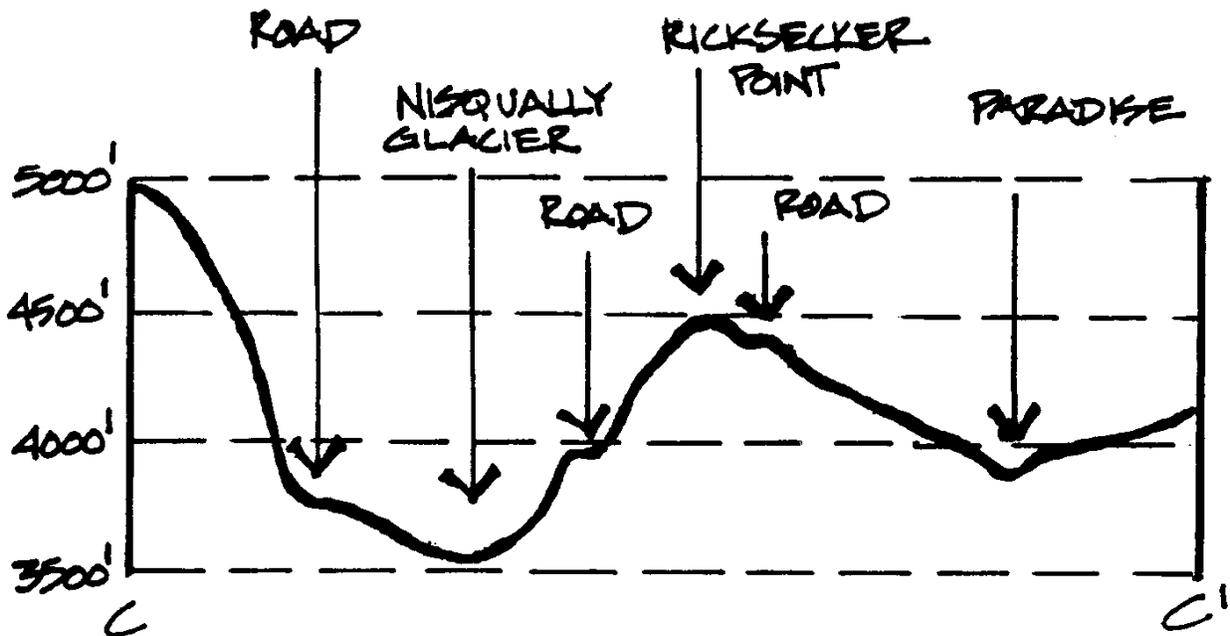
Cross section C-C', indicating the topography surrounding the Road to Paradise where the road winds around Ricksecker Point.

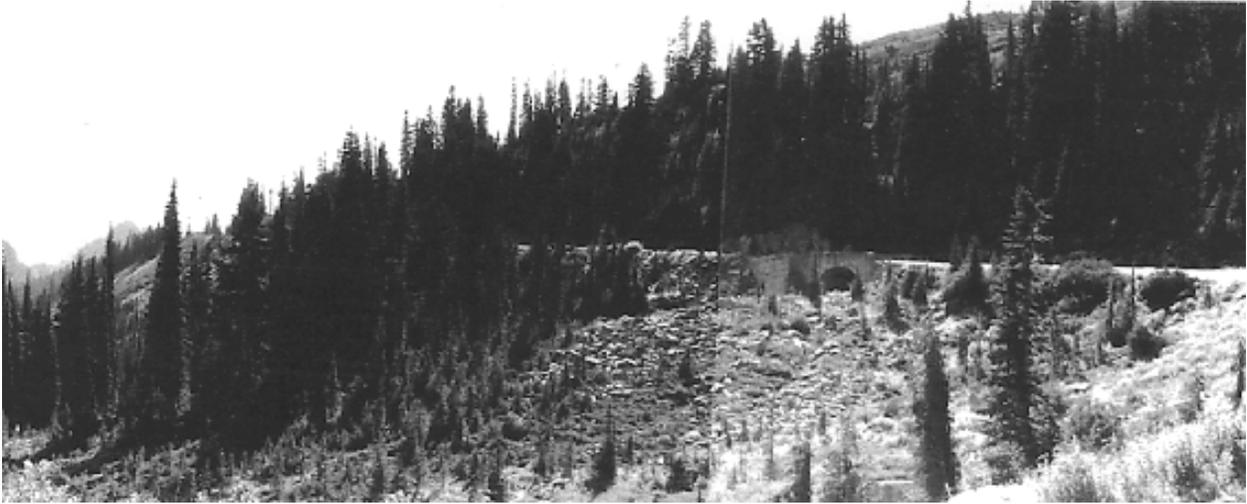
Photograph of the view of Edith Creek Bridge in the upper Paradise Valley from the road, looking southwest. (CCSO, 1994.)
