Cultural Landscape Inventory Stevens Canyon Highway

Mount Rainier National Park

November 2004

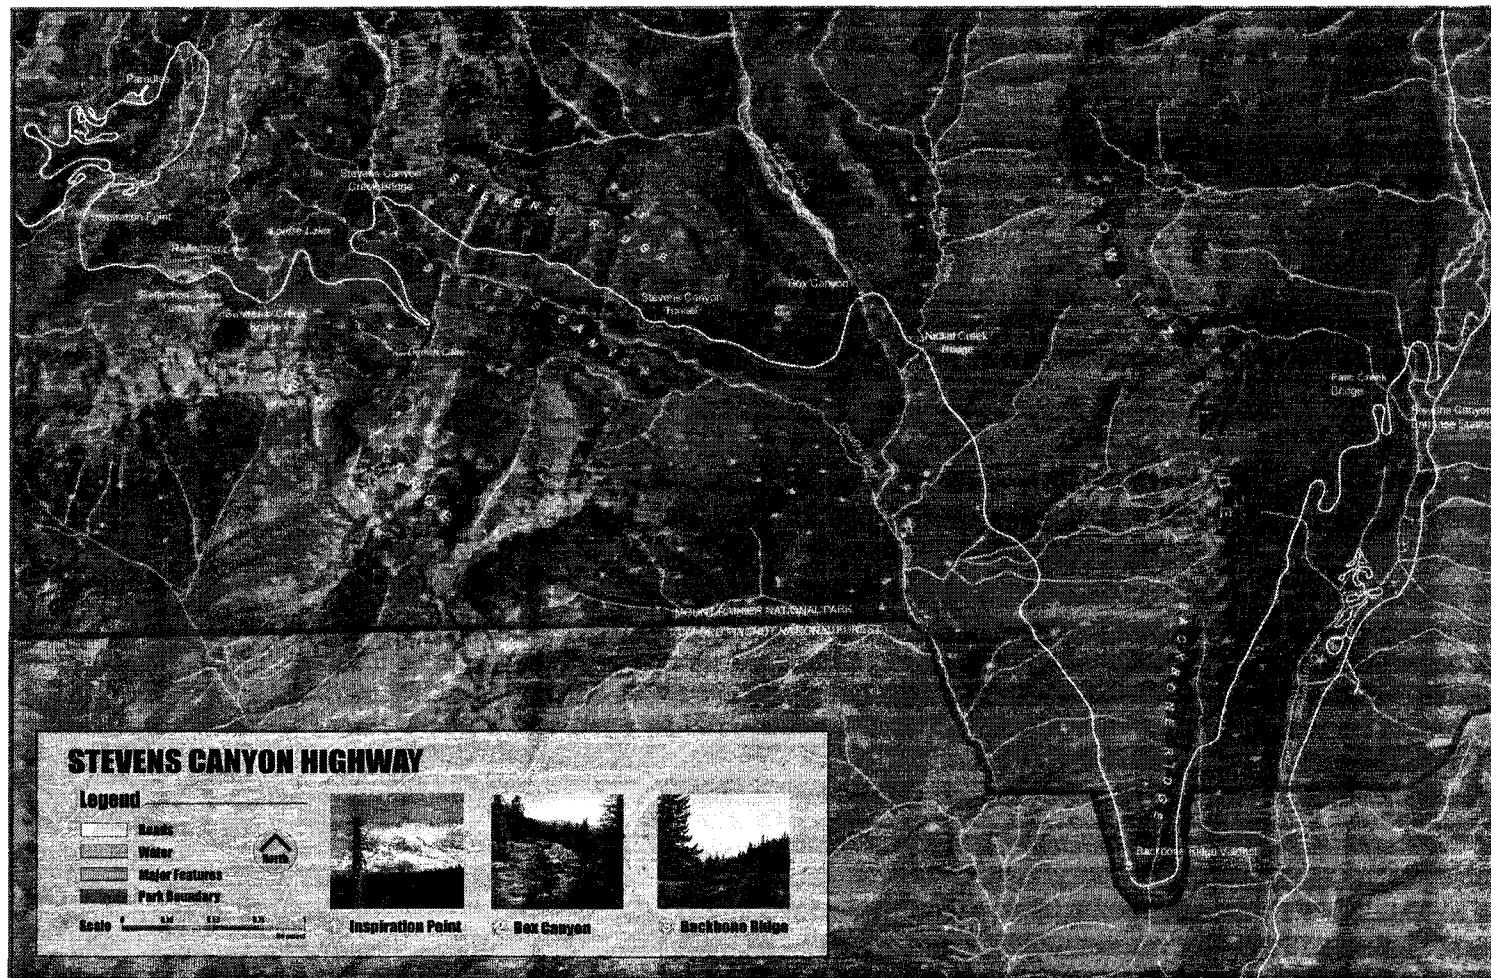
Site Plan

Site plan showing major structures and natural features along the Stevens Canyon Highway.

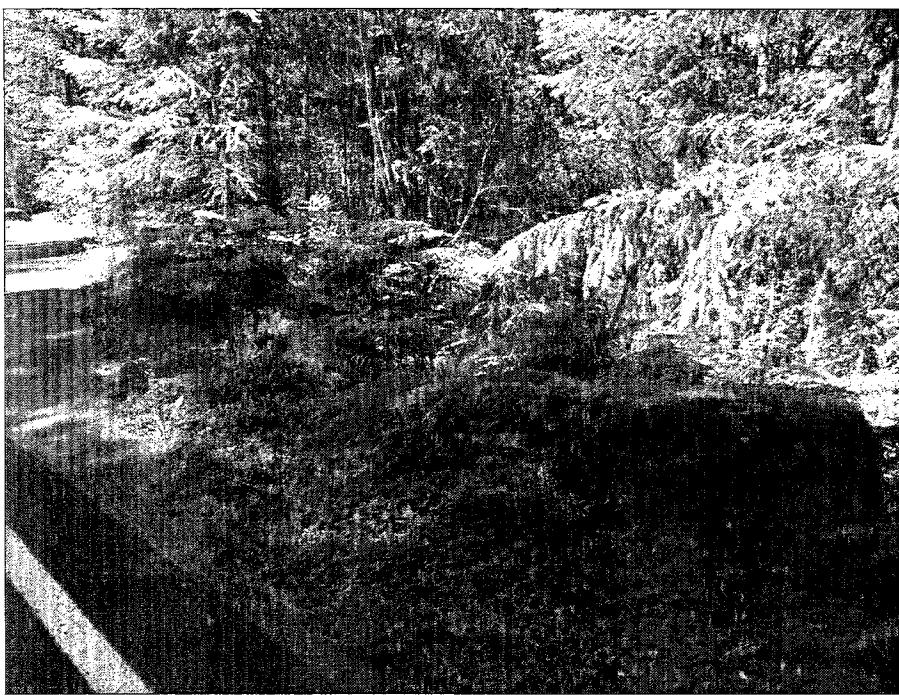
Figure 3.16. Contemporary photo showing contributing rock barrier (MORA 2004).

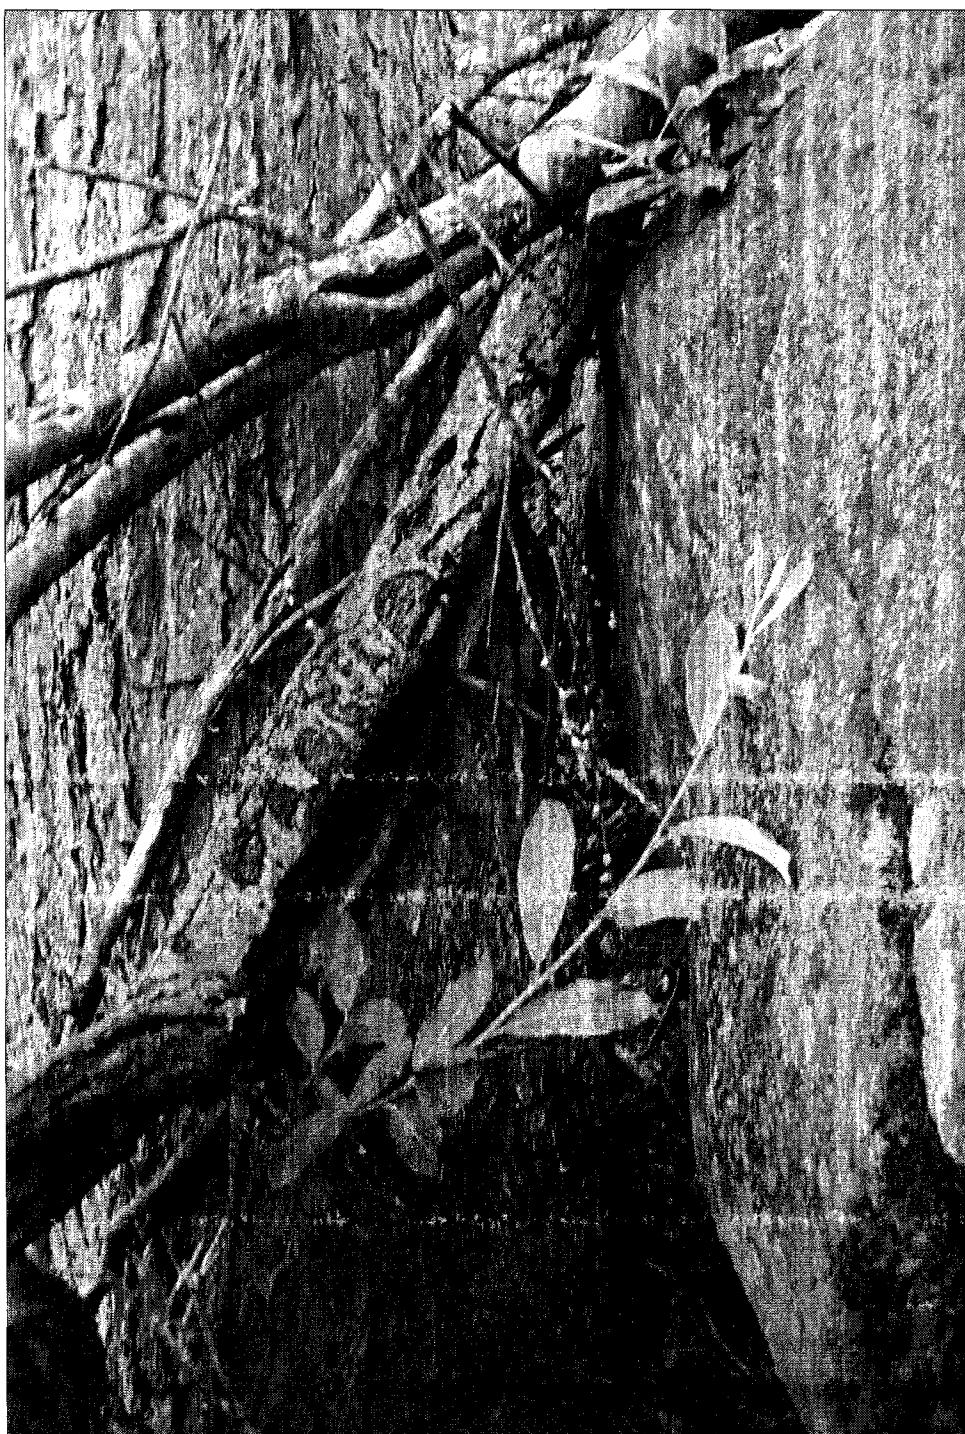
Figure 3.29. Contemporary photo showing contributing dry-laid stone treewell next to a specimen tree close to Inspiration Point (MORA 2004).

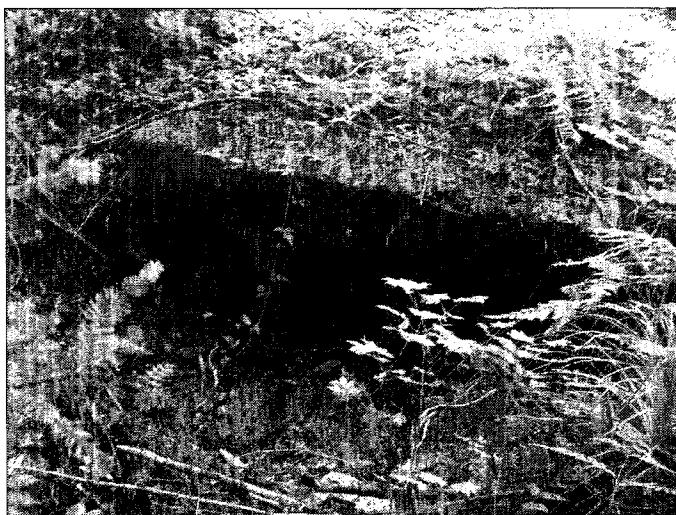
Figure 3.48. Contemporary photo showing contributing culvert located between Backbone and Nickel Creek (MORA 2004).
