National Park Service  
Cultural Landscapes Inventory  
2010

Sunrise Developed Area  
Mount Rainier National Park

**MOUNT RAINIER NATIONAL PARK**  
**Sunrise Developed Area**

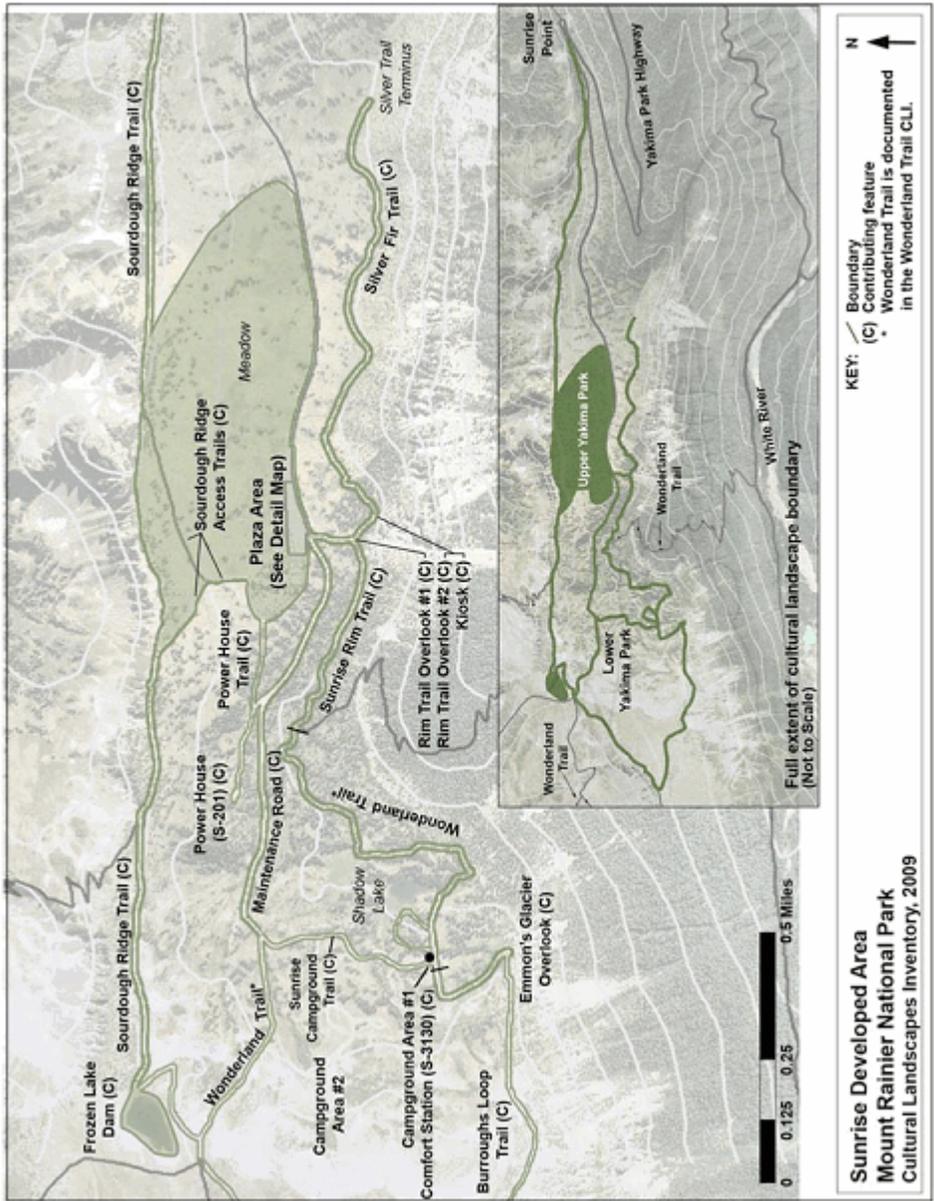
Map showing the cultural landscape boundary for Sunrise Developed Area (PWRO 2009). See "Supplemental Information" for a larger version of this map.

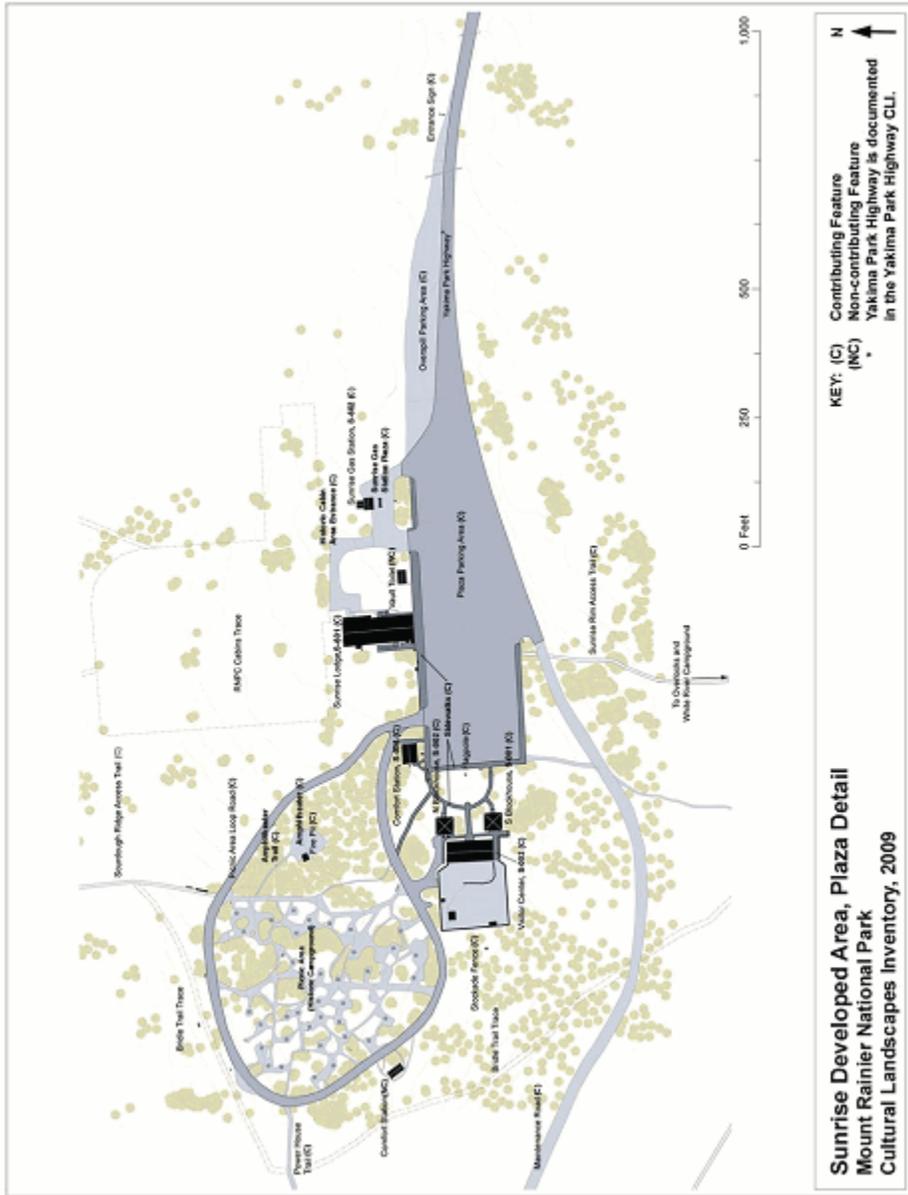
Map showing details of the Sunrise Developed Area plaza (PWRO 2006). See "Supplemental Information" for a larger version of this map.

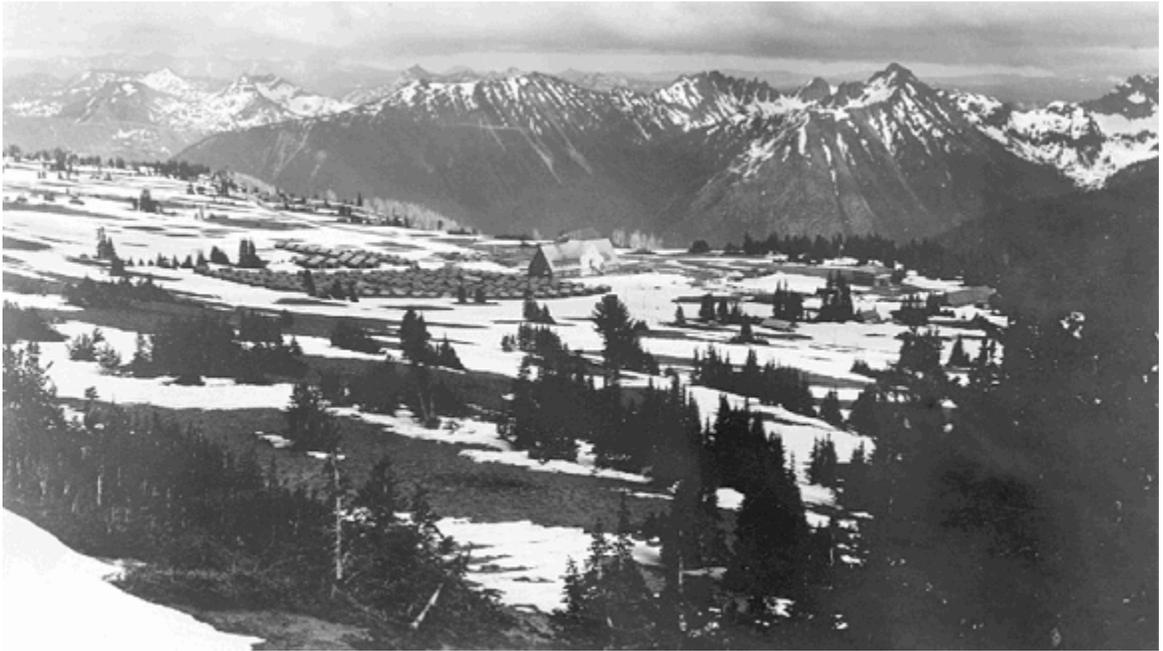
*Historic photo of early Sunrise development in the "park proper" showing subalpine meadow and fir trees. (Tahoma Woods Collection, twc3125)*

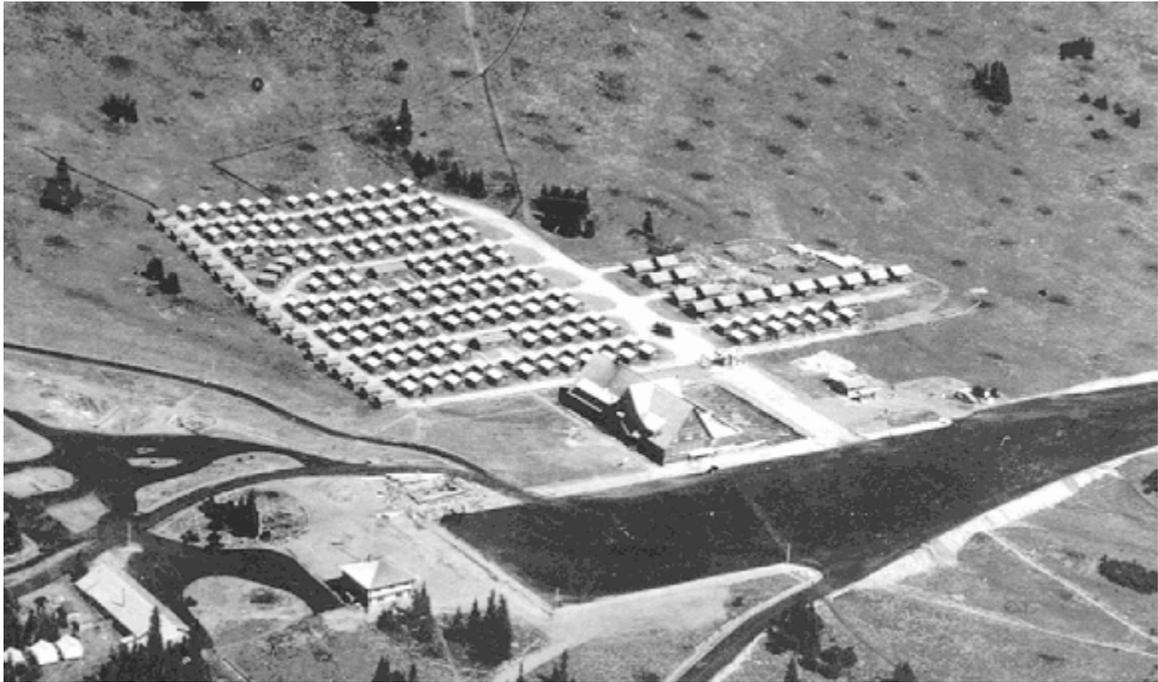
*Aerial photo of Sunrise from 1932 showing the visitor services group with the lodge, the service station to its right, and the rows of visitor cabins. (Tahoma Woods Collection, is1185)*

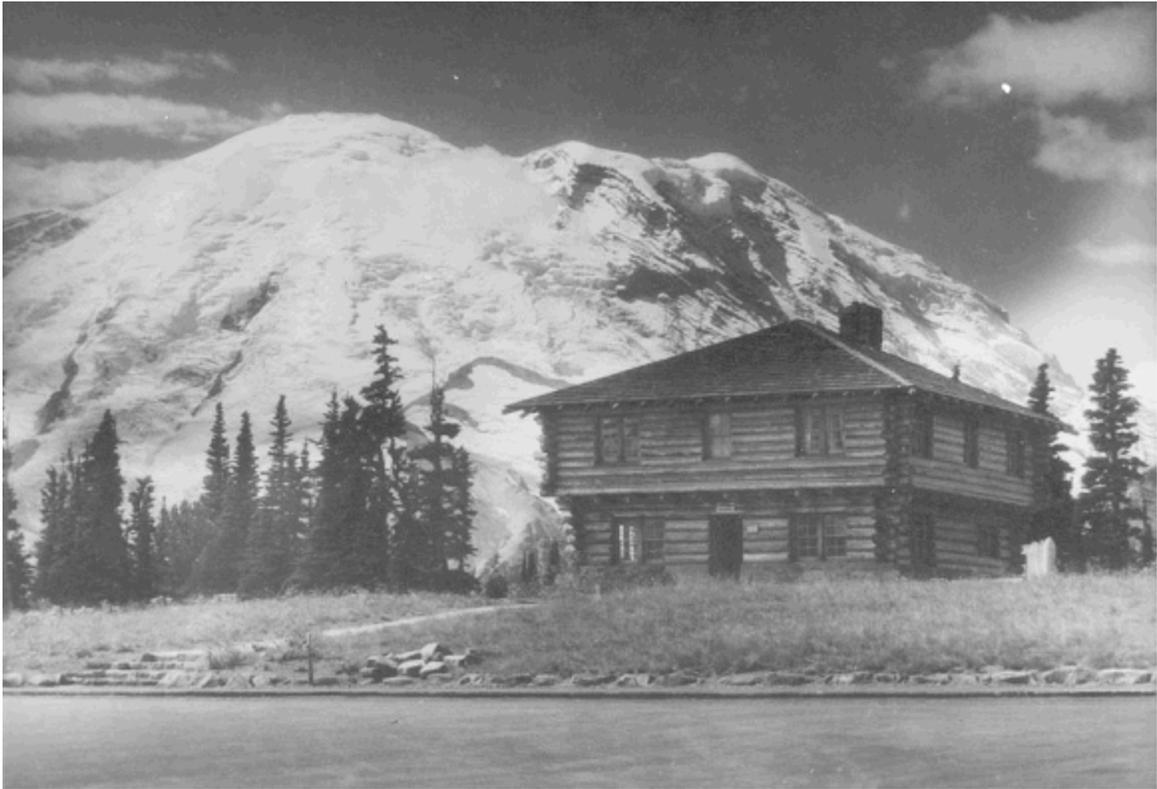
*Historic photo of the south blockhouse, taken in the mid-1930s. After construction was completed in 1930, the area in front of the blockhouse was revegetated with native meadow grass species. (Tahoma Woods Collection, is1056)*

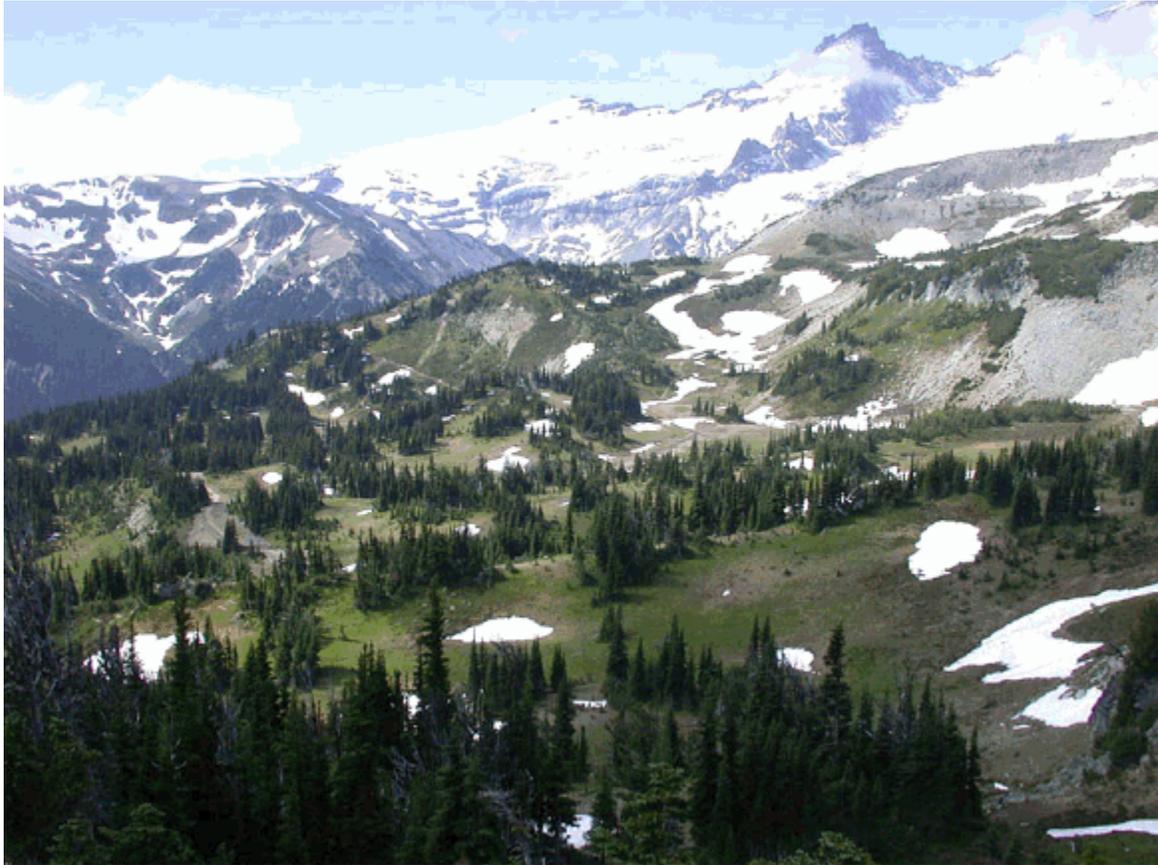
*Contemporary photo of the west-end parkland showing the site's characteristic subalpine meadows interspersed between dense stands of fir and pine. (PWRO 2002)*

Large scale vegetation patterns in Yakima Park have been relatively stable. However, there has been encroachment of the fir forest on the meadows. Careful comparison of historic and modern photographs of the large meadow area north and east of the lodge shows an increase in number and size of fir trees. While this encroachment has not altered the character of the meadow enough to affect the integrity of the cultural landscape, it may eventually. The meadow is mentioned repeatedly in early descriptions of Yakima Park and in the narratives associated with the design of Sunrise. It played a major part in the master plan of the village and thus contributes to the significance of the cultural landscape. Continued encroachment of the fir forest will eventually diminish the integrity by reducing the visual and experiential impact of the meadow, fundamentally altering the character of Sunrise.

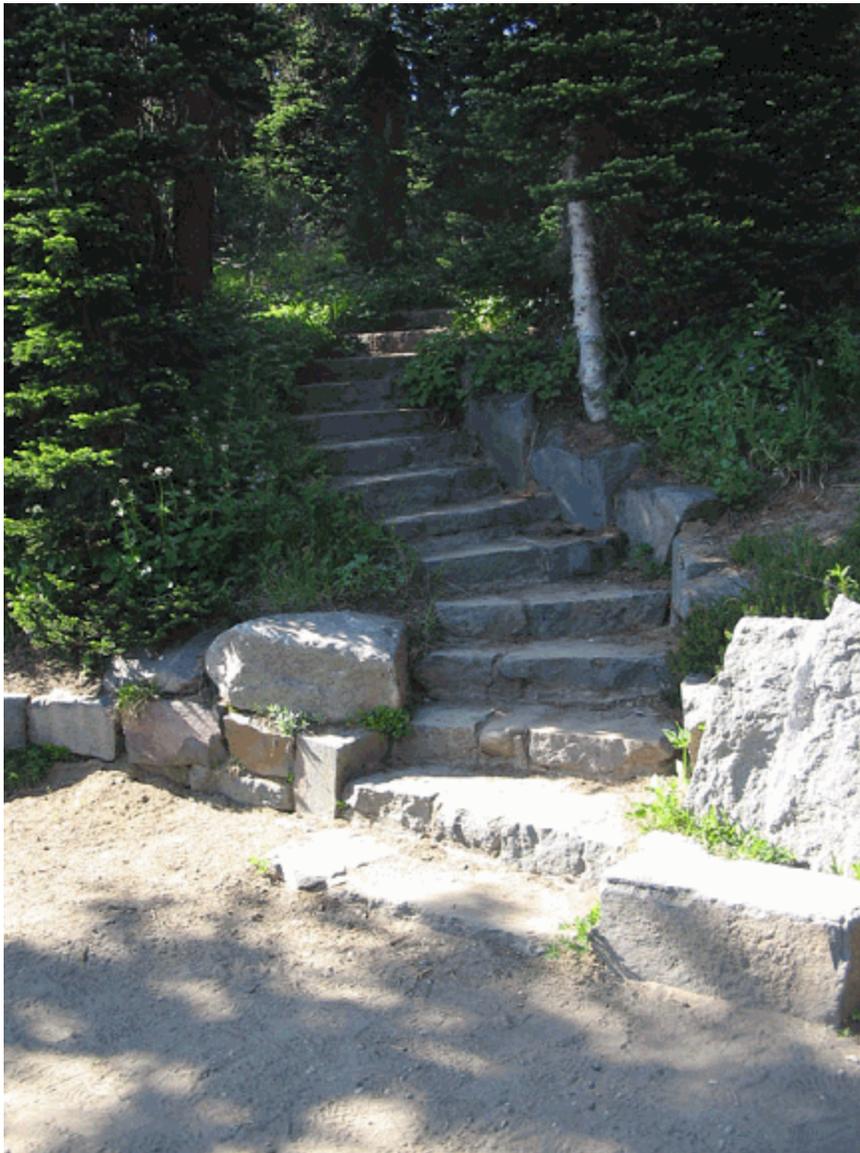
*Contemporary photo of staircase connecting an overlook to Sunrise Rim Trail. (PWRO 2008)*

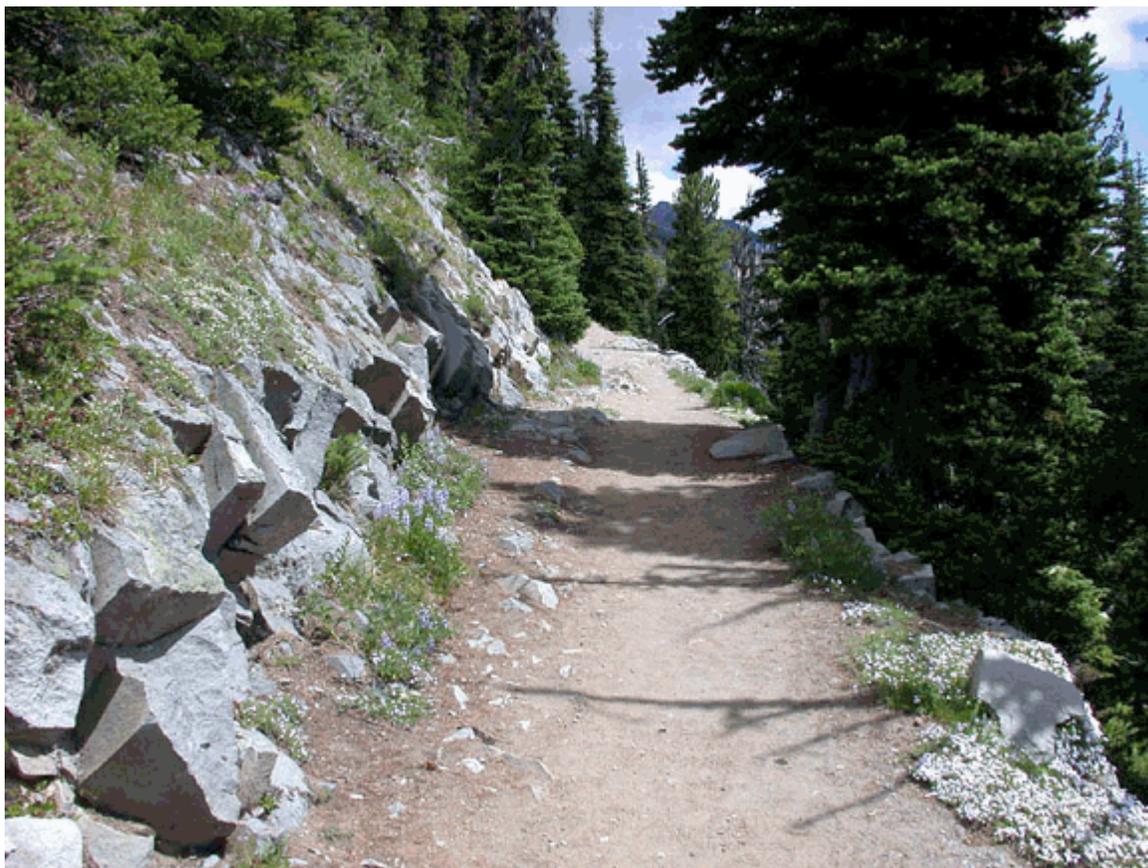
*Contemporary photo of Sourdough Ridge Trail northwest of Sunrise showing dry-stacked retaining wall. (PWRO 2002)*

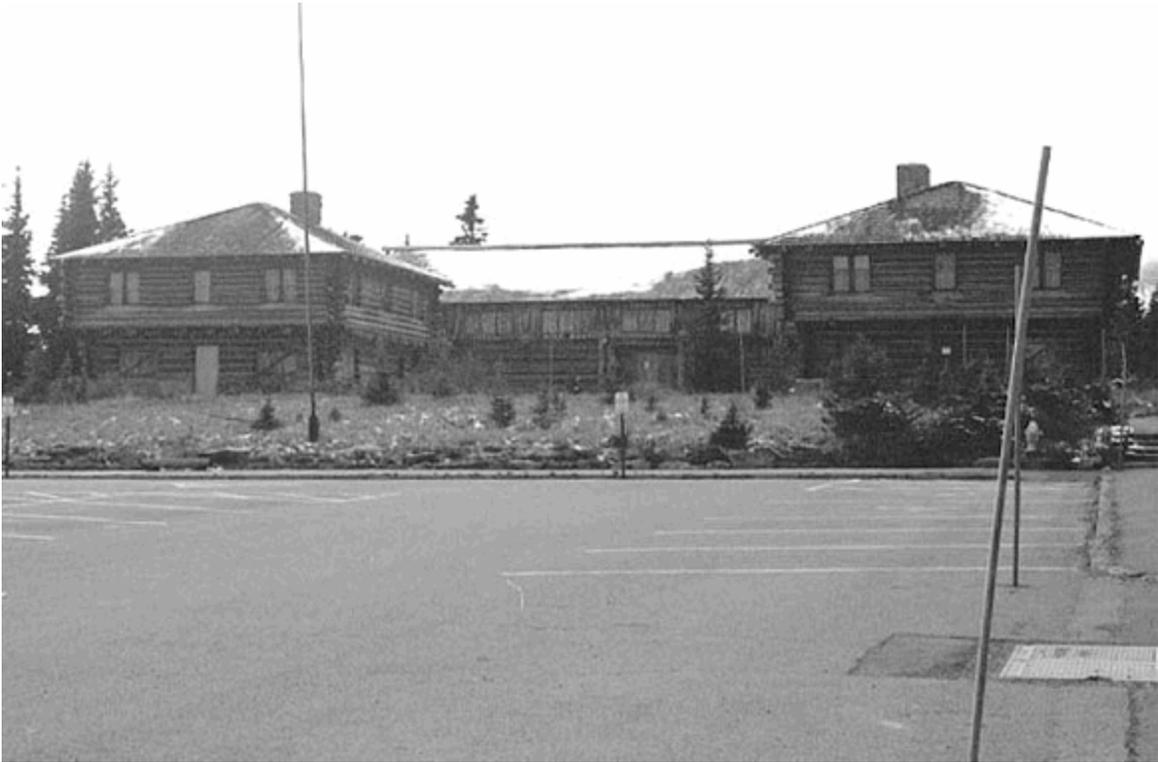
*Contemporary photo of stockade buildings: the South Blockhouse (S-001), North Blockhouse (S-002) and Sunrise Visitor Center (S-003). (PWRO 2002)*

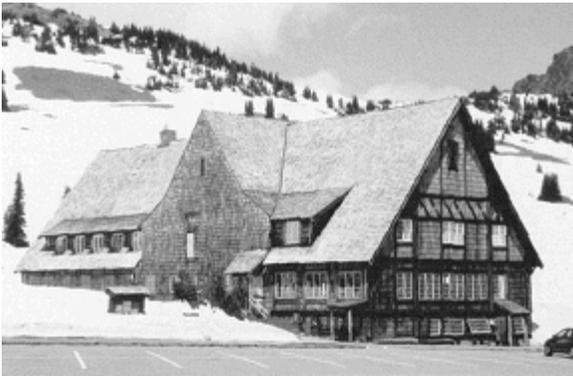
*Contemporary photo of Sunrise Lodge (S-601). (PWRO 2002)*

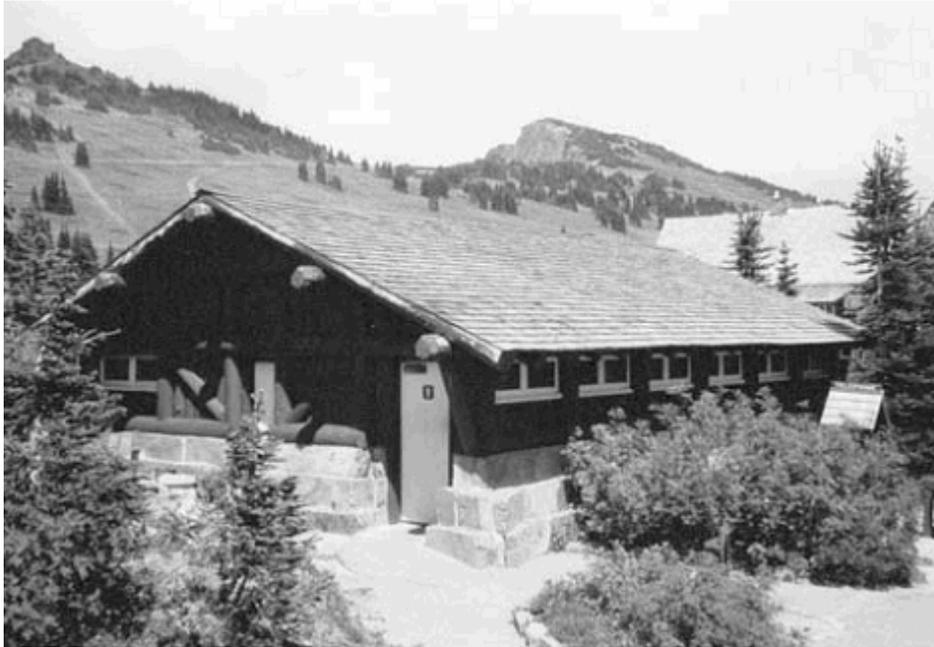
*Contemporary photo of the Comfort Station (S-005). (PWRO 2002)*

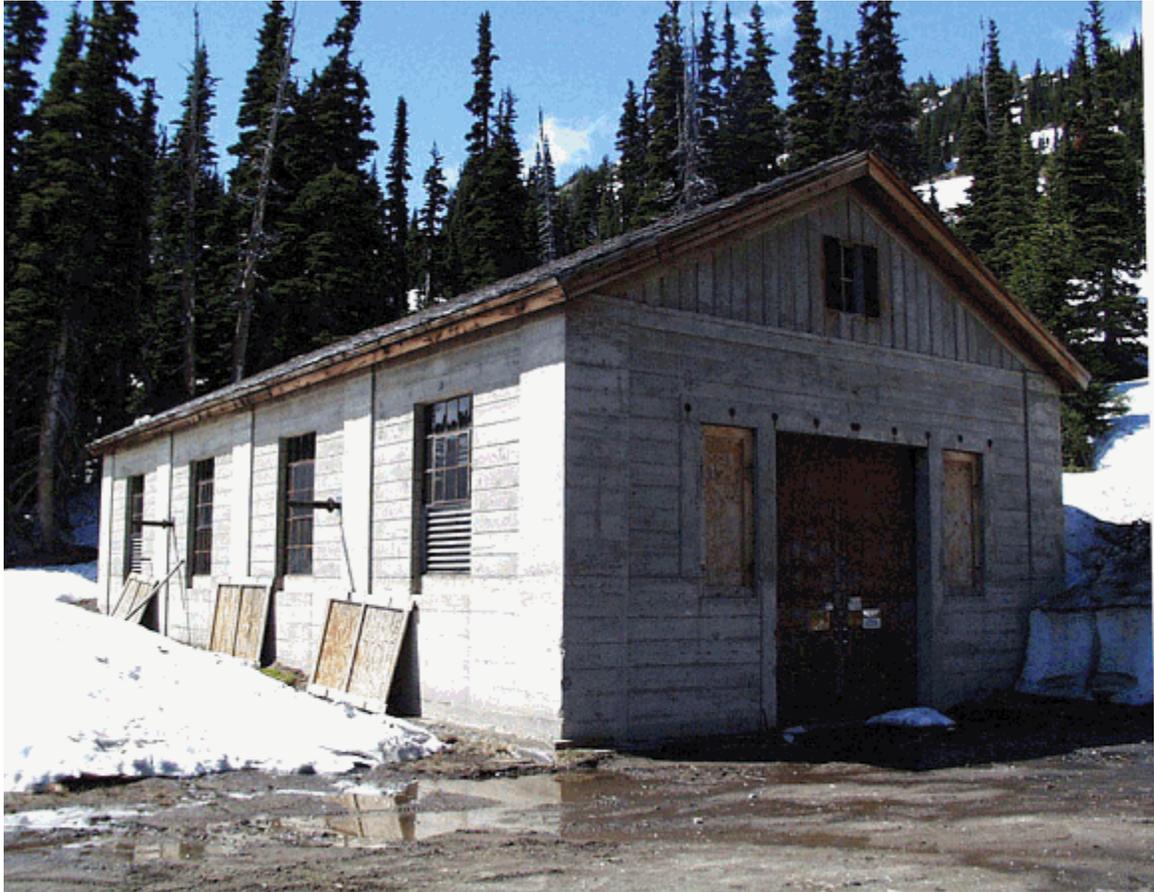
*Contemporary photo of the Power House (S-201). (PWRO, 2002)*

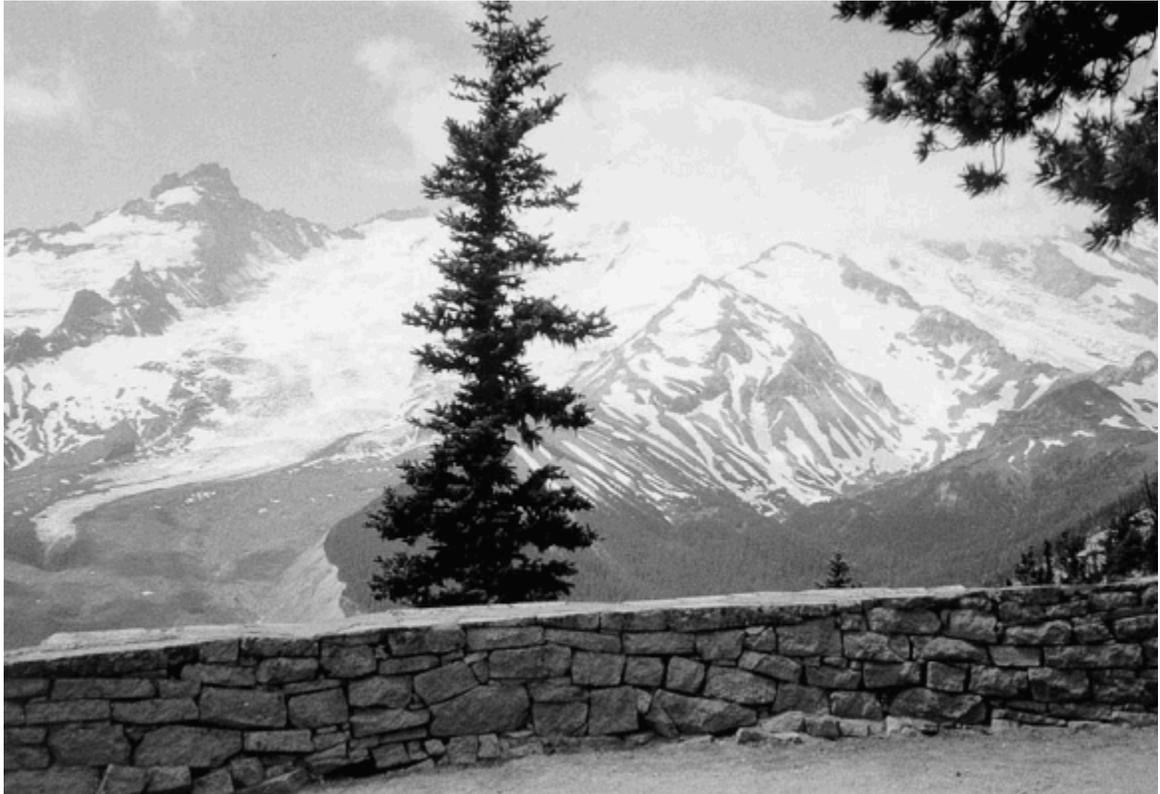
*Contemporary photo showing rock wall at Emmon's Glacier Overlook along Burroughs Mountain Trail. (PWRO 2002)*

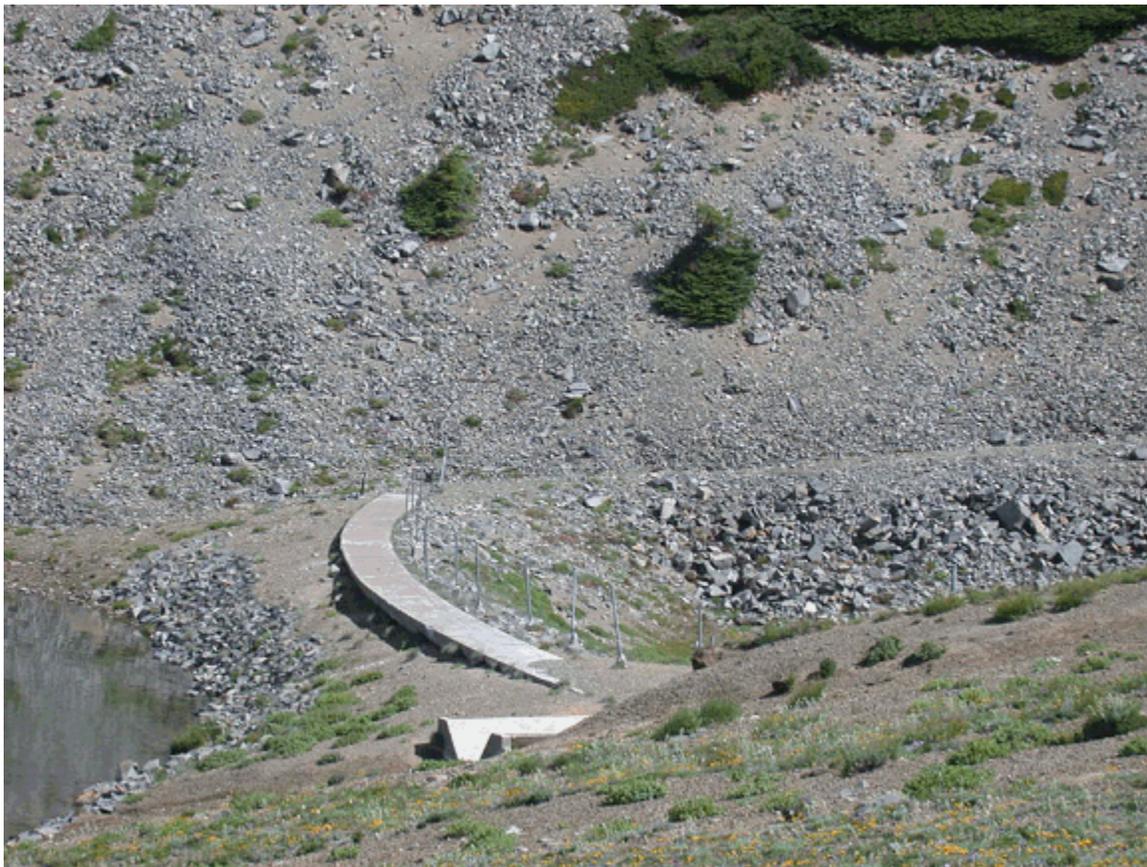
*Contemporary photo of Frozen Lake Dam structure. (PWRO 2002)*

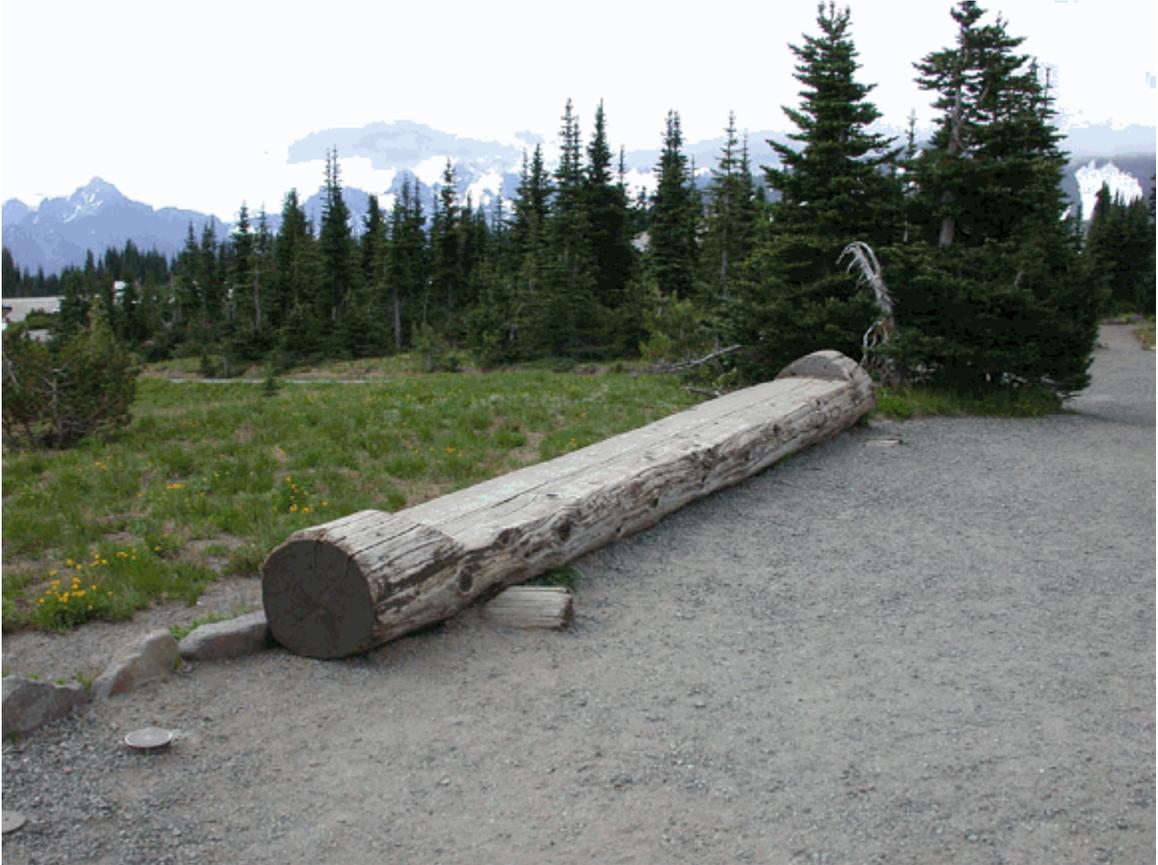
*Contemporary photo of historic whole-log bench. The log support footings have decayed causing the bench to sink onto the ground. (PWRO 2002)*

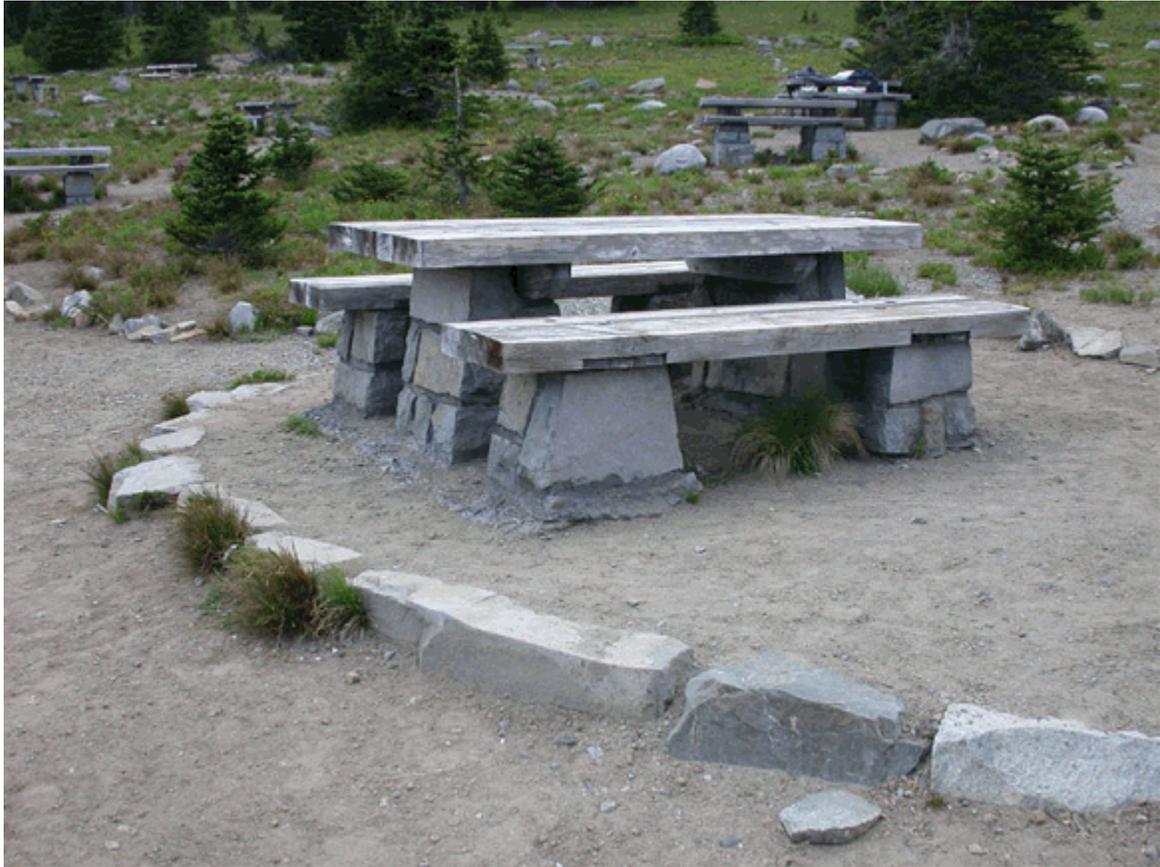
*Contemporary photo of historic picnic bench in good condition. (PWRO 2002)*

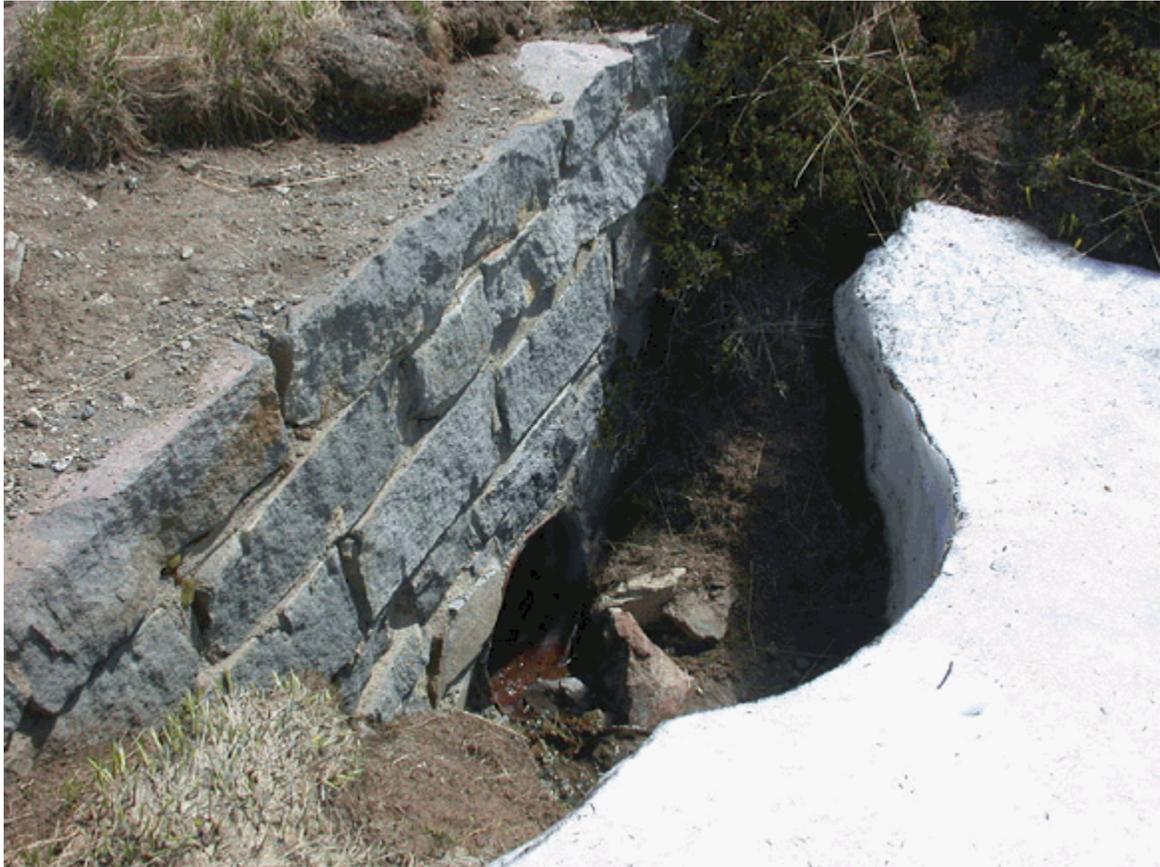
*Contemporary photo of historic culvert along the historic road to the rock quarry (now a part of the Wonderland Trail). (PWRO 2002)*

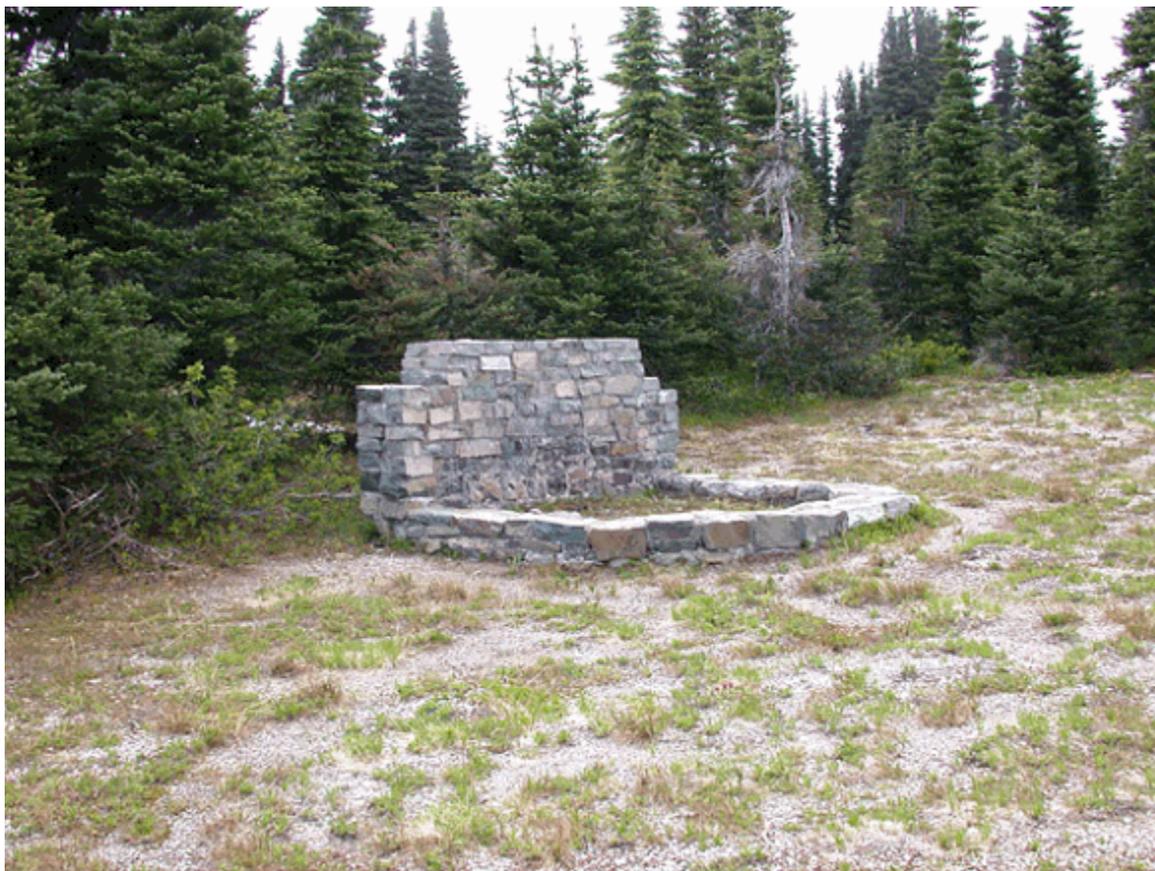
*Contemporary photo of historic amphitheater firepit in the picnic area. (PWRO 2002)*

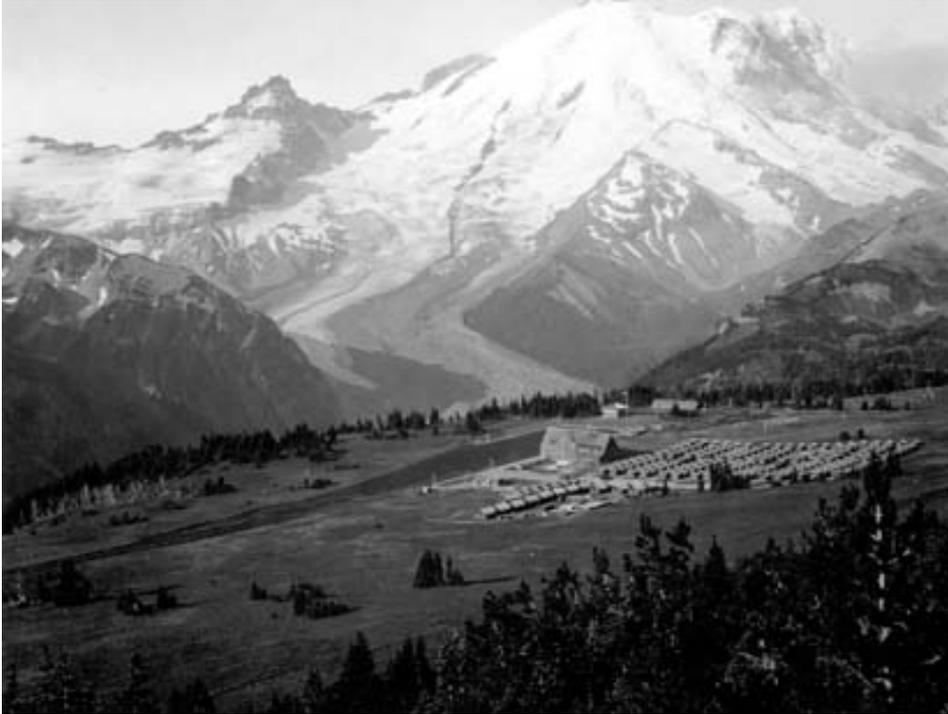
Historic photograph taken from the Sourdough Ridge Trail showing view circa 1930 of Sunrise and Mount Rainier. (Tahoma Woods Collection, twc2988) Note: the cabins north of the Lodge were removed near the end of the period of significance in 1944.

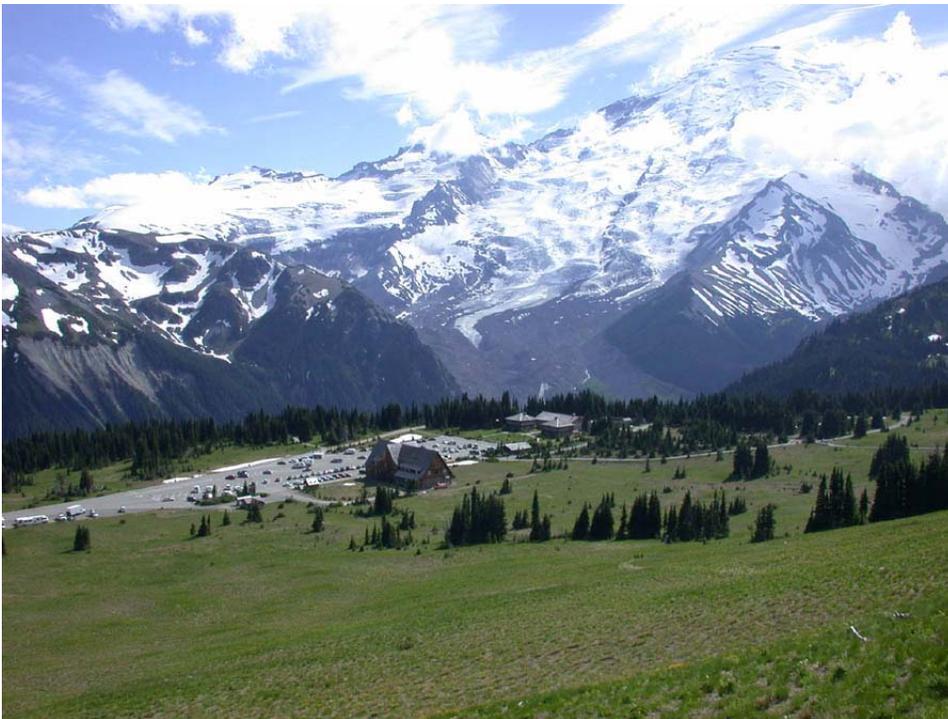
Contemporary photograph taken from the Sourdough Ridge Trail showing view of Sunrise and Mount Rainier. (PWRO 2002)

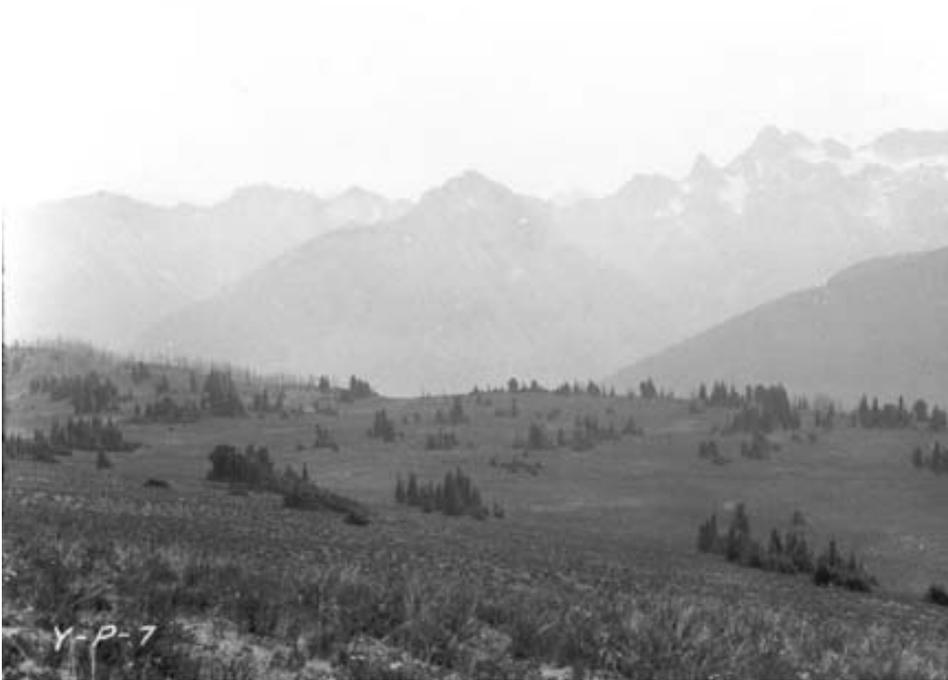
Historic photograph taken from the Sourdough Ridge Trail showing view in 1930 of the Sunrise meadow and mountain ridges beyond. (Tahoma Woods Collection, n3032)

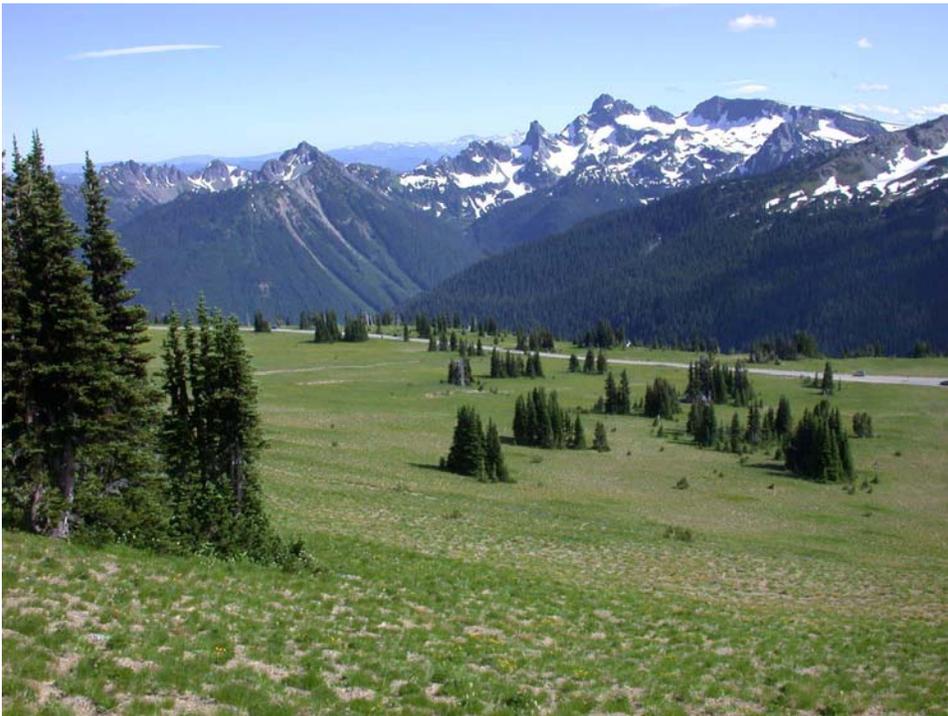
Contemporary photograph from Sourdough Ridge Trail showing view in 2002 of the Sunrise meadow and mountain ridges beyond. (PWRO 2002)

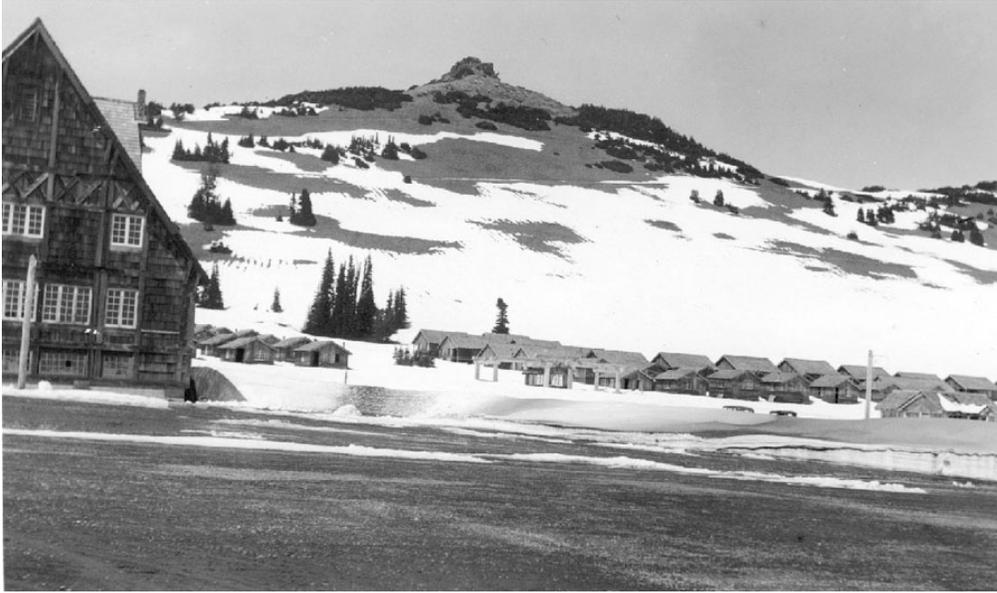
Sunrise lodge and housekeeping cabins with Sourdough Ridge and Sunrise meadow behind, circa 1935. (Tahoma Woods Collection, twc3132)

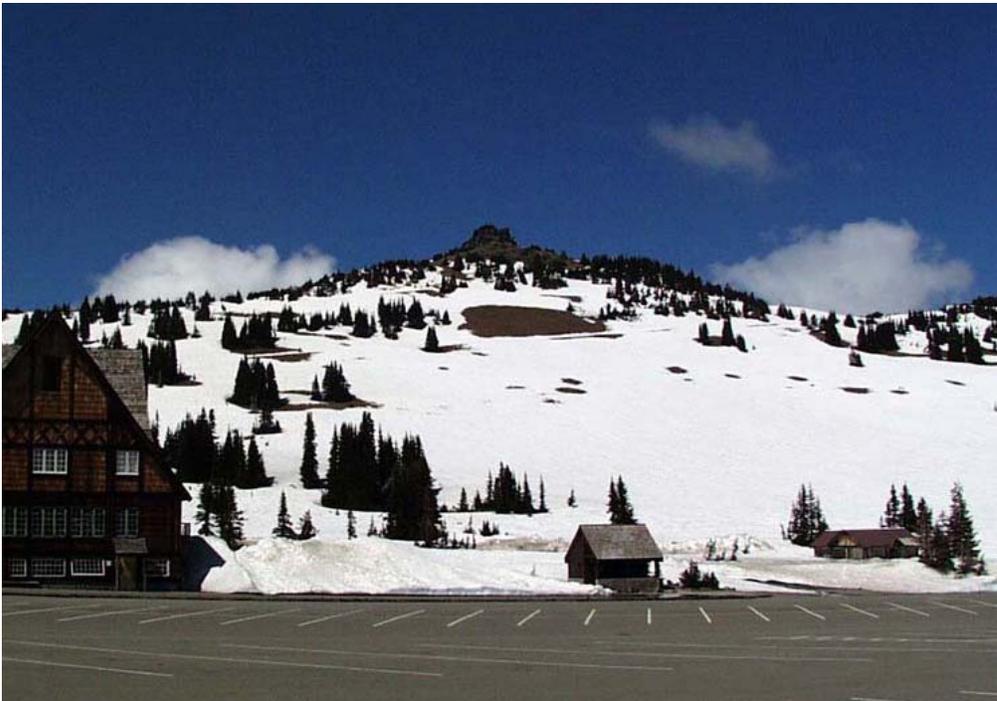
Contemporary view of the meadow. An increase in both the number and size of the fir trees in the meadow is evident. (PWRO 2002)

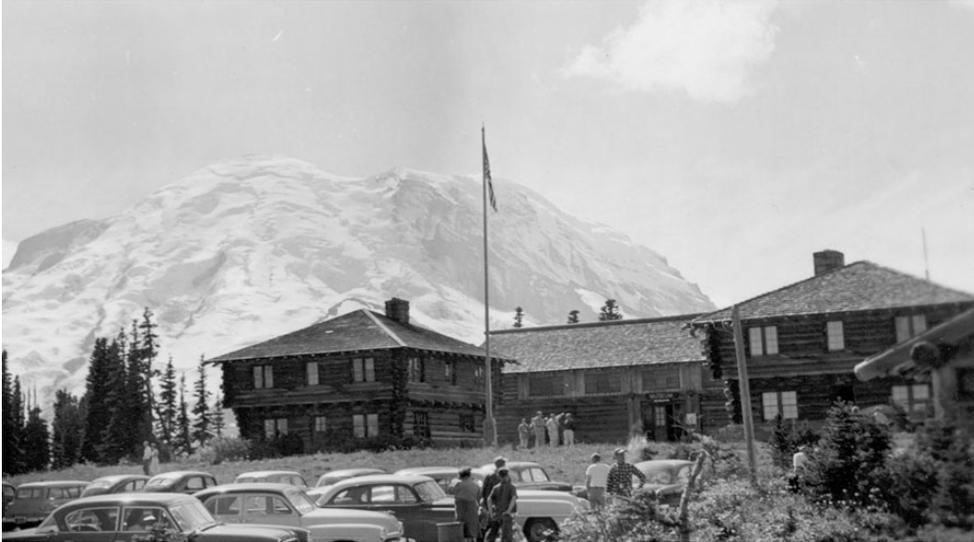
Historic photo, 1951, showing the administration buildings as viewed from the lodge. The strong, symmetric arrangement and the dramatic backdrop of Mount Rainier created a commanding presence. (Tahoma Woods Collection, is318)

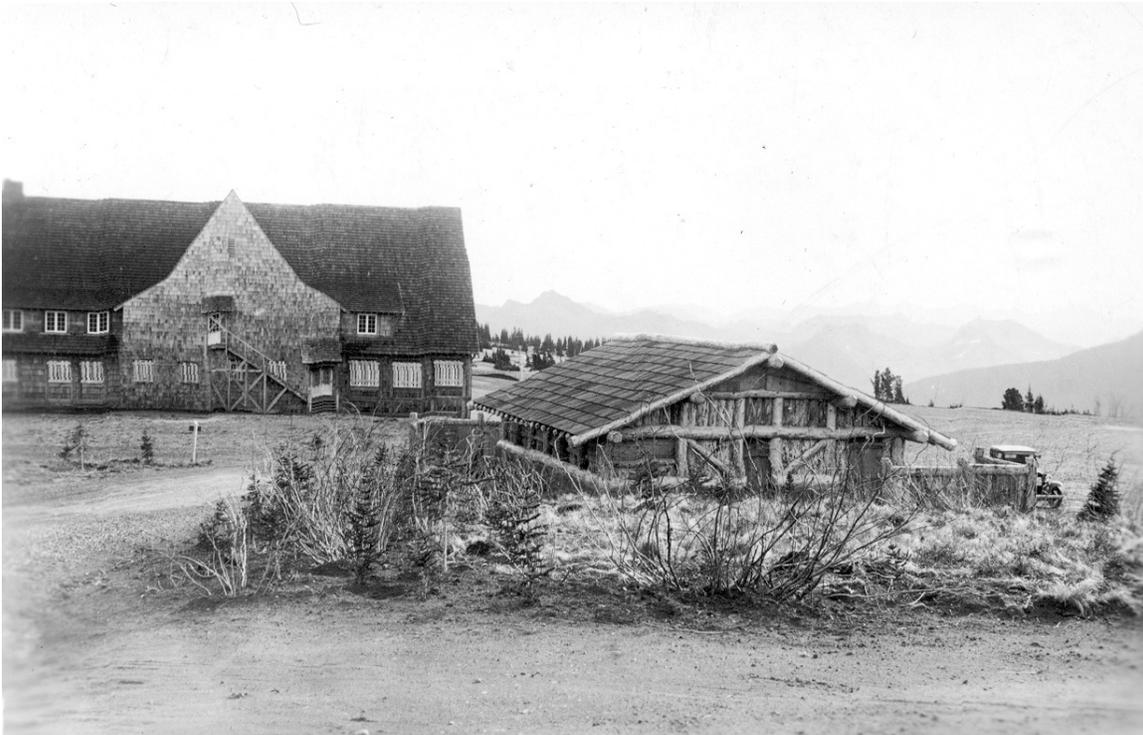
Historic photo, taken in 1933, showing native plantings on the north side of the comfort station. (Tahoma Woods Collection, twc3135)
