National Park Service  
Cultural Landscapes Inventory  
2010

Sunrise Developed Area  
Mount Rainier National Park

**MOUNT RAINIER NATIONAL PARK**  
**Sunrise Developed Area**

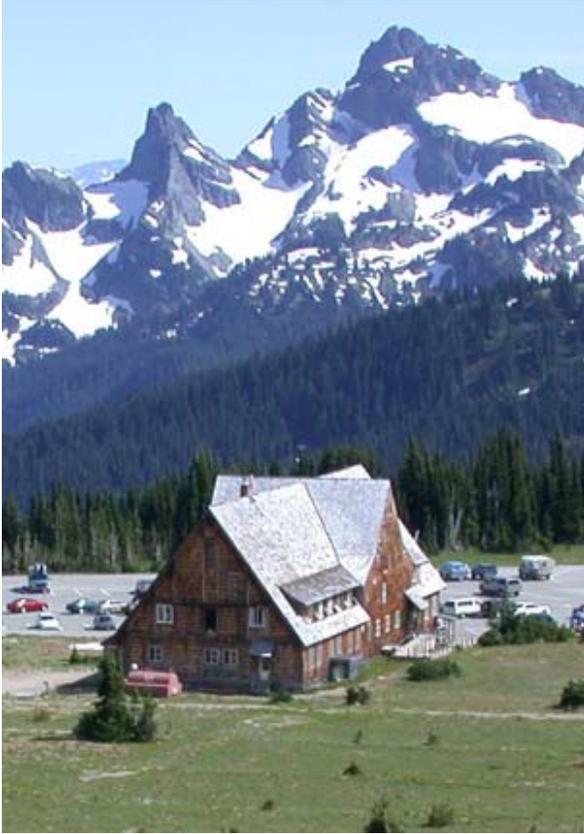
Contemporary photo of north façade of Sunrise Lodge from the Sourdough Ridge Trail. (PWRO 2002)

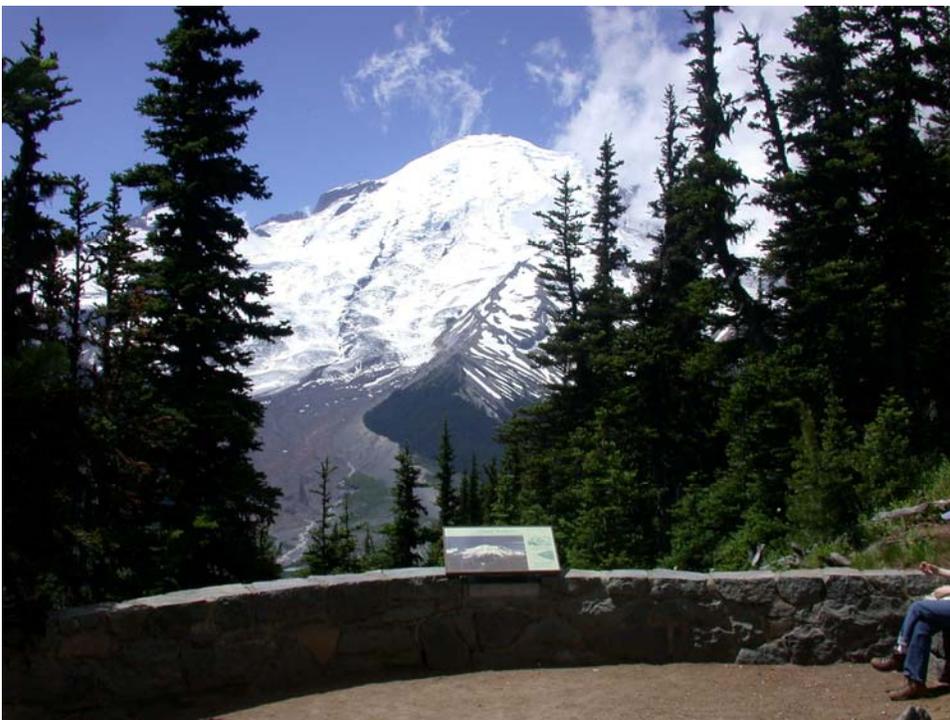
Contemporary photo of view from the historic Rim Trail Overlook #1. (PWRO 2002) Non-historic wayside panels have been mounted on the historic mortared stone wall.

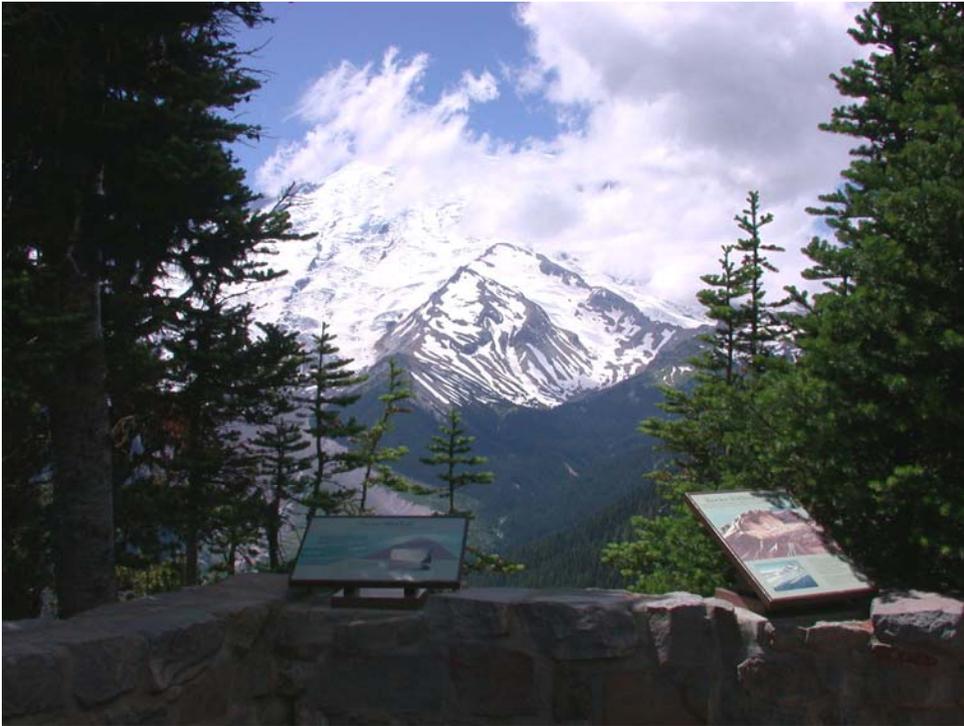
Contemporary photo showing view from the historic Rim Trail Overlook #2. (PWRO 2002) Non-historic wayside panels have been mounted on the historic mortared stone wall.

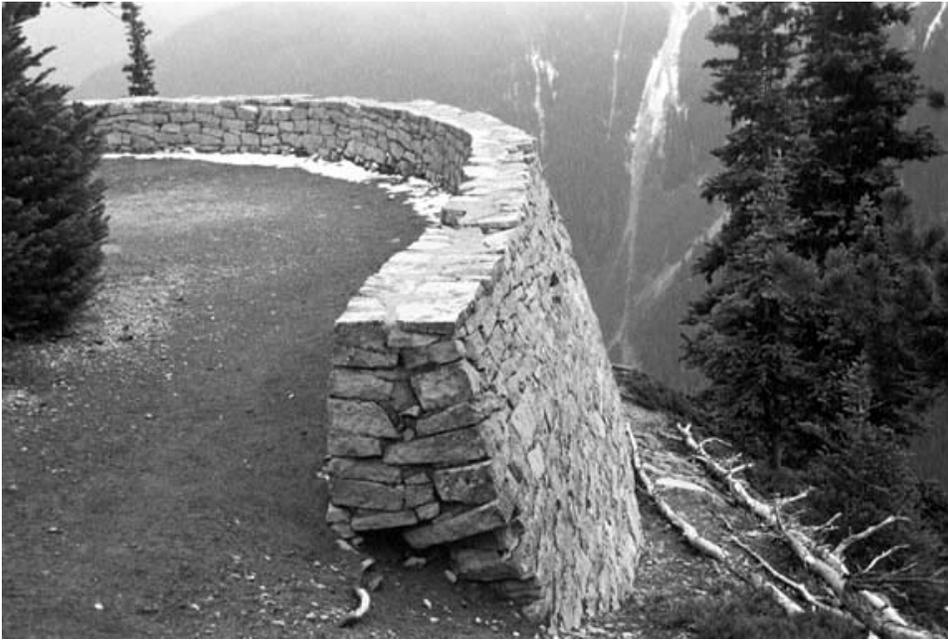
Contemporary photograph showing the wall and terrace of the Emmon's Glacier overlook along the Burrough's Mountain Trail. (PWRO 2001)

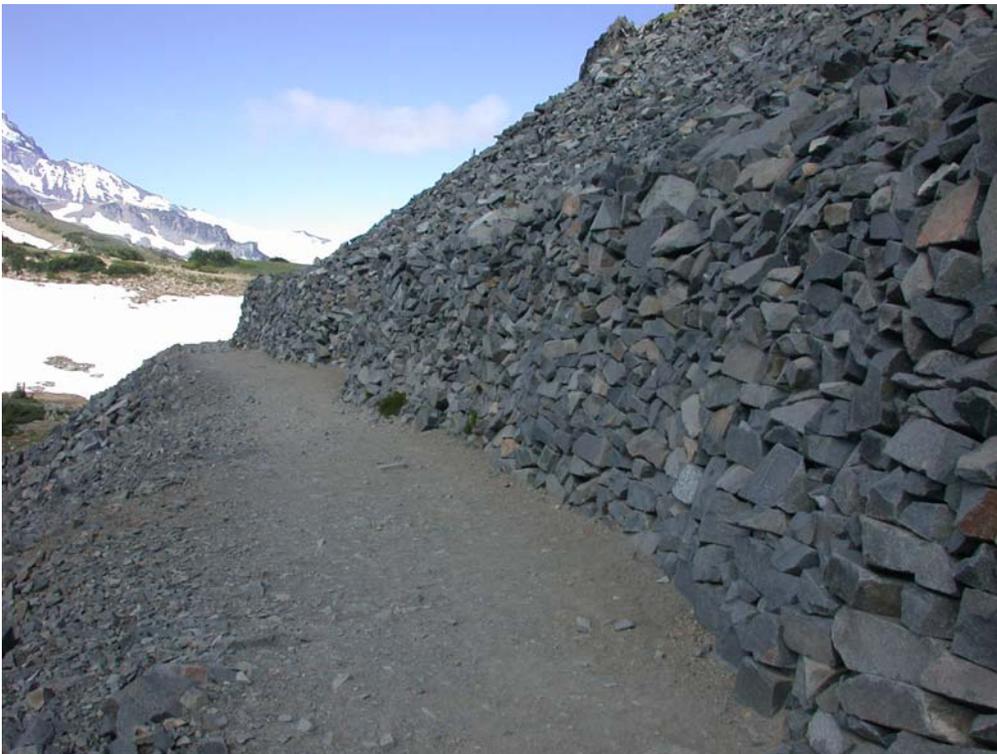
Contemporary photo of Sourdough Ridge Trail northwest of Sunrise showing dry-stacked retaining wall. (PWRO 2002)

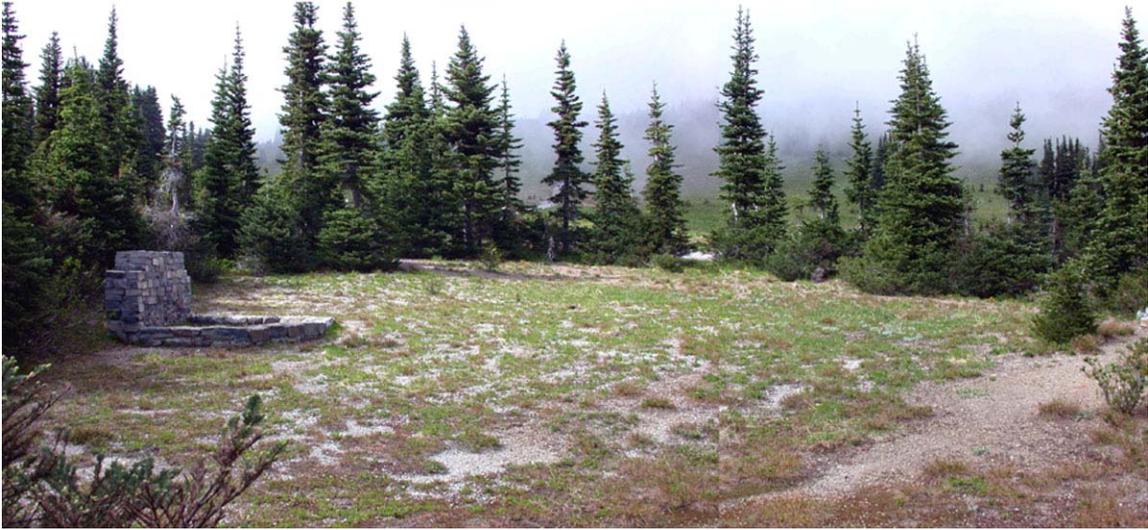
Contemporary photo of historic amphitheater area. Semi-circle of log benches has been removed but the space retains historic proportion. (PWRO 2002)

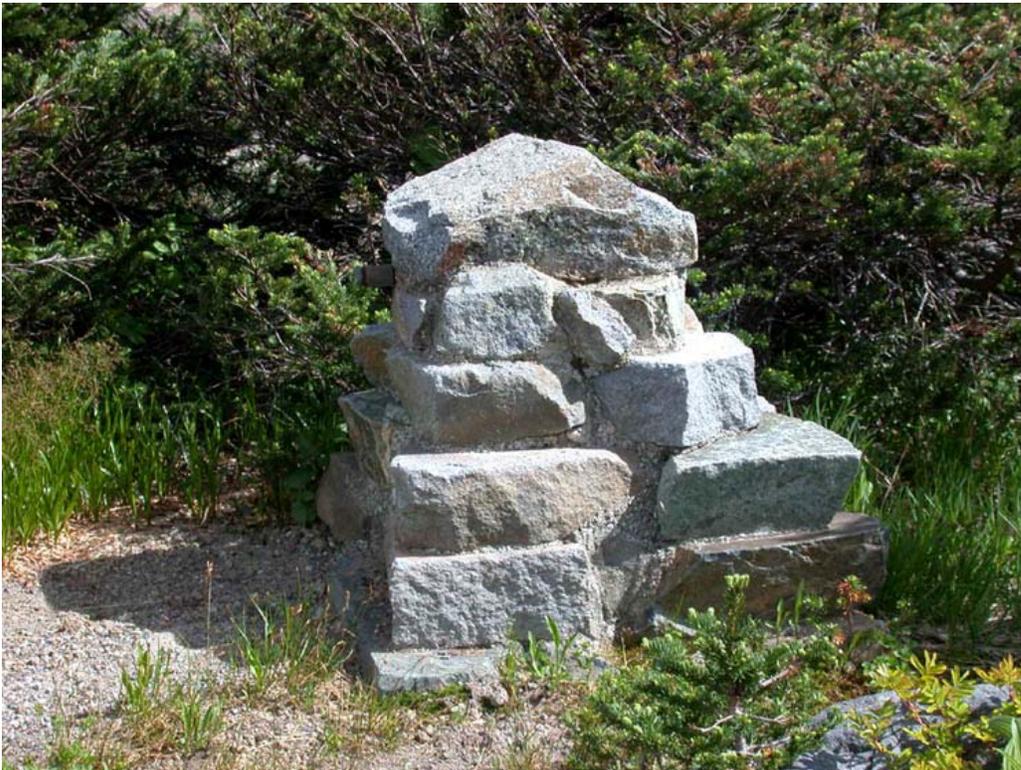
Contemporary photo of historic water station in the picnic area. Spigot has been capped. (PWRO 2002)

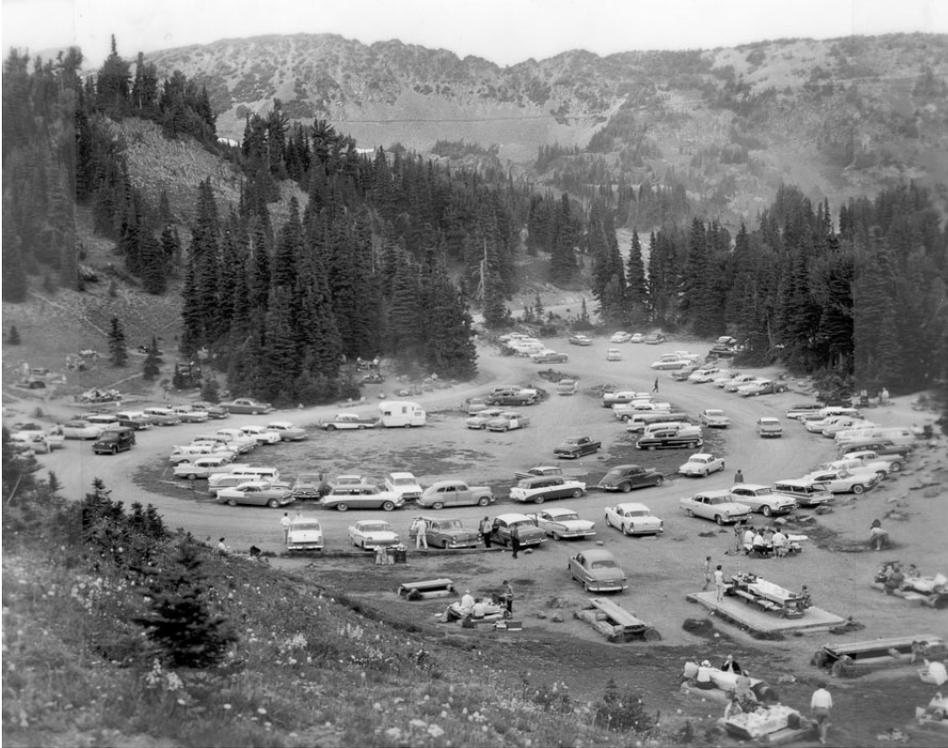
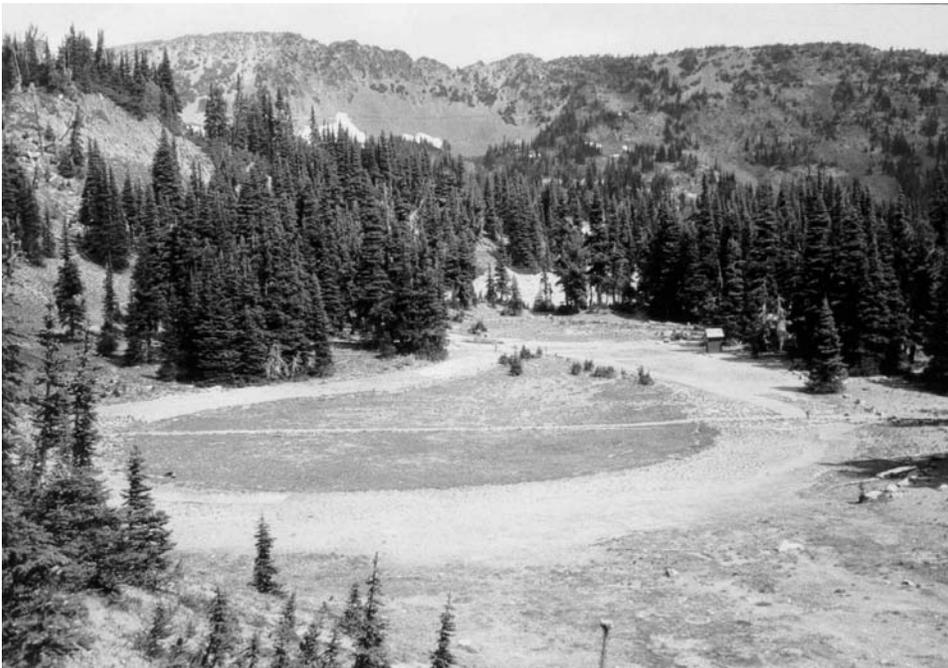
A historic photograph, taken in 1960, of the Shadow Lake Campground Area #1 juxtaposed with a contemporary photo taken in 2002. Restoration projects are underway to revegetated the former parking area. (Tahoma Woods Archives, is2293/ PWRO 2002)

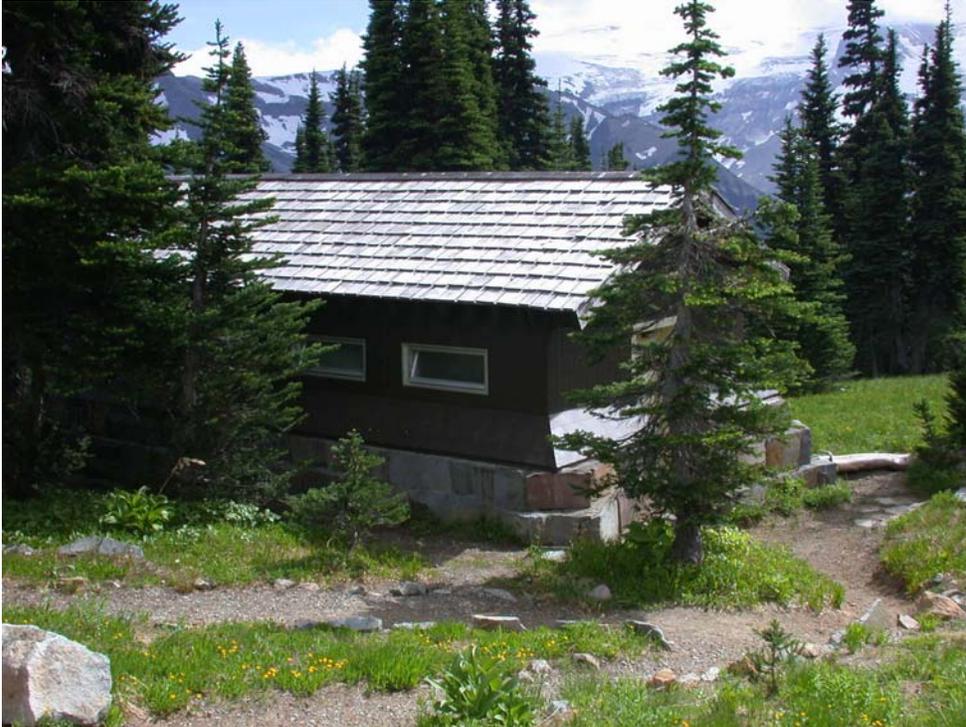
Contemporary photograph of the Sunrise Picnic Area Comfort Station. (PWRO 2002) This building was constructed in the 1930s, but the wooden portion of the walls and roof have been so altered that it has lost integrity and is no longer contributing. The stone foundation walls still remain, however, and this comfort station has the potential to be restored.
