**Historic
Structures
Maintenance
Guide**

**Mount Rainier
National Park**

**National Park Service
Pacific Northwest Region
Cultural Resources Division**

15 April 1983

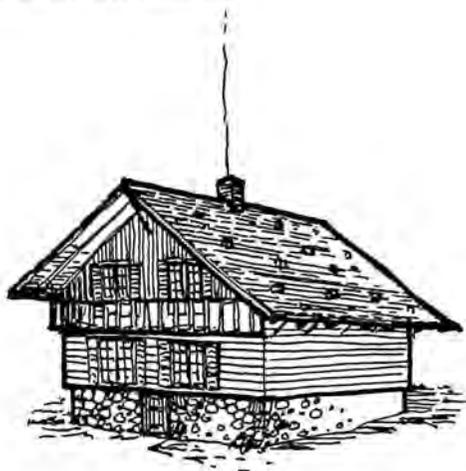
Alpine Chalet

along with descriptions of The Rustic Style. A "chalet" is a Swiss herdsman's hut or cottage in the Alps. Alpine and Chalet Style buildings are characterized by their generally low pitched roofs (5:12 and less), were frequently roofed with slate or other flat stones or tiles, and were intended to offer low wind resistance and to retain their snow covering for added insulation, having snow guards and snow retaining stones or blocks on the roof surfaces.

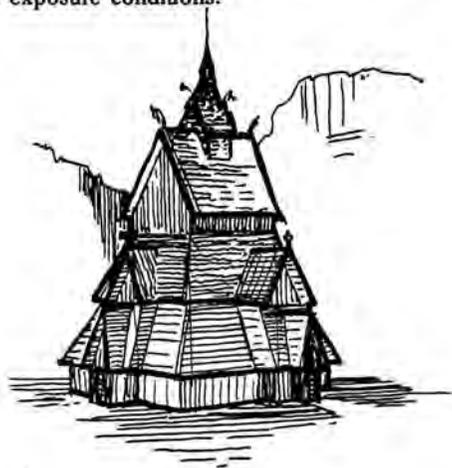
A Nordic Church

The Nordic Style of building is characterized by its steeply pitched roof (6:12 and steeper) designed to shed its snow covering as rapidly as possible. The Nordic roof is covered with wood shingles and shakes or vertically run board-on-board. While stylistic distinctions between roof pitches and their coverings are not perfect, there is a general respect for the nature of the materials involved and their suitability under different exposure conditions.

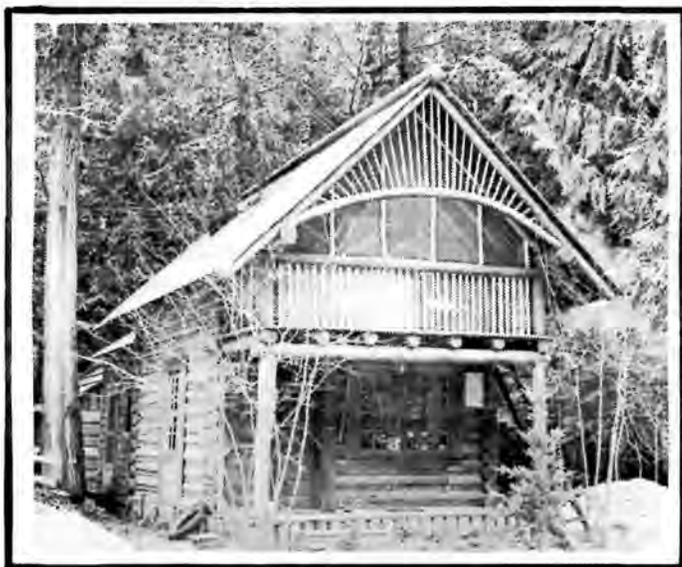
**Oscar Brown
Cabin (1908)**

In addition to incorporating elements of the Chalet or Nordic buildings, Rustic Style buildings typically use heavy rubble stone masonry for foundations, basement or ground story walls, and fireplaces and chimneys. They feature heavy exposed timber framing or log construction with emphasized joinery and projecting ends. Like the Bungalow Style, there is a piling-on of beams-on-beams reminiscent of oriental architecture for porches and eaves. Logs may be barked or with bark left on (a romantic and very poor practice). Some have described Rustic Style as being “Bird House Architecture,” and there is a conscious connection to the romantic sentiments of books like *Wind in the Willows* and the hope that people might enjoy nature like the animals of the woods. Hence, the occasional use of naturally bent tree limbs and forks to make railings, supports, and furnishings in Rustic Style buildings. The original Oscar Brown Cabin, Longmire, was an ideal Rustic Style building.

Photographs of the Oscar Brown Cabin, Longmire Gas Station, and possible the Longmire H.Q. Building show that log pole ridges were originally used and are now all removed. Of the many options, the ridge boarding and metal ridge covering is the most dependable and easiest to maintain, the shingles tend to break off more readily exposing the under flashing metal. Roof edges at eaves and rakes should have a one and one-half inch projection of the shingles over the fascia board and any trim mouldings. Anything less looks bob-tailed and exposes the under shingles and sheathing to weather damage. Ridges and valleys must have good metal flashing whatever the style of cover used.

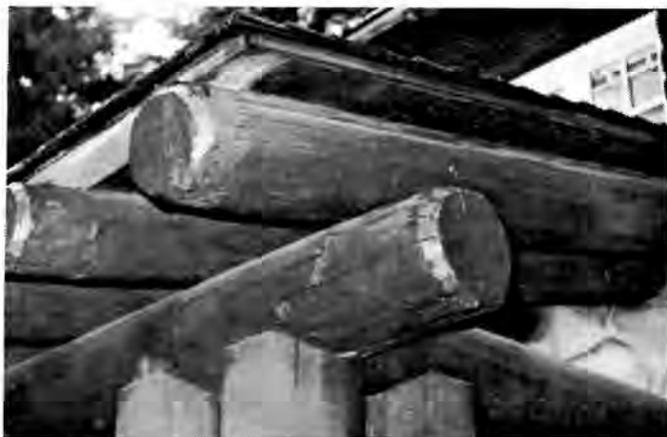
Stacked Timber
Detail

The maintenance and preservation of Rustic Style buildings is a special problem. The Rustic Style's love of massively used stacked and clustered timbers without concern for their weather, rot, and insect protection is inconsistent with building design which facilitates long life and low maintenance. The building's built-in maintenance problems make necessary any *special efforts and methods for their preservation and maintenance* if they are being preserved as landmarks. If these rustic elements are removed, replaced, or improperly maintained, the essential quality of the buildings as historic landmarks is correspondingly reduced. Each increment of change to a historic building made in a manner inconsistent with its original design, adds to those accumulated changes which make it a new building and none of the former landmark, a candidate for either documentation or reconstruction but not preservation. The challenge is to maintain these old limited life expectancy buildings with all their original qualities so that they will endure indefinitely, one hundred years and not just another ten.

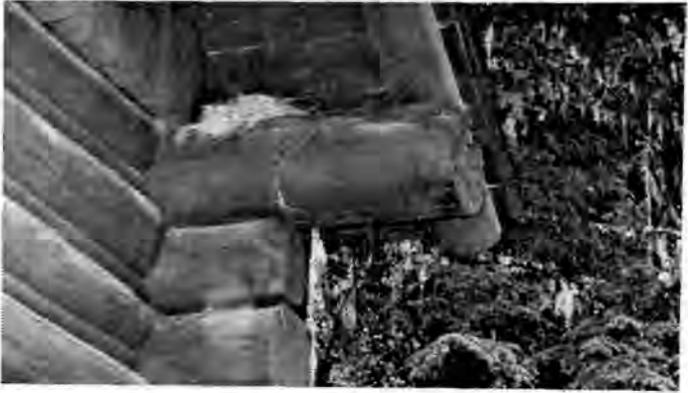
Picturesque Details

In a true sense, many of the characteristic elements of Rustic Style and its emulation of the picturesque alpine chalet or nordic hut are contrary to the very well thought out details of those Old World buildings which enabled them to survive and continue in use in a similar mountain environment. A brief

study of good Scandanavian and Swiss building examples in the United States and of the French-Canadian log buildings in Canada shows that the extremely exposed log ends, projecting beams and rafters, and the unprotected sills and foundation timbers is a *romantic conceit and not representative of permanent traditional log and timber construction methods*, maybe used for temporary out-buildings, but not for the principal house and barn or other permanent buildings. Foundation timbers laid on the ground were always known to be highly subject to rot, and a permanent building always had its sills, floor beams, and joists raised off grade on some kind of foundation, above moisture and insect attack. Measures were always taken to protect the principal structure from weather damage by designing its joints and corners to be resistant to water retention, to minimize the exposure of end grain of wood to the weather, or to provide an outer

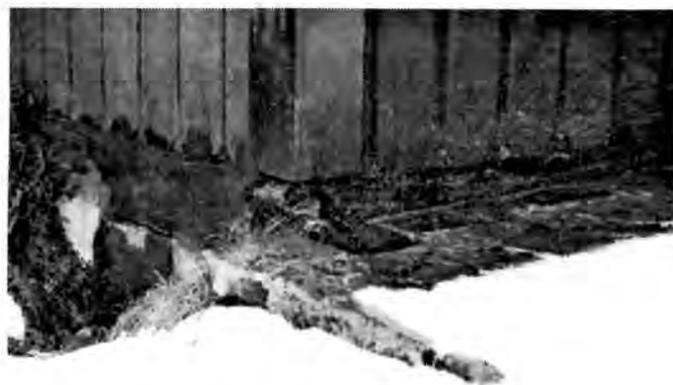
Rotten Details

Where Rustic Style buildings are based on sound building principals and an understanding of traditional "Well Buildings" methods, their preservation and maintenance presents no greater challenge to the trained craftsman than does another building of similar construction in the same environment. Where, however, a Rustic Style building is built employing romantic notions of rural architecture, too often derived from temporary buildings, then the preservation and maintenance of that building presents a challenge to the responsible people, a common challenge with that presented by temporary and vernacular buildings of many types.

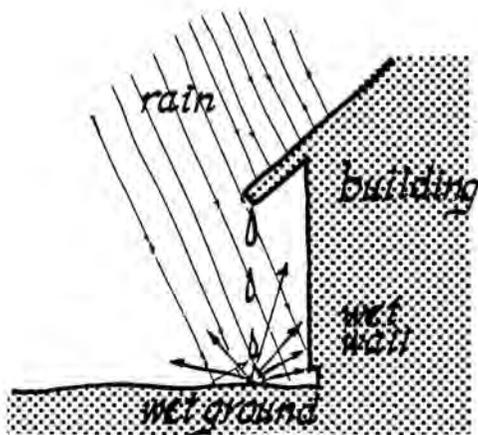
Wet Design

Rustic Style buildings are often intentionally built close to the ground to make them appear to be more natural and less of an imposition in the park landscape scene. This close to the ground construction may mean that the foundation sills or timbers are in direct contact with earth, extremely subject to rot, or are otherwise unprotected from ground moisture and from roof run-off splashing. Only temporary rural buildings and outbuildings were normally built so vulnerable to deterioration. Good site planning and maintenance helps to keep ground and rain water away from the building, keeping its materials dry.

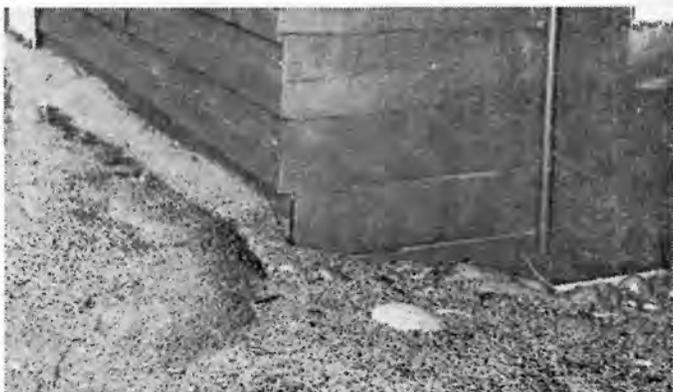
Backfill Problems

Proper maintenance of the grounds, plantings, and paving adjacent to the park's historic buildings will help to reduce damage to the buildings and consequent maintenance work due to their vulnerable design. Grounds should be maintained or lowered adjacent to the buildings rather than filled so that the foundations and sidings are even wetter. Backfilling against a wood building is sure to promote rot in the siding and framing. Backfilling up against a masonry building wall will raise the water table within that wall, either increasing or creating a moisture problem to the construction above or behind the masonry.

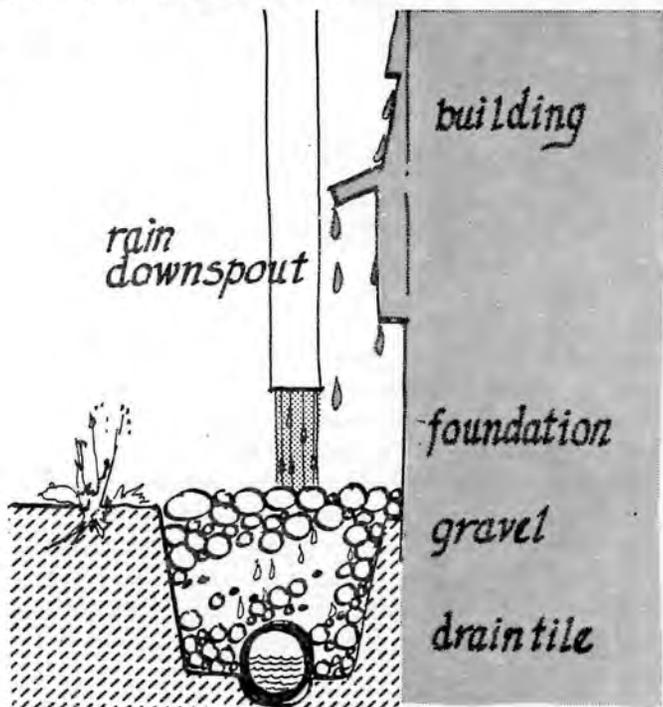
Ideally, ground surfaces around a historic building (or any building) should have a minimum four percent slope down away from the building so that any surface water is channeled away to a satisfactory drain or water course. Where eave troughs and downspouts are not used to contain roof water, it is often advisable to install French Drains around the perimeter of the building to receive the run-off and channel it away to a drain course. Where there is a natural watercourse or high water table under a building, the installation of subdrains and ground moisture barriers are recommended to dry the crawl space under the building.

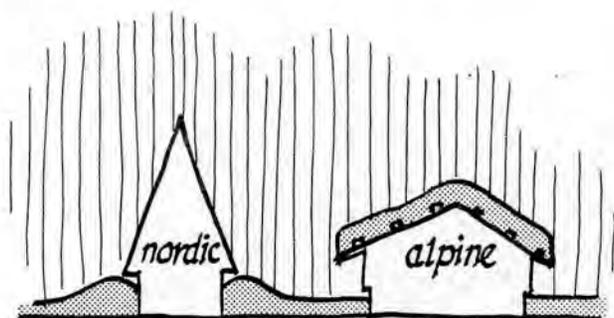
Snow Shedding & Retaining

Nordic Style roofs with steep pitches (5:12 and up) are good for wood shingles, shakes, and for plank roofing. The steep pitches shed snow and rain rapidly and dry quickly after being wetted by rain or dew. Avalanches of ice and snow are a problem of Nordic Style roofs, damaging any projecting vent stacks and other projections through the roof and tearing off any eave troughs. Snow guards on steep pitch roofs have to be heavily built and anchored to resist the weight of the ice and snow they retain, and a failure can be disastrous to the roof and any person or construction below the avalanche area.

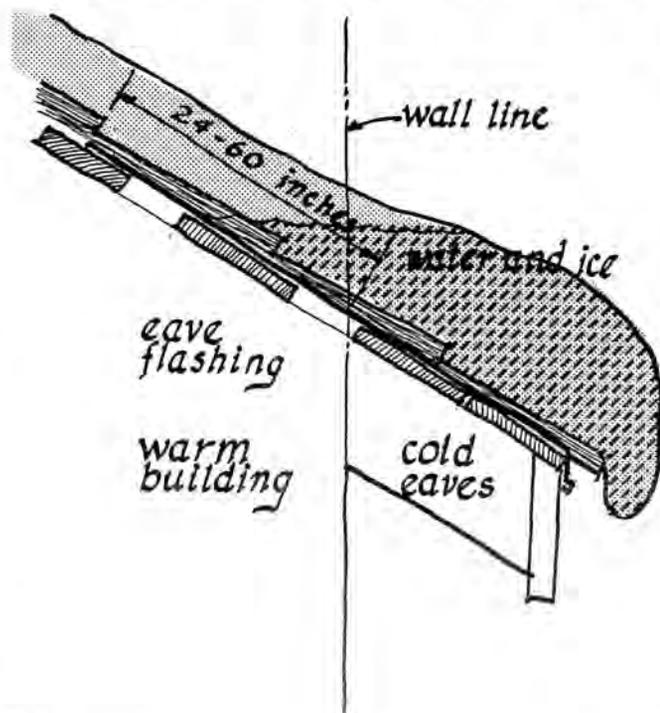
Ice Dams

Retention of snow and ice on a roof, particularly the eaves of the roof, is not desirable unless the structure of the roof and eaves is designed for the considerable weight that builds up from repeated thawing and freezing of the ice and snow retained. Eaves which retain snow and ice and were not designed for that condition are subject to severe damage when the resulting mass loosens and slides off, frequently carrying sections of the roofing with the frozen mass.

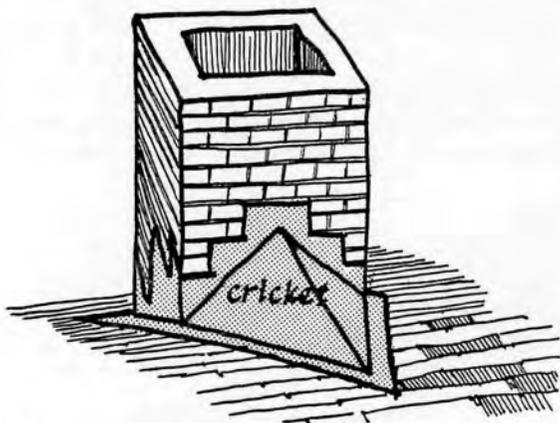
Cricket Protection

Damage to plumbing vent stacks, smokestacks, antennas, and other roof mounted structures frequently is caused by the moving glacier of snow and ice which accumulates on alpine roofs. Forethought in locating vents and smoke pipes at ridges prevents much of this kind of maintenance problem. The Guide House at Paradise is a good example. Other care should be given to insuring that these roof projections are

protected and reinforced to prevent snow and ice damage; vents and stacks as well as chimneys should have steeply sloped crickets behind them to divert the snow mass around them.

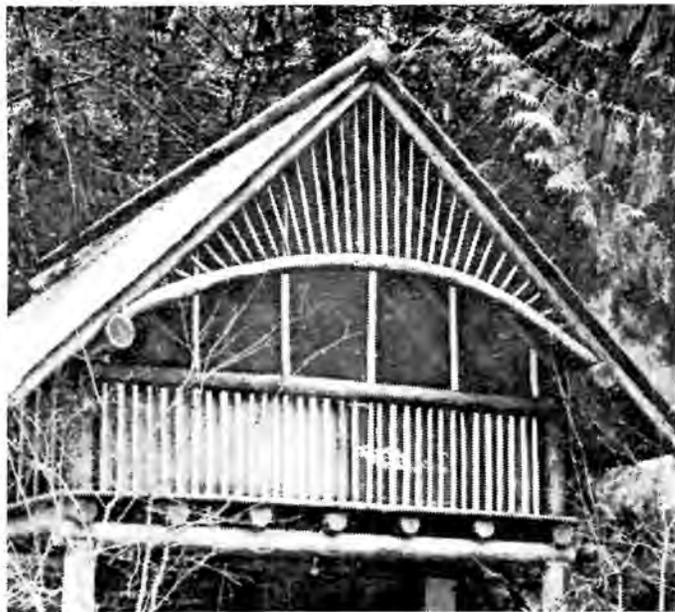
Lost Rustic Details

The roof edges and ridges are important design elements of Rustic Style buildings. Old photographs may show that the roofs originally had accented shingle or board ridges or they may have had prefabricated metal ridges of various designs.

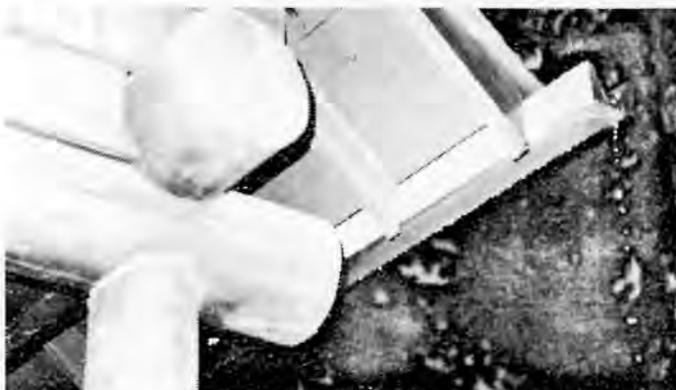
Wooden Gutter

Two kinds of eaves troughs and downspout systems are recommended as being appropriate to the Mt. Rainier buildings, the half-round style metal gutters and the cedar wooden gutters which have been salvaged for reuse at some places on Longmire buildings. Because of the susceptibility of any gutters to damage from ice and snow in this area and because of the need to readily remove and reinstall some short sections of gutters over entrances, as at Paradise, gutters

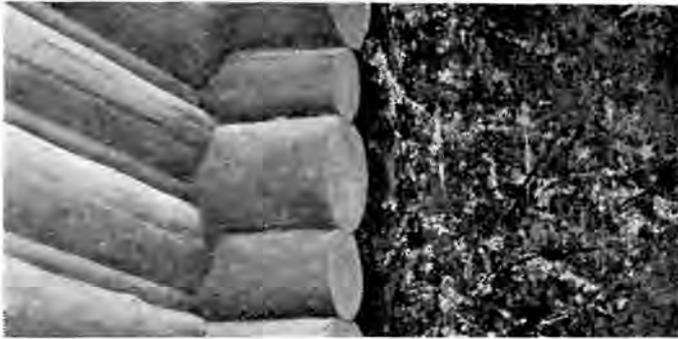
Log Building

The Rustic Style of building incorporates many bad design elements in order to appear more rural and romantic than would be the case if it had conformed to the good design standards which were well developed for permanent buildings built for long life instead of for appearance. Maintaining these buildings forces many choices between improving their maintainability, even for conserving their original elements, and for preserving their original appearance. The alternative choices are not always compatible.

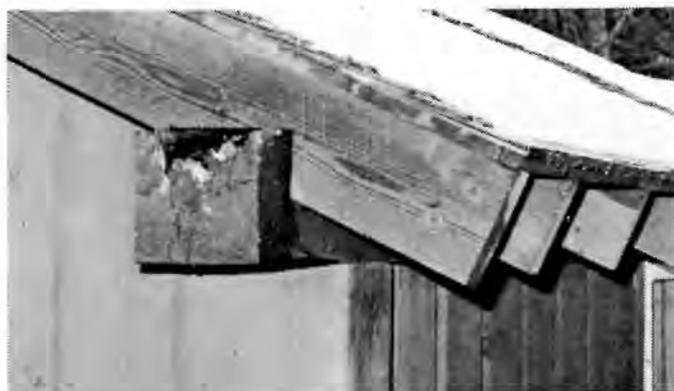
Unprotected Wood Detail

The conservation and preservation of wood in buildings depends on removing or conditioning one or more of the four necessary elements conducive to decay and insect growth in wood: right temperature, moisture content between approximately twenty and thirty percent, nutrient (the wood), and oxygen. In practice the two methods used are either poisoning the wood (removal of nutrient) by preservative treatment or lowering the moisture content of the wood below the level necessary for fungus growth by painting, flashing, covering, and other means. In marine environments, fully immersed wood such as pilings and float logs where the moisture content is at or above saturation similarly prevents decay by excluding sufficient oxygen for fungus growth.

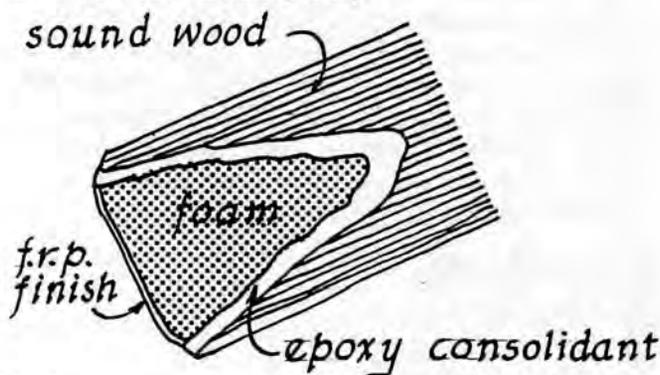
Epoxy-Foam Restoration

Several methods of restoration for both wood structural and decorative elements on historic buildings have been devised. The epoxy consolidant, foam filler, and fiberglass reinforced plastic repair method which was used on the rafter ends of the Longmire Headquarters Building is one which can be used by maintenance people as well as by contractors. This cosmetic restoration method cannot be said to offer permanent protection and restoration to the treated timbers as rot may still continue or begin in any adjacent sections of wood which are infected and sufficiently damp.

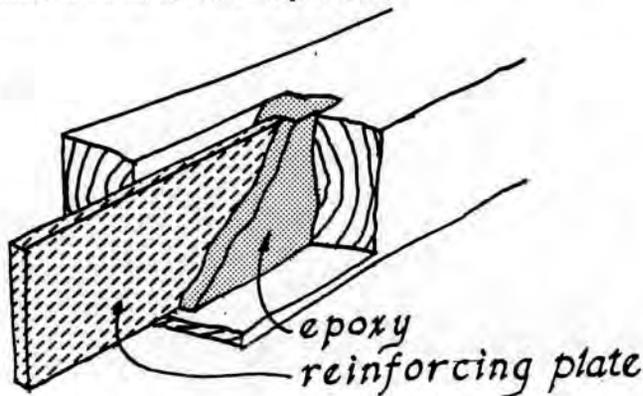
W.E.R. System

The Wood-Epoxy-Reinforcing System (WER) detailed in the booklet published by the Association for Preservation Technology is both a cosmetic and structural restoration method and may be used in maintenance work by In-House forces or by contractors for large restorations. Restorations done by this method require the designing and computations of a structural engineer to insure that the restored joint or timber meets its structural requirements.

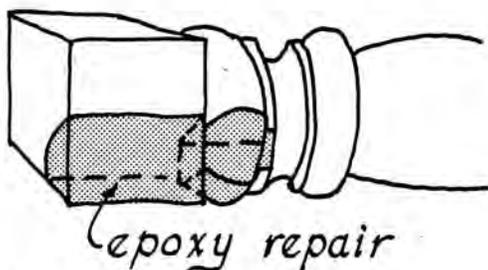
Carvable Epoxy Fillers

For strictly cosmetic restoration of damaged or missing pieces of wood trim and framing members, a variety of flexible, carvable, epoxy restoration compounds can be mixed from readily available ingredients following the instructions in the NPS booklet, **Epoxies for Wood Repairs in Historic Buildings**.

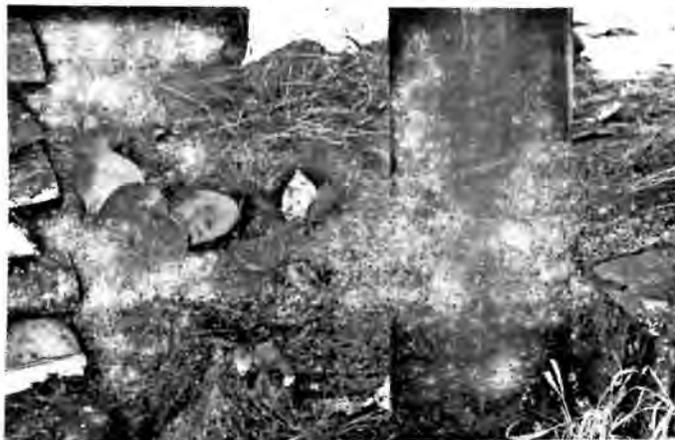
Machine Barked Poles

Where repair and restoration are not practicable, replacement of the damaged member is the only remaining solution. For highly visible and principal wood members on the primary historic buildings, replacement in kind is required. The replacement member should match the original member as exactly as possible, conforming to the original species of wood, dimensions, and finish of the piece being replaced. The method of fabrication of the timber, its fastening, and shaping should be as close to the original as possible. This often means that custom dimension timbers must be sawn as the current sizes are generally smaller. A machine de-barked log or a plywood peeler core does not match the appearance of a natural log which has been hand de-barked, as at the Nisqually Entrance Oscar Brown Cabin and Longmire Clubhouse.

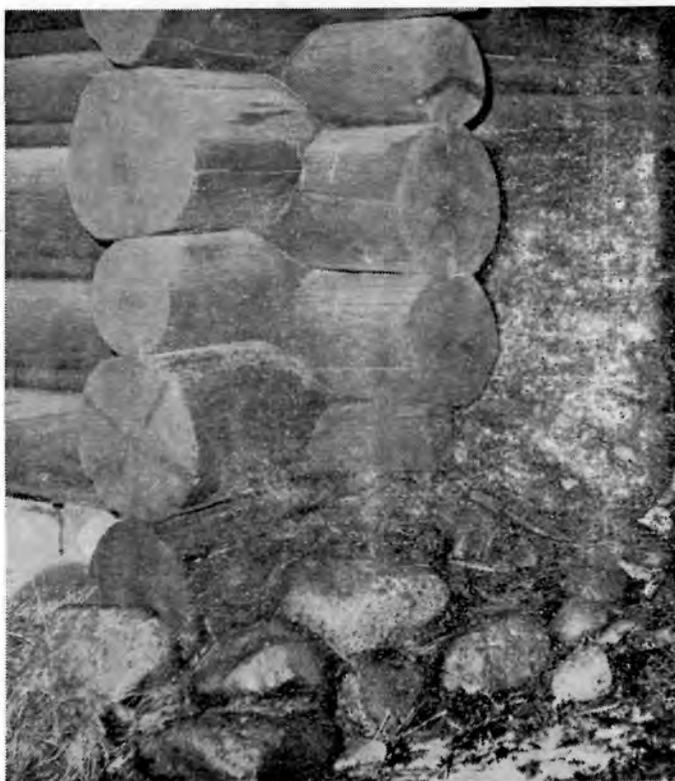
New Log Treatments

The problem of rot in foundation timbers and sills which are too close to the ground, or in it, will not be solved by the replacement with pressure preservative treated timbers as the preservative is only in the outer shell of the wood and not in the core. Where a timber replacement is required, it is possible to obtain pressure preservative treated glu-lam timbers which have been treated before lamination in which case the protection is throughout the timber.

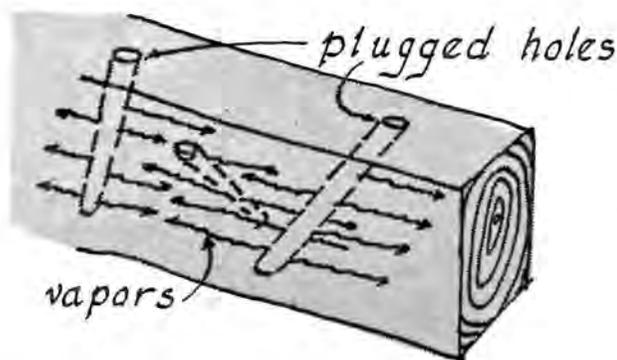
**Fumigant
Protection
of Wood**

A new experimental preservation method is available which uses vapor fumigants placed within the timbers. This method was developed by Oregon State University for extending the life of wood power poles and pilings.

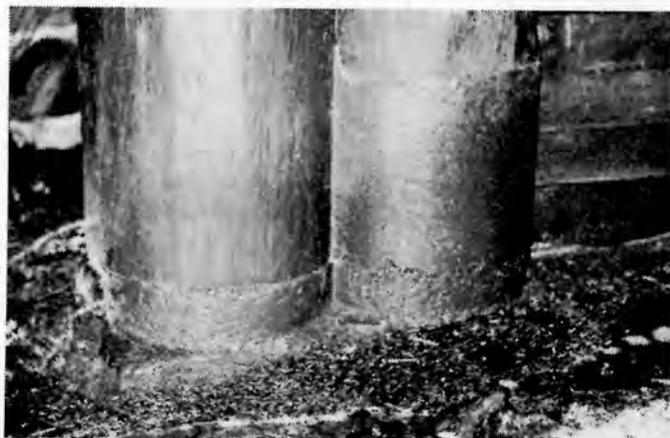
Creeping Concretion

In some cases, a substitute for the original timber can be made using precast reinforced concrete finished and painted to resemble the original timber or log. There is a degree of phoniness about this which requires separate consideration in each case.

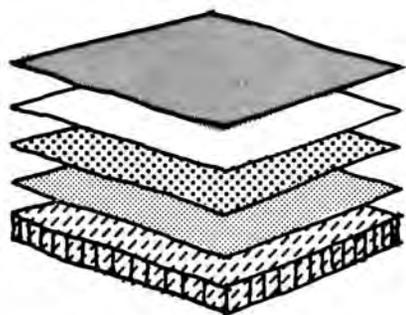
*finish
finish
primer
primer
iron-steel*

Rust prevention on hardware and fastenings installed with wood members is a practical necessity for the conservation of those members and for lower maintenance. Iron and steel hardware should be hot dip galvanized whenever possible. In addition to the galvanizing, and especially when not galvanized, ferrous metal items should be given two coats of rust inhibiting metal primer before installation and a touch-up coat of primer and the finish coats of paint after installation. This seems like a lot of paint, but it is necessary if the rust protection expected is to be realized. Avoid quick drying primers and spray coats of primer whenever possible. The best primer for iron and steel remains the traditional red lead in linseed oil type in a slow drying formula. There are no special benefits from particular brands of metal primer with fish oil bases.

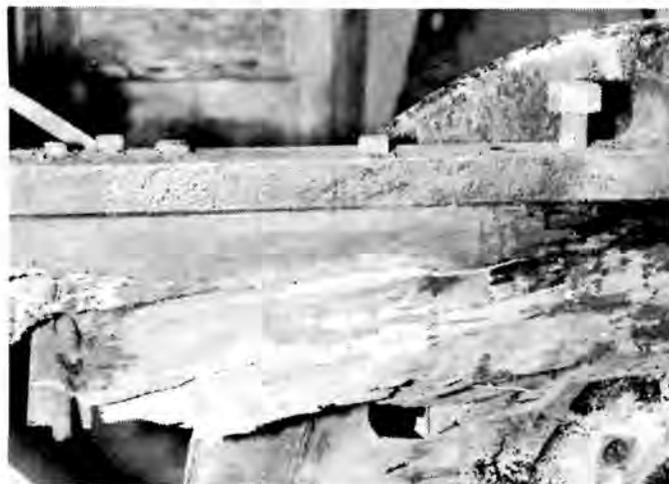
**Linked Rust
& Rot**

Maintenance on the metal fastenings and hardware on Rainier's historic buildings may be facilitated by using rust prevention technology borrowed from the railroad industry. Concealed surfaces and fastenings made of iron and steel which are in contact or contained within damp wood can be additionally protected by coating them before installation with a cosmoline-like protective film, "Rust Cote OS" sold by Interlube Corporation, Cincinnati, Ohio. Preventing rust on through bolts and lag screws enables them to retain their full strength and to prevent splitting of the timbers from rust-jacking, a progressive deterioration process which destroys the strength of the fastening and promotes rot in the wood member.

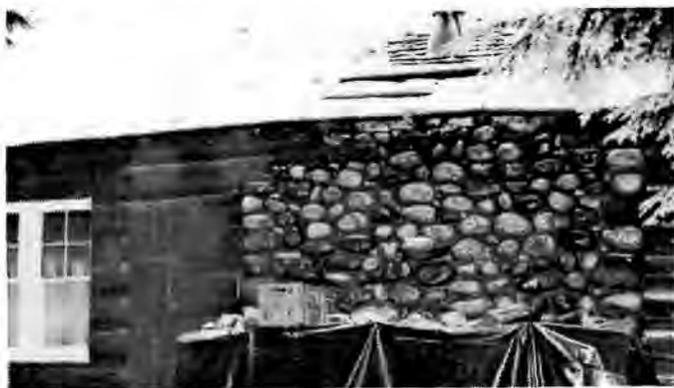
The Clubhouse Chimney

An example of an original design deficiency is the joint between the south end wall framing and finish and the stone masonry chimney at Paradise Inn. Here, there is a one to two inch wide gap between the frame wall and finish and the stonework which permits direct entry of rain, snow, wind, and dirt into the main lobby. There is evidence that various temporary measures have been attempted to close and control this gap for over sixty years, but there have been no serious measures taken to make a permanent system of closure for this breach in the building's physical envelope with its consequent damage to the interior environment and contents. The roof-wall joint at north lobby end also looks like a long time problem area.

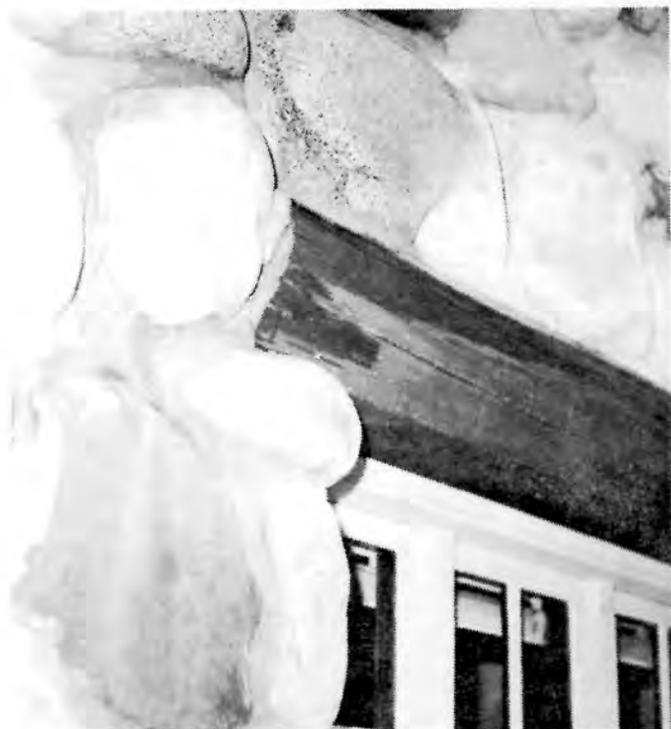
Wood Lintels

warrants frequent monitoring to insure that timely preventive measures can be taken to prevent rot in the lintel, especially the spread of any such rot into the inner structure and trim of the building. When replacing such a rotted lintel timber, consideration should be given to its replacement with either a steel or treated wood structural lintel concealed behind a veneer of log section, with appropriate concealed flashing to protect the structure.

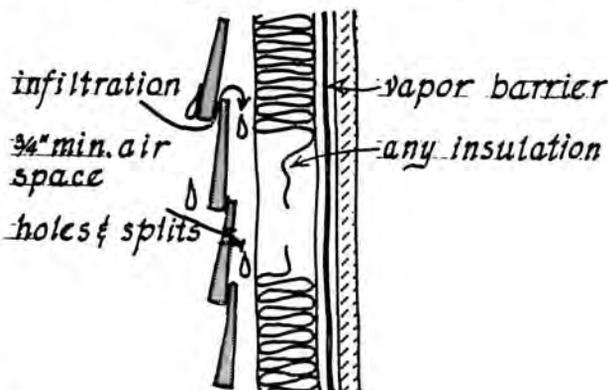
**Keep
Insulation Dry**

Special attention must be given to the problems inherent in the older buildings which have no sheathing, building paper, and flashings installed under their sidings over the stud framing. These walls tend to leak under storm conditions and have survived without rotting because the water which enters them is permitted to dry out rapidly when the storm has passed and dry weather returns. The same openings which permit the water to enter also permit air to enter and circulate within the wall cavity to dry it out. Adding insulation to one of these walls, without insuring its watertightness, upsets what has been a stable condition and is sure to promote rot where none existed before. The Library and National Park Inn buildings at Longmire were particularly noted as being buildings which should be closely monitored for evidence of wet insulation and new rot within their walls because of this changed condition.

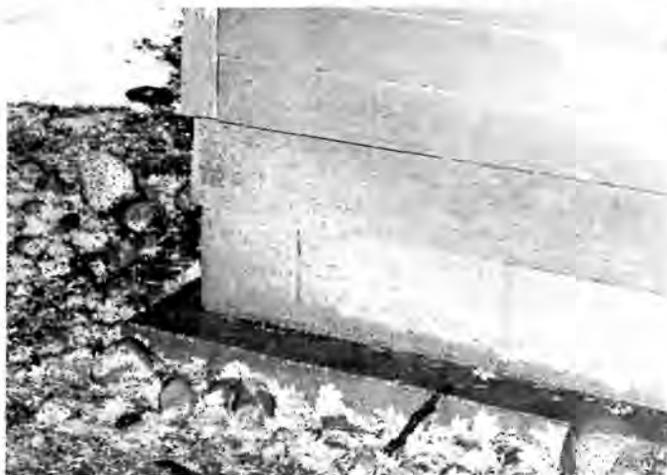
Exposed New Foundation

The need to replace foundations of historic buildings is not peculiar to Rustic Style Buildings. The fact that these buildings typically were built very close to the ground does make the need for foundation replacement necessary in many cases if the building is to be preserved, making the design of that replacement foundation critical if the low-to-ground quality is to be preserved. Covering existing wood foundation structures with stone veneer is not recommended without substantial reconstruction and weather protection of the frame construction to be concealed. New foundations of either monolithic concrete or concrete masonry can be very satisfactory if sensitively designed and painted to match. Installing replaceable wood skirting over the new foundations can fully conceal their new appearance. Attention must be given to the preservation and maintenance of the upper weather protection systems of the original wall which are designed to protect and save the foundation timbers and framing, specifically any water table trim and skirting or apron boards. In some cases, the installation of original style, expendable, skirting and apron boards is an acceptable means of concealing the fact that a new footing has been installed; however, any expendable skirting and aprons must be separated from the permanent construction above by flashing. Any foundation crawl spaces created by new foundations must be ventilated and the ventilation maintained during cold weather as well as warm. Insulate any water pipes and heating ducts to prevent heat loss and freezing rather than closing crawl space vents.

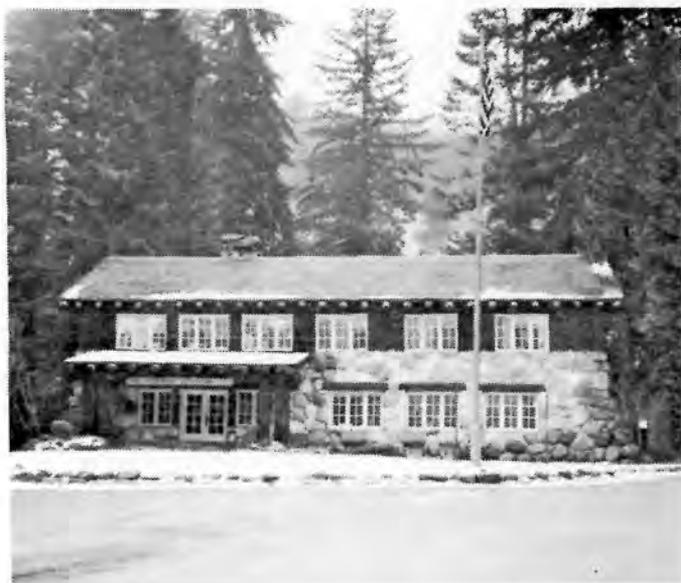
Window & Door Importance

Rustic Style Buildings in Rainier Park are fitted with several varieties of the stock millwork doors and window sash which were commonly available throughout the time of their construction. Many of these types of doors and sash are still available or can be readily manufactured by millwork shops. Doors were variously multi panelled stile and rail types of northwest softwoods, either half-lite or full multi-lite styles. Windows are either double run or casement styles, two, six and eight lite upper sash over one and two lite sash and multi-lite divided style casement sash. Window casings are uniformly plain rectangular style terminating at sills on the exterior and at sills and plain aprons on the interior, with door casings to match. Window and door hardware was stock utility type without ornamental escutcheon rings and knobs, plain brass, bronze, bauer-barff (dull black), or japanned finishes. Architectural bronze, black anodized, black chrome, and black nylon finishes would be suitable modern replacements for the original finishes, some of which are no longer available.

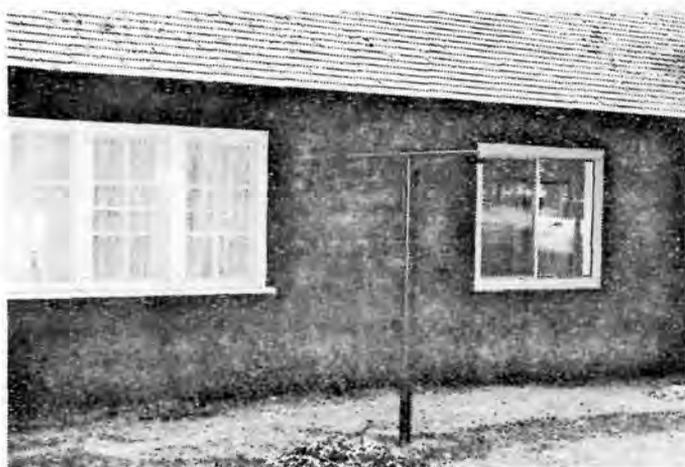
Good Stormsash Poor Replacement

The installation of large frame, externally mounted, combination storm sash and screen storm sash and doors overwhelms the plain appearance of the Rustic Style buildings as well as tending to "flatten" the appearance of the building faces more than the other styles do. Other types of either wood, plastic covered, and metal prime replacement window wash do not have the same visual qualities as the original windows and are an objectionable alteration to the appearance of the buildings.

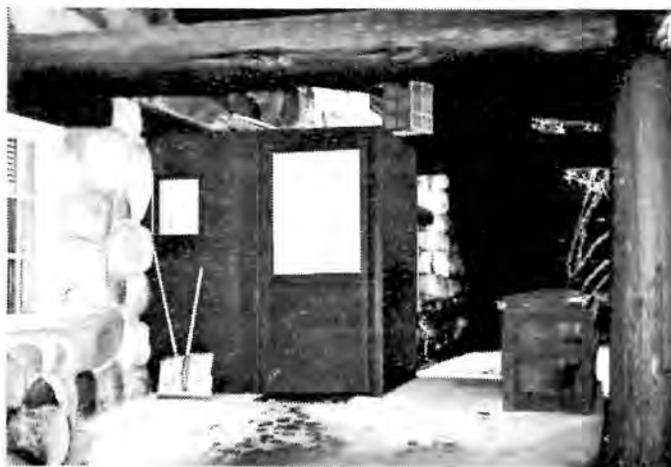
**Inappropriate
Vestibule**

The wooden storm doors which have been used at many entrances to buildings within the Park appear very appropriate to the buildings, as if original to them. Not so the storm vestibule addition used at several buildings. When storm vestibules are required, their construction using the same materials and finishes as the original buildings should be encouraged.

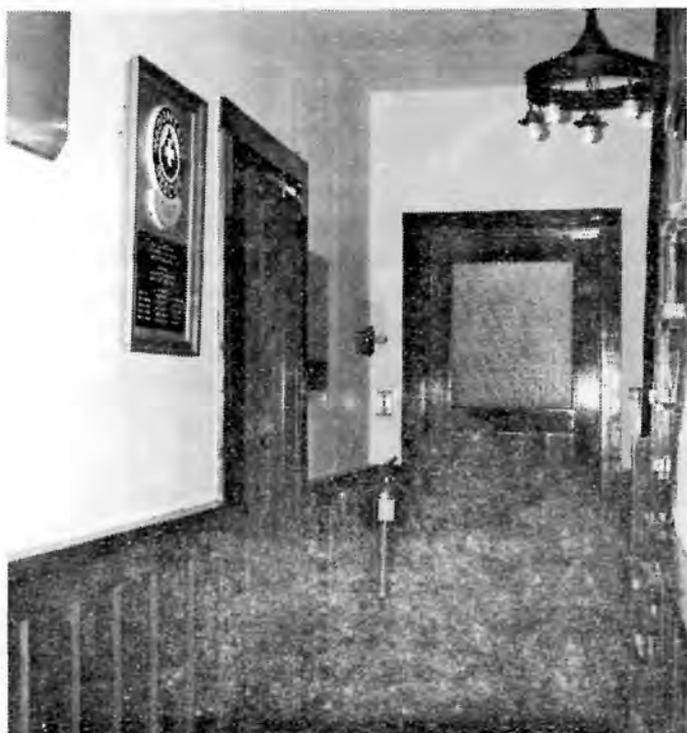
Mount Rainier National Park building interiors have been altered and "improved" in many cases so that the original design intent of the Rustic Style builders has been lost. Interior qualities which are important and need to be preserved are the plain oil finished wood floors, plain unpatterned (battleship), linoleum, paving stone and concrete flooring, natural finished softwood trim, wainscoting, paneling and other interior finish woodwork, original doors and glazing, hardware, decorative painting as in Paradise Inn, and painted stipple textured upper walls and ceilings whether plaster, gypsum wallboard or Celotex board.

Original Interiors

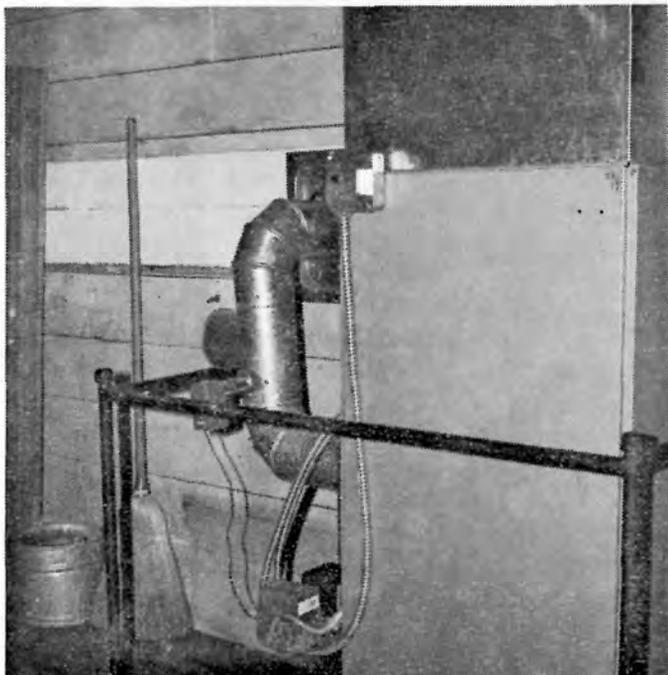
Lost Valuable Space

New furnace types and locations inside historic buildings require careful consideration. The wrong location can waste valuable space and add to maintenance problems. Newer types of furnaces are more efficient and do not require the addition of large exterior smoke stacks.

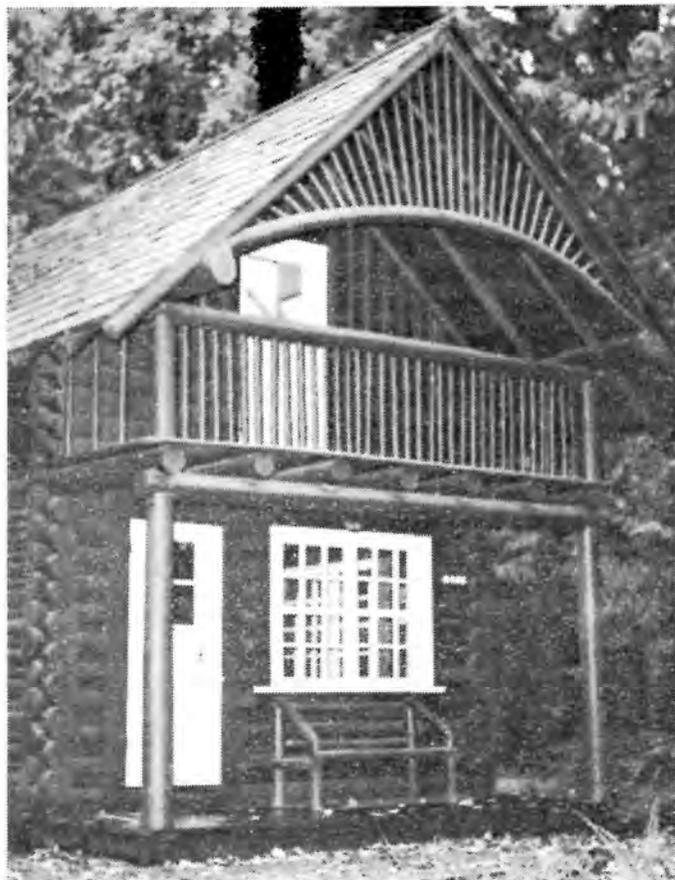
Almost Looks Too Good

Historic preservation enthusiasts too frequently make the mistake of “restoring” a historic building so that it appears better than it ever was, resulting in a “Best of All Possible Worlds Restoration.” It is very rare that any single building or group of buildings incorporates all the best qualities associated with a particular style or era.

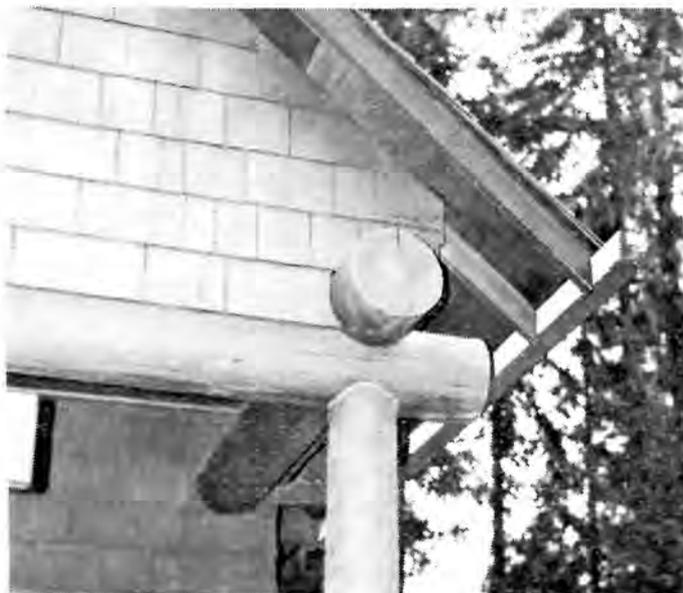
Maintaining historic landmark buildings is more difficult if the right materials in the right quantities are unavailable. Rare and special materials may need to be ordered well in advance of their need and maintained in adequate stock ready for timely use. The salvaging and stockpiling of exceptional original doors (like the ones from Sunrise Lodge) and old cedar gutter sections are examples of conservation methods which should be encouraged.

Salvage Gutter

Salvaged pieces from historic buildings make invaluable patterns from which to have replacement pieces remanufactured; no drawings or photographs can adequately replace them. Unique millwork such as cedar gutter stock may be no longer commercially available, and any salvaged sections will be more appropriate materials for use where a short gutter trough is needed than any new metal section would be.
