NATIONAL REGISTER OF HISTORIC PLACES INVENTORY -- NOMINATION FORM

Longmire Administration Building, Community Building, and Service Station

Mount Rainier National Park

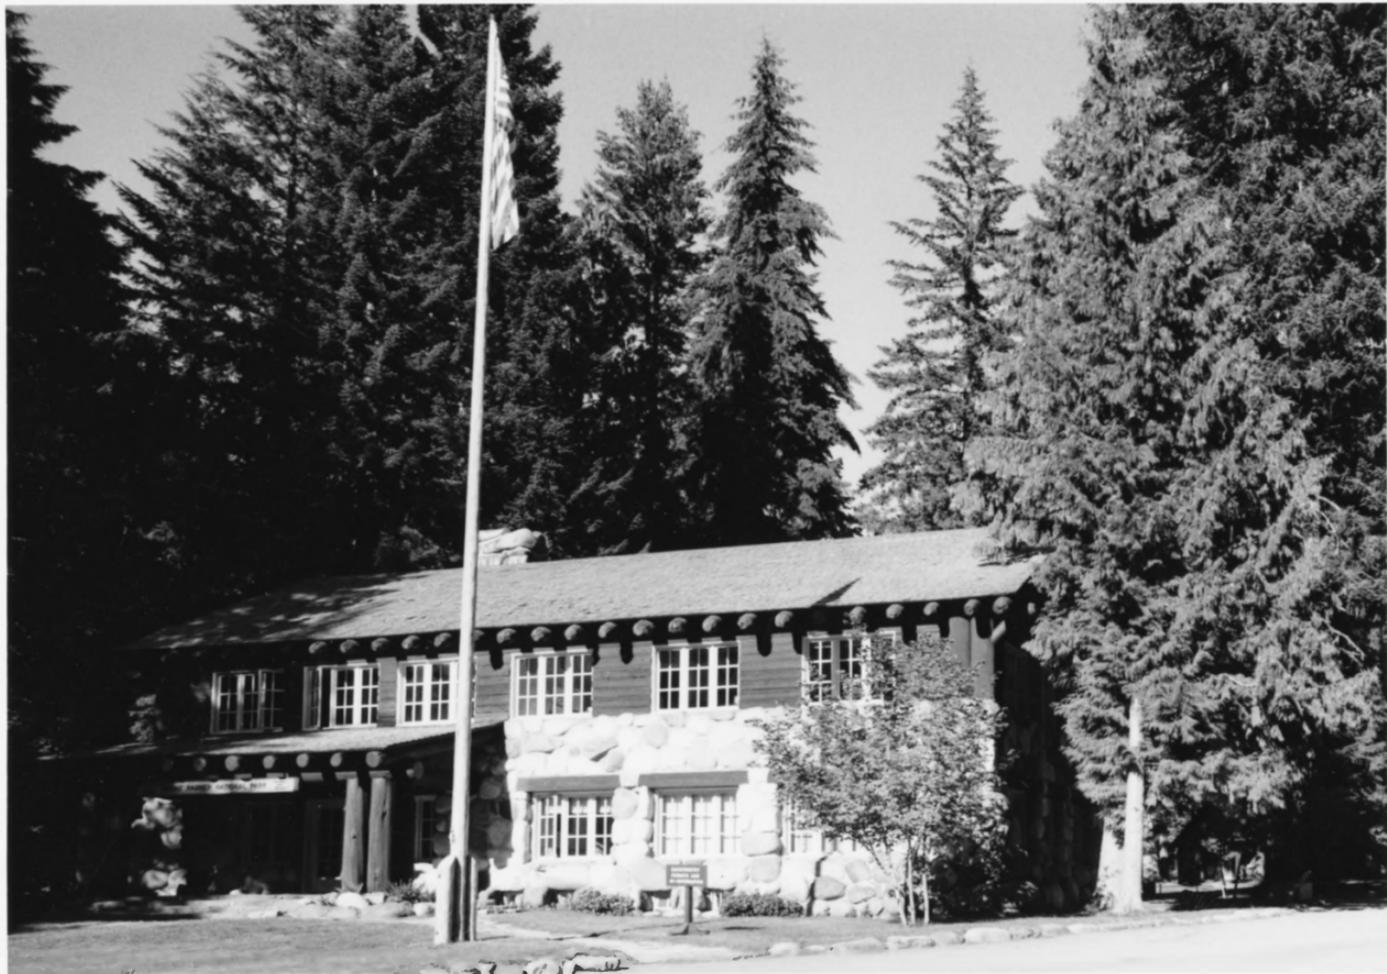
Front Elevation, Longmire Administration
Building

The most architecturally important structure at Longmire is the administration building. The building's foundation, first-story, and second-story walls up to sill height are composed of glacial boulders bonded with cement mortar. The stone walls of the first story are battered, and the smooth, rounded glacial boulders soften the building's edges even further. The largest boulders are in the lower wall sections. The second story above window-sill height has the appearance log and timber framing, although the fabric actually is wood framing covered with log-slab siding. Three logs edge the corners of the upper portion and serve as corner posts. They also continue the visual pattern established by the logs of the entrance porch. The gable roof is finished with wood shingles.

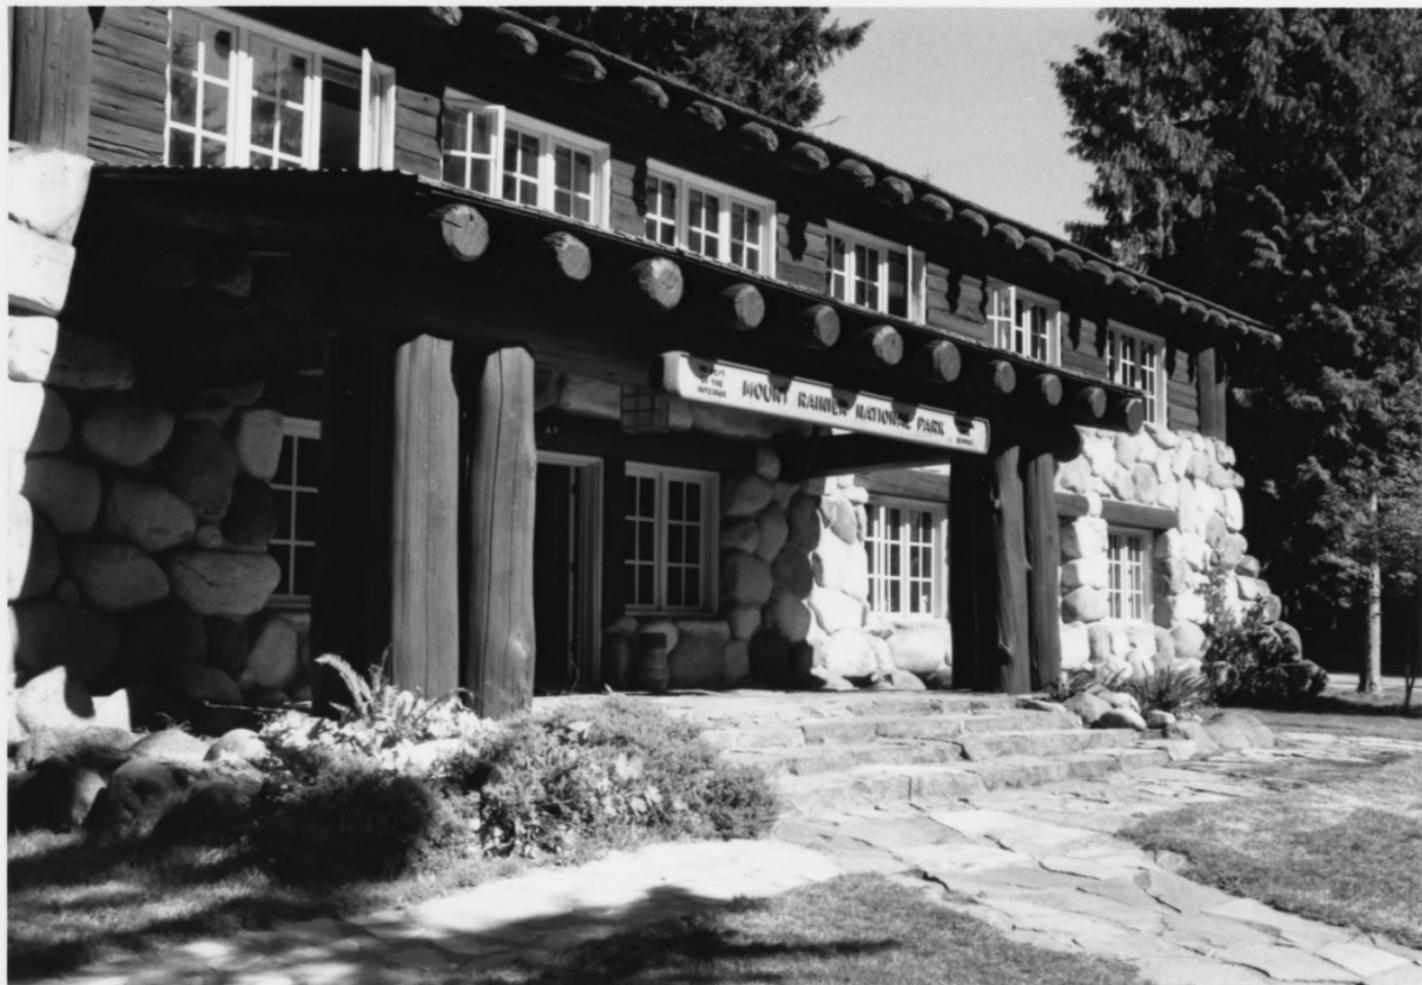
Front Entrance, Longmire Administration
Building

The main entrance into the building is through a porch constructed of massive logs with a shingle-covered shed roof. Corners of the porch have small planted islands made of glacial boulders and filled with low, native shrubs. The walkway up to the building and the porch floor are flagstone. The entrance consists of French doors flanked by paired casements. Casement windows throughout the rest of the structure are clustered in groups of two, three, and four. Windows and doors on the first floor are capped with huge log lintels. Axe-cut rafter tails and bracketed outlookers project out beyond the roof from the eaves and gable ends respectively. The rear entrance to the building is sheltered by a large porch. A concrete ramp provides wheelchair access into the structure. The rear entrance door is wood with heavy log slabs on the exterior. A small grotto outlined by massive boulders and containing a plaque commemorating Stephen T. Mather, first director of the National Park Service, is adjacent to the building and included within the

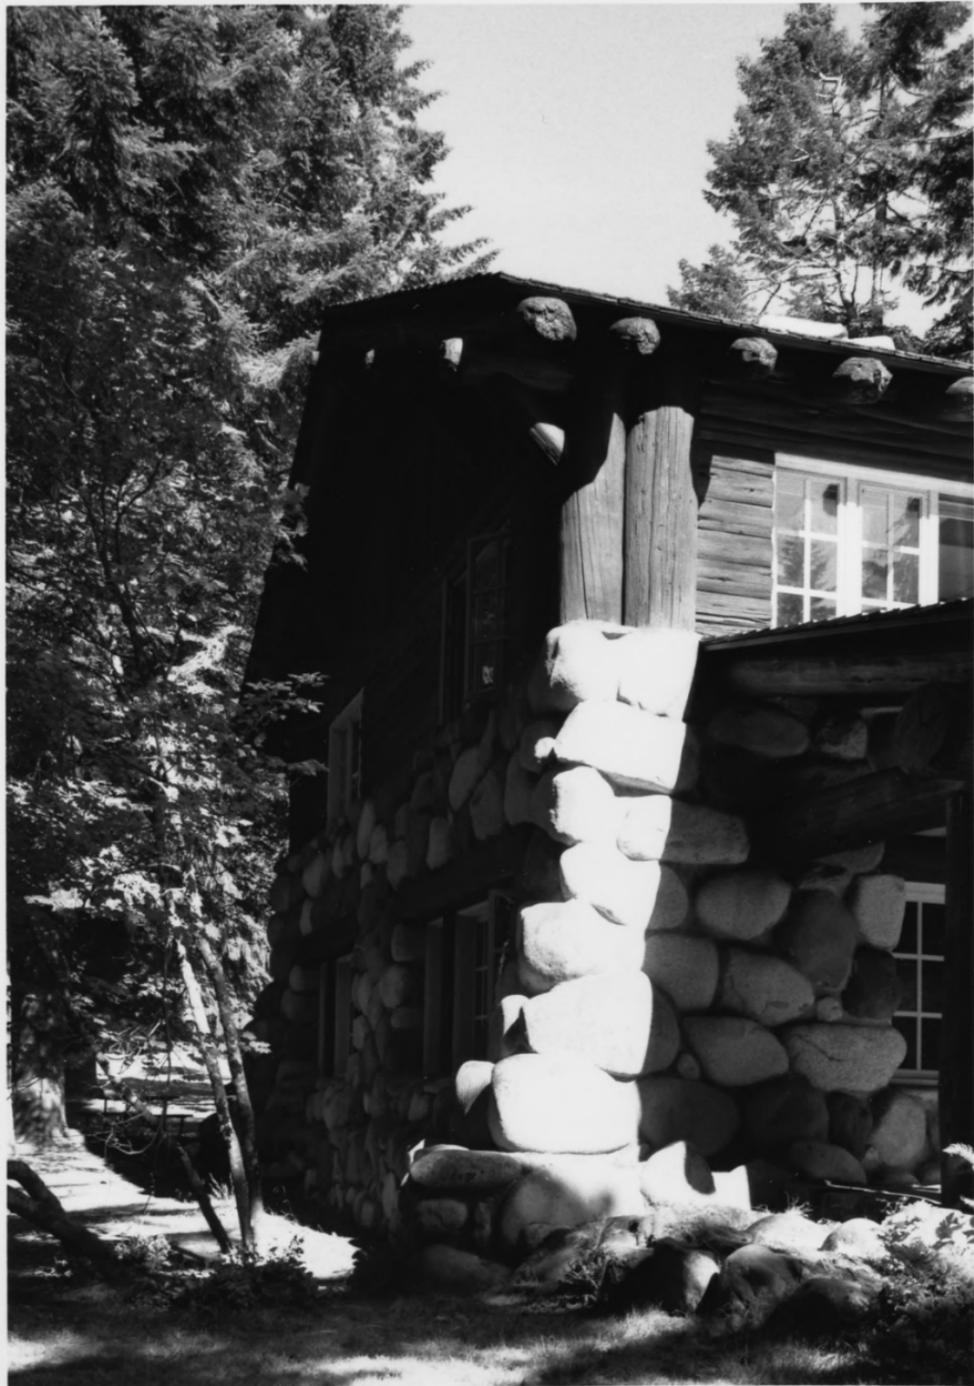
Corner Detail, Longmire Administration
Building

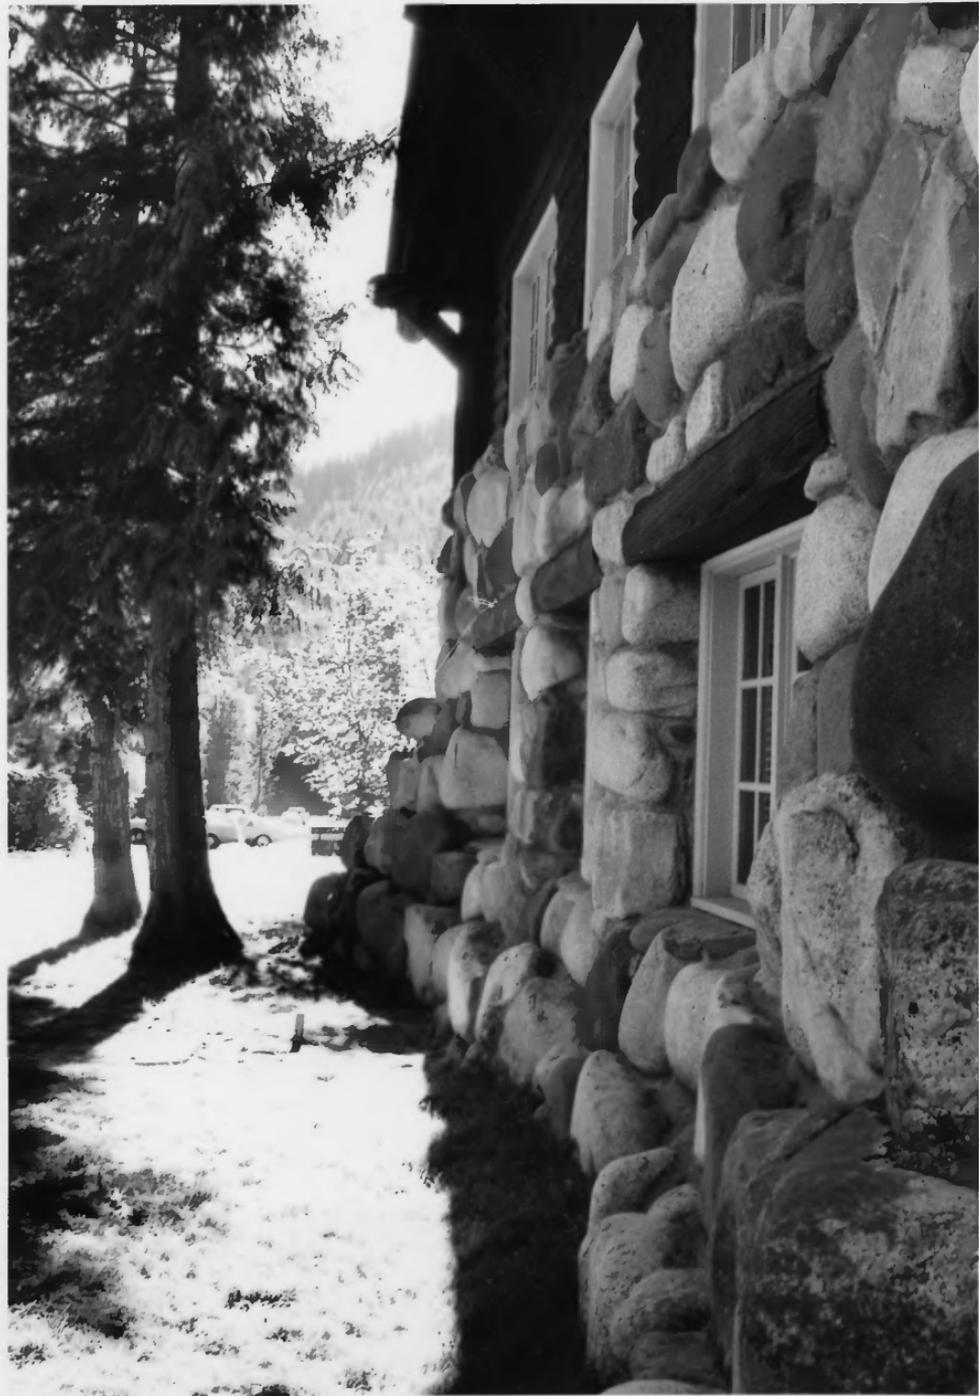
South wall, Longmire Administration
Building. Note concavity and battering
of stone wall

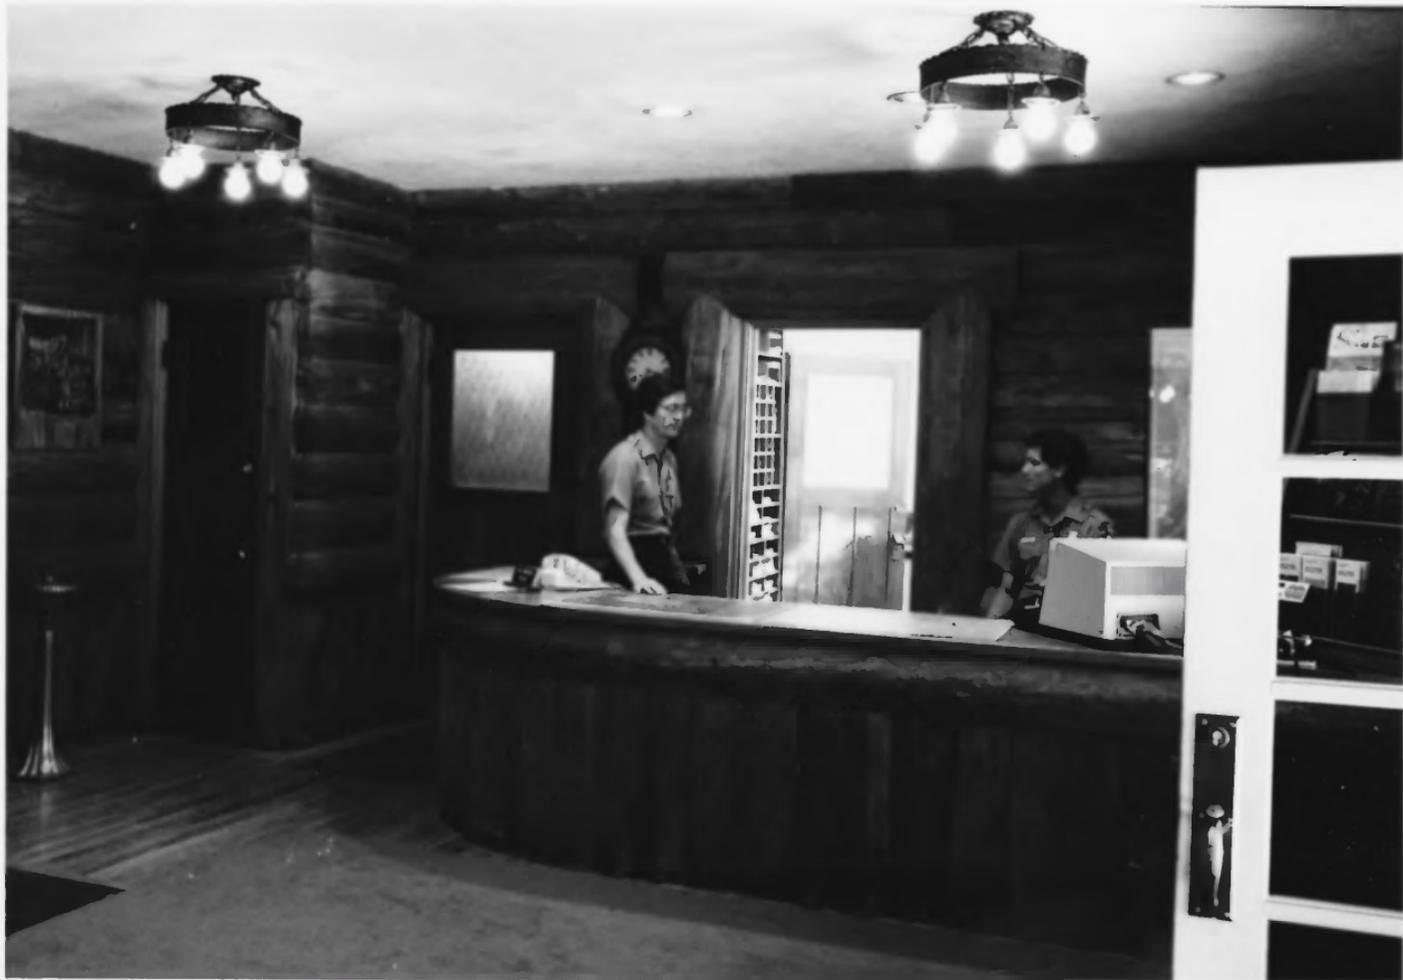
Log-slab panelling and lobby desk,
Longmire Administration Building lobby

The room configuration on the interior has undergone a few slight changes, but basically remains intact. The main lobby area is a handsomely executed space and now contains the visitor contact desk. The highlight of the room is the fireplace constructed of oversized, smooth glacial boulders. Largest of the fireplace stones is the elongated mantle stone that spans the opening. Hanging above the mantle are crossed snowshoes, and ice-axe, and other glacial climbing equipment added in 1980 and not considered part of this nomination. The hardwood floors of this space are finished with a polyurethane varnish and covered with carpet in the high-traffic areas. Walls are log-slab siding laid horizontal, with a low wainscot of horizontal slabs. All the doors and windows in this room are surrounded by massive moldings of log slabs. The ceiling is not original and consists of sheetrock with a rough plaster finish. Recessed spotlights in this new ceiling augment the original wrought-iron chandeliers hanging from the ceiling. The new ceiling treatment and the spotlighting are not included in this nomination. The visitor-information desk is sheathed with log slabs, adding to the room's rustic character. A fluted bronze drinking fountain sits in one corner of the room. Other rooms on the first floor are offices and storage space.

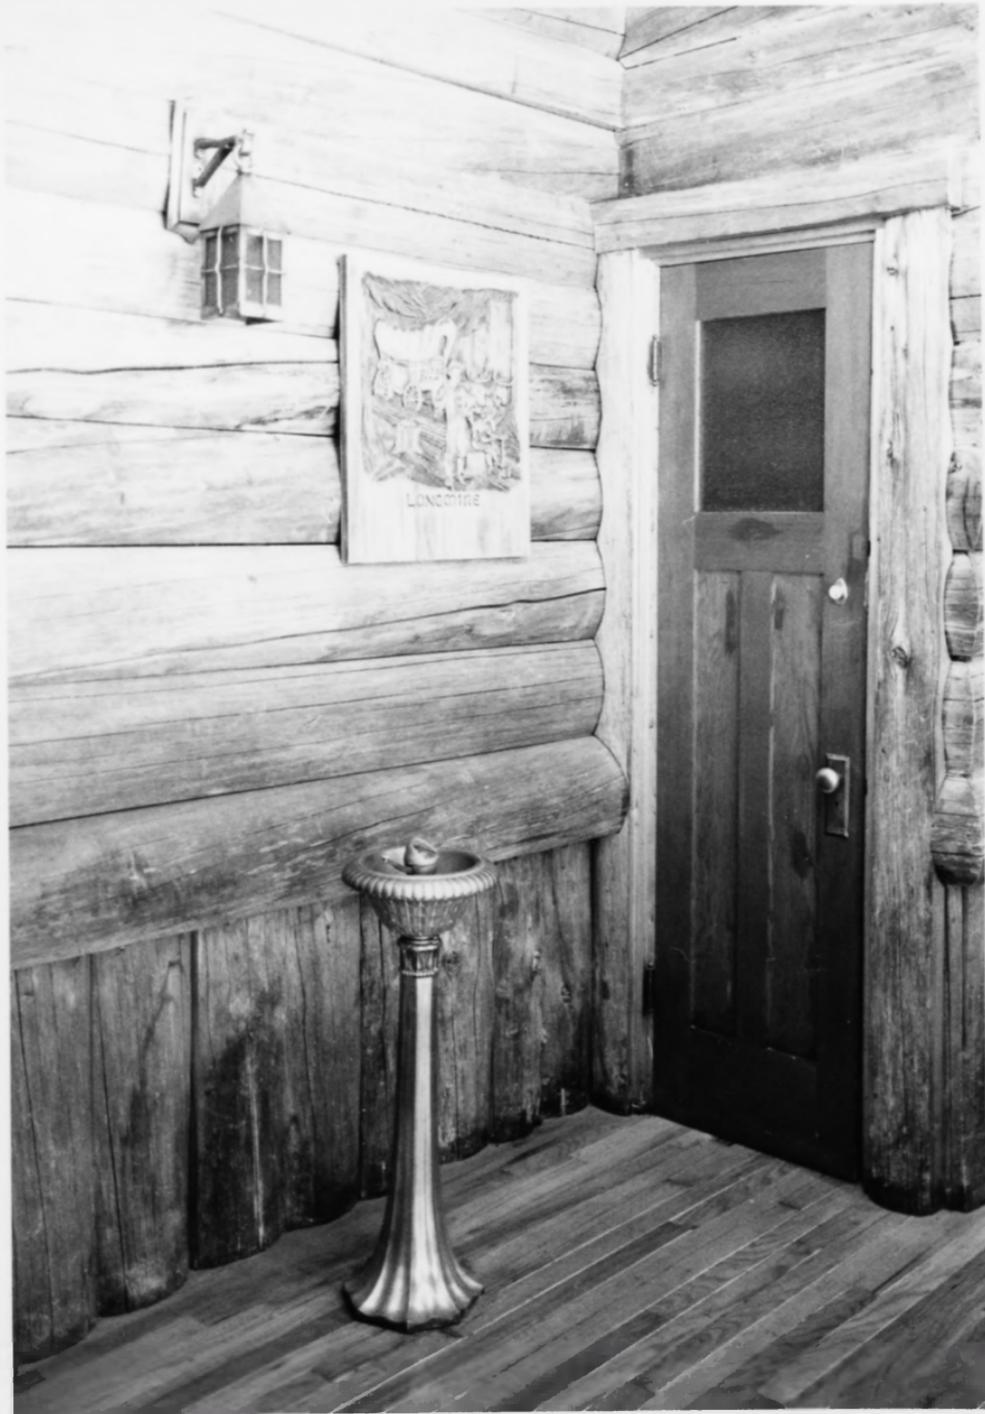
Fluted Pedestal Drinking Fountain, carved
Plaque and Wrought-iron Lamp, lobby of
Longmire Administration Building

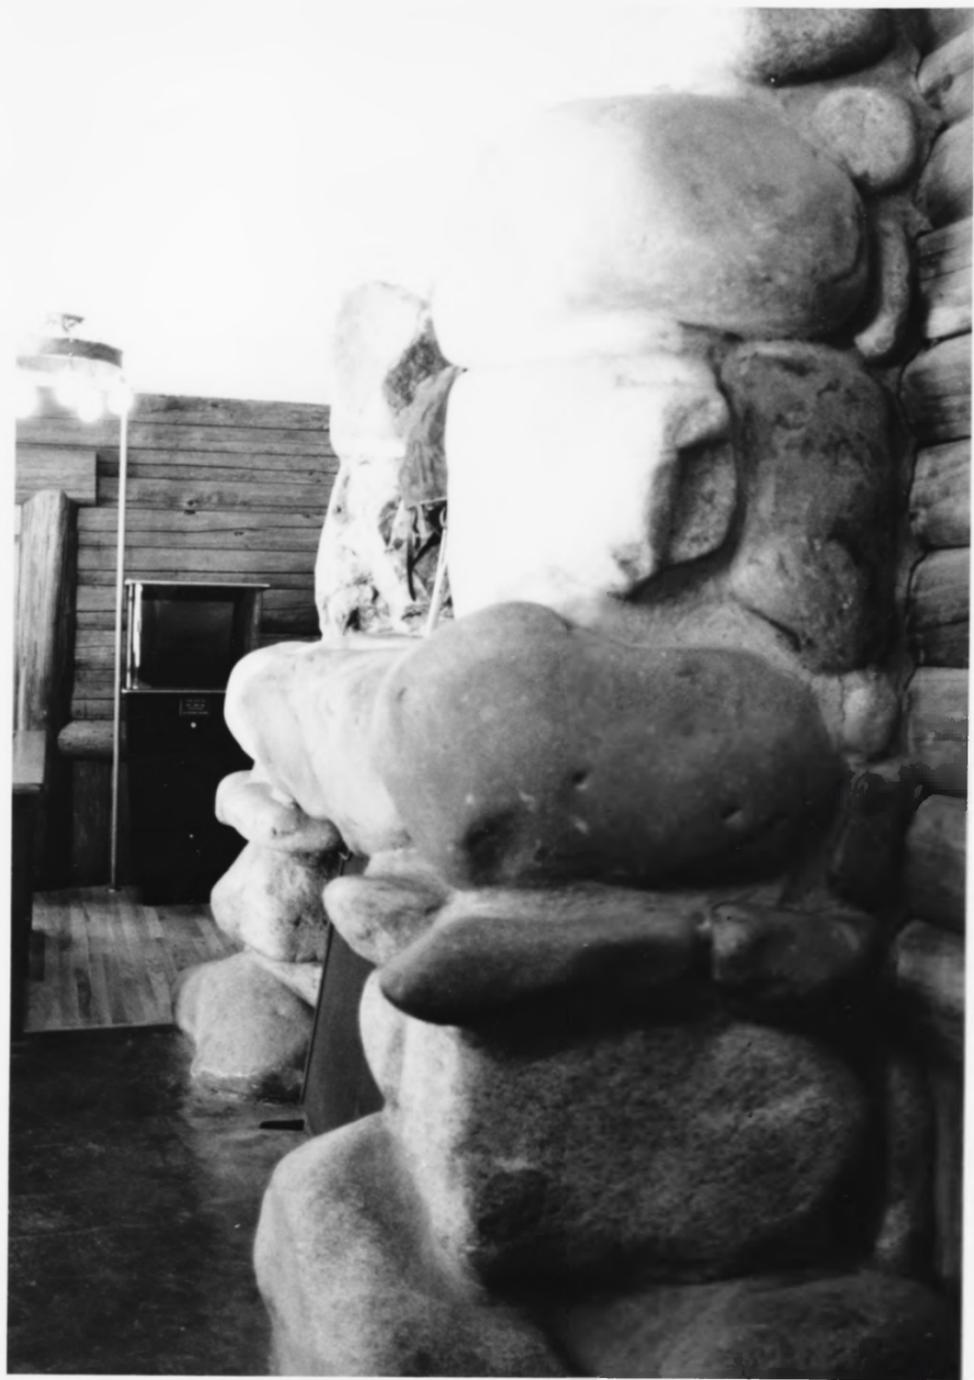
Fireplace details, Longmire Administration
Building lobby

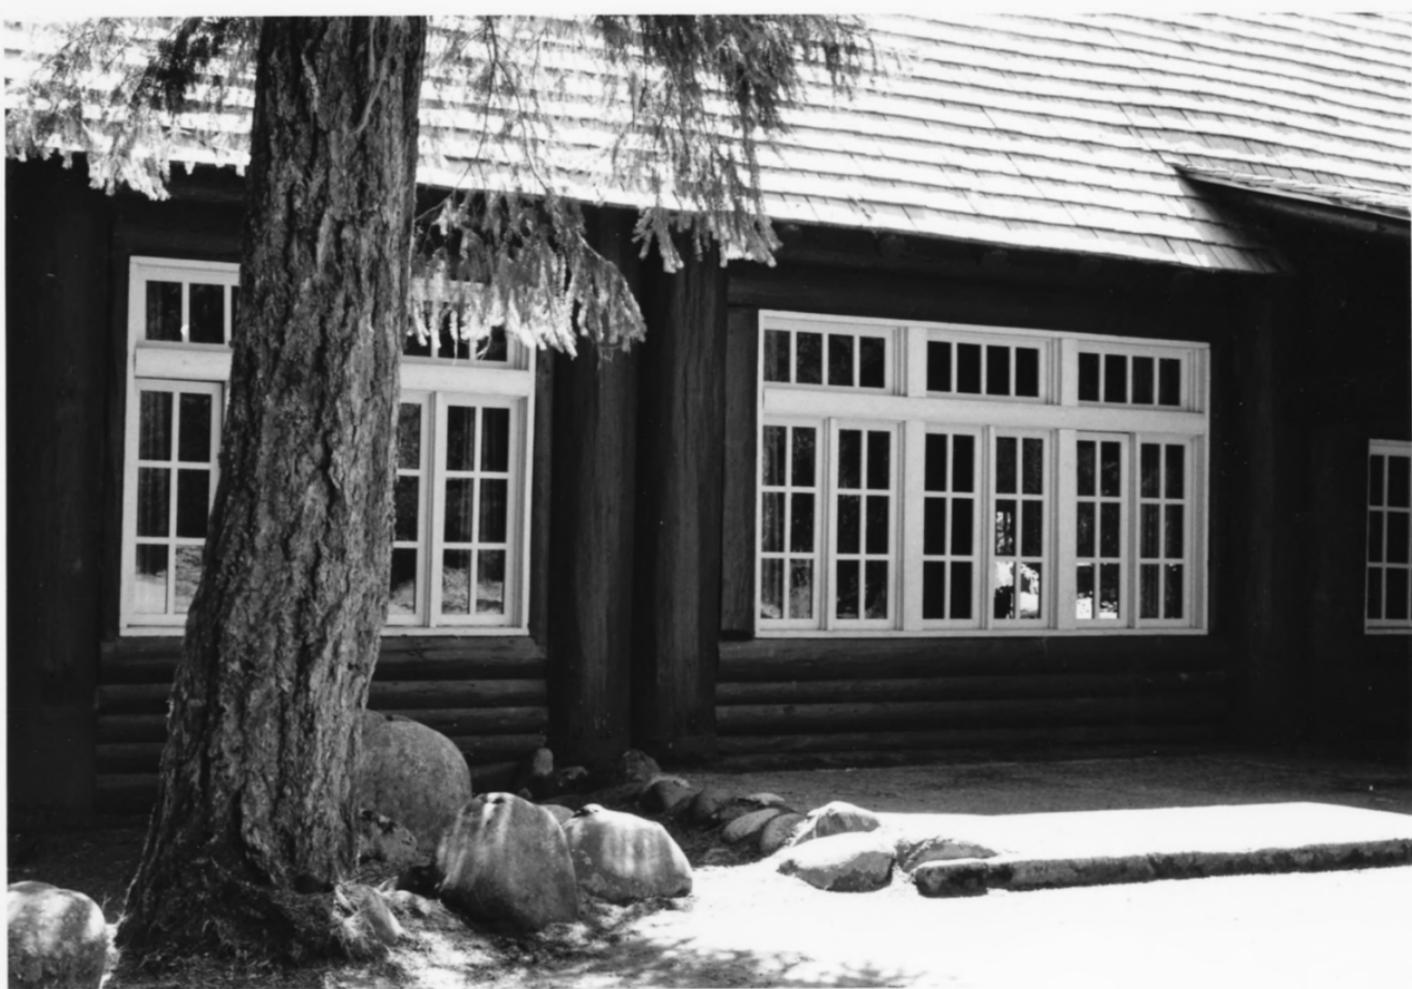
Window Details, Front Elevation, Longmire
Community Building

First of these buildings to be constructed was the Longmire community building, completed in 1927. The building has changed little since construction. Generally T-shaped in plan the building has a concrete foundation finished with a stone veneer and a wood-frame superstructure. The wood-frame walls of the main wing are finished with a thick log-slab veneer on the interior and exterior. The front elevation, divided into four bays, has an entrance porch in the third bay. The corners of this wing and the bay divisions are articulated by pairs of peeled log posts, giving the building the appearance of massive timber framing. Small portions of the lower sections of these logs have rotted and have been replaced with circular (non-historic) concrete pads. The walls of the rear wing are finished with board-and-batten siding. The intersecting gable roofs are steeply pitched and finished with wood shingles. Most of the windows in the structure are paired, multi-light casements with transoms above. The paired casements on the front elevation are clustered in groups of two and three. The multi-light French doors at the front entrance are flanked by additional casements.

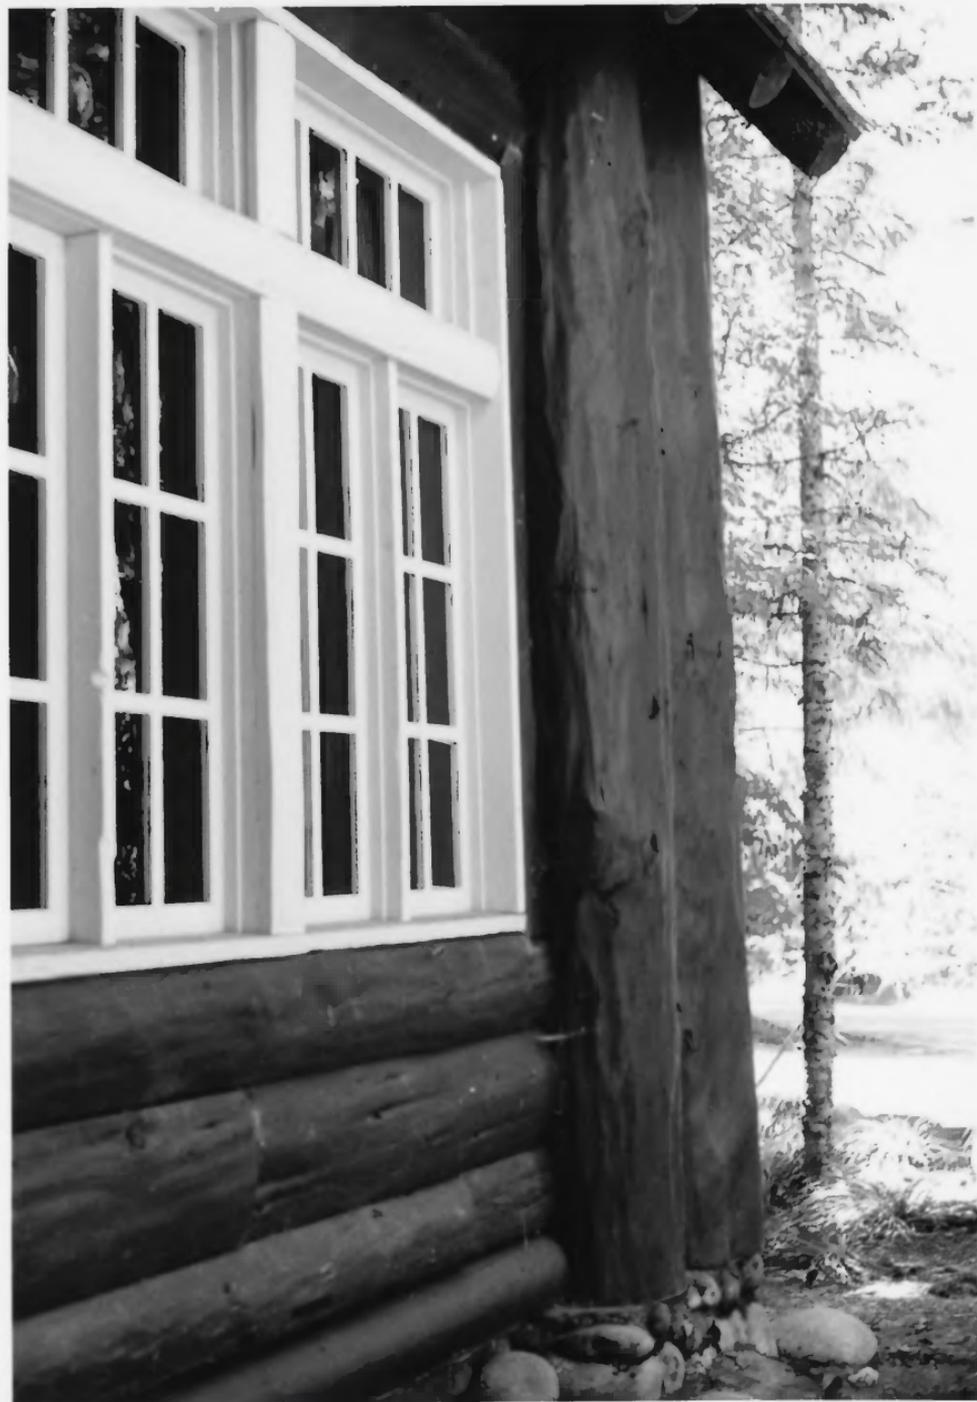
Corner Post Details, Longmire Community
Building

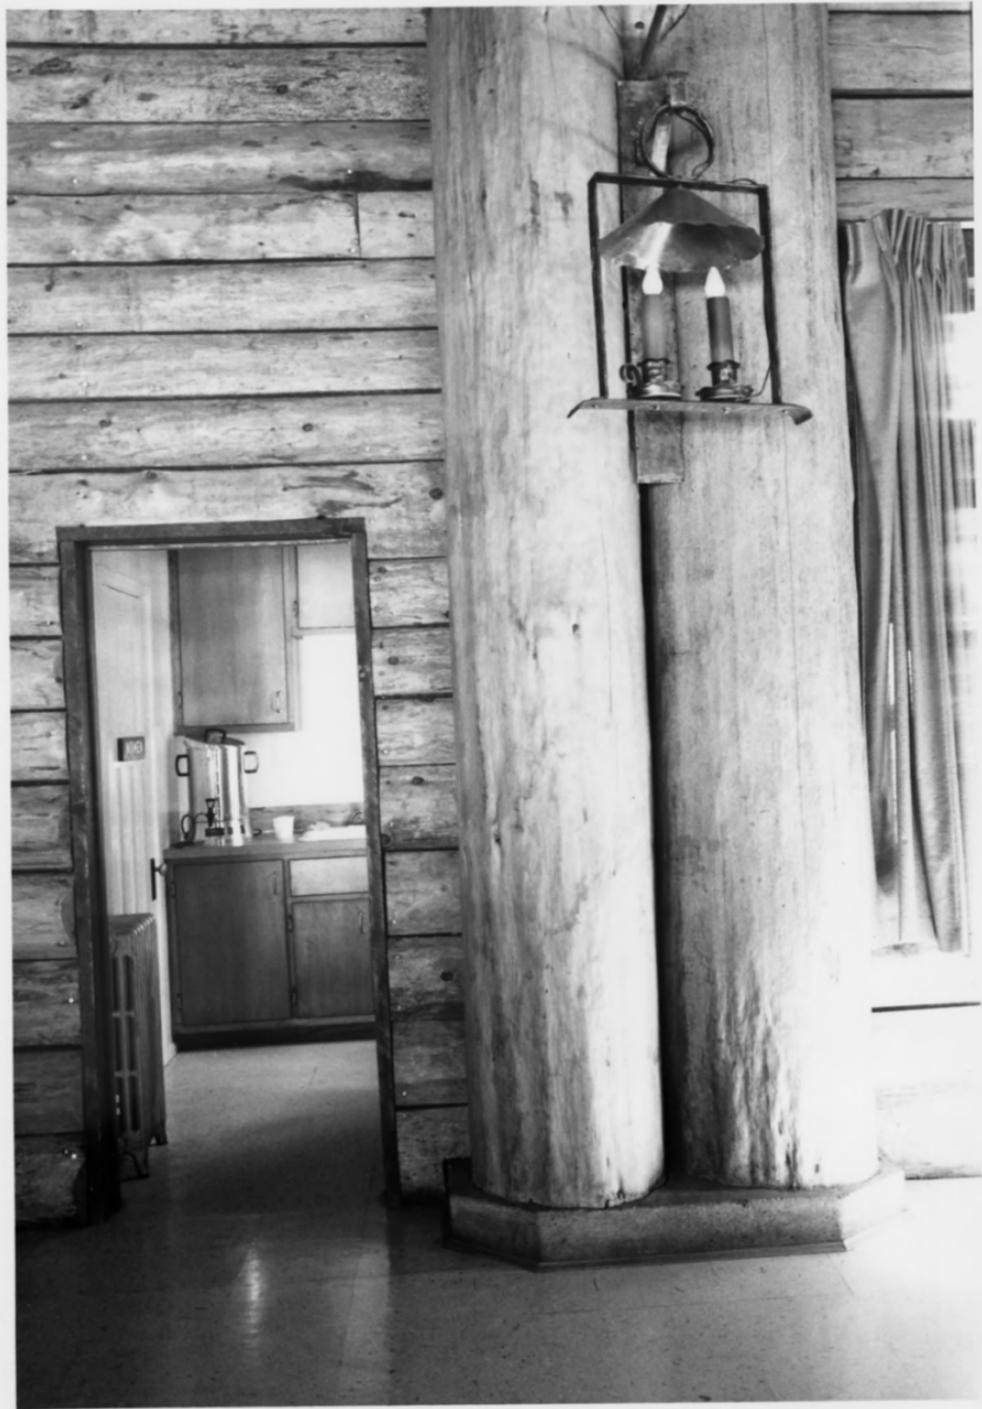
Interior peeled-long posts and wrought-
iron sconce, Longmire Community Building

The most important interior space is the community room. The room, little changed since construction, has an impressive exposed roof structure. The scissors truss, rafters, and purlins are all peeled logs that support a decking of cedar tongue-and-groove boards. Original wrought-iron chandeliers and sconces light the interior. One gable-end wall contains the massive stone fireplace and chimney. Stones in the lowest portion are coursed, roughly squared stones, while those of the upper portion, including the central niche in the chimney, are glacial boulders. The opposite gable end contains a small stage set in a

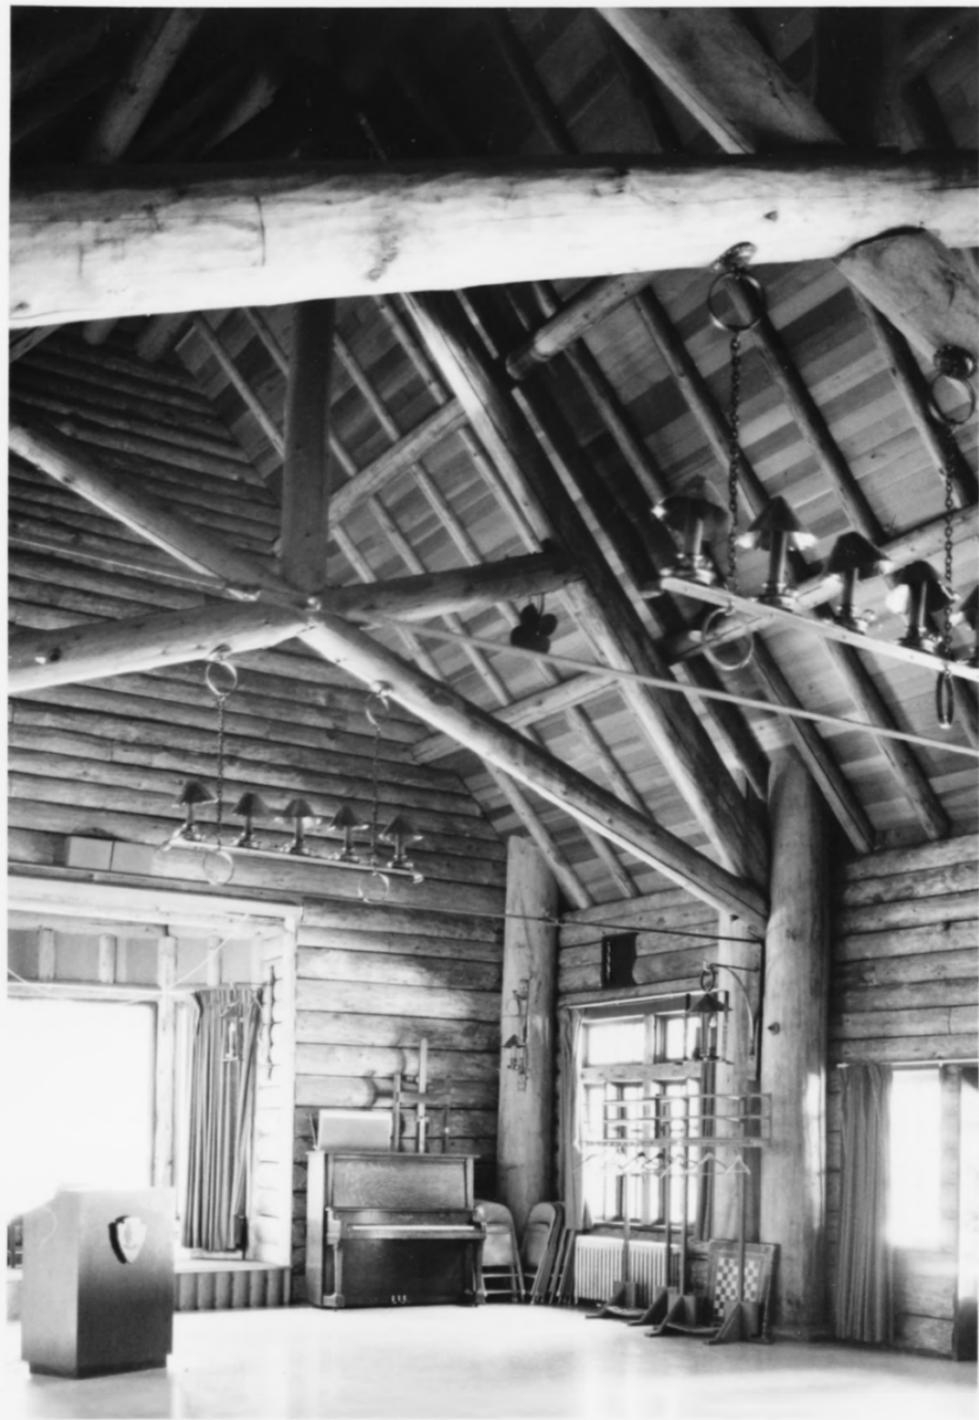
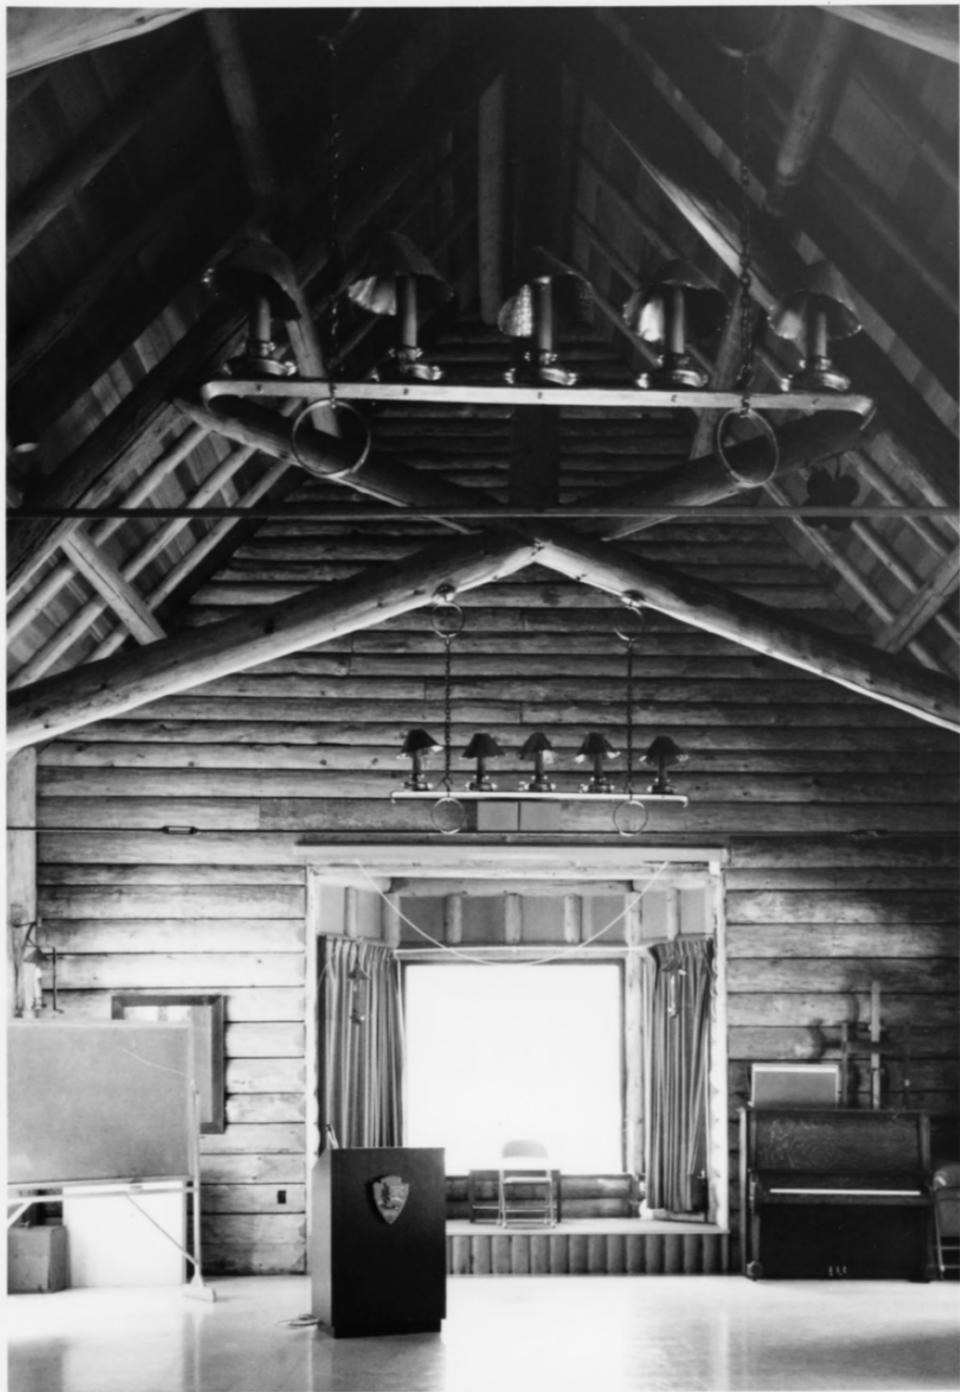
Interior, Longmire Community Building
