Topographic and Hydrologic Insight for the Westside Road Problem

Mount Rainier National Park

Natural Resource Report NPS/MORA/NRR—2015/1057

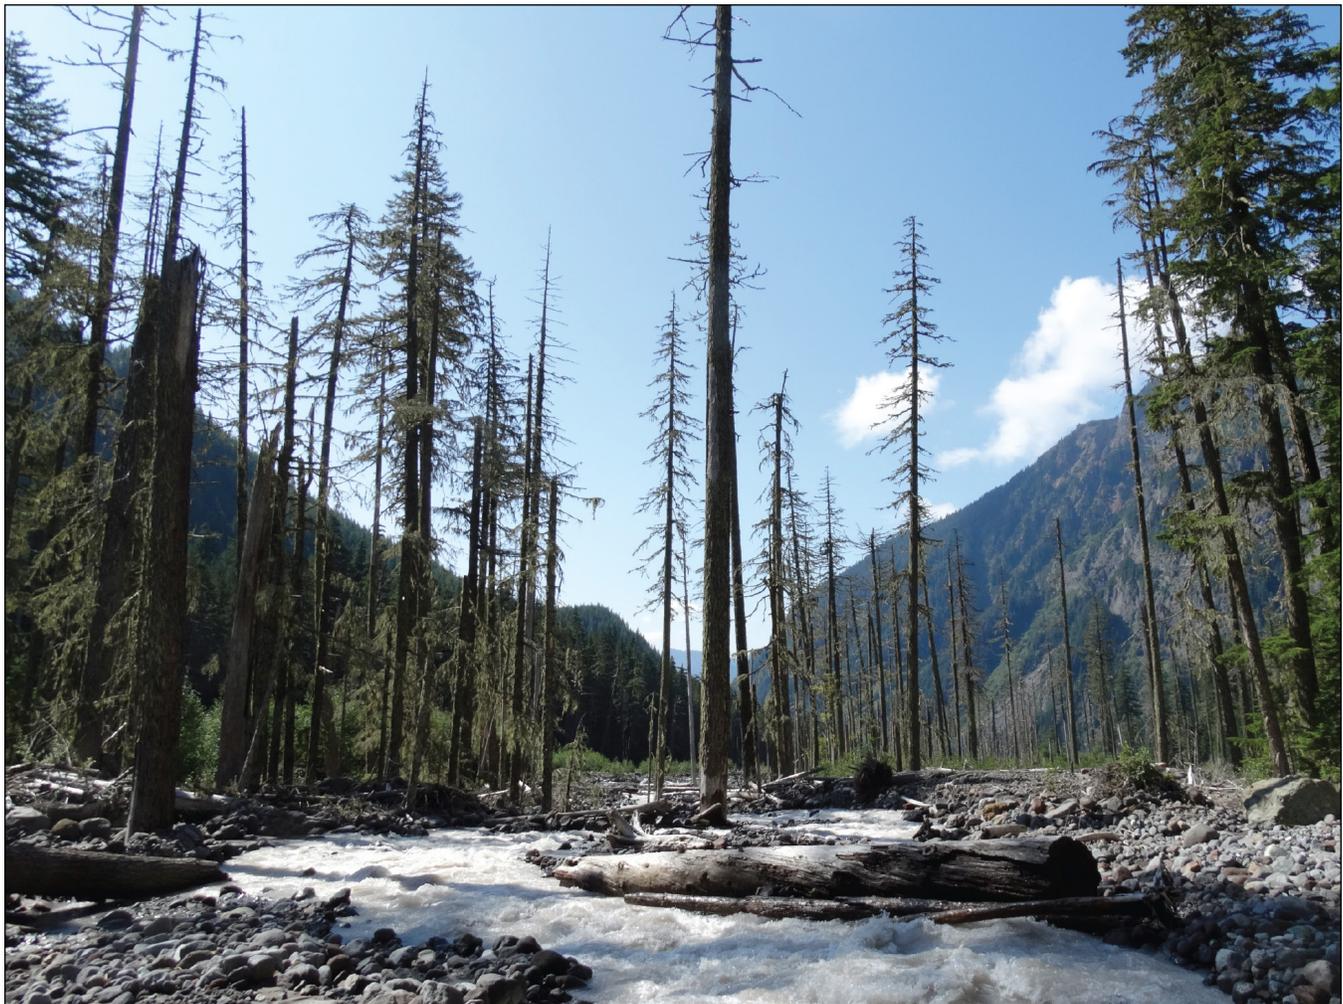
Photograph of an echelon, current-aligned logs within a channel in the Tahoma Creek valley.
Photograph courtesy of Matthew A. Thomas.
