| 2. NAME(S) OF STRUCTURE<br>(CARD 1 of 2)<br>Mowich Lake Patrol Cabin | | Ranger Patrol Cabin | | | | 10. DATE<br>1922 | |
| 3. SITE ADDRESS (STREET & NO)<br>Mowich Lake C-252 | | 6. PRESENT USE<br>Same | | 8. UTM ZONE EASTING NORTHING | | 11. REGION | |

17 PHOTOS AND SKETCH MAP OF LOCATION

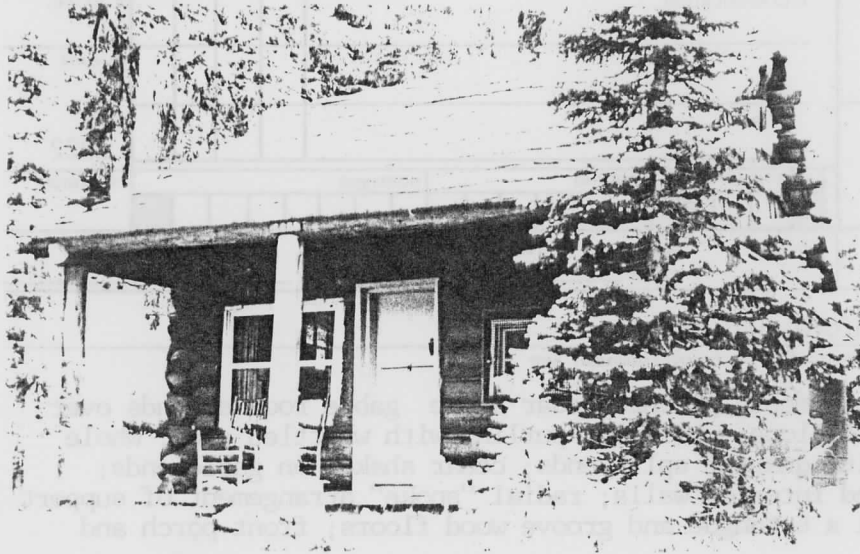
Log frame, one story, one room (and loft), rectangular cabin; steeply pitched cedar shake gable roof extends over log post and beam frame front porch; stove pipe on front gable slope; whole log purlins with whittled ends; whole log walls with cedar slab chinking; saddle notch cornering with quarter split ends; cedar shakes on gable ends; dirt and wood chinking; log sill on rock foundation; varnished interior walls; radial "spoke" arrangement of support beams that run vertically from floor of loft to ridge beam; 1 x 6 tongue and groove wood floors; front porch and loft have 2 x 6 decking.

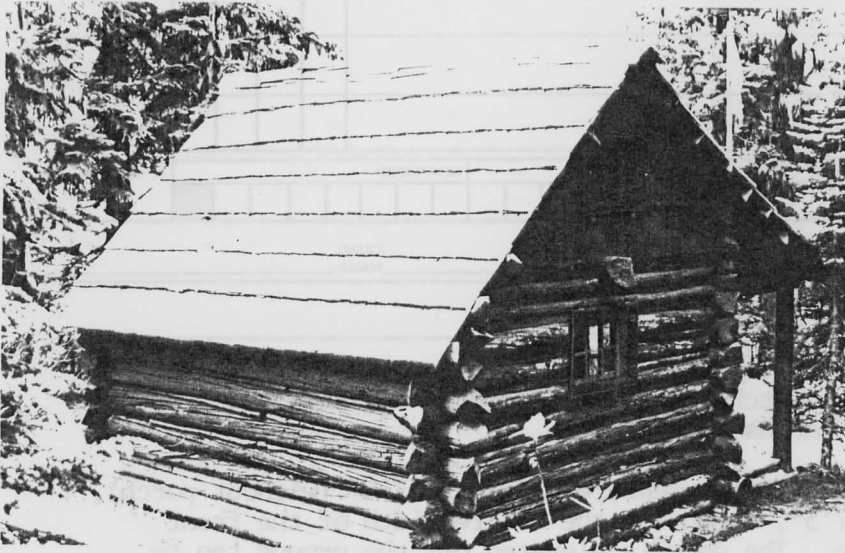
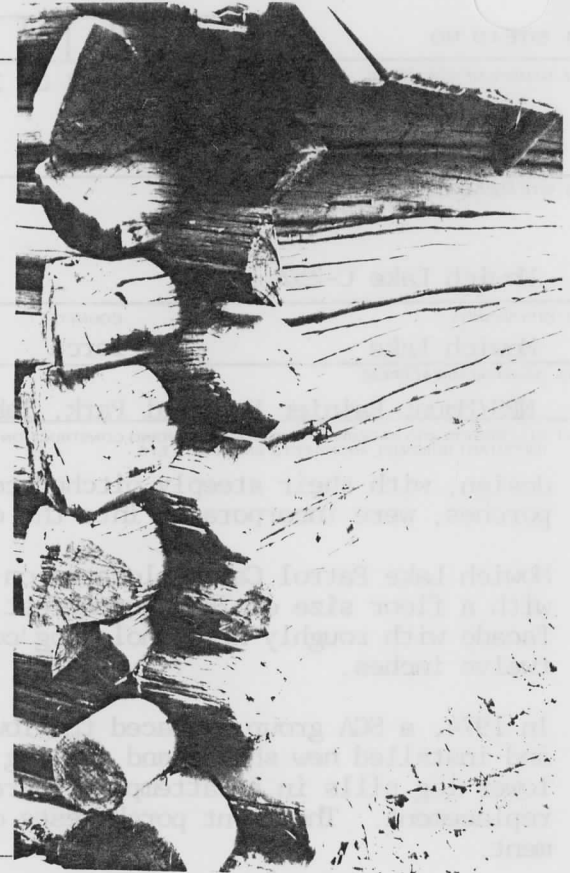
17. PHOTOS AND SKETCH MAP OF LOCATION

Mowich Lake Patrol Cabin, located on Mowich Lake near the Wonderland Trail, measures 15'7" x 17'5" (without porch), with a floor size of 267 square feet. The open porch is 5'9" x 17'5", extending the entire width of the front facade with roughly hewn whole log columns and rough board decking. The deck is elevated off the ground ten to twelve inches.

In 1974, a SCA group replaced the lower log sills, installed a new floor, sealed off the loft for heating purposes, and installed new shakes and ceiling sheathing. They dug a "trench" around three sides of the cabin to expose the lower log sills in an attempt to forestall the occurrence of log rot. Three middle logs on the rear facade need replacement. The front porch rests on deteriorated log sills and several of the log purlins are in need of replacement.
