Mt. Freemont Fire Lookout

13. DESCRIPTION AND BACKGROUND HISTORY INCLUDING CONSTRUCTION DATE(S), PHYSICAL DIMENSIONS, MATERIALS, MAJOR ALTERATIONS, EXANT EQUIPMENT, AND IMPORTANT BUILDERS, ARCHITECTS, ENGINEERS, ETC.

National Register of Historic Places
Continuation Sheet

PROPERTY NAME: Mt. Fremont Fire Lookout

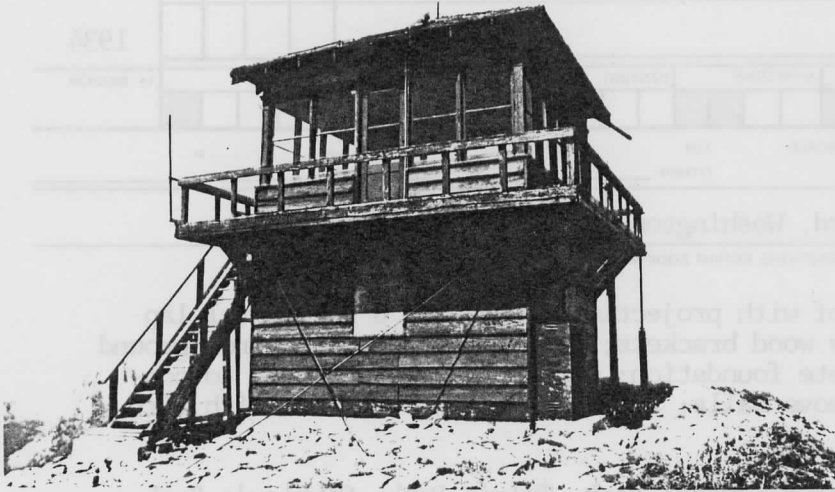
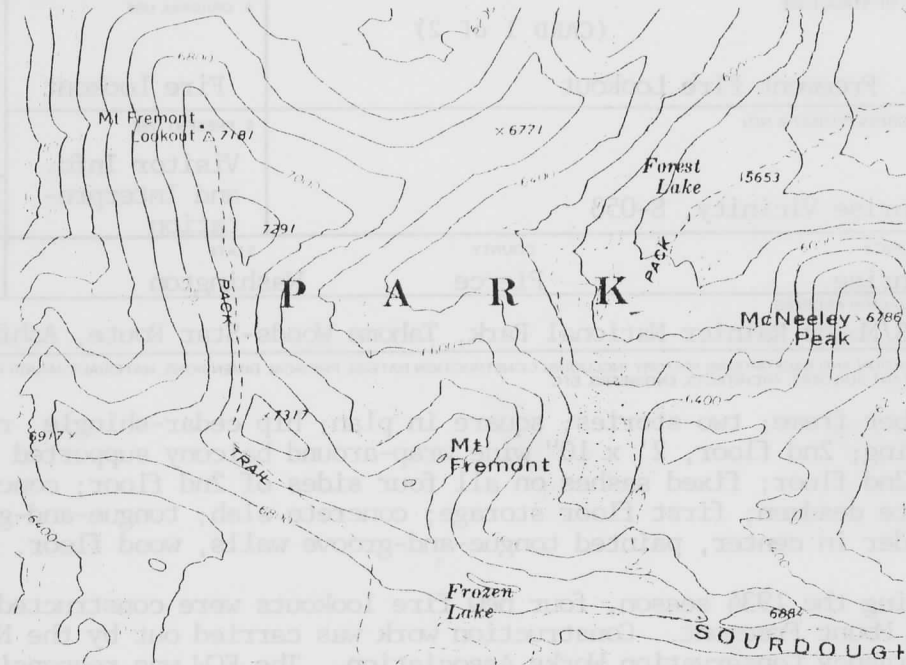
Original Drawing "Standard Lookout House - Type No.1, For all Parks," NPS Branch of Plans Design, by Edward A. Nickel, Acting Chief Architect, 4/27/34 (MORA DRG. NO.95).

The Mount Freemont lookout, located about two miles north of Yakima Park (Sunrise) at elevation 7181 feet, was built from the standard design plans developed in the early thirties. The "Standard Lookout House - Type No.1, For all Parks" was created by the NPS Western Division, Branch of Plans and Design with Edward A. Nickel (CONT'D)

(Associate Structural Engineer) supervising the design. Typically, the wood frame buildings measured 14' x 14' and contained two stories. The ground floor was used for storage and the one room, upper floor contained a fire finder, charts and supplies, a bed, and cooking facilities. Large fixed-glass windows were on all four sides and a cantilevered balcony, 2' x 10" wide, wrapped around the second floor. The lookouts were founded on concrete and wire rope guys connected to concrete deadmen anchored the structures to the ground. This was done to provide lateral stability during severe wind conditions that the exposed lookouts were often subjected to. Indeed, shortly after its completion, a windstorm destroyed the Mount Freemont lookout's hip roof. The building was immediately repaired. It was then occupied, primarily during times of extreme fire danger. Fire spotting by airplane eventually superseded the stationary lookouts. Four lookout houses remain in the park and all are generally used for visitor assistance and interpretation.

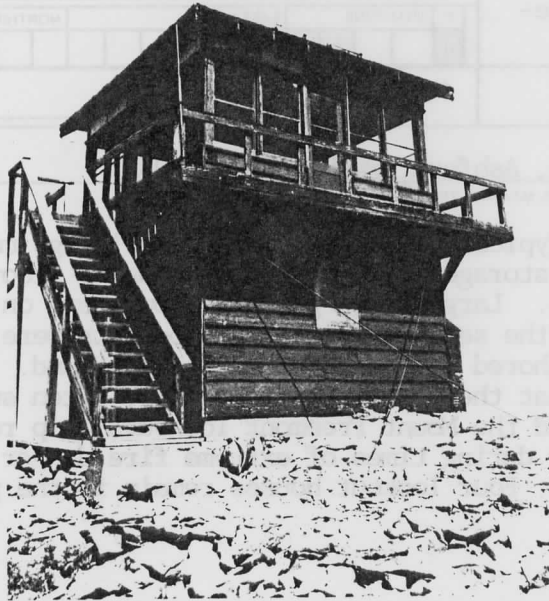
17. PHOTOS AND SKETCH MAP OF LOCATION

Timber frame; two-stories; square in plan; hip cedar-shingle roof with projecting eaves; 1 x 8 horizontal lap siding; 2nd floor, 2' x 10" wide wrap-around balcony supported by wood brackets; exterior wood stairs from ground to 2nd floor; fixed sashes on all four sides of 2nd floor; concrete foundation; wire rope guys anchored to concrete deadmen; first floor storage; concrete slab; tongue-and-groove walls; 2nd floor living quarters with fire finder in center, painted tongue-and-groove walls, wood floor.

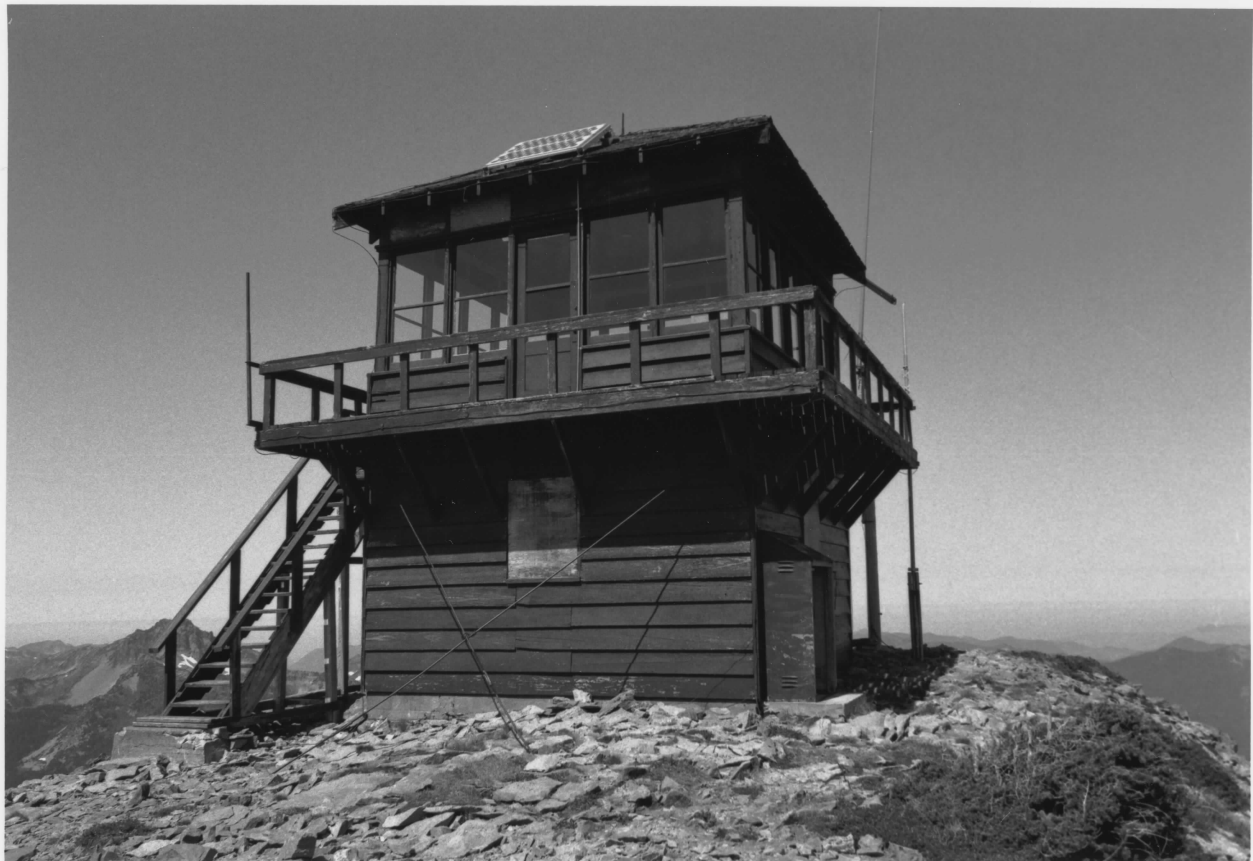
Photo 74

Mt. Fremont Fire Lookout
