Summerland Trail Shelter

13. DESCRIPTION AND BACKGROUND HISTORY INCLUDING CONSTRUCTION DATE(S), PHYSICAL DIMENSIONS, MATERIALS, MAJOR ALTERATIONS, EXTANT EQUIPMENT, AND IMPORTANT BUILDERS, ARCHITECTS, ENGINEERS, ETC.

United States Department of the Interior  
National Park Service

National Register of Historic Places  
Continuation Sheet

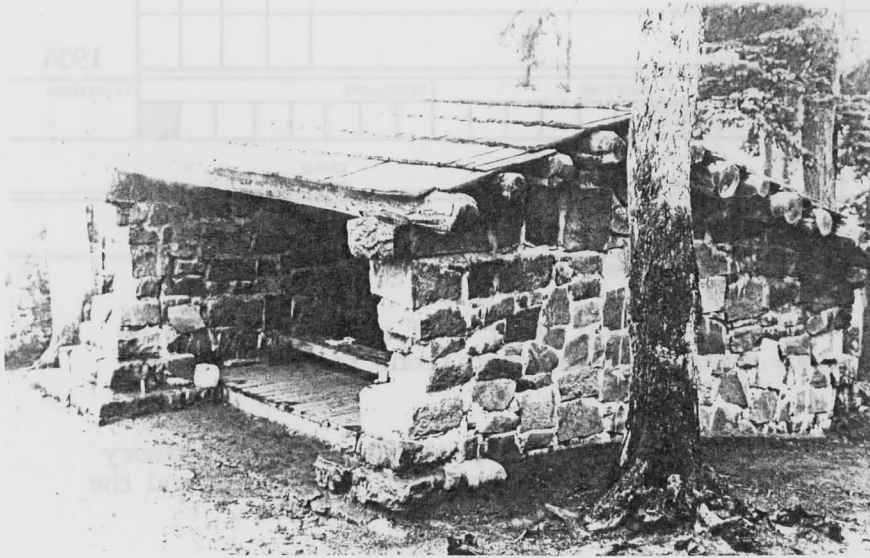
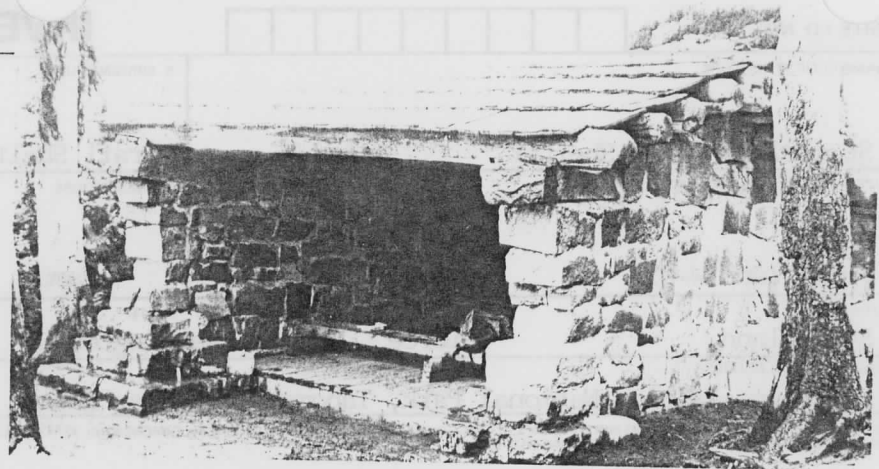
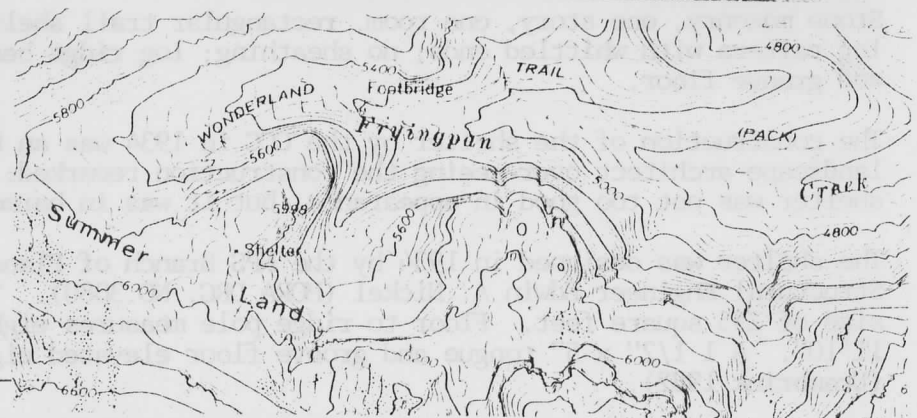
17. PHOTOS AND SKETCH MAP OF LOCATION

Stone masonry, one story, one room, rectangular trail shelter; "saltbox" design; cedar roof shakes over whole log rafters with whittled ends; no sheathing; log ridge beam; stone masonry walls; open front facade; tongue and groove floor.

The condition of the shelter is tight and dry. The roof does have a few holes, and the cedar shakes need to be

replaced. There is minor log rot, concentrated on the exposed rafter ends.

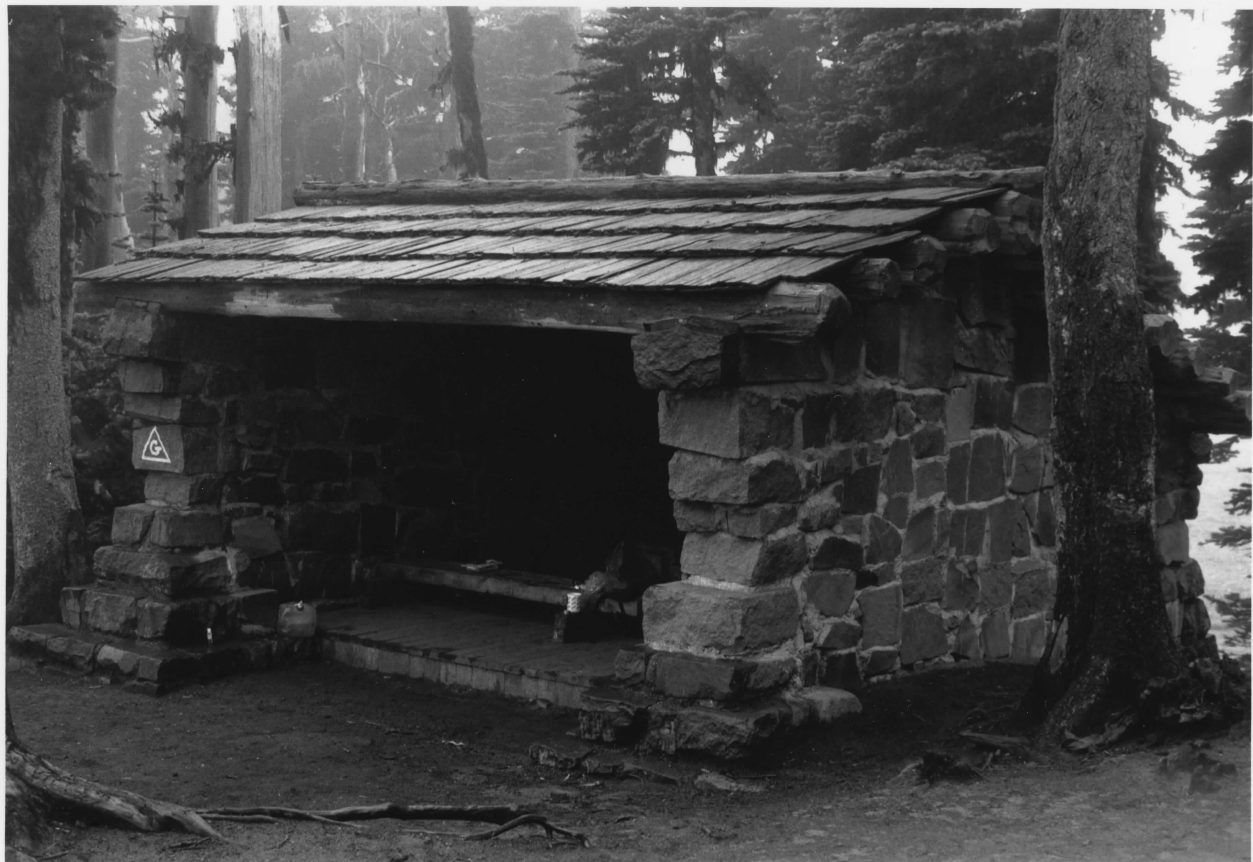
Photo 66

Summerland Trail Shelter
