# **Rivers Gone Wild: Extreme landscape response to climate-induced flooding and debris flows, and implications to long-term management at Mount Rainier National Park**

*Field Trip Guide #410, 2017 Geological Society of America Annual Meeting, Seattle, WA*

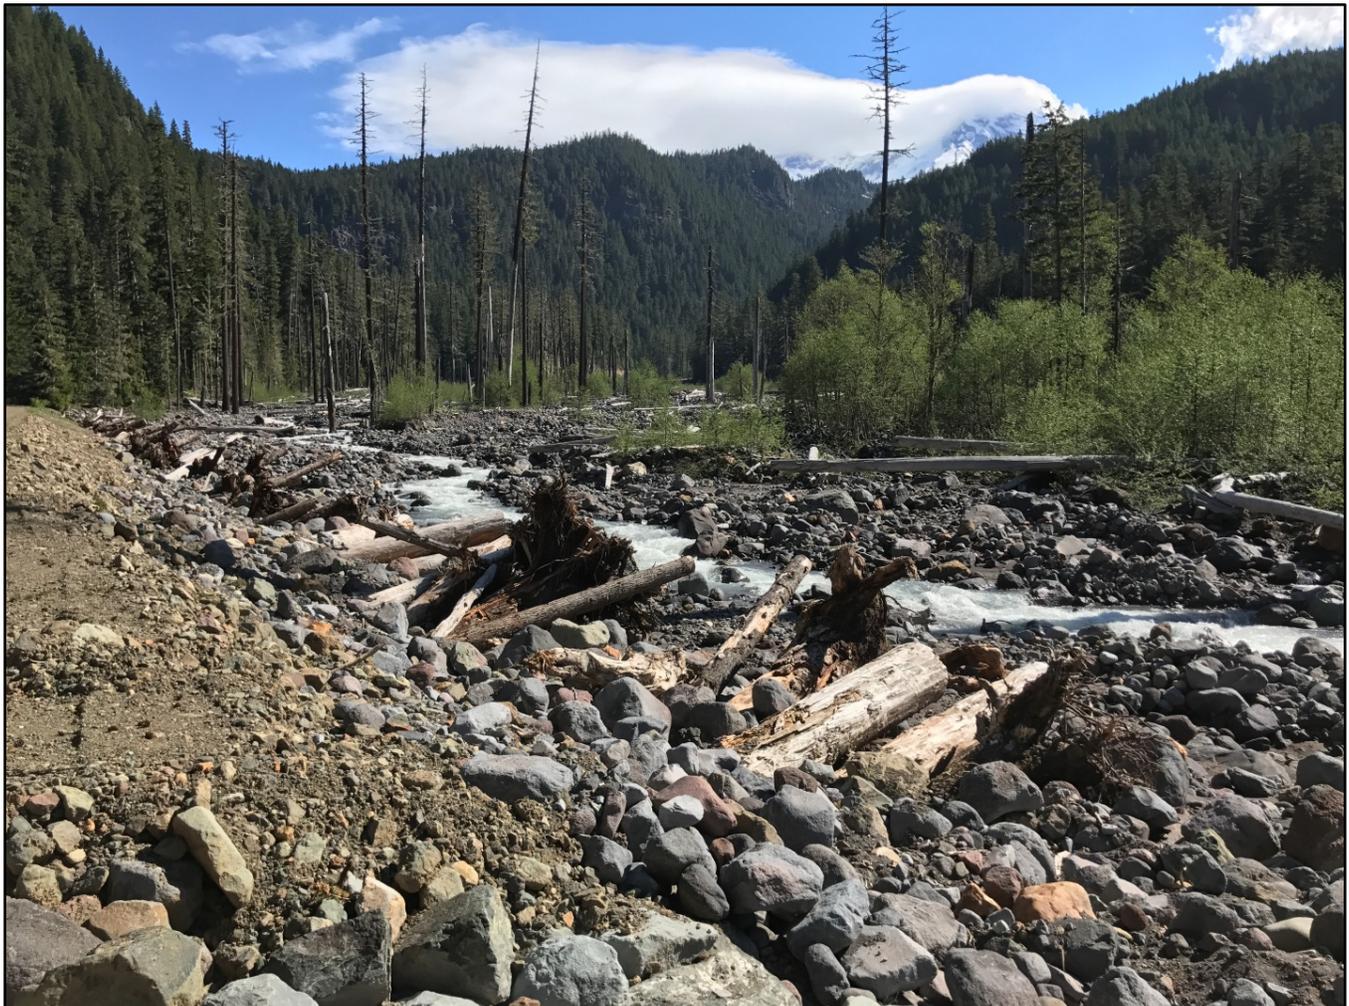
Debris flow deposit left in the Tahoma Creek Picnic Area (then a campground and now abandoned) on the evening of August 31, 1967 following the genesis of modern debris flow activity in the Tahoma Creek reach. The un-vegetated part of the Tahoma Creek active channel is faintly visible in the background. (Photo modified from Richardson, 1968)

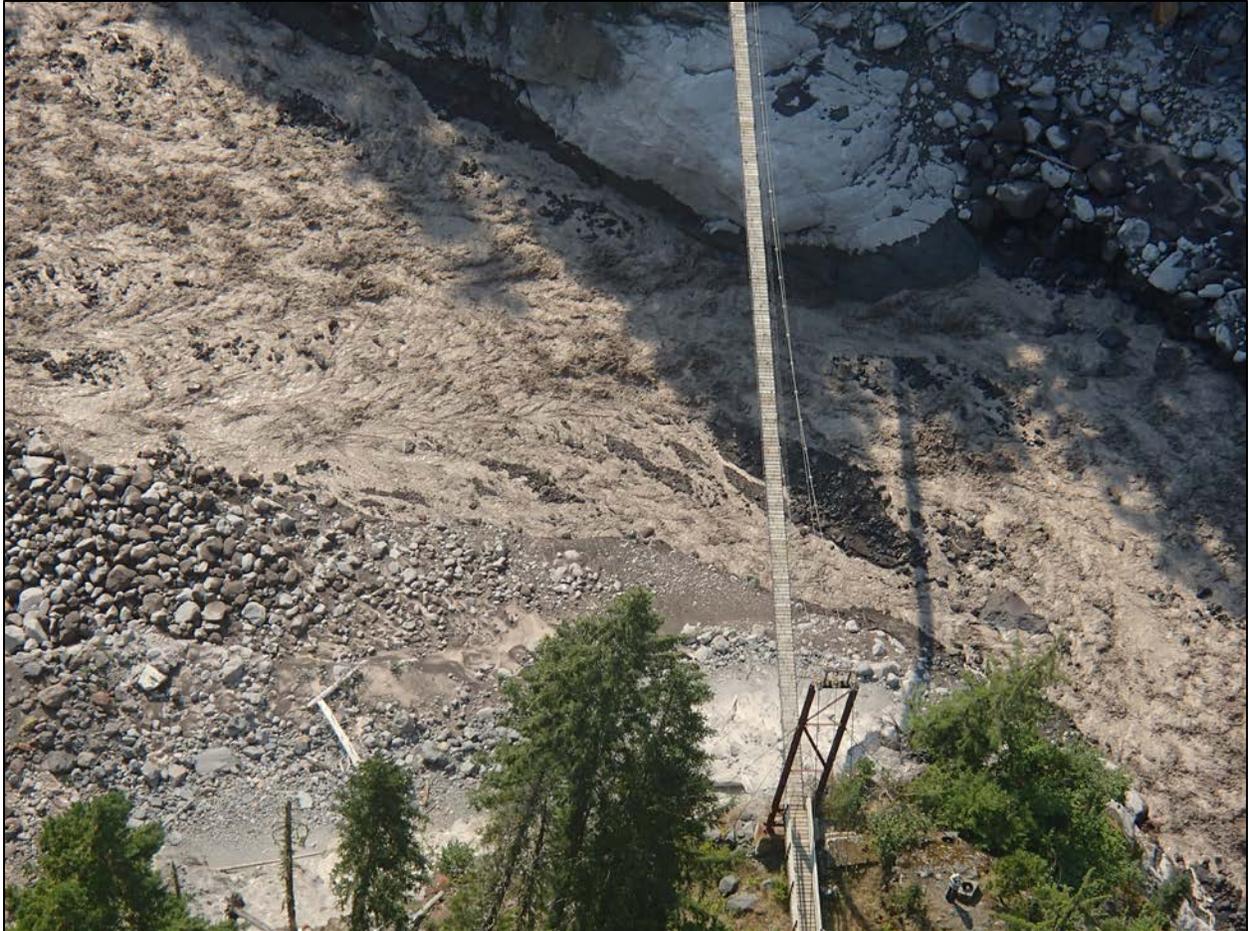
**Photo 2:** Hyper-concentrated flow passing the Wonderland Trail/Tahoma Creek Suspension Bridge on August 13, 2015 during the August 2015 South Tahoma Glacier outburst flood and debris flow event (Scott Beason/NPS Photo).

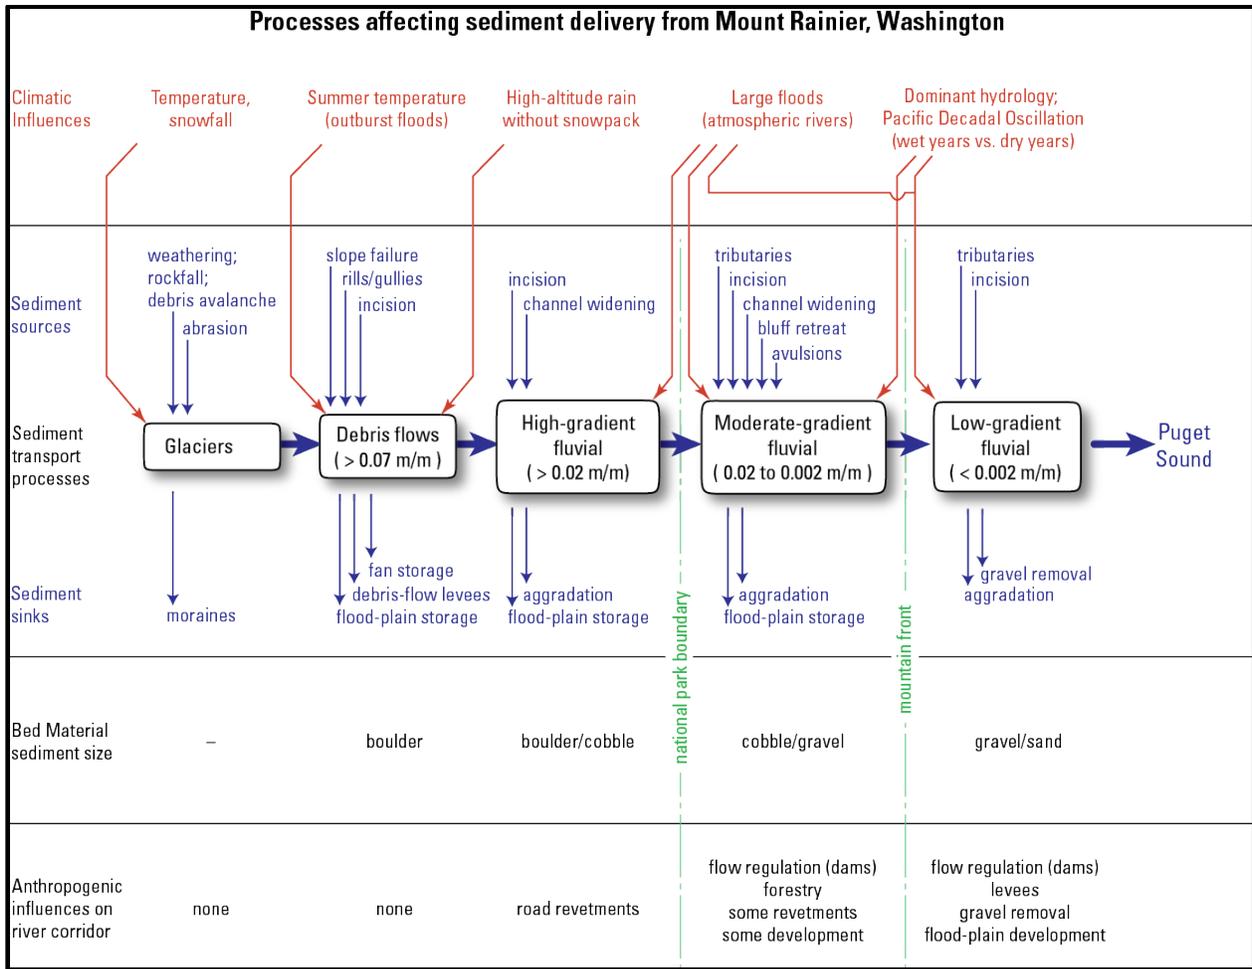
**Figure 2:** Conceptual model of processes affecting sediment delivery from Mount Rainier, Washington (from Czuba et al., 2012b).

Conceptually, sediment is transported from Mount Rainier to the Puget Lowland through a sequence of glacial and fluvial processes (Czuba et al., 2012b; Figure 2). High on the mountain, glaciers entrain sediment through bedrock erosion and carry colluvium deposited by rockfalls. Englacial sediment is transported by glaciers to lower elevations and deposited in moraines. Debris flows mobilize sediment from moraines as well as from superglacial deposits transporting sediment downstream into the river network. Finally, floods work to transport coarse-grained and fine-grained sediment down main-stem rivers to the Puget Lowland and Puget Sound.

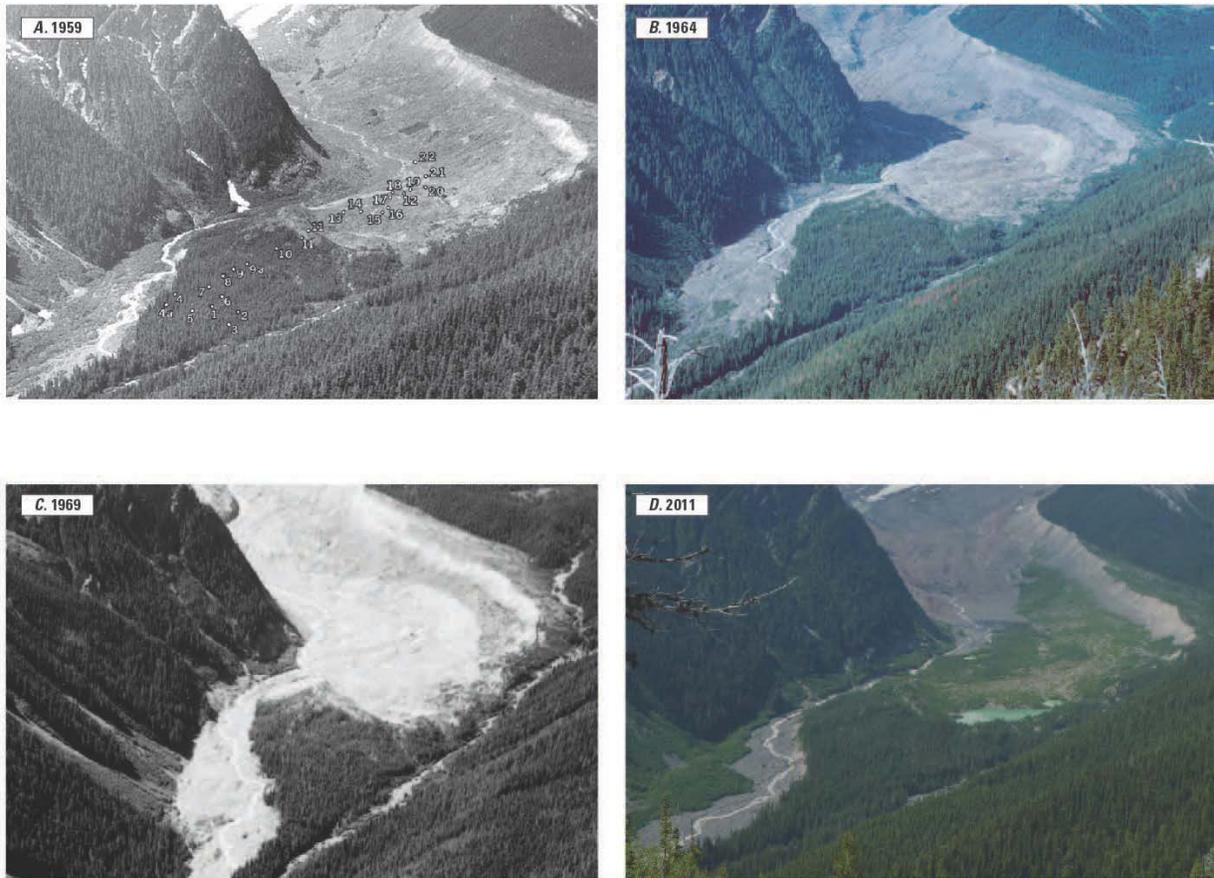
**Figure 3:** Images of the headwaters of the White River at the terminus of the Emmons Glacier, Mount Rainier, Washington: (A) July 18, 1959 (published by Sigafoos and Hendricks, 1961; numbered points indicate botanical study locations), (B) 1964 (photo by D.R. Crandell), (C) August 29, 1969 (published by Sigafoos and Hendricks, 1972), and (D) August 14, 2011 (photo by C.S. Magirl). Figure from Czuba et al. (2012b).

On Mount Rainier, large rockfalls and debris avalanches are a dominant source of sediment that ultimately ends up in rivers of the Puget Lowland (Czuba et al., 2012b). The largest rockfall/debris avalanche in the Mount Rainier historical record occurred in December 1963, when 11 million m<sup>3</sup> fell during at least seven separate avalanches that traveled a distance of more than 6 km down Emmons Glacier and left a sizeable deposit on the valley floor in front of the glacier terminus (Figure 3). A photograph of the region downslope of the Emmons Glacier terminus taken in the summer following the debris avalanche shows the extent of the debris coverage (Figure 3 (B)), and a photograph taken from a similar vantage point five years later shows the progression of the rockfall-sourced sediment down the White River (Figure 3 (C)). By the summer of 2011, vegetation had grown on much of the 1963 debris-avalanche surface, and fluvial processes appeared to have significantly reworked the deposit and transported a portion downstream (Figure 3 (D)).

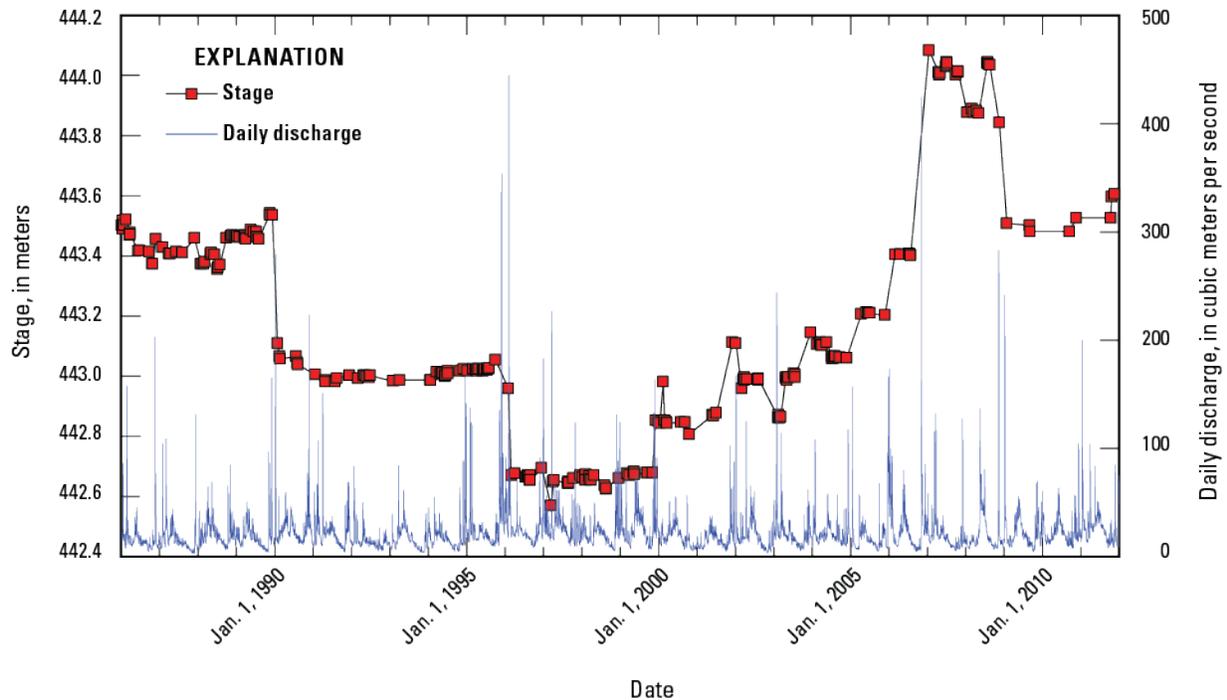
**Figure 4:** Graph showing stage for median flow and daily discharge as measured at the U.S. Geological Survey streamflow-gaging station Nisqually River near National (12082500). Figure from Czuba et al. (2012b).

Flood-induced incision or aggradation of a particular river reach is governed by the mass balance of sediment entering and exiting the reach and the resulting storage of bed material. Using gage analysis, Czuba and others (2010) found the Nisqually River near National had experienced significant changes in the stage-discharge relation since 1942. Plotting stage for the median flow for the Nisqually River along with the daily discharge from 1986 to 2011 showed an apparent relation between stage changes recorded at the gage and during peak flow events (Figure 4). During some large peak-flow events (notably, the February 1996 storm), the median-flow stage at the gaging station decreased significantly. In contrast, other peak-flow events (for example, during the November 2006 storm) were associated with a net increase in median-flow stage at the gage. Still other peak-flow events were associated with little or no change in median-flow stage.

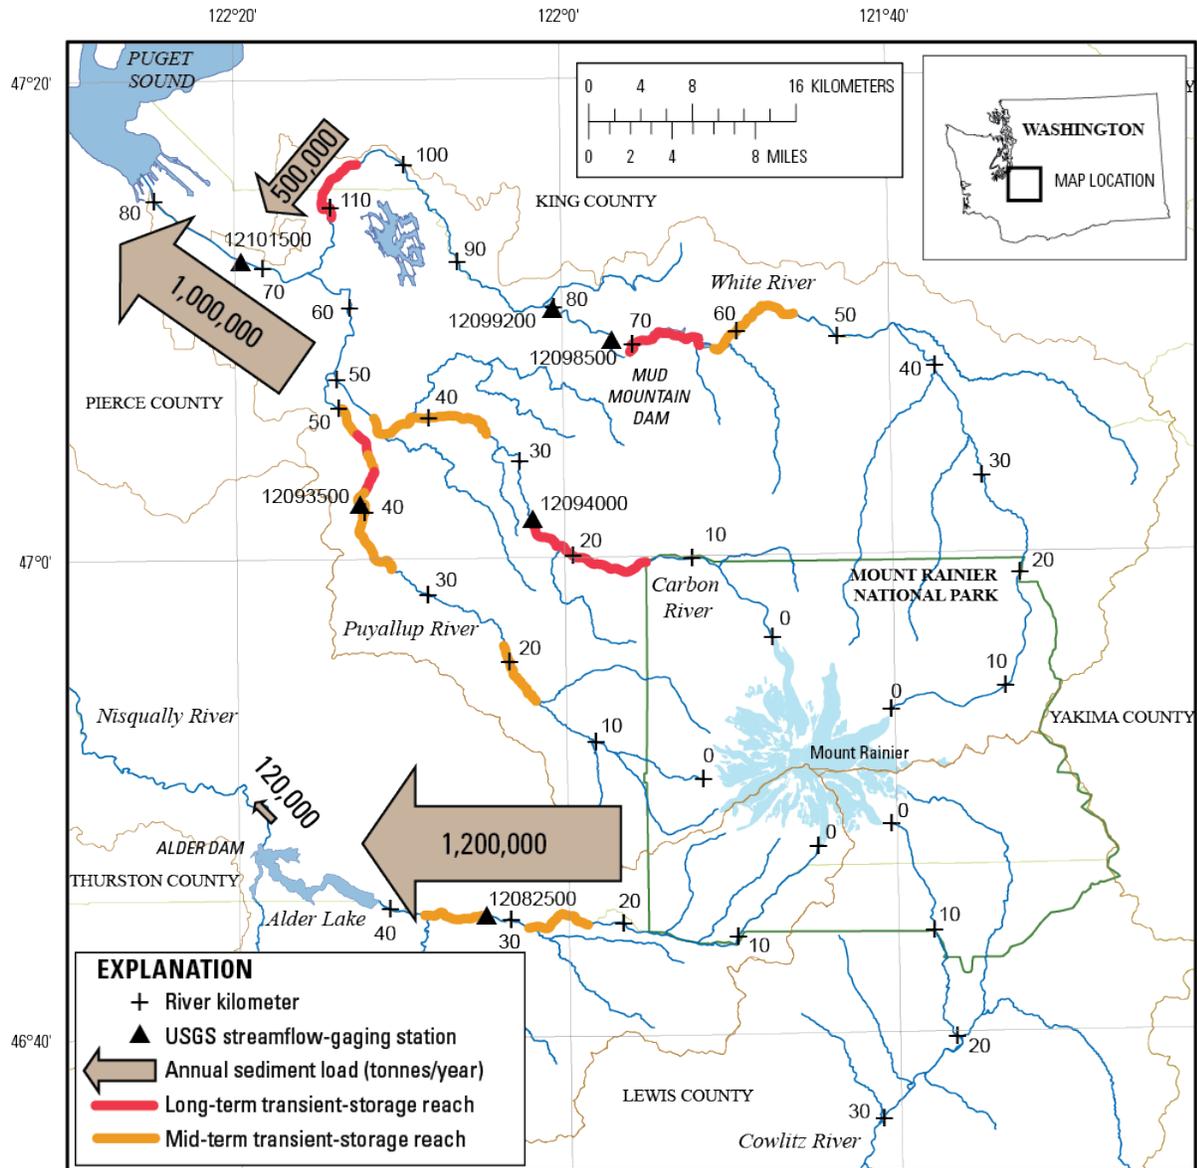
**Figure 5:** Map of Mount Rainier, Washington, showing where potential sediment-management actions would be most effective based on geomorphic conditions that suggest sediment accumulates naturally, including both long- and mid-term transient-storage reaches. Also shown are best estimates for long-term sediment-load values for rivers in the study (from Czuba et al., 2012b).

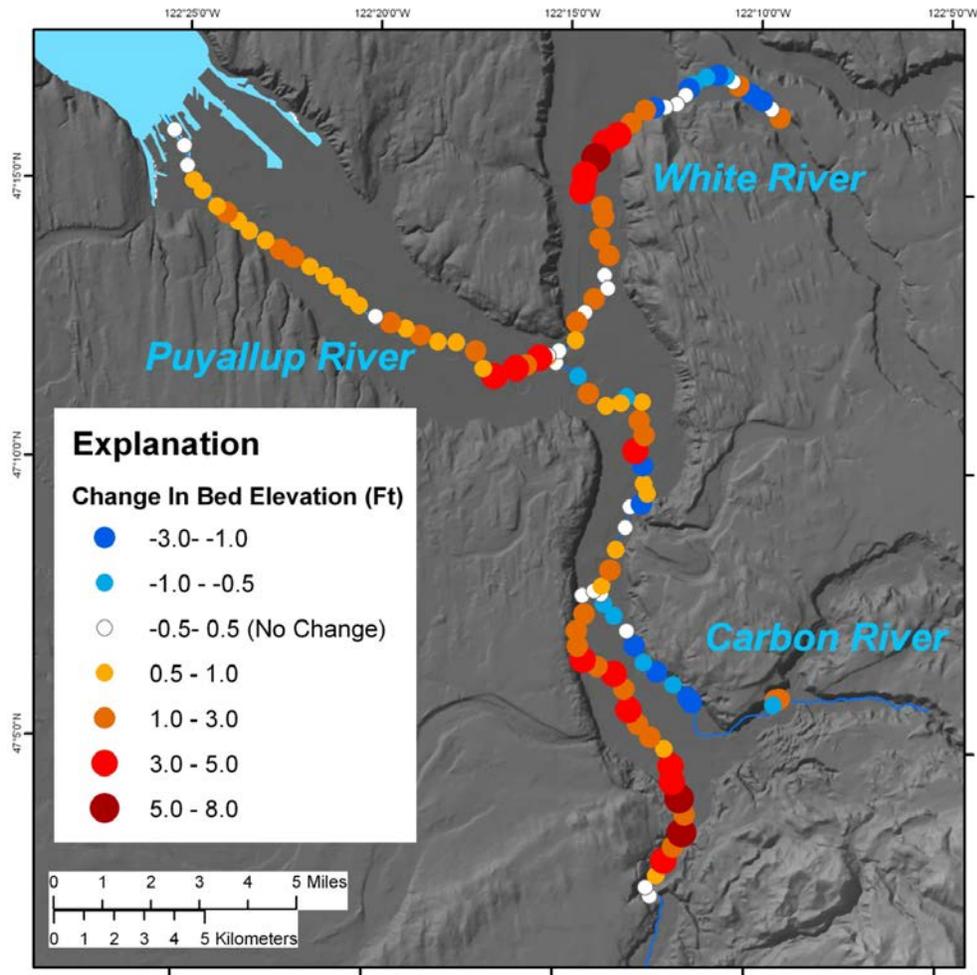
**Figure 6:** Map showing change in average elevation at about 100 cross section between 1984 and 2009 in the Puyallup, White, and Carbon Rivers, western Washington. Aggradation is most pronounced in the White and Puyallup Rivers. Figure modified from Czuba et al. (2012a).

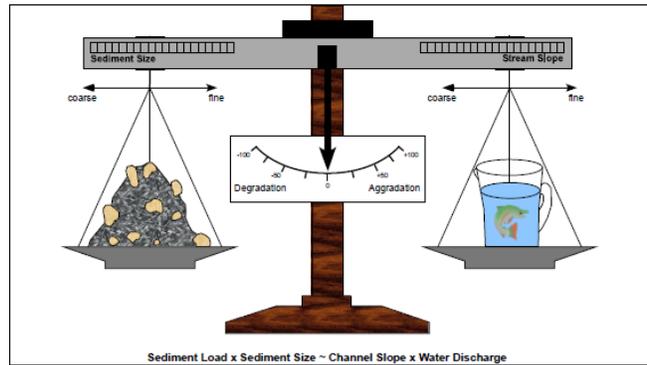
**Figure 7:** A conceptual model proposed by Lane (1955) and Rosgen (1996) that describes four factors that influence sediment transport in fluvial systems. The principle factors that may tip the scales right or left are: stream slope, discharge, sediment size, and sediment load. A fifth factor particularly relevant in the Pacific Northwest region is the effects of large woody debris.

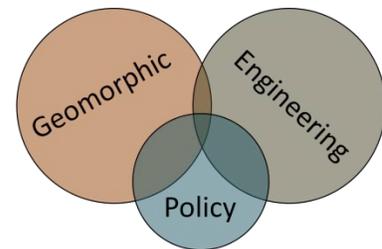
**Figure 8:** The three ring hazard model utilized by the imminent threats program at Mount Rainier

The first site to undergo a full evaluation following the three ring model was along a 700 foot section of the Westside Road. The first phase began in 2014 and involved a comprehensive literature review of prior geomorphic research completed in the Tahoma Creek watershed and field investigations to assess the current conditions at the proposed construction site (Figure 9). The following summer another team of geologists continued to monitor the site and began developing a suite of engineered solutions to mitigate the damage caused by numerous flooding and debris flow events.

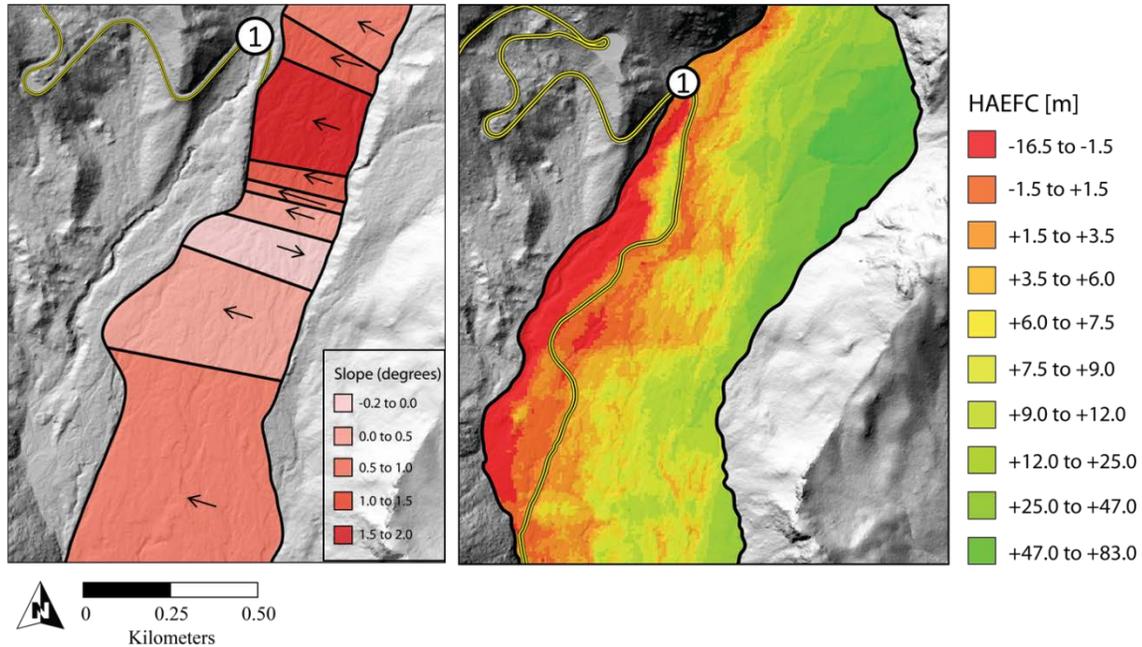
**Figure 9:** Products from a geomorphic assessment along Tahoma Creek completed in 2014. (Left) Delineates the east-west cross valley gradient along the bottom of Tahoma Creek. (Right) Denotes the height of the valley bottom relative to the Westside Road. These figures indicate that the lower portions of the Westside Road are highly susceptible to flooding given the valley geometry of Tahoma creek in conjunction with the destruction of old growth forest in the active floodplain.

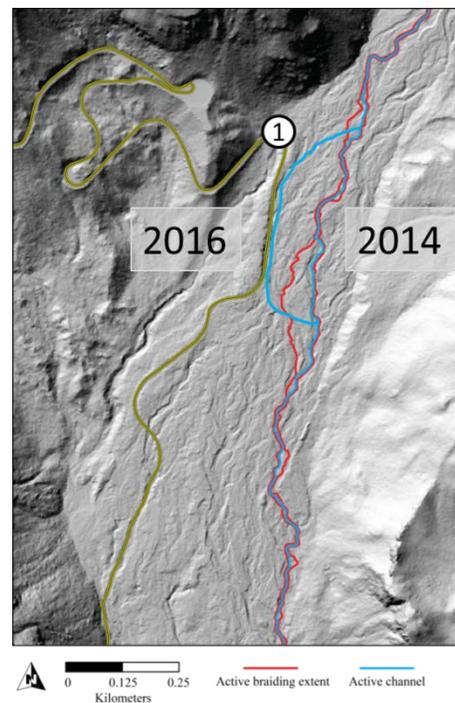
**Figure 10:** The path of Tahoma Creek active channel after the stream bed was rearranged by a series of debris flows and subsequent high water events during the winter of 2015/2016

Another round of geomorphic assessment was completed after a series of debris flows and high water events rerouted the main flow of Tahoma Creek 500 feet (~154 m) to the west of the historic channel (Figure 10).

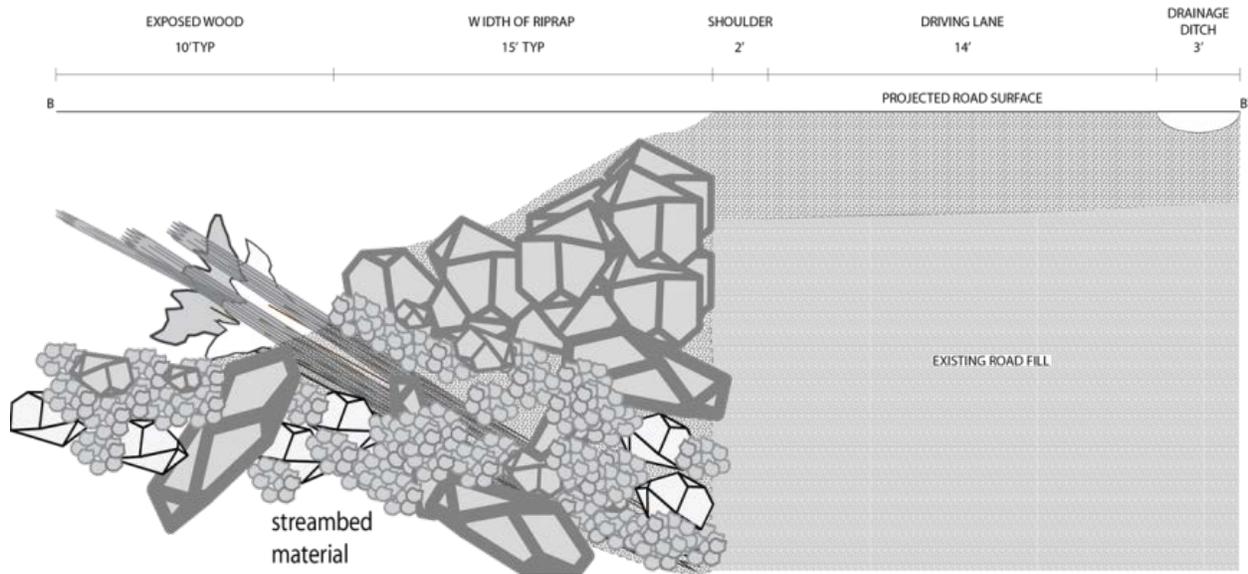
**Figure 11:** Cross section view of the flood protection constructed along a portion of the Westside Road in 2016. Discrete bundles comprised of 4-5 logs with attached root wads were dug into the streambed margins and covered with ~20 of rock ballast. This coupling of woody debris and rock is designed to increase roughness along the toe of the road thereby dissipating the erosive power of a high water event. Reducing the velocity of streamflow along the banks should facilitate deposition of sediment and accumulate additional pieces of large woody debris, making the structure more stable over time.

Finally during the summer of 2016, construction was completed on a flood protection design that utilized wood and rock (Figure 11). The Large Woody Structure (LWS) is designed to mimic naturally formed log jams and was designed based on standard engineering principles. After the installation of the LWS was completed, a second phase of construction took place using phyto-engineering concepts and the planting of pioneer species such as the Sitka Willow in order to revive the riparian gallery forest along Tahoma Creek's edge. To date, this project is unique in Mount Rainier as it is the first to combine rock, wood, and live plants in an effort to create low-cost, effective solutions to reduce the damages that result from geologic events.

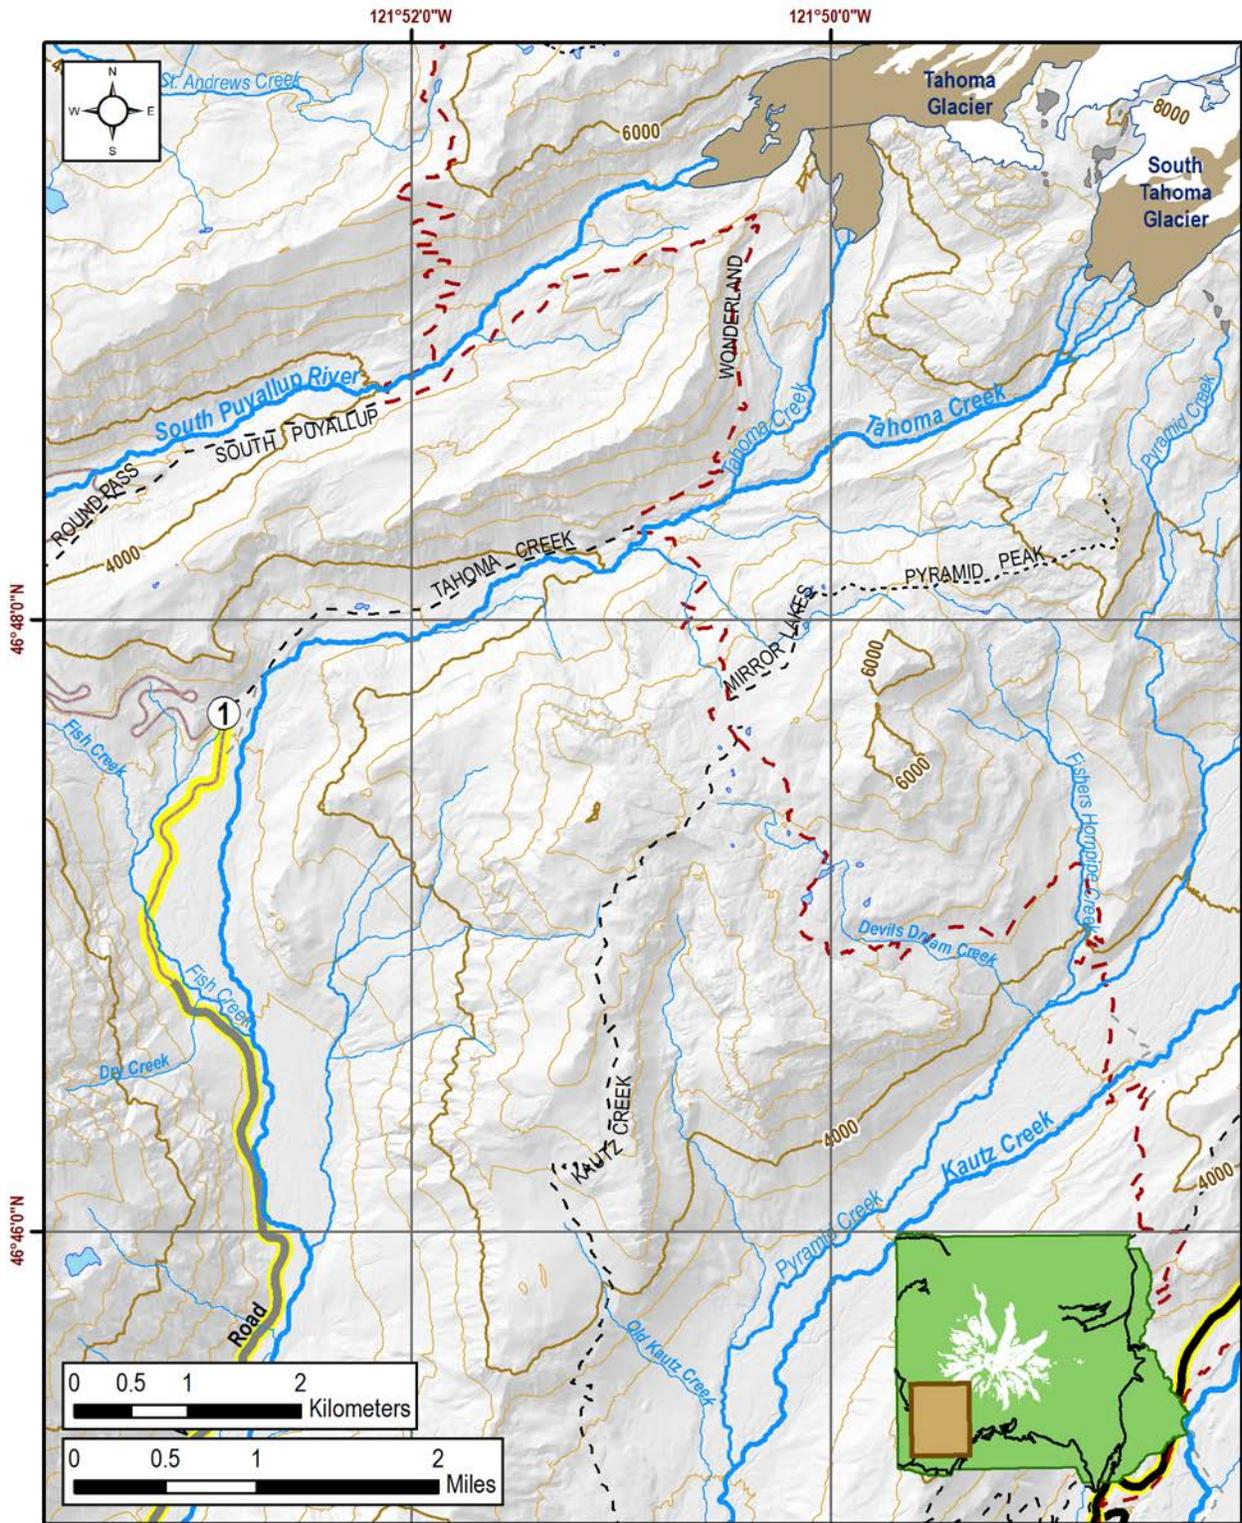
Figure 12: Location map for stop 1 along the West Side Road.

The West Side Road is located on the southwest corner of MORA. The road travels three miles from the junction of the Nisqually-Paradise Road to the parking area at Dry Creek. From there, the abandoned road bed turns into a visitor-accessible trail that travels six miles to Round Pass. A trail continues north from Round Pass to the North Puyallup River.

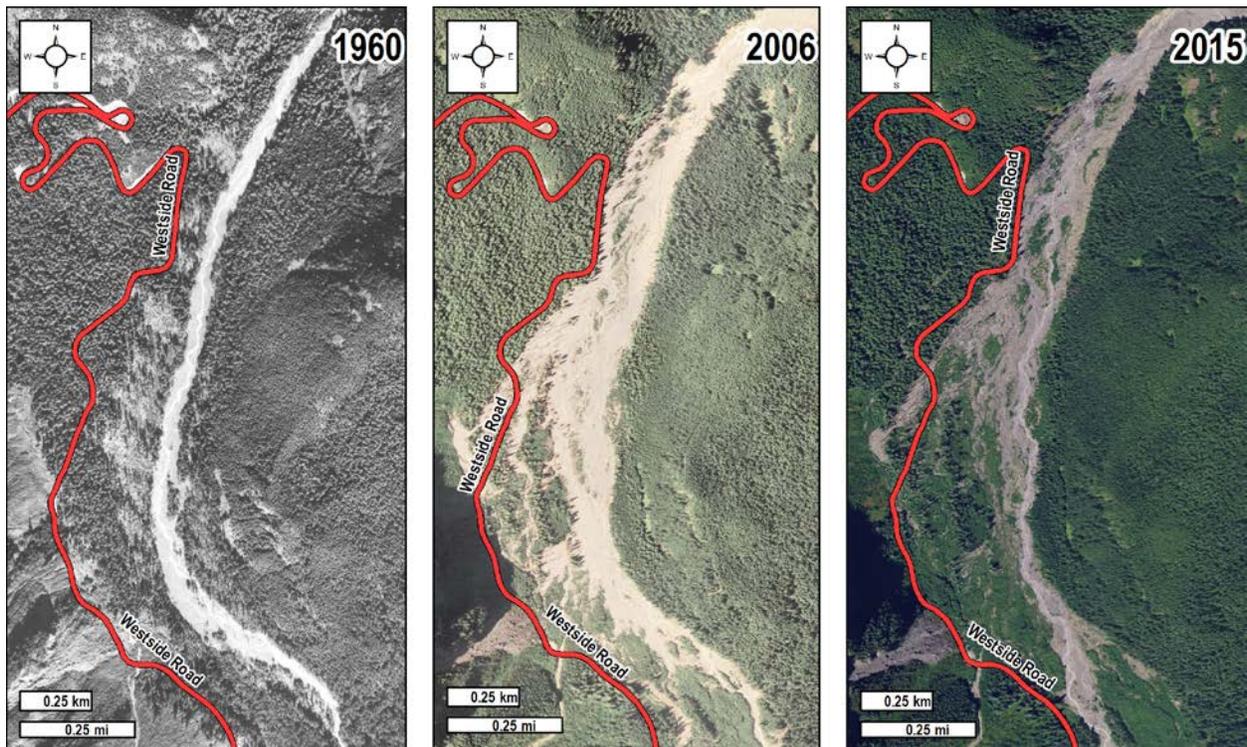
**Figure 13:** Aerial images from 1960, 2006 and 2015 showing loss of riparian habitat by incursion of Tahoma Creek during successive debris flows from 1967-2015.

Starting in the late 1960s, a series of destructive debris flows from the South Tahoma Glacier surged down Tahoma Creek, which destroyed a campground/picnic area, a popular trailhead, and damaged a significant section of the West Side Road. Debris flow and flood events have continued to impact the lower reaches of the Westside Road prompting the Park Service to close the road indefinitely to vehicular traffic beginning in 1993. While the road remains open to pedestrian and bicycle traffic

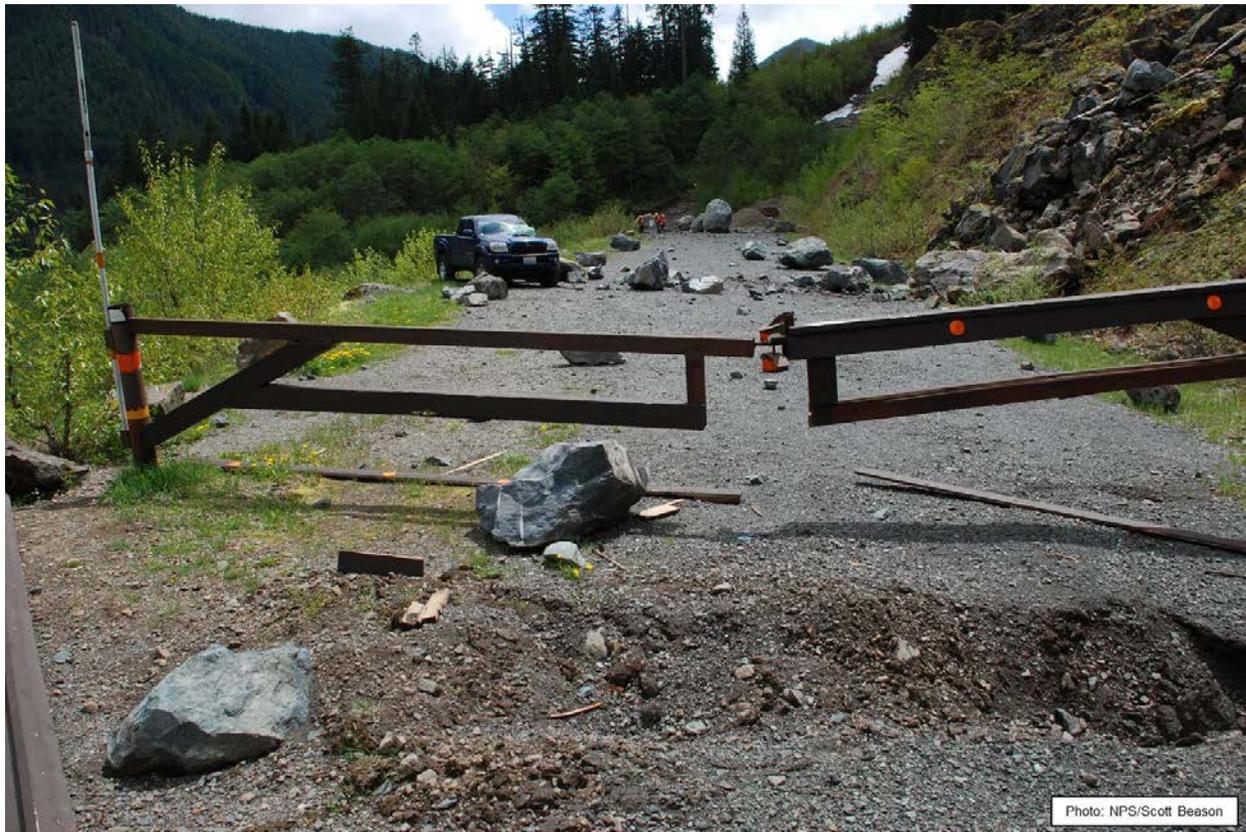
**Figure 14:** View facing south of the West Side Road parking area following 2014 Mount Wow rockfall, including damage to the roadway, an NPS gate and a visitor vehicle (Photo: NPS/Scott Beason)

On Thursday, May 15, 2014 at about 10:30 AM, approximately 8,500 cubic feet of Oligocene-age (~30 ma) Ohanapecosh Formation andesite slid off the east face of Mount Wow at about the 4,000-foot level. The rock fall traveled approximately one-quarter-mile down a steep talus and scree slope, and deposited large boulders on the West Side Road parking area at the 2,800-foot level. An NPS volunteer further up the West Side Road heard the rock fall, allowing the timing of the event to be determined. A visitor’s vehicle was totaled by a large rock and the parking area sustained impact crater damage from the boulders (Figure 14). No eyewitnesses directly observed the event itself and there were no injuries sustained. The largest of the craters in the road/parking area was

approximately 8 feet wide by 3 feet deep. Numerous boulders were deposited on the scree field between the source and deposition areas, including a boulder that is roughly 30 feet wide by 20 feet long by 5 feet high. About 45 boulders with a diameter greater than 1 foot reached the parking area, with an estimated combined volume of 4,345 cubic feet. It is estimated that at least this much additional material stopped short of the parking area and is deposited on the scree field above the road. Therefore, we estimate the size of the rock fall to be approximately 8,500 cubic feet (315 cubic yards; or 31.5 dump trucks worth of material).

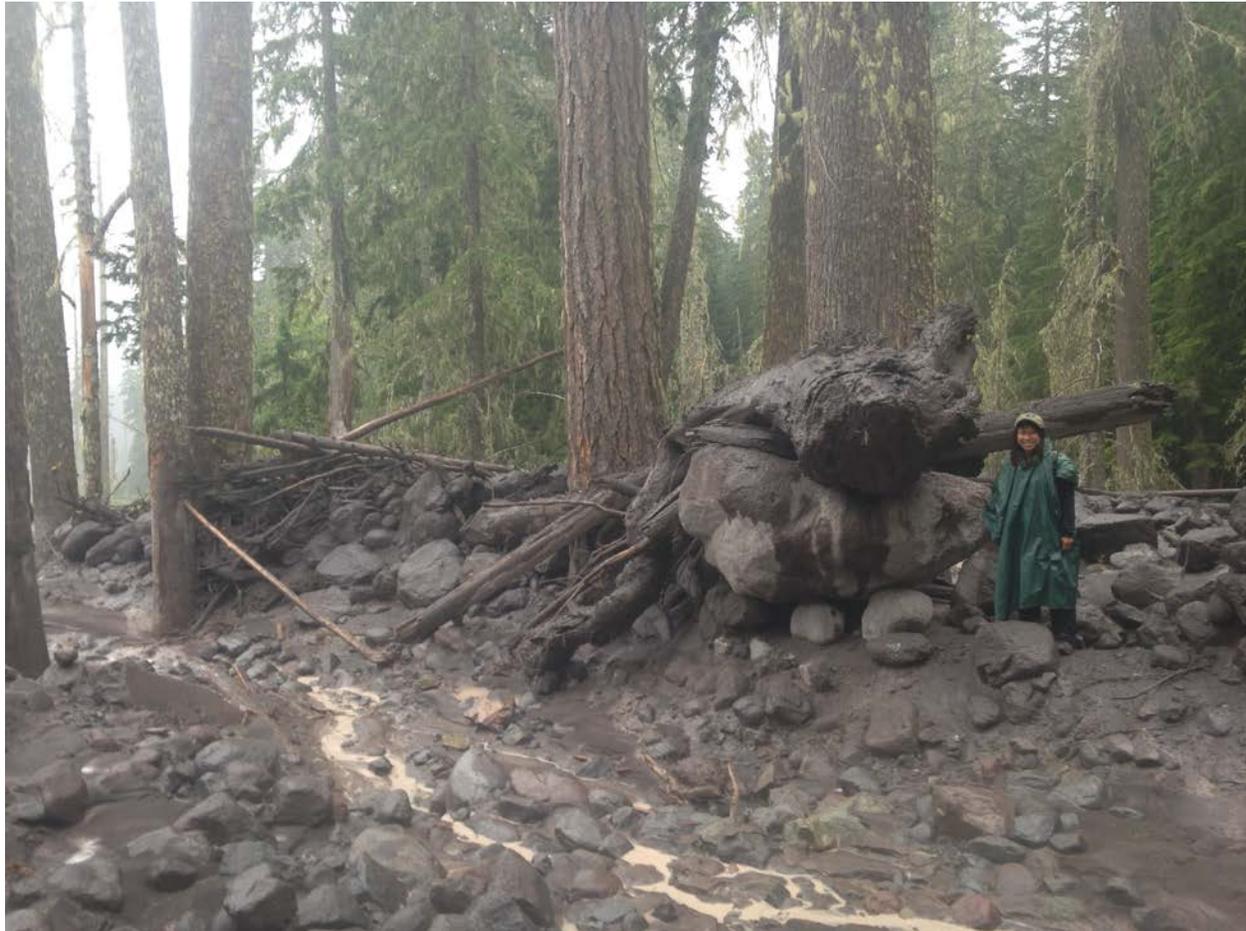
**Figure 15:** Debris flow levee on the Tahoma Creek Trail as result of the August 13, 2015 South Tahoma Glacier outburst flood and debris flow (NPS/Mitch Haynes photo).

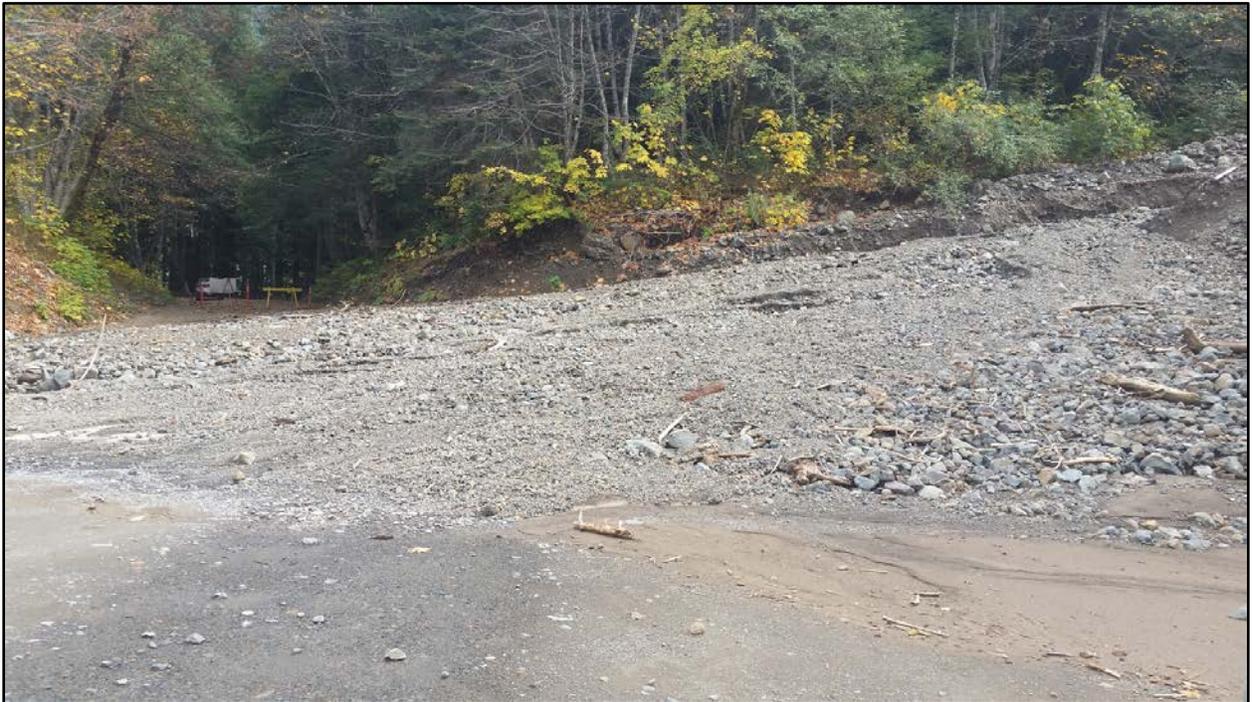
**Figure 16:** Dry Creek debris flow deposit as viewed on October 10, 2015. Photo taken facing south, toward public road closure (Scott Beason/NPS photo).

Fortunately, no injuries were reported to park staff or visitors during the events, and only minor damage occurred to park infrastructure. Other debris flows have occurred sporadically throughout the West Side Road area, especially in Dry Creek, a small tributary of Tahoma Creek (Figure 16).

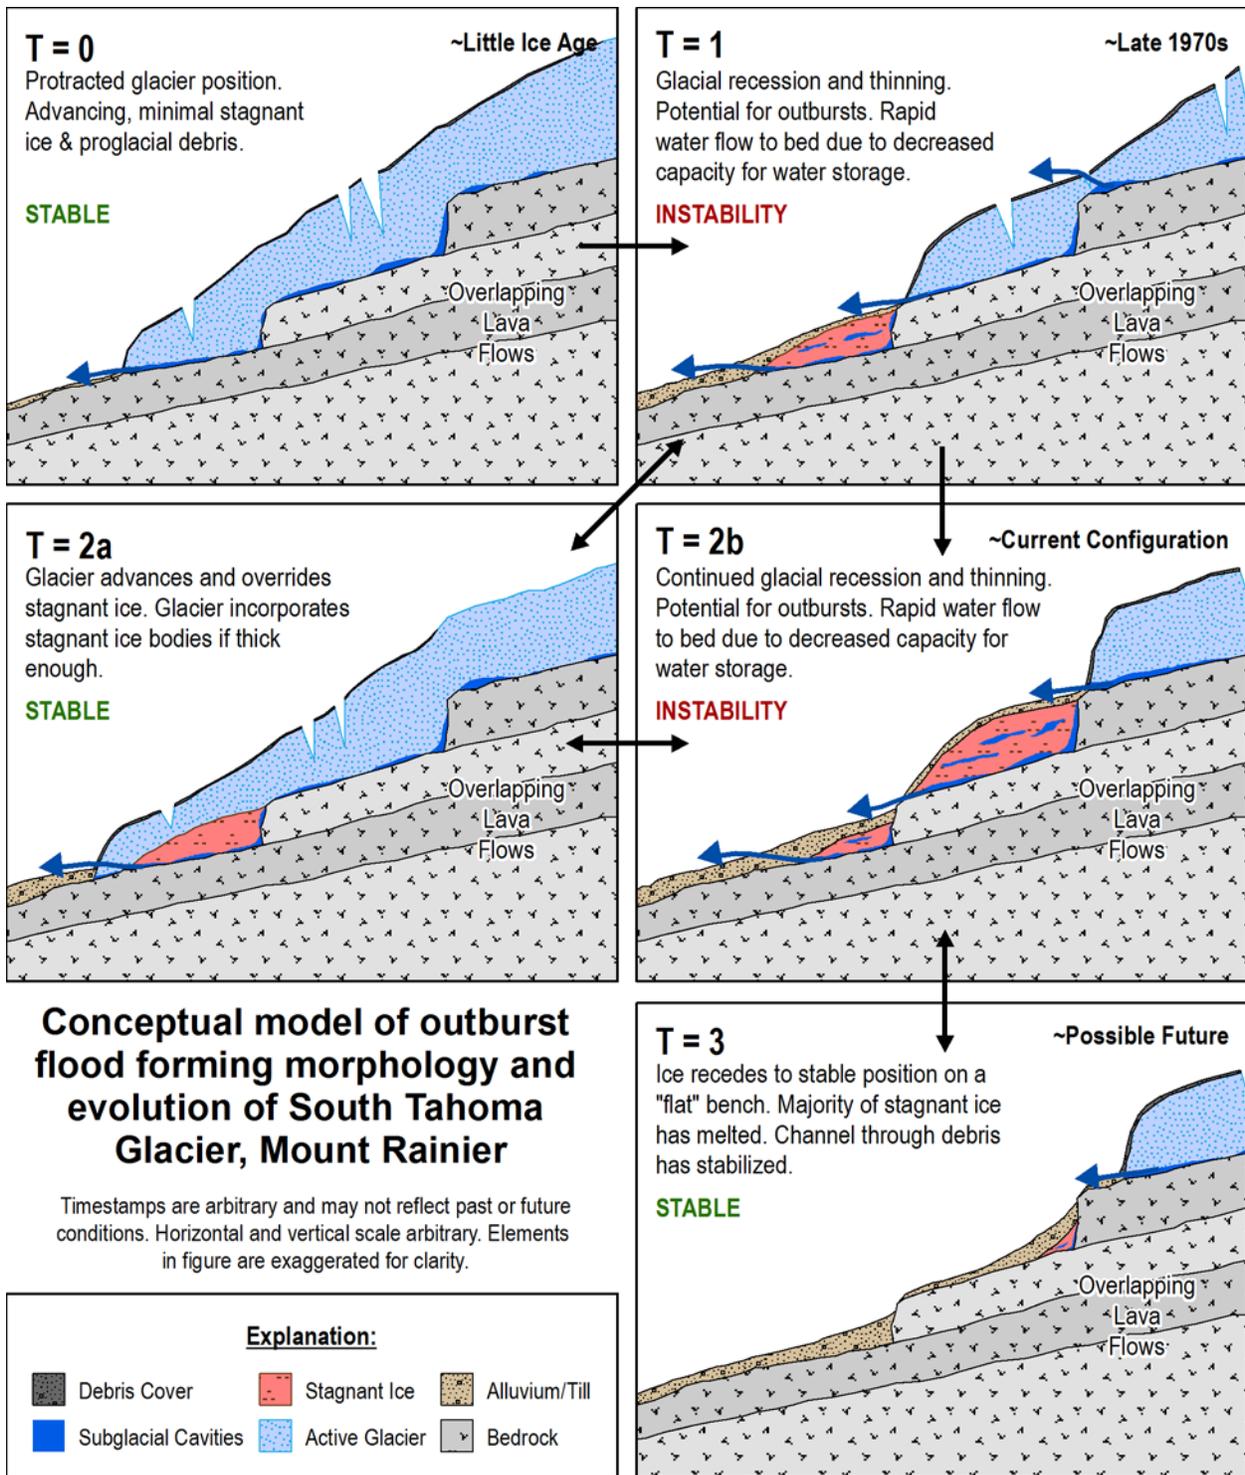
**Figure 17:** Conceptual model for storage and release of water as outburst floods by stagnant ice during glacial thinning/retreat and evolution of the South Tahoma Glacier. Timestamp 2b represents the approximate current configuration of the South Tahoma Glacier. (Modified from Beason, in prep)

Geomorphic evidence indicates that a large field of debris-covered stagnant ice exists downslope of the current terminus of South Tahoma Glacier. The zone is physically cut off from the upper ice by a bedrock ledge outcropping. This debris-rich stagnant ice can store up water and release the water catastrophically, though, the exact mechanisms through which this occurs are not well known (Figure 17). As the glacier continues to retreat, it is likely that further bedrock ledges may be exposed and cutoff lower parts of the glacier. This would lead to periods of increased hydrologic events from the glacier until the area stabilizes.
