# **Rivers Gone Wild: Extreme landscape response to climate-induced flooding and debris flows, and implications to long-term management at Mount Rainier National Park**

*Field Trip Guide #410, 2017 Geological Society of America Annual Meeting, Seattle, WA*

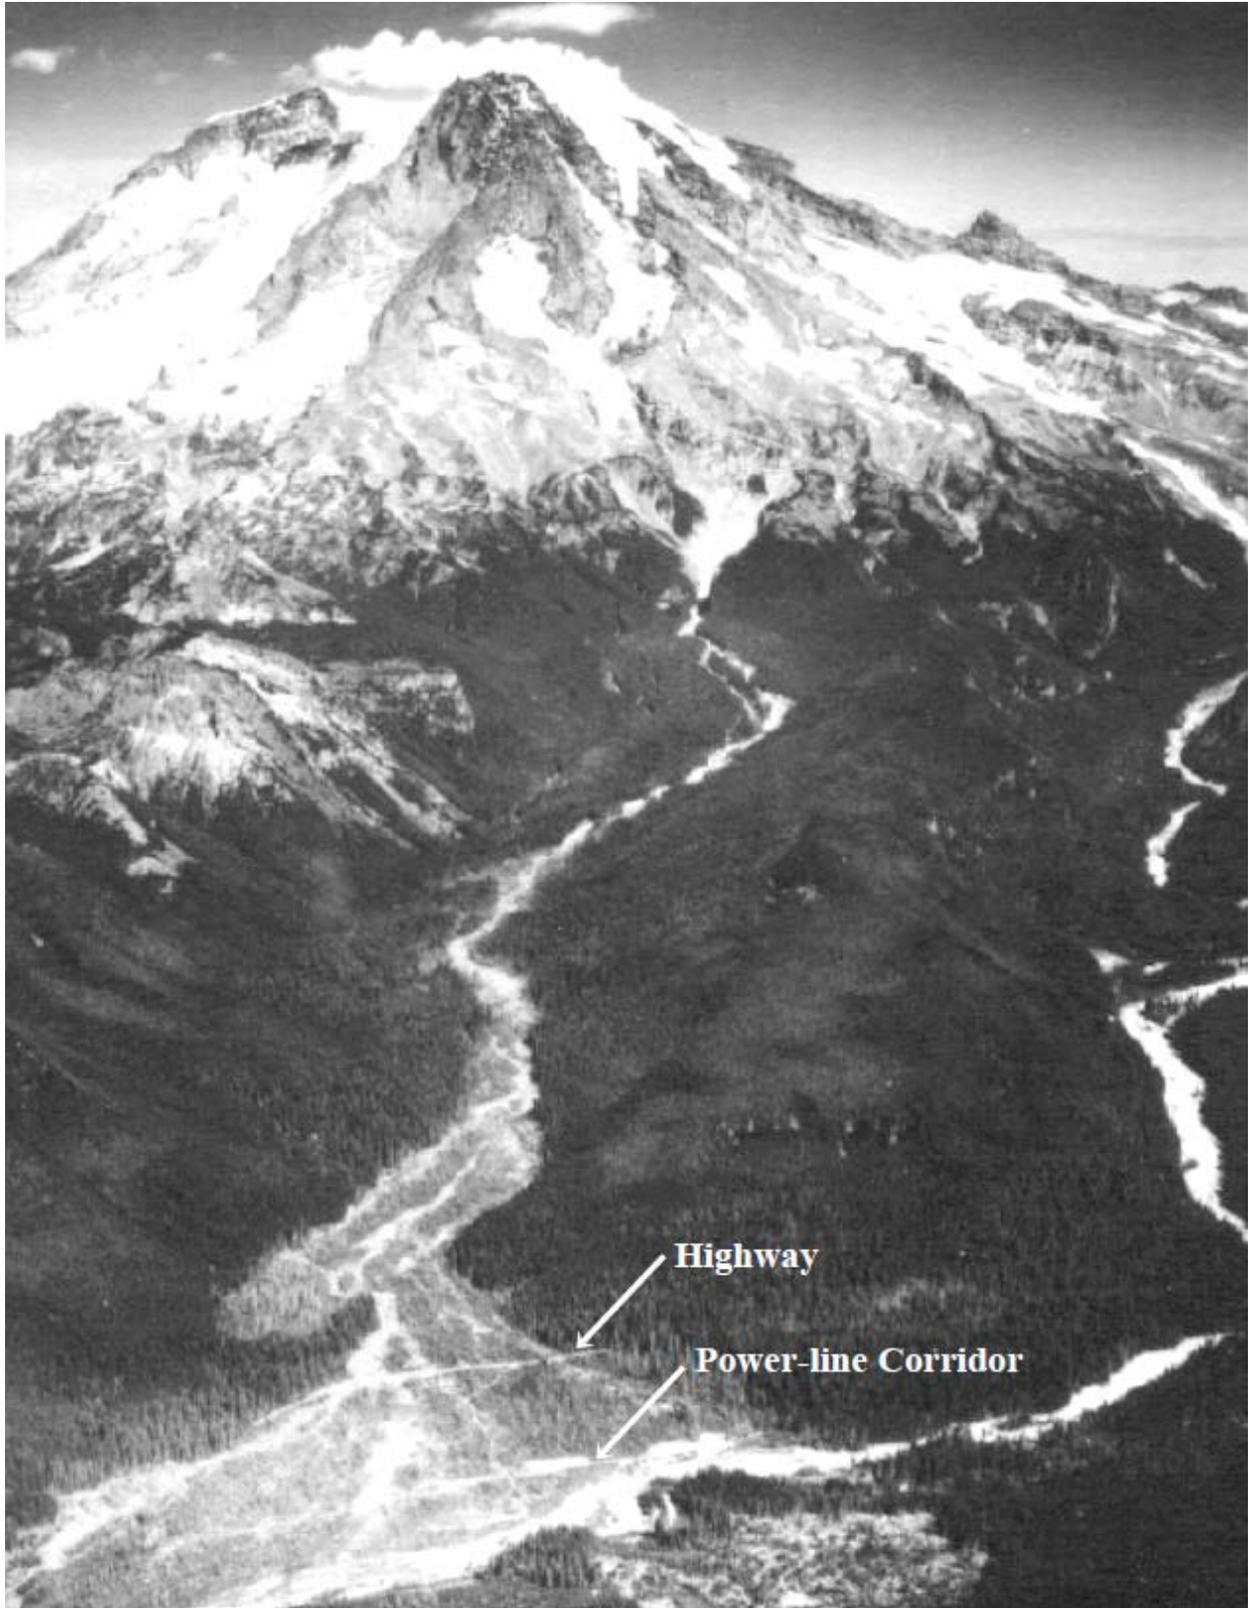
**Figure 19:** Oblique aerial photo of the 1947 Kautz Creek mudflow (Modified from Burtchard et al., 2008).

Looking downstream from the Kautz creek bridge there are several dead standing trees. These trees were killed in October of 1947 when a debris flow was initiated by intense rainfall covering the Nisqually road with 20 feet (6 m) of debris and damming the entire Nisqually River (Figure 19). Although debris flows triggered by heavy rainfall are common within the park the 1947 event was exceptionally large. During a reconnaissance to the terminus of the Kautz glacier after the storm, Crandell (1971) noted that many large blocks of ice had been calved off the terminus over the course of the storm and suggested that an additional input of water had been released from the glacier terminus and could account for the size of the 1947 debris flow. These sudden outbursts of glacial melt (jökullhlaup) have been ascribed to the retreat of alpine glaciers since the end of the 'Little Ice Age' maximum. The mechanics and timing of jökullhlaups are an ongoing area of research in Mount Rainier.

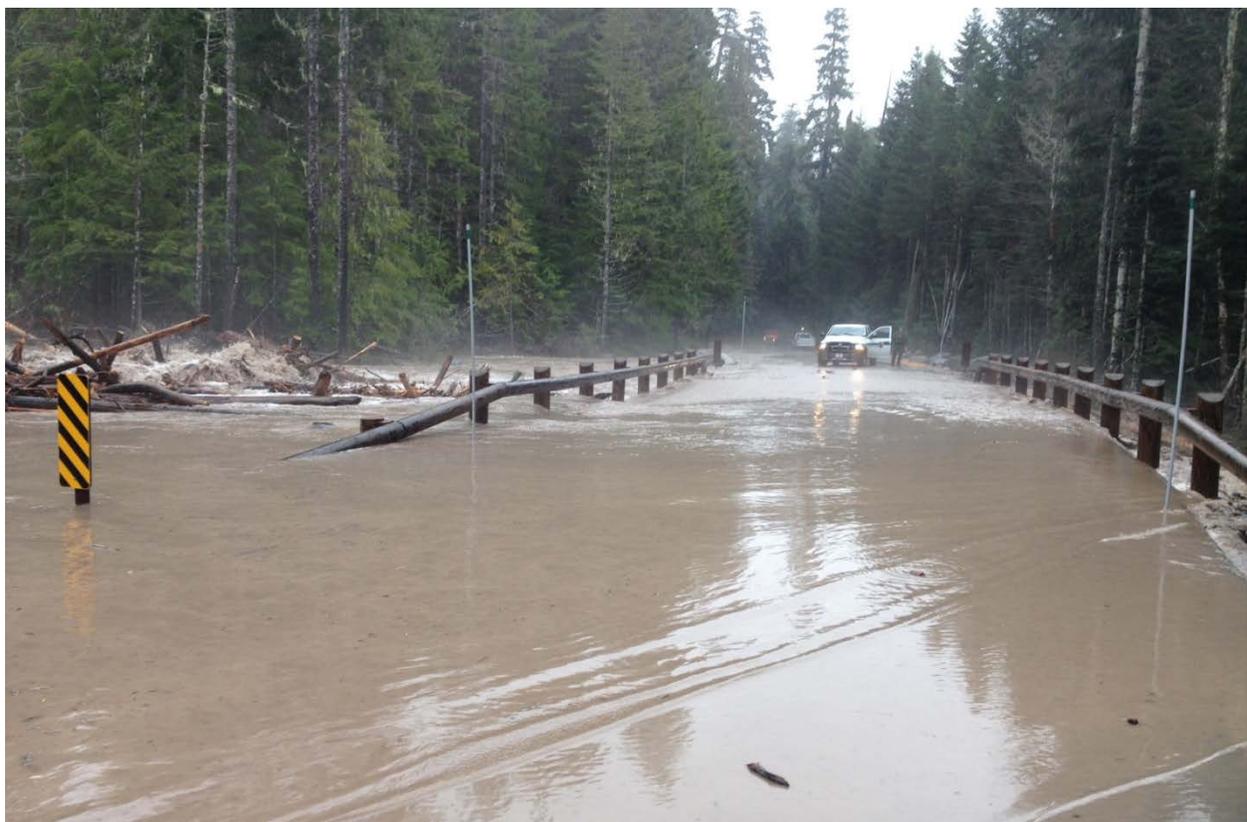
**Figure 20:** Floodwaters overtopping the Kautz Creek culverts (NPS Photo).

During the historic flood event of 2006 Kautz Creek abandoned the historic channel and began carving a new course along the eastern margin of the 1947 debris fan; the ‘new’ Kautz creek crosses the Nisqually road 0.2 miles (0.3 km) east of the Kautz Bridge. Twin culverts were installed to accommodate the new channel but the efficacy of these culverts is questionable as subsequent high water events have overtopped the Nisqually Road when the culverts became clogged with sediment and large woody debris (Figure 20; Figure 21).

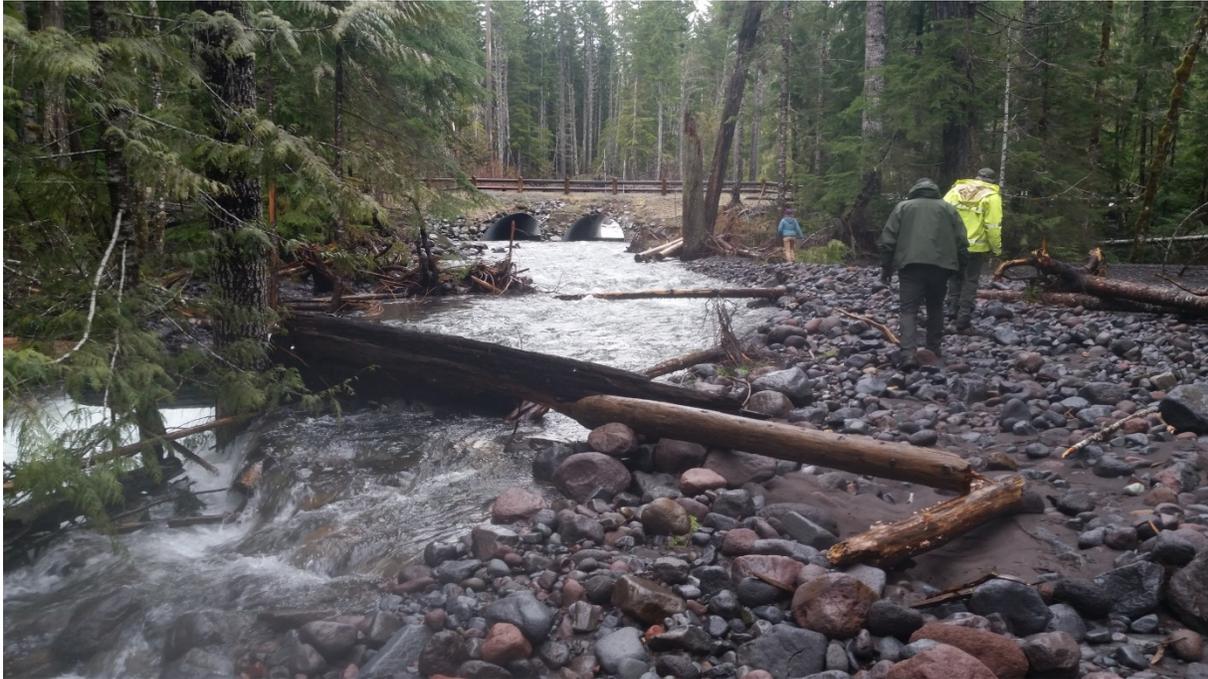
**Figure 21:** Looking upstream at the twin culverts located 0.2 miles east of the Kautz Creek bridge.

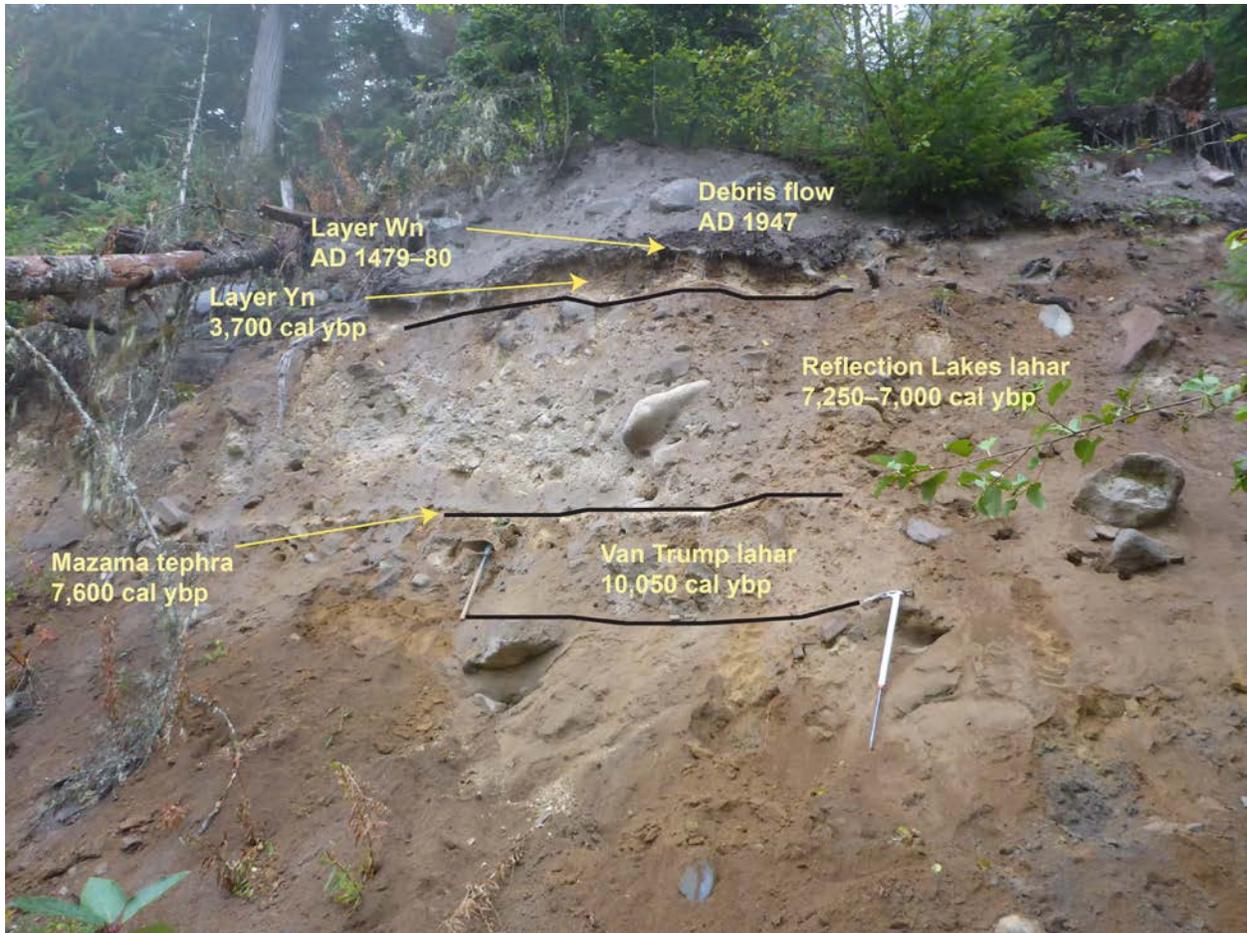
**Figure 22:** Lahar exposure near Kautz Creek viewpoint (Photo courtesy of Jim Vallance, USGS/CVO).

North of the old Kautz Creek channel bridge about 100 m along the west bank of the former Kautz Creek (46.73747, -121.85666), deposits of the 1947 debris flow and of previous lahars are exposed (Figure 22) (J. Vallance, personal communication). The neutral gray deposit at the top of the section is the 1947 debris flow. Beneath it are two Mount St. Helens pumice falls, Wn (A.D. 1479) and Yn (3,700 cal ybp). The lower part of the sequence includes the Reflection Lakes lahar, Mazama ash, Van Trump lahar (10,050 cal ybp), and another lahar. The Van Trump lahar was emplaced during the Sunrise eruptive period and is the oldest of three avalanche-induced lahars found on the south flank of Mount Rainier.

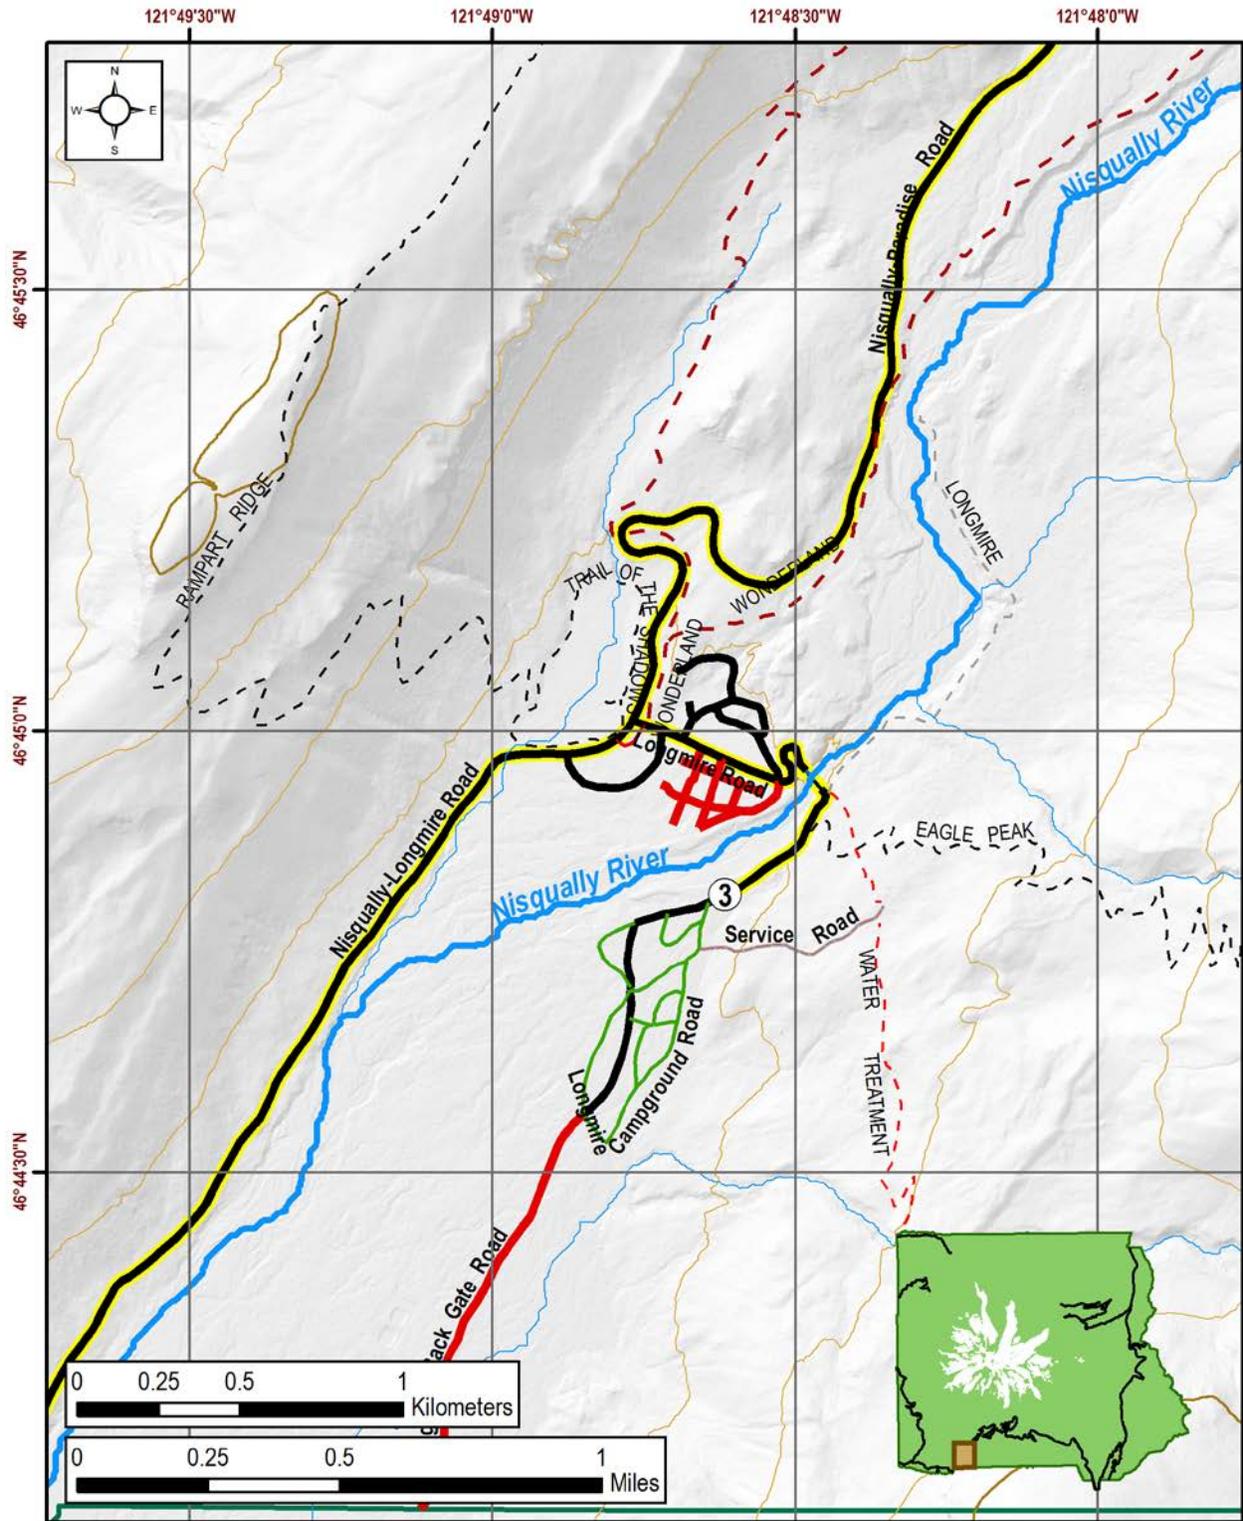
Figure 23: Location map for Stop 3 at Longmire

Longmire is the name of one of the two primary year-round visitor use and administrative areas on the southwest side of MORA. This area was formerly the park's main administration area until the development of the Tahoma Woods administration area, west of Ashford. The Longmire area has been used as a developed visitor destination since the late 1800s. The presence of springs with temperatures up to 80°F in the Longmire Meadow (within the "Trail of Shadows," Figure 23) led to the establishment of visitor facilities once the road to the park was established (Pringle, 2008).

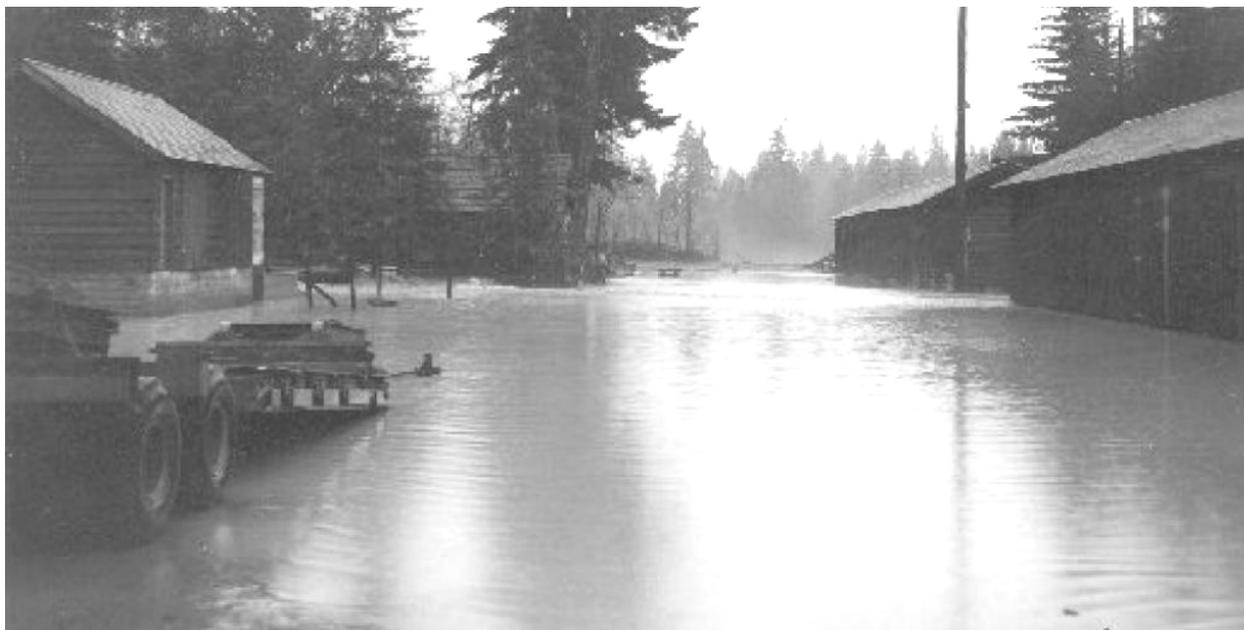
**Figure 24:** Longmire Maintenance Area during November 1959 flood (Modified from Burtchard et al., 2008)

Four years later, a storm on November 21-22, 1959 caused extensive damage to roads, trails and bridges throughout the park. The Nisqually River overflowed its banks at Longmire and water ran through the utility area and down the main entrance road leading to the then park headquarters (Samora, 1991; Figure 24). Extensive damage was done to the roads above and below Longmire as well. Flooding in 2003 also caused some damage to the roads and infrastructure in this area.

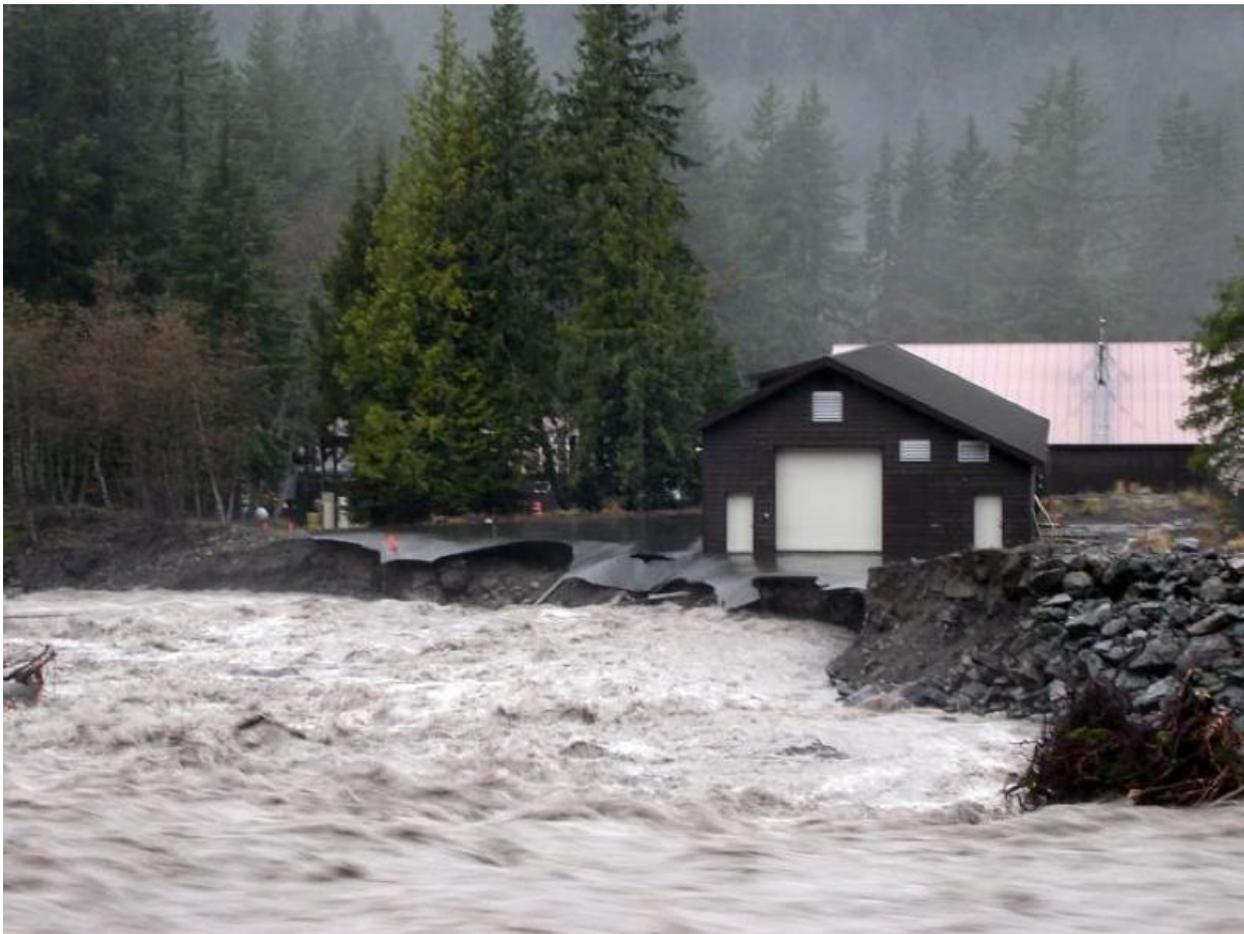
**Figure 25:** Damage to the park infrastructure near the recently-constructed Emergency Operations Center at Longmire during the November 2006 flood (National Park Service Photo).

The most recent and most extensive damage occurred as part of an atmospheric river flood event that occurred between November 5-7, 2006. Nearly 18 inches of rain fell in 36 hours during the storm. Additionally, a high freezing level and low antecedent snow pack lead to debris flow generation and flooding in all areas of the park. High winds also damaged exposed infrastructure, like fire lookouts. The Nisqually River responded to these hydrologic inputs and caused extensive damage to park infrastructure in the Longmire Area. The recently-constructed emergency operations center nearly was lost when a river berm and parking area were eroded by the Nisqually River (Figure 25). All told, an estimated \$36 million in damage was incurred to the park during this storm. This damage, as well as other major damage to park roads and infrastructure, lead to the longest single closure in the park's history (November 7, 2006 to April 27, 2007).

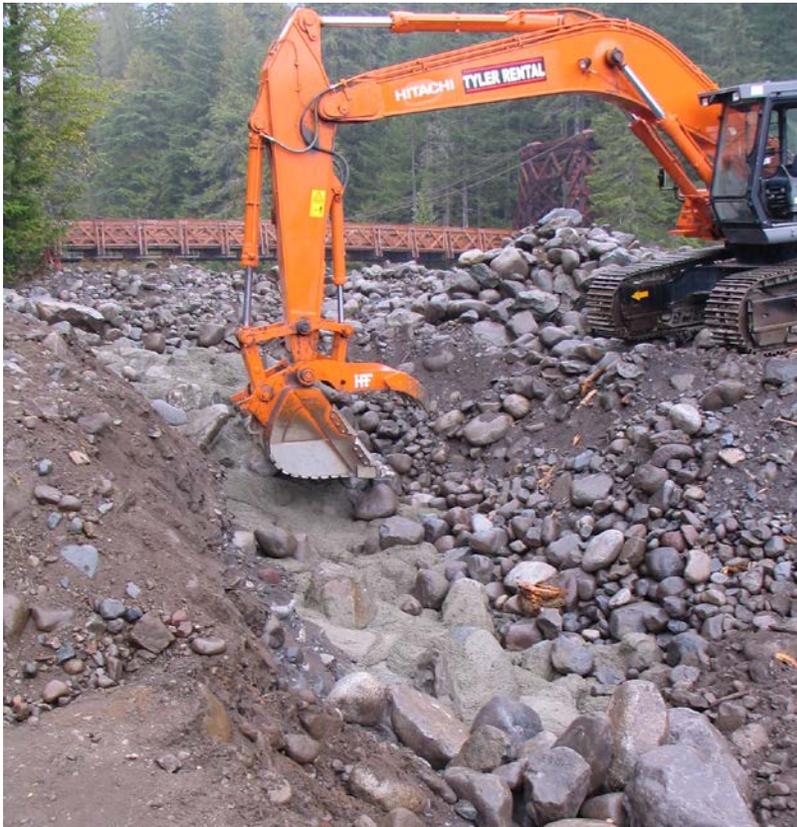
**Figure 26:** Construction of a flood wall in 2007 to help protect the Longmire administrative area from floods on the Nisqually River (Scott Beason/NPS Photo).

One of the more unusual features of Longmire is that most of the facilities in the Longmire area are below the elevation of the river (one has to walk uphill to get to the river). In some places, like the National Park Inn, this difference is over 40 feet (12 meters). This floodplain disequilibrium is result of the 1686 channel abandonment (in the area of the Longmire Meadow) and reestablishment in the current river channel. To help alleviate worries about future flooding and to prevent situations like those that occurred in the 1950s, the park constructed a buried concrete and large rock clast flood wall in 2007 in the footprint of the levee that separate the Nisqually River channel from the Longmire campground (Figure 26). This flood wall is built below the elevation of the river or tied into bedrock where exposed.

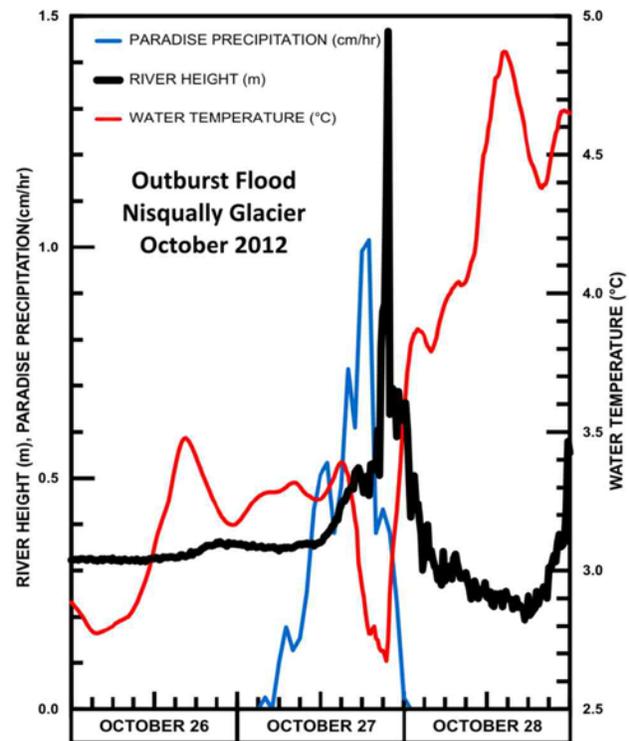
**Figure 27:** River stage, temperature and precipitation during the October 27, 2012 Nisqually Glacier outburst flood, as recorded on stream gaging equipment at Longmire.

The presence of the stream gage at this location is useful for detecting hydrologic events from the Nisqually Glacier. For example, a small glacial outburst flood occurred from the Nisqually Glacier on Saturday, October 27, 2012 at approximately 9:00 PM (Beason, 2012; Figure 27). This event, while significant, was localized in scale, caused no damage to park facilities, and was not volcanic in origin. It likely originated from the Nisqually Glacier as result of moderate to intense rainfall. The Longmire stream gage registered a 2.8 foot (0.85 meter) rise in river water level between 8:30 and 9:45 pm and the spike was seen on other gages downstream of the park. Field data concurs with the stream gage and shows evidence of a several-foot surge of water in the Nisqually River. Additionally, water temperature data from the Longmire showed a 1.3°F (0.7°C) dip during the peak, which concurs with a glacial source of the event (Figure 27).

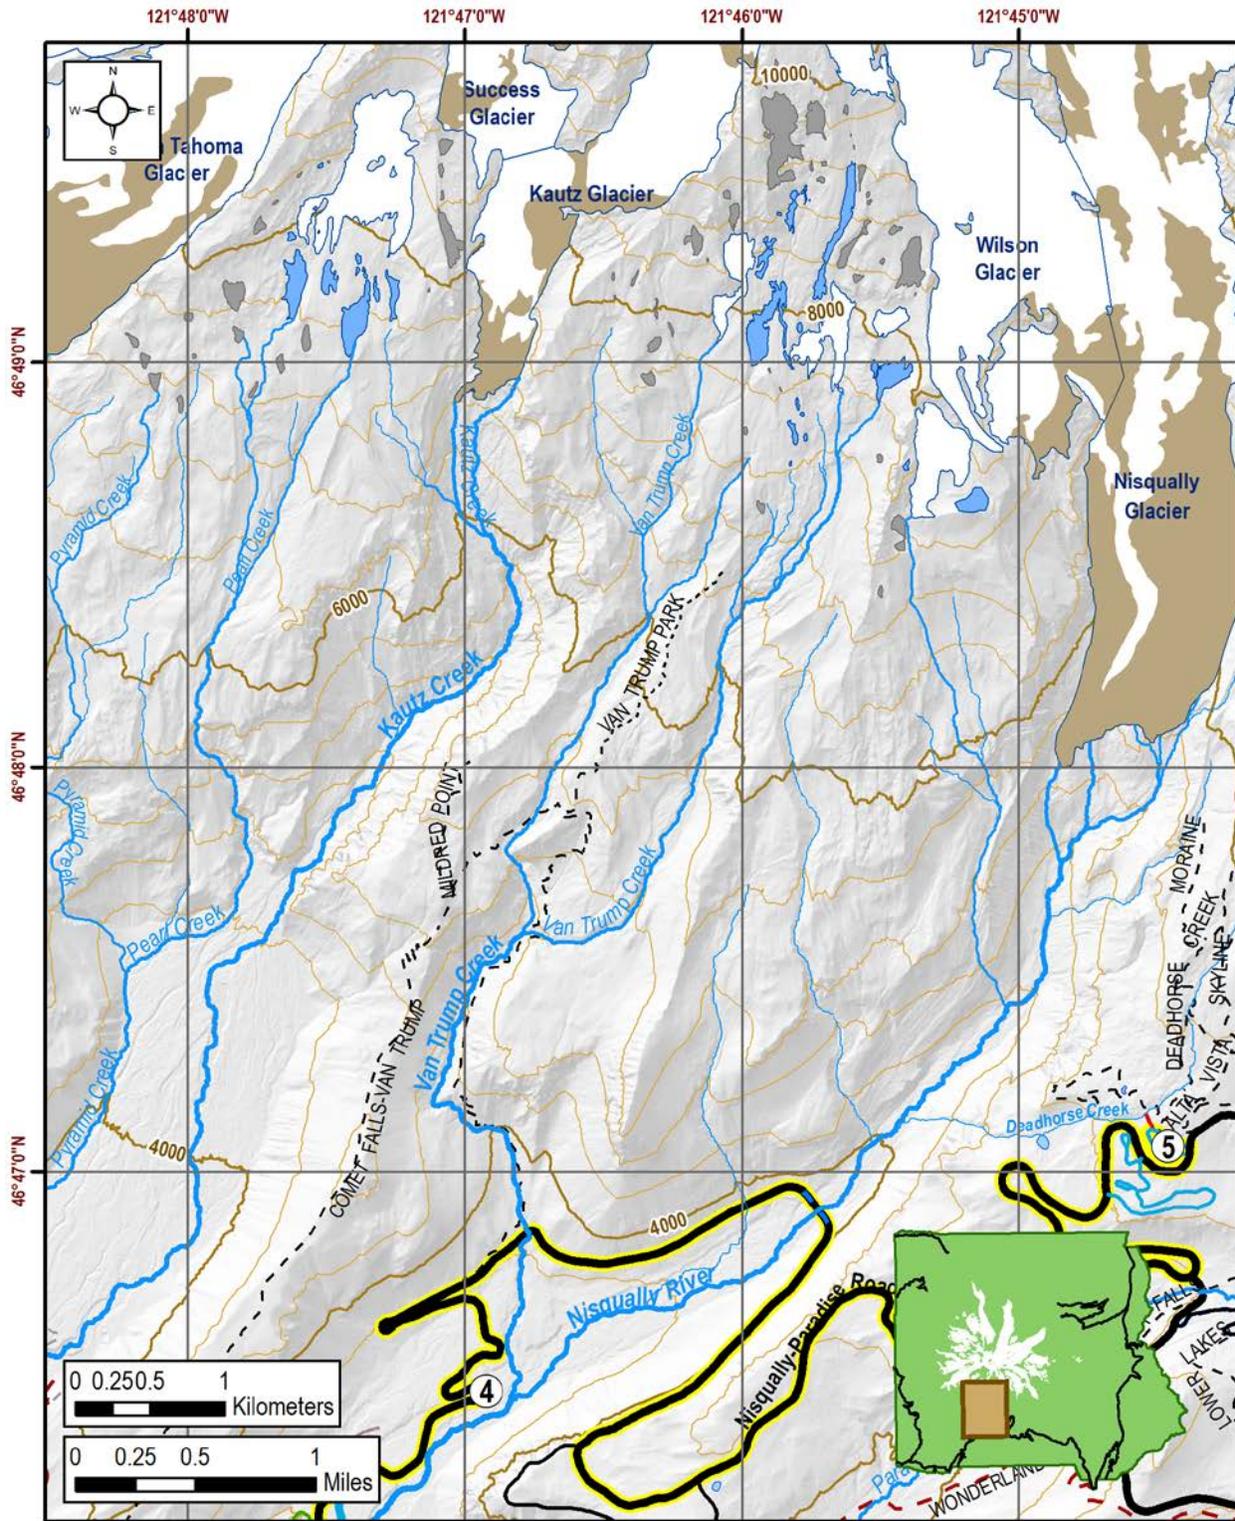
Figure 28: Location map for Stop 4 at Lower Van Trump Hairpin

Lower Van Trump Hairpin is the moniker given to a curve located at mile 9.3 (kilometer 15.1) along Paradise Road, the main road through MORA. This curve is located at the confluence of Van Trump Creek and the Nisqually River, just upstream from Cougar Rock Campground and Picnic Area.

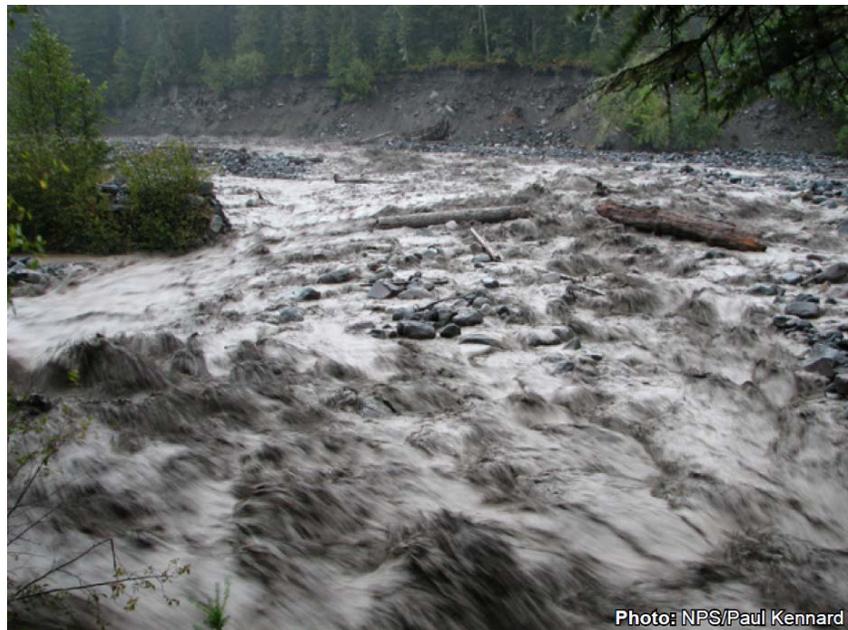
**Figure 29:** Van Trump Creek flooding into the Nisqually during the September 29, 2005 debris flow. Photo taken during the waning stages of the debris flow.

The Lower Van Trump Hairpin area has been subject to numerous debris flows. Between 2001 and 2006, four separate debris flows have deposited ~375,000 m<sup>3</sup> of material in the active channel of the Nisqually River (Beason et al., 2014; Figure 29). An influx of sediment from a 2005 debris flow caused widespread aggradation in the active channel of the Nisqually River. This debris flow deposit pinned the Nisqually River into a narrow channel against its left bank, adjacent to a cliff base. In 2008, a

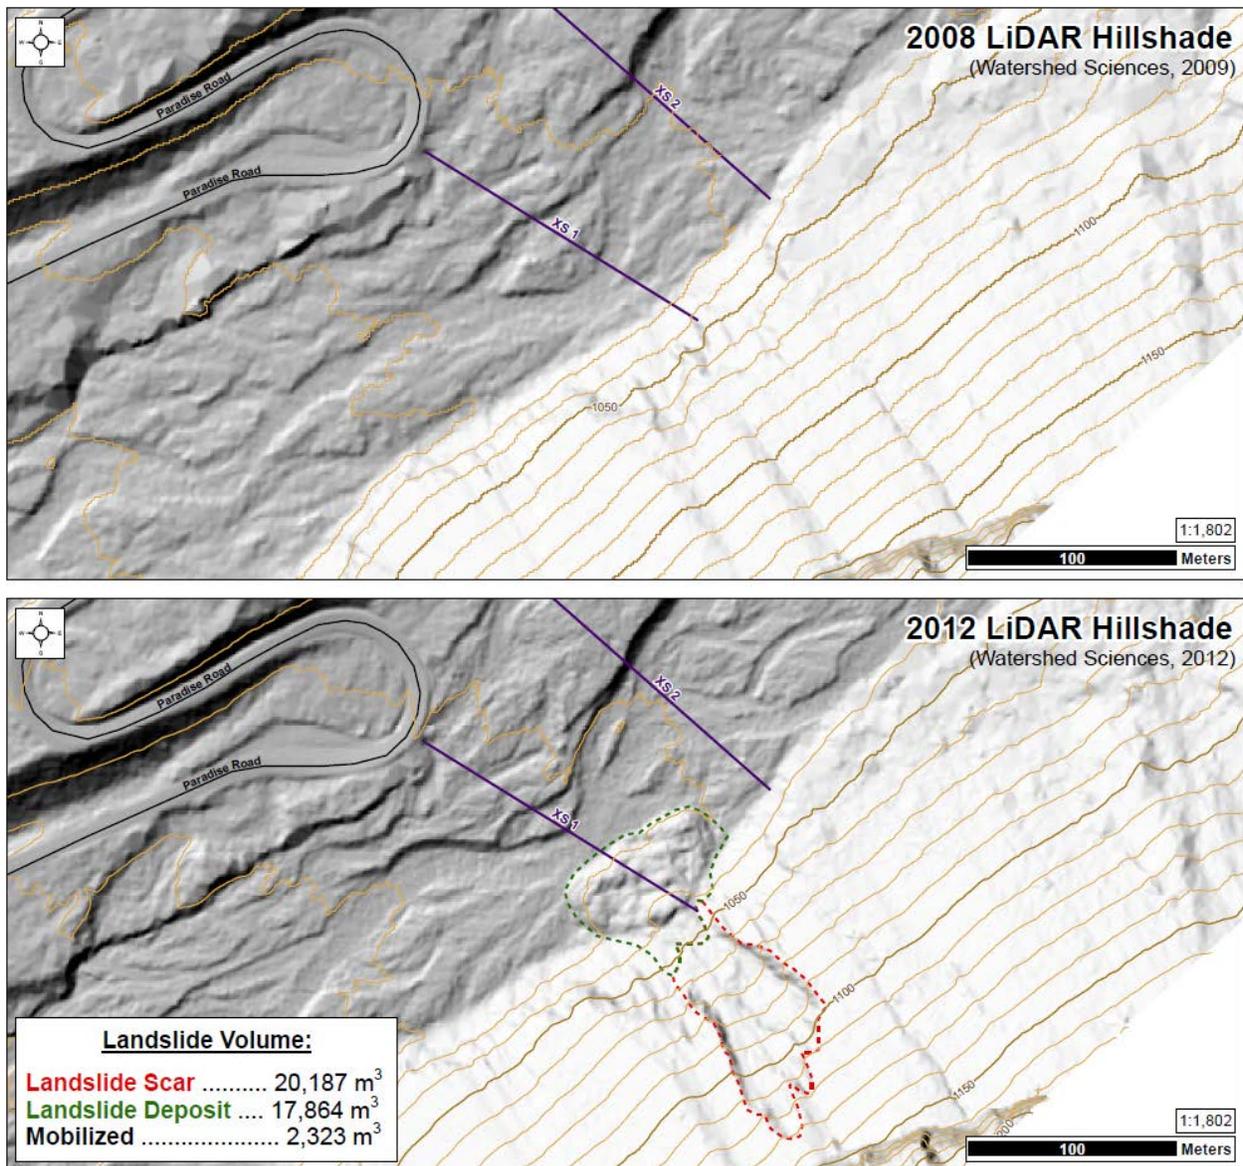
**Figure 30:** LiDAR hillshade comparison between 2008 and 2012 at Lower Van Trump Hairpin, clearly showing the 2008 landslide scar and deposit.

storm with an approximately 14-year recurrence interval increased flows in the Nisqually River and initiated a landslide across the channel from the aforementioned debris flow deposit (Figure 30). The resulting ~20,000 m<sup>3</sup> of sediment deposited into the Nisqually blocked the active channel and was capable of damming the river for a short time (Figure 31). The Nisqually River soon breached this dam, flowing in a narrow channel before successively widening as stream velocities and shear stresses increased.

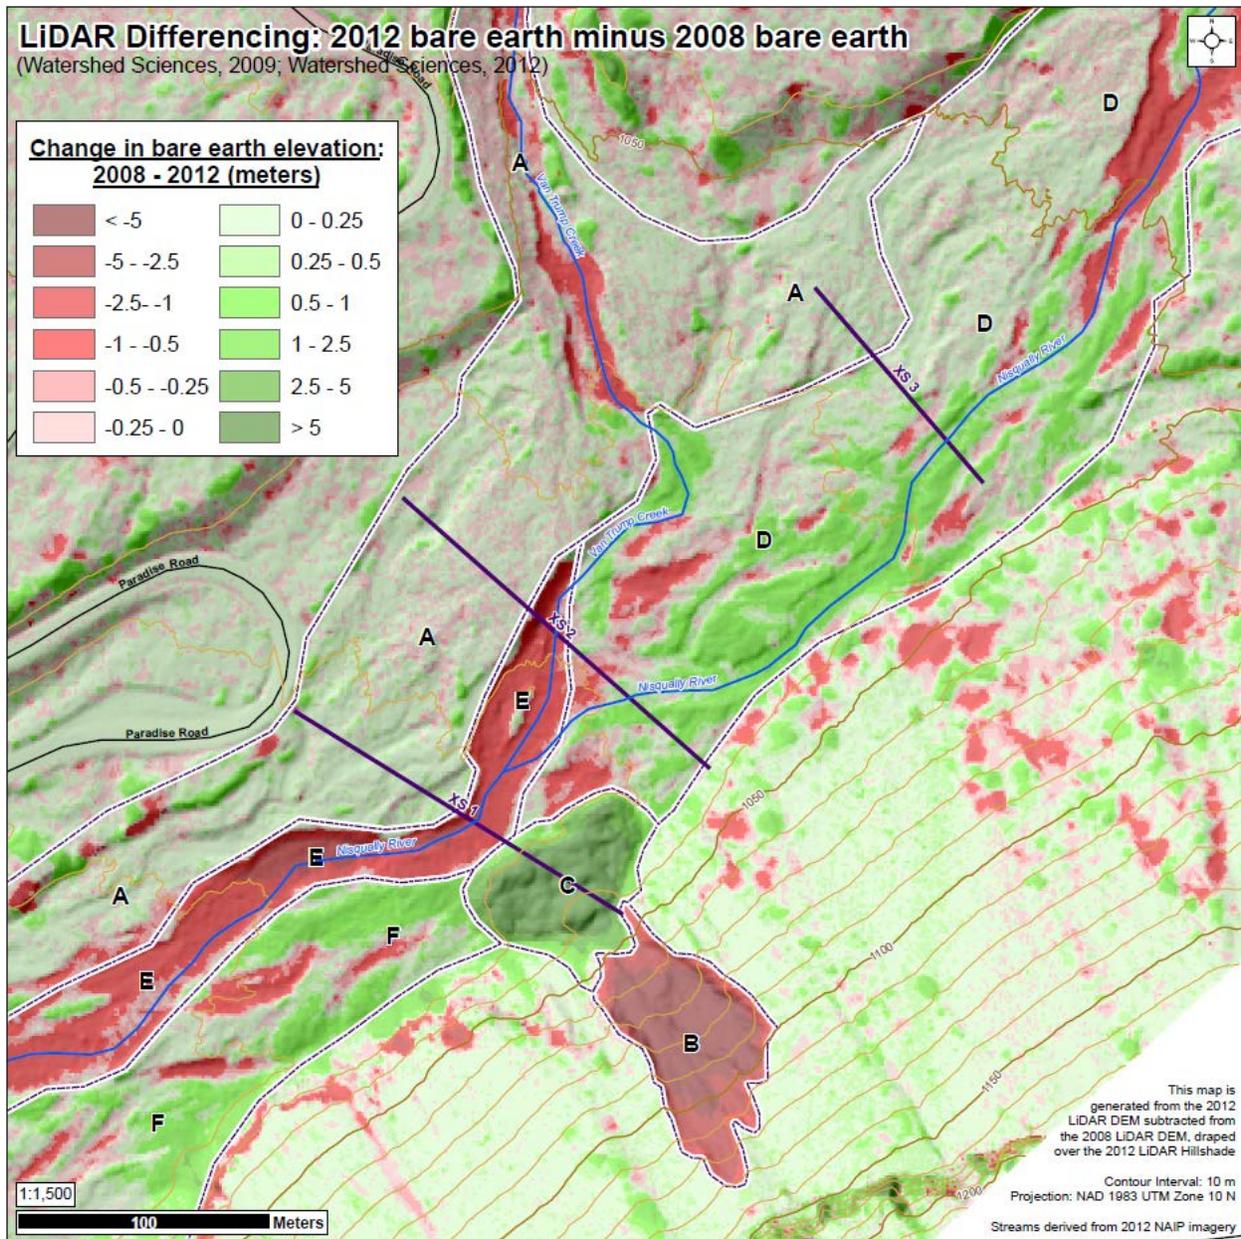
**Figure 31:** LiDAR difference map (2012 surface minus 2008 surface) showing distinct zones of aggradation and incision. Zone (A) is the 2001-2006 debris flow fan; (B) 2008 landslide scar; (C) 2008 landslide deposit; (D) Aggradation upstream of landslide deposit due to blockage of channel and pooling of sediment-laden water; (E) Incision and headcutting through and downstream of constriction provided by landslide deposit; and (F) Deposition downstream of headcut likely caused by eddying of water.

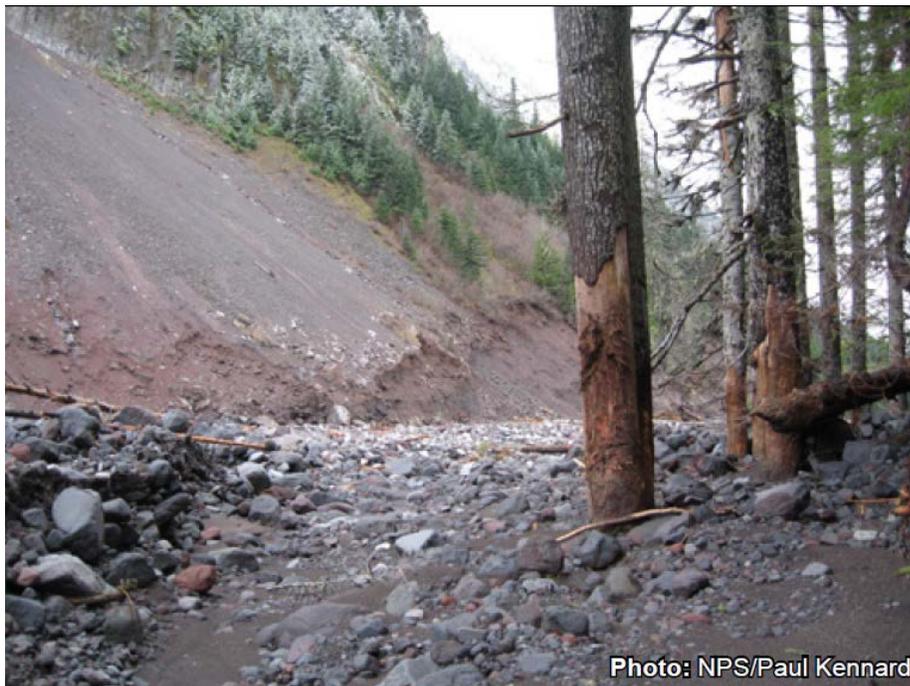
**Figure 32:** Boulder levees (left) and battered tree trunks (right) are evidence of the 2005 Van Trump debris flow. Photo taken facing downstream.

Because of the large sediment delivery in this location, channel equilibrium is unlikely to be exhibited here for decades. Reach-weighted aggradation was strongly observed here in 2005-2006 as result of a 2005 debris flow that deposited an impressive 15,500 m<sup>3</sup> (547,500 ft<sup>3</sup>) of material, an aggradation rate corresponding to 1.55 m (5.09 ft) in a one year period. Some incision has occurred in this area, namely in the intervals 2006-2008 and 2010-2011, and ranging between -0.03 to -0.18 m yr<sup>-1</sup> (-0.10 to -0.59 ft yr<sup>-1</sup>). However, the periods 2008-2009, 2009-2010, and 2011-2012 have seen aggradation ranging from 0.01 to 0.12 m yr<sup>-1</sup> (0.03 - 0.39 ft yr<sup>-1</sup>). Overall, 13,130 m<sup>3</sup> (463,700 ft<sup>3</sup>) of sediment have accumulated in this area since 2005. It is anticipated that, without further sediment inputs, the Nisqually River will continually erode away at these deposits, mobilizing them downstream. However, future debris flow deposition here is very likely, so this area is not expected to return to equilibrium in the near future.

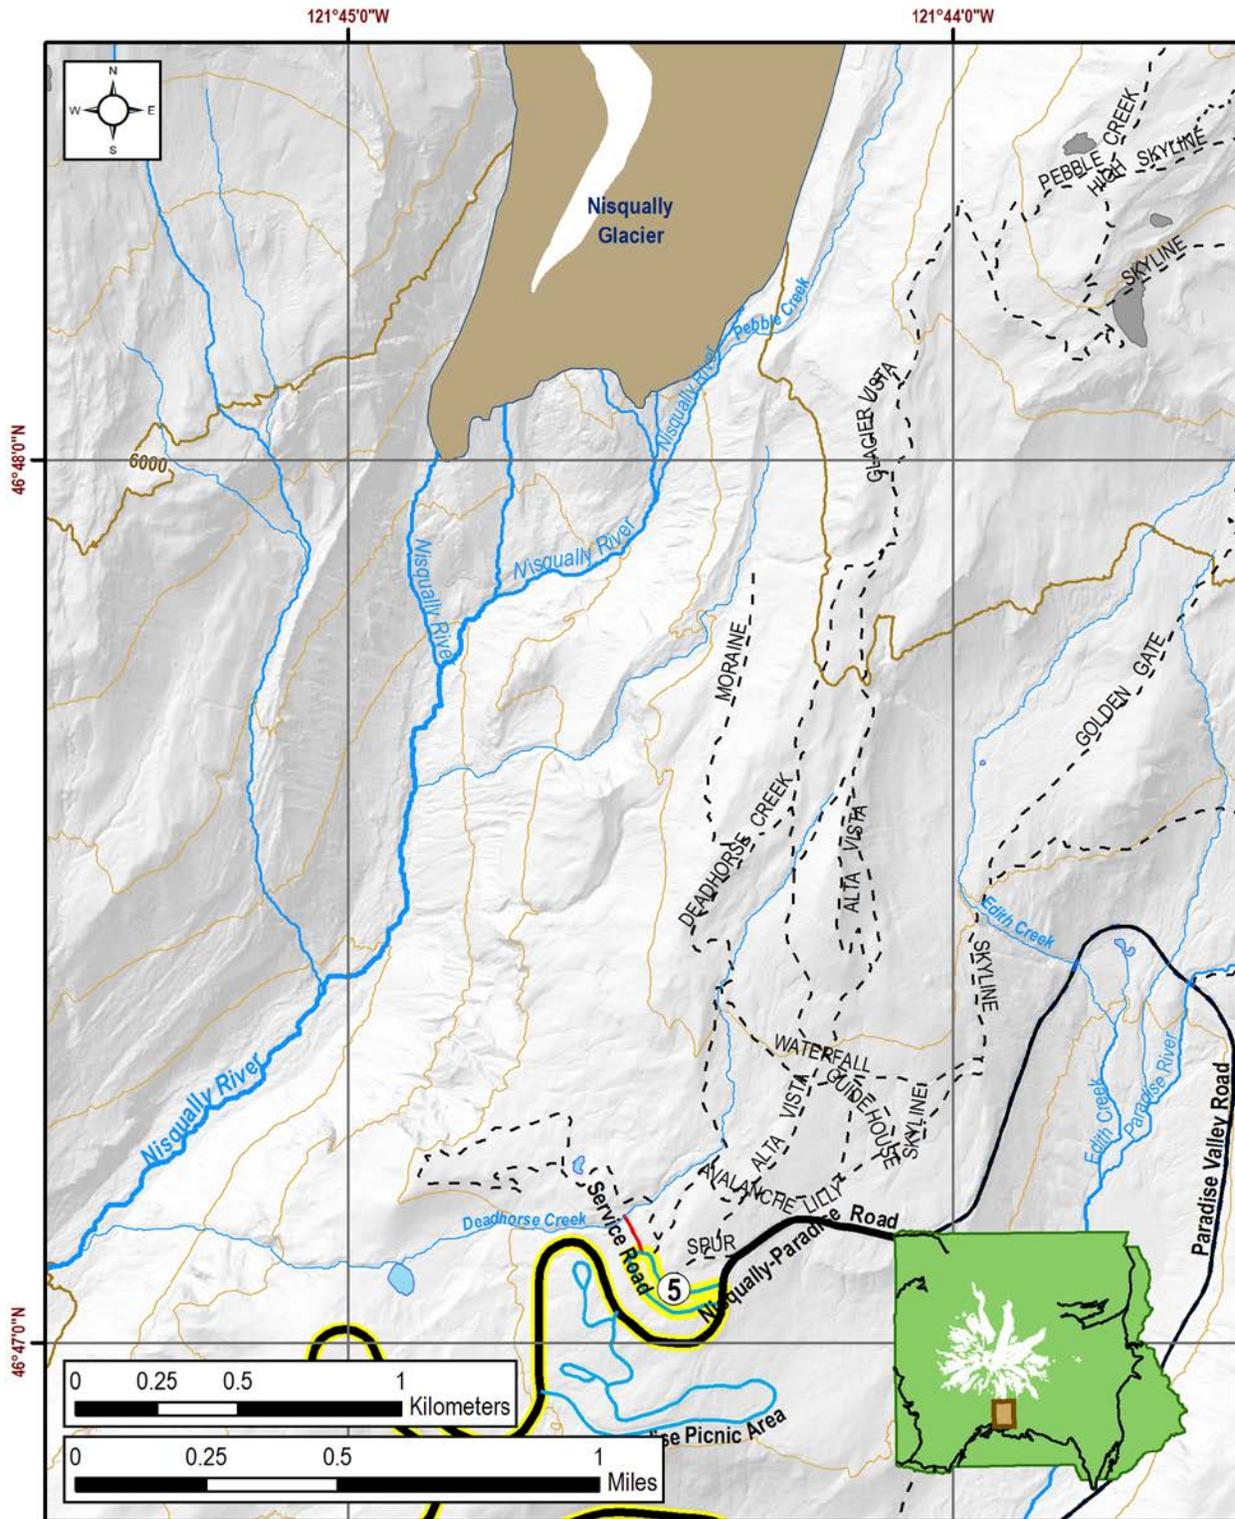
Figure 33: Location map for Stop 5 at Paradise.

Paradise is the name of a year-round visitor destination located at the 5,400 foot (1,645 meter) elevation level on the south side of Mount Rainier. This area is home to the Henry M. Jackson Visitor Center and Paradise Inn, a hotel that operates during the busy summer months. Paradise is one of the most popular destinations in the park – in 2000, over 62% of the 1.3 million visitors to the park went to Paradise. It is also home to one of the more spectacular subalpine wildflower meadows in the park. The name “Paradise” was established by Virinda Longmire in the summer of 1885, when she viewed the subalpine wildflowers and stated “Oh, what a paradise!”

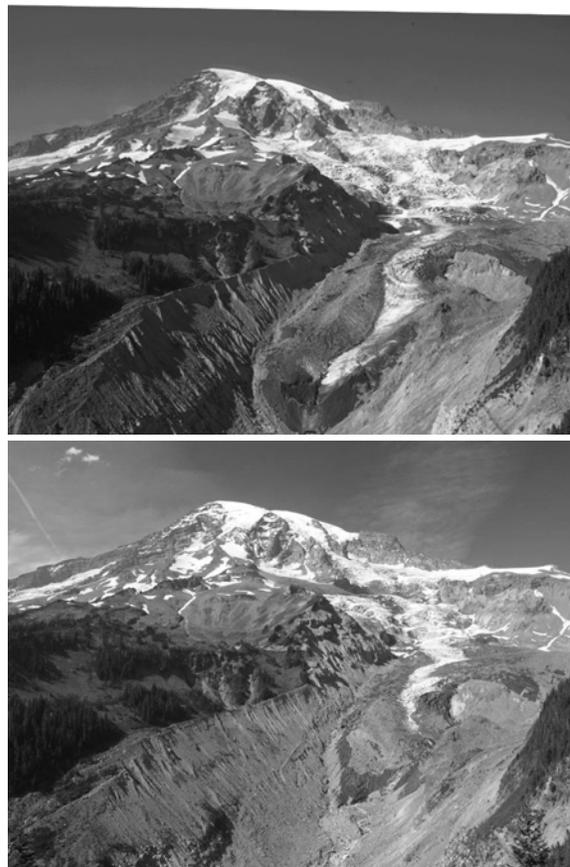
**Figure 34:** View of the Nisqually Glacier terminus from the Nisqually Vista trail in 1974 (top) and 2004 (bottom). The glacier retreated about 1000 ft (300 m) during this timeframe.
