# **Rivers Gone Wild: Extreme landscape response to climate-induced flooding and debris flows, and implications to long-term management at Mount Rainier National Park**

*Field Trip Guide #410, 2017 Geological Society of America Annual Meeting, Seattle, WA*

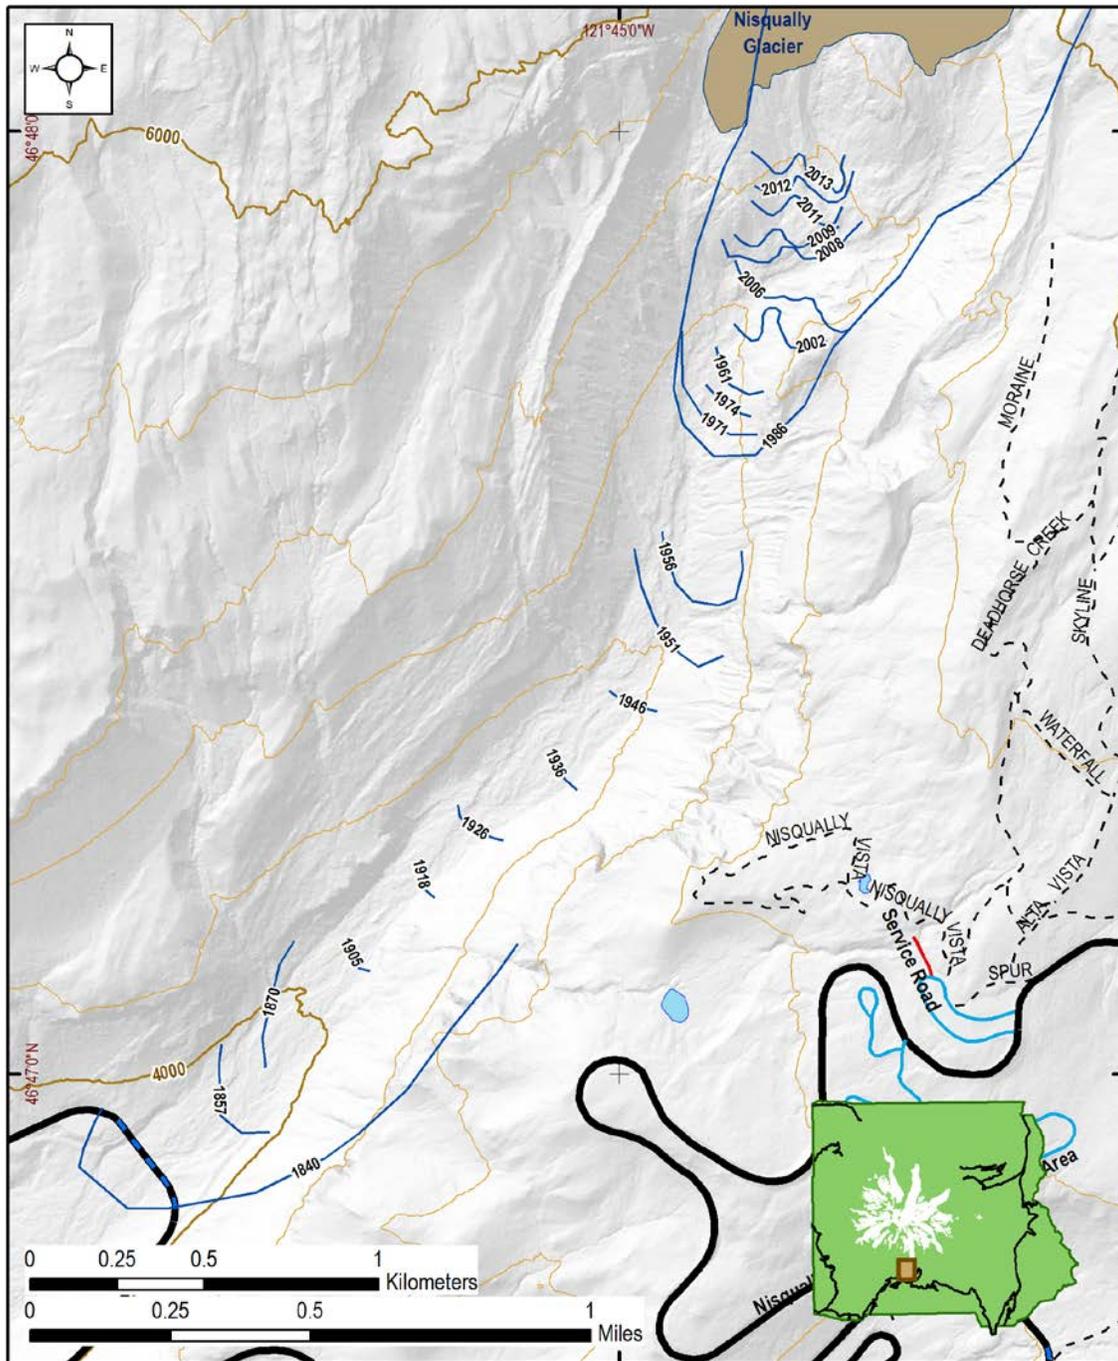
**Figure 35:** Terminus position of the Nisqually Glacier, 1840-2015. The current mapped glacier terminus is as of 2015 (Beason, 2017).

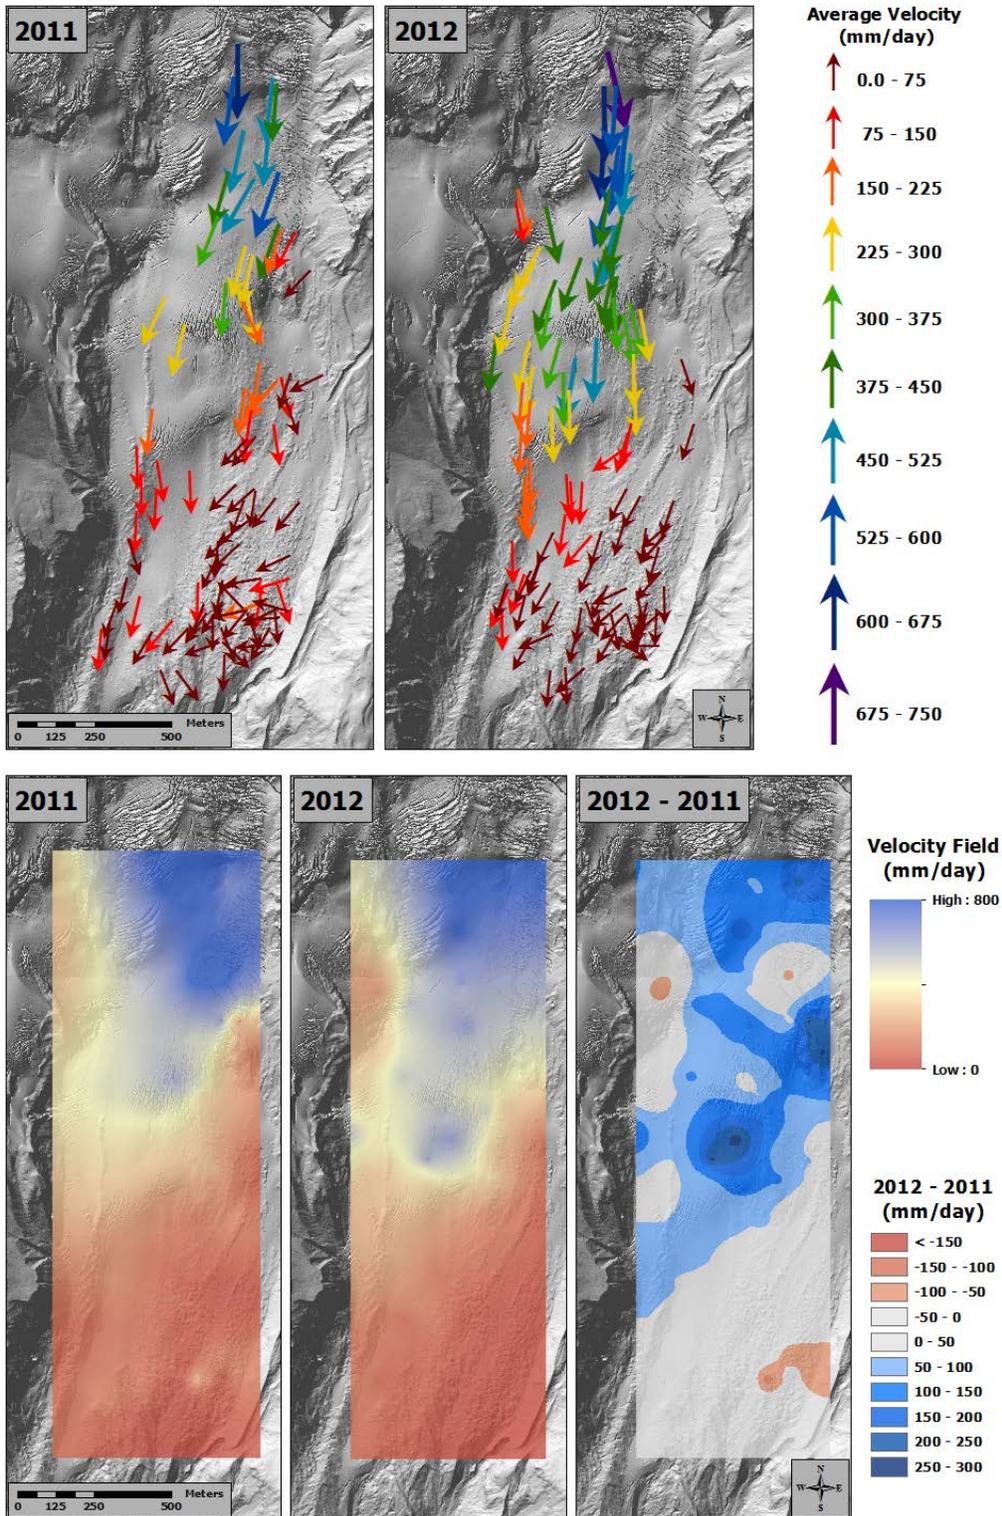
**Figure 36:** Velocity of individual features (top) and extrapolated velocity fields (bottom) on the lower Nisqually Glacier during the 2011 and 2012 field seasons (Modified from Walkup et al., 2013).

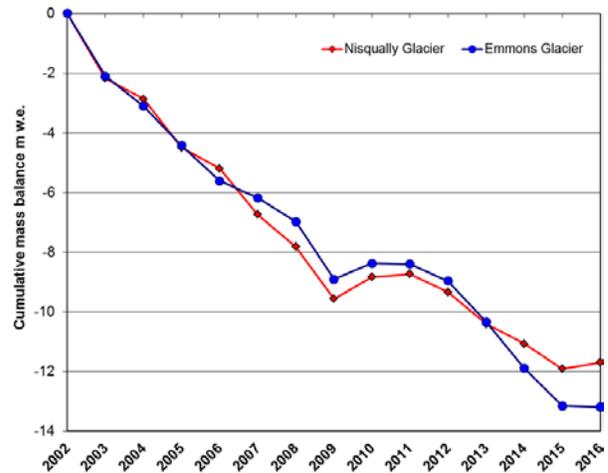
**Figure 37:** Overall mass balance on the Nisqually and Emmons Glacier, 2003-2013 (Riedel and Larrabee, 2017).

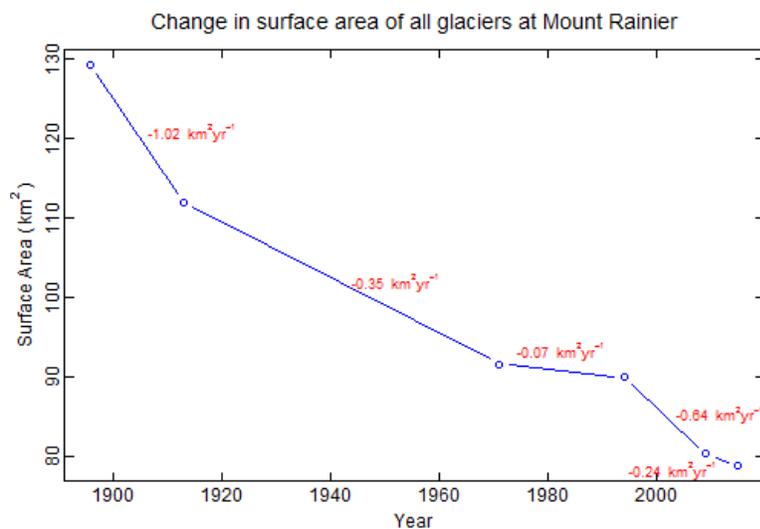
**Figure 38:** Change in surface area of all glaciers at Mount Rainier from 1896 to 2015 (Beason, 2007).

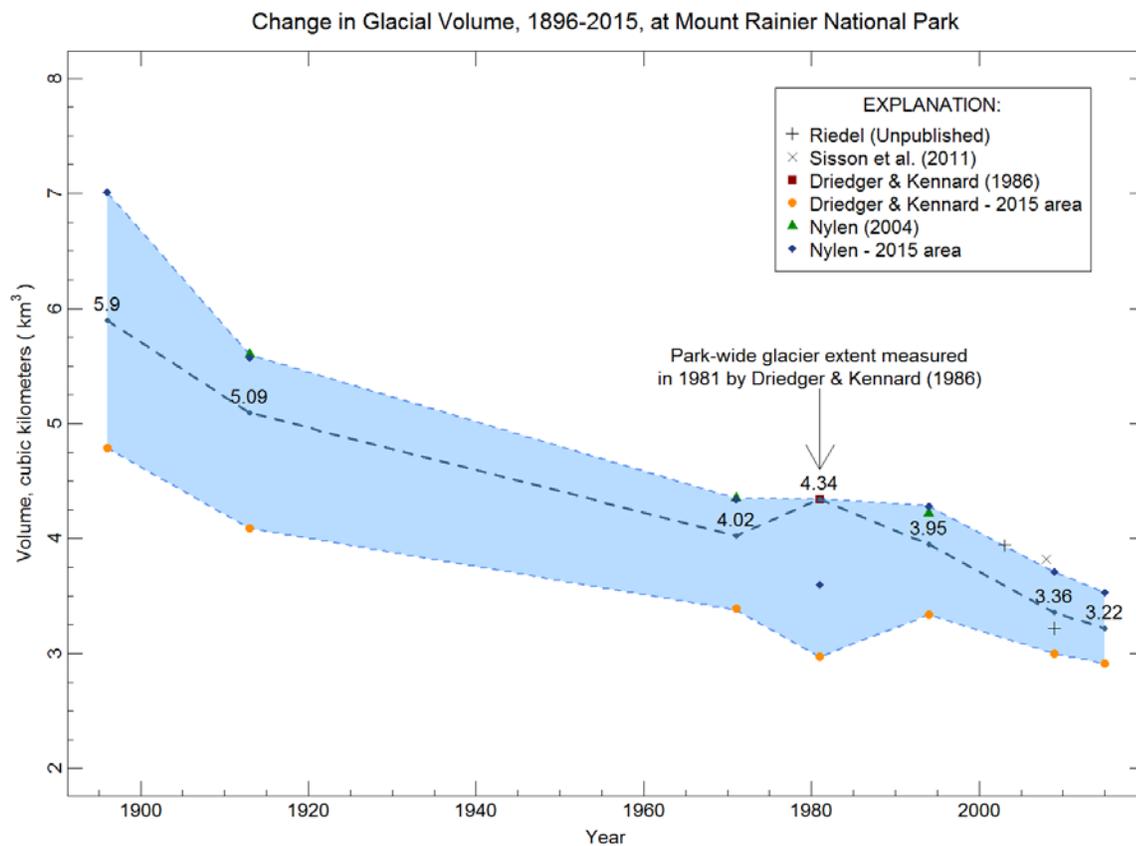
**Figure 39:** Change in volume of glaciers at Mount Rainier from 1896-2015 (George and Beason, 2017)

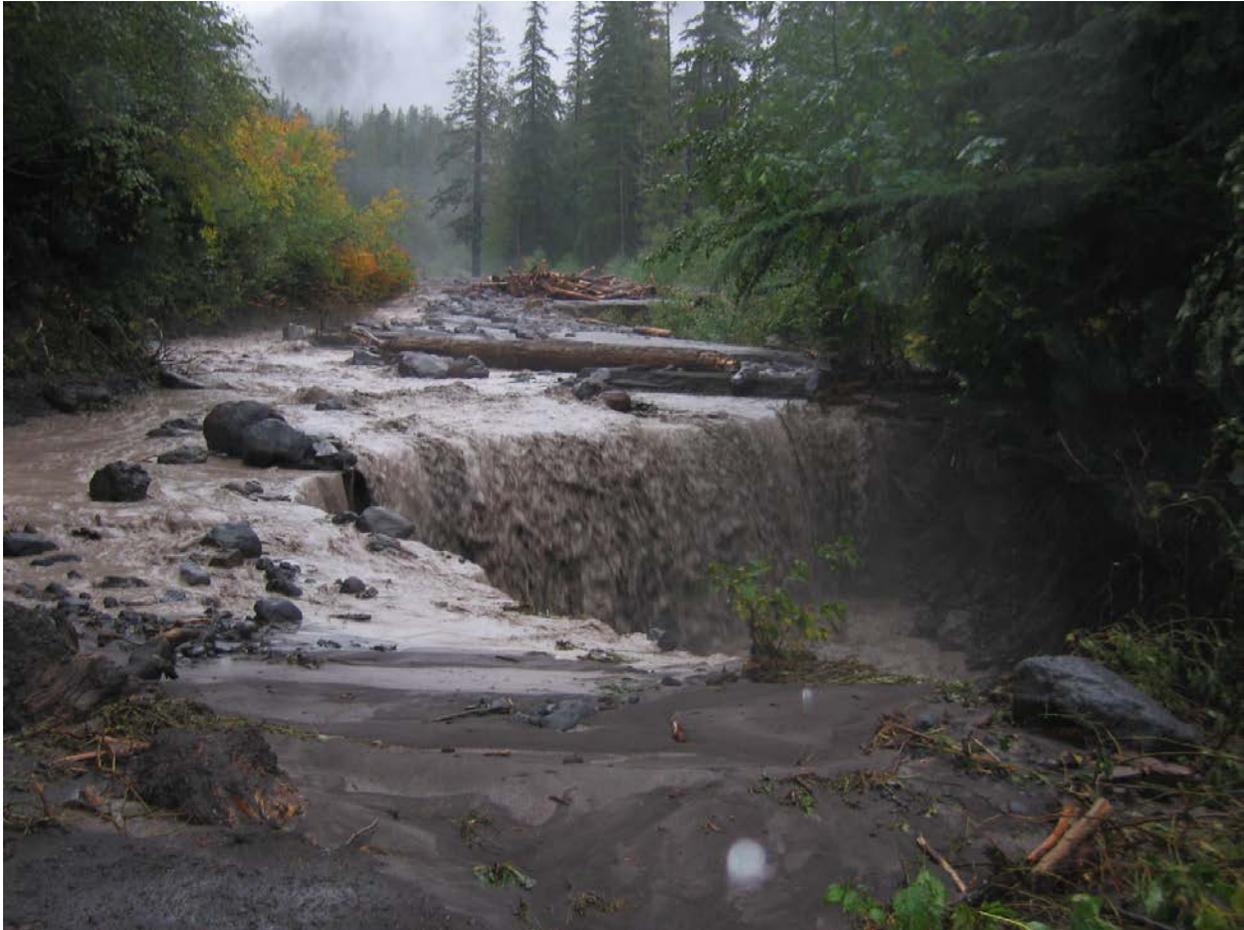
**Photo 3:** Damage to the West Side Road during the September 29, 2005 flood at Mount Rainier (NPS Photo).
